Re: Water License 2AM-MEA1525 Part D, Item 14 - Submission of Landfarm As-Built Report

APPENDIX B
Landfarm 2 As-built

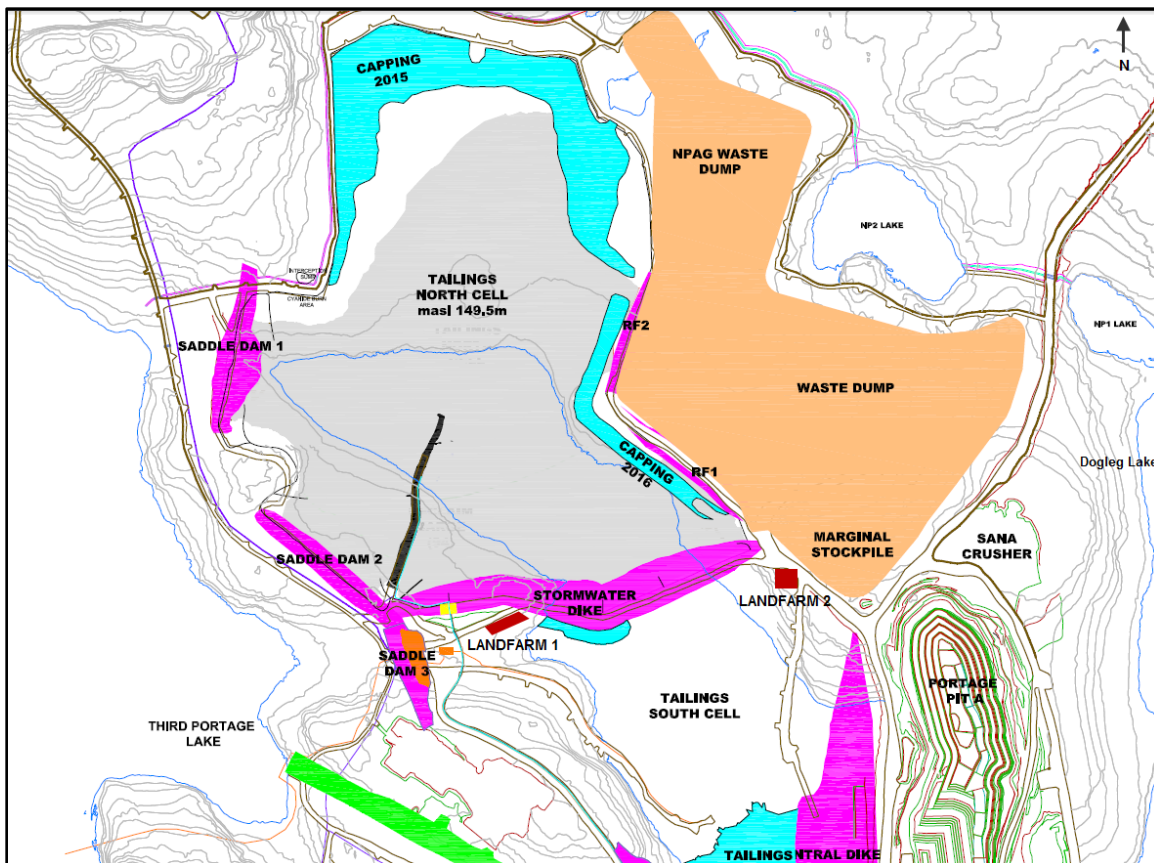
Figure 1 – Landfarm 1 and Landfarm 2 General Location

The landfarm design was submitted by Agnico to the Nunavut Water Board in October 2012 and has been in use for soil decontamination since then. As presented on Figure 1 below, the previous landfarm is located on the north-west side of the South Tailings Cell (Tailing Storage Facility – TSF). The South Tailings Cell is currently active; tailings are deposited and water is reclaimed from the cell. The tailings and water level in the South Tailings Cell are increasing in elevation over time. With the current tailings deposition plan and water balance models, the Landfarm 1 is predicted to be flooded with reclaim water in summer 2017. For this reason, AEM decided to find an alternate location for a new landfarm (Landfarm 2), in order to continue the treatment of contaminated soil. Also, due to operational work at the buttress of Stormwater Dike an extension of the Landfarm 1 was also constructed to a higher elevation in order to continue treatment of soil in the Landfarm 1.

The Landfarm 1 is in operation since October 2012. As mentioned, the Landfarm 1 is located in the South Tailings Cell as presented on Figure 1. Due to operational work required in September 2016 at the buttress of Stormwater Dike (as-built of these works to be submitted under a separate document), a part of the east section of the Landfarm 1 could not be used anymore. To ensure

As presented on Figure 1, the Landfarm 2 is located on the north east side of the South Tailing Cell, north of the Central Dike. This location was chosen to minimize the waste footprint on site and the transport distance of contaminated material from spill locations. All of the waste generated at Meadowbank in the form of tailings, waste rock and site landfill is in close proximity. This location will facilitate the landfarm operation at closure. The Landfarm 2 is located within the South Tailings Cell, providing containment in case of runoff water from the contaminated material.

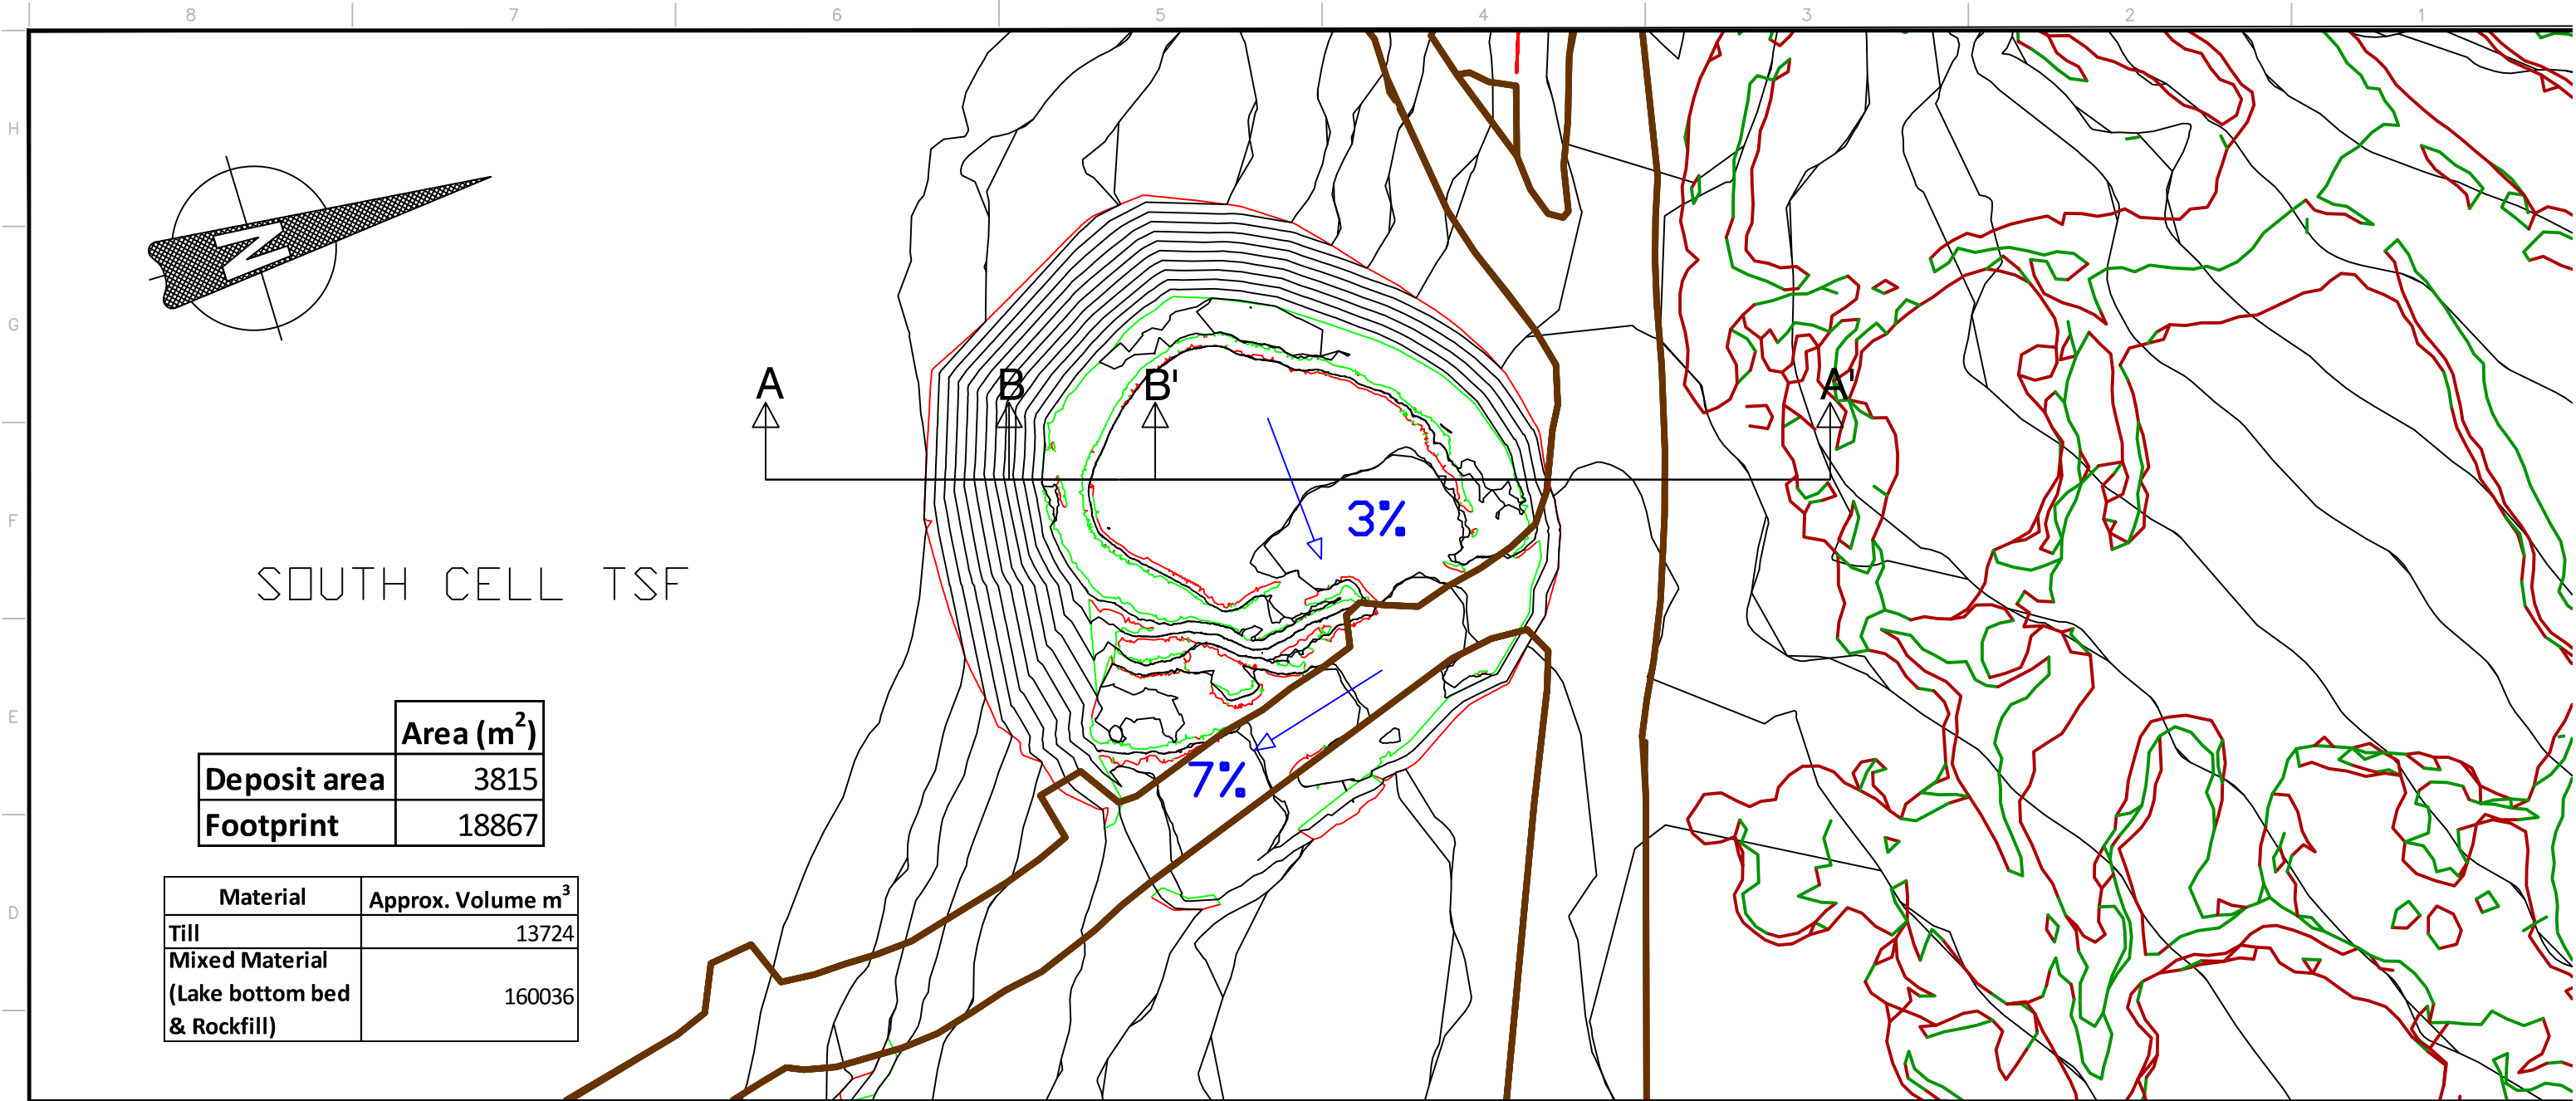
SOUTH CELL TSF

Area (m ²)
Deposit area	3815
Footprint	18867

Material	Approx. Volume m ³
Till	13724
Mixed Material (Lake bottom bed & Rockfill)	160036
