MEADOWBANK DIVISION

Monitoring Program Summary Report

March 2016

Type A Water License 2AM-MEA1525

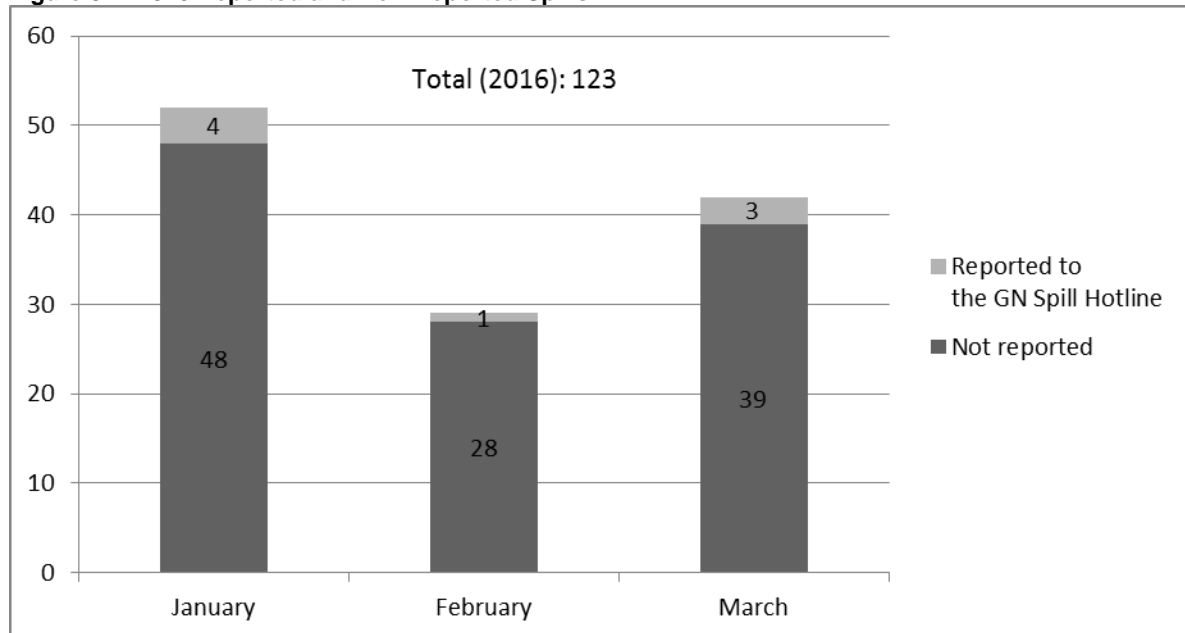
Figure 3-1. 2016 Reported and Non-Reported Spills

AEM has developed a thorough internal system of tracking spills on-site. Figure 3.1 shows reported and non-reported spills for 2016 broken down per month and Table 3.1 summarizes AEM spill reports for March 2016. All spills reported internally and to regulators were managed appropriately on site according to AEM's spill contingency plan. Spills were contained and cleaned, contaminated material was disposed to the appropriate area (landfarm, TSF if required), and the clean-up actions were monitored closely by the Environment Department. There was no off site impact to any watercourses.
