MEADOWBANK DIVISION

Monitoring Program Summary Report

June 2017

Type A Water License 2AM-MEA1525

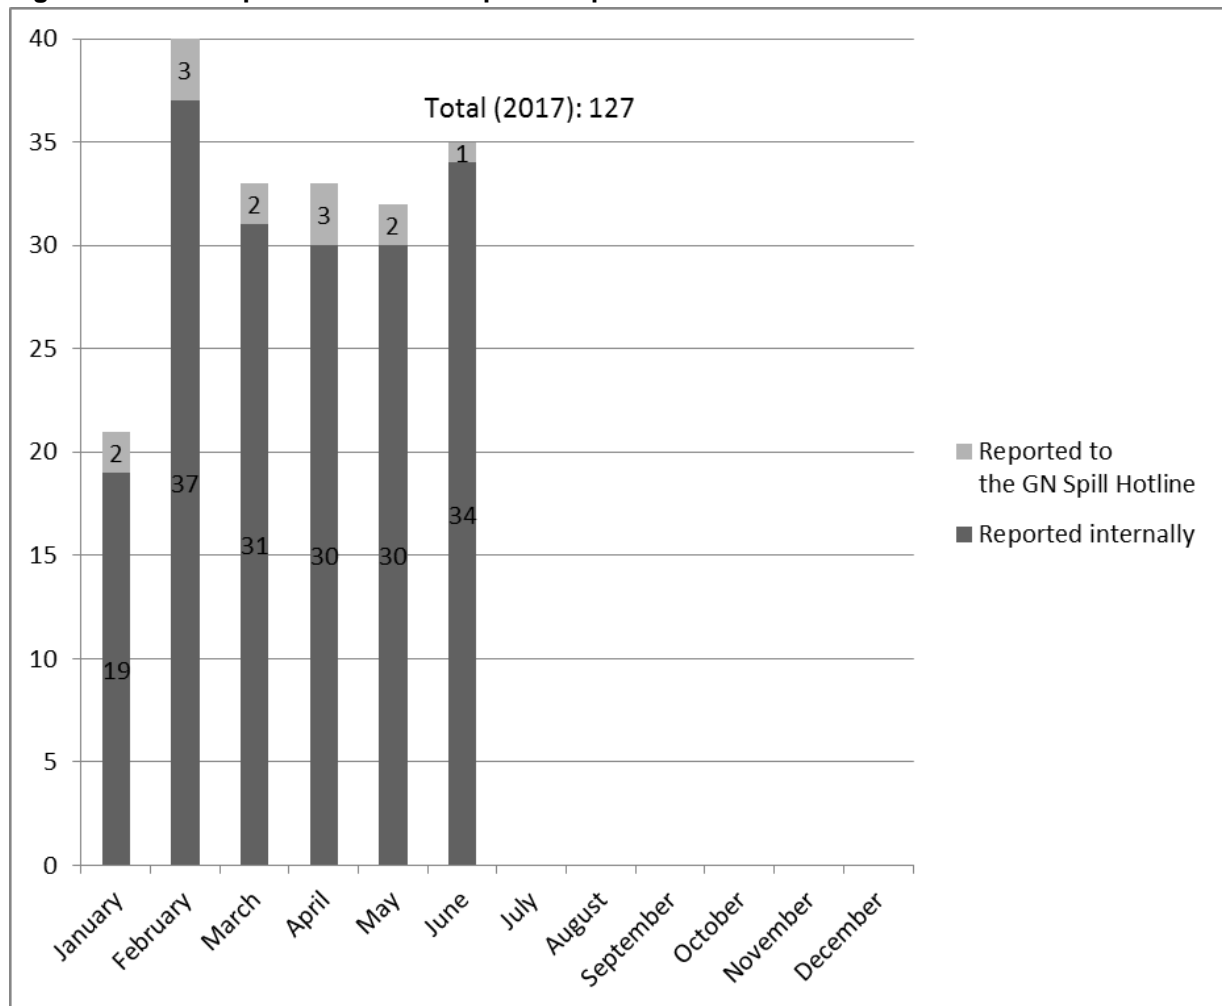
Figure 3.1 2017 Reported and Non-Reported Spills

Figure 3.1 shows reported and non-reported spills for 2017 broken down per month and Table 3.1 summarizes Agnico spill reports for June 2017. All spills reported internally (34) and to regulators (1) were managed appropriately on site according to Agnico's spill contingency plan. Spills were contained and cleaned, contaminated material was disposed to the appropriate area (landfarm, TSF if required), and the clean-up actions were monitored closely by the Environment Department. There was no off site impact to any watercourses.
