MEADOWBANK DIVISION

## **Monitoring Program Summary Report**

**June 2018**

Type A Water License 2AM-MEA1526

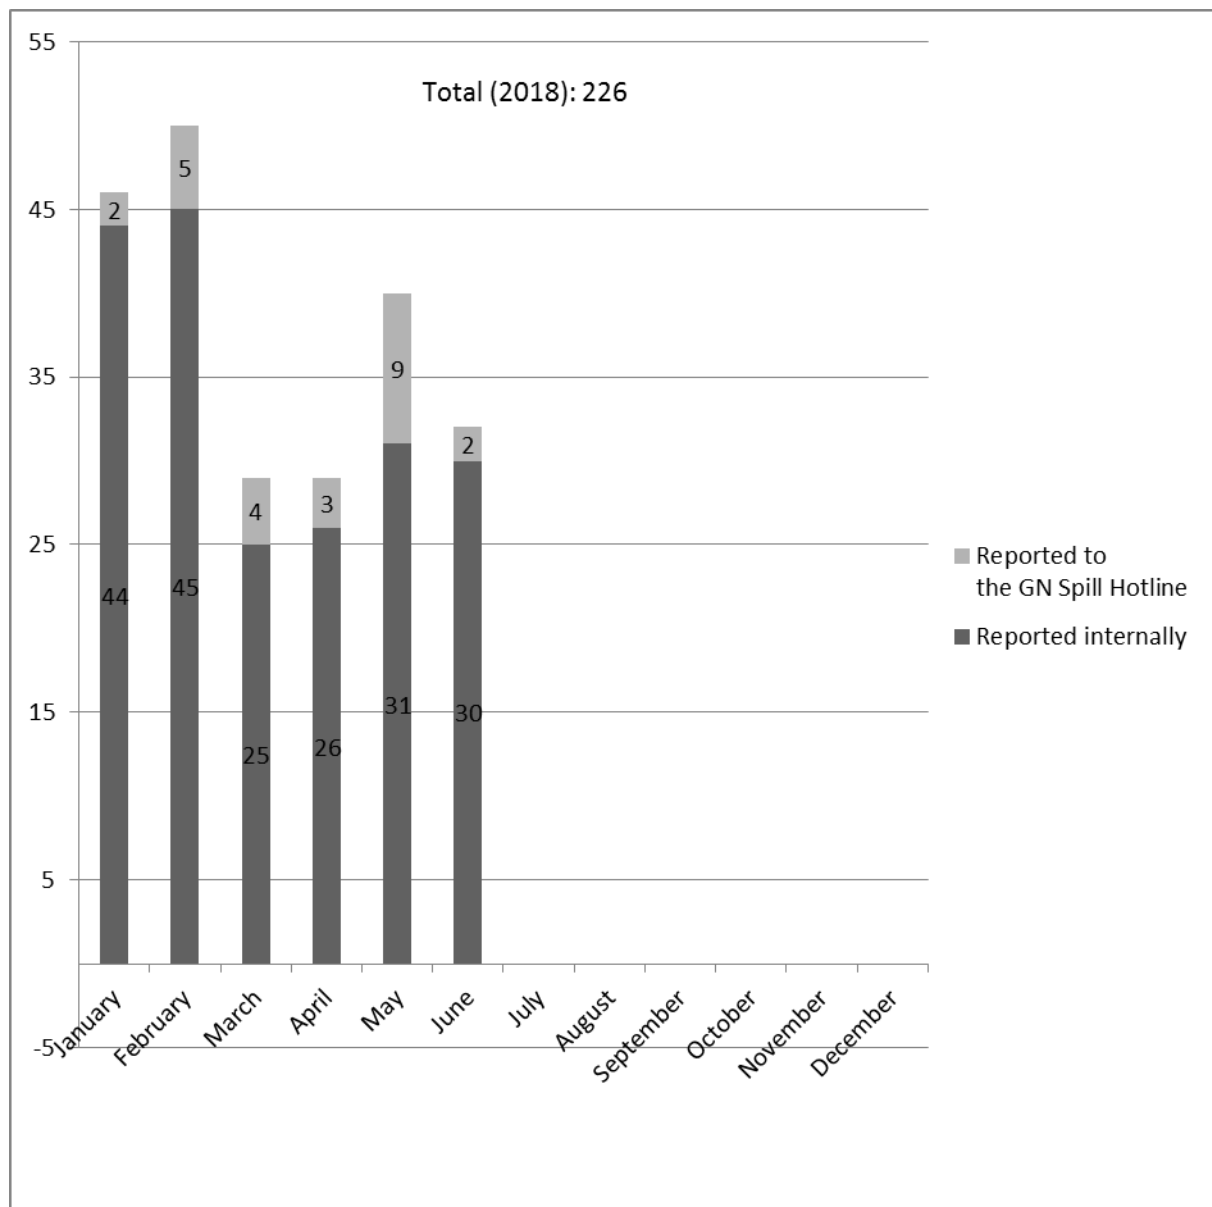
**Figure 3.1 2018 Reported and Non-Reported Spills**

Figure 3.1 shows reported and non-reported spills for 2018 broken down per month and Table 3.1 summarizes Agnico Eagle spill reports for June. All spills reported internally (30) and to regulators (2) were managed appropriately on site according to Agnico's spill contingency plan. Spills were contained and cleaned, contaminated material was disposed to the appropriate area (landfarm, TSF if required), and the clean-up actions were monitored closely by the Environment Department. There was no off site impact to any watercourses.
