MEADOWBANK DIVISION

Monitoring Program Summary Report

January 2019

Type A Water License 2AM-MEA1526

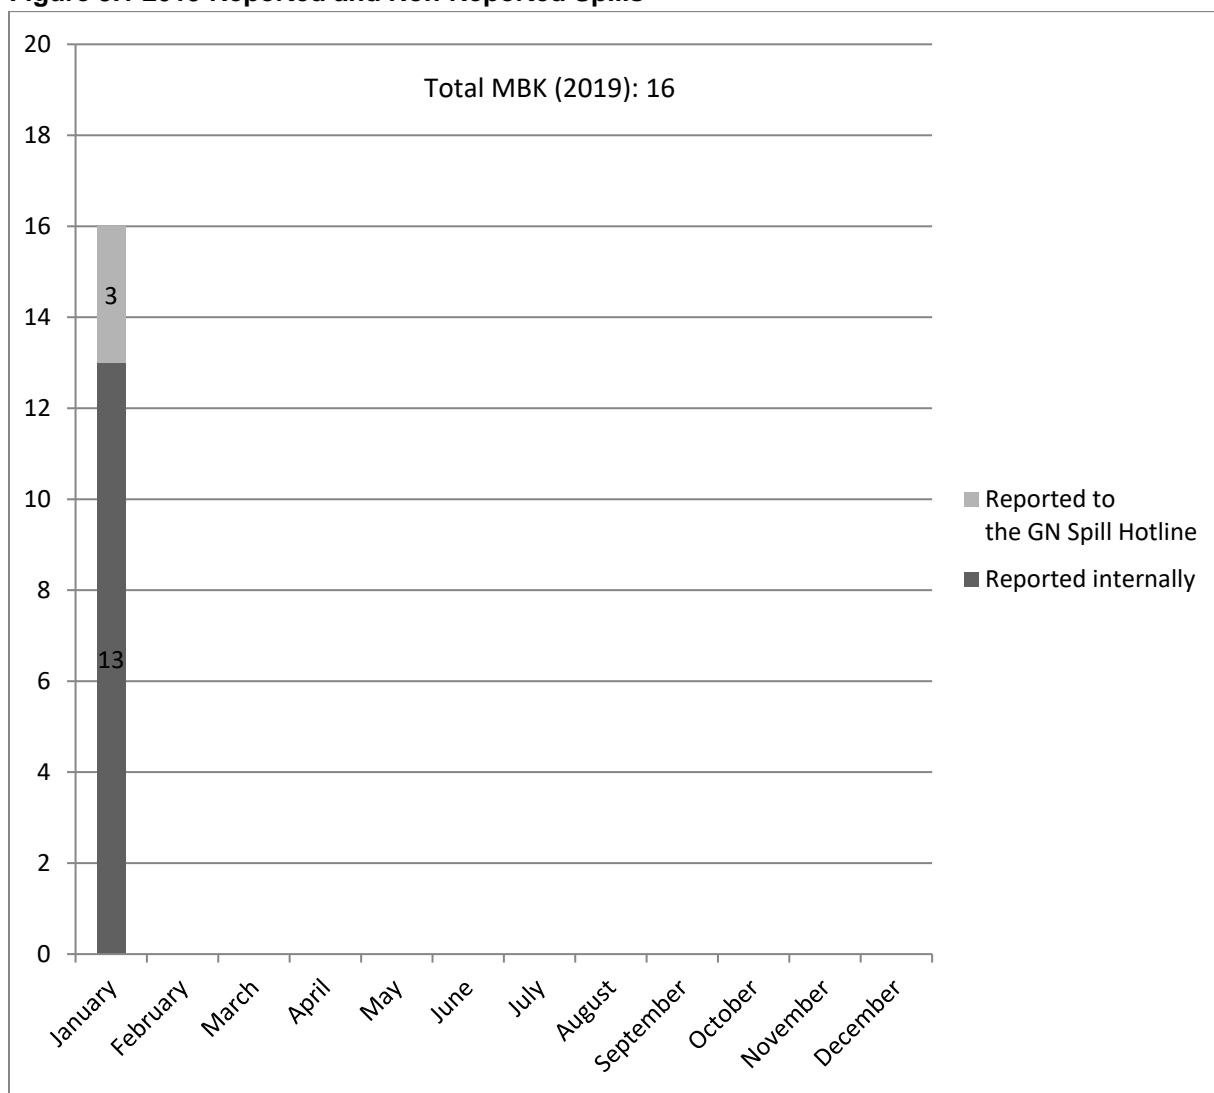
Figure 3.1 2019 Reported and Non-Reported Spills

Figure 3.1 shows reported and non-reported spills for 2019 broken down per month and Table 3.1 summarizes Agnico Eagle spill reports for January.

All spills reported internally (13) were managed appropriately on site according to Agnico's spill contingency plan. Three (3) were reported to regulators in January. Spills were contained and cleaned, contaminated material was disposed to the appropriate area (landfarm, TSF if required), and the clean-up actions were monitored closely by the Environment Department. There was no off site impact to any watercourses.
