MEADOWBANK DIVISION

Monitoring Program Summary Report

February 2020

Type A Water License 2AM-MEA1526

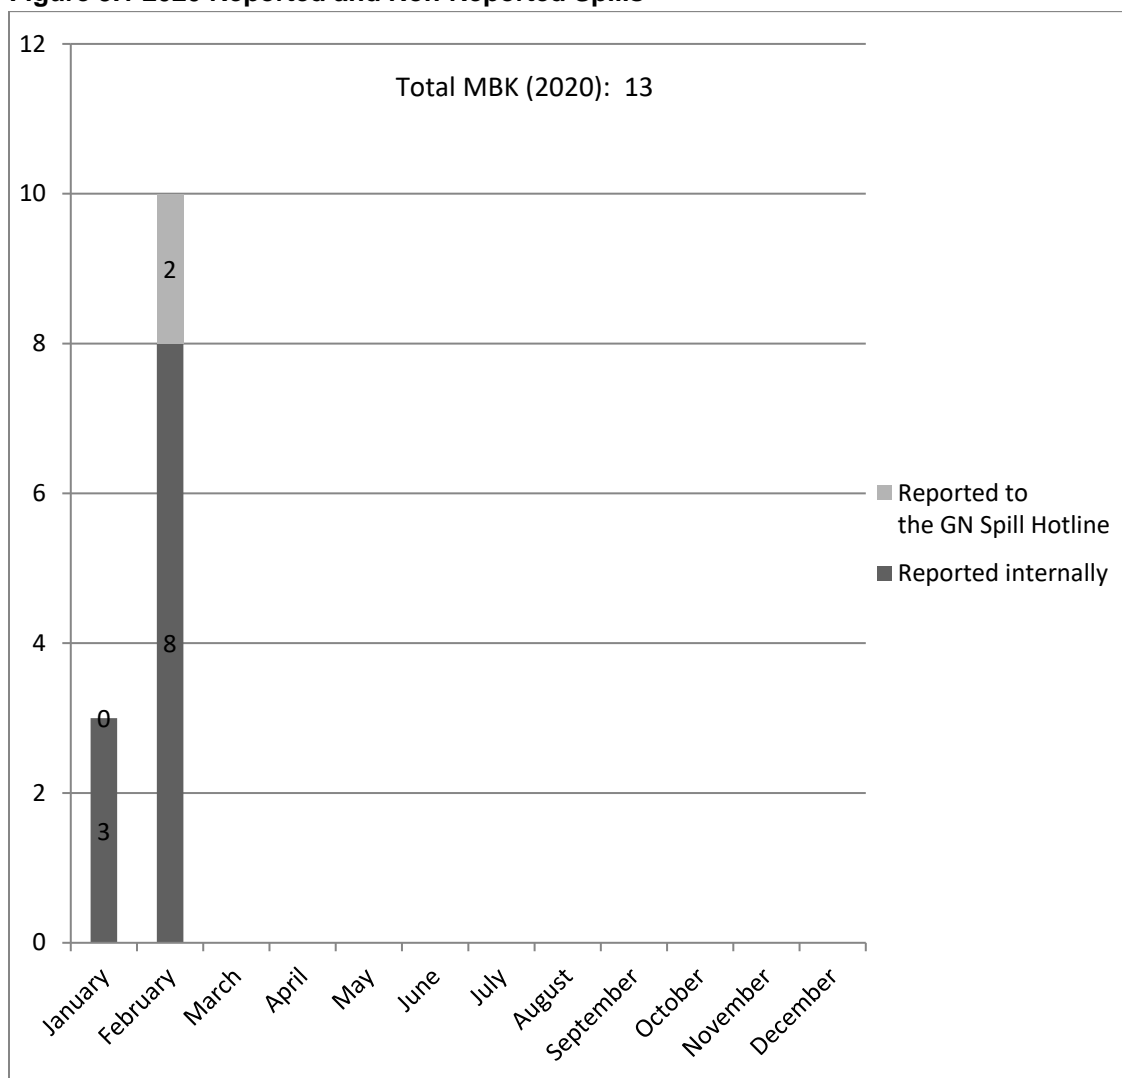
Figure 3.1 2020 Reported and Non-Reported Spills

Figure 3.1 shows reported and non-reported spills for 2020 broken down per month and Table 3.1 summarizes Agnico Eagle spill reports for February.

All spills reported internally (8) were managed appropriately on site according to Agnico's spill contingency plan. Two (2) spills were reported to regulators in February. Spills were contained and cleaned, contaminated material was disposed to the appropriate area (landfarm, TSF if required), and the clean-up actions were monitored closely by the Environment Department. There was no off-site impact to any watercourses.
