MEADOWBANK DIVISION

Monitoring Program Summary Report

September 2021

Type A Water License 2AM-MEA1530

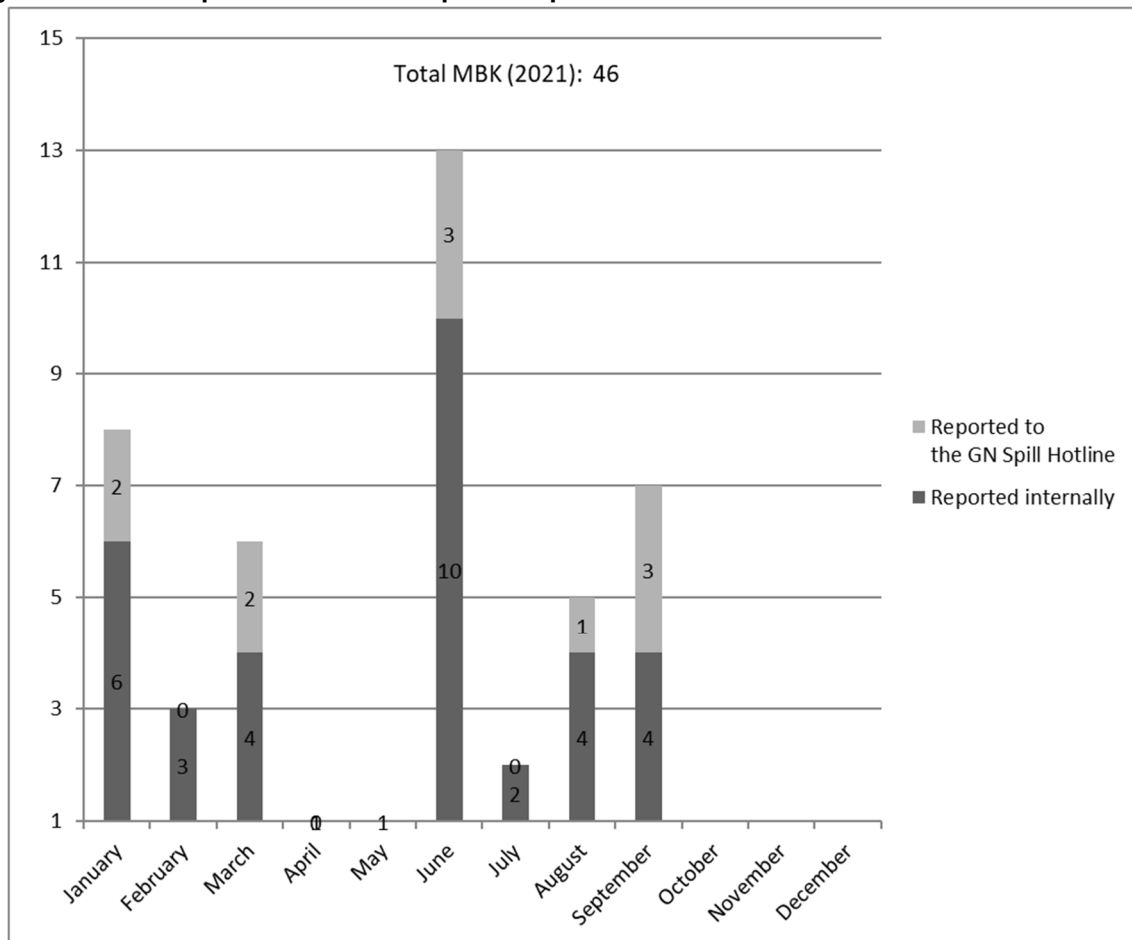
Figure 3.1 2021 Reported and Non-Reported Spills

Figure 3.1 shows reported and non-reported spills for 2021 broken down per month and Table 3.1 summarizes Agnico Eagle spill reports for September.

Seven (7) spills occurred on site during the month with three (3) reported to regulators. Spills were contained and cleaned, contaminated material was disposed to the appropriate area, and the clean-up actions were monitored closely by the Environment Department.
