MEADOWBANK COMPLEX

Monitoring Program Summary Report

May 2024

Type A Water License 2AM-MEA1530

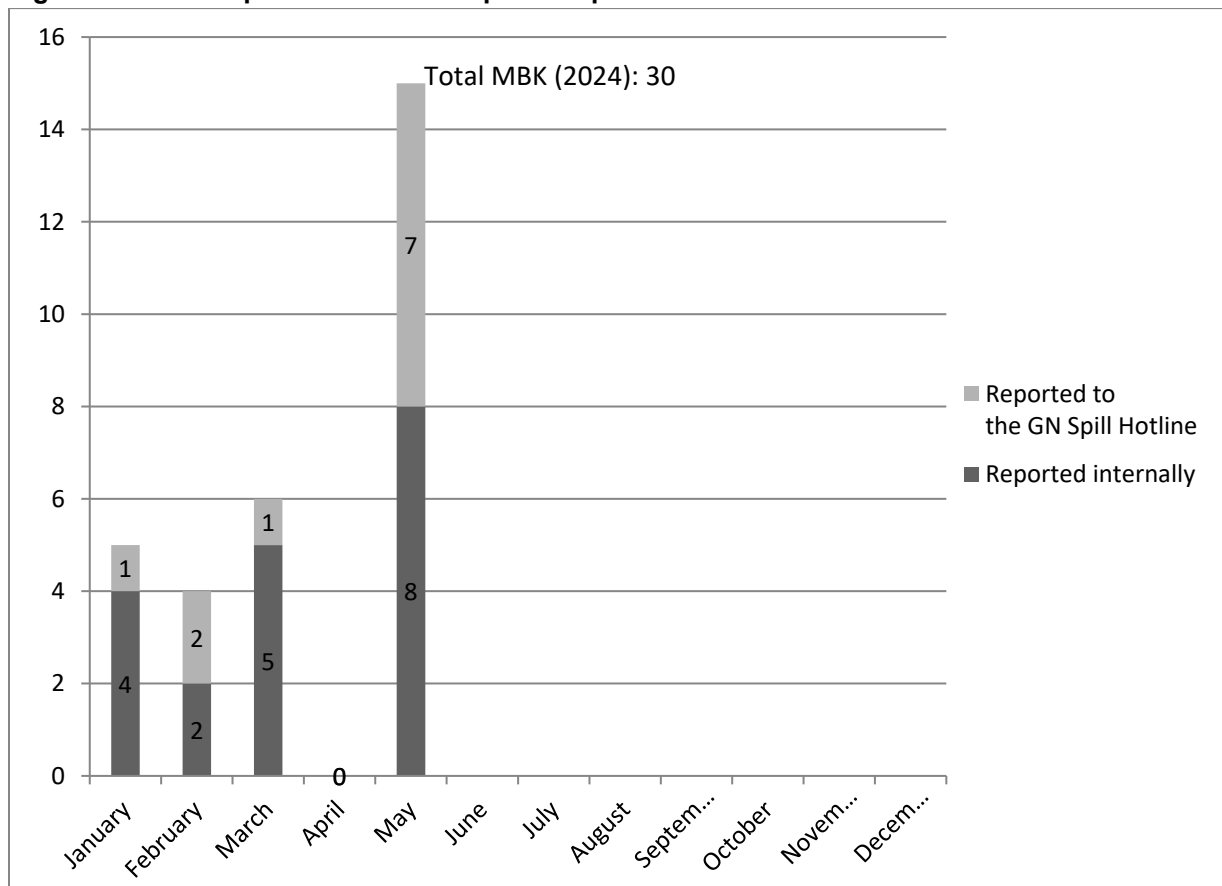
Figure 3.1 2024 Reported and Non-Reported Spills

Figure 3.1 shows reported and non-reported spills for 2024 broken down per month and Table 3.1 summarizes Agnico Eagle spill reports for May.

Fifteen (15) spills occurred on site during the month with seven (7) being reported to regulators. Spills were contained and cleaned, contaminated material was disposed of in the appropriate area, and the clean-up actions were monitored closely by the Environment Department. There was no off-site impact to any watercourses.
