MEADOWBANK COMPLEX

Monitoring Program Summary Report

September 2024

Type A Water License 2AM-MEA1530

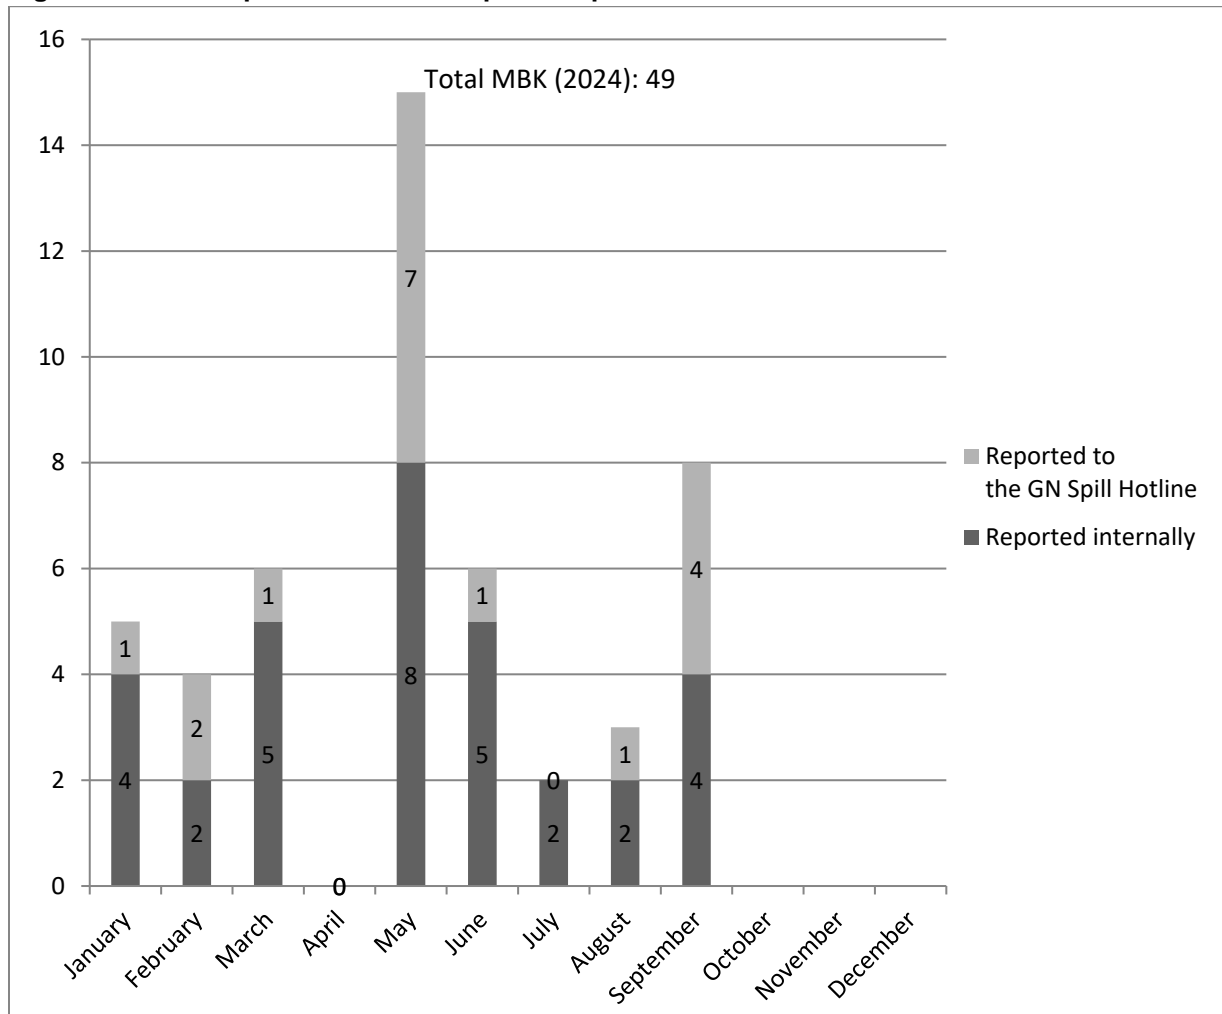
Figure 3.1 2024 Reported and Non-Reported Spills

Figure 3.1 shows reported and non-reported spills for 2024 broken down per month and Table 3.1 summarizes Agnico Eagle spill reports for September.

Eight (8) spills occurred on site during the month with four (4) being reported to regulators. Spills were contained and cleaned, contaminated material was disposed of in the appropriate area, and the clean-up actions were monitored closely by the Environment Department.
