## CONSTRUCTION SUMMARY (AS-BUILT) REPORT FOR JETTY-CP1 AND JETTY-CP5 MELIADINE PROJECT, NUNAVUT

## Agnico Eagle Mines Ltd.

OCTOBER 2017
ISSUED FOR USE
TETRA TECH PROJECT NUMBER: 28920
AGNICO EAGLE DOCUMENT NUMBER: 6515-E-132-005-132-REP-012

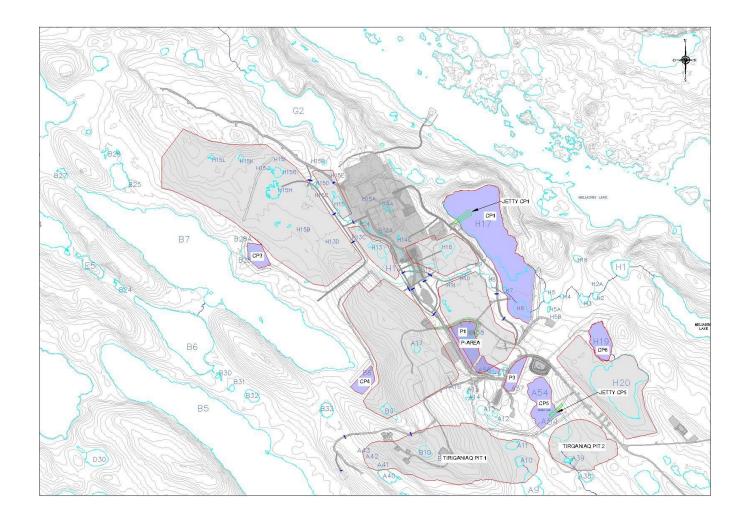
### 2.1 Site Location Plan

The figure below presents a site location plan for Jetty-CP1 and Jetty-CP5.

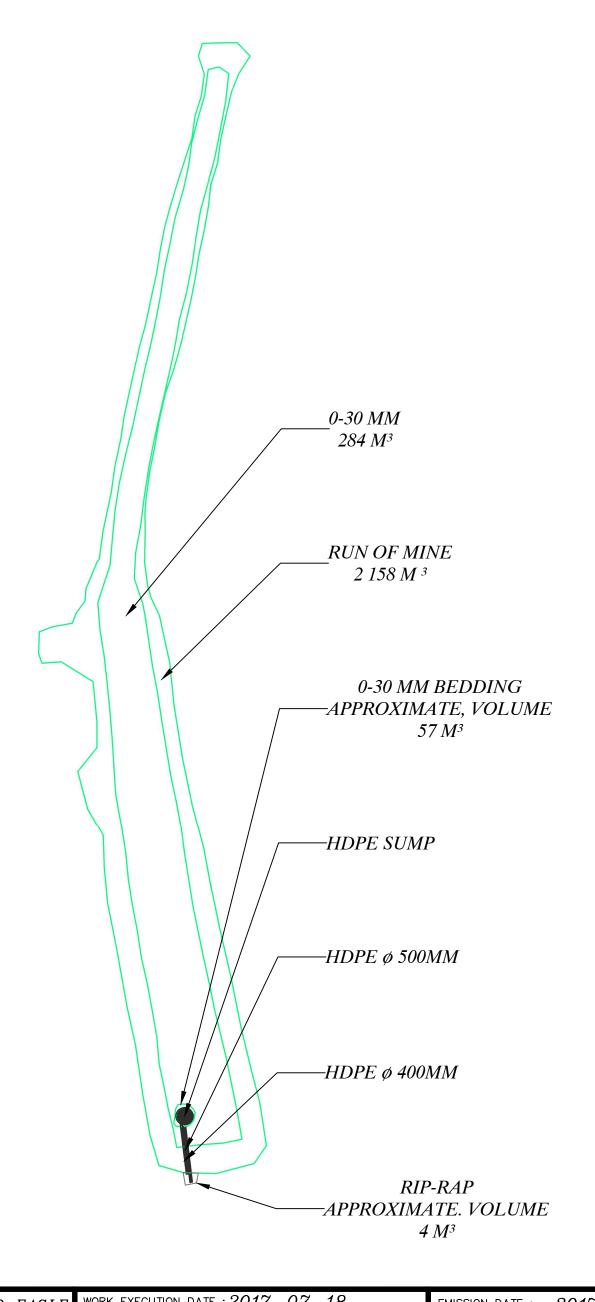
AGNICO E'AGLE	WORK EXECUTION DATE :2017-07-18	EMISSION DATE: $2017-10-22$
COORD. SYSTEME: UTM15 NAD83	AS BUILT JETTY CP5	DRAWN BY: $R.CLOUATRE$
SCALE:	PLAN NO.:	APPROVED BY: $Hamel \ arpentage$
1:750	417-QT-20170718-02	натег атретице

A survey drawing conducted during the construction of Jetty-CP1 and CP5 can be found in Appendix B.
