Follow Up Report – 18-287 July 8th 2018 Sewage Spill

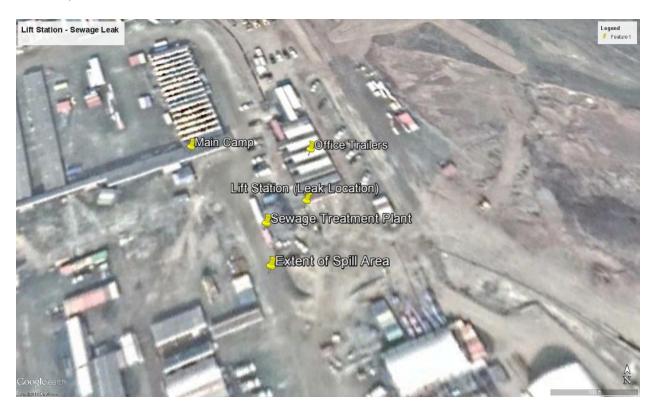
The spill occurred at the Meliadine main camp sewage treatment plant. The sewage flowed from the sewage treatment plant to the ground. The impacted area is within the footprint of the mine and did not reach any water bodies.

Figure 1: View from above – Main Camp: Location of Sewage Treatment Plant.
