Mary River Iron Mine Nunavut Water Board Water License Application Section 9 Representative Crossing Summary Sheet

## CV-17-1

Zone: 17W Easting: 5578068 Northing: 7902643 Station: 17+890

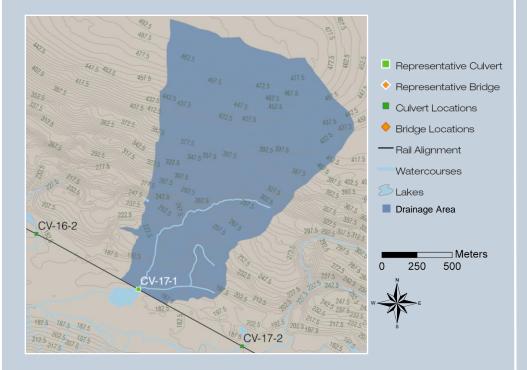
One stream channel (labeled Trib. 1 in Photo 1) will be re-aligned to redirect the stream to the CV-17-1 crossing. In addition to the channelization, a portion of the downstream pond will be infilled to allow for the rail embankment slope.

Photo 1 is annotated to identify the two tributary streams. Photos 2 and 3 are of Tributary 1 and 2 respectively at the crossing site.
