CV-51-2

E337697-2000-07-124-0006

Description of Crossing Structure

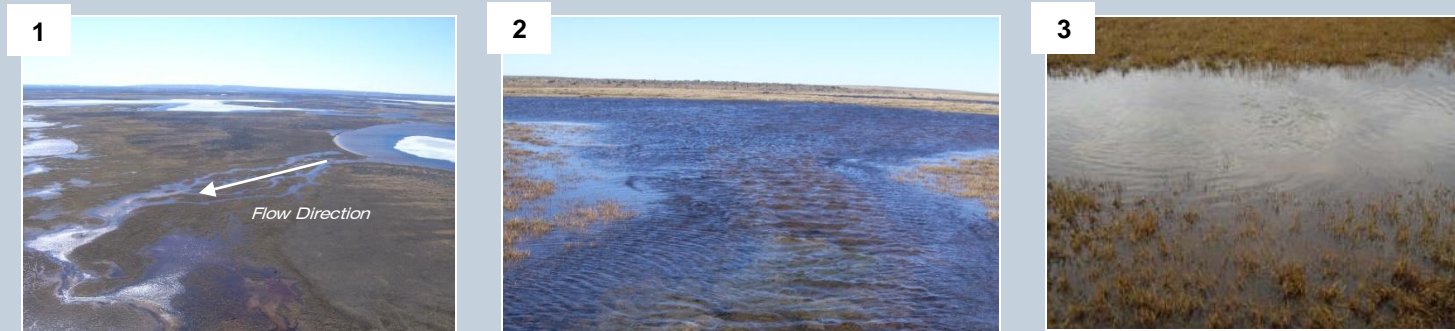
Site Photos

Photo 1 is an aerial image looking upstream of the crossing area. Photo 2 is looking upstream from the approximate crossing location, while Photo 3 was taken 20m downstream of the crossing.

The surrounding area is flat and pockmarked with lakes. The channel here is braided upstream, but narrows to a single channel before it discharges to the downstream lake. The substrate is organic muck, but the bottom of the downstream lake is sand. The sand is found in the channel just upstream of the lake. It is possible that some of it has been deposited through wave action. The entire area of the crossing was flooded at the time of the field visit. Field observations suggest high water was approximated 15 cm than levels observed. The channel at the approximate crossing is 2 – 3 m wide, and 0.8-1m deep. The velocity was noticeable but laminar. There is no sign of erosion.
