CV-76-3

Fish Habitat	No fish habitat
Structure Design	No. Spans: 1 Span Lengths: 30m Bridge Type: Through Plate Girder (TPG) Slope: 3.1 %
Drainage Area	12.93 km ²
Design Flow	10 yr 3 day delay = 2.80 m ³ /s 200-yr = 25.26 m ³ /s
Downstream Velocity	10 yr 3 day delay = 1.23 m/s 200 yr = 2.45 m/s

Description of Crossing Structure

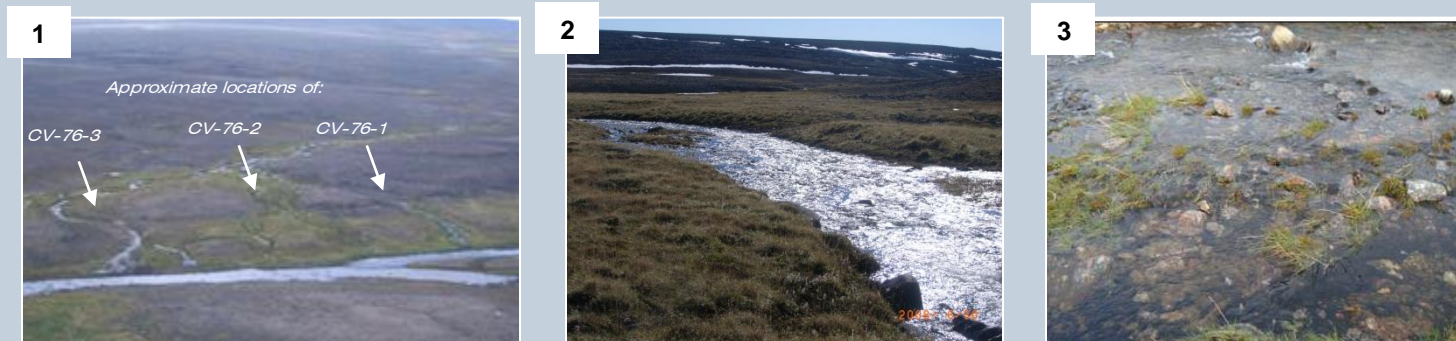
Site Photos

Photo 1 is an aerial image giving the approximate locations of CV-76-1 to CV-76-3, demonstrating the topography of the alluvial fan. Photo 2 is looking downstream from the approximate crossing location, while Photo 3 shows the habitat conditions at the approximate crossing location.

The area where CV-76-3 is located is an alluvial fan area. There are three distinct braids. CV-76-3 is a relatively steep stream and carries most of the flow out of the 3 main braids. Because of the nature of drainage features in these fan areas (i.e., multiple shallow watercourses), the distribution of flow under design flow conditions does not necessarily follow the flow paths apparent under low flow conditions. Hydraulic analysis indicates that the channel CV-76-3 can convey the total 200 year design flow.
