Mary River Project – Phase 2 Proposal

NORTH RAILWAY FRESHWATER HABITAT SURVEY: 2018

North/South Consultants Inc.

April 2019

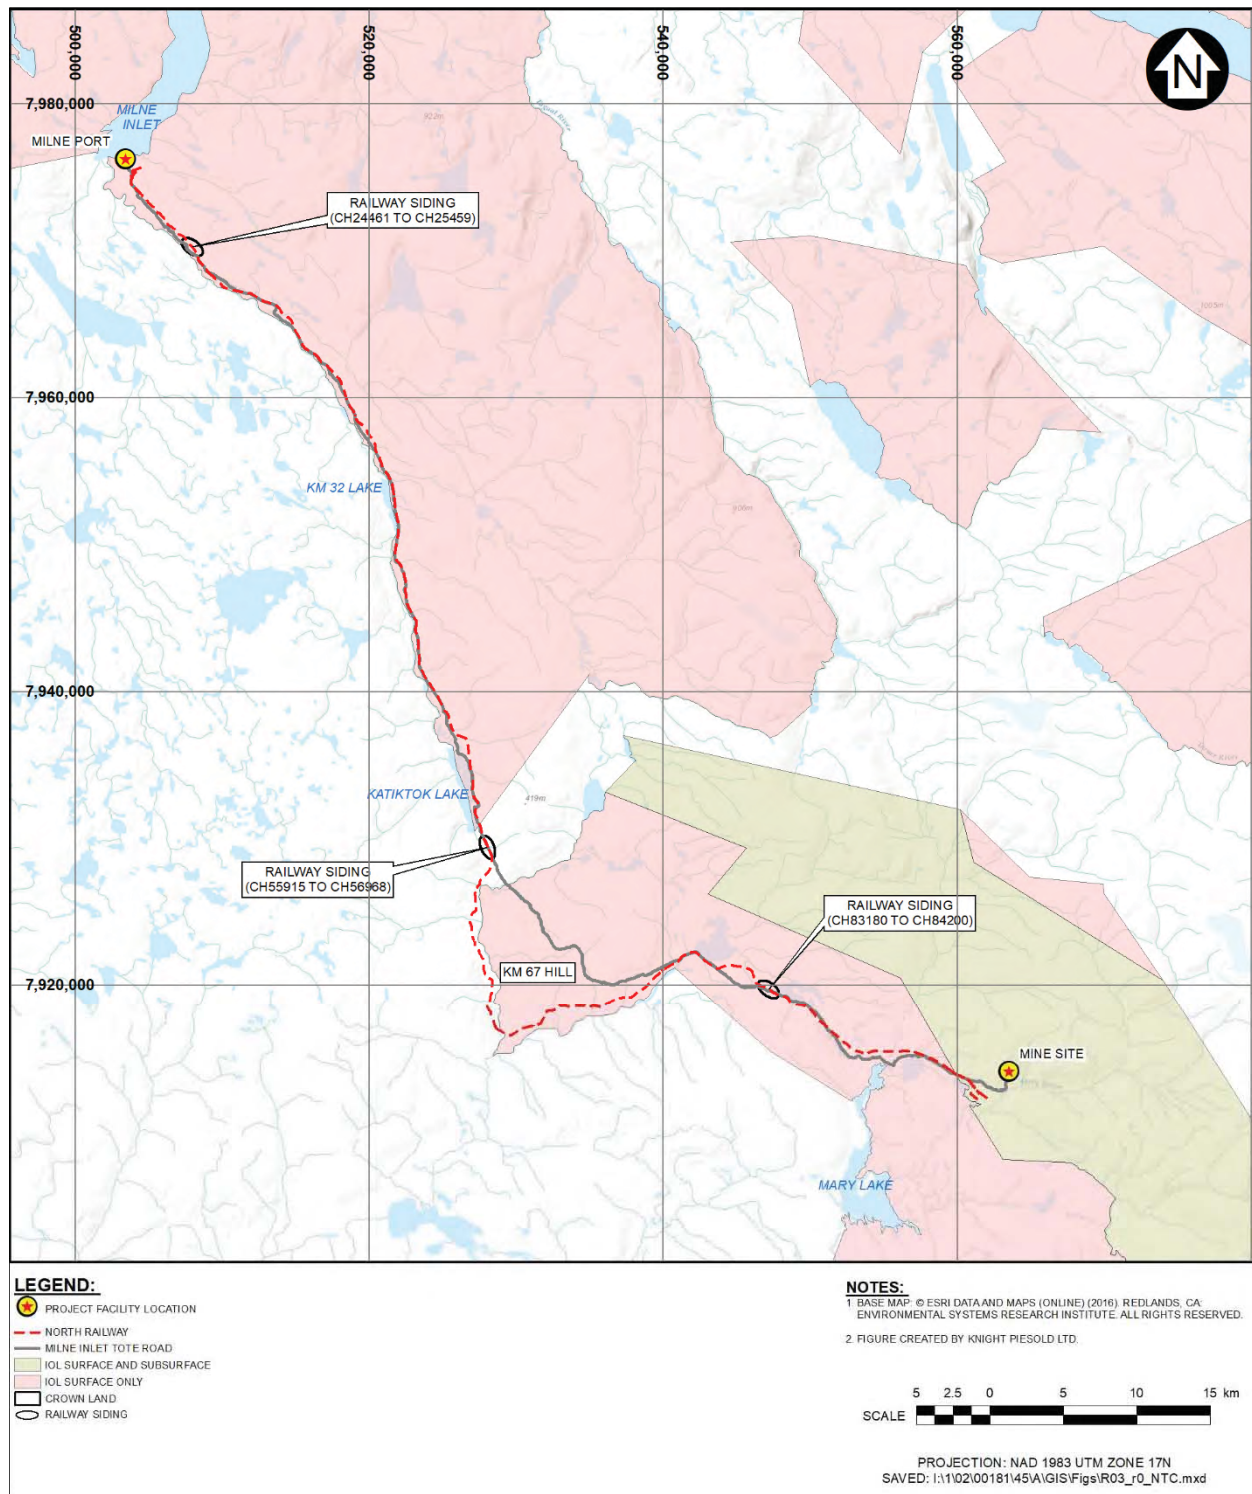
Figure 2. Location of Project activities.

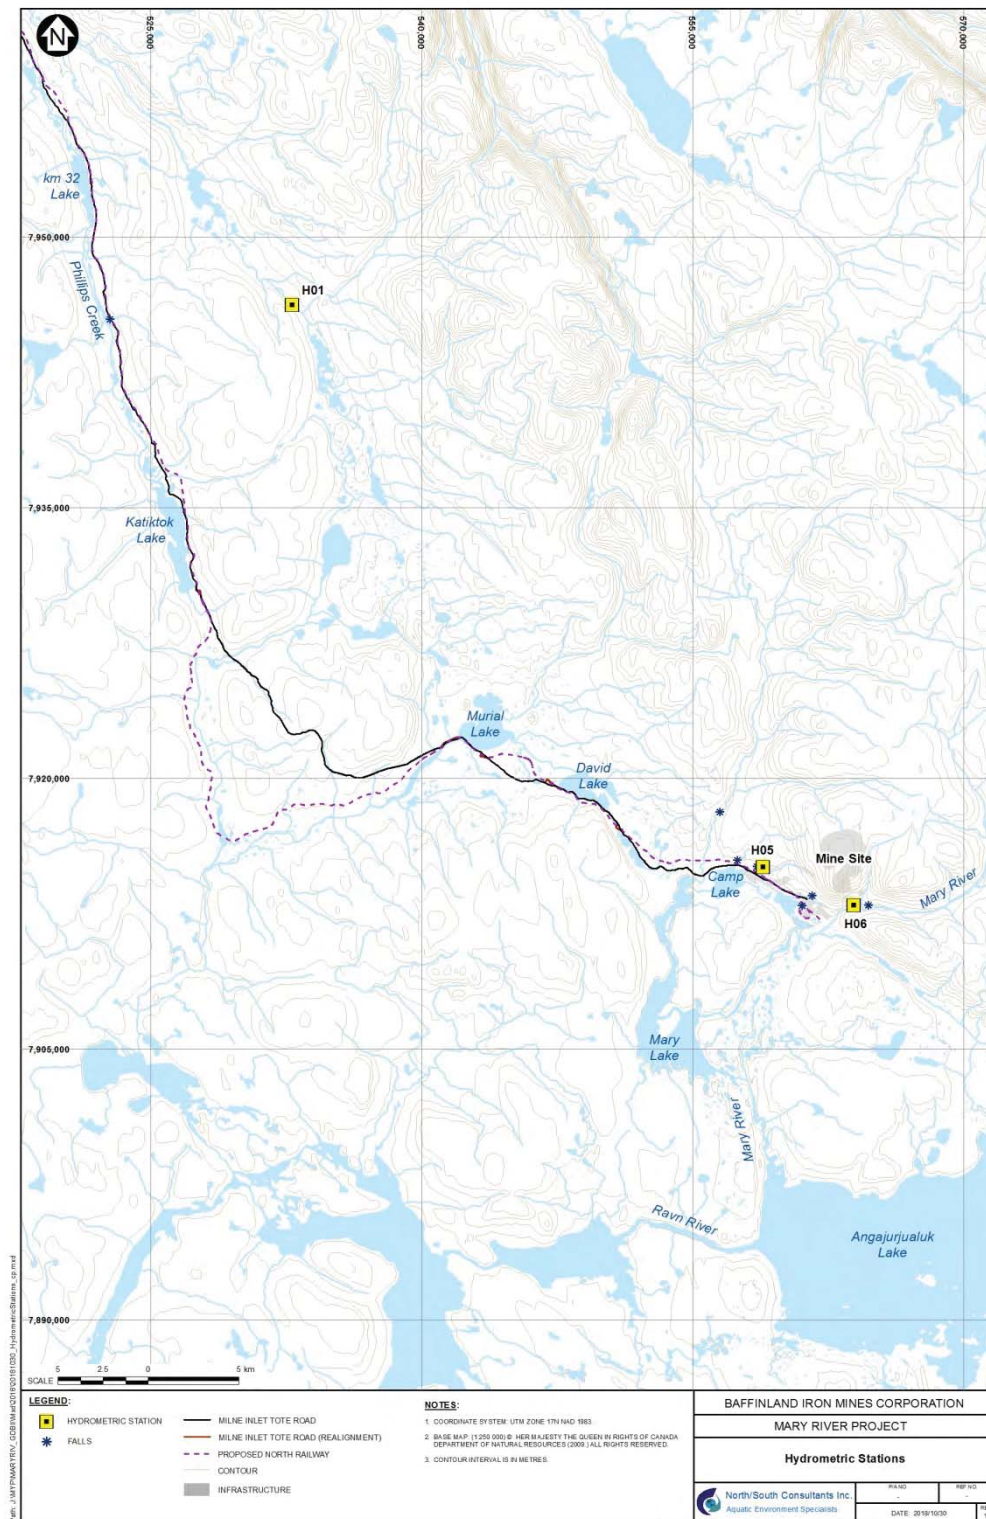
Figure 3. Hydrometric stations in the study area.

Preliminary results of the 2018 stream flow monitoring program operated by Baffinland were provided by A. Rees (pers. comm. 2018) for three sites representative of different catchment sizes located within the study area (Table 2 and Figure 3). Flows at these locations were plotted to provide a general context regarding the flow conditions in the study area in 2018, as well as during the conduct of the field programs. Results for 2018 were compared to data for other years (2006-2017) directly and to mean, median, maximum, and minimum flows recorded for that period.

Preliminary stream flow gauging measurements collected at three representative sites (Phillips Creek tributary, Camp Lake Tributary 1, and the Mary River; Figure 3) in the open-water season of 2018 were reviewed to provide supporting information for the fish habitat field program. These preliminary results indicate that the summer field program was conducted during periods of near average (or median) flow conditions for this time of year, as estimated from the three gauging stations (Figure 4). However, the late summer/fall survey was conducted during largely below average flows (Figure 4). The summer survey also captured a brief period of relatively high flow. These short duration high flow events are common during early to mid-summer and result in higher flow compared to average summer flows for the period of record. As a result, discharge was greater during the summer survey relative to the late summer/fall program (Figure 4). The 2018 field programs therefore captured relatively high and low discharge periods

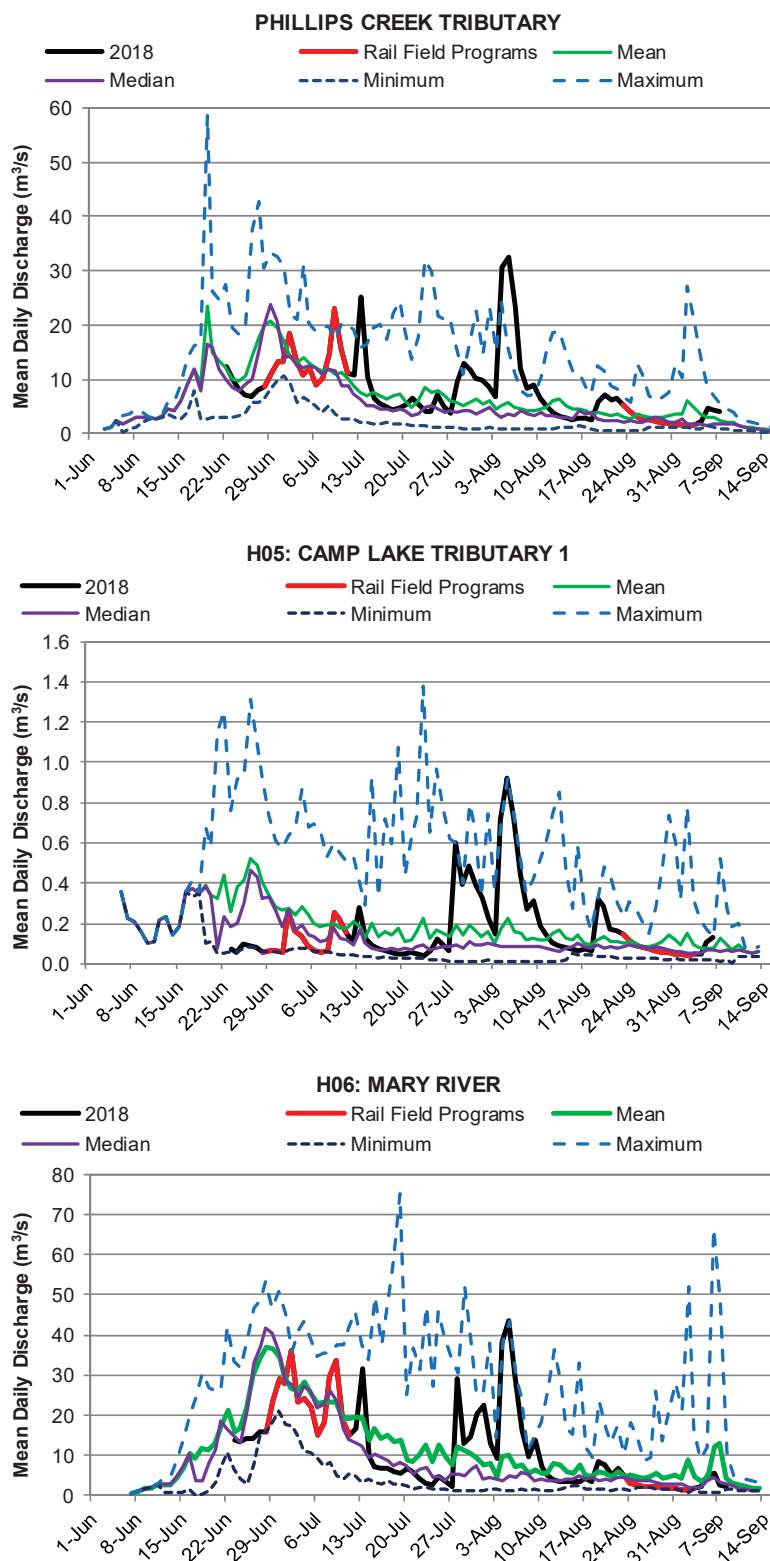
Figure 4. Preliminary 2018 daily discharge and mean, median, minimum, and maximum daily discharges (2006-2017) for three stream gauging stations in the study area. Data provided by A. Rees (pers. comm. 2018).

within the study area. It is noted, however, as shown in Figure 4, that discharge is typically higher during the spring freshet than discharge encountered during the summer field program.

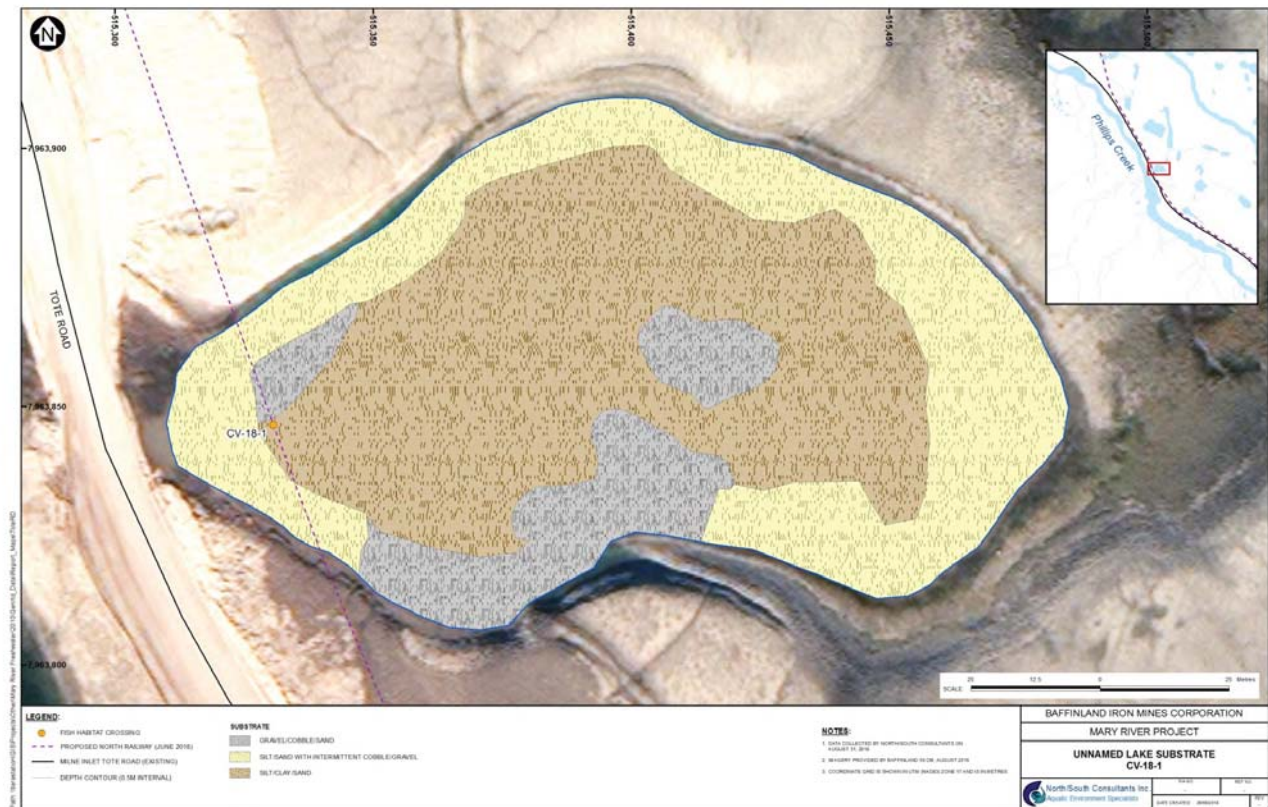
Figure 6. Substrate distribution map for the unnamed lake at site CV-18-1.

cobble, particularly along the south shore (Figure 6). Habitat at the rail footprint is sand/silt with some submerged vegetation on the west side of the alignment and a mixture of silt/clay/sand and patches of gravel/cobble east of the alignment to a depth of 3.0-3.5 m. As this lake is isolated from any other waterbodies, it is used for the entire life cycle of the resident stickleback population.

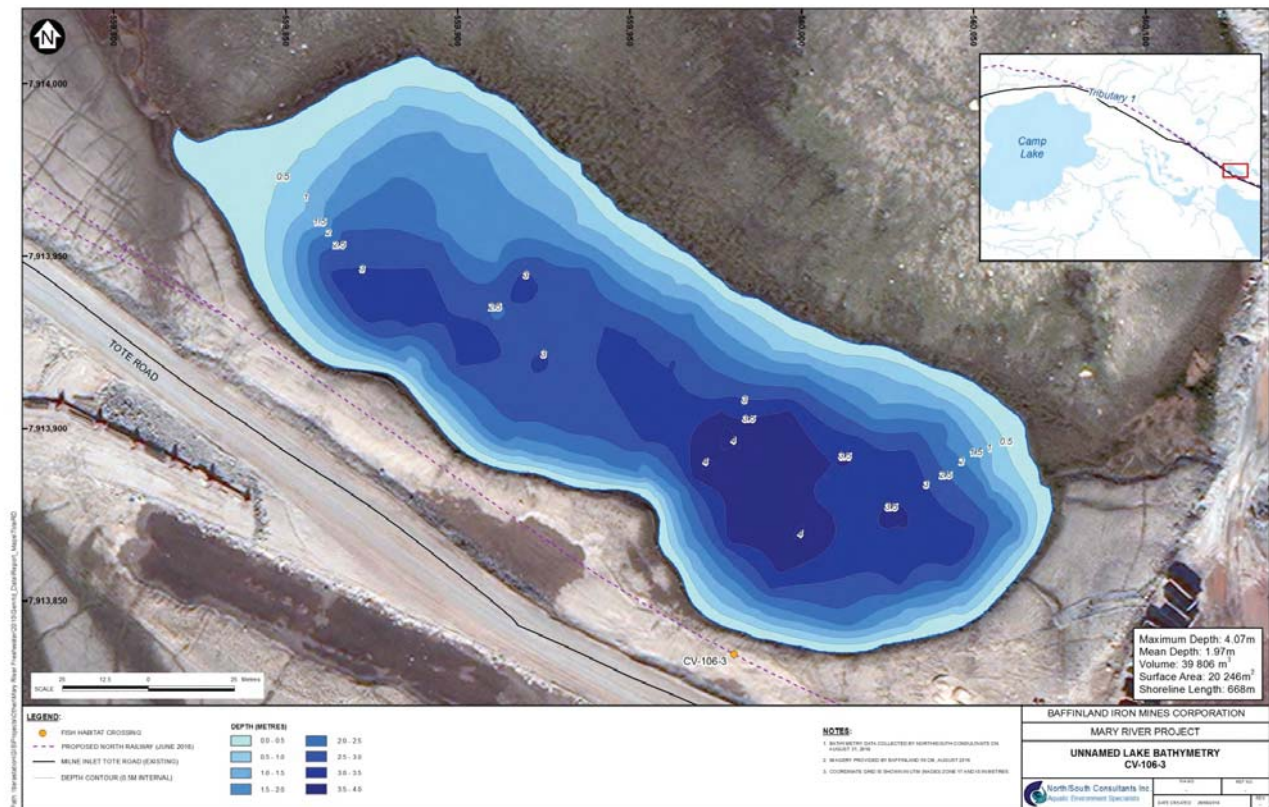
Figure 7. Bathymetry of the unnamed pond at site CV-106-3.

The pond at CV-106-3 had a maximum and mean depth of 4.07 m and 1.97 m in fall 2018, respectively (Figure 7), and substrate was cobble/sand/boulder in most nearshore areas and sand/gravel or silt/clay at depth (Figure 8). Habitat at the encroachment site is predominantly sand with some small cobble to approximately 1.5 m depth and sparse aquatic vegetation. Shoreline electrofishing captured only stickleback, but this lake is connected downstream to known juvenile char habitat (multiple streams and ponds between Camp Lake and CV-106-3); as char were observed in the inflow and outflow of the pond, it was identified as marginal char habitat. The lake provides suitable habitat for the entire life cycle of stickleback, though spawning is also known from nearby, shallower ponds and interconnected streams.

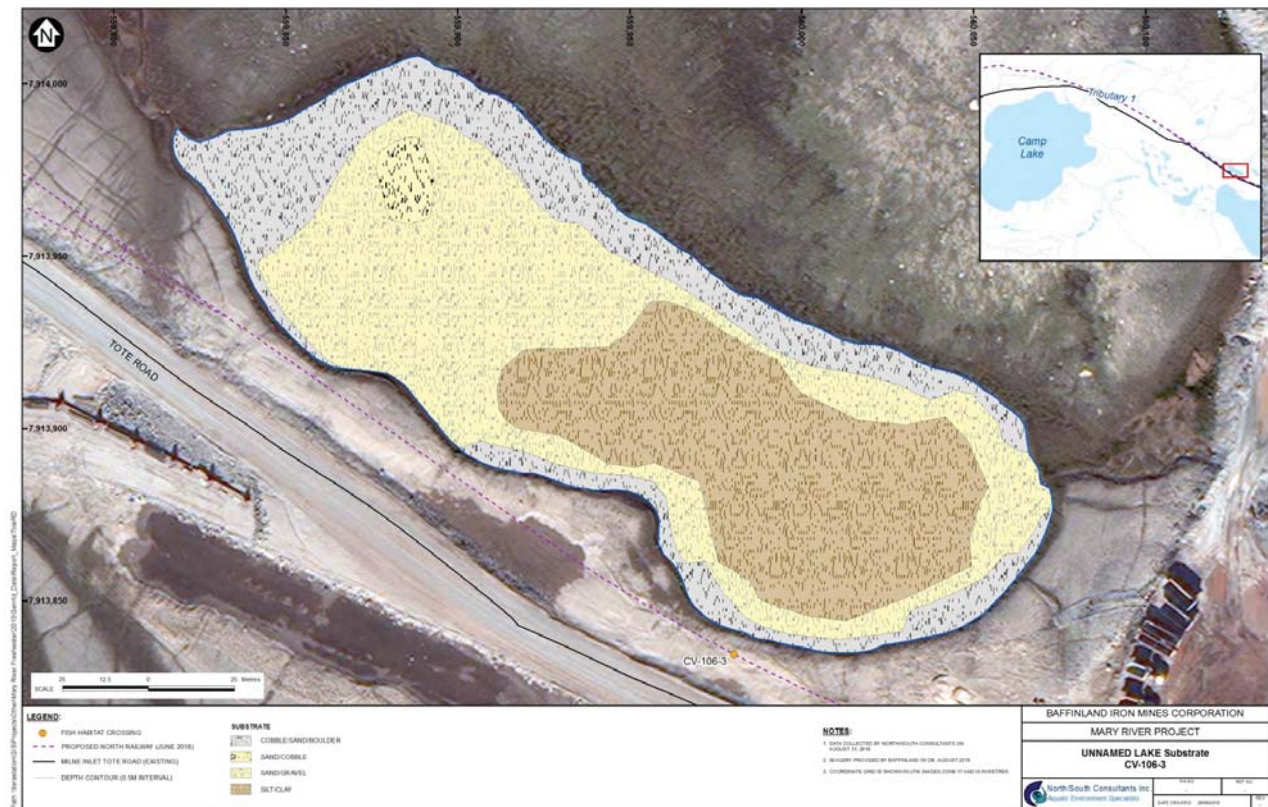
Figure 8. Substrate distribution map for the unnamed lake at site CV-106-3.

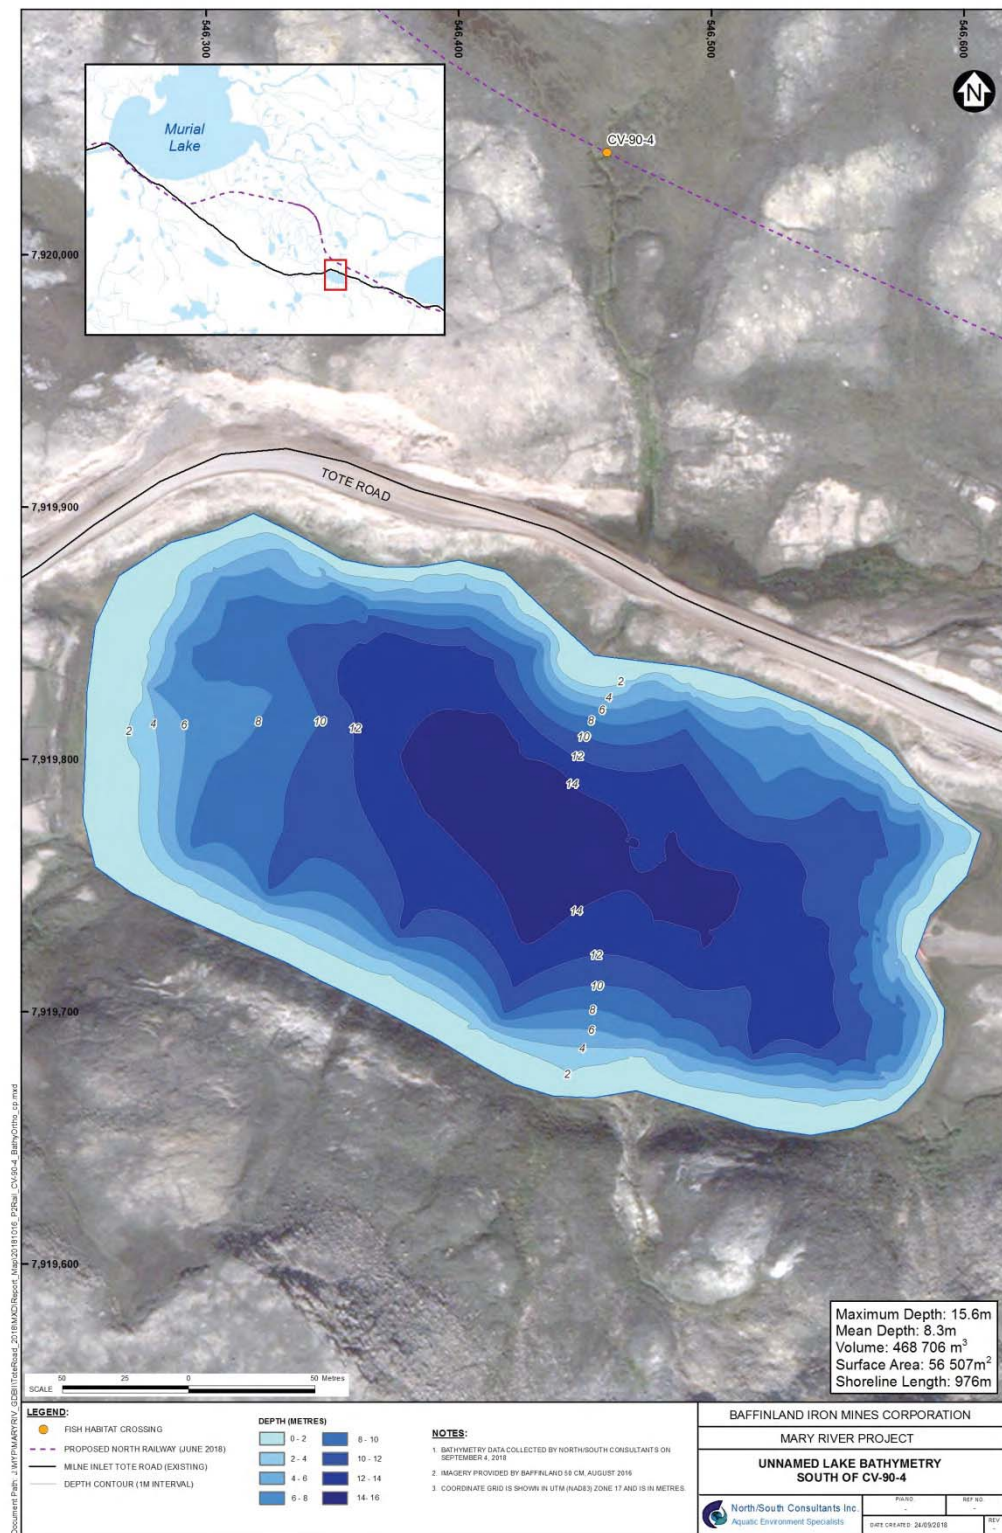
Figure 9. Bathymetry of the unnamed pond located downstream of the stream diversion site CV-90-4.

Bathymetric surfaces were interpolated from the corrected transducer depths and vector shorelines of the lakes (provided by Eagle Mapping 2008) using the Topo to Raster interpolation tool in ESRI® ArcGIS 10.6 software. A 0.5 metre bathymetric grid was produced for each lake. Areas, volumes, and depth statistics were calculated in ArcGIS for each of the three lakes.

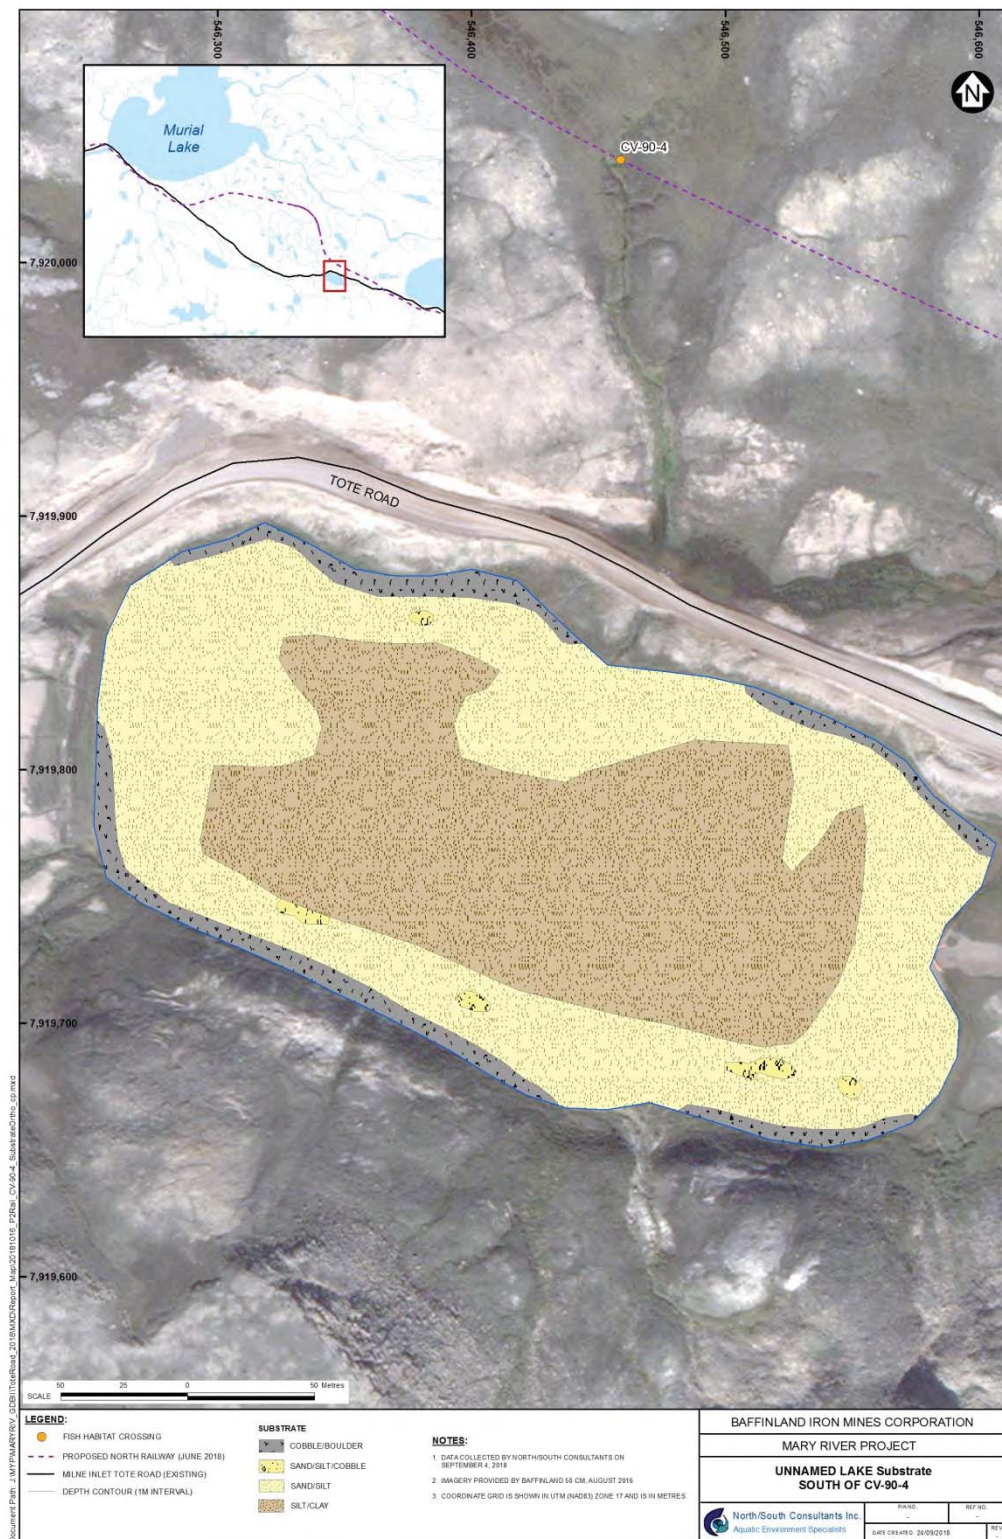
Figure 10. Substrate distribution map for the unnamed pond located downstream of the stream diversion site CV-90-4.

Side scan images of the lake bottoms of the waterbodies collected during the field surveys using the Lowrance Elite 7 with the 455 kHz StructureScan® frequency were imported into Reefmaster 2.0. Reefmaster 2.0 uses the positional and bearing information from the GPS data to georeference the side scan images of the waterbody and displays them in a seamless mosaic. The side scan image mosaic was exported to a .mbtile format and imported into QGIS, from here it was saved as a GeoTIFF and brought into ArcGIS where major substrate change boundaries were delineated and digitized from the imagery, the mapped Peak SV, E1, and E2, variables and validation data (ponar grabs) obtained during field studies were used to verify the visually delineated substrate classes. Substrates in the field were previously classed according to size by the Wentworth scale (Wentworth 1922). Final symbolization of substrate classes and cartographic output were generated in ArcGIS® 10.6.
