Baffinland Iron Mines Corporation Mary River Project

Steensby Port and Railway Freshwater Habitat Surveys: 2021-2023

REPORT

Prepared for Baffinland Iron Mines Corporation
By North/South Consultants Inc. • 83 Scurfield Blvd. • Winnipeg, MB • R3Y 1G4

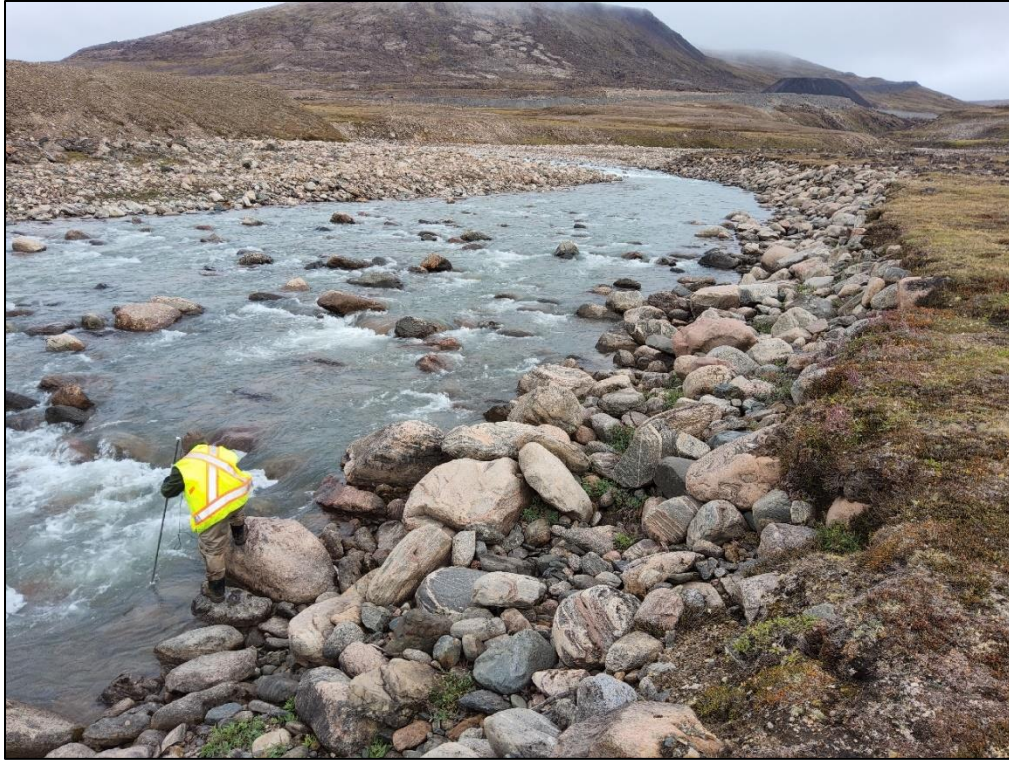
Photograph 1. Photo of the Mary River taken near the rail crossing in August 2022.

Streams within the first 39 km of the proposed rail alignment largely originate at high elevation along a plateau to the north of the rail centreline, flowing down hills towards one of two larger river systems (the Mary and Ravn rivers). Streams crossed by the rail alignment from the Mary River to km 5.5 are within the Mary River/Mary Lake sub-catchment. Streams from km 5.5 to the Ravn River are within the Ravn River/Angijurjuk Lake catchment. There are several potential overwintering lakes within a relatively short swimming distance of most crossings in this area.

Most of the streams in this area have moderate to high gradients often creating barriers to fish movements. Riffles, cascades, and rapids are common, particularly in the larger streams, and substrates are predominantly coarse material (large cobble/boulder) except for a few low-lying crossings near the larger downstream lakes. Streams in this stretch are consistently the last along the Steensby Railway to become snow/ice-free and begin flowing during spring. Both fish species are present in this area, but Arctic Char are more abundant and widespread in streams crossed by the rail. Ninespine Stickleback are uncommon and mainly restricted to ponds/lakes and the lower reaches of these streams where average velocities are lower.

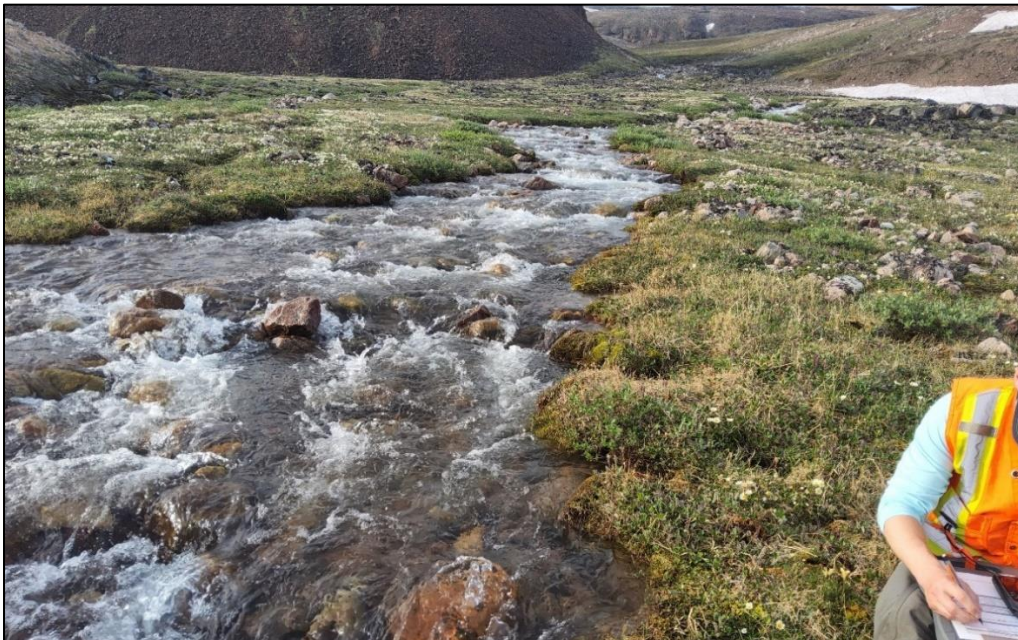
Photograph 2. Photo of rail site CV-006-1 taken near the rail crossing in spring 2022.

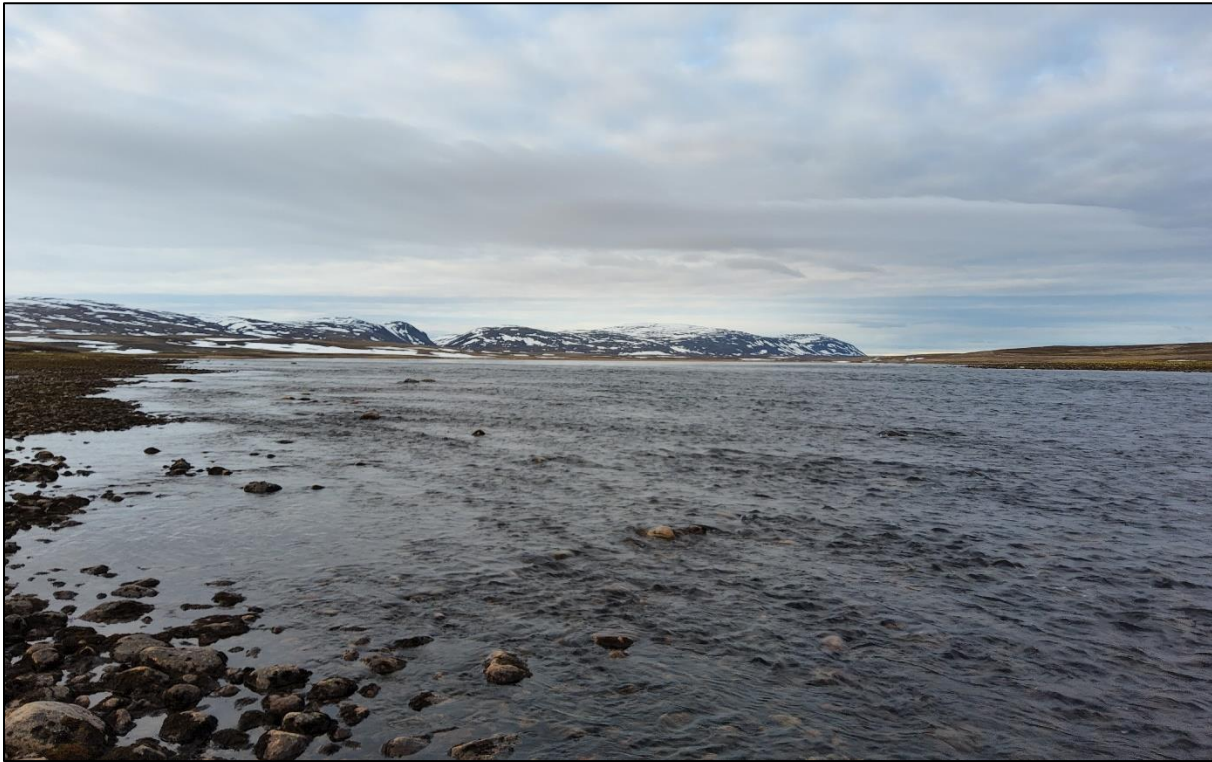
Photograph 3. Photo of the Ravn River taken near the rail crossing in spring 2022.

The mid-rail area, from the Ravn River to km 73, consists of waterbodies within the Ravn River/Angijurjuk Lake catchment. Terrain in this area is low-relief resulting in a large number of small, shallow ponds, wetlands, and slow-moving streams with poor channel definition and silt/organic substrates. There is typically substantive overland flooding in spring as snow melts, creating intermittent connectivity among many of the waterbodies.

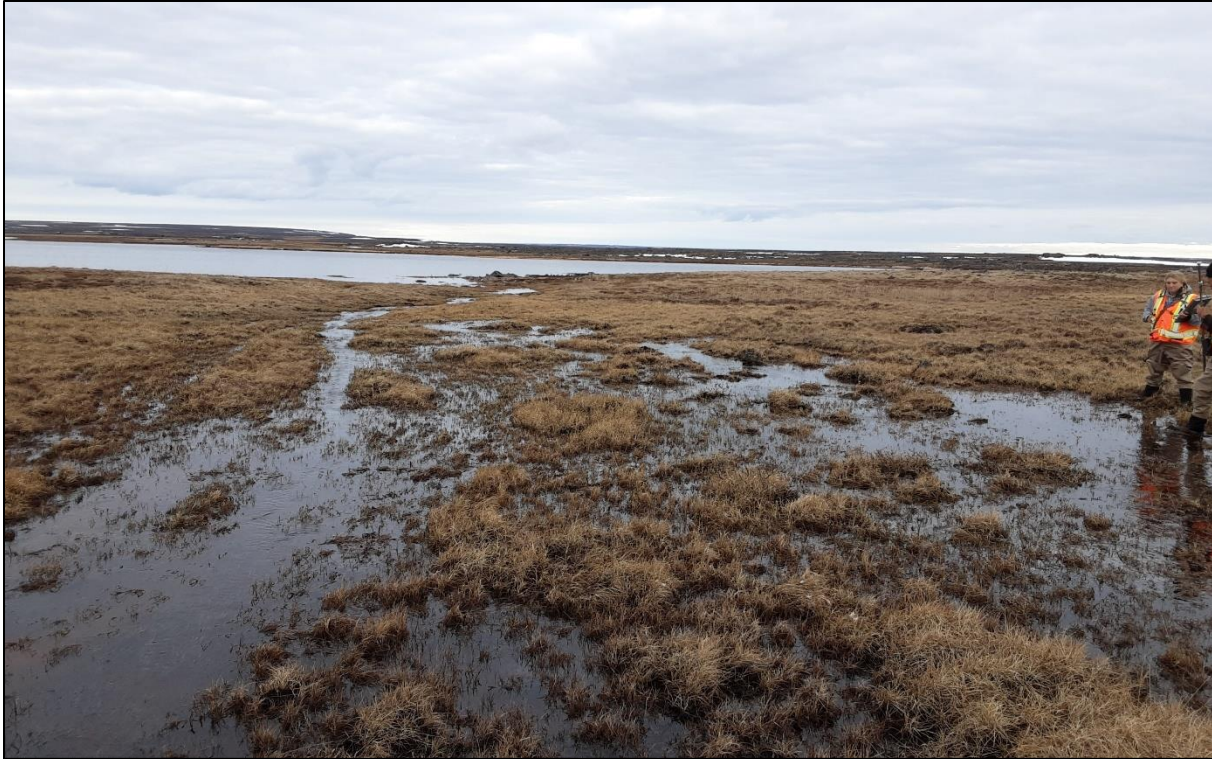
Photograph 4. Photo of rail site CV-049-2 taken near the rail crossing in spring 2022.

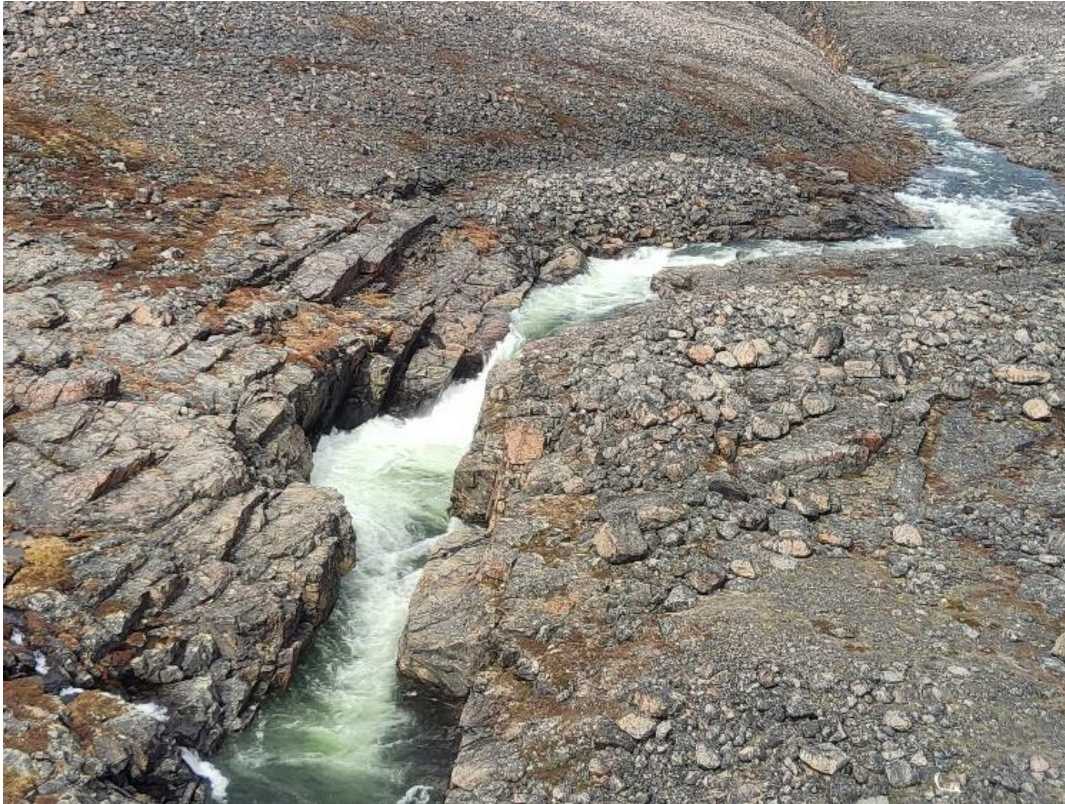
Photograph 5. Photograph of one of the sets of falls on the northwest branch of the Cockburn River taken in August 2023.

The Steensby Railway alignment interacts with 47 streams/ponds in this sub-catchment upstream of the falls. All of these waterbodies that are capable of supporting fish (i.e., suitable habitat with access from the northwest Cockburn River) have been surveyed a minimum of three times between the earlier FEIS field studies (2007-2011) and the recent field studies (2021-2023). Surveys have been conducted during various seasons and under low and high flow conditions. Char have never been observed or captured in any of

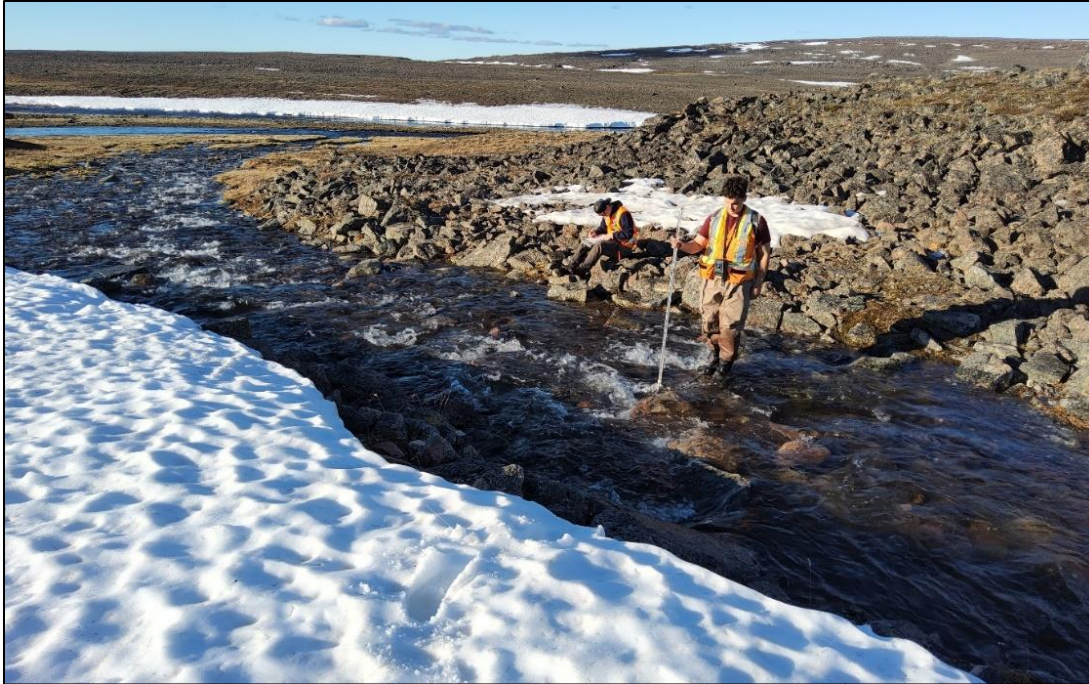
Photograph 6. Photo of rail site CV-076-1 taken near the rail crossing in spring 2022.

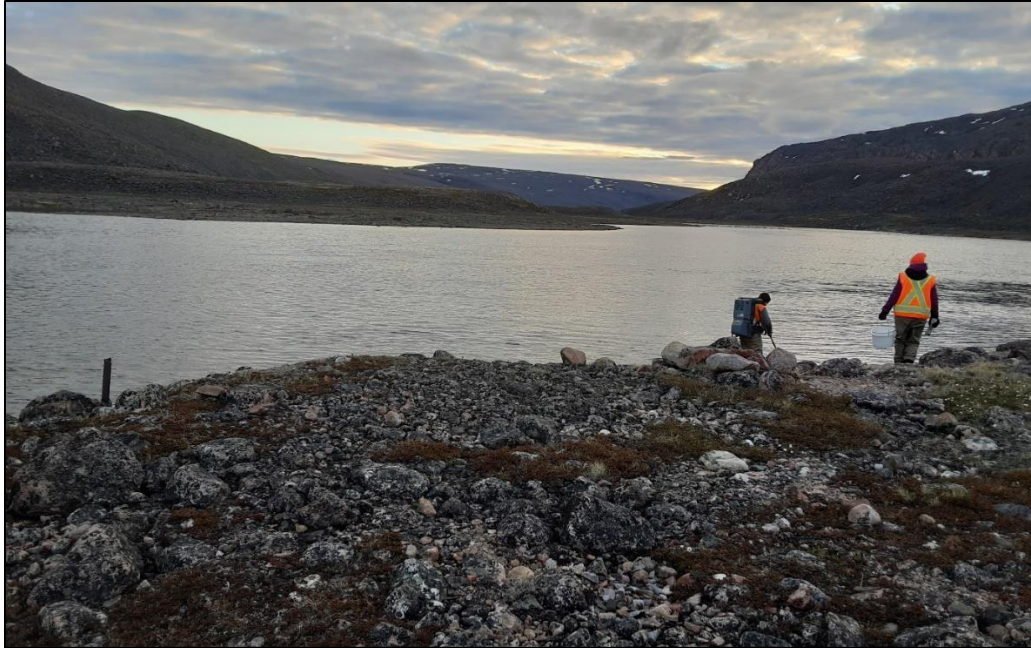
Photograph 7. Photo of the Cockburn Lake bridge crossing area (BR-095-1) taken in spring 2022.

Both species are present in the catchment, but the frequency of barriers and habitat type limits their distribution, particularly for stickleback. Most fish habitat in this area is found in the Cockburn Lake/River itself and some alluvial fan habitat in a large tributary stream at the southernmost end of Cockburn Lake where the surrounding terrain is lower relief.

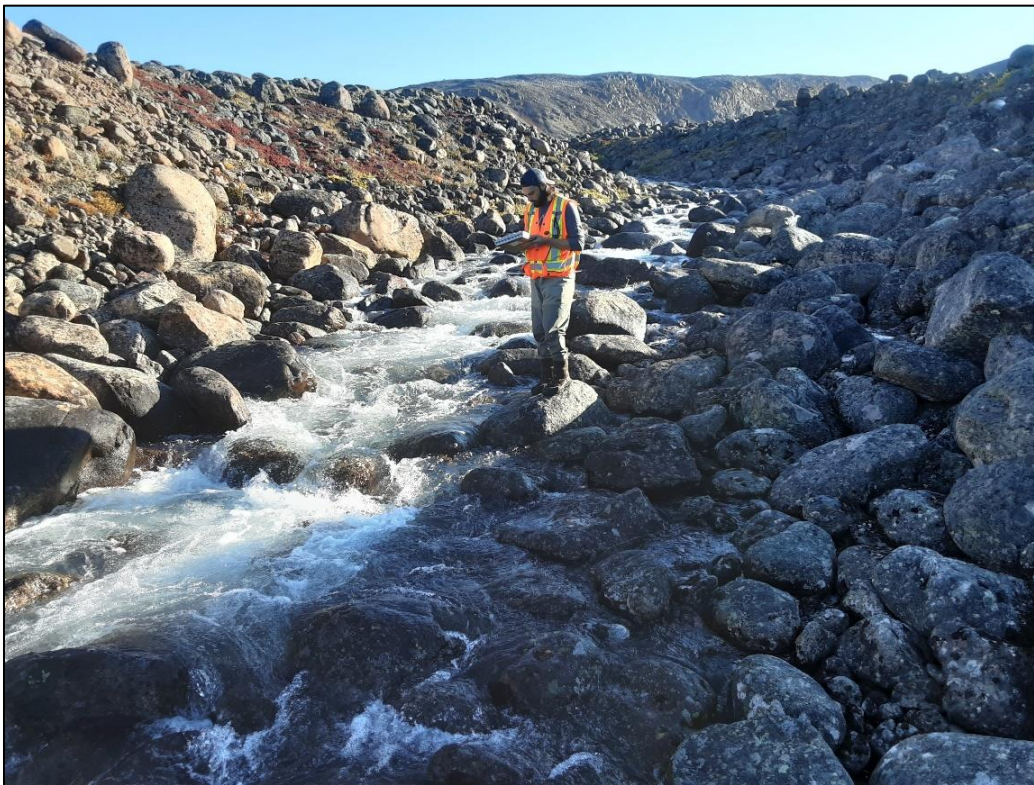
Photograph 8. Photo of a typical stream (BR-096-1) flowing into the east side of Cockburn Lake taken in August 2021.

Waterbodies along the rail alignment from km 91 to km 132 are part of the Cockburn Lake/Cockburn River catchment. Most streams in this section originate at high elevation from cliffs on either side of Cockburn Lake/River. Streams are frequently very high gradient with mainly cascade/boulder habitat and permanent barriers to fish movements are common.
