**HABITAT ASSESSMENT PROTOCOL AND SAMPLE
DATA SHEET USED FOR DESCRIBING AVAILABLE
AQUATIC HABITAT IN WATERCOURSES IN THE
RAILWAY/ACCESS ROAD AREA.**

MARY RIVER PROJECT RAILWAY/ACCESS ROAD WATERCOURSE CROSSING ASSESSMENT PROTOCOL

North/South Consultants Inc. and Knight Piésold Ltd.

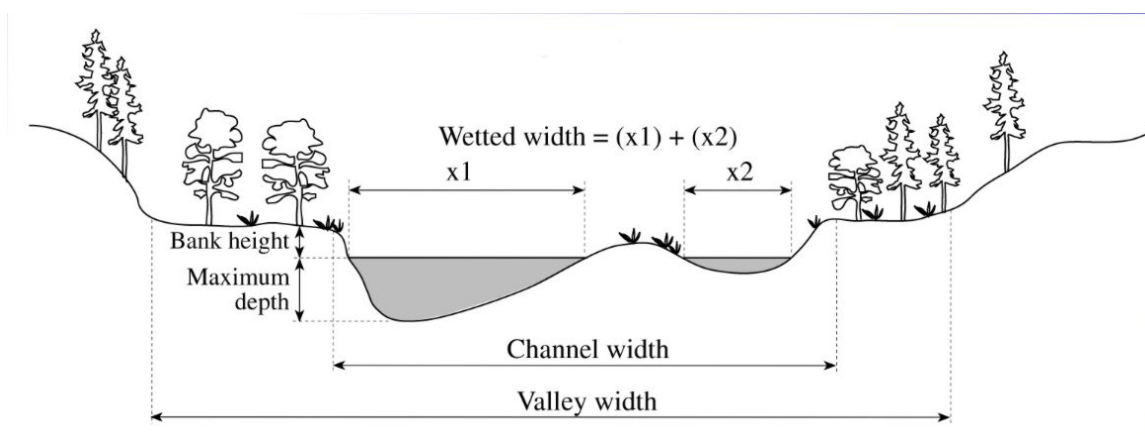
At the watercourse crossing site, the following information pertaining to the channel profile should be collected for each transect:

- wetted width (water's edge)
- water depth and velocity at 25%, 50%, and 75% of the wetted width, starting at the left bank
- channel width (i.e., high water width or bankfull width; bank to bank – usually defined by rooted terrestrial vegetation)

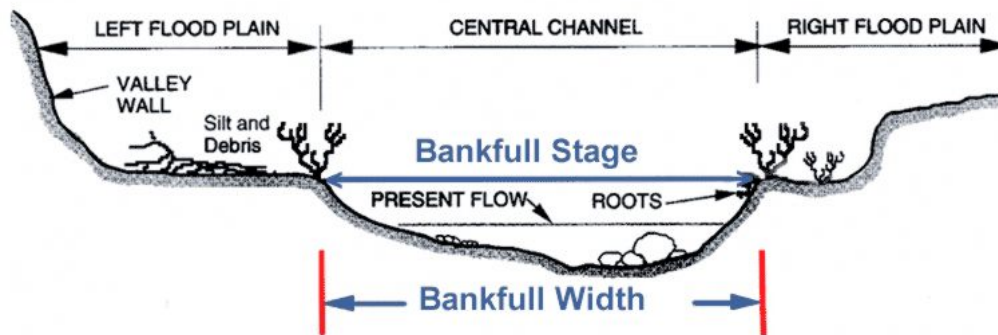
For the stream as a whole within the study reaches, record the approximate average floodplain or valley distance and vegetation type(s) present, if applicable.

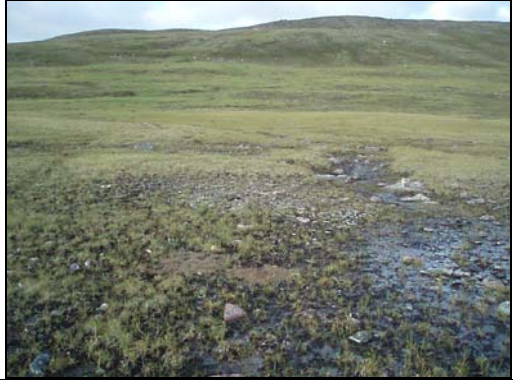
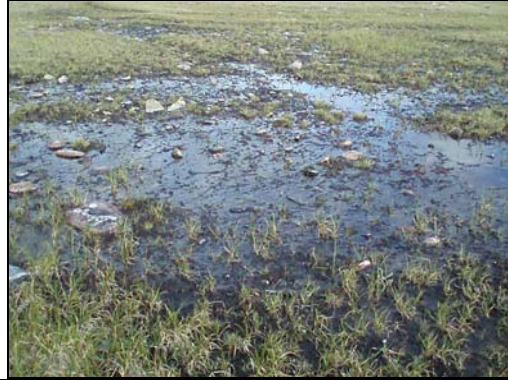
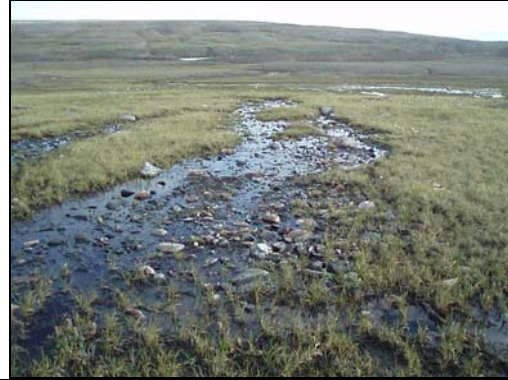
Figure 1. View of habitat upstream of crossing (A), at the crossing (B) and downstream of crossing (C).

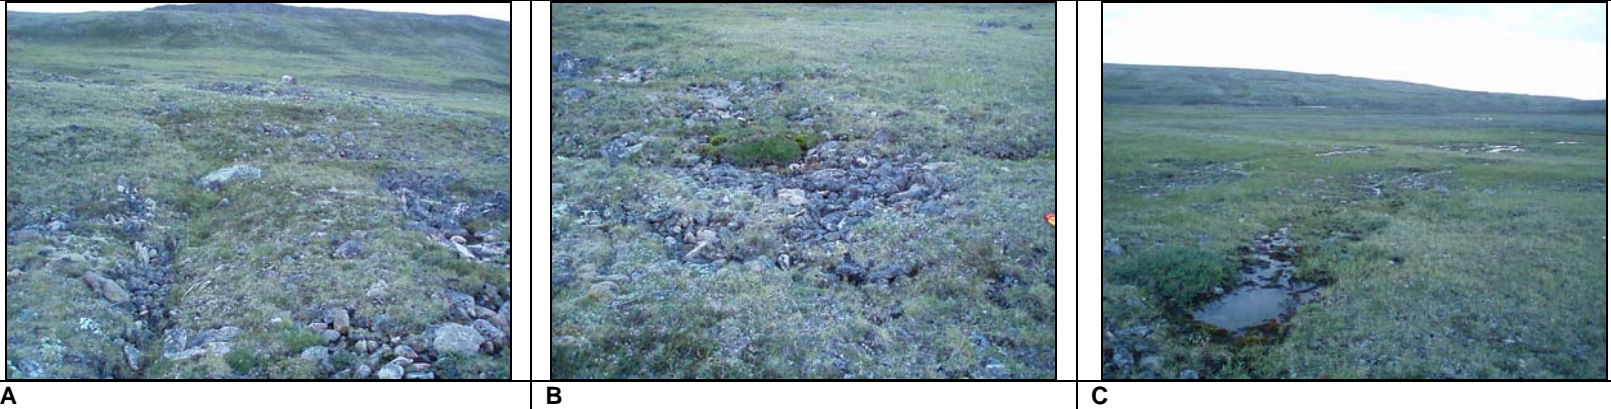
Figure 1. View of habitat upstream of crossing (A), at the crossing (B) and downstream of crossing (C).

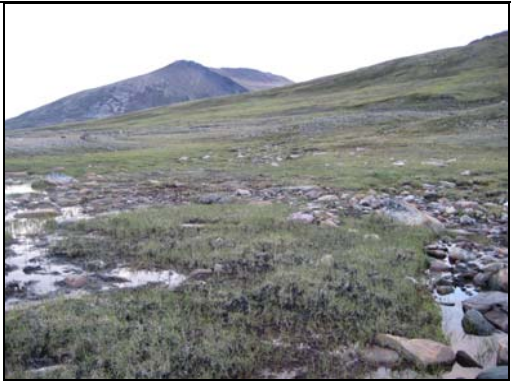
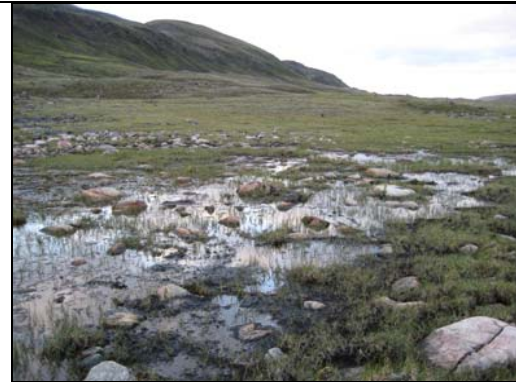
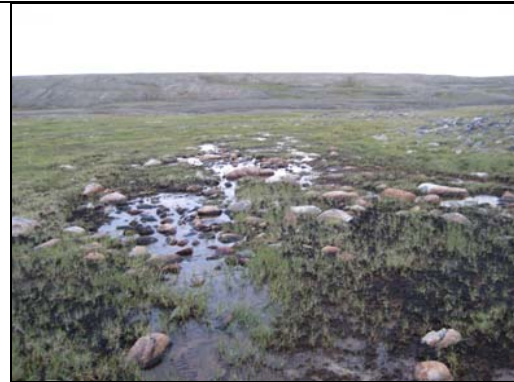
Figure 1. View of habitat upstream of crossing (A), at the crossing (B) and downstream of crossing (C).

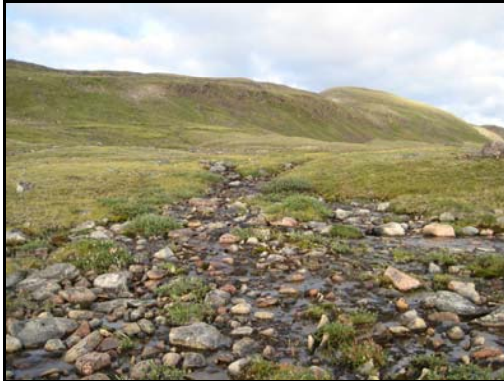
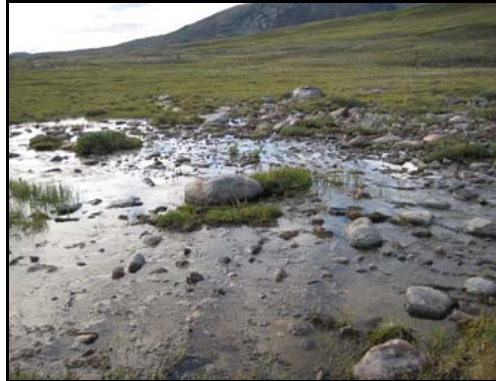
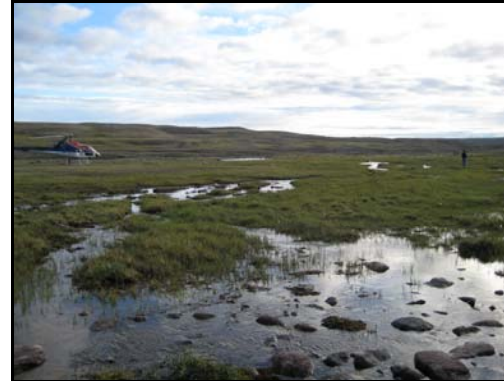
Figure 1. View of habitat upstream of crossing (A), at the crossing (B) and downstream of crossing (C).

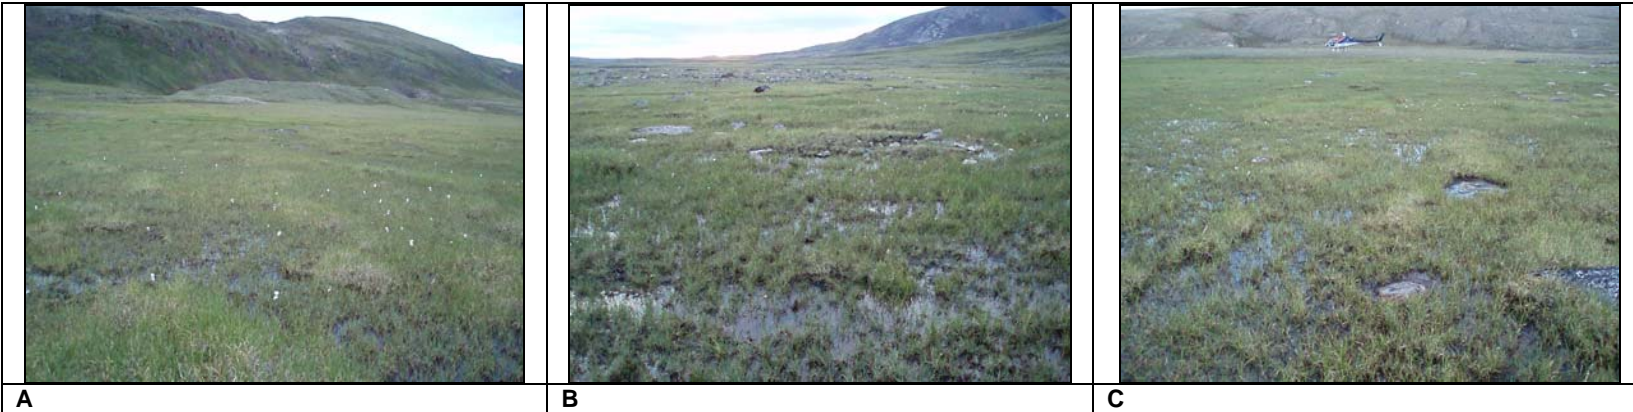
Figure 1. View of habitat upstream of crossing (A), at the crossing (B) and downstream of crossing (C).

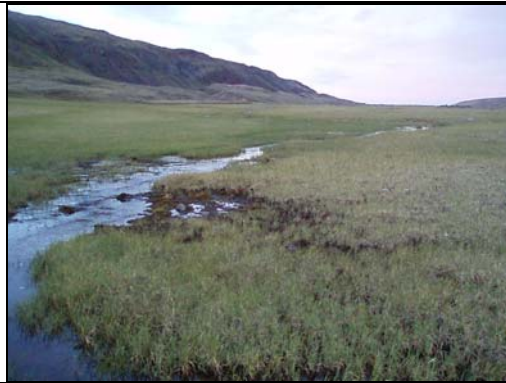
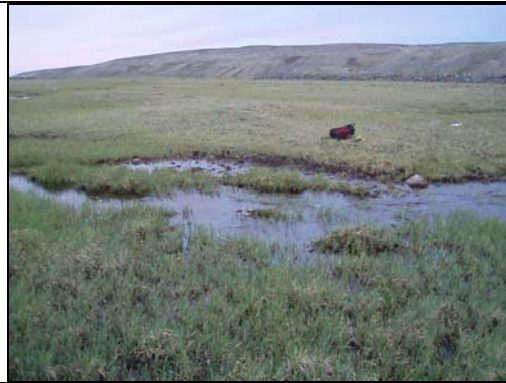
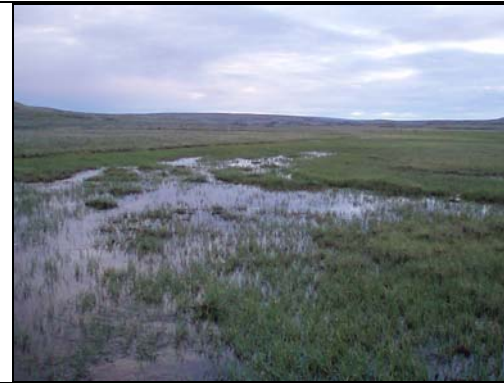
Figure 1. View of habitat upstream of crossing (A), at the crossing (B) and downstream of crossing (C).

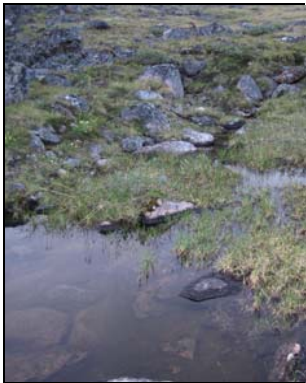
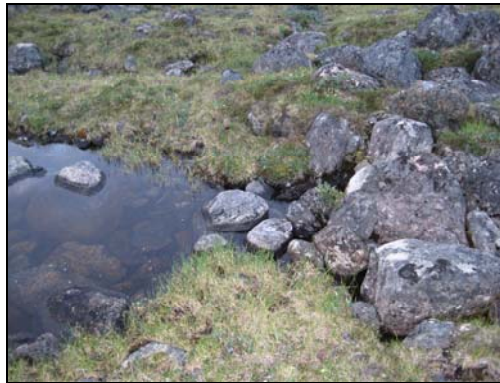
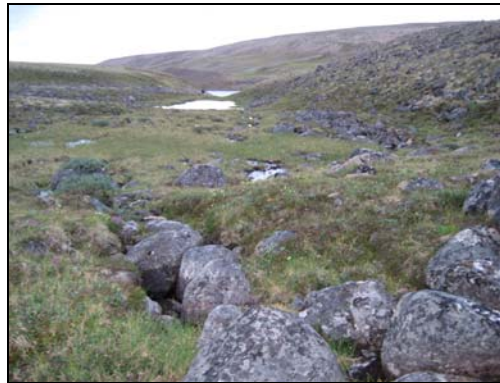
Very little flow; most wetted area is under and between boulders. Isolated pools offer habitat but they are inaccessible.

Figure 1. View of habitat, (A) View upstream of crossing , (B) View across crossing from left bank, (C) View downstream of crossing

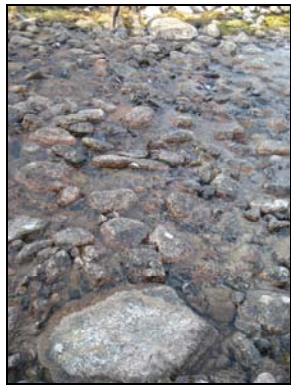
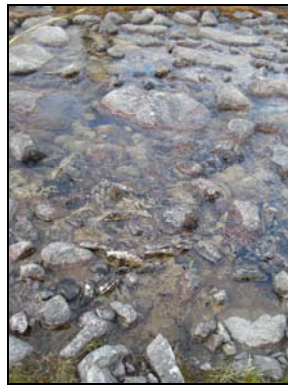
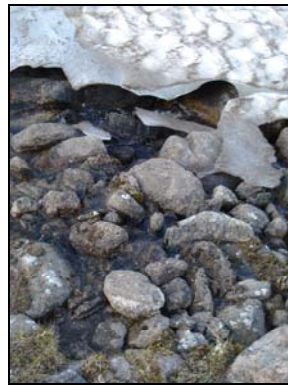
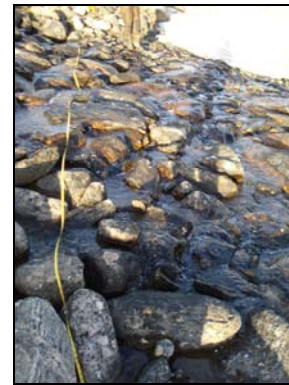
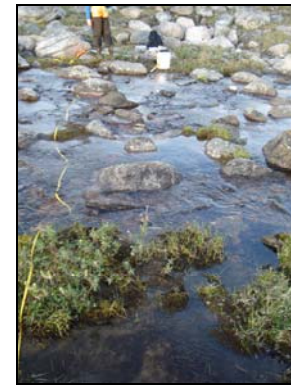
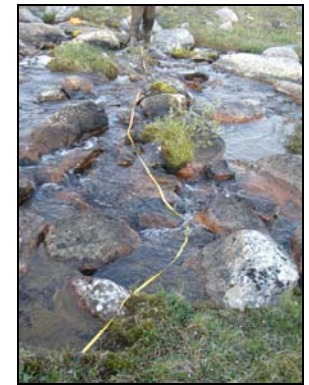
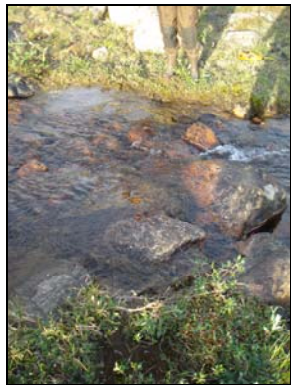
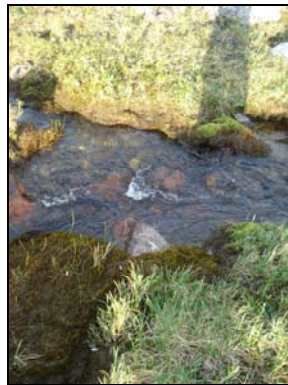
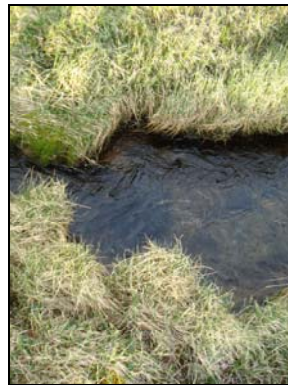
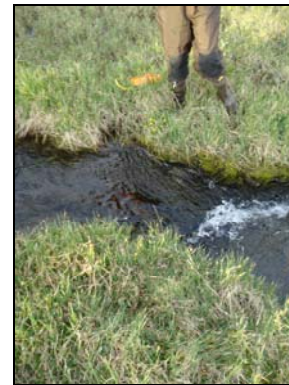
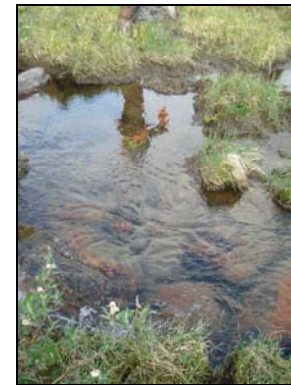
Figure 1. Views of available stream habitat at 20 m intervals starting at 100 m downstream (A) and ending at 100 m upstream (K).

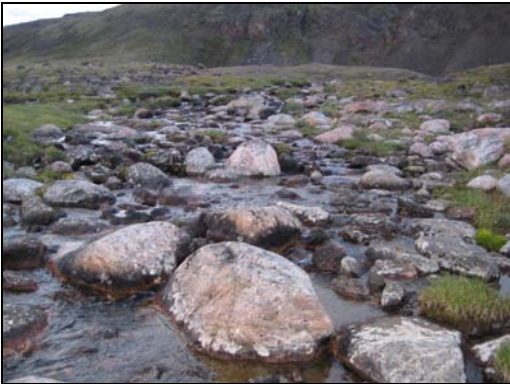
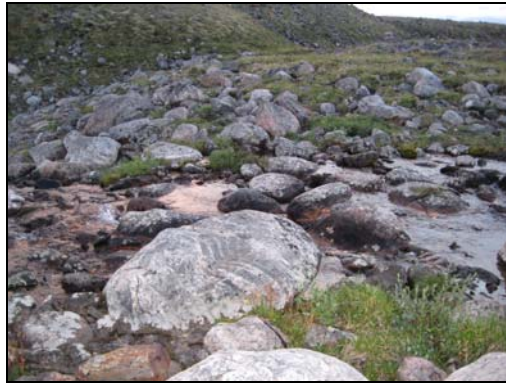
Figure 1. View of habitat (A) View DS of crossing looking upstream, (B) View DS of crossing across from right bank

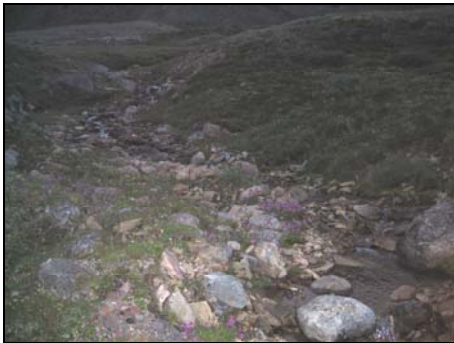
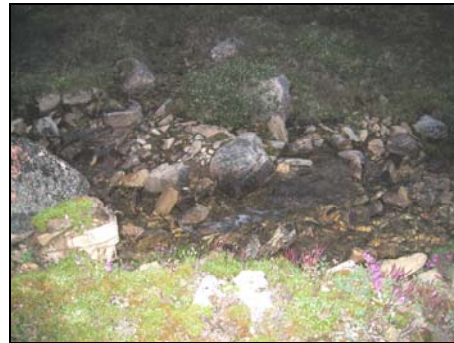
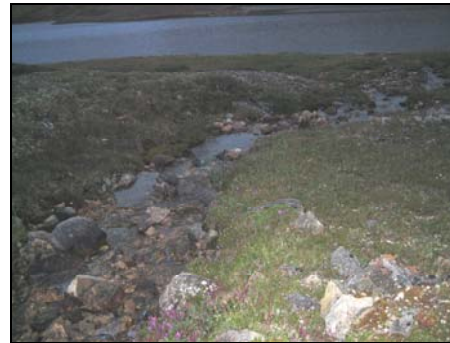
A nearly vertical water fall (< 1 m in height) located downstream of crossing is likely a barrier to fish movement. Stretch below falls leading down to lake is accessible to fish and likely important habitat for juvenile fish (ARCH were observed), especially YOY.

Figure 1. View of habitat (A) View upstream of crossing, (B) View across crossing from left bank, (C) View downstream of crossing.

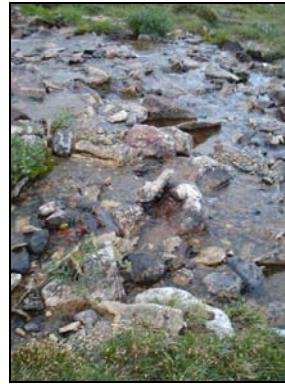
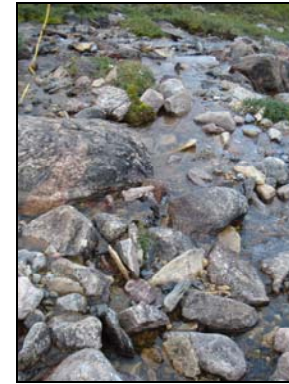
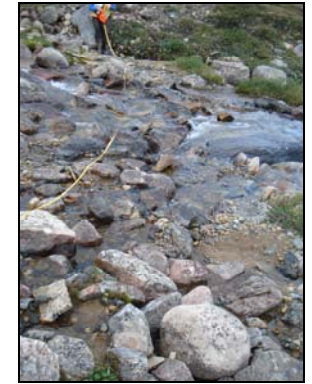
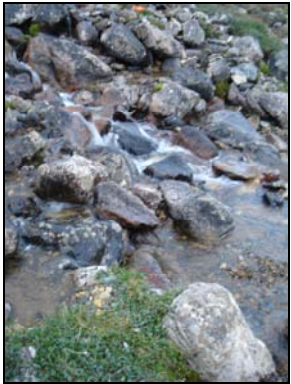
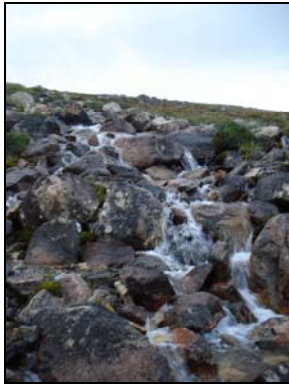
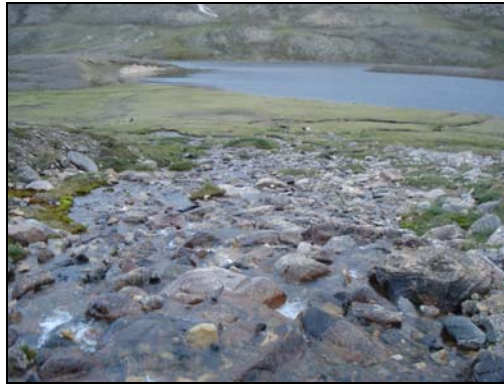
Figure 1. View of habitat 80 (A), 60 – right channel (B), 40 – right channel (C), and 20 m – right channel (D) downstream of the crossing, at the crossing (E), and 20 (F) and 40 m (G) upstream of the crossing. Views upstream (H) and downstream (I) from the fish barrier are also presented.

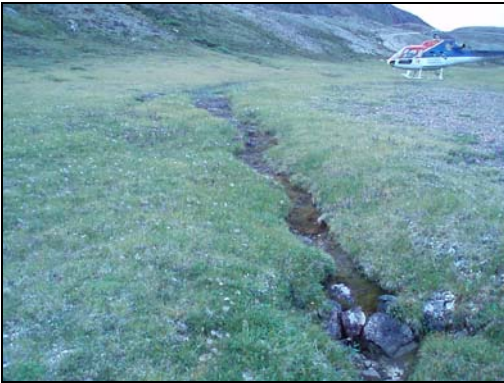
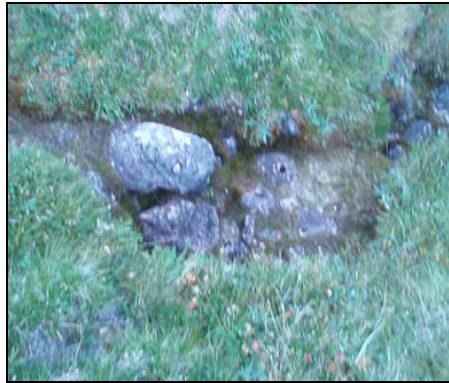
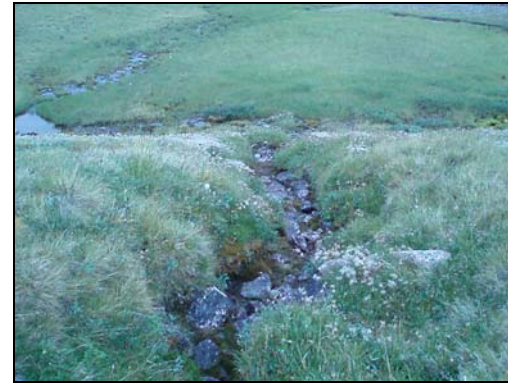
The high water channel width was 1.46 m. Barrier present-marsh D/S.

Figure 1. View of habitat, (A) View upstream of crossing, (B) View across crossing 10 from left bank, (C) View downstream of crossing.

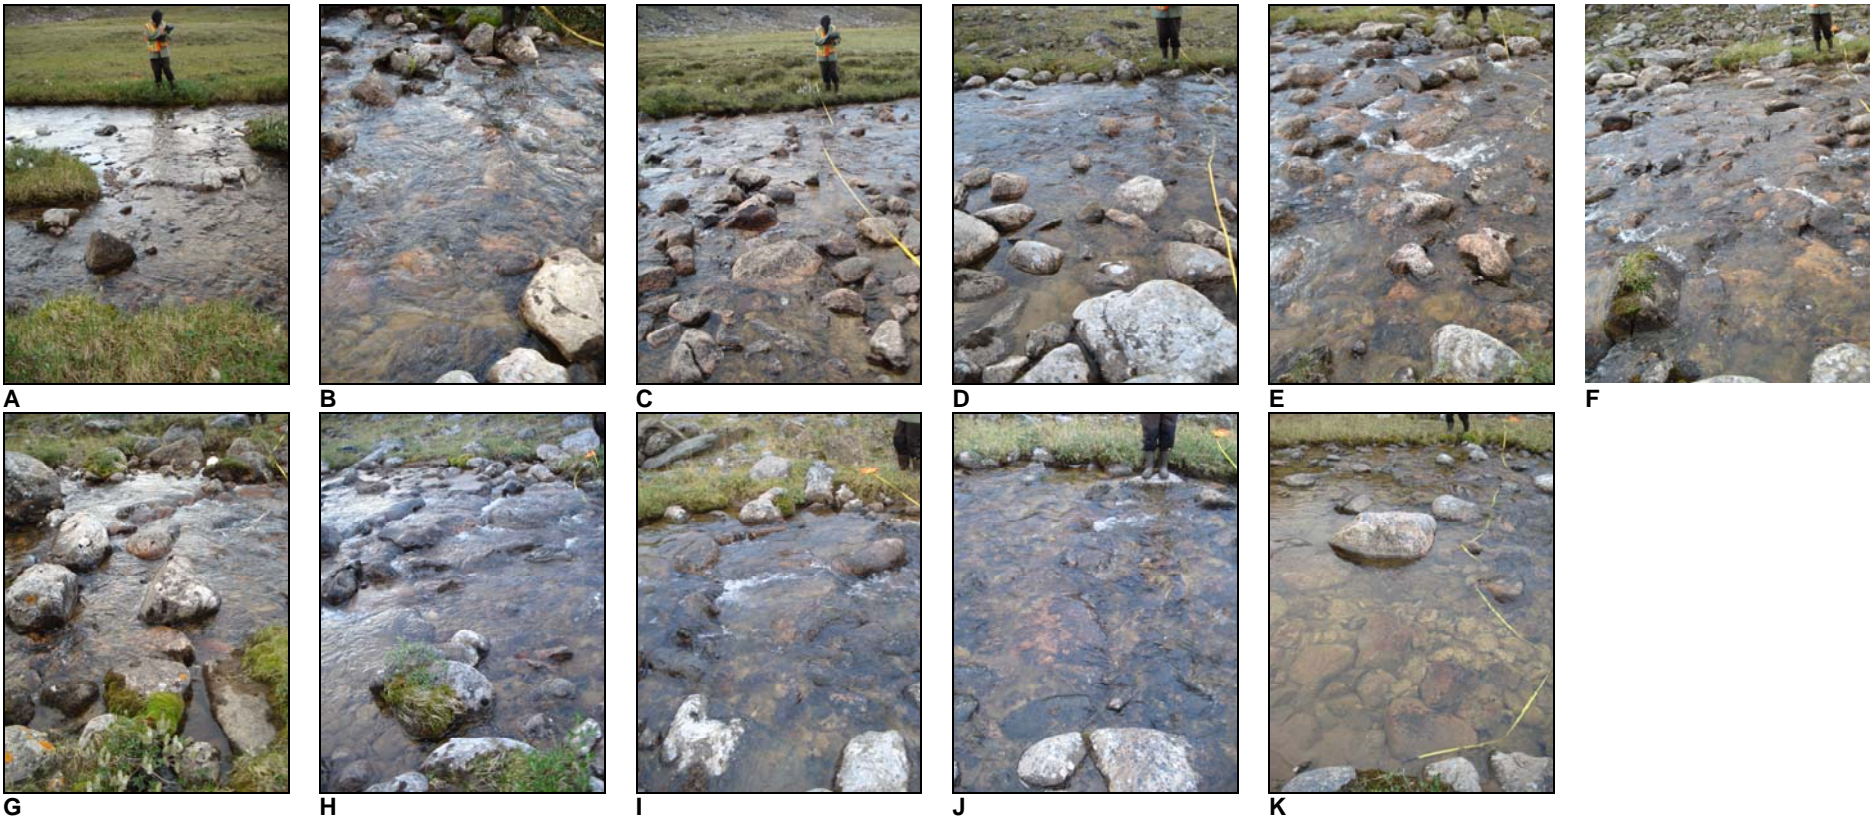
Figure 1. View of habitat 100 (A), 80 (B), 60 (C), 40 (D), and 20 m (E) downstream of crossing, at the crossing (F), and 20 (G), 40 (H), 60 (I), 80 (J), and 100 m (K) upstream of the crossing.

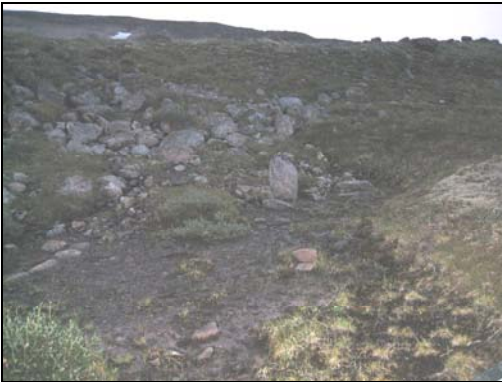
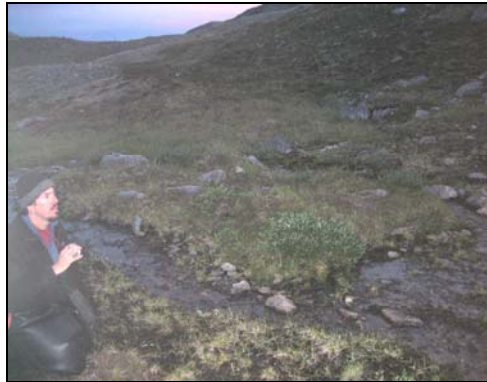
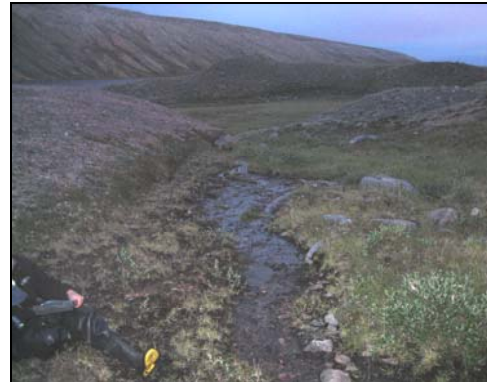
Low water level and steep gradient make the crossing site unsuitable habitat for any fish. DS of the crossing site it joins with the watercourse from crossing #11, which is fish habitat.

Figure 1. View of habitat, (A) View upstream of crossing, (B) View across crossing from left bank, (C) View downstream of crossing.

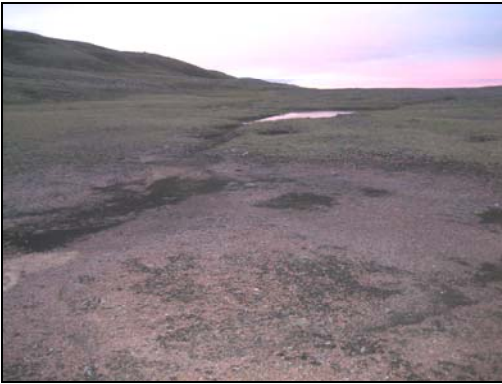
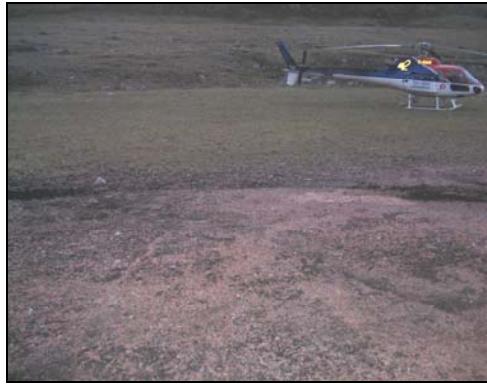
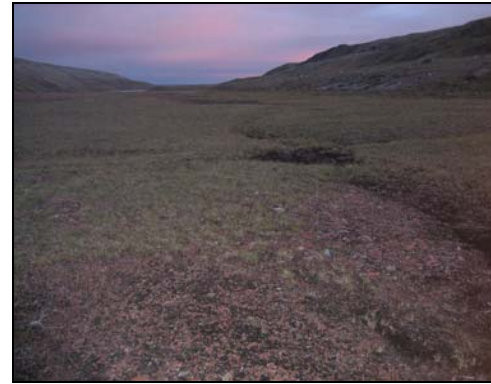
Figure 1. View of habitat, (A) View upstream of crossing, (B) View across crossing from right bank, (C) View downstream of crossing.

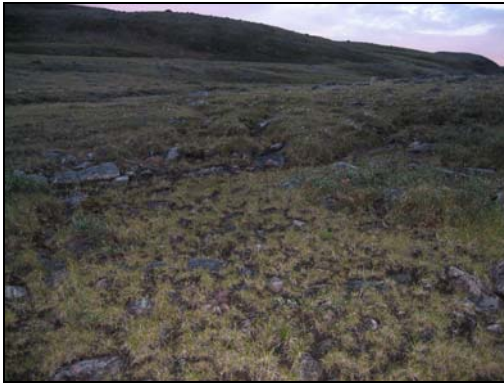
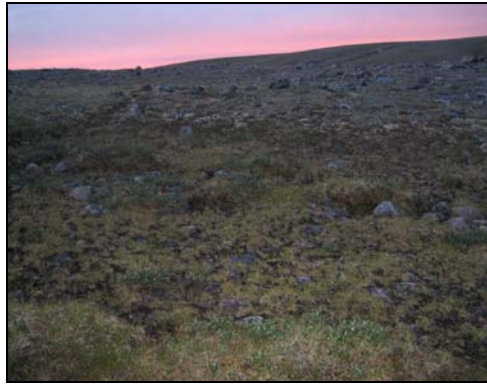
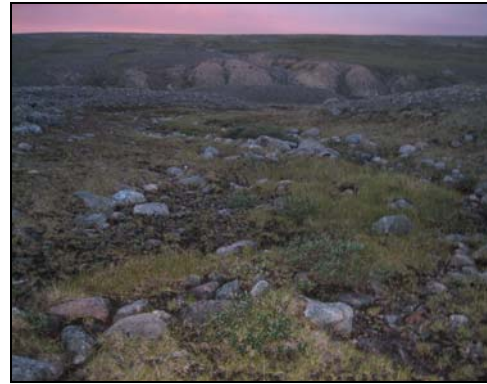
Figure 1. View of habitat, (A) View upstream of crossing, (B) View across crossing from left bank, (C) View downstream of crossing.

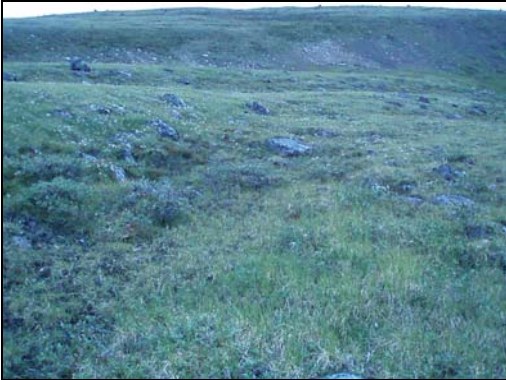
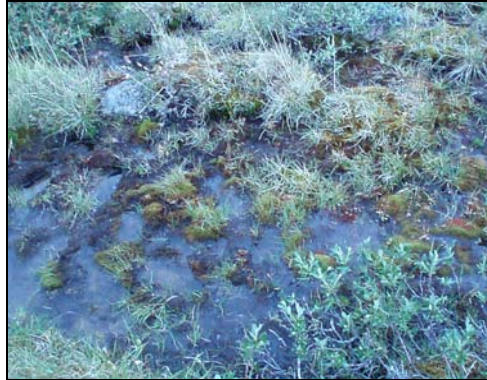
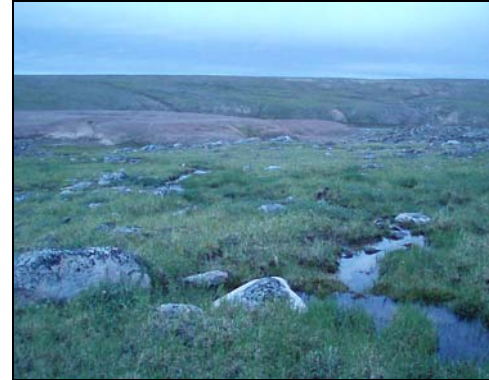
Unlikely fish habitat due to very low water levels and substrate that is entirely flooded terrestrial vegetation. Even at high water levels, fish could not move upstream to crossing due to steep incline downstream that would become a cascade. Barriers present downstream. Bank stability is moderate.

Figure 1. View of habitat, (A) View upstream of crossing, (B) View across crossing from right bank, (C) View downstream of crossing.

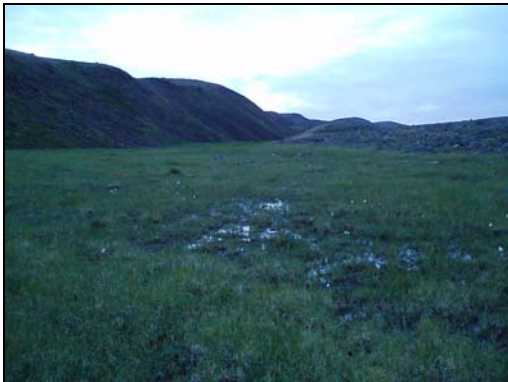
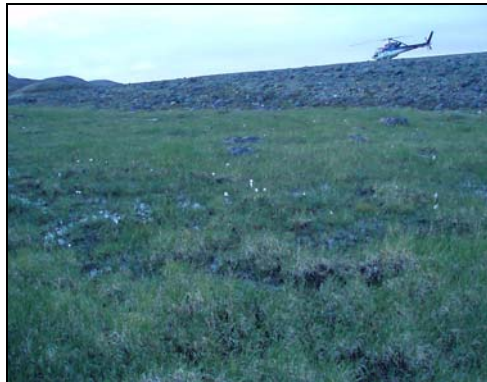
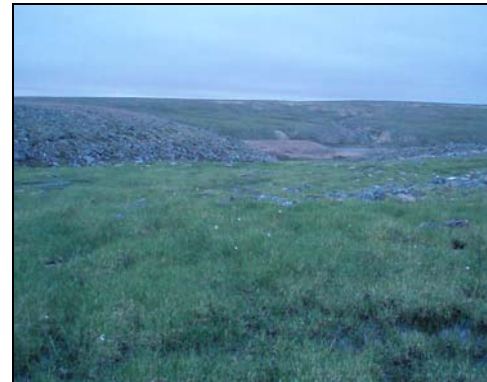
Figure 1. View of habitat, (A) View upstream of crossing, (B) View across crossing from left bank, (C) View downstream of crossing.

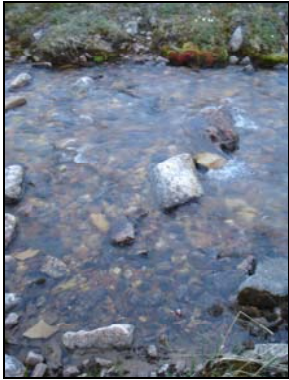
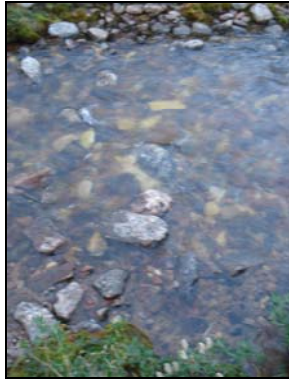
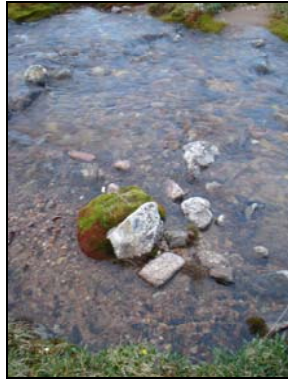
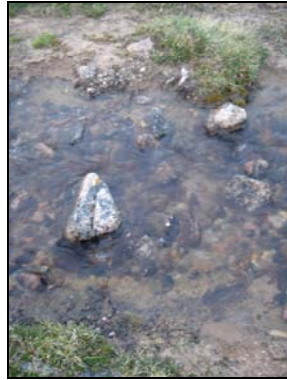
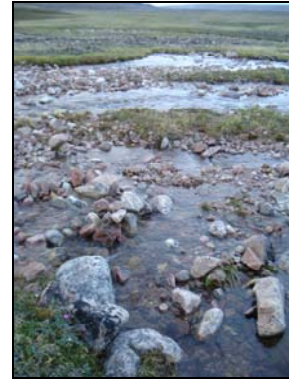
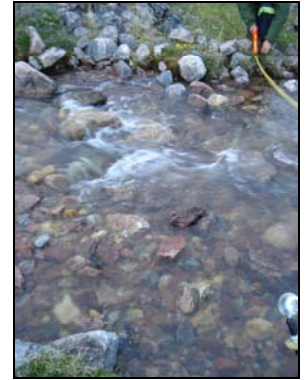
Figure 1. View of habitat 100 (A), 80 (B), 60 (C), 40 (D), and 20 m (E) downstream of crossing, at the crossing (F), and 20 (G), 40 (H), 60 (I), 80 (J), and 100 m (K) upstream of the crossing.

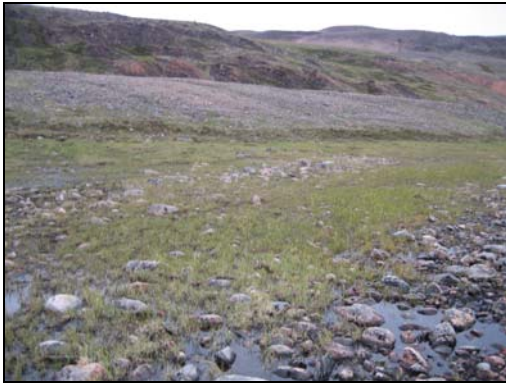
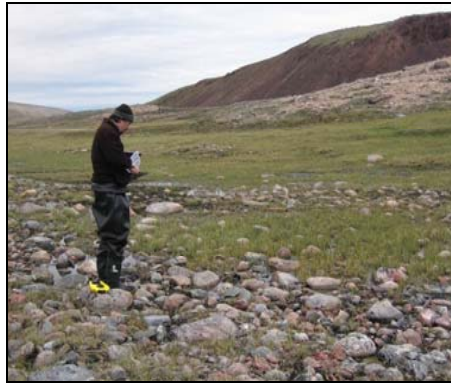
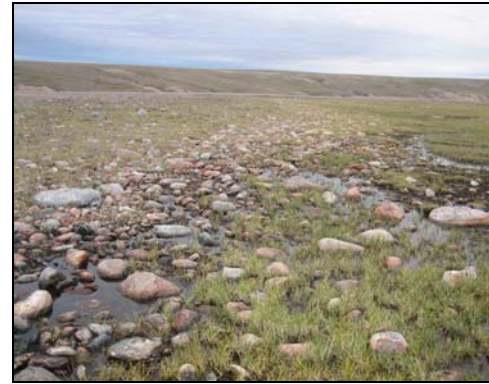
Figure 1. View of habitat, (A) View upstream of crossing, (B) View across crossing from left bank, (C) View downstream of crossing.

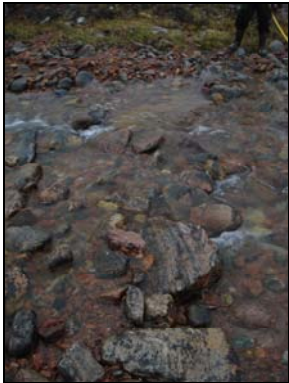
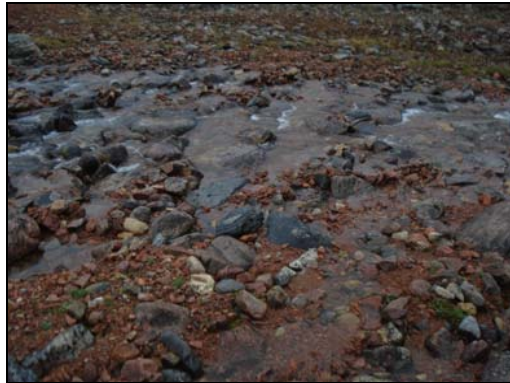
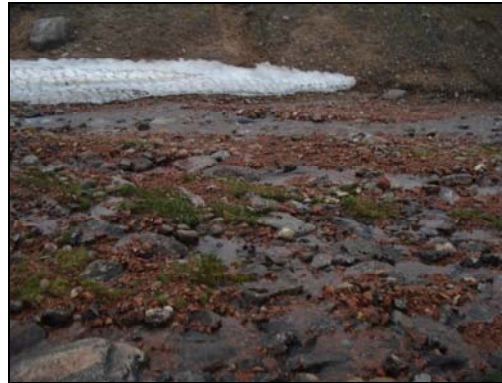
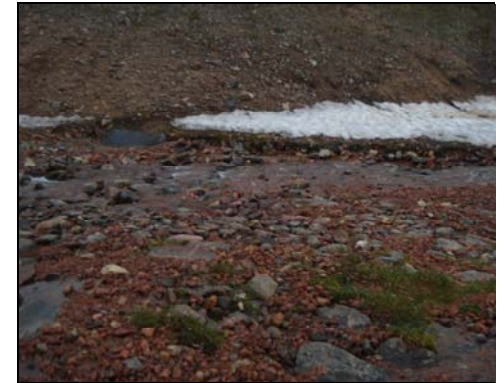
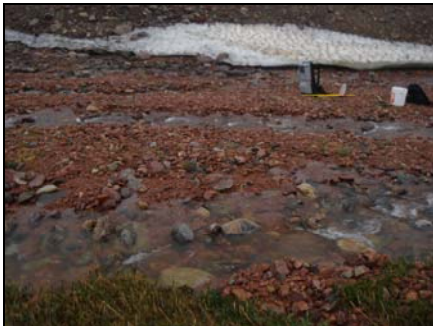
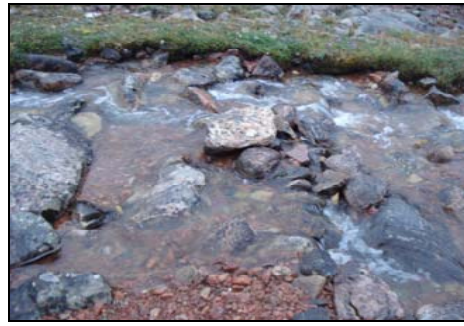
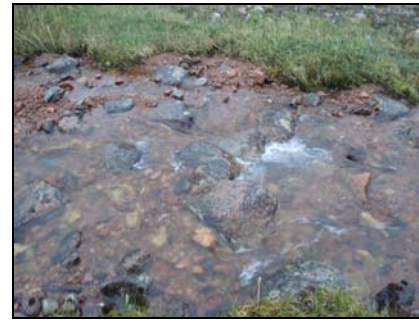
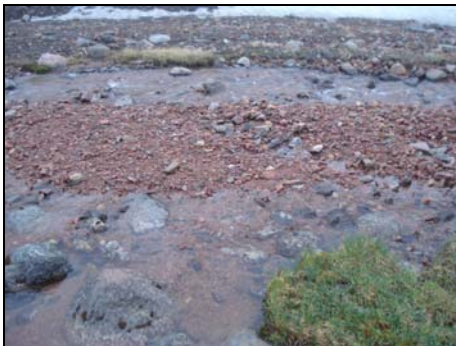
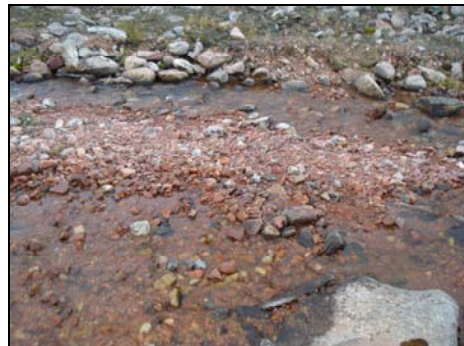
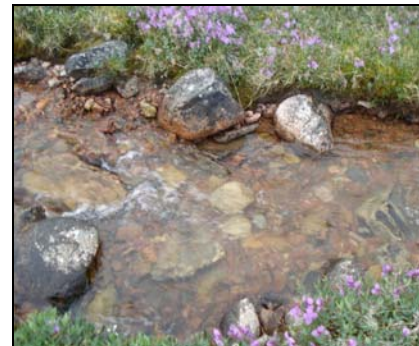
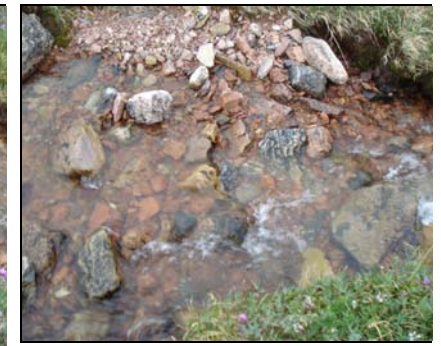
³
Figure 1. View of habitat 100 (A), 80 (B), 60 (C), 40 (D), and 20 m (E) downstream of crossing, at the crossing (F), and 20 (G), 40 (H), 60 (I), 80 (J), and 100 m (K) upstream of the crossing.

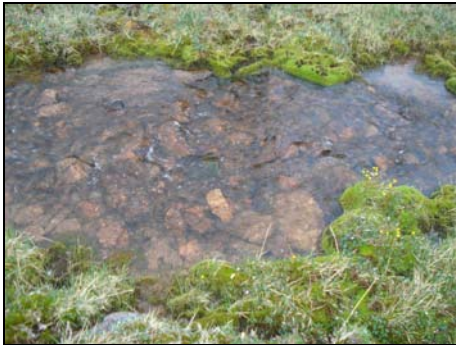
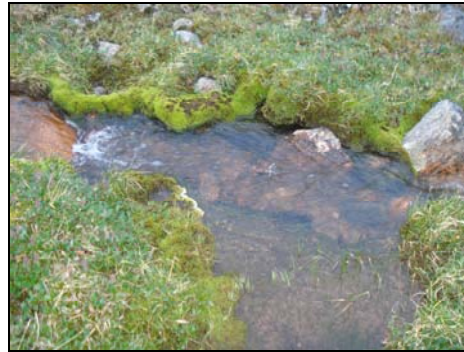
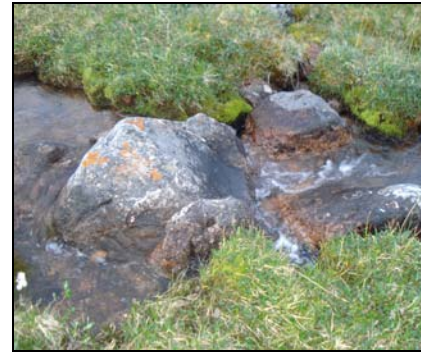
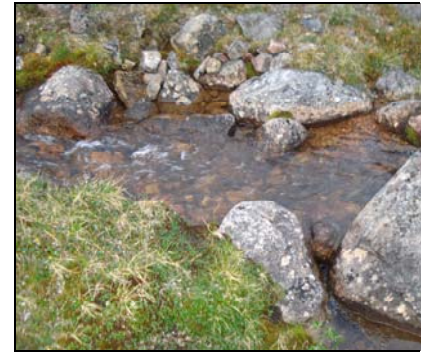
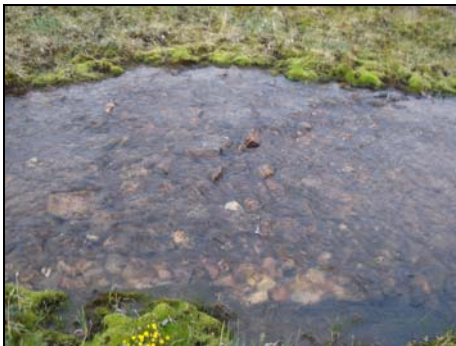
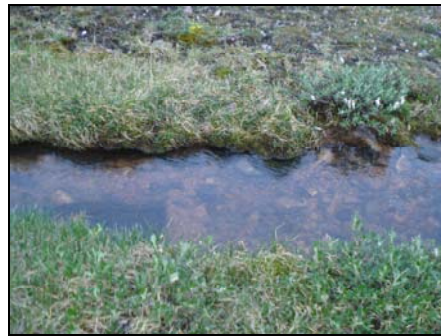
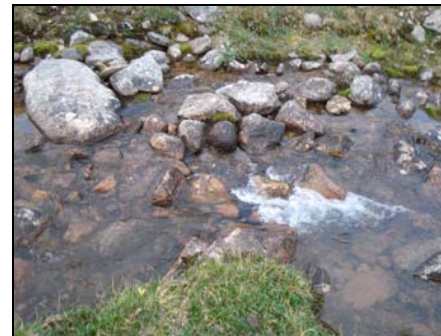
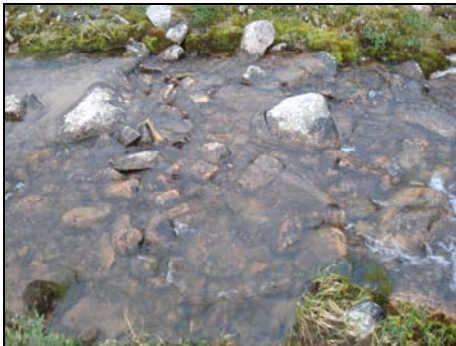
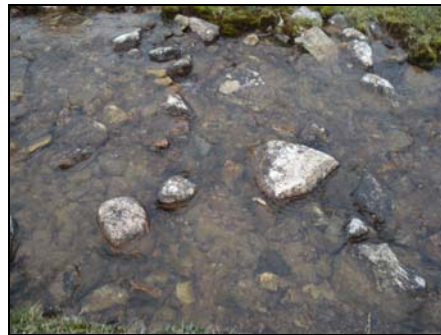
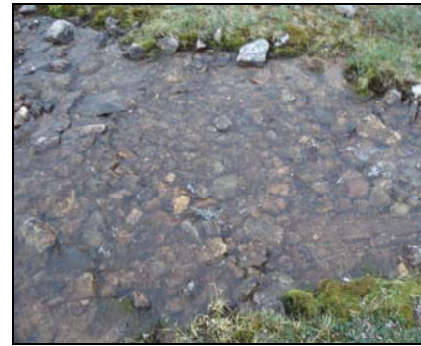
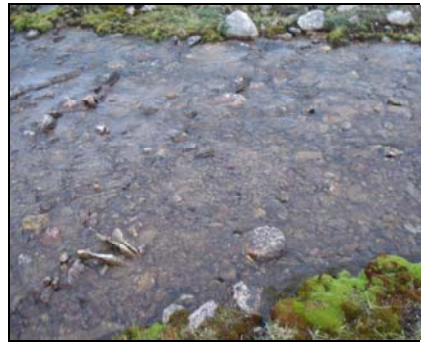
Figure 1. View of habitat 100 (A), 80 (B), 60 (C), 40 (D), and 20 m (E) downstream of crossing, at the crossing (F), and 20 (G), 40 (H), 60 (I), 80 (J), and 100 m (K) upstream of the crossing.

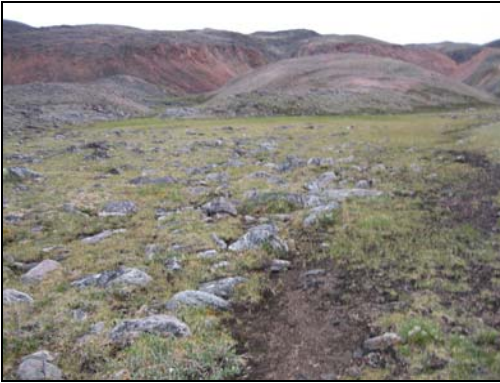
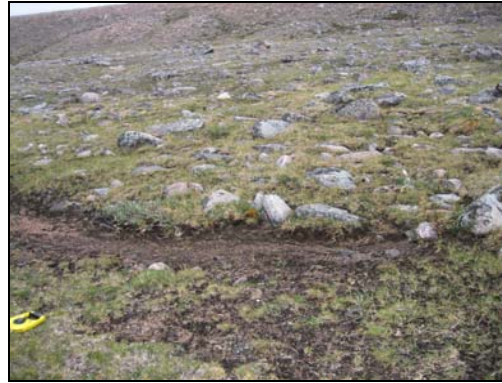
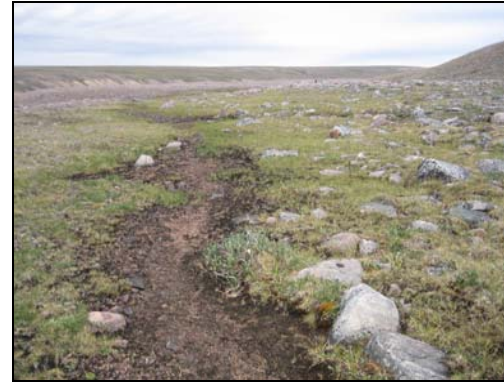
Figure 1. (A) View upstream of crossing, (B) View across crossing from left bank, (C) View downstream of crossing.

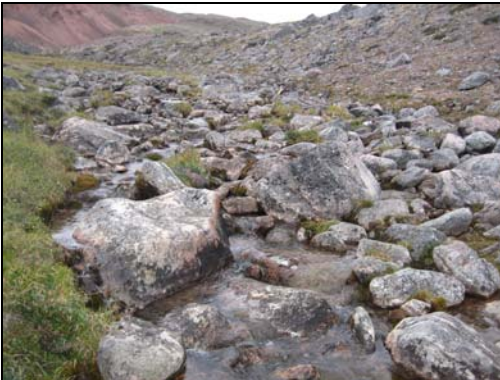
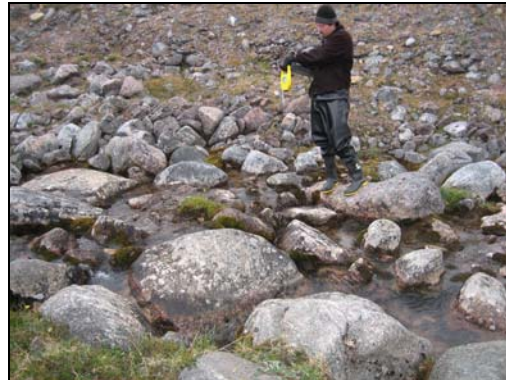
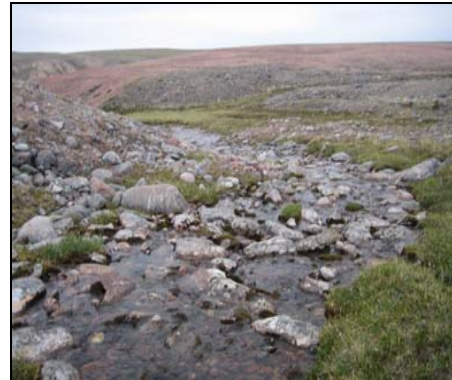
Figure 1. (A) View upstream of crossing, (B) View across crossing from left bank, (C) View downstream of crossing.

Suitable fish habitat is present at the crossing, but access must be denied due to a downstream barrier because there are no fish present.

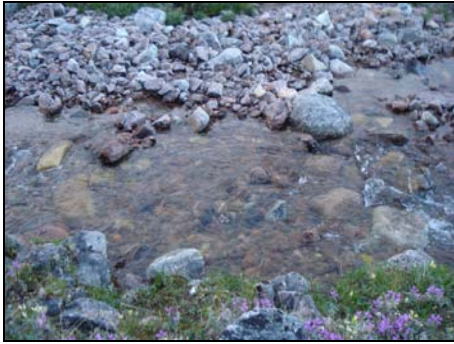
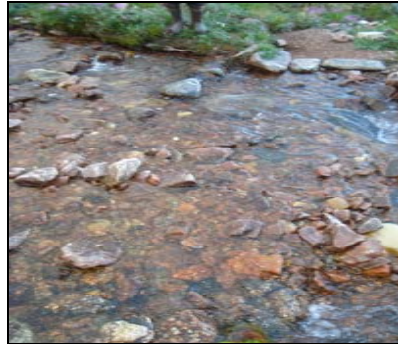
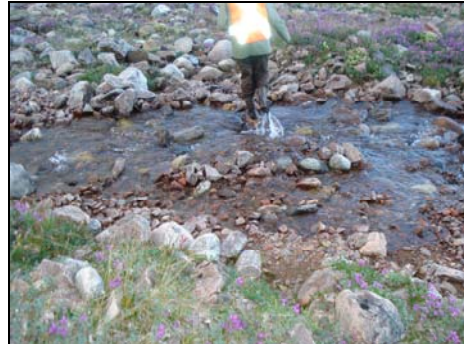
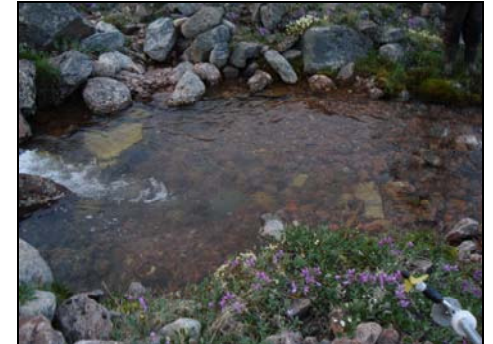
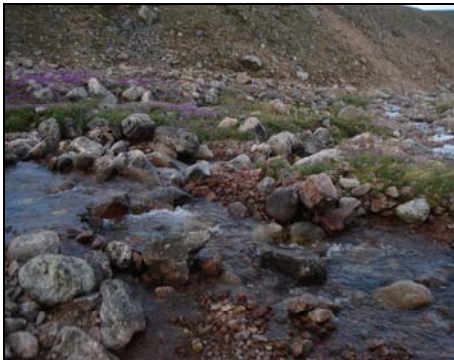
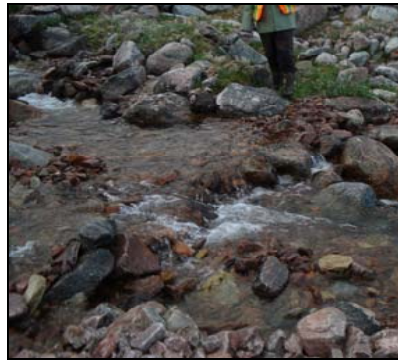
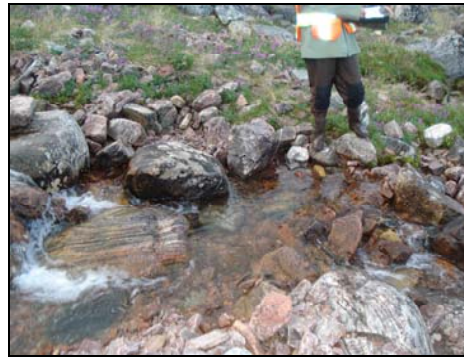
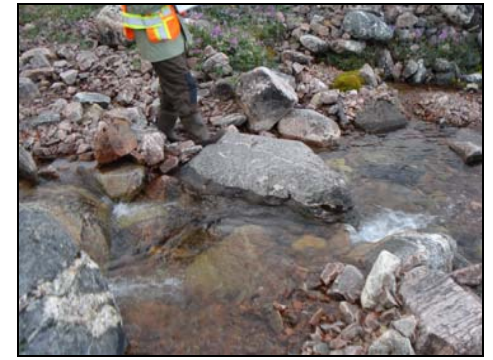
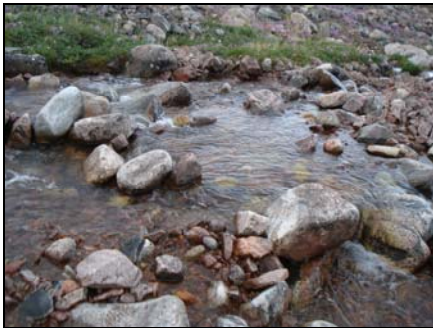
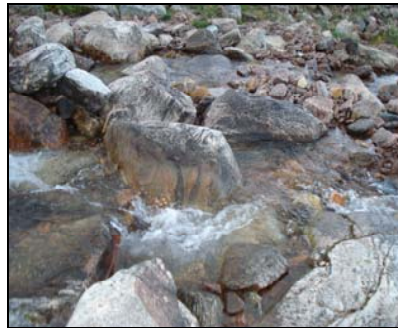
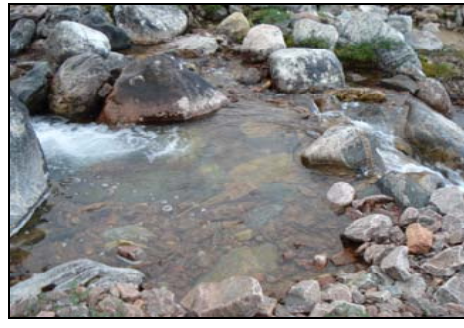
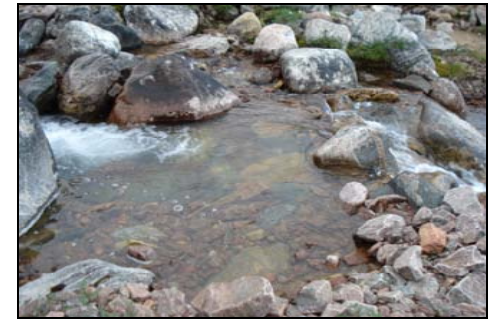
Figure 1. View of habitat 100-channel 1 (A), 80 (B), 60 (C), 40 (D), and 20 m (E) downstream of crossing, at the crossing (F), and 20 (G), 40 (H), 60 (I), 80 (J), and 100 m (K) upstream of the crossing. (A-D are channel 1)

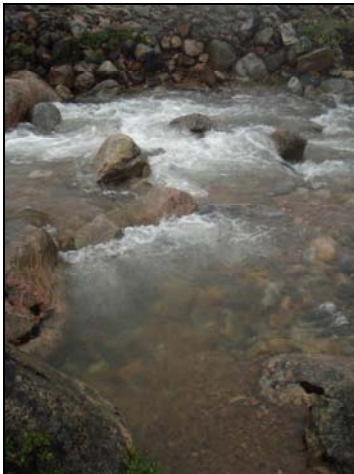
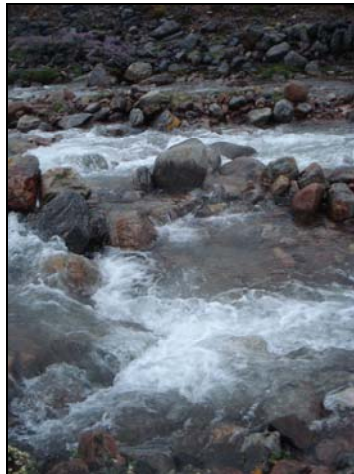
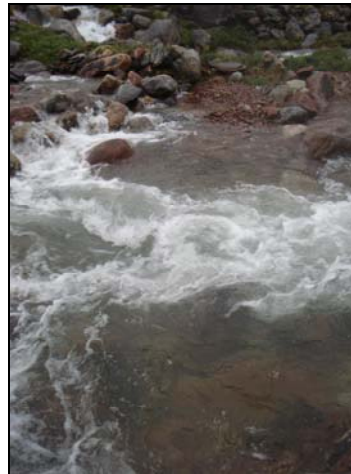
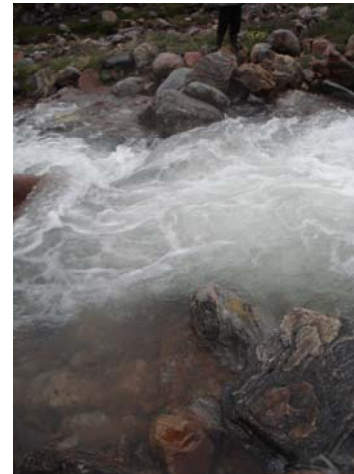
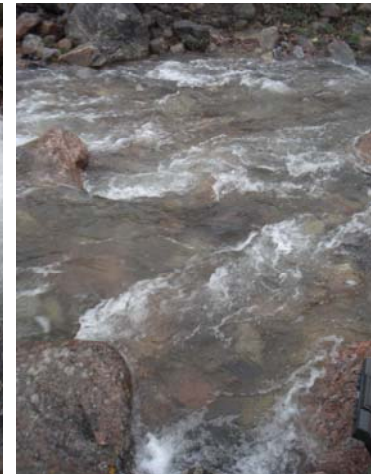
Figure 1: View of habitat 40 (A), and 20 m downstream of crossing (B), at the crossing (C), and 20 (D) and 40 m upstream of crossing (E).

Only larger juveniles can use crossing. At 40 m downstream, there were two channels and 40 m upstream pictures were taken from the right bank.
