**HABITAT ASSESSMENT PROTOCOL AND SAMPLE
DATA SHEET USED FOR DESCRIBING AVAILABLE
AQUATIC HABITAT IN WATERCOURSES IN THE
RAILWAY/ACCESS ROAD AREA.**

MARY RIVER PROJECT RAILWAY/ACCESS ROAD WATERCOURSE CROSSING ASSESSMENT PROTOCOL

North/South Consultants Inc. and Knight Piésold Ltd.

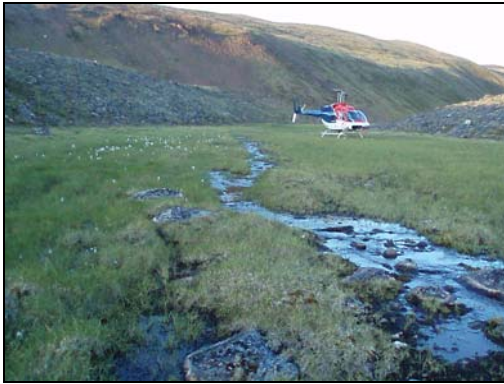
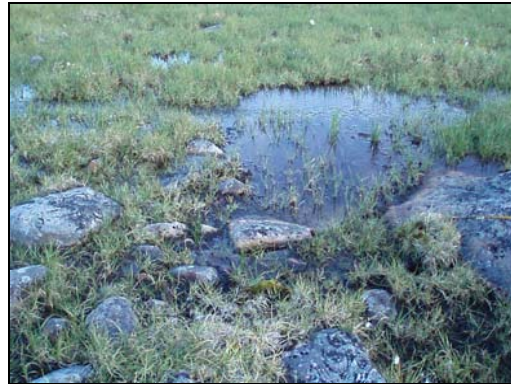
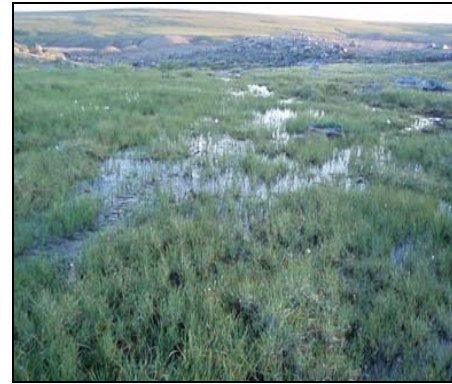
Figure 1. (A) View upstream of crossing, (B) View across crossing from left bank, (C) View downstream of crossing.

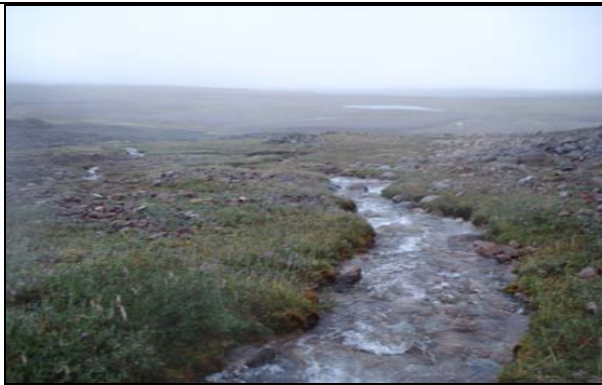
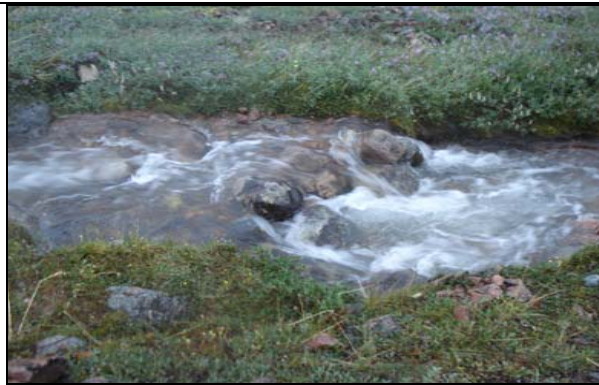
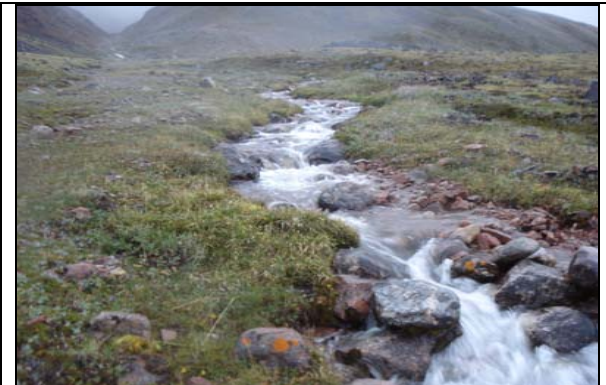
Figure 1. View of habitat downstream of crossing (A), at the crossing (B), and upstream of crossing (C).

The stream contains excellent fish habitat. Downstream barrier approximately 50m long at UTM 17 W 578121 7902674.

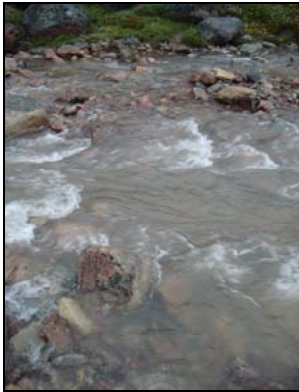
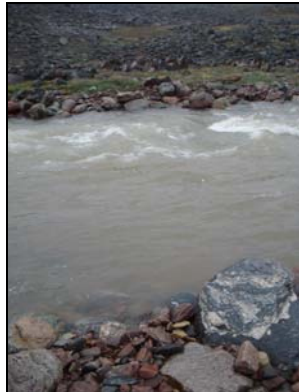
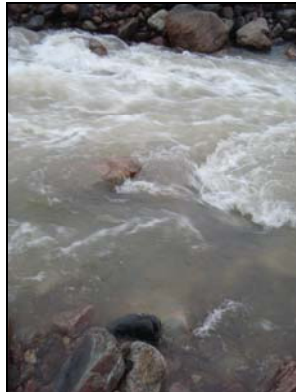
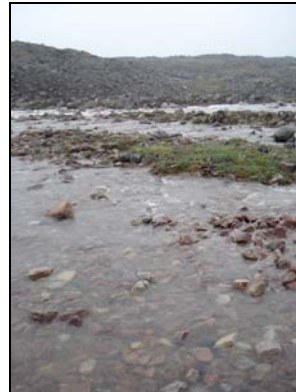
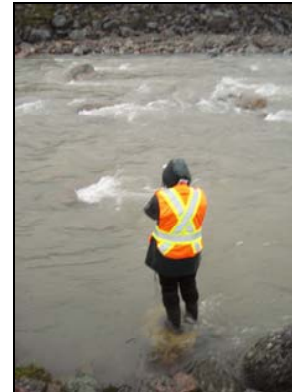
Figure 1. View of habitat 40 (A), and 20 m downstream of crossing (B), at the crossing (C), and 20 (D), and 40 m upstream of crossing (E). (A-C pictures are from Channel 1).

At 40 D/S water too fast to get across to measure.

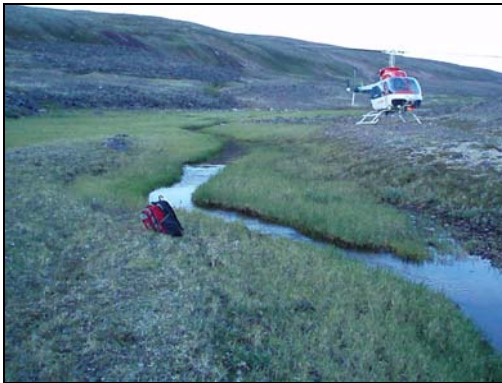
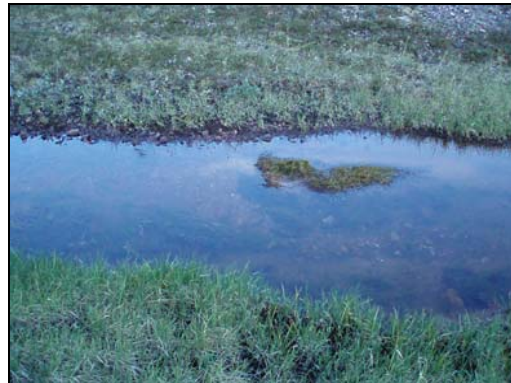
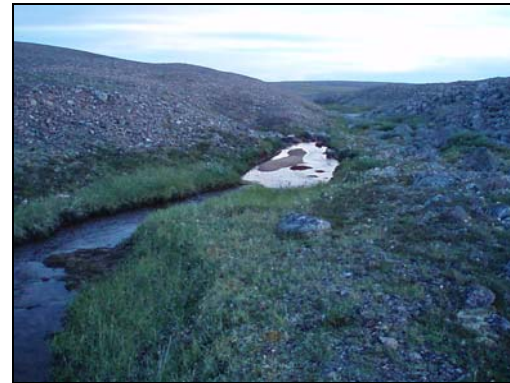
Figure 1. (A) View upstream of crossing, (B) View across crossing from left bank, (C) View downstream of crossing.

Excellent habitat for NNST, but downstream of the crossing the water flows beneath boulders. The area near the crossing is, therefore, inaccessible. Lake present downstream.

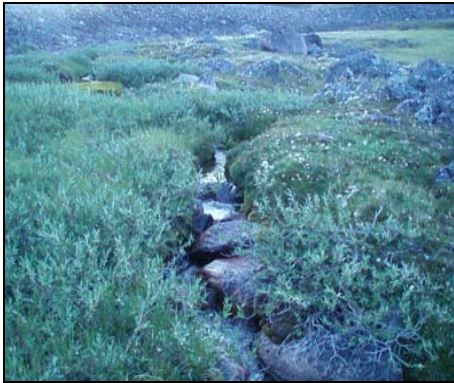
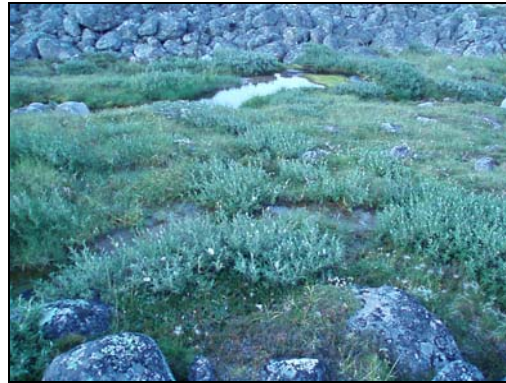
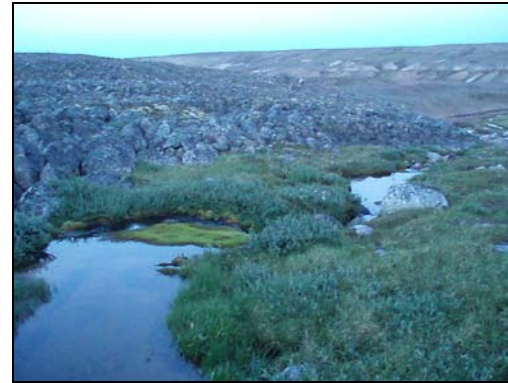
Figure 1. (A) View upstream of crossing, (B) View across crossing from left bank, (C) View downstream of crossing.

Ideal ARCH and NNST habitat present at the crossing, but due to a downstream cascade and low water levels, fish would be unable to reach the crossing site. During periods of high water, larger juvenile ARCH may be able to move upstream of the cascades to the crossing. Many juvenile ARCH were observed DS of the barrier.

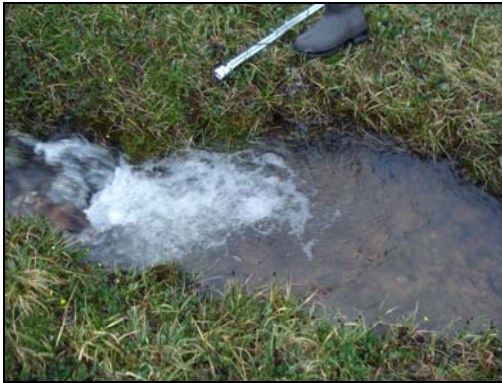
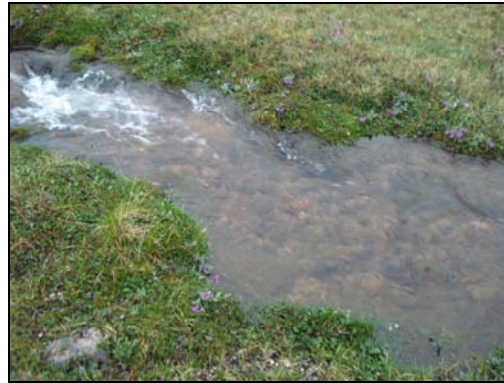
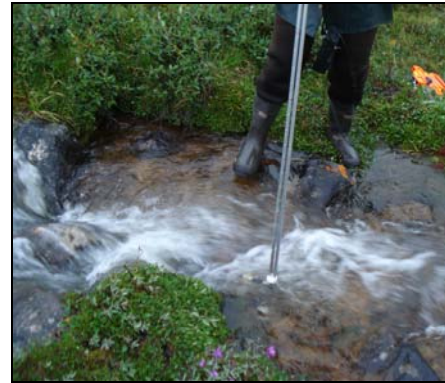
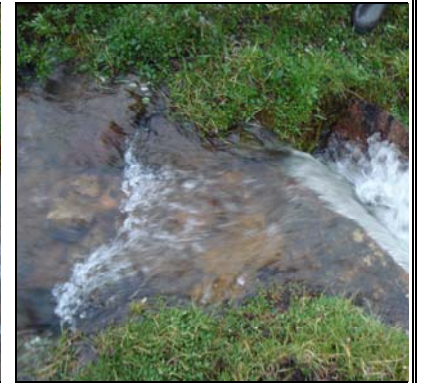
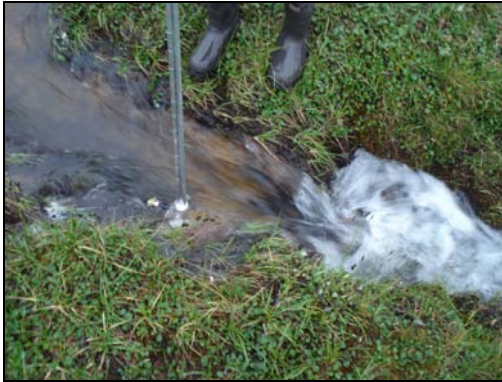
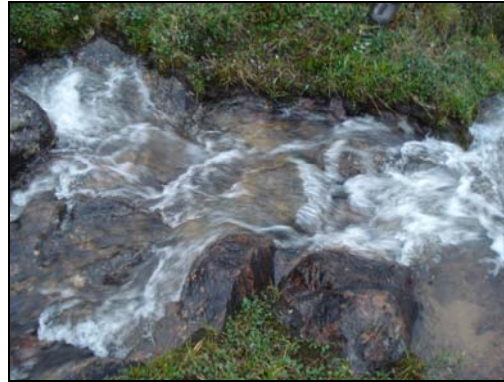
Figure 1. View of habitat 100 (A), 60 (B), and 20 m (C), downstream of crossing, at the crossing (D), 20 (E), and 60 m (F) upstream of the crossing.

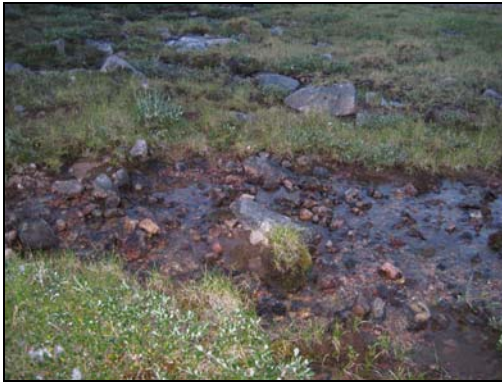
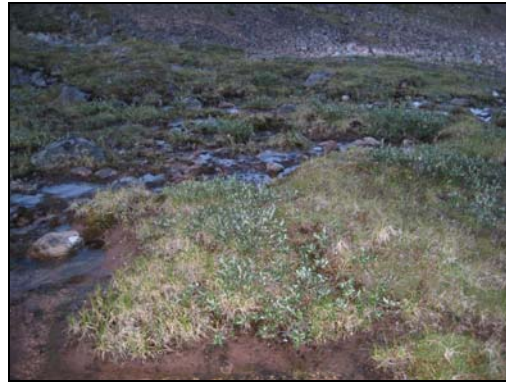
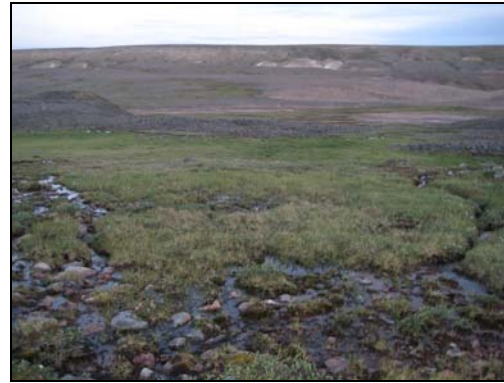
Figure 1. (A) View upstream of crossing, (B) View across crossing from left bank, (C) View downstream of crossing.

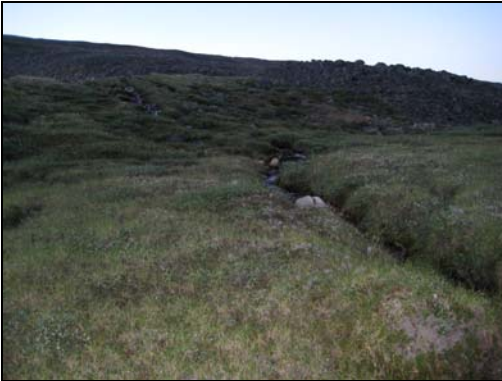
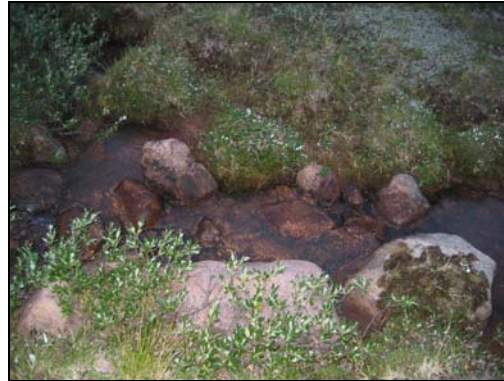
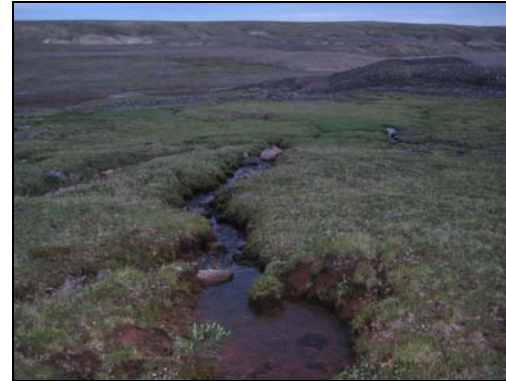
Figure 1. (A) View upstream of crossing, (B) View across crossing from left bank, (C) View downstream of crossing.

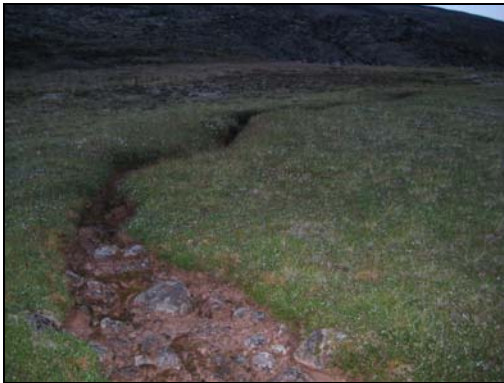
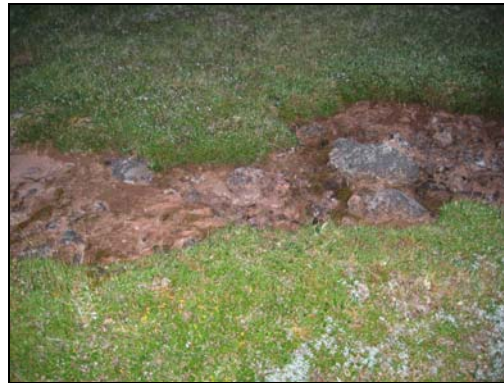
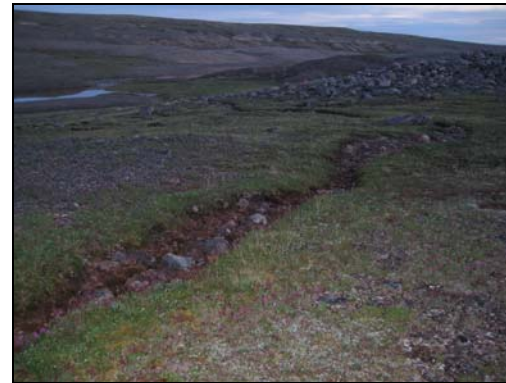
Figure 1. (A) View upstream of crossing, (B) View across crossing from left bank, (C) View downstream of crossing.

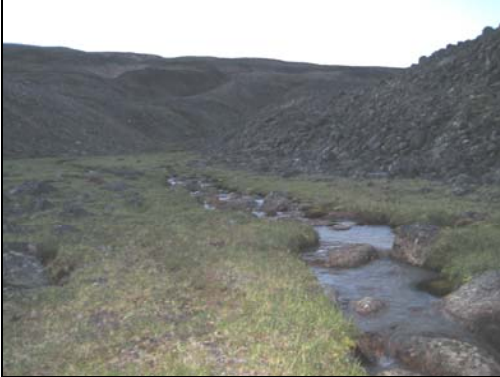
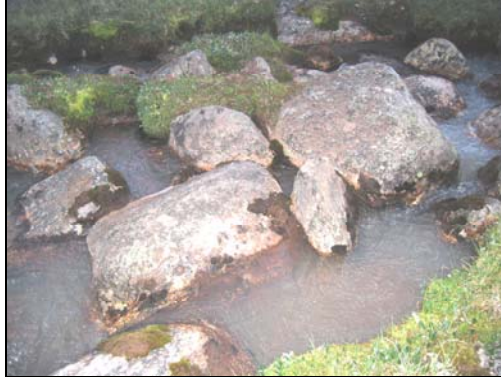
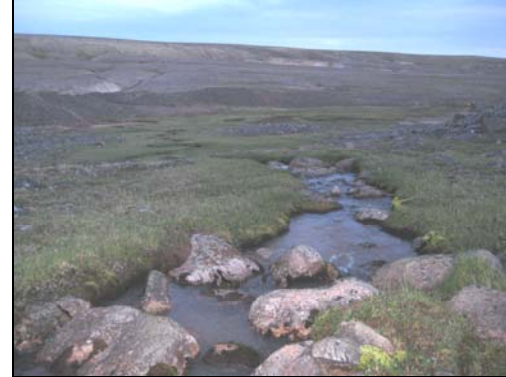
Figure 1. (A) View upstream of crossing, (B) View across crossing from left bank, (C) View downstream of crossing.

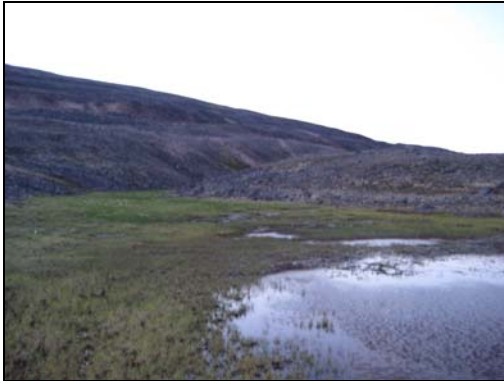
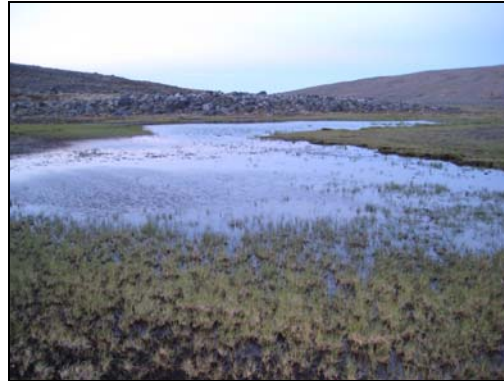
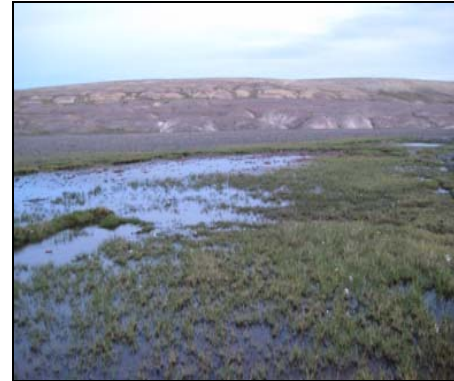
Figure 1. (A) View upstream of crossing, (B) View across crossing from left bank, (C) View downstream of crossing.

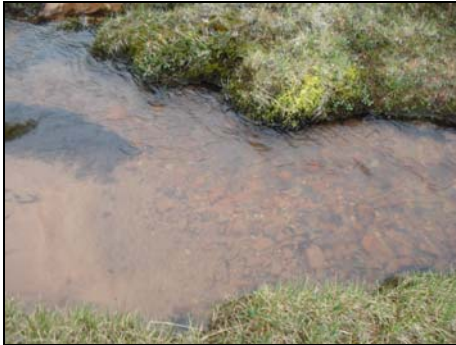
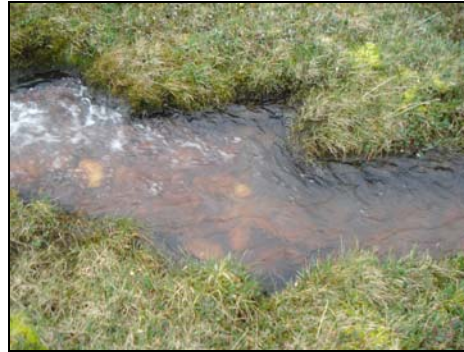
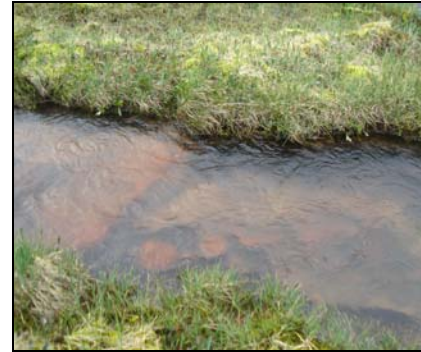
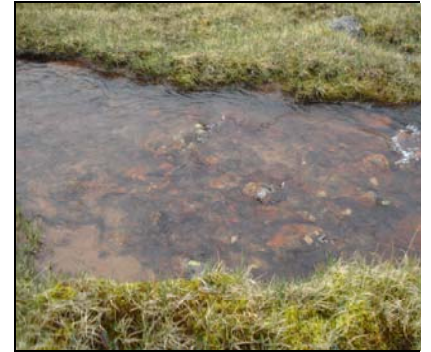
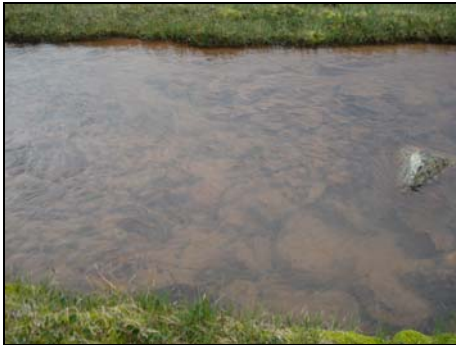
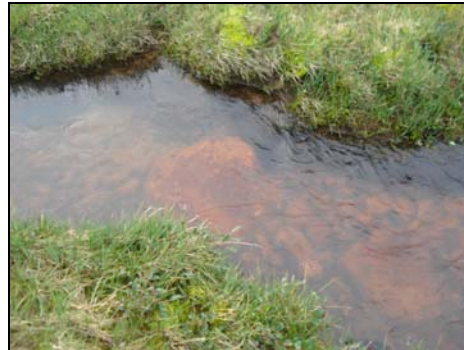
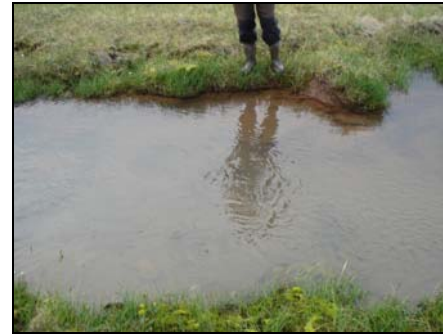
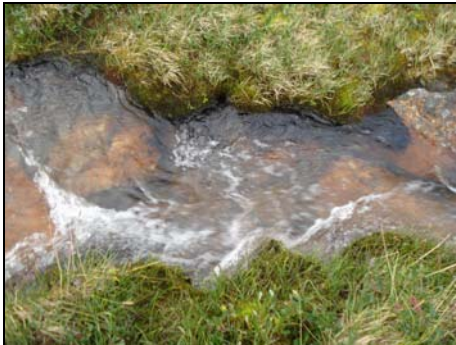
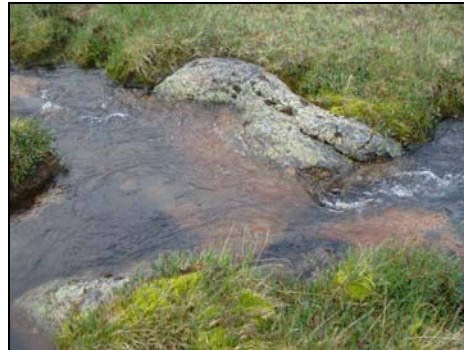
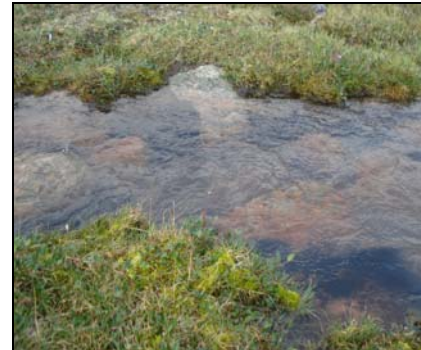
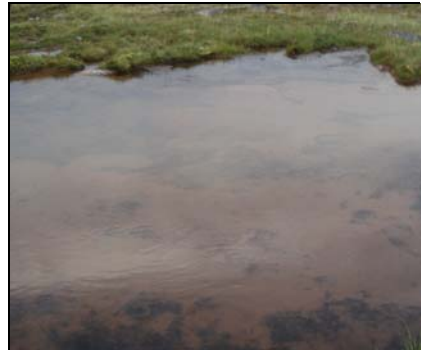
Figure 1. View of habitat 100 (A), 80 (B), 60 – left channel (C), 40 – left channel (D), and 20 m (E) downstream of crossing, at the crossing (F), and 20 (G), 40 (H), 60 (I), 80 (J), and 100 m (K) upstream of the crossing.

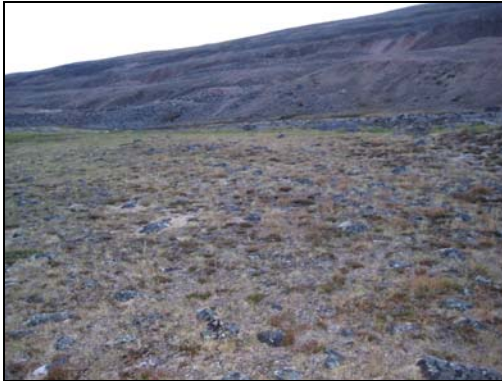
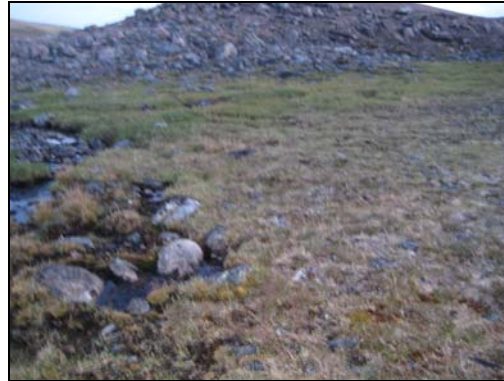
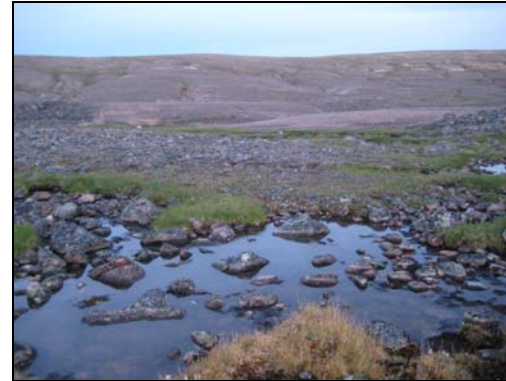
Figure 1. (A) View upstream of crossing, (B) View across crossing from left bank, (C) View downstream of crossing.

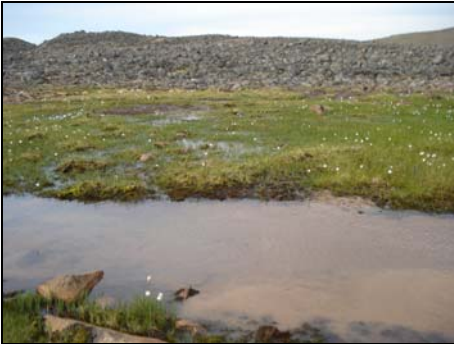
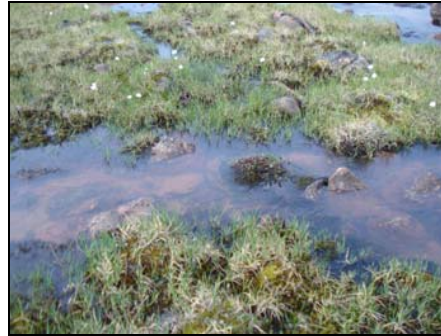
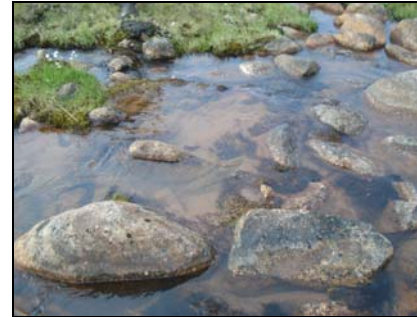
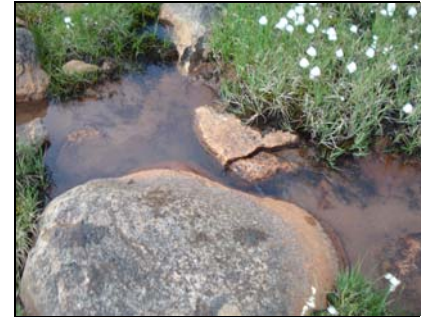
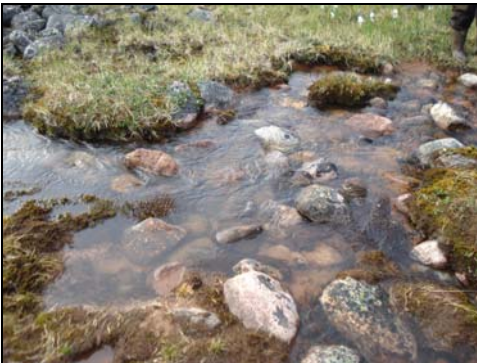
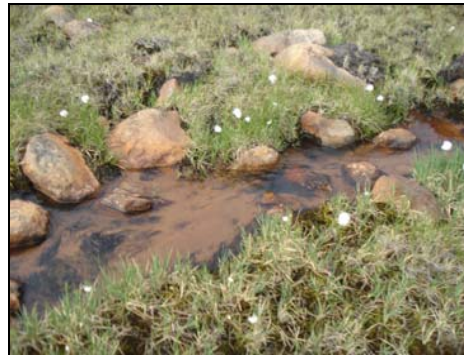
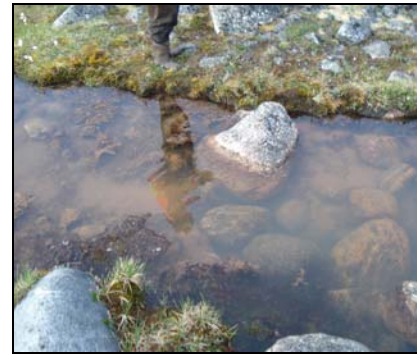
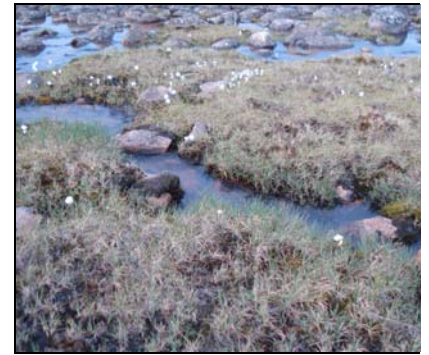
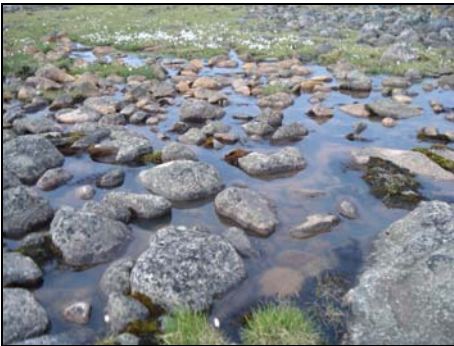
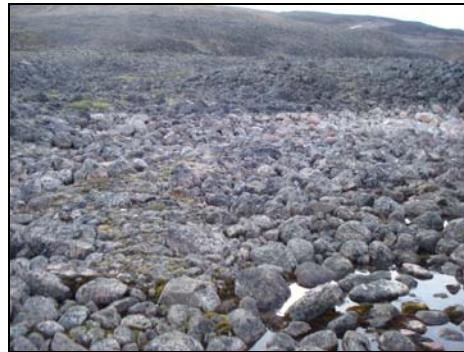
Figure 1. View of habitat at the crossing in the left (A) and right (B) channels, 10 m upstream in the left (C) and right (D) channels, 20 m US in the left (E) and right (F) channels, 30 m US in the left (G) and right (H) channels, 40 m US (I), and of the fish barrier (J) upstream of the crossing.

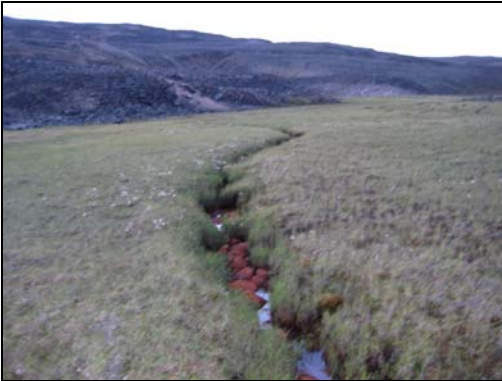
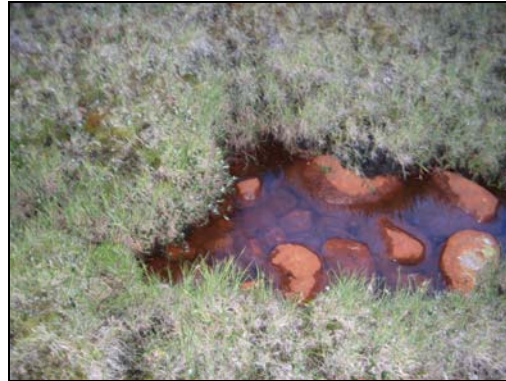
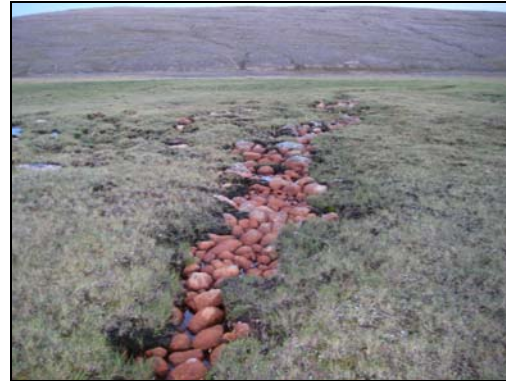
Figure 1. (A) View upstream of crossing, (B) View across crossing from left bank, (C) View downstream of crossing.

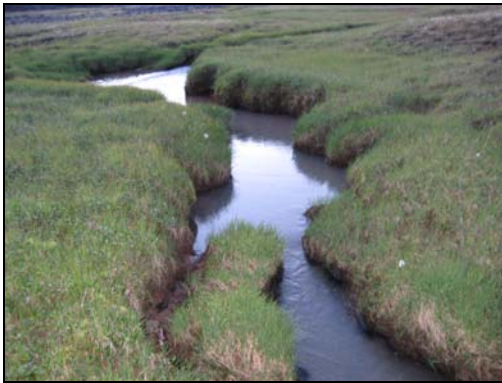
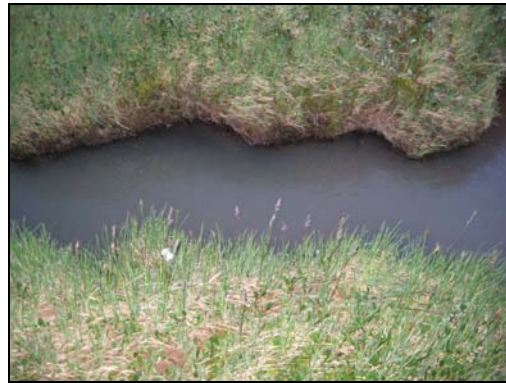
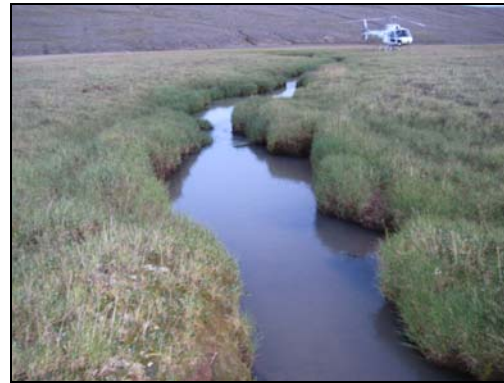
Figure 1. (A) View upstream of crossing, (B) View across crossing from left bank, (C) View downstream of crossing.

Water at the site is turbid, and the substrate is not ideal for fish. Juvenile ARCH are present at the crossing, but may not use this habitat preferentially. As long as there are no barriers preventing their upstream migration, NNST may also be present (habitat is more suitable for this species).

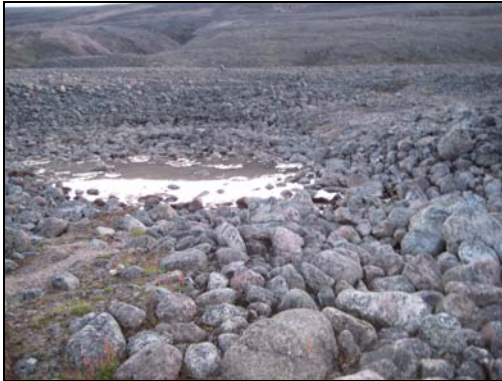
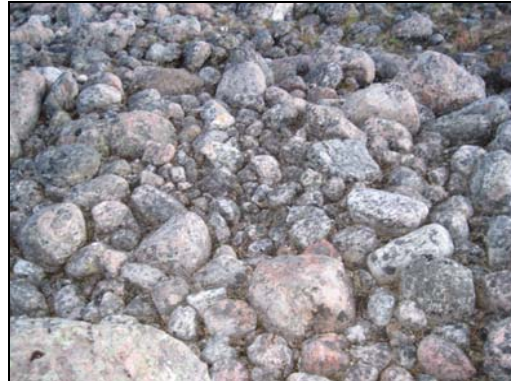
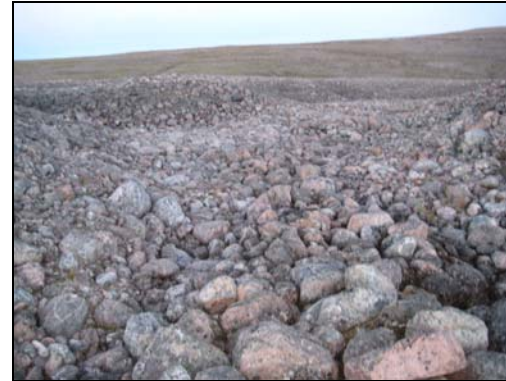
Figure 1. (A) View upstream of crossing, (B) View across crossing from left bank, (C) View downstream of crossing.

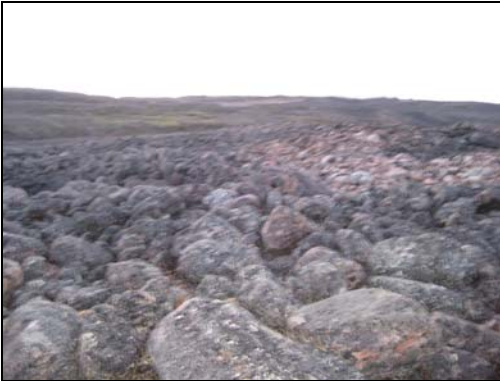
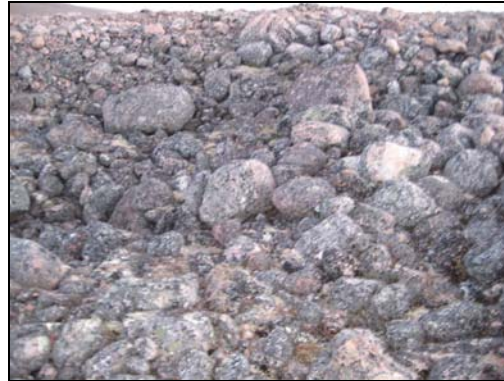
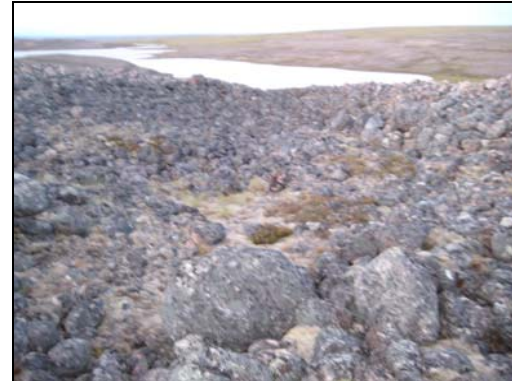
Figure 1. (A) View upstream of crossing, (B) View across crossing from right bank, (C) View downstream of crossing.

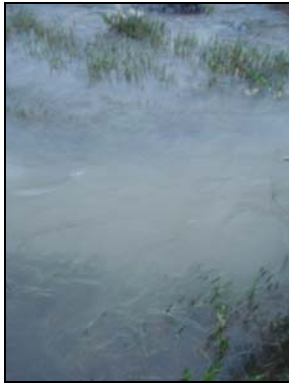
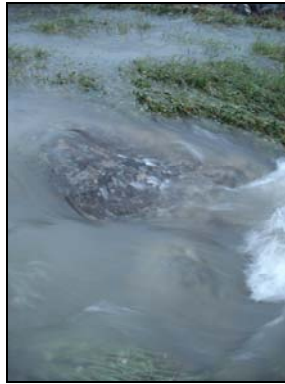
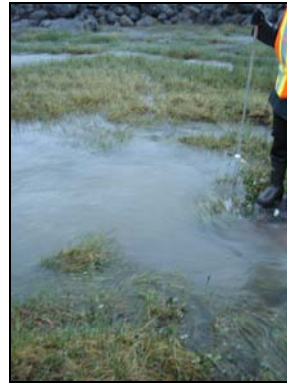
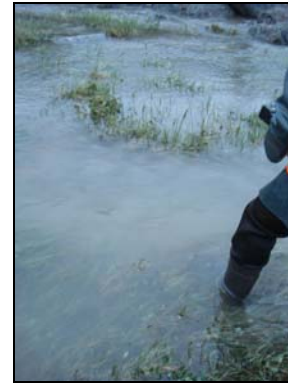
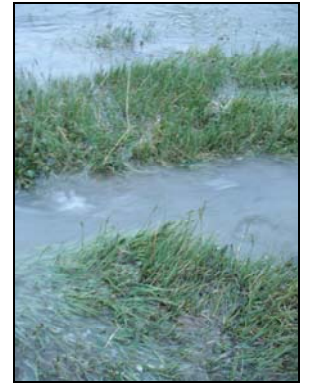
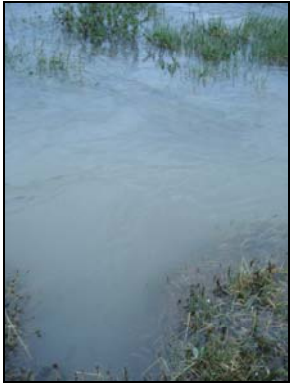
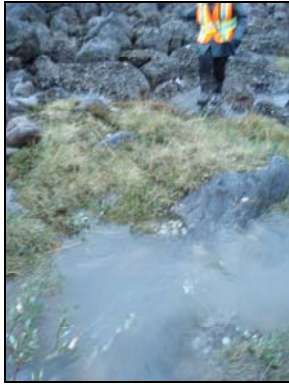
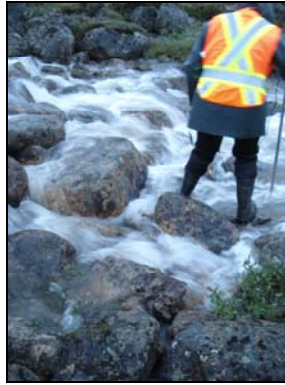
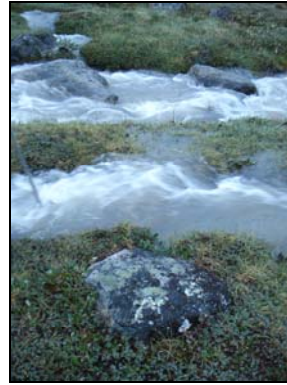
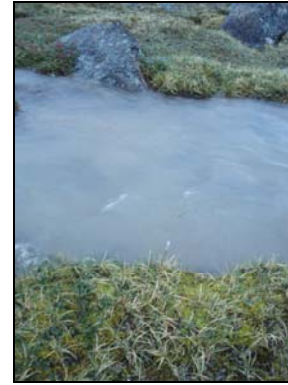
Figure 1. View of habitat 100 (A), 80 (B), 60 (C), 40 (D), and 20 m (E) downstream of crossing, at the crossing (F), and 20 (G), 40 (H), 60 (I), 80 (J), and 100 m (K) upstream of the crossing.

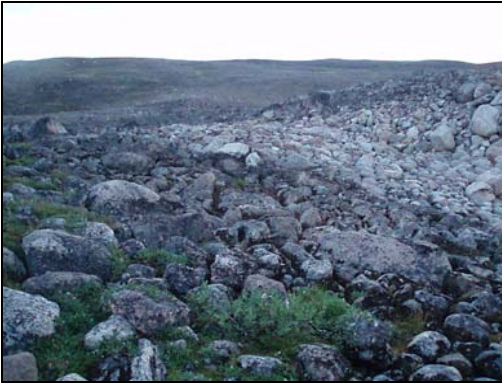
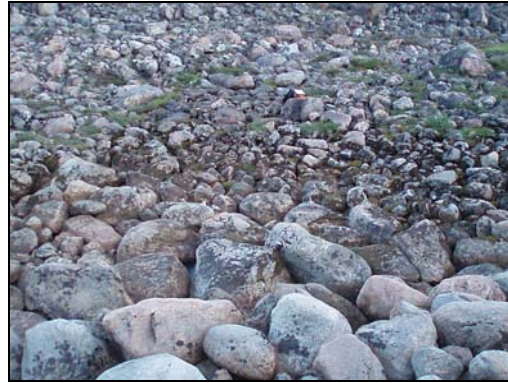
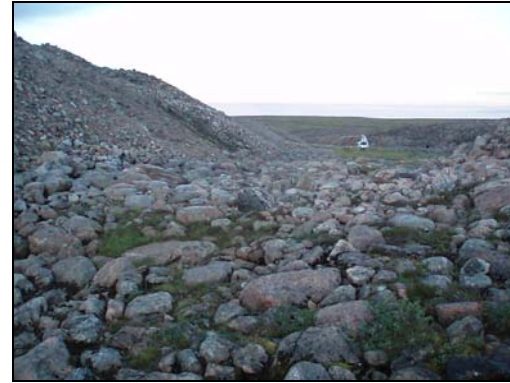
Figure 1. (A) View upstream of crossing, (B) View across crossing from right bank, (C) View downstream of crossing.

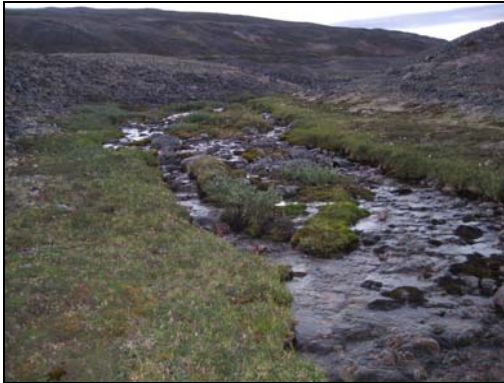
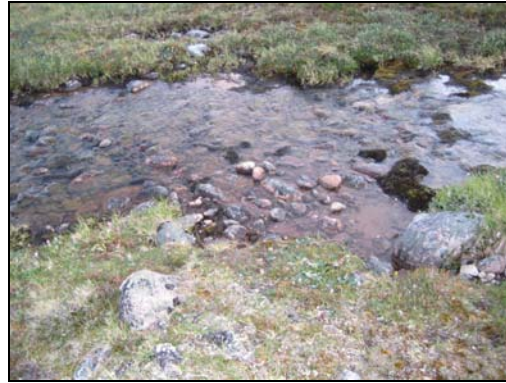
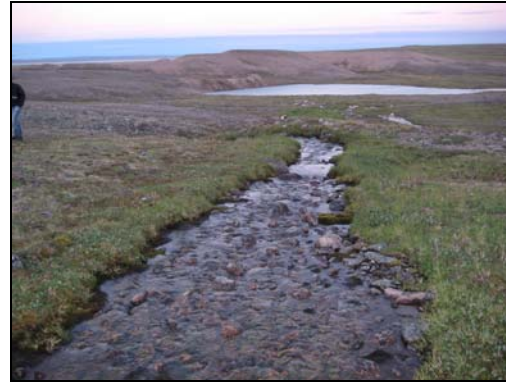
Figure 1. (A) View upstream of crossing, (B) View across crossing from right bank, (C) View downstream of crossing.

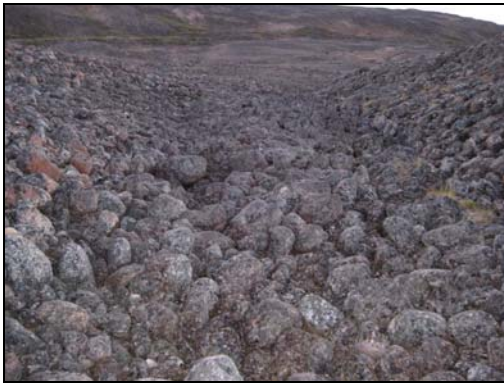
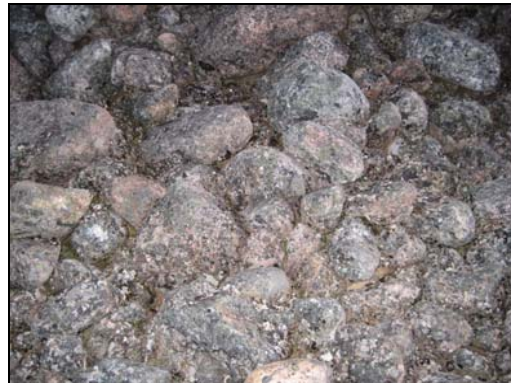
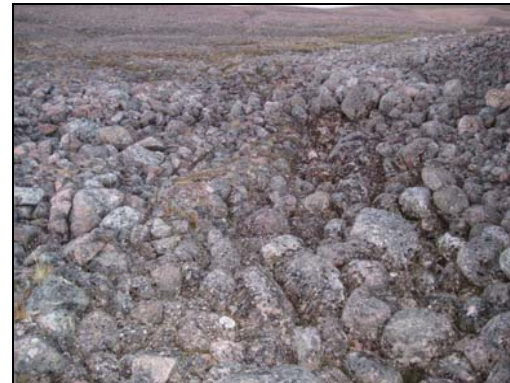
Figure 1. (A) View upstream of crossing, (B) View across crossing from right bank, (C) View downstream of crossing.

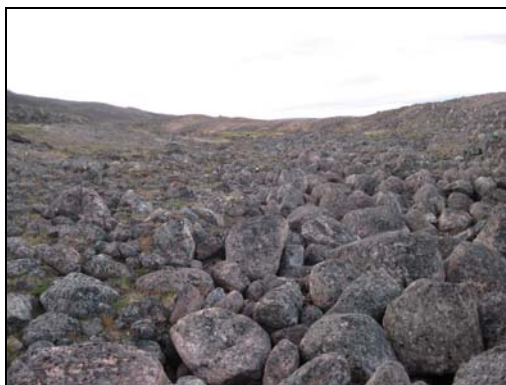
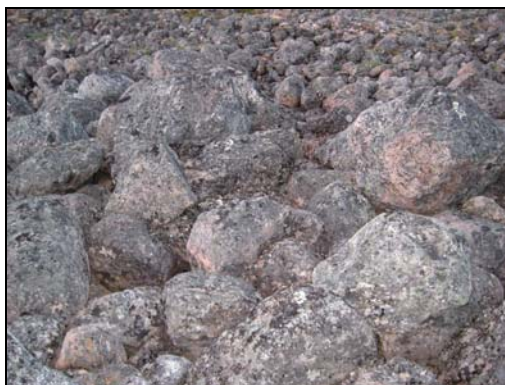
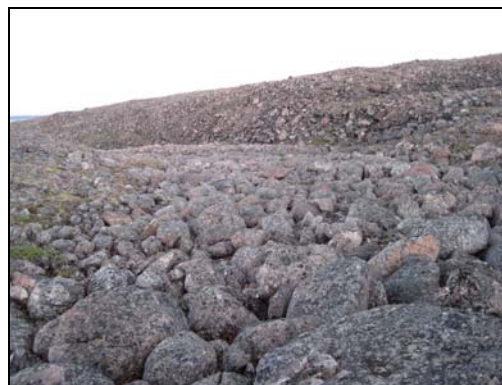
Figure 1. (A) View upstream of crossing, (B) View across crossing from left bank, (C) View downstream of crossing.

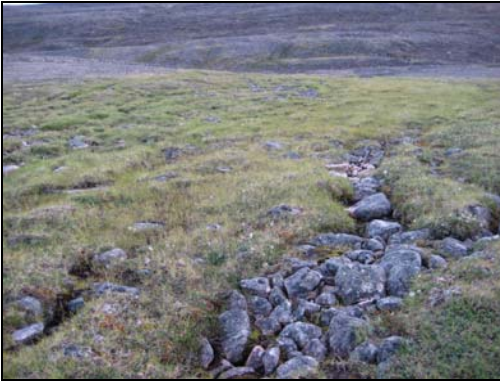
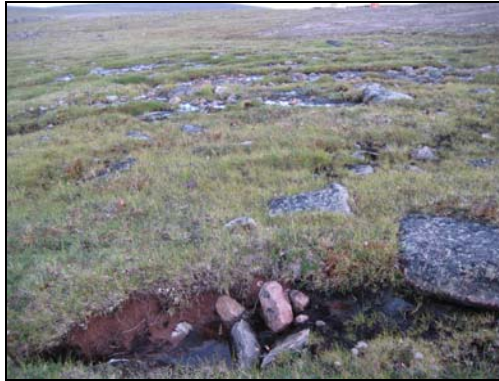
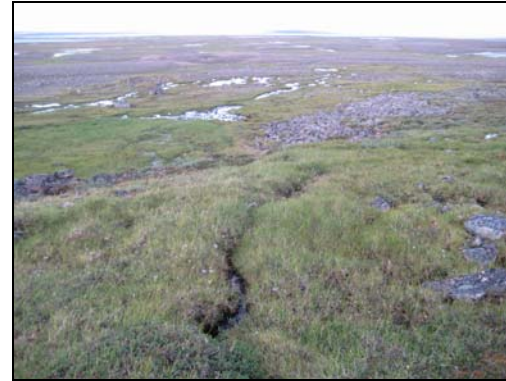
Figure 1. (A) View upstream of crossing, (B) View across crossing from right bank, (C) View downstream of crossing.

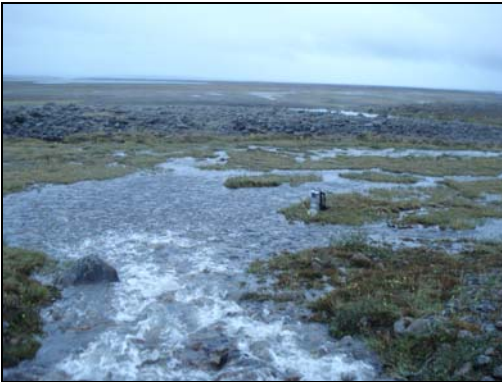
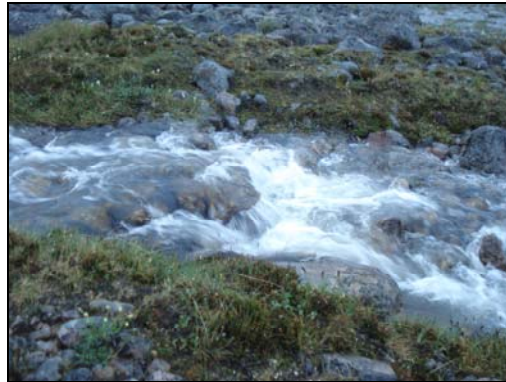
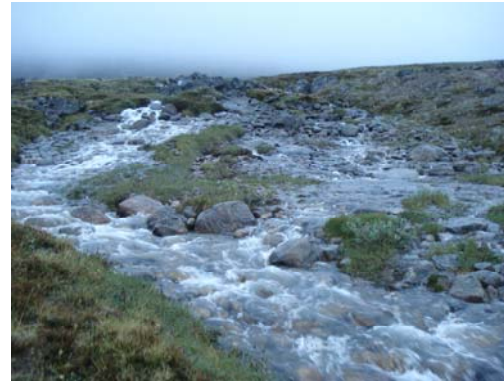
Figure 1. View of habitat downstream of crossing (A), at the crossing (B), and upstream of the crossing (C).

No fish captured for at least 300m D/S. Barrier of high gradient and little surface water exists further downstream.

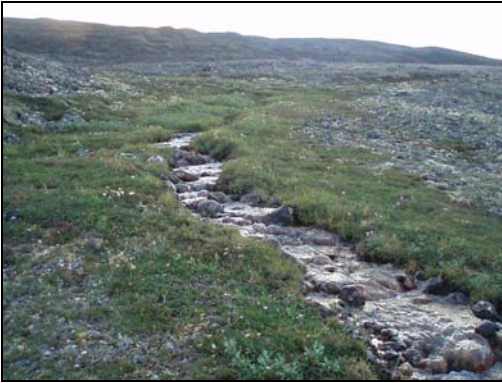
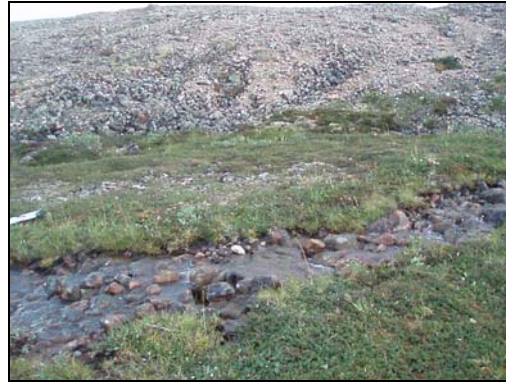
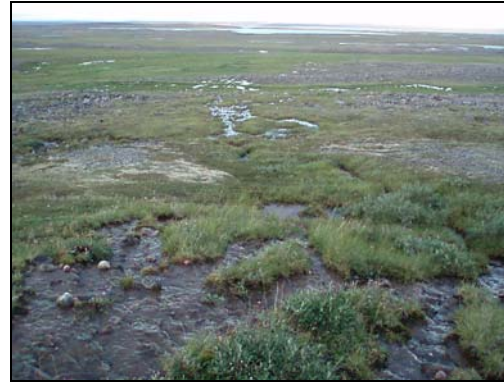
Figure 1. (A) View upstream of crossing, (B) View across crossing from right bank, (C) View downstream of crossing.

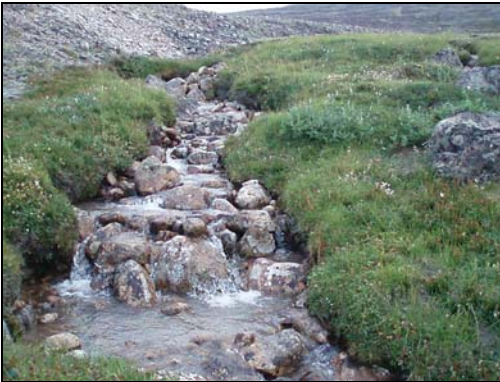
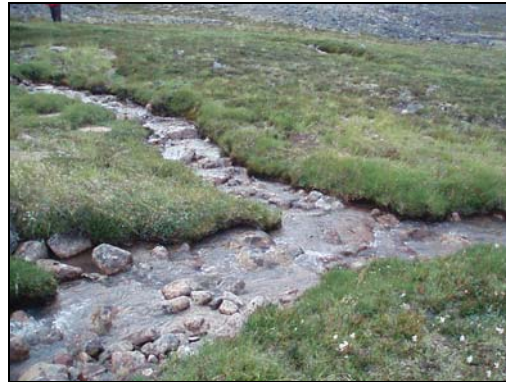
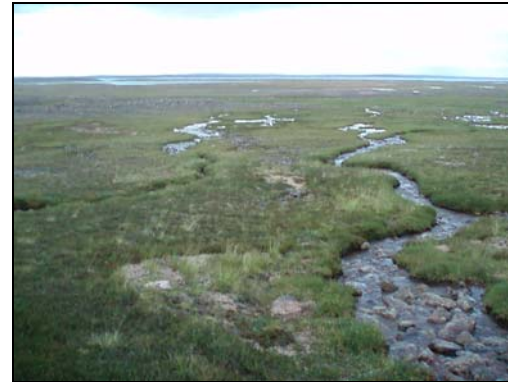
Figure 1. View of habitat upstream of crossing (A), crossing from left bank (B), and downstream of crossing (C).

Habitat at the crossing and downstream are suitable for ARCH, although the water is a little turbid. It is not ideal NNST habitat. One ARCH was observed below some cascades. Steep cascades at the crossing and low water levels prevent further upstream movement. Bank stability was high. Stream cover was 5% boulder and 5% deep pool.

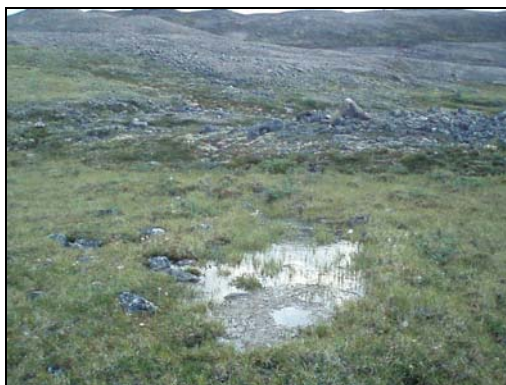
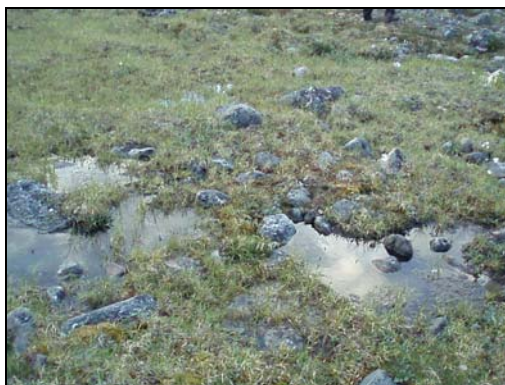
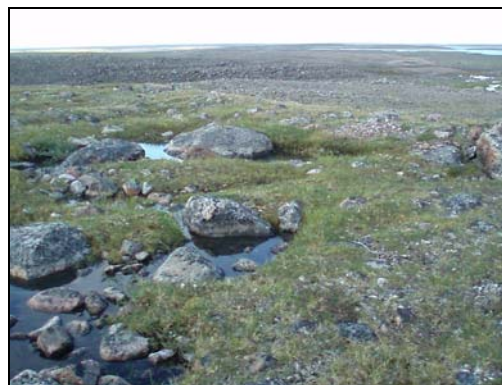
Figure 1. (A) View upstream of crossing, (B) View across crossing from the left bank, (C) View downstream of crossing.

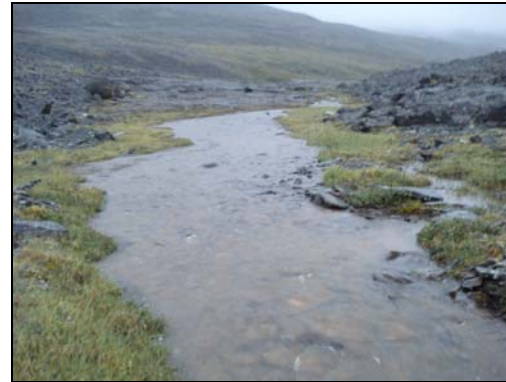
C

Figure 1. View of habitat downstream of crossing (A), at the crossing (B), and upstream of the crossing (C).

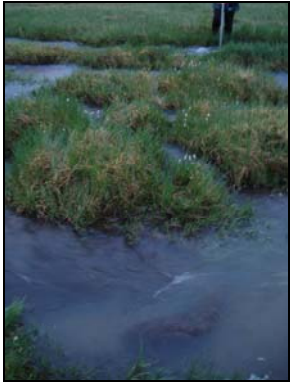
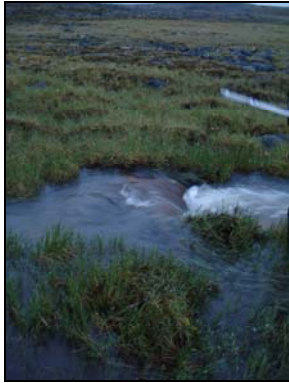
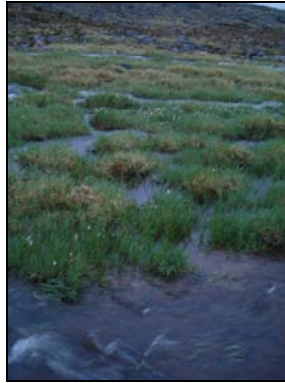
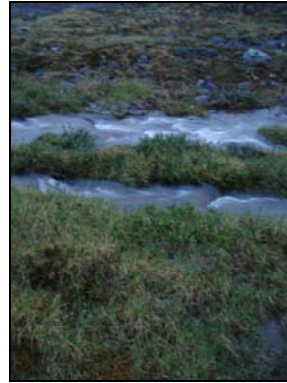
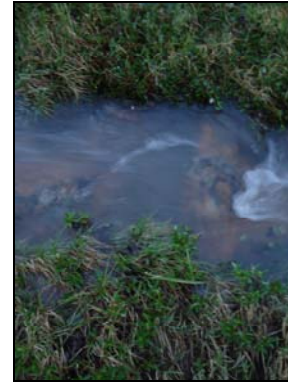
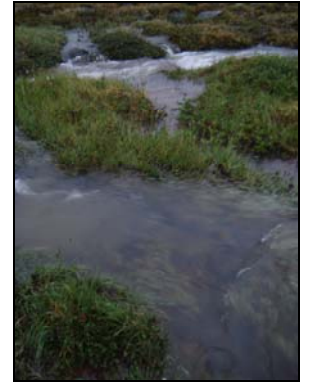
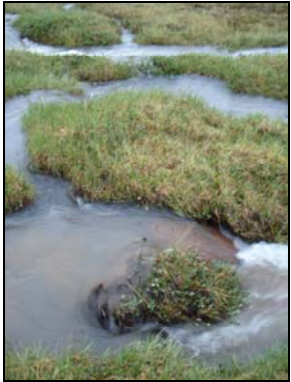
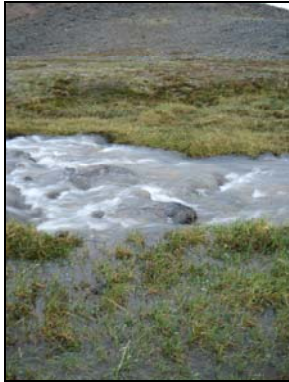
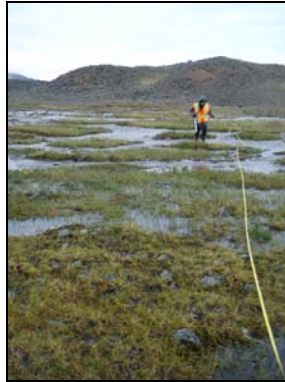
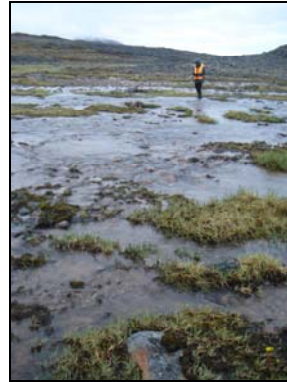
Figure 1: View of habitat 100 (A), 80 (B), 60 (C), 40 (D), and 20 m (E) downstream of crossing, at the crossing (F), and 20 (G), 40 (H), 80 (I), and 100 m (J), upstream of the crossing.

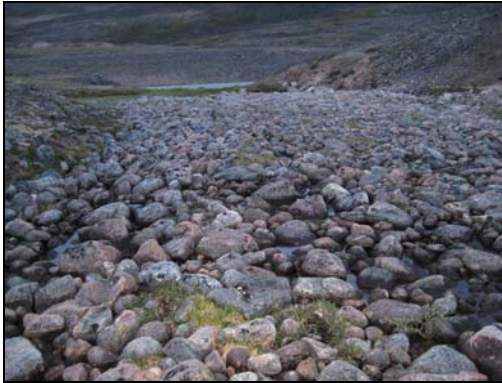
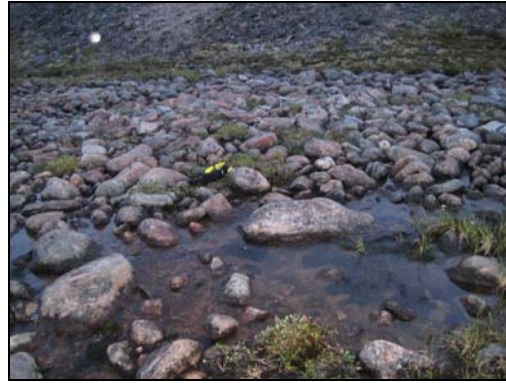
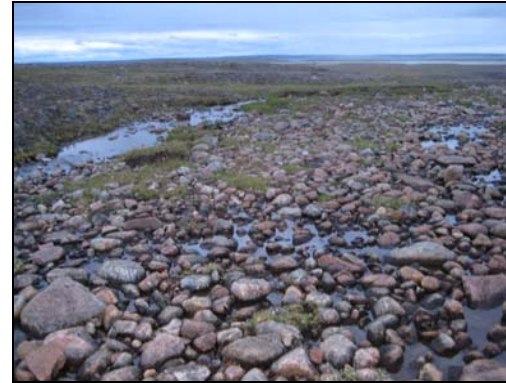
Figure 1. (A) View upstream of crossing, (B) View across crossing from right bank, (C) View downstream of crossing.
