**HABITAT ASSESSMENT PROTOCOL AND SAMPLE
DATA SHEET USED FOR DESCRIBING AVAILABLE
AQUATIC HABITAT IN WATERCOURSES IN THE
RAILWAY/ACCESS ROAD AREA.**

MARY RIVER PROJECT RAILWAY/ACCESS ROAD WATERCOURSE CROSSING ASSESSMENT PROTOCOL

North/South Consultants Inc. and Knight Piésold Ltd.

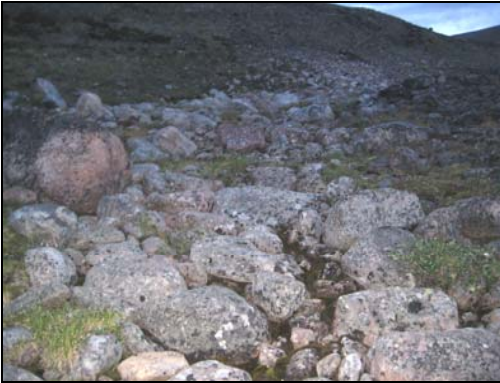
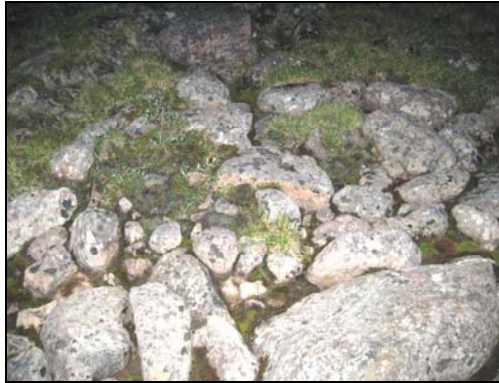
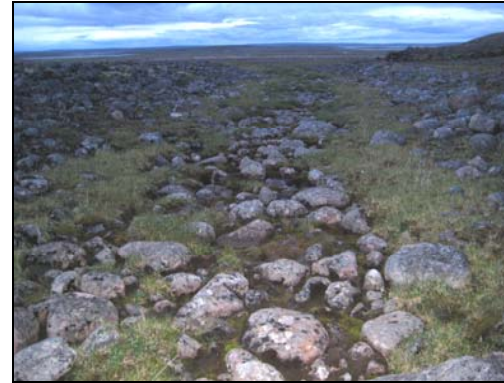
Figure 1. (A) View upstream of crossing, (B) View across crossing from left bank, (C) View downstream of crossing.

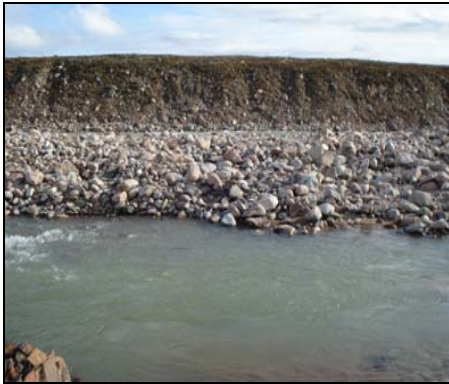
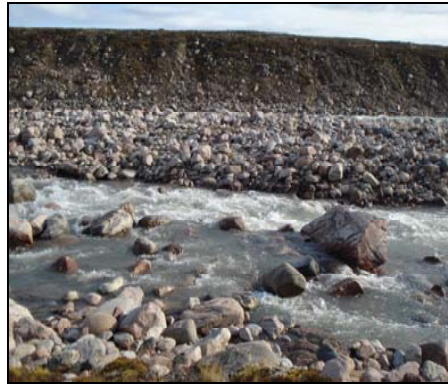
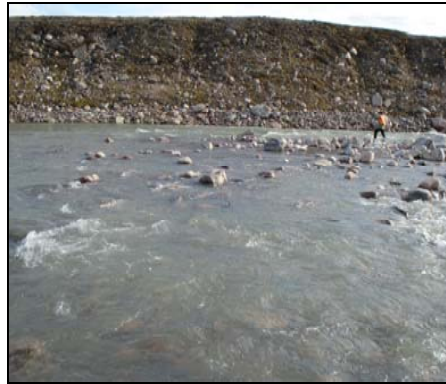
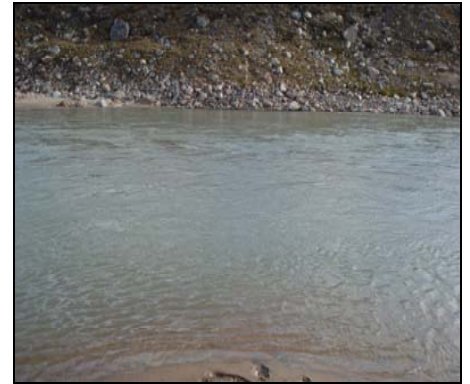
Figure 1. View at 40m downstream across (A), 20m (B), 20m upstream across (C), and 40m (D).

All habitat substrate was judged from 25% of the location. No downstream barrier, extremely braided downstream. Many serve as rapids meandering upstream but all likely passable by large fish under lower water conditions. UTM 17 W 586881 7913688 is where the stream starts.

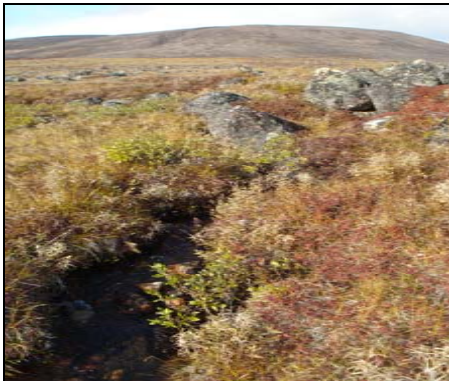
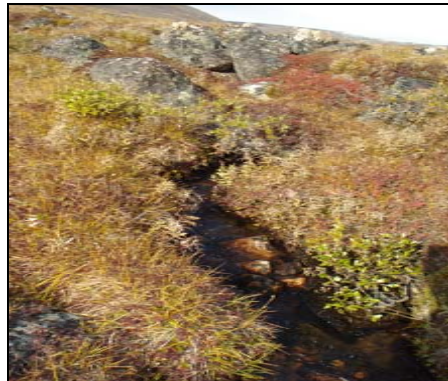
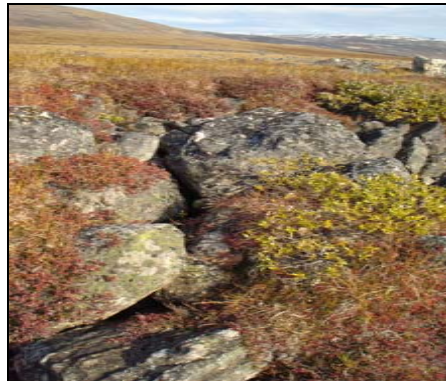
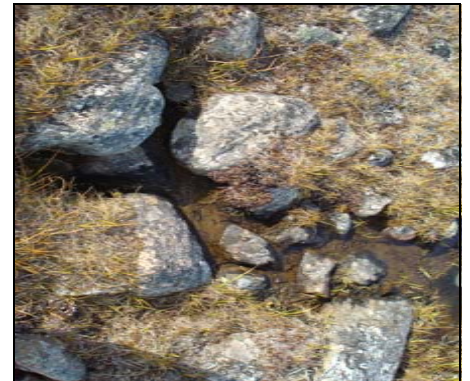
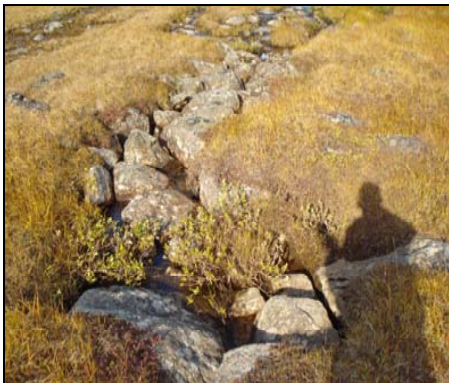
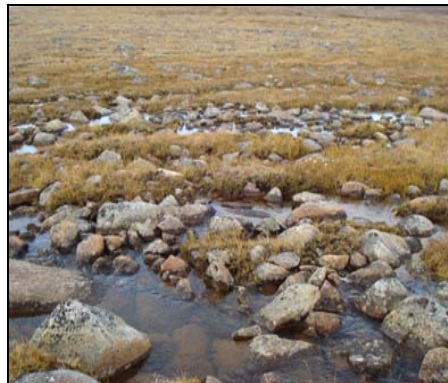
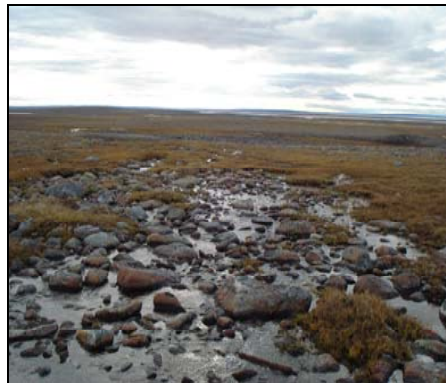
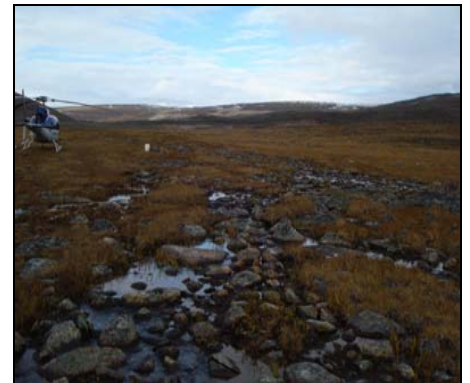
Figure 1. View of barrier downstream (A), downstream barrier 2 (B), downstream barrier 3 (C), downstream barrier 4 (D), downstream barrier 5 (E), crossing downstream (F), crossing across (G), and crossing upstream (H).

Water flows under boulders for ~ 10m at UTM 17 W 585787 7899615 (probably a barrier). This stream eventually joins with BR-025-1 downstream. Stream begins at UTM 17 W 585943 7900136 in small shallow upstream pond.

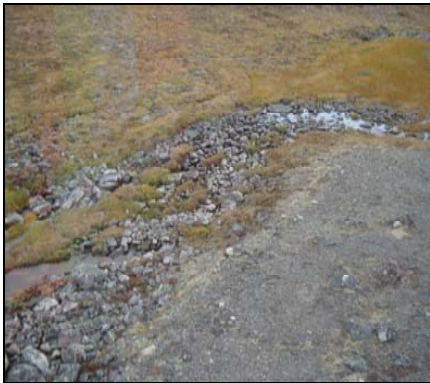
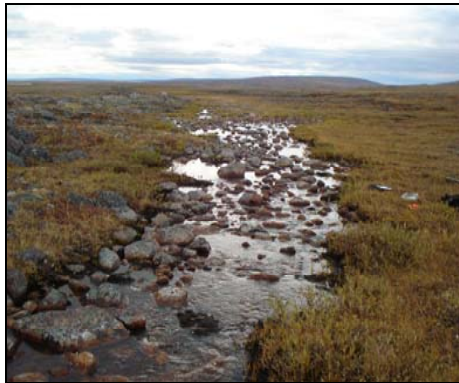
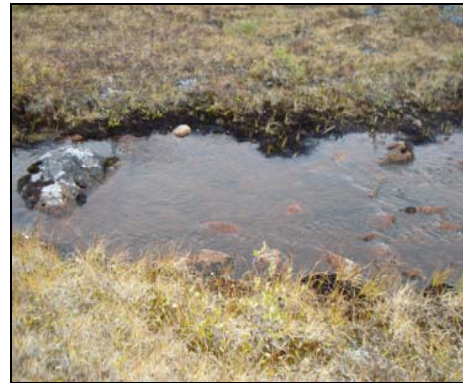
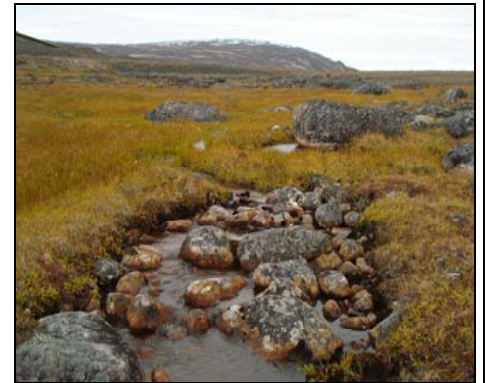
Figure 1. Aerial view of downstream barrier (A), crossing downstream (B), crossing across (C), and crossing upstream (D).

Starts on a grassy plateau, UTM 17 W 586410 7899551. UTM 17 W 565849 7904565 = barrier of rocks in stream. Downstream of both CV-R01 and CV-R02 as well as the barrier at UTM 17 W 585787 7899615.

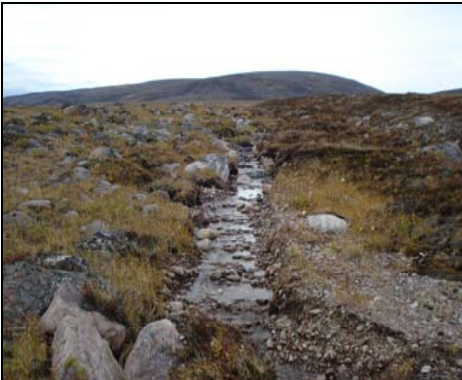
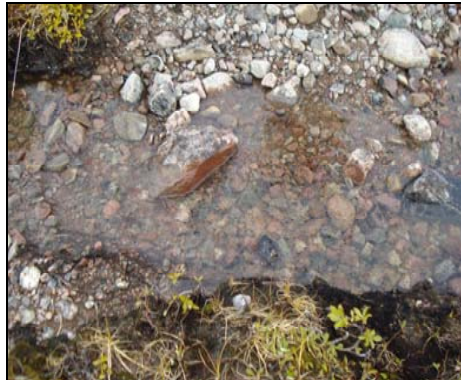
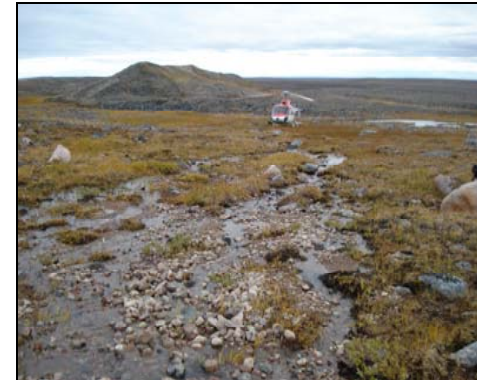
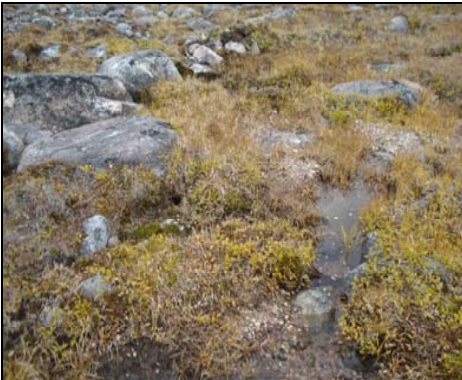
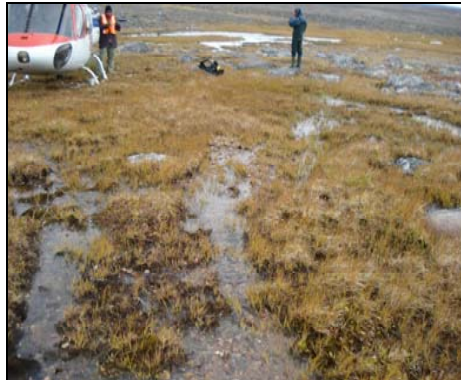
Figure 1. View at crossing upstream (A), crossing across (B), crossing downstream (C), and water flows underground downstream of crossing (D-E).

Flows underground at UTM 17 W 586698 7899003 and branches off over flooded terrestrial. Fish cannot reach crossing site because there is no channel leading up to it. Did not look for upstream most reach since this habitat is inaccessible.

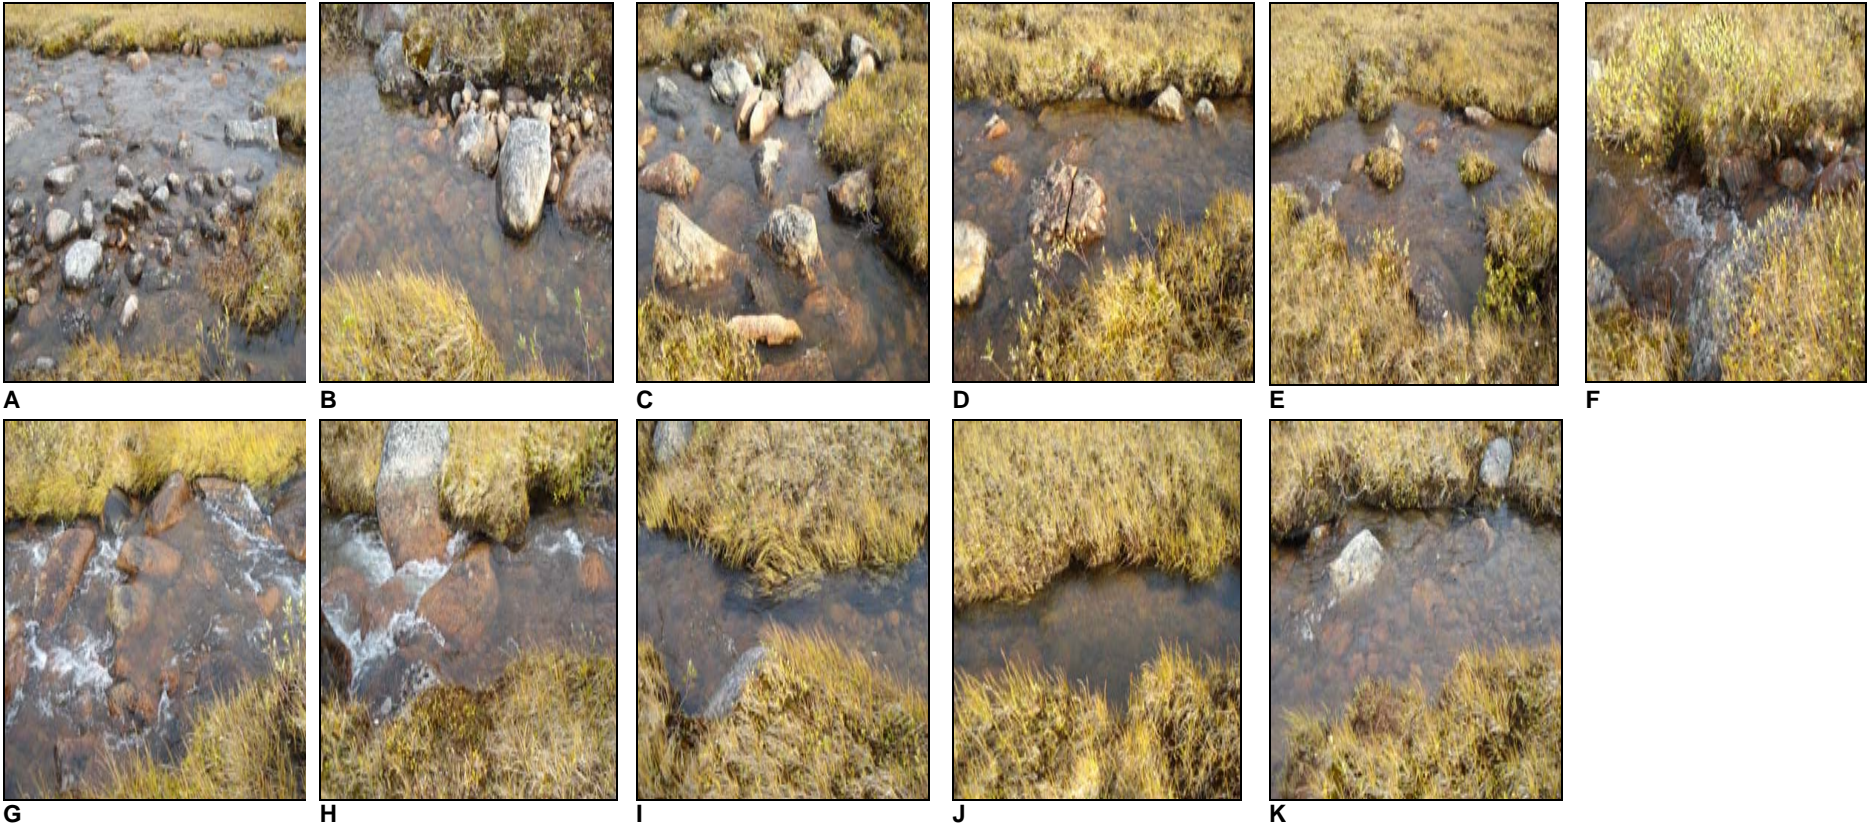
Figure 1. View at 100m downstream across (A), 80m (B), 60m (C), 40m (D), 20m (E), crossing across (F), 20m upstream across (G), 40m (H), 60m (I), 80m (J), and 100m (K).

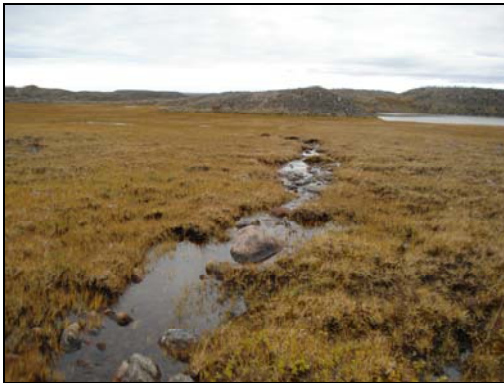
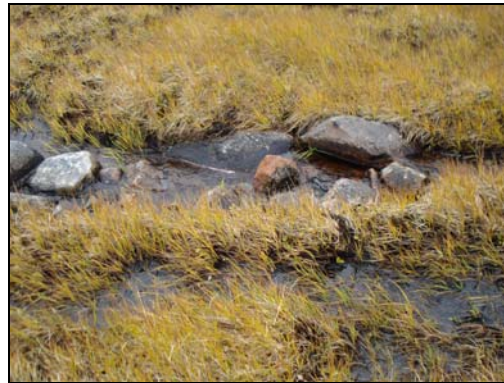
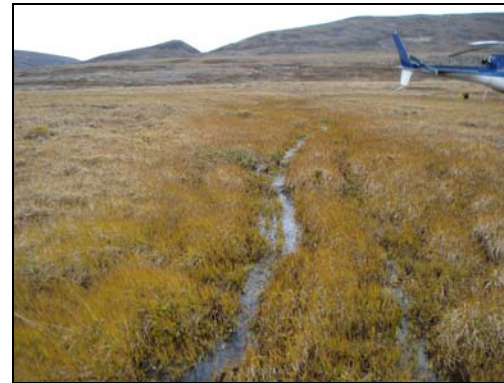
Figure 1. View at crossing downstream (A), crossing across (B), and crossing upstream (C).

The downstream end of this stream flows into an isolated pool. Disappears underground upstream at UTM 17 W 587723 7898682.

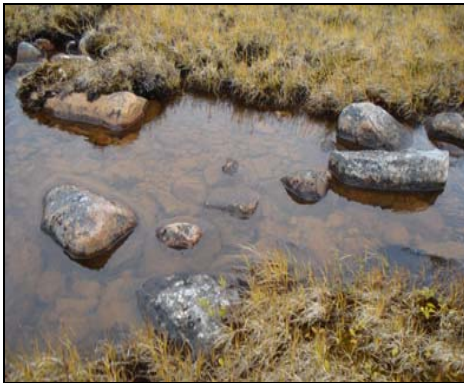
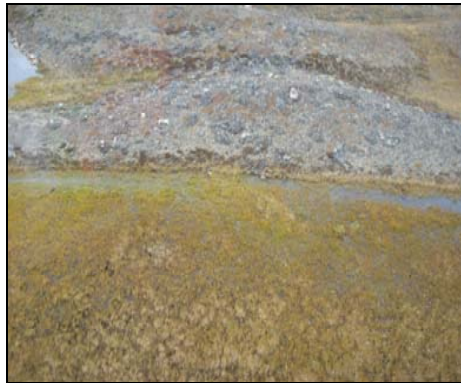
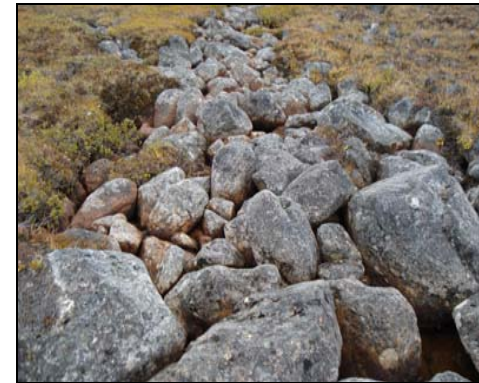
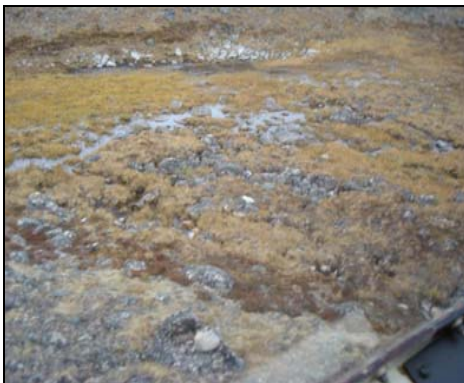
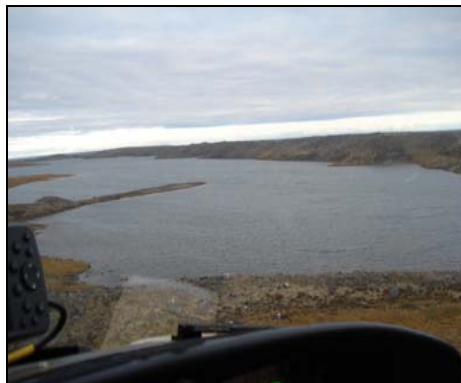
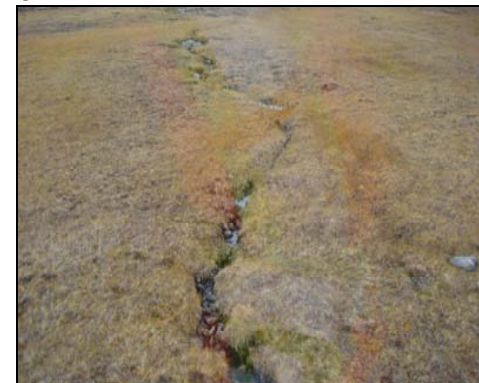
Figure 1. View at crossing across (A), downstream barrier in marshy area (B), upstream barrier (C), downstream of marshy barrier (D), downstream lake (E), source of runoff (F).

Barrier upstream at UTM 17 W 587744 7898530. Water is under boulders downstream at UTM 17 W 587714 7898301, swampy area separates it from a very large (probably overwintering lake). Upstream of barrier, simply drains a plateau.

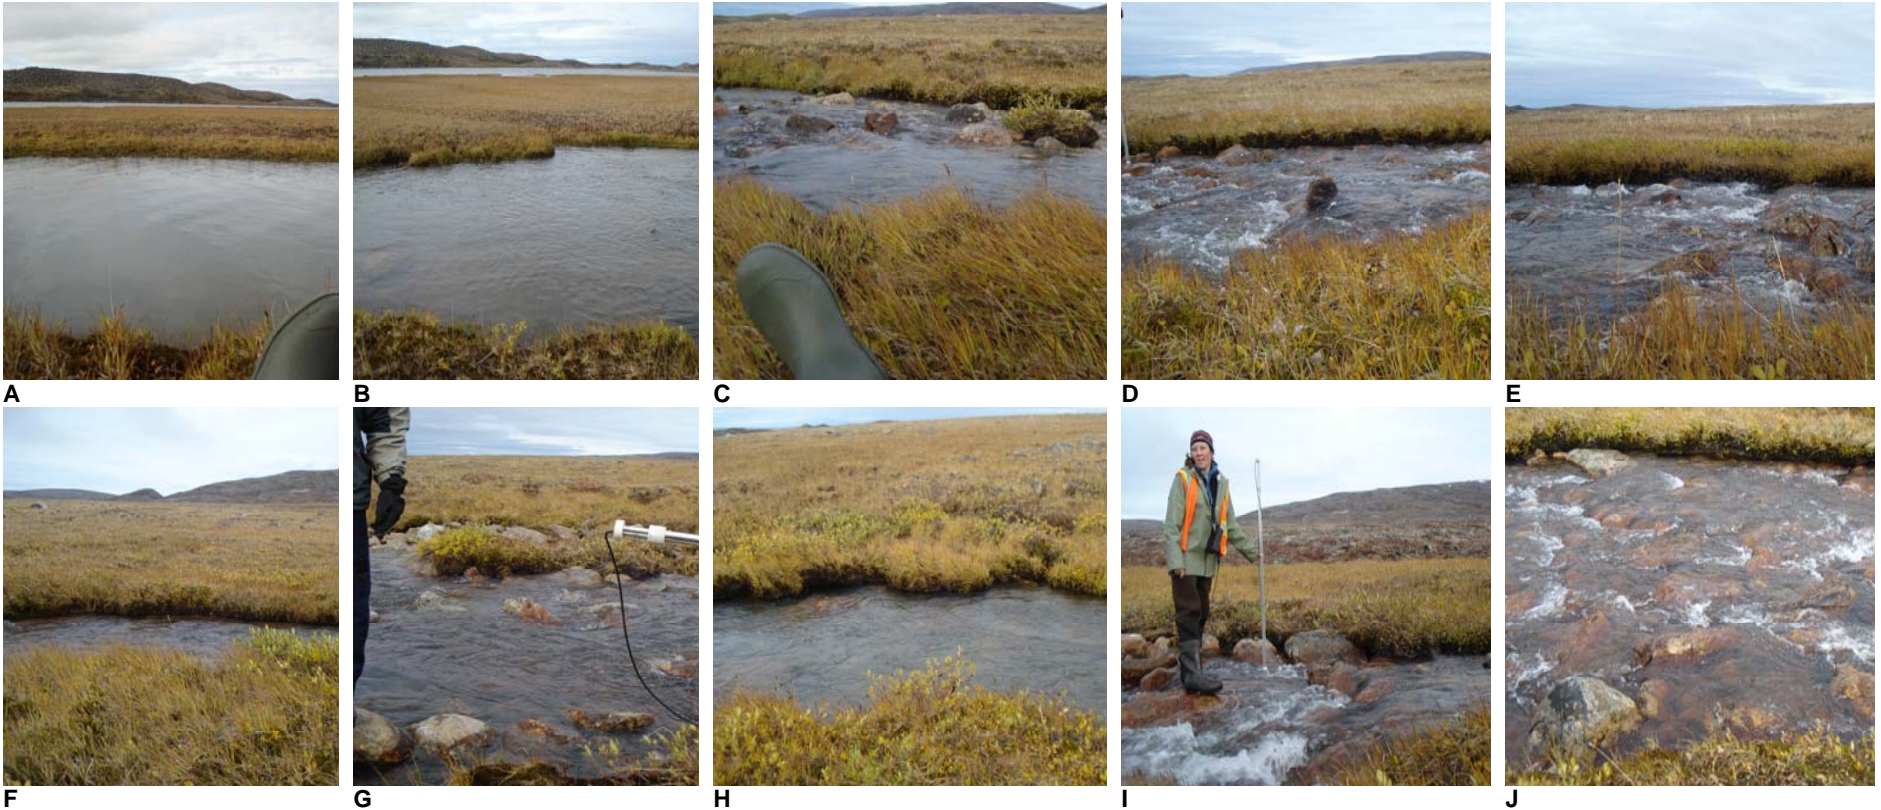
Figure 1. View at 100m downstream across (A), 80m (B), 60m (C), 20m (D), crossing across (E), 20m upstream across (F), 40m (G), 60m (H), 80m (I), and 100m (J).

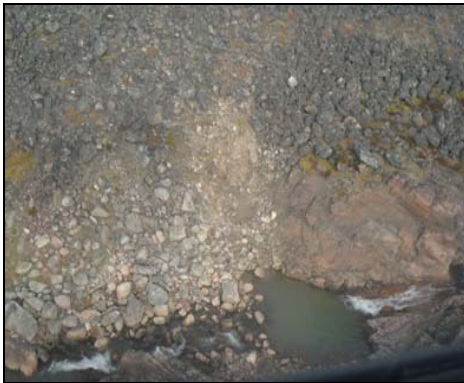
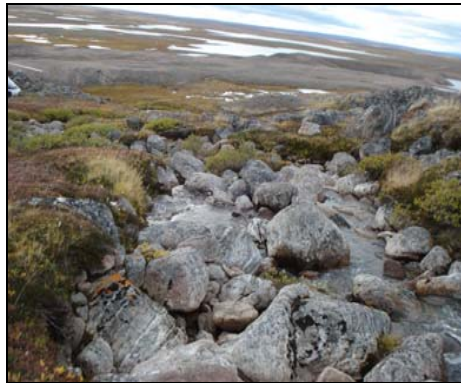
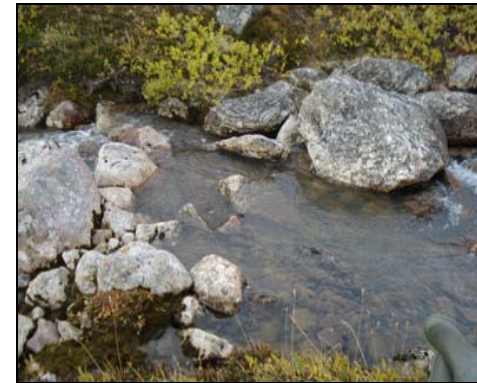
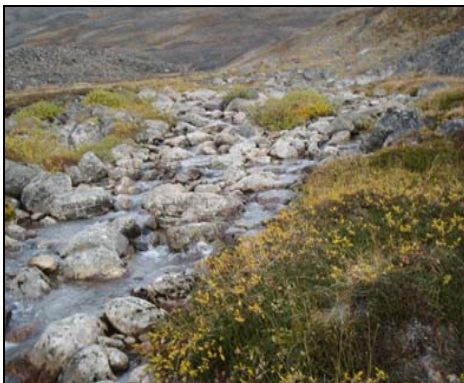
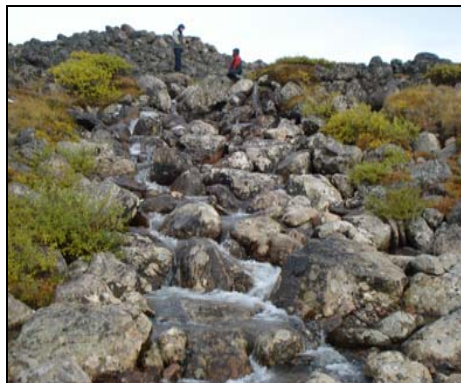
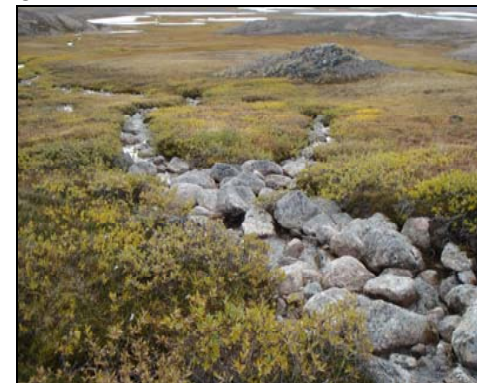
Figure 1. View of upstream barrier falls (A), crossing upstream (B), crossing across (C), crossing downstream (D), downstream barrier –left channel (E), downstream barrier – right channel (F).

There are two channels downstream of the crossing; right has very low water and the left has barrier at UTM 17 W 591306 7897090. UTM 17 W 591306 7897090 is ~60m downstream of crossing and very likely acts as a barrier. At UTM 17 W 591364 7897500 two sets of falls that act as an upstream barrier.

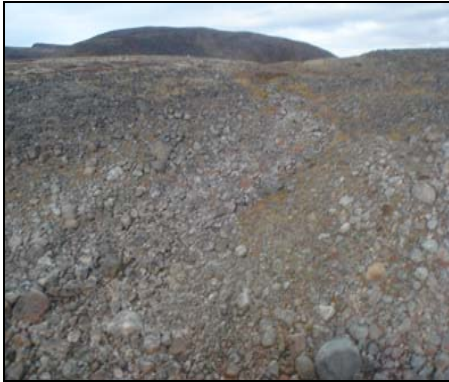
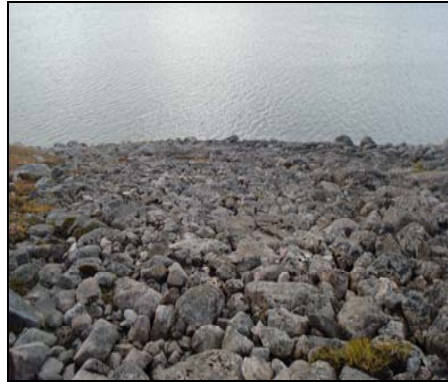
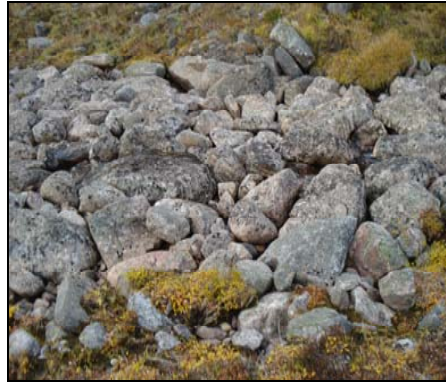
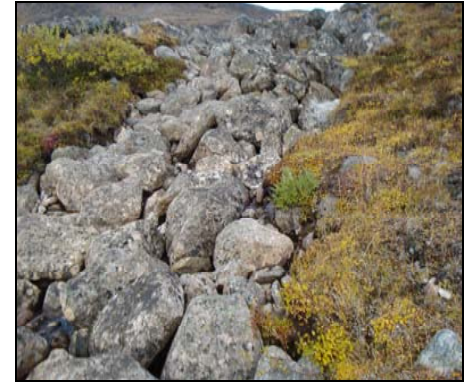
Figure 1. Aerial view of crossing site (A), crossing downstream (B), crossing across (C), and crossing upstream (D).

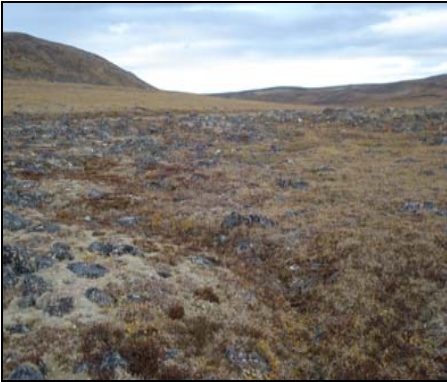
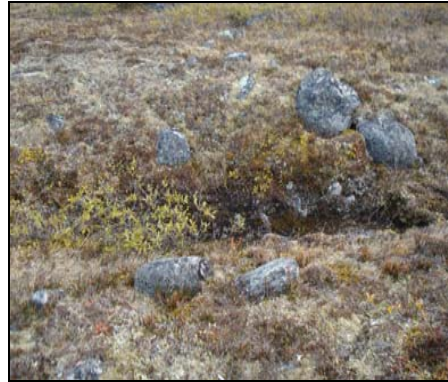
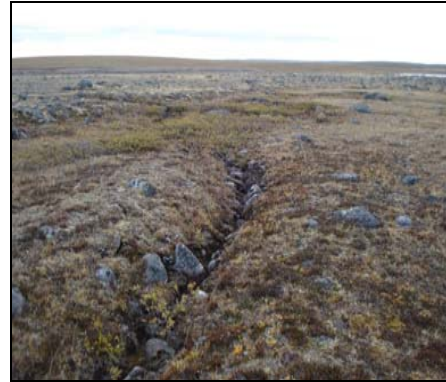
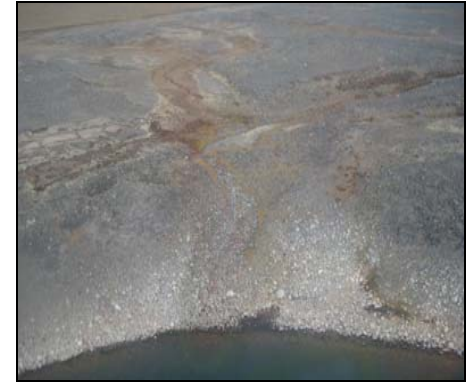
Figure 1. View at crossing upstream (A), crossing across (B) crossing downstream (C), and downstream barrier (dry, steep) (D).

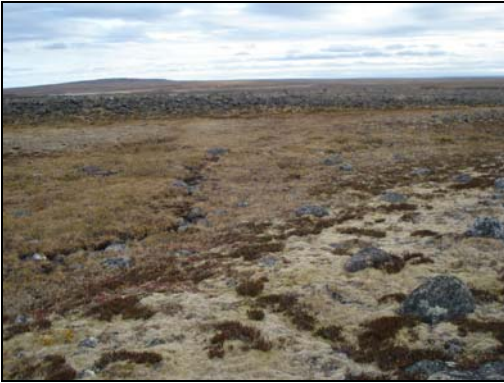
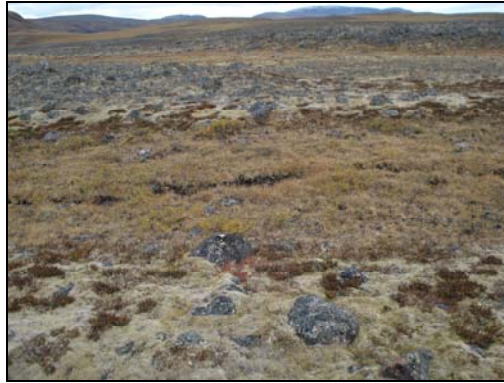
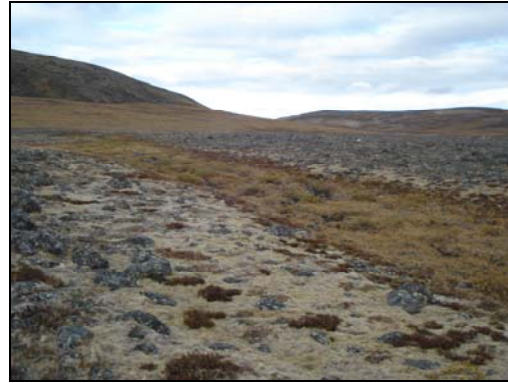
Figure 1. View at crossing downstream (A), crossing across (B), and crossing upstream (C).

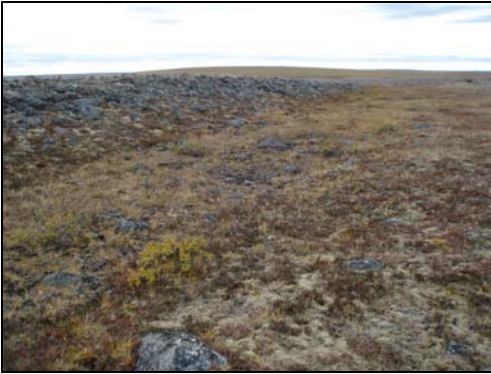
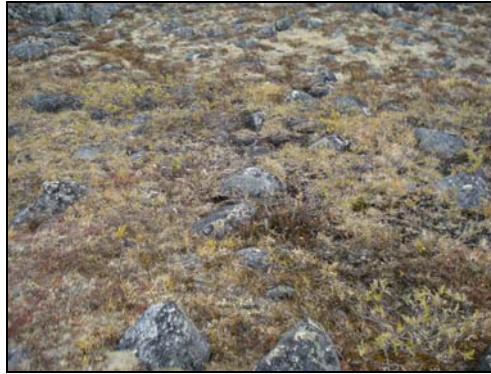
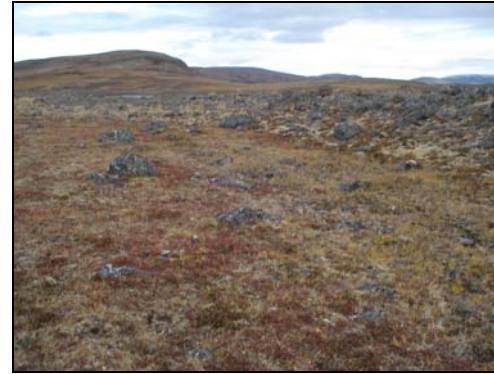
Figure 1. View at crossing downstream (A), crossing across (B), and crossing upstream (C).

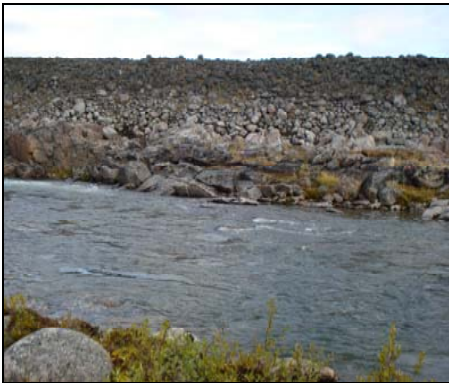
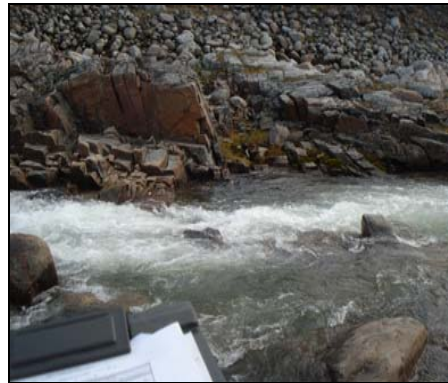
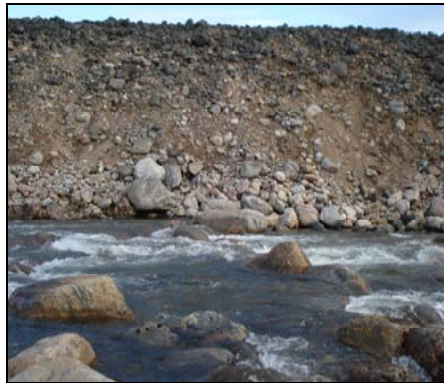
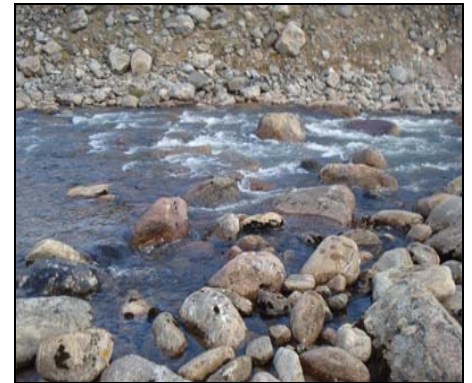
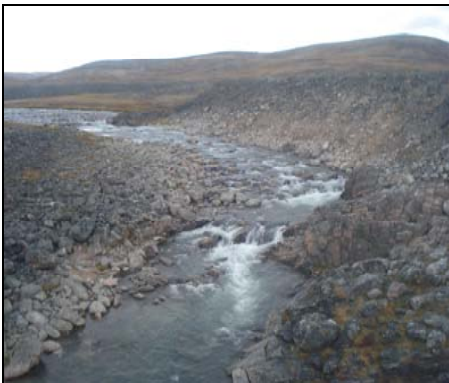
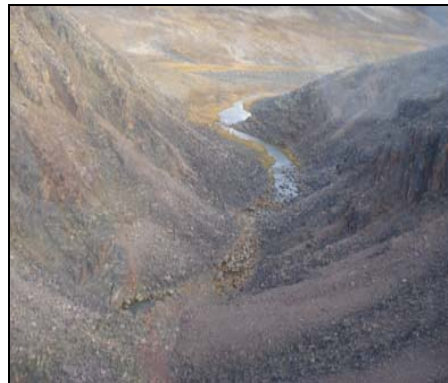
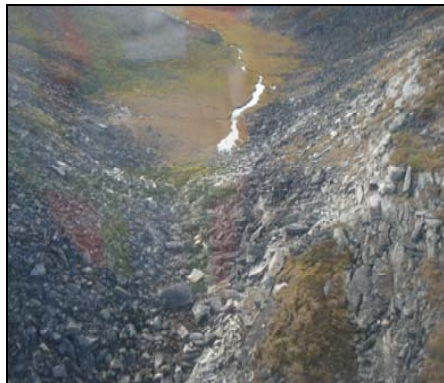
Figure 1. View at 40m downstream across (A), crossing across (B), 20m upstream across (C), 40m upstream across (D), large cascades upstream on left arm (E), upstream barrier on right arm downstream (F), and upstream barrier on right arm upstream (G).

Fished along the right shore only. Upstream limit at UTM 17 W 597007 7904134, and UTM 17 W 597520 7904346. Up left arm, all steep cascades that only large fish could get up.

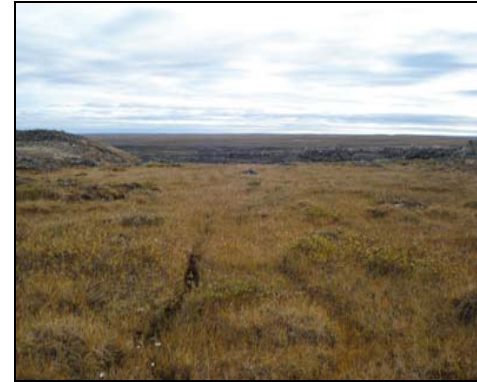
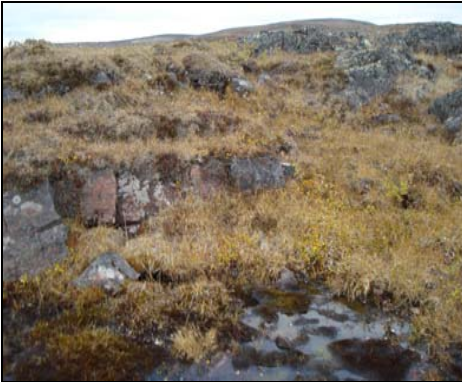
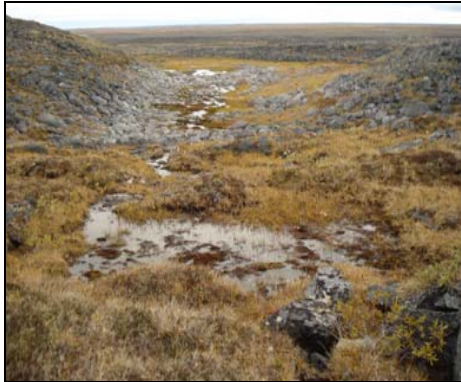
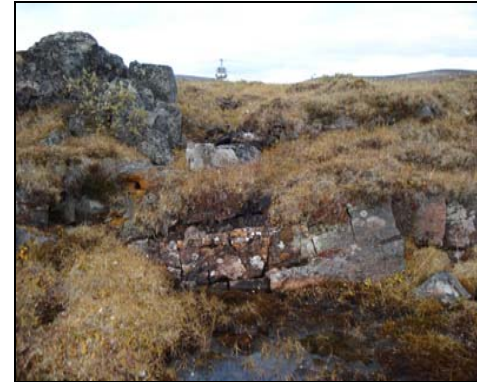
Figure 1. View at crossing upstream (A), crossing across (B), crossing downstream (C), downstream barrier across (D), downstream barrier facing downstream (E), and downstream barrier facing upstream (F).

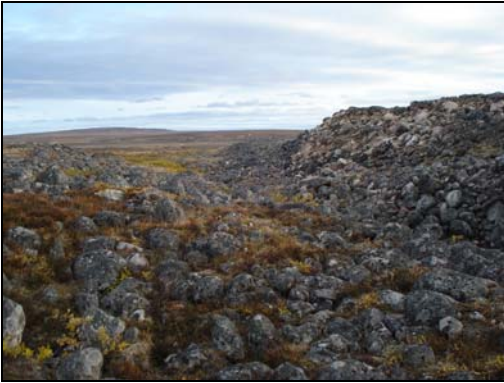
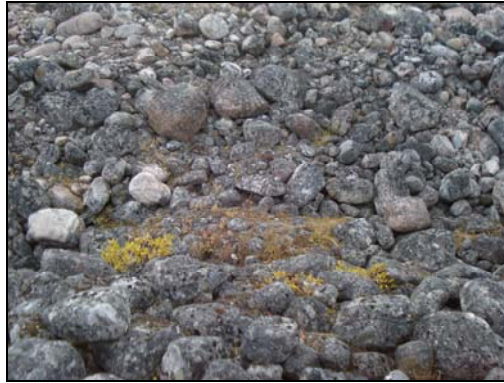
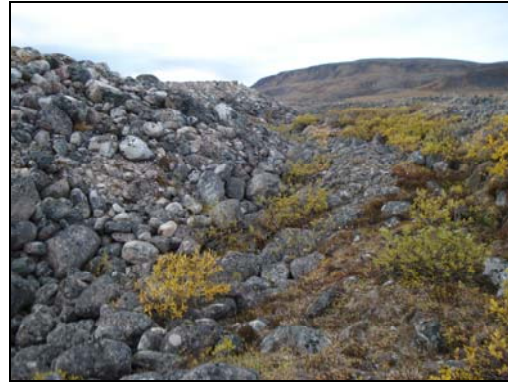
Figure 1. View at crossing downstream (A), crossing across (B), and crossing upstream (C).

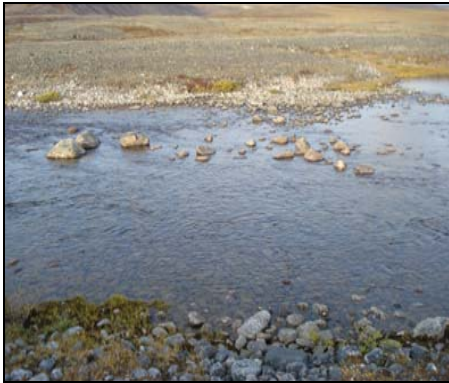
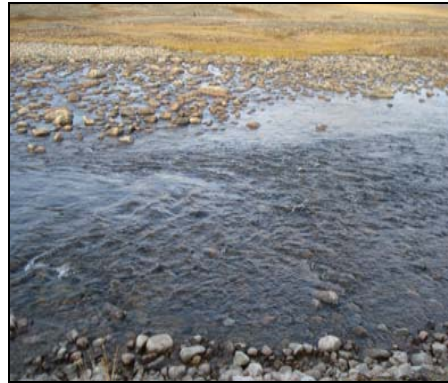
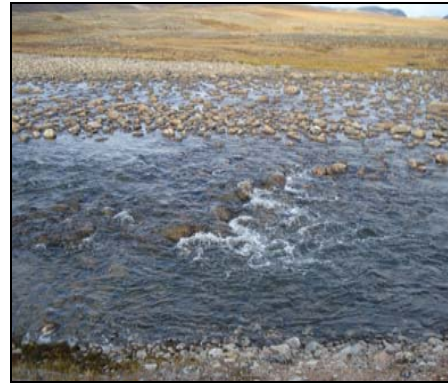
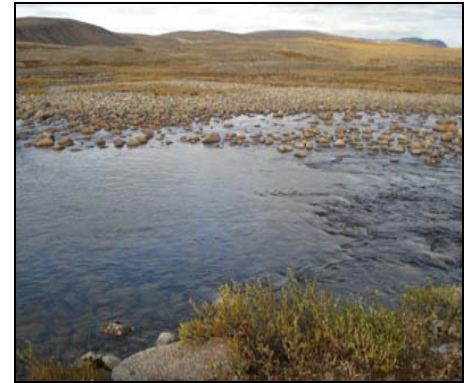
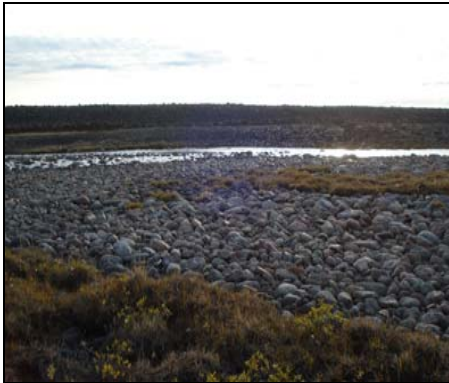
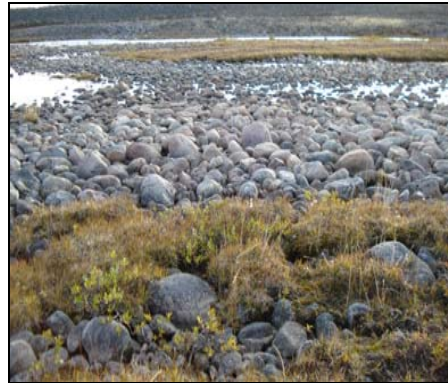
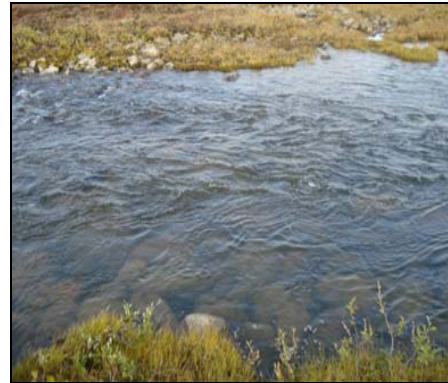
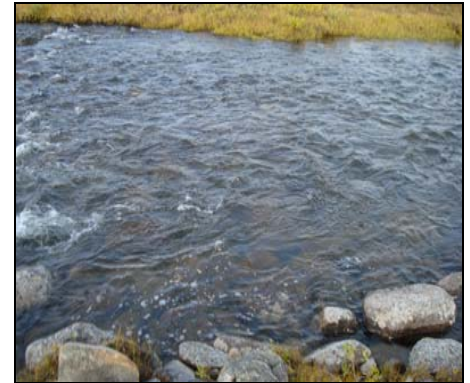
Figure 1. View at 100m downstream across (A), 20m (B), crossing across (C), 20m upstream across (D), 20m upstream right channel (E), 40m upstream across (F), 80m (G), and 100m (H).

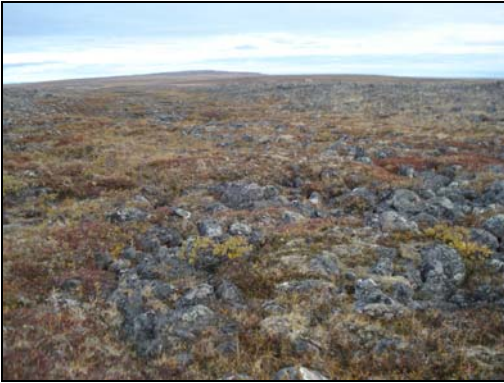
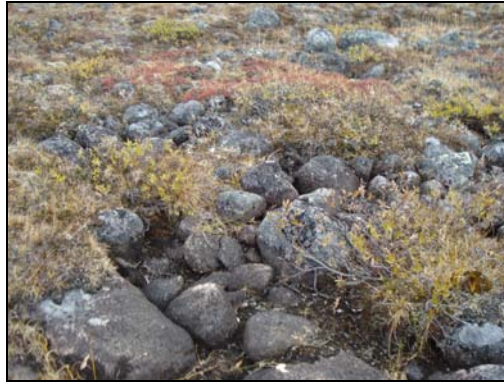
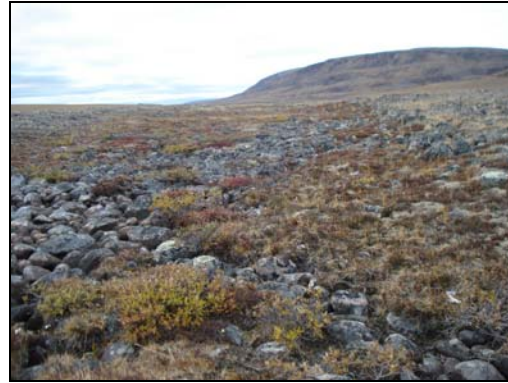
Figure 1. View at crossing downstream (A), crossing across (B), and crossing upstream (C).

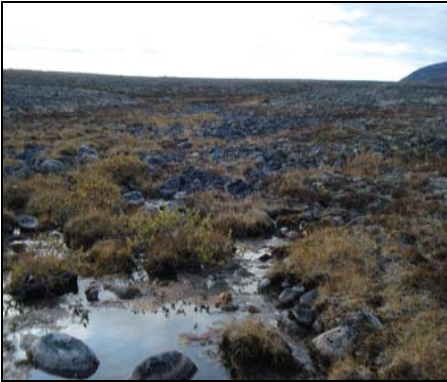
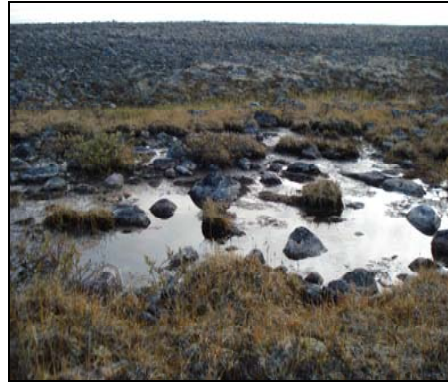
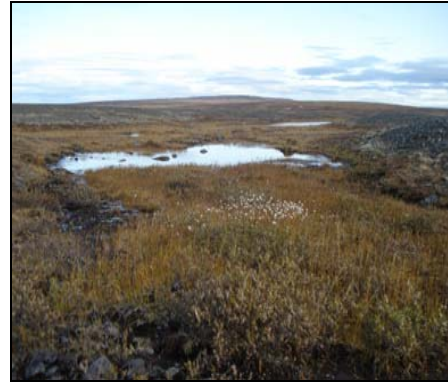
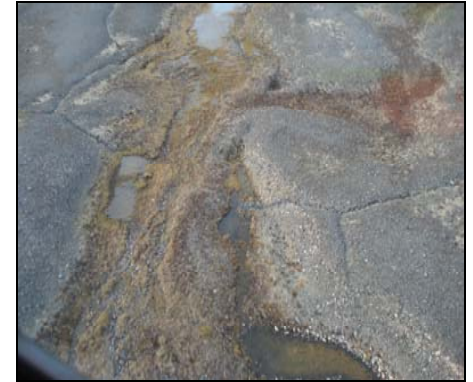
Figure 1. View at crossing upstream (A), crossing across (B), crossing downstream (C), and dry downstream barrier (D).

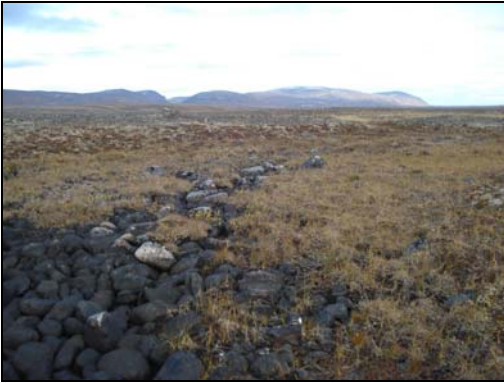
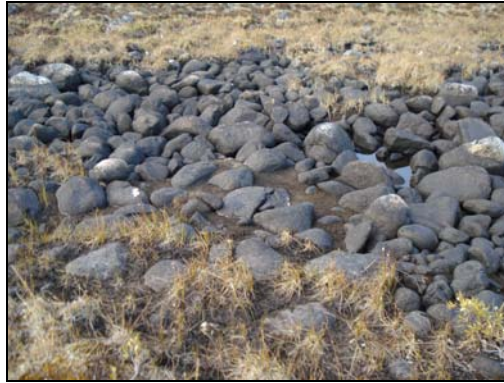
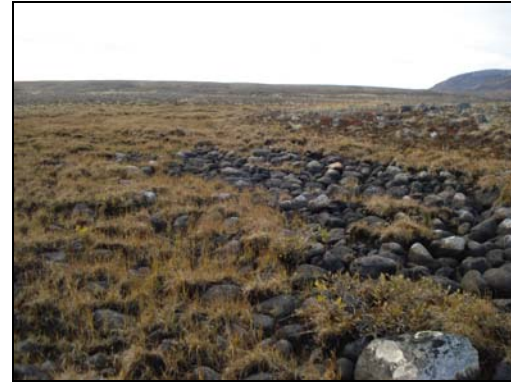
Figure 1. View at crossing downstream (A), crossing across (B), and crossing upstream (C).

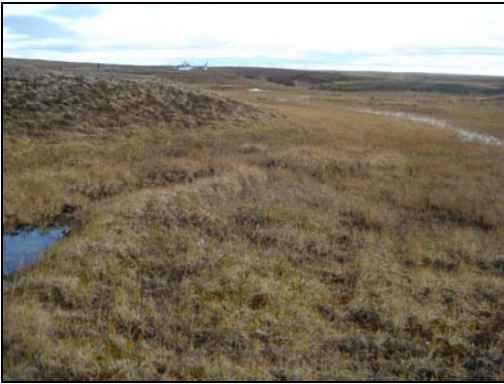
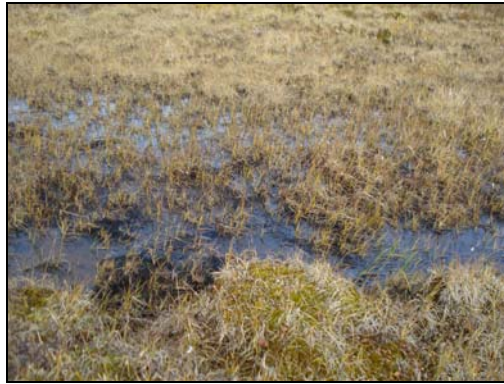
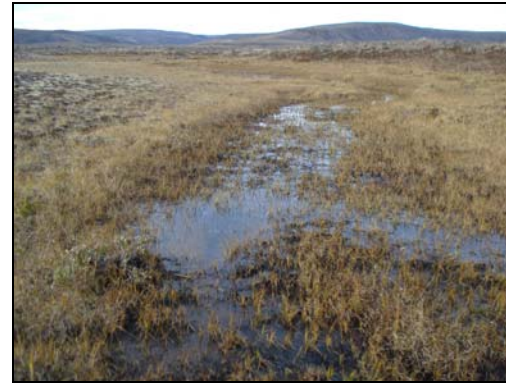
Figure 1. View at crossing downstream (A), crossing across (B), and crossing upstream (C).

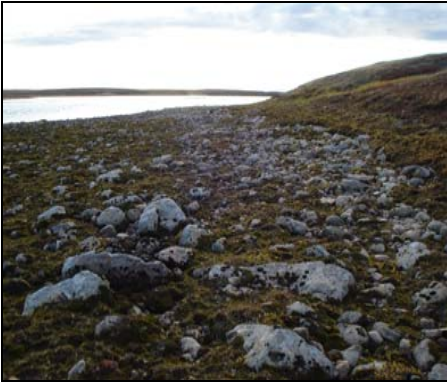
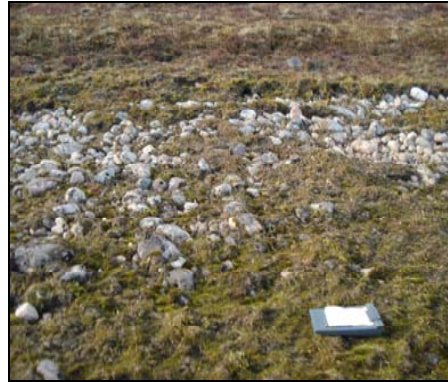
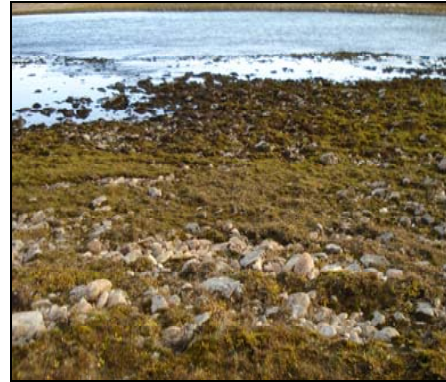
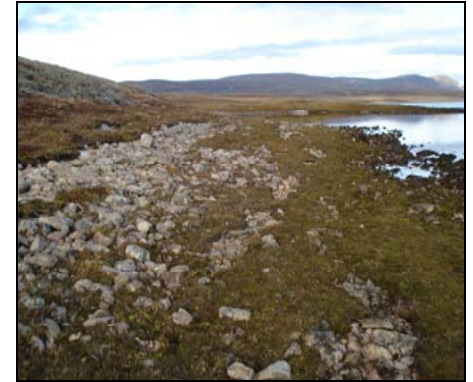
Figure 1. View at crossing downstream (A), crossing towards bank (B), crossing towards river (C), and crossing upstream (D).

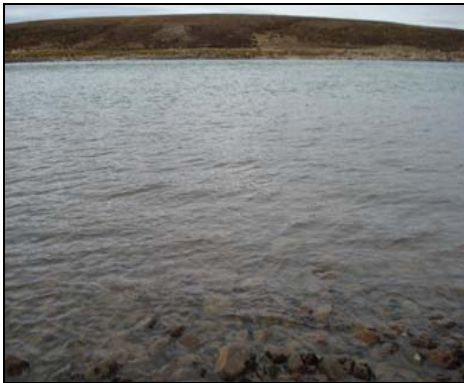
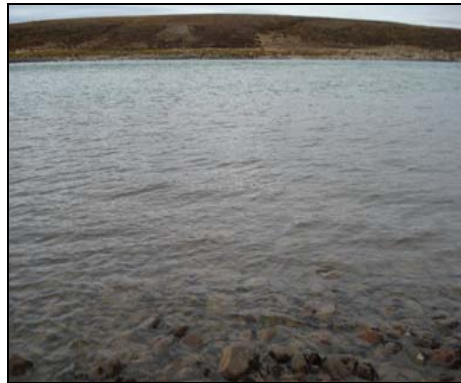
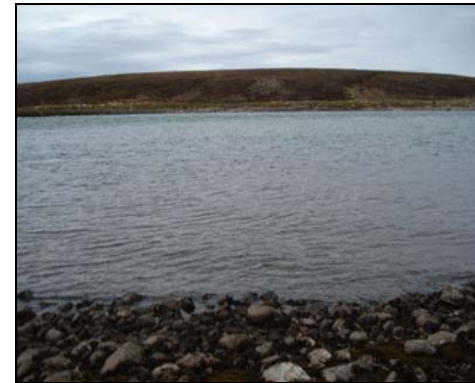
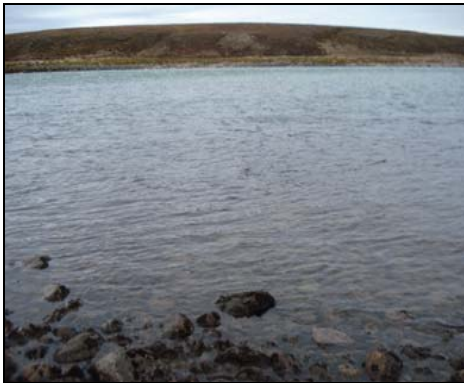
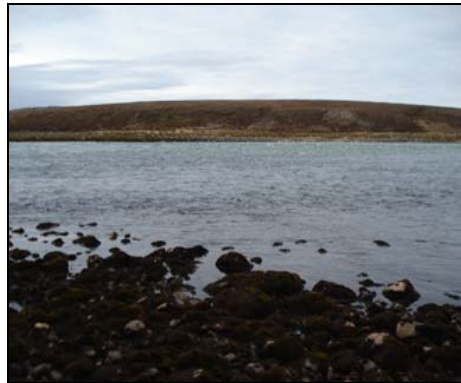
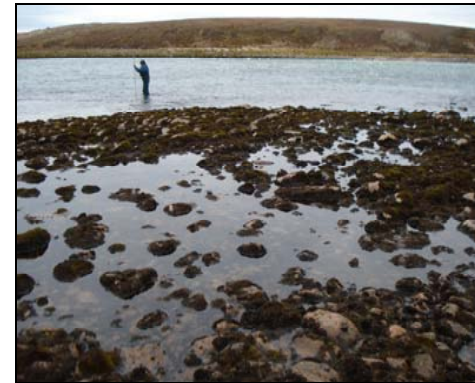
Figure 1. View at 40m downstream across (A), 20m (B-C), crossing across (D), 20m upstream across (E), and 40m (F).

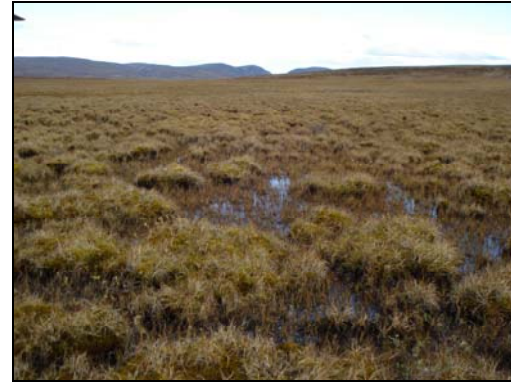
B

Figure 1. View at crossing downstream (A), crossing across (B), and crossing upstream (C).

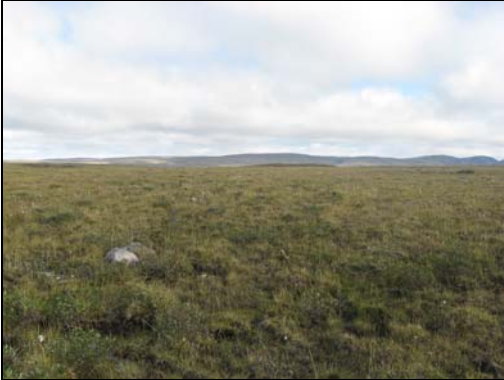
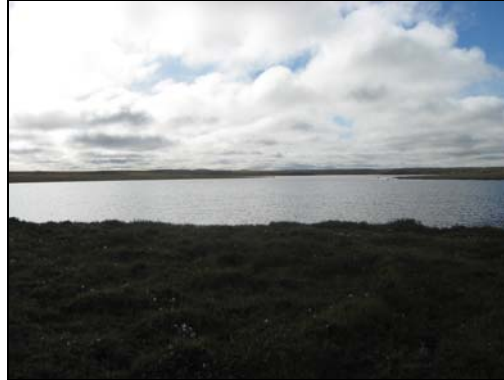
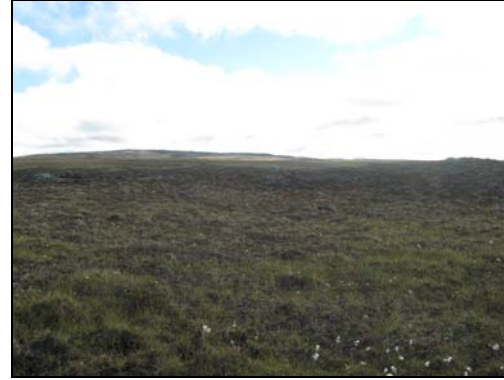
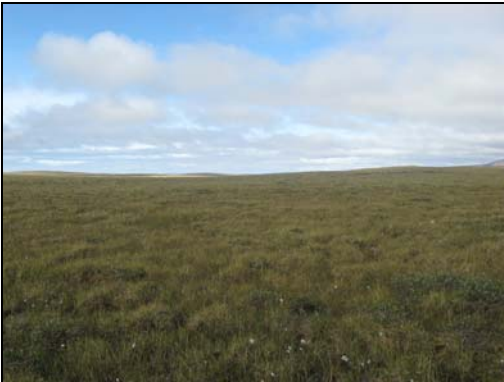
Figure 1. View of habitat facing, north (A), south (B) east (C), west (D) at the crossing.
