**HABITAT ASSESSMENT PROTOCOL AND SAMPLE
DATA SHEET USED FOR DESCRIBING AVAILABLE
AQUATIC HABITAT IN WATERCOURSES IN THE
RAILWAY/ACCESS ROAD AREA.**

MARY RIVER PROJECT RAILWAY/ACCESS ROAD WATERCOURSE CROSSING ASSESSMENT PROTOCOL

North/South Consultants Inc. and Knight Piésold Ltd.

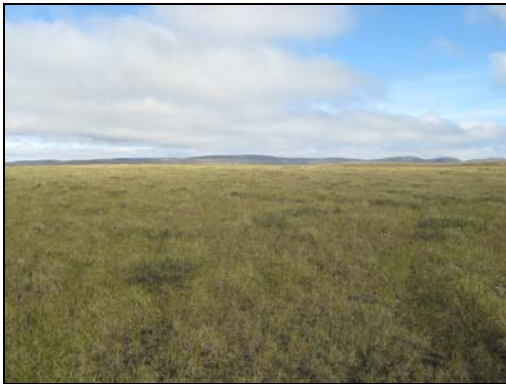
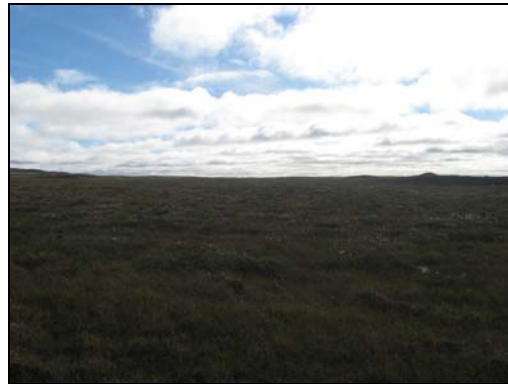
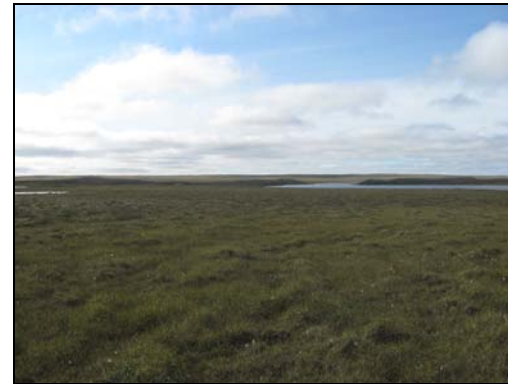
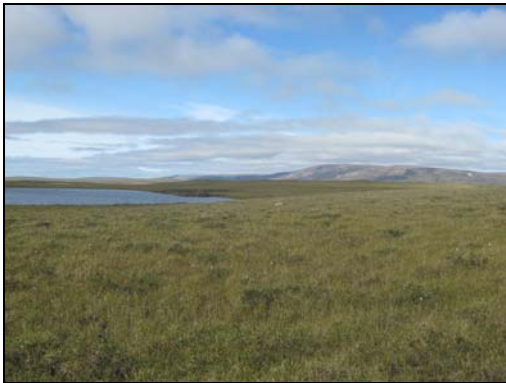
Figure 1. View of the crossing facing north (A), east (B), south (C), and west (D).

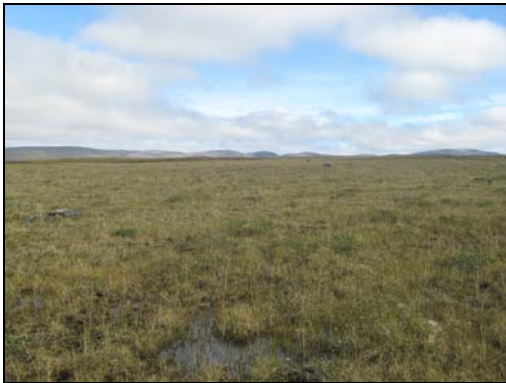
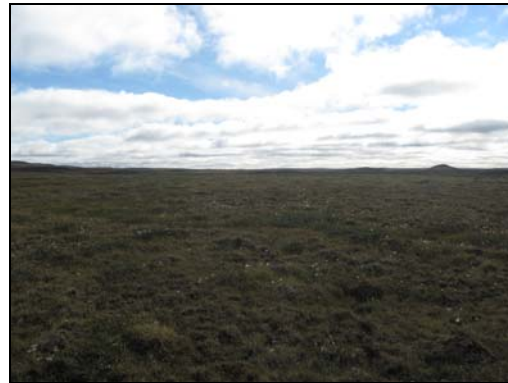
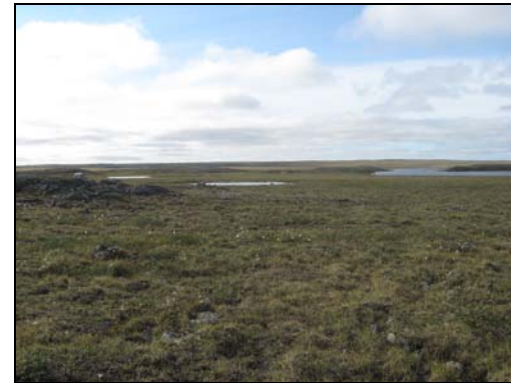
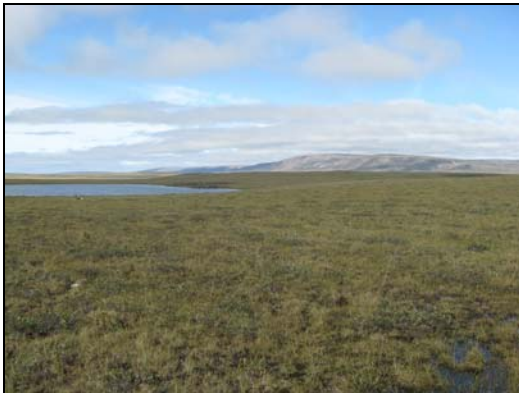
Figure 1. View of crossing facing north (A), east (B), south (C), and west (D).

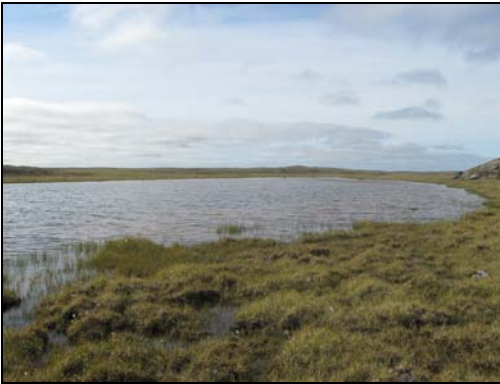
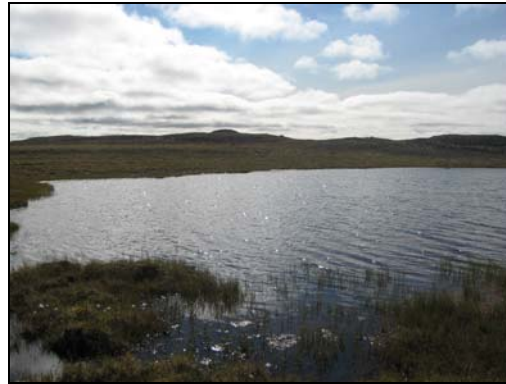
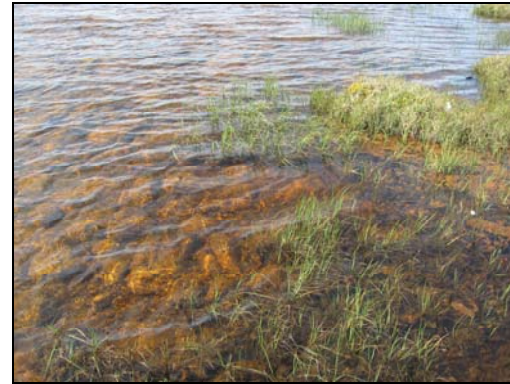
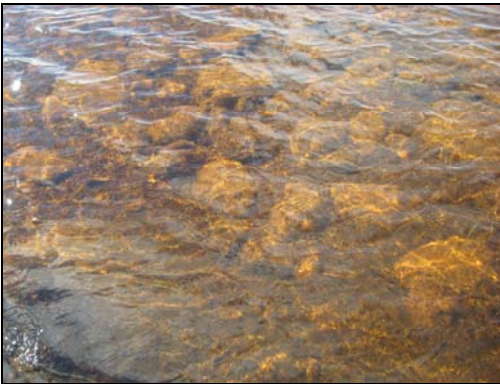
Figure 1. View of habitat facing south (A), and southeast of crossing (B), and of substrate (C-D).

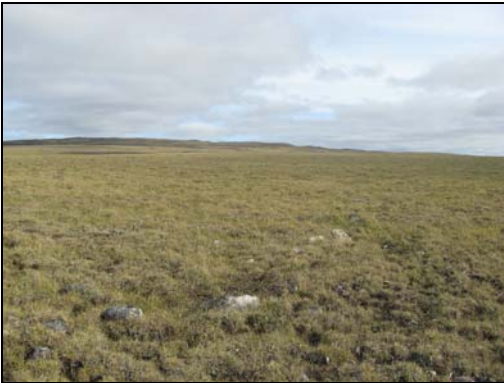
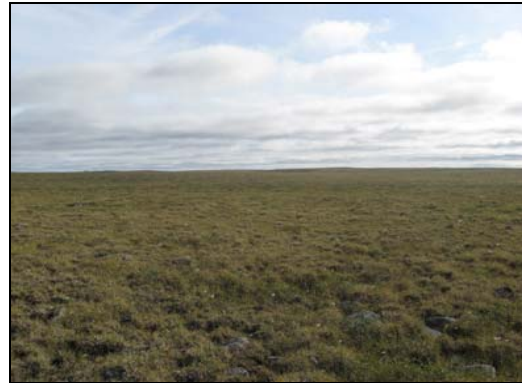
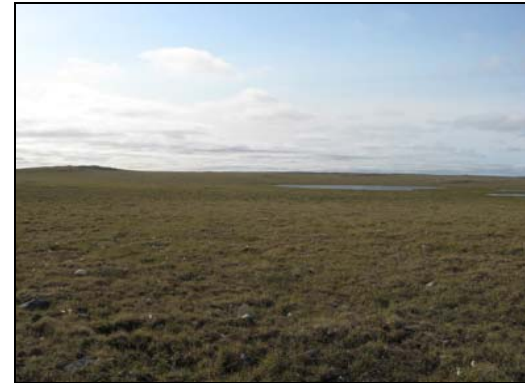
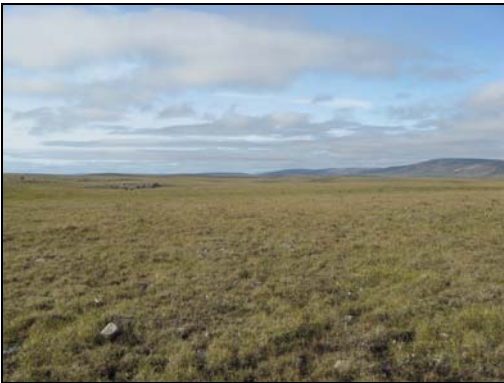
Figure 1. View of crossing facing north (A), east (B), south (C), and west (D).

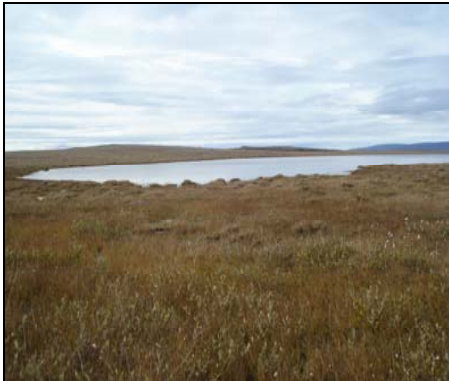
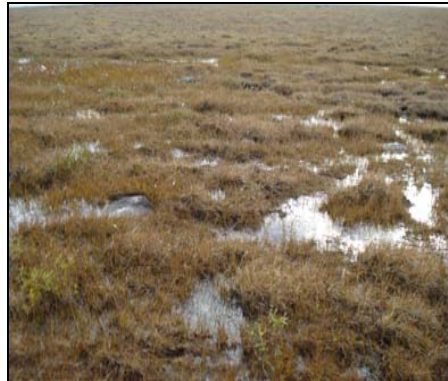
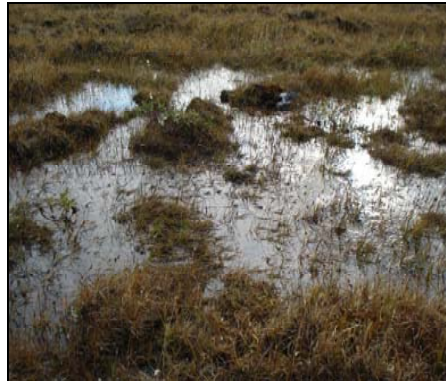
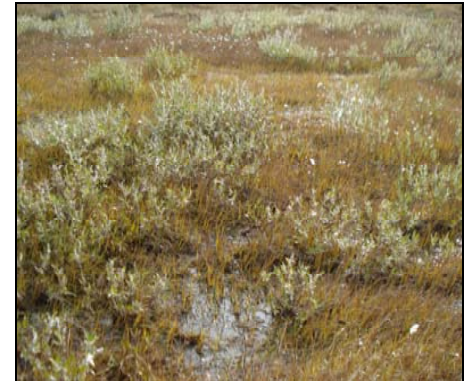
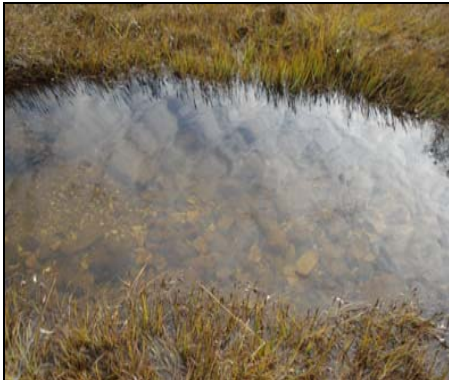
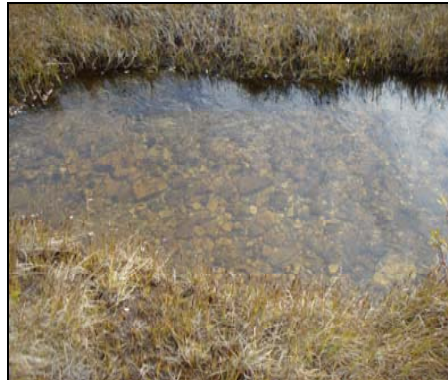
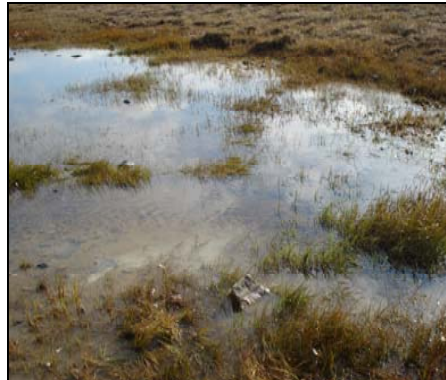
Stream between two lakes. North lake (D/S lake) has a deep hole in it (>3-4 m) Lake to the South (U/S lake) is not deep enough to overwinter fish.

Figure 1. View of downstream lake (A), 20m downstream across (B), crossing across (C), substrate at crossing (D), 20m upstream across (E), 40m (F), 60m (G), and upstream lake (H).

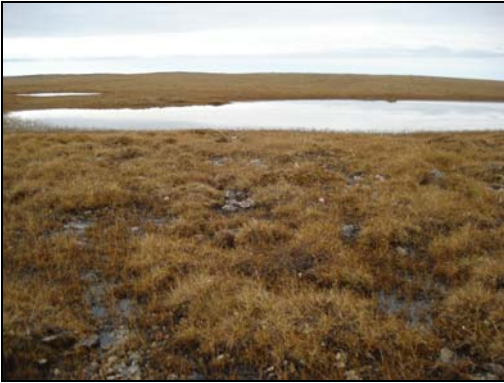
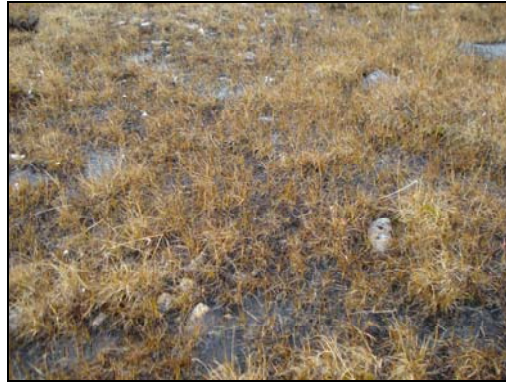
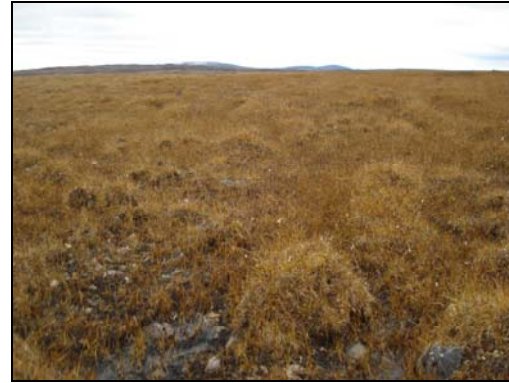
Figure 1. View at crossing downstream (A), crossing across (B), and crossing upstream.

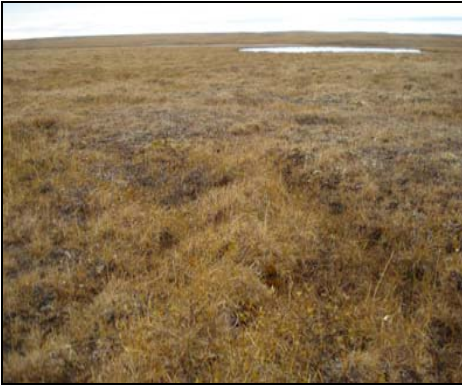
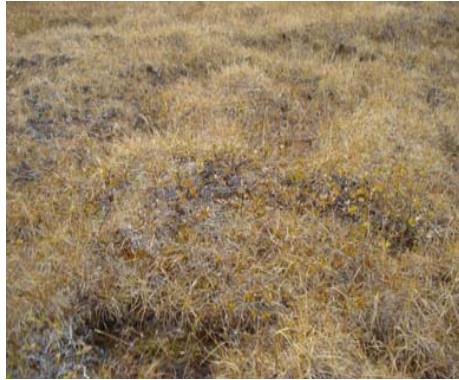
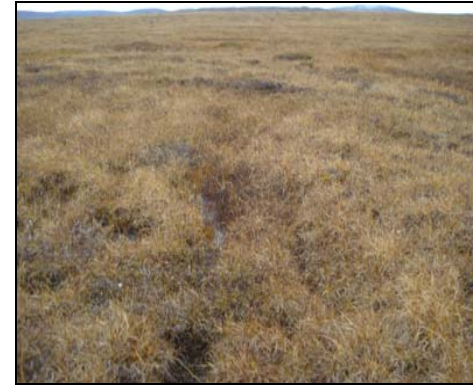
Figure 1. View at crossing downstream (A), crossing across (B), and crossing upstream (C).

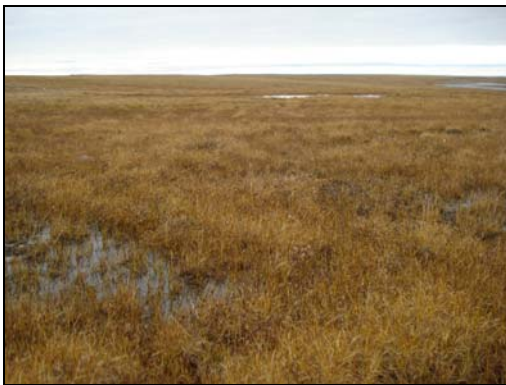
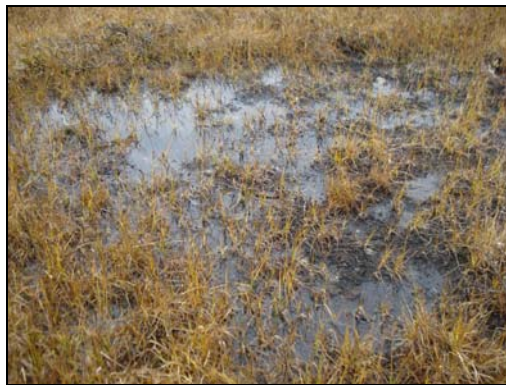
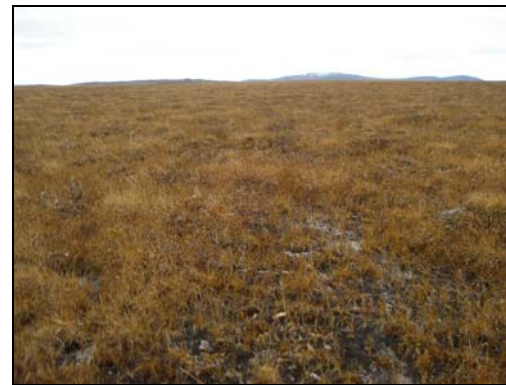
Figure 1. View at crossing downstream (A), crossing across (B), and crossing upstream.

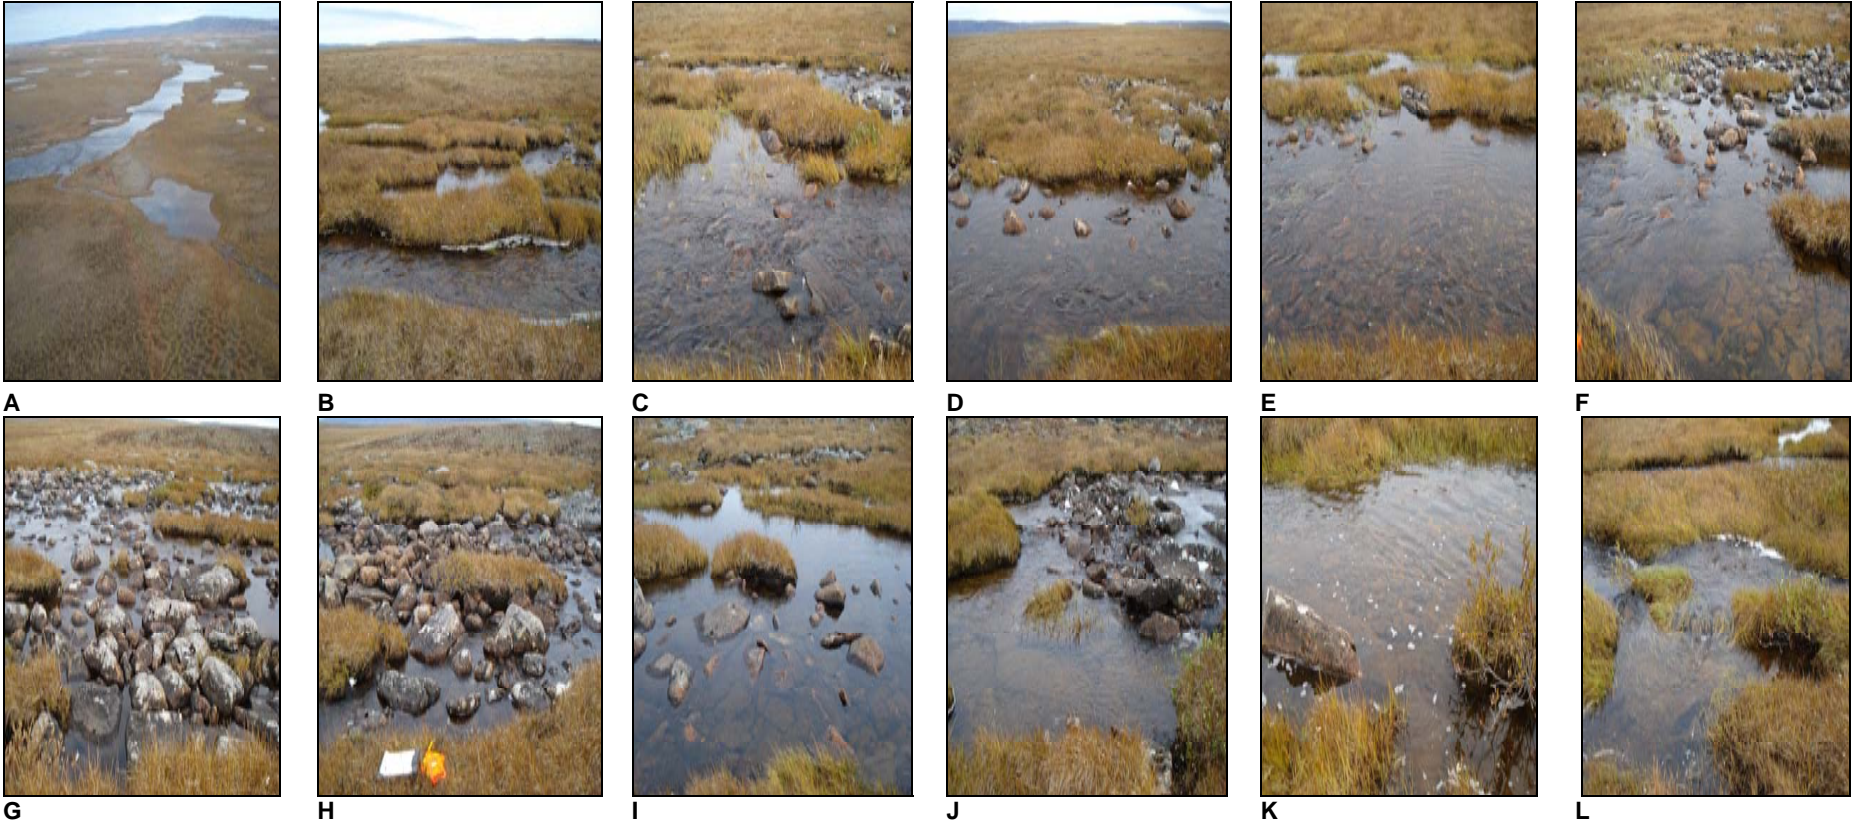
Figure 1. Aerial view of confluence with river (A), 100m downstream across (B), 80m (C), 60m (D), 40m (E), 20m (F), crossing across (G), 20m upstream across (H), 40m (I), 60m (J), 80m (K), and 100m (L).

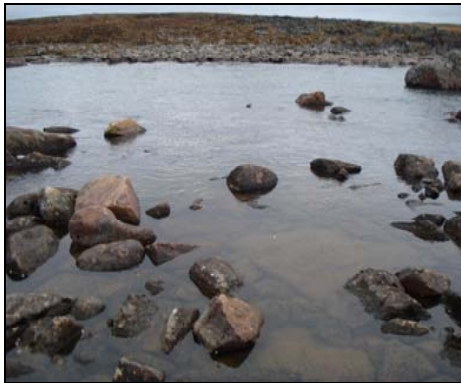
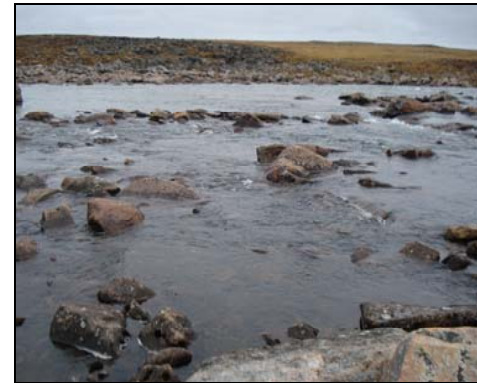
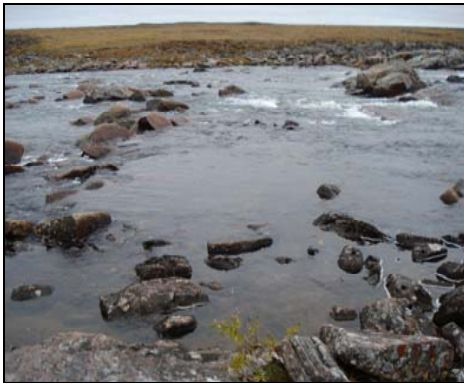
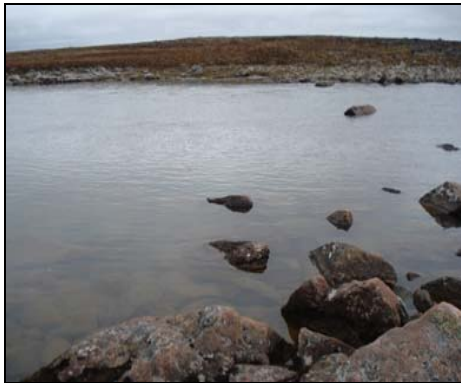
Figure 1. View at 40m upstream across (A), 20m (B), crossing across (C), 20m downstream across (D), and 40m (E).

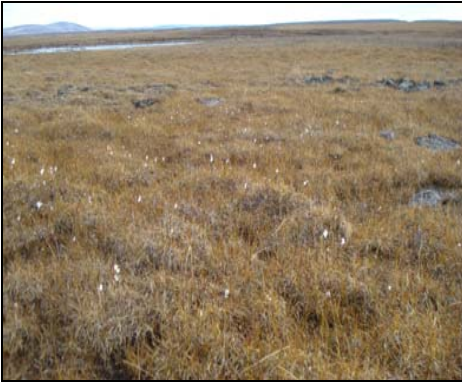
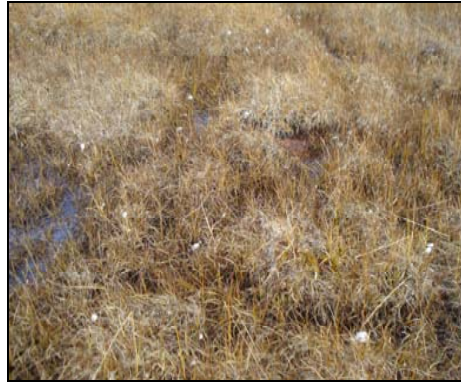
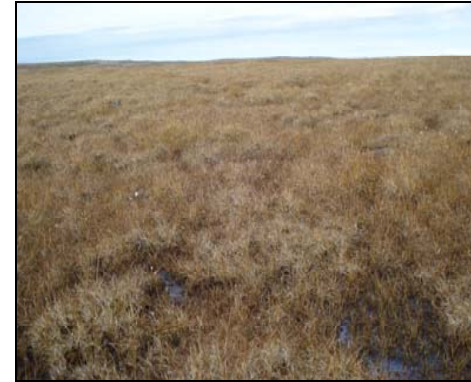
Figure 1. View at crossing downstream (A), crossing across (B), and crossing upstream (C).

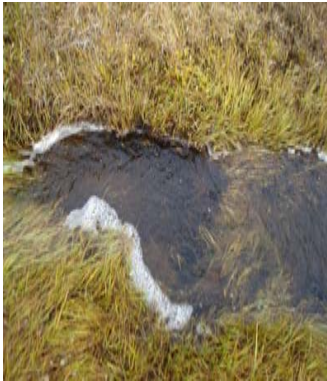
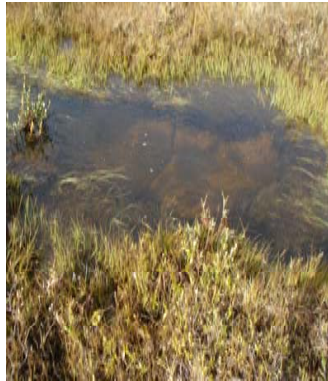
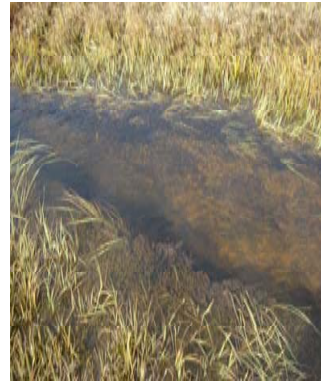
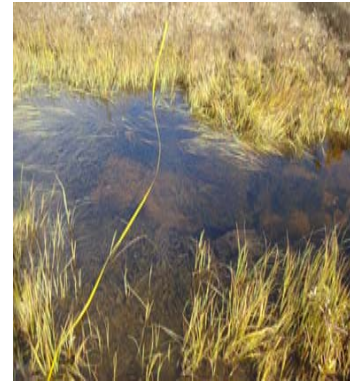
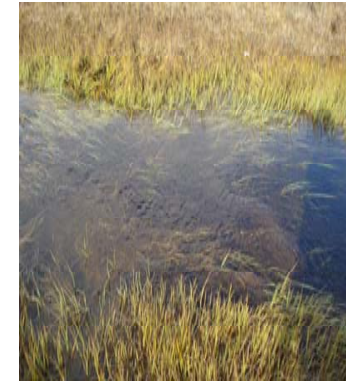
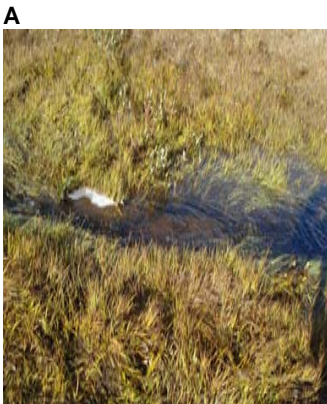
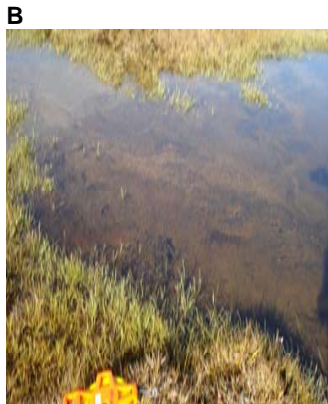
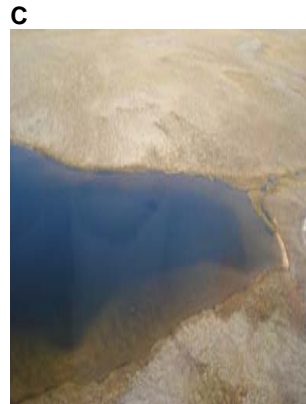
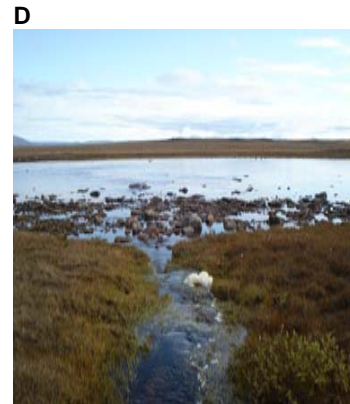
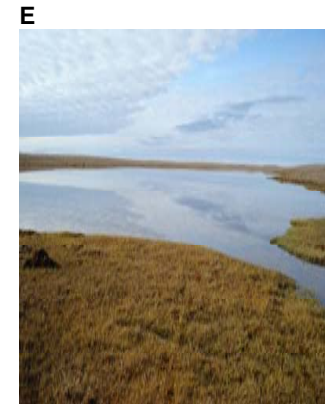
Figure 1. View at 60m downstream across (A), 40m (B), 20m (C), crossing (D), 20m upstream across (E), 40m (F), 60m (G), deep lake further upstream (H), large river downstream (I), and pond upstream (J).

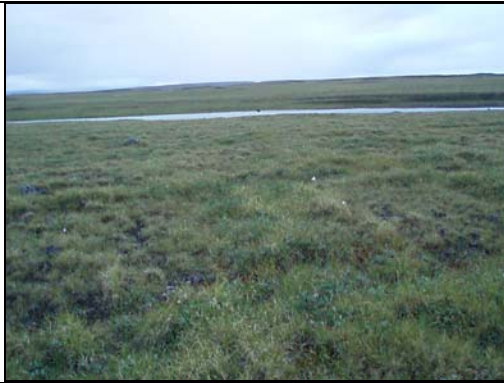
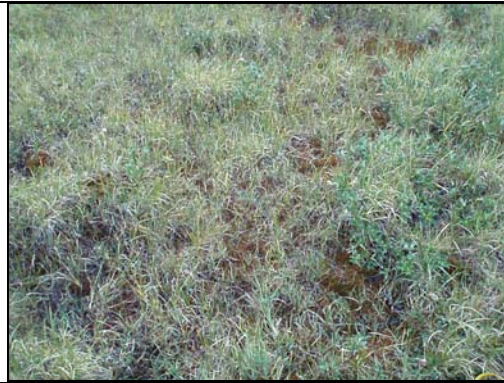
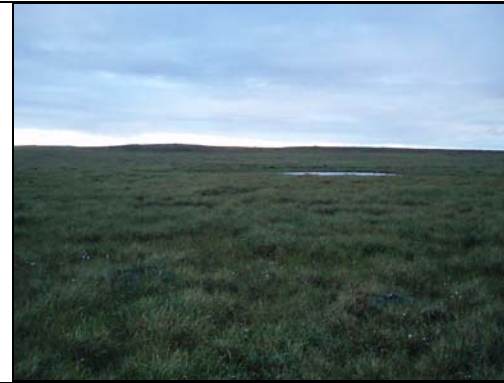
Figure 1. View of habitat upstream of crossing (A), at the crossing (B) and downstream of crossing (C).

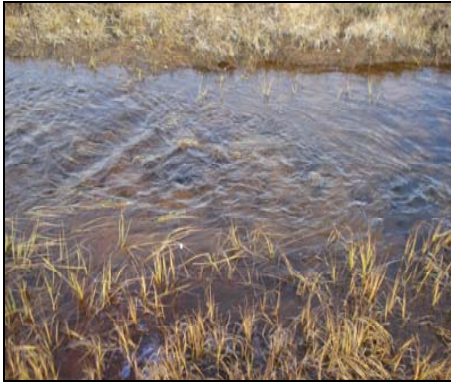
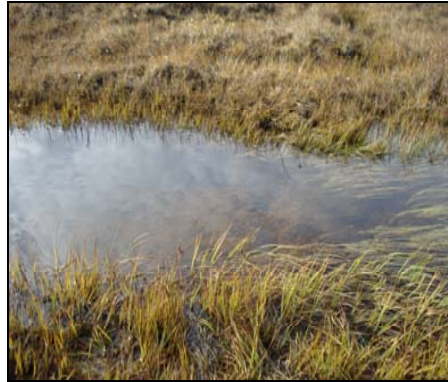
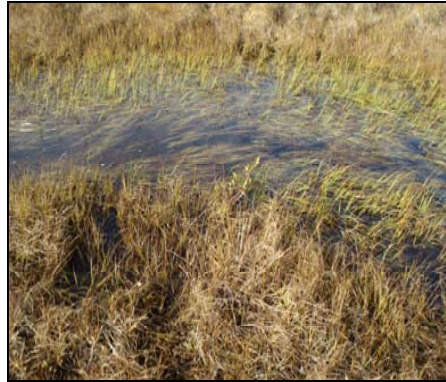
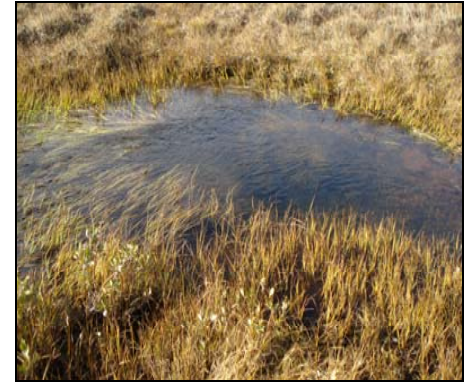
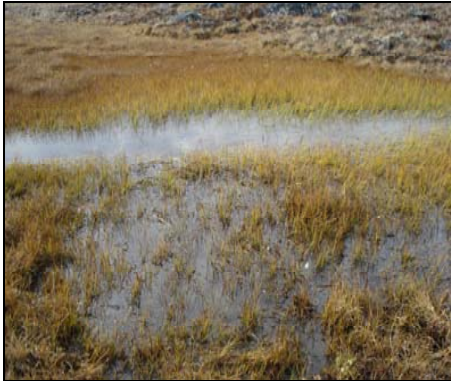
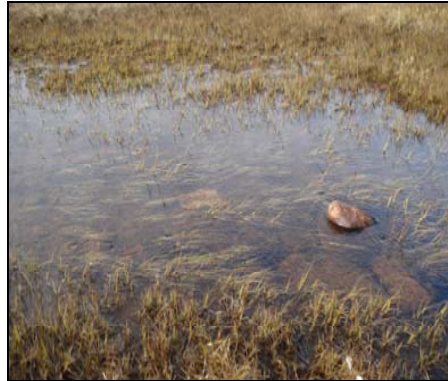
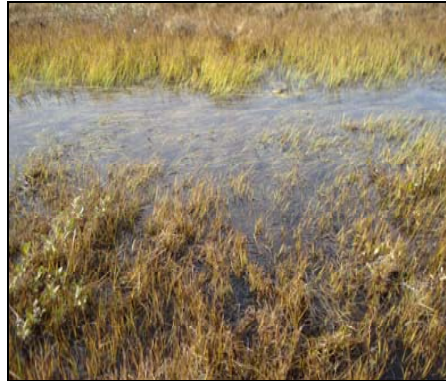
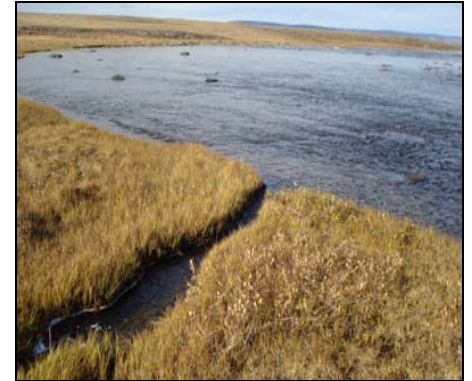
Figure 1. View at 100m downstream across (A), 80m (B), 60m (C), 40m (D), 20m (E), crossing across (F), 20m upstream across (G), and large river confluence (H).

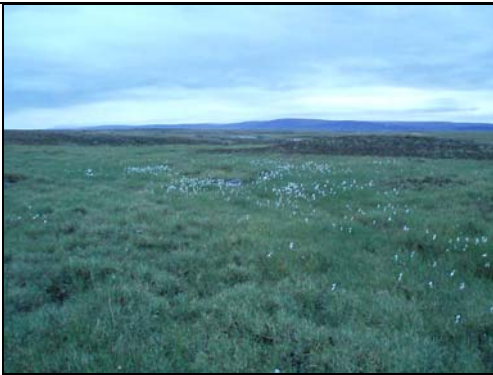
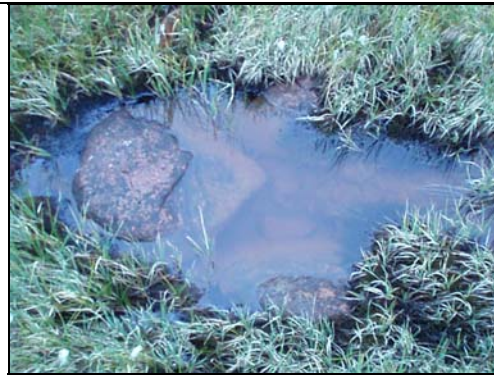
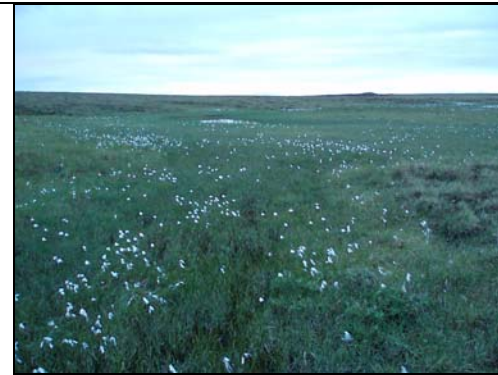
Figure 1. View of habitat upstream of the crossing (A), at the crossing (B) and downstream of the crossing (C)

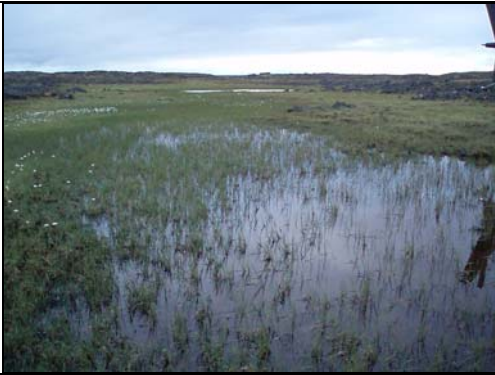
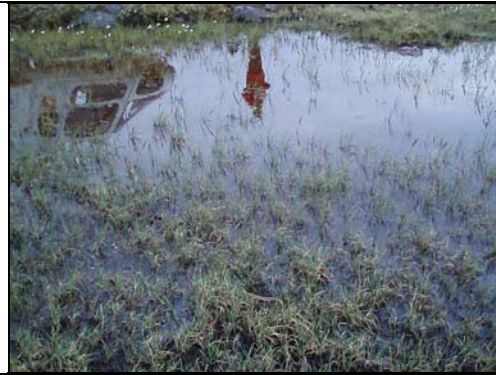
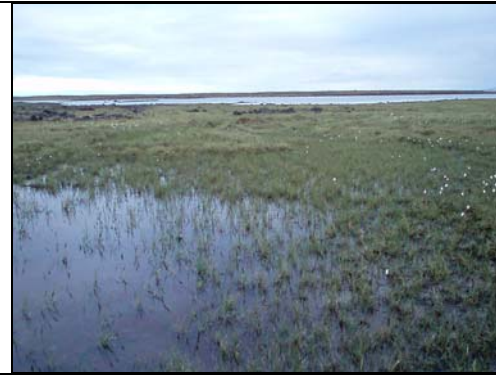
Figure 1. View of habitat upstream of crossing (A), at the crossing (B) and downstream of crossing (C).

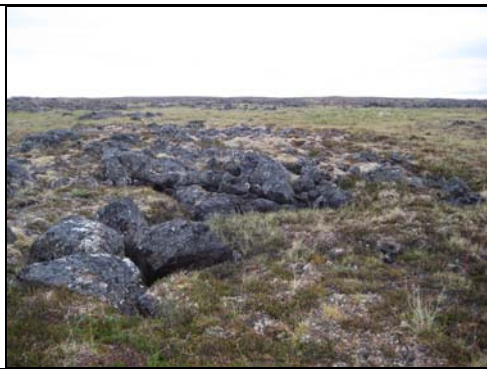
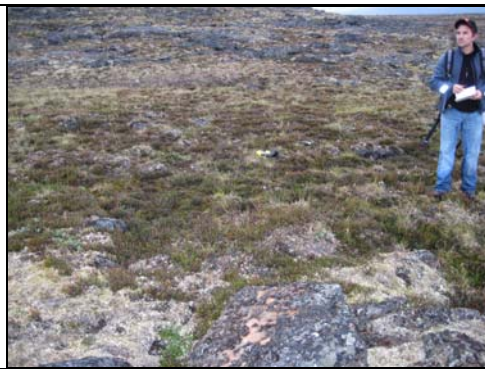
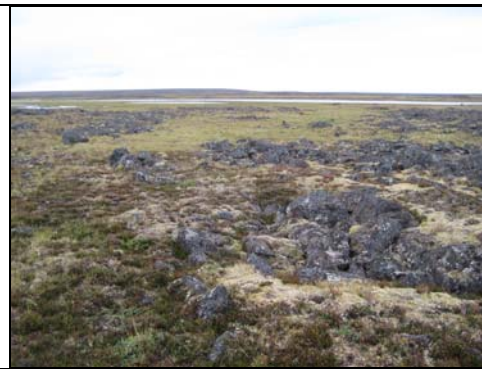
Figure 1. View of habitat upstream of crossing (A), at the crossing (B) and downstream of crossing (C).

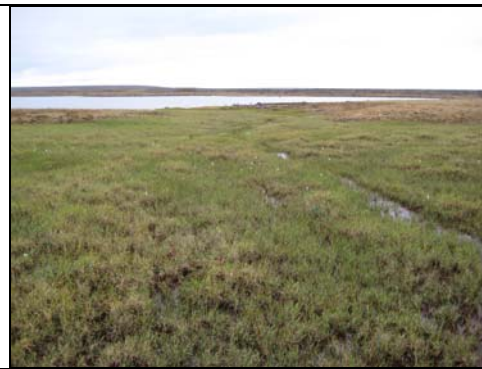
C

Figure 1. View of habitat upstream of crossing (A), at the crossing (B) and downstream of crossing (C).

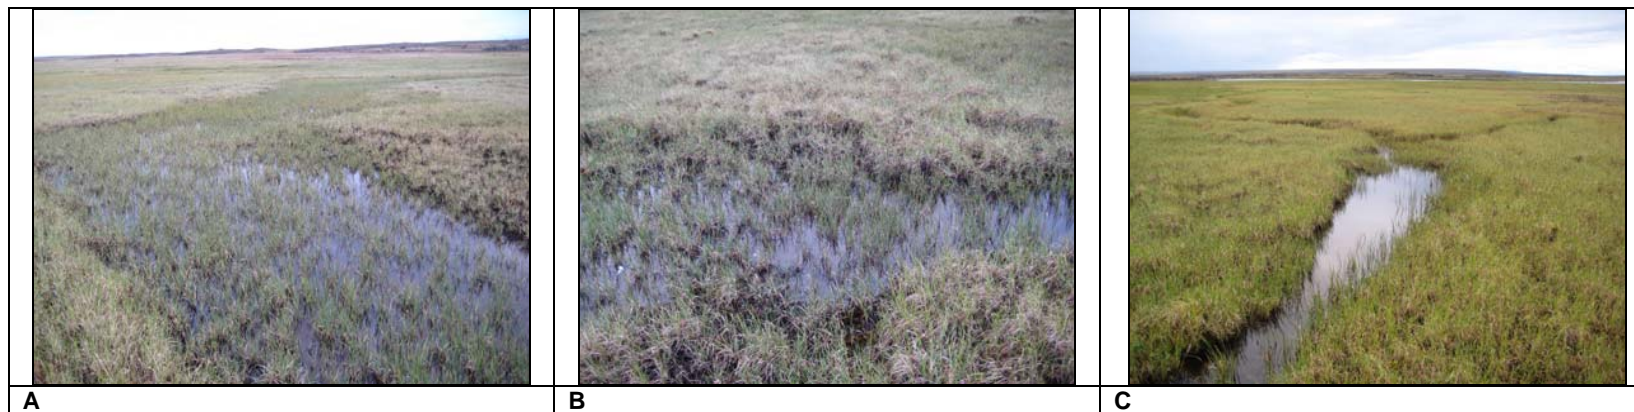
Figure 1. View of habitat upstream of crossing (A), at the crossing (B) and downstream of crossing (C).

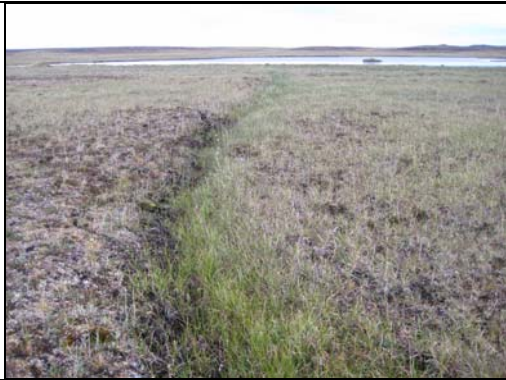
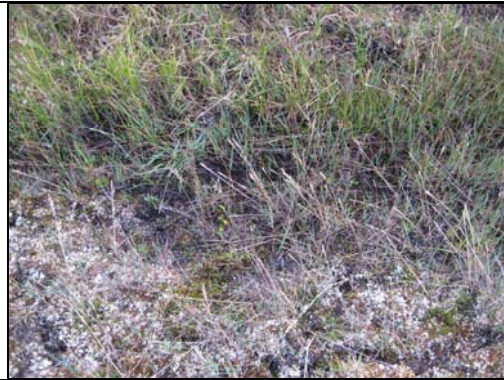
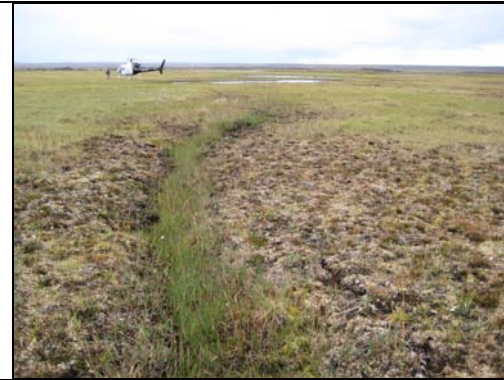
Figure 1. View of habitat upstream of crossing (A), at the crossing (B) and downstream of crossing (C).

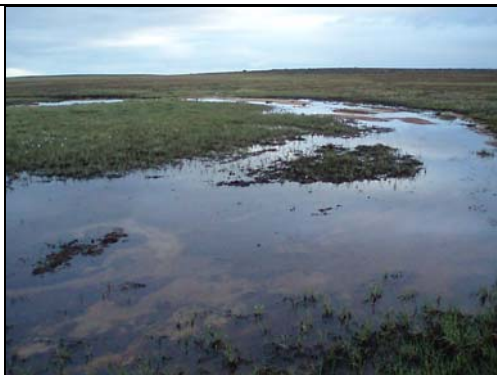
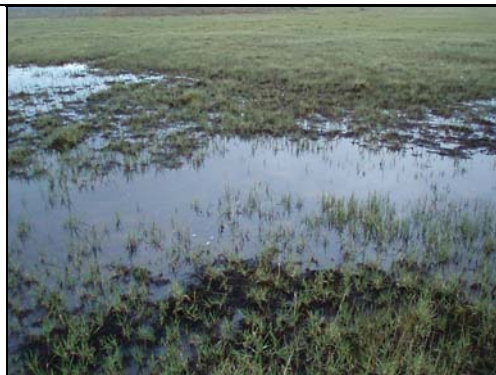
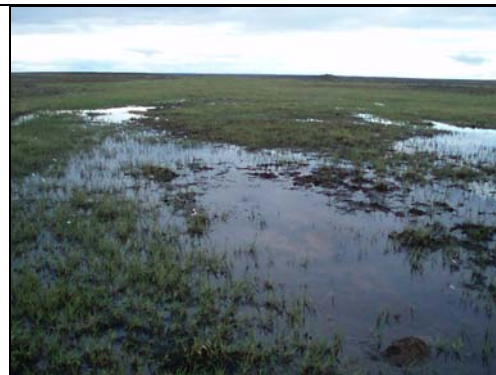
Figure 1. View of habitat upstream of crossing (A), at the crossing (B) and downstream of crossing (C).

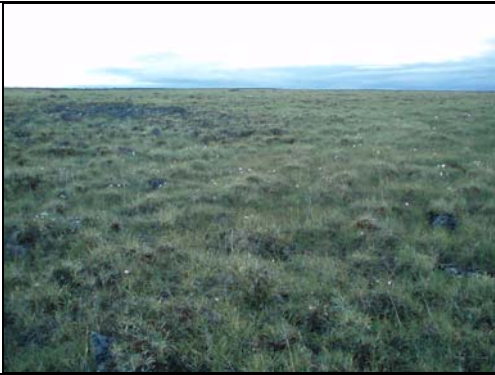
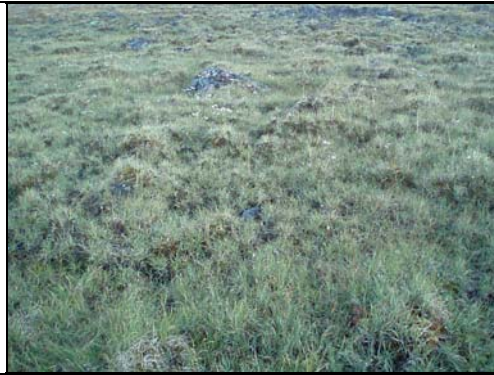
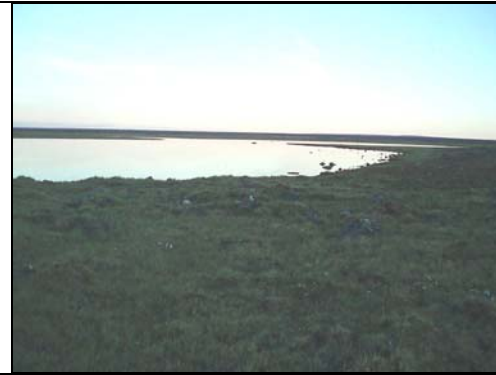
Figure 1. View of habitat upstream of crossing (A), at the crossing (B) and downstream of crossing (C).

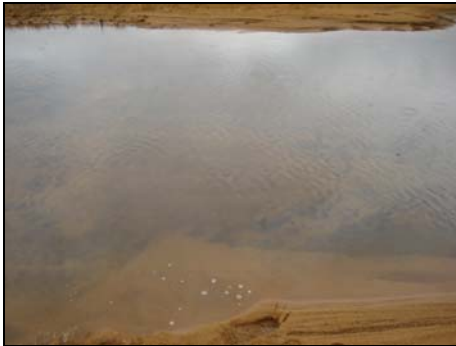
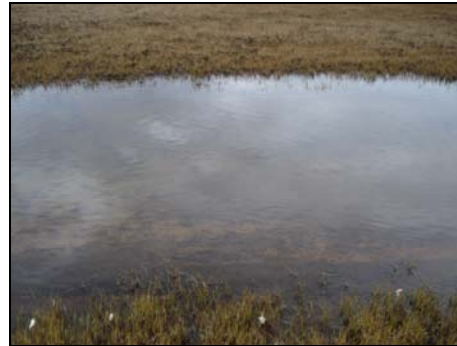
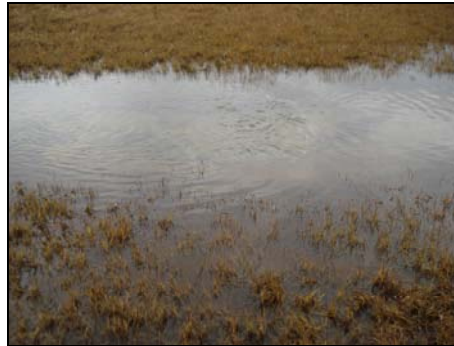
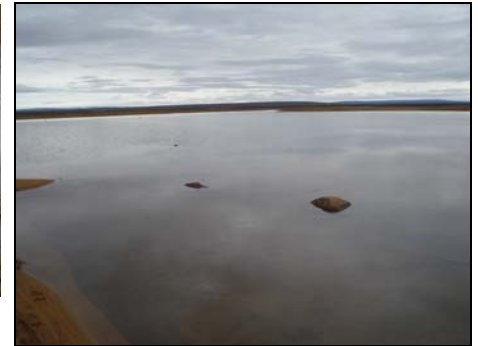
Figure 1. View of habitat, 60 (A), 40 (B), and 20 m (C) downstream of crossing, and at a pond 70 m D/S from crossing (D).

The crossing UTM is actually located within the same lake as LE-051-1, and the lake flows into a stream that starts 10m downstream of the crossing. The upper limit of fish passage is located at UTM 17 W 594158 7879582. Many adult and YOY NNST were observed during a 2007 assessment of this site, suggesting at least occasional use by both species.

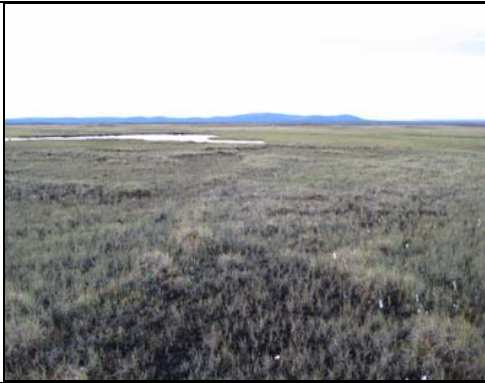
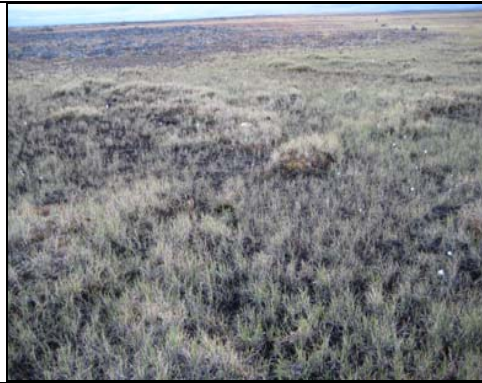
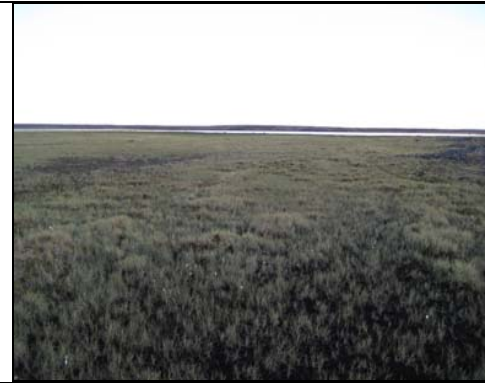
Figure 1. View of habitat upstream of crossing (A), at the crossing (B) and downstream of crossing (C).

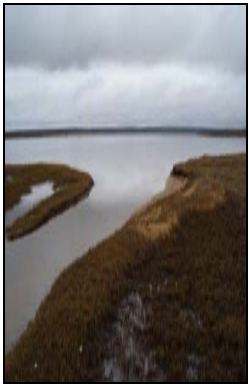
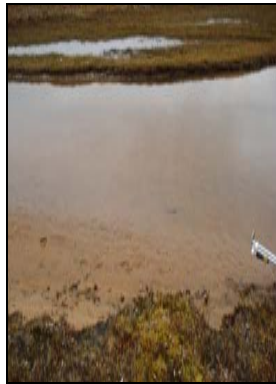
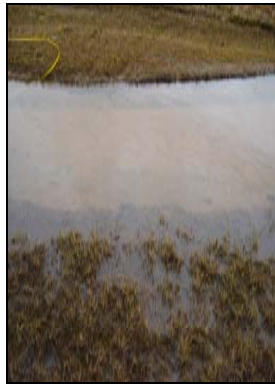
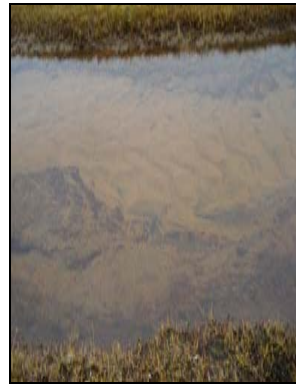
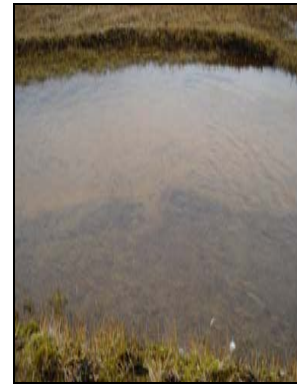
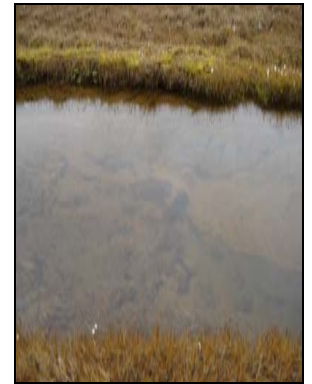
Figure 1. View of upstream pond (A), 100m upstream across (B), 80m (C), 60m (D), 40m (E), 20m (F), crossing across (G), 20m downstream across (H), 40m (I), 60m (J), 80m (K), and downstream pond (L).

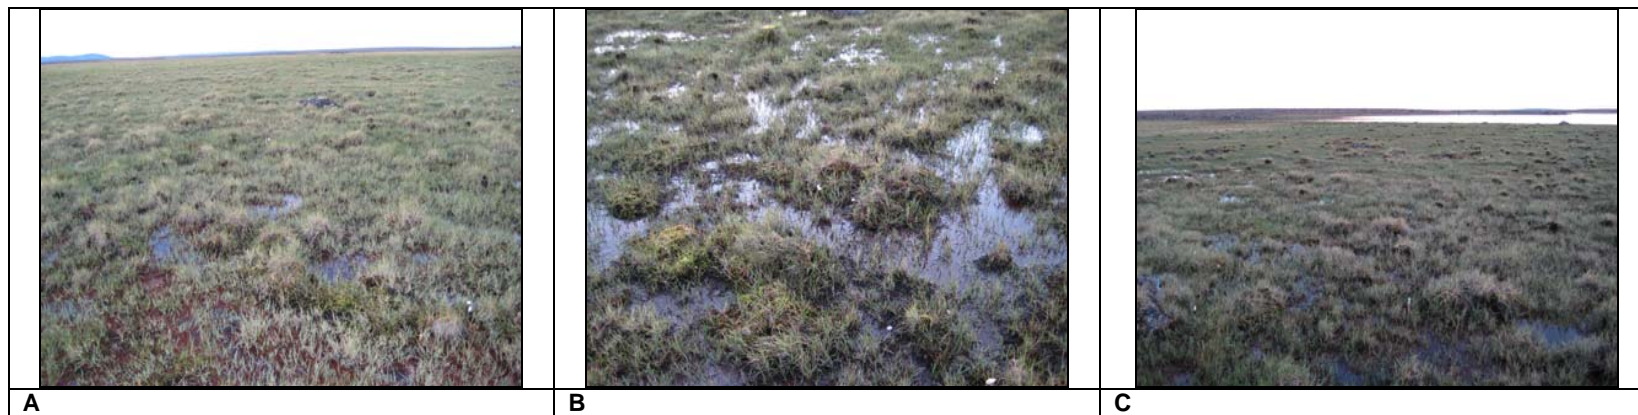
Figure 1. View of habitat upstream of crossing (A), at the crossing (B) and downstream of crossing (C).

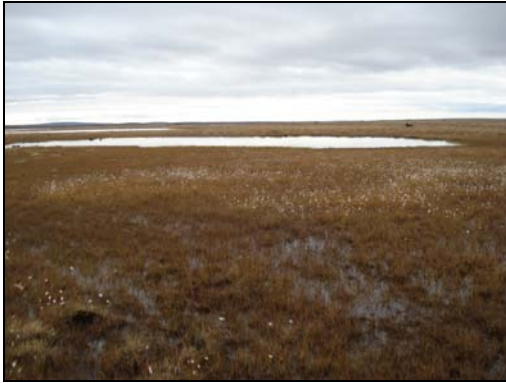
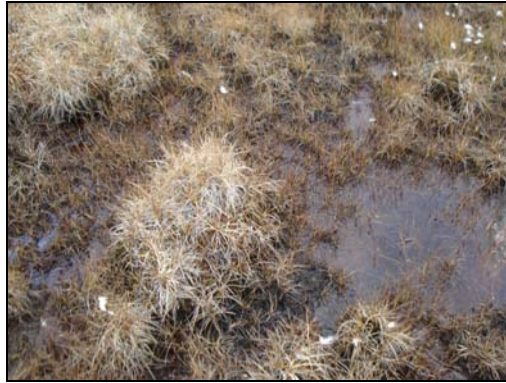
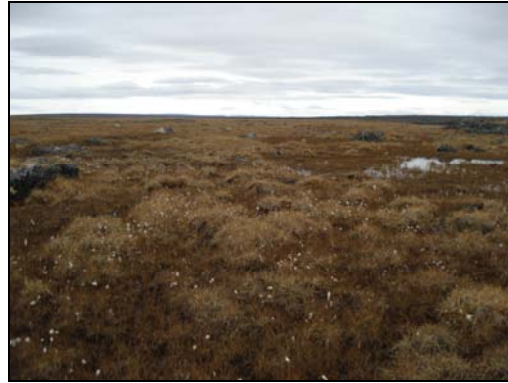
Figure 1. View at crossing downstream (A), crossing across (B), and crossing upstream (C).

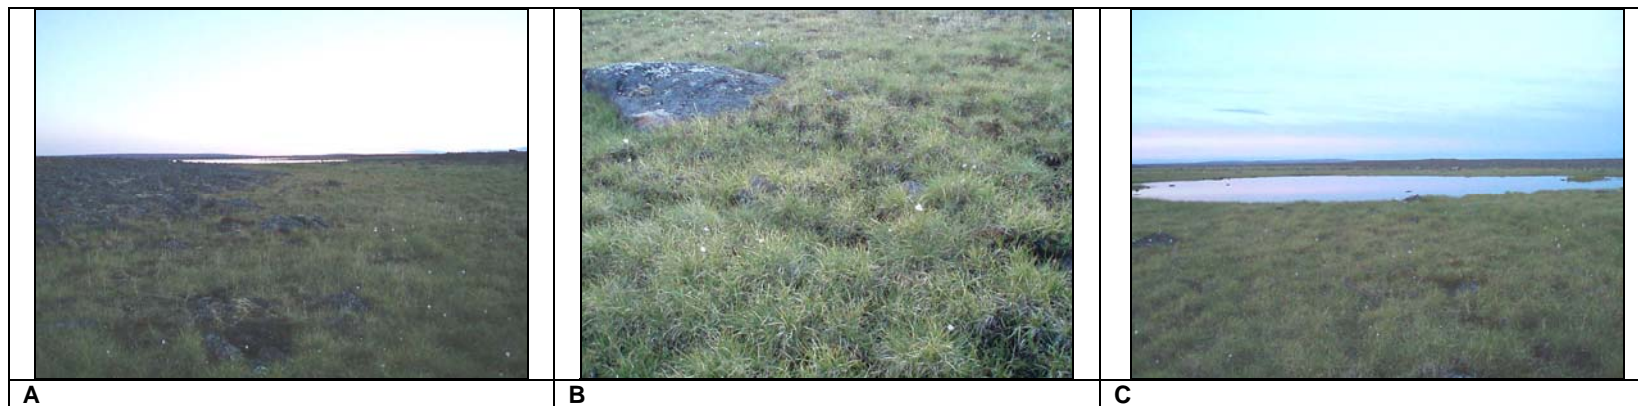
Figure 1. View of habitat upstream of crossing (A), at the crossing (B) and downstream of crossing (C).

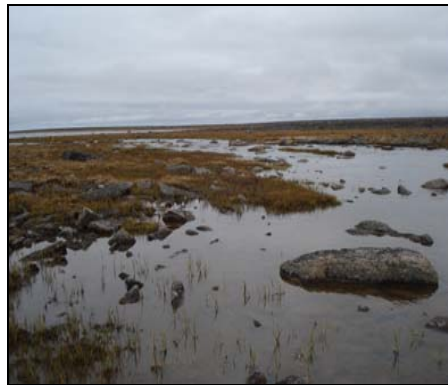
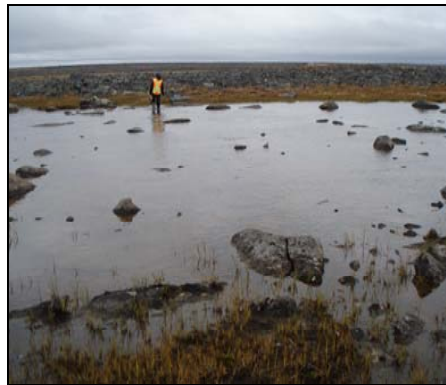
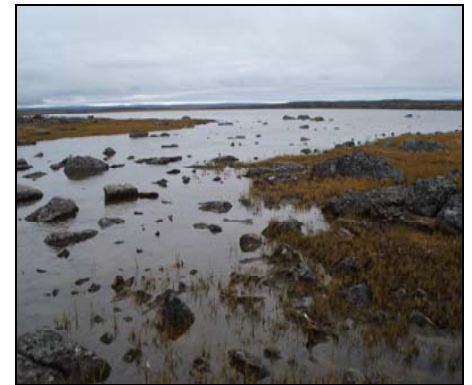
Figure 1. View 40m downstream across (A), 40m downstream facing downstream (B), 20m downstream across (C), crossing across (D), 20m upstream across (E), 40m upstream downstream (F), 40m upstream across (G), and 40m upstream facing upstream (H).
