**HABITAT ASSESSMENT PROTOCOL AND SAMPLE
DATA SHEET USED FOR DESCRIBING AVAILABLE
AQUATIC HABITAT IN WATERCOURSES IN THE
RAILWAY/ACCESS ROAD AREA.**

MARY RIVER PROJECT RAILWAY/ACCESS ROAD WATERCOURSE CROSSING ASSESSMENT PROTOCOL

North/South Consultants Inc. and Knight Piésold Ltd.

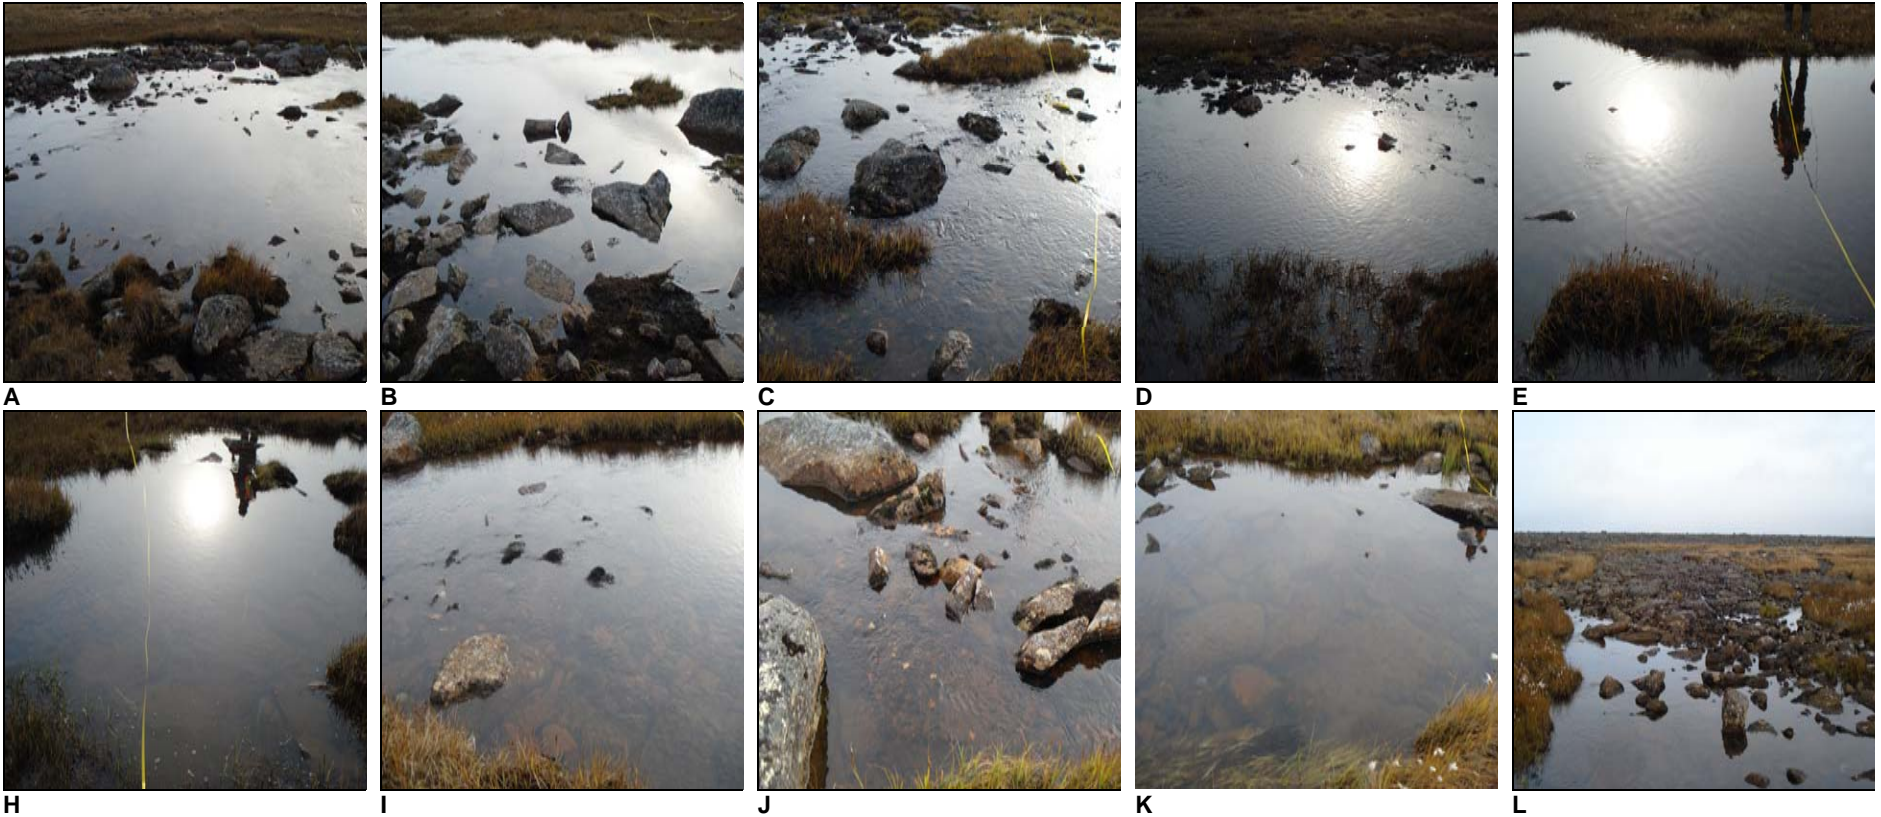
Figure 1. View at 100m downstream across (A), 80m (B), 40m (C), 20m (D), crossing across (E), 20m upstream across (F), 40m (G), 60m (H), 80m (I), and 80m upstream facing upstream towards barrier (J).

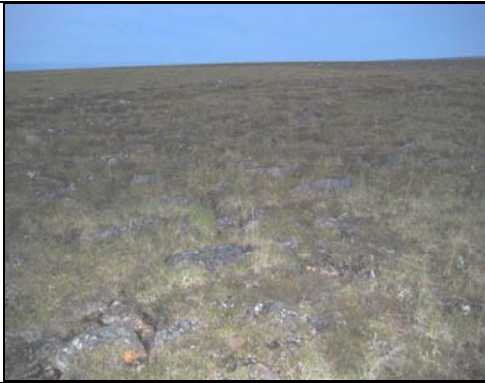
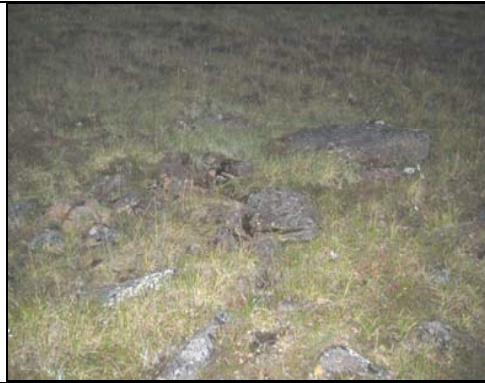
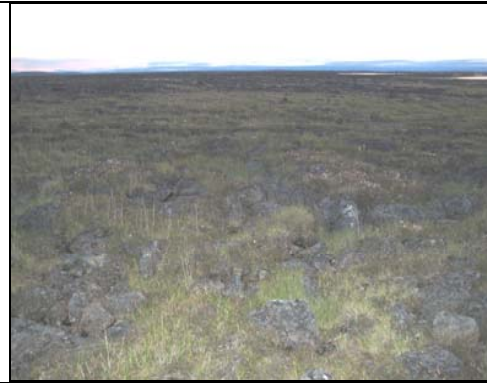
Figure 1. View of habitat upstream of crossing (A), at the crossing (B) and downstream of crossing (C).

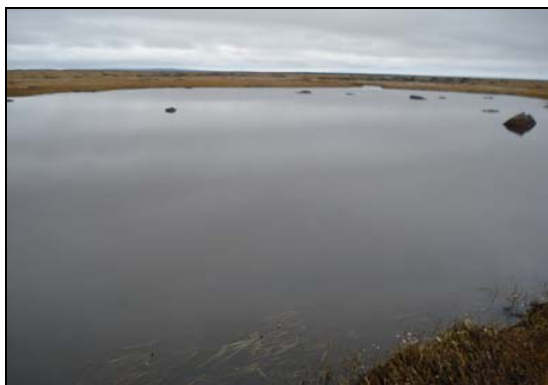
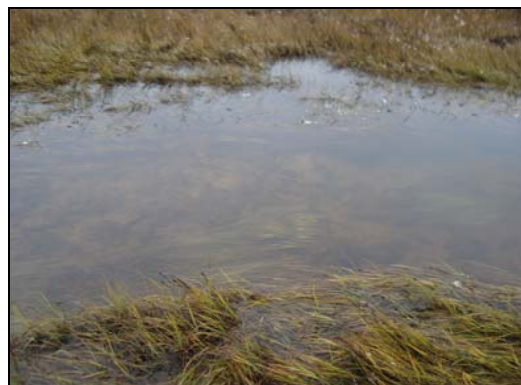
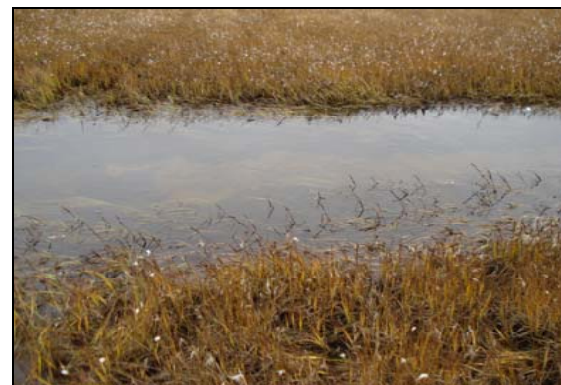
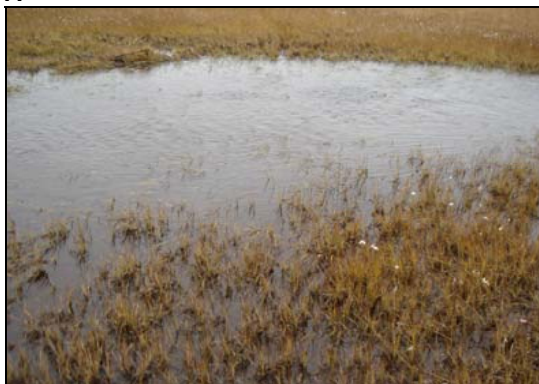
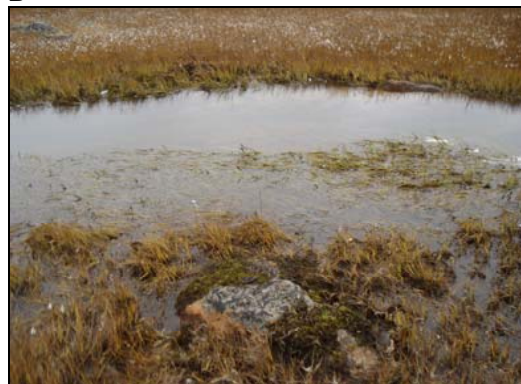
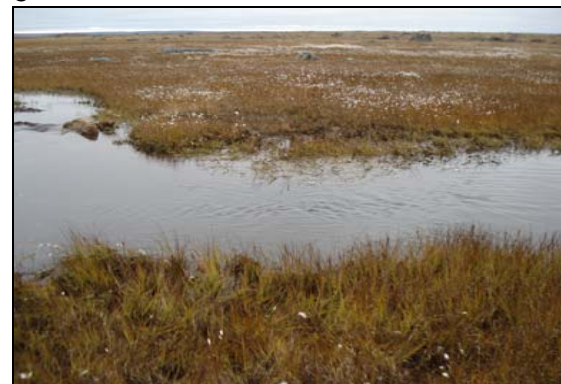
Figure 1. View of upstream pond (A), 20m downstream across (B), 40m (C), 60m (D), 80m (E), and 100m (F).

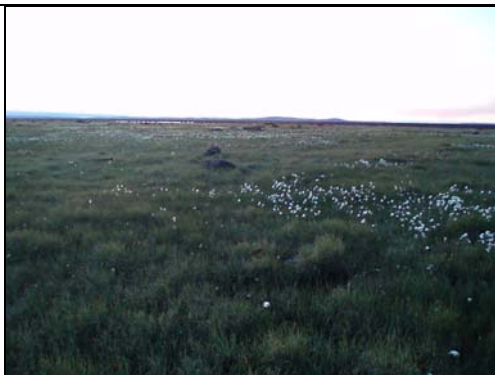
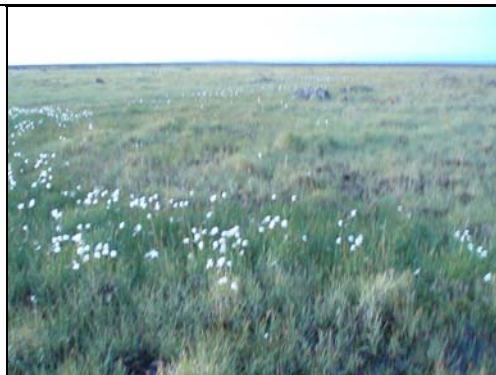
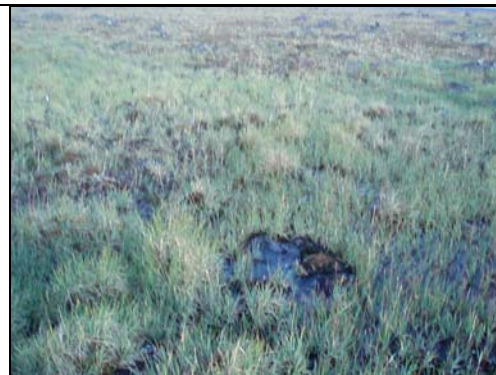
Figure 1. View of habitat north of crossing (A), east of the crossing (B) and south of crossing (C).

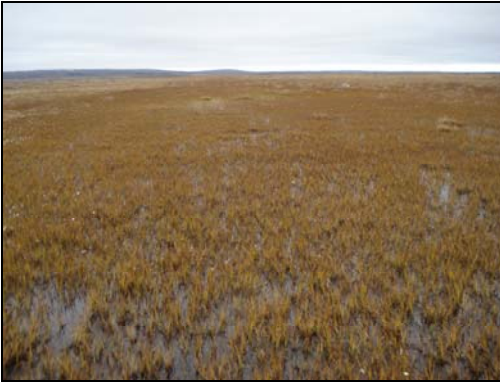
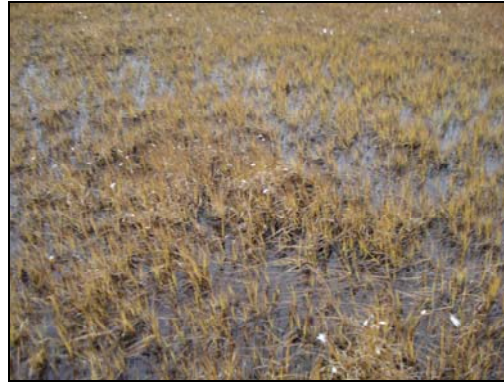
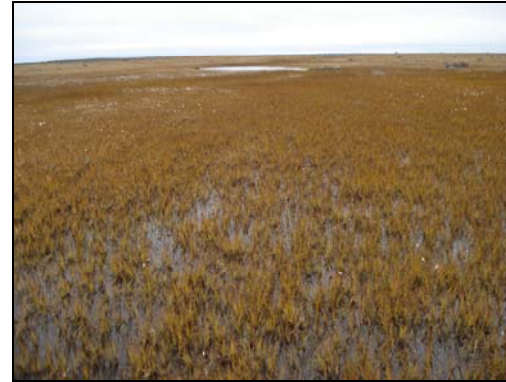
Figure 1. View at crossing downstream (A), crossing across (B), and crossing upstream (C).

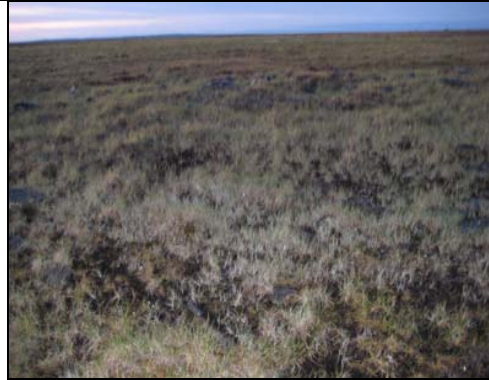
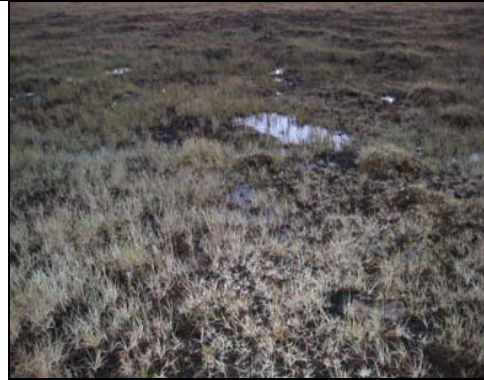
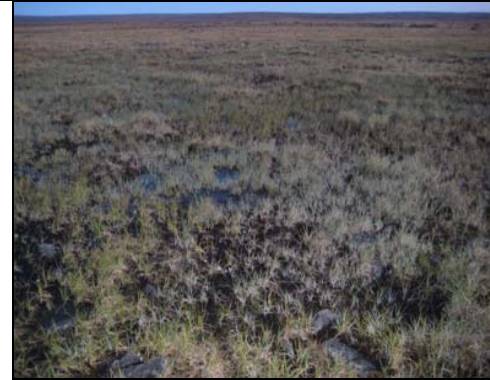
Figure 1. View of habitat upstream of crossing (A), at the crossing (B) and downstream of crossing (C).

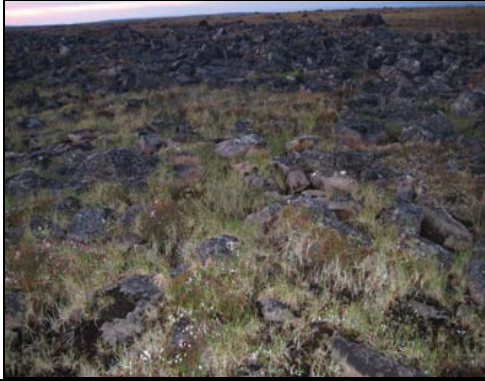
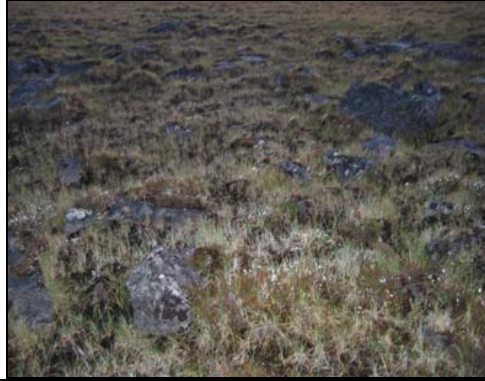
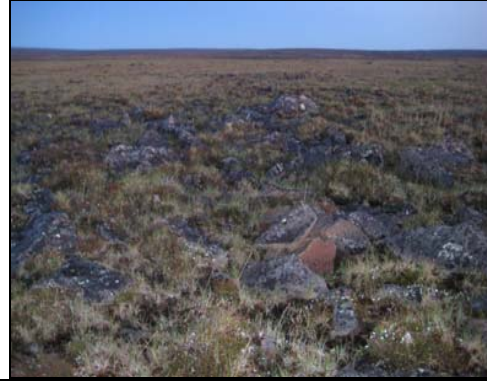
Figure 1. View of habitat upstream of crossing (A), at the crossing (B) and downstream of crossing (C).

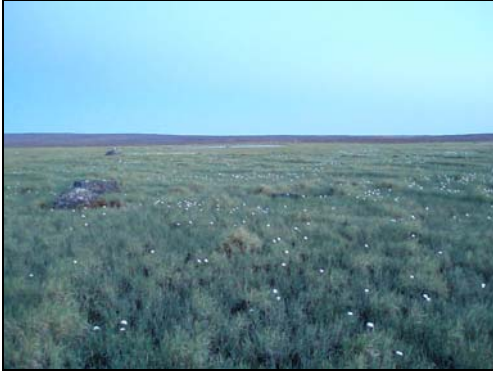
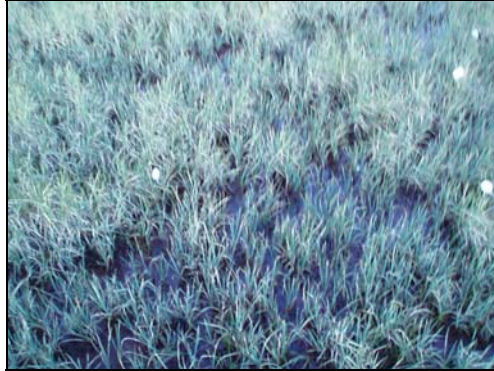
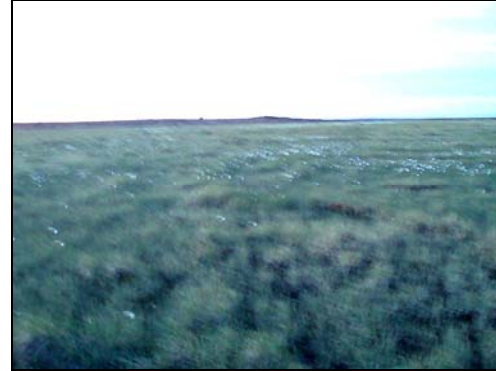
Figure 1. View of habitat upstream of crossing (A), at the crossing (B) and downstream of crossing (C).

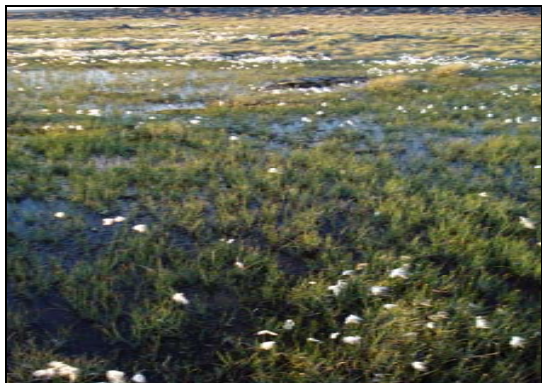
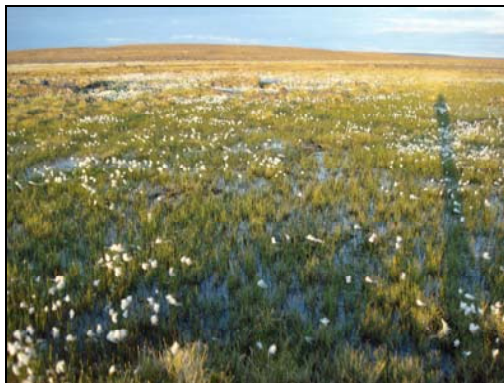
Figure 1. View of habitat at crossing (A-B)

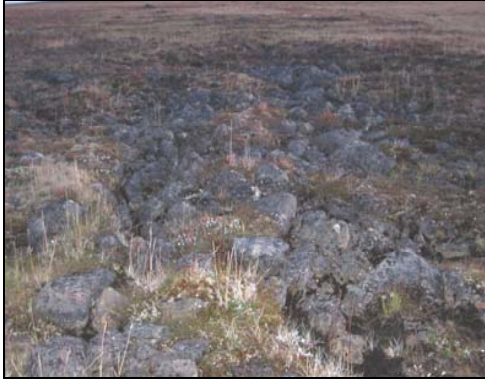
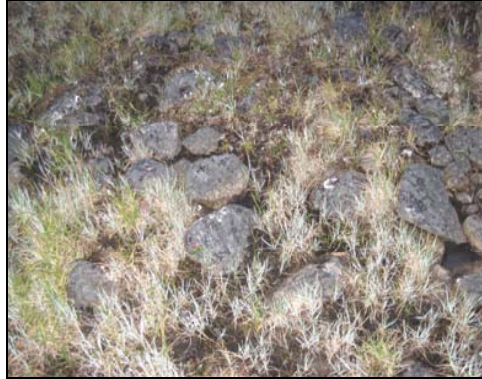
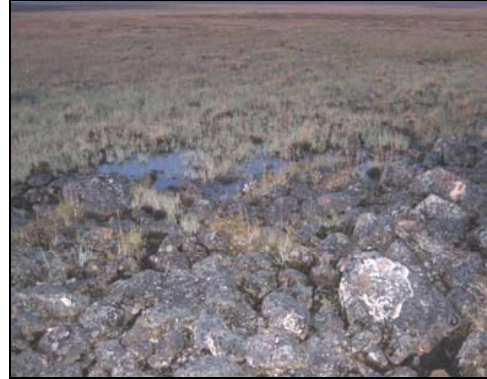
Figure 1. View of habitat upstream of crossing (A), at the crossing (B) and downstream of crossing (C).

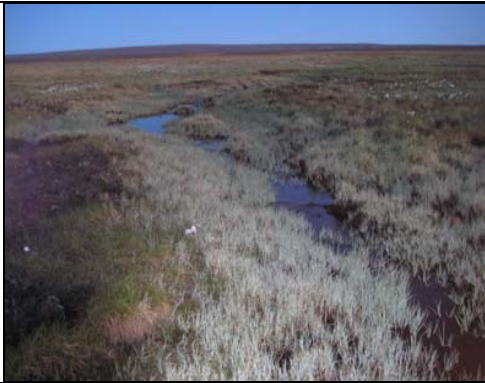
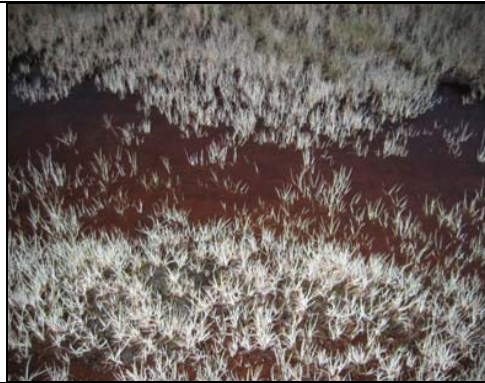
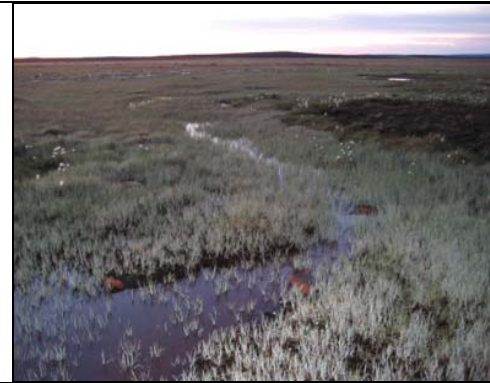
Figure 1. View of habitat upstream of crossing (A), at the crossing (B) and downstream of crossing (C).

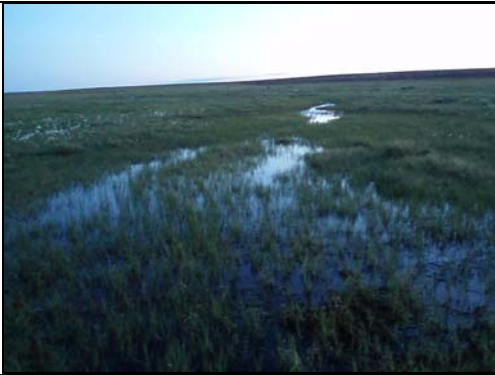
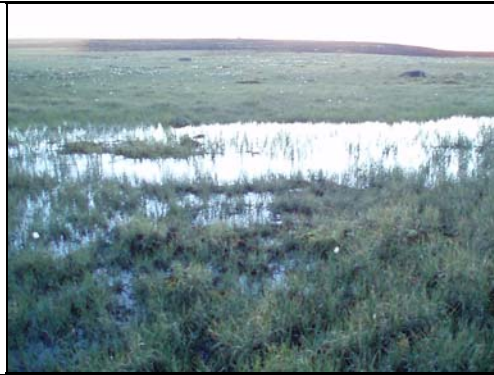
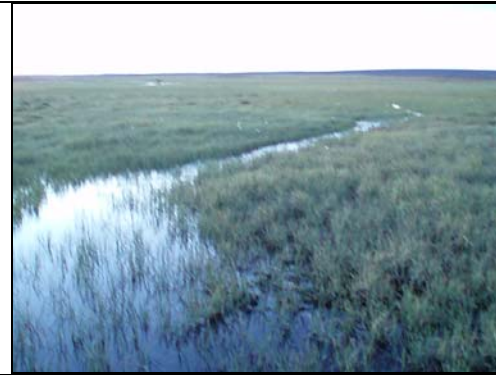
Figure 1. View of habitat upstream of crossing (A), at the crossing (B) and downstream of crossing (C).

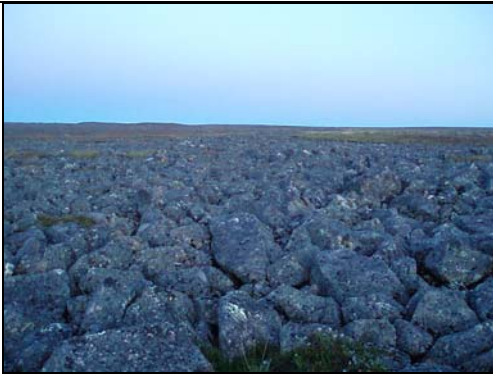
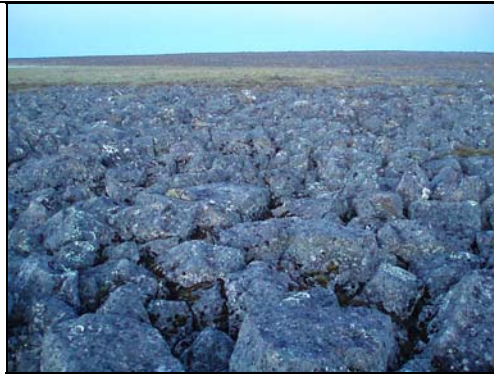
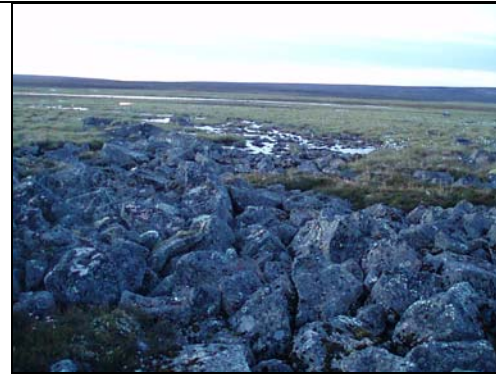
Figure 1. View of habitat upstream of crossing (A), at the crossing (B) and downstream of crossing (C).

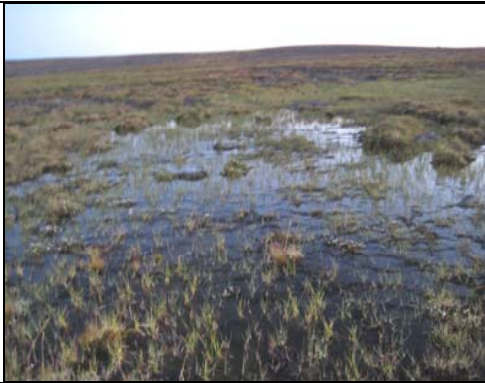
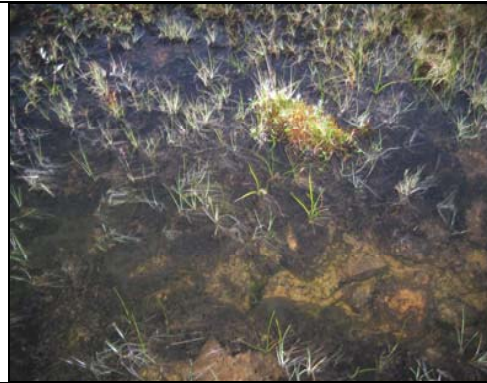
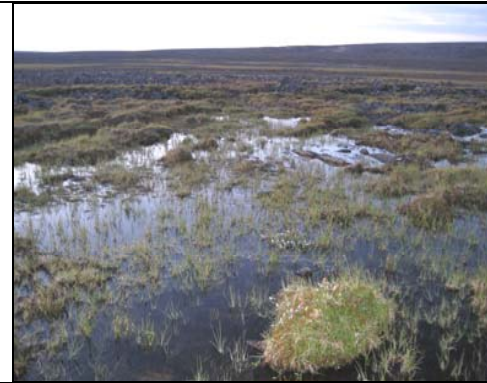
Figure 1. View of habitat upstream of crossing (A), at the crossing (B) and downstream of crossing (C).

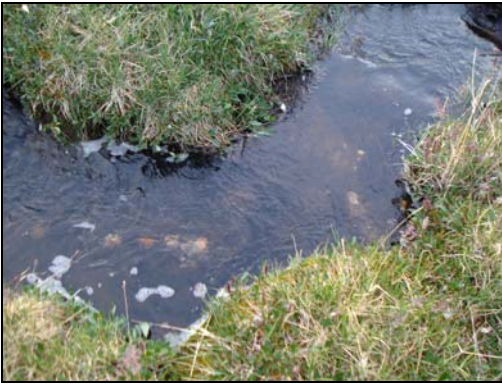
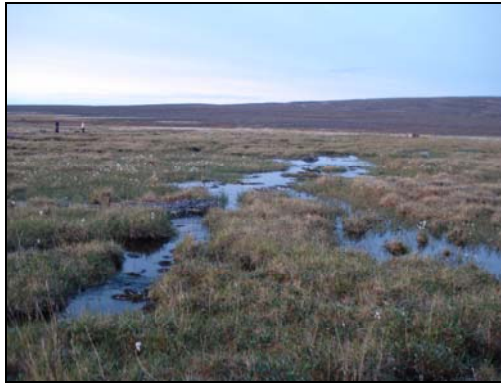
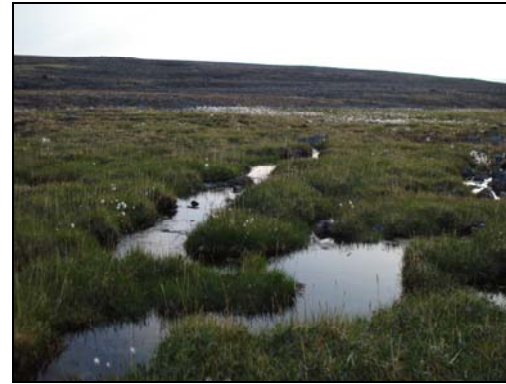
Figure 1. View of habitat, at crossing (A), downstream of crossing (B), and upstream of crossing (C).

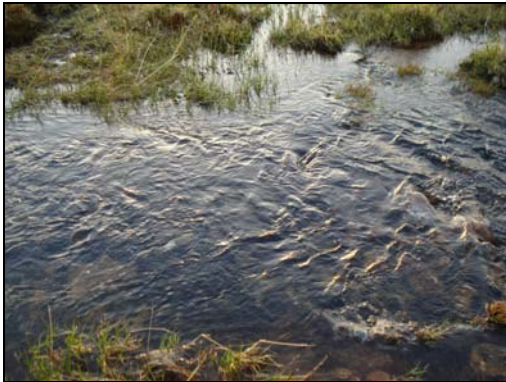
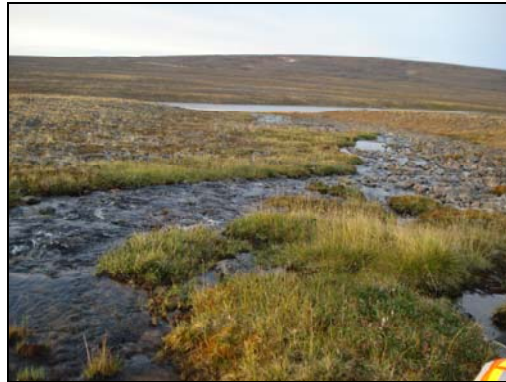
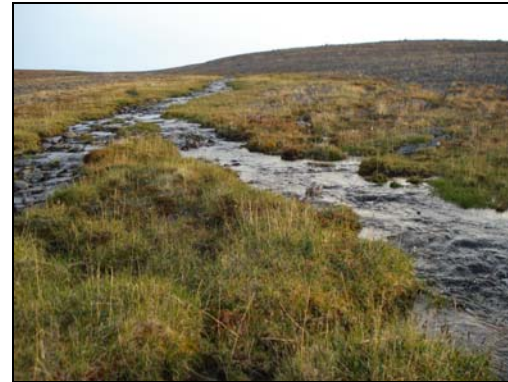
No habitat.

Figure 1. View of habitat, at crossing (A), downstream of crossing (B), and upstream of crossing (C).

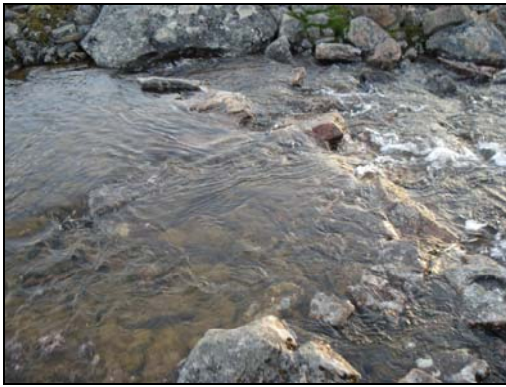
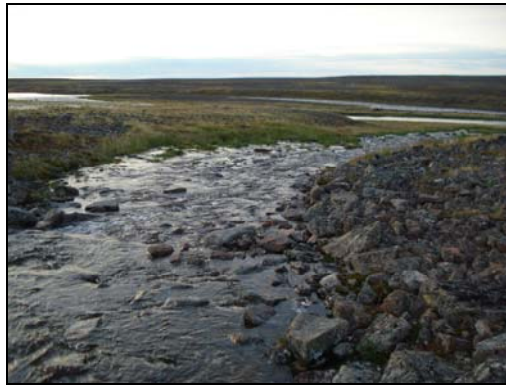
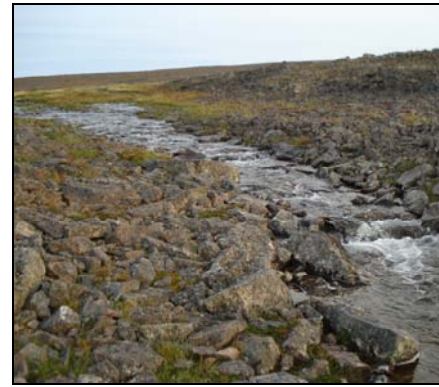
Although it appears to be suitable fish habitat, Arctic char are not present in the large river downstream, so this crossing does not provide Arctic char habitat. No fish.

Figure 1. View of habitat across at the crossing (A), downstream of the crossing (B), and upstream of the crossing(C).

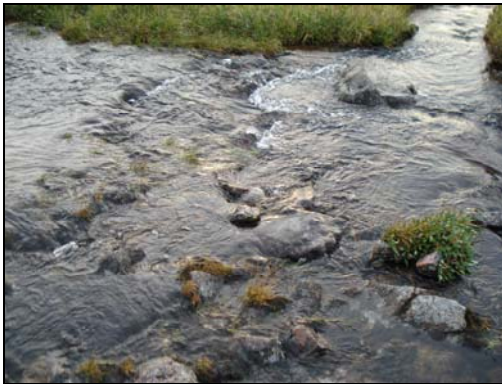
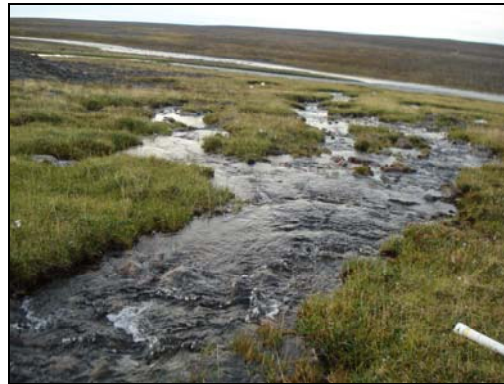
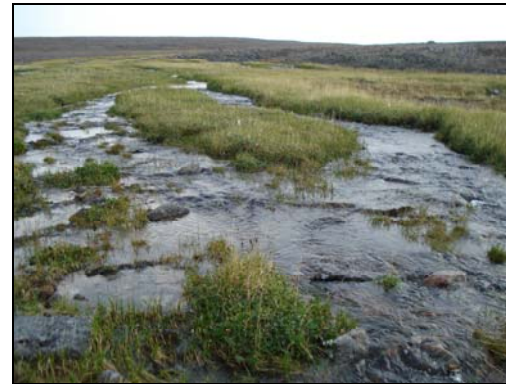
Although it appears to be suitable fish habitat, Arctic char are not present in the large river downstream, so this crossing does not provide Arctic char habitat.
No fish, no habitat

Figure 1. View of habitat, at crossing (A), downstream of crossing (B), and upstream of crossing (C).

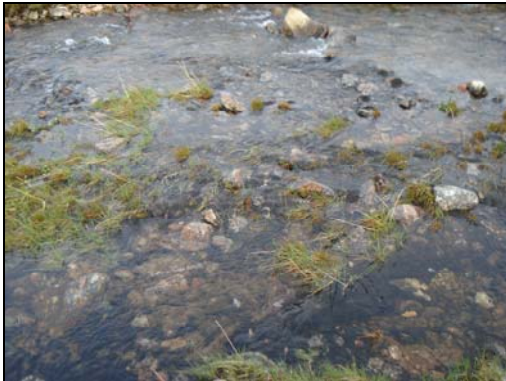
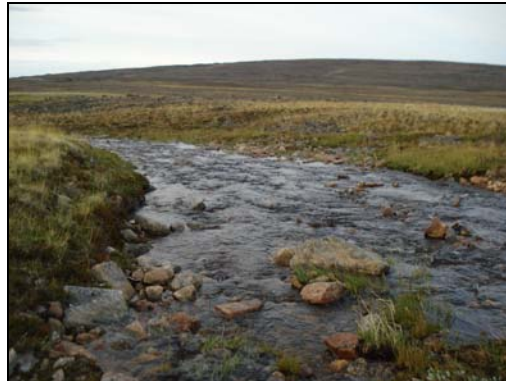
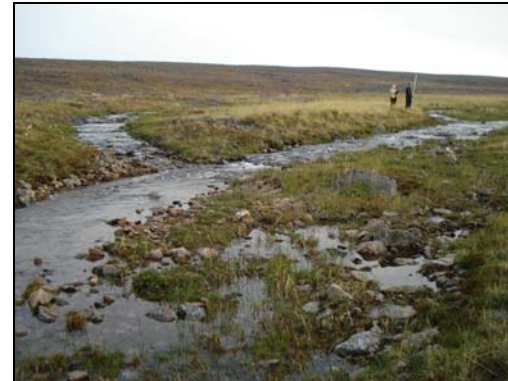
Although it appears to be suitable fish habitat, Arctic char are not present in the large river downstream, so this crossing does not provide Arctic char habitat.

Figure1. View of habitat, at crossing (A), downstream of crossing (B), and upstream of crossing (C).

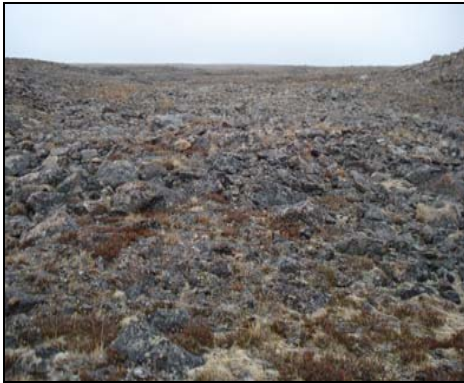
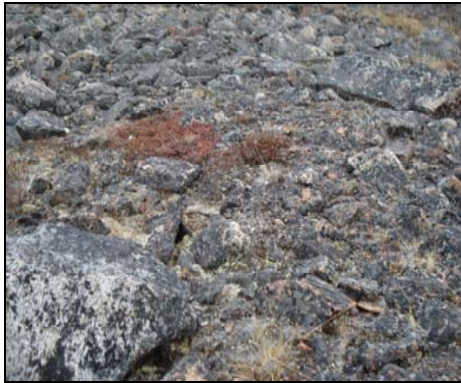
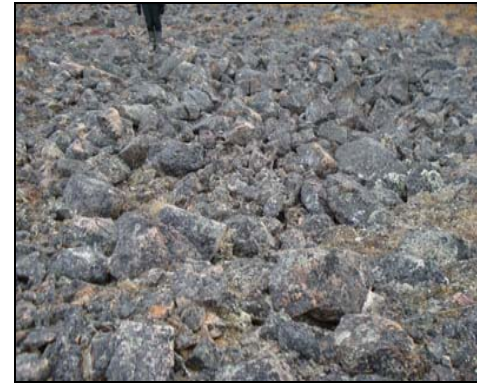
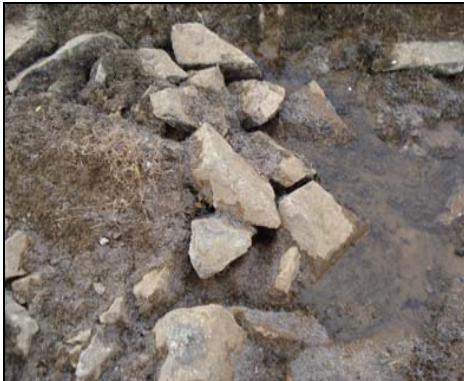
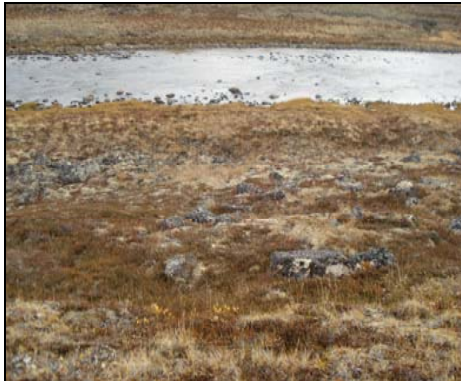
Figure 1. View at crossing upstream (A), crossing across (B), crossing downstream (C), downstream barrier (water goes underground at 90m) (D), and dry stretch between downstream river and wetted stream (E).

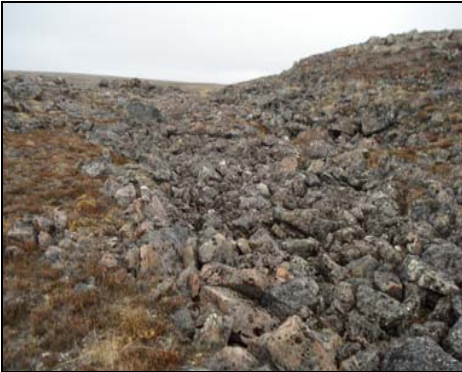
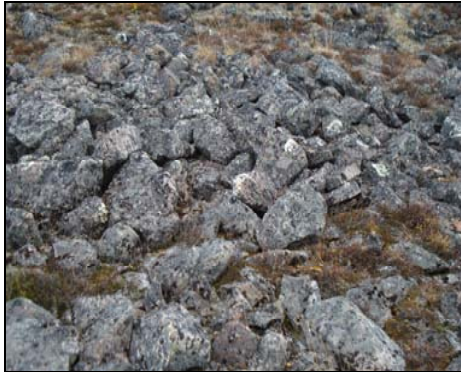
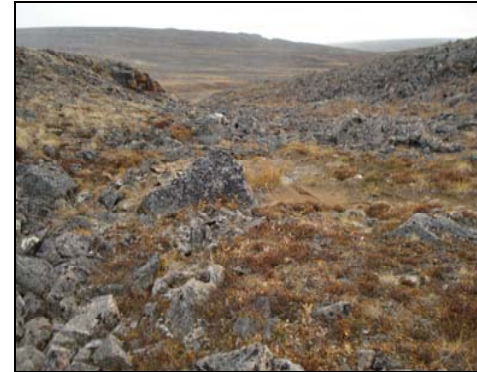
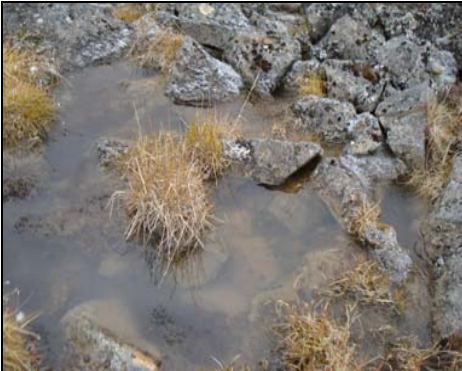
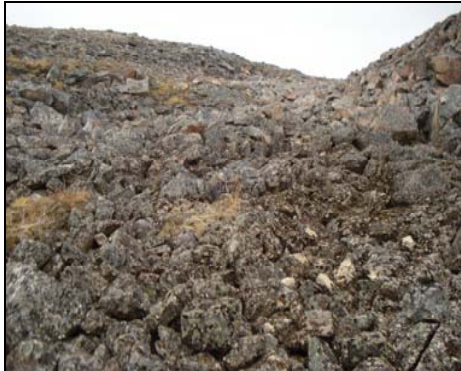
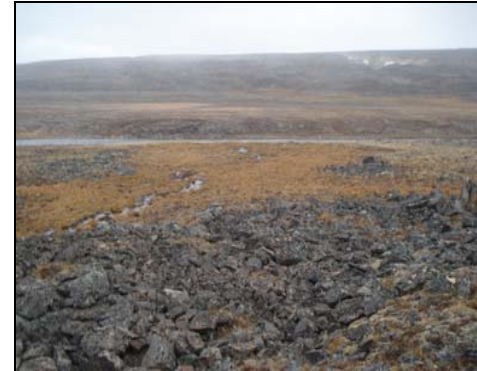
Figure 1. View at crossing upstream (A), crossing across (B), crossing downstream (C), closest surface water 80m of site (D), gradient and rock barriers between crossing and downstream river (E), and water downstream of crossing and barrier (F).

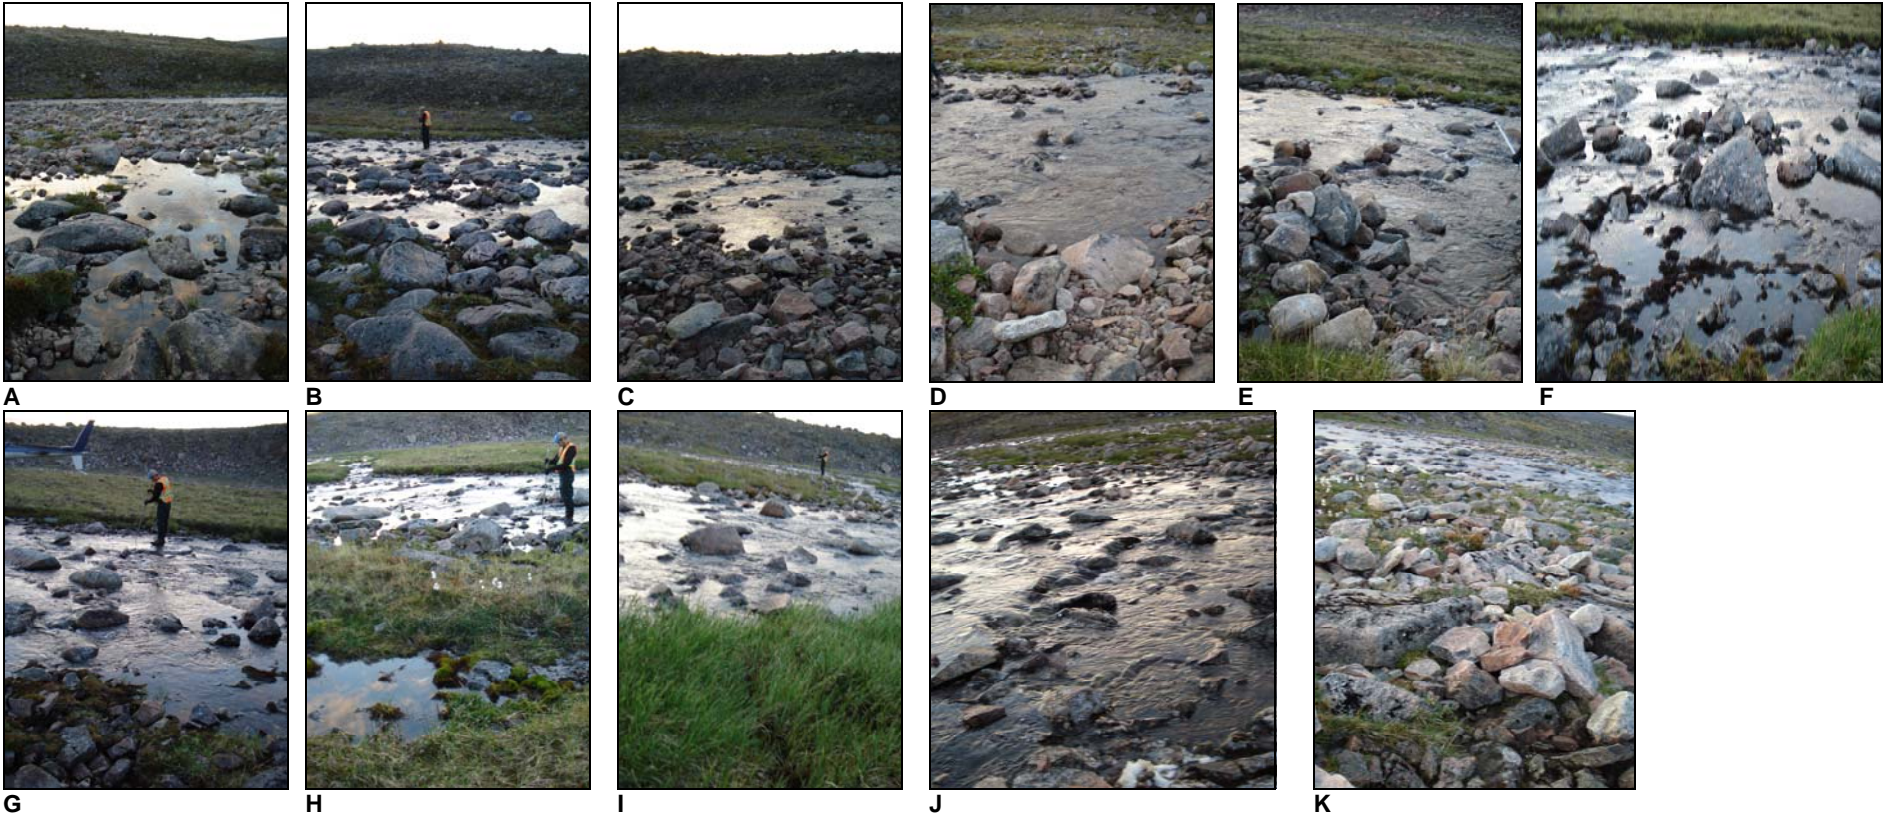
Figure 1. View of habitat 100 (A), 80 (B), 60 (C), 40 (D), and 20 m (E) downstream of crossing, at the crossing (F), and 20 (G), 40 (H), 60 (I), 80 (J), and 100 m (K) upstream of the crossing.

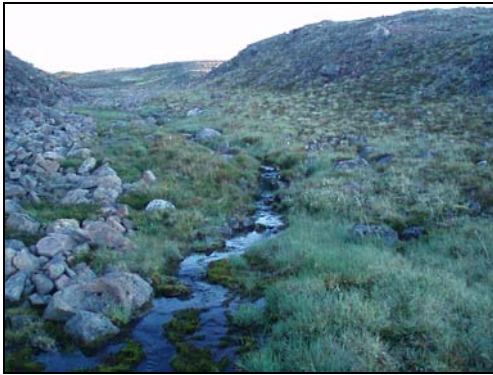
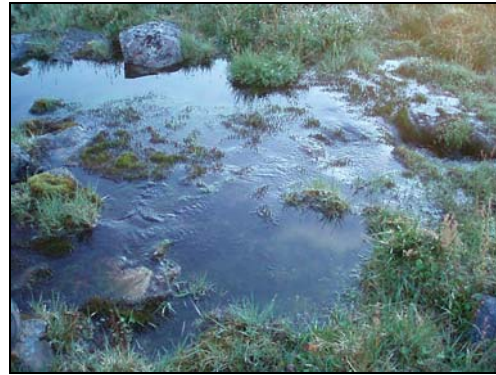
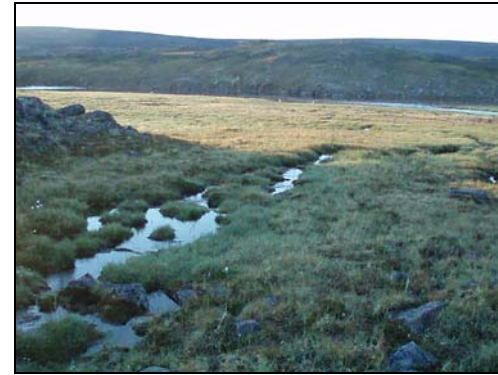
Figure 1. View of habitat upstream of crossing (A), at the crossing (B) and downstream of crossing (C).

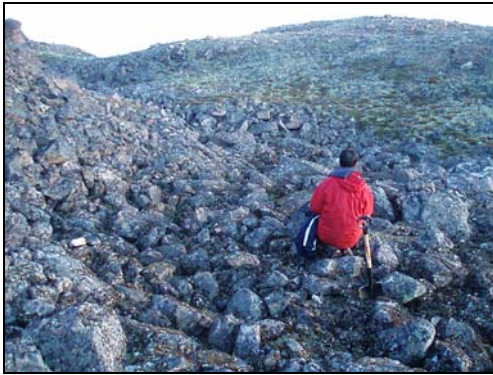
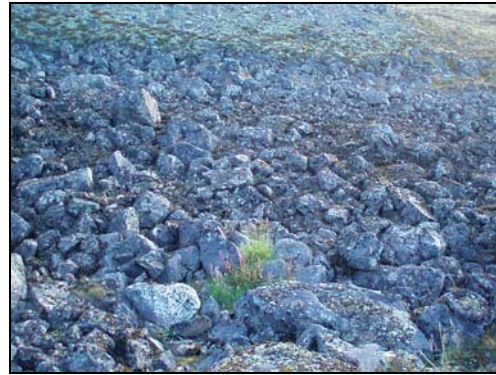
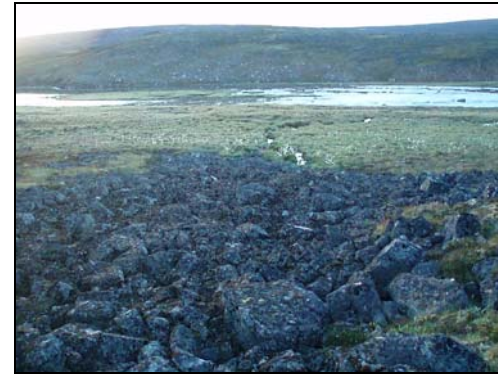
Figure 1. View of habitat upstream of crossing (A), at the crossing (B) and downstream of crossing (C).

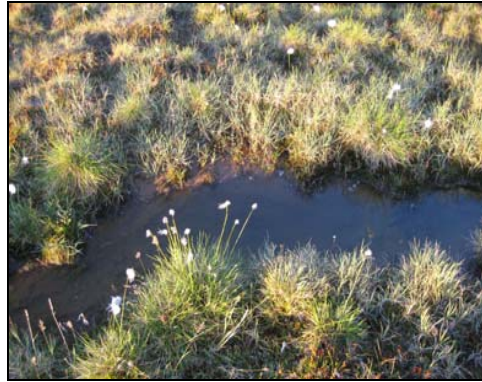
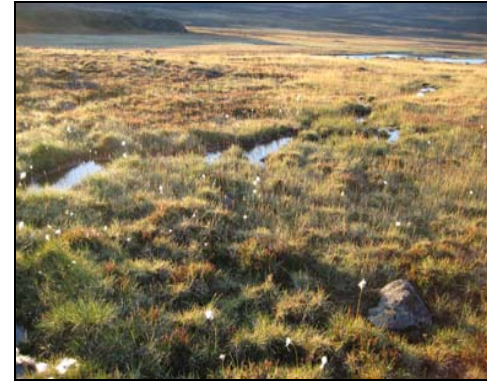
Figure 1. View of habitat upstream of crossing (A), at the crossing (B) and downstream of crossing (C).

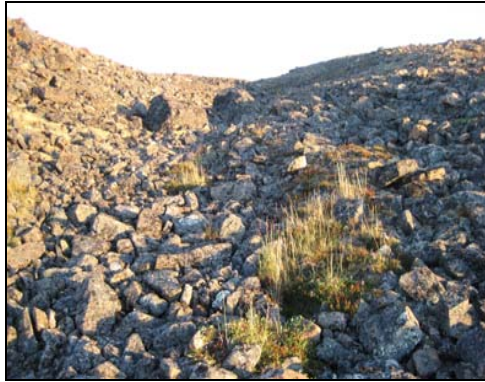
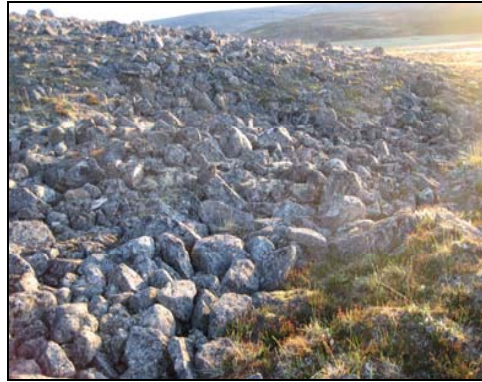
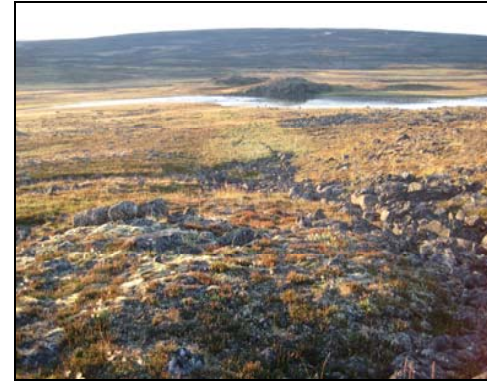
Figure 1. View of habitat upstream of crossing (A), at the crossing (B) and downstream of crossing (C).

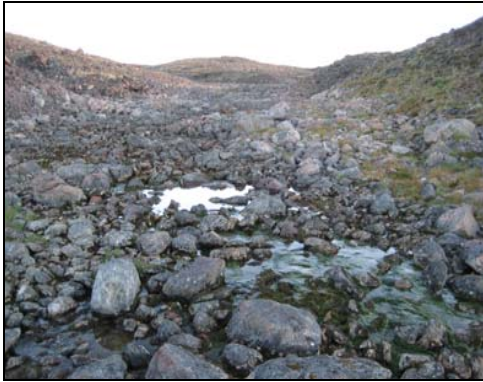
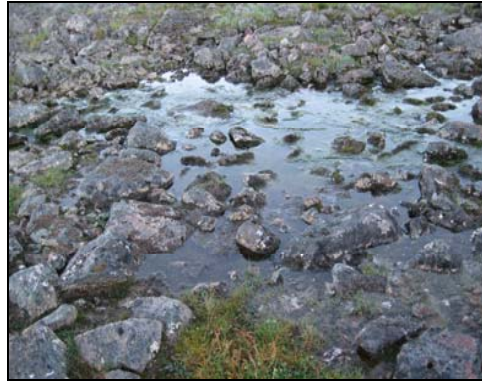
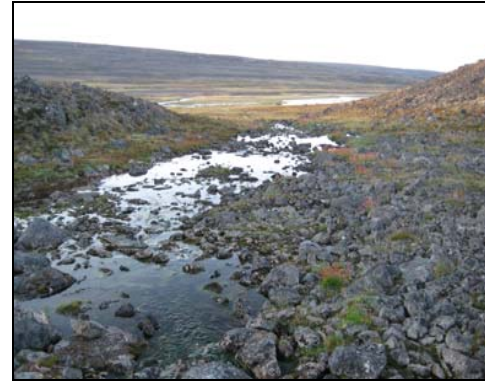
Figure 1. View of habitat upstream of crossing (A), at the crossing (B) and downstream of crossing (C).

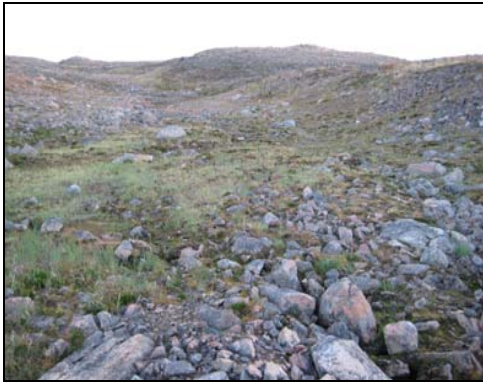
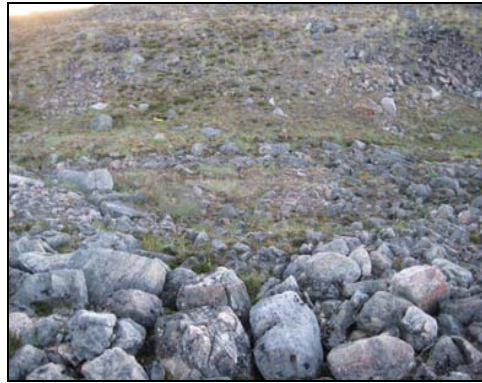
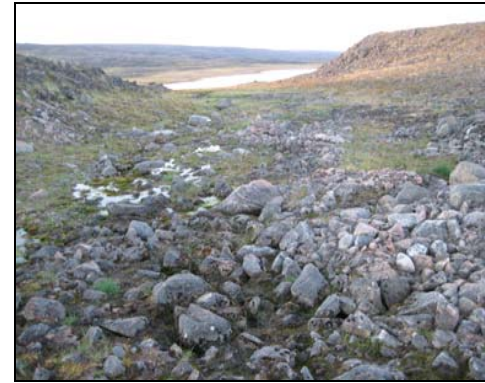
Figure 1. View of habitat upstream of crossing (A), at the crossing (B) and downstream of crossing (C).

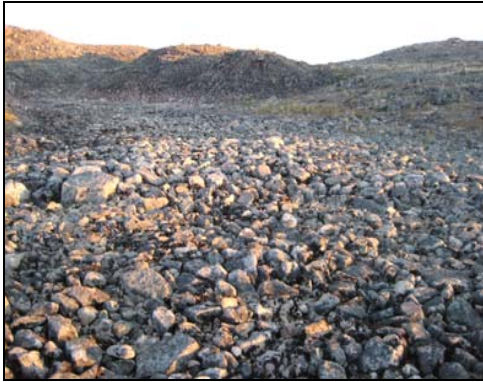
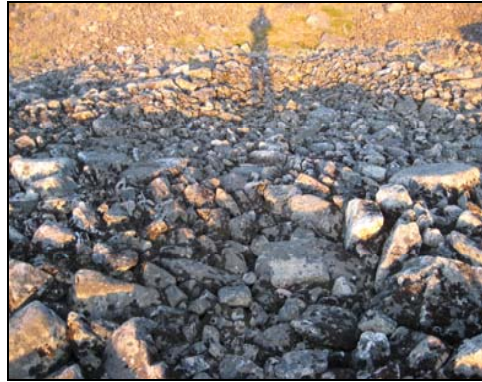
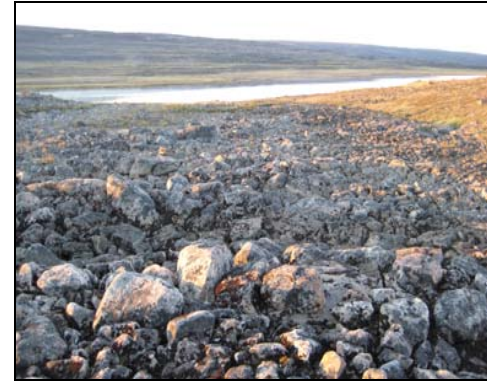
Figure 1. View of habitat upstream of crossing (A), at the crossing (B) and downstream of crossing (C).

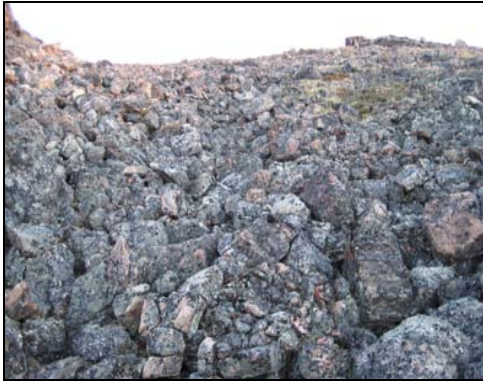
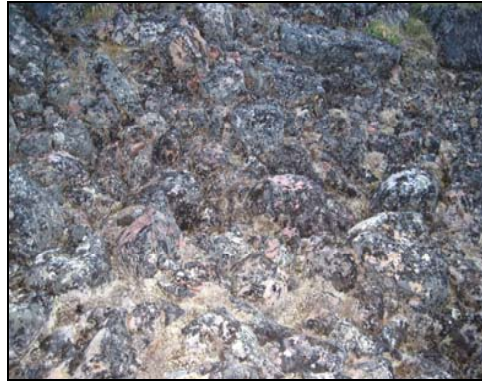
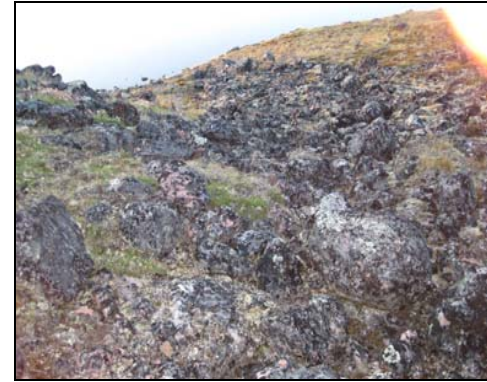
Figure 1. View of habitat upstream of crossing (A), at the crossing (B) and downstream of crossing (C).

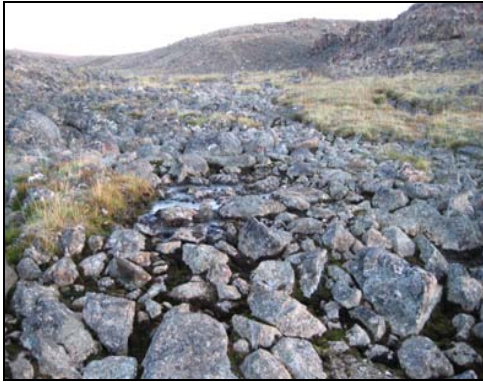
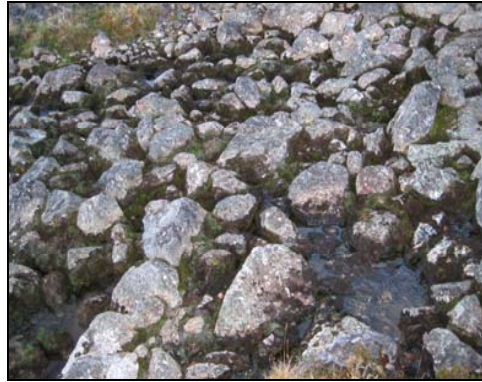
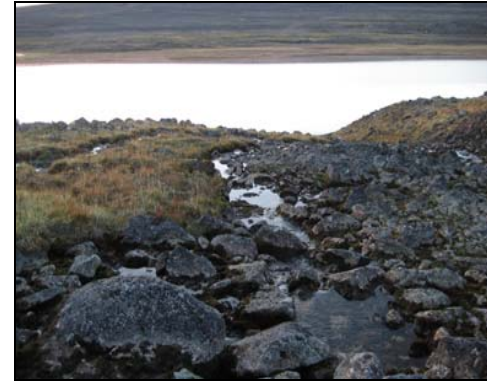
Figure 1. View of habitat upstream of crossing (A), at the crossing (B) and downstream of crossing (C).

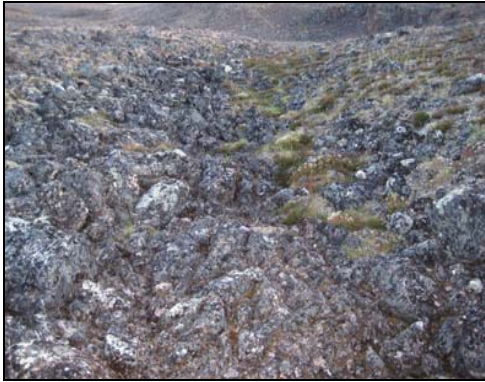
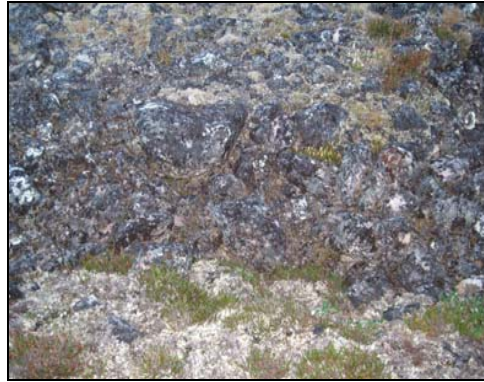
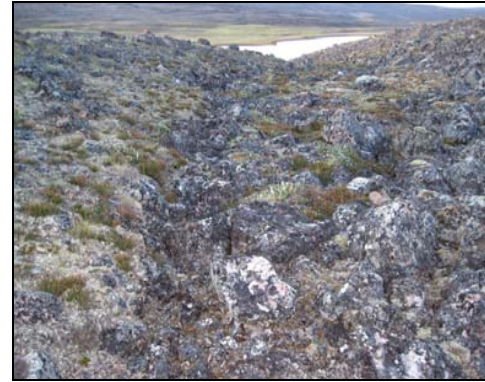
Figure 1. View of habitat upstream of crossing (A), at the crossing (B) and downstream of crossing (C).

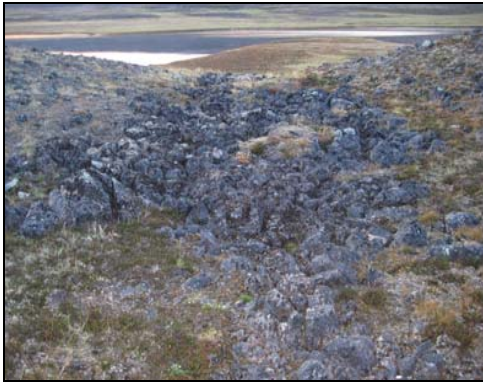
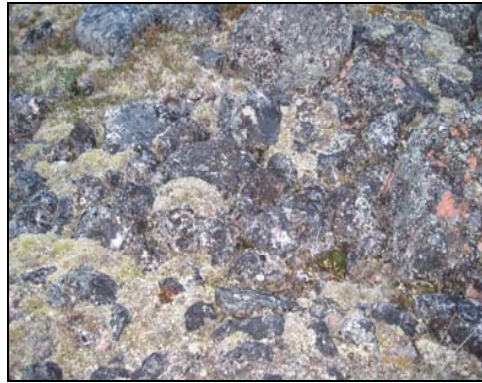
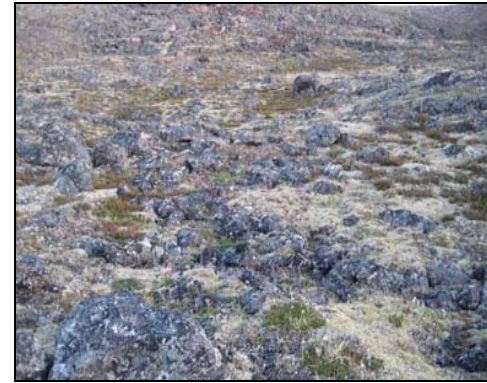
Figure 1. View of habitat upstream of crossing (A), at the crossing (B) and downstream of crossing (C).
