**HABITAT ASSESSMENT PROTOCOL AND SAMPLE
DATA SHEET USED FOR DESCRIBING AVAILABLE
AQUATIC HABITAT IN WATERCOURSES IN THE
RAILWAY/ACCESS ROAD AREA.**

MARY RIVER PROJECT RAILWAY/ACCESS ROAD WATERCOURSE CROSSING ASSESSMENT PROTOCOL

North/South Consultants Inc. and Knight Piésold Ltd.

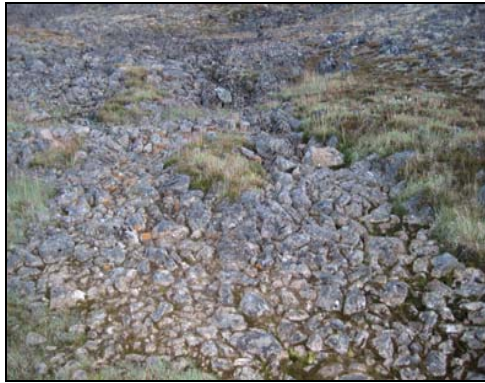
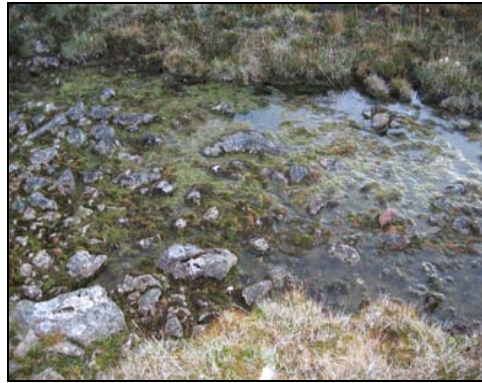
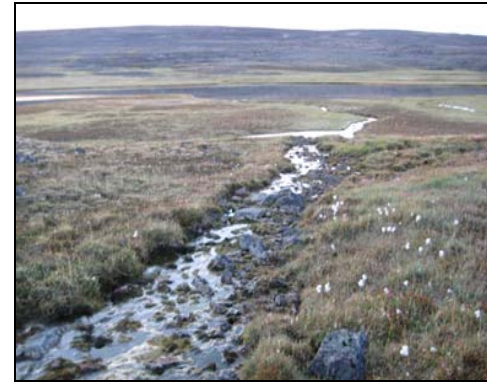
Figure 1. View of habitat upstream of crossing (A), at the crossing (B) and downstream of crossing (C).

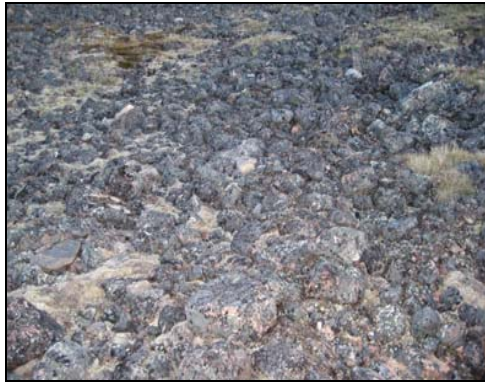
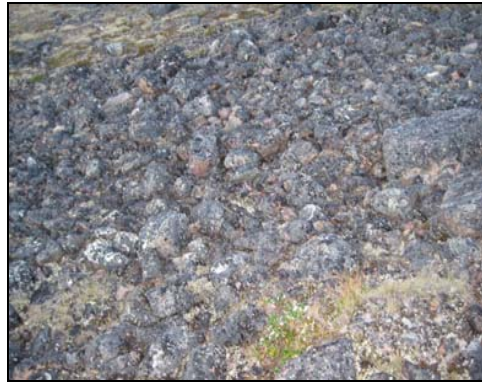
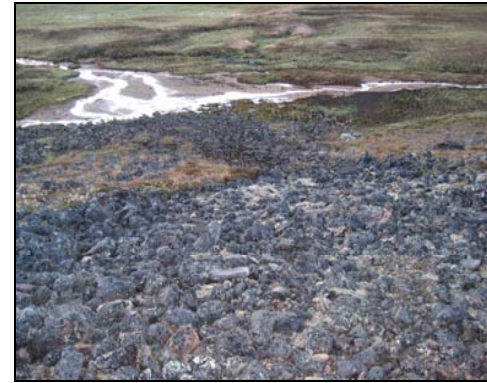
Figure 1. View of habitat upstream of crossing (A), at the crossing (B) and downstream of crossing (C).

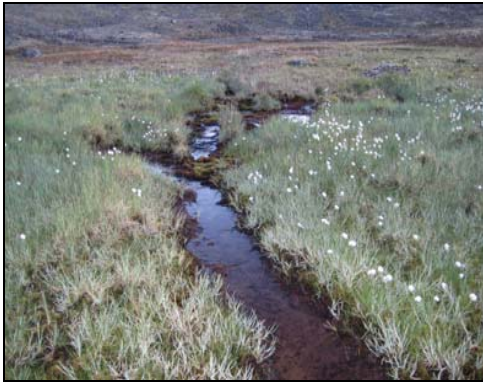
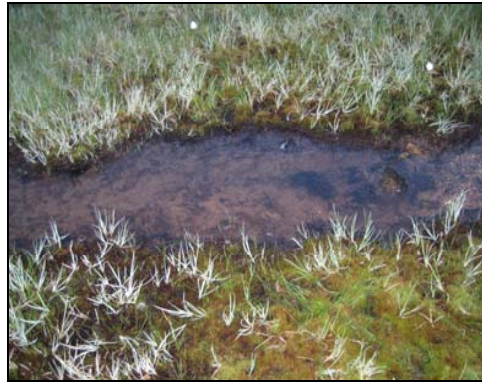
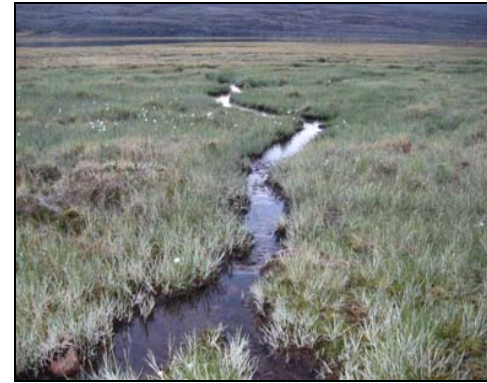
Figure 1. View of habitat upstream of crossing (A), at the crossing (B) and downstream of crossing (C).

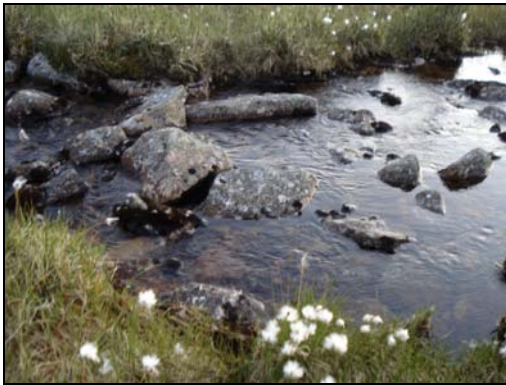
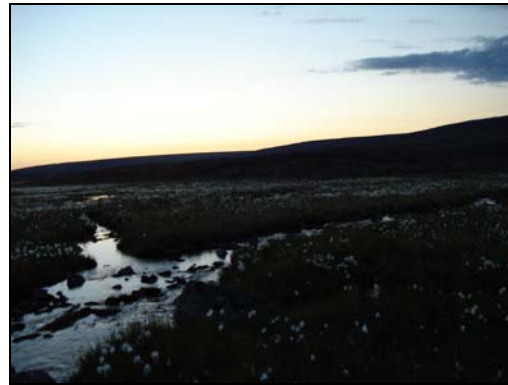
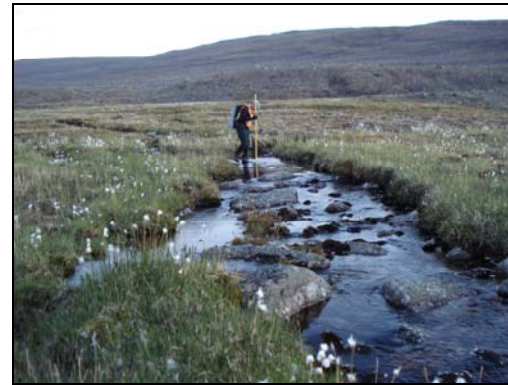
Entire wetted area at crossing approximately 50 m, including braids and pools.

Figure 1. View of habitat, at crossing (A), downstream of the crossing (B), and upstream of the crossing (C).

The site is not Arctic char habitat as they are not present in the large river downstream. Young-of-the-year ninespine stickleback were observed downstream of this site during a 2007 assessment, but barriers prevent their upstream passage to the crossing site.

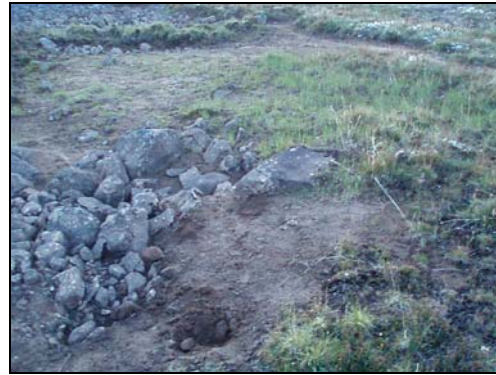
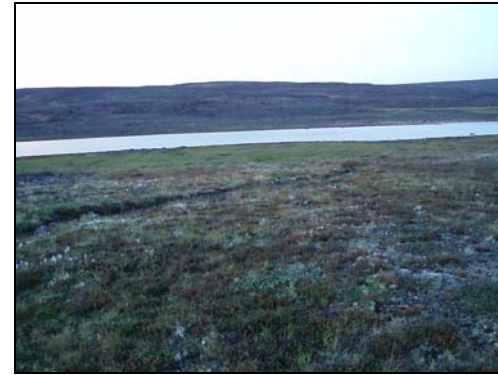
Figure 1. View of habitat upstream of crossing (A), at the crossing (B) and downstream of crossing (C).

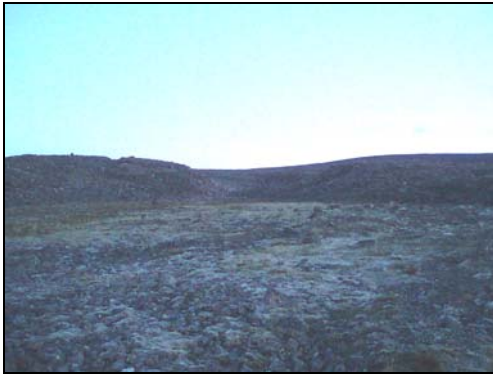
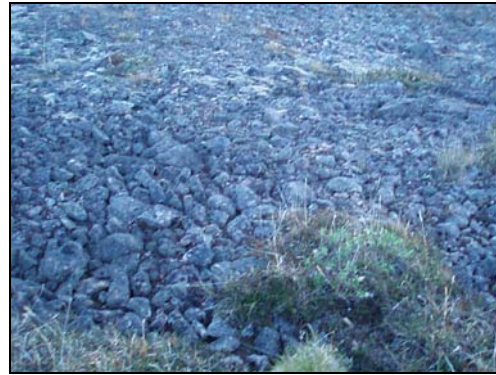
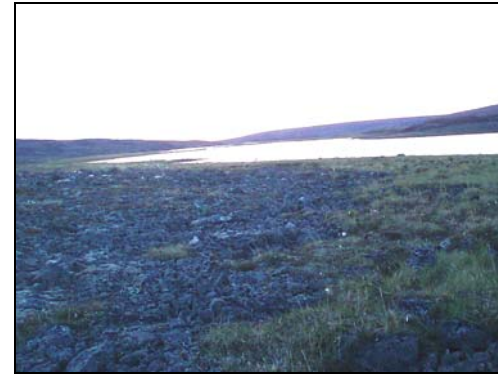
Figure 1. View of habitat upstream of crossing (A), at the crossing (B) and downstream of crossing (C).

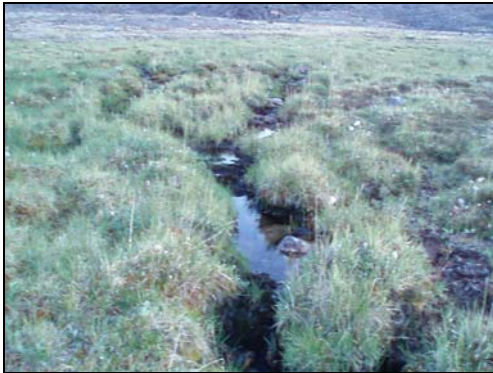
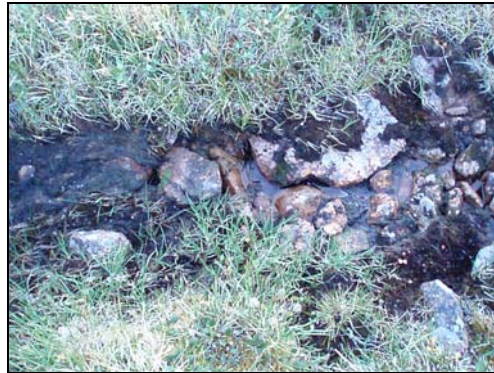
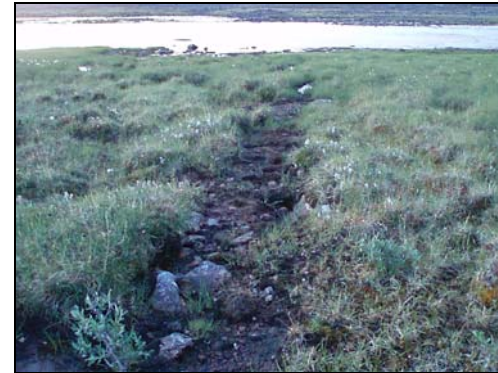
Figure 1. View of habitat upstream of crossing (A), at the crossing (B) and downstream of crossing (C).

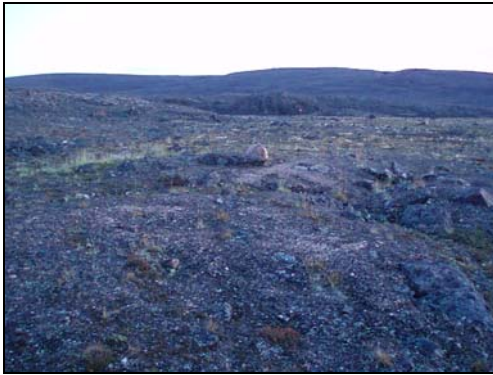
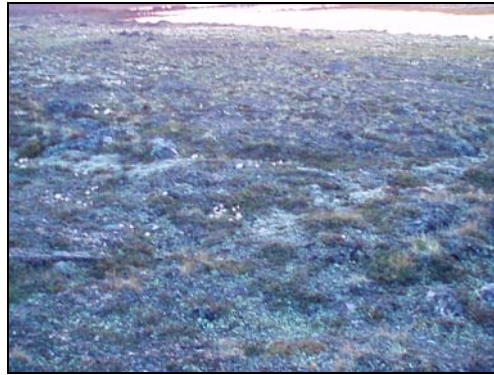
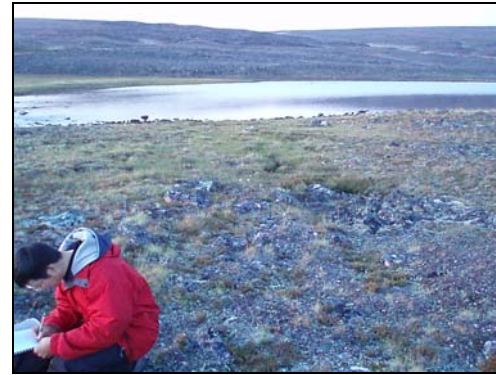
Figure 1. View of habitat upstream of crossing (A), at the crossing (B) and downstream of crossing (C).

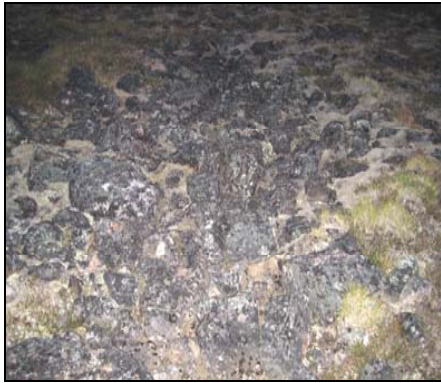
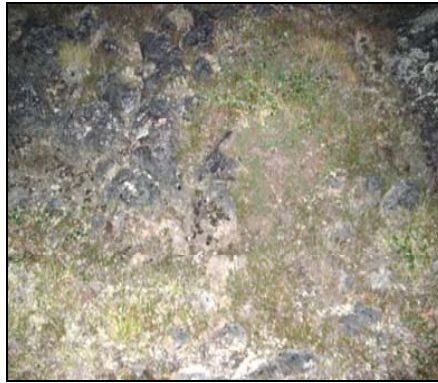
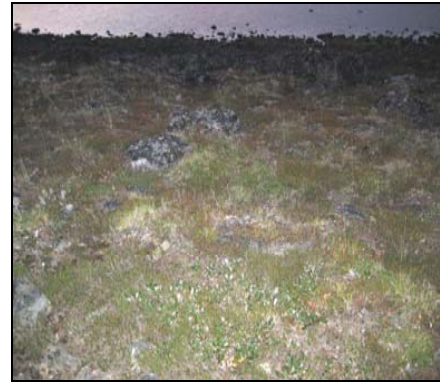
Figure 1. View of habitat upstream of crossing (A), at the crossing (B) and downstream of crossing (C).

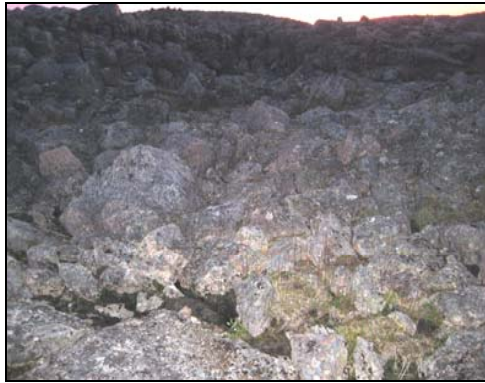
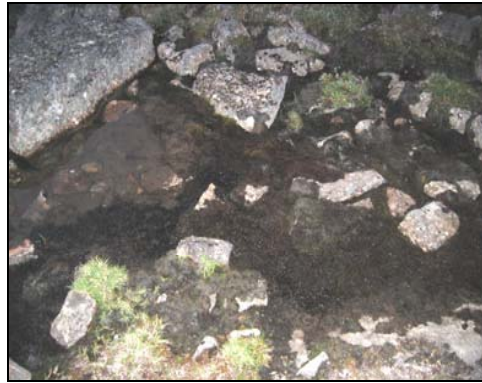
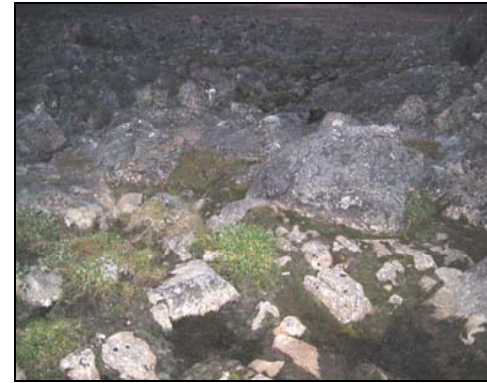
Figure 1. View of habitat upstream of crossing (A), at the crossing (B) and downstream of crossing (C).

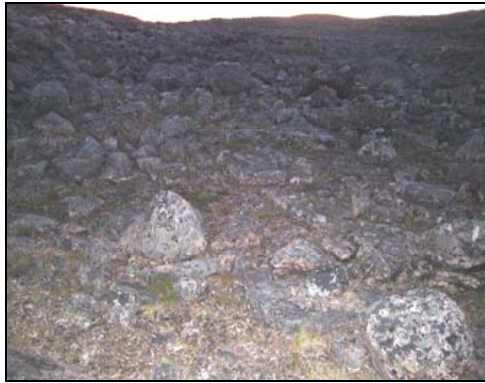
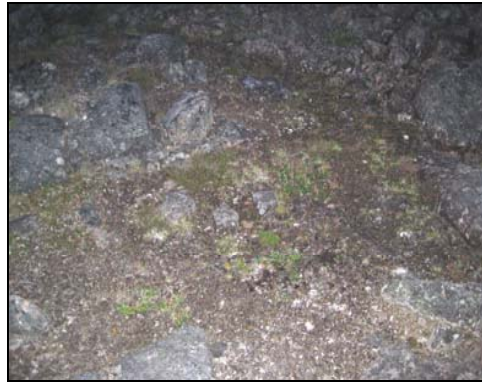
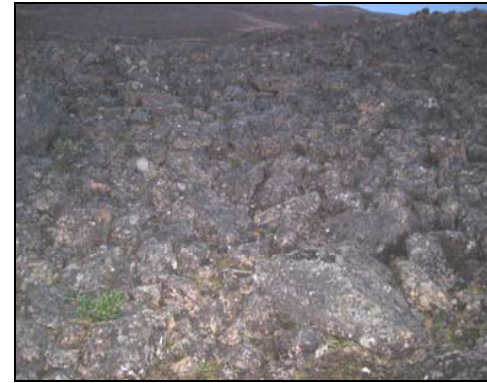
Figure 1. View of habitat upstream of crossing (A), at the crossing (B) and downstream of crossing (C).

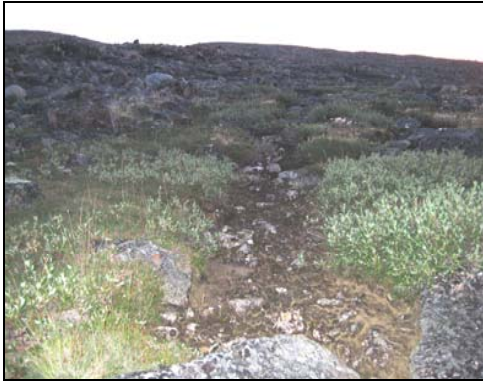
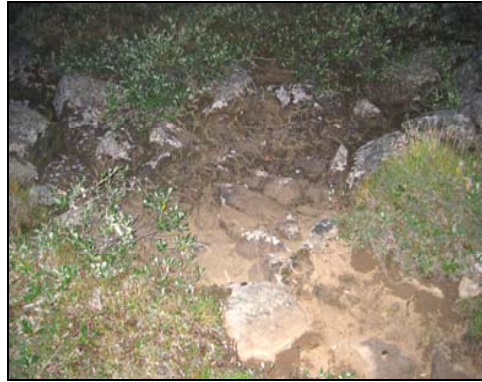
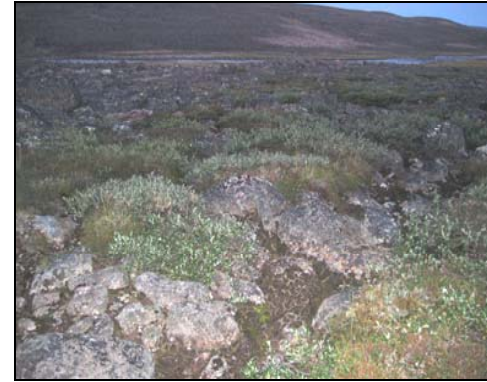
Figure 1. View of habitat upstream of crossing (A), at the crossing (B) and downstream of crossing (C).

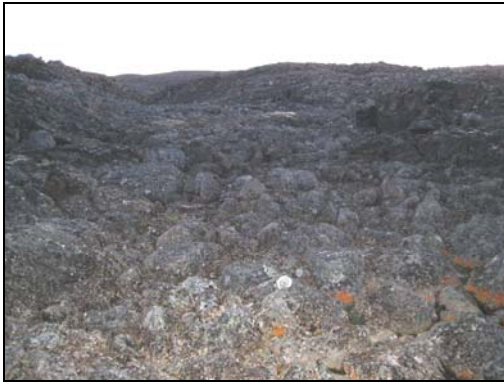
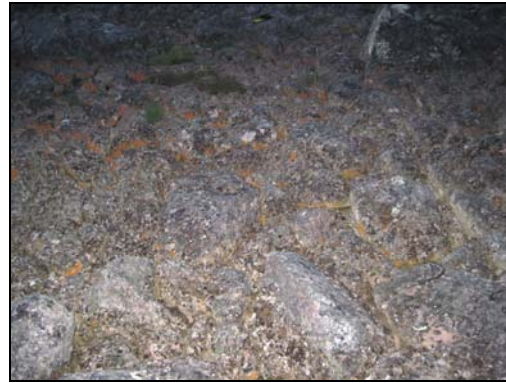
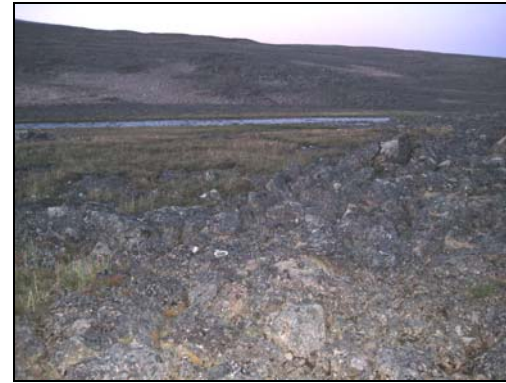
Figure 1. View of habitat upstream of crossing (A), at the crossing (B) and downstream of crossing (C).

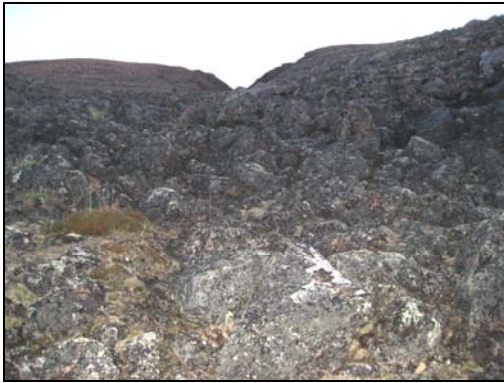
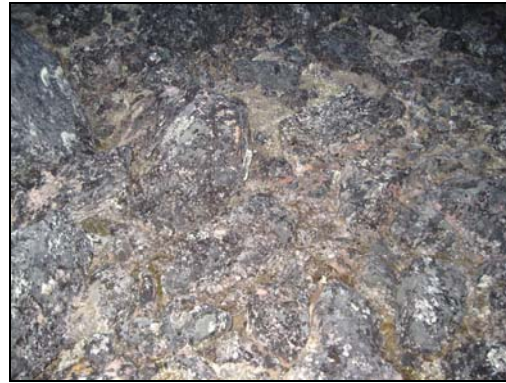
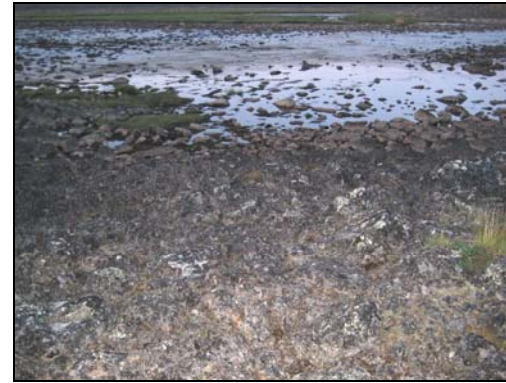
Figure 1. View of habitat upstream of crossing (A), at the crossing (B) and downstream of crossing (C).

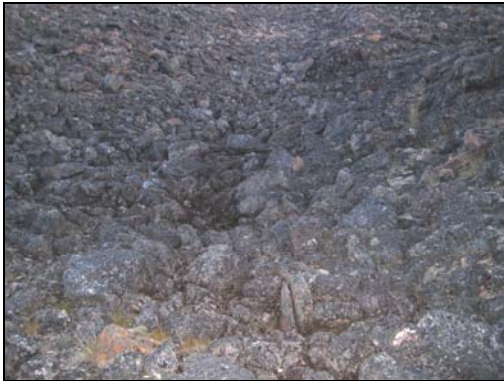
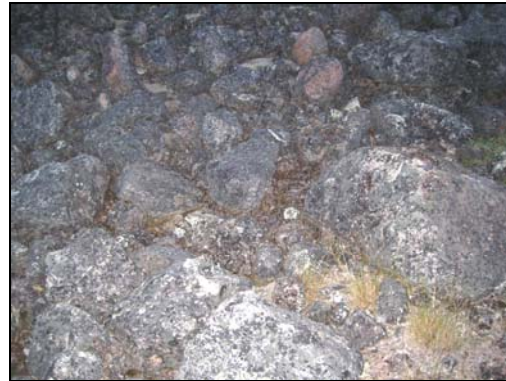
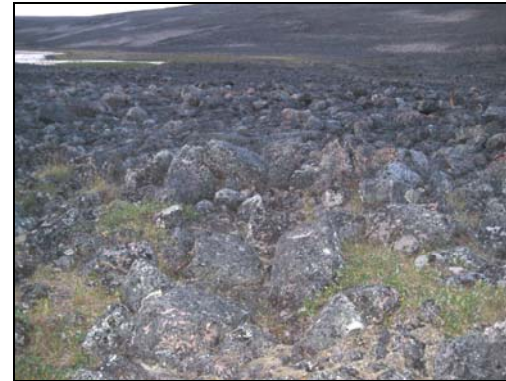
Figure 1. View of habitat upstream of crossing (A), at the crossing (B) and downstream of crossing (C).

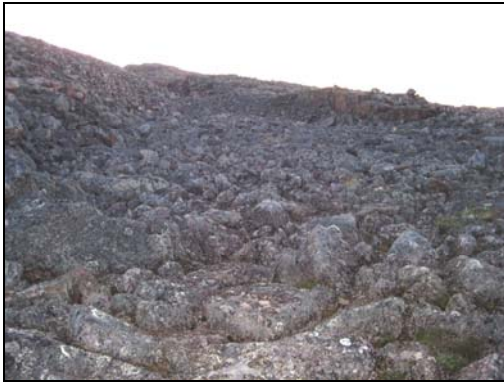
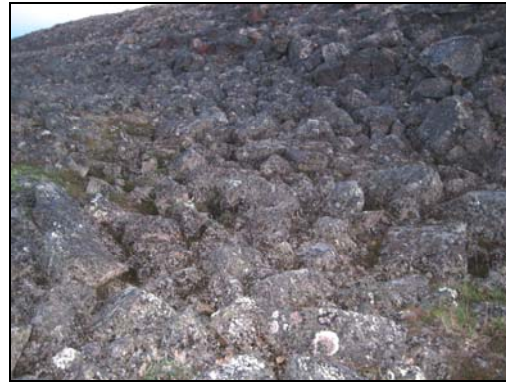
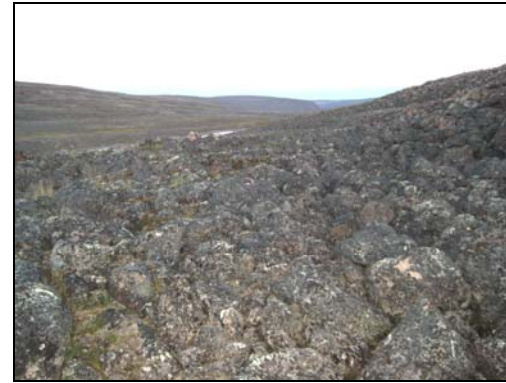
Figure 1. View of habitat upstream of crossing (A), at the crossing (B) and downstream of crossing (C).

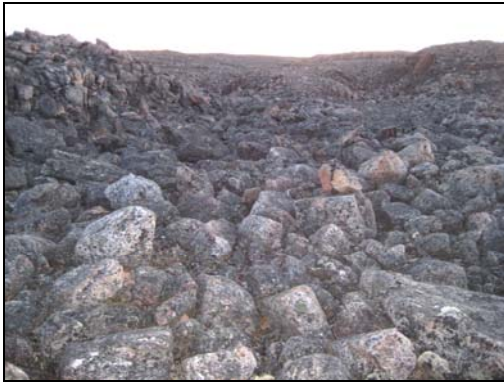
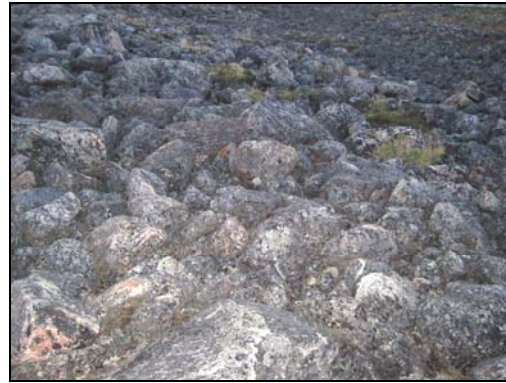
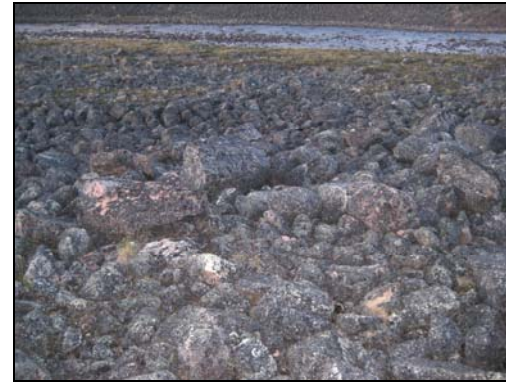
Figure 1. View of habitat upstream of crossing (A), at the crossing (B) and downstream of crossing (C).

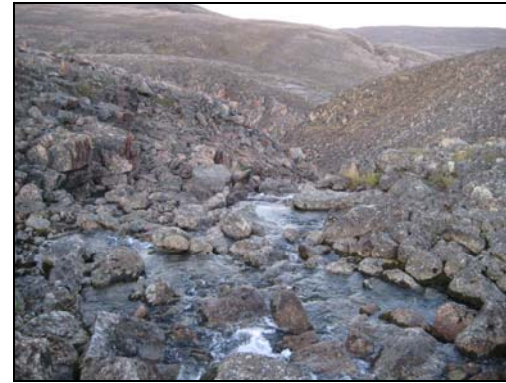
C

Figure 1. View of habitat upstream of crossing (A), at the crossing (B) and downstream of crossing (C).

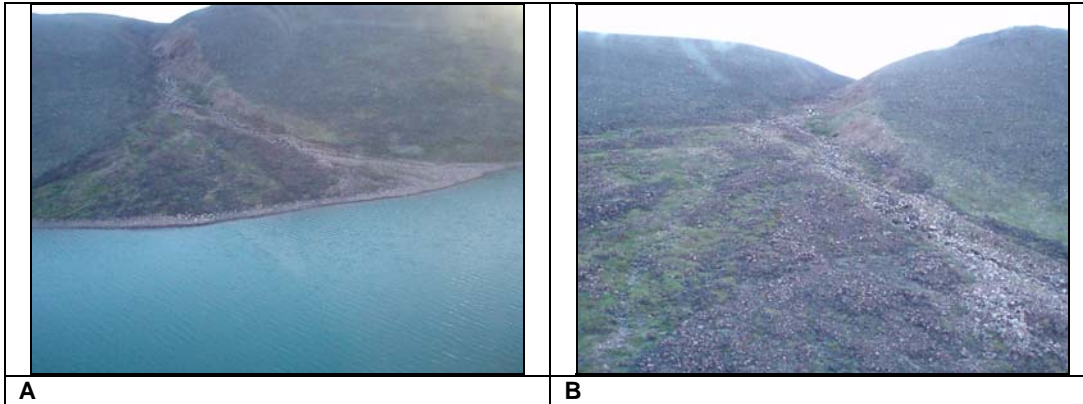
Figure 1. Aerial view of area near crossing (A) and another aerial view of area near the crossing (B).

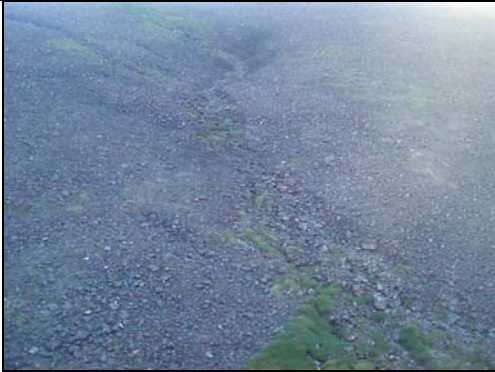
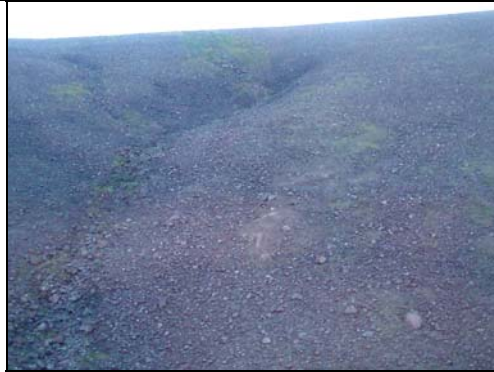
Figure 1. Aerial view of area near crossing (A) and another aerial view of area near crossing (B).

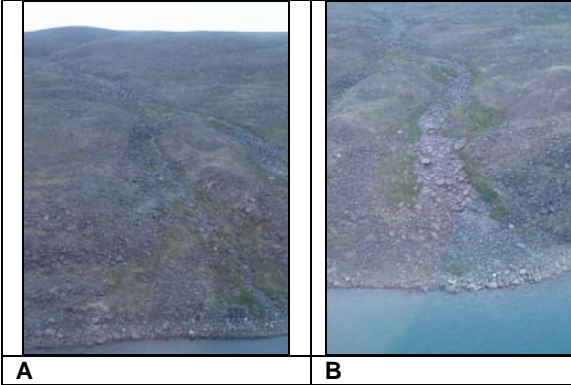
Figure 1. Aerial view of area near crossing (A-B).

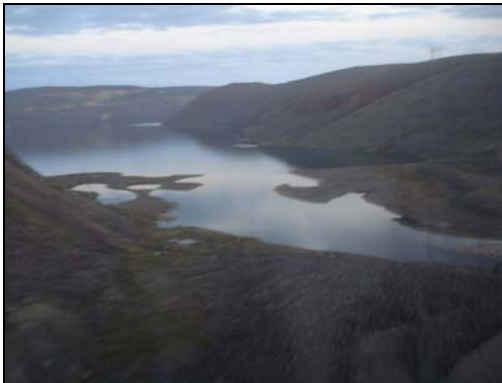
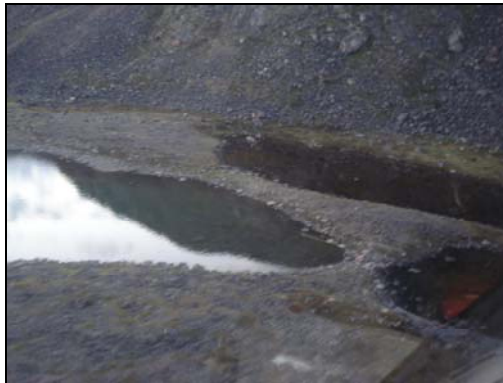
Crossing occurs over a narrow section of Cockburn Lake. Obvious fish habitat.
Water temperature was 9.0 °C.

Figure 1. Aerial view of habitat in the vicinity of the crossing (A) and a closer view of the available substrate (B).

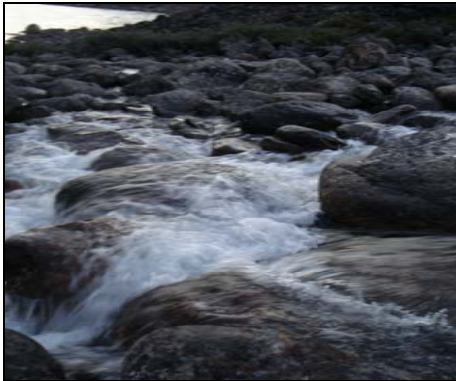
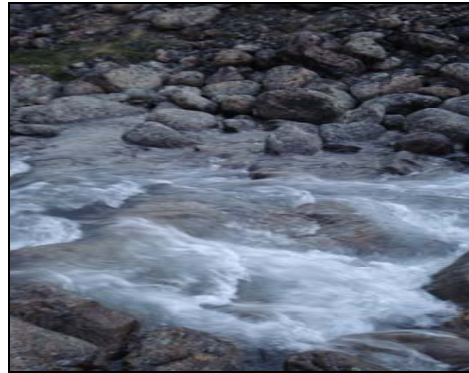
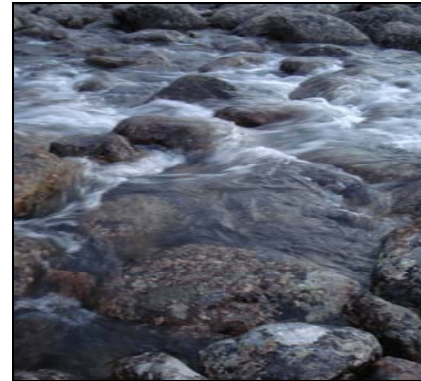
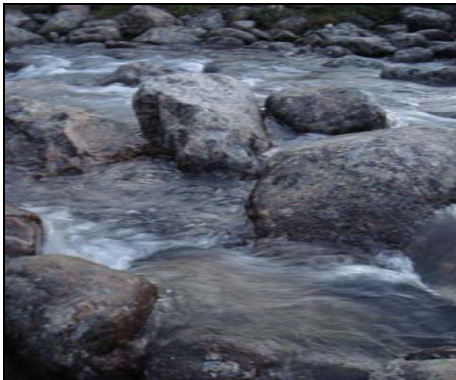
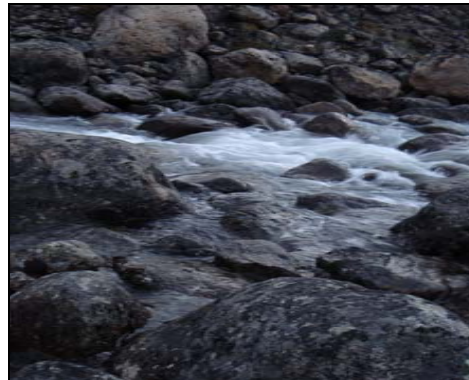
High quality Arctic char habitat with no apparent barriers for use by multiple size classes of juveniles.

Figure 1. View of habitat 40 m (A), and 20 m downstream of crossing (B), at 40 m (C) and 20 m upstream of crossing (D), and at the crossing (E).

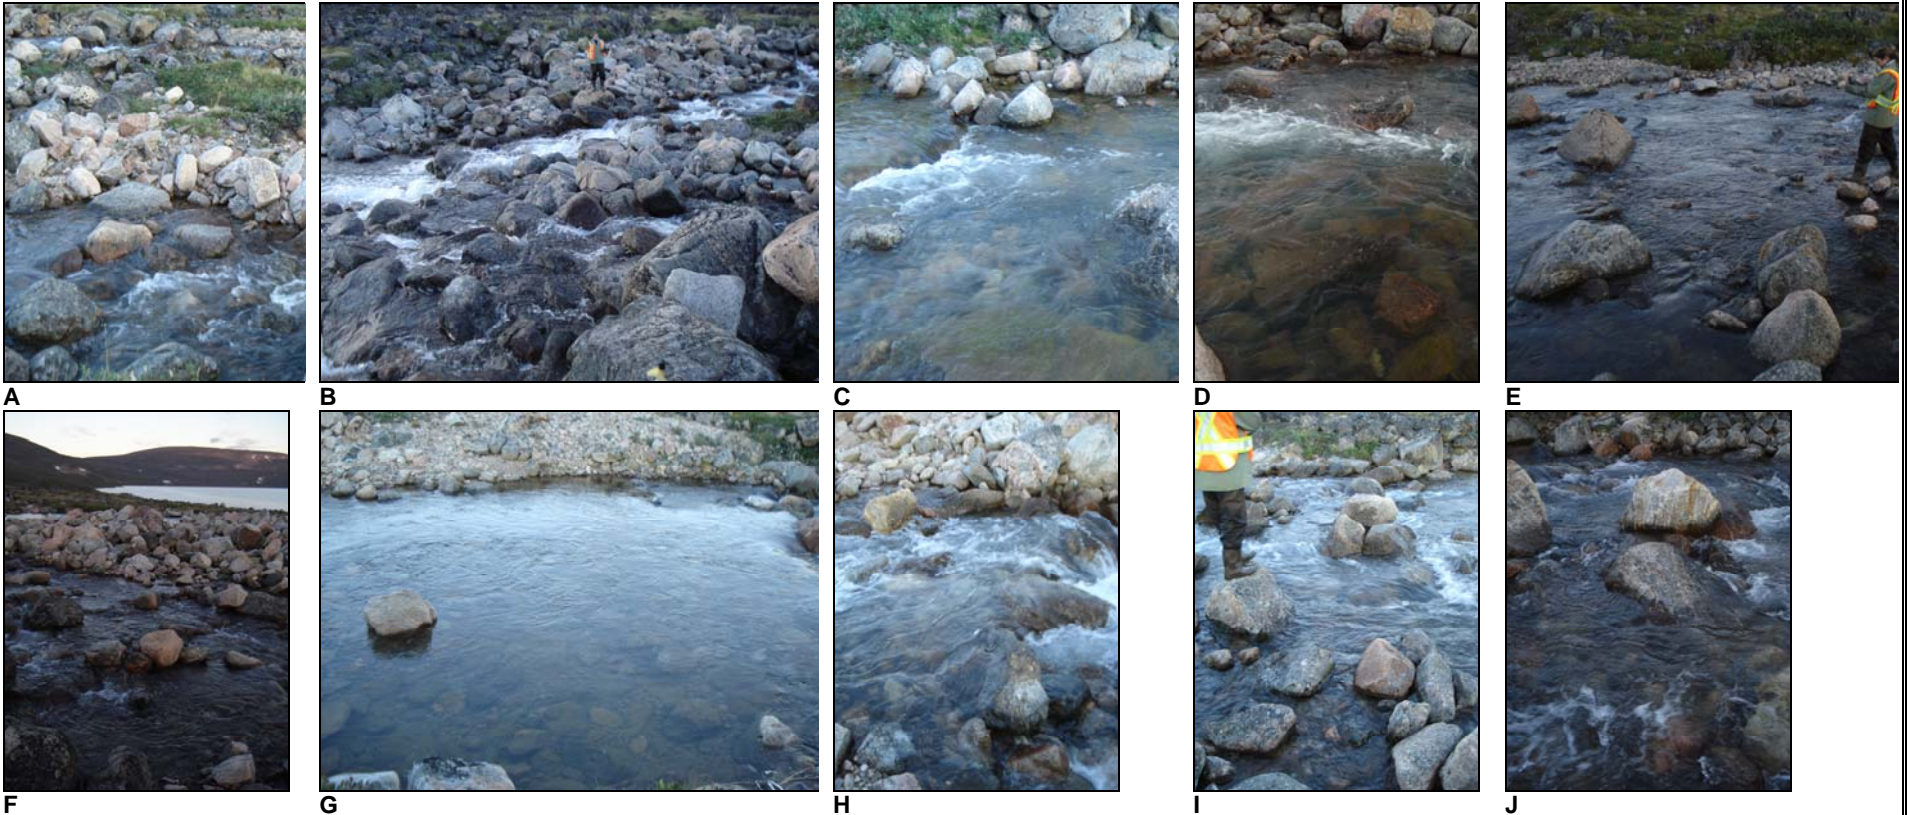
Figure 1: View of habitat from 100 (A) 80 (B) 60 (C) 40 (D) 20 m downstream of crossing (E), at the crossing (F), and 20 (G) 40 (H) 60 (I) 80 (J) and 100 m upstream of crossing (K).

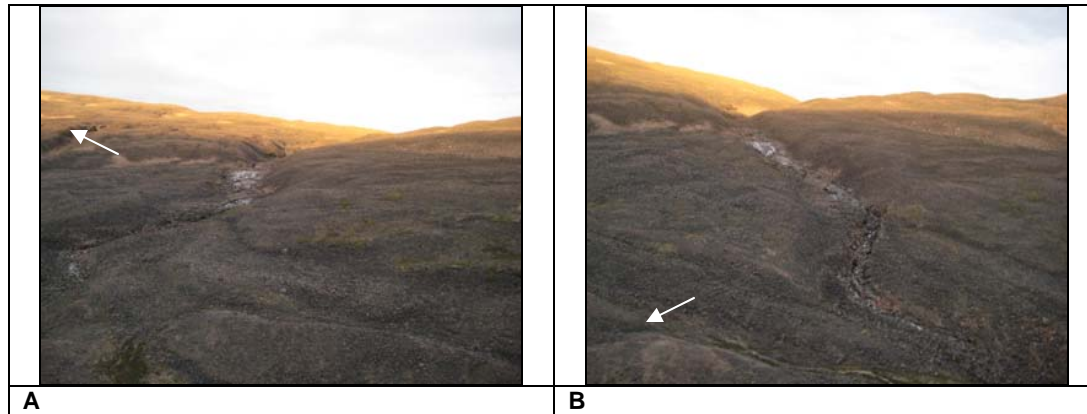
Figure 1. Aerial view of area near crossing (white arrow) (A-B).

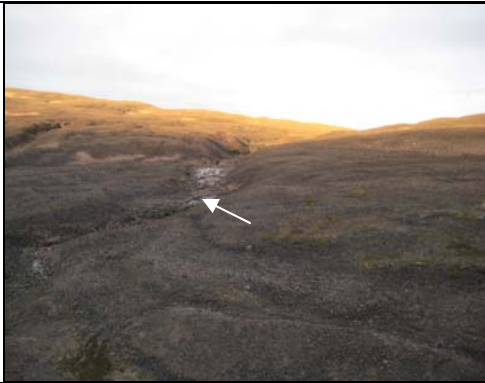
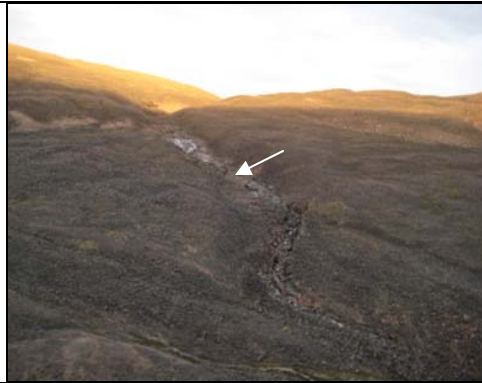
Figure 1. Aerial view of area near crossing (white arrow) (A-B).

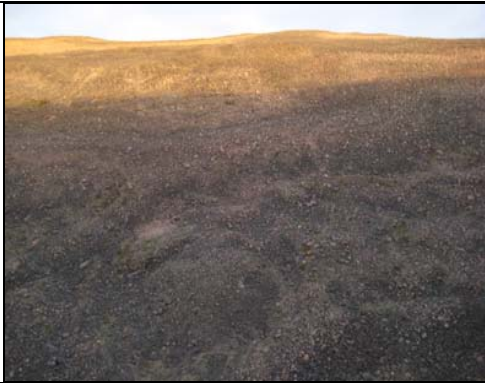
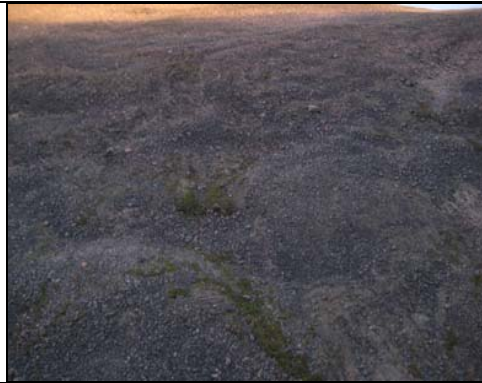
Figure 1. Aerial view of area near crossing (A-B).

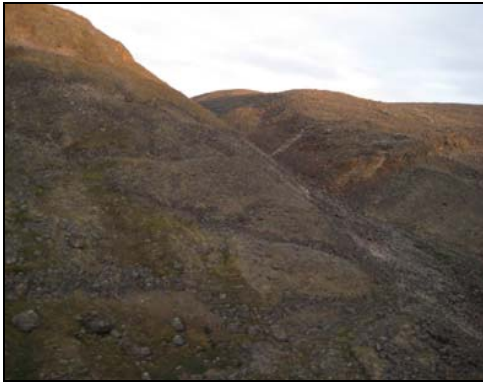
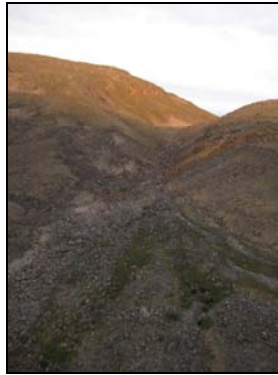
Figure 1. Aerial view of area near crossing (A-B).

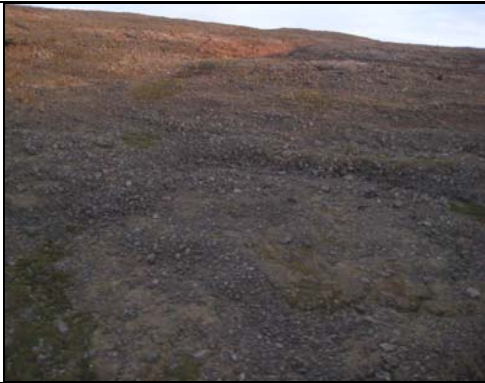
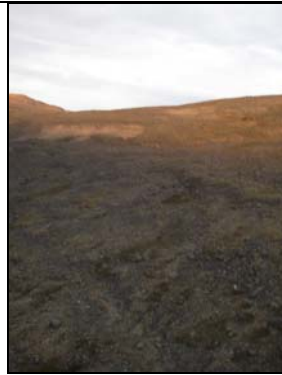
Figure 1. Aerial view of area near crossing (A-B).

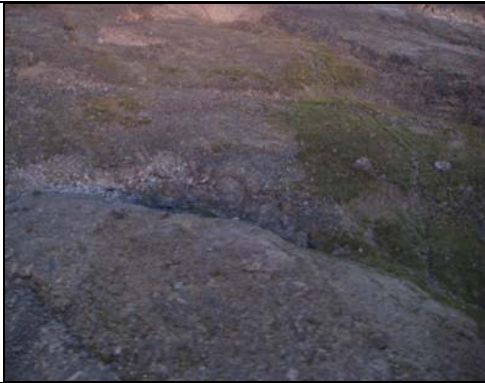
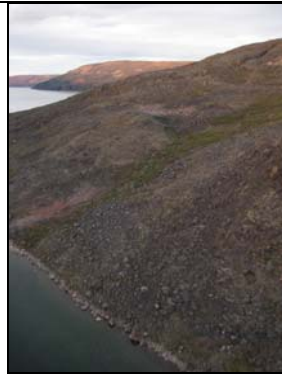
Figure 1. Aerial view of area near crossing (A-B).

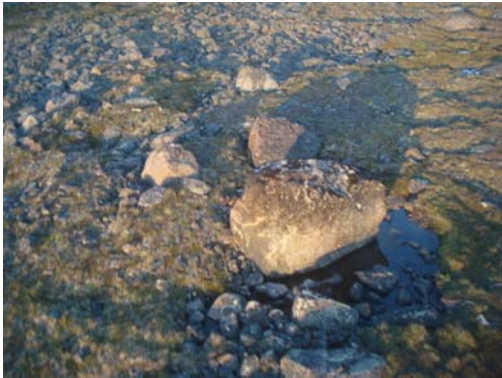
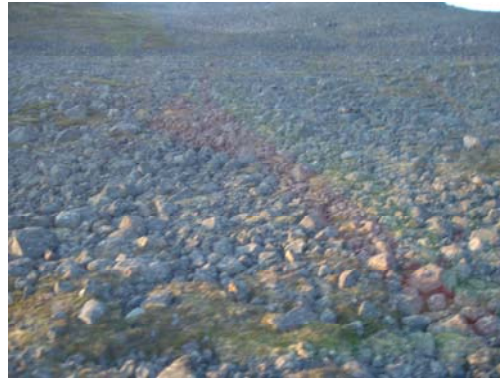
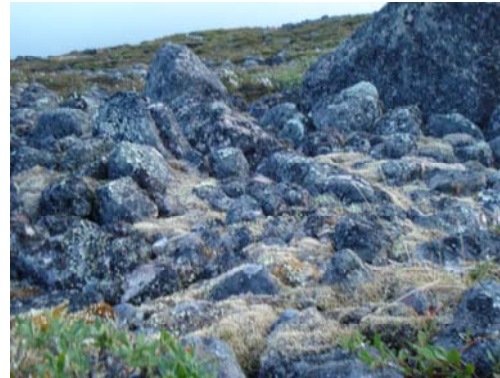
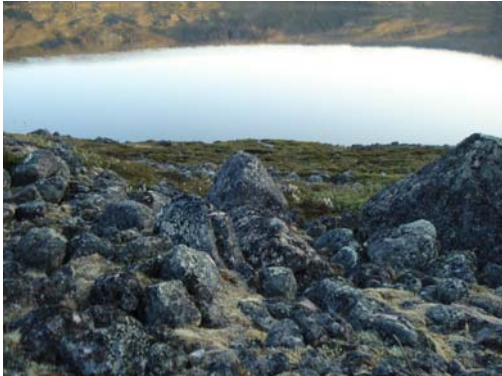
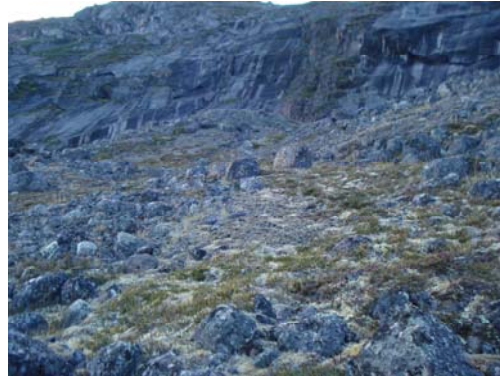
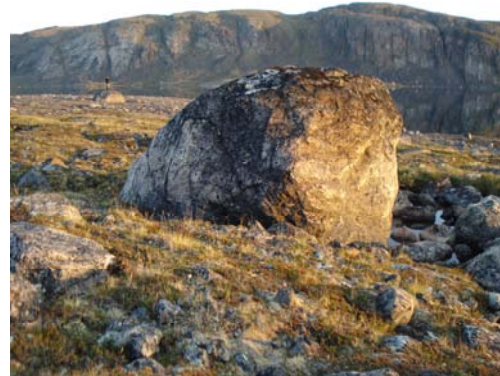
Figure 1. View of habitat near crossing (A -F).

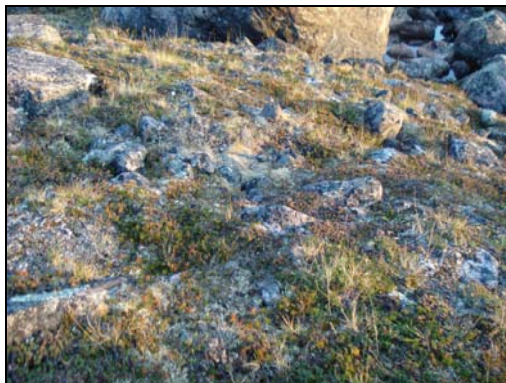
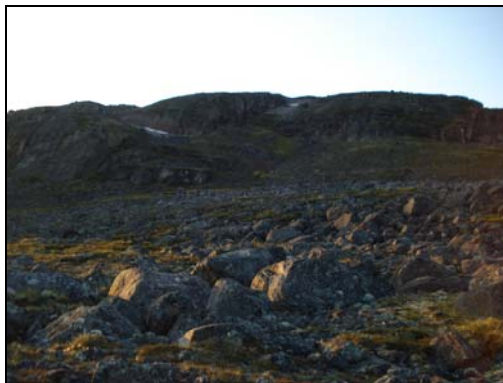
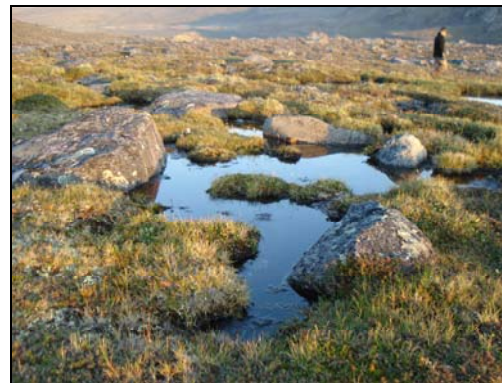
Figure 1. View of habitat, at crossing (A), downstream of crossing (B), and a nearby pool (C)

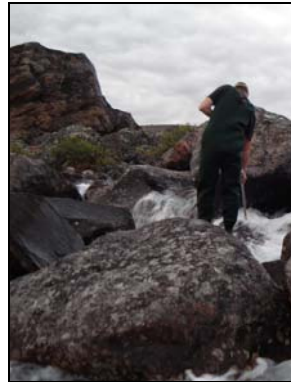
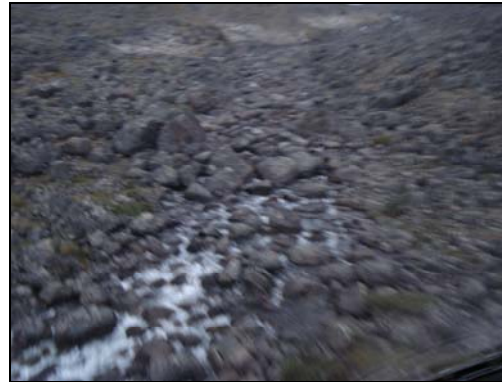
Figure 1. View of habitat, at crossing (A-B), downstream of crossing, (C-D), the downstream barrier, (E-F) and the upstream barrier (G).

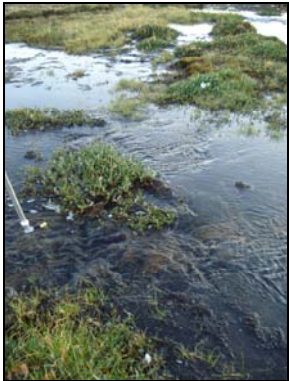
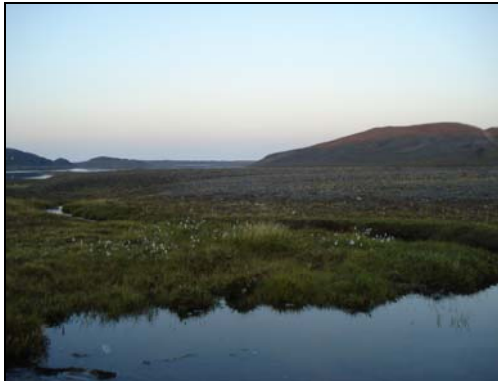
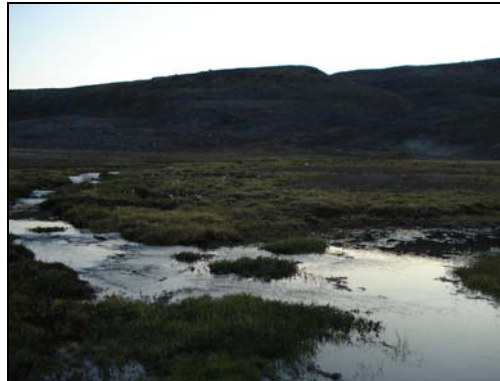
Figure 1. View of habitat, at crossing (A), downstream of crossing (B) and upstream of crossing (C).

Fish were not observed or captured at this location despite the presence of suitable habitat. Although not identified, it appears there is a barrier to fish movements preventing access to the site from overwintering habitat.

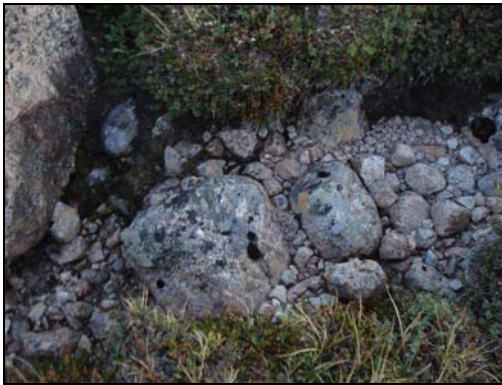
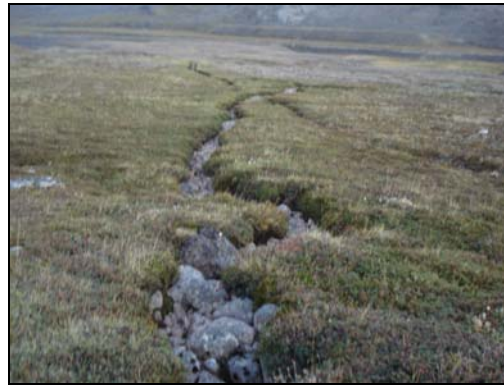
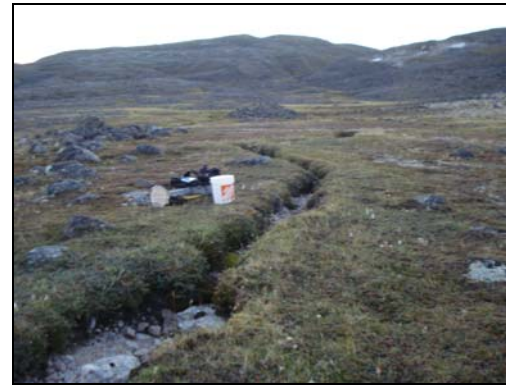
Figure 1. View of habitat at crossing (A), downstream of crossing (B) and upstream of crossing (C).

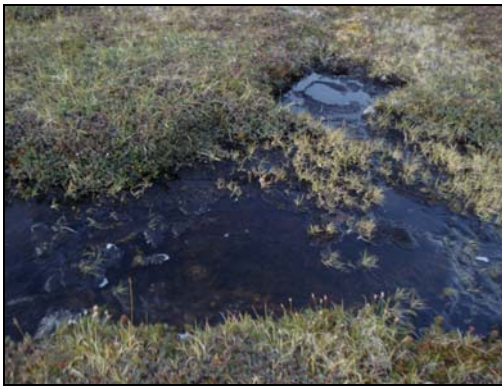
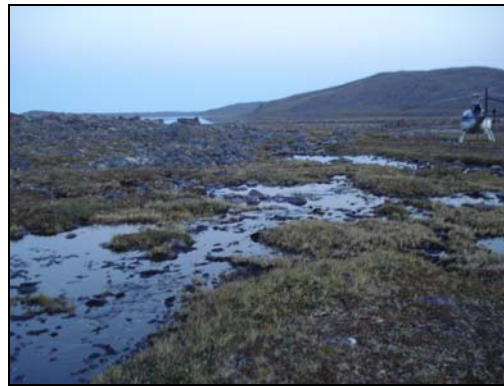
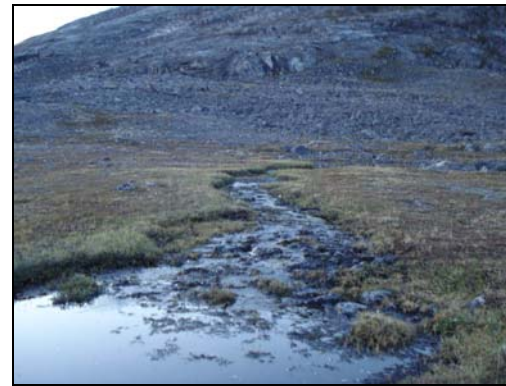
Figure 1. View of habitat, at crossing (A) downstream of crossing (B) and upstream of crossing (C).

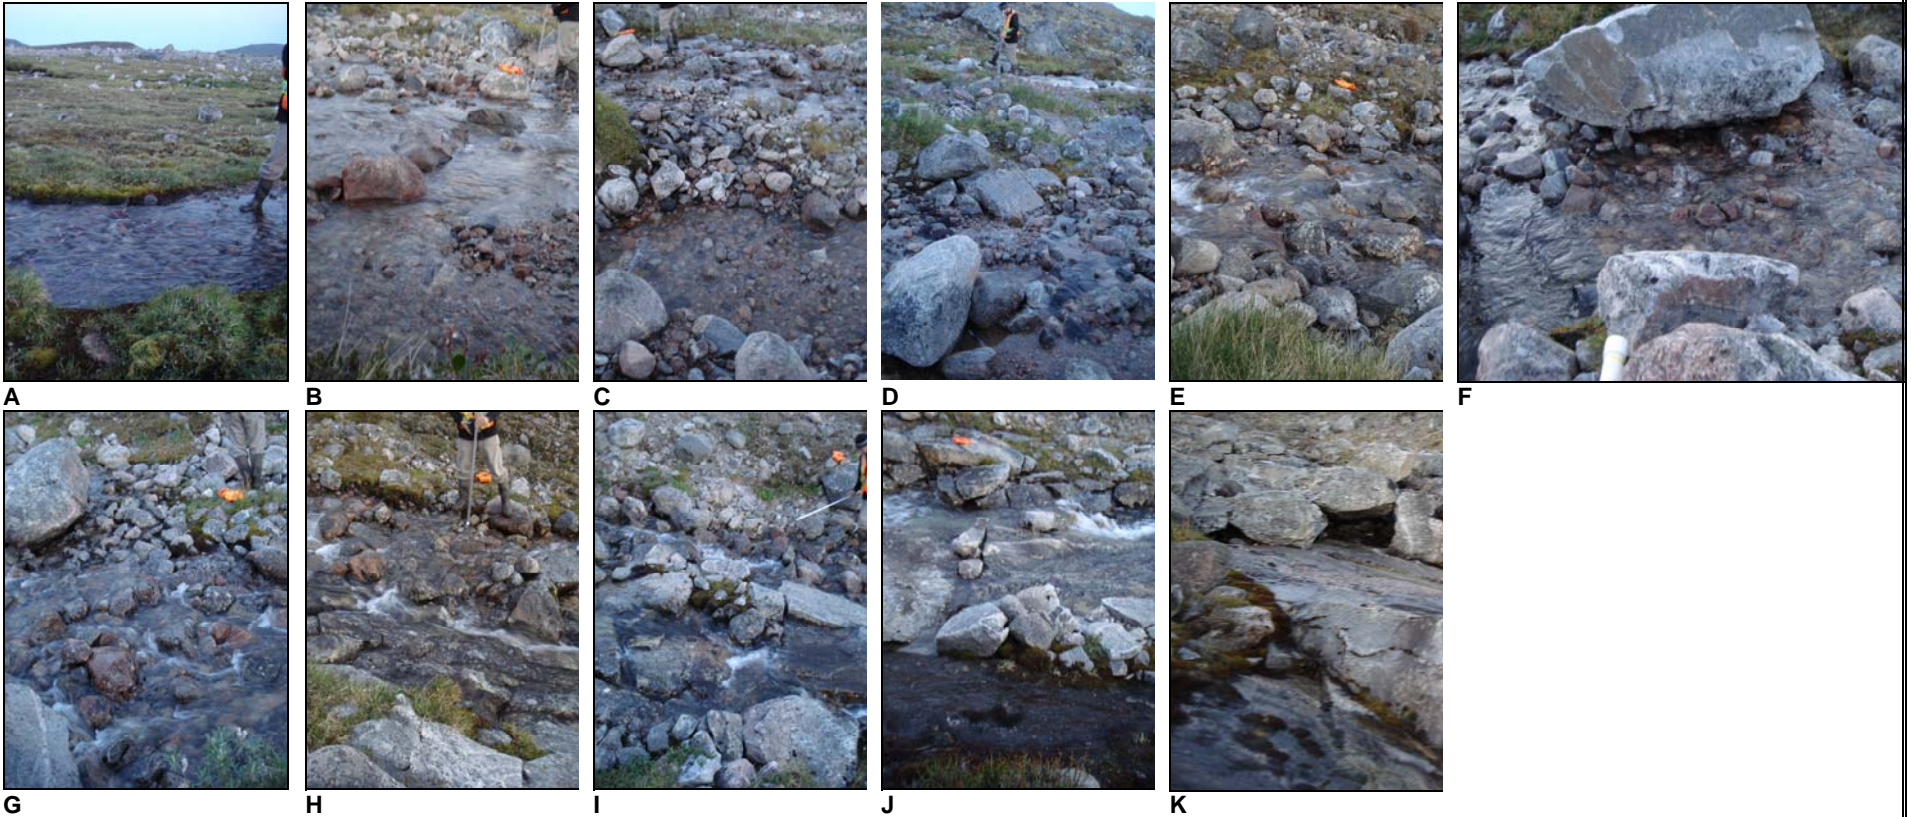
Figure 1. View of habitat 100 (A), 80 (B), 60 (C), 40 (D), and 20 m (E) downstream of crossing, at the crossing (F), and 20 (G), 40 (H), 60 (I), 80 (J), and 100 m (K) upstream of the crossing.

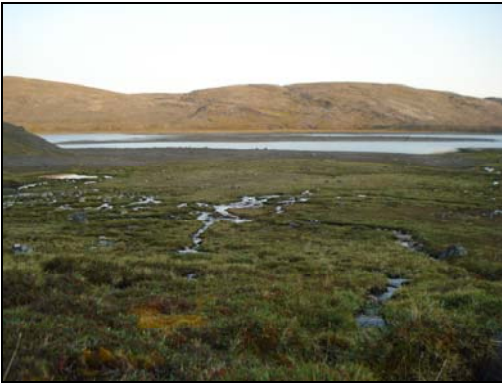
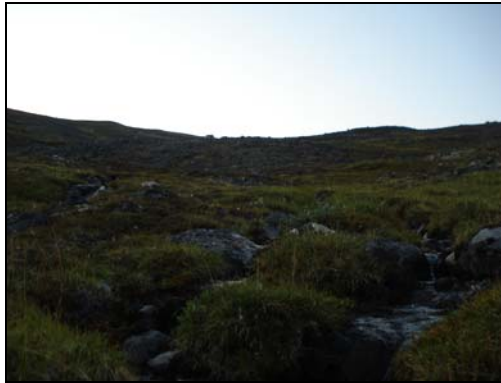
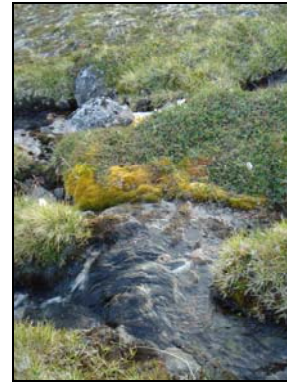
Figure 1. View of habitat (A-C)
