**HABITAT ASSESSMENT PROTOCOL AND SAMPLE
DATA SHEET USED FOR DESCRIBING AVAILABLE
AQUATIC HABITAT IN WATERCOURSES IN THE
RAILWAY/ACCESS ROAD AREA.**

MARY RIVER PROJECT RAILWAY/ACCESS ROAD WATERCOURSE CROSSING ASSESSMENT PROTOCOL

North/South Consultants Inc. and Knight Piésold Ltd.

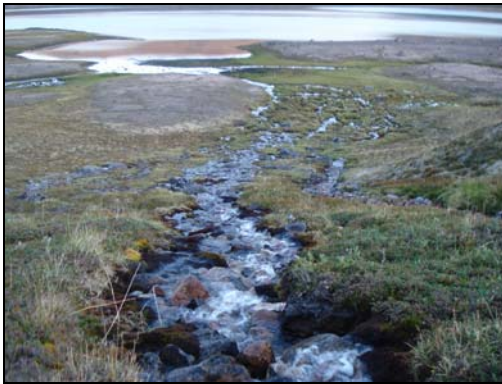
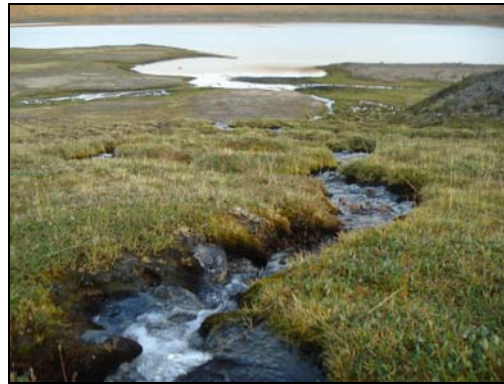
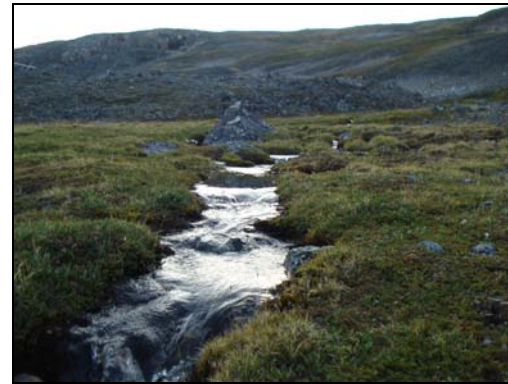
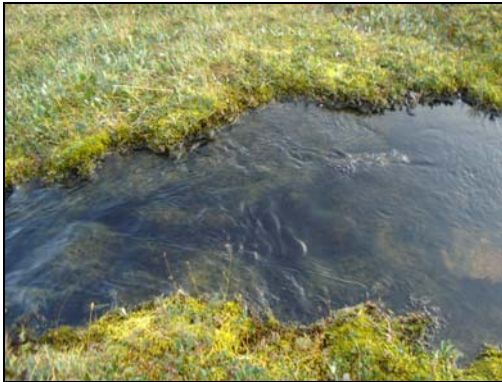
Figure 1. View of habitat (A-D).

15 meters DS crossing steep gradient.

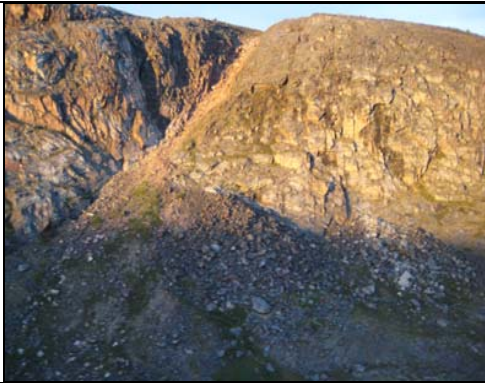
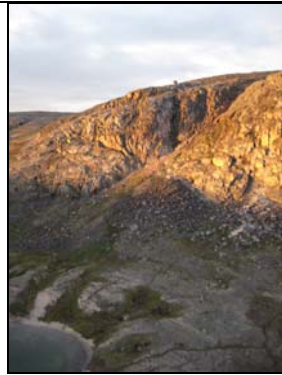
Figure 1. Aerial view of area near crossing (A-B).

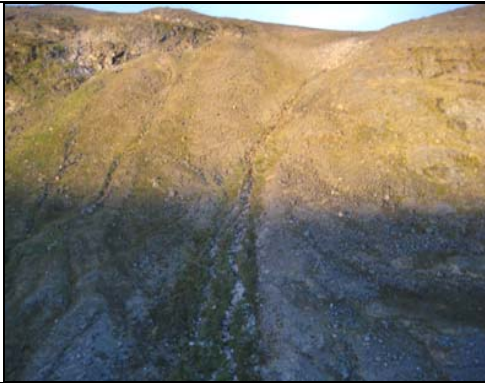
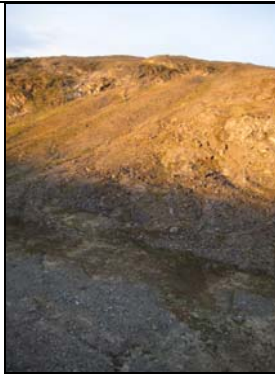
Figure 1. Aerial view of area near crossing (A-B).

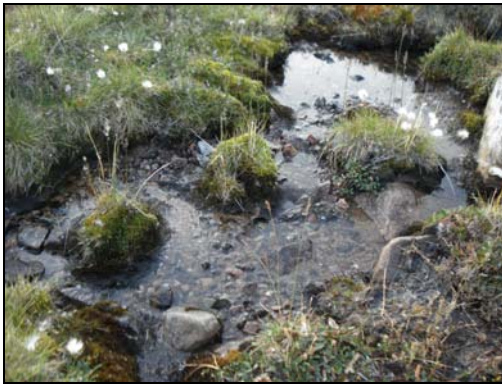
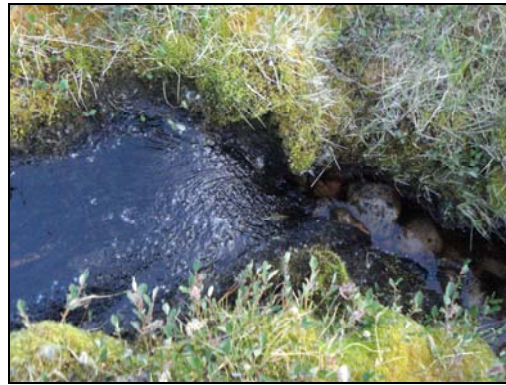
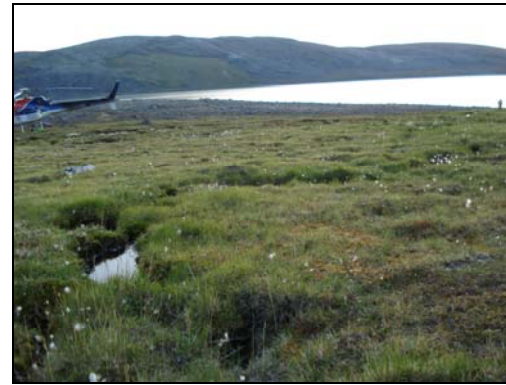
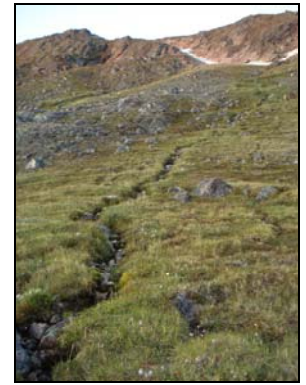
Figure 1. View of habitat, at crossing (A), the barrier (B) downstream of crossing (C) and upstream of crossing (D).

Lots of barriers, mountain, broken dry channels, very narrow. Dry at UTM 17 W 598564 7822261.

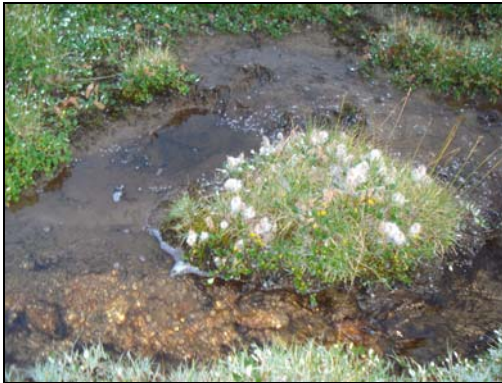
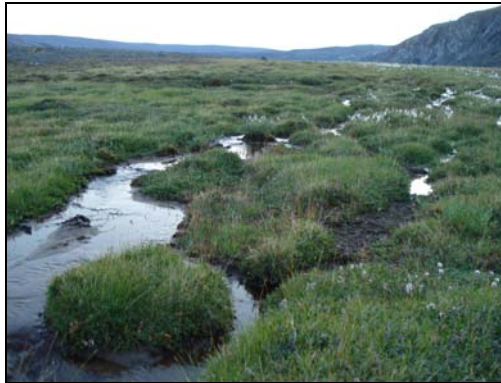
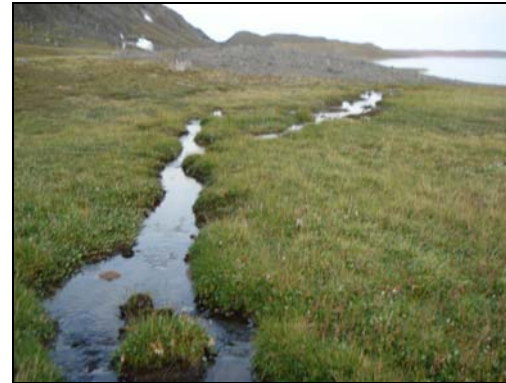
Figure 1. View of habitat (A-D), and site at UTM 17 W 598565 7822107 (E-F).

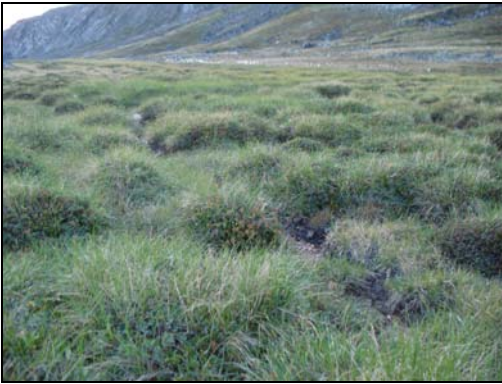
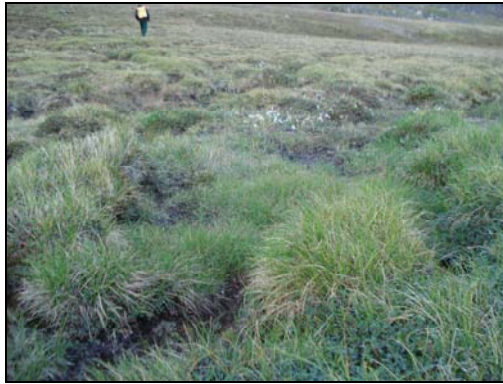
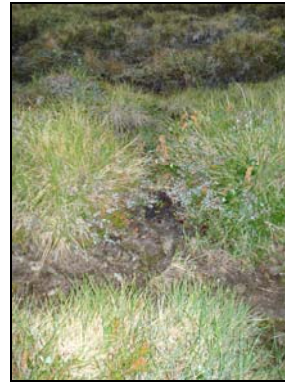
Figure 1. View of habitat near stream bed (A-C).

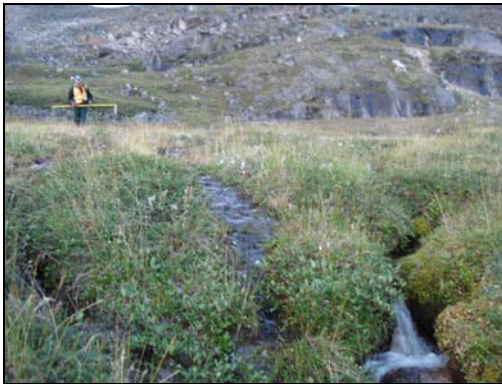
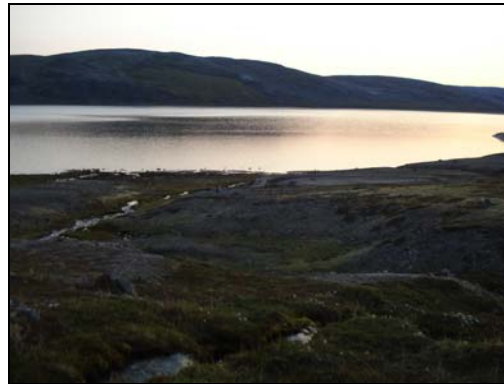
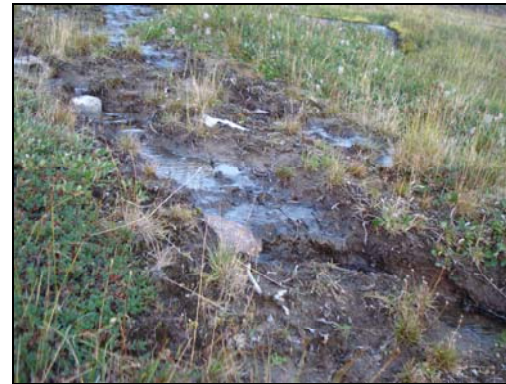
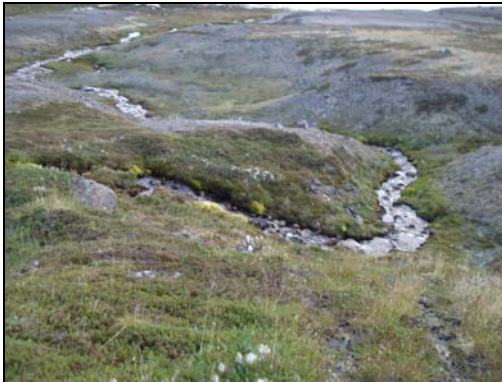
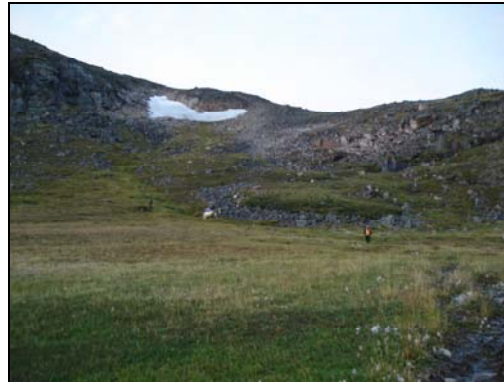
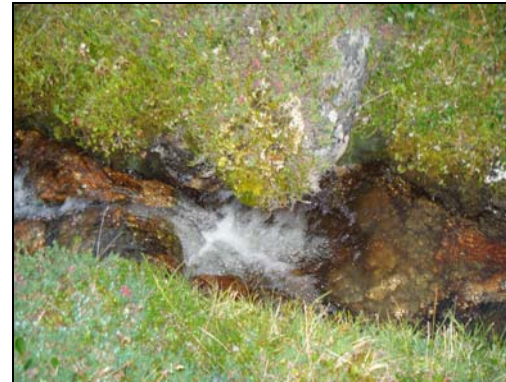
Figure 1. View of habitat near the crossing (A-F).

Although no fish were captured during a fisheries survey, there do not appear to be any significant barriers preventing access from the nearby lake. Low water temperature at the time of sampling and some potential partial barriers (small falls) may have resulted in no catches, but fish use cannot be completely ruled out.

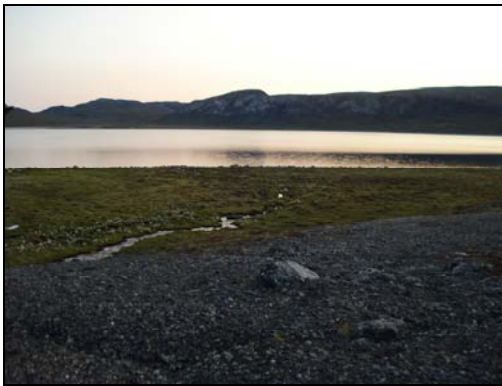
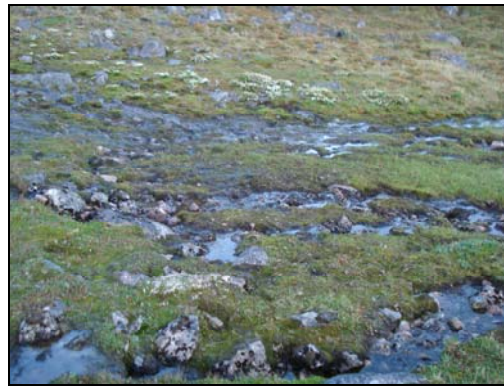
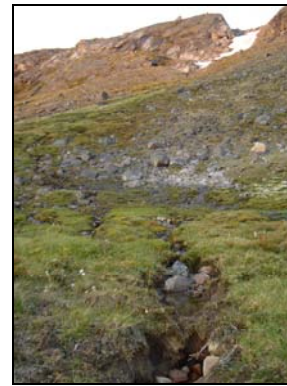
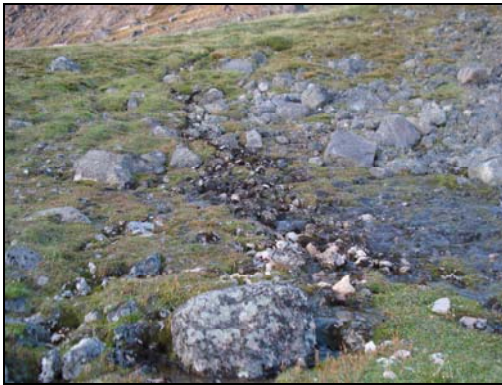
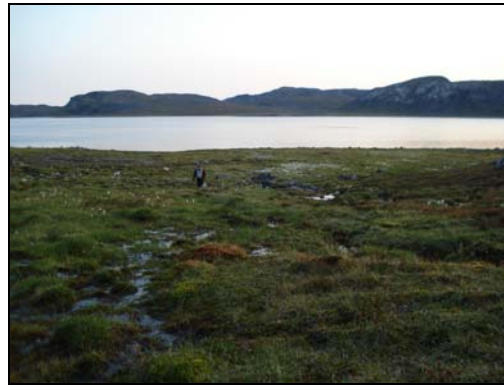
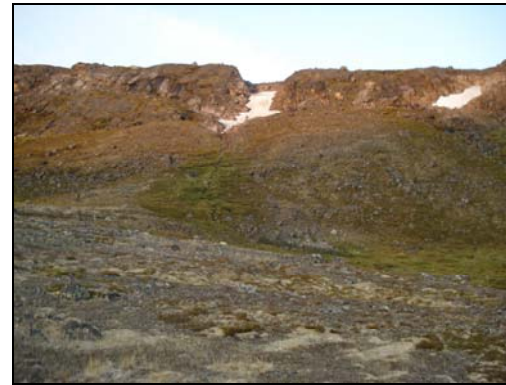
Figure 1. View of habitat, at crossing (A) at UTM 17 W 598345 7821407 (B), at the barrier (C) downstream of site (D), at electrofishing site, (E) and upstream of site (F).

Barrier is a mountain where stream is running off snow/ice. At the crossing the water is too shallow to electrofish, therefore, started at UTM 0598345 7821402.

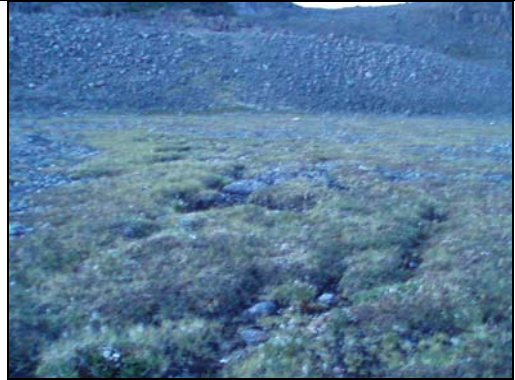
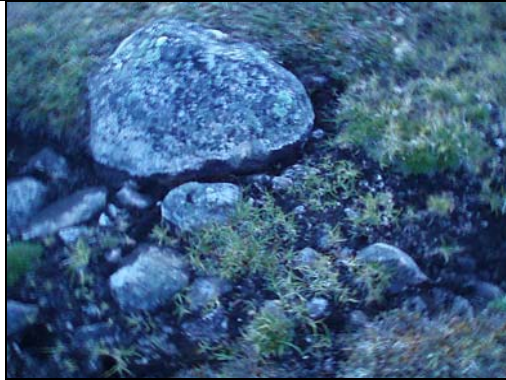
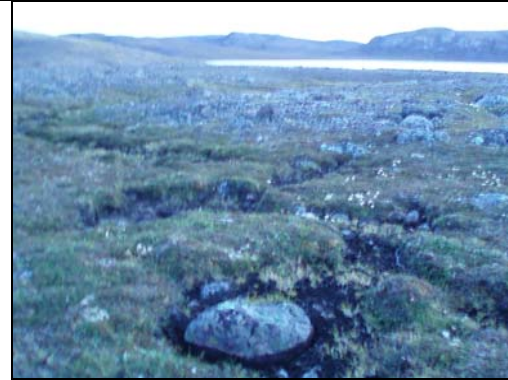
Figure 1. View of habitat upstream of crossings (A), at the crossings (B) and downstream of crossings (C).

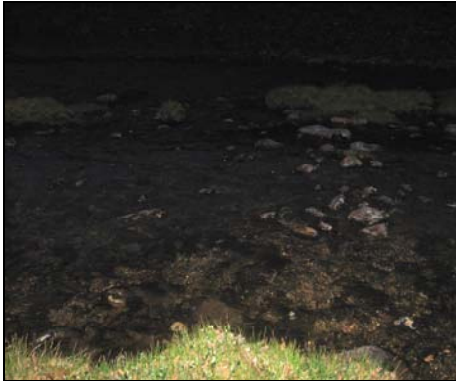
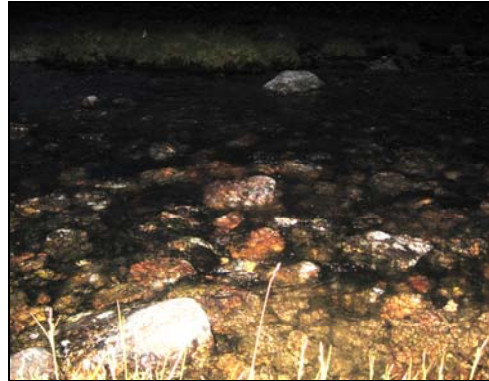
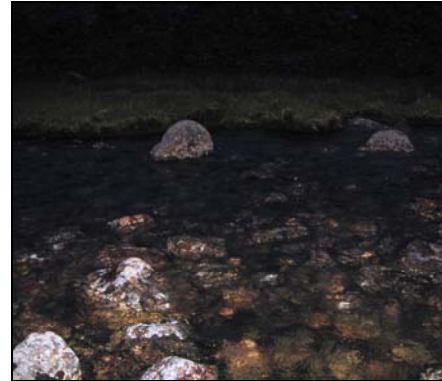
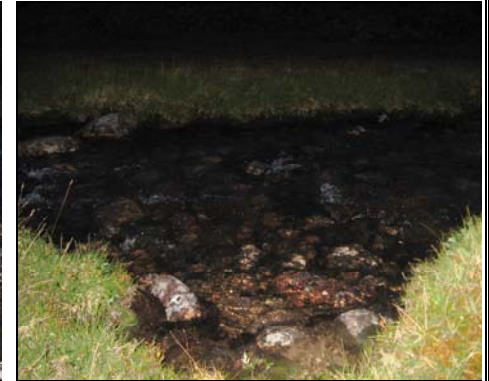
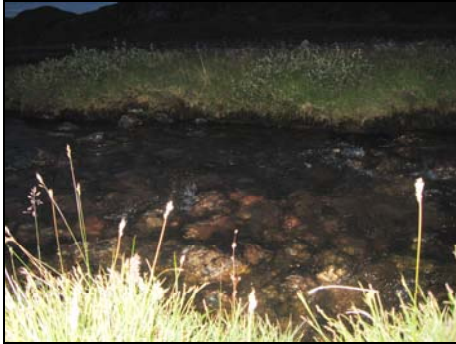
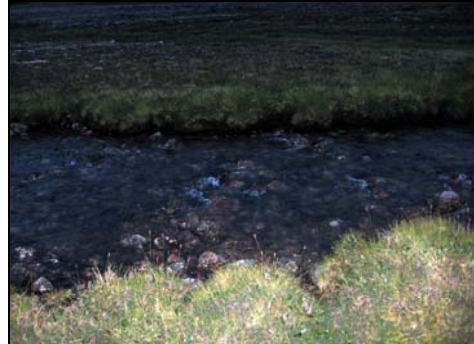
Figure 1. View of habitat 100 (A), 80 (B), 60 (C), 40 (D), and 20 m (E) downstream of crossing, at the crossing (F), and 20 (G), 40 (H), 60 (I), 80 (J), and 100 m (K) upstream of the crossing.

At 40 U/S- right channel is a tributary. Several juvenile ARCH were observed at this site during a 2007 survey, suggesting at least occasional use by this species.

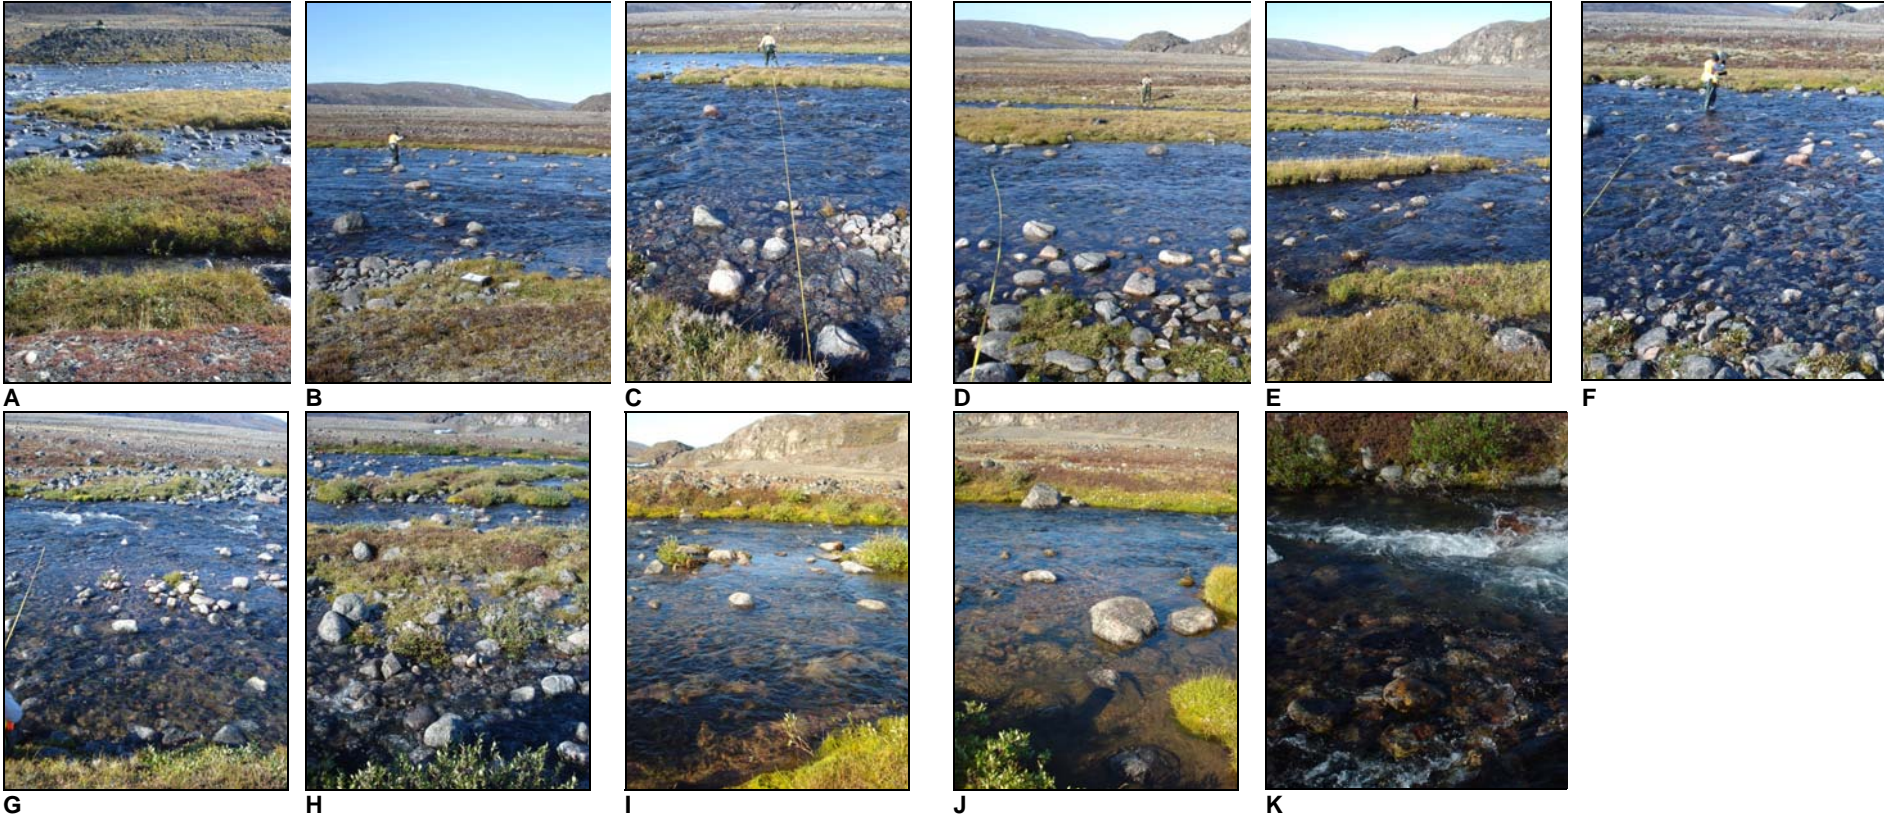
Figure 1. Views of available stream habitat at 20 m intervals starting at 100 m downstream (A) and ending at 100 m upstream (K).

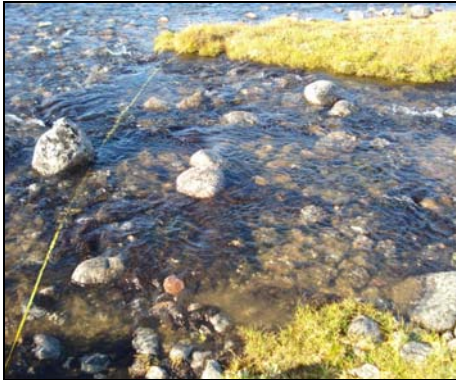
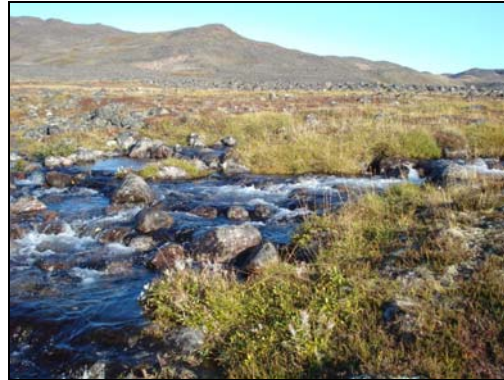
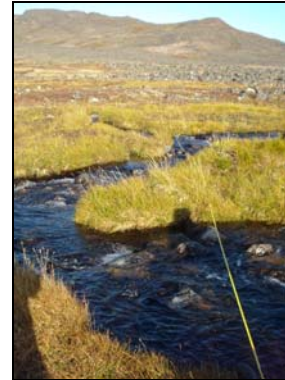
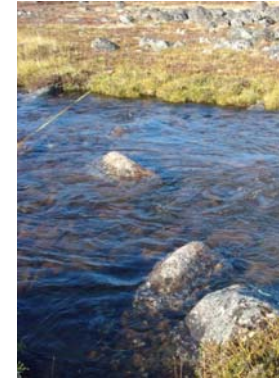
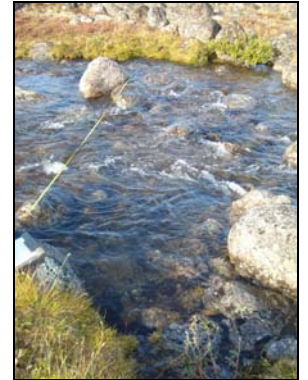
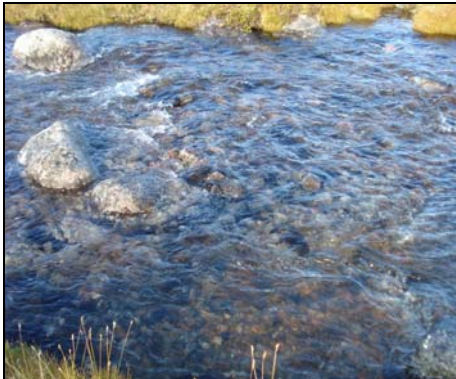
Figure 1. Views of available stream habitat at 20 m intervals starting at 20 m downstream (A) and ending at 100 m upstream (F).

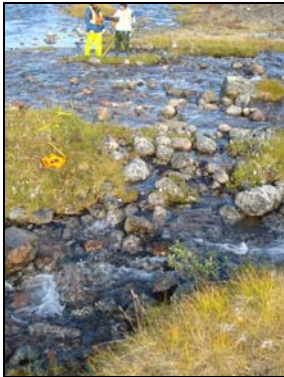
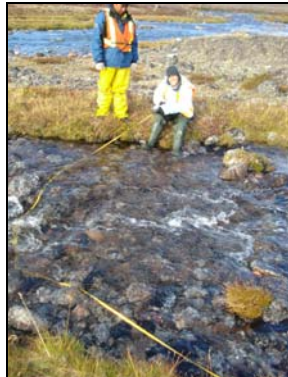
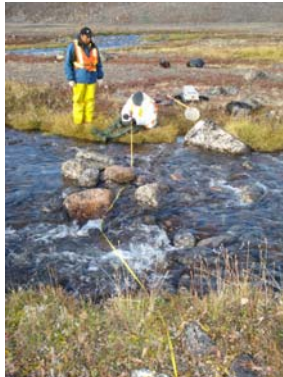
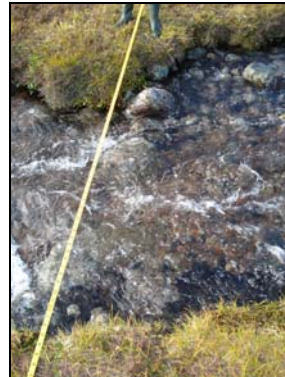
Figure 1. Views of available stream habitat at 20 m intervals starting at 20 m downstream (A) and ending at 40 m upstream (D).

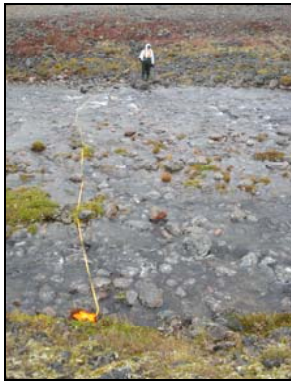
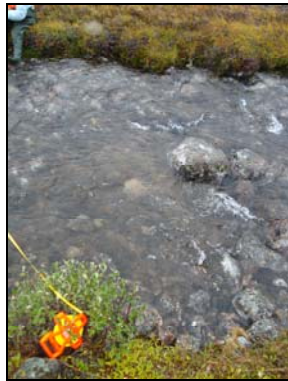
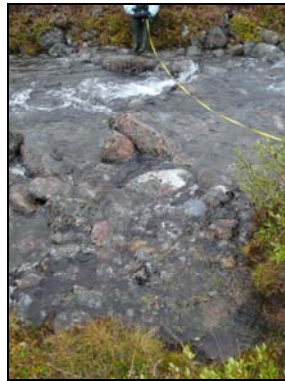
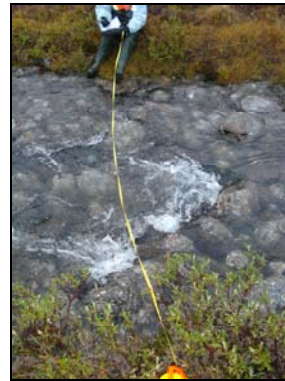
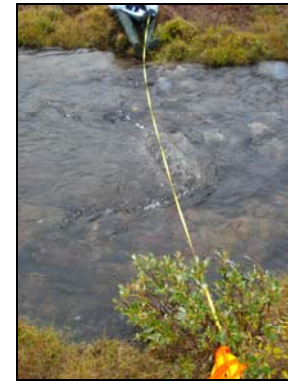
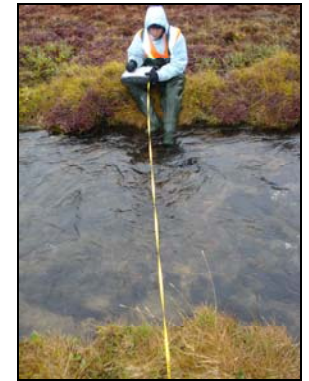
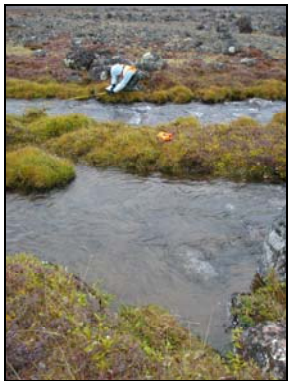
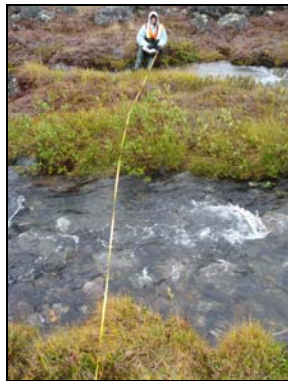
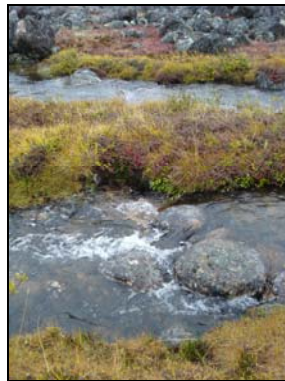
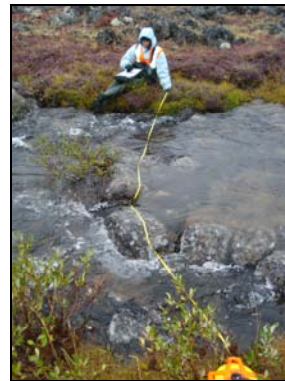
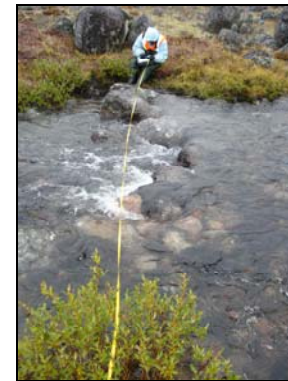
Figure 1. Views of available stream habitat at 20 m intervals starting at 100 m downstream (A) and ending at 100 m upstream (K).

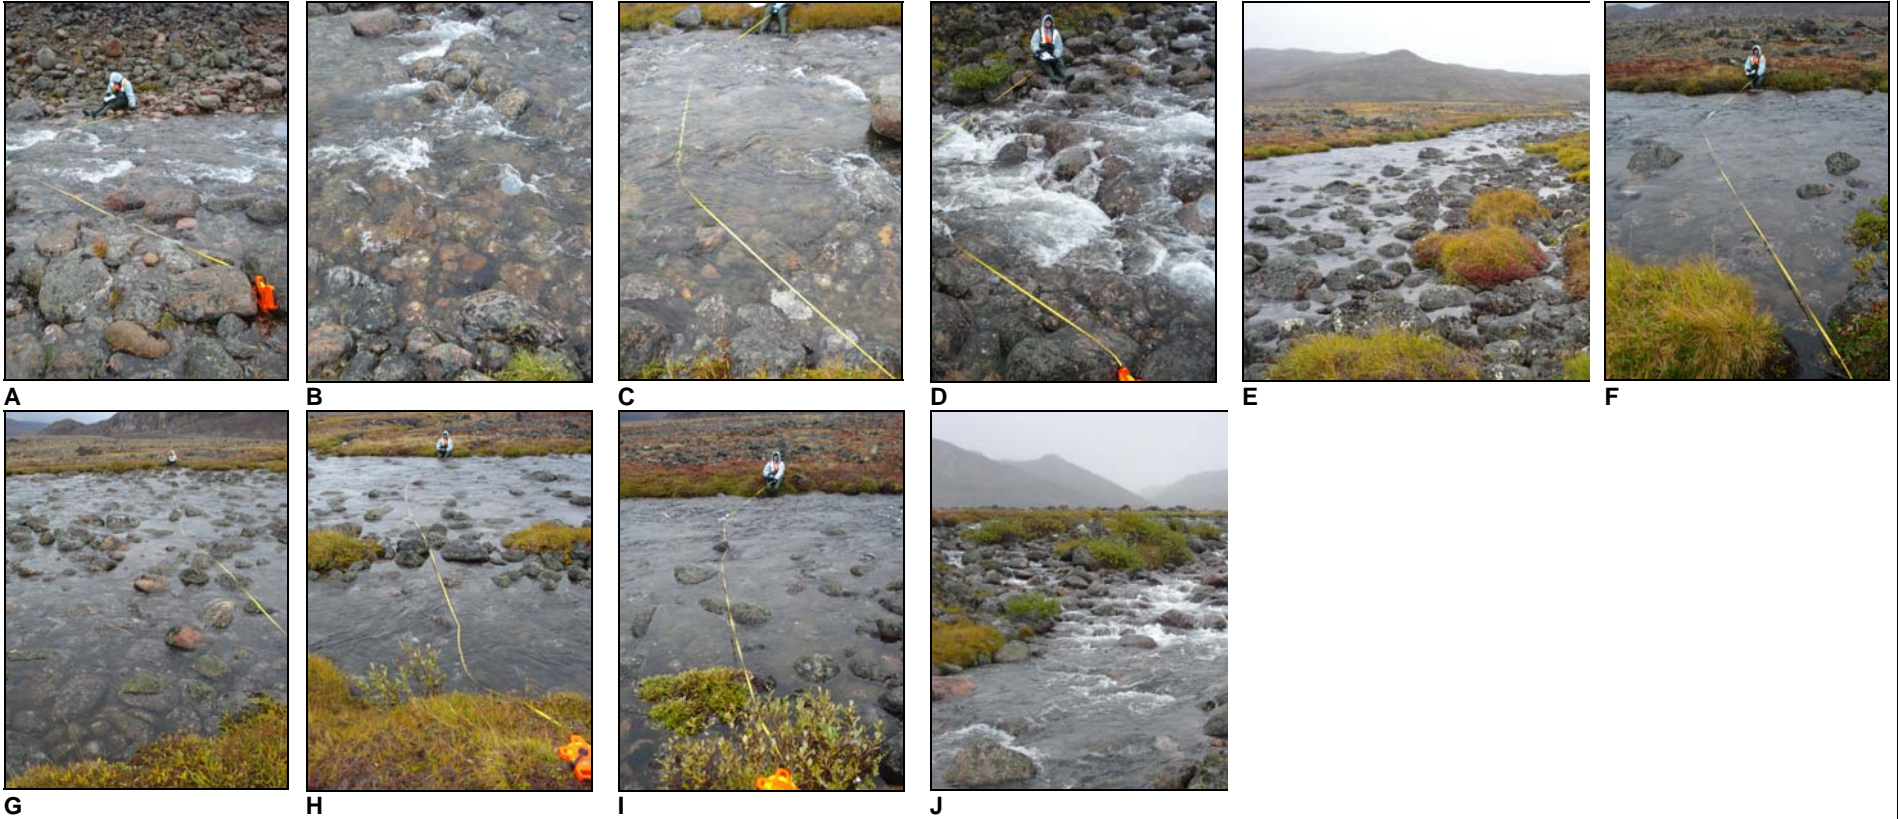
Figure 1. View of available stream habitat at 100 m d/s (A), 80 m d/s (B), 60 m d/s (C), 40 m d/s (D) at the crossing (E), 20 m u/s (F) 40 m u/s (G) 60 m u/s (H) 80 m u/s (I) and possible NNST barriers located downstream (J).

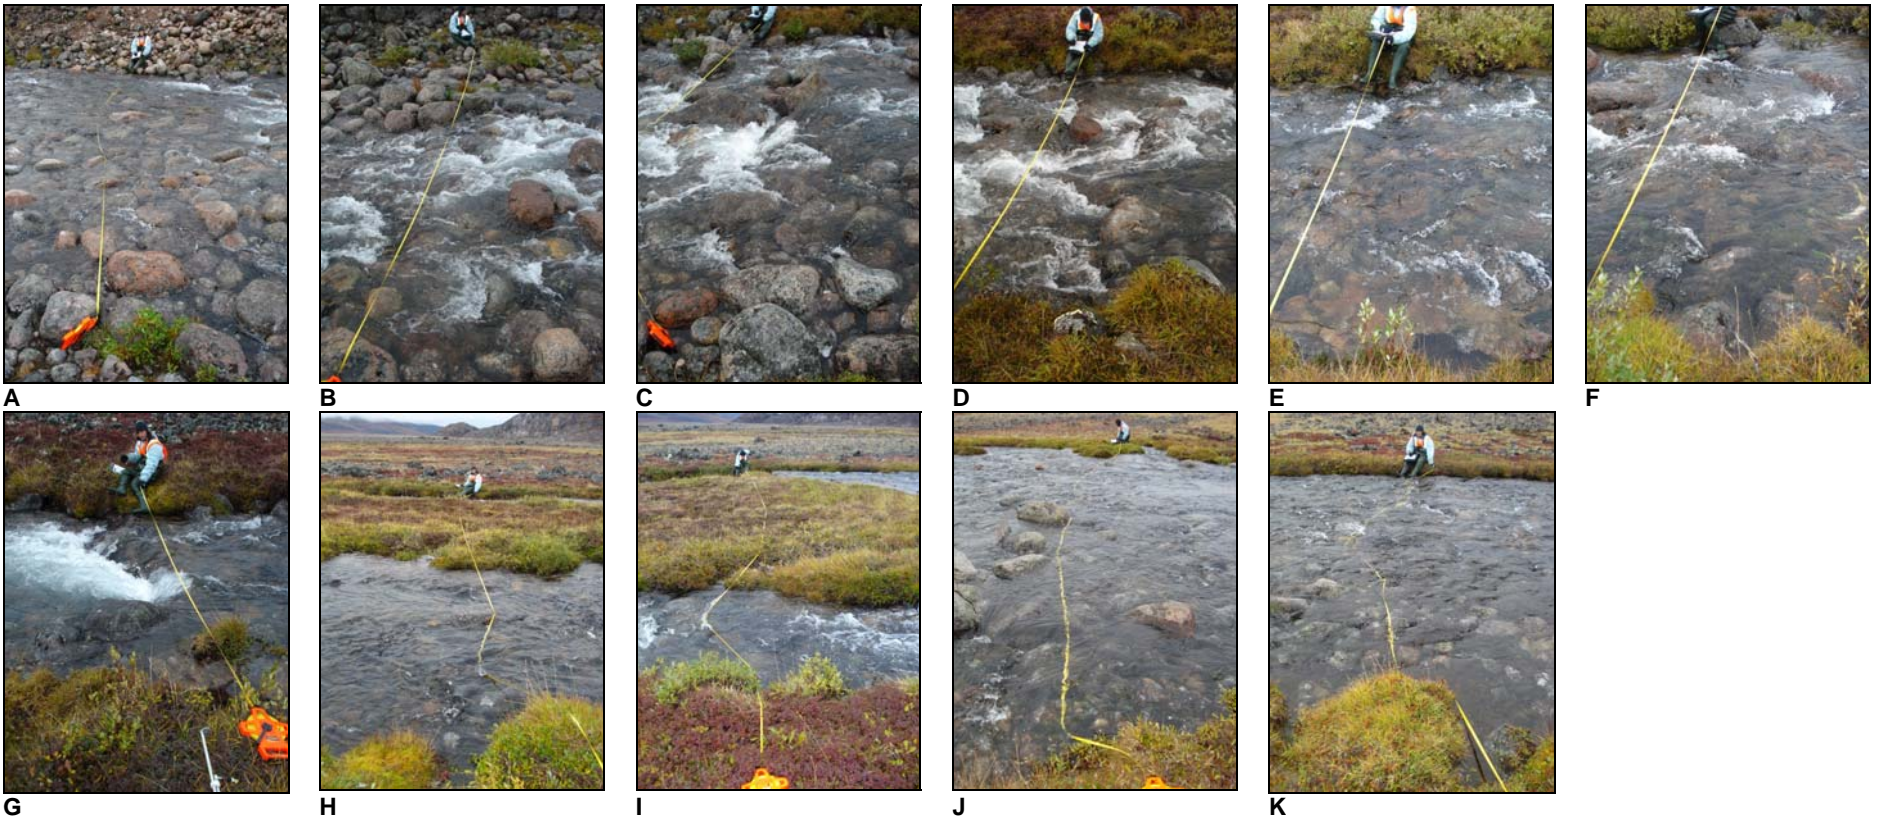
Figure 1. View of available stream habitat at 100 m d/s (A), 80 m d/s (B), 60 m d/s (C), 40 m d/s (D) 20 m d/s (E), at the crossing (F) 20 m u/s (G) 40 m u/s (H) 60 m u/s (I) 80 m u/s (J) 100 m u/s (K)

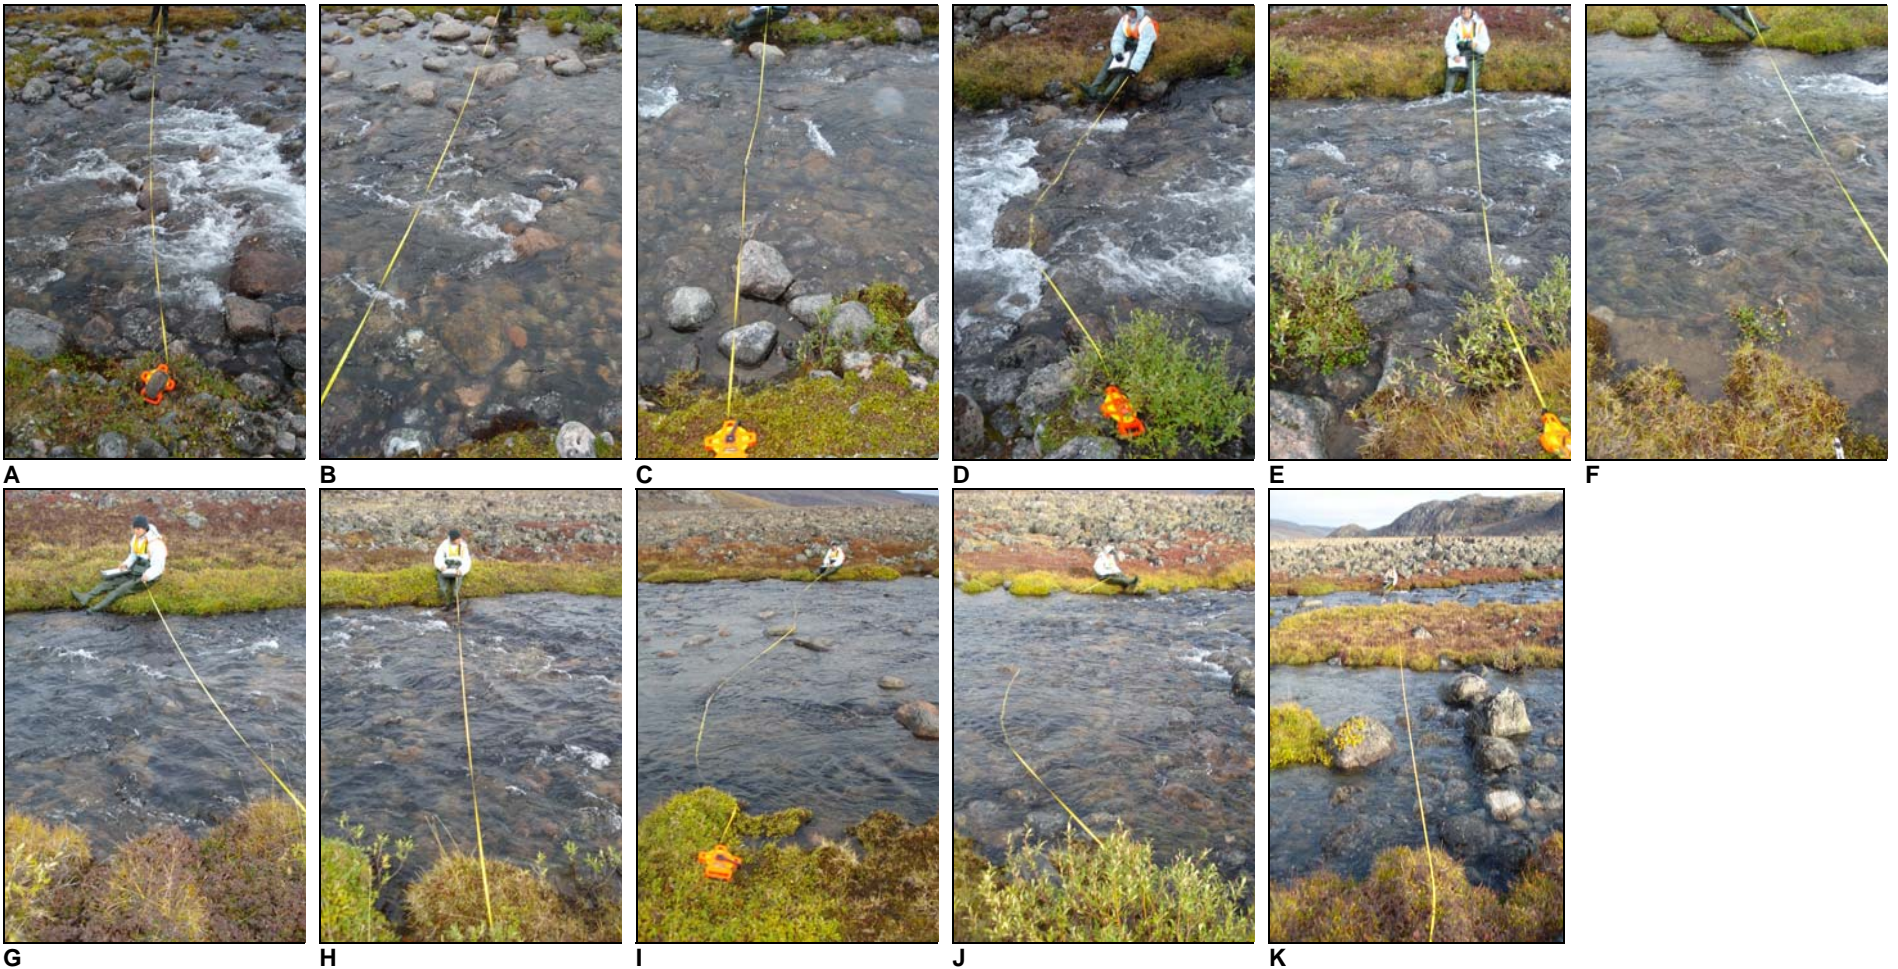
Figure 1. View of available stream habitat at 100 m d/s (A), 80 m d/s (B), 60 m d/s (C), 40 m d/s (D) 20 m d/s (E), at the crossing (F) 20 m u/s (G) 40 m u/s (H) 60 m u/s (I) 80 m u/s (J) 100 m u/s (K)

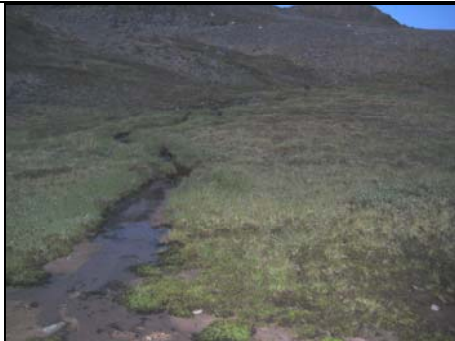
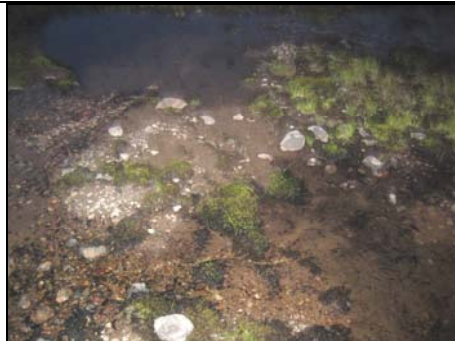
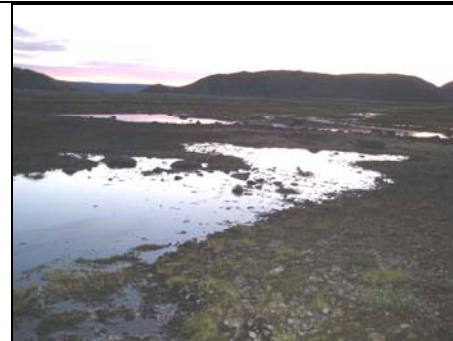
Figure 1. View of habitat upstream of crossings (A), at the crossings (B) and downstream of crossings (C).

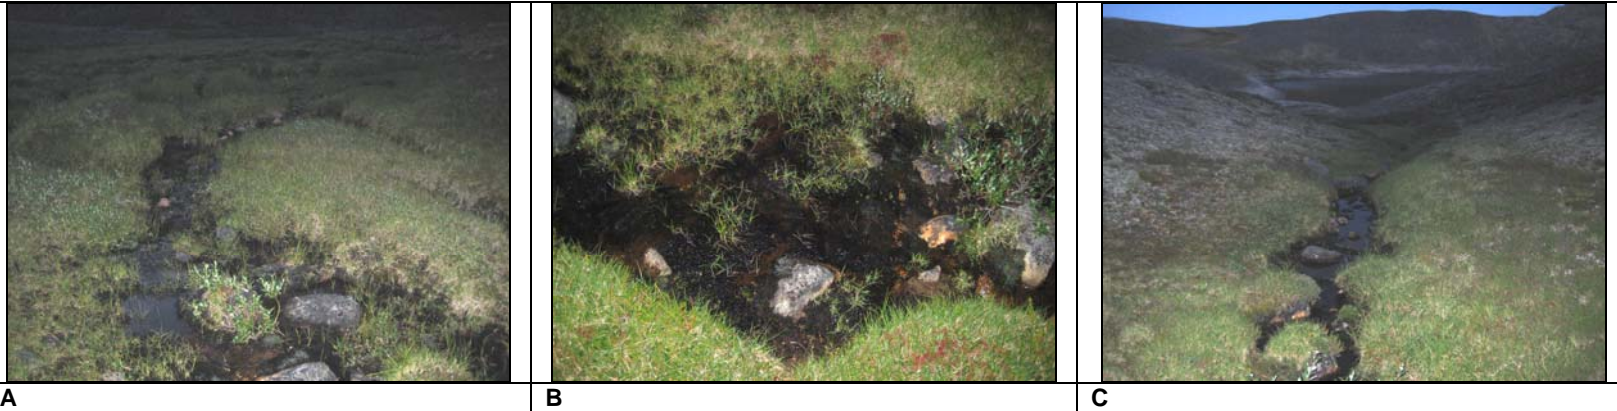
Figure 1. View of habitat upstream of crossing (A), at the crossing (B) and downstream of crossing (C).

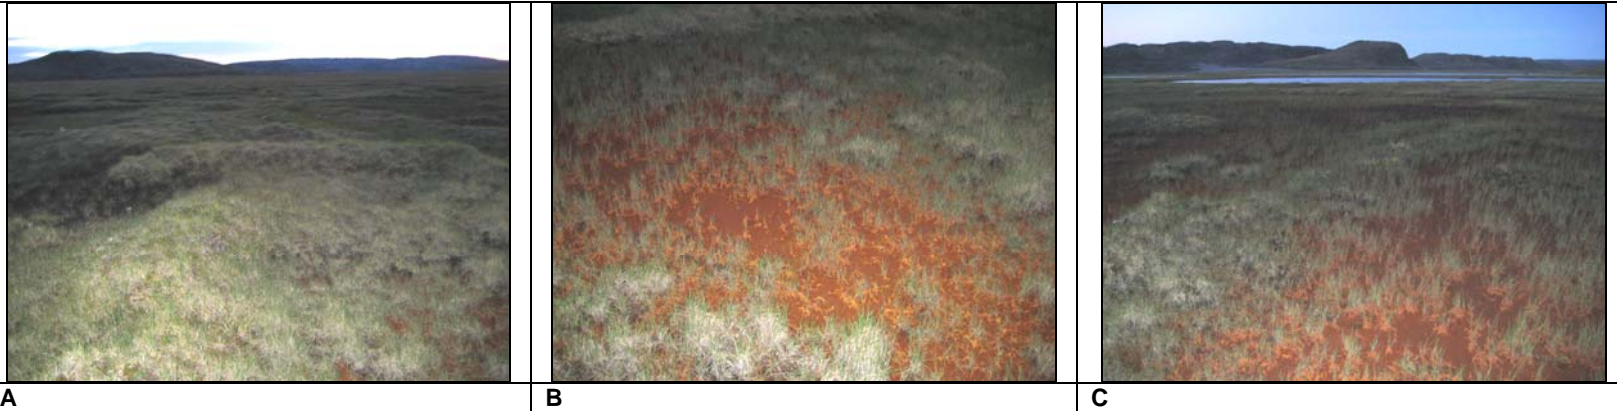
Figure 1. View of habitat upstream of crossing (A), at the crossing (B) and downstream of crossing (C).

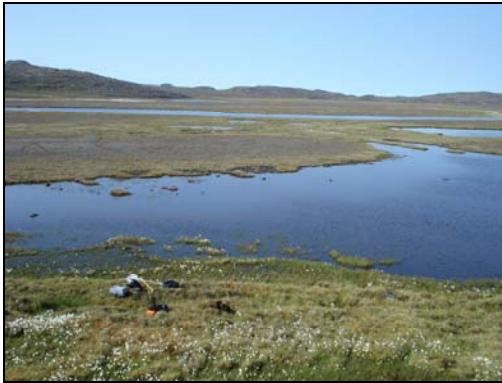
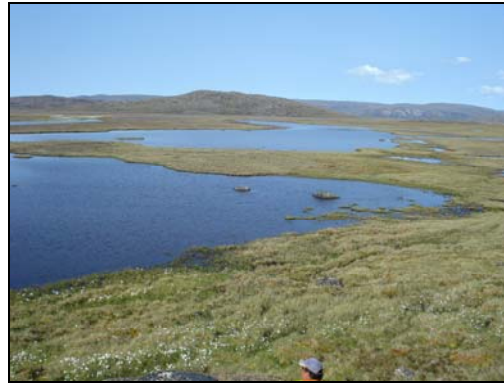
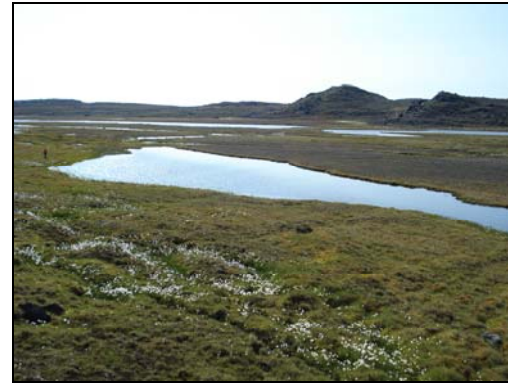
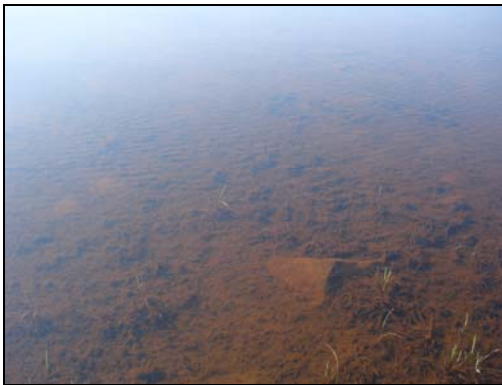
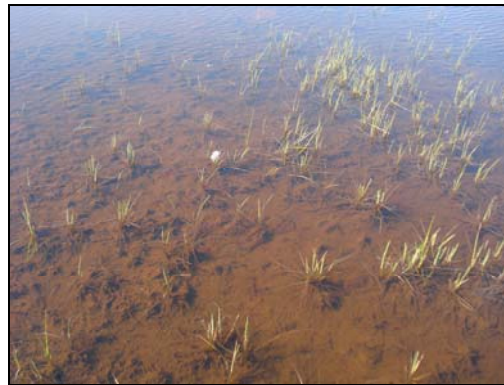
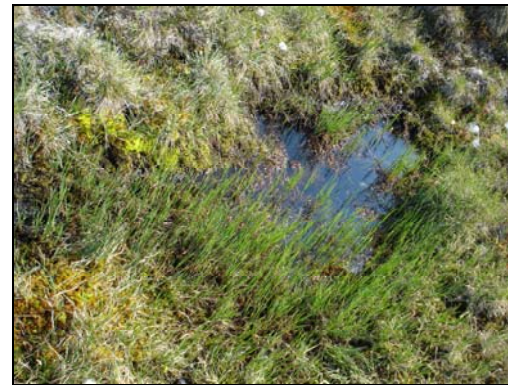
Figure 1. View of habitat including nearby lake encroachment site, at crossing (A), facing north (B), dry creek and lake encroachment site facing south (C), a close-up of substrate at lake encroachment site (D-E), and wetted sections of the stream (F).

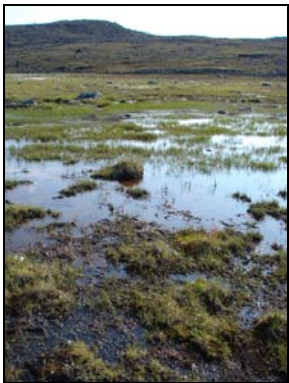
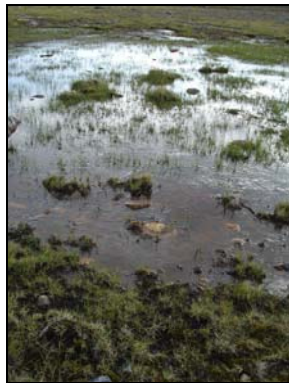
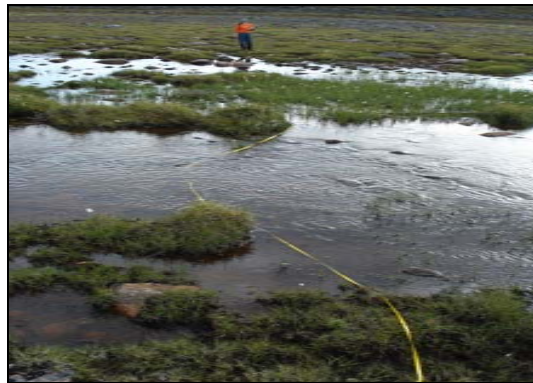
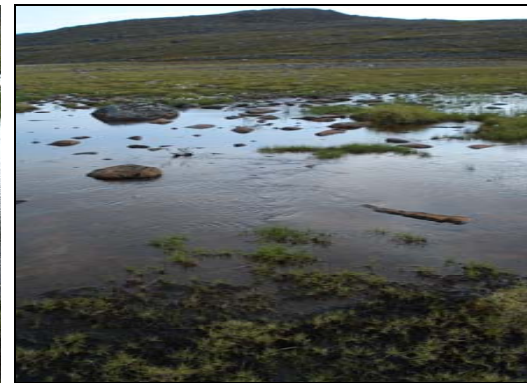
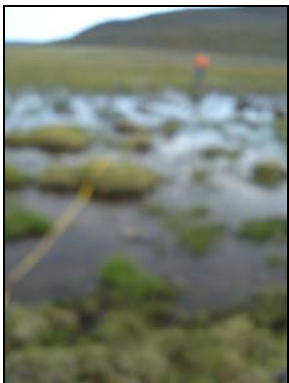
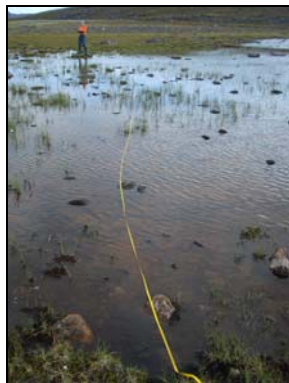
Figure 1. View of habitat, 100 (A), 80 (B), 60 (C), 40 (D), and 20 m (E) downstream of crossing, and at the crossing (F).

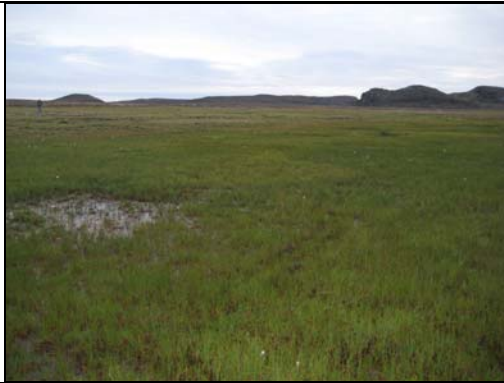
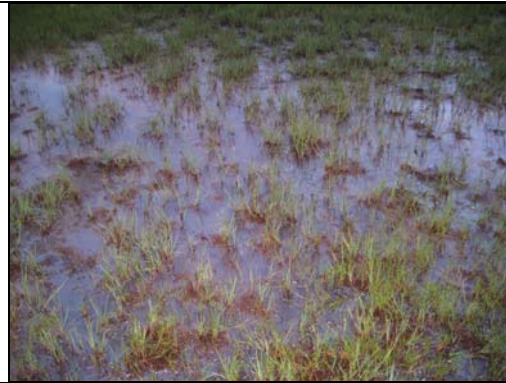
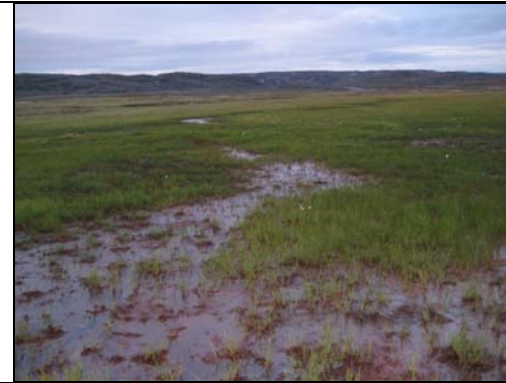
Figure 1. View of habitat upstream of crossing (A), at the crossing (B) and downstream of crossing (C).

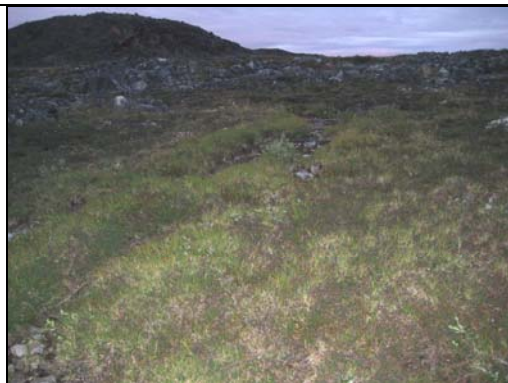
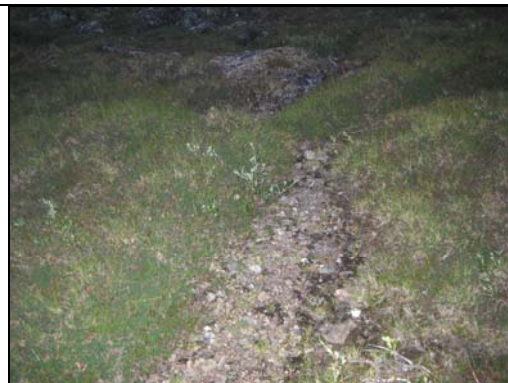
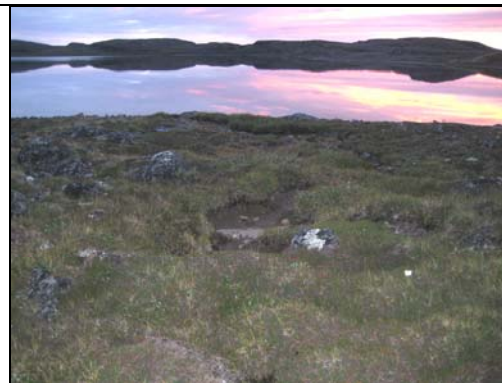
Figure 1. View of habitat upstream of crossing (A), at the crossing (B) and downstream of crossing (C).

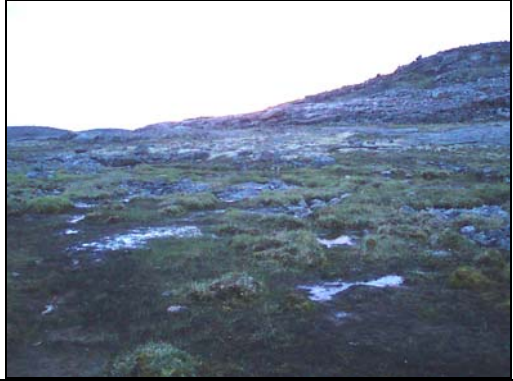
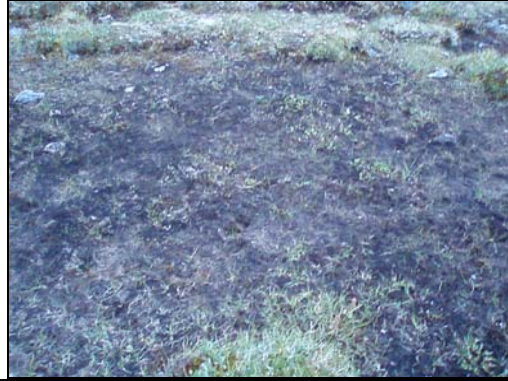
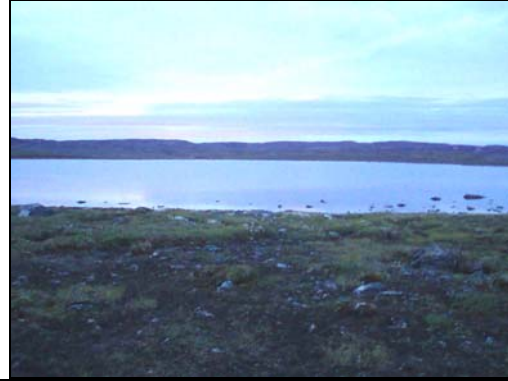
Figure 1. View of habitat upstream of crossing (A), at the crossing (B) and downstream of crossing (C).
