**HABITAT ASSESSMENT PROTOCOL AND SAMPLE
DATA SHEET USED FOR DESCRIBING AVAILABLE
AQUATIC HABITAT IN WATERCOURSES IN THE
RAILWAY/ACCESS ROAD AREA.**

MARY RIVER PROJECT RAILWAY/ACCESS ROAD WATERCOURSE CROSSING ASSESSMENT PROTOCOL

North/South Consultants Inc. and Knight Piésold Ltd.

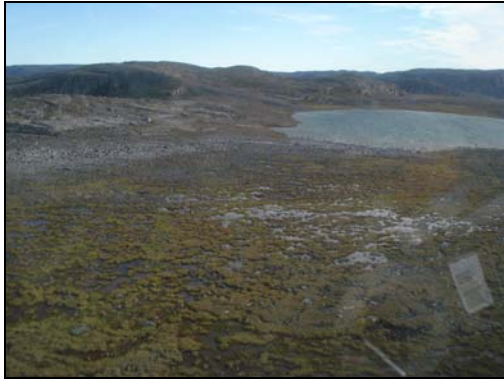
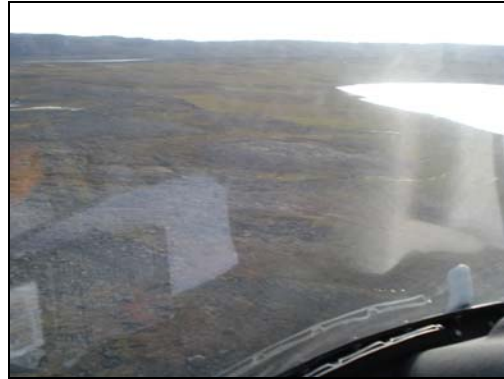
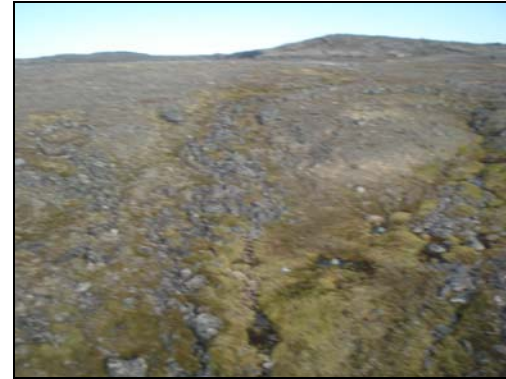
Figure 1. View of upstream waterbody (A), View of drainages and downstream waterbody on the left hand side (B) View from large waterbody looking upstream towards crossing area (C).

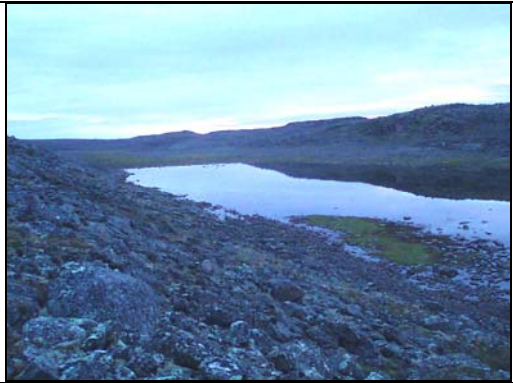
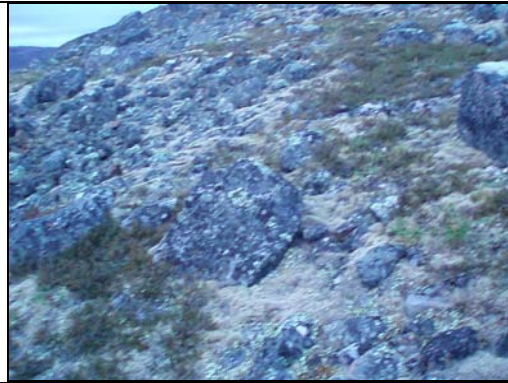
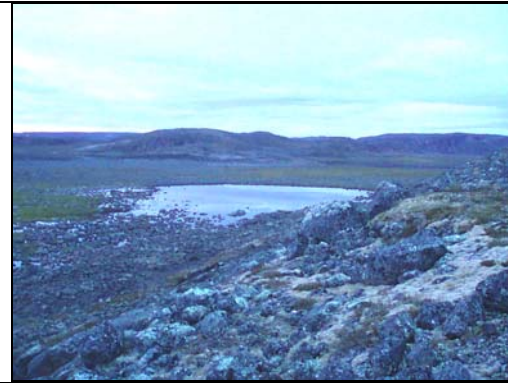
Figure 1. View of habitat upstream of crossing (A), at the crossing (B) and downstream of crossing (C).

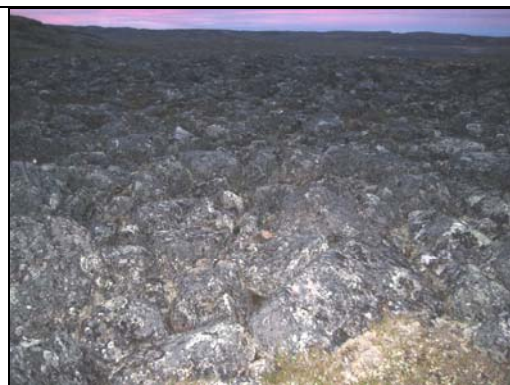
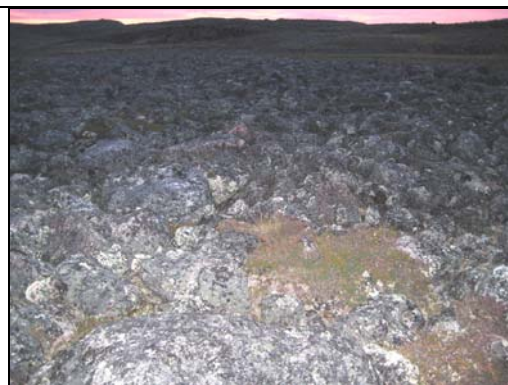
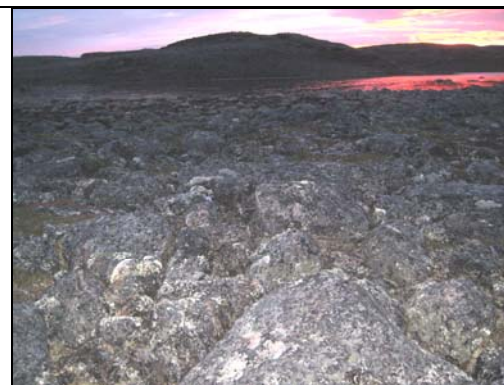
Figure 1. View of habitat upstream of crossing (A), at the crossing (B) and downstream of crossing (C).

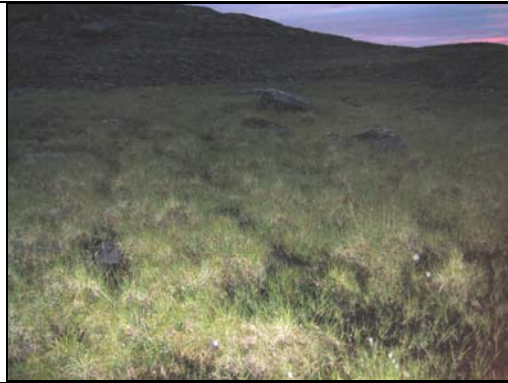
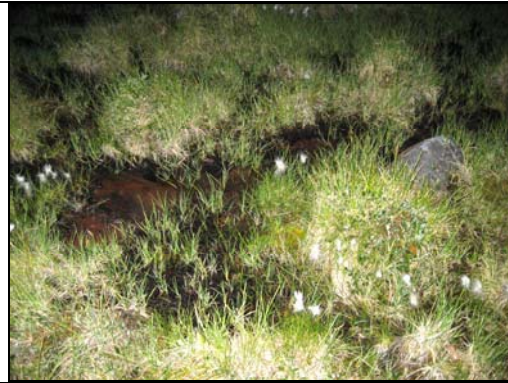
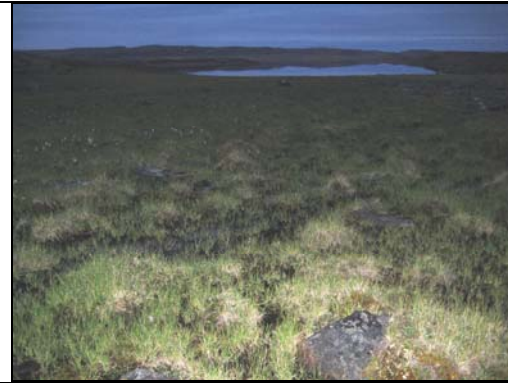
Figure 1. View of habitat upstream of crossing (A), at the crossing (B) and downstream of crossing (C).

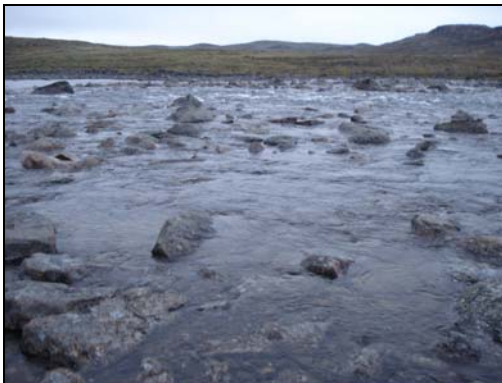
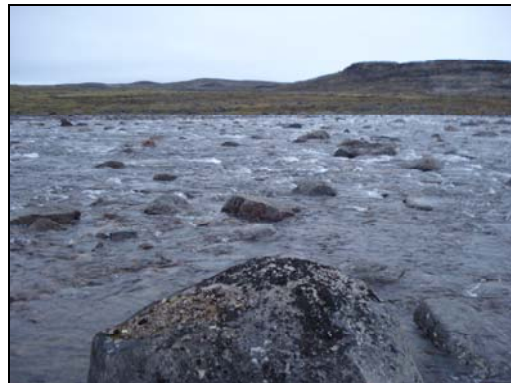
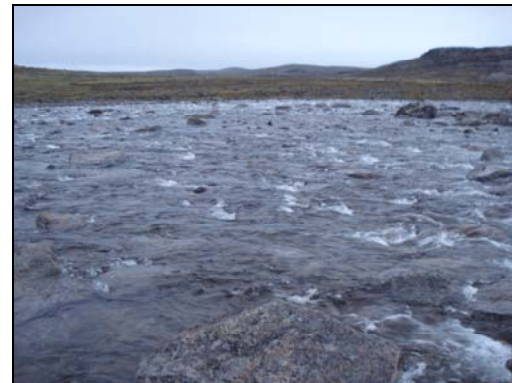
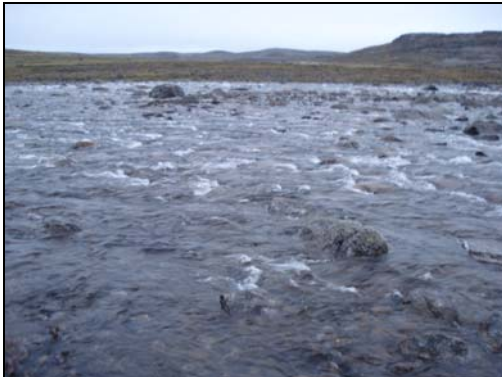
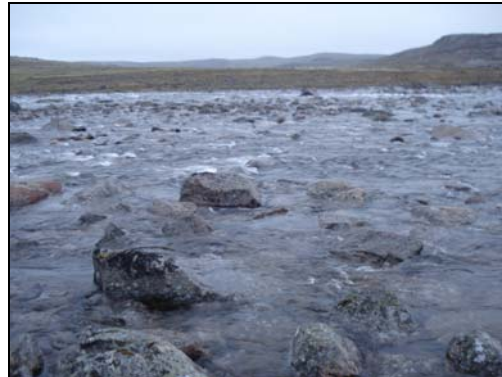
Figure 1. View of habitat at 40 (A) and 20 m downstream of crossing (B), at the crossing (C), and 20 (D) and 40 m upstream of crossing (E).

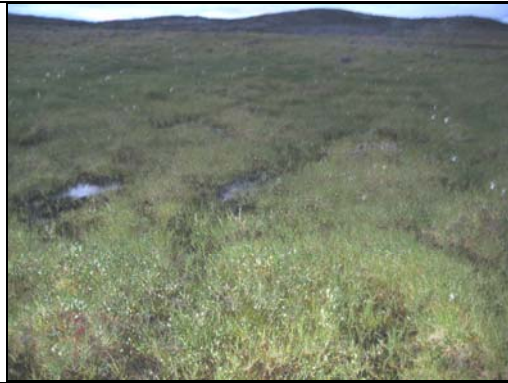
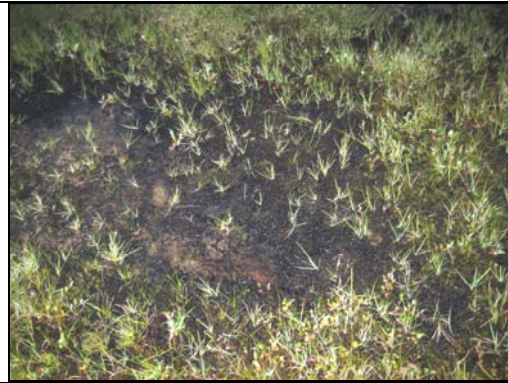
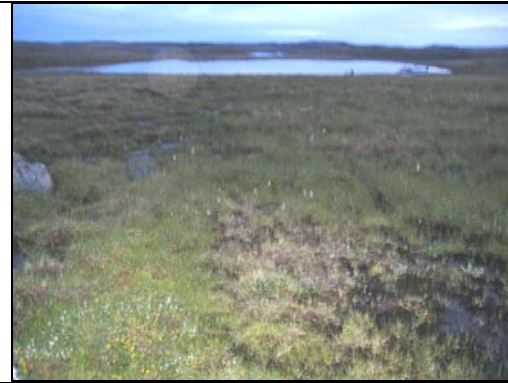
Figure 1. View of habitat upstream of crossing (A), at the crossing (B) and downstream of crossing (C).

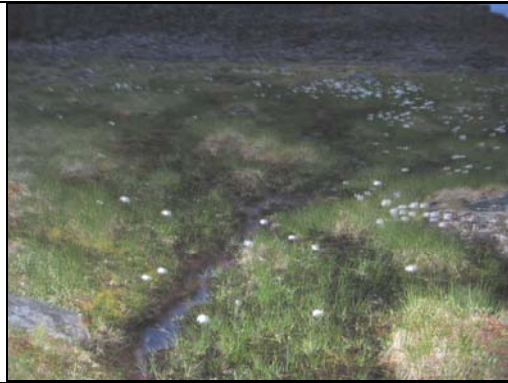
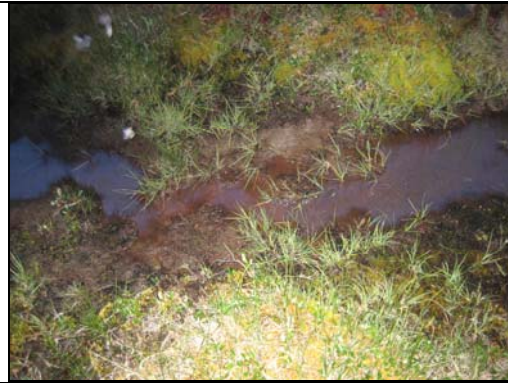
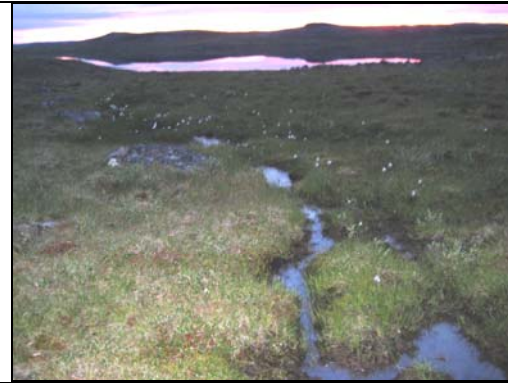
Figure 1. View of habitat upstream of crossing (A), at the crossing (B) and downstream of crossing (C).

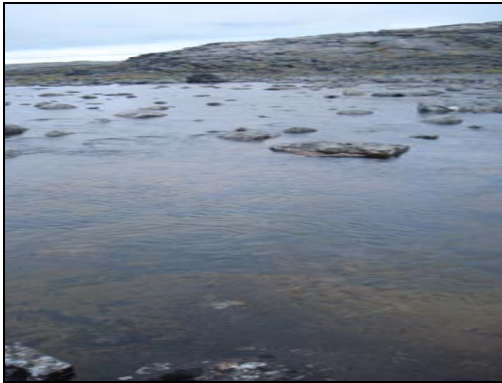
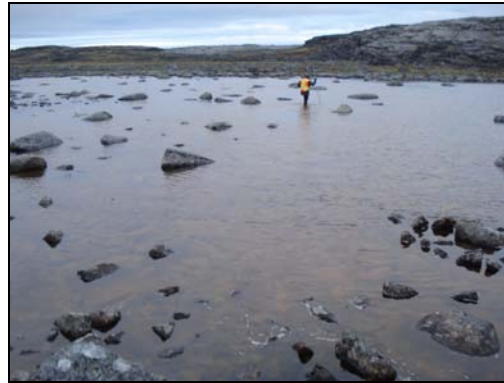
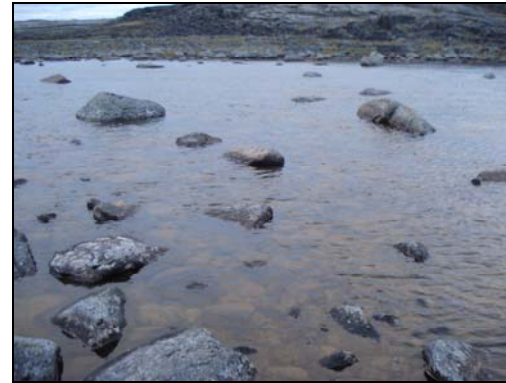
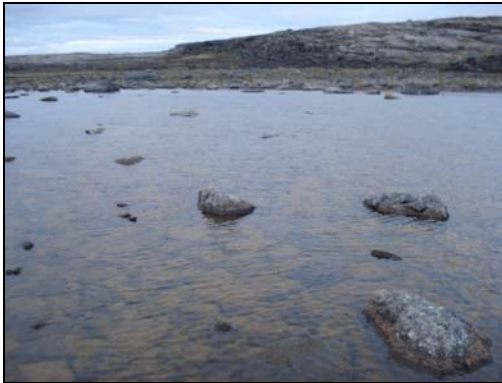
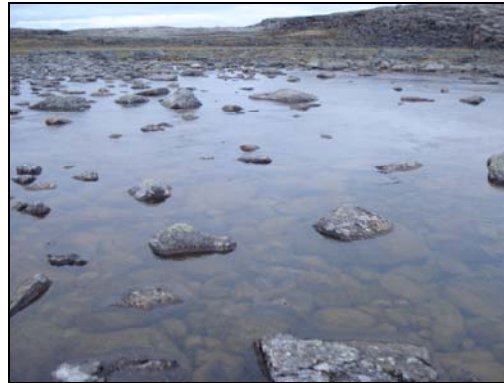
Figure 1. View of habitat at (A) 40 (A) and 20 m downstream of crossing (B), at the crossing (C) and at 20 (D) and 40 m upstream of crossing.

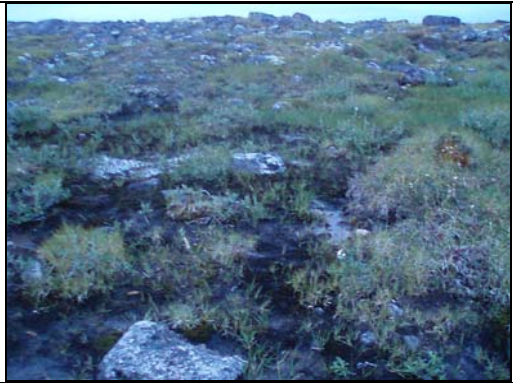
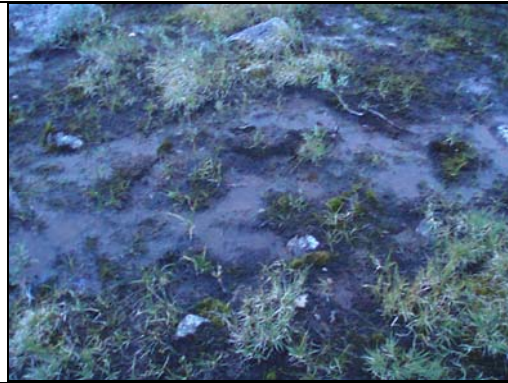
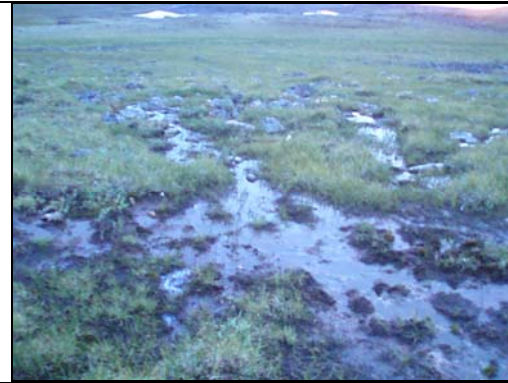
Figure 1. View of habitat upstream of crossing (A), at the crossing (B) and downstream of crossing (C).

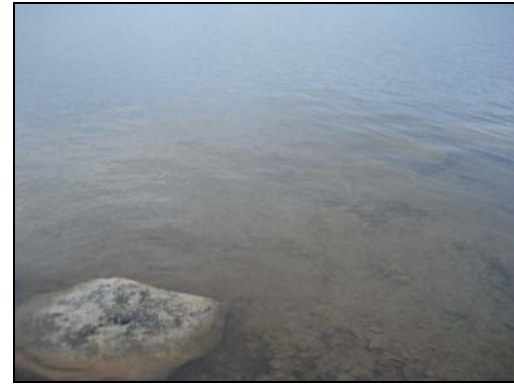
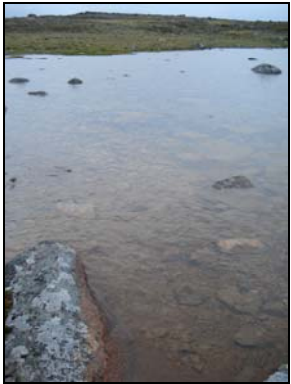
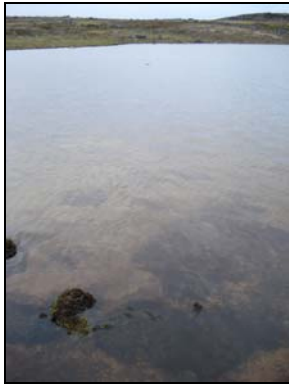
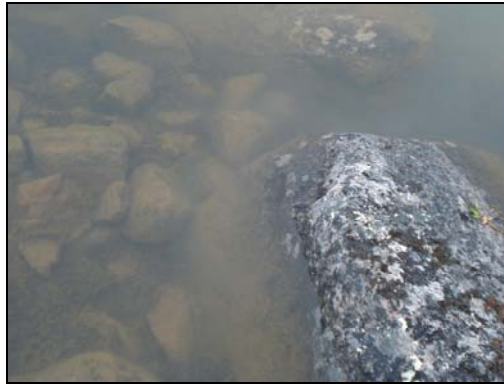
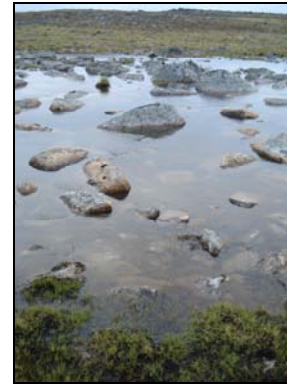
Figure 1. View of habitat (A-H).

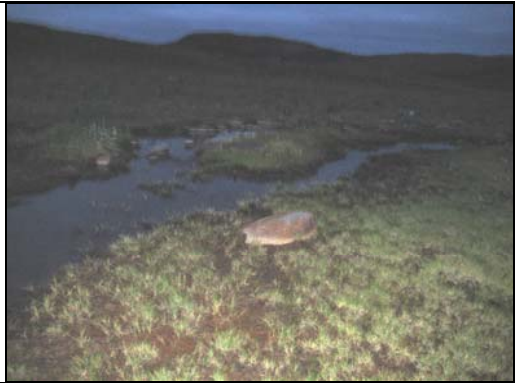
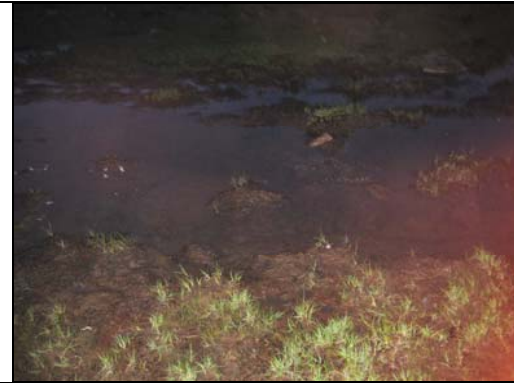
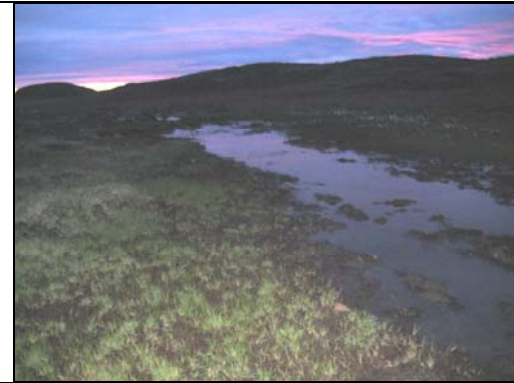
Figure 1. View of habitat upstream of crossing (A), at the crossing (B) and downstream of crossing (C).
