APPENDIX 5.1-3.

DETAILED HABITAT ASSESSMENTS AND SUMMARY OF RESULTS FOR ACCESS ROAD STREAM CROSSINGS.

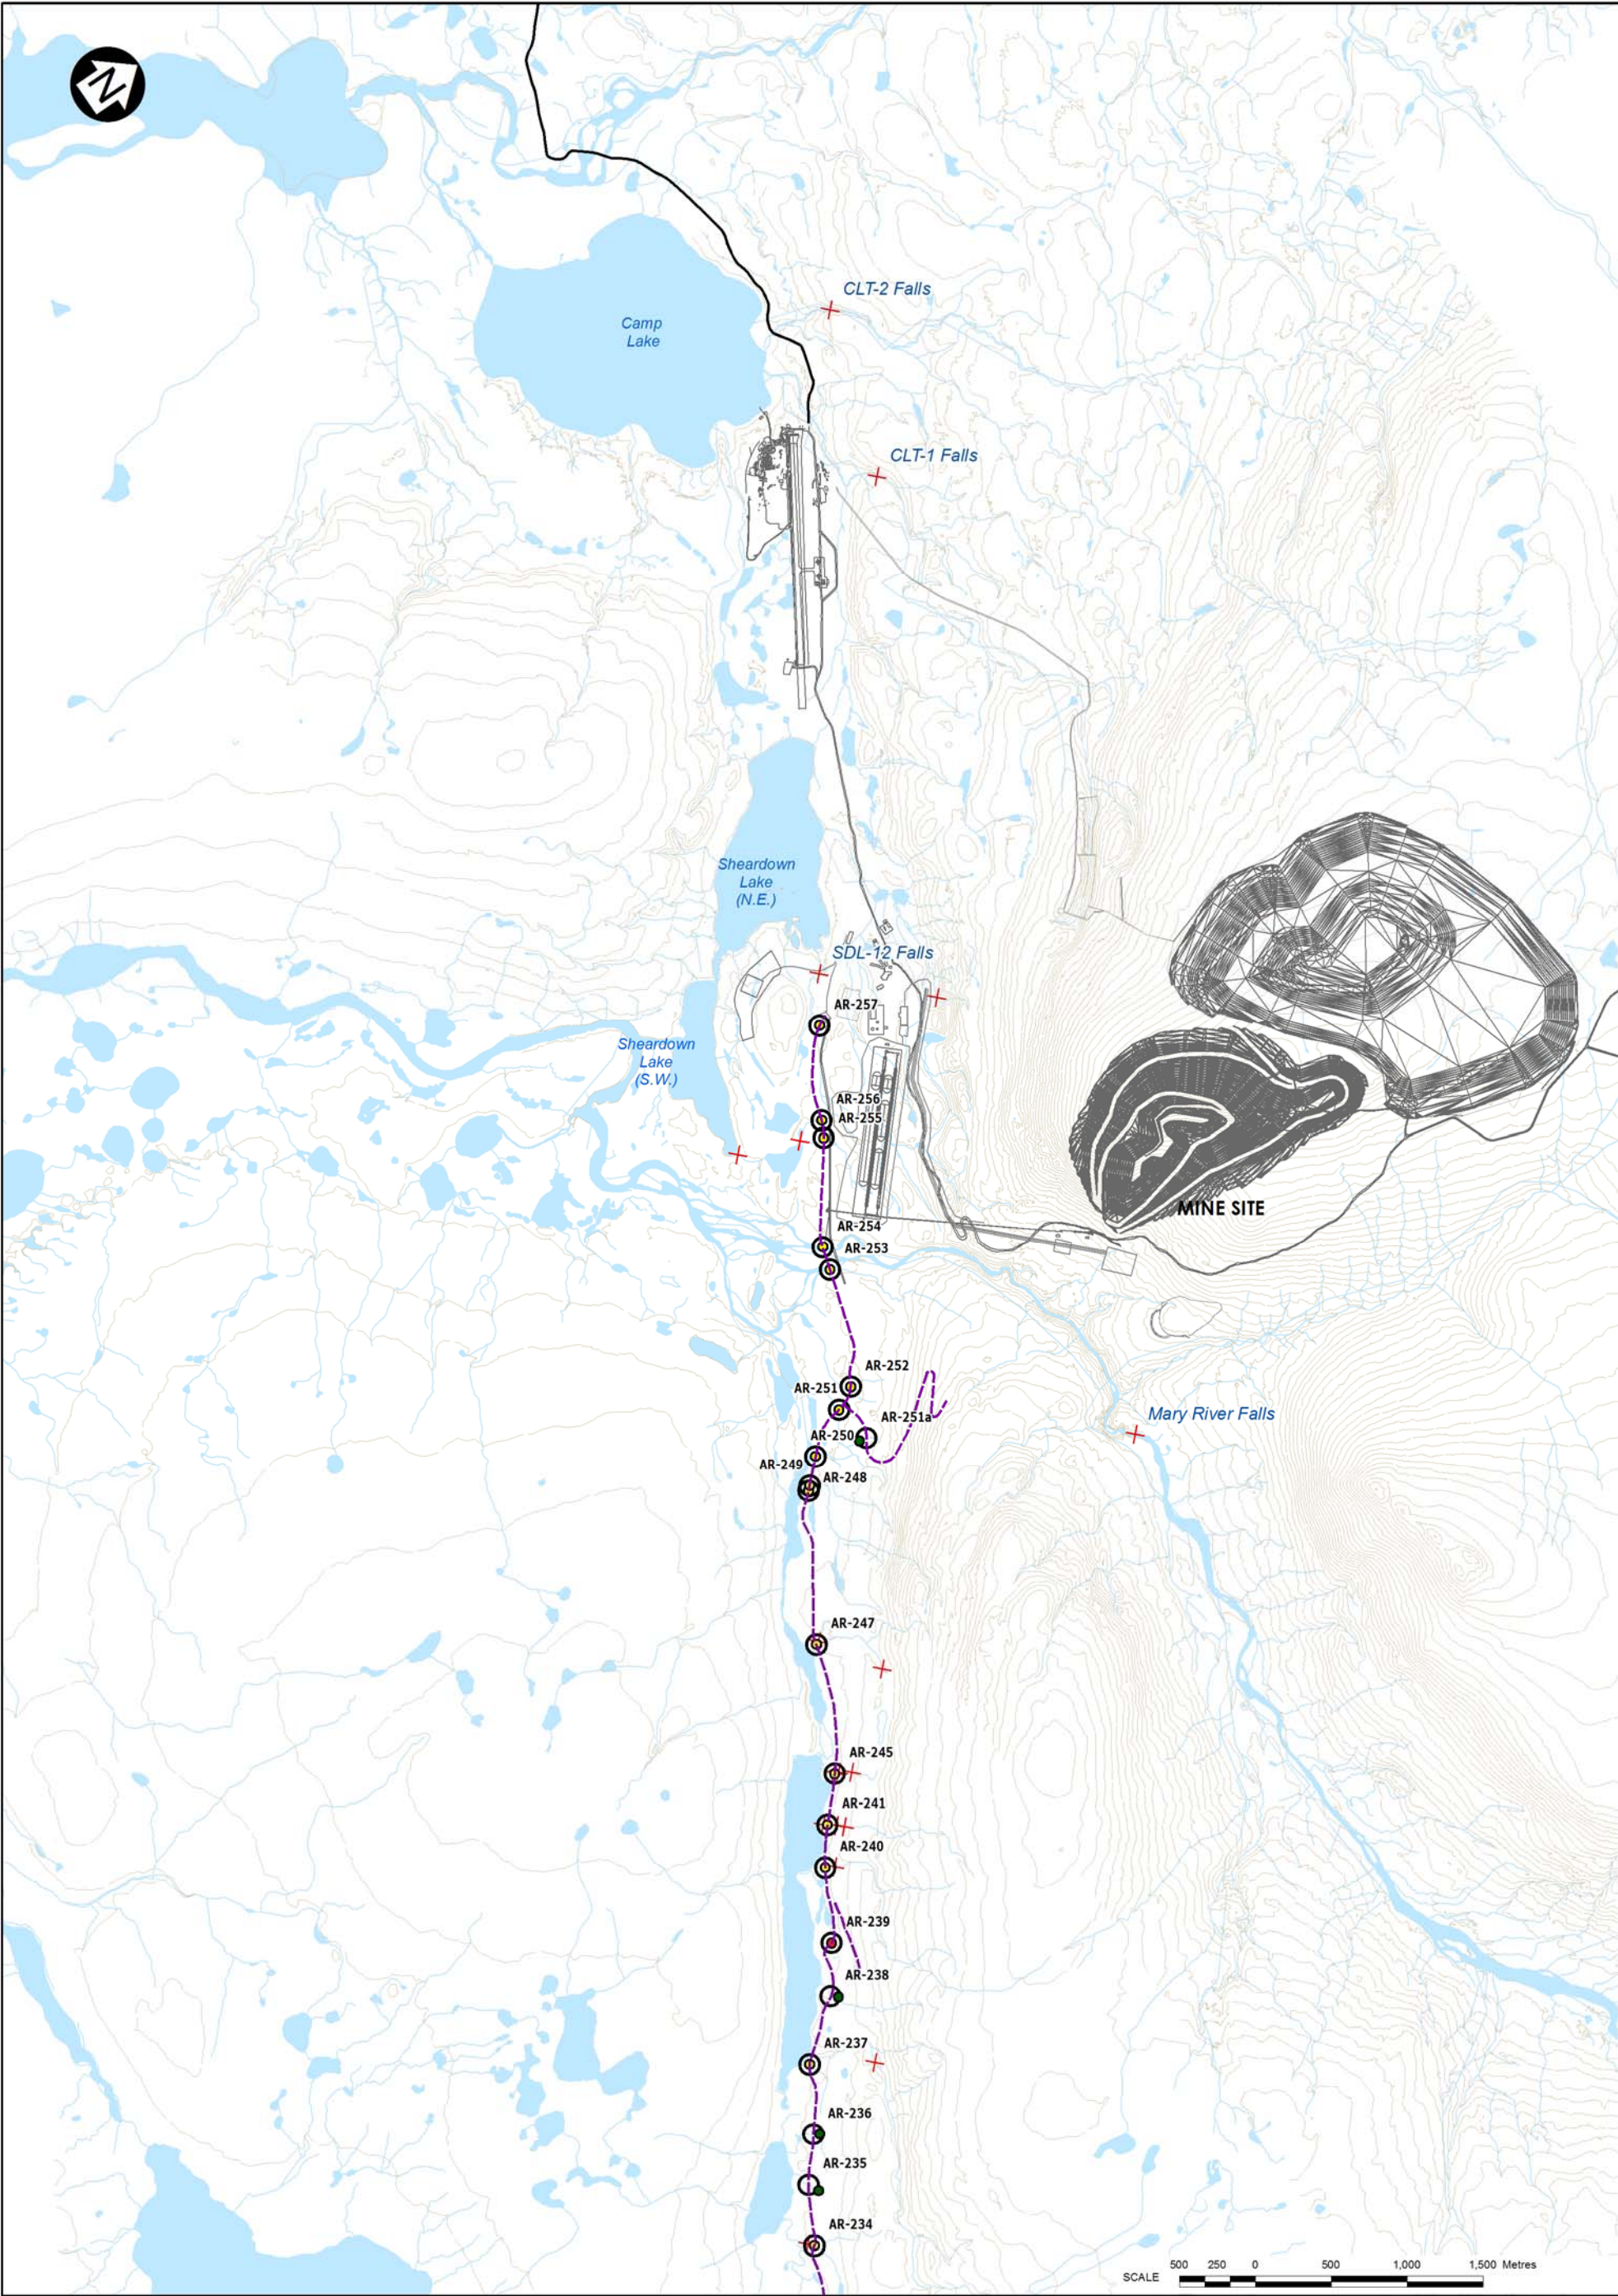
LEGEND:

- ACCESS ROAD CROSSING SURVEY YEAR

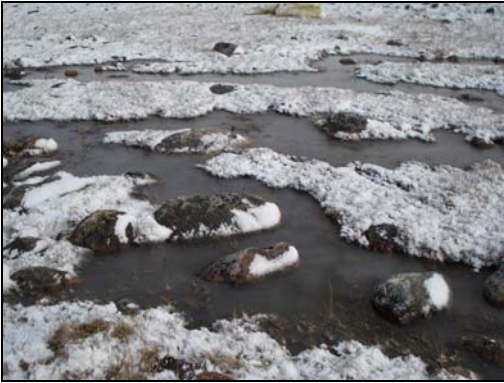
A

Figure 1. View at crossing across (A).

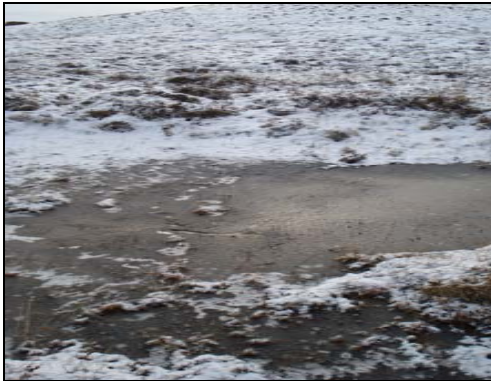
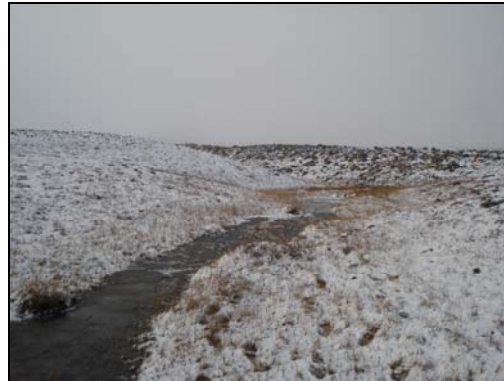
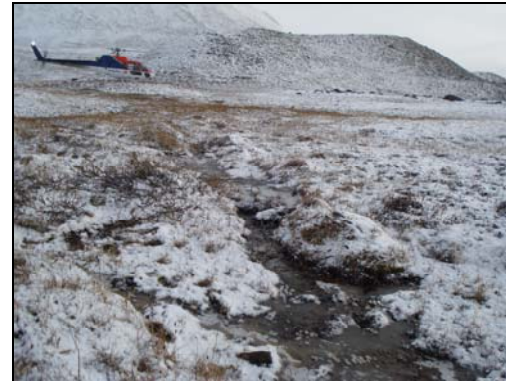
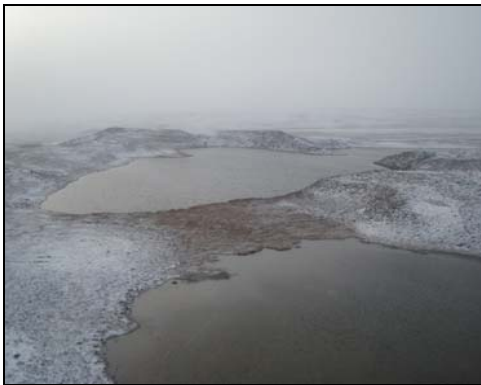
Figure 1. View of habitat at crossing (A), downstream of crossing (B), upstream of crossing (C), and an aerial view of the barrier between downstream pond and lake (D).

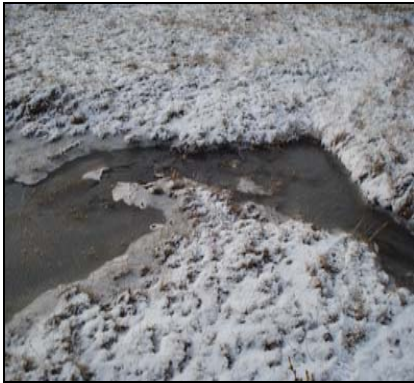
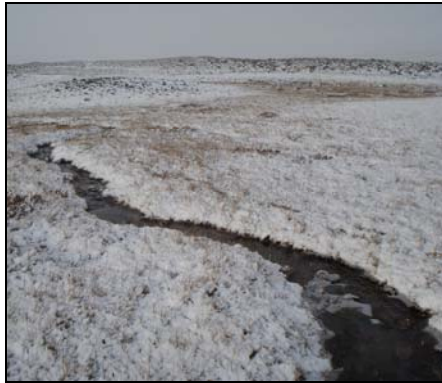
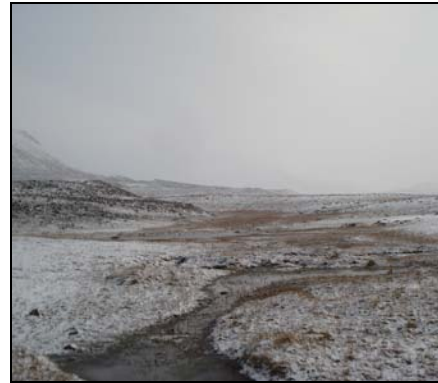
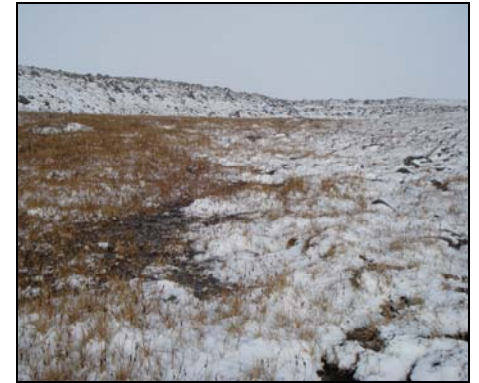
Figure 1. View of habitat at crossing (A), downstream of crossing (B), upstream of crossing (C), and of downstream barrier (dry) (D).

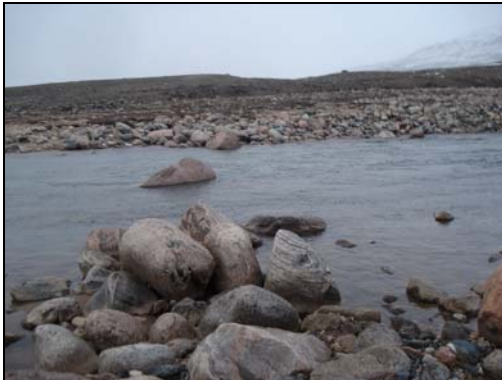
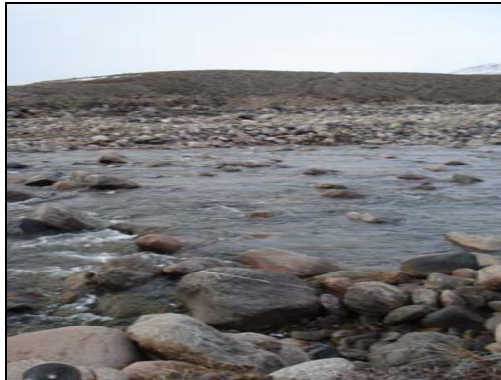
This is the Mary River. Many fish have been captured/observed in this river in previous surveys

Figure 1. View at 40m upstream across (A), and crossing across (B).

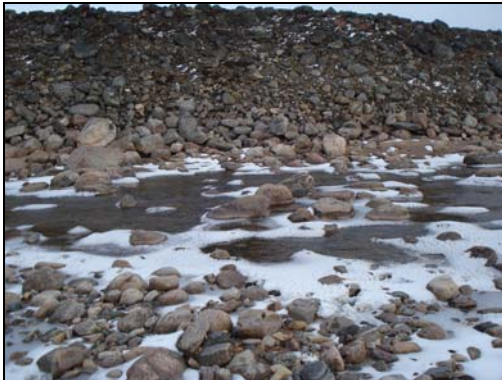
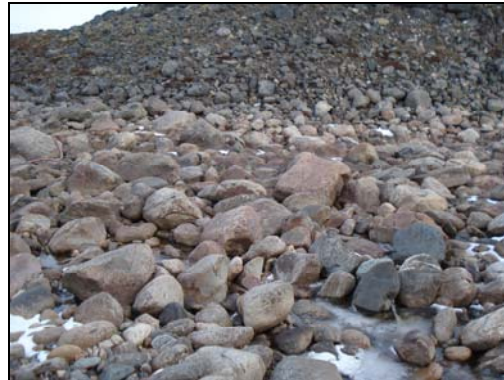
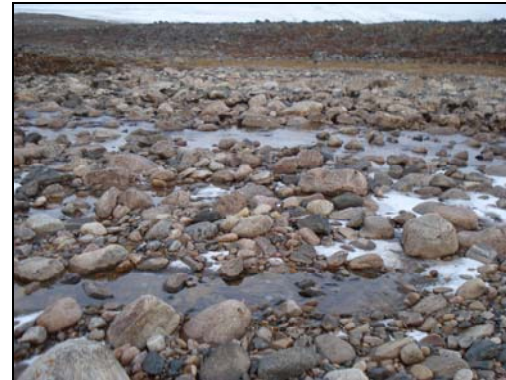
Many fish observed in this stream previously.

Figure 1. View at 40m downstream across (A), crossing across (B), and 40m upstream across (C).

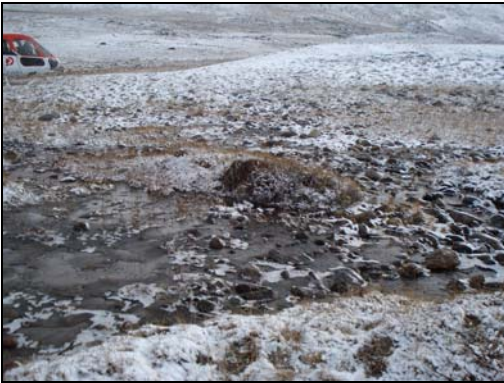
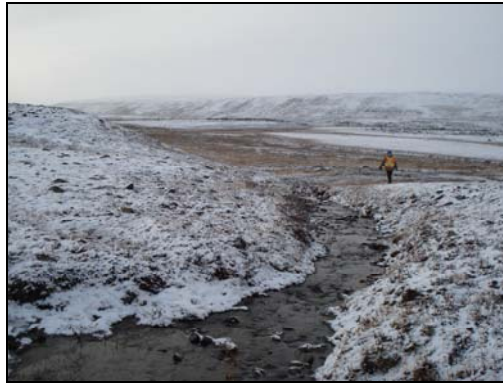
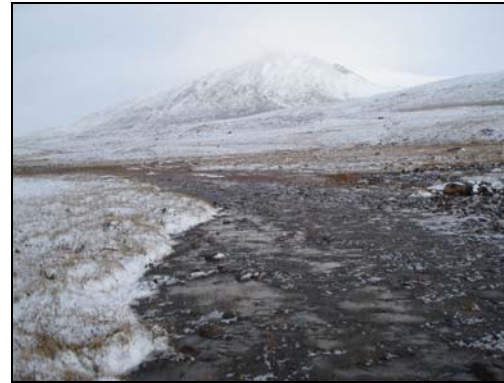
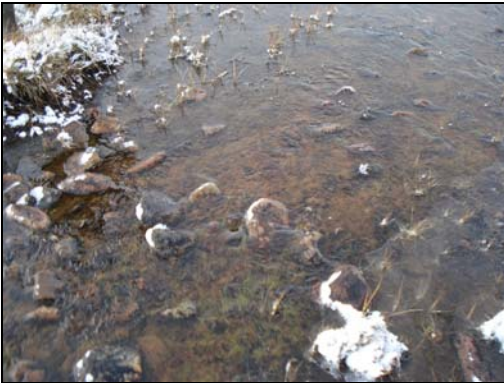
Figure 1. View of habitat at crossing (A), downstream of crossing (B), upstream of crossing (C), and of substrate (D).

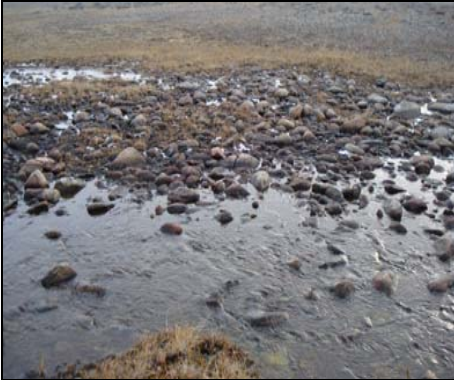
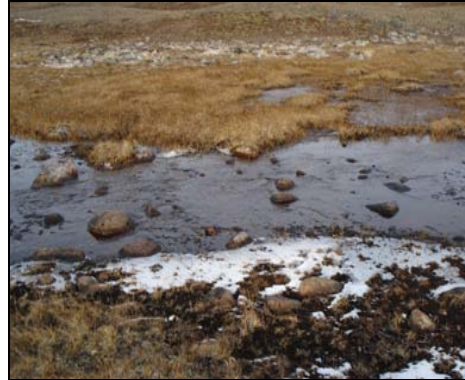
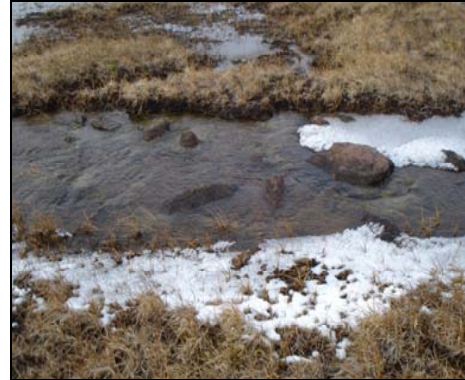
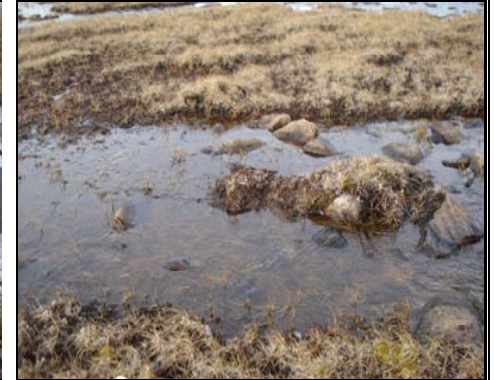
Upstream limit at UTM 17 W 563970 7911354. Connected to downstream large river in the area.

Figure 1. View at 40m downstream across (A), 40m upstream across (B), crossing channel 1 across (C), and crossing channel 2 across (D).

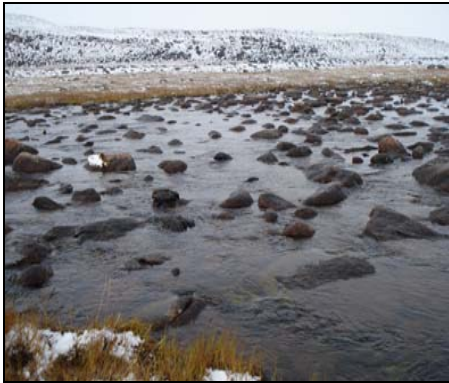
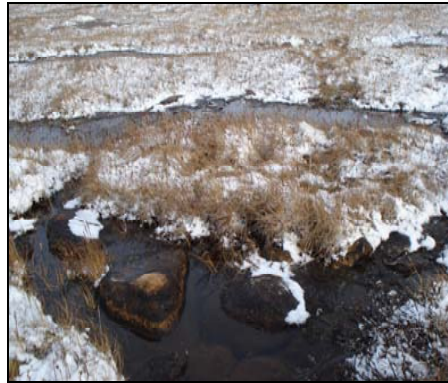
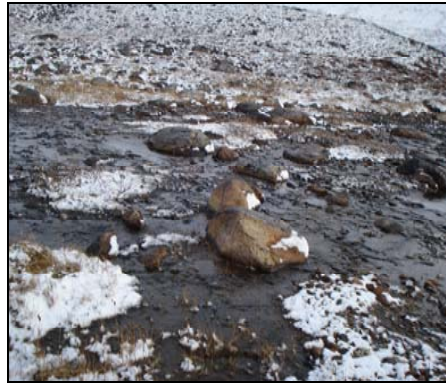
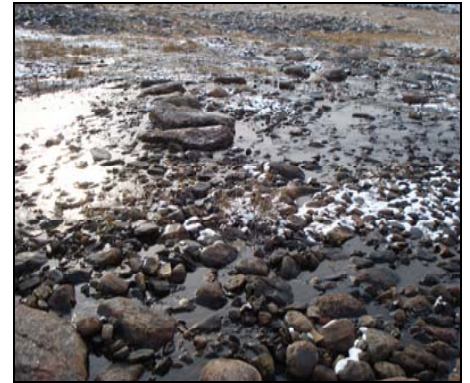
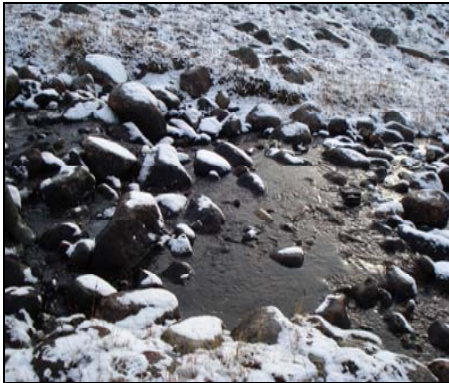
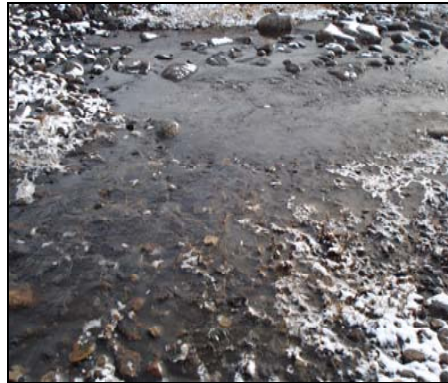
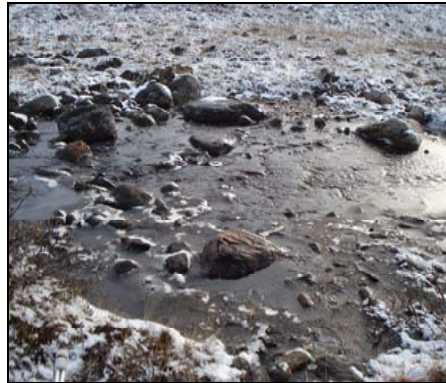
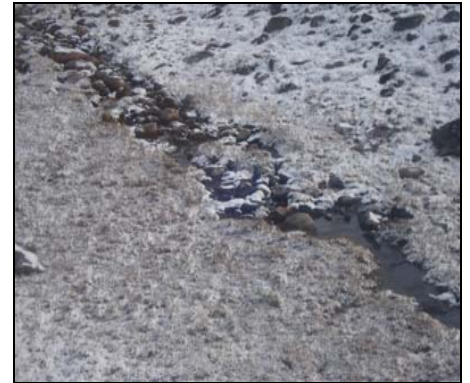
Figure 1. View at 60m downstream across (A), 40m (B), 20m (C), crossing across (D), 20m upstream across (E), 40m (F), 60m (G), and upstream limit of fish passage (H).

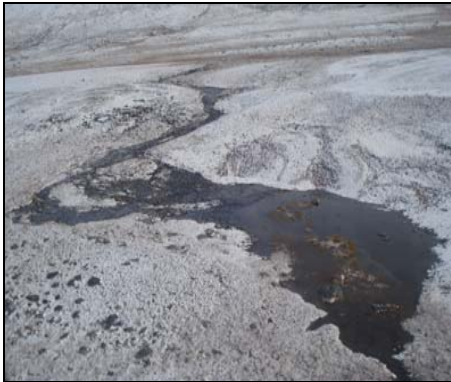
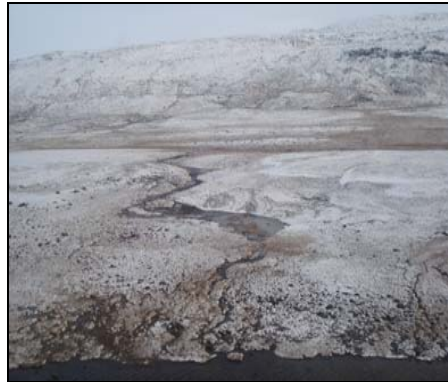
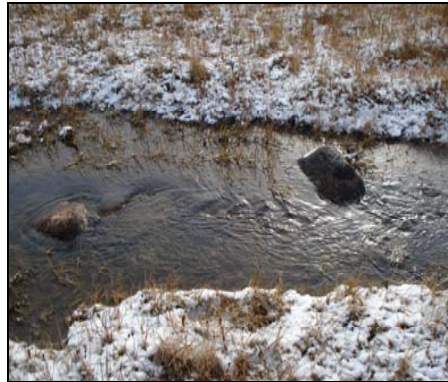
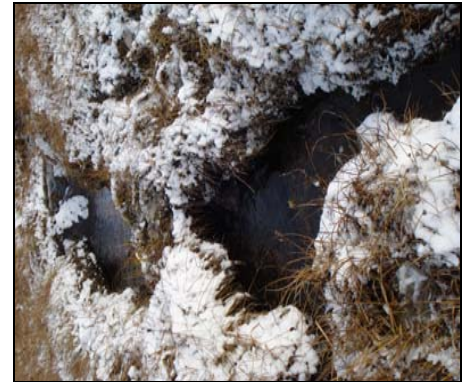
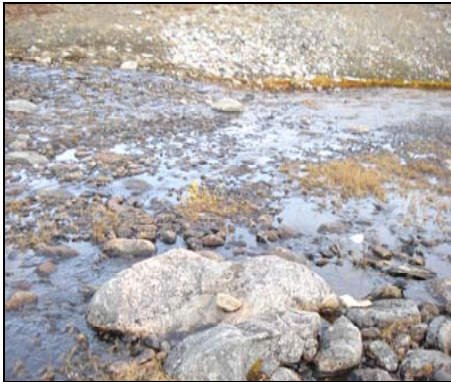
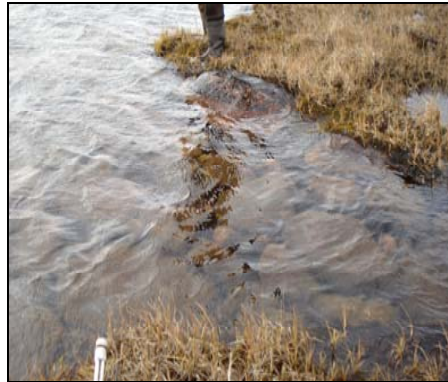
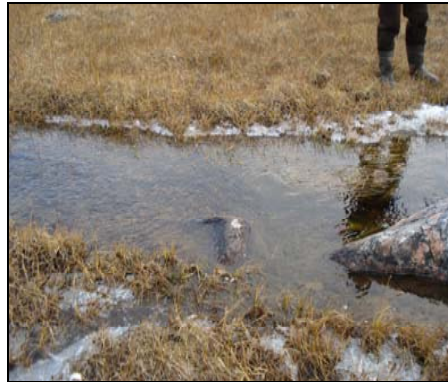
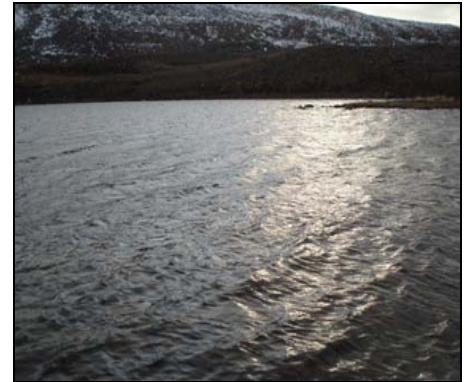
Last September this site was fished and fish were present. Downstream lake is located at 17 W 563803 7910936. This site looks like nice fish habitat. There is one main channel that leads down to the DS lake, but it goes underground for ~0.5 m. The subterranean flow is still quite strong, so the fish may be able to get through.

Figure 1. Aerial view of crossing upstream (A), confluence with downstream river (B), crossing (C), potential downstream barrier (water underground) (D), 40m upstream across (E), confluence with downstream lake across (F), crossing across (G), and downstream lake (H).

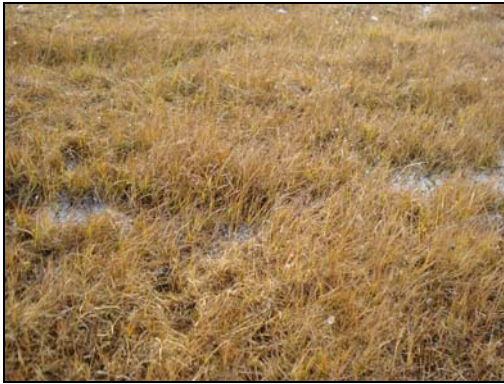
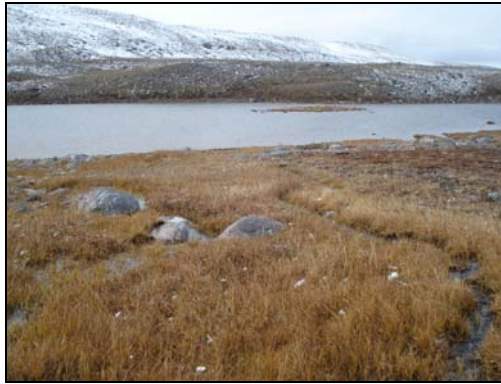
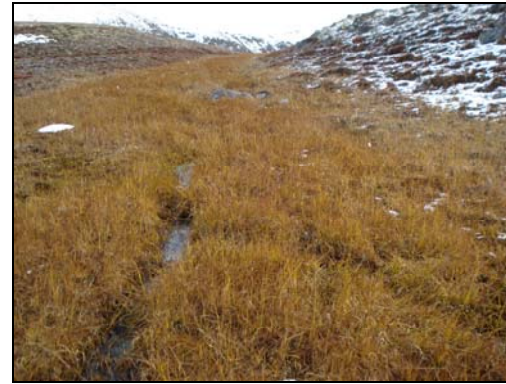
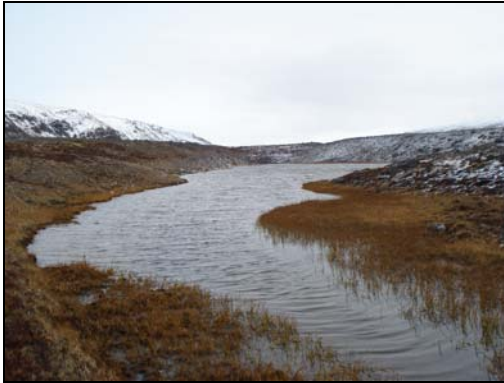
Figure 1. View of habitat at crossing (A), downstream of crossing (B), upstream of crossing (C), and at the upstream pond (D).

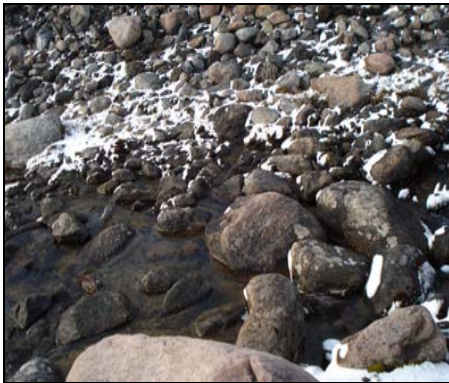
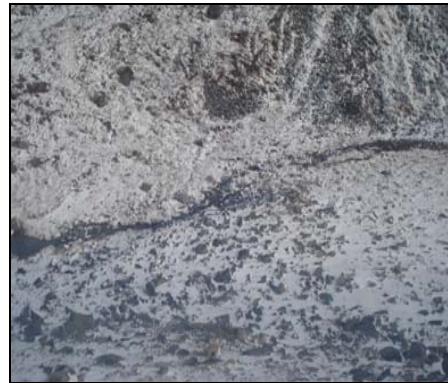
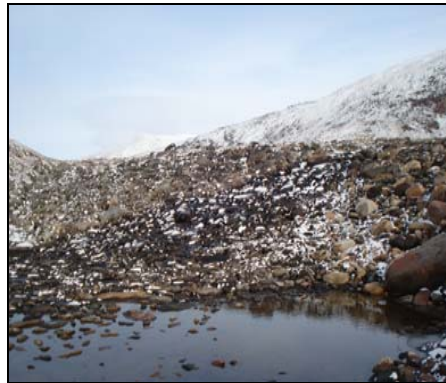
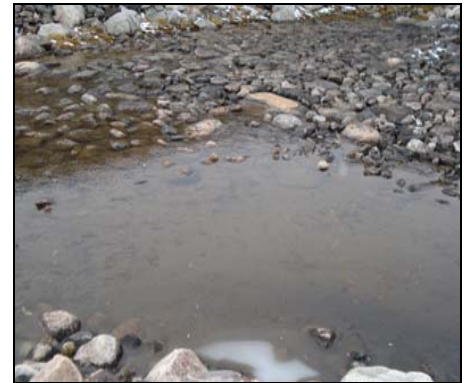
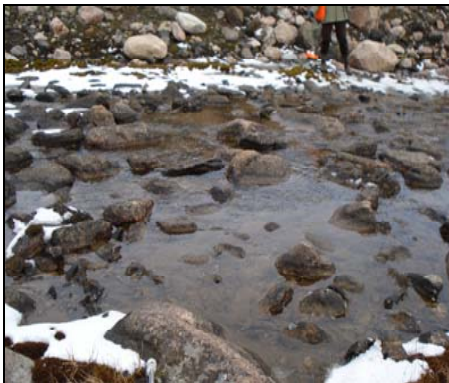
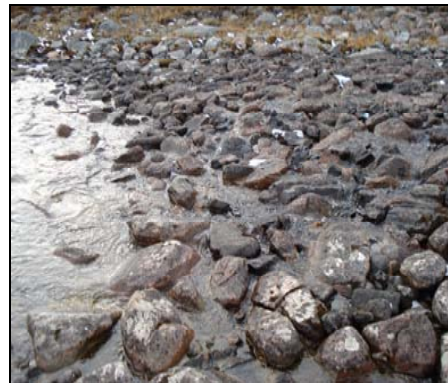
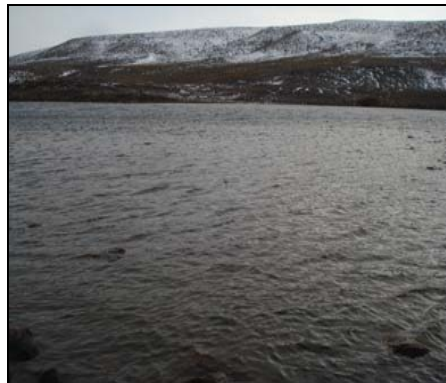
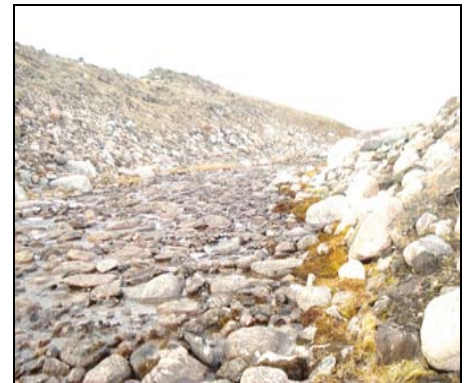
Downstream lake at UTM 17 W 564738 7910386. Fish can reach the crossing site from the downstream lake. The crossing site itself has lots of algae all over the rocks, which often indicates an absence of fish in the Project Study Area. There is a cascade upstream at UTM 17 W 564708 7910441, which is currently a barrier with low water, but could possibly be passed, but could possibly be passed during periods of high water. Upstream limit of passage at UTM 17 W 564971 7910651.

Figure 1. view at crossing (A), upstream barrier (B), upstream cascade (C), 40m upstream across (D), crossing across (E), confluence with downstream lake across (F), confluence with downstream (G), and confluence with downstream lake upstream (H).

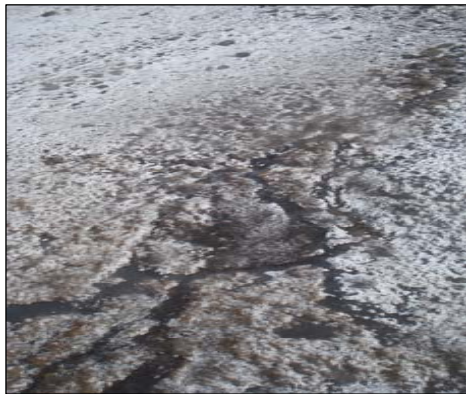
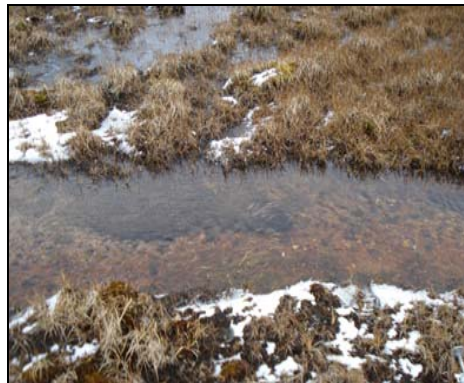
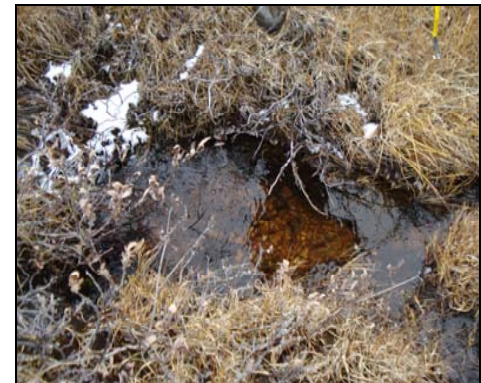
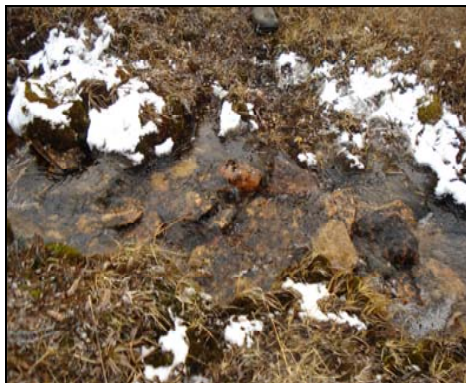
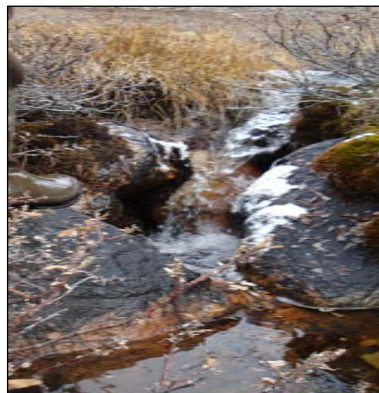
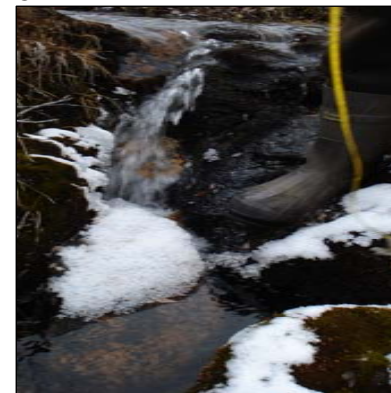
Potential partial barrier at UTM 17 W 565480 7910031 (~ 5m downstream of crossing), it is 0.51 m high and the velocity is 1.01 m/s. This site is lower down on the same watercourse as AR-246 fish habitat.

Figure 1. Aerial view of crossing (A), 40m downstream across (B), crossing across (C), 40m upstream across (D), downstream barrier (E), and upstream barrier-cascade 40m upstream (F).

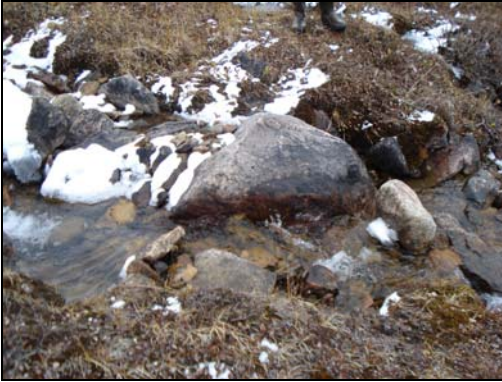
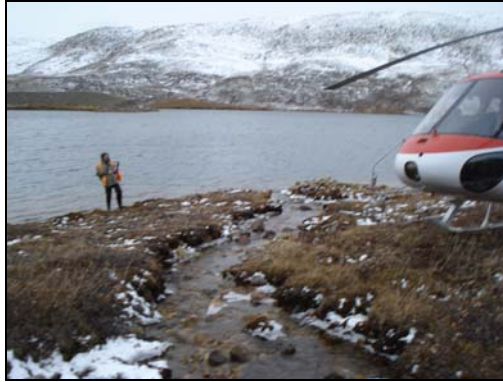
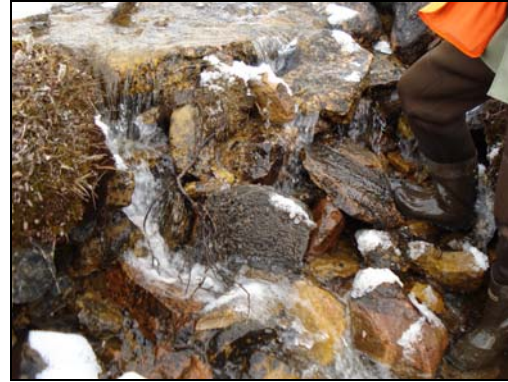
Figure 1. View at crossing across (A), downstream barrier facing downstream (B), and downstream barrier (C).

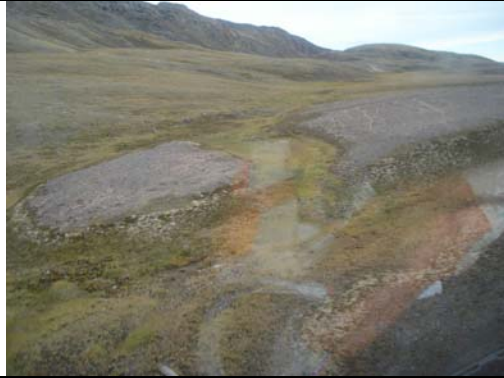
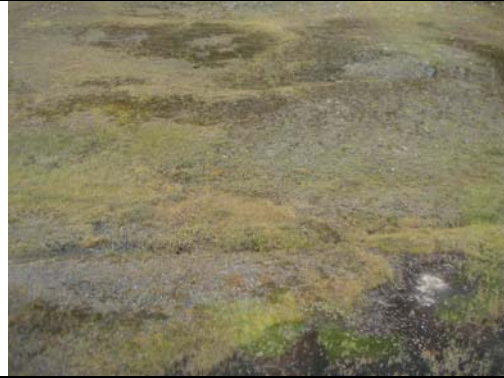
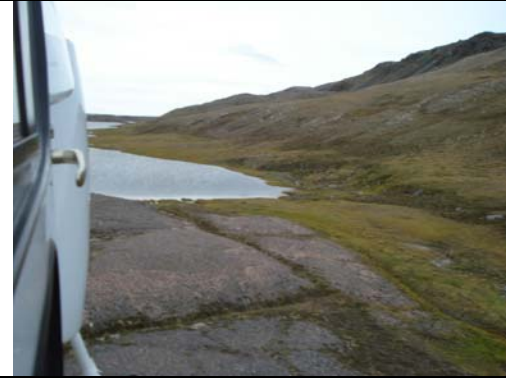
Figure 1. Upstream from crossing (A), view at crossing (B), view downstream from crossing (C).

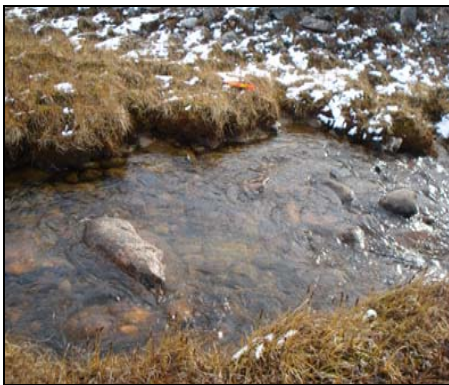
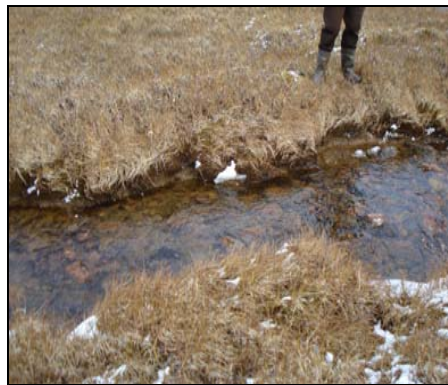
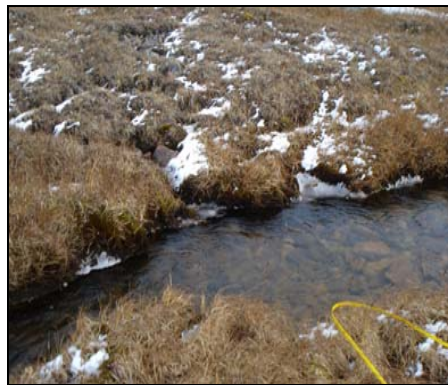
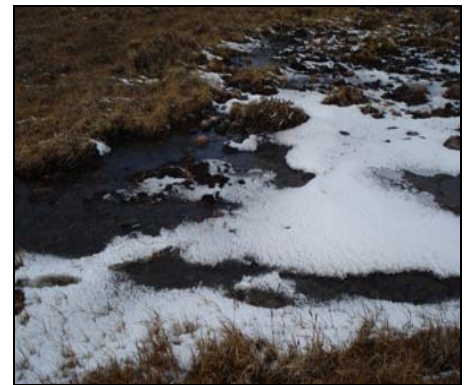
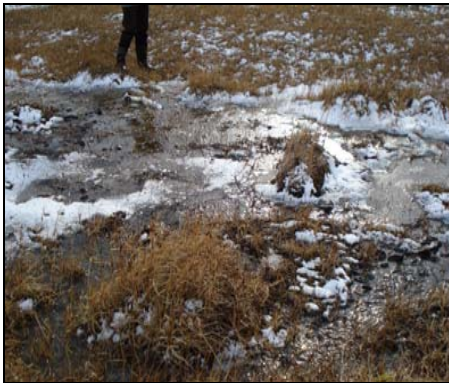
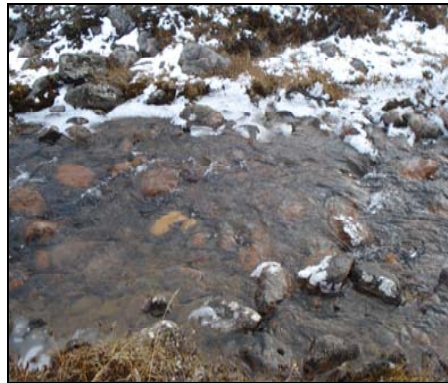
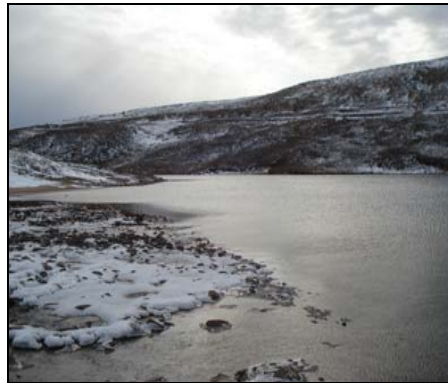
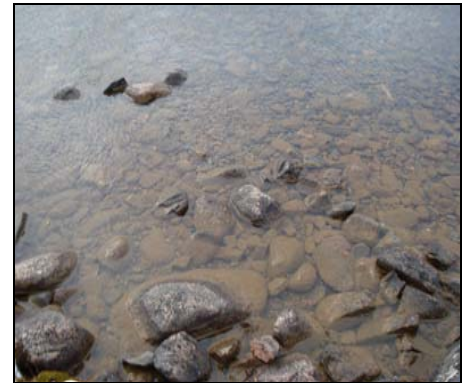
Large lake 5% shallow, 95% deep pool, 30 m downstream at UTM 17 W 566940 7908817. Definitely fish habitat / Wetted width =2.47. Just upstream of the crossing the stream splits to the left and the right (~10 m upstream). There is a large lake just downstream of the crossing, same stream as CV-004-1

Figure 1. View at crossing across (A), 40m upstream left channel 1 (B), 40m upstream left channel 2 across (C), 40m upstream centre channel across (D), 40m upstream right channel across (E), crossing across (F), downstream lake (G), and downstream lake substrate (H).

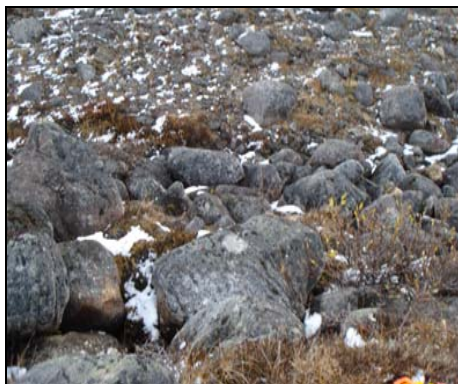
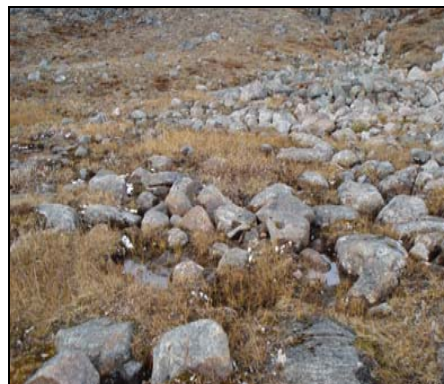
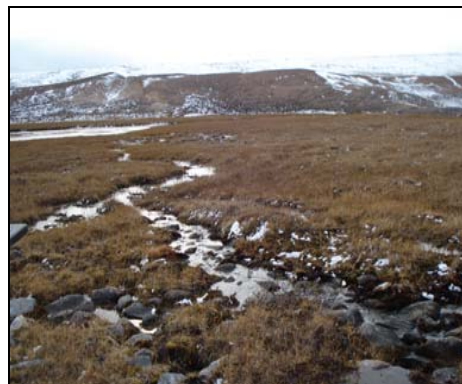
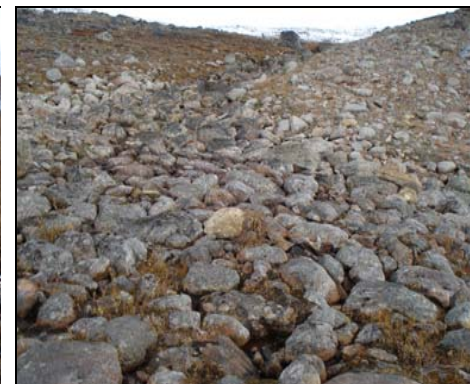
Figure 1. View of habitat at crossing (A), at downstream barrier (B), downstream of barrier (C), and upstream of barrier (D).

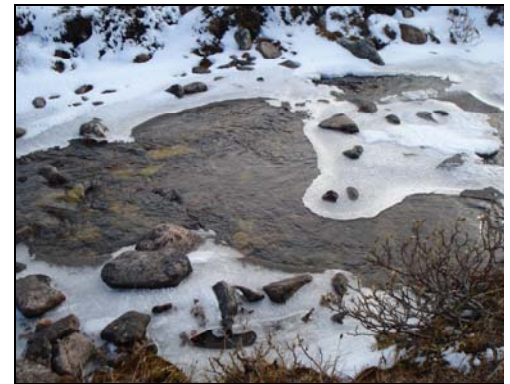
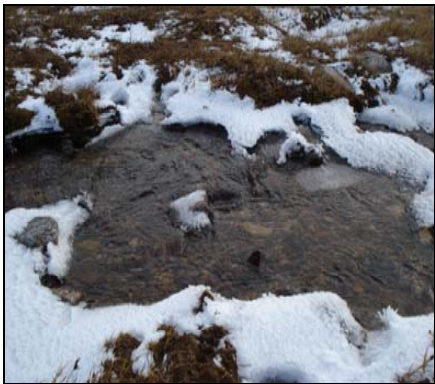
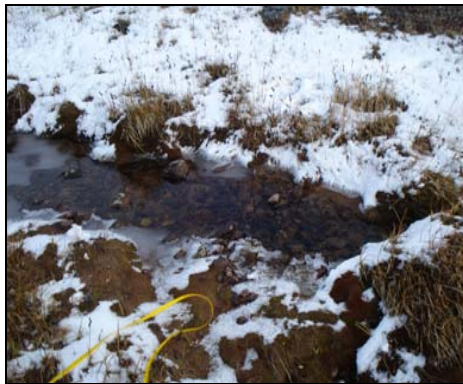
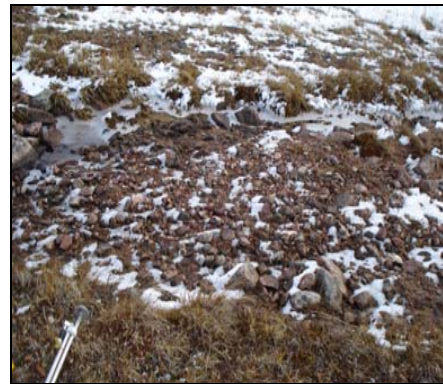
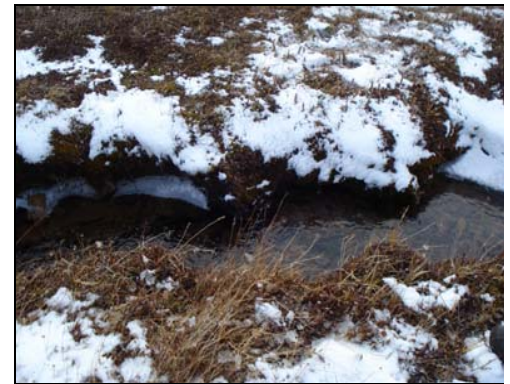
Figure 1. View at 40m DS channel 1 from right across (A), 40m DS channel 3 from right across (B), 40m DS channel 4 from right across (C), crossing channel 1 from right across (D), crossing channel 2 from right across (E), crossing channel 3 from right across (F), at crossing channel 4 from right across (G), and crossing channel 5 across (H).

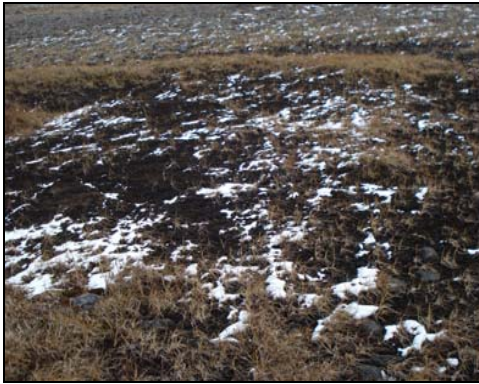
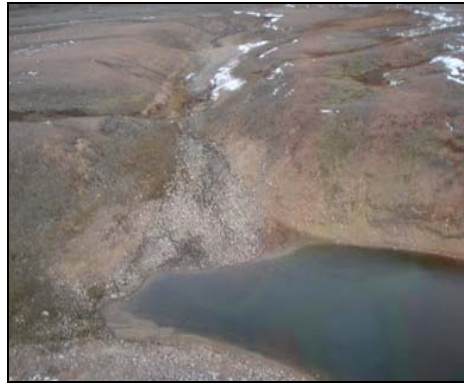
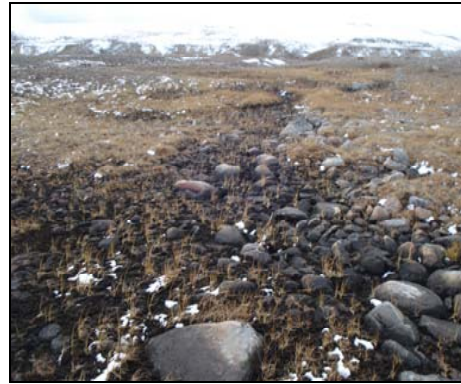
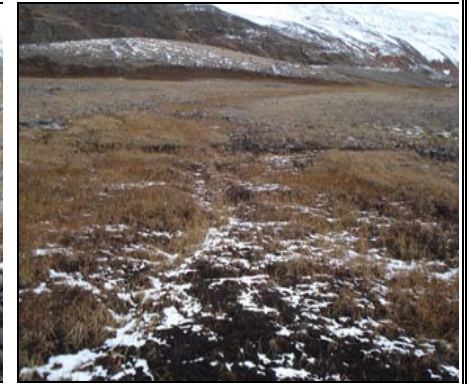
Figure 1. View of habitat at crossing (A), downstream barrier (B), downstream of crossing (C), and upstream of crossing (D).

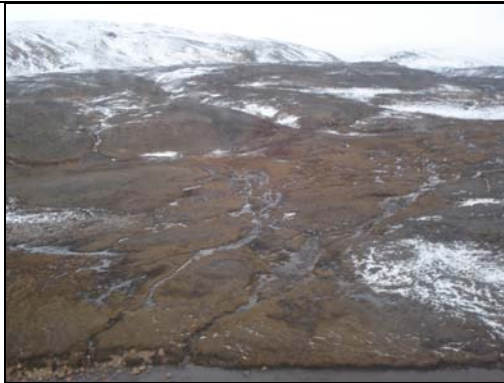
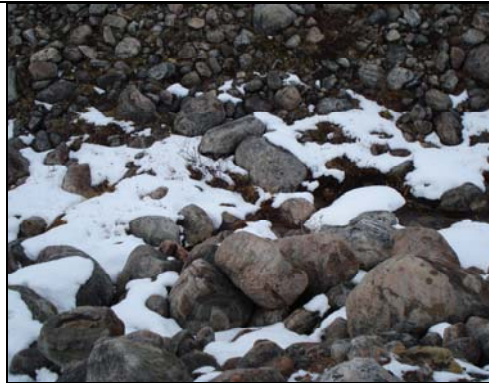
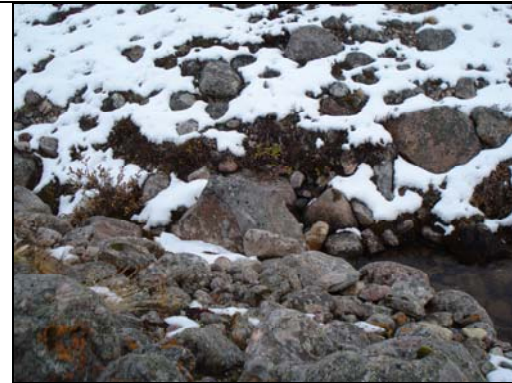
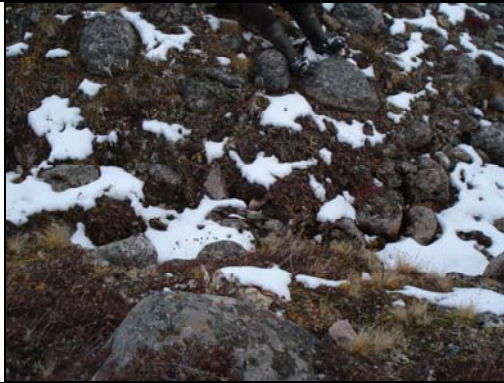
Figure 1. Aerial view of confluence with lake downstream (A), view of habitat at the crossing (B), and of downstream barriers (C-D).

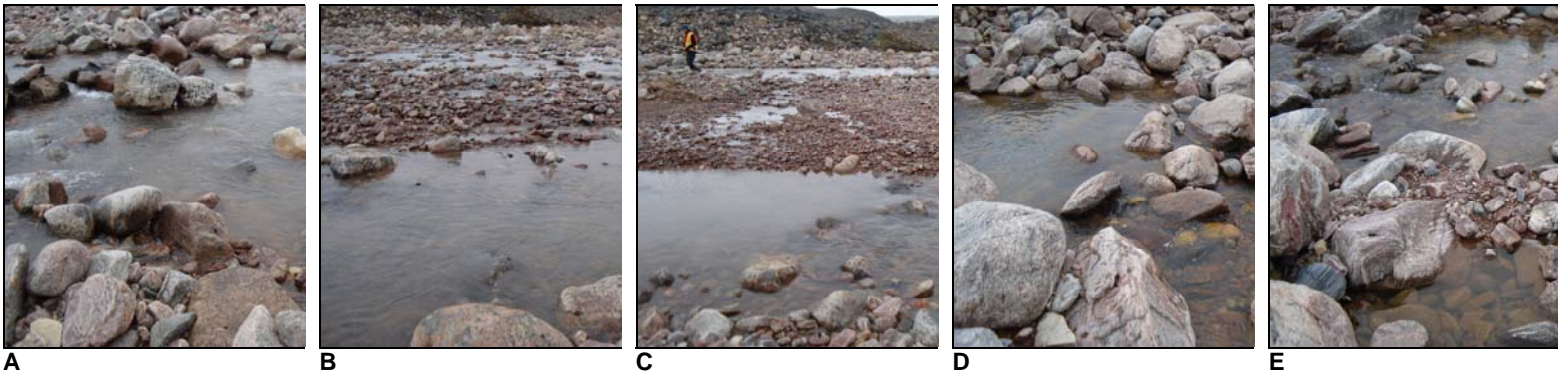
This is the same stream as BR-011-1. Crossing site on left bank at UTM 17 W 572901 7904834.

Figure 1. View of habitat 40 (A) and 20 m (B) downstream of crossing, at the crossing (C), and 20 (D), and 40 m (E), upstream of the crossing.

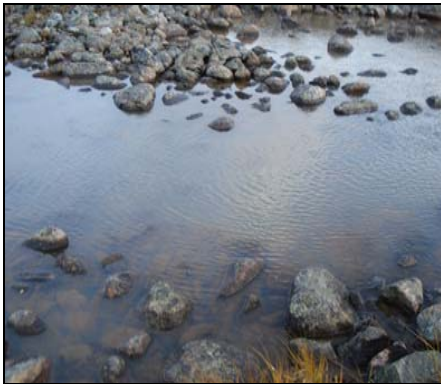
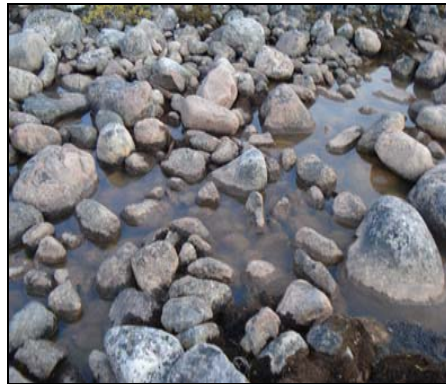
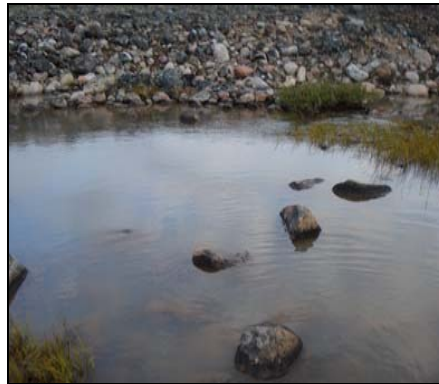
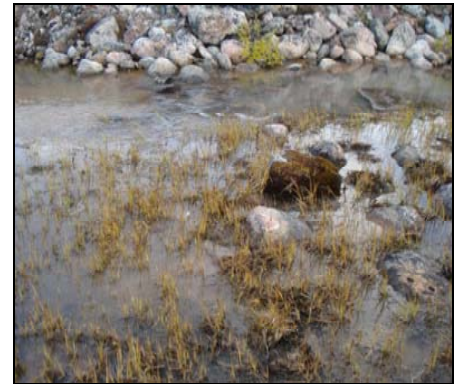
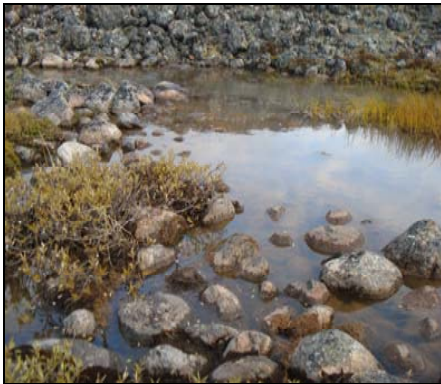
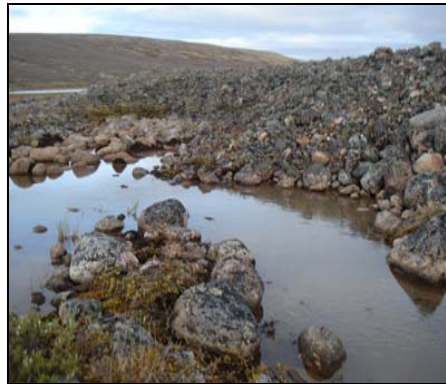
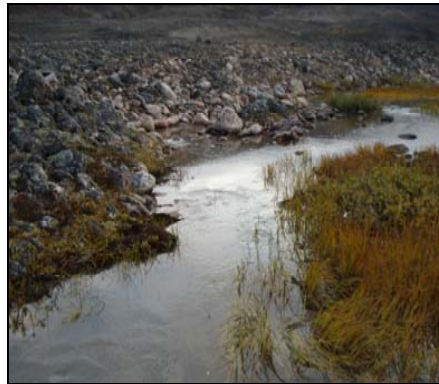
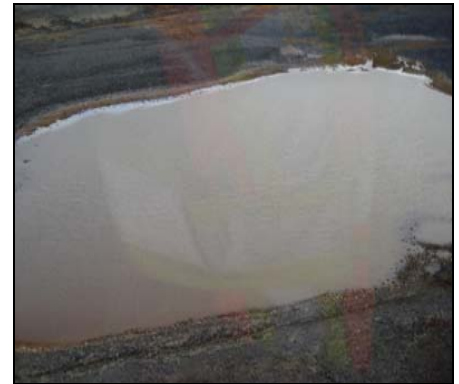
Figure 1. View at 40m DS across (A), 20m downstream across (B), 20m upstream across (C), 40m upstream across (D), crossing (E), crossing downstream (F), crossing upstream (G), and upstream lake (H).
