APPENDIX 5.1-3.

DETAILED HABITAT ASSESSMENTS AND SUMMARY OF RESULTS FOR ACCESS ROAD STREAM CROSSINGS.

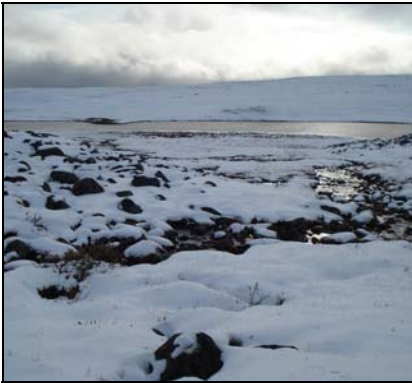
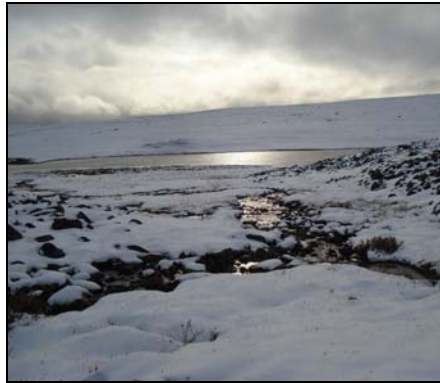
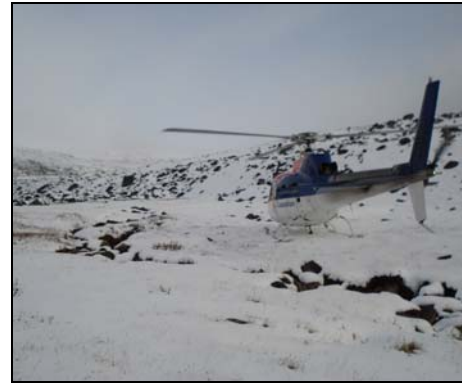
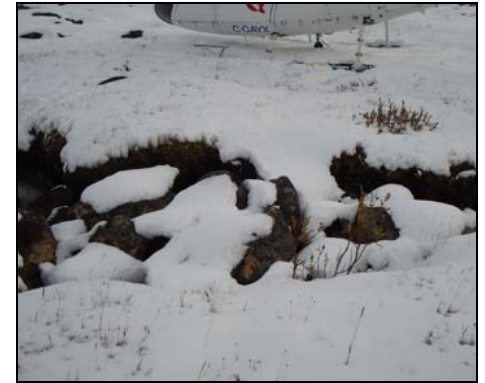
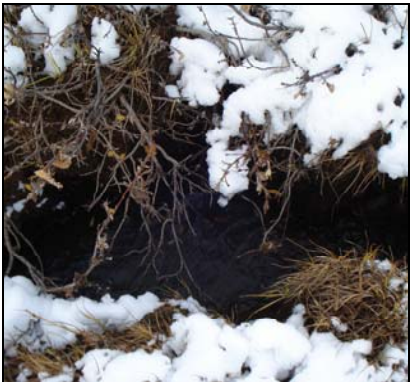
Figure 1. View of habitat at crossing (A), downstream of crossing (B), upstream of crossing (C), boulders in channel (D), and of channel disappearing underground downstream of crossing (E).

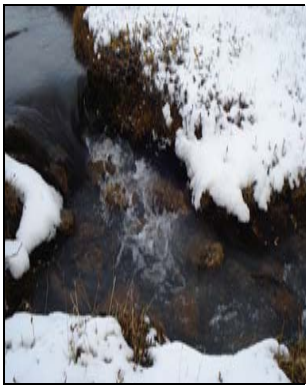
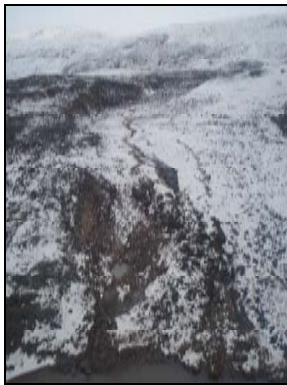
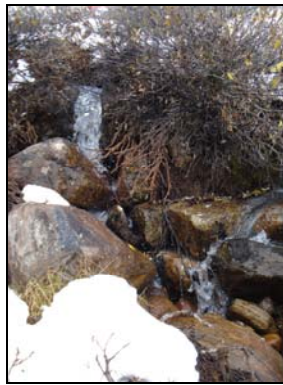
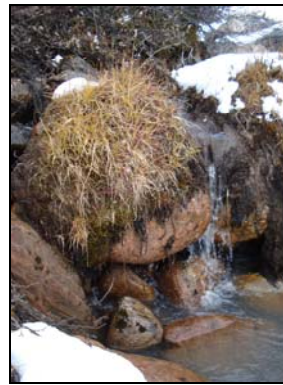
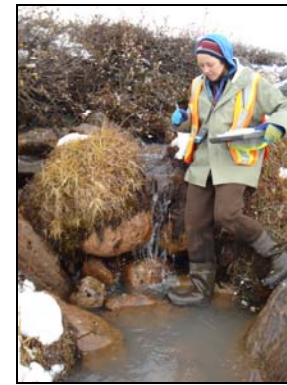
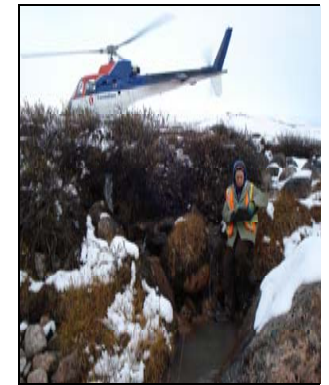
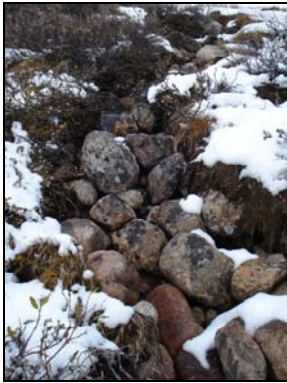
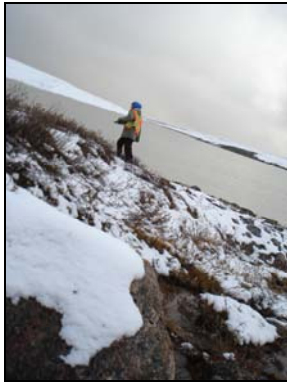
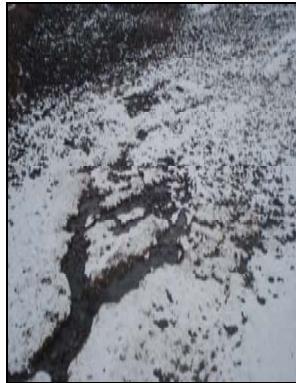
Figure 1. View of habitat at crossing (A), confluence with lake downstream (B), downstream barriers (C-G), downstream lake (H), and upstream limit of potential habitat (I).

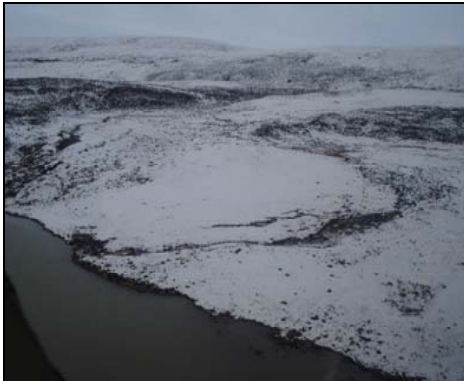
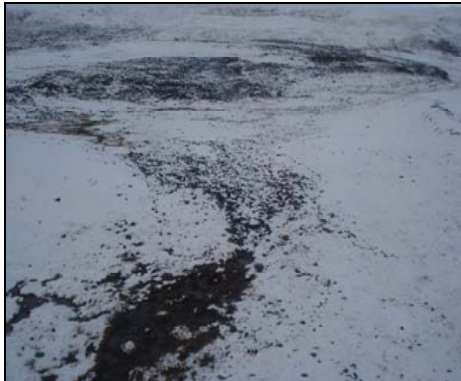
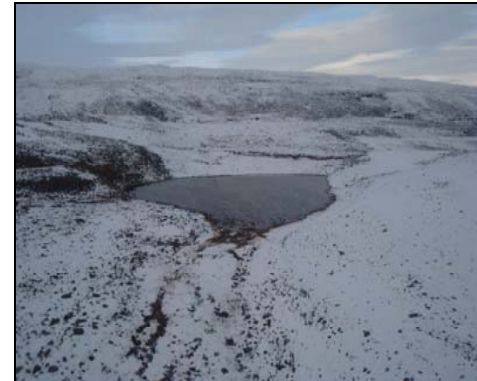
Figure 1. View at crossing downstream (A), crossing across (B), crossing upstream (C), confluence with downstream lake (D), downstream boulder barrier (E), and upstream pond (F).

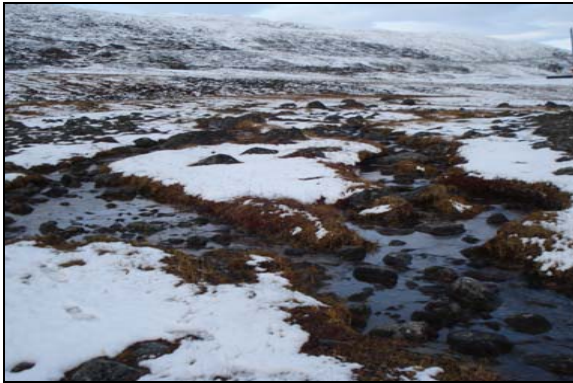
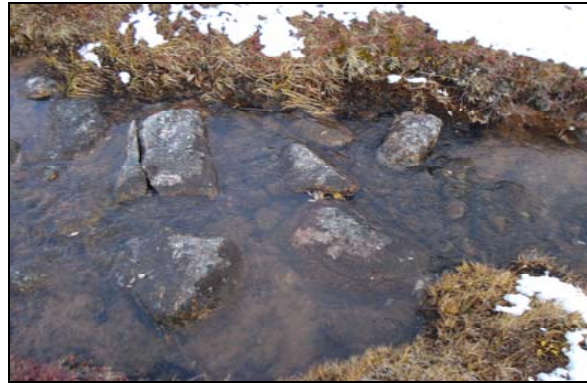
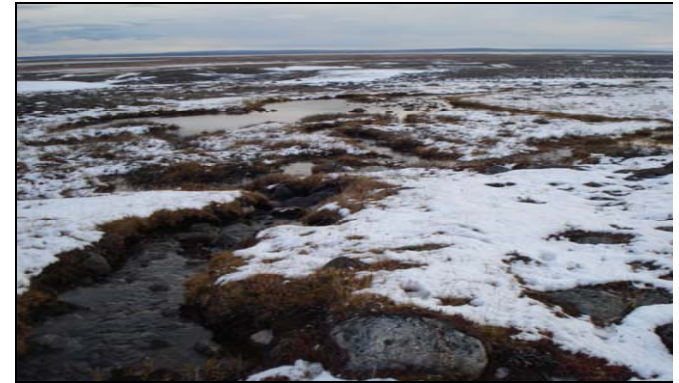
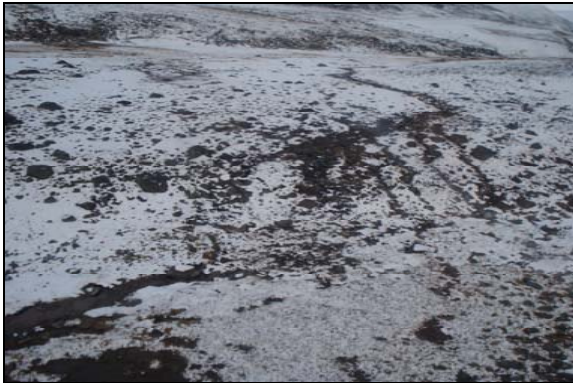
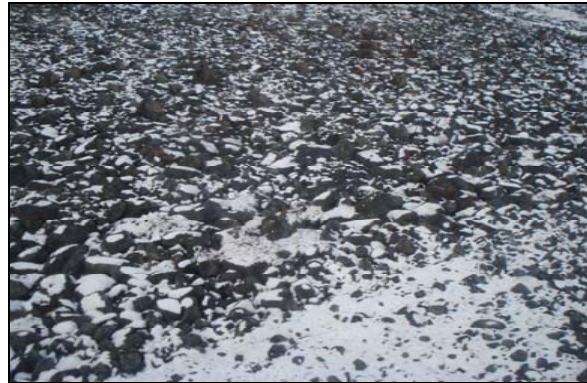
Figure 1. View at crossing downstream (A), crossing across (B), crossing upstream (C), downstream barrier (D), and upstream barrier (E).

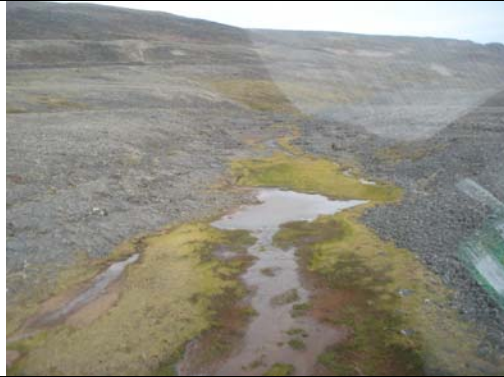
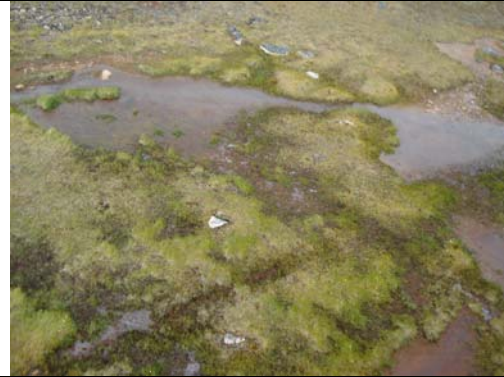
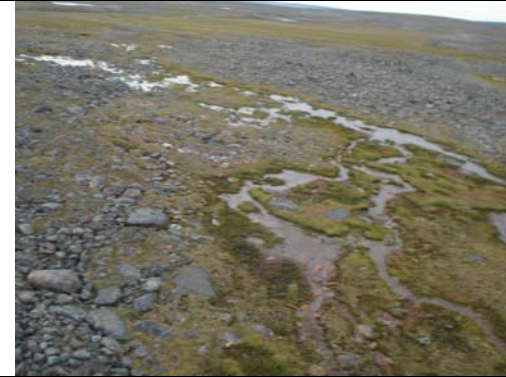
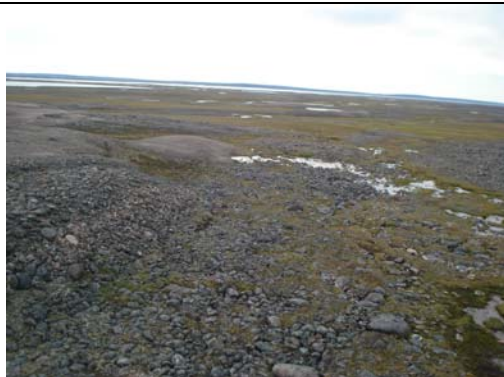
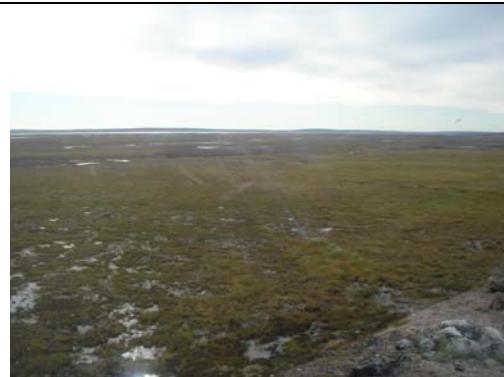
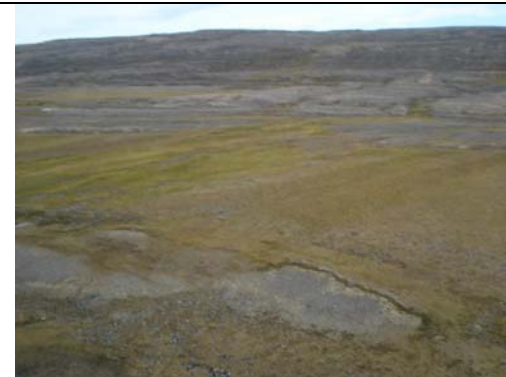
Figure 1. Upstream from crossing (A), view at crossing (B), view downstream of crossing (C and D), view of saturated flat area downstream of crossing area (E), looking upstream towards crossing area at saturated flat area (F).

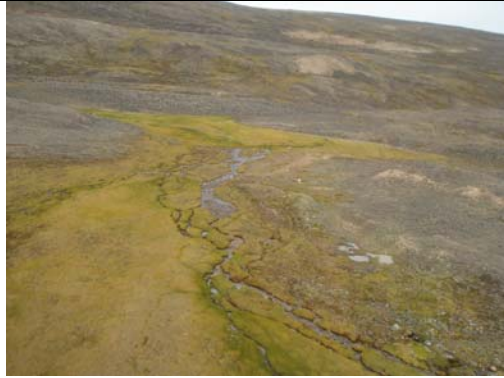
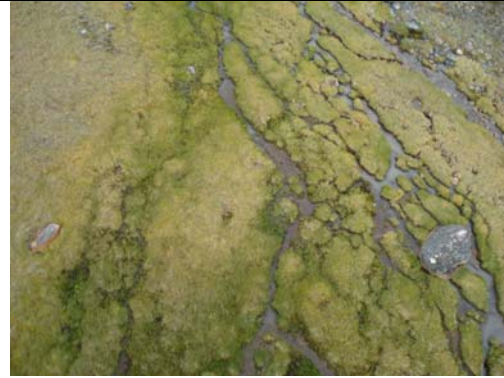
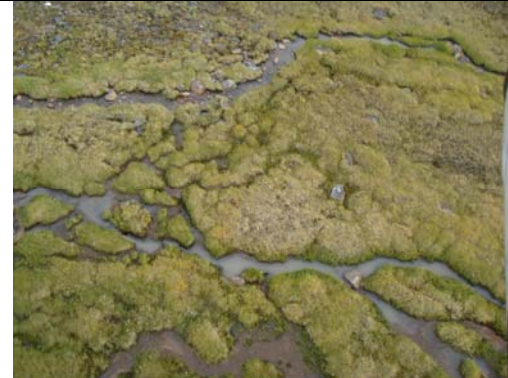
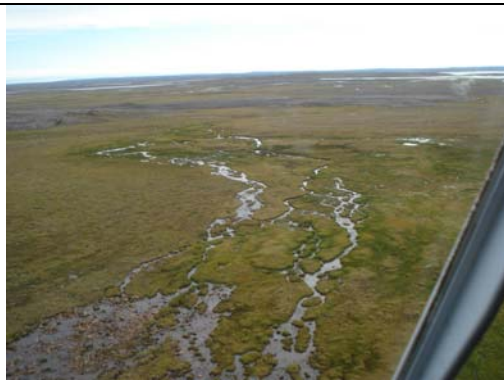
Figure 1. At crossing looking upstream (A), view at crossing (B), view at crossing (C), view downstream of crossing (D).

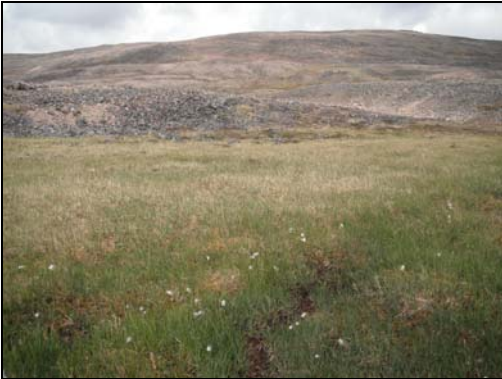
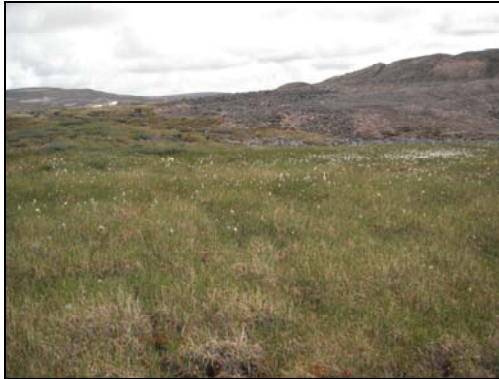
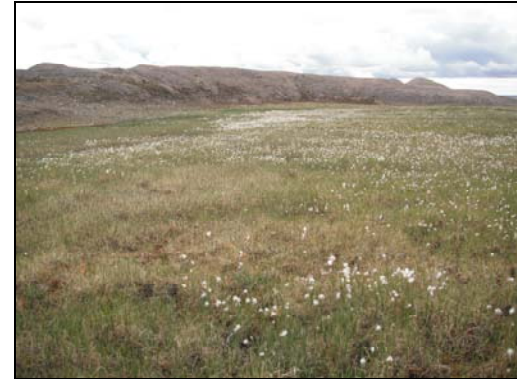
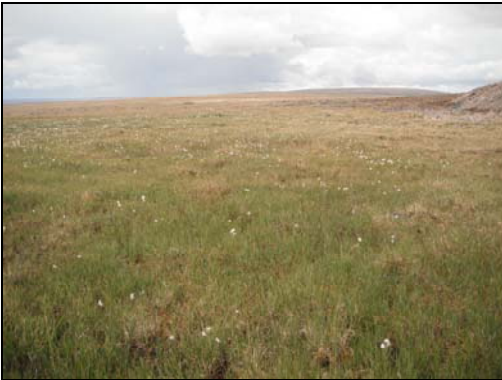
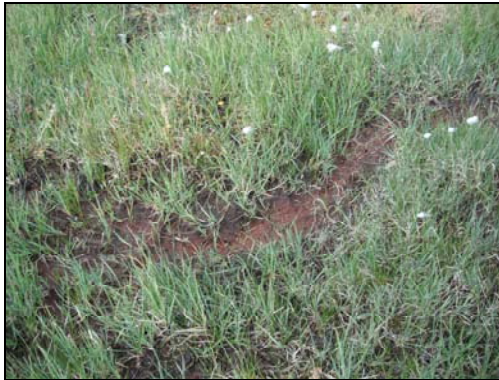
Figure 1. View at the crossing to the north (A), east (B), south (C) and west (D), and of the substrate (E).

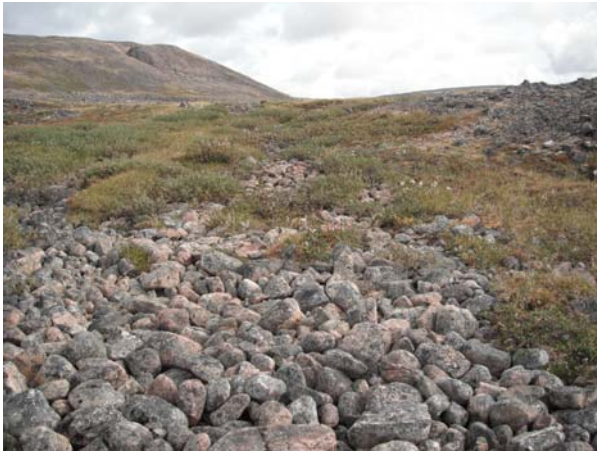
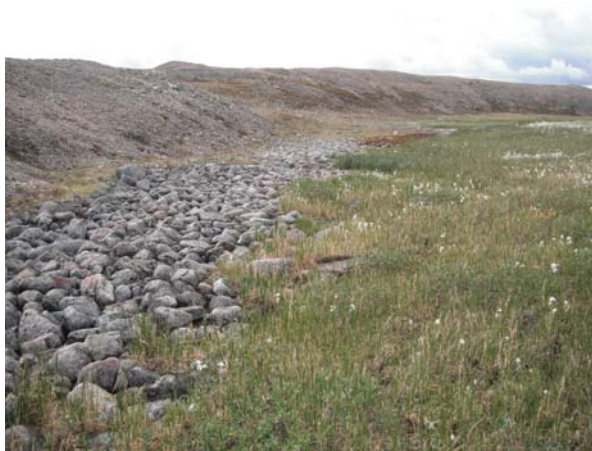
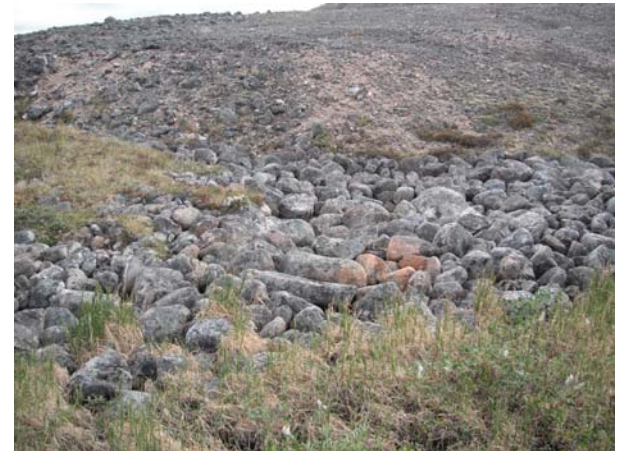
Figure 1. View upstream (A), downstream (B), and across (C) at the crossing.

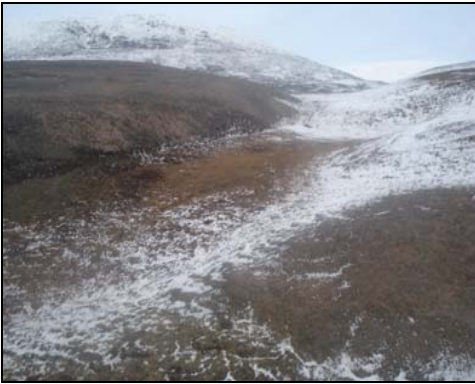
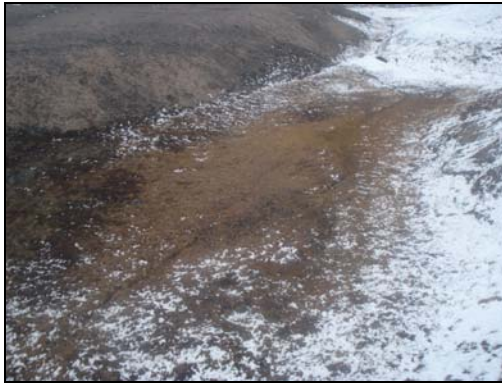
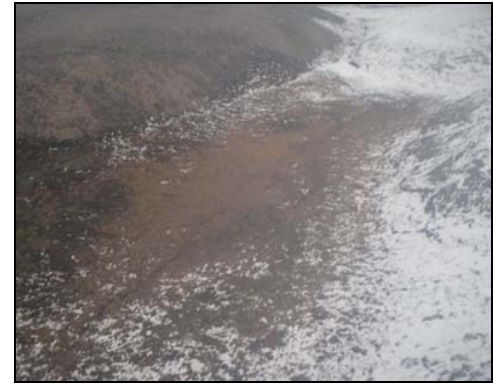
Figure 1. Aerial views of the crossing site (A-C).

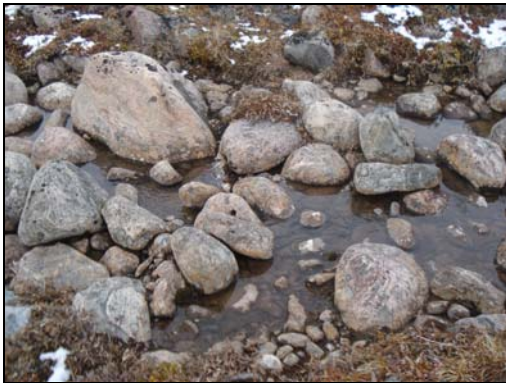
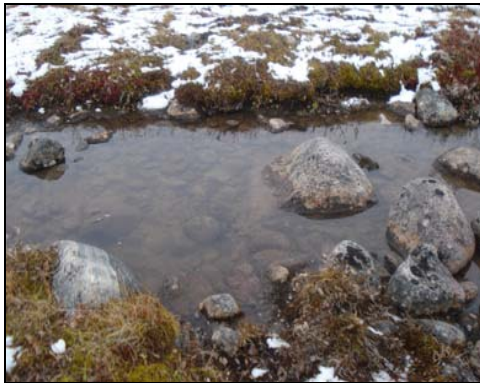
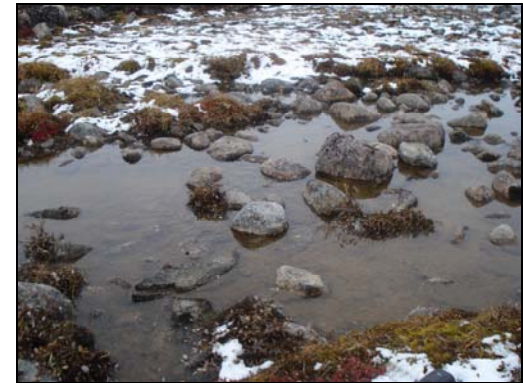
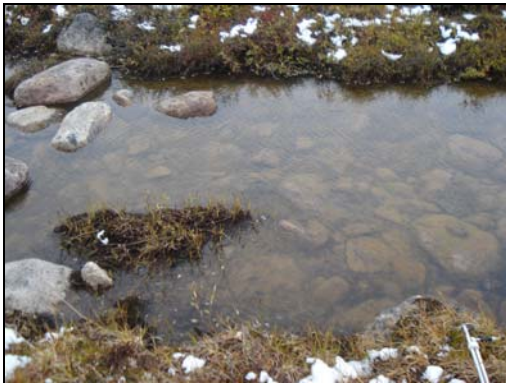
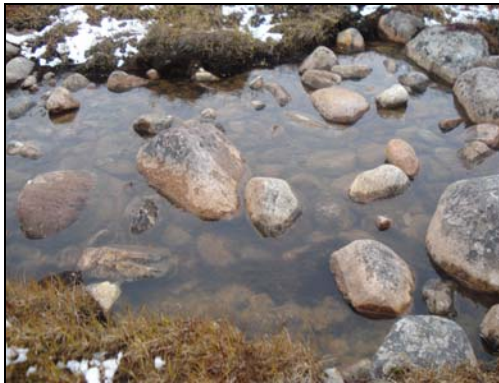
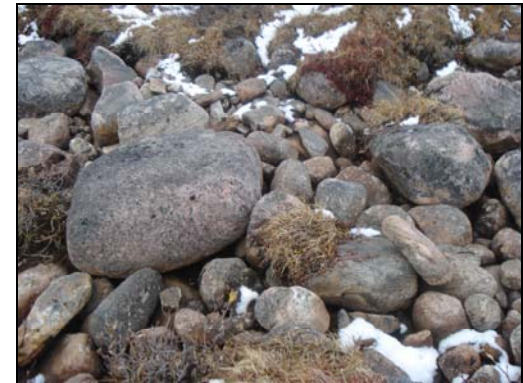
Figure 1. View at 40m downstream across (A), 20m downstream (B), crossing across (C), 20m upstream across (D), 40m upstream (E), and 60m upstream (F).

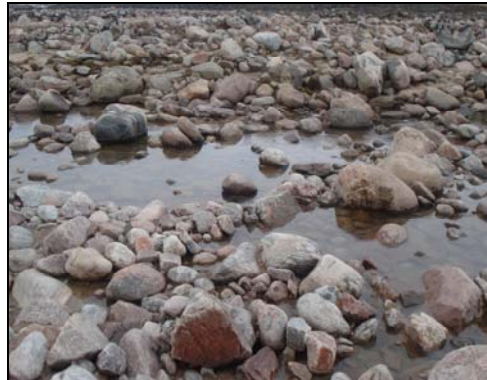
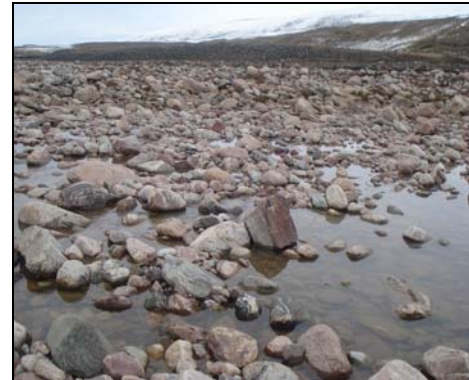
Figure 1. View at 60m downstream across (A), 40m (B), 20m (C), crossing across (D), 20m upstream across (E), 40m (F), and 60m (G).

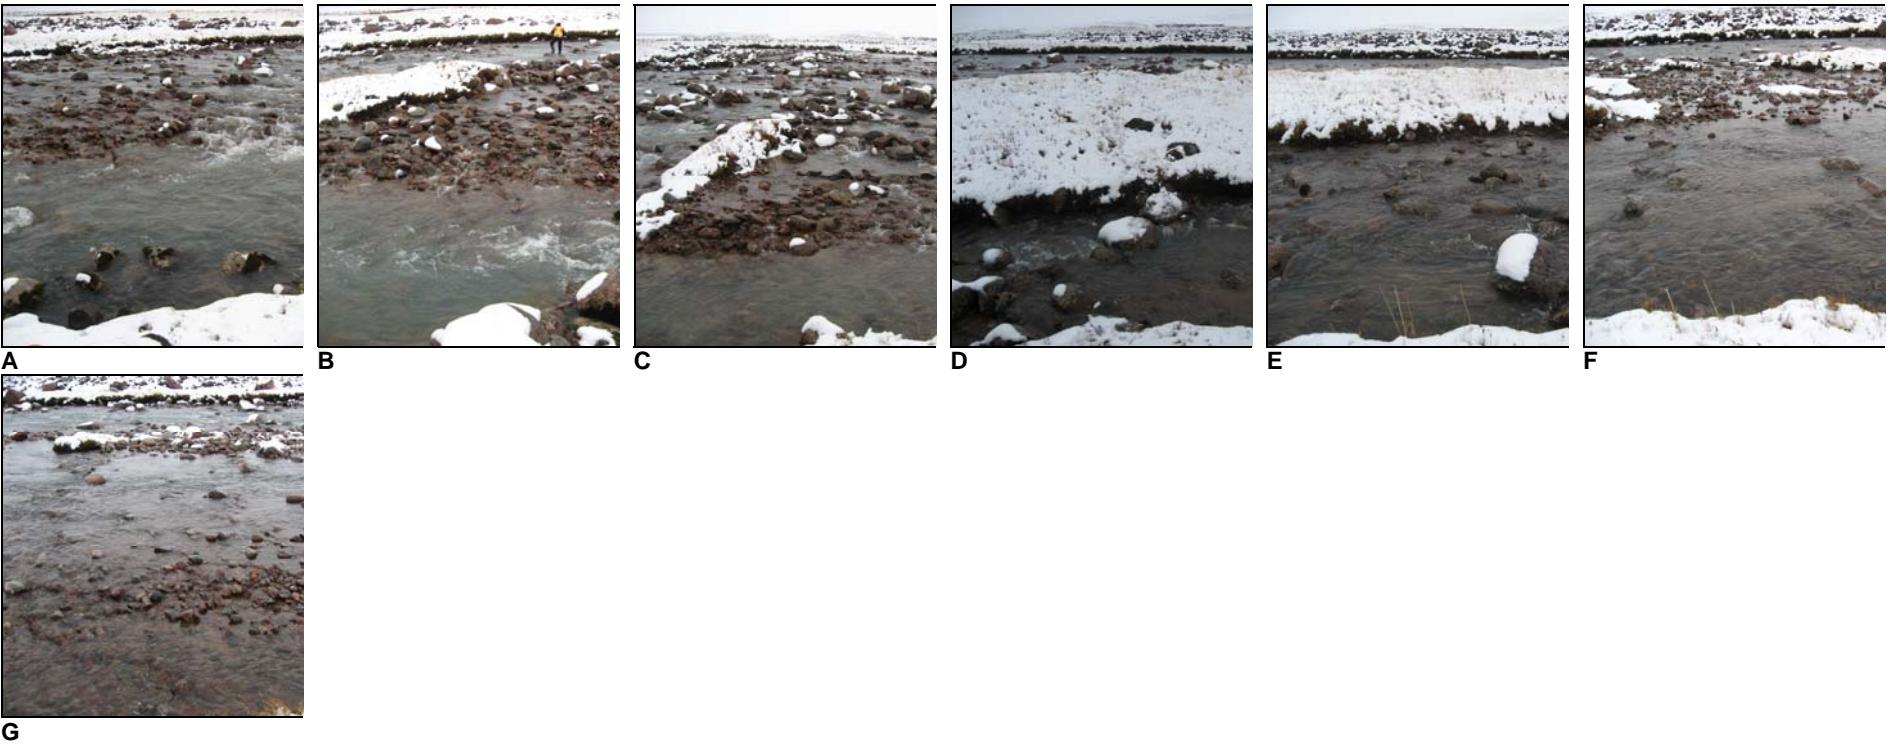
Figure 1. View of habitat 100 (A), 80 (B), 60 (C), 40 (D), and 20 m (E) downstream of crossing, at the crossing (F), and 20 (G) upstream of the crossing.

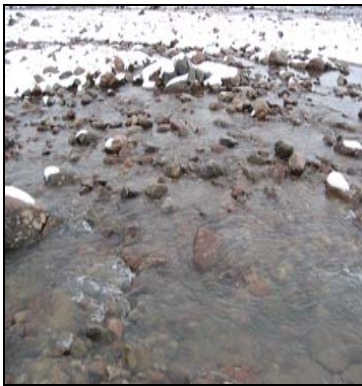
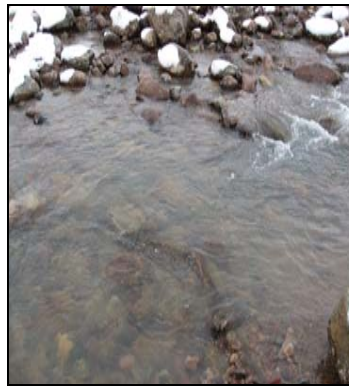
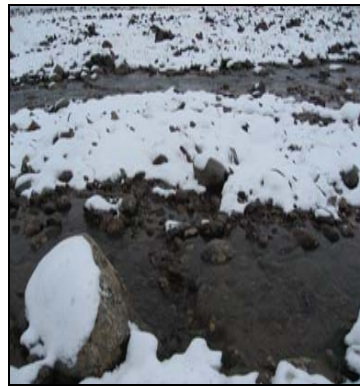
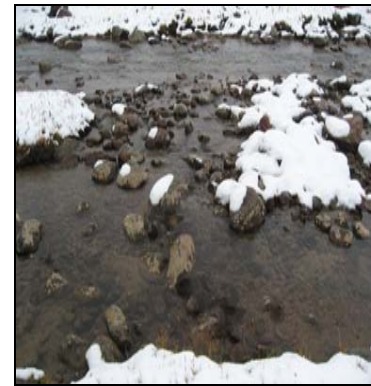
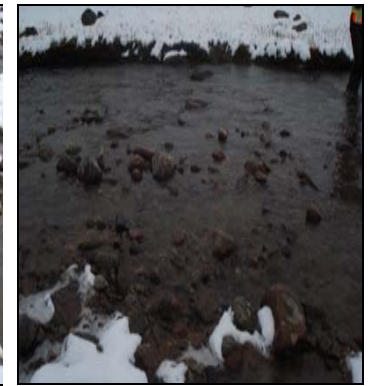
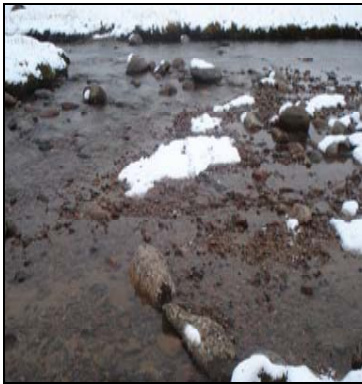
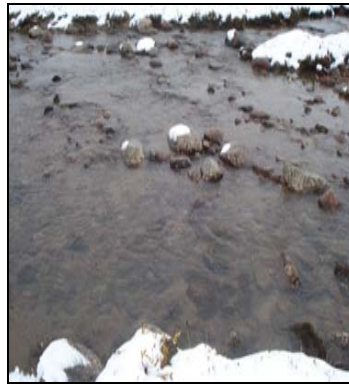
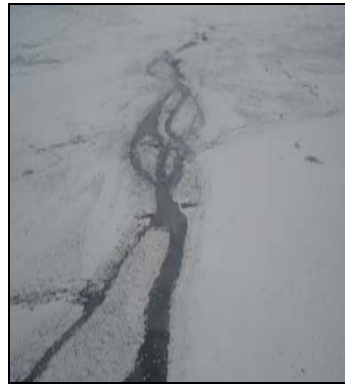
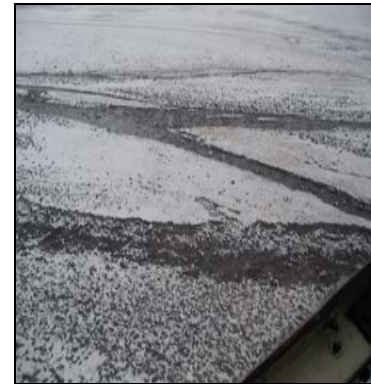
Figure 1. View at 60m downstream across (A), 40m (B), 20m (C), at crossing across (D), 20m upstream across (E), 40m (F), 60m (G), aerial of crossing (H), and aerials of AR-197 & AR-188 crossings (I).

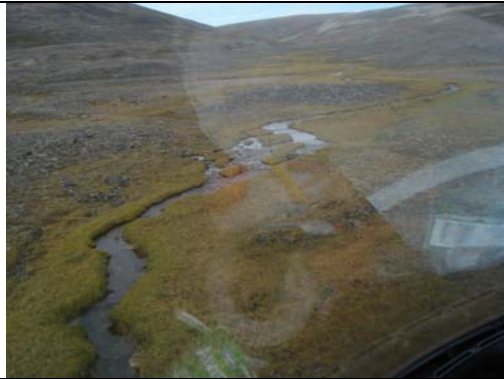
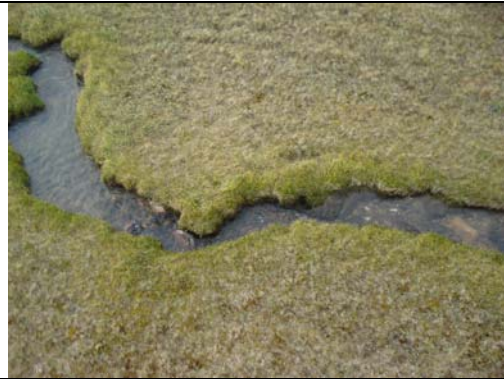
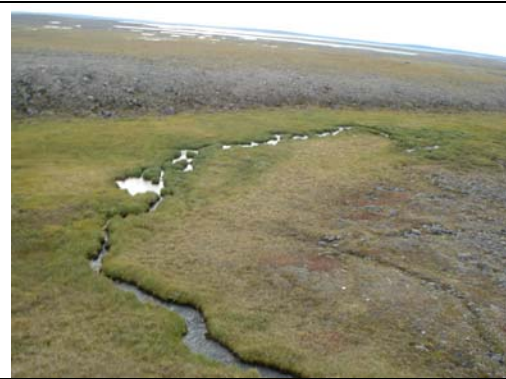
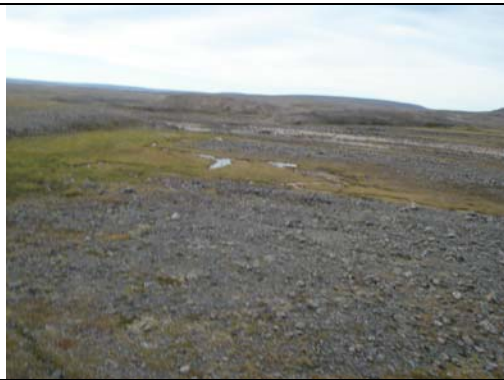
Figure 1. At crossing looking upstream (A), view at crossing (B), downstream of crossing (C), view further downstream of crossing (D).

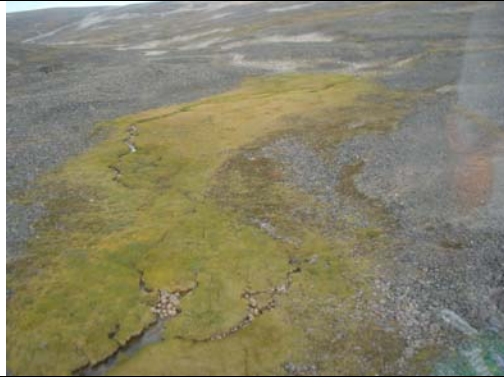
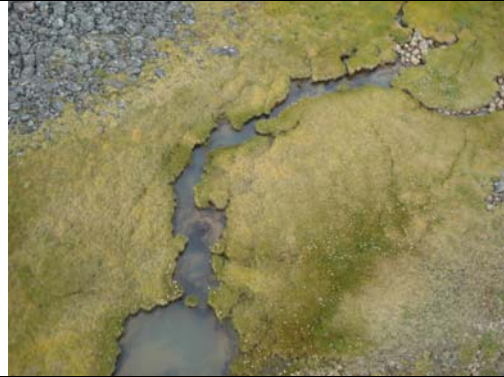
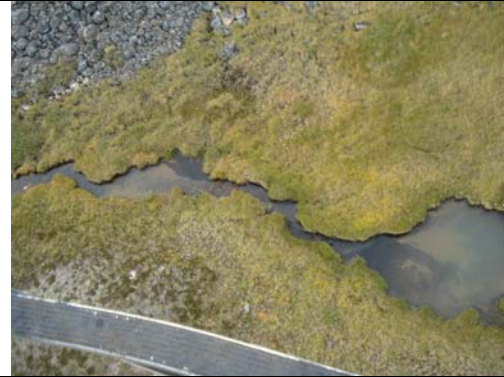
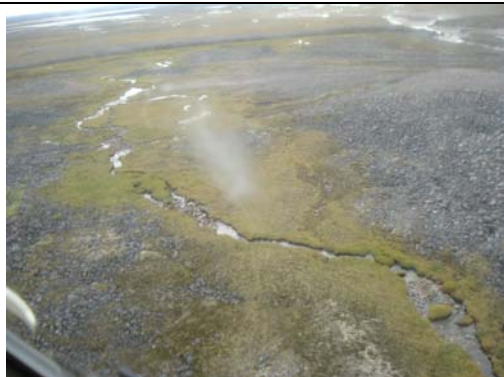
Figure 1. At crossing looking upstream (A), view at crossing (B), view at crossing (C), view downstream of crossing (D).

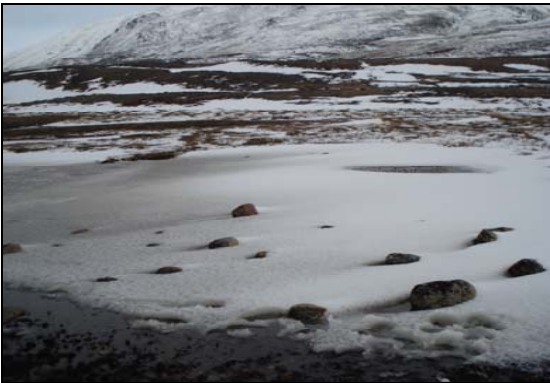
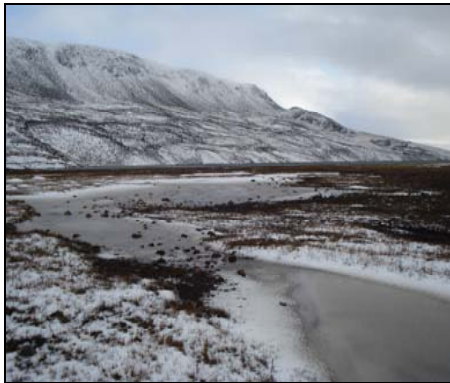
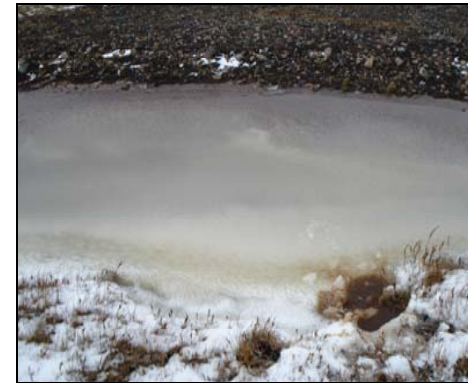
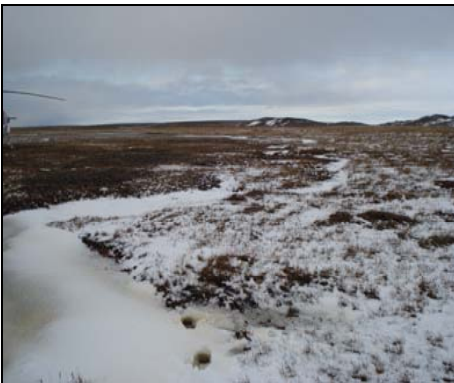
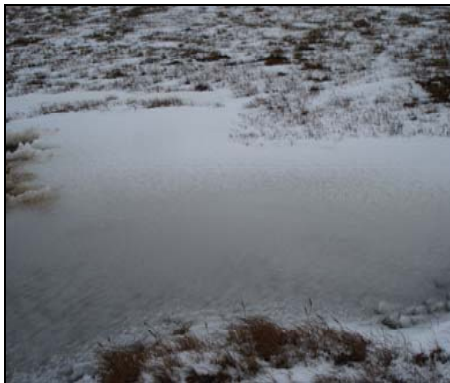
Figure 1. View at 40m downstream across (A), crossing downstream (B), crossing across (C), crossing upstream (D), and 40m upstream across (E).

is an area to the north of a previously assessed stream that might be a second channel during higher, fluid water. Currently they are just isolated pools. Water velocity and stream morphology weren't sampled because the water was frozen. Some dry patches exist between this stream and the nearby lake. Under higher water conditions this would be excellent habitat. Downstream lake at UTM 17 W 591741 7896728. Upstream limit of passage = UTM 17 W 591477 7896575. This is a very nice NNST habitat. Water levels would need to be a little higher to make it ideal, but the banks make it look as though in the summer, spring water might be 0.1m deep, wetted width = 4.85m

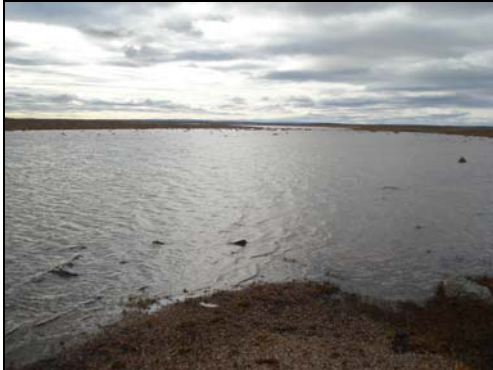
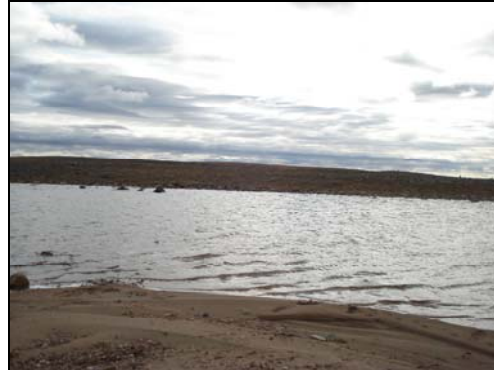
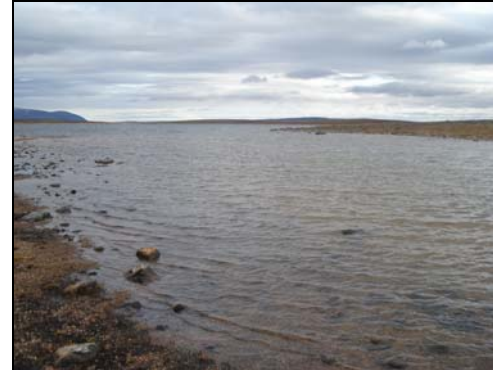
Figure 1. View at crossing downstream (A), crossing cross (B), and crossing upstream (C).

Not ideal fish habitat due to predominantly fine substrate and no cover, but at least a migration corridor to more suitable habitat. The large lake upstream is very likely an overwintering habitat, it appears deep from the air. Downstream there are no barriers between it and another big lake.

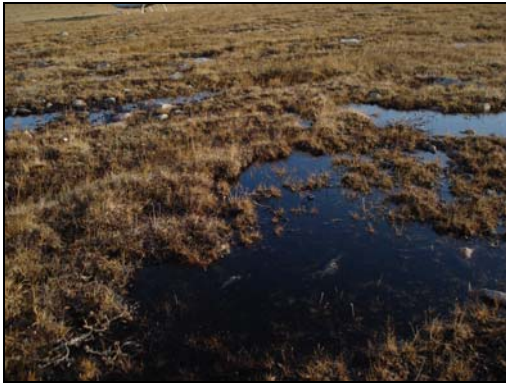
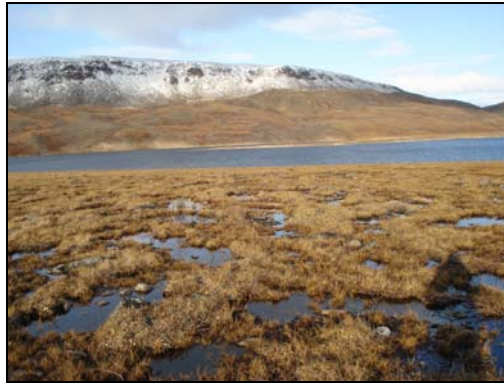
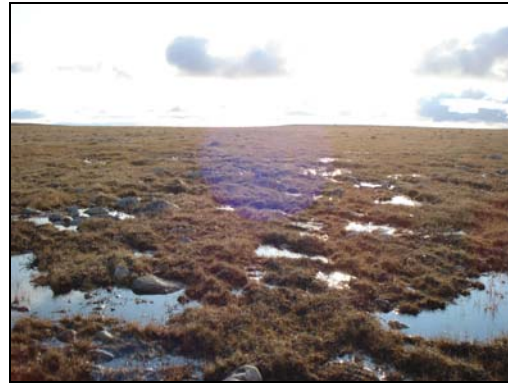
Figure 1. View of habitat at crossing (A), downstream of crossing (B), and upstream of crossing (C).

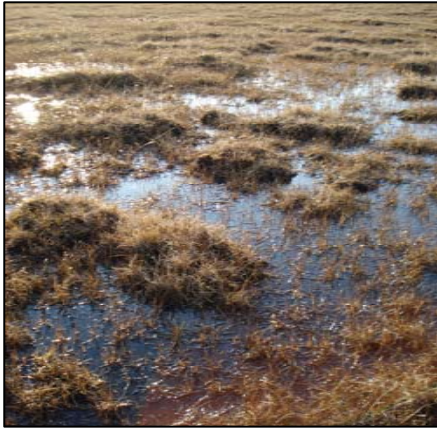
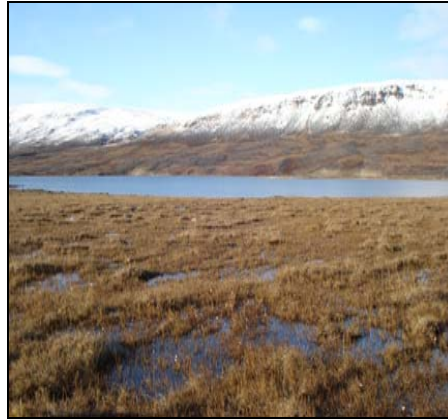
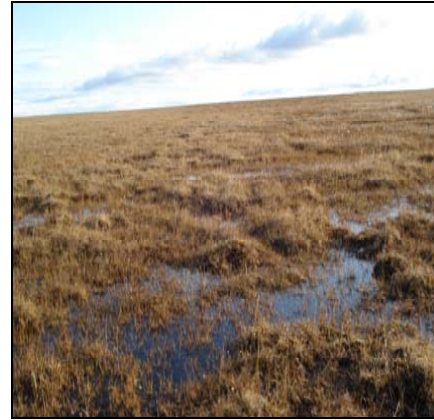
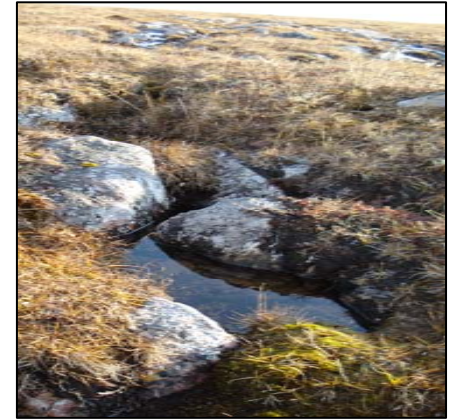
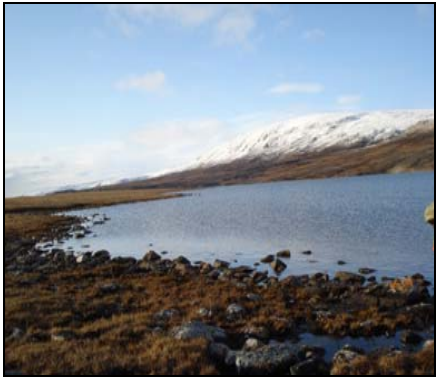
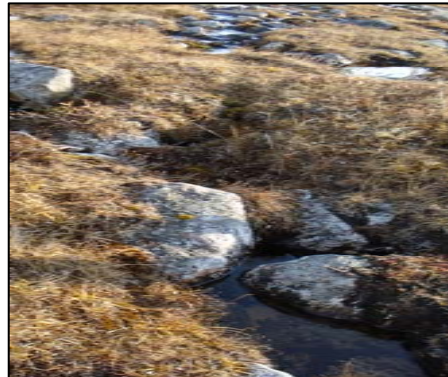
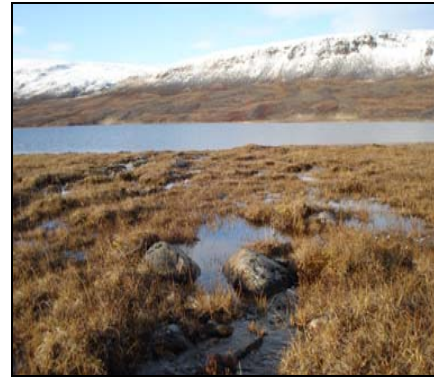
Figure 1. View at crossing (A), at crossing downstream (B), at crossing upstream (C), downstream barrier (D), downstream lake (E), limit of fish passage downstream of crossing (F), and limit of fish passage downstream of downstream crossing (G).

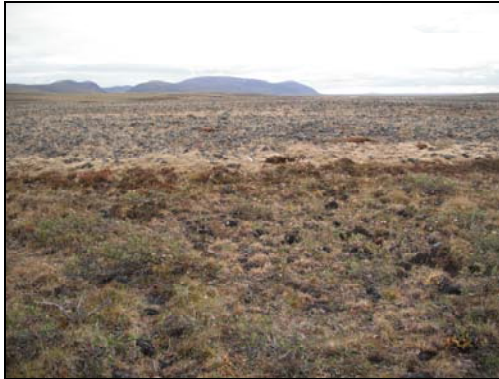
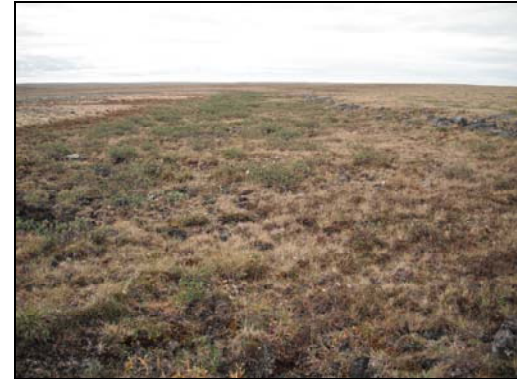
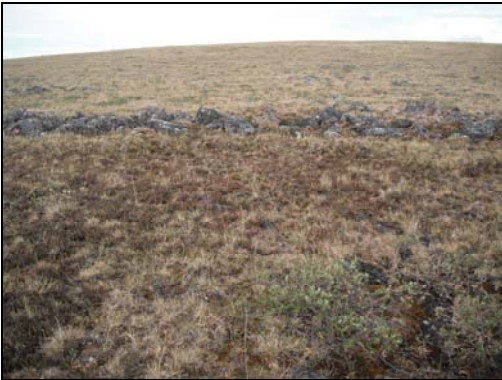
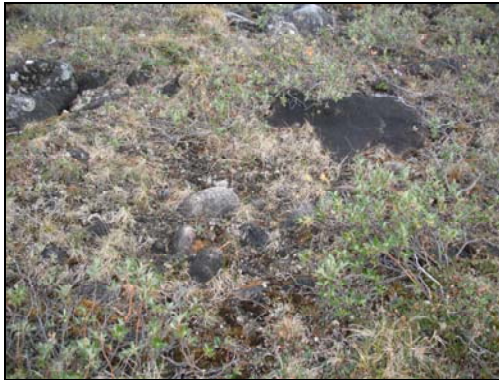
Figure 1. View to the north (A), east (B), south (C), and west (D) of the crossing, substrate at crossing (E).

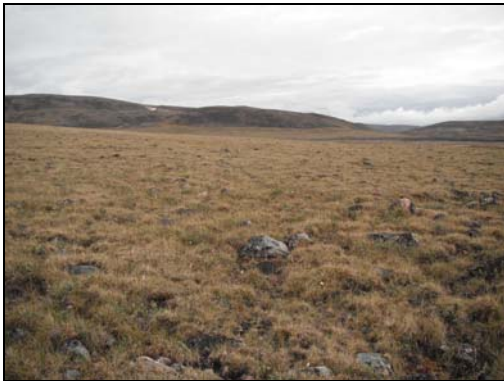
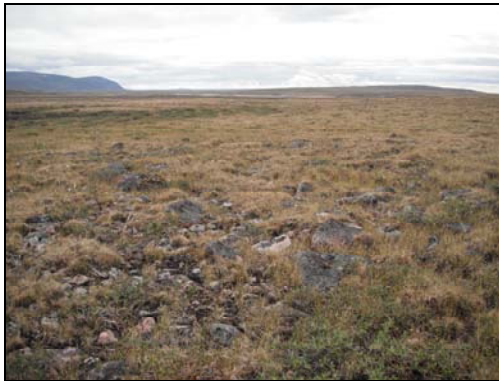
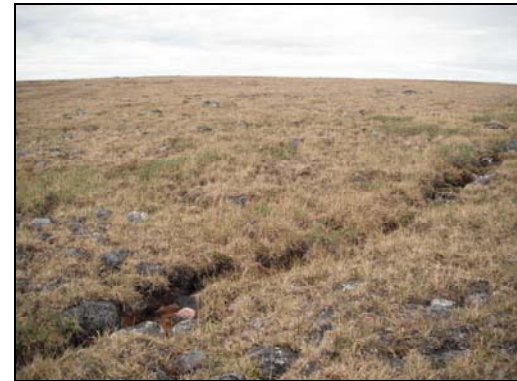
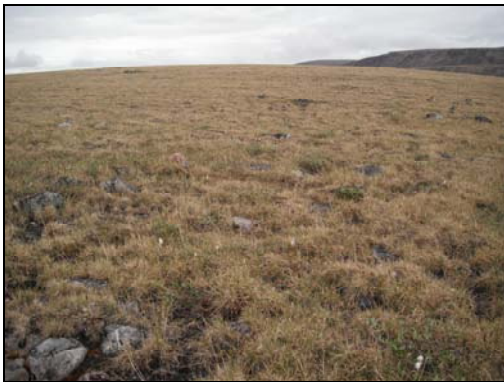
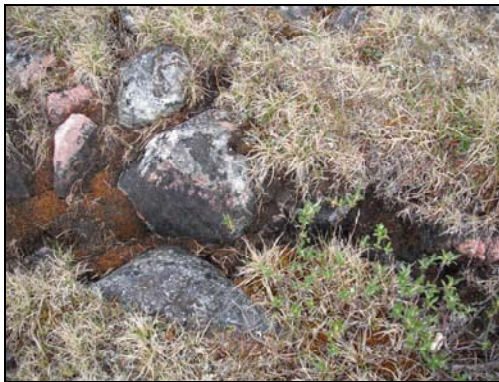
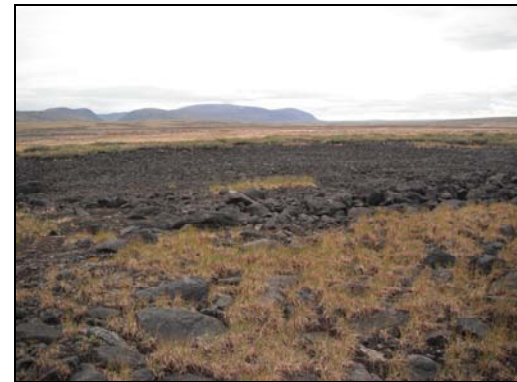
Figure 1. View to the north (A), east (B), south (C), and west (D) of the crossing, substrate at crossing (E), and dry pond near the crossing (F).

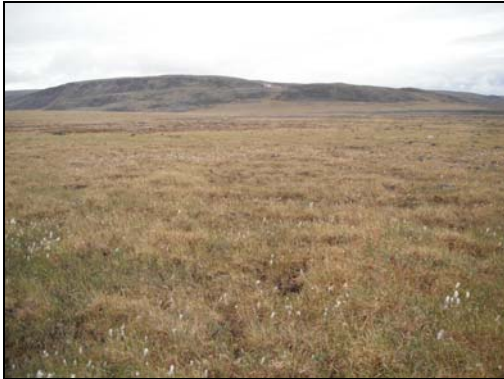
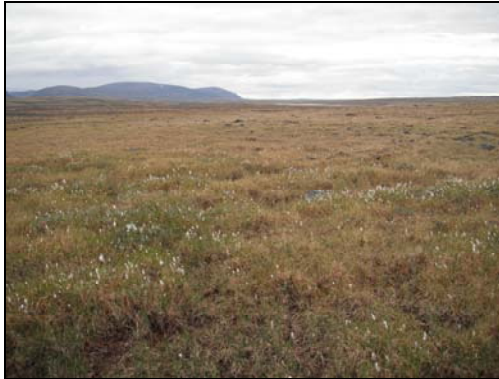
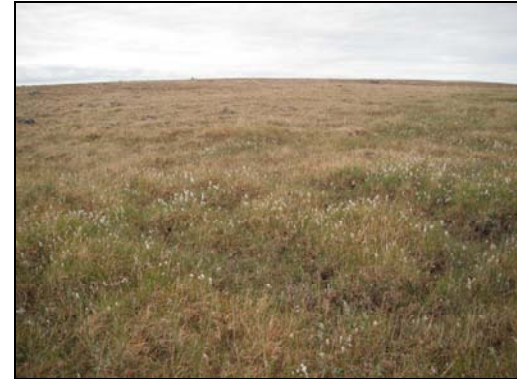
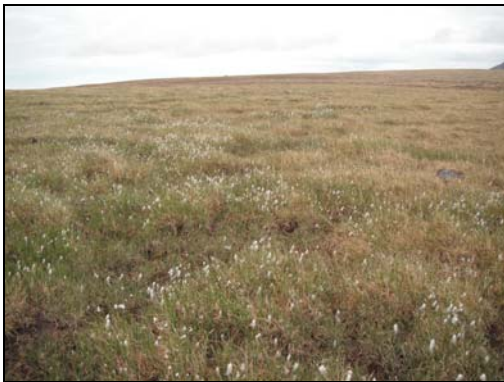
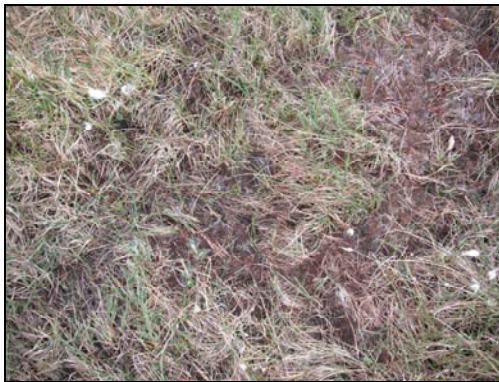
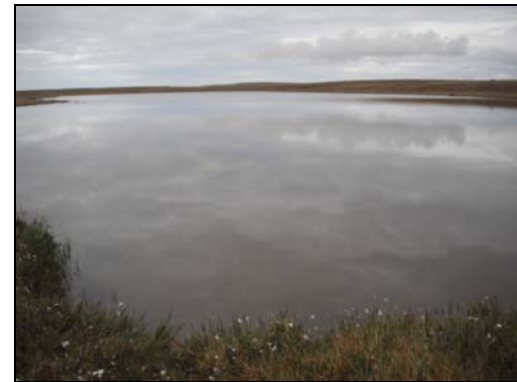
Figure 1. View to the north (A), east (B), south (C), and west (D) of the crossing, substrate at crossing (E), and upstream pond (F).

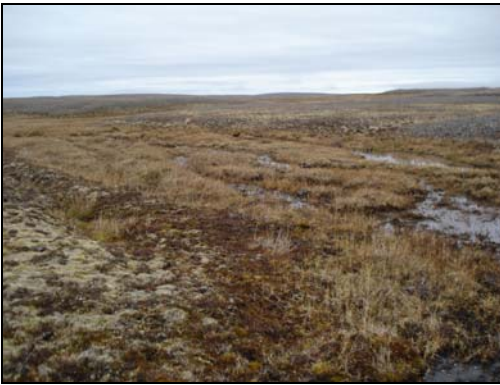
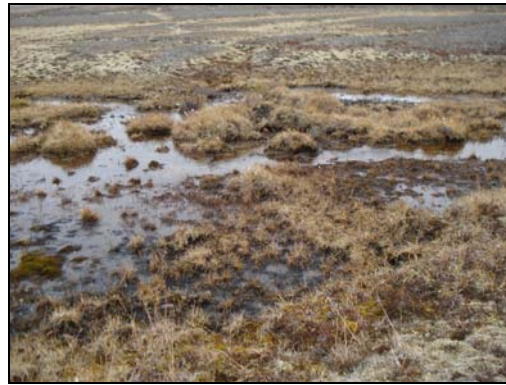
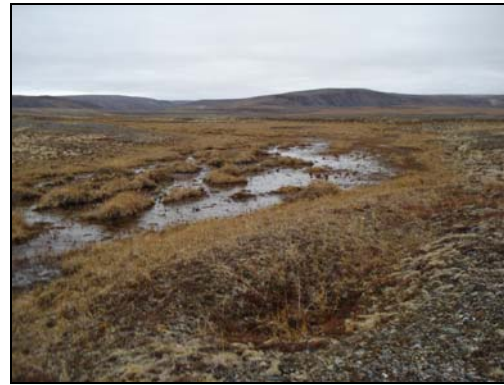
Figure 1. View at crossing downstream (A), crossing across (B), and crossing upstream (C).

There is a lot of FT downstream. Most of the substrate here is FT due to recent rains. Water source is the same for CV-R19 and R20. This is the preferred channel. The site probably has a small amount of water throughout the open water season pools, but fish would not be able to reach it due to dry patches downstream. Even if water were higher, the cascades downstream near the Ravn River would likely prevent fish passage. Cascade is at UTM 17 W 595165 7894042.

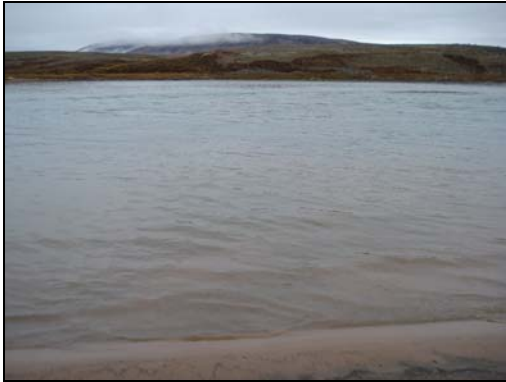
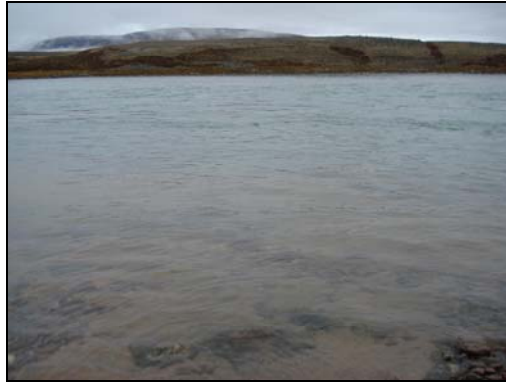
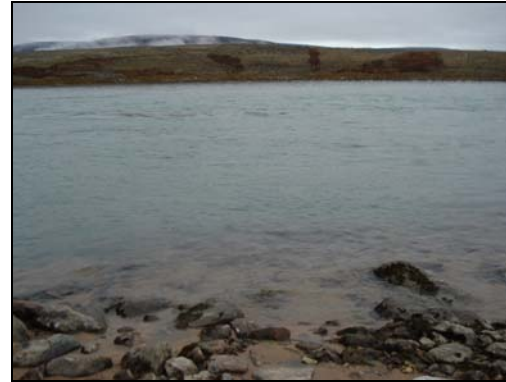
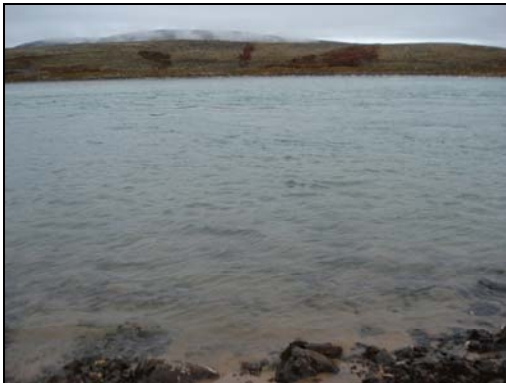
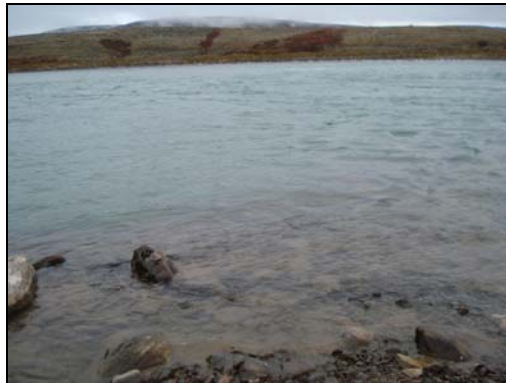
Figure 1. View at 40m downstream across (A), 20m downstream across (B), crossing across (C), 20m upstream across (D), and 40m upstream across (E).
