APPENDIX 5.1-3.

DETAILED HABITAT ASSESSMENTS AND SUMMARY OF RESULTS FOR ACCESS ROAD STREAM CROSSINGS.

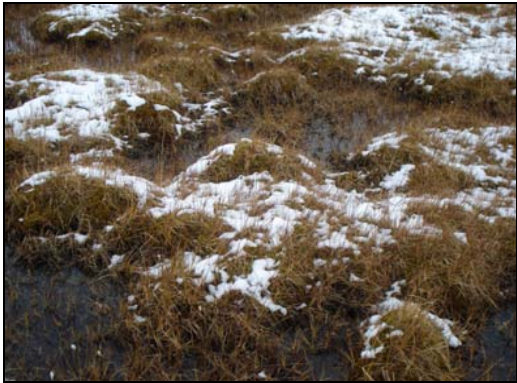
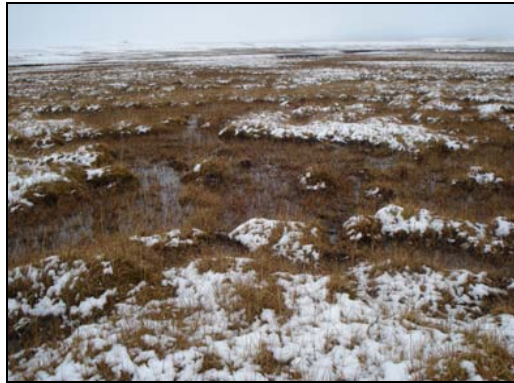
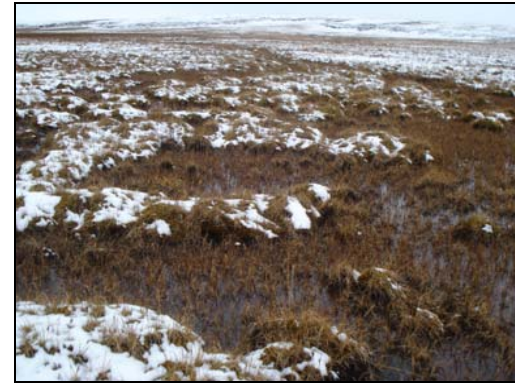
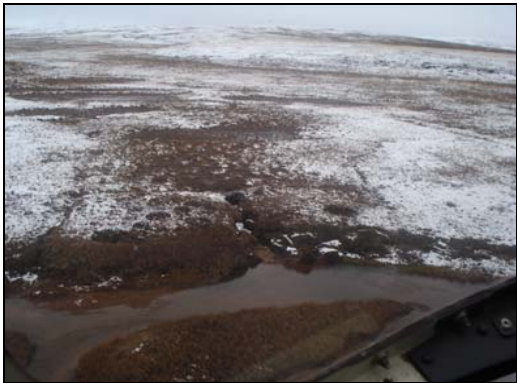
Figure 1. View of habitat at crossing (A), downstream of crossing (B), upstream of crossing (C), and at the confluence with the downstream river (D).

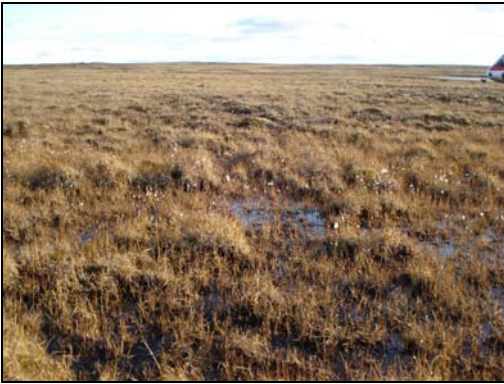
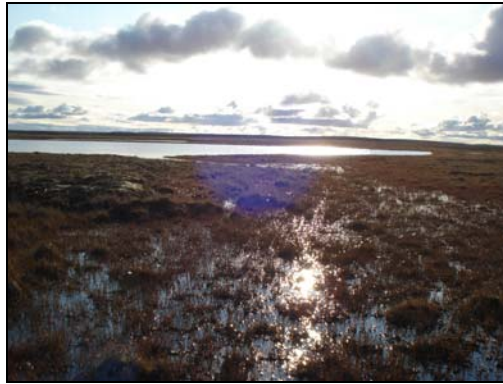
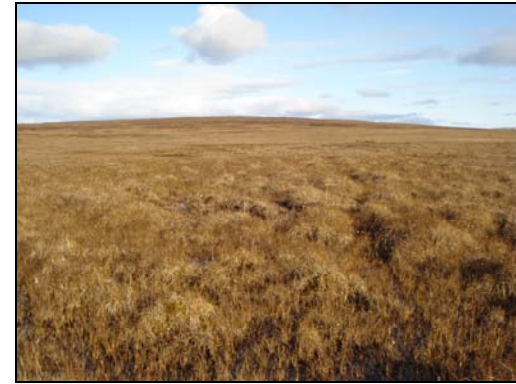
Figure 1. View of habitat at crossing (A), downstream of crossing (B), and upstream of crossing (C).

There is a small amount of water at the crossing (max = 0.05m) and it is flowing towards the downstream pond (UTM 17 W 595617 7893080). Site is over flooded terrestrial vegetation, and there is no obvious channel or persistent source of water (flow caused by recent snow). There is a shallow pond upstream, but its banks are too high for it to currently drain downhill (UTM 17 W 595743 7893082).

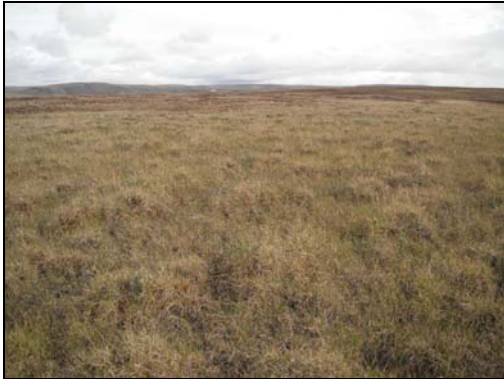
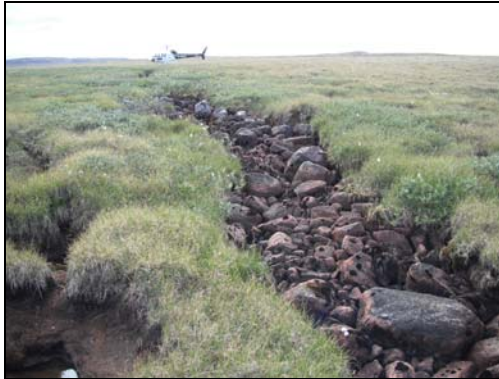
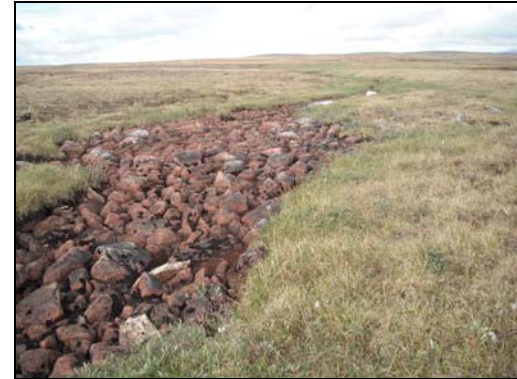
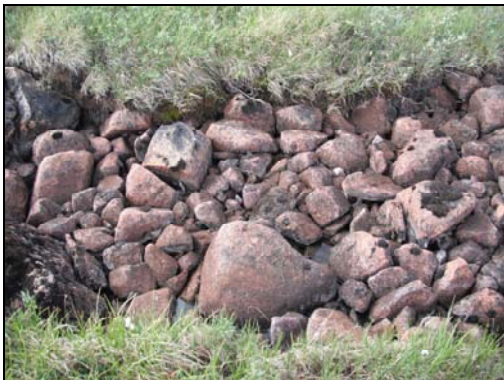
Figure 1. View at crossing (A); nearby stream looking upstream (B), downstream (C), and across (D).

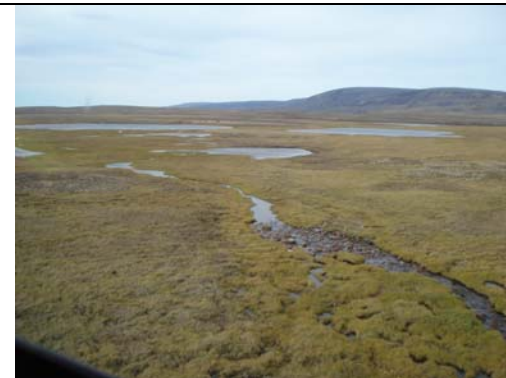
F

Figure 1. Overview of crossing looking upstream (A), view looking upstream from crossing (B), crossing area panned upstream to downstream (C-E), downstream view from crossing area (F).

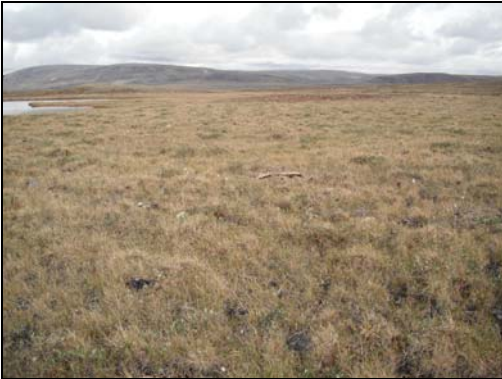
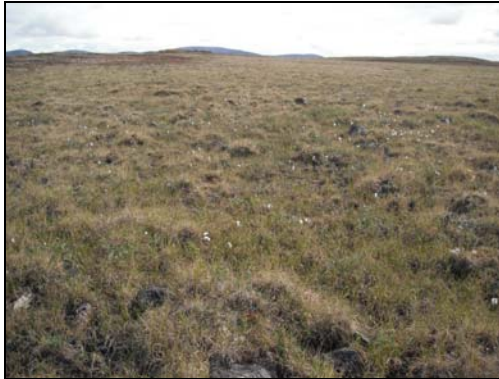
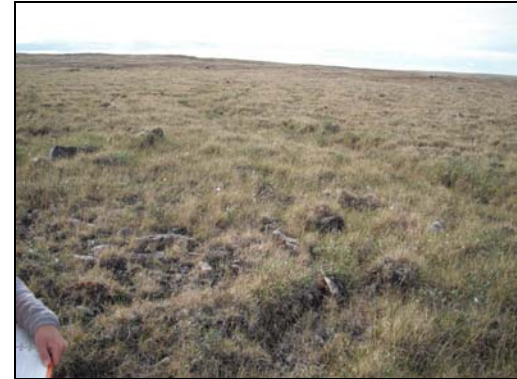
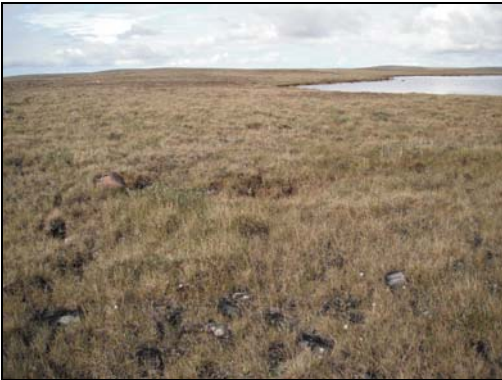
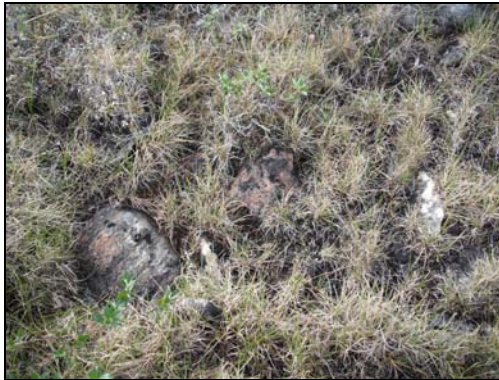
Figure 1. View upstream (A), downstream (B), and across (C) at crossing.

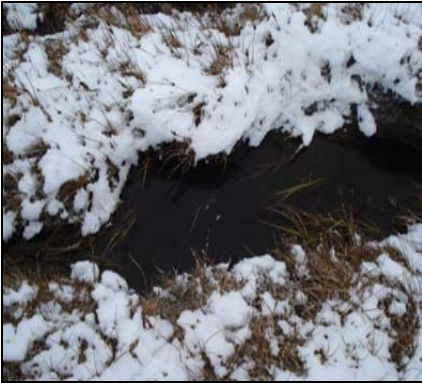
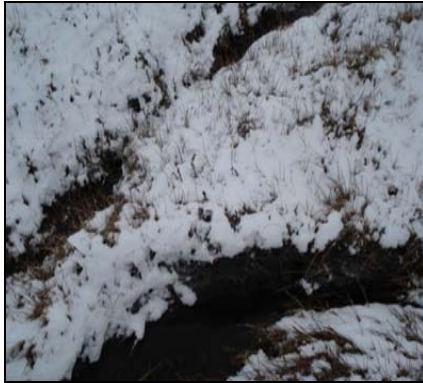
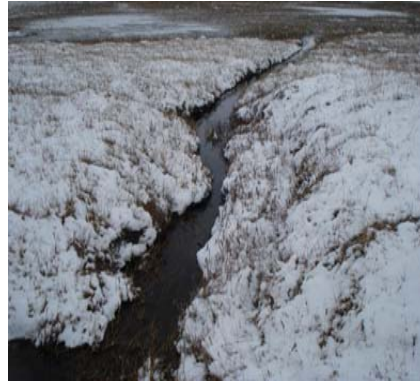
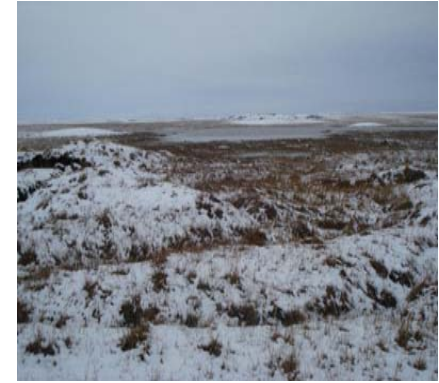
Figure 1. View at crossing (across right channel) (A), at crossing across (B), at crossing downstream (C), and at crossing upstream (D).

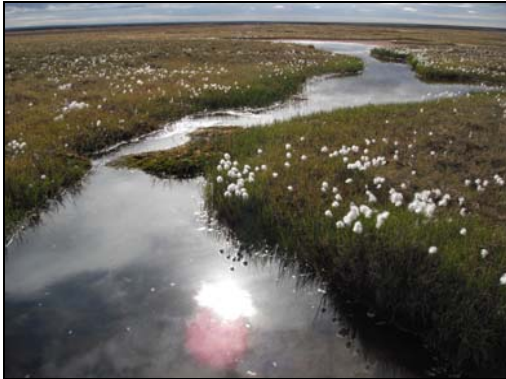
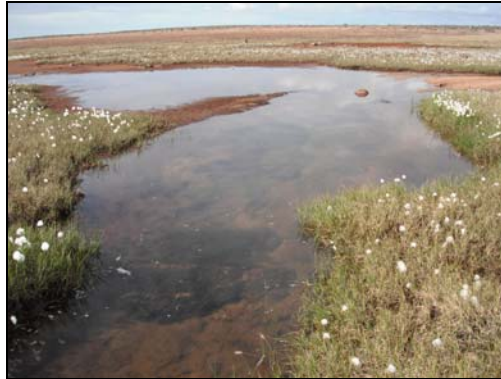
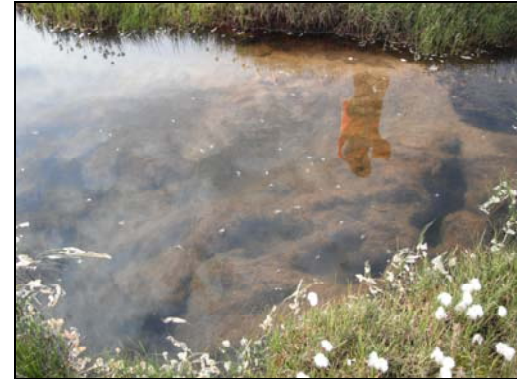
Figure 1. View upstream (A), downstream (B), and across (C) at crossing.

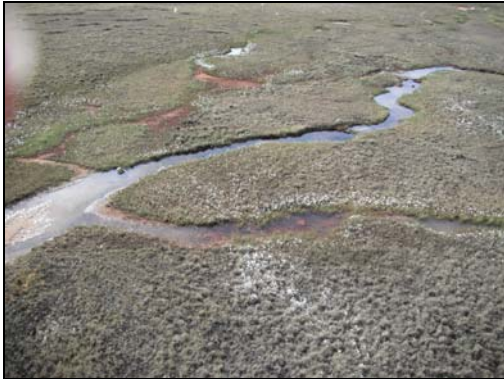
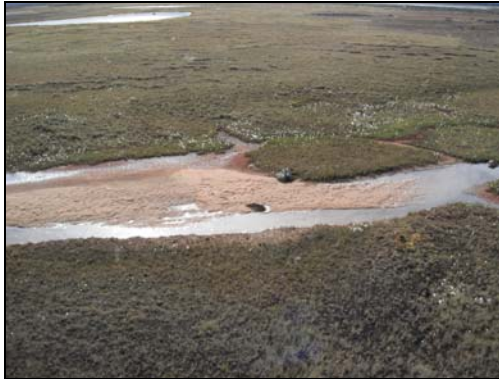
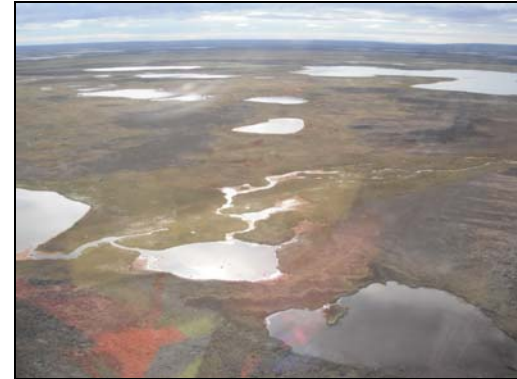
Figure 1. Aerial view upstream of the crossing (A), at the crossing (B), and the series of interconnected lakes and streams in the area (C).

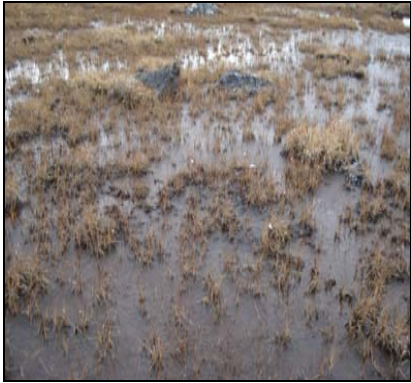
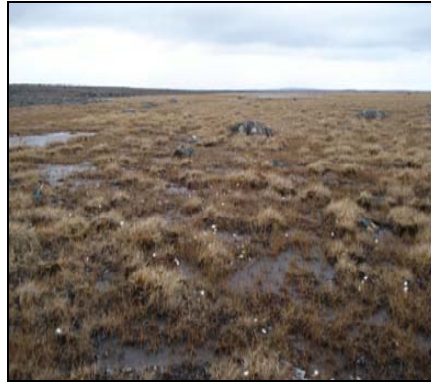
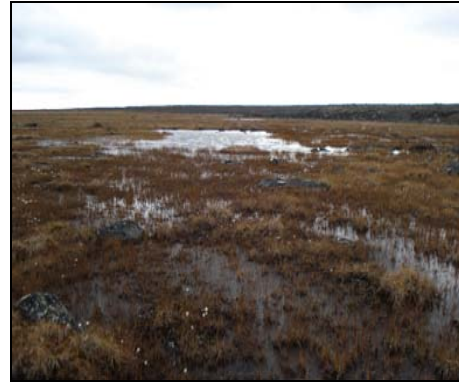
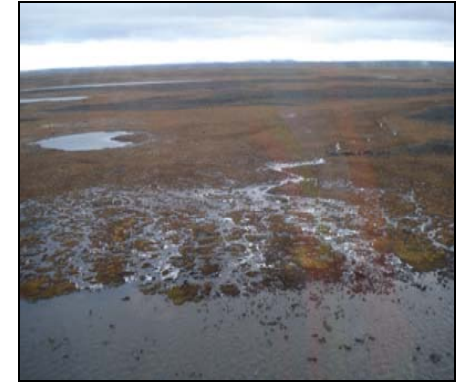
Figure 1. View at crossing across (A), at crossing downstream (B), at crossing upstream (C), and downstream confluence with large lake (D).

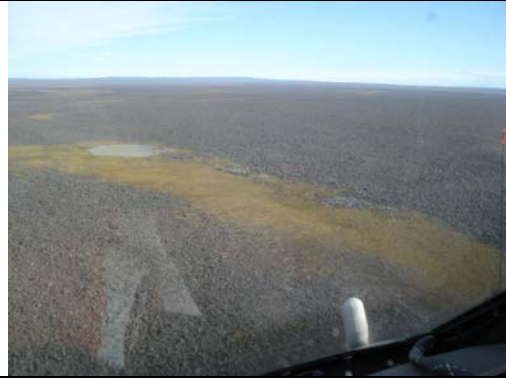
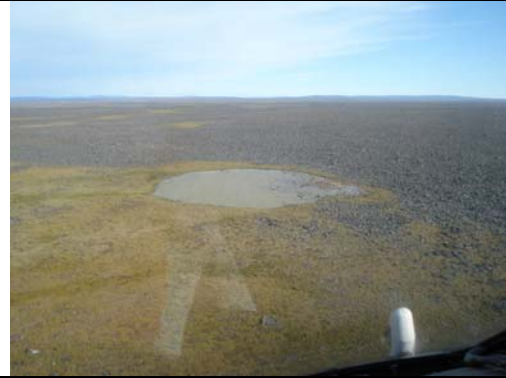
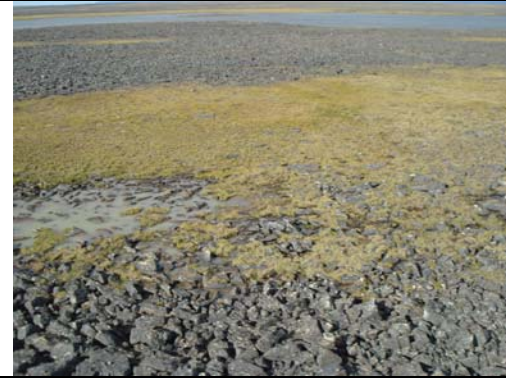
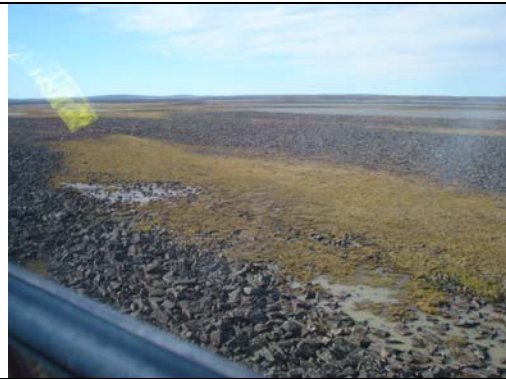
Figure 1. Overview of crossing area (A), at crossing area looking upstream at small pond (B), close-up of crossing area (C), view looking upstream (D).

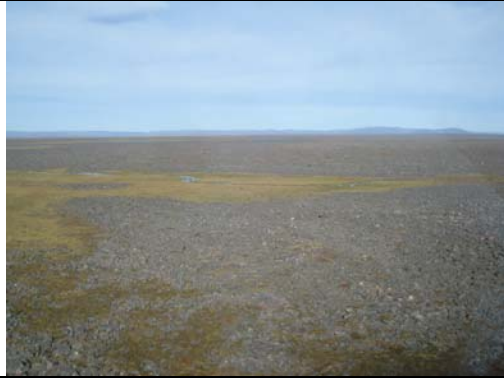
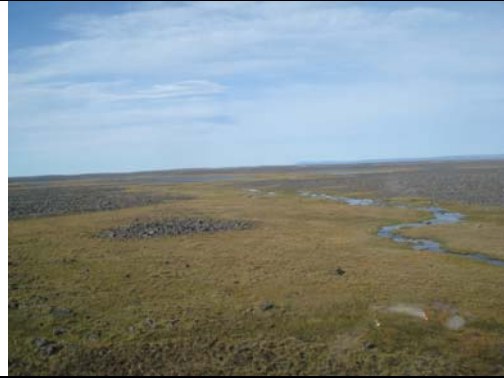
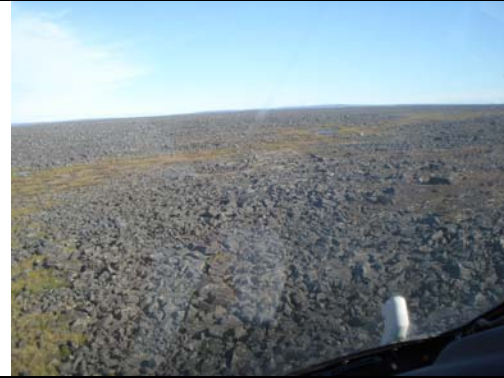
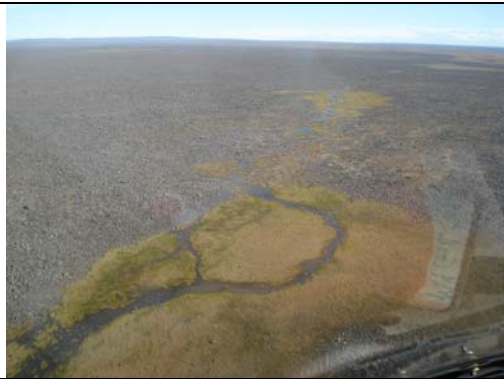
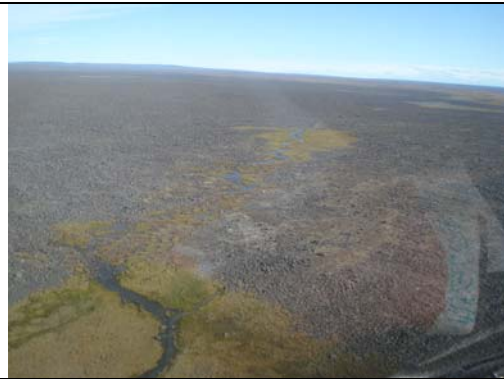
Figure 1. View looking at crossing area (A), view looking downstream from crossing (B), view looking upstream from crossing (C), upstream view from downstream extent of watercourse (D), aerial view of crossing area; looking upstream (E).

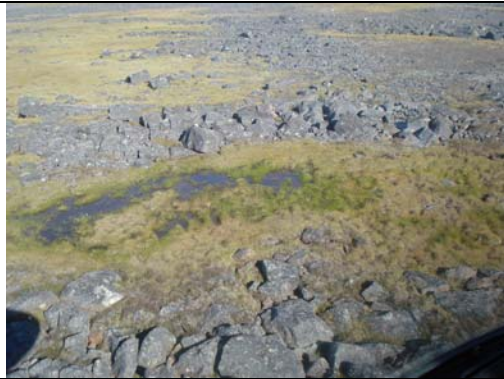
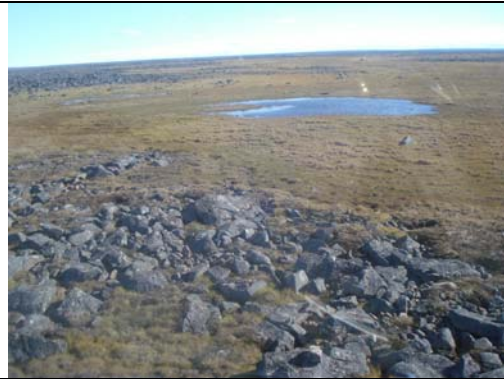
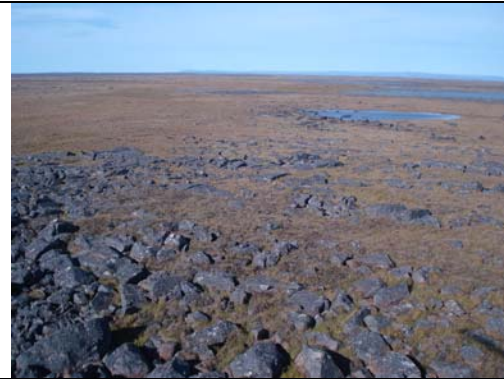
Figure 1. View at crossing (A), view south from crossing (B), view north from crossing (C).

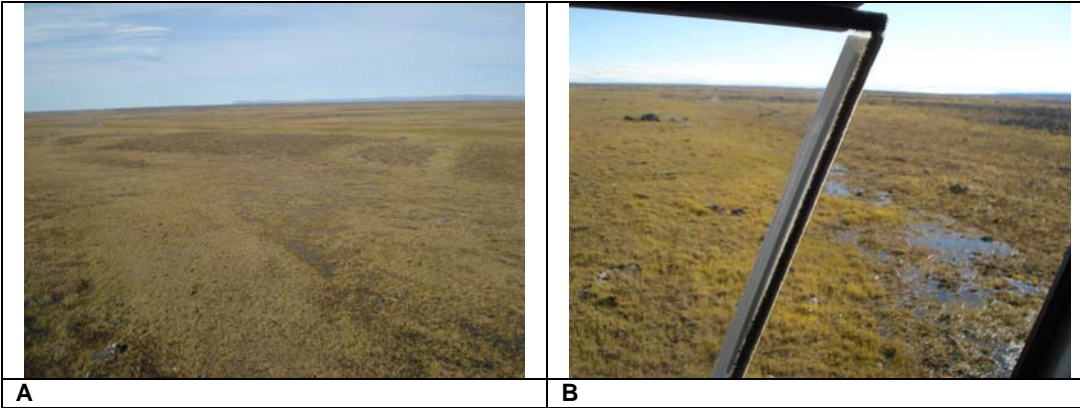
Figure 1. View looking upstream (A), view looking downstream (B).

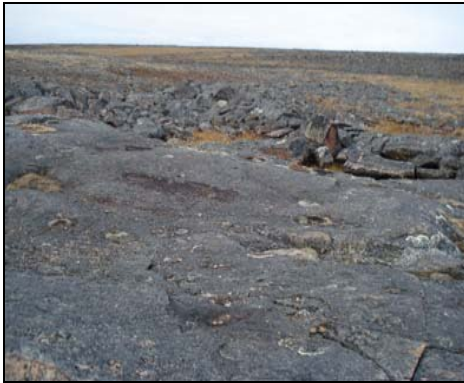
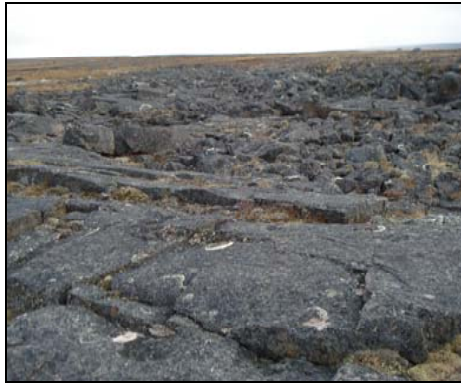
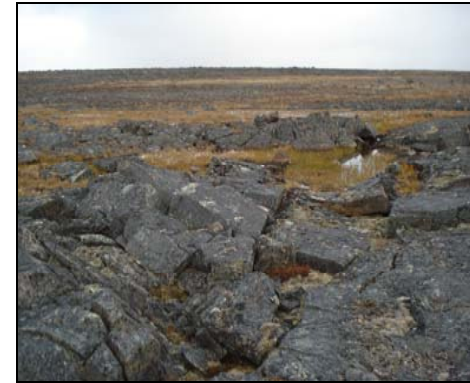
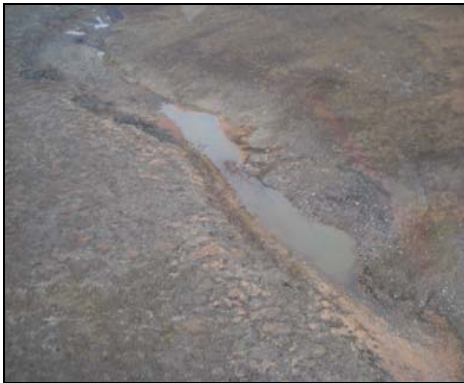
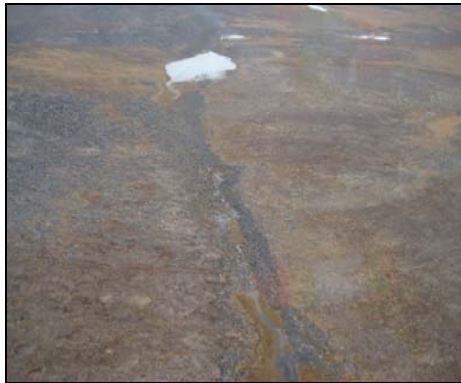
The area between the quarry as the proposed road location contains two channels that are currently mostly dry pools, but probably provide fish habitat during high water levels. Electrofished between the pond downstream of the potential barrier at UTM 17 W 599767 7865644 and the pond upstream of the barrier in the left channel. More barriers (dry patch of rock) exist downstream of the large pool we fished (UTM 17 W 600224 7865358. UTM 17 W 599326 7865694, UTM17 W 598927 7865411). It appears that habitat is only accessible during high water in the spring.

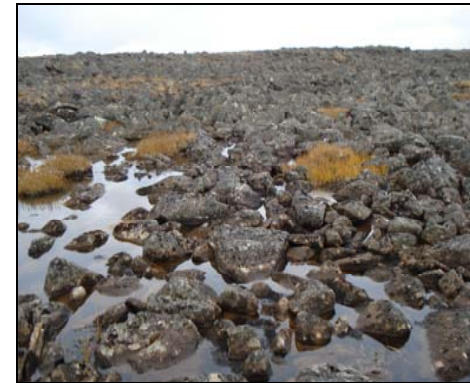
F

Figure 1. View of quarry upstream (A), quarry across (B), quarry downstream (C), downstream barriers (D-E), and barrier between upstream and downstream pond (F).

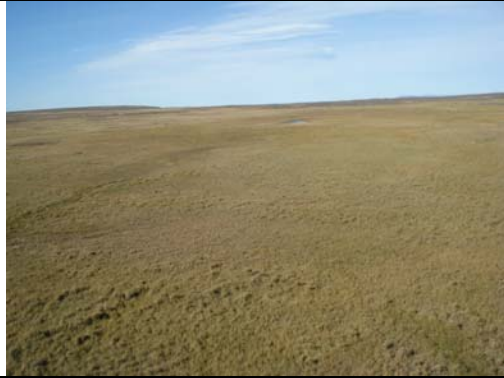
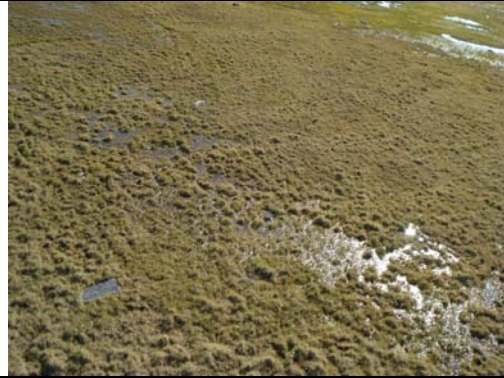
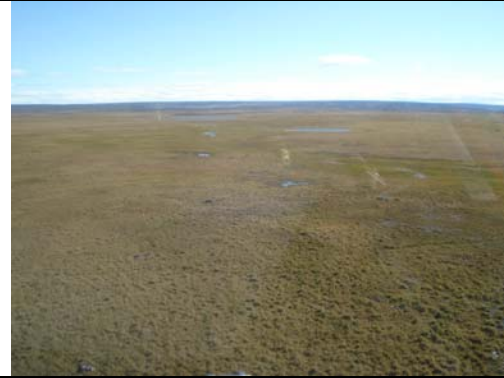
Figure 1. View looking upstream from crossing (A), view at crossing (B), downstream from crossing (C).

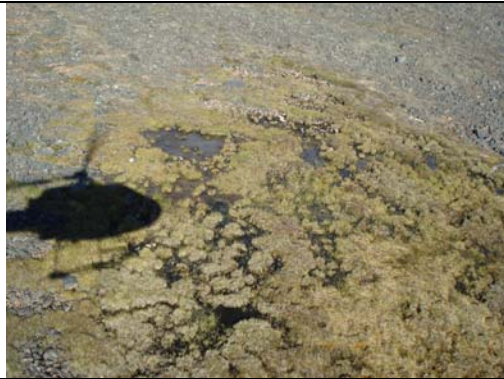
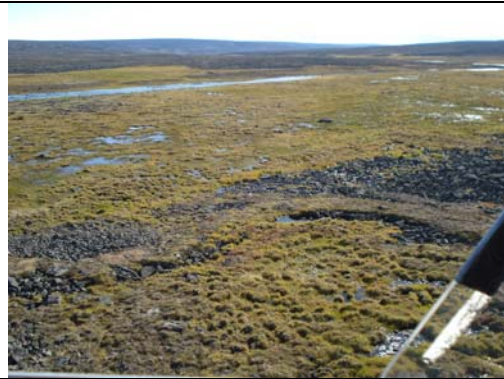
Figure 1. View of crossing (A), view looking downstream (B).

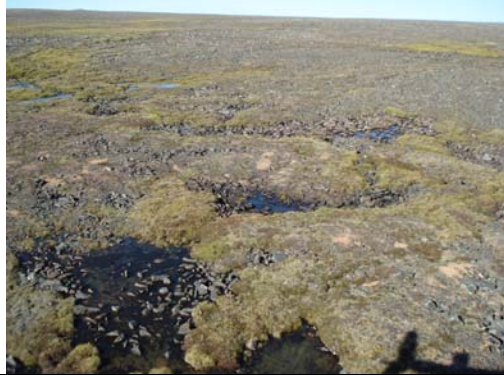
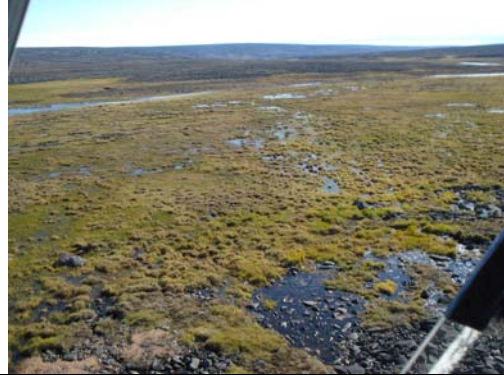
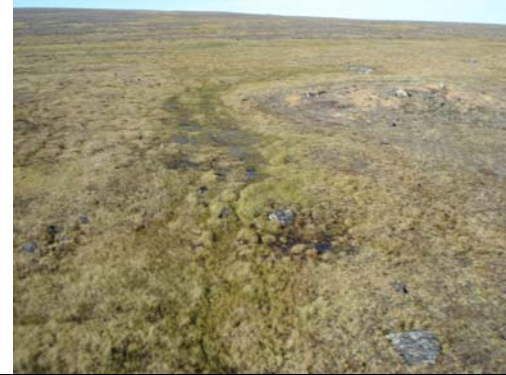
Figure 1. View looking upstream (A), view looking downstream (B), view upstream of crossing area (C).

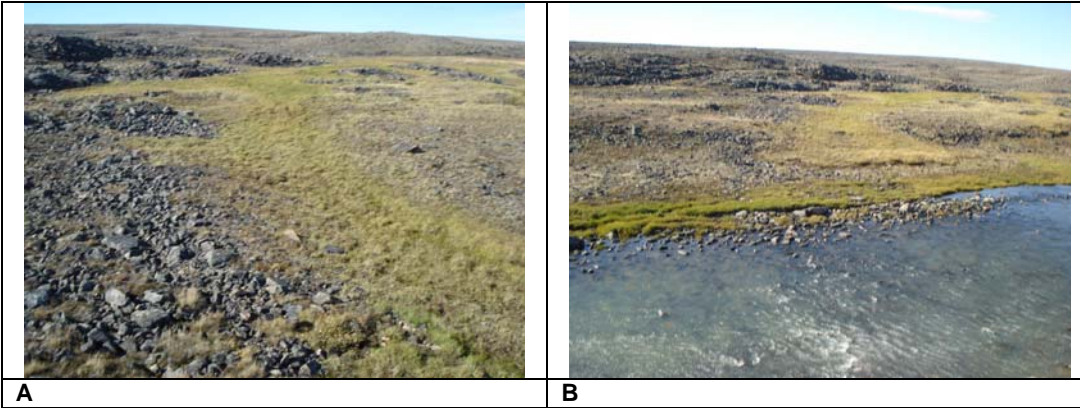
Figure 1. View at crossing looking upstream (A), looking upstream from river to crossing (B).

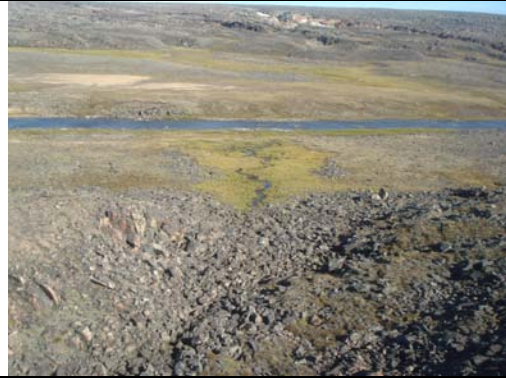
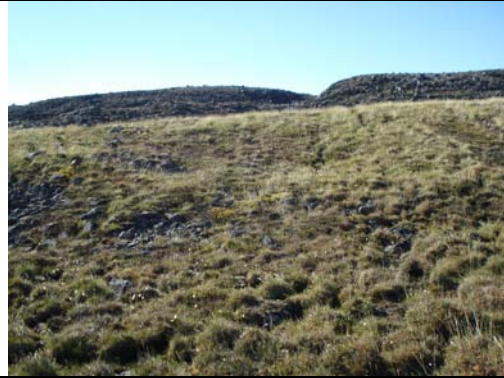
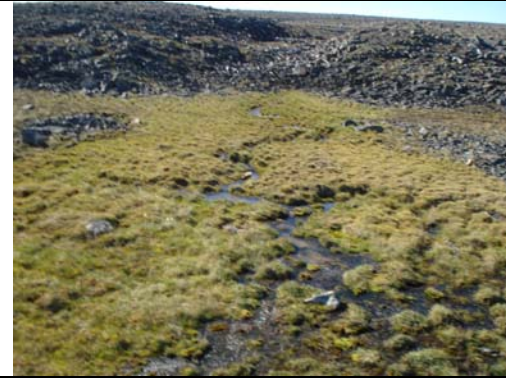
Figure 1. Looking downstream from upstream of crossing (A), looking upstream from Cockburn River at high bank (B), looking at saturated crossing area (C).

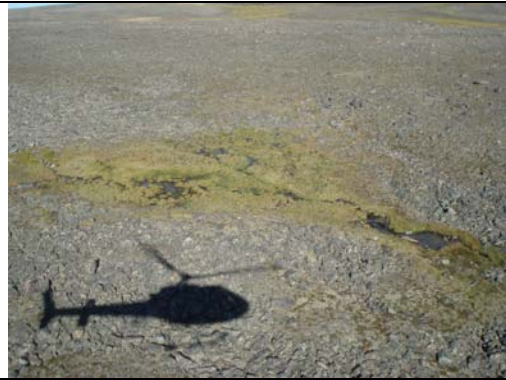
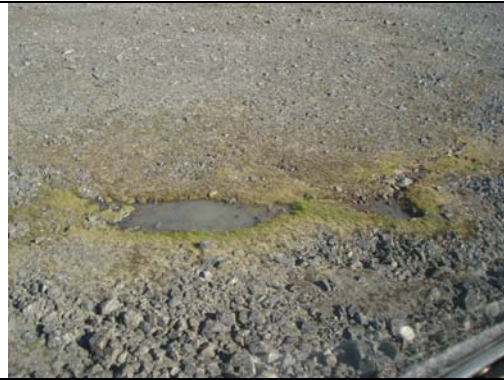
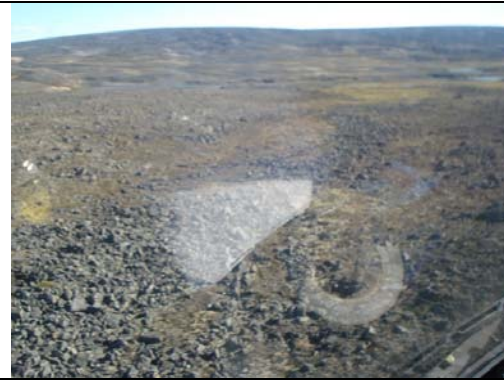
Figure 1. Upstream extent of drainage (A), at crossing location (B), looking downstream from crossing area (C).

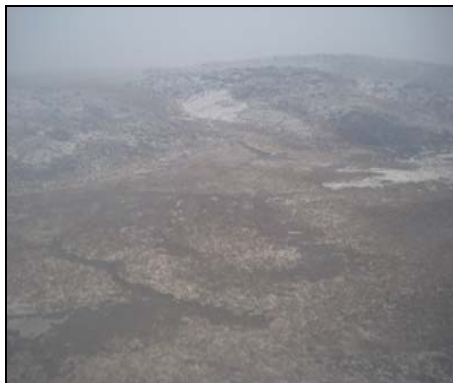
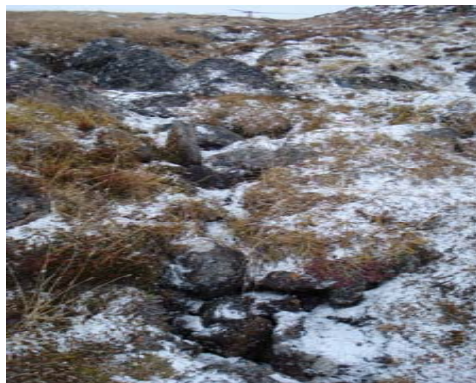
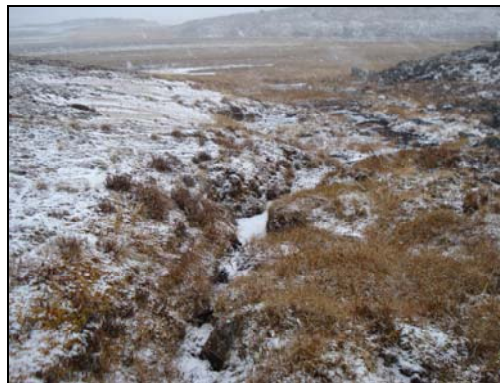
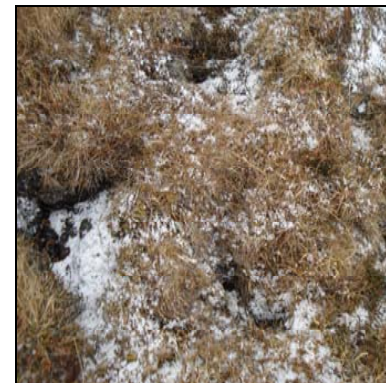
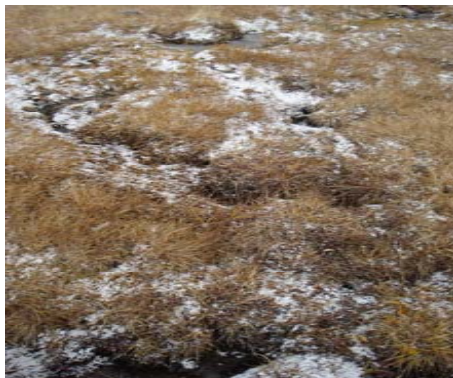
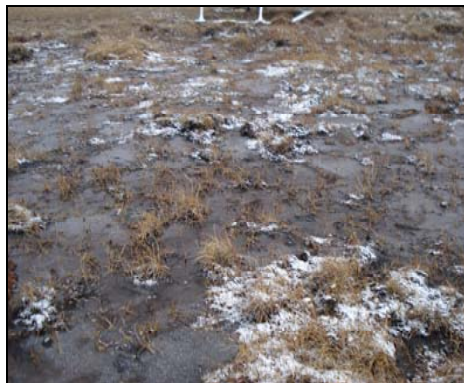
Figure 1. Aerial view of downstream (A), downstream barrier (B), downstream barrier 2 (C), subsurface water (D-E), at crossing across (F), at crossing downstream (G), and crossing upstream (H).

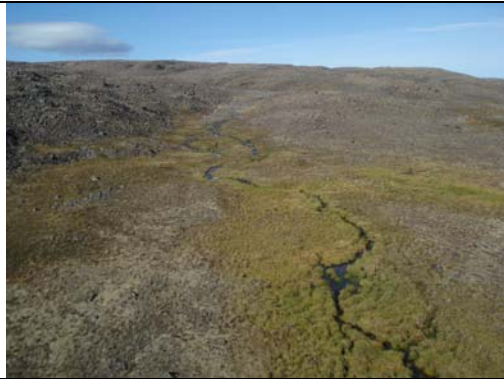
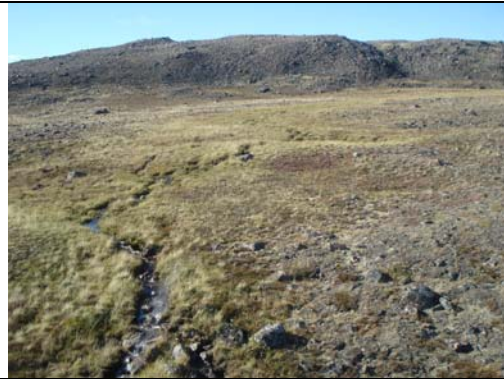
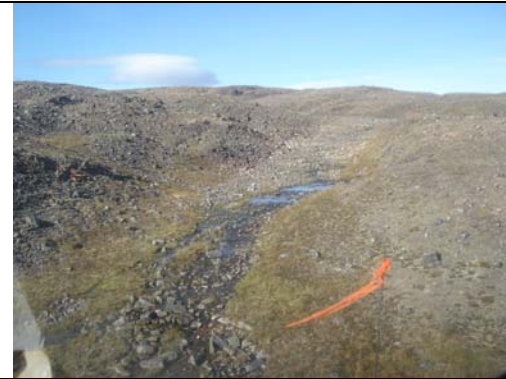
Figure 1. View upstream from crossing (A), view looking upstream from Cockburn River (B), upstream view where channel begins to disappear (C).

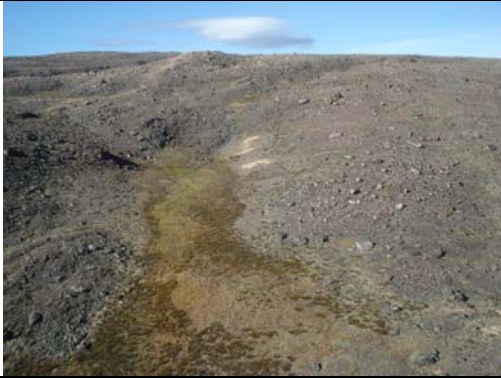
Figure 1. View of dry drain (A).

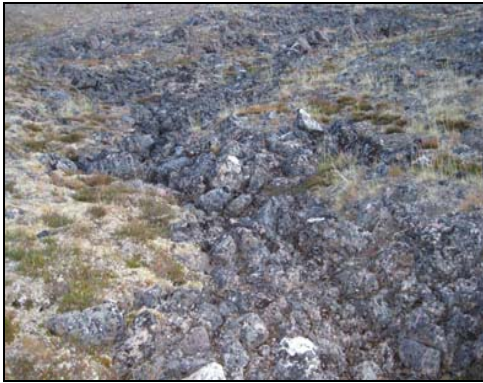
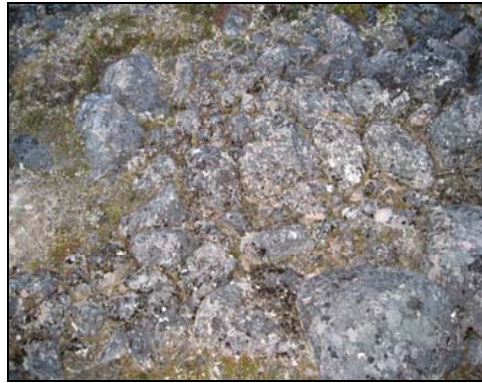
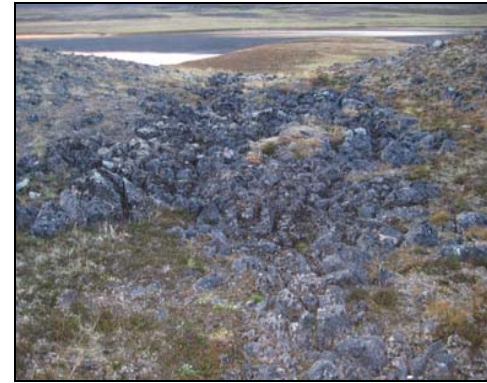
Figure 1. View of habitat upstream of crossing (A), at the crossing (B) and downstream of crossing (C).

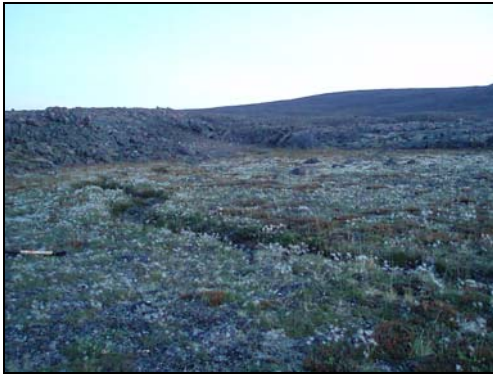
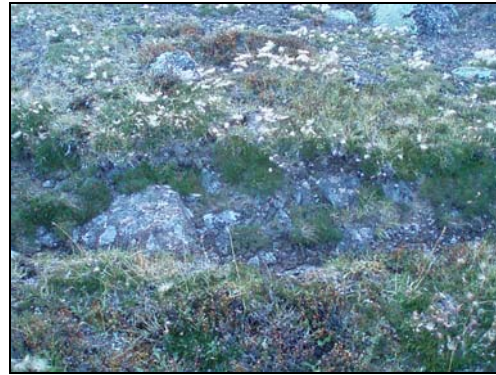
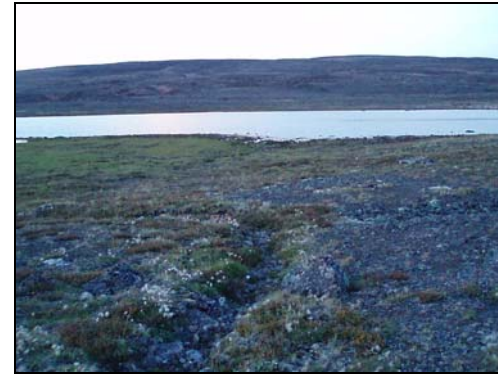
Figure 1. View of habitat upstream of crossing (A), at the crossing (B) and downstream of crossing (C).

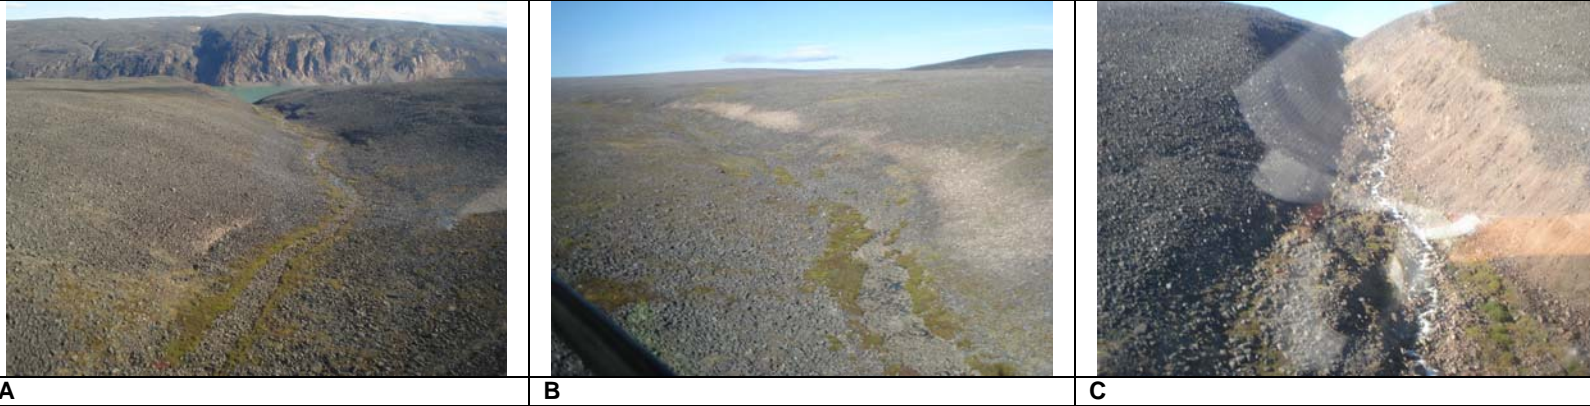
Figure 1. Downstream view of crossing (A), view upstream of crossing (B), view of steep gradient downstream of crossing near Cockburn Lake (C).

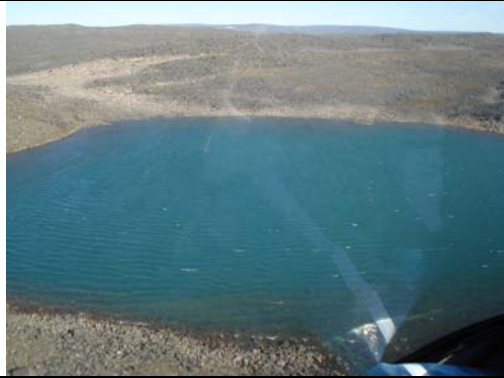
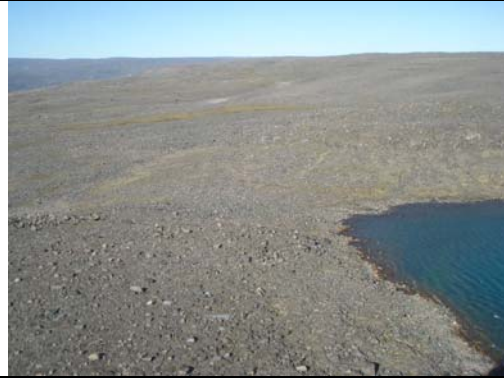
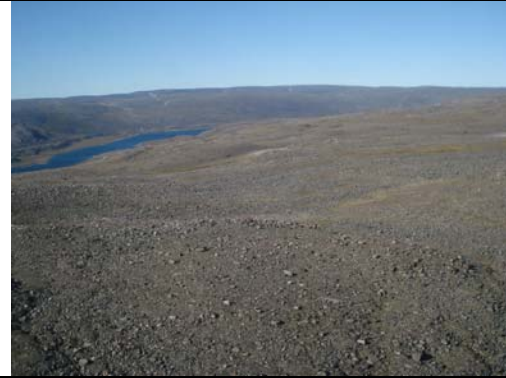
Figure 1. Aerial view upstream of crossing area at headwaters (A), aerial view of crossing area (B), aerial view looking downstream of crossing location (C).

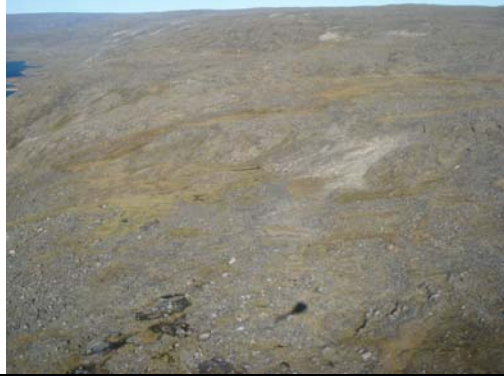
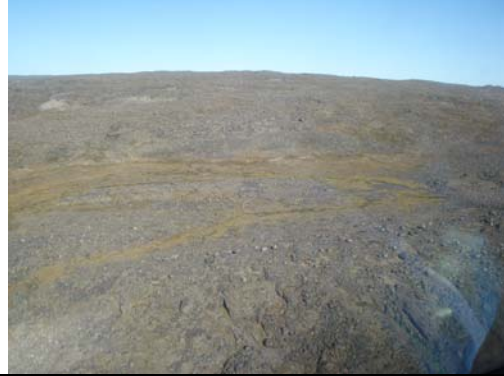
Figure 1. Aerial view of crossing location (A), aerial view upstream of crossing location (B).

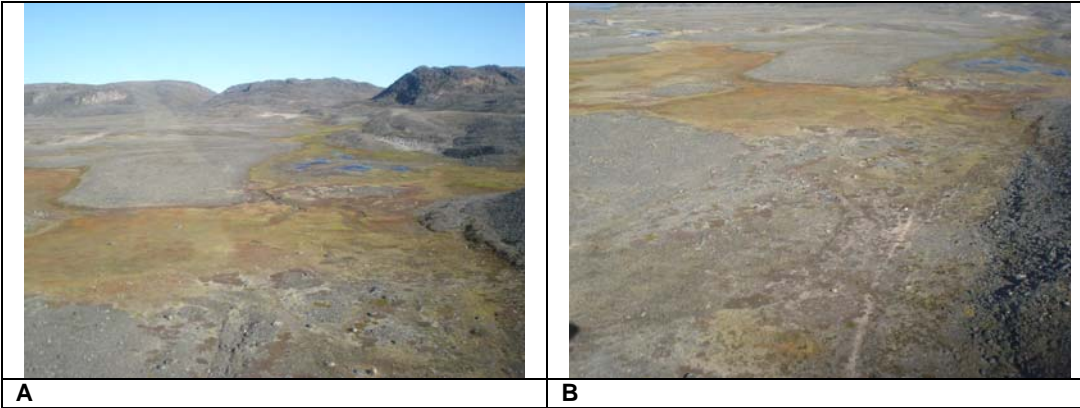
Figure 1. Aerial view of drainage (A), aerial view of crossing location (B).

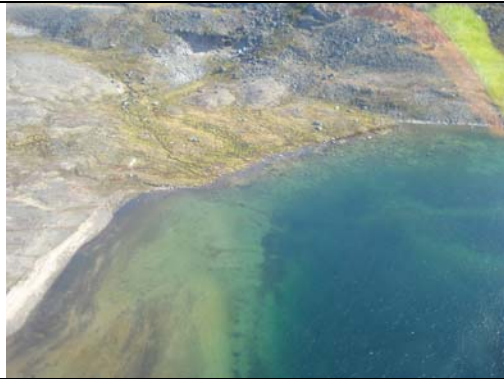
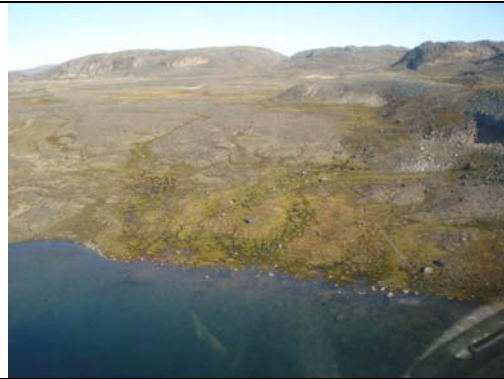
Figure 1. Aerial view of drain entering waterbody downstream of crossing location (A), aerial view of drain; crossing location above sloped area (B).

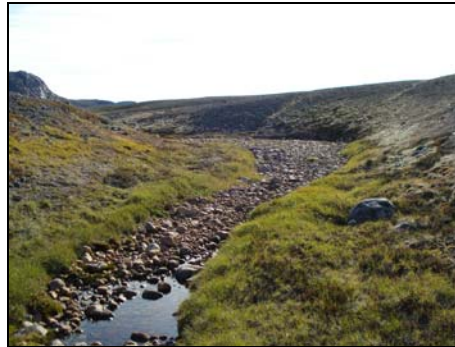
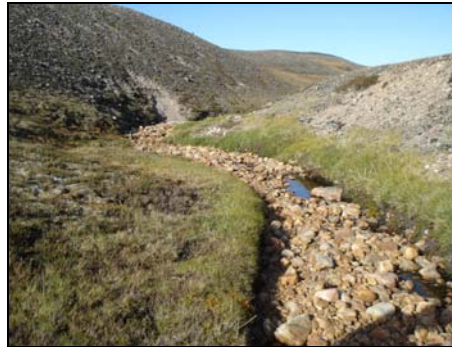
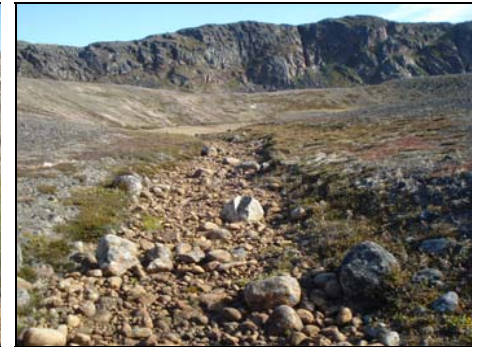
Figure 1. Aerial view of crossing area (A), view upstream of crossing (B), downstream of crossing (C), and view upstream from 60 m upstream of the crossing (D).

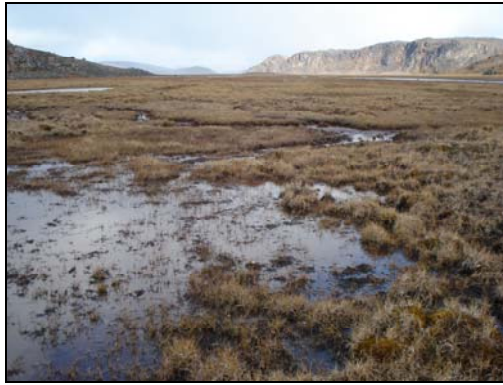
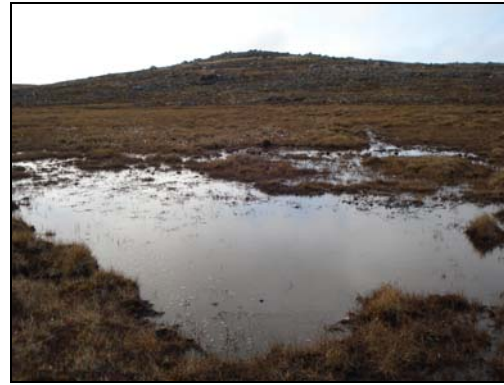
Figure 1. View of habitat at crossing (A), downstream of crossing (B) and upstream of crossing (C).

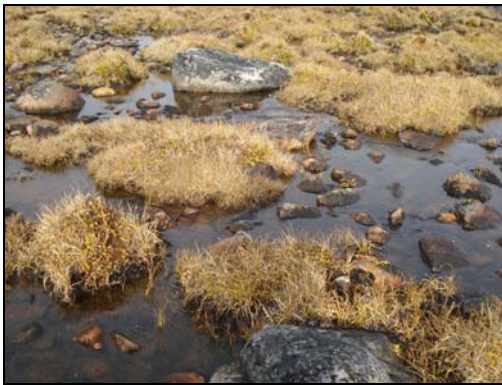
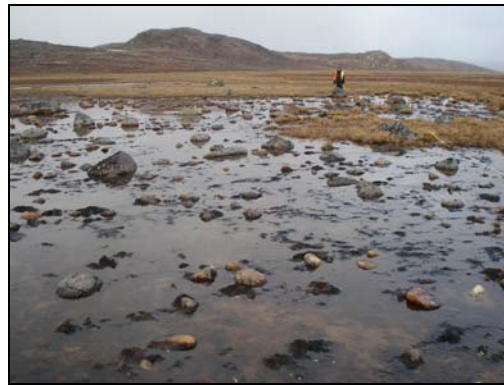
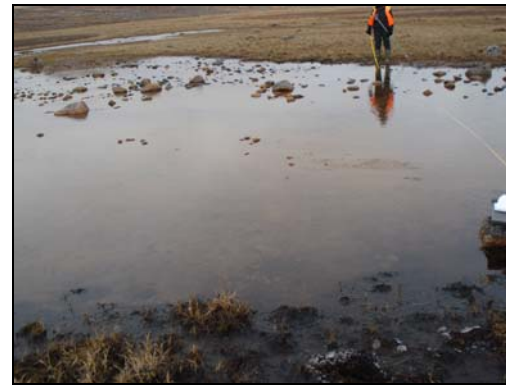
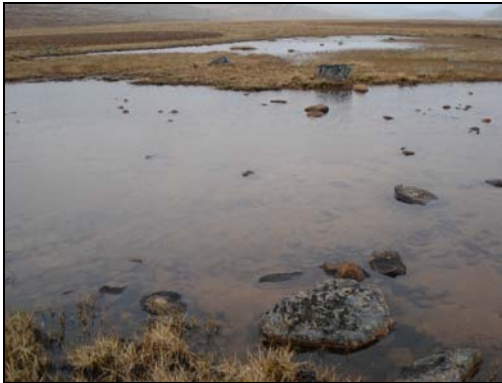
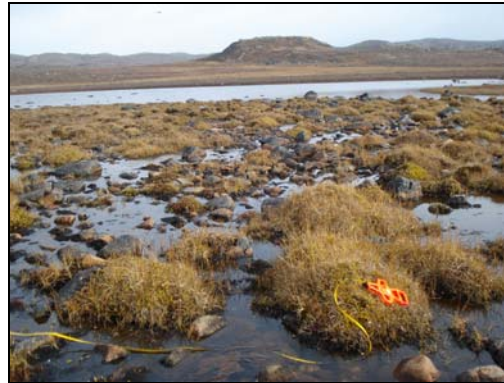
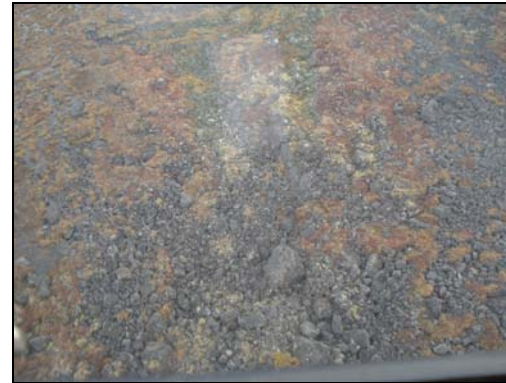
Figure 1. View of habitat, (A) 40m downstream across, (B) 20m downstream, (C) 20m upstream, (D) 40m upstream across, (E) at crossing across, and (F) upstream barrier.

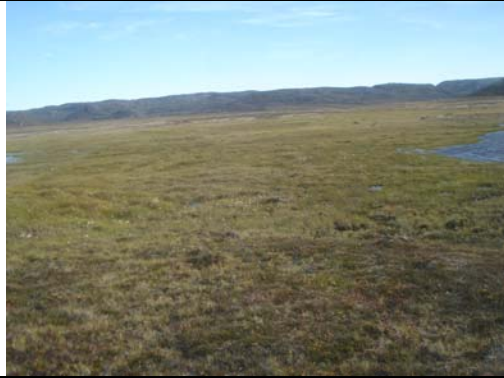
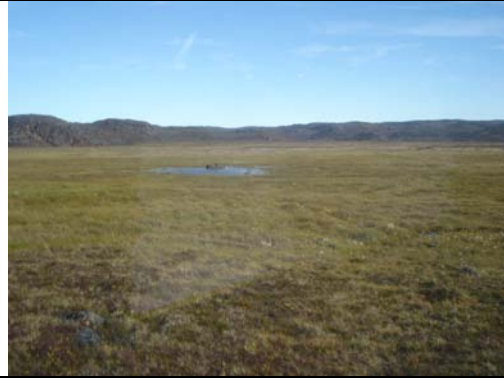
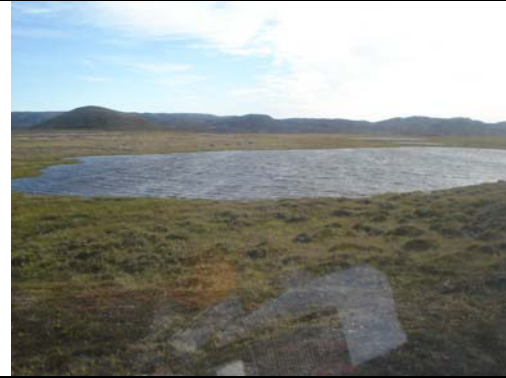
Figure 1. View of crossing area (A), view upstream of crossing (B), view downstream of crossing (C).

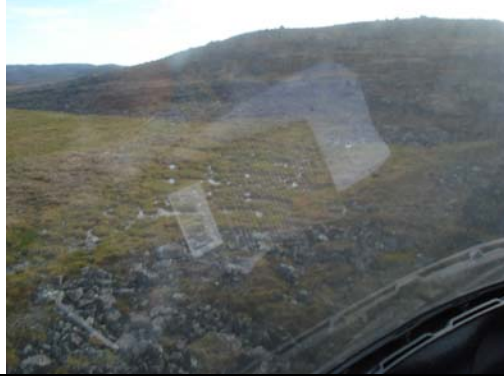
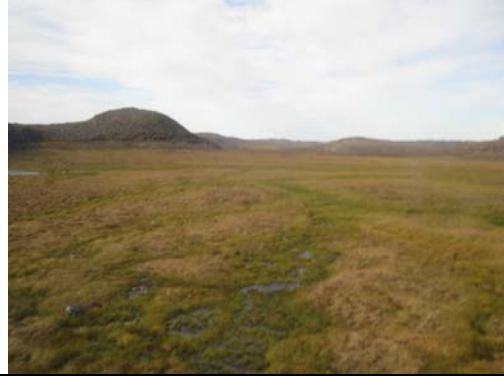
Figure 1. Aerial view of crossing looking upstream (A), aerial view of crossing looking downstream (B).

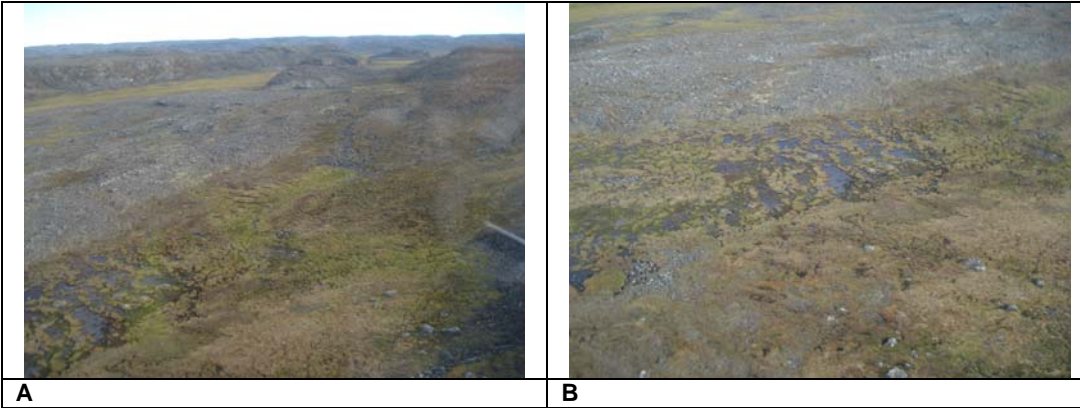
Figure 1. Aerial view of crossing location (A), close-up aerial view of crossing location (B).
