APPENDIX 5.1-3.

DETAILED HABITAT ASSESSMENTS AND SUMMARY OF RESULTS FOR ACCESS ROAD STREAM CROSSINGS.

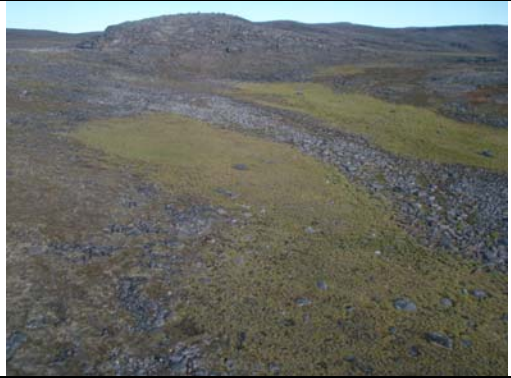
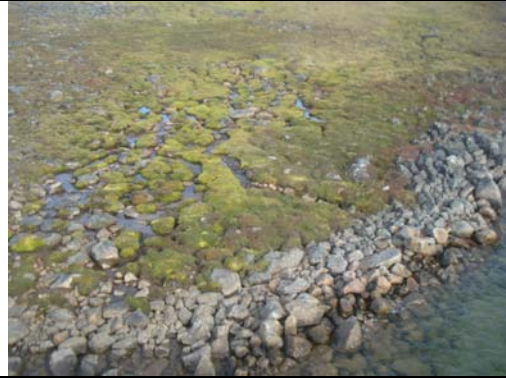
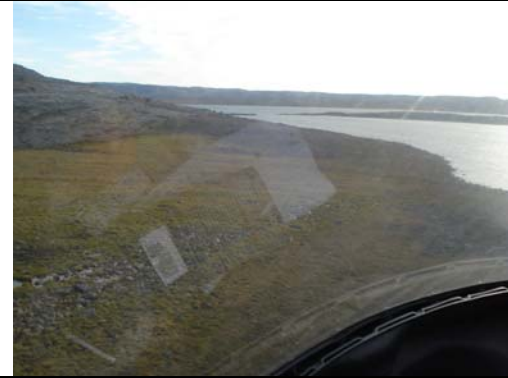
Figure 1. Aerial view looking upstream from crossing location (A), aerial view of drain inlet to waterbody (B), aerial view of crossing location (C).

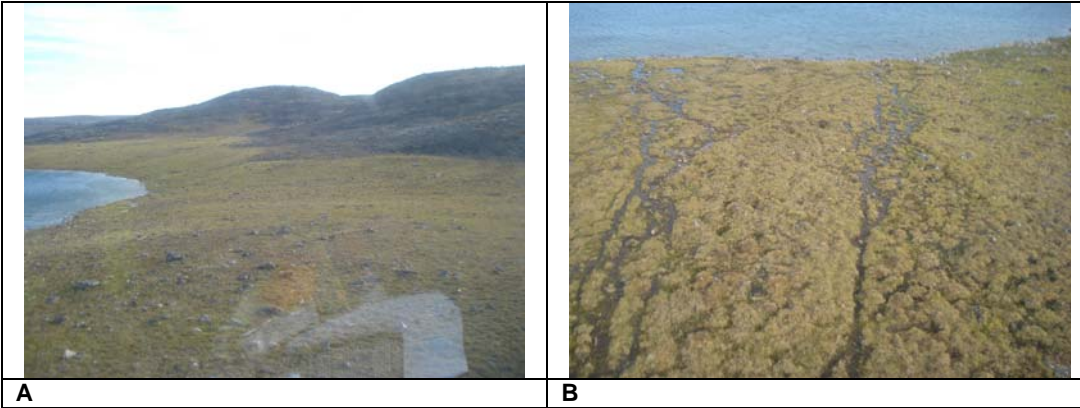
Figure 1. Aerial view of drainage (A), aerial view of crossing location (B)

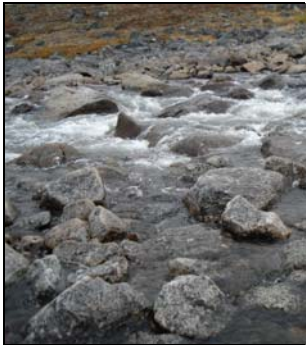
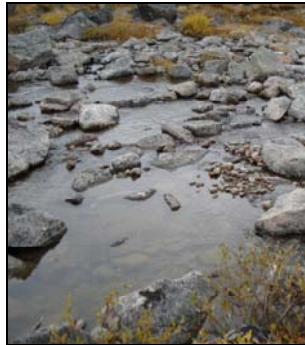
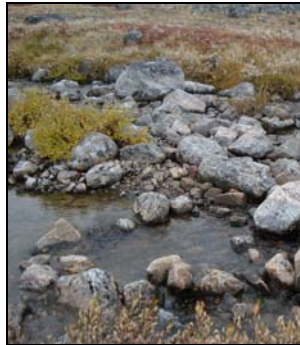
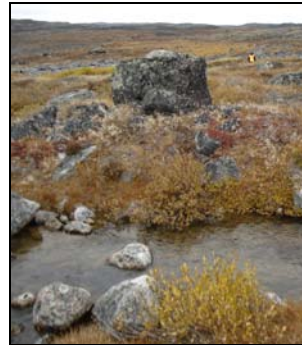
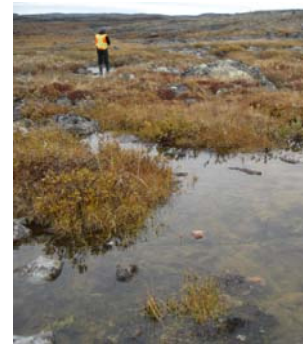
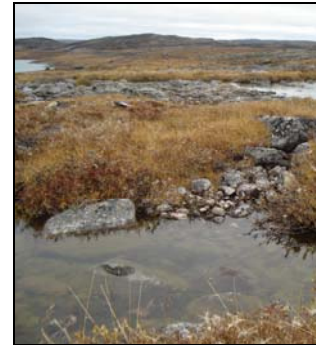
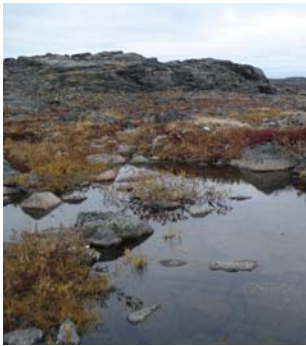
Figure 1. View of habitat 60 (A), 40 (B), and 20 m (C) downstream of crossing, at the crossing (D), and 20 (E), 40 (F), and 60 m (G) upstream of crossing.

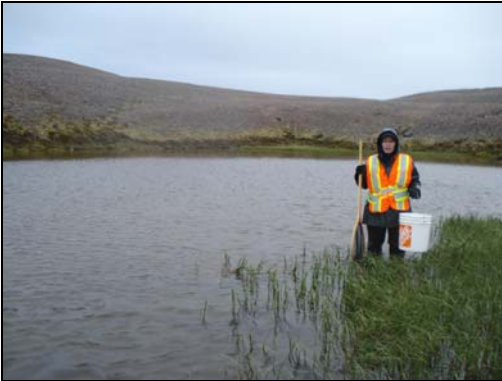
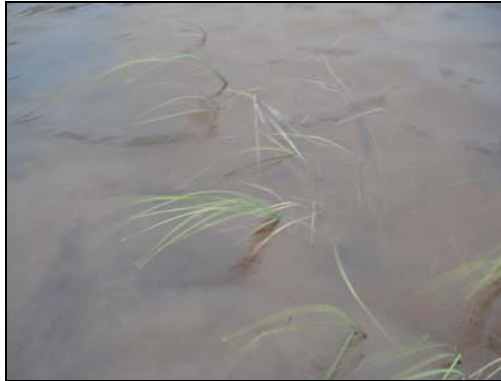
Figure 1. View of habitat (A) and substrate (B).

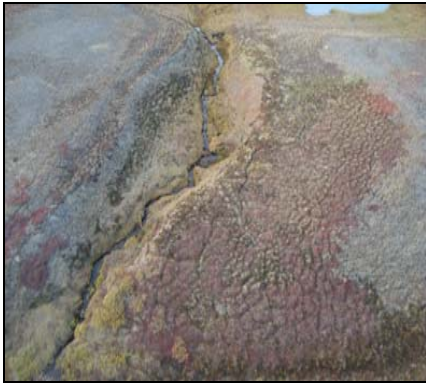
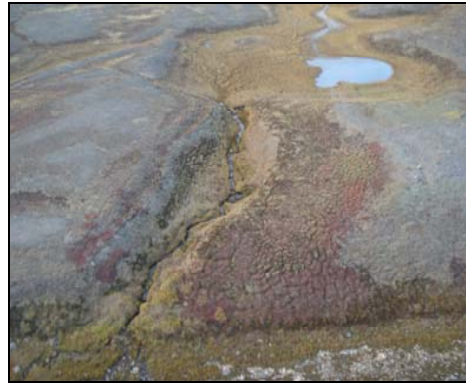
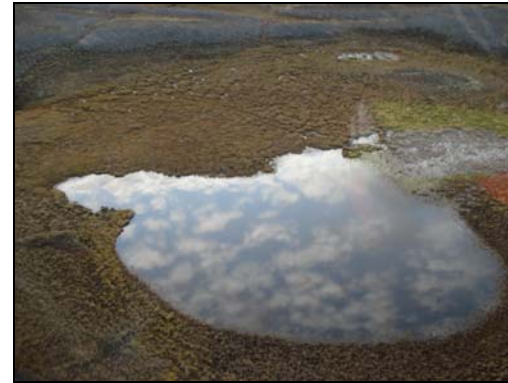
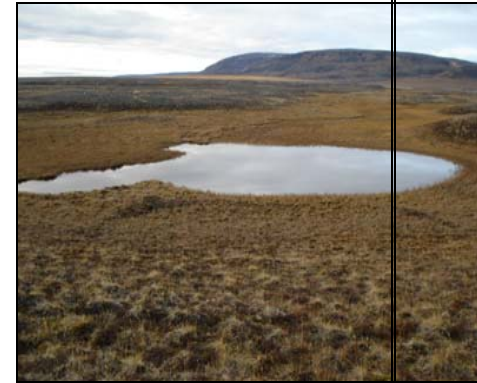
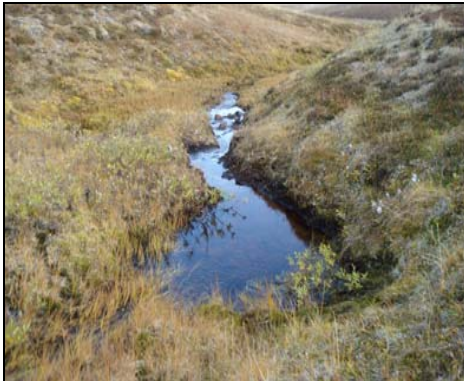
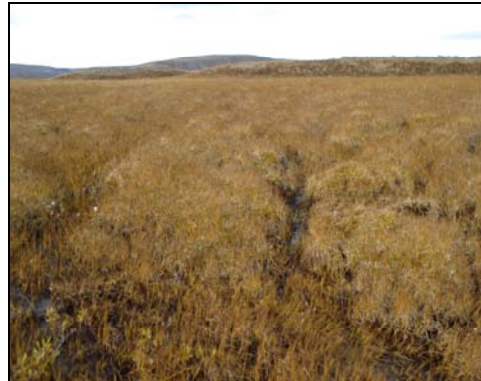
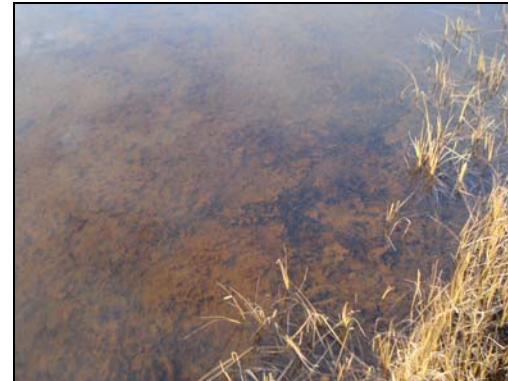
Figure 1. Aerial view of downstream stream (A), barrier between lake and downstream (B), lake (C), lake (D), disconnected stream downstream of lake (E), barrier downstream of lake (F), and lake substrate (G).

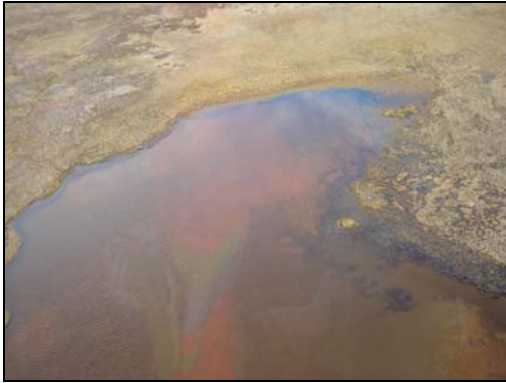
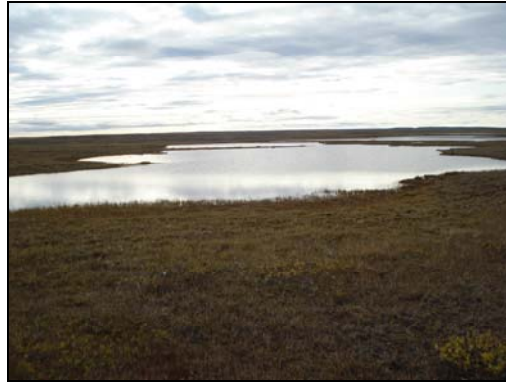
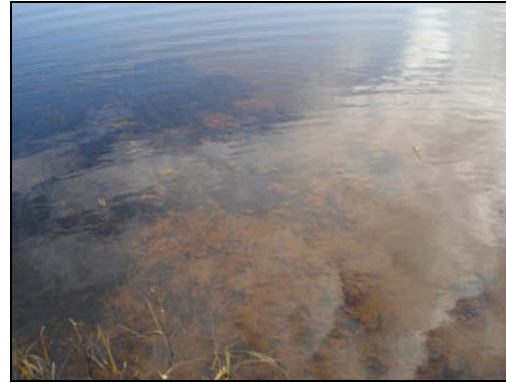
Figure 1. Aerial view of lake (A), lake (B), and substrate of lake (C).

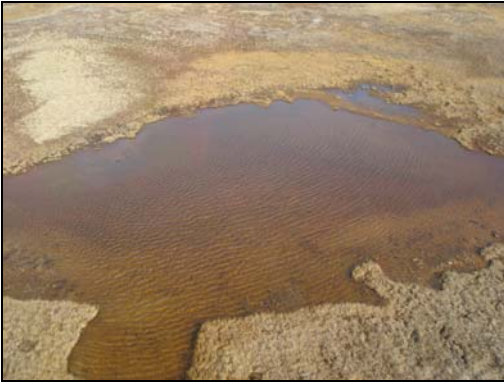
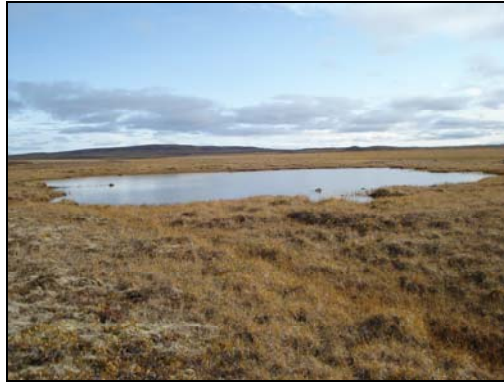
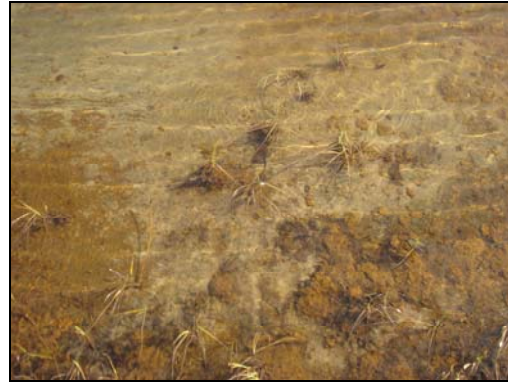
Figure 1. Aerial view of lake (A), lake (B), and substrate (C).

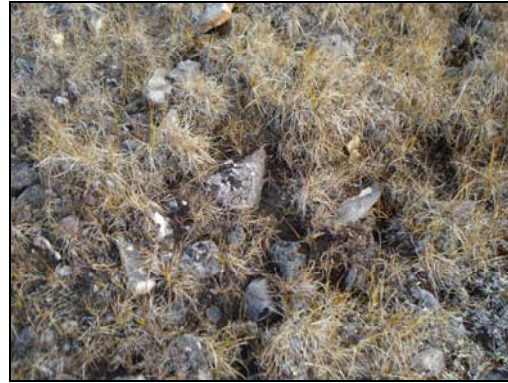
B

Figure 1. View of nearby lake (A), nearby lake substrate (B), and substrate at the crossing (C).

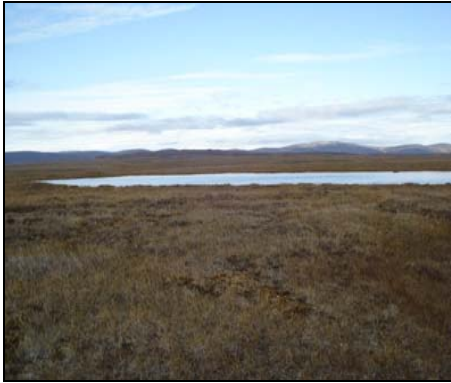
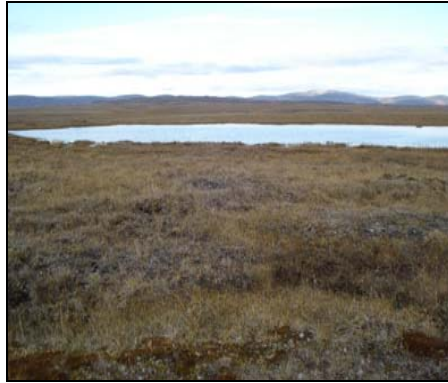
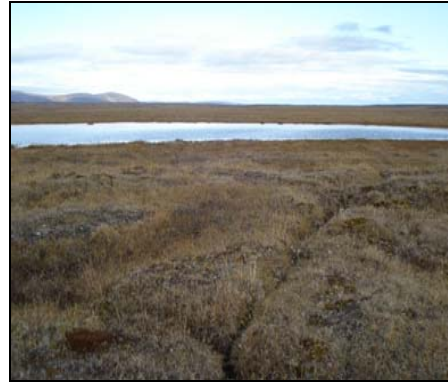
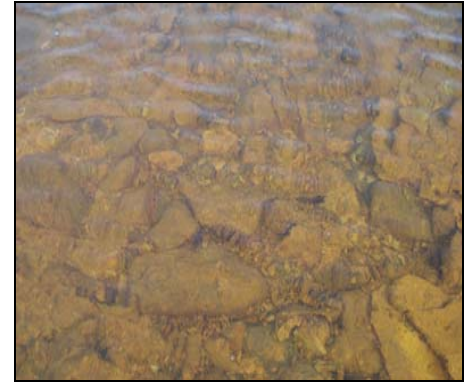
Figure 1. Views of lake (A-C), and lake substrate (D).

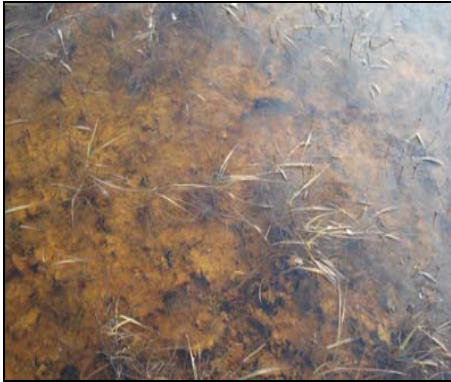
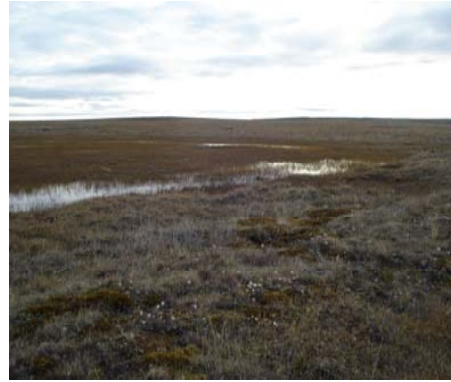
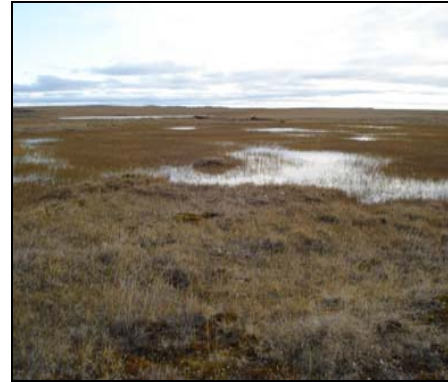
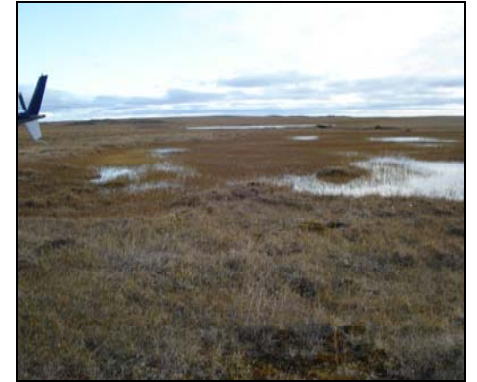
Figure 1. View of lake substrate (A), and lake from (B-D).

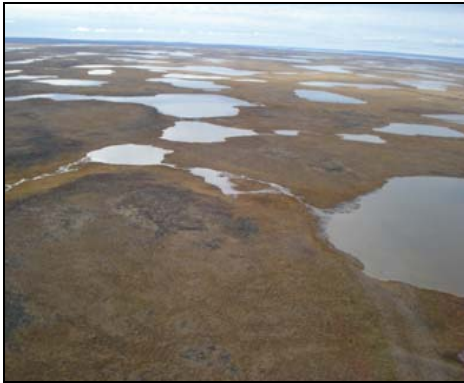
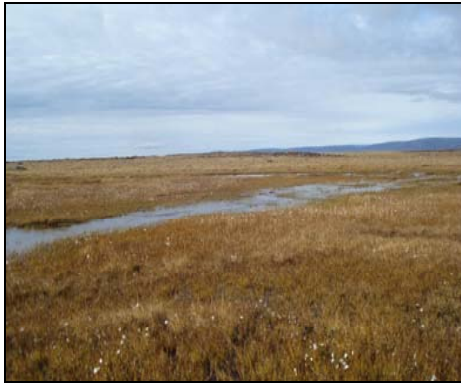
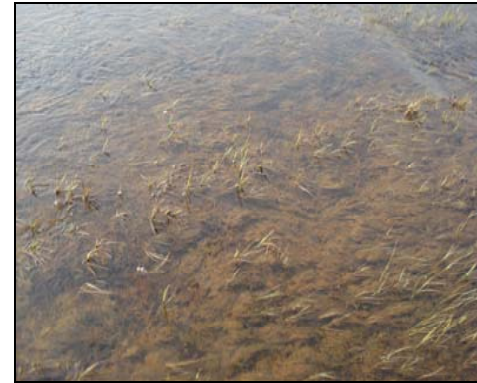
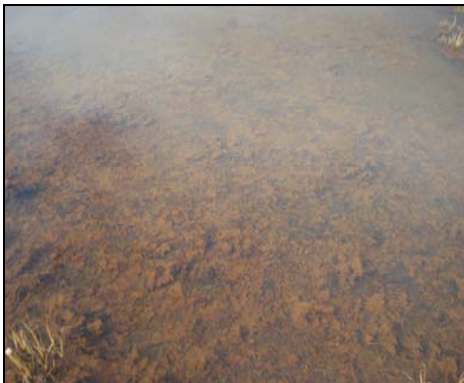
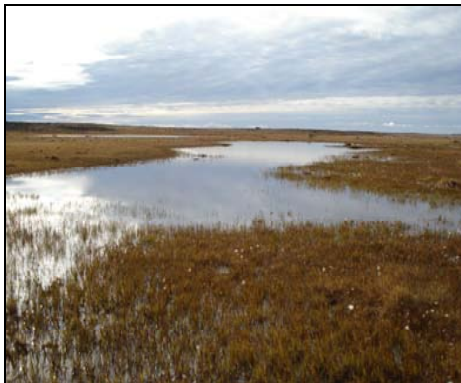
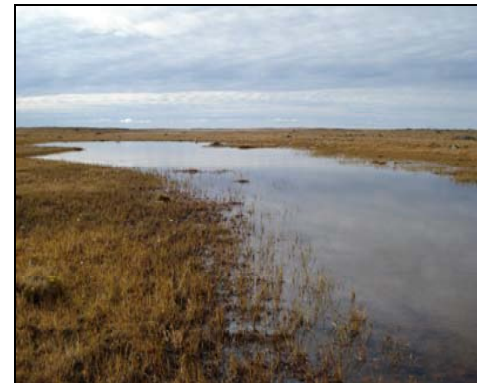
Figure 1. Aerial view of crossing between two ponds (A), crossing downstream (B), substrate and flow in downstream channel (C), crossing substrate (D), crossing upstream (E), and upstream pond (F).

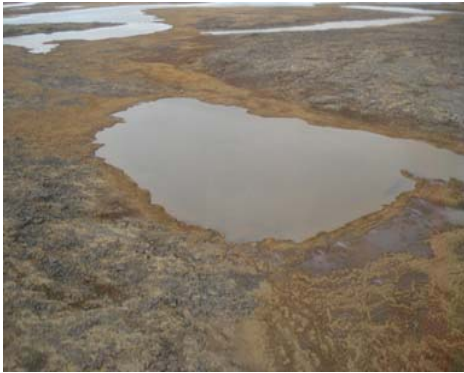
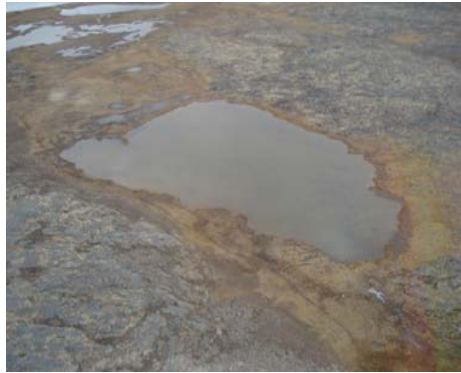
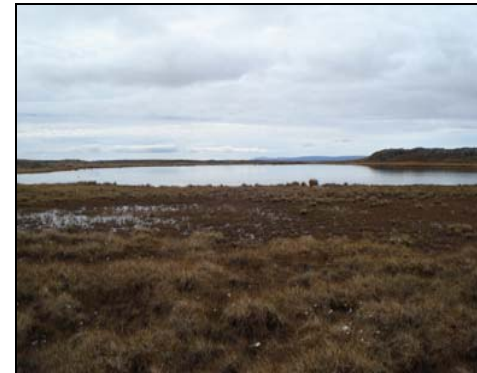
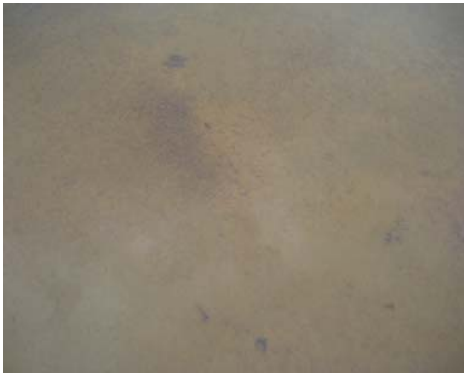
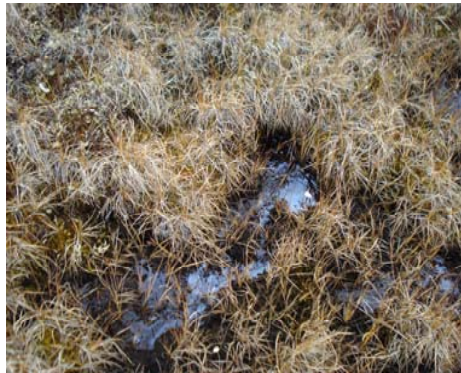
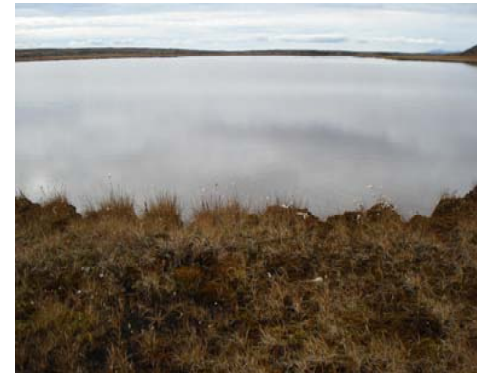
Figure 1. Aerial view of lake 1 (A), lake 2 (B), lake from ground (C), lake substrate (D), substrate of waypoint (E), and view of lake from waypoint (F).

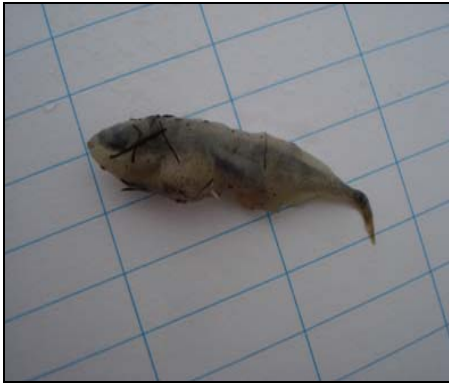
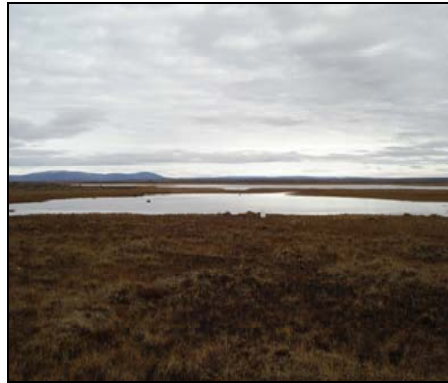
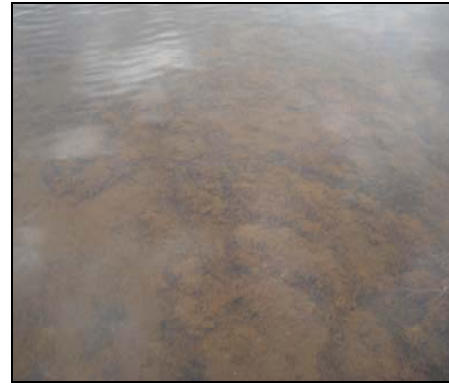
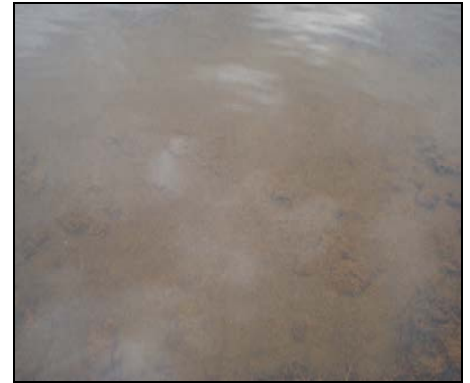
Figure 1. Dead fish found along shore (A), lake (B), and substrate of lake (C-D).

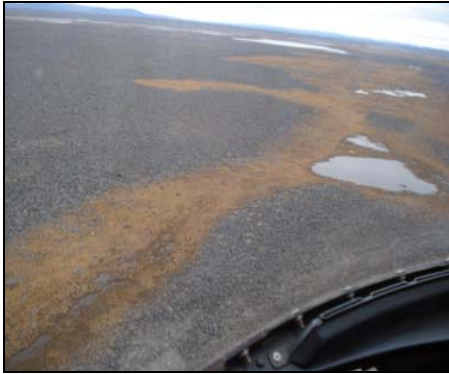
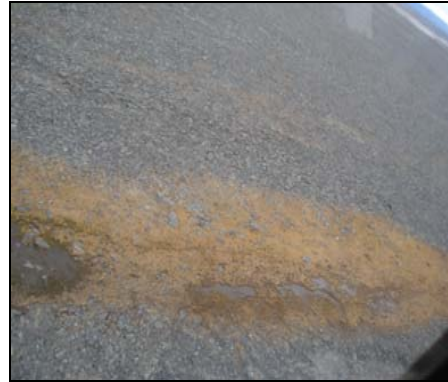
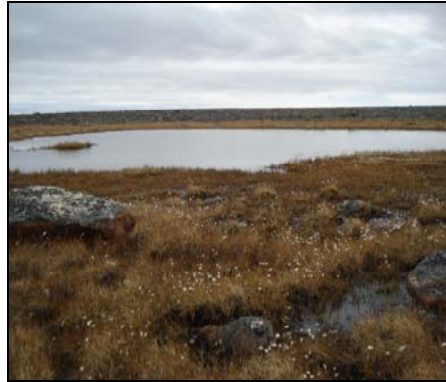
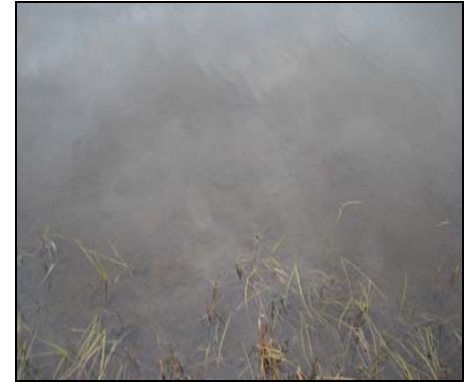
Figure 1. Aerial view of dry connection to overwintering lake (A-B), lake (C), and lake substrate (D).

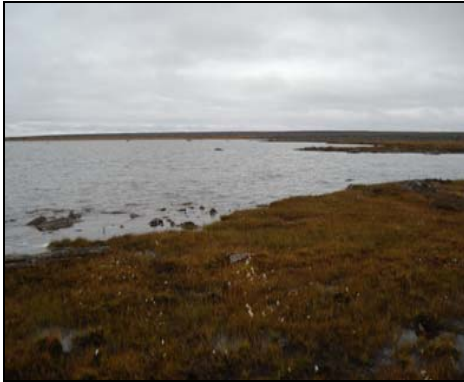
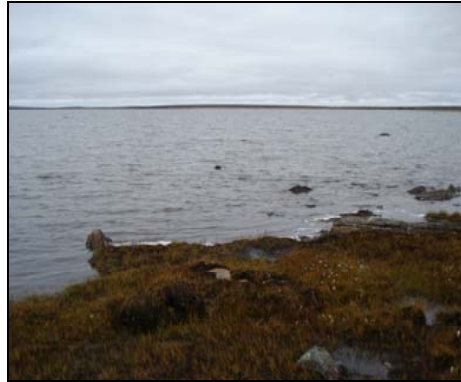
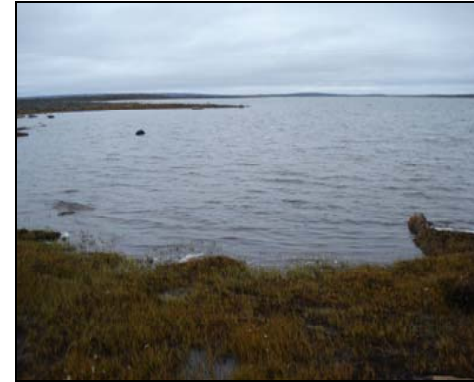
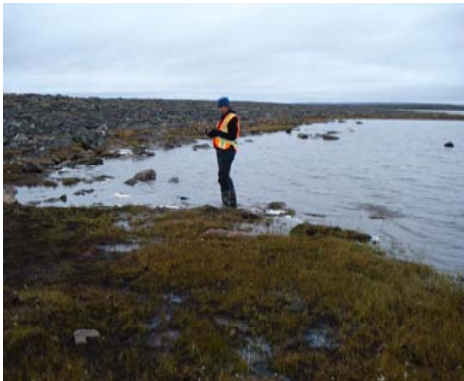
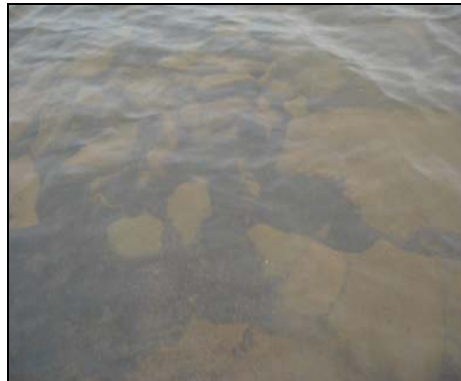
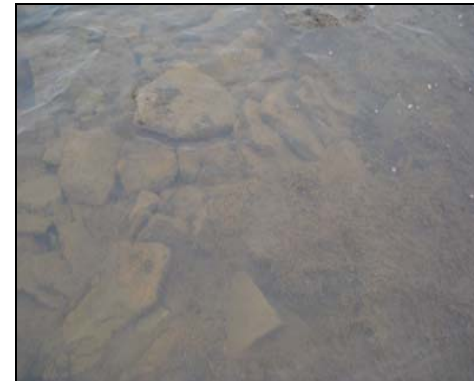
Figure 1. Views across lake (A-D), and lake substrate (E-F).

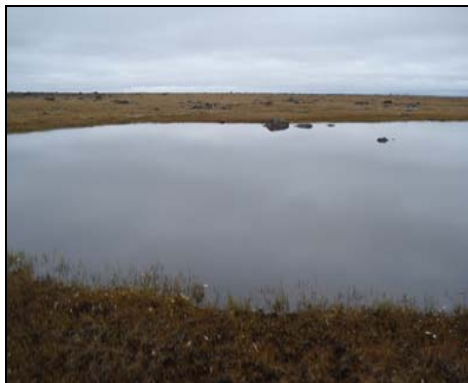
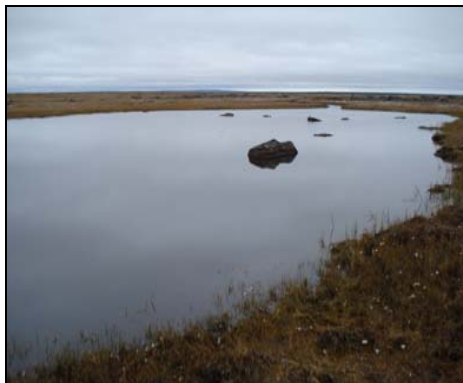
Figure 1. View of crossing across (A-B), and crossing substrate (C).

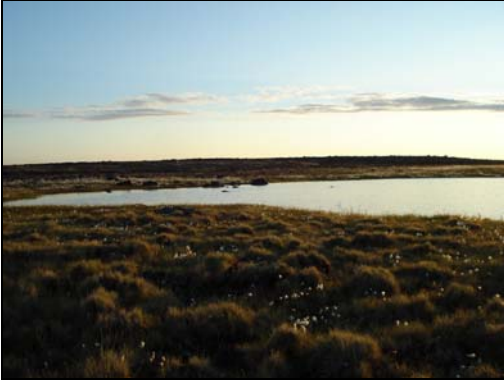
Figure 1. View of habitat (A).
