APPENDIX 5.3-1.

DETAILED HABITAT ASSESSMENTS AND SUMMARY OF RESULTS FOR WATERBODIES IN QUARRY SITES.

Table A5.3-1.1. Summary of results from surveys and assessments that fall within Quarry boundaries.

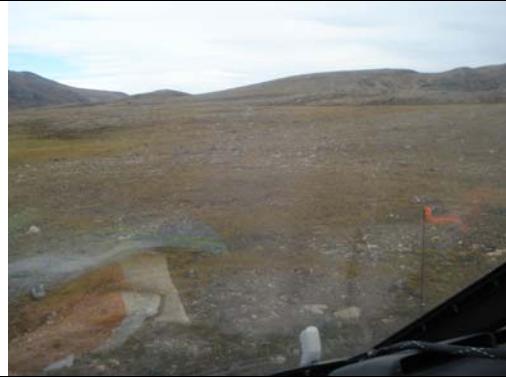
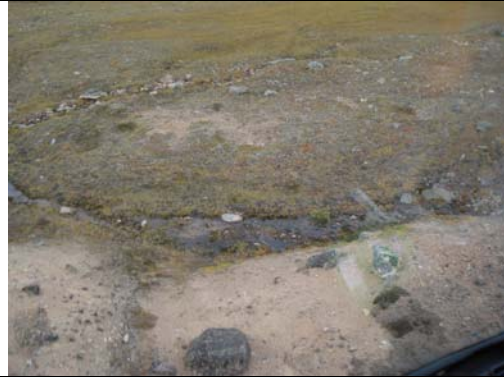
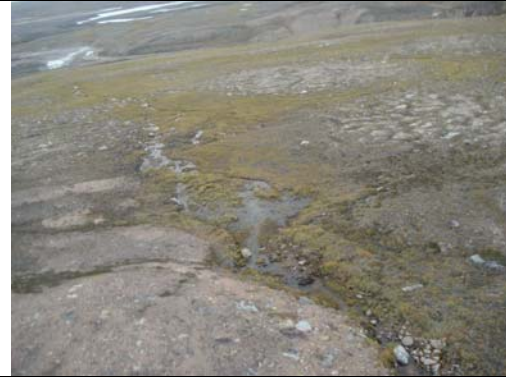
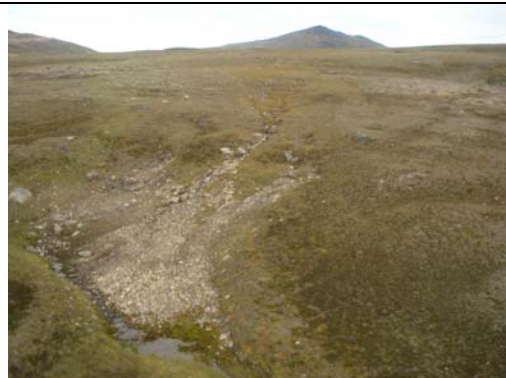
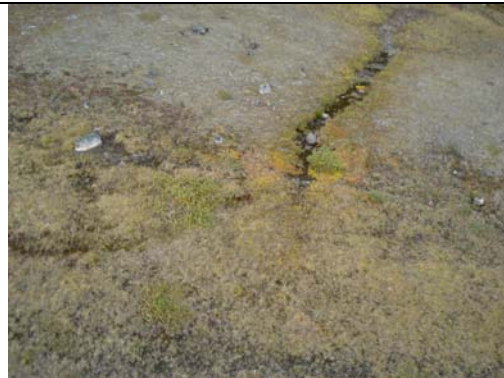
Figure 1. Upstream from site coordinates (A), view near coordinates (B), view downstream from coordinates (C), view of steep gradient drop off and the beginning of some channel development approximately 250 m downstream from coordinates (D), discontinuous channel downstream of D (E).

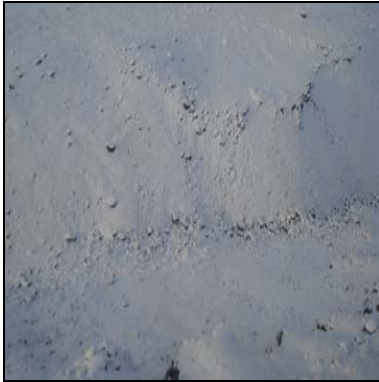
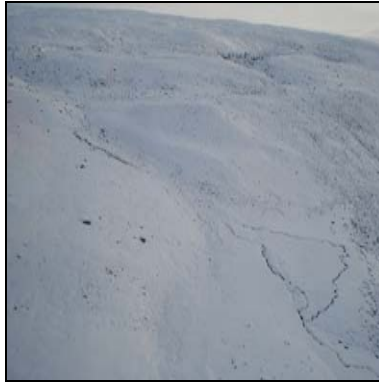
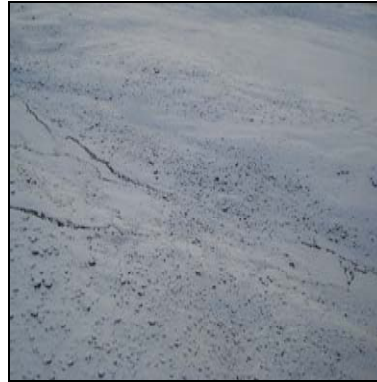
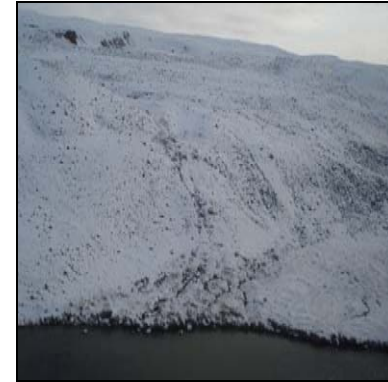
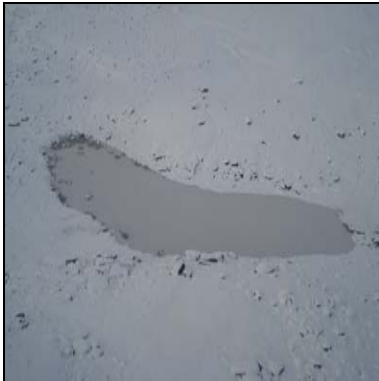
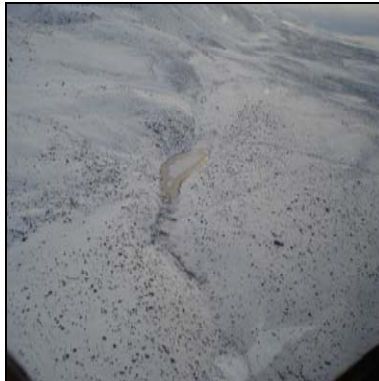
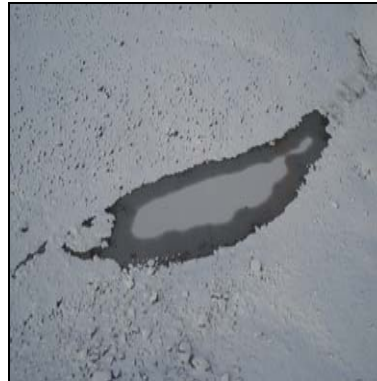
Figure 1. View of dry or frozen channel (A-C), downstream barrier (D), frozen pond (E), and high altitude lake (F-G).

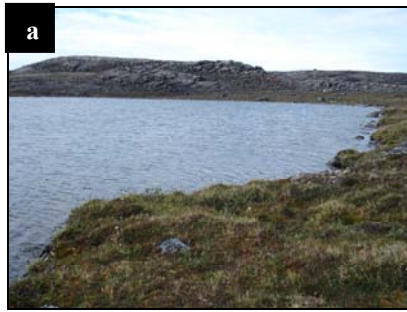
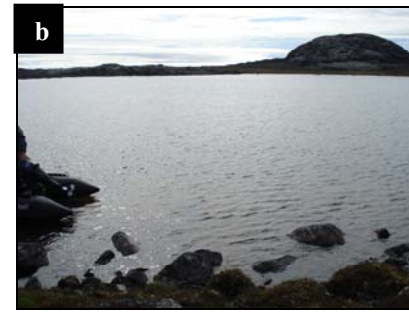
Figure 1. Pan view from north shore of ST-029 during summer (a and b) 2008.

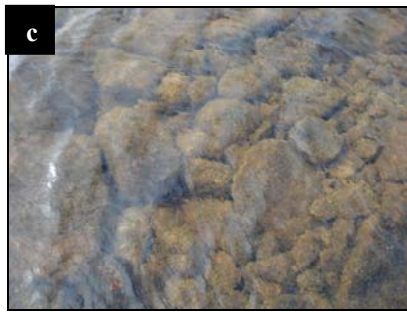
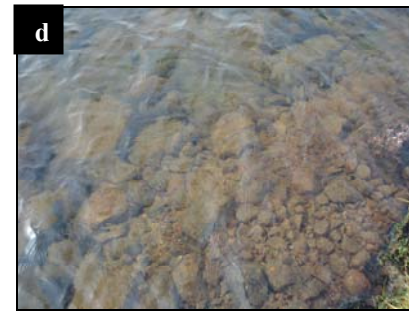
Figure 2. View of substrate along north shore (c and d) of ST-029 during summer 2008.

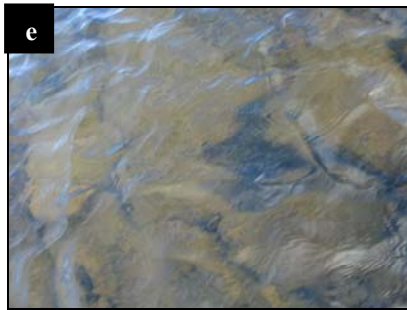
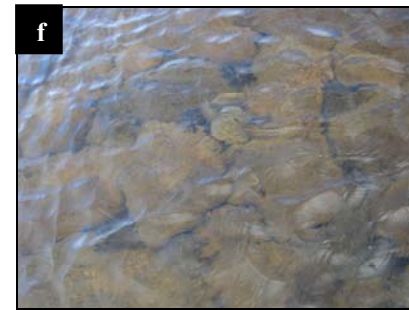
Figure 3. View of substrate near gill net set (e and f) in ST-029 during summer 2008.

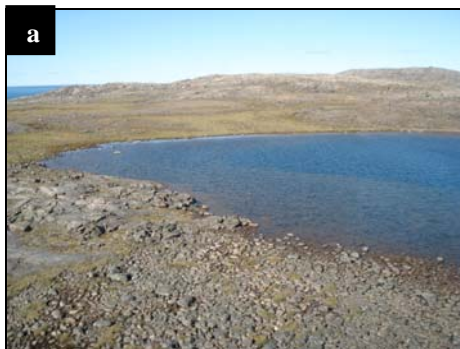
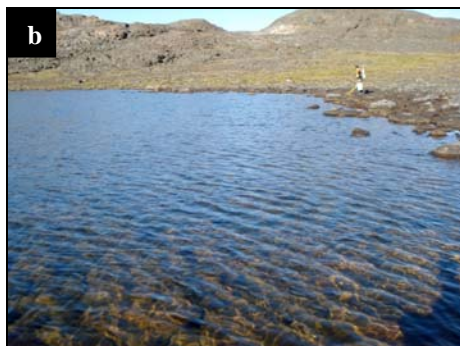
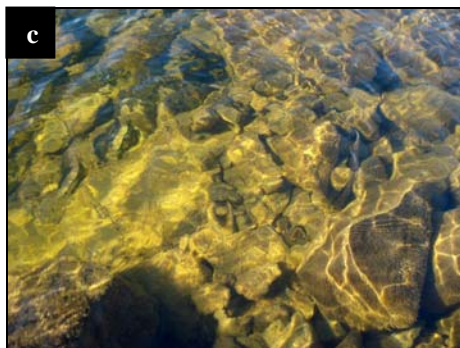
Figure 1. Aerial view of ST-029 (a), view from the shoreline (b), and substrate (c).

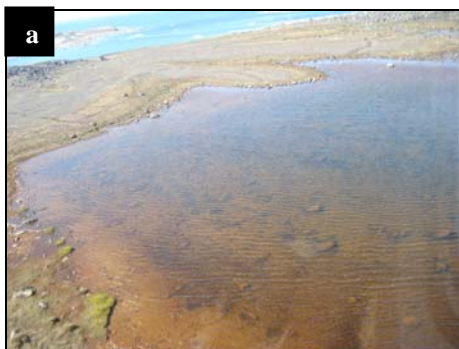
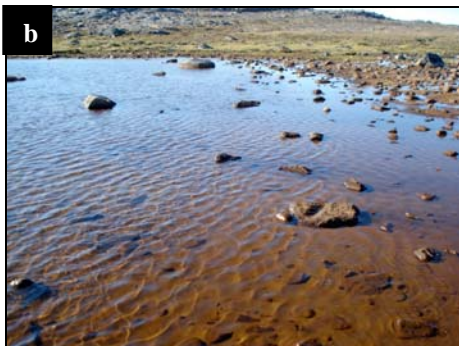
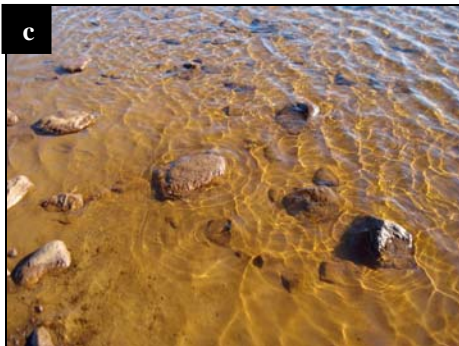
Figure 1. Aerial view of ST-030 (a), view from the shoreline (b), and substrate (c).

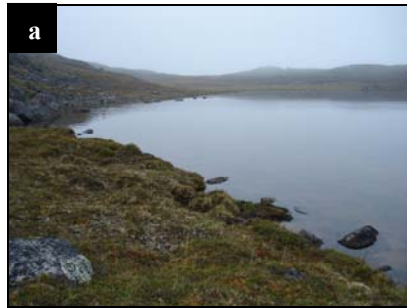
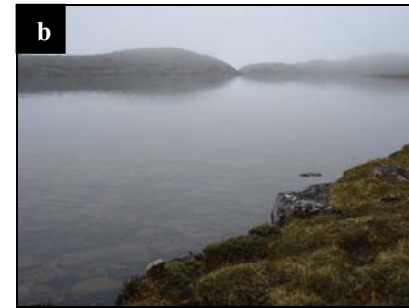
Figure 1. View of ST-032 from shore during summer (a and b) 2008.

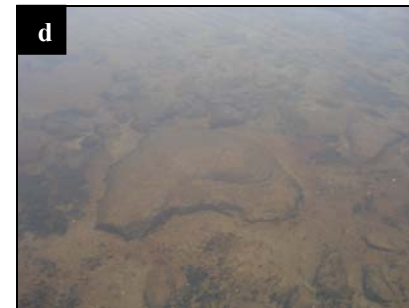
Figure 2 View of substrate (c and d) in ST-032 during summer 2008.

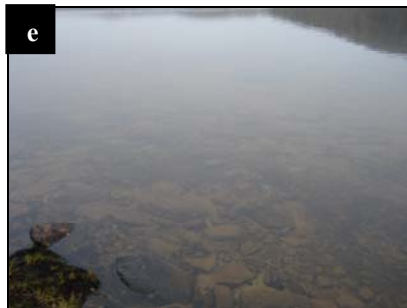
Figure 3. View of substrate (e) in ST-032 during summer 2008.

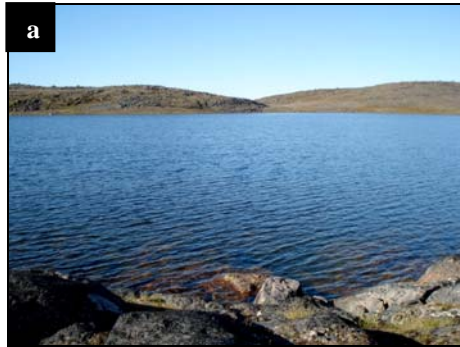
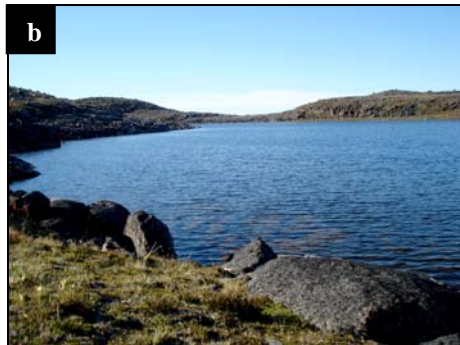
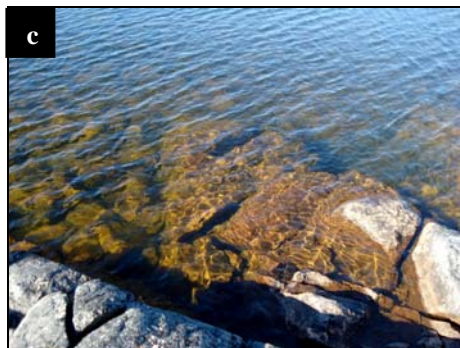
Figure 1. Aerial view of ST-032 (a), view from the shoreline (b), and substrate (c).

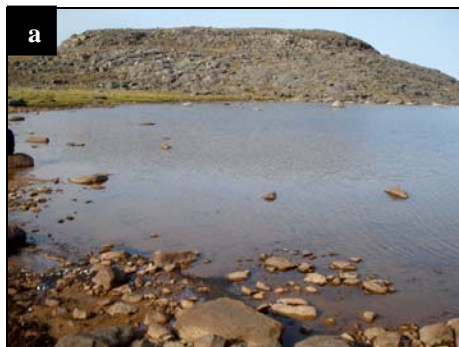
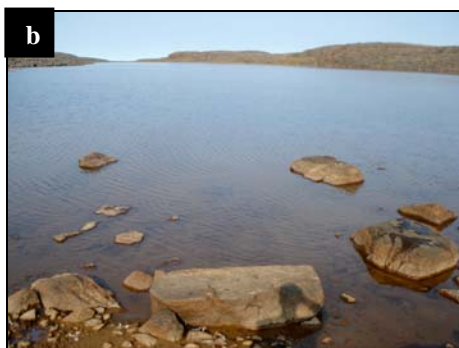
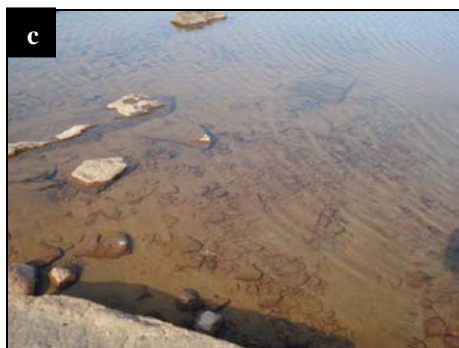
Figure 1. Aerial view of ST-038 (a), view from the shoreline (b), and substrate (c).

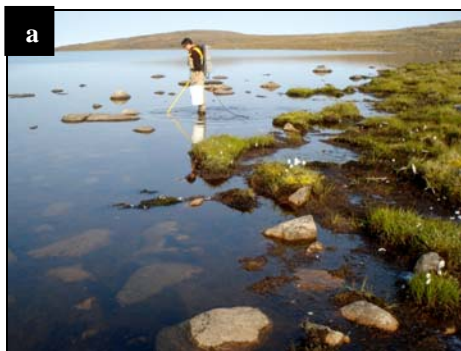
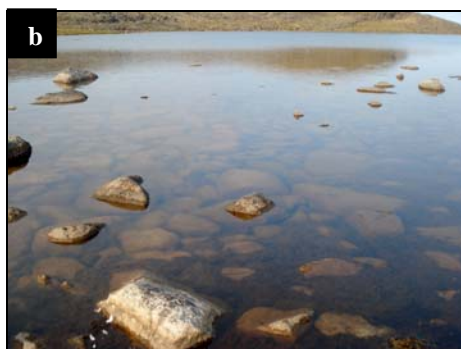
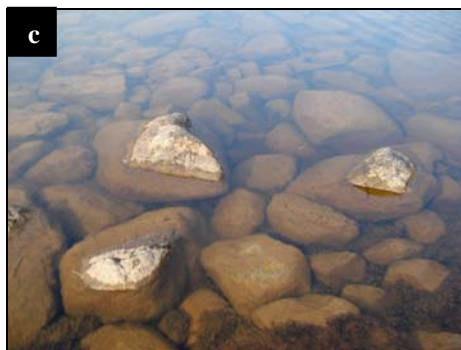
Figure 1. Aerial view of ST-039 (a), view from the shoreline (b), and substrate (c).

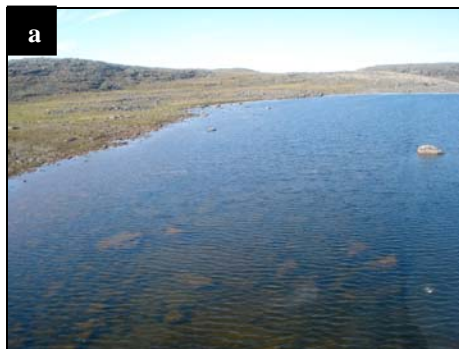
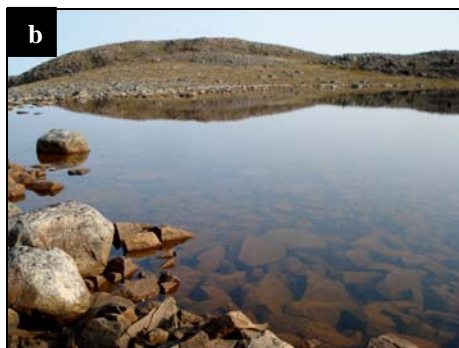
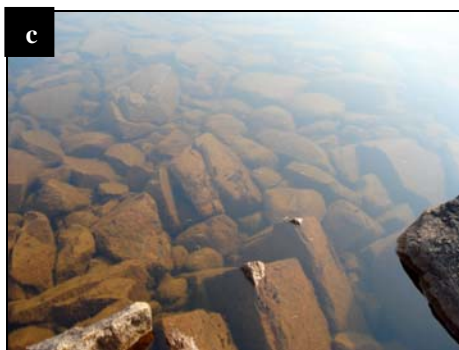
Figure 1. Aerial view of ST-040 (a), view from the shoreline (b), and substrate (c).

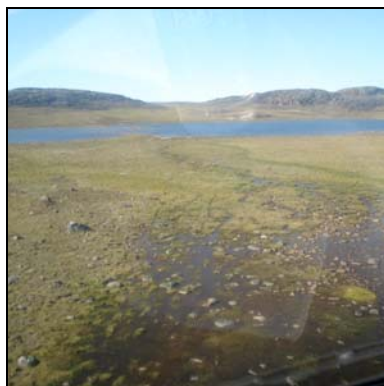
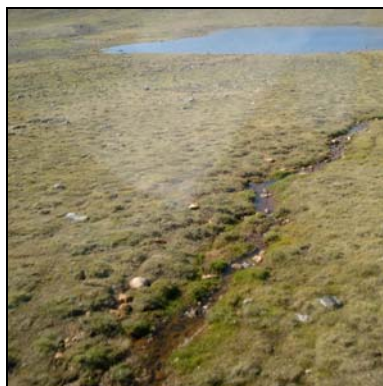
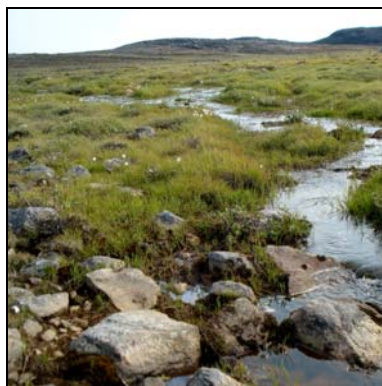
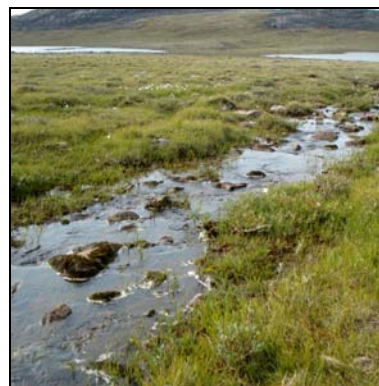
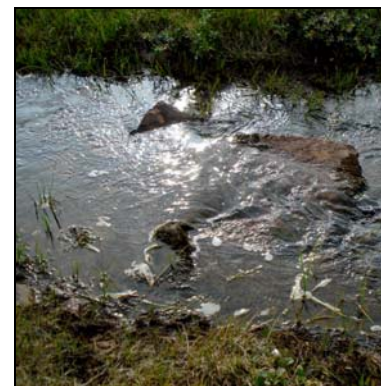
Figure 1. (A) Upstream and (B) downstream aerial views of stream SPS-002b; (C) view upstream of the habitat assessment; (D) view downstream of the habitat assessment; (E) view across the habitat assessment .

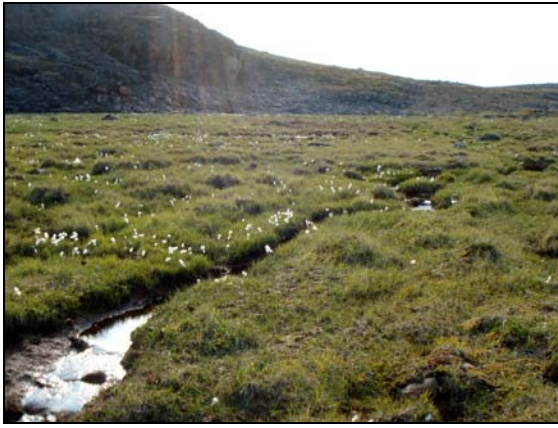
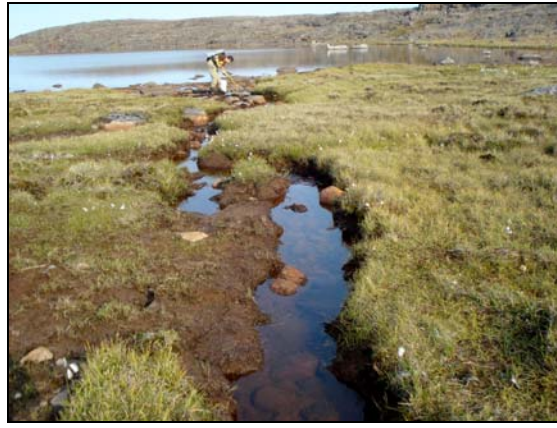
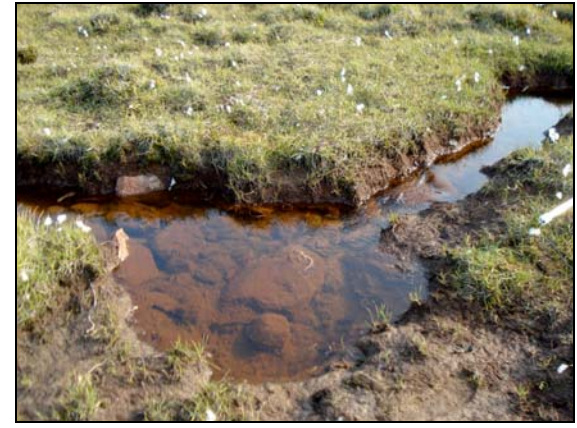
Figure 1. (A) view upstream of habitat assessment; (B) view downstream of habitat assessment; and (C) view across the habitat assessment site.

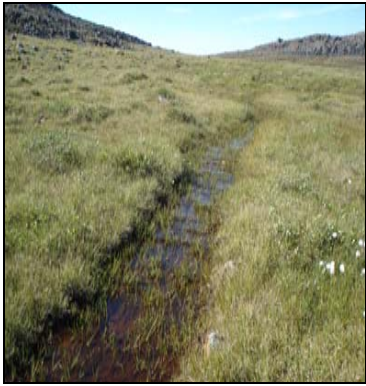
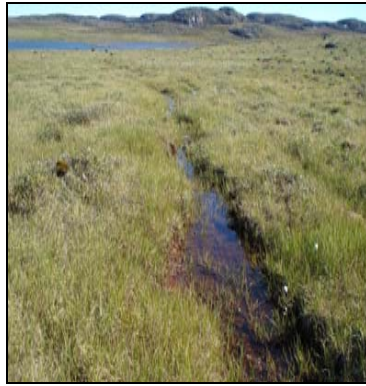
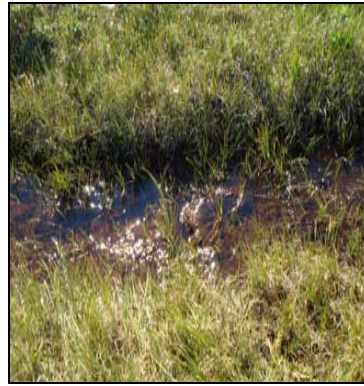
Figure 1. (A) view upstream of the habitat assessment; (B) view downstream of the habitat assessment; (C) view across the habitat assessment.

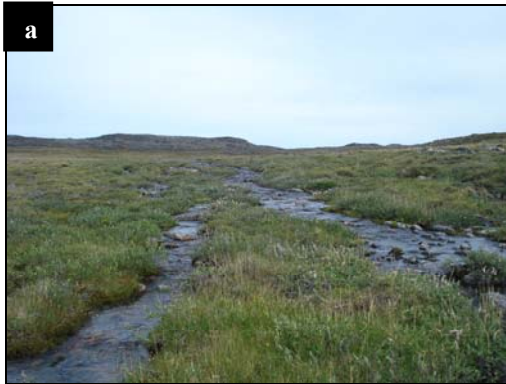
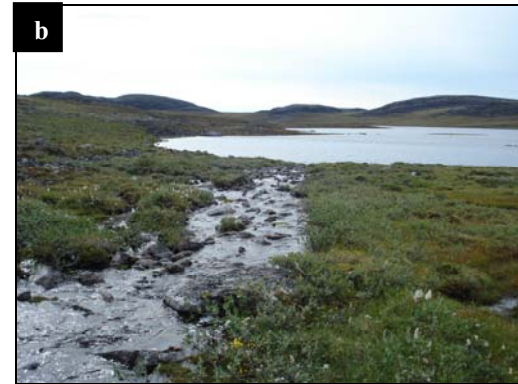
Figure 1. View upstream (a) and downstream (b) from habitat assessment of SPS-002i during summer 2008.

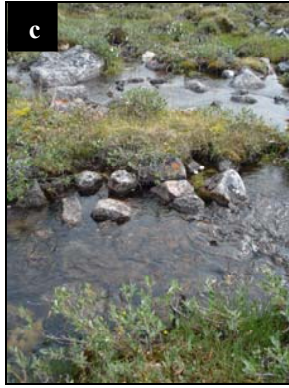
Figure 3. View across (c) the habitat assessment site of SPS-002i during summer 2008.

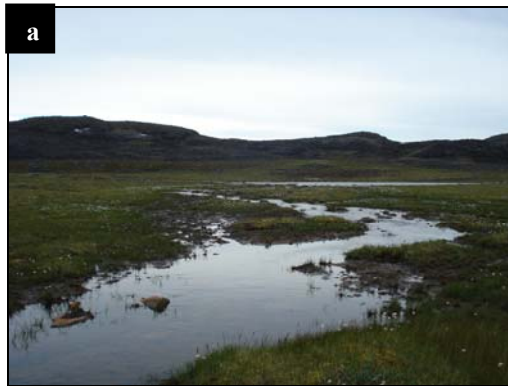
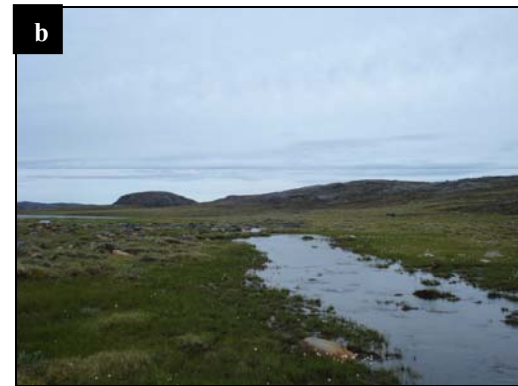
Figure 1. View upstream (a) and downstream (b) from habitat assessment in reach 1 of SPS-017 during summer 2008.

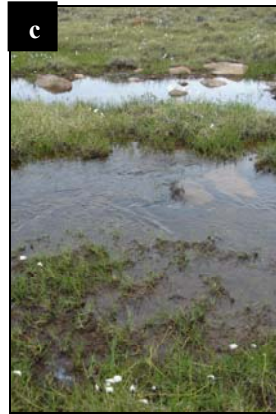
Figure 2. View across (c) the habitat assessment site in reach 1 of SPS-017 during summer 2008.

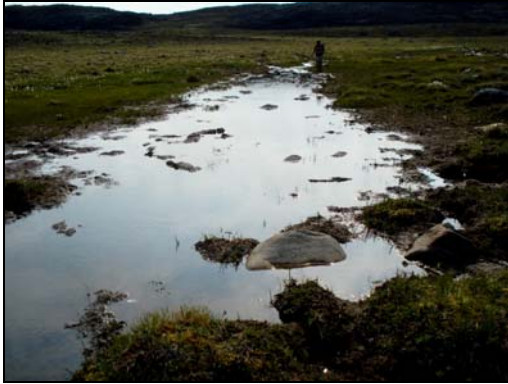
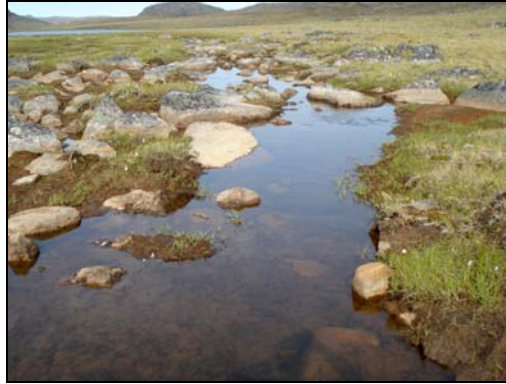
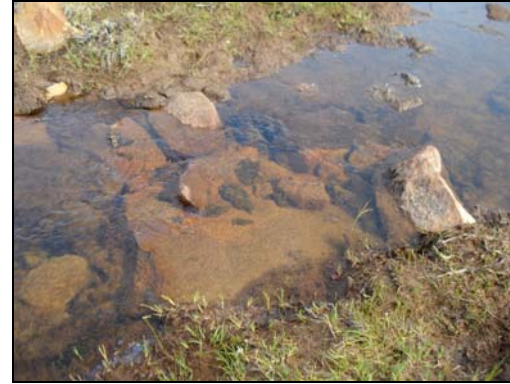
Figure 1. (A) view upstream of habitat assessment; (B) view downstream of habitat assessment; and (C) view across habitat assessment.

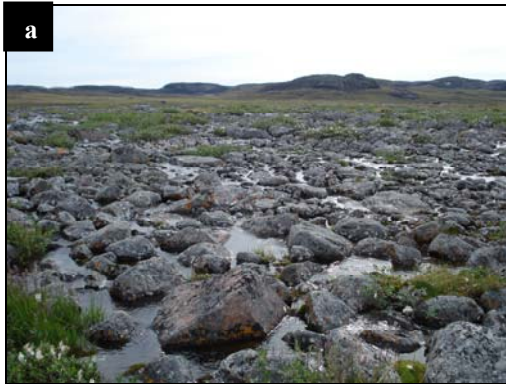
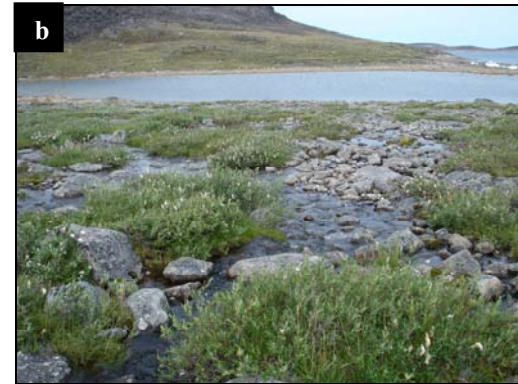
Figure 1. View upstream (a) and downstream (b) from habitat assessment of SPS-022 during summer 2008.

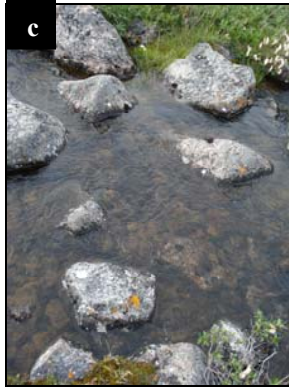
Figure 2. View across (c) the habitat assessment site of SPS-022 during summer 2008.

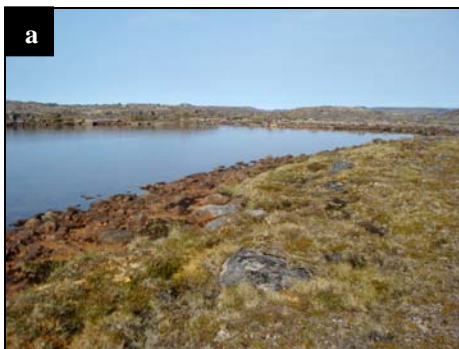
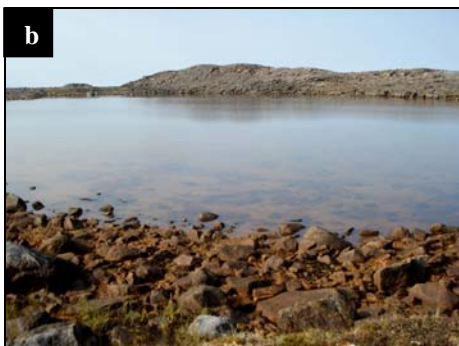
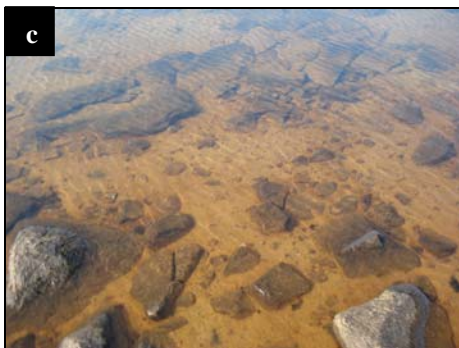
Figure 1. View from the shoreline of ST-085 (a,b) and substrate (c).

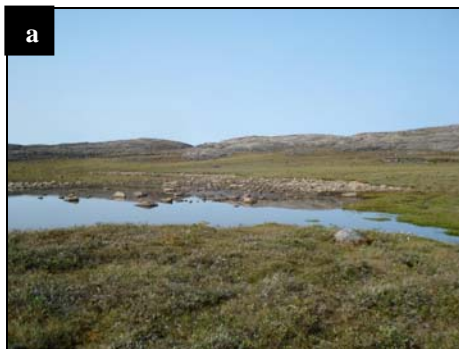
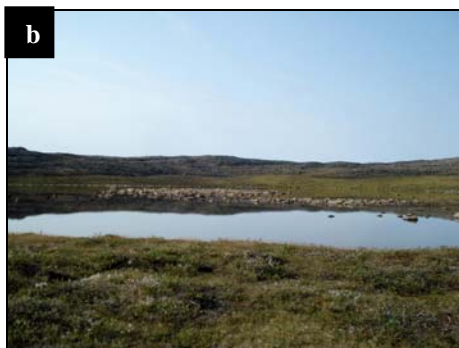
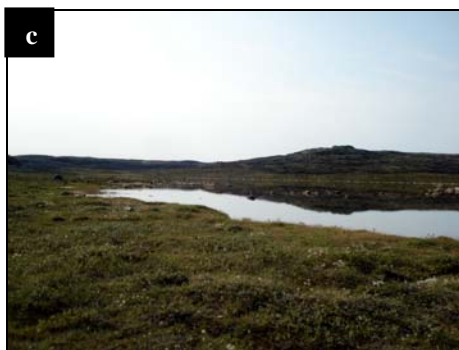
Figure 1. View from the shoreline of ST-086 (a,b,c).

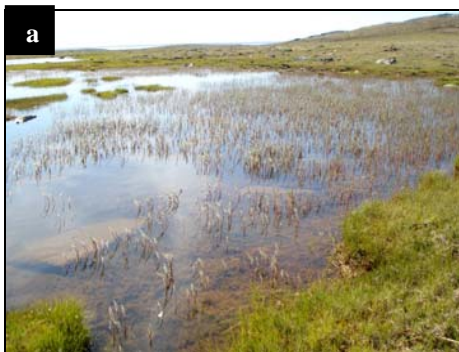
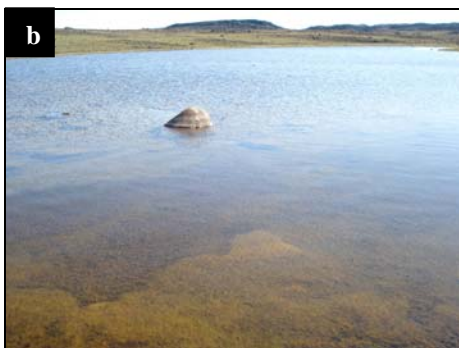
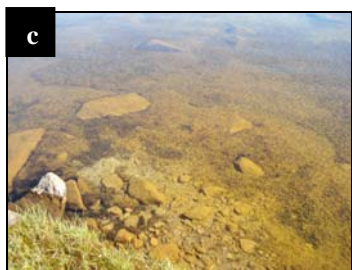
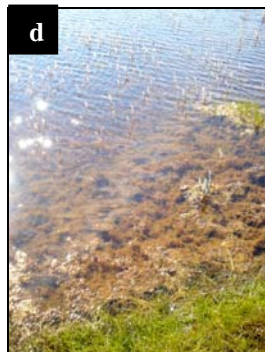
Figure 1. View from the shoreline of ST-061-062 (a,b), and substrate (c,d).

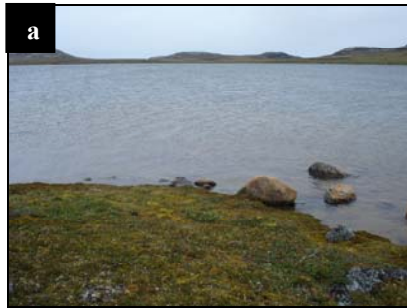
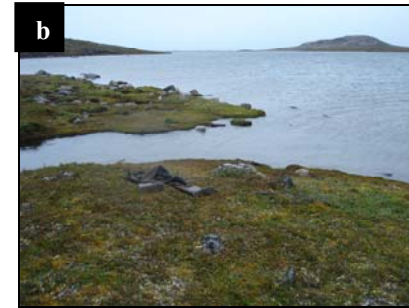
Figure 1. Pan view from SE shore of ST-063 during summer (a and b) 2008.

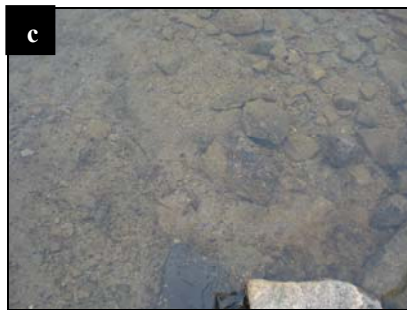
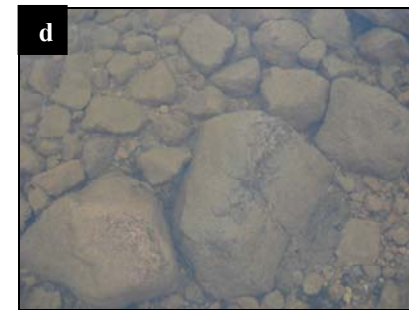
Figure 2. View of substrate along SE shore (c and d) of ST-063 during summer 2008.

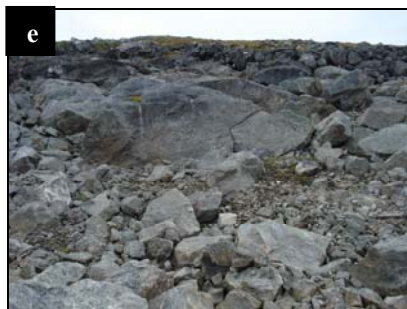
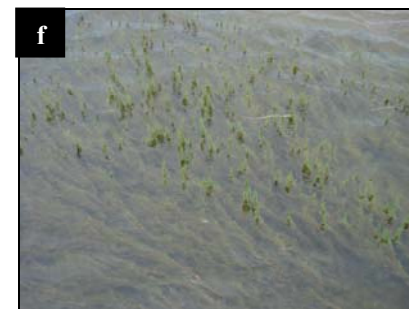
Figure 3. View of SE shore bedrock (e) and SE shore macrophytes (f) of ST-063 during summer 2008.

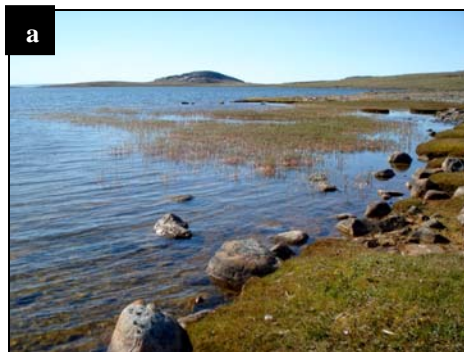
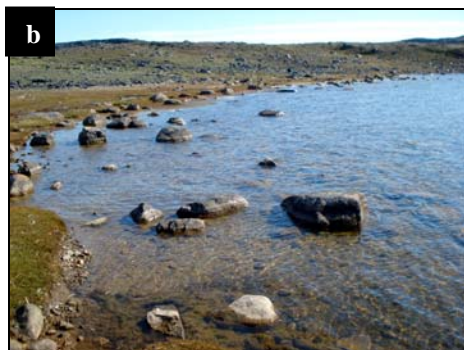
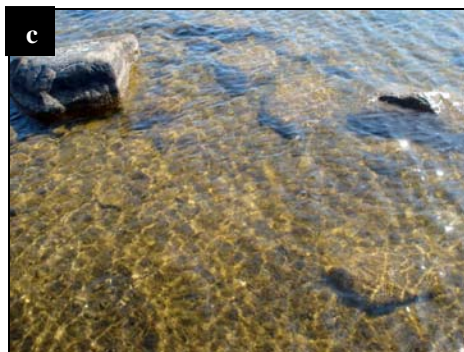
Figure 1. View from the shoreline of ST-063 (a,b) and substrate (c).

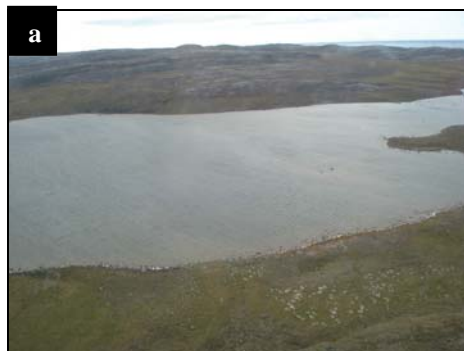
Figure 1. Aerial view of ST-064 (a).

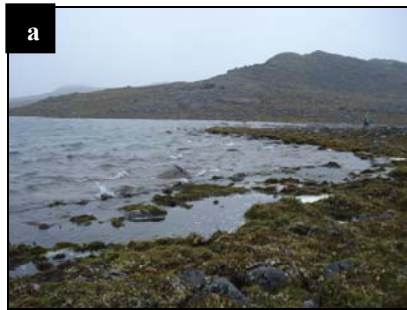
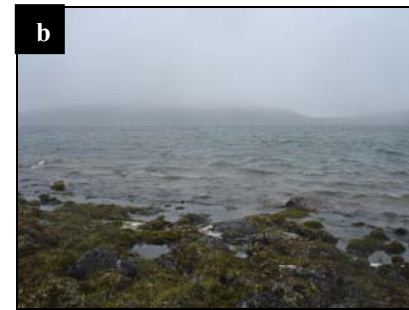
Figure 1. Pan view from west shore of ST-072 during summer (a and b) 2008.

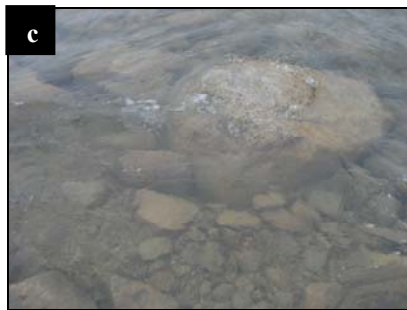
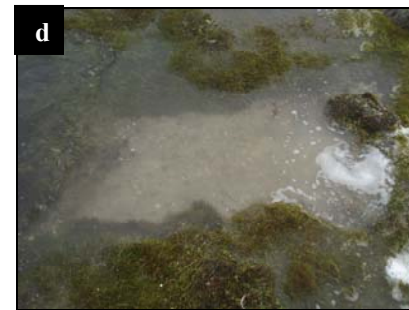
Figure 2. View of substrate along west shore (c and d) of ST-072 during summer 2008.

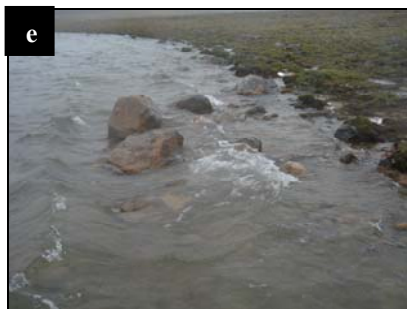
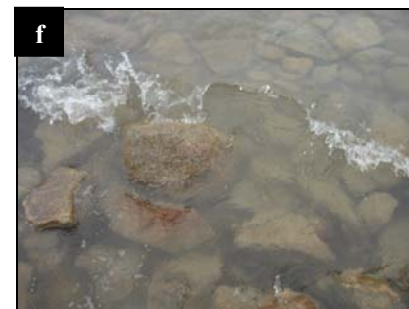
Figure 3. View of substrate along NW shore (e and f) of ST-072 during summer 2008.

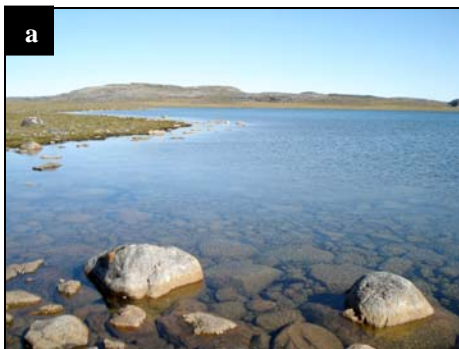
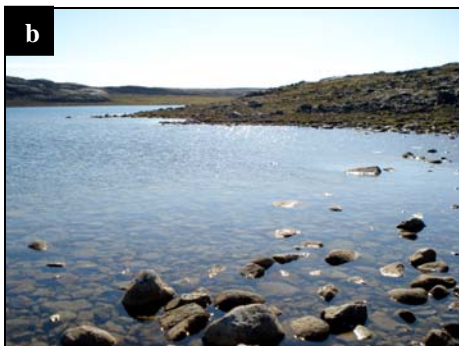
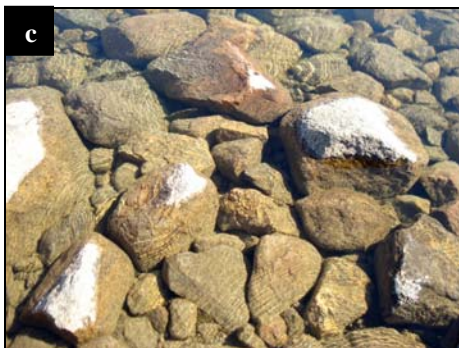
Figure 1. View from the shoreline of ST-072 (a,b) and substrate (c).

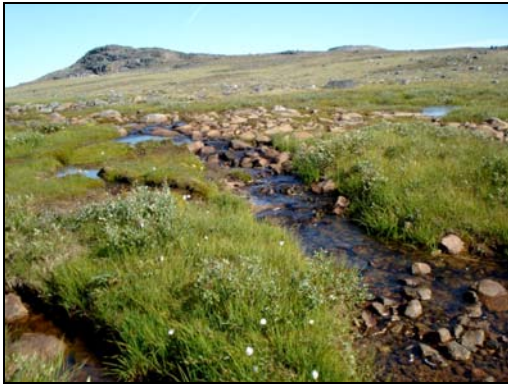
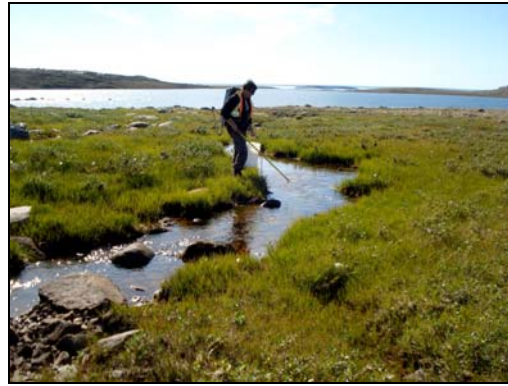
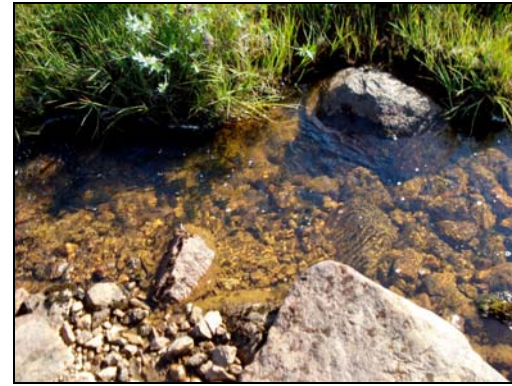
Figure 1. (A) view upstream of habitat assessment; (B) view downstream of habitat assessment; and (C) view across habitat assessment.

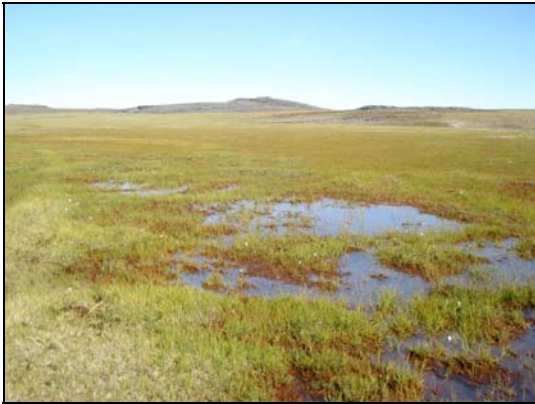
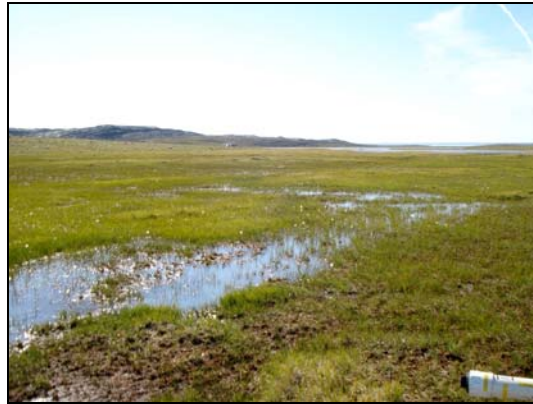
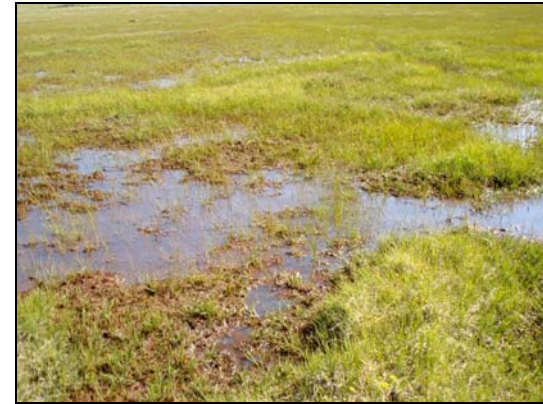
Figure 1. (A) view upstream of habitat assessment; (B) view downstream of habitat assessment; and (C) view across habitat assessment.

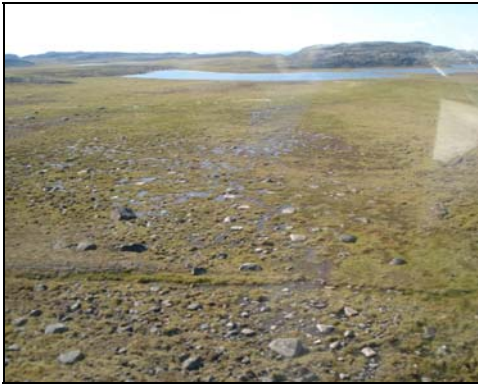
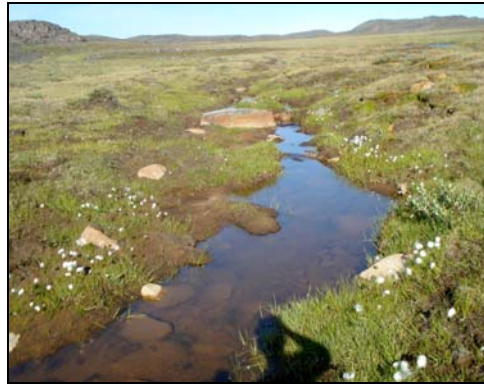
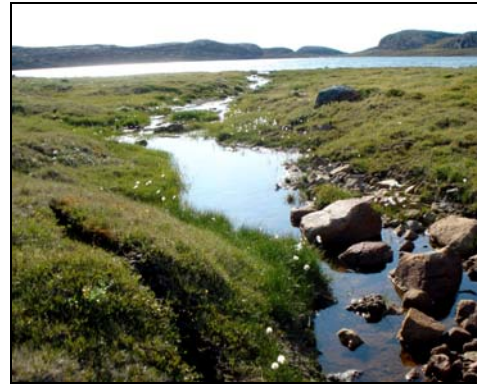
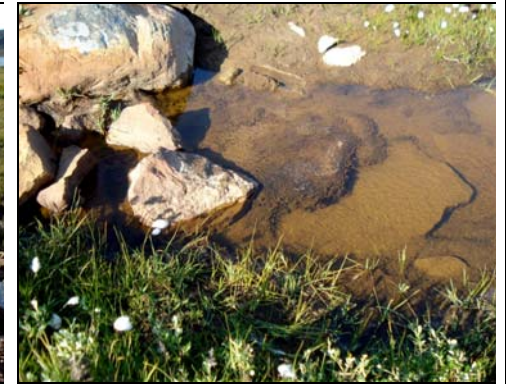
Figure 1. (A) Aerial view of stream SPS-005j; (B) view upstream of habitat assessment; (C) view downstream of habitat assessment; and (D) view across habitat assessment.

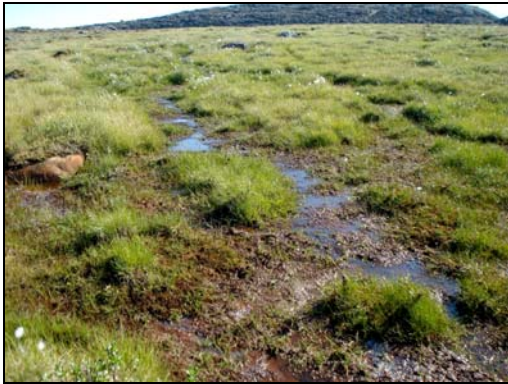
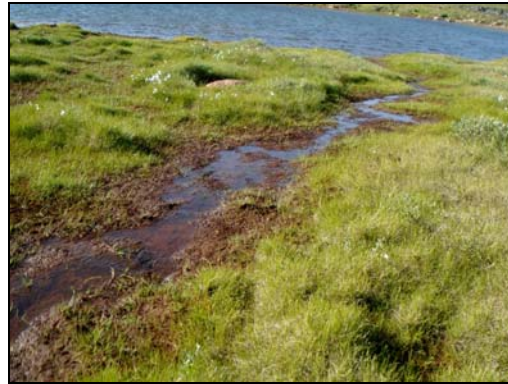
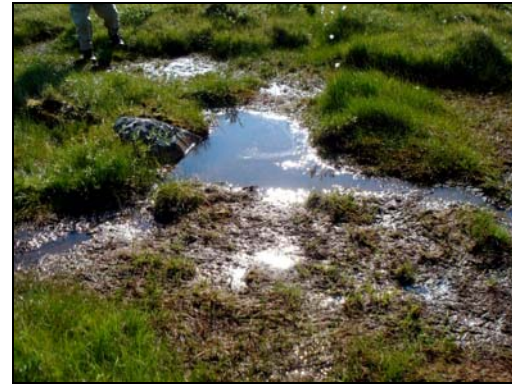
Figure 1. (A) view upstream of habitat assessment; (B) view downstream of habitat assessment; and (C) view across habitat assessment.

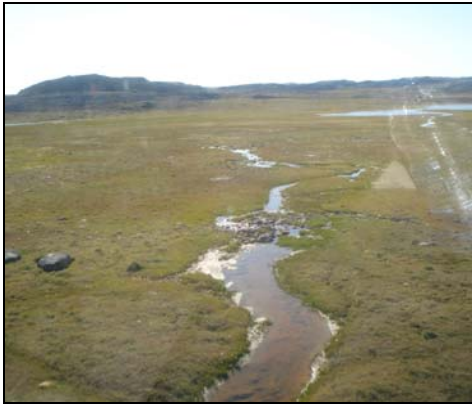
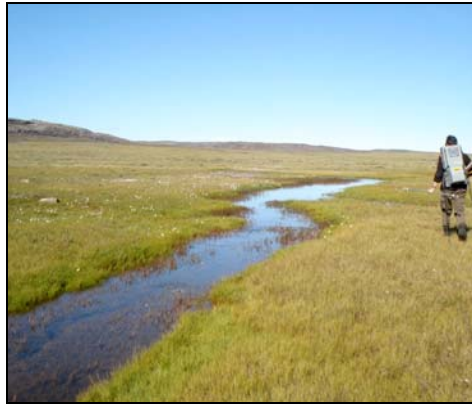
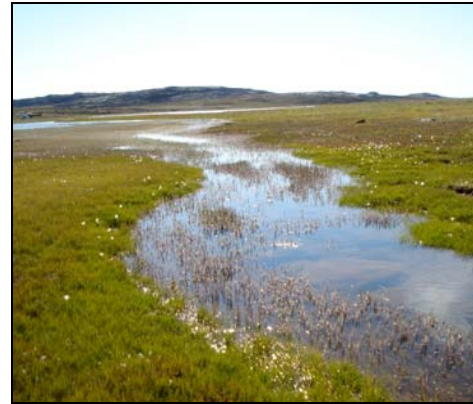
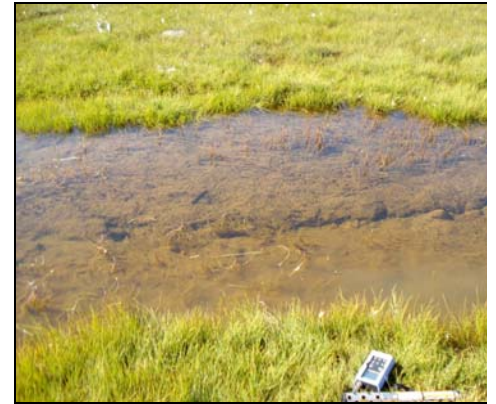
Figure 1. (A) Aerial photo of SPS-005q; (B) view upstream from habitat assessment; (C) view downstream from habitat assessment; (D) view across the habitat assessment.

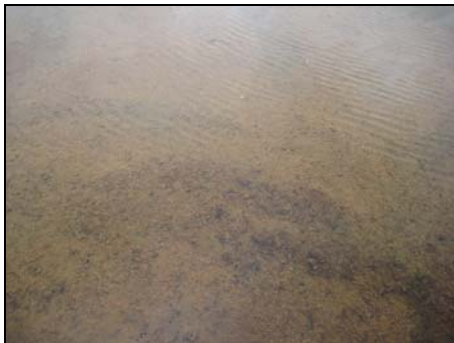
Figure 3: View of substrate in ST-014.

Location	
Crossing ID: ST-014 (formerly IP-10) UTM: 17W 593295 / 7799451	
Date/Time Surveyed: 29-Aug-07 / 15:30	
Site Description/Physical Characteristics	Biotic Characteristics
Floodplain Width (m): N/A	Fisheries
Channel Pattern: N/A	Electrofishing Conducted (Y/N): Y
Channel Confinement: N/A	Effort: 120 s
Channel Gradient: N/A	Settings: 400V 30Hz
	Fish Observed (Y/N): N
	Species/Totals: N/A
	Length Range: N/A
Hydrology	Potential Fish Utilization
Bankfull Width (m): N/M	Arctic char (ARCH)
Wetted Width x Length (m): ~ 80 x 60	Spawning: N Rearing: N
Depth Profile (25%, 50%, 75%; m): N/M	Overwintering: N Migration: N
Max Depth (m): ~ 0.40	Ninespine stickleback (NNST)
Flow Regime: per	Spawning: N Rearing: N
	Overwintering: N Migration: N
Bank Characteristics	Habitat Assessment Summary & Potential Habitat Compensation Notes
Bank Height (L/R; m): N/M	This pond does not provide overwintering habitat, nor is it connected to any waterbody that does. The substrate is comprised of soft, organic fines; not preferred substrate for local freshwater fish species.

Bank Shape (L/R): N/M	
Bank Stability: N/M	
Stream/Riparian Habitat	
Channel Morphology: Pond	
Substrate Composition: 98% Fi, 1% Co, 1% Bo	
Stream Cover: 1% Bo	
Barriers Present (Y/N): N	
Description/Location: N/A	
Lakes Present (Y/N): N	Fish Habitat Quality
Description/Location: N/A	No Fish Habitat

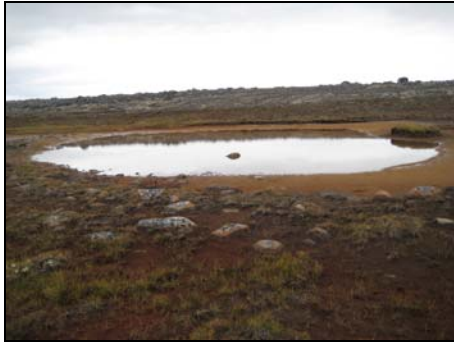
Figure 1: View across ST-015.

Location		
Crossing ID: ST-015 (formerly IP-11) UTM: 17W 593315 / 7799411		
Date/Time Surveyed: 29-Aug-07 / 15:46		
Site Description/Physical Characteristics	Biotic Characteristics	
Floodplain Width (m): N/A	Fisheries Electrofishing Conducted (Y/N): Y Effort: 60 s Settings: 400V 30Hz Fish Observed (Y/N): N Species/Totals: N/A Length Range: N/A	
Channel Pattern: N/A		
Channel Confinement: N/A		
Channel Gradient: N/A		
Hydrology		
Bankfull Width (m): N/M	Potential Fish Utilization Arctic char (ARCH) Spawning: N Rearing: N Overwintering: N Migration: N Ninespine stickleback (NNST) Spawning: N Rearing: N Overwintering: N Migration: N	
Wetted Width x Length (m): ~ 30 x 30		
Depth Profile (25%, 50%, 75%; m): N/M		
Max Depth (m): ~ 0.15		
Flow Regime: per		
Bank Characteristics		
Bank Height (L/R; m): N/M	Habitat Assessment Summary & Potential Habitat Compensation Notes This pond does not provide overwintering habitat, nor is it connected to any waterbody that does. The substrate is comprised of soft, organic fines; not preferred substrate for local freshwater fish species.

Bank Shape (L/R): N/M		
Bank Stability: N/M		
Stream/Riparian Habitat		
Channel Morphology: Pond		
Substrate Composition: 100% Fi		
Stream Cover: None		
Barriers Present (Y/N): N		
Description/Location: N/A		
Lakes Present (Y/N): N		
Description/Location: N/A		
Fish Habitat Quality		
No Fish Habitat

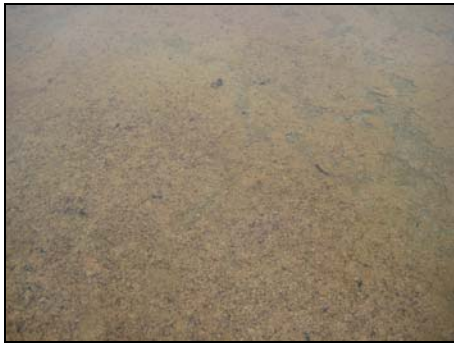
Figure 2: View of substrate in ST-015.

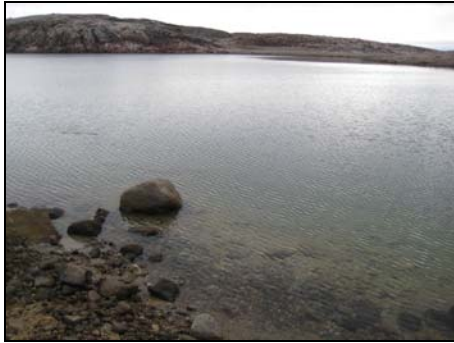
Figure 1: View across ST-015a.

Location	
Crossing ID: ST-015a (formerly IP-12) UTM: 17W 593222 / 7799203	Date/Time Surveyed: 29-Aug-07 / 15:38
Site Description/Physical Characteristics	Biotic Characteristics
Floodplain Width (m): N/A Channel Pattern: N/A Channel Confinement: N/A Channel Gradient: N/A	Fisheries Electrofishing Conducted (Y/N): Y Effort: 600 s Settings: 100V 30Hz Fish Observed (Y/N): N Species/Totals: N/A Length Range: N/A
Hydrology	Potential Fish Utilization
Bankfull Width (m): N/M Wetted Width x Length (m): ~ 200 x 200 Depth Profile (25%, 50%, 75%; m): N/M Max Depth (m): > 1.00 Flow Regime: tidal	Arctic char (ARCH) Spawning: N Rearing: M Overwintering: M Migration: N Ninespine stickleback (NNST) Spawning: N Rearing: N Overwintering: N Migration: N
Bank Characteristics	Habitat Assessment Summary & Potential Habitat Compensation Notes
Bank Height (L/R; m): N/M Bank Shape (L/R): N/M Bank Stability: N/M	This is a marine tidal pool with periodic connections to Steensby Inlet. This pool can provide habitat for several species of nearshore marine fish, including adult anadromous ARCH. Although no fish were captured during electrofishing surveys, several large fish were observed from the air. This pool should be revisited and extensively characterized.

Stream/Riparian Habitat	Fish Habitat Quality
Channel Morphology: Tidal pool Substrate Composition: 80% Fi, 10% Co, 9% Gr, 1% Bo Stream Cover: 1% Bo, deep Po Barriers Present (Y/N): N Description/Location: N/A Lakes Present (Y/N): N Description/Location: N/A	Important

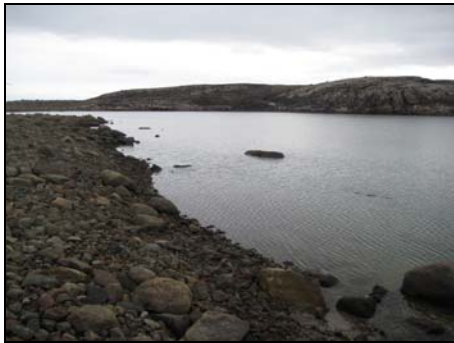
Figure 2: View along shoreline of ST-015a.

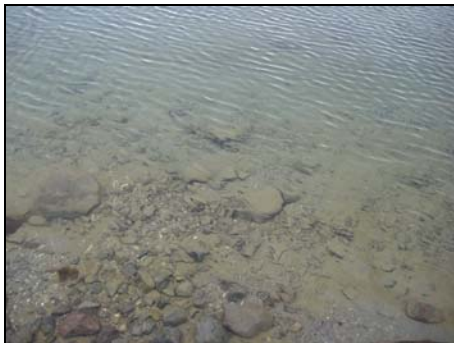
Figure 3: View of substrate in ST-015a.

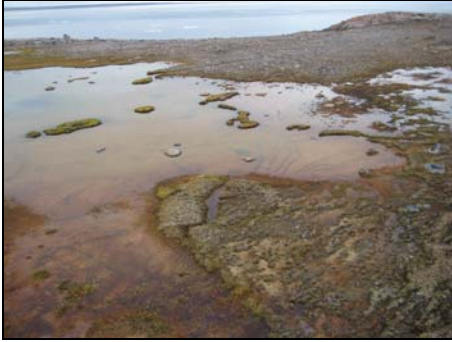
Figure 1: Aerial view across ST-015b.

Location	
Crossing ID: ST-015b (formerly IP-13) UTM: 17W 593085 / 7798516	Date/Time Surveyed: 29-Aug-07 / 15:56
Site Description/Physical Characteristics	Biotic Characteristics
Floodplain Width (m): N/A Channel Pattern: N/A Channel Confinement: N/A Channel Gradient: N/A	Fisheries Electrofishing Conducted (Y/N): N Effort: N/A Settings: N/A Fish Observed (Y/N): N Species/Totals: N/A Length Range: N/A
Hydrology	Potential Fish Utilization
Bankfull Width (m): N/M Wetted Width x Length (m): N/M Depth Profile (25%, 50%, 75%; m): N/M Max Depth (m): ~ 0.40 Flow Regime: per	Arctic char (ARCH) Spawning: N Rearing: N Overwintering: N Migration: N Ninespine stickleback (NNST) Spawning: N Rearing: N Overwintering: N Migration: N
Bank Characteristics	Habitat Assessment Summary & Potential Habitat Compensation Notes
Bank Height (L/R; m): N/M Bank Shape (L/R): N/M Bank Stability: N/M	Assessment of this pond was limited to aerial observations. This pond does not provide overwintering habitat, nor is it connected to any waterbody that does. The substrate is comprised of soft, organic fines; not preferred substrate for local freshwater fish species.

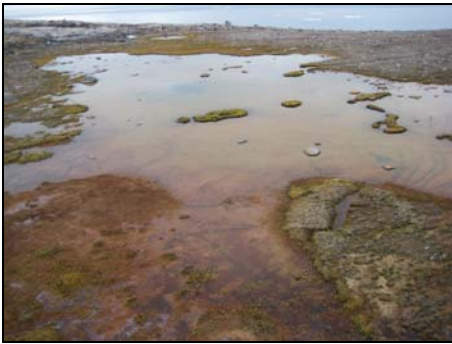
Figure 2: Another aerial view of ST-015b.

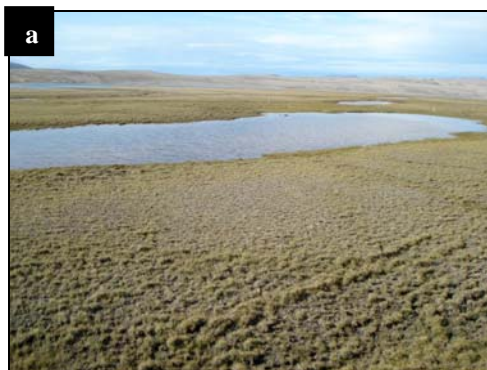
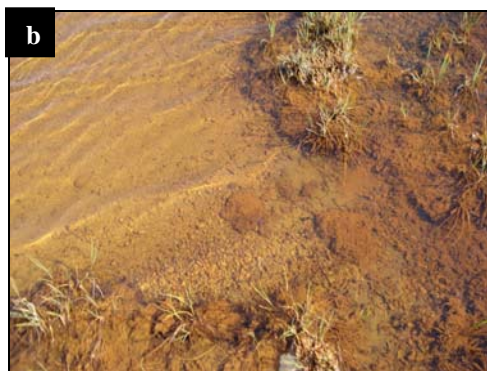
Figure 1. Aerial view of ML-03 (a) and substrate (b).

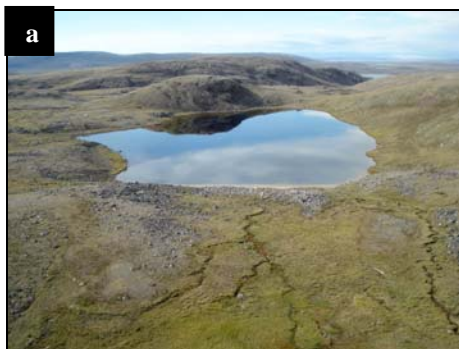
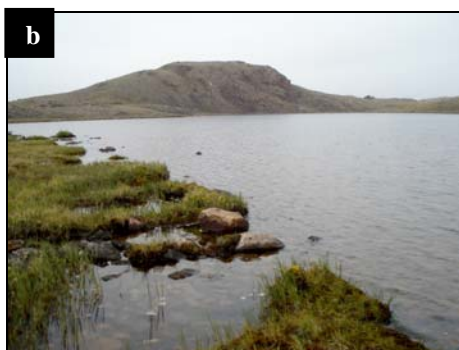
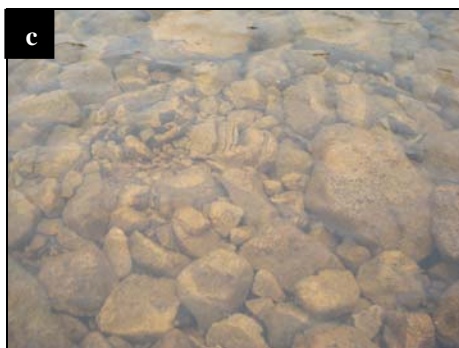
Figure 1. Aerial view of ML-15 (a), view from the shoreline (b), and substrate (c).

Excellent habitat but no fish caught or observed. No access to other waterbodies. No *in situ* water quality recorded.
