APPENDIX 5.3-1.

DETAILED HABITAT ASSESSMENTS AND SUMMARY OF RESULTS FOR WATERBODIES IN QUARRY SITES.

Table A5.3-1.1. Summary of results from surveys and assessments that fall within Quarry boundaries.

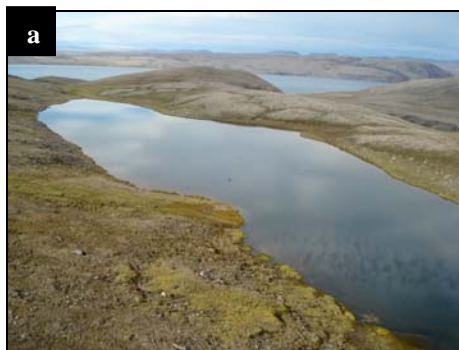
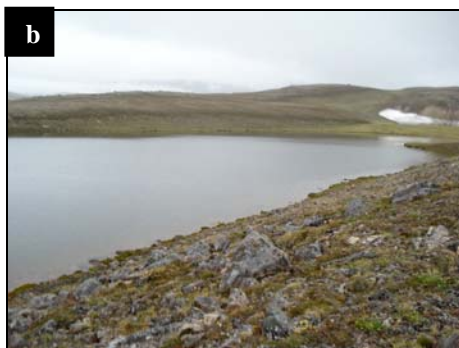
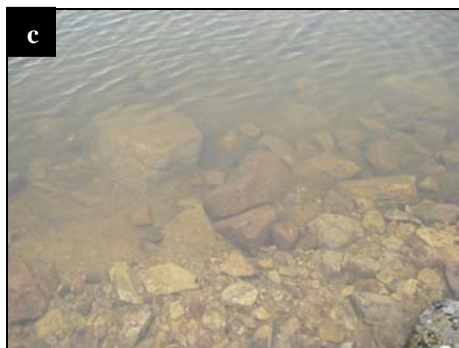
Figure 1. Aerial view of ML-16 (a), view from the shoreline (b), and substrate (c).

High quality habitat but no fish caught or observed. No connections with other waterbodies. No *in situ* water quality recorded.

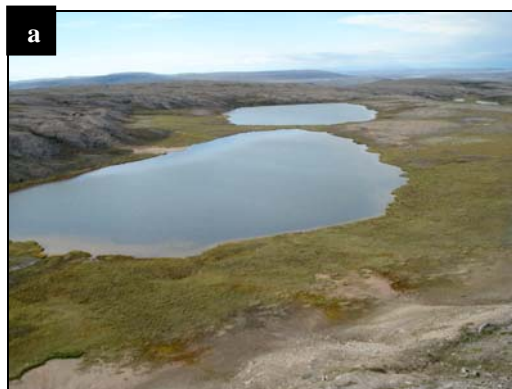
Figure 1. Aerial view of ML-18 and Lake ML-19 in the background (a).

No fish caught or observed. Connected to ML-19, but nothing else.

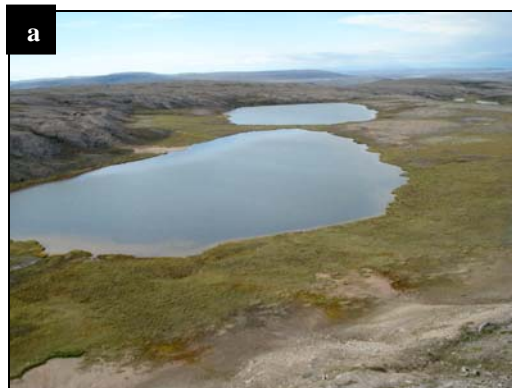
Figure 1. Aerial view of ML-19 in the background and ML-18 in the forefront (a).

No water quality data recorded. No fish caught or observed. Connected to ML-18, but nothing else.

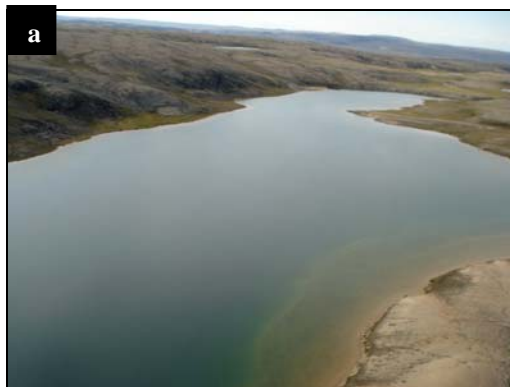
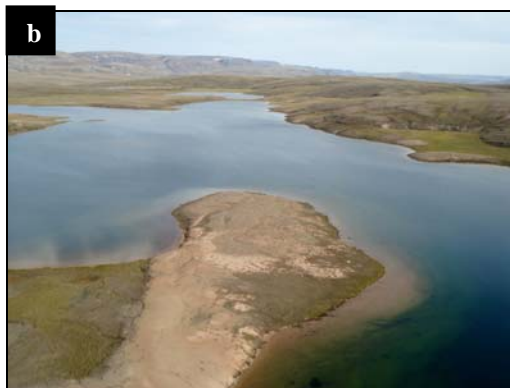
Figure 1. Aerial view of ML-20 (a, b).

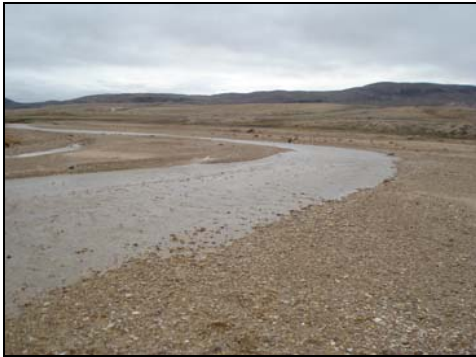
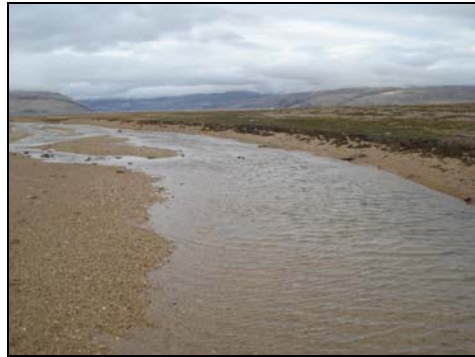
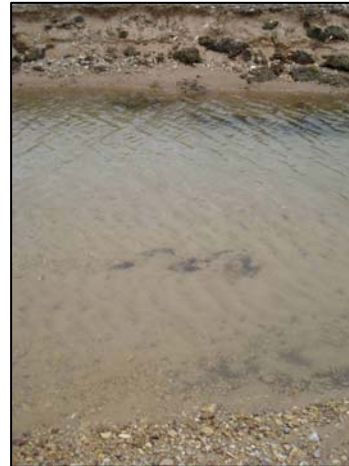
Figure 1. (A) View upstream of habitat assessment; (B) view downstream of habitat assessment; and (C) view across habitat assessment.

No fish, but potential is there because searun char were observed in the lower reaches of M13-1 and M18-1.
 Water quality sample collected, ID= M3-1 at 10:15 @ 0.60m depth.

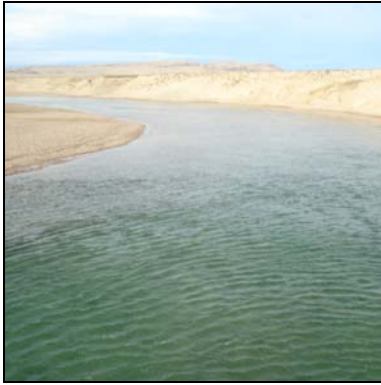
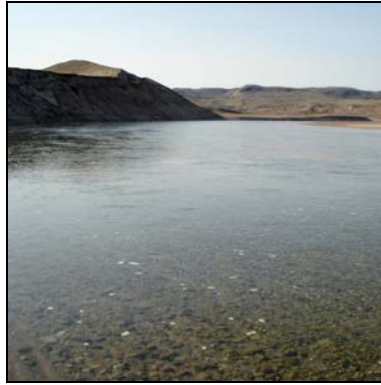
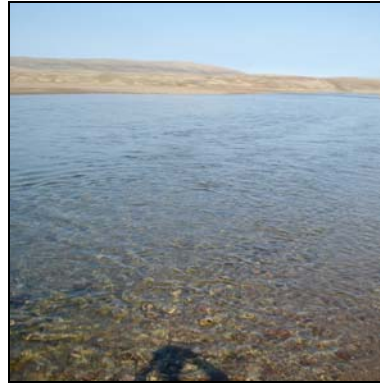
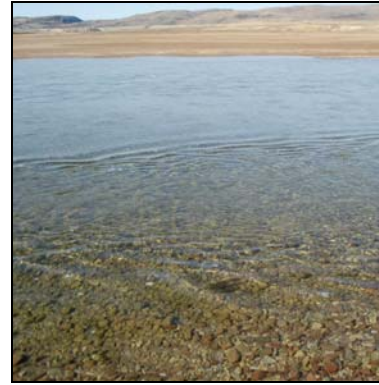
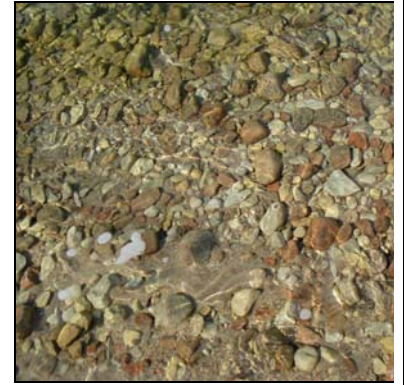
Figure 1. (A) Aerial view of stream M03-1; (B) view upstream of habitat assessment; (C) view downstream of habitat assessment; (D) view across habitat assessment; and (E) view of substrate along bank of habitat assessment.

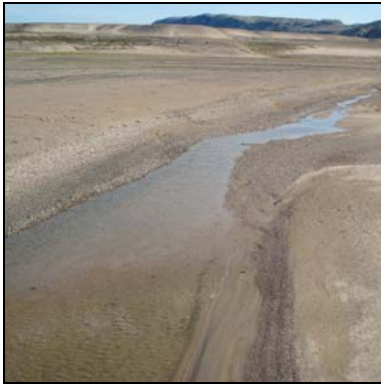
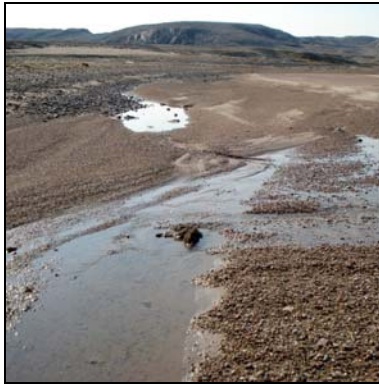
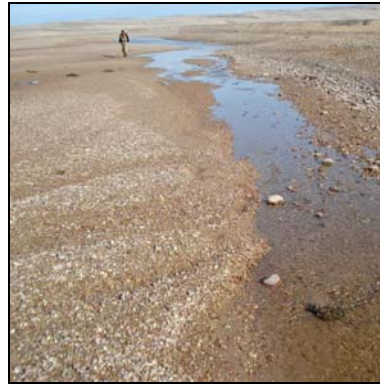
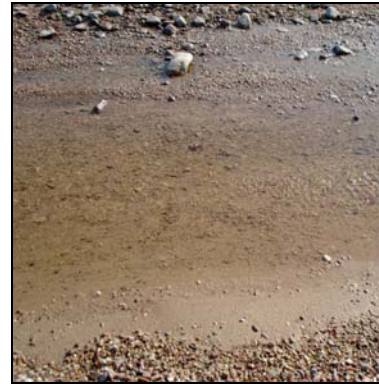
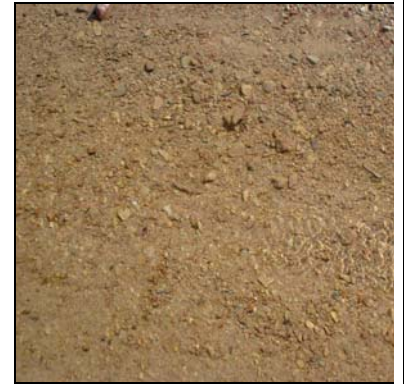
Figure 1. (A) Aerial view of stream M03-3; (B) view upstream of habitat assessment; (C) view downstream of habitat assessment; (D) view across habitat assessment; and (E) view of substrate along the bank of habitat assessment.

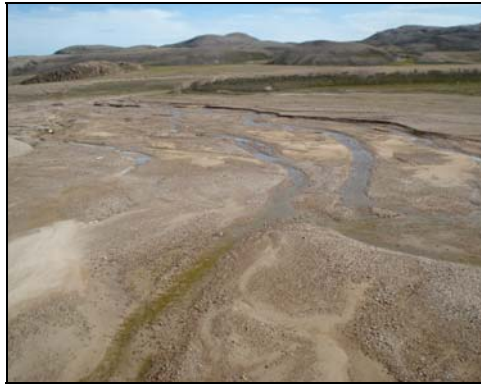
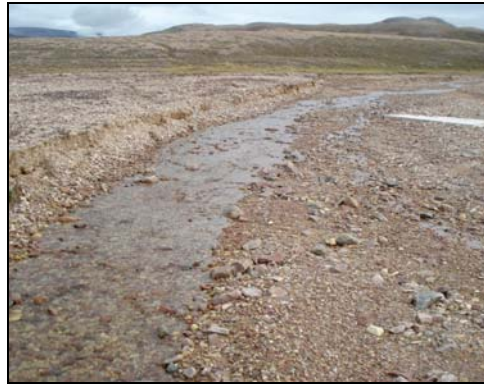
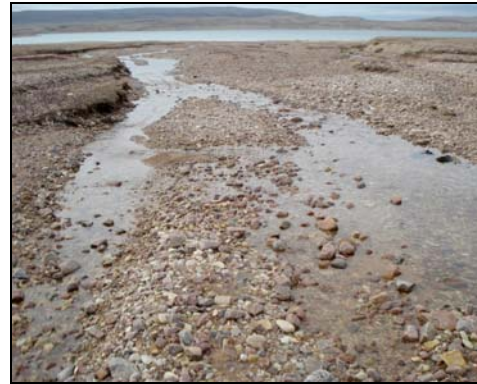
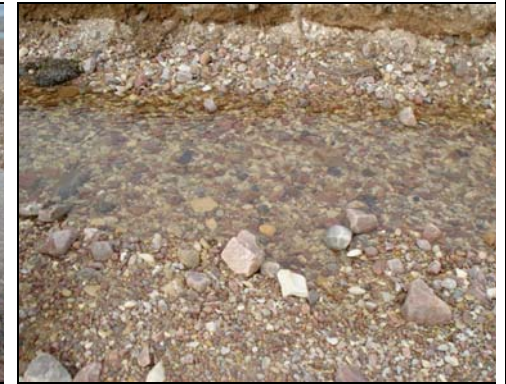
Figure 1. (A) Aerial view of stream M11-1; (B) view upstream of habitat assessment; (C) view downstream of habitat assessment; and (D) view across habitat assessment.

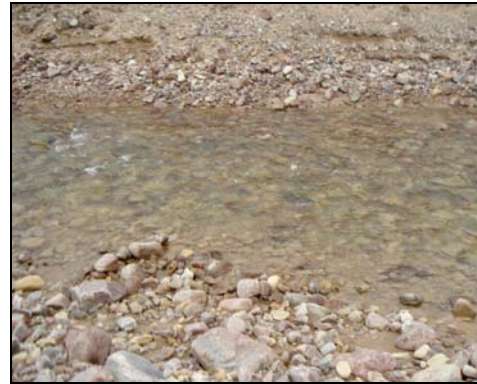
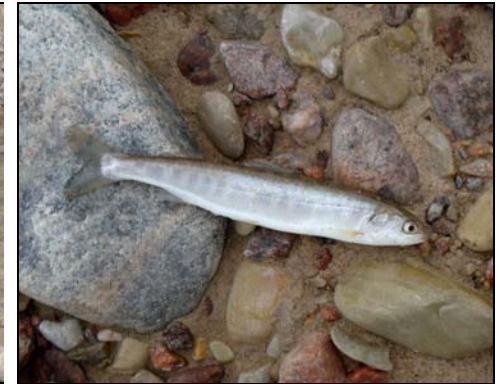
Figure 1. (A) View upstream of habitat assessment; (B) view downstream of habitat assessment; (C) view across habitat assessment; and (D) photo of arctic char caught during habitat assessment (~150 mm).

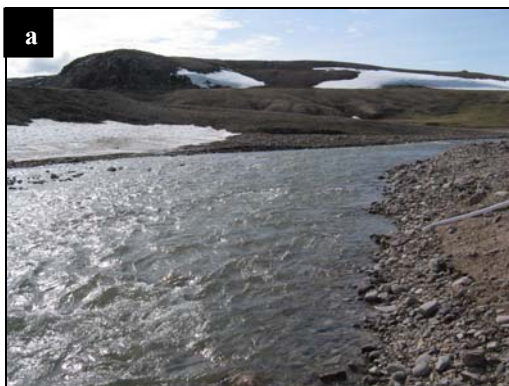
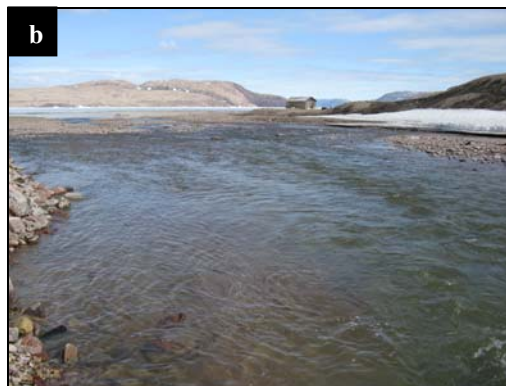
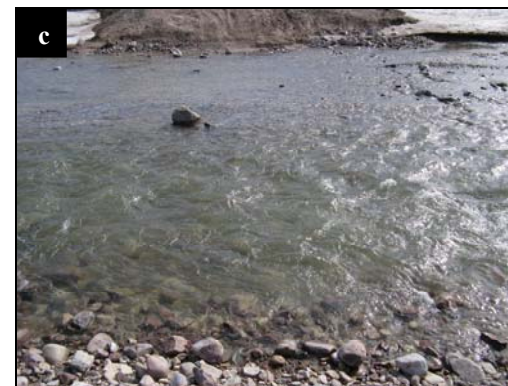
Figure 1. View upstream (a), downstream (b), and across (c) from the removed culvert location at CV-183 during early July, 2009.

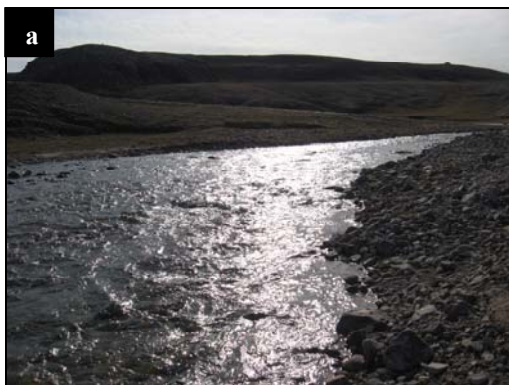
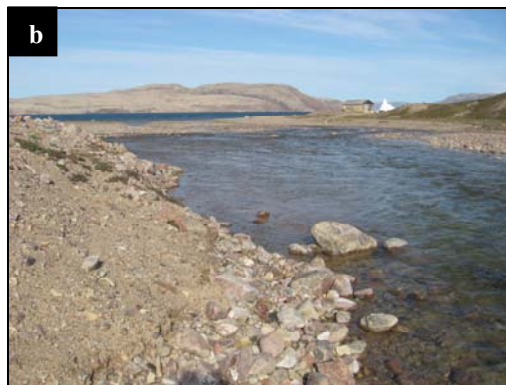
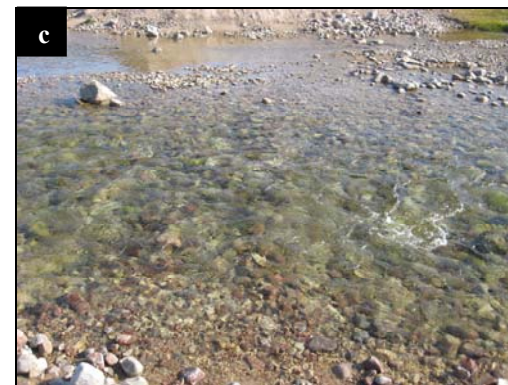
Figure 2. View upstream (a), downstream (b), and across (b) from the removed culvert location at CV-183 during late August, 2009.

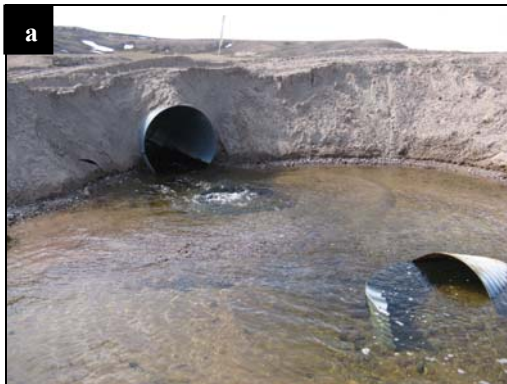
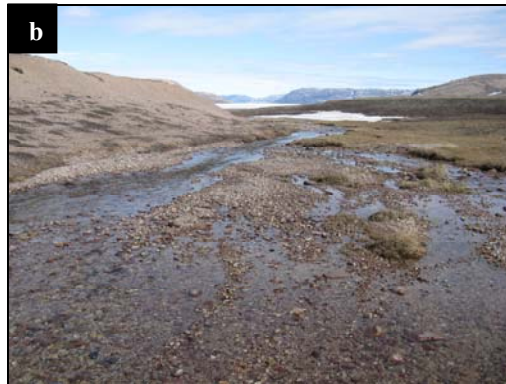
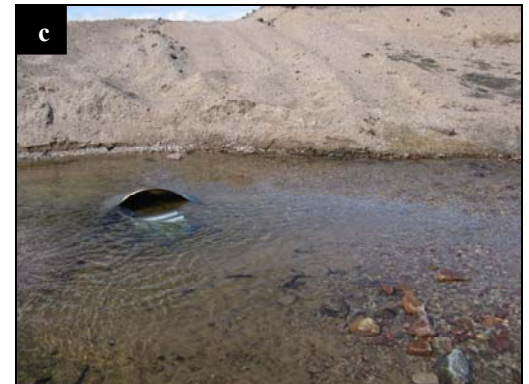
Figure 1. View upstream (a), downstream (b), and across (c) at the habitat assessment site downstream of the crossing at CV-181 during early July, 2009.

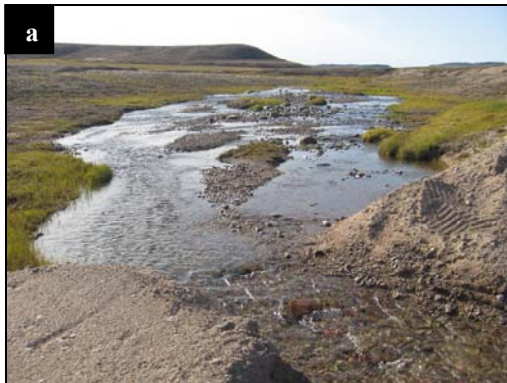
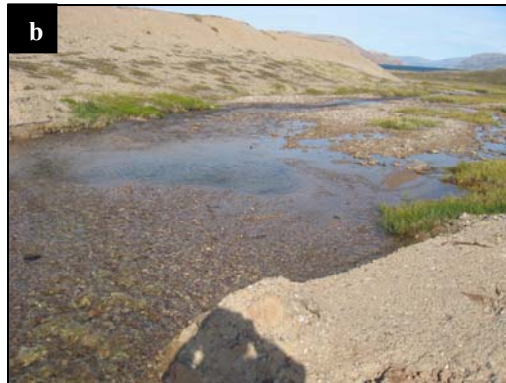
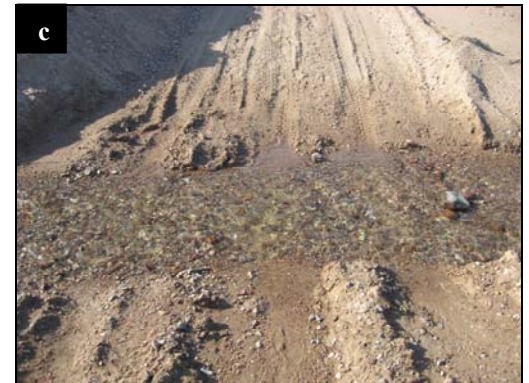
Figure 2. View upstream (a), downstream (b), and across (b) from the removed culvert location at CV-181 during late August, 2009.

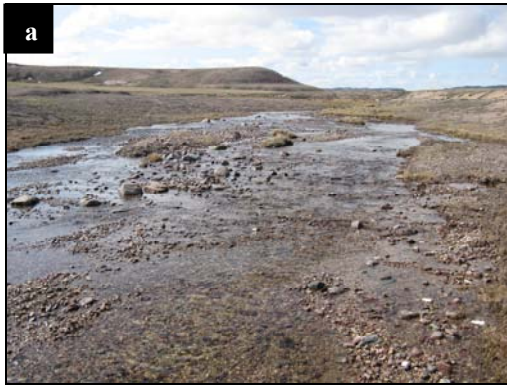
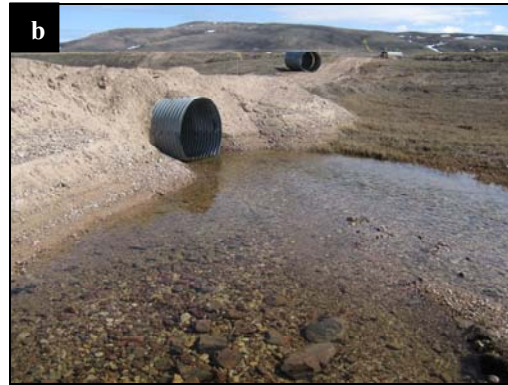
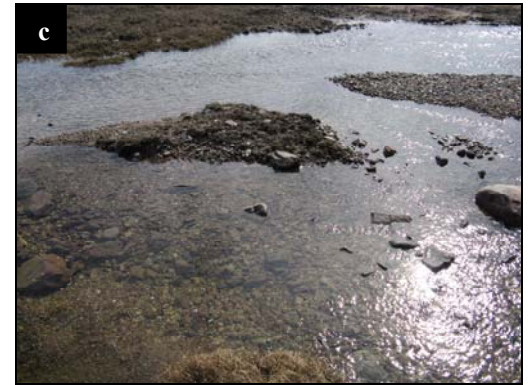
Figure 1. View upstream (a), downstream (b), and across (c) at the habitat assessment site upstream of the crossing at CV-181 during early July, 2009.

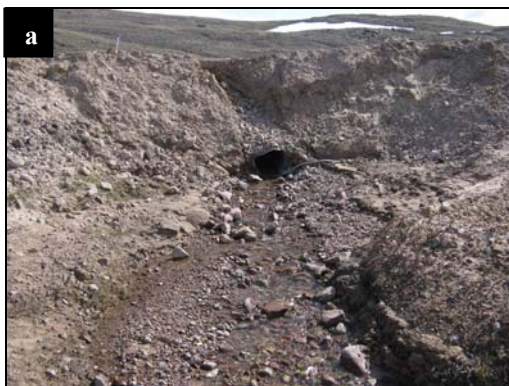
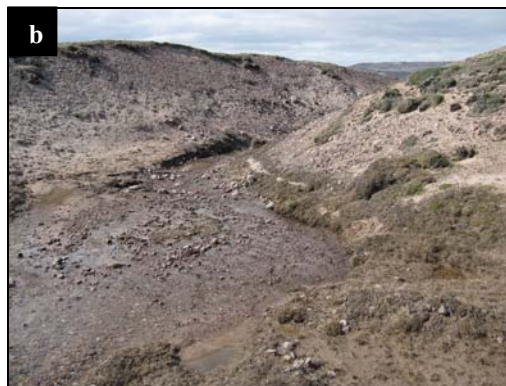
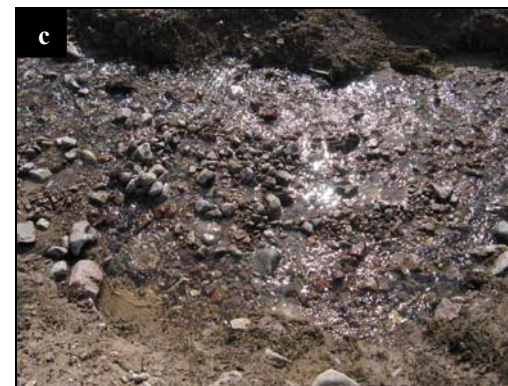
Figure 1. View upstream (a), downstream (b), and across (c) at the habitat assessment site downstream of the crossing at CV-176 during early July, 2009.

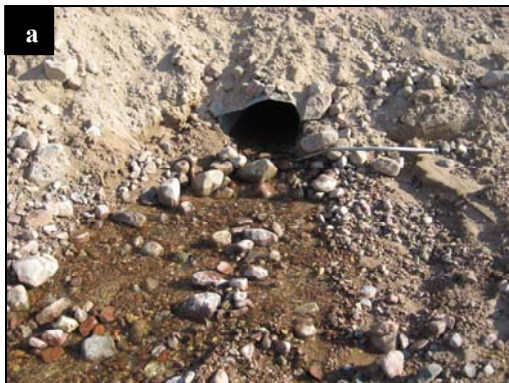
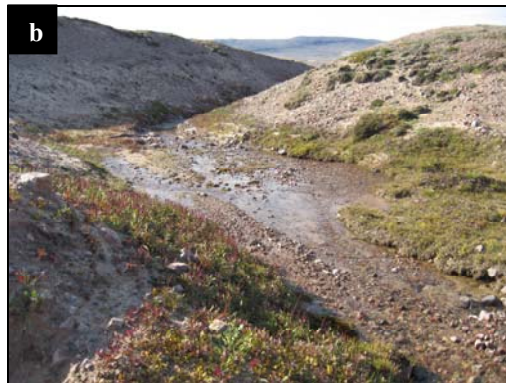
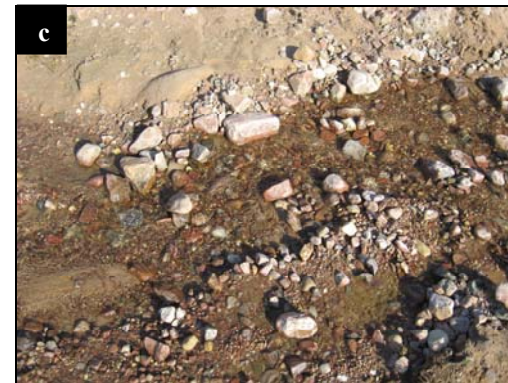
Figure 2. View upstream (a), downstream (b), and across (b) at the habitat assessment site downstream of the crossing at CV-176 during late August, 2009.

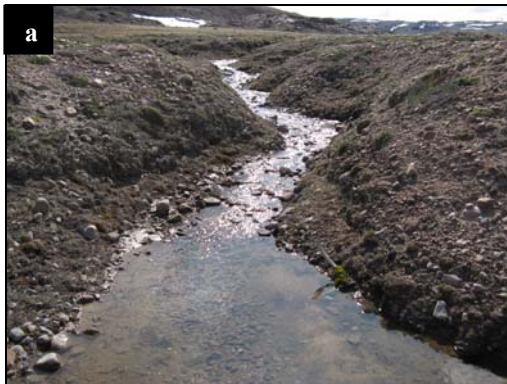
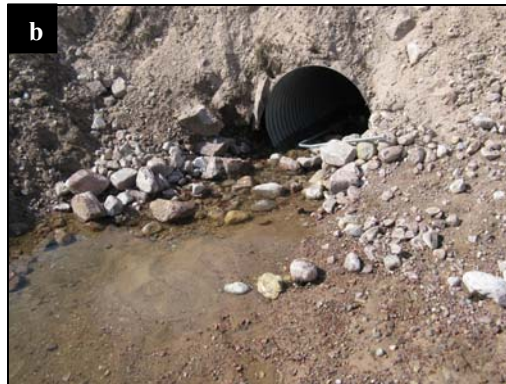
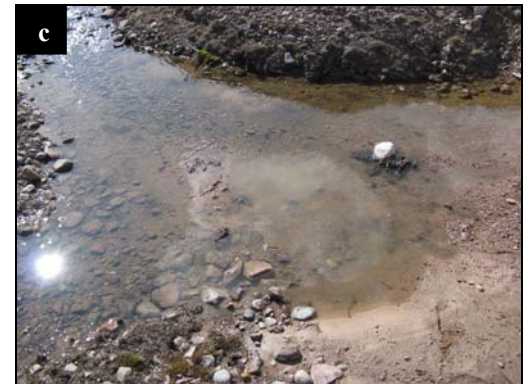
Figure 1. View upstream (a), downstream (b), and across (c) at the habitat assessment site upstream of the crossing at CV-176 during early July, 2009.

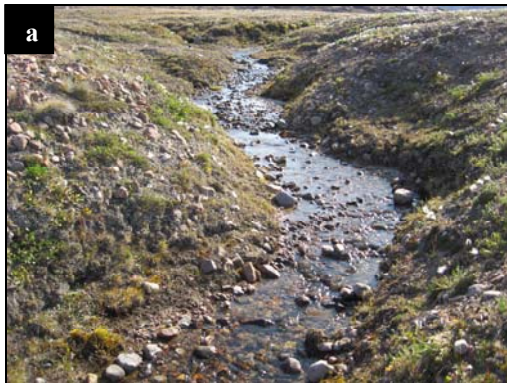
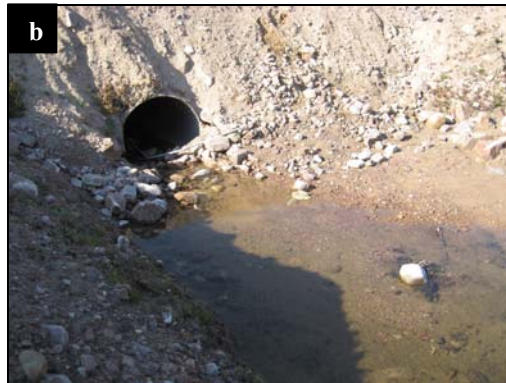
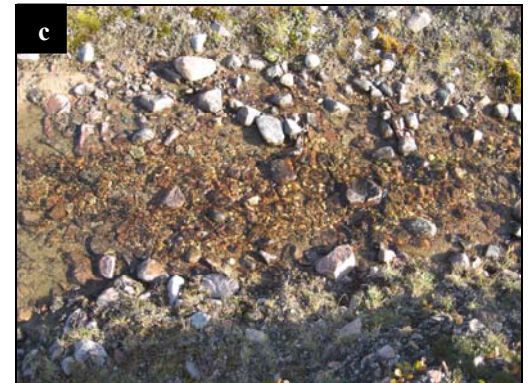
Figure 2. View upstream (a), downstream (b), and across (c) at the habitat assessment site upstream of the crossing at CV-176 during late August, 2009.

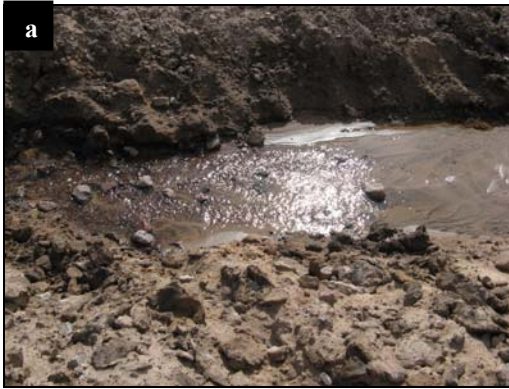
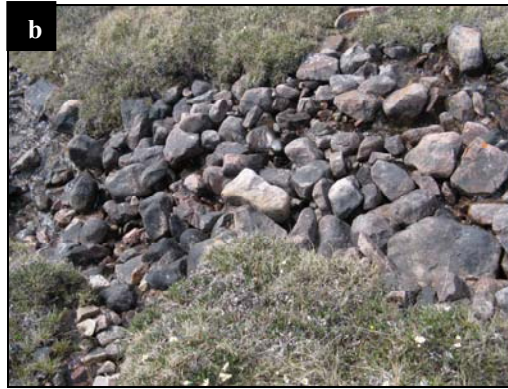
Figure 1. View across (a) and of barrier (b) at the habitat assessment site downstream of the crossing at CV-173 during spring, 2009.

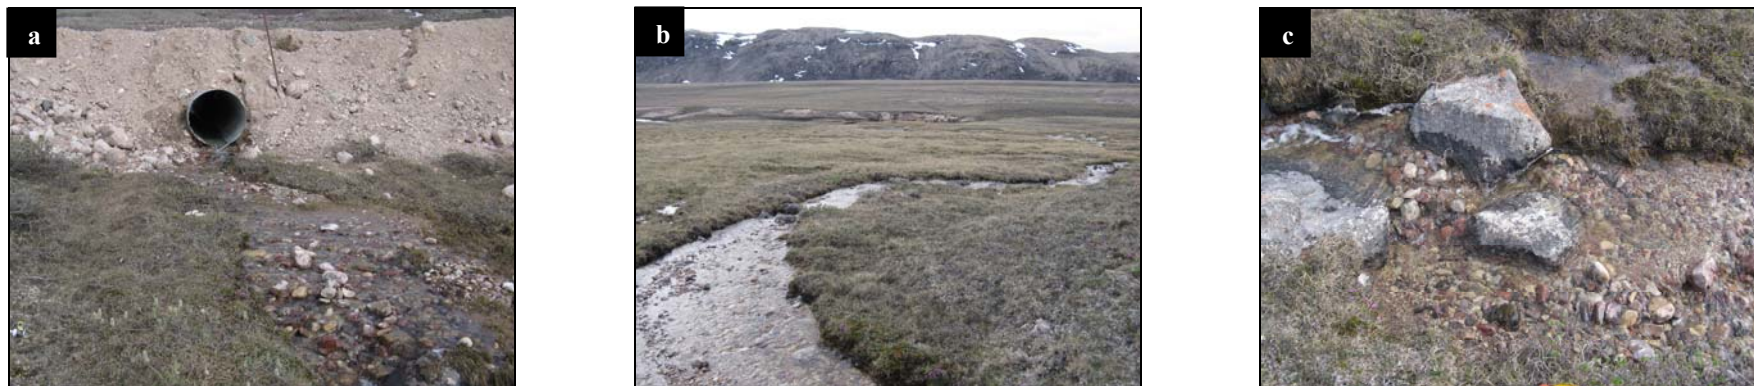
Figure 1. View upstream (a), downstream (b), and across (c) at the habitat assessment site downstream of the crossing at CV-170 during early July, 2009.

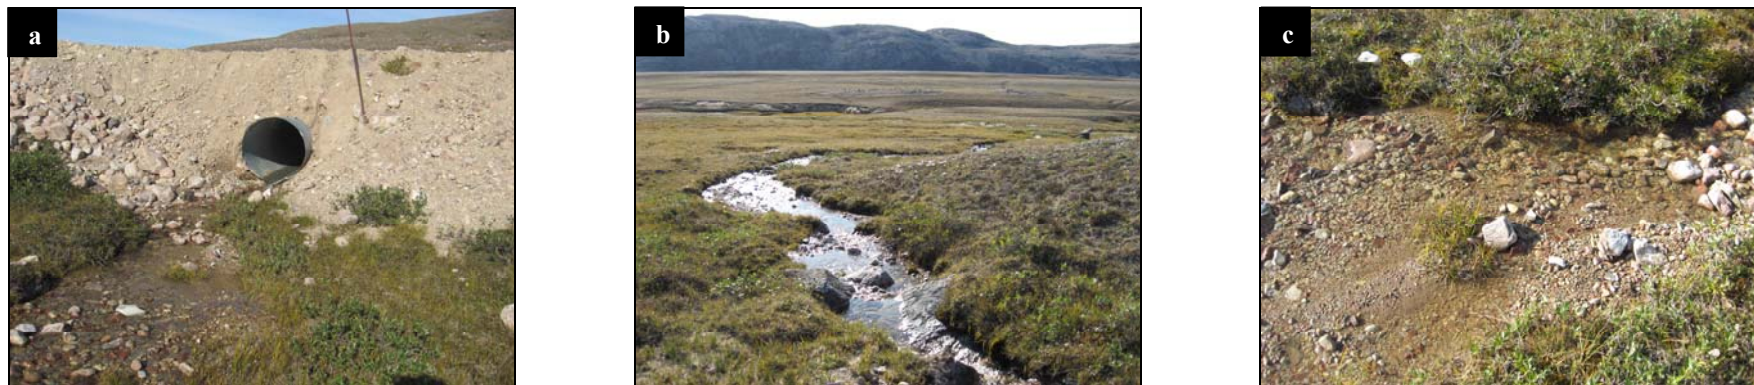
Figure 2. View upstream (a), downstream (b), and across (b) at the habitat assessment site downstream of the crossing at CV-170 during late August, 2009.

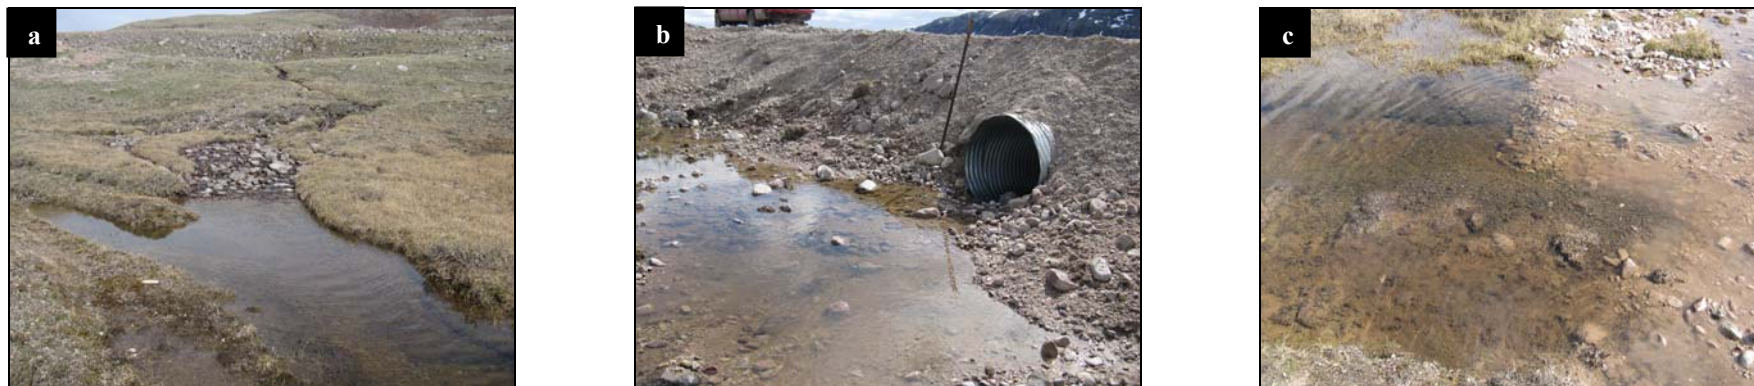
Figure 1. View upstream (a), downstream (b), and across (c) at the habitat assessment site upstream of the crossing at CV-170 during early July, 2009.

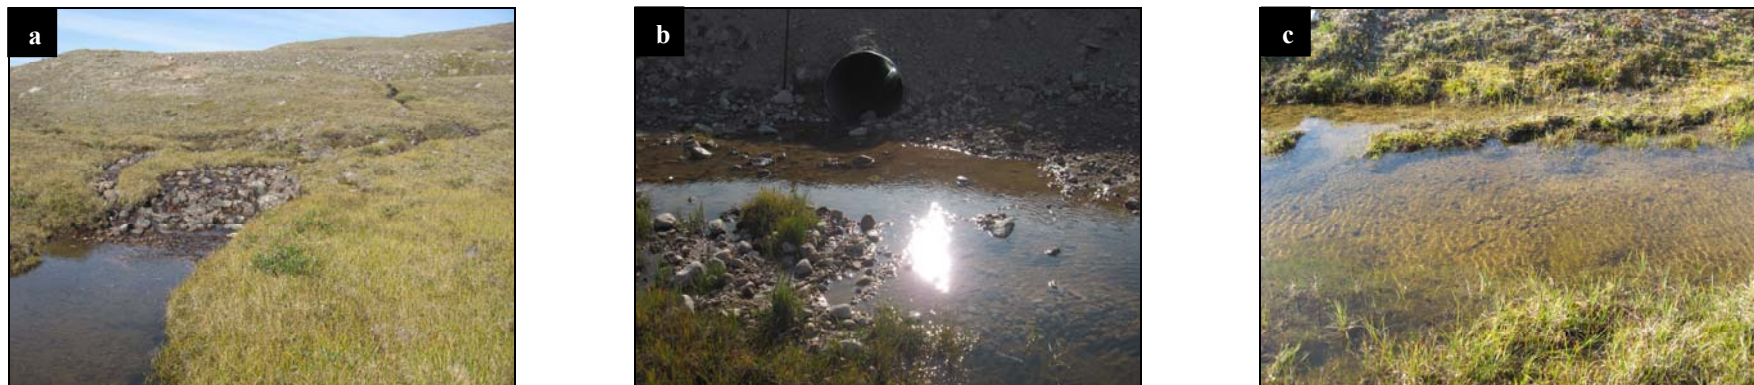
Figure 2. View upstream (a), downstream (b), and across (c) at the habitat assessment site upstream of the crossing at CV-170 during late August, 2009.

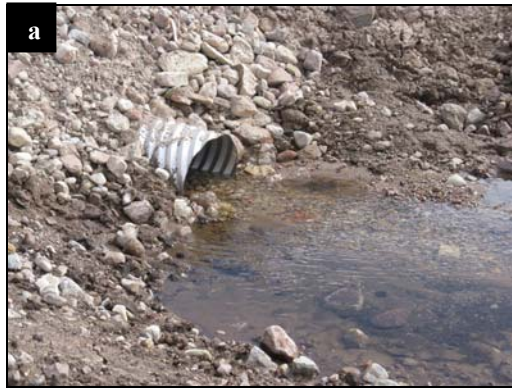
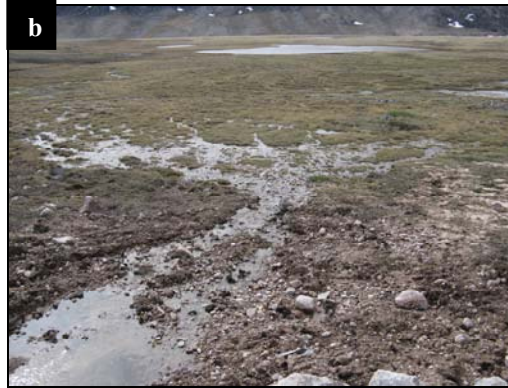
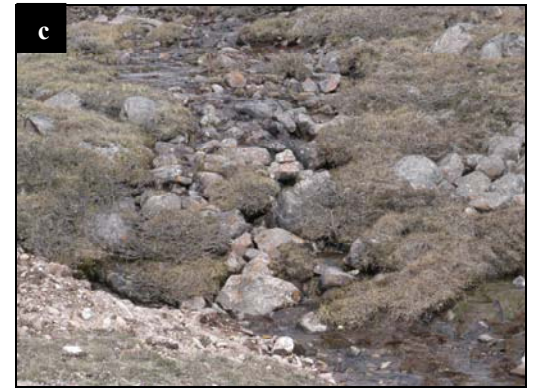
Figure 1. View upstream (a) and downstream (b) at the habitat assessment site downstream of the crossing and the upstream barrier (c) at CV-167 during spring, 2009.

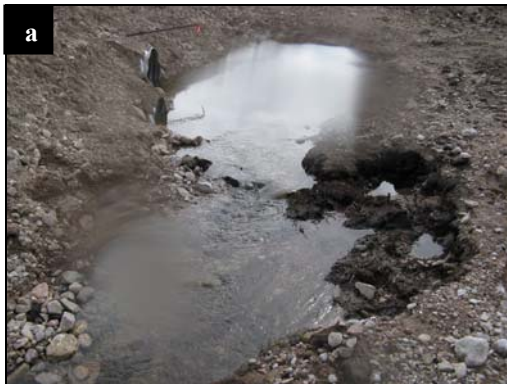
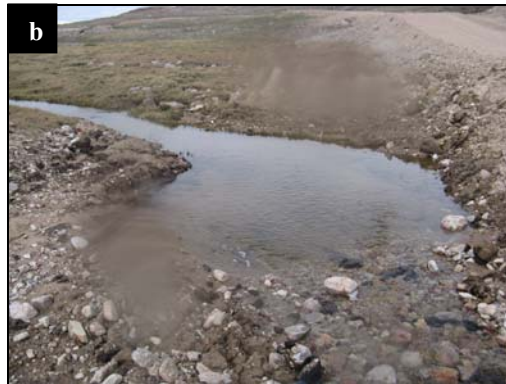
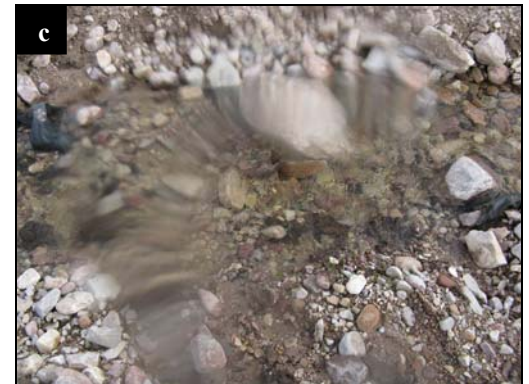
Figure 1. View upstream (a), downstream (b), and across (c) at the habitat assessment site downstream of the crossing at CV-166 during early July, 2009.

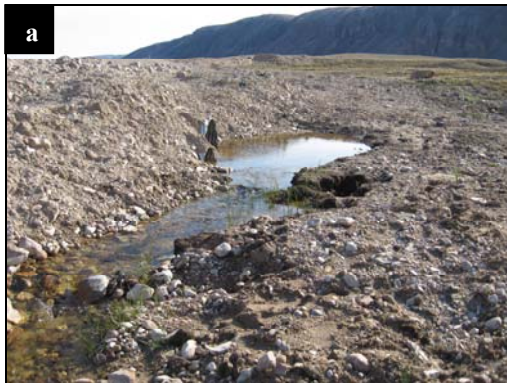
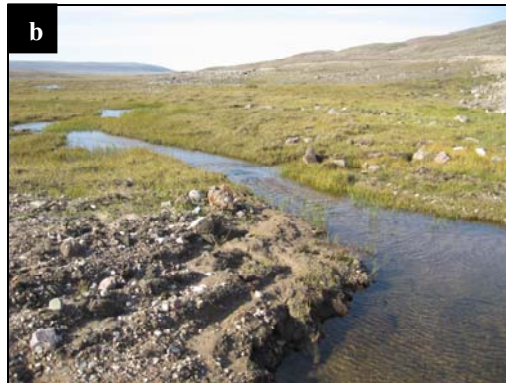
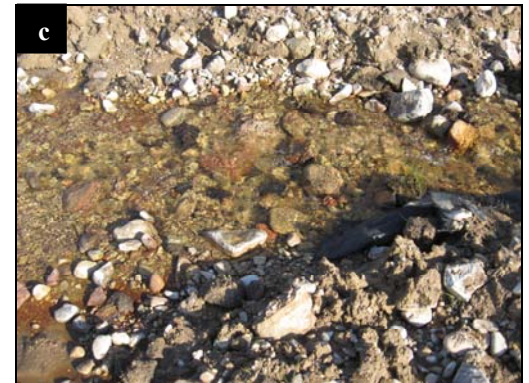
Figure 2. View upstream (a), downstream (b), and across (b) at the habitat assessment site downstream of the crossing at CV-166 during late August, 2009.

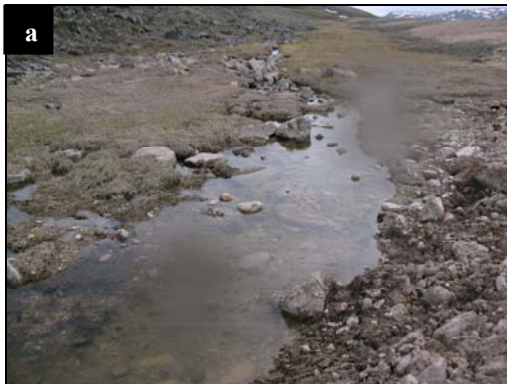
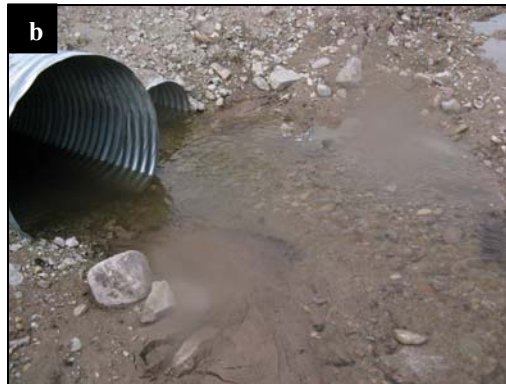
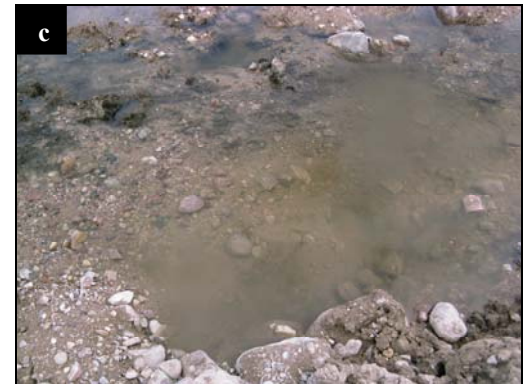
Figure 1. View upstream (a), downstream (b), and across (c) at the habitat assessment site upstream of the crossing at CV-166 during early July, 2009.

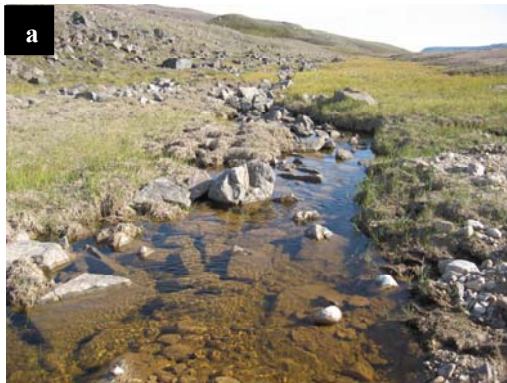
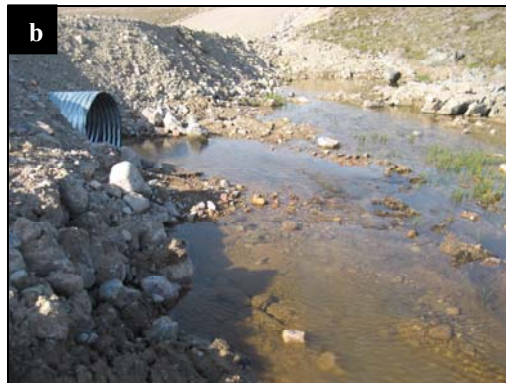
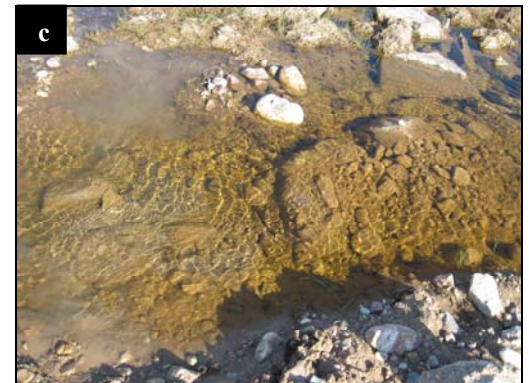
Figure 2. View upstream (a), downstream (b), and across (c) at the habitat assessment site upstream of the crossing at CV-166 during late August, 2009.

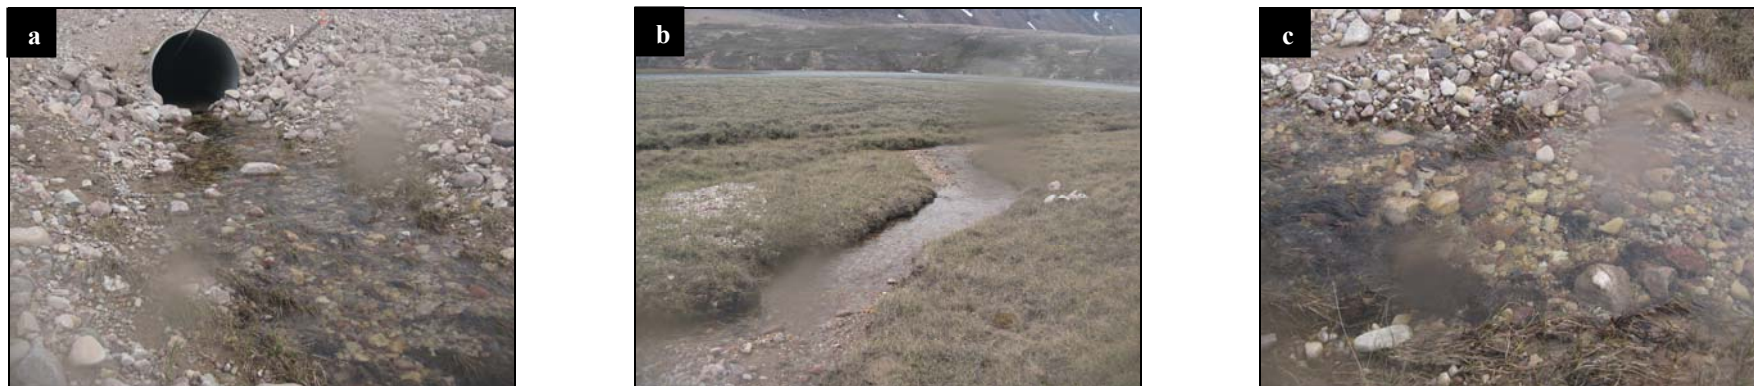
Figure 1. View upstream (a), downstream (b), and across (c) at the habitat assessment site downstream of the crossing at CV-159 during early July, 2009.

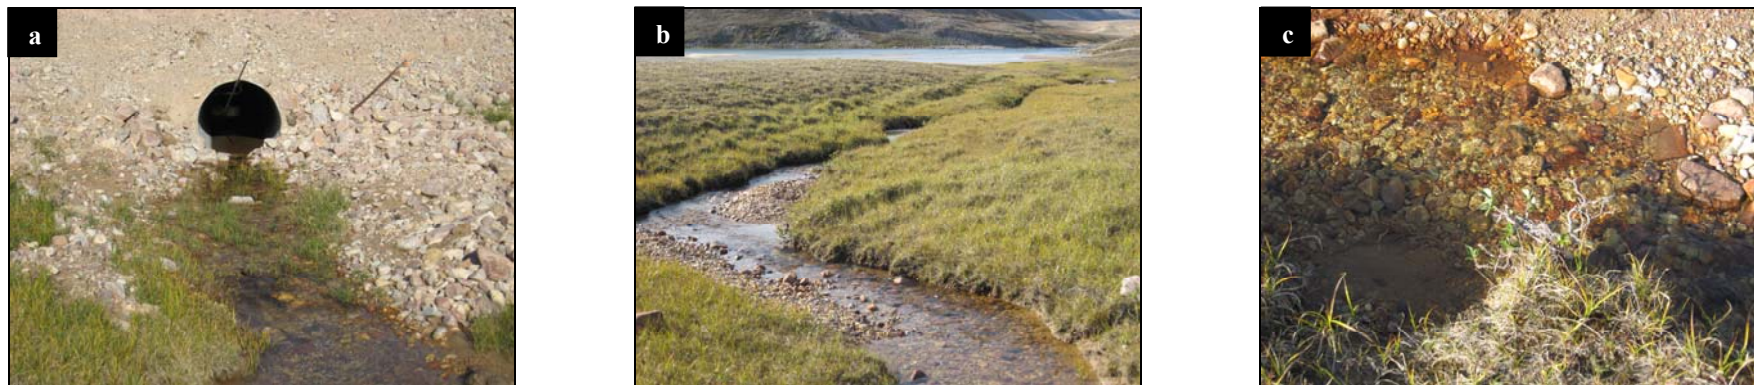
Figure 2. View upstream (a), downstream (b), and across (b) at the habitat assessment site downstream of the crossing at CV-159 during late August, 2009.

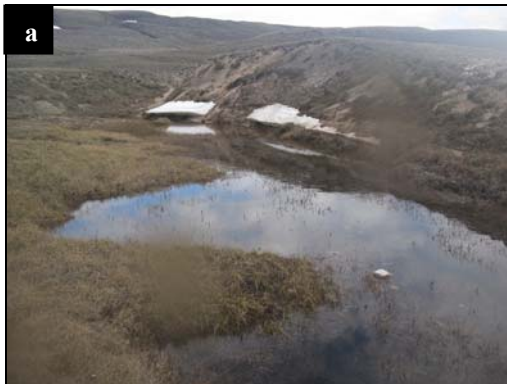
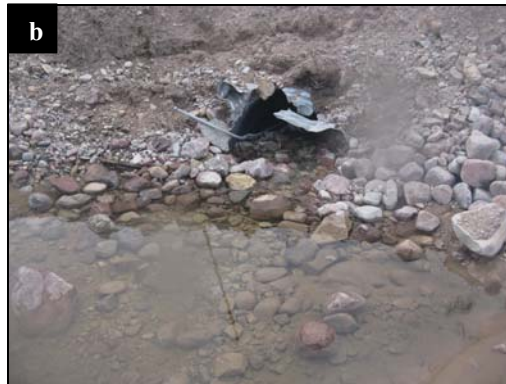
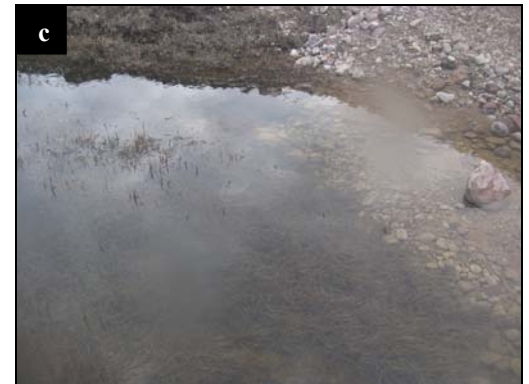
Figure 1. View upstream (a), downstream (b), and across (c) at the habitat assessment site upstream of the crossing at CV-159 during early July, 2009.

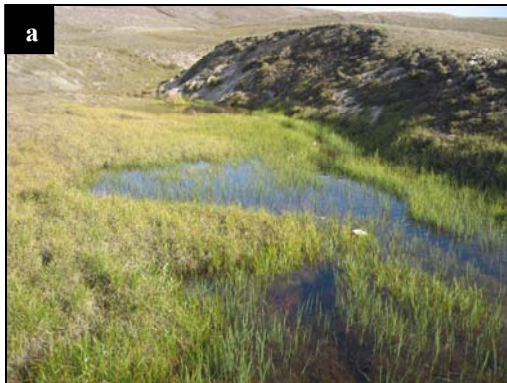
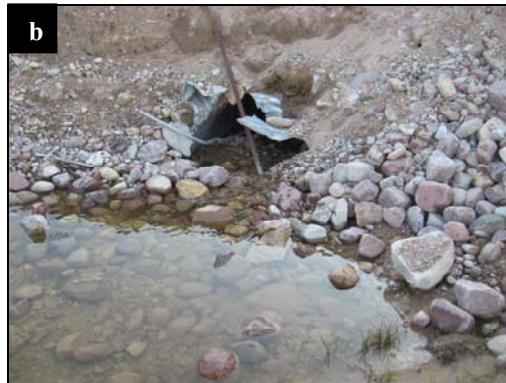
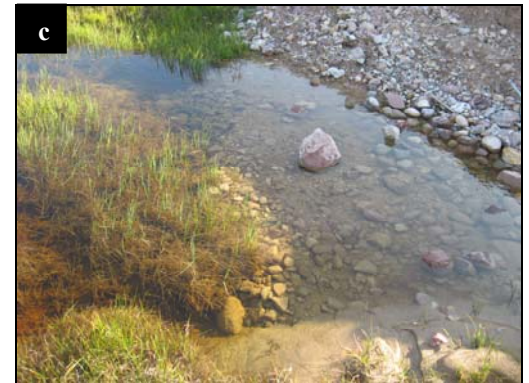
Figure 2. View upstream (a), downstream (b), and across (c) at the habitat assessment site upstream of the crossing at CV-159 during late August, 2009.

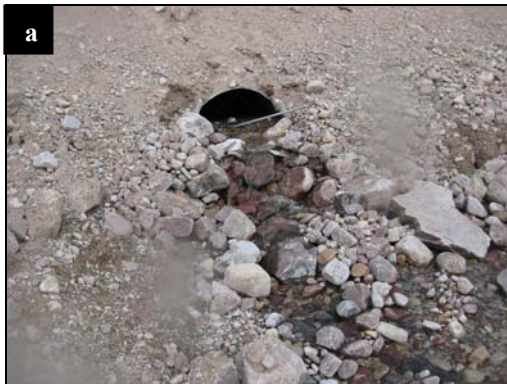
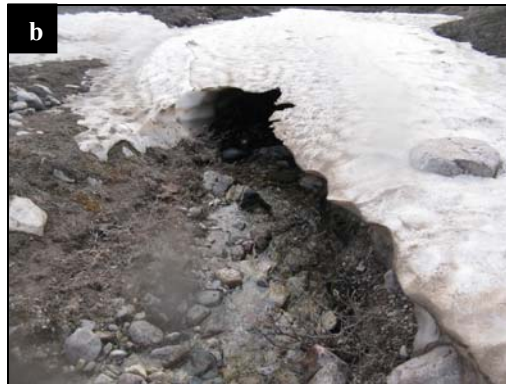
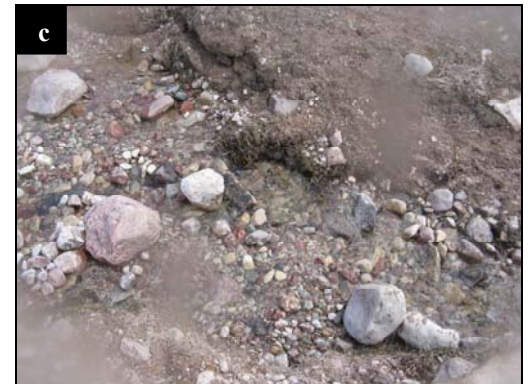
Figure 1. View upstream (a), downstream (b), and across (c) at the habitat assessment site downstream of the crossing at CV-157 during early July, 2009.

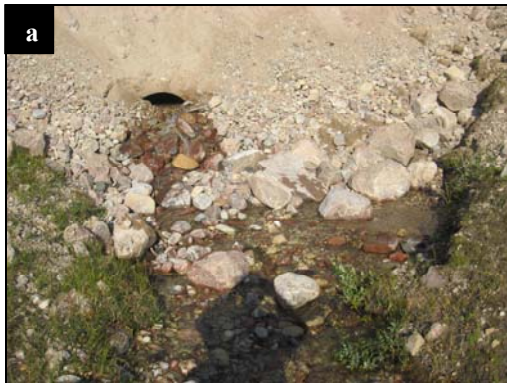
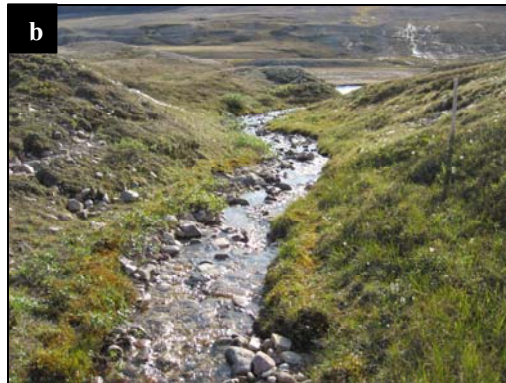
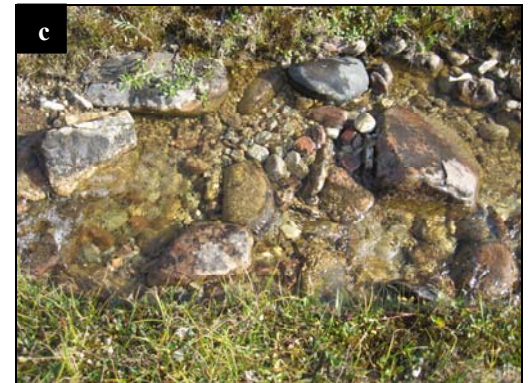
Figure 2. View upstream (a), downstream (b), and across (b) at the habitat assessment site downstream of the crossing at CV-157 during late August, 2009.

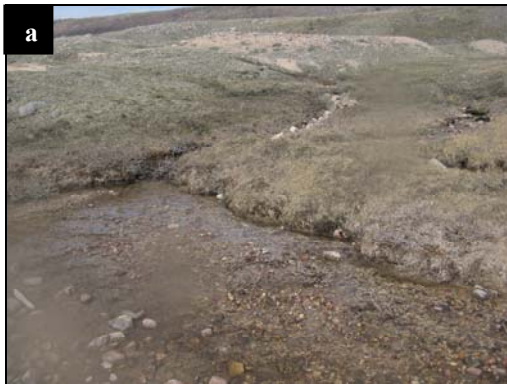
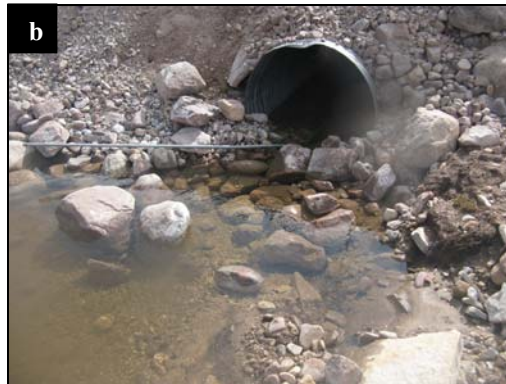
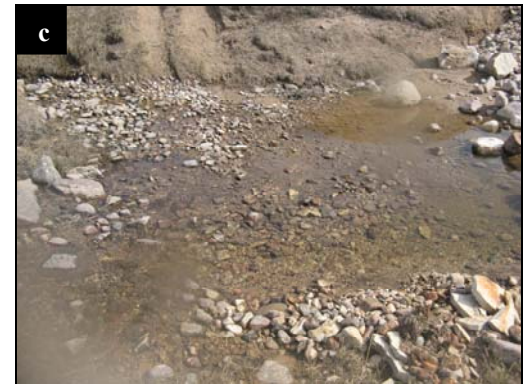
Figure 1. View upstream (a), downstream (b), and across (c) at the habitat assessment site upstream of the crossing at CV-157 during early July, 2009.

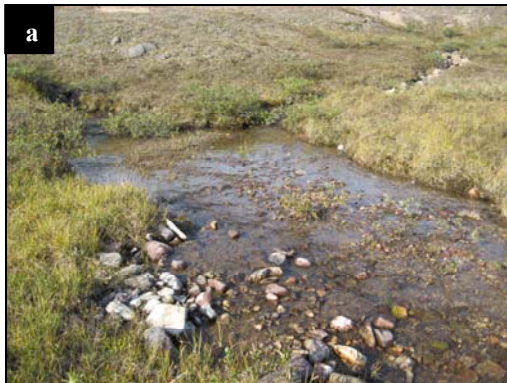
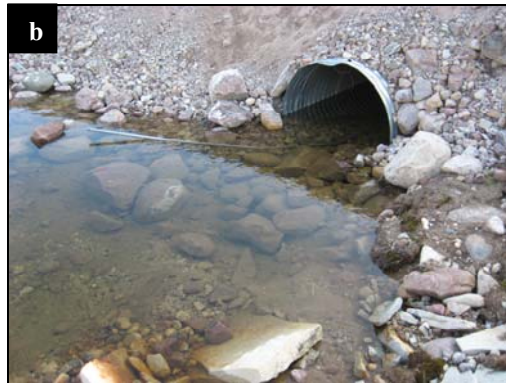
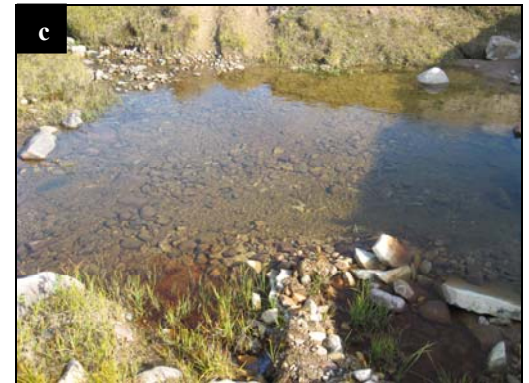
Figure 2. View upstream (a), downstream (b), and across (c) at the habitat assessment site upstream of the crossing at CV-157 during late August, 2009.

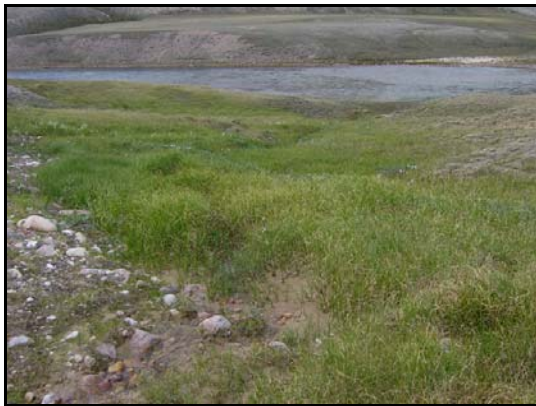
</div> <p>Figure 1: Downstream view from proposed crossing with Phillips Creek visible. Riffle habitat type with predominantly sand/gravel substrate.</p> <div>

Riffle Crest Depth: 0.03 m		Unique Features: None		
Residual Pool Depth: N/A		Summary: This is an extra small, nearly waterless stream with predominantly sand substrate and low-moderate erosion potential. There is relatively little significant cover.		Ninespine Stickleback	
Bankfull Depth: 0.10 m				Spawning: No	
Bank Height: 0.07 m				Migration: No	
D ₉₅ : 0.16 m				Rearing: No	
D: 0.001 m				Overwintering: No	
Confinement: Unconfined					
Channel Morphology: Riffle					
Channel Gradient: 15 ⁰					
Turbidity: 0.00 FTU					
Side Slope R – 5%; L – 5%					
Approach: R – 95%; L – 95%					
Bank Stability: Moderate-High					
Erosion Potential: Low-Moderate					
Undercut Banks: None					
		Fish Habitat Quality		Comments	
		None		This waterbody is likely significant only as a spring runoff stream. Even at peak flows, the gradient is likely too steep and water levels too low to offer useful habitat even for stickleback or young-of-the-year char from nearby Phillips Creek.

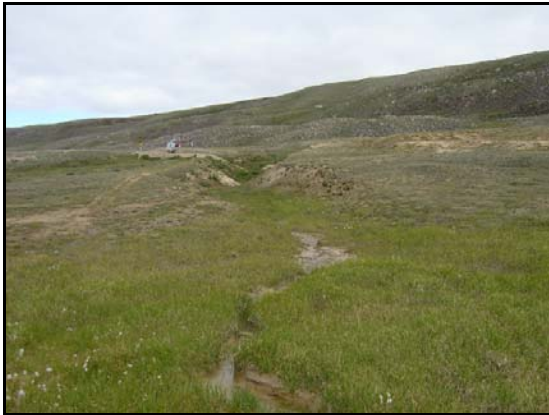
</div> <p>Figure 2: Upstream view from proposed crossing showing relatively steep gradient.</p> <div>
