APPENDIX 5.3-1.

DETAILED HABITAT ASSESSMENTS AND SUMMARY OF RESULTS FOR WATERBODIES IN QUARRY SITES.

Table A5.3-1.1. Summary of results from surveys and assessments that fall within Quarry boundaries.

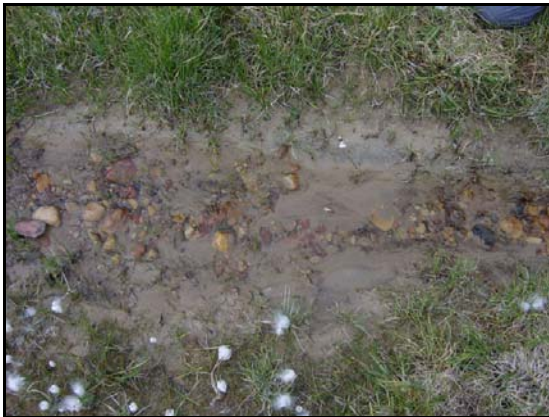
</div> <p>Figure 3: View across CV-156.</p>	Location				
	Site: CV-156		Watercourse Name: Unknown River		
	UTM: 17W 0507580 / 7970389				
	Site Description			Potential Fish Utilization	
	Watershed Size: 0.066 km ²		Mesohabitat Composition: Riffle – 100%		Arctic Char
	Regulated: No		Substrate Composition: Sand – 75%; Gravel – 20%; Cobble – 5%		Spawning: No
	Channelized: No		Stream Cover: In- and Overstream vegetation – 2%;		Migration: No
	Bankfull Width: 0.60 m		Riparian Vegetation: Grasses		Rearing: No
	Wetted Width: 0.26 m		Aquatic Vegetation: Submerged grasses		Overwintering: No

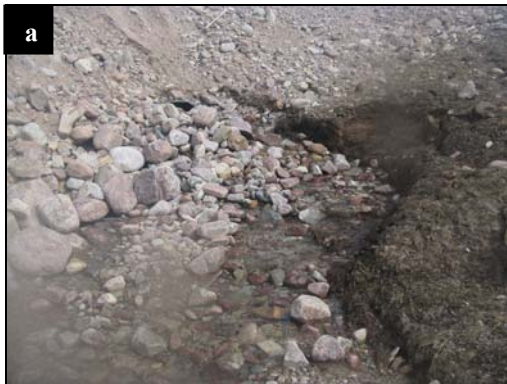
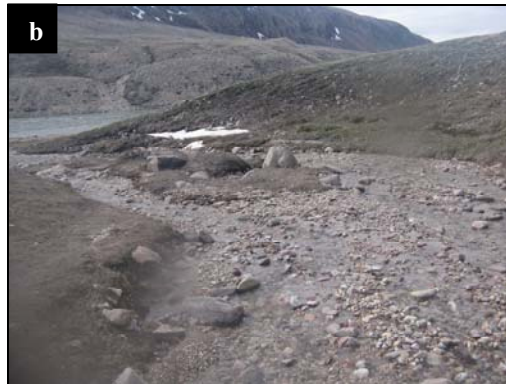
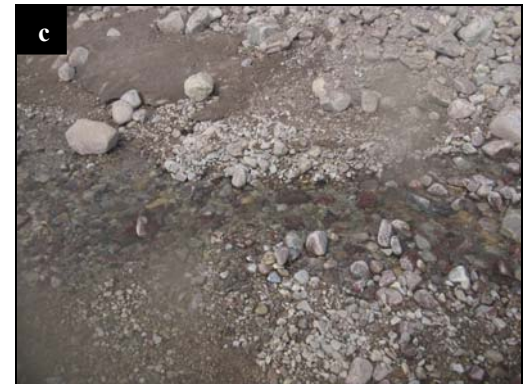
Figure 1. View upstream (a), downstream (b), and across (c) at the habitat assessment site downstream of the crossing at CV-154 during early July, 2009.

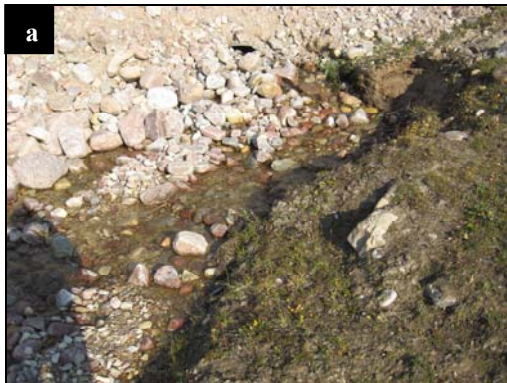
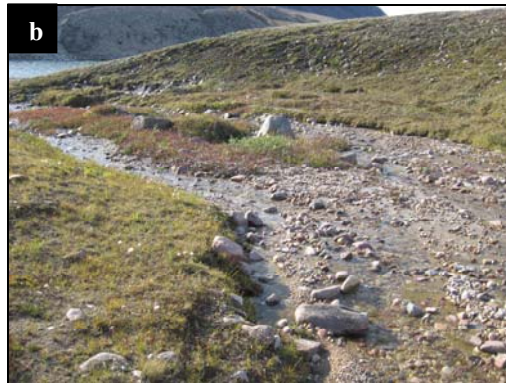
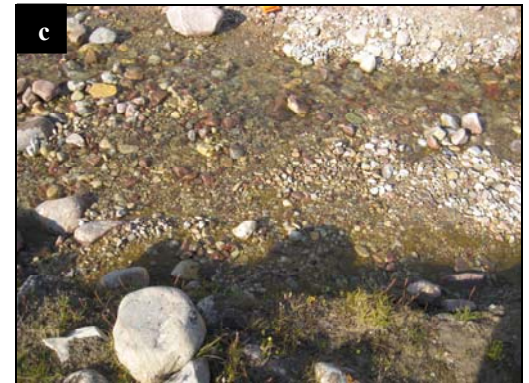
Figure 2. View upstream (a), downstream (b), and across (b) at the habitat assessment site downstream of the crossing at CV-154 during late August, 2009.

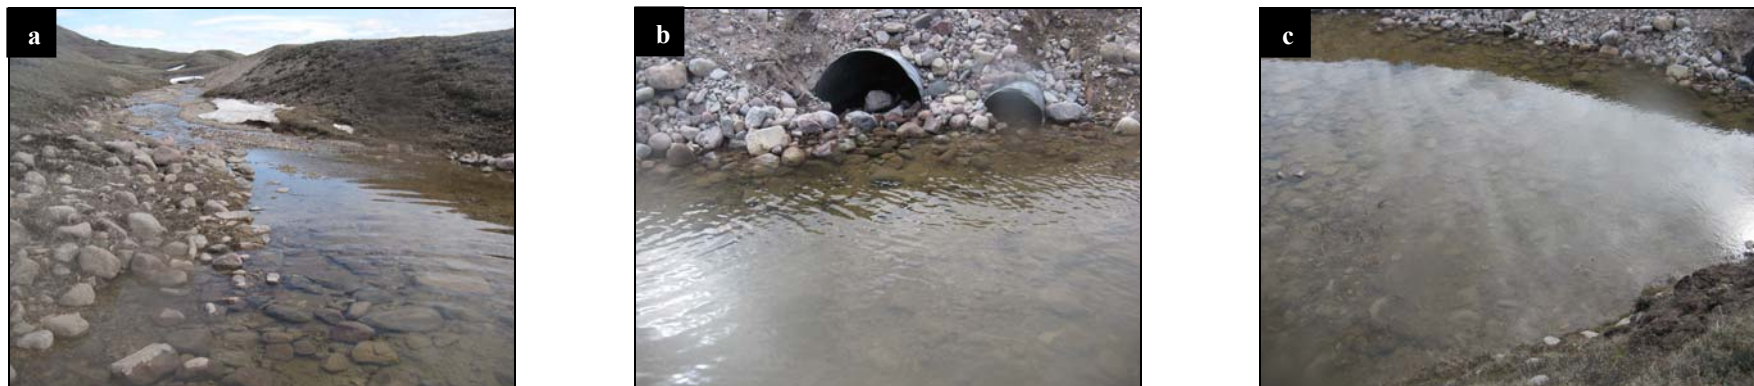
Figure 1. View upstream (a), downstream (b), and across (c) at the habitat assessment site 50 m upstream of the crossing at CV-154 during early July, 2009.

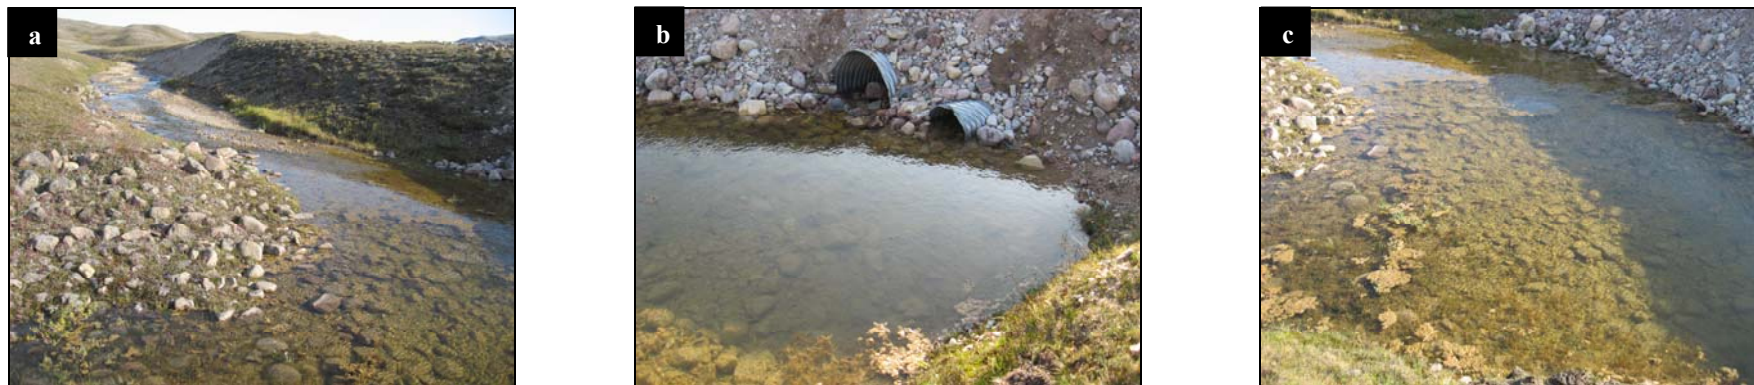
Figure 2. View upstream (a), downstream (b), and across (c) at the habitat assessment site 50 m upstream of the crossing at CV-154 during late August, 2009.

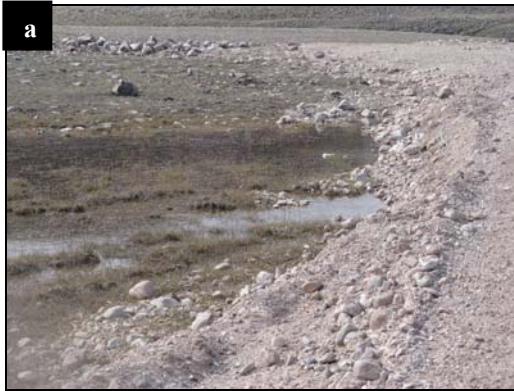
Figure 1. View across (a) at the habitat assessment site downstream of the crossing at CV-153 during spring, 2009.

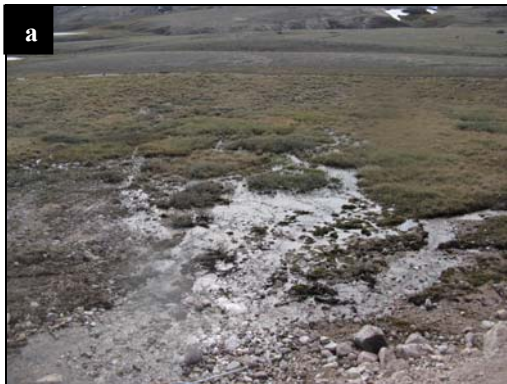
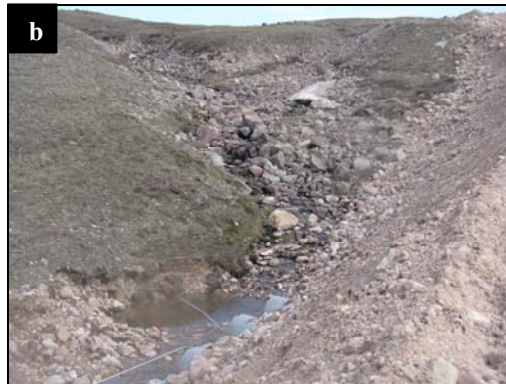
Figure 1. View downstream (a) and upstream (b) of the crossing at CV-152 during early July, 2009.

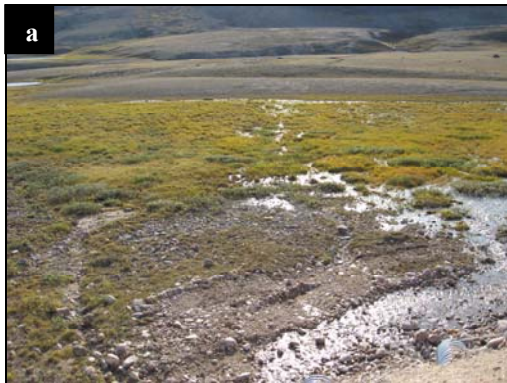
Figure 2. View downstream (a) of the crossing at CV-152 during late August, 2009.

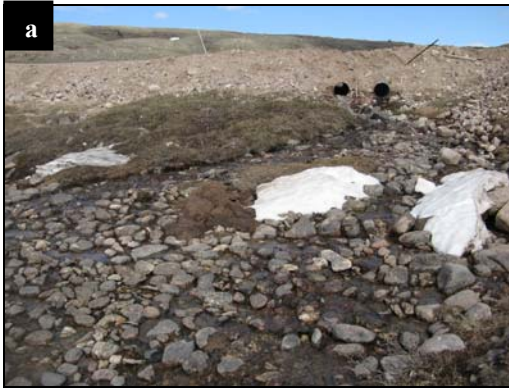
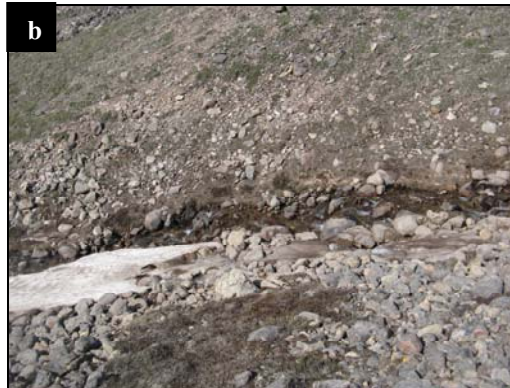
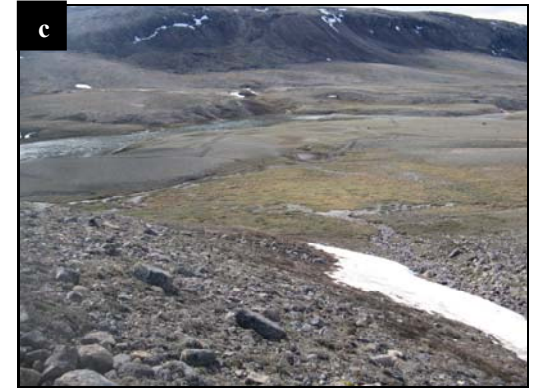
Figure 1. View upstream (a) and barriers (b,c) at the habitat assessment site downstream of the crossing at CV-151 during spring, 2009.

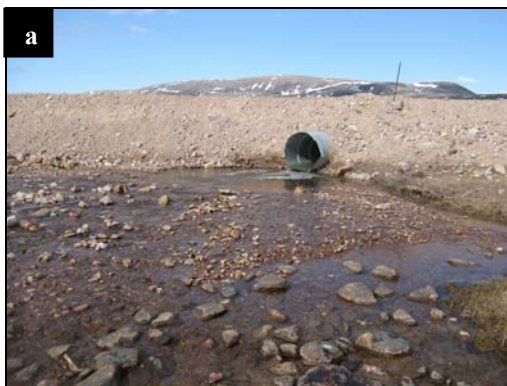
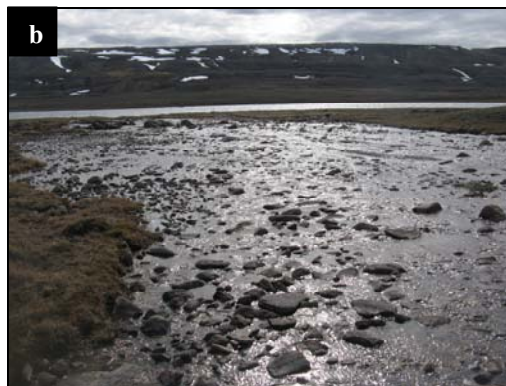
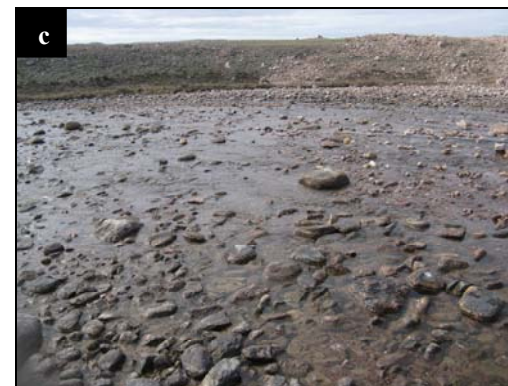
Figure 1. View upstream (a), downstream (b), and across (c) at the habitat assessment site downstream of the crossing at CV-129 during early July, 2009.

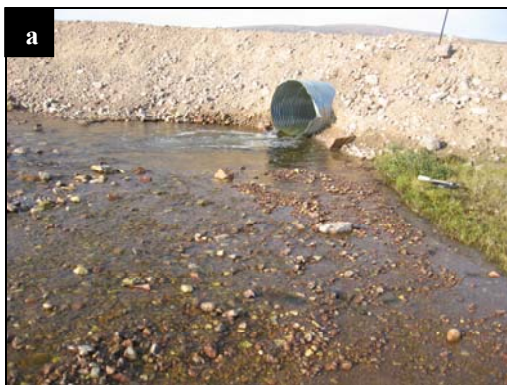
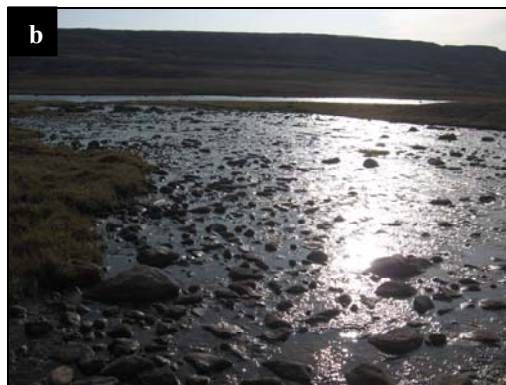
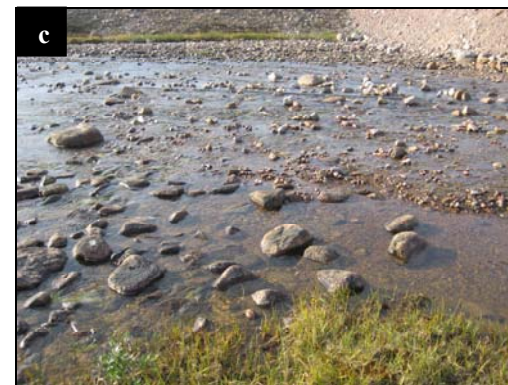
Figure 2. View upstream (a), downstream (b), and across (b) at the habitat assessment site downstream of the crossing at CV-129 during late August, 2009.

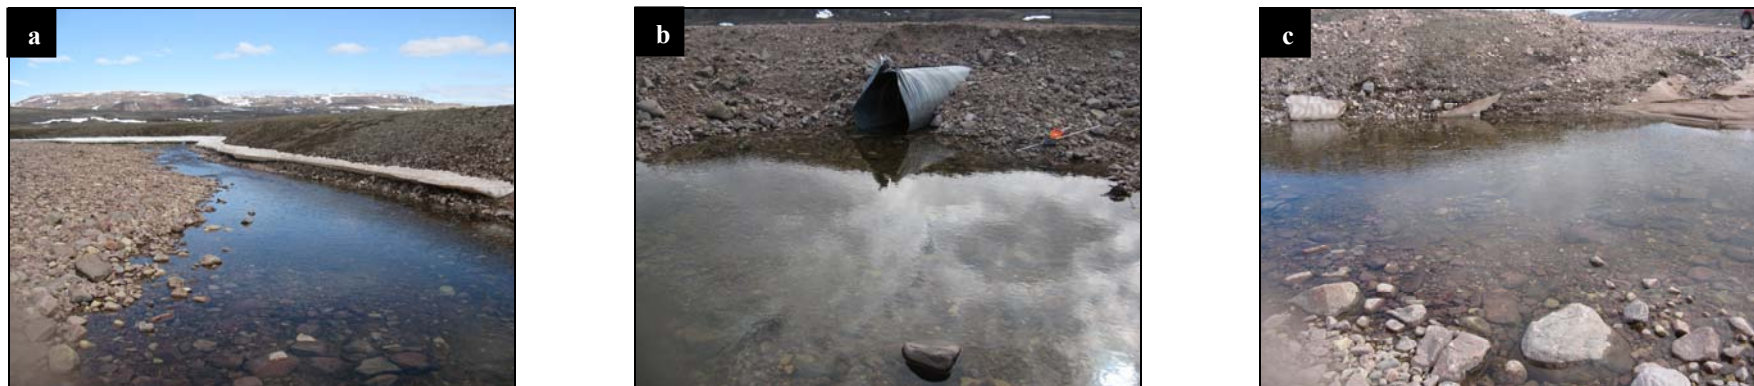
Figure 1. View upstream (a), downstream (b), and across (c) at the habitat assessment site upstream of the crossing at CV-129 during early July, 2009.

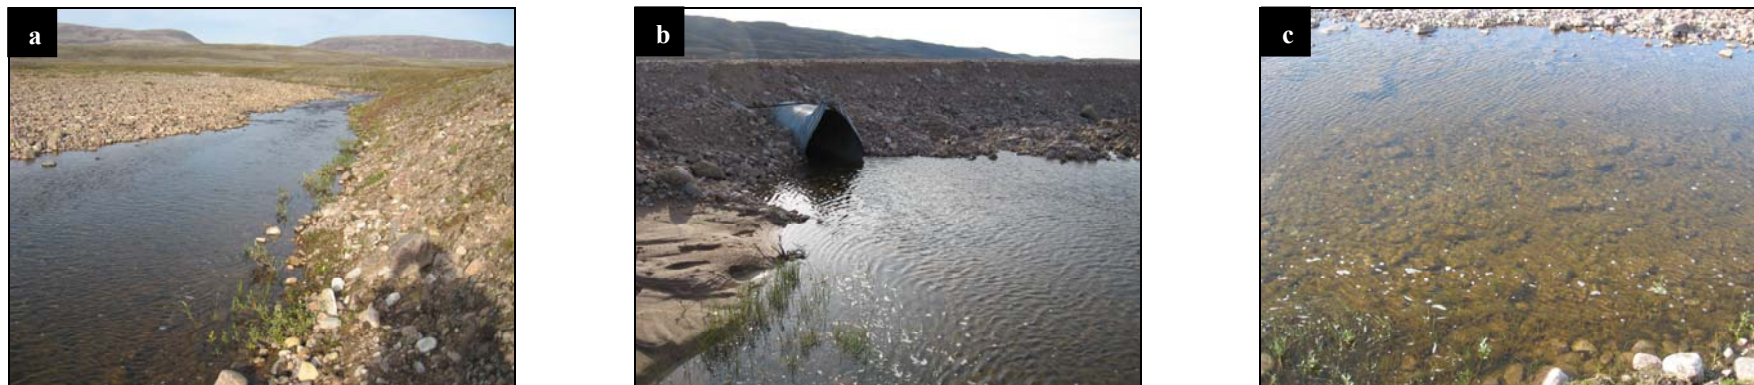
Figure 2. View upstream (a), downstream (b), and across (c) at the habitat assessment site upstream of the crossing at CV-129 during late August, 2009.

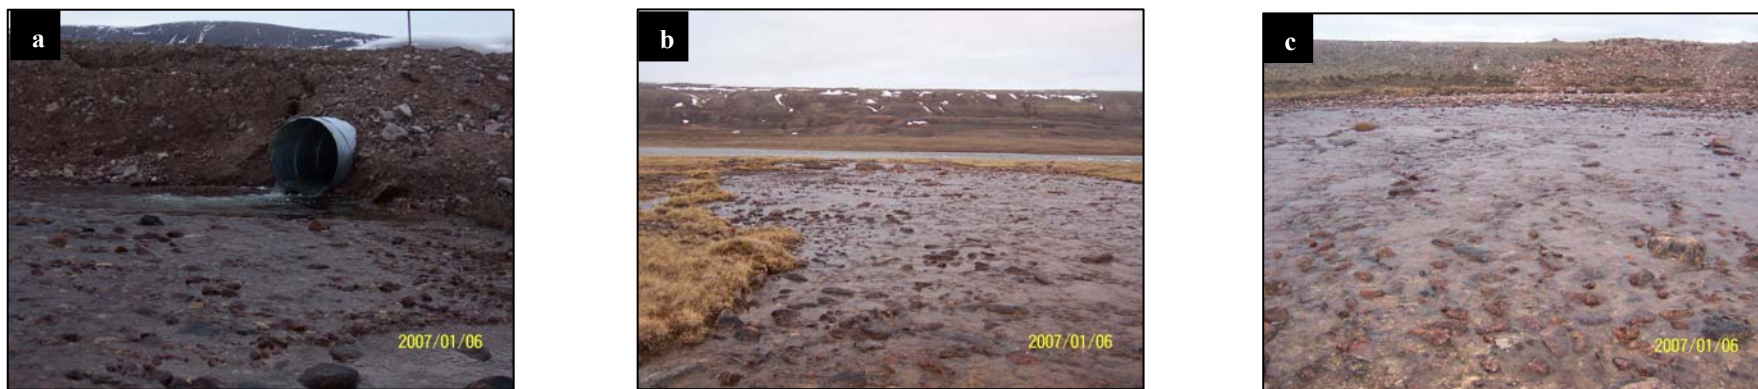
Figure 1. View upstream (a), downstream (b), and across (c) from the habitat assessment downstream of CV-129 during spring 2008.

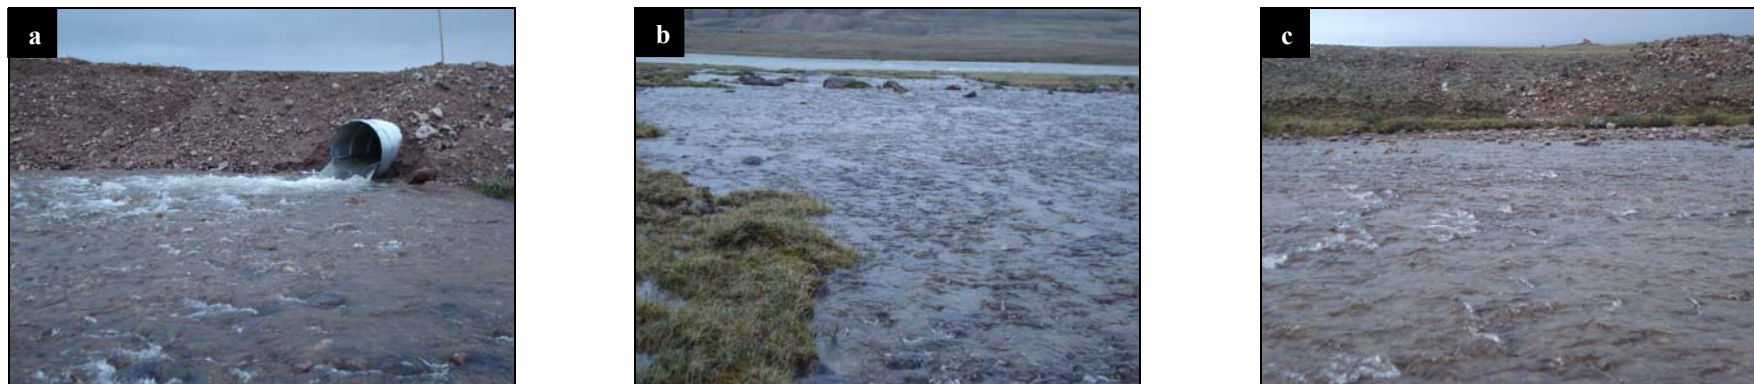
Figure 2. View upstream (a), downstream (b), and across (c) from the habitat assessment downstream of CV-129 during summer 2008.

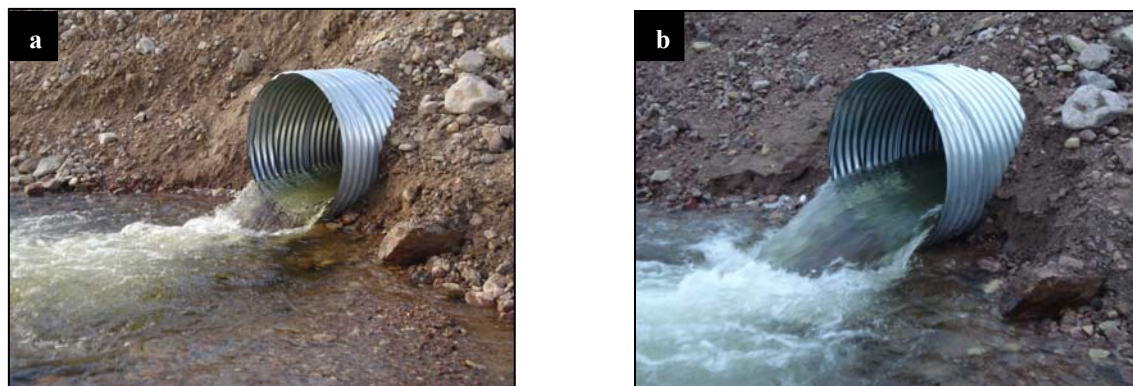
Figure 3. View from the downstream end of the culvert at crossing CV-129 during spring (a) and summer (b) 2008.

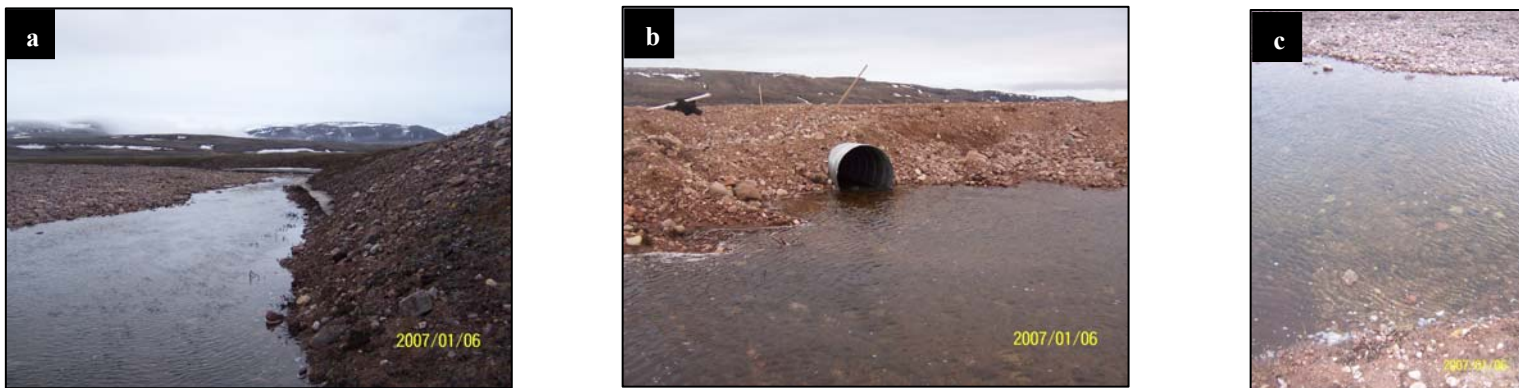
Figure 1. View upstream (a), downstream (b), and across (c) from the habitat assessment upstream of CV-129 during spring 2008.

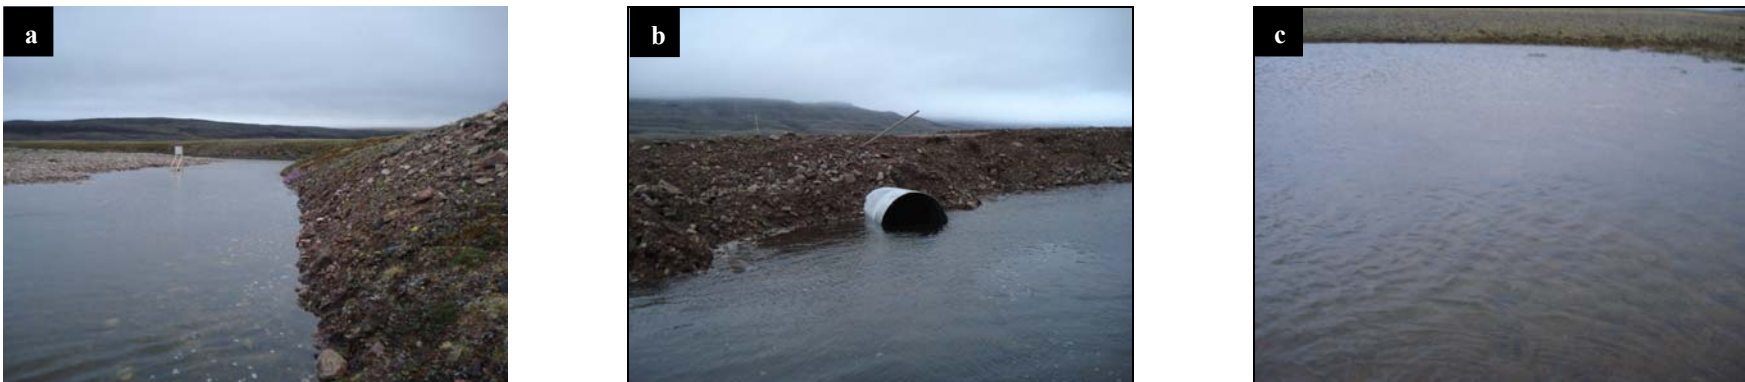
Figure 2. View upstream (a), downstream (b), and across (c) from the habitat assessment upstream of CV-129 during summer 2008.

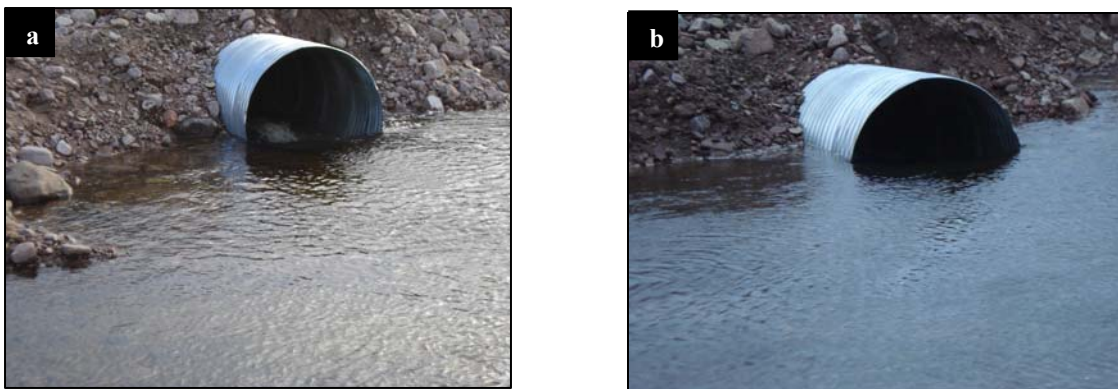
Figure 3. View from the upstream end of the culverts at crossing CV-129 during spring (a) and summer (b) 2008.

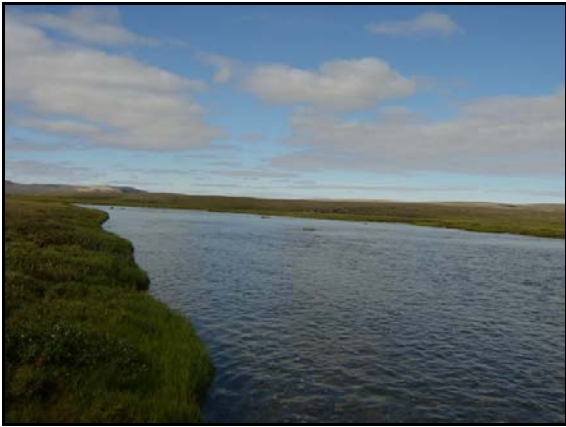
Figure 1: Downstream view from proposed crossing showing predominantly run habitat.

This large stream has suitable habitat for all life-cycle stages of char and stickleback though only juvenile char were observed during fisheries investigations. The water may be too fast and too clear for stickleback. In addition, accessibility to larger char may decrease the value of the stream as refuge habitat for juveniles.

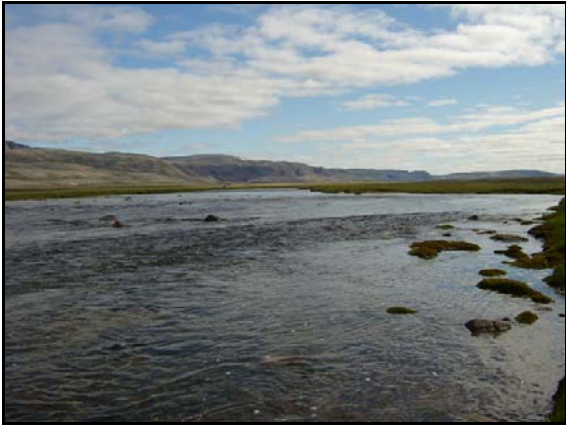
Figure 2: Upstream view from proposed crossing showing riffle-pool habitat and cobble substrate.

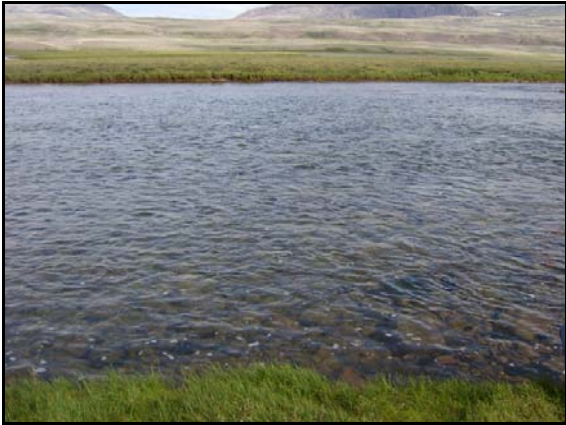
Figure 3: View across CV-128.

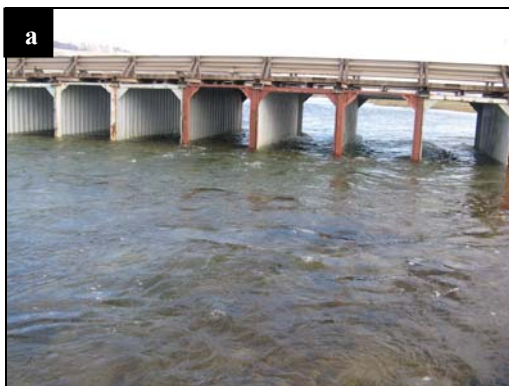
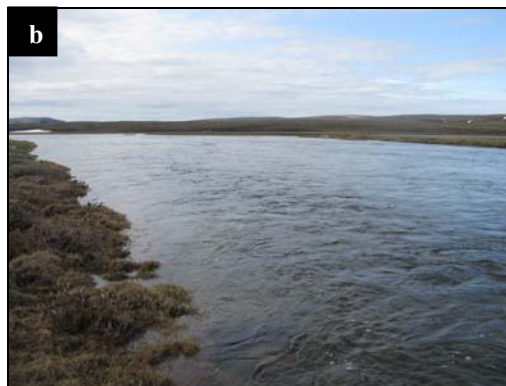
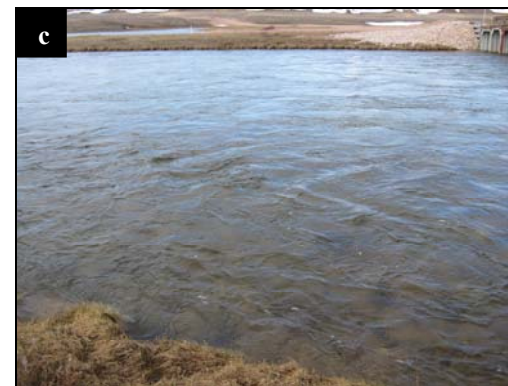
Figure 1. View upstream (a), downstream (b), and across (c) at the habitat assessment site downstream of the crossing at CV-128 during early July, 2009.

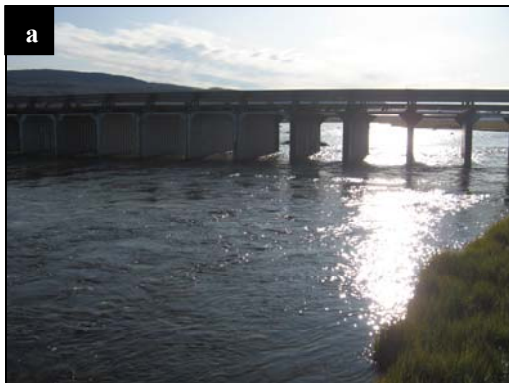
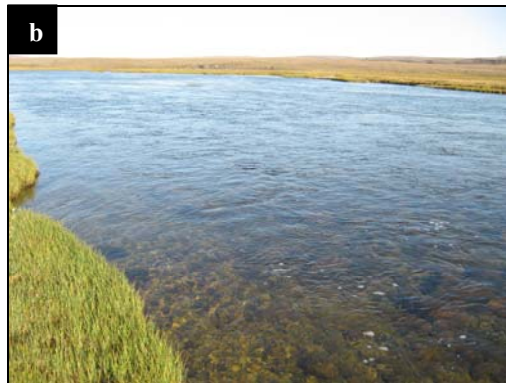
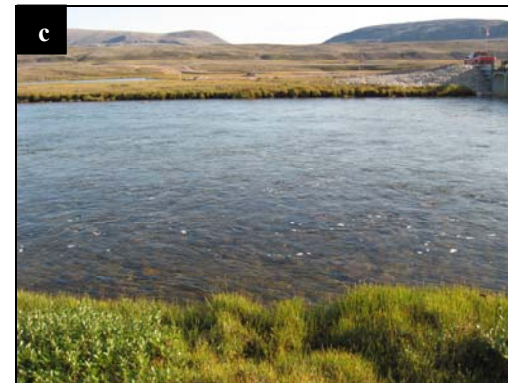
Figure 2. View upstream (a), downstream (b), and across (b) at the habitat assessment site downstream of the crossing at CV-128 during late August, 2009.

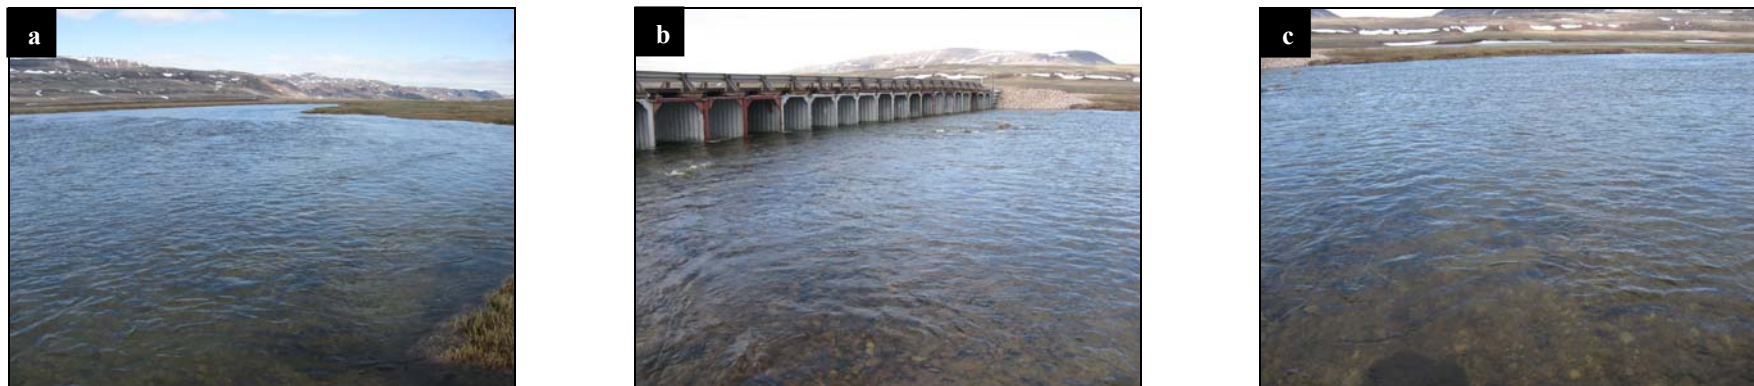
Figure 1. View upstream (a), downstream (b), and across (c) at the habitat assessment site upstream of the crossing at CV-128 during early July, 2009.

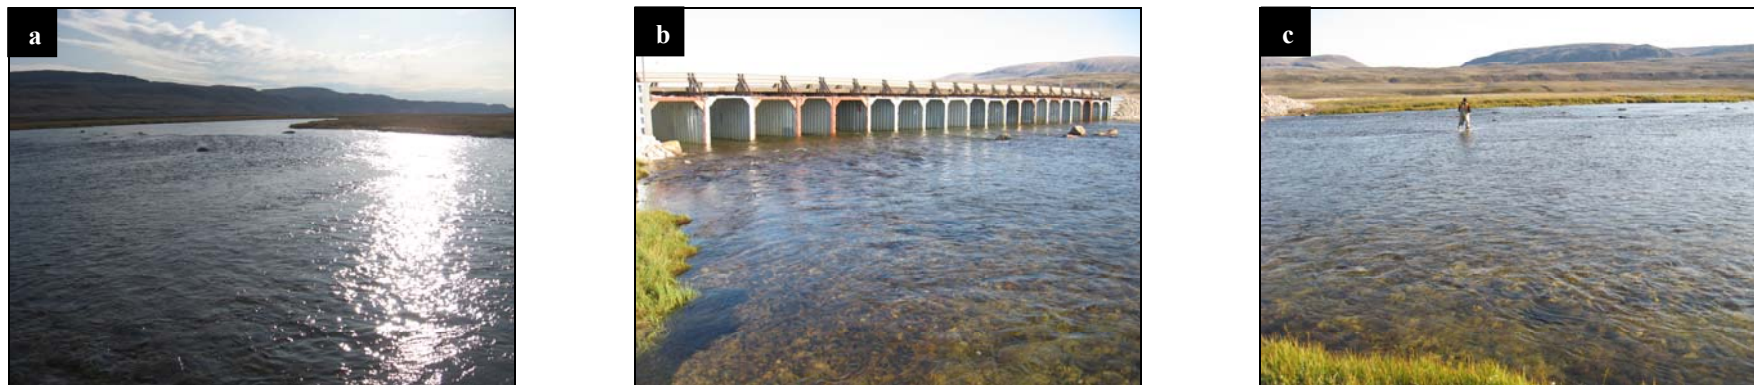
Figure 2. View upstream (a), downstream (b), and across (c) at the habitat assessment site upstream of the crossing at CV-128 during late August, 2009.

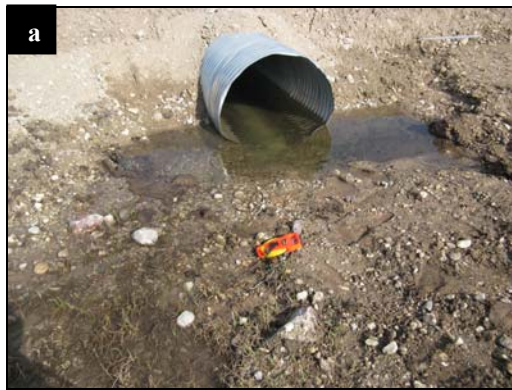
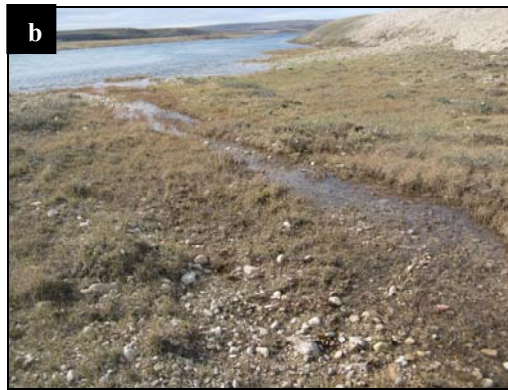
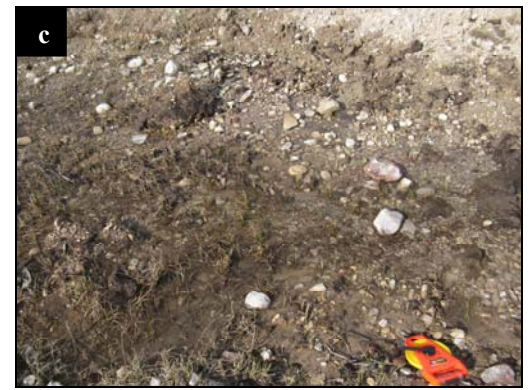
Figure 1. View upstream (a), downstream (b), and across (c) at the habitat assessment site downstream of the crossing at CV-125 during spring, 2009.

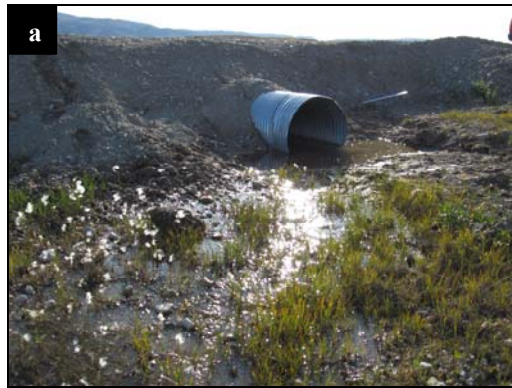
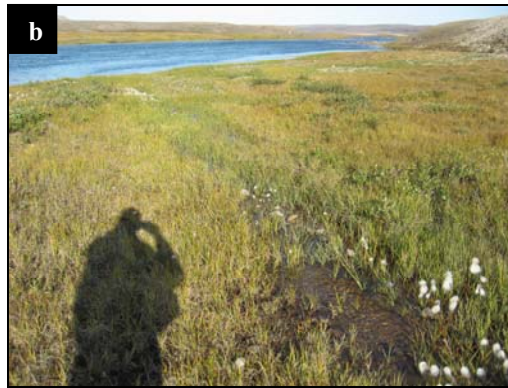
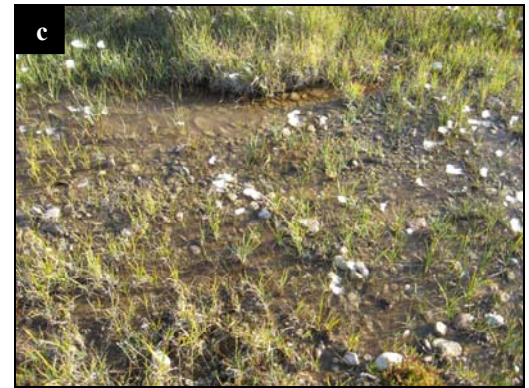
Figure 2. View upstream (a), downstream (b), and across (b) at the habitat assessment site downstream of the crossing at CV-125 during fall, 2009.

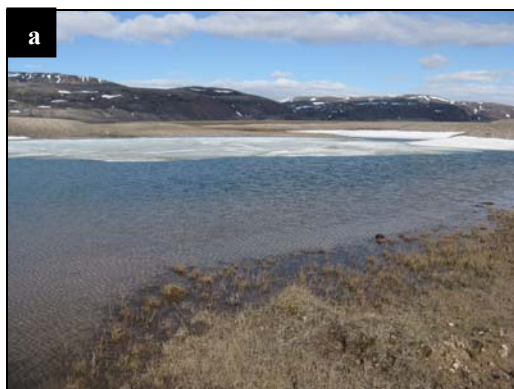
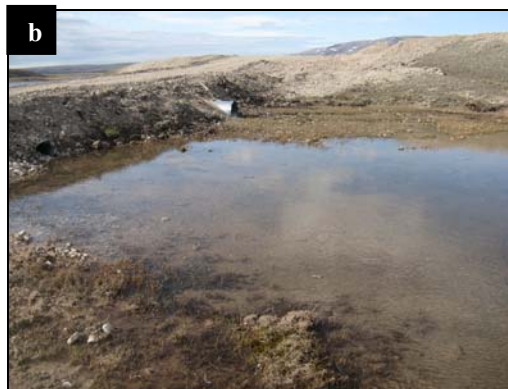
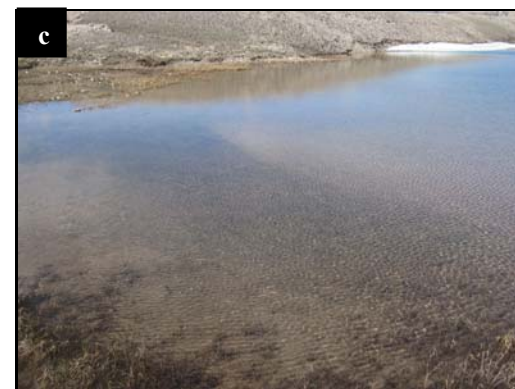
Figure 1. View upstream (a), downstream (b), and across (c) at the habitat assessment site upstream of the crossing at CV-125 during spring, 2009.

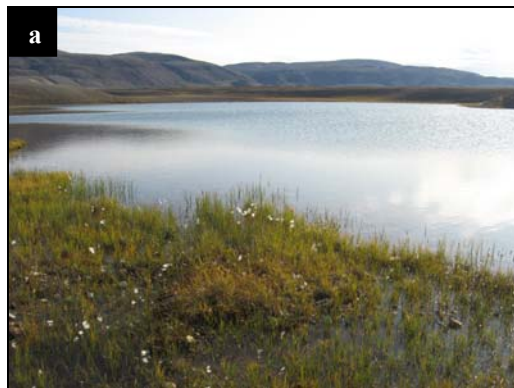
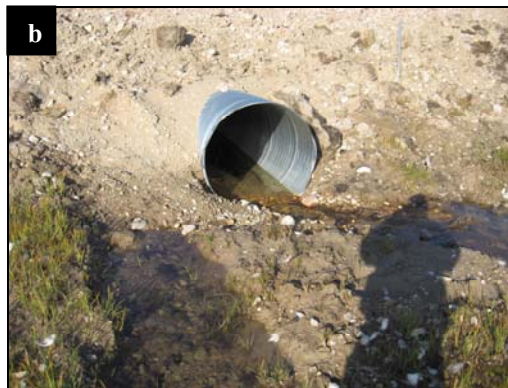
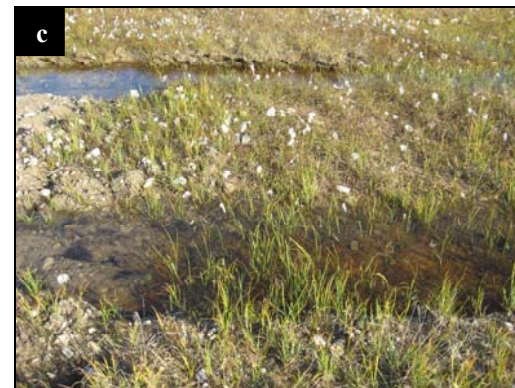
Figure 2. View upstream (a), downstream (b), and across (c) at the habitat assessment site upstream of the crossing at CV-125 during fall, 2009.

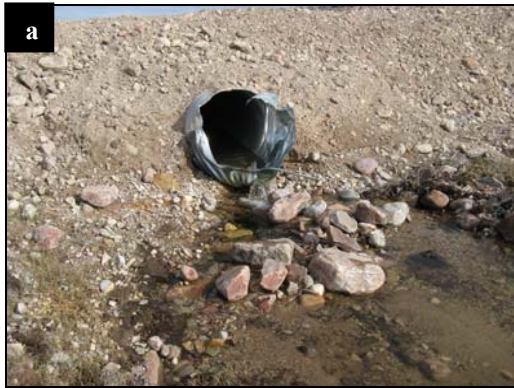
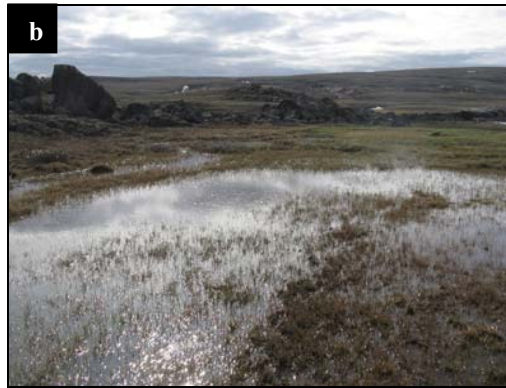
Figure 1. View upstream (a), and downstream (b) at the habitat assessment site downstream of the crossing at CV-120 during spring, 2009.

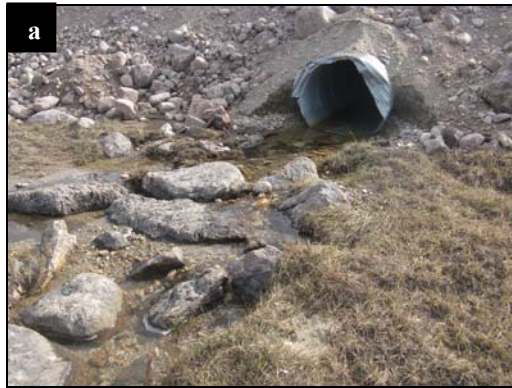
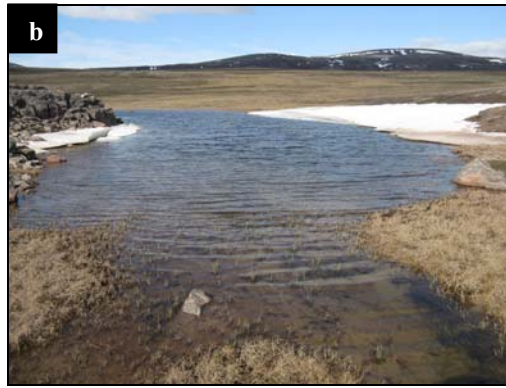
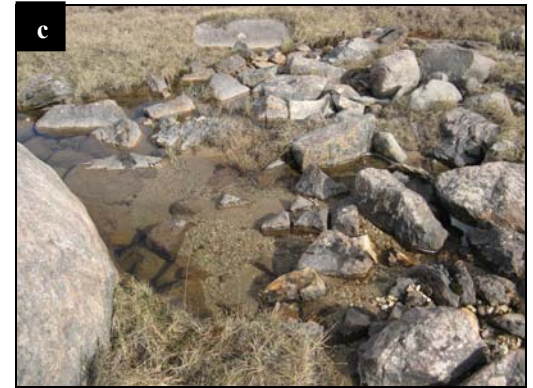
Figure 1. View upstream (a), downstream (b), and across (c) at the habitat assessment site downstream of the crossing at CV-119 during spring, 2009.

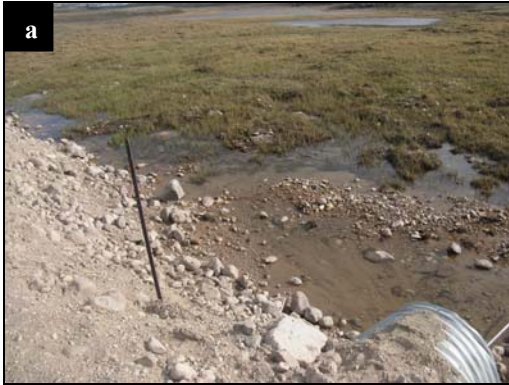
Figure 1. View upstream (a) at the habitat assessment site upstream of the crossing at CV-119 during spring, 2009.

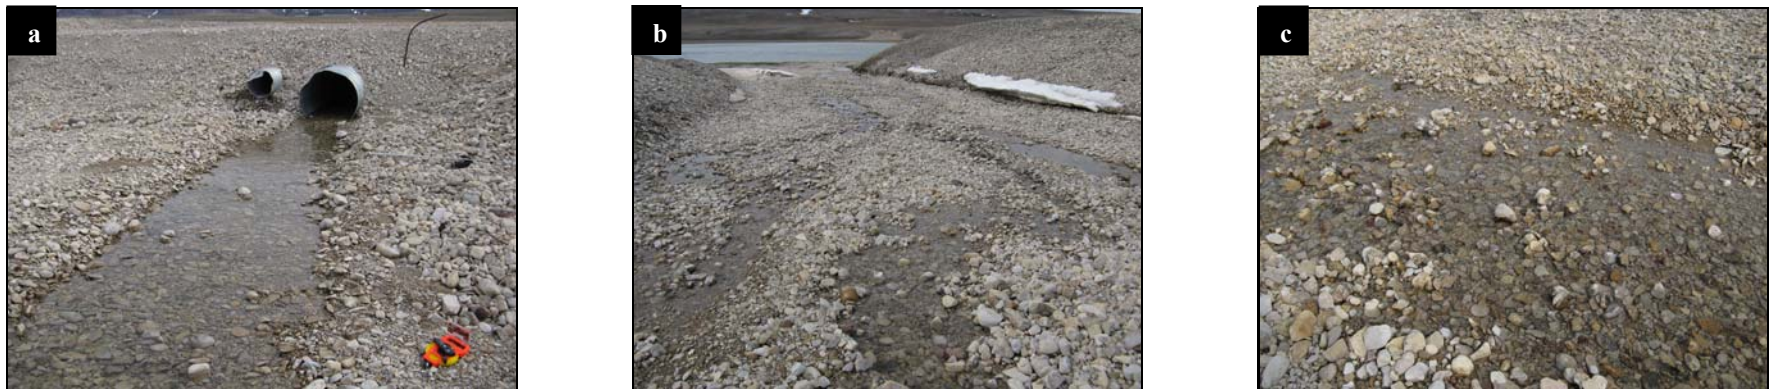
Figure 1. View upstream (a), downstream (b), and across (c) at the habitat assessment site downstream of the crossing at CV-115 during spring, 2009.

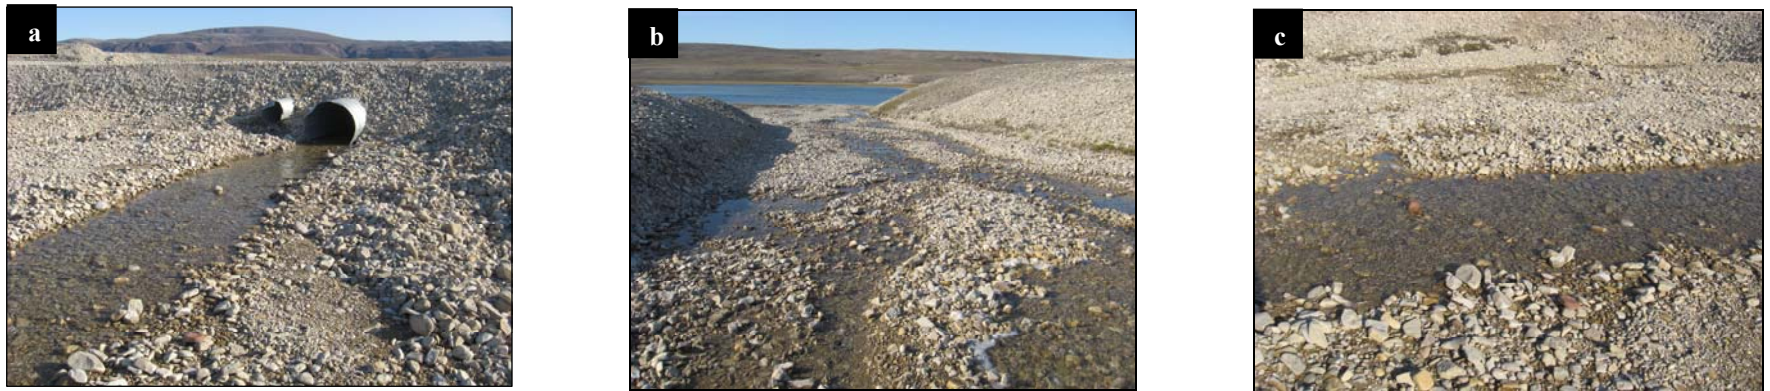
Figure 2. View upstream (a), downstream (b), and across (c) at the habitat assessment site downstream of the crossing at CV-115 during fall, 2009.

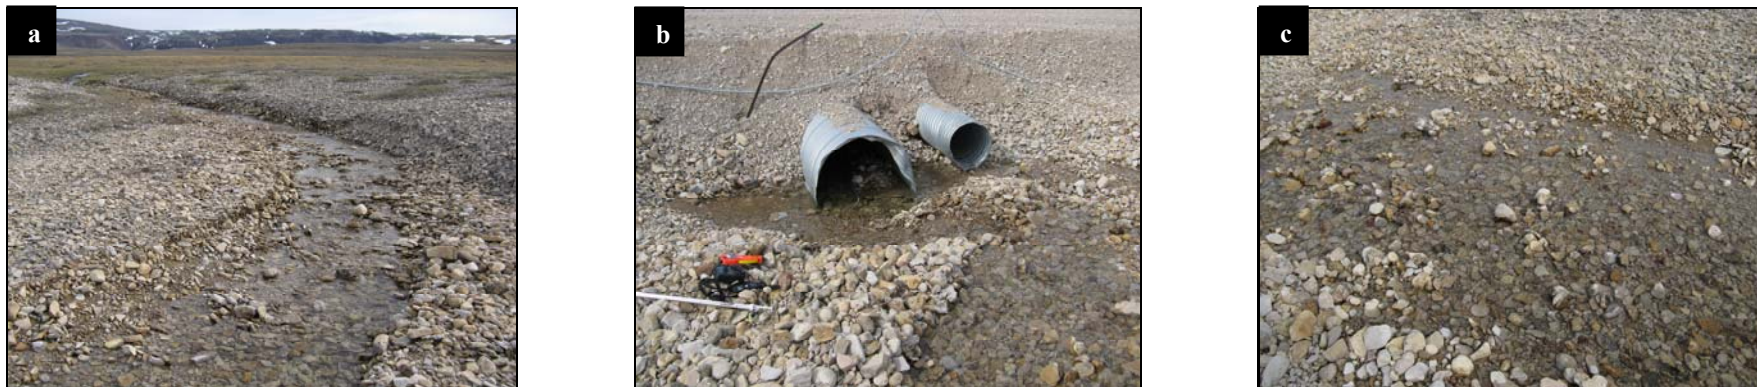
Figure 1. View upstream (a), downstream (b), and across (c) at the habitat assessment site upstream of the crossing at CV-115 during spring, 2009.

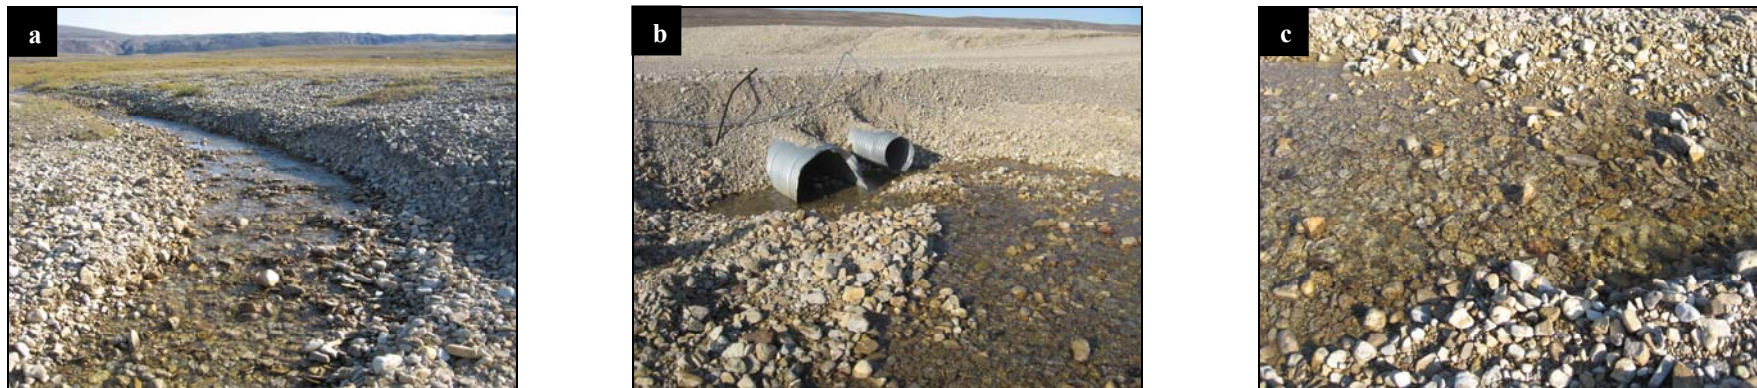
Figure 2. View upstream (a), downstream (b), and across (c) at the habitat assessment site upstream of the crossing at CV-115 during fall, 2009.

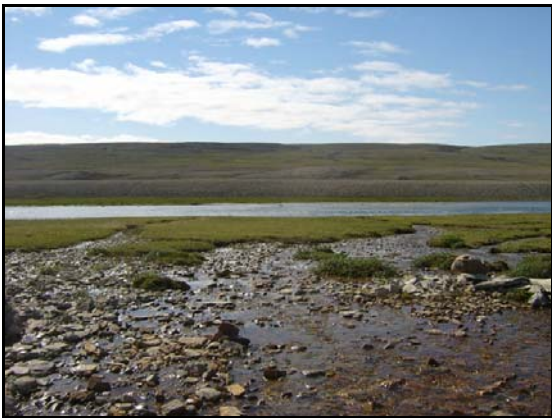
Figure 1: Downstream view from proposed crossing showing predominantly cascade habitat.

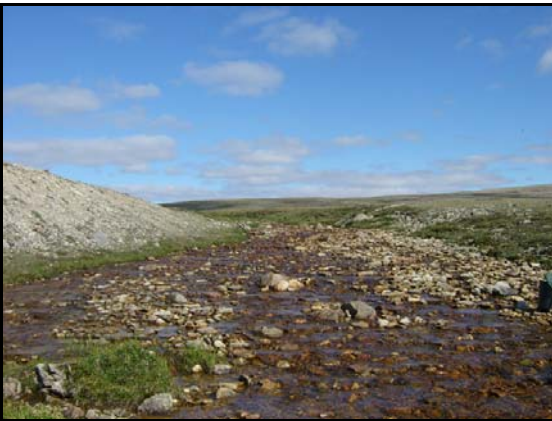
Figure 2: Upstream view from proposed crossing showing more cascade-riffle habitat and cobble substrate.

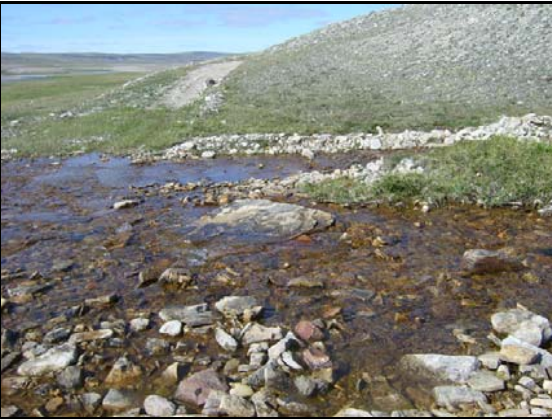
Figure 3: View across CV-114.

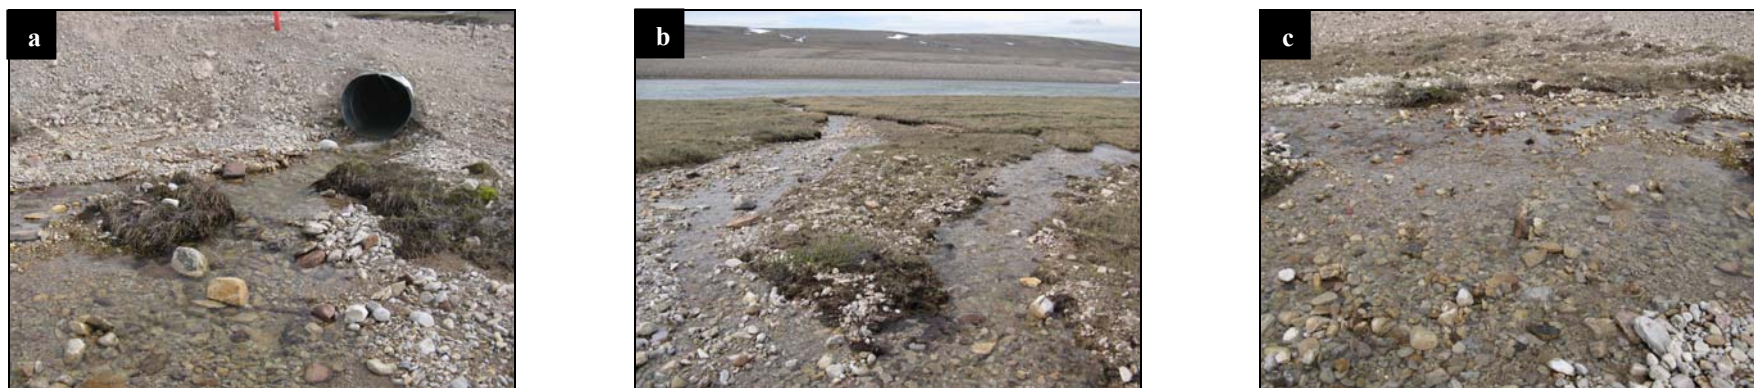
Figure 1. View upstream (a), downstream (b), and across (c) at the habitat assessment site downstream of the crossing at CV-114 during early July, 2009.
