APPENDIX 5.3-1.

DETAILED HABITAT ASSESSMENTS AND SUMMARY OF RESULTS FOR WATERBODIES IN QUARRY SITES.

Table A5.3-1.1. Summary of results from surveys and assessments that fall within Quarry boundaries.

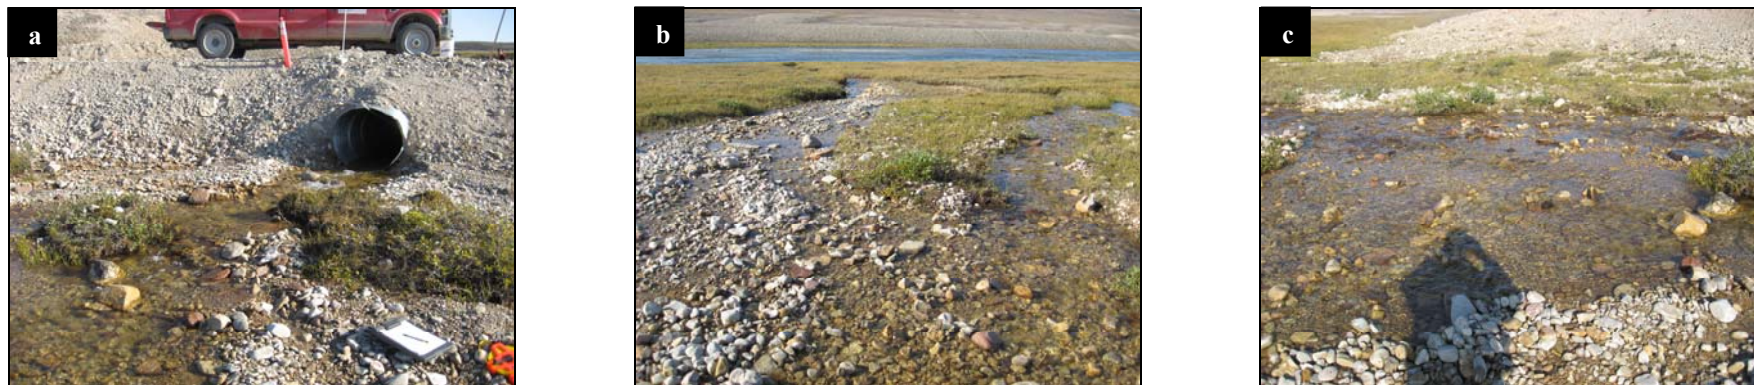
Figure 2. View upstream (a), downstream (b), and across (b) at the habitat assessment site downstream of the crossing at CV-114 during late August, 2009.

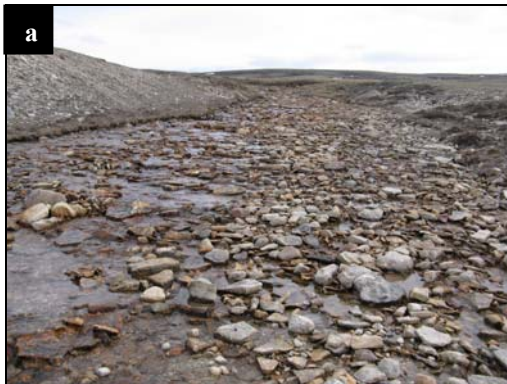
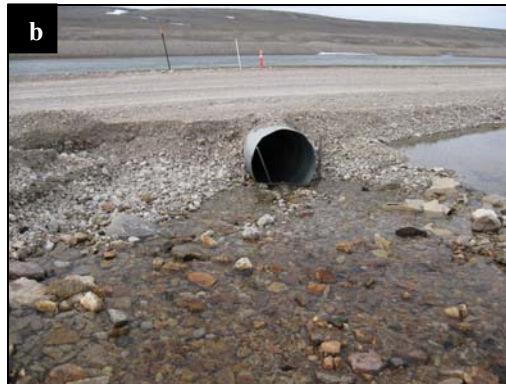
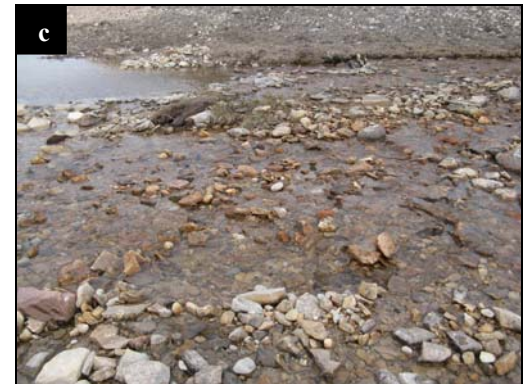
Figure 1. View upstream (a), downstream (b), and across (c) at the habitat assessment site upstream of the crossing at CV-114 during early July, 2009.

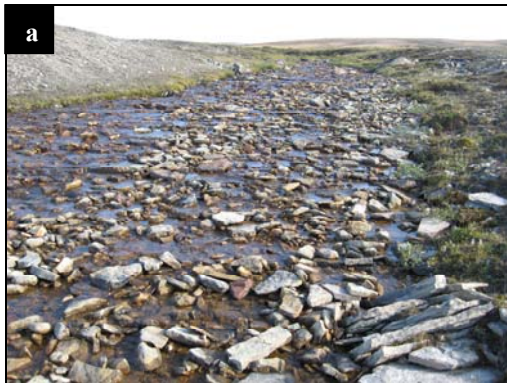
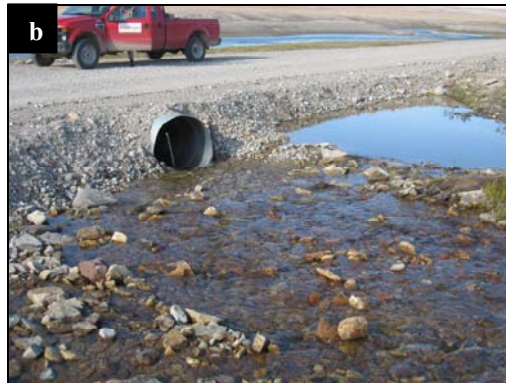
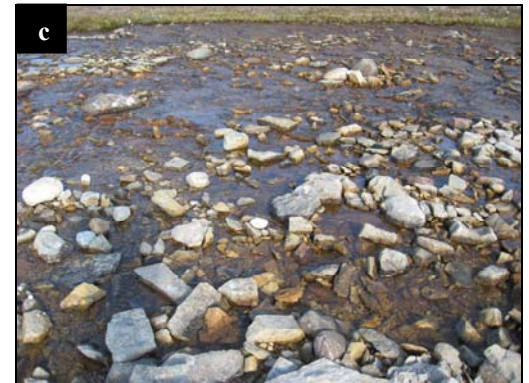
Figure 2. View upstream (a), downstream (b), and across (c) at the habitat assessment site upstream of the crossing at CV-114 during late August, 2009.

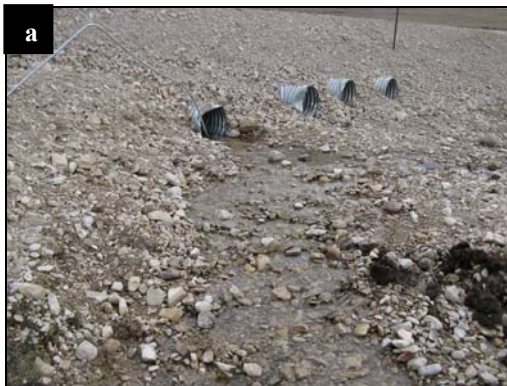
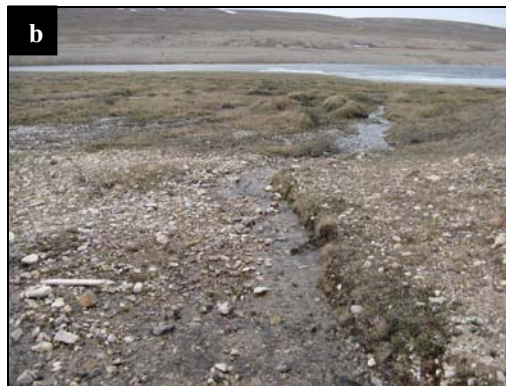
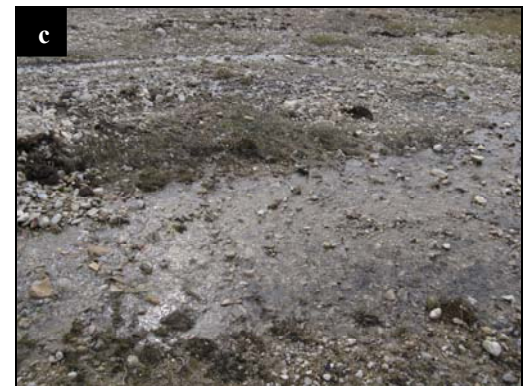
Figure 1. View upstream (a), downstream (b), and across (c) at the habitat assessment site downstream of the crossing at CV-113 during early July, 2009.

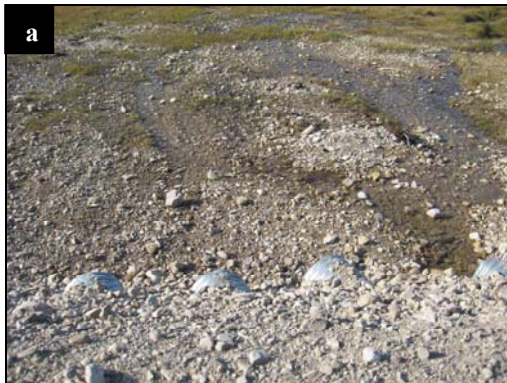
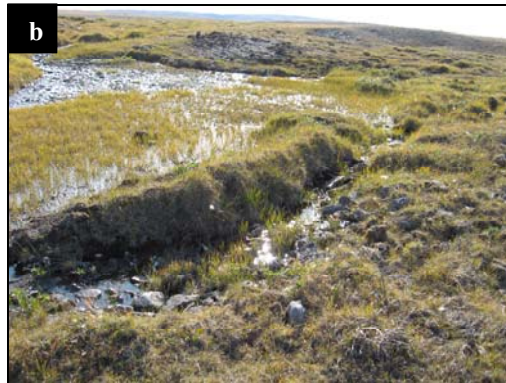
Figure 2. View of remaining wetted habitat (a) and natural barrier (b) downstream of the crossing at CV-113 during late August, 2009.

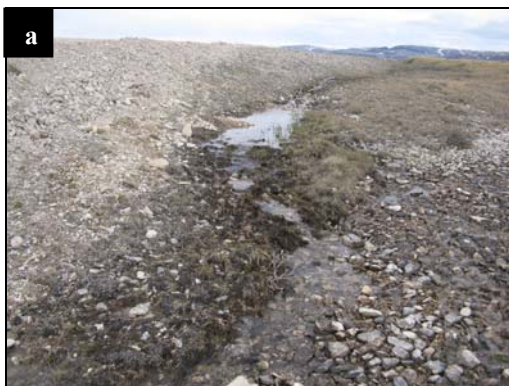
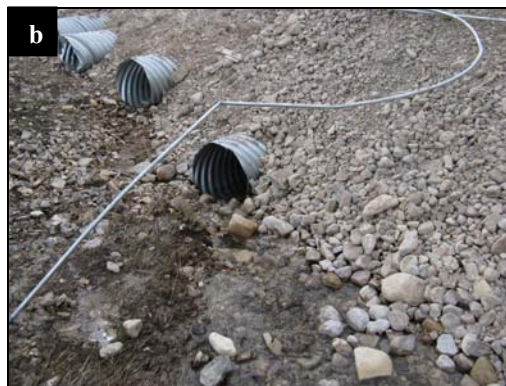
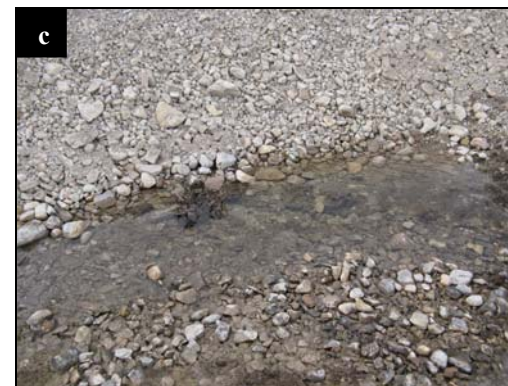
Figure 1. View upstream (a), downstream (b), and across (c) at the habitat assessment site upstream of the crossing at CV-113 during early July, 2009.

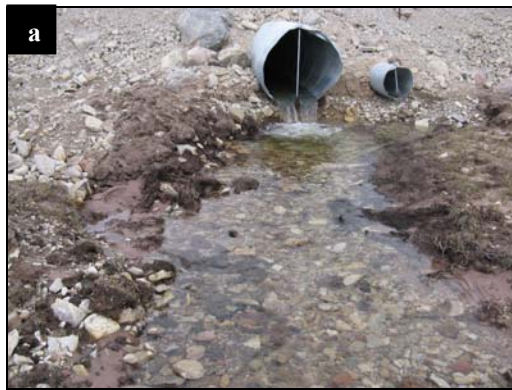
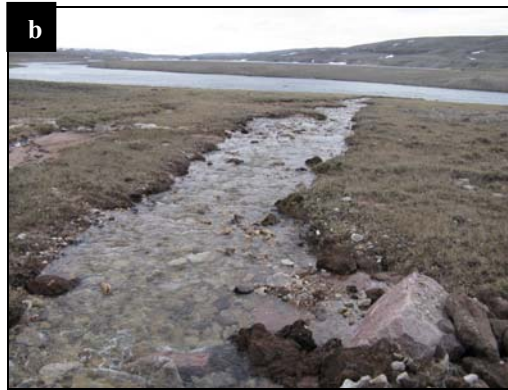
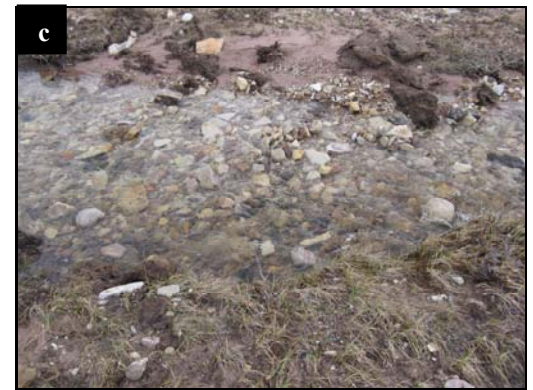
Figure 1. View upstream (a), downstream (b), and across (c) at the habitat assessment site downstream of the crossing at CV-112 during spring, 2009.

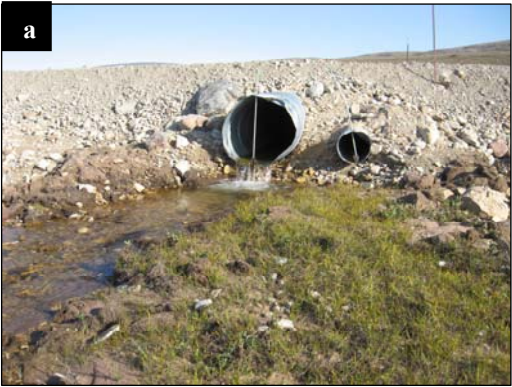
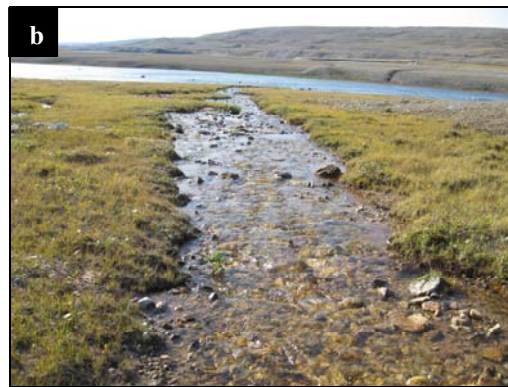
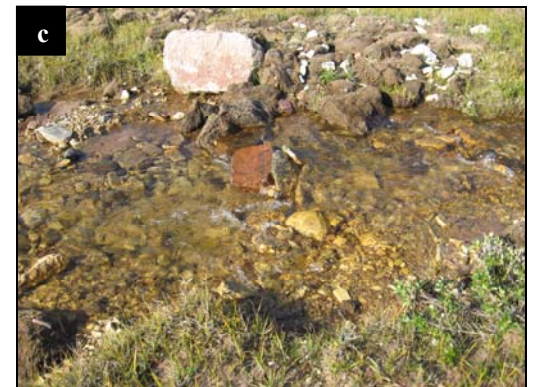
Figure 2. View upstream (a), downstream (b), and across (c) at the habitat assessment site downstream of the crossing at CV-112 during fall, 2009.

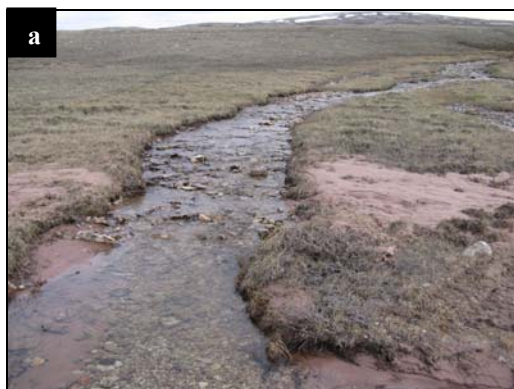
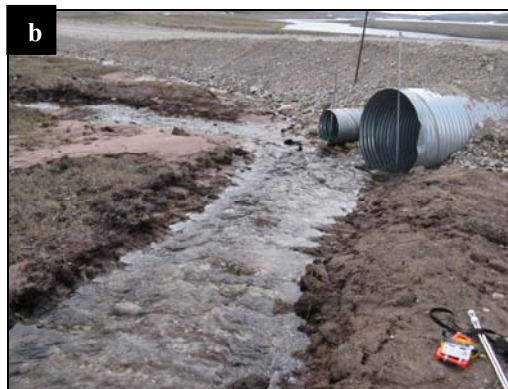
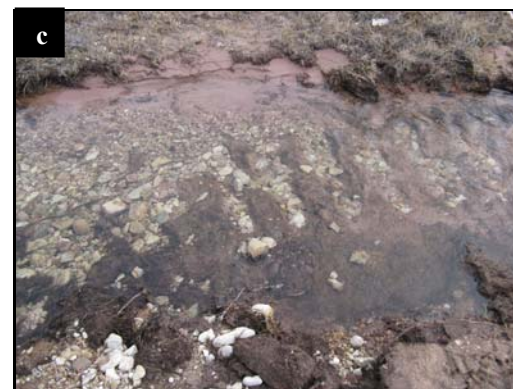
Figure 1. View upstream (a), downstream (b), and across (c) at the habitat assessment site upstream of the crossing at CV-112 during spring, 2009.

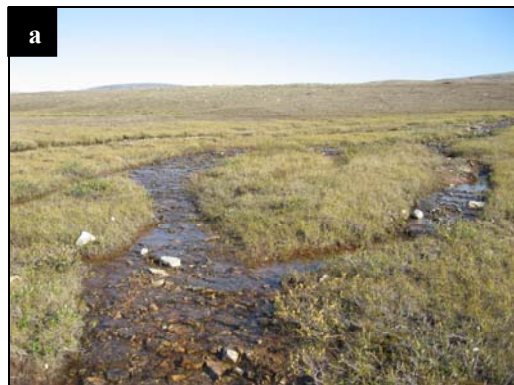
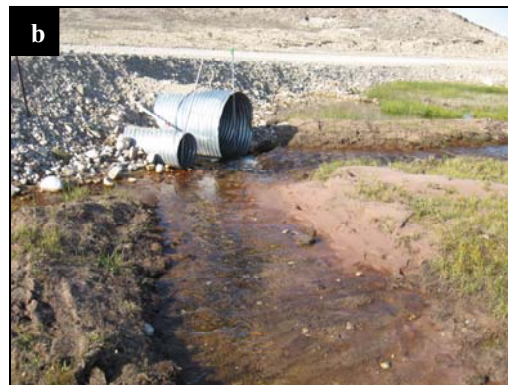
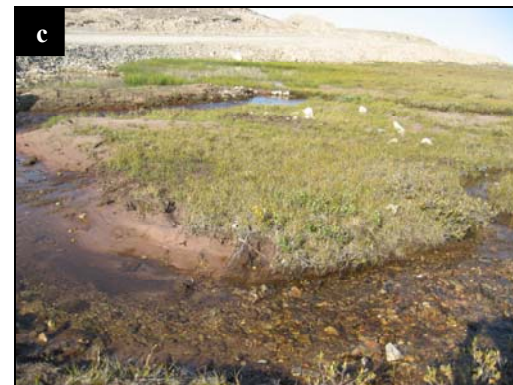
Figure 2. View upstream (a), downstream (b), and across (c) at the habitat assessment site upstream of the crossing at CV-112 during fall, 2009.

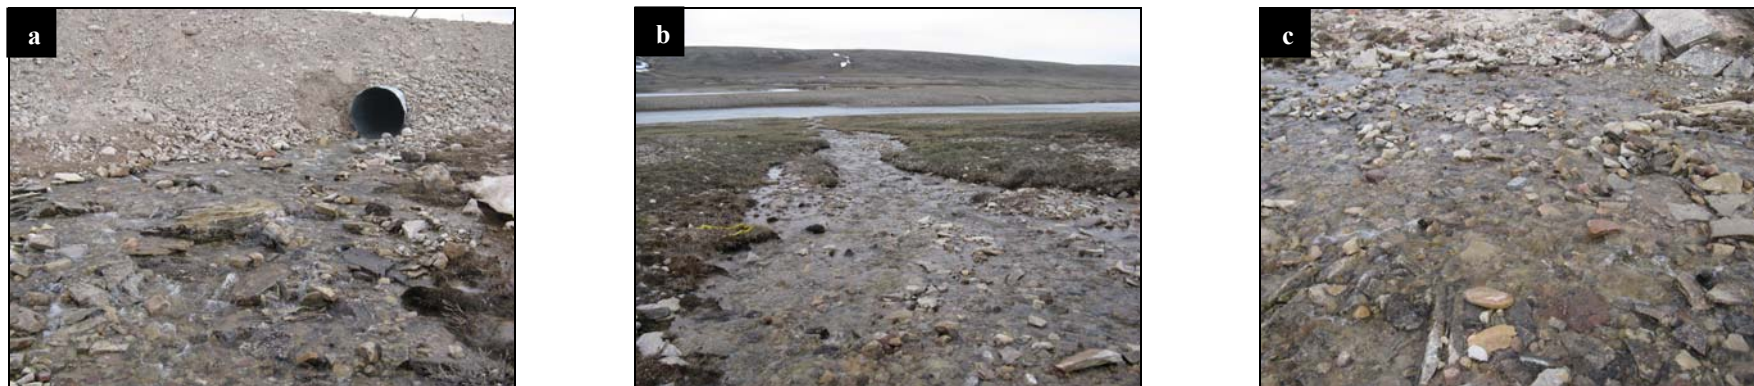
Figure 1. View upstream (a), downstream (b), and across (c) at the habitat assessment site downstream of the crossing at CV-111 during early July, 2009.

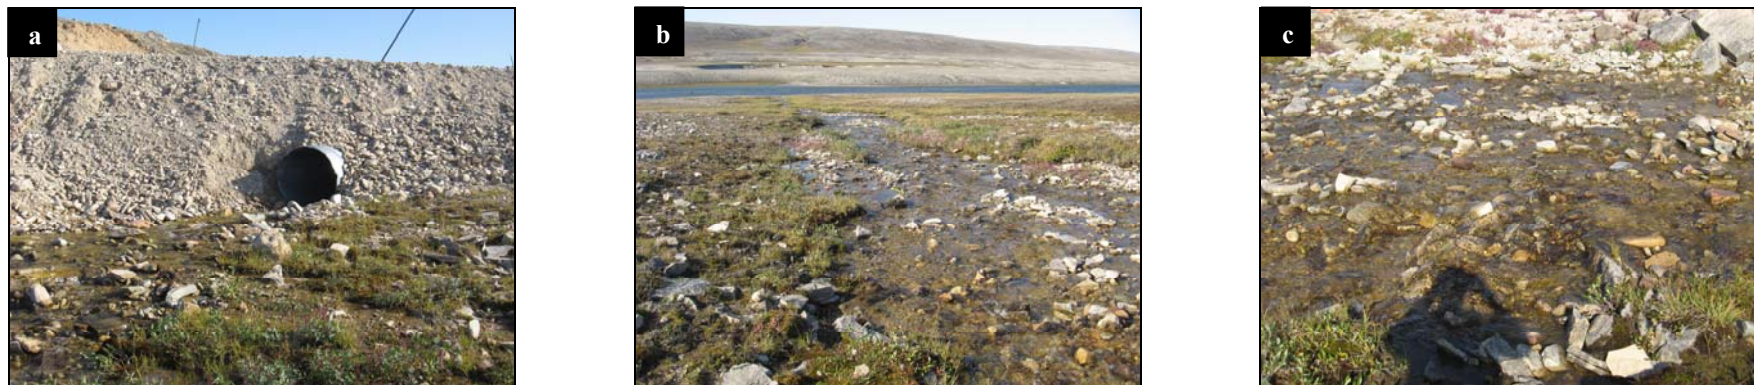
Figure 2. View upstream (a), downstream (b), and across (b) at the habitat assessment site downstream of the crossing at CV-111 during late August, 2009.

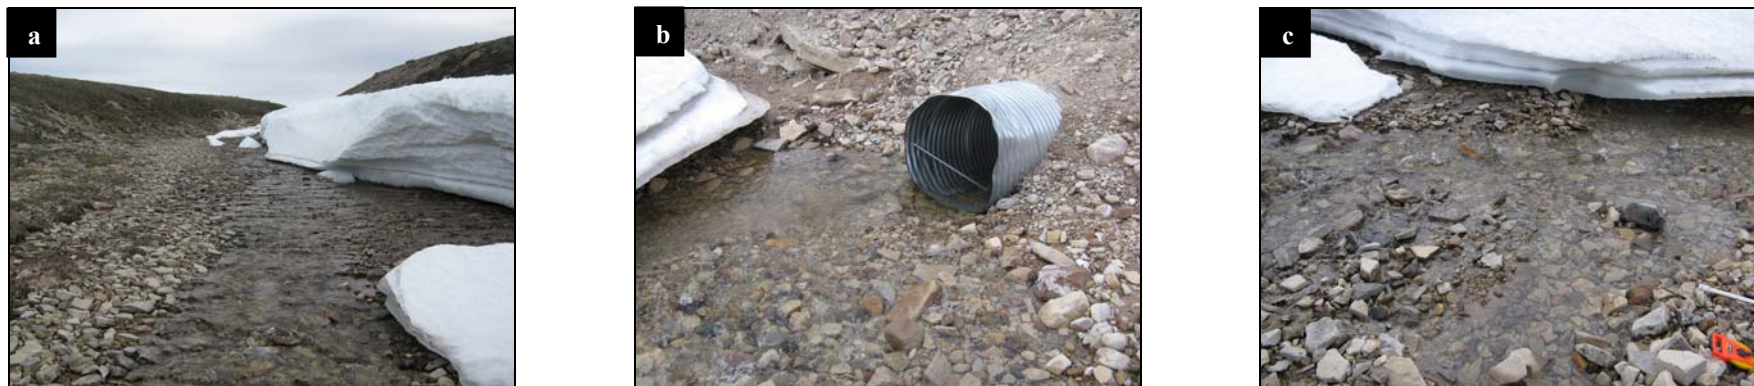
Figure 1. View upstream (a), downstream (b), and across (c) at the habitat assessment site upstream of the crossing at CV-111 during early July, 2009.

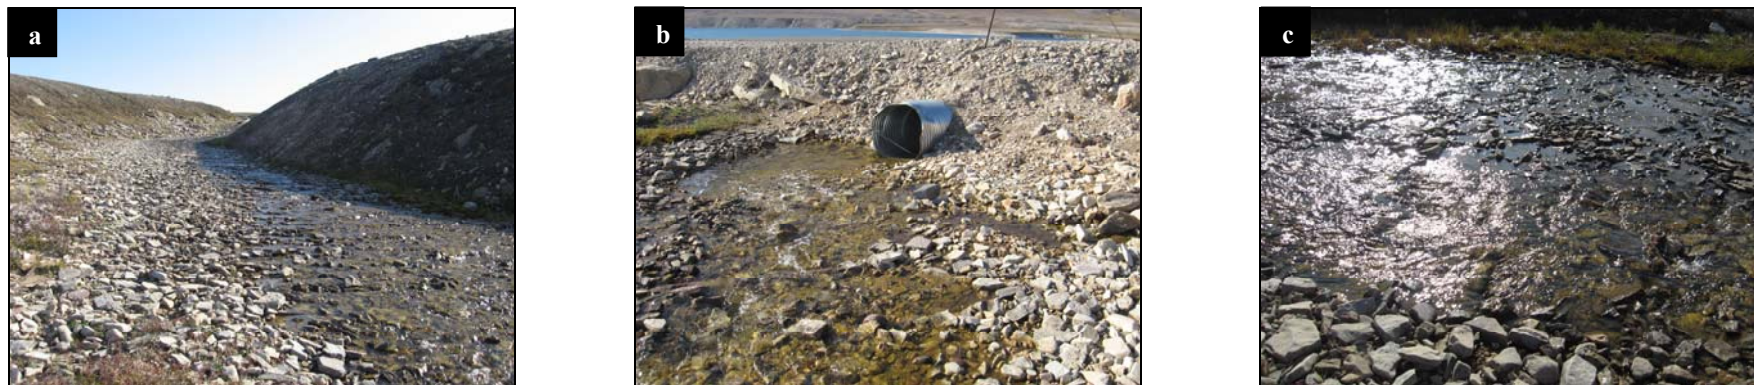
Figure 2. View upstream (a), downstream (b), and across (c) at the habitat assessment site upstream of the crossing at CV-111 during late August, 2009.

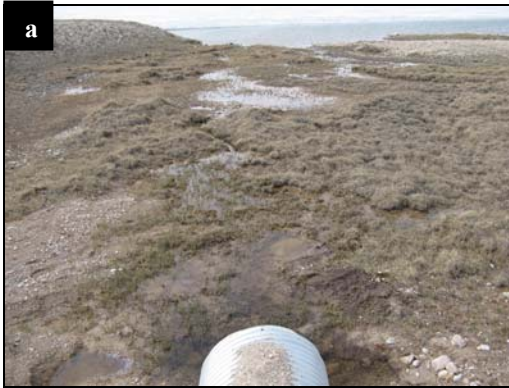
Figure 1. View downstream from the crossing site at CV-202 during spring, 2009.

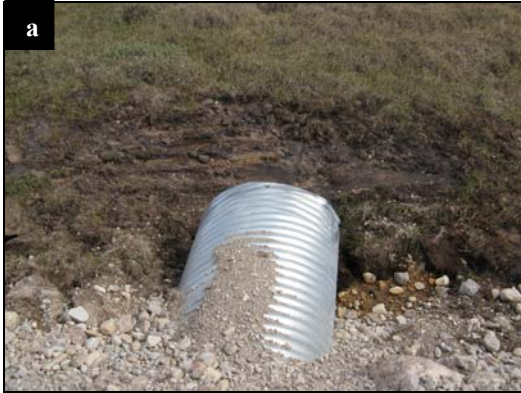
Figure 1. View upstream from the crossing site at CV-202 during spring, 2009.

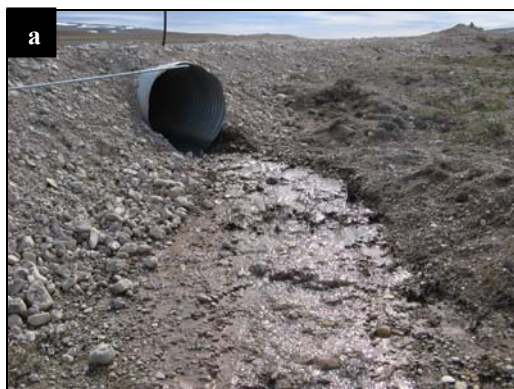
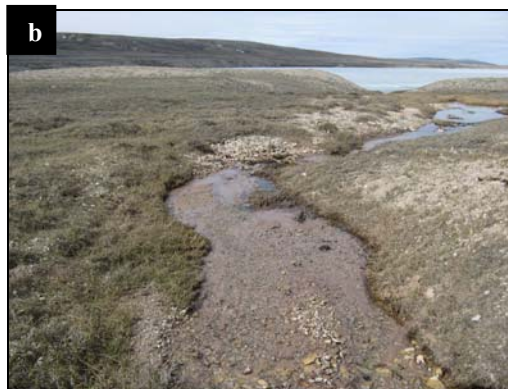
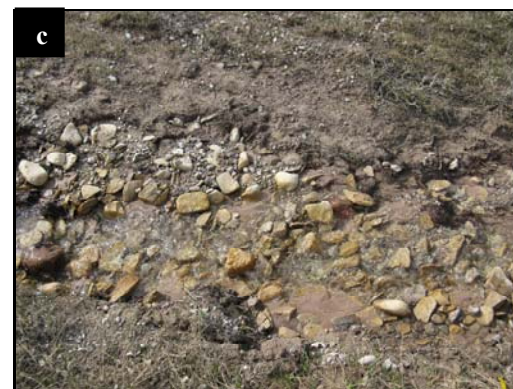
Figure 1. View upstream (a), downstream (b), and across (c) at the habitat assessment site downstream of the crossing at CV-106 during spring, 2009.

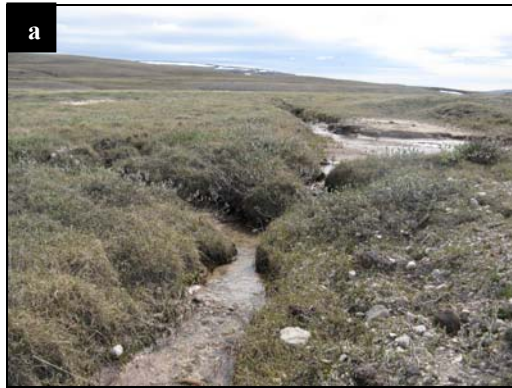
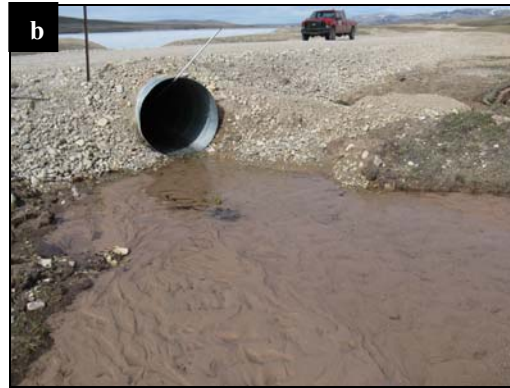
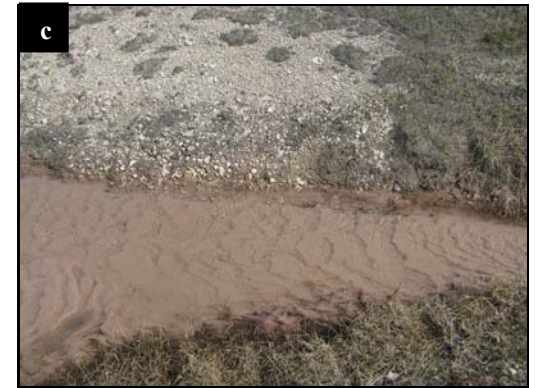
Figure 1. View upstream (a), downstream (b), and across (c) at the habitat assessment site upstream of the crossing at CV-106 during spring, 2009.

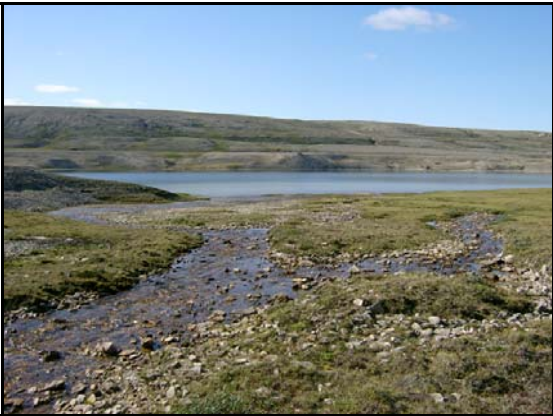
</div> <p>Figure 1: Downstream view from proposed crossing showing cascade-riffle habitat.</p> <div>

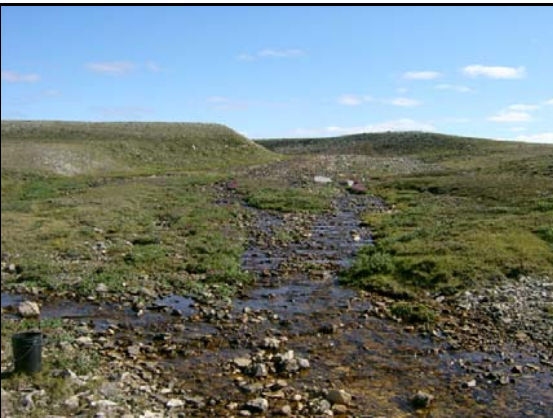
</div> <p>Figure 2: Upstream view from proposed crossing showing more cascade-riffle habitat and cobble substrate.</p> <div>

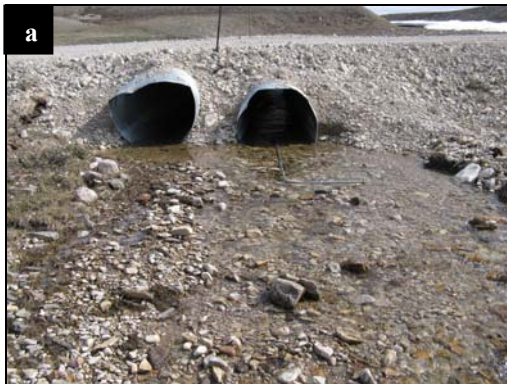
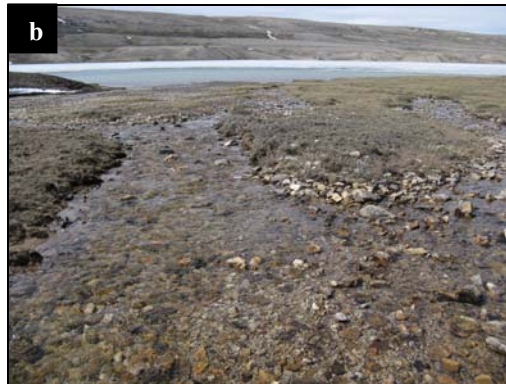
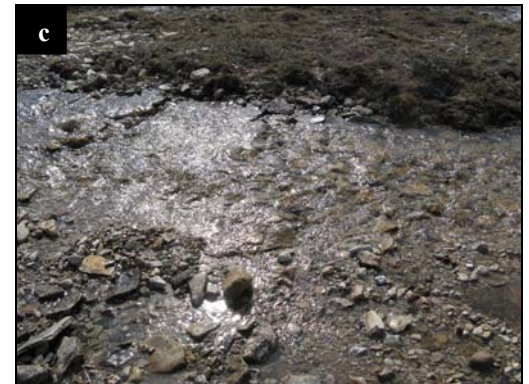
Figure 1. View upstream (a), downstream (b), and across (c) at the habitat assessment site downstream of the crossing at CV-104 during early July, 2009.

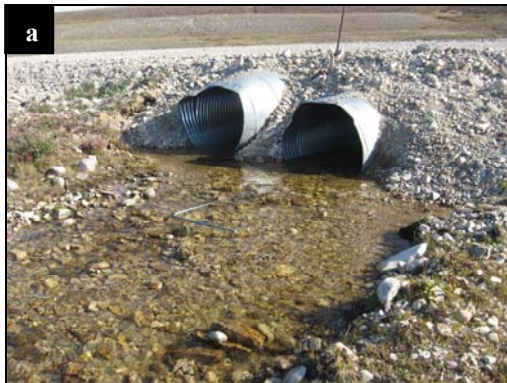
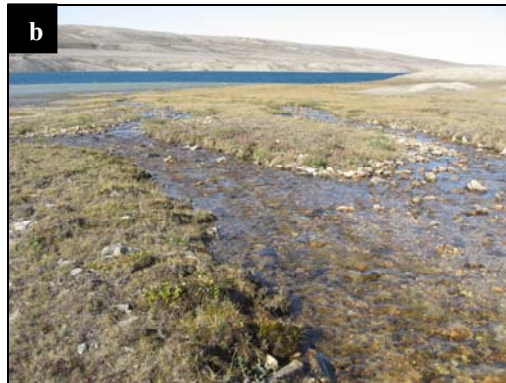
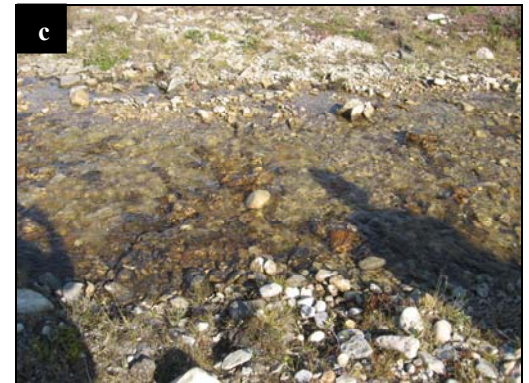
Figure 2. View upstream (a), downstream (b), and across (b) at the habitat assessment site downstream of the crossing at CV-104 during late August, 2009.

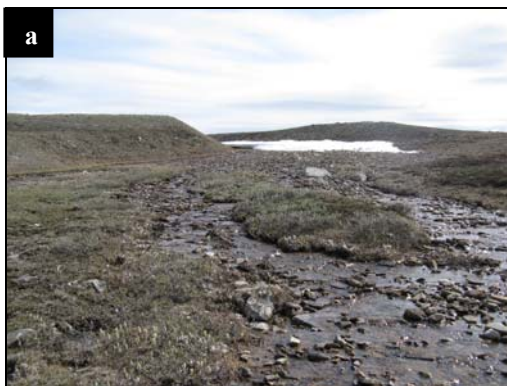
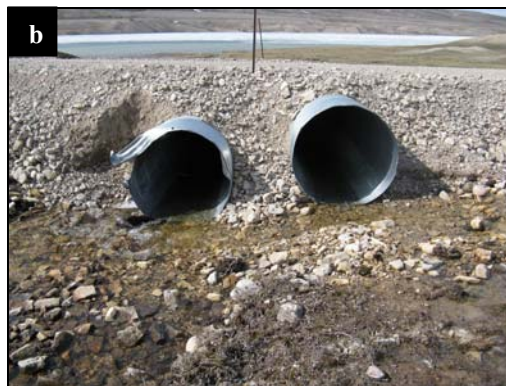
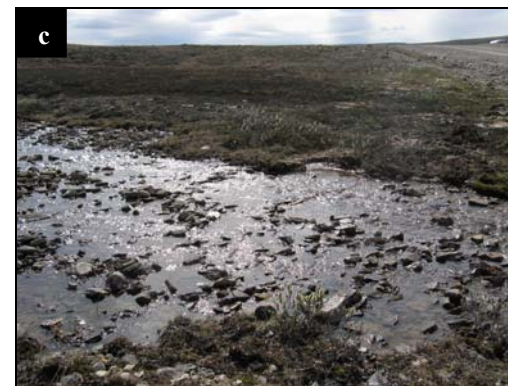
Figure 1. View upstream (a), downstream (b), and across (c) at the habitat assessment site upstream of the crossing at CV-104 during early July, 2009.

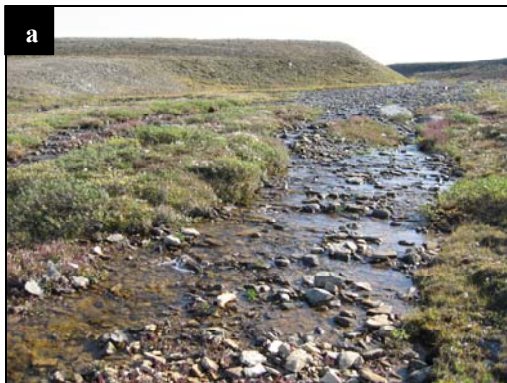
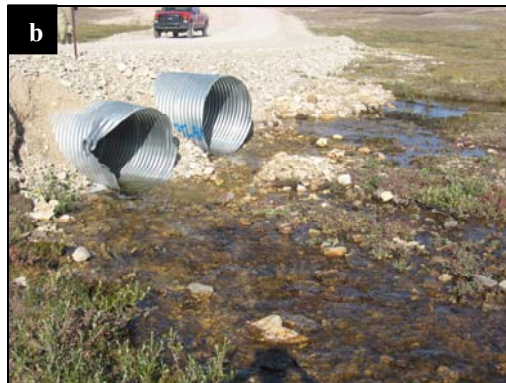
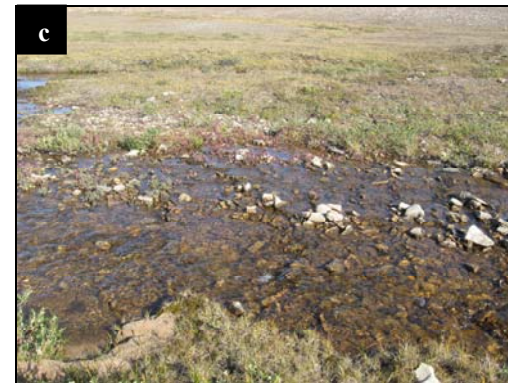
Figure 2. View upstream (a), downstream (b), and across (c) at the habitat assessment site upstream of the crossing at CV-104 during late August, 2009.

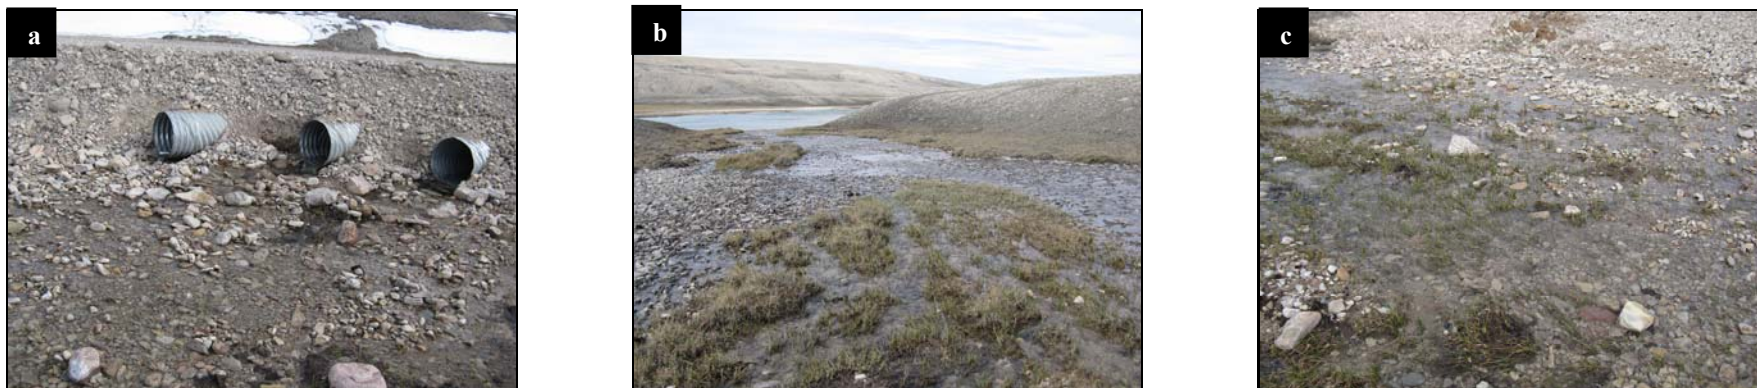
Figure 1. View upstream (a), downstream (b), and across (c) at the habitat assessment site downstream of the crossing at CV-102 during spring, 2009.

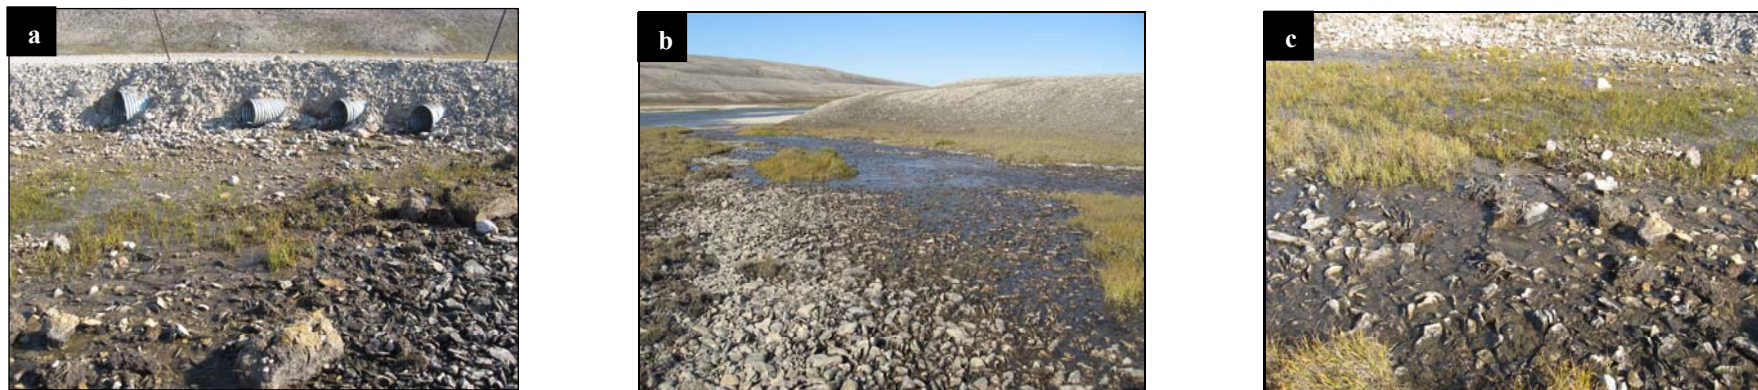
Figure 2. View upstream (a), downstream (b), and across (c) at the habitat assessment site downstream of the crossing at CV-102 during fall, 2009.

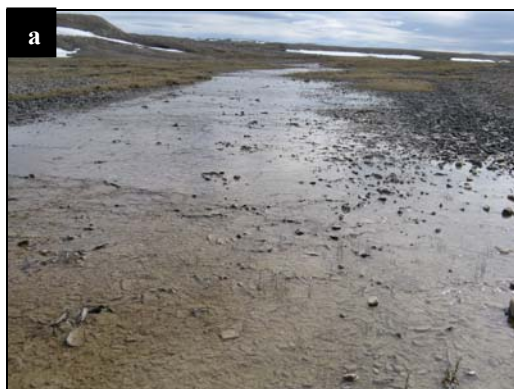
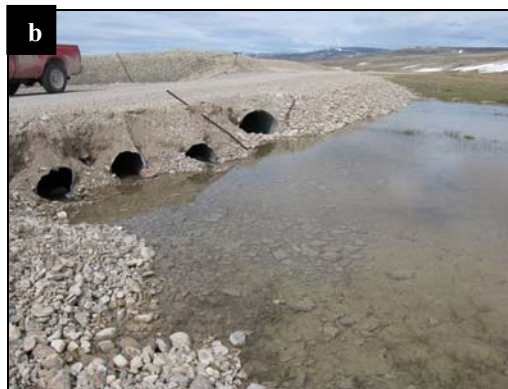
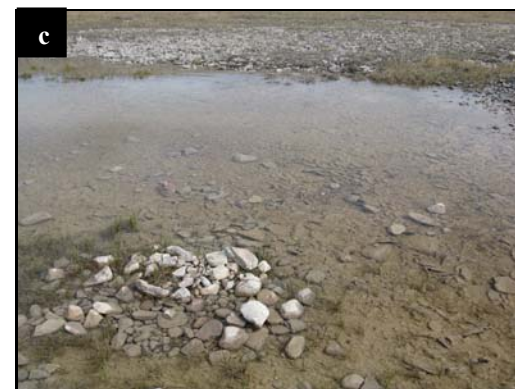
Figure 1. View upstream (a), downstream (b), and across (c) at the habitat assessment site upstream of the crossing at CV-102 during spring, 2009.

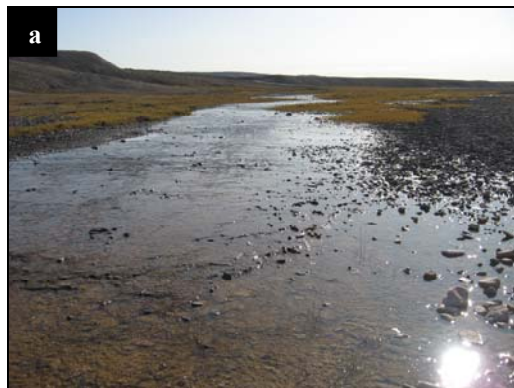
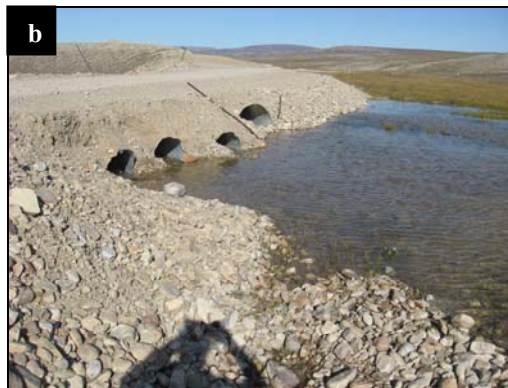
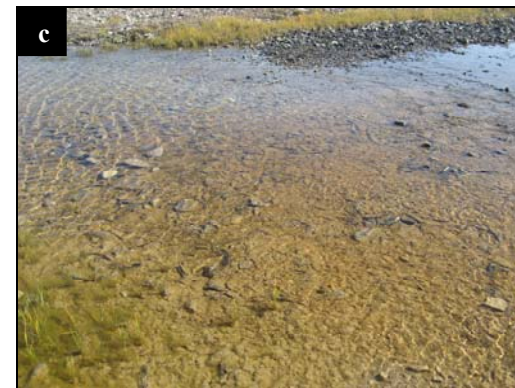
Figure 2. View upstream (a), downstream (b), and across (c) at the habitat assessment site upstream of the crossing at CV-102 during fall, 2009.

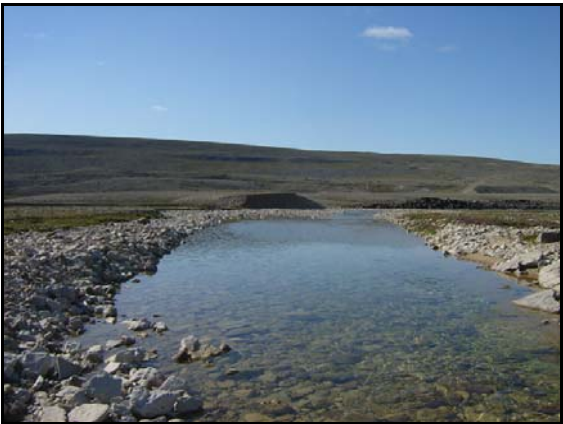
Figure 1: Downstream view from proposed crossing showing pool habitat.

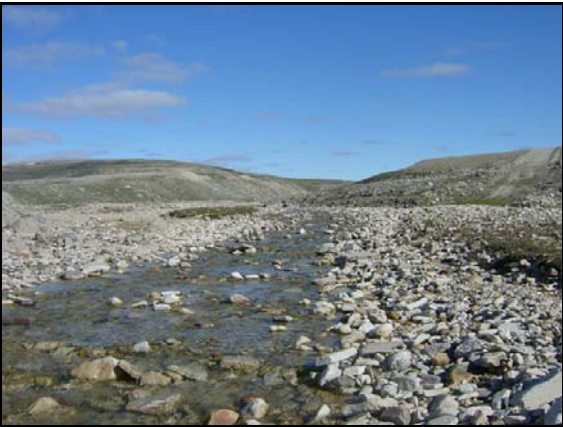
Figure 2: Upstream view from proposed crossing showing more cascade-riffle habitat and cobble substrate.

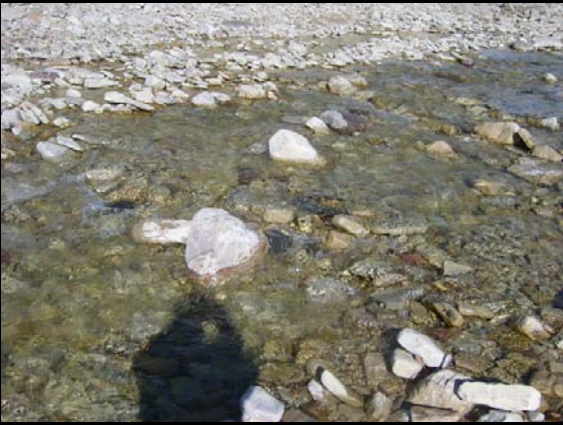
Figure 3: View across CV-99.

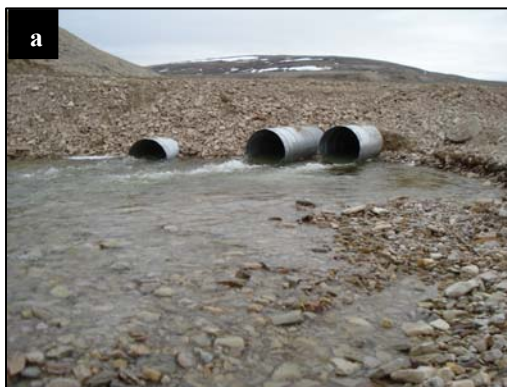
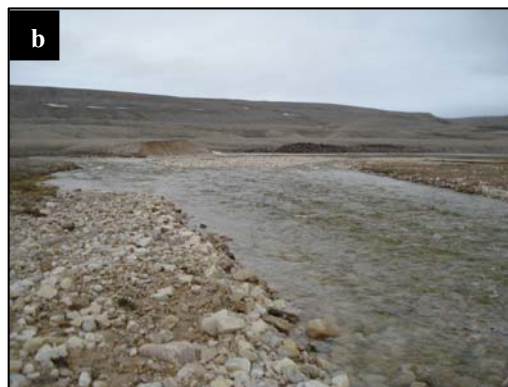
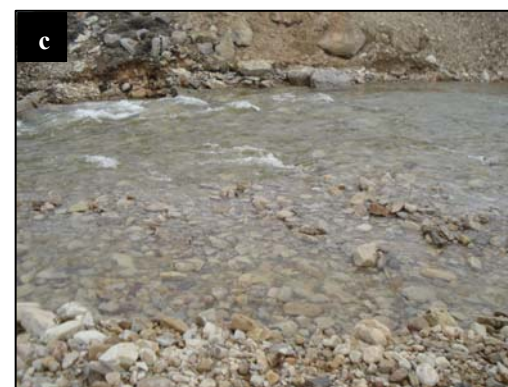
Figure 1. View upstream (a), downstream (b), and across (c) from the habitat assessment downstream of CV-099 during spring 2008.

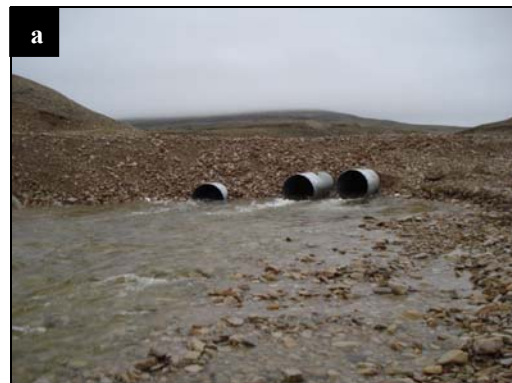
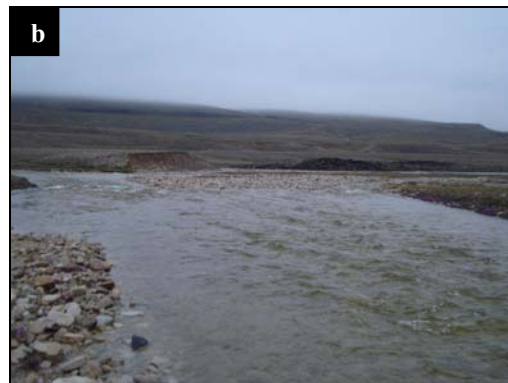
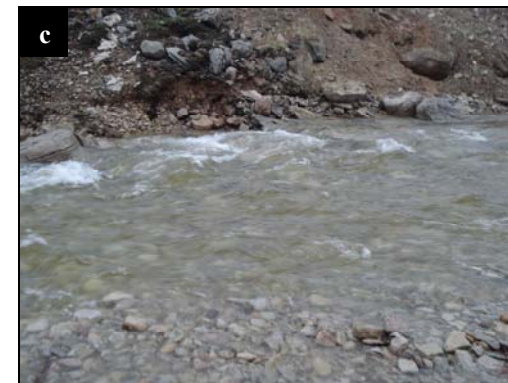
Figure 2. View upstream (a), downstream (b), and across (c) from the habitat assessment downstream of CV-099 during summer 2008.

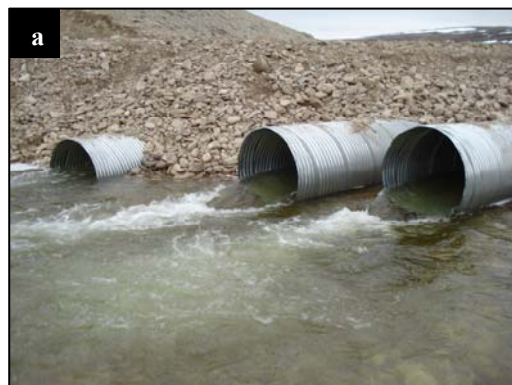
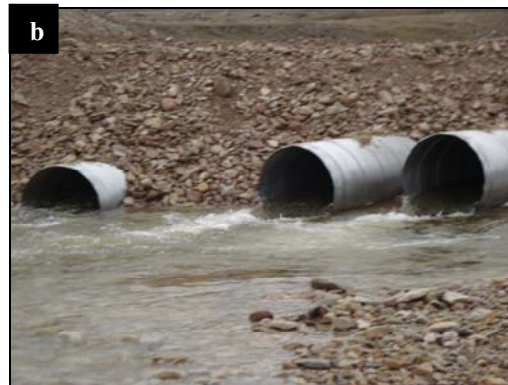
Figure 3. View from the downstream end of the culvert at crossing CV-099 during spring (a) and summer (b) 2008.

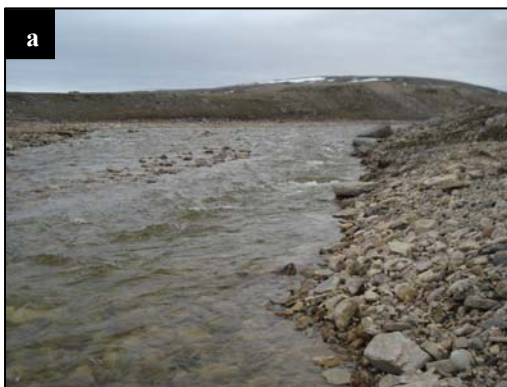
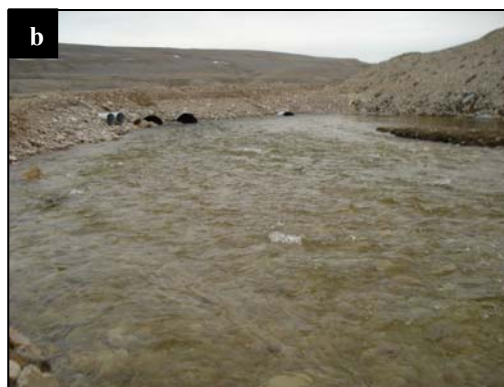
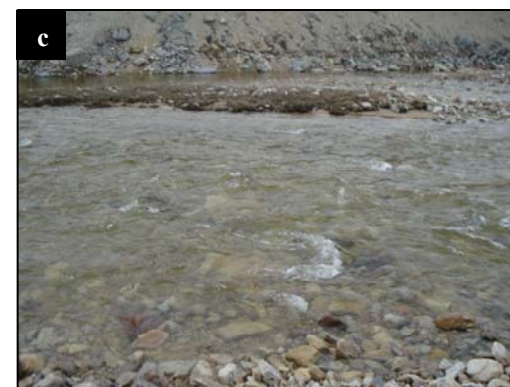
Figure 1. View upstream (a), downstream (b), and across (c) from the habitat assessment upstream of CV-099 during spring 2008.

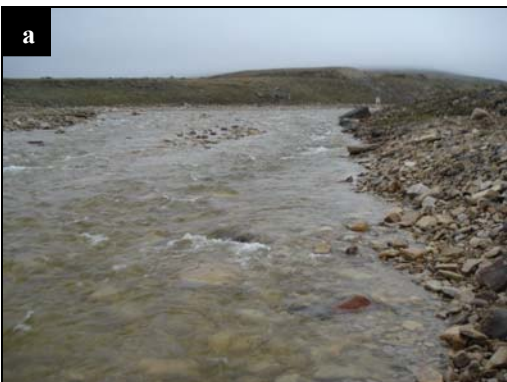
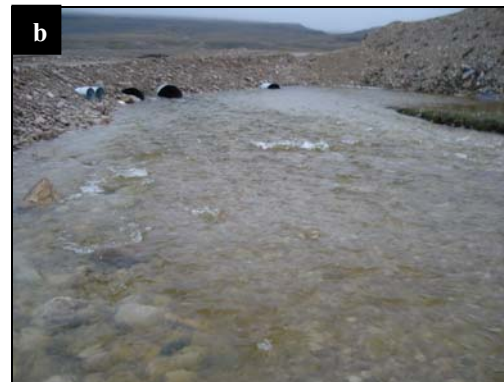
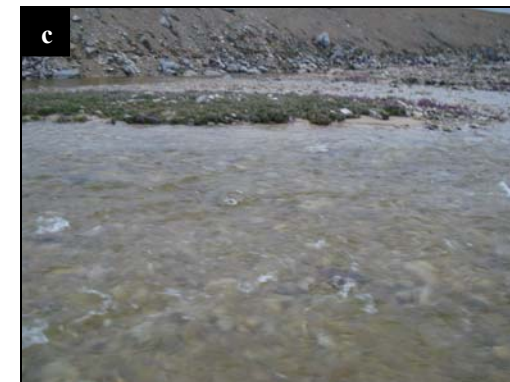
Figure 2. View upstream (a), downstream (b), and across (c) from the habitat assessment upstream of CV-099 during summer 2008.

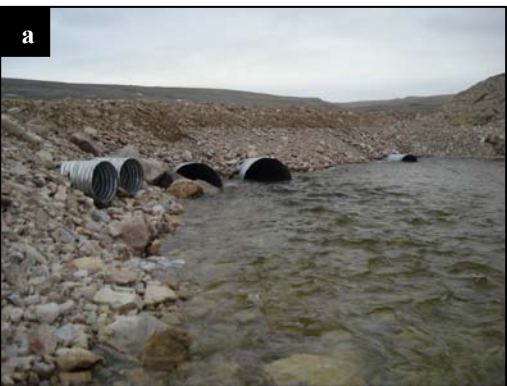
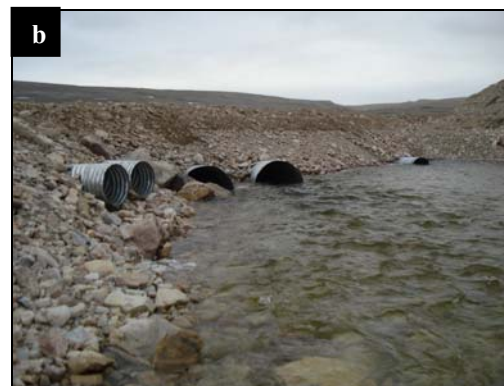
Figure 3. View from the upstream end of the culverts at crossing CV-099 during spring (a) and summer (b) 2008.

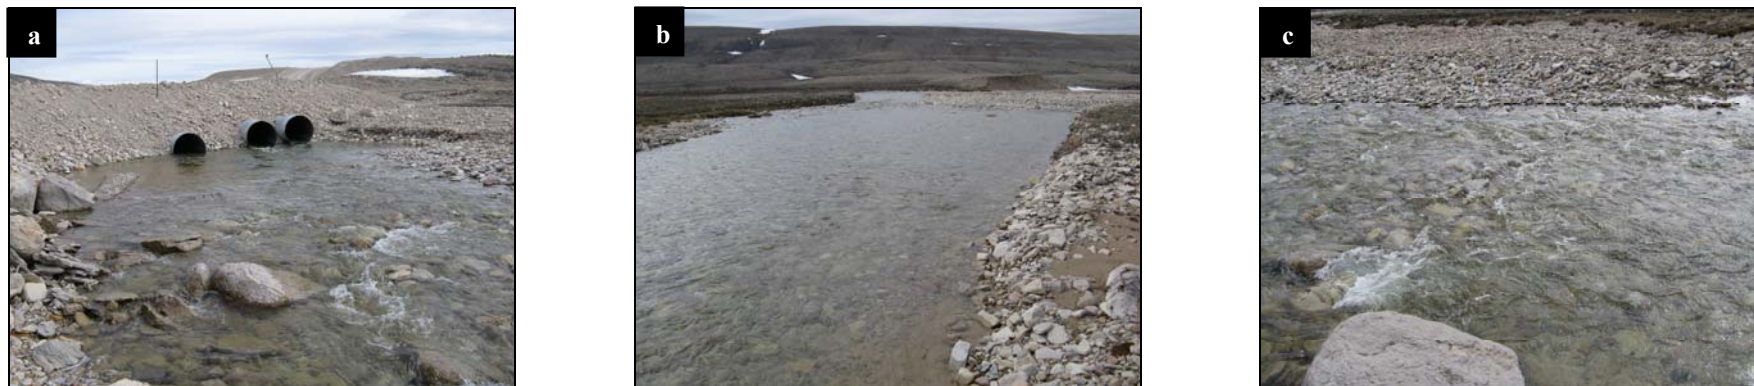
Figure 1. View upstream (a), downstream (b), and across (c) at the habitat assessment site downstream of the crossing at CV-099 during early July, 2009.

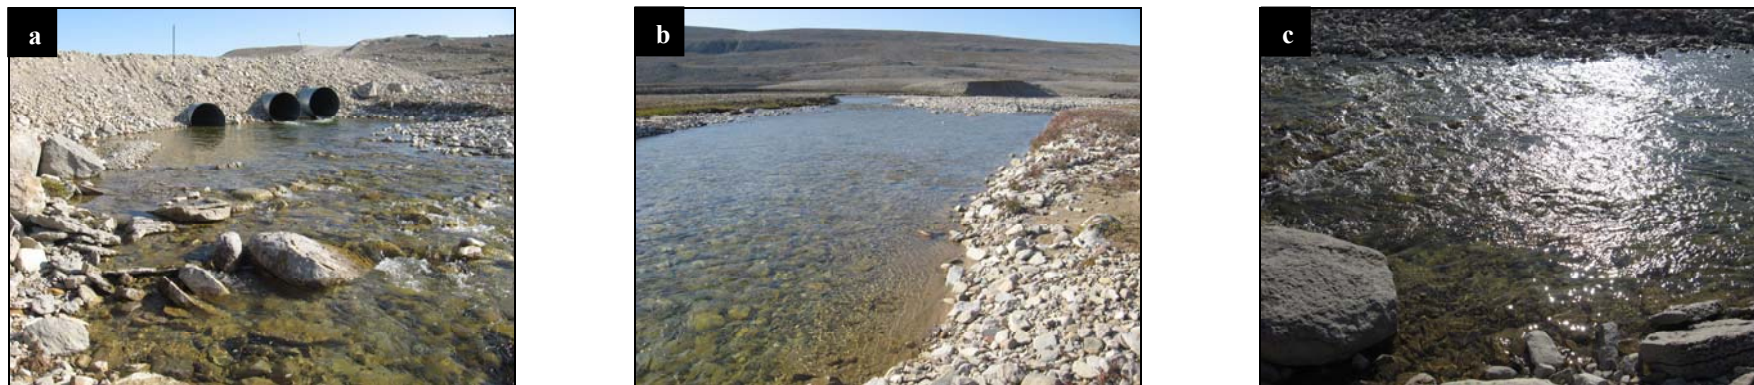
Figure 2. View upstream (a), downstream (b), and across (b) at the habitat assessment site downstream of the crossing at CV-099 during late August, 2009.

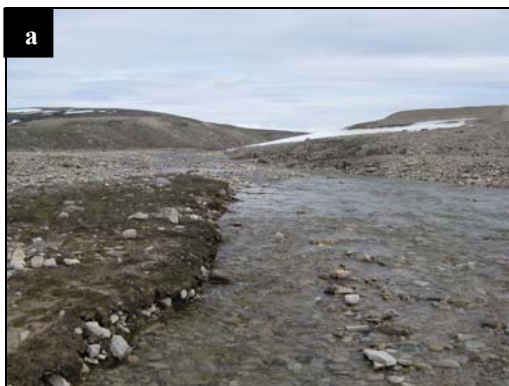
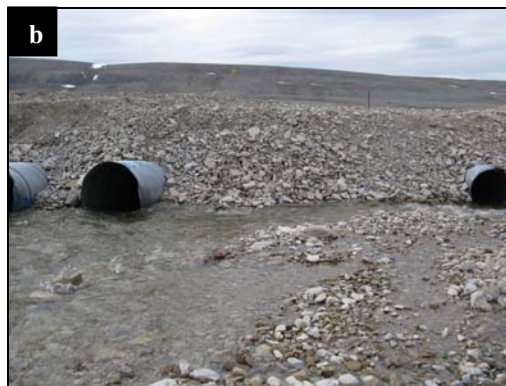
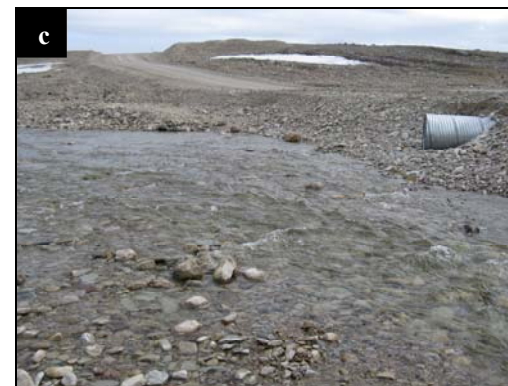
Figure 1. View upstream (a), downstream (b), and across (c) at the habitat assessment site upstream of the crossing at CV-099 during early July, 2009.
