APPENDIX 5.3-1.

DETAILED HABITAT ASSESSMENTS AND SUMMARY OF RESULTS FOR WATERBODIES IN QUARRY SITES.

Table A5.3-1.1. Summary of results from surveys and assessments that fall within Quarry boundaries.

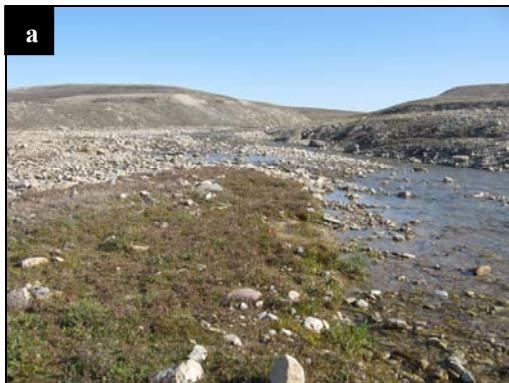
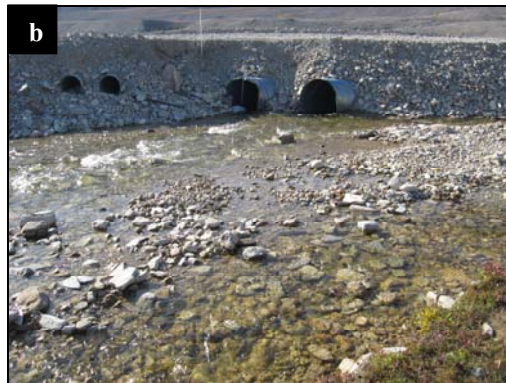
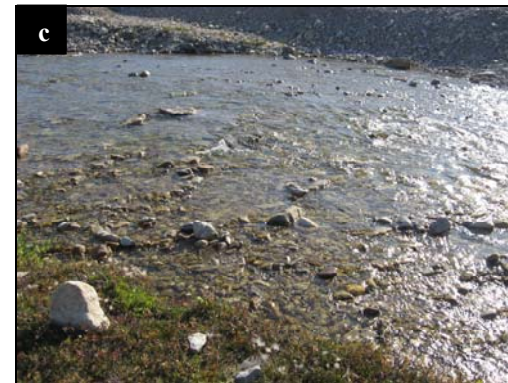
Figure 2. View upstream (a), downstream (b), and across (c) at the habitat assessment site upstream of the crossing at CV-099 during late August, 2009.

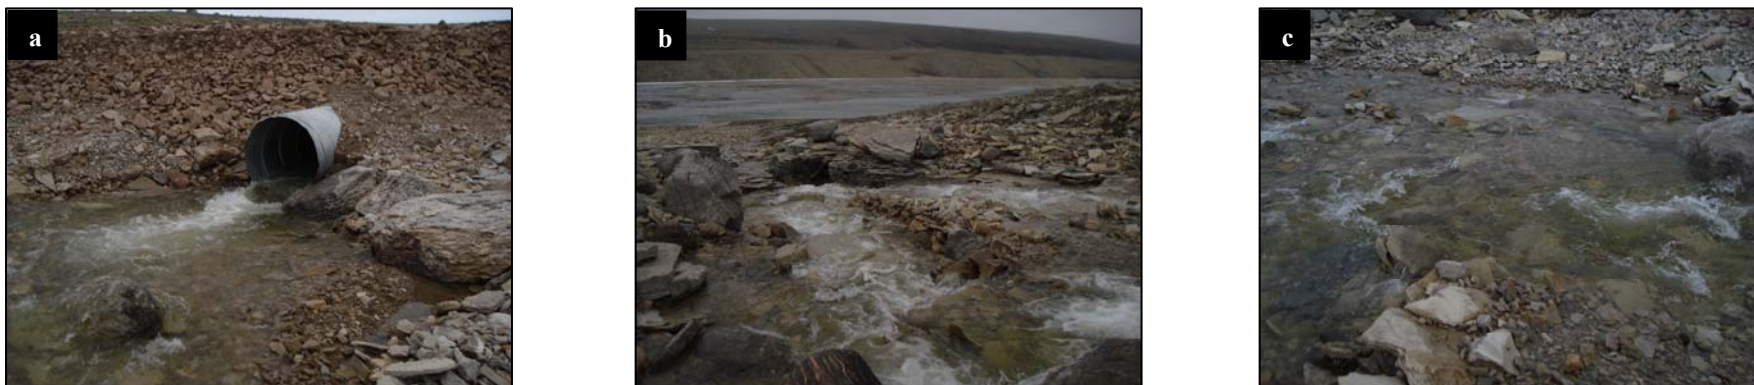
Figure 1. View upstream (a), downstream (b), and across (c) from the habitat assessment downstream of CV-094 during spring 2008.

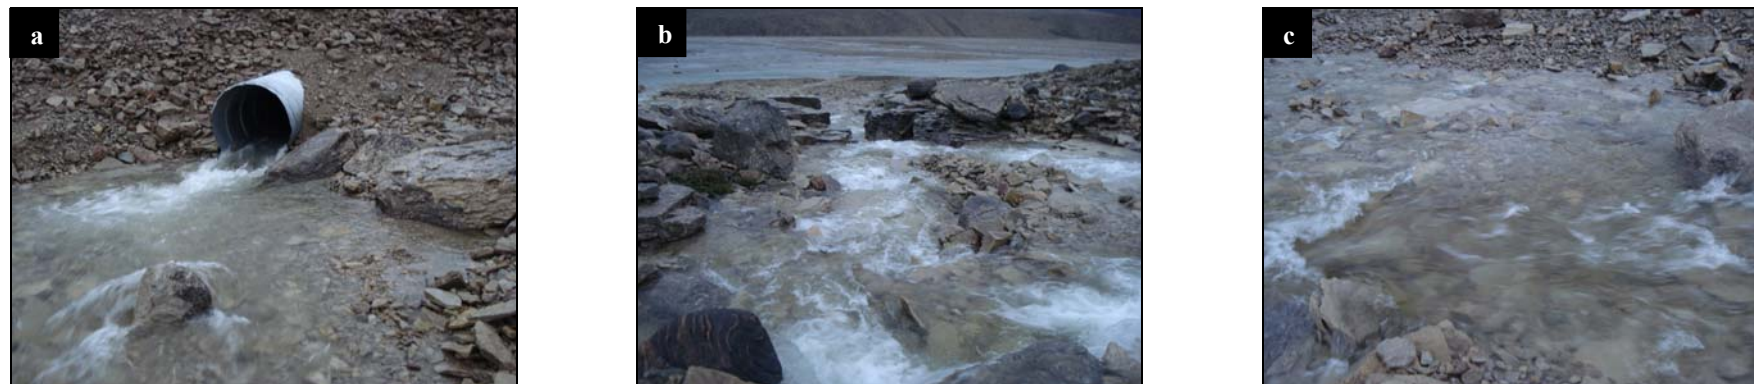
Figure 2. View upstream (a), downstream (b), and across (c) from the habitat assessment downstream of CV-094 during summer 2008.

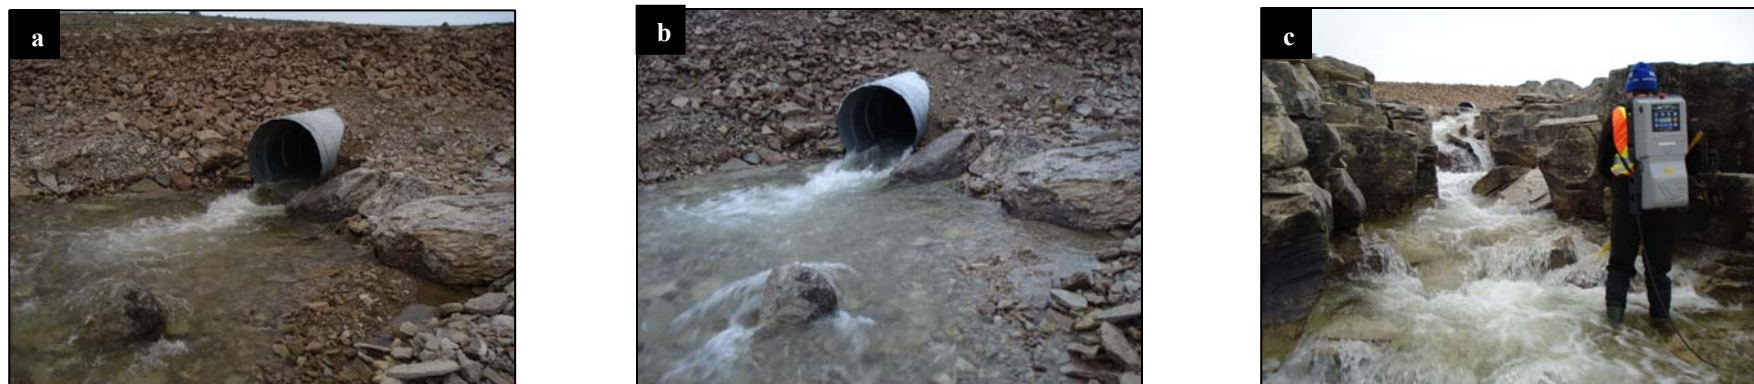
Figure 3. View from the downstream end of the culvert at crossing CV-094 during spring (a) and summer (b) 2008. View of the natural fish barrier 30 m downstream from the crossing at CV-094 (c).

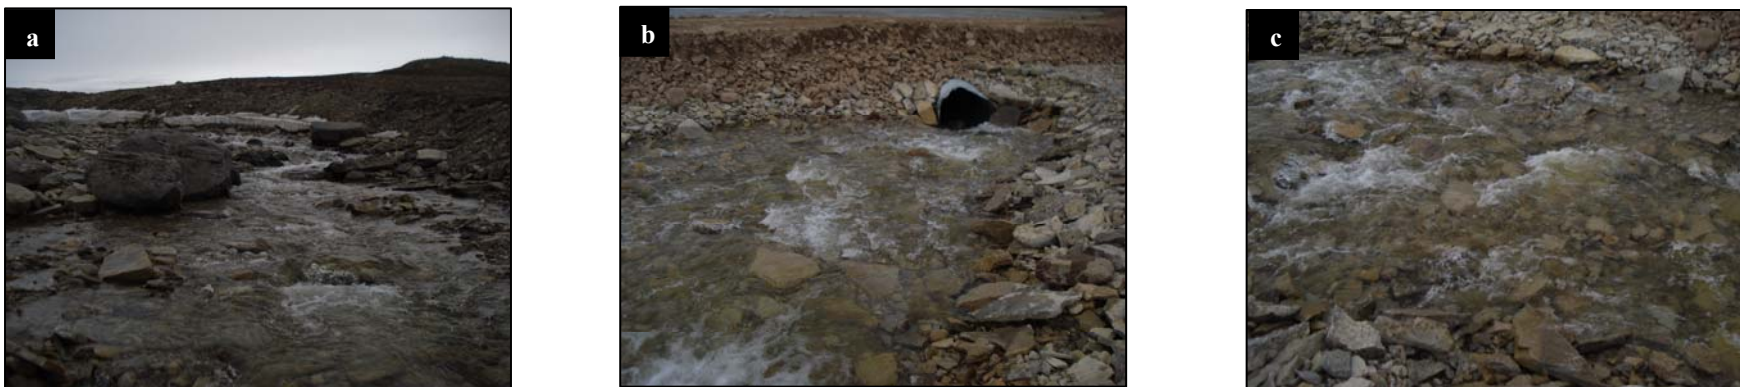
Figure 1. View upstream (a), downstream (b), and across (c) from the habitat assessment upstream of CV-094 during spring 2008.

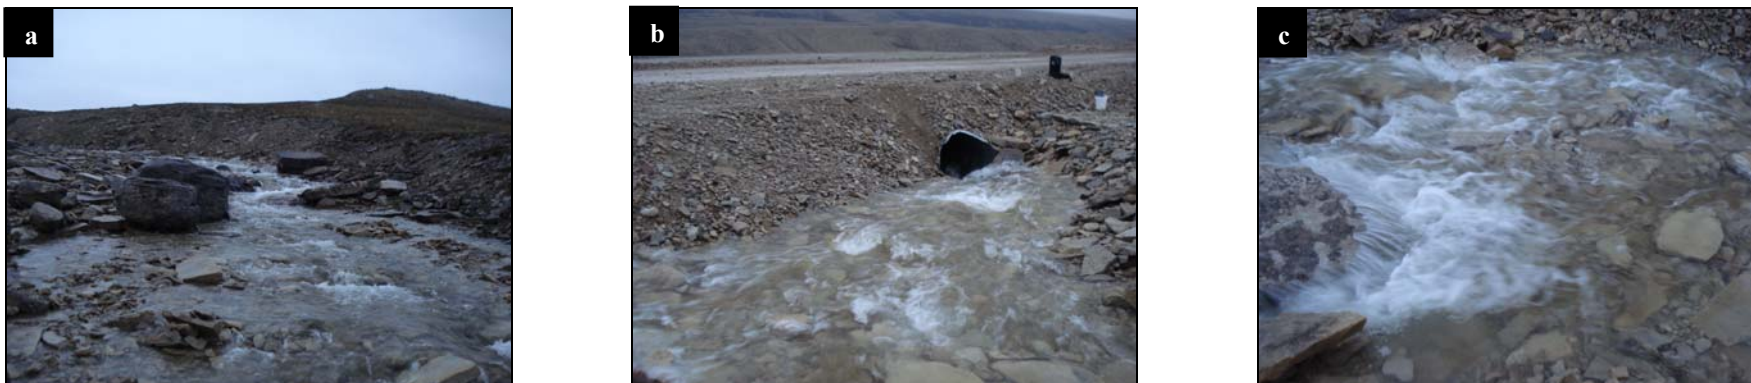
Figure 2. View upstream (a), downstream (b), and across (c) from the habitat assessment upstream of CV-094 during summer 2008.

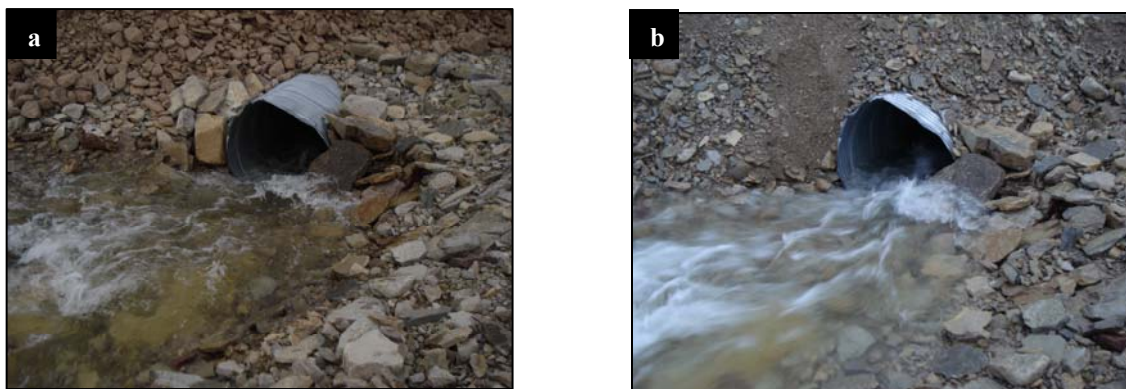
Figure 3. View from the upstream end of the culverts at crossing CV-094 during spring (a) and summer (b) 2008.

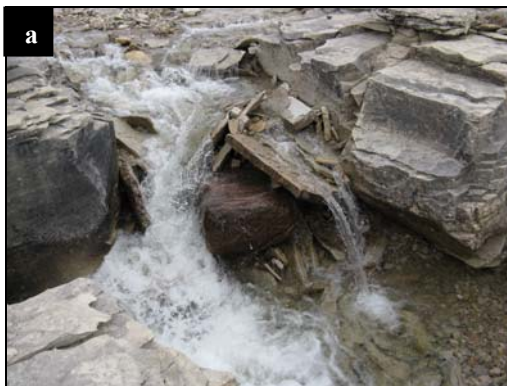
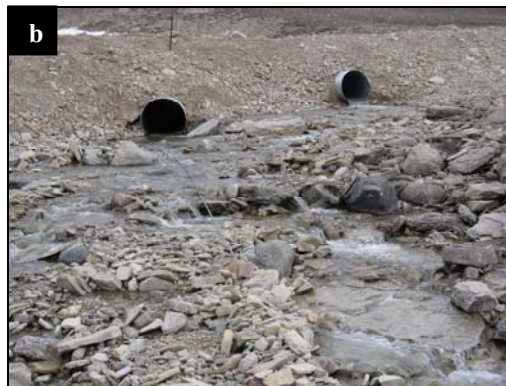
Figure 1. View of the natural downstream barrier (a) and habitat downstream of the crossing (b) at CV-094 during early July, 2009.

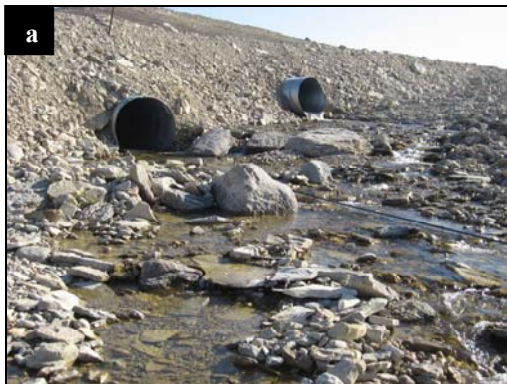
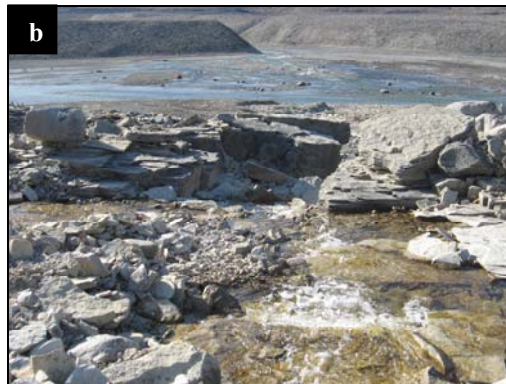
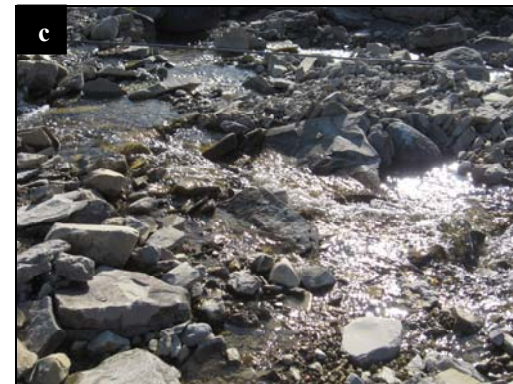
Figure 2. View upstream (a), downstream (b), and across (b) at the habitat assessment site downstream of the crossing at CV-094 during late August, 2009.

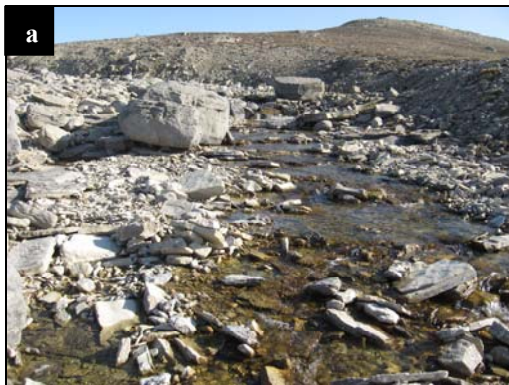
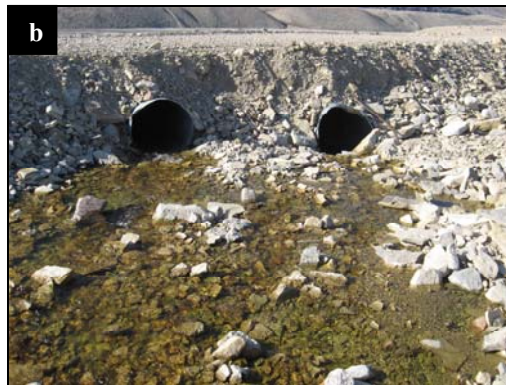
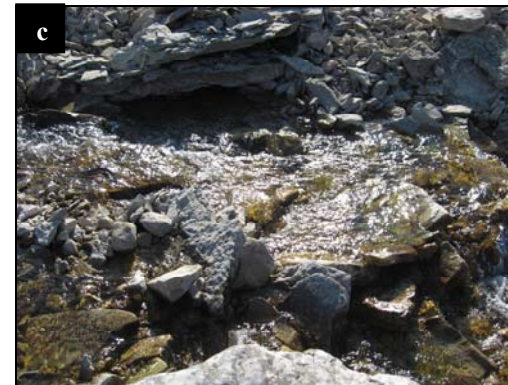
Figure 2. View upstream (a), downstream (b), and across (c) at the habitat assessment site upstream of the crossing at CV-094 during late August, 2009.

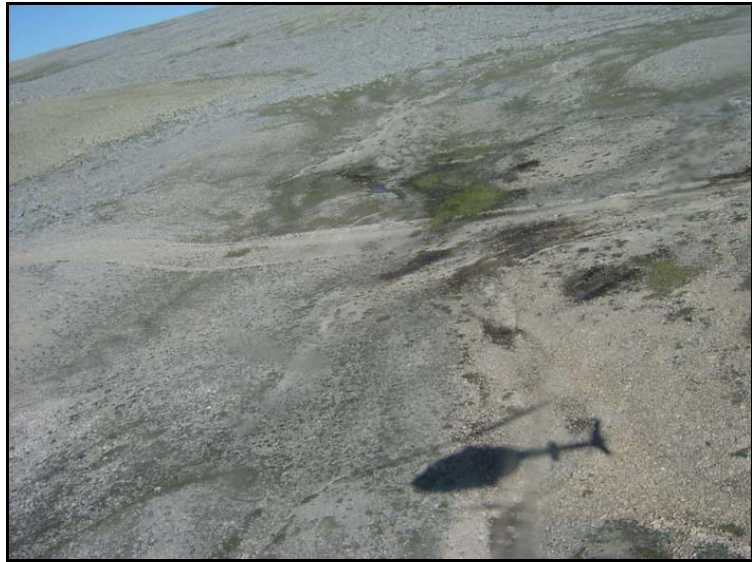
Figure 1: Aerial view of proposed crossing showing an almost completely dry cobble/gravel creek bed.

Location				
Site:	CV-93	Watercourse Name:	Unknown River	
UTM:	17W 0523116 / 7944890			
Site Description		Potential Fish Utilization		
Watershed Size: 0.880 km ² Regulated: No Channelized: No Bankfull Width: N/A Wetted Width: N/A Riffle-Crest Depth: N/A Pool Depth: N/A Residual Pool Depth: N/A Bankfull Depth: N/A Bank Height: N/A D ₉₅ : N/A D: N/A Confinement: N/A Channel Morphology: N/A Channel Gradient: N/A Turbidity: N/A Side Slope: N/A Approach: N/A Bank Stability: N/A Erosion Potential: N/A Undercut Banks: N/A	Mesohabitat Composition:	N/A	Arctic Char	
	Substrate Composition:	N/A	Spawning:	None
	Stream Cover:	N/A	Migration:	None
	Riparian Vegetation:	N/A	Rearing:	None
	Aquatic Vegetation:	N/A	Overwintering:	None
	Unique Features:	N/A	Ninespine Stickleback	
	Summary:	This is a small waterbody that was almost completely dry at the time of sampling in August. It is exclusively a spring run-off stream	Spawning:	None

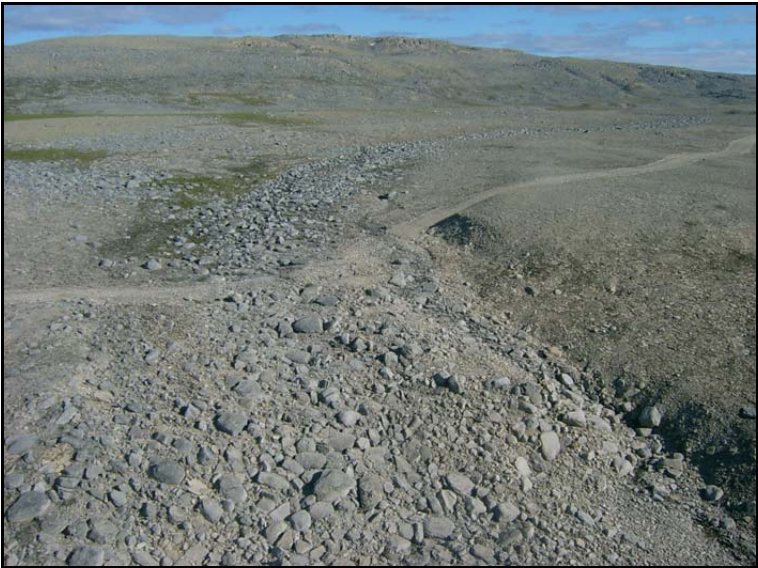
Figure 1: Aerial view of proposed crossing showing a completely dry cobble/gravel creek bed.

Location			
Site:	CV-92	Watercourse Name:	Unknown River
UTM:	17W 0523106 / 7944186		
Site Description		Potential Fish Utilization	
Watershed Size:	3.453 km ²	Arctic Char	
Regulated:	No	Spawning:	None
Channelized:	No	Migration:	None
Bankfull Width:	N/A	Rearing:	None
Wetted Width:	N/A	Overwintering:	None
Riffle-Crest Depth:	N/A	Ninespine Stickleback	
Pool Depth:	N/A	Spawning:	None
Residual Pool Depth:	N/A	Migration:	None
Bankfull Depth:	N/A	Rearing:	None
Bank Height:	N/A	Overwintering:	None
D ₉₅ :	N/A	Comments	
D:	N/A		
Confinement:	N/A	None	
Channel Morphology:	N/A		
Channel Gradient:	N/A	None	
Turbidity:	N/A		
Side Slope	N/A	None	
Approach:	N/A		
Bank Stability:	N/A	None	
Erosion Potential:	N/A		
Undercut Banks:	N/A	None	
Baffinland Iron Mines Mary River Project Watercourse Crossing Assessment

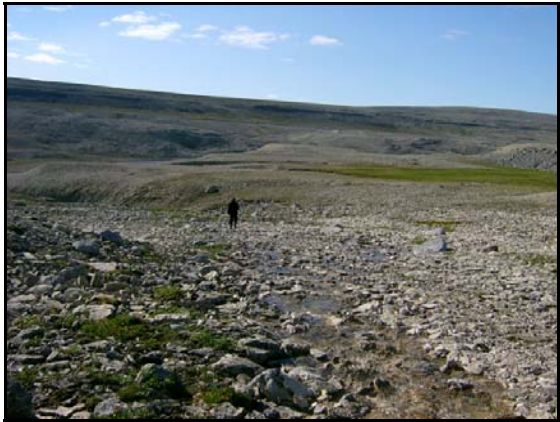
Figure 1: Downstream view from proposed crossing showing cascade habitat with cobble and boulders.

Location			
Site:	CV-87	Watercourse Name:	Unknown River
UTM:	17W 0523704 / 7941040		
Site Description		Potential Fish Utilization	
Watershed Size:	9.873 km ²	Arctic Char	
Regulated:	No	Spawning:	None
Channelized:	No	Migration:	None
Bankfull Width:	55.0 m	Rearing:	Possible but Unlikely
Wetted Width:	10.0 m	Overwintering:	None
Riffle-Crest Depth:	0.20 m	Ninespine Stickleback	
Pool Depth:	N/A	Spawning:	None
Residual Pool Depth:	N/A	Migration:	None
Bankfull Depth:	0.52 m	Rearing:	None
Bank Height:	0.32 m	Overwintering:	None
D ₉₅ :	0.72 m	Comments	
D:	0.04 m		
Confinement:	N/A (braided stream)	Marginal	
Channel Morphology:	Cascade		
Channel Gradient:	11 ⁰		
Turbidity:	0.00 FTU		
Side Slope	R – 10%; L – 10%		
Approach:	R – 90%; L – 90%		
Bank Stability:	High		
Erosion Potential:	Low-Moderate		
Undercut Banks:	None		
Summary:		This is a large-sized waterbody but it has relatively shallow depths and higher velocities characterized by cascades. Substrate is predominantly cobble and the banks have low erosion potential.

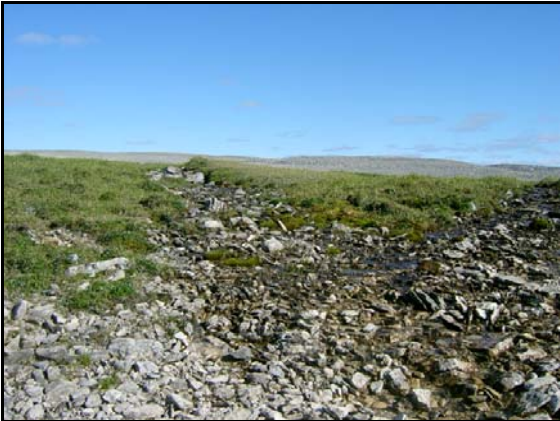
Figure 2: Upstream view from proposed crossing showing more cascade habitat and cobble substrate.

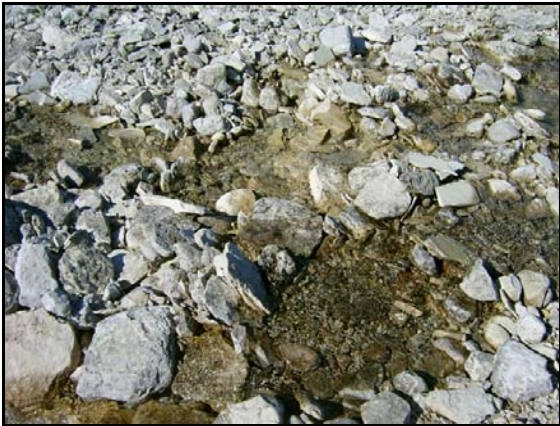
Figure 3: View across CV-87.

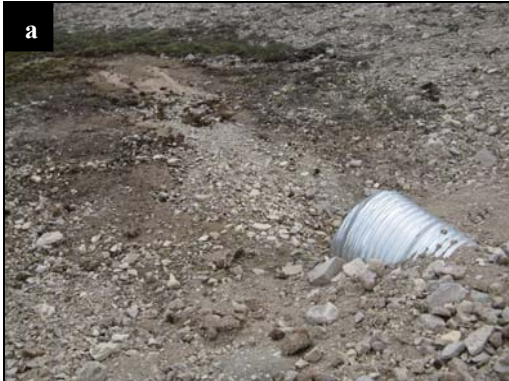
Figure 1. View downstream from the crossing site at CV-086 during spring, 2009.

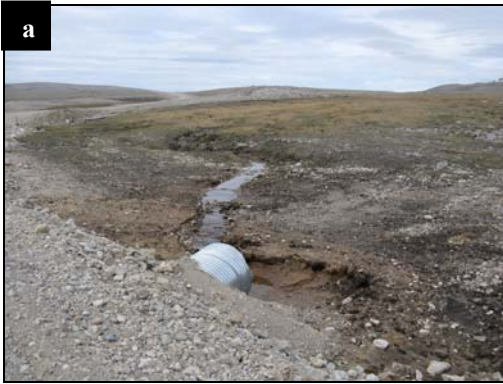
Figure 1. View upstream (a) from the crossing site at CV-086 during spring, 2009.

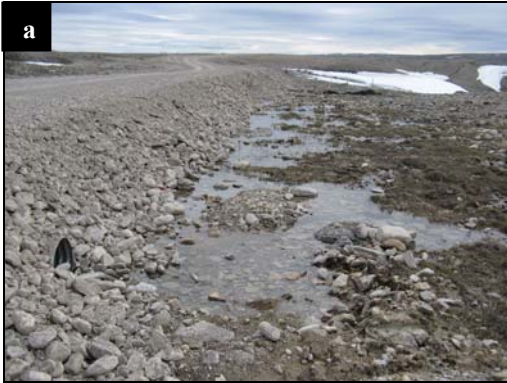
Figure 1. View downstream from the crossing site at CV-082 during spring, 2009.

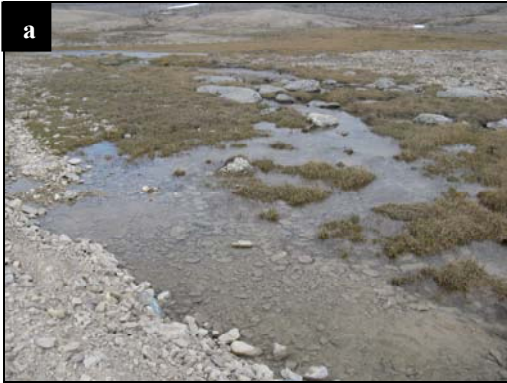
Figure 1. View upstream from the crossing site at CV-082 during spring, 2009.

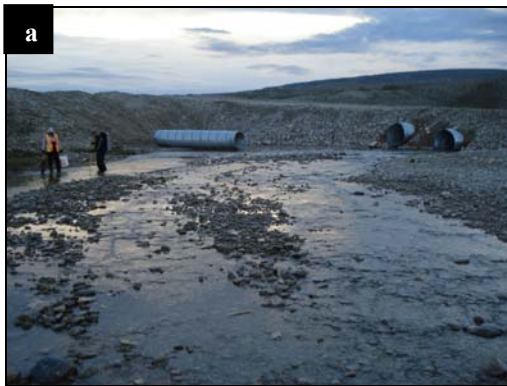
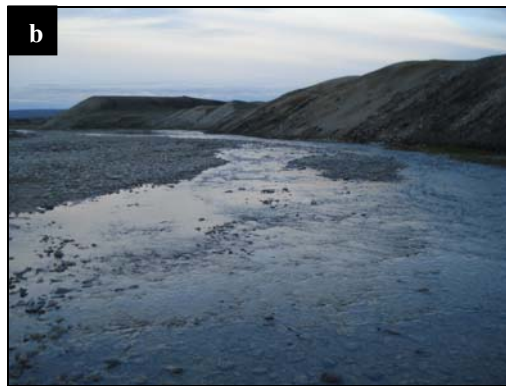
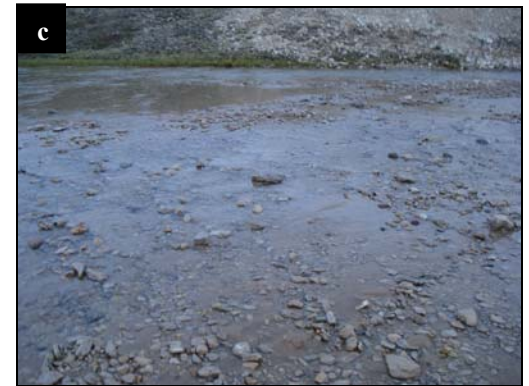
Figure 1. View upstream (a), downstream (b), and across (c) from the habitat assessment downstream of CV-079 during summer 2008.

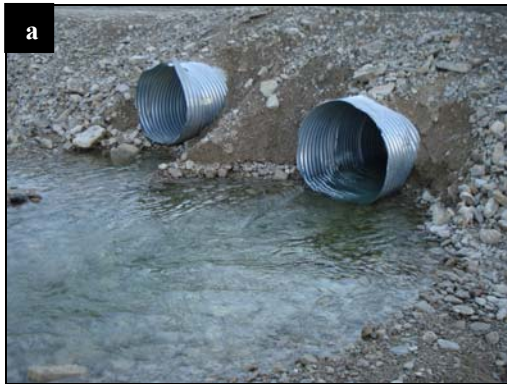
Figure 2. View from the downstream end of the culvert at crossing CV-079 during summer 2008.

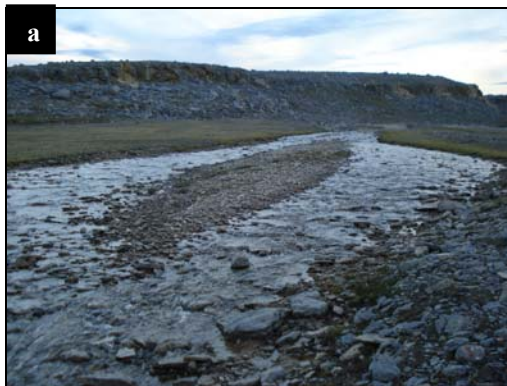
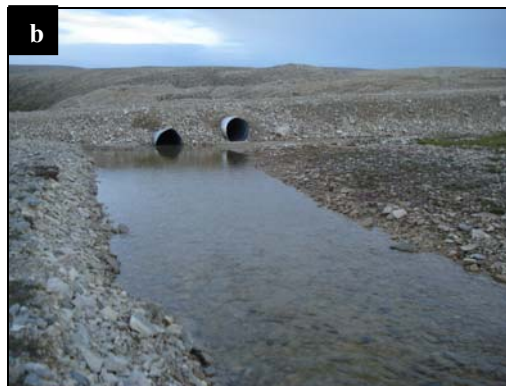
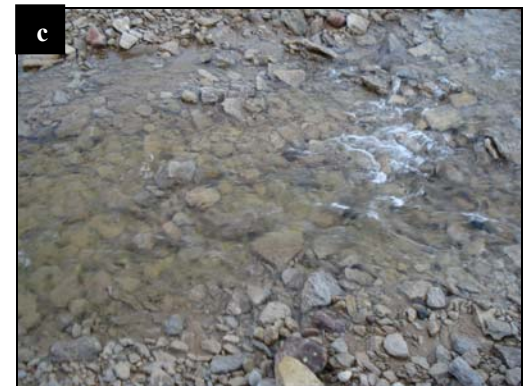
Figure 1. View upstream (a), downstream (b), and across (c) from the habitat assessment upstream of CV-079 during summer 2008.

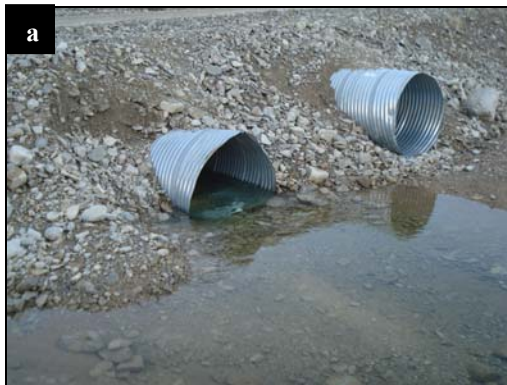
Figure 2. View from the upstream end of the culverts at crossing CV-079 during summer 2008.

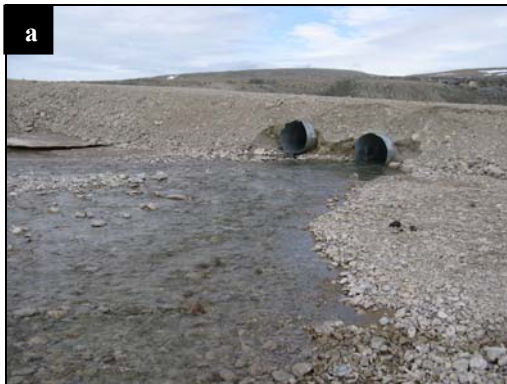
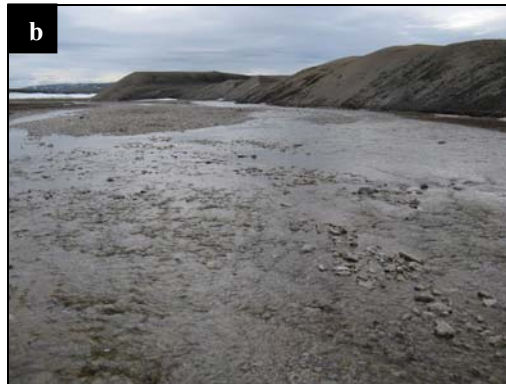
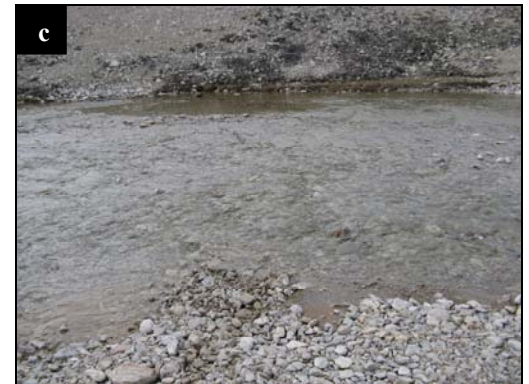
Figure 1. View upstream (a), downstream (b), and across (c) at the habitat assessment site downstream of the crossing at CV-079 during early July, 2009.

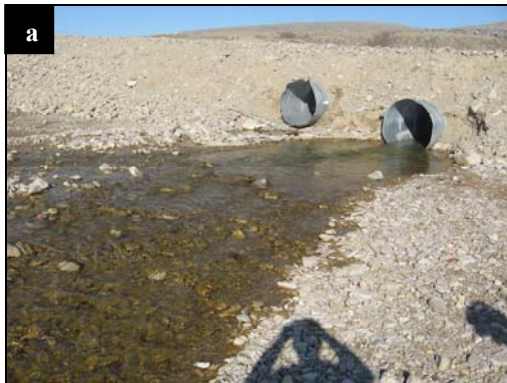
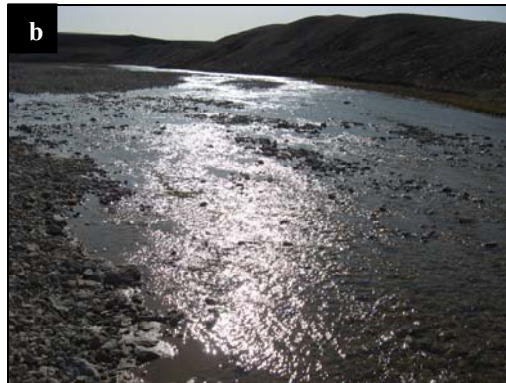
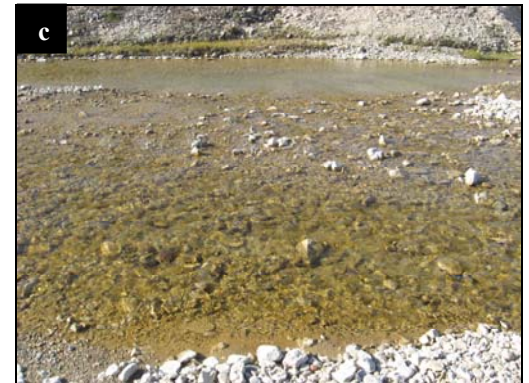
Figure 2. View upstream (a), downstream (b), and across (b) at the habitat assessment site downstream of the crossing at CV-079 during late August, 2009.

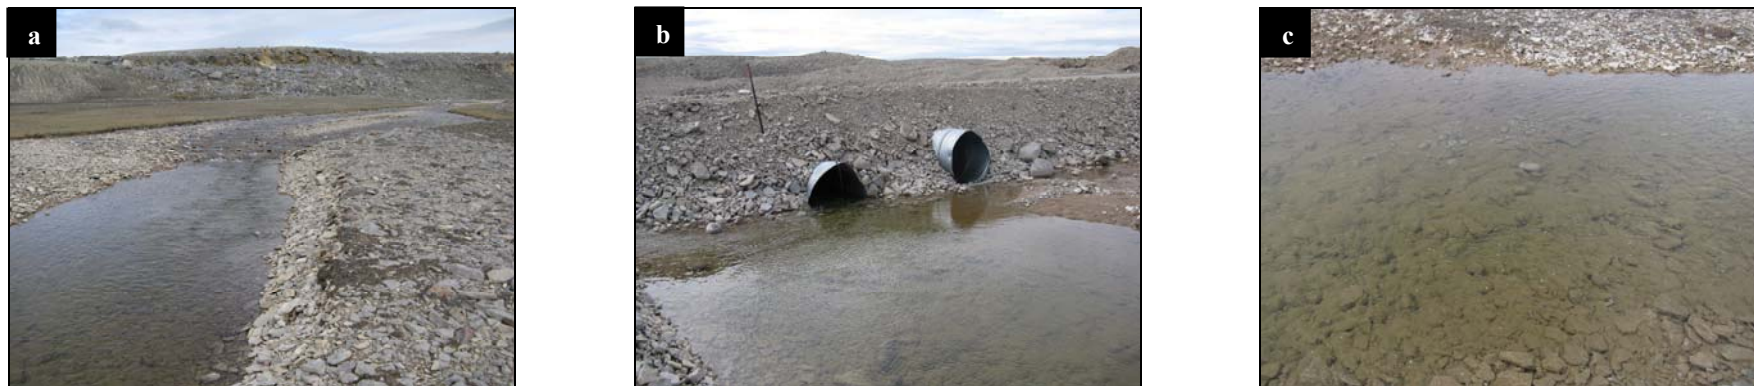
Figure 1. View upstream (a), downstream (b), and across (c) at the habitat assessment site upstream of the crossing at CV-079 during early July, 2009.

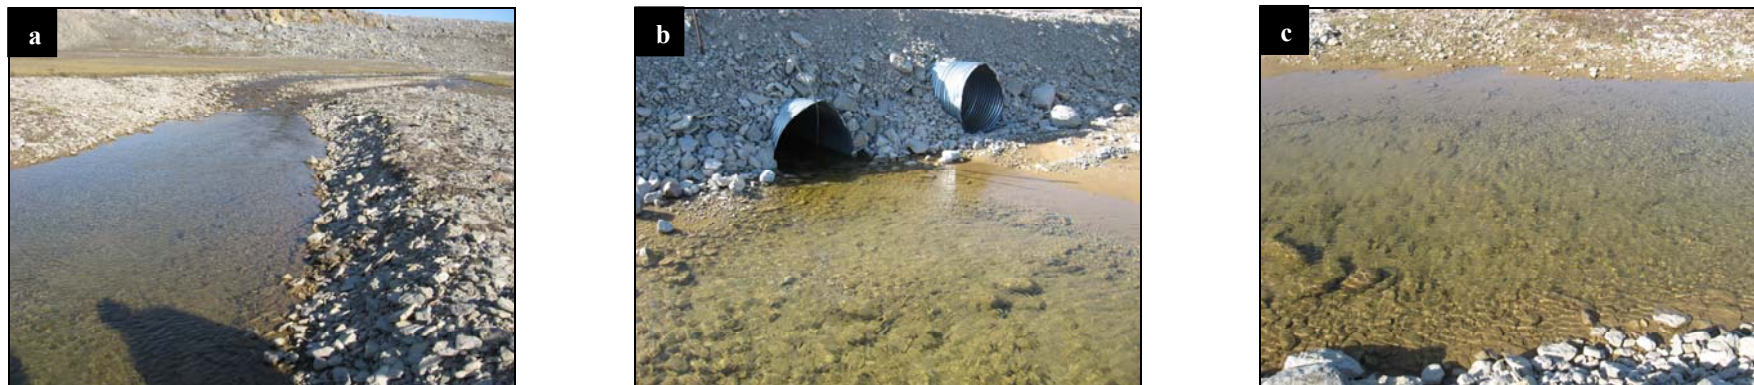
Figure 2. View upstream (a), downstream (b), and across (c) at the habitat assessment site upstream of the crossing at CV-079 during late August, 2009.

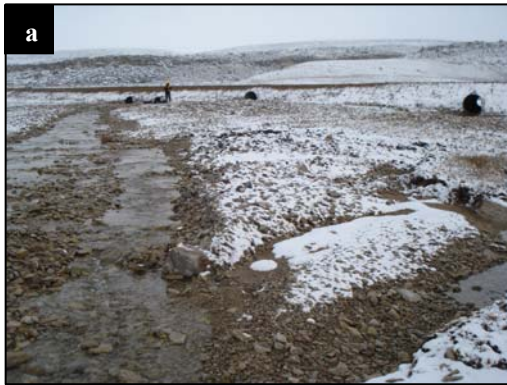
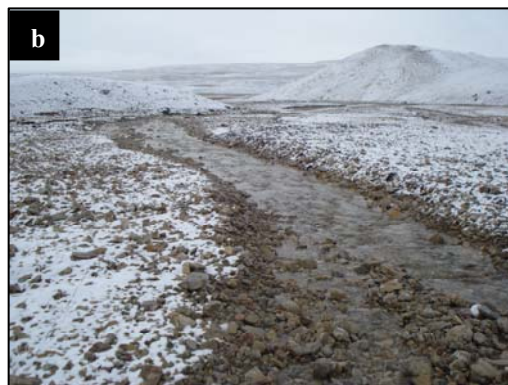
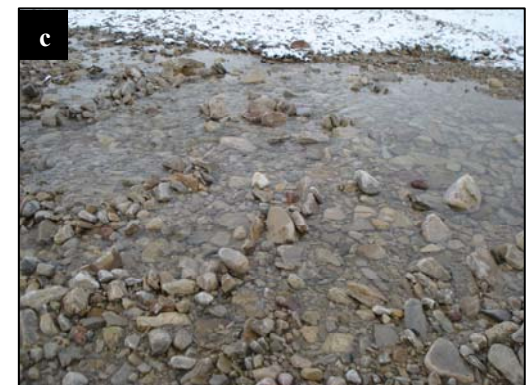
Figure 1. View upstream (a), downstream (b), and across (c) from habitat assessment in reach 1 of CV-207 during fall 2008.

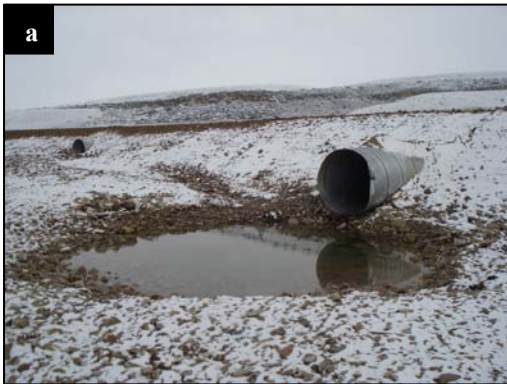
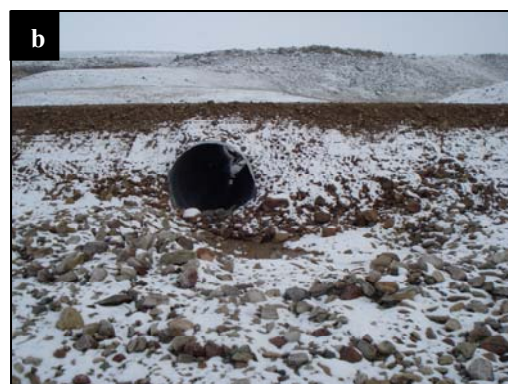
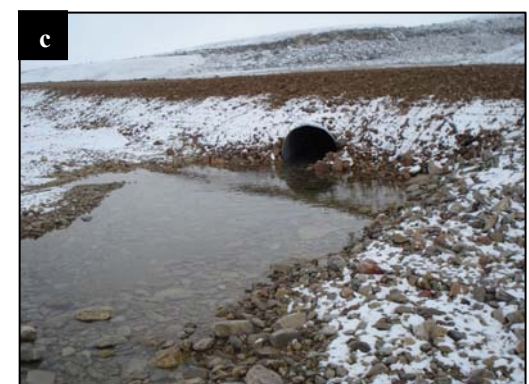
Figure 1. Views of the culverts at CV-207 from the downstream end (a, b, & c) during fall 2008.

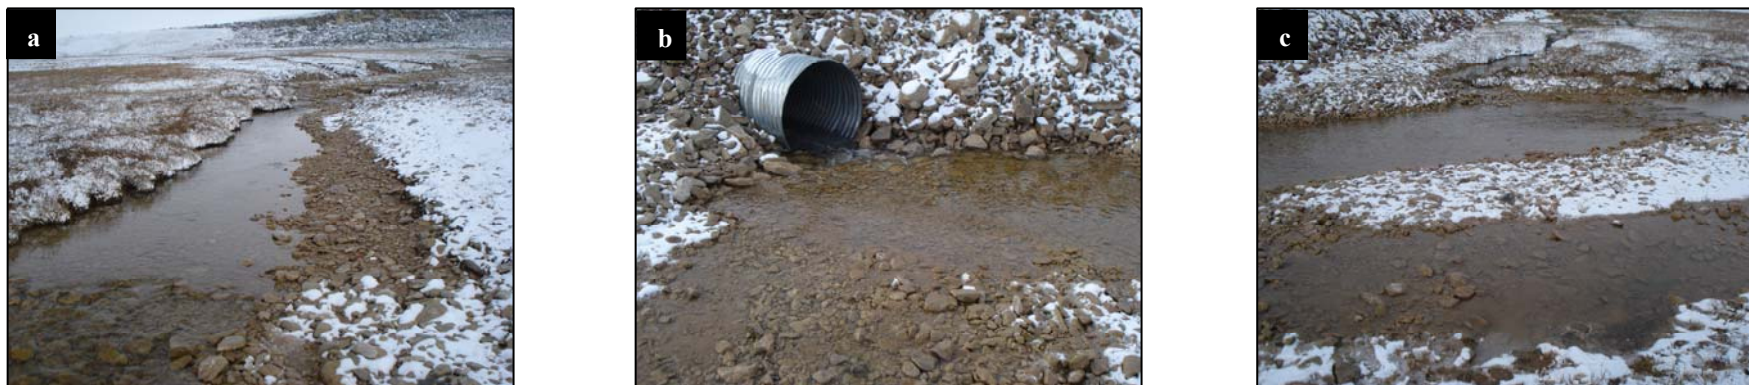
Figure 1. View upstream (a), downstream (b), and across (c) from habitat assessment in reach 2 of CV-207 during fall 2008.

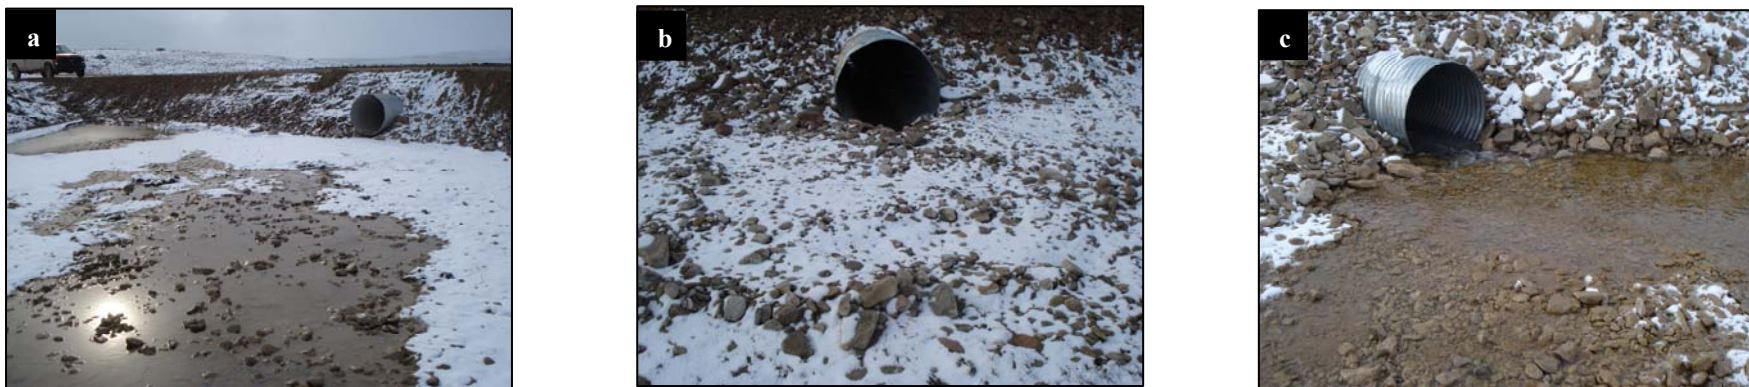
Figure 1. Views of the culverts at CV-207 from the upstream end (a, b, & c) during fall 2008.

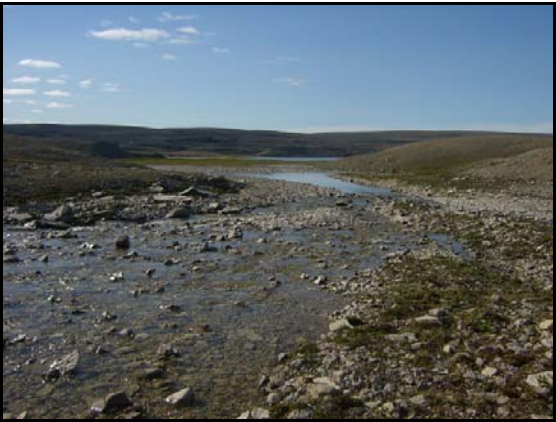
Figure 1: Downstream view from proposed crossing showing riffle-pool habitat with cobble and boulders.

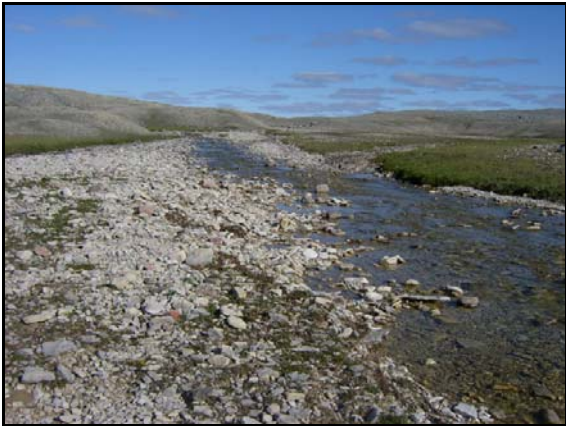
Figure 2: Upstream view from proposed crossing showing more cascade habitat and cobble substrate.

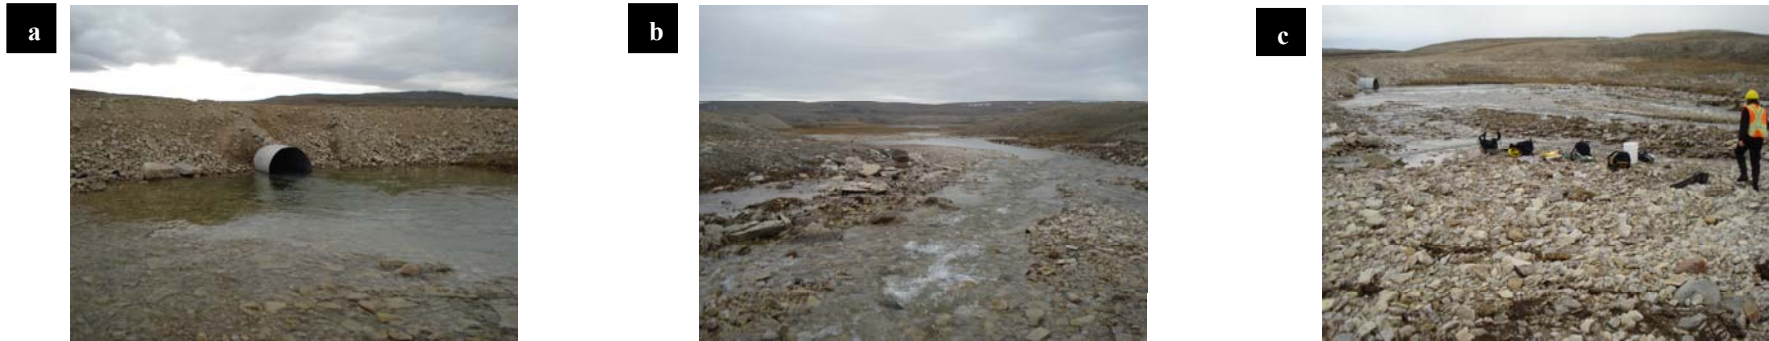
Figure 1. View upstream (a), downstream (b), and across (c) from the habitat assessment downstream of CV-078 during fall 2008.

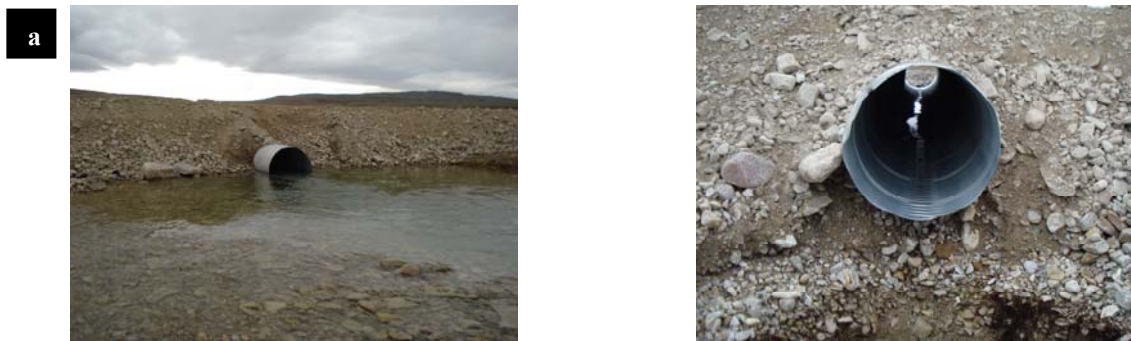
Figure 2. View upstream of culvert #1 (a) and culvert #2 (b) downstream of CV-078 during fall 2008.

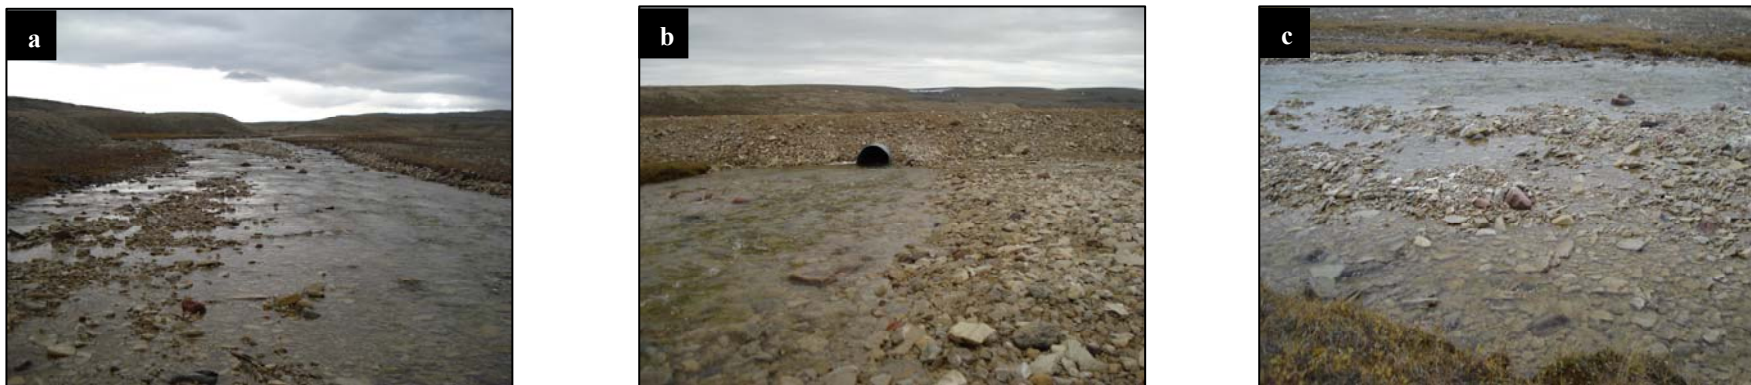
Figure 1. View upstream (a), downstream (b), and across (c) from the habitat assessment upstream of CV-078 during fall 2008.

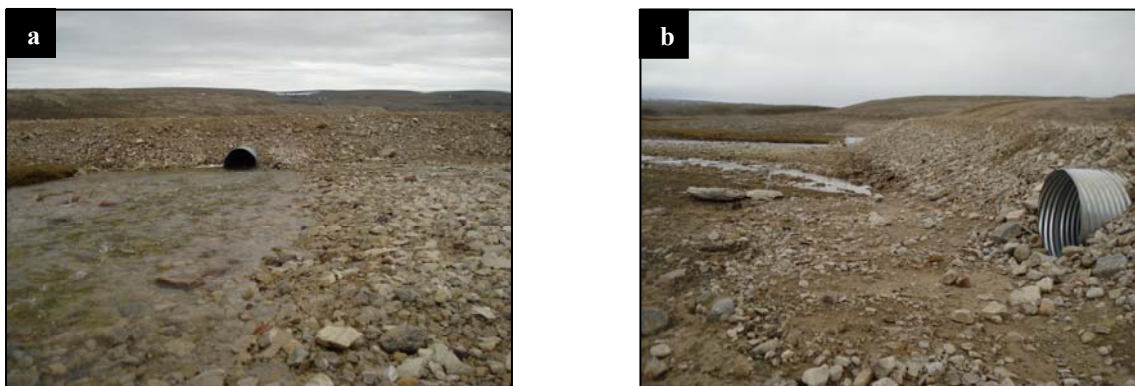
Figure 2. View of the culverts from the upstream end (a & b) upstream of CV-078 during fall 2008.

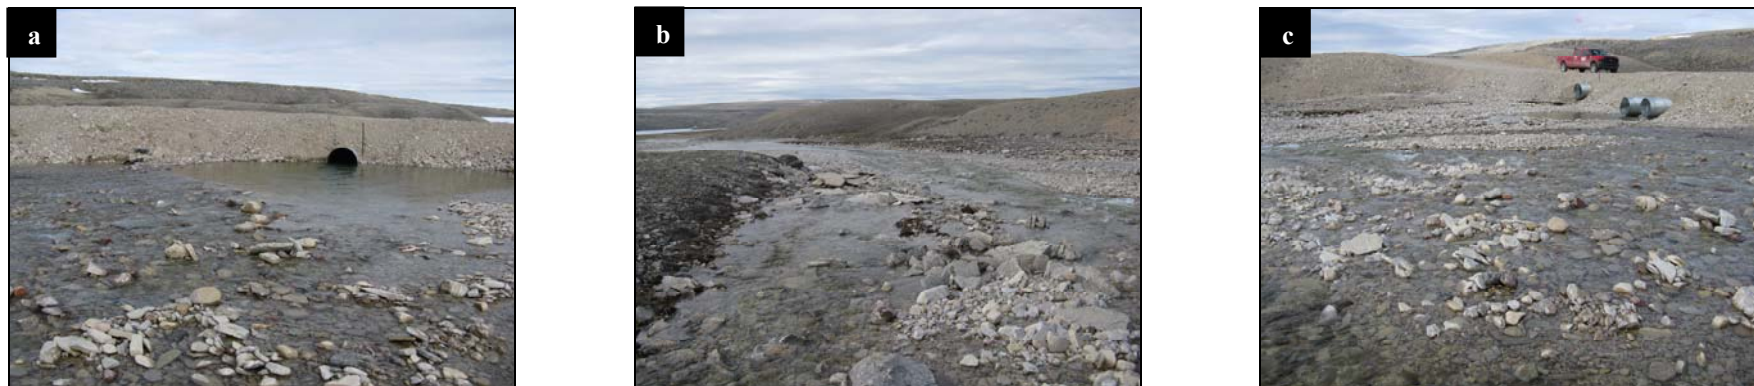
Figure 1. View upstream (a), downstream (b), and across (c) at the habitat assessment site downstream of the crossing at CV-078 during early July, 2009.

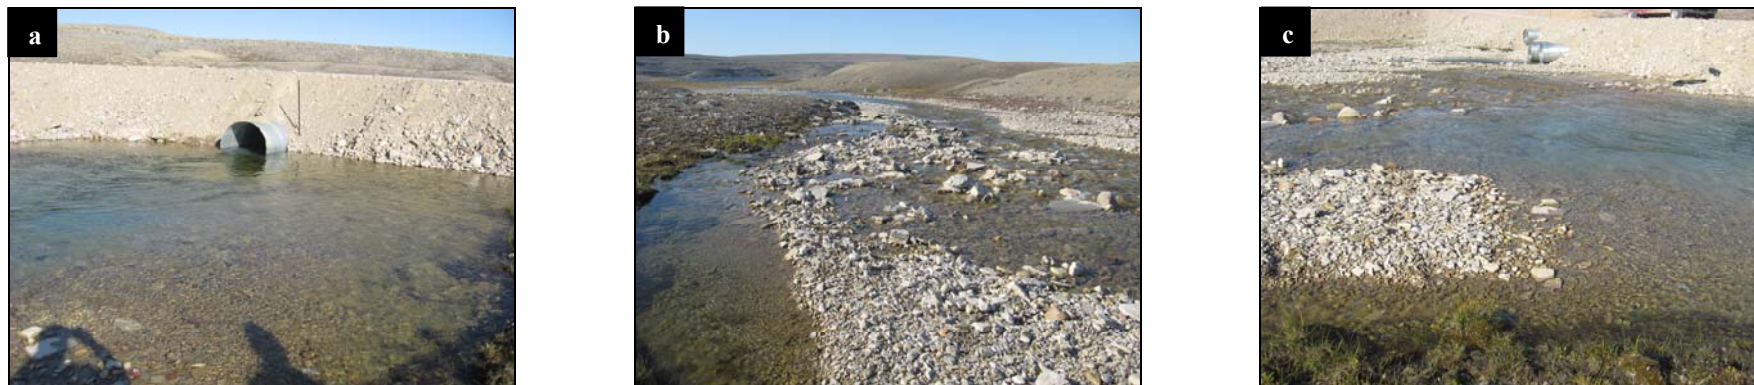
Figure 2. View upstream (a), downstream (b), and across (b) at the habitat assessment site downstream of the crossing at CV-078 during late August, 2009.

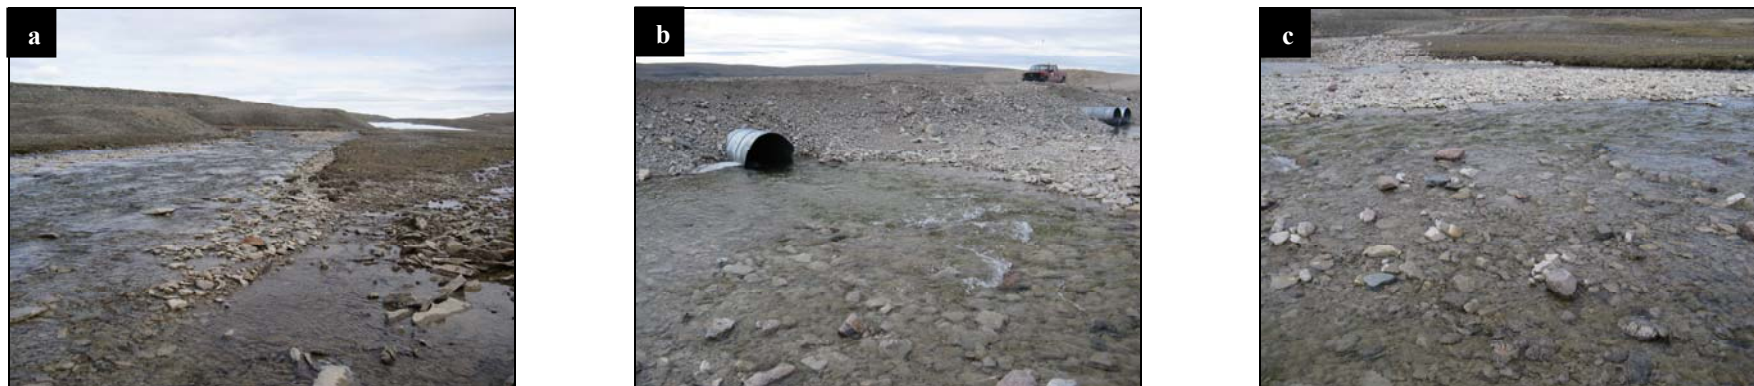
Figure 1. View upstream (a), downstream (b), and across (c) at the habitat assessment site upstream of the crossing at CV-078 during early July, 2009.

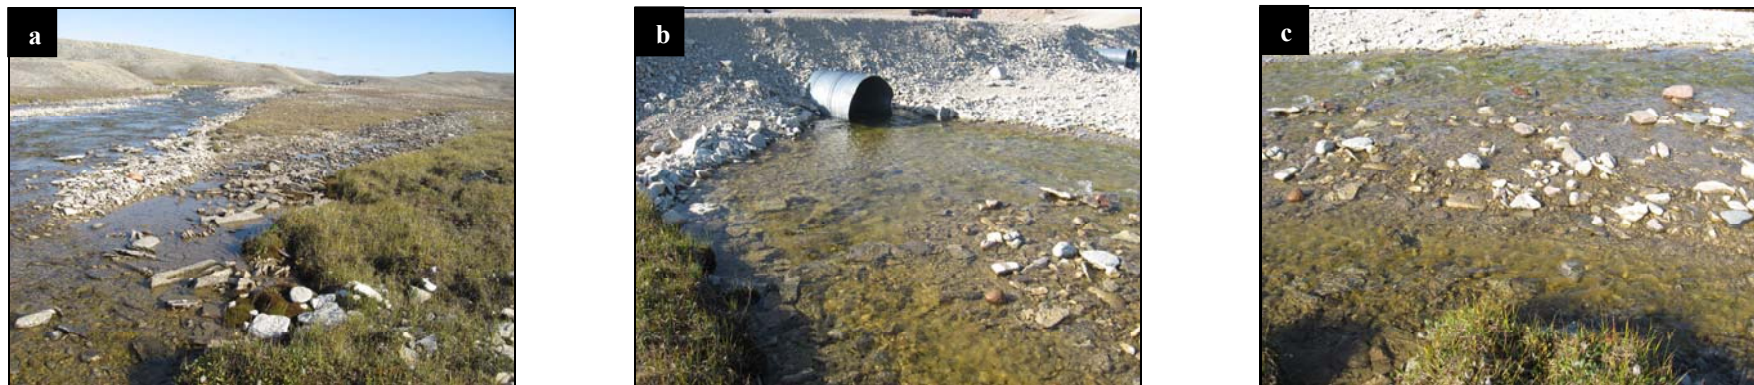
Figure 2. View upstream (a), downstream (b), and across (c) at the habitat assessment site upstream of the crossing at CV-078 during late August, 2009.

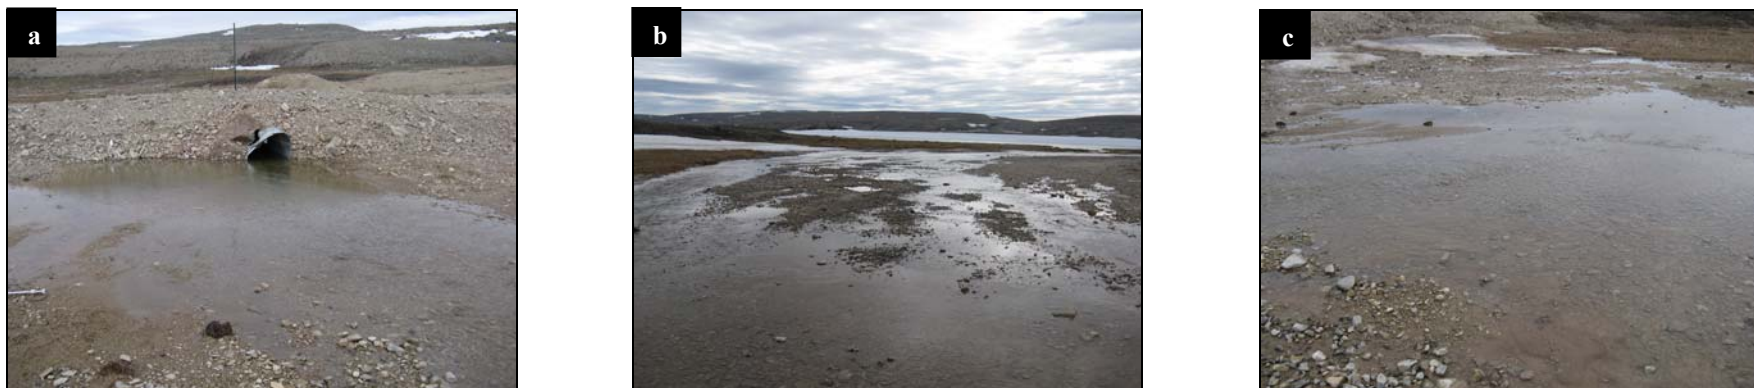
Figure 1. View upstream (a), downstream (b), and across (c) at the habitat assessment site downstream of the crossing at CV-076 during spring, 2009.
