APPENDIX 5.3-1.

DETAILED HABITAT ASSESSMENTS AND SUMMARY OF RESULTS FOR WATERBODIES IN QUARRY SITES.

Table A5.3-1.1. Summary of results from surveys and assessments that fall within Quarry boundaries.

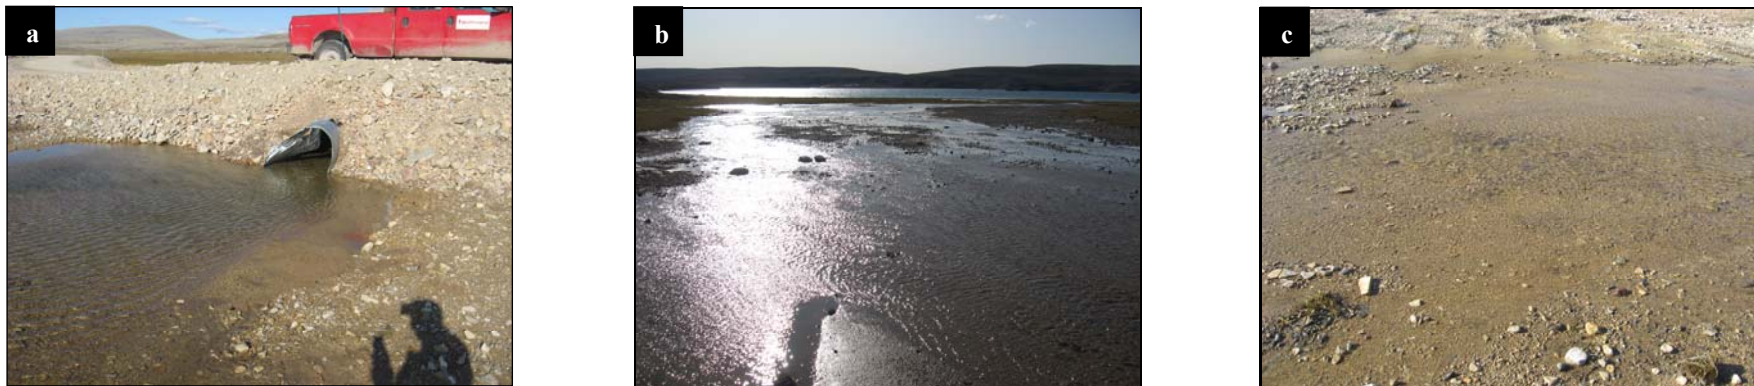
Figure 2. View upstream (a), downstream (b), and across (c) at the habitat assessment site downstream of the crossing at CV-076 during fall, 2009.

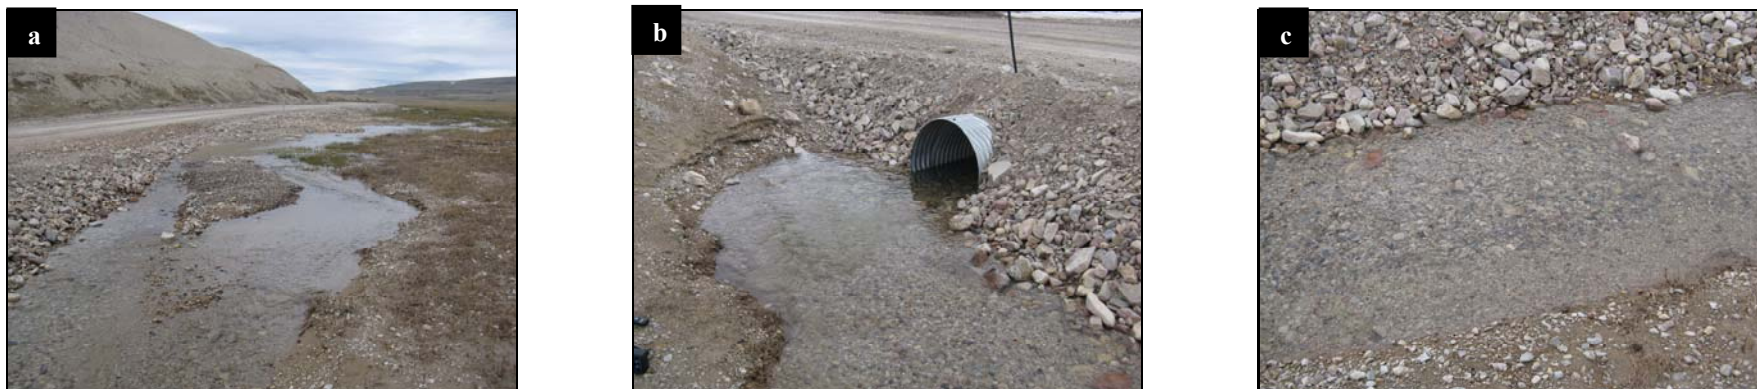
Figure 1. View upstream (a), downstream (b), and across (c) at the habitat assessment site upstream of the crossing at CV-076 during spring, 2009.

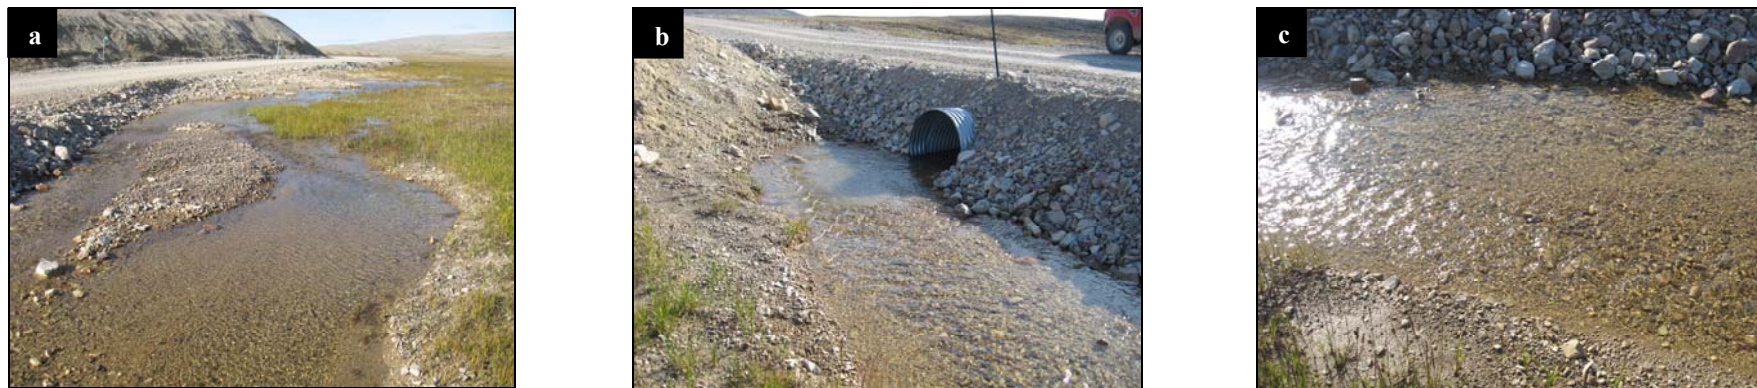
Figure 2. View upstream (a), downstream (b), and across (c) at the habitat assessment site upstream of the crossing at CV-076 during fall, 2009.

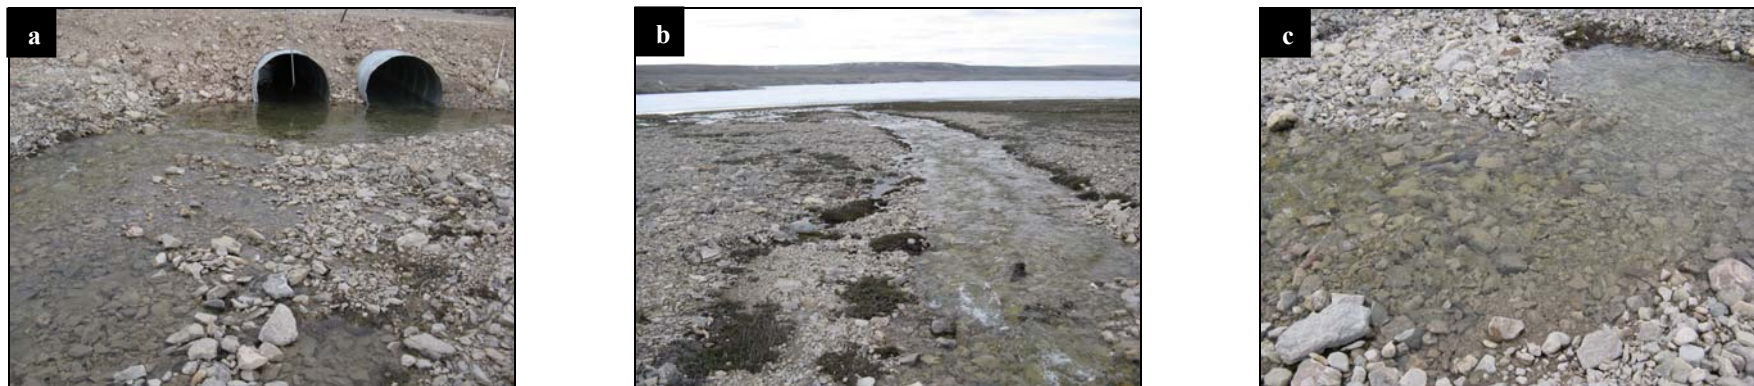
Figure 1. View upstream (a), downstream (b), and across (c) at the habitat assessment site downstream of the crossing at CV-072 during early July, 2009.

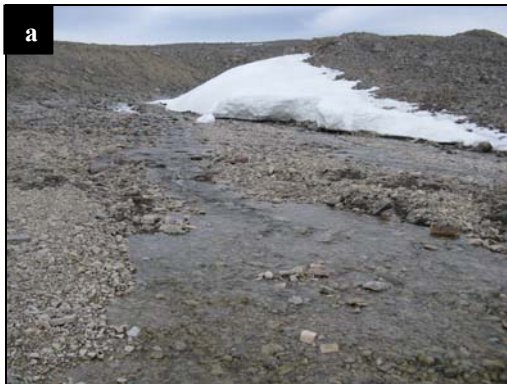
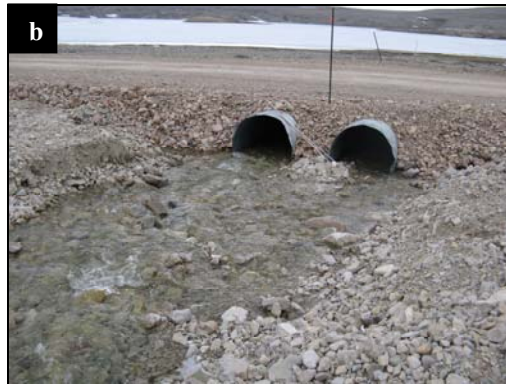
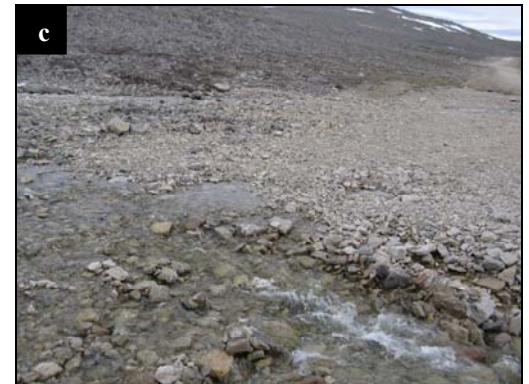
Figure 1. View upstream (a), downstream (b), and across (c) at the habitat assessment site upstream of the crossing at CV-072 during early July, 2009.

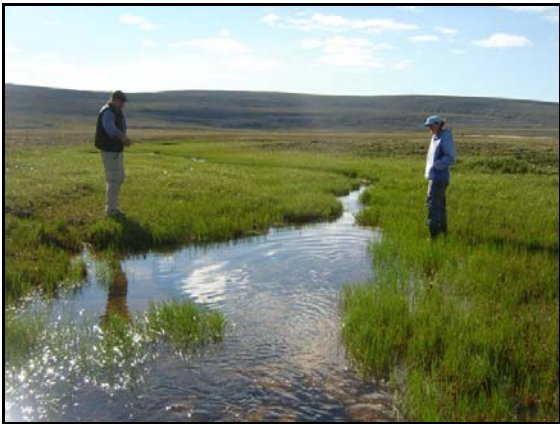
Figure 1: Downstream view from proposed crossing showing abundant pool habitat and vegetation.

This waterbody has abundant pool habitat for juvenile char. Many small char were observed or captured during fisheries studies. There is likely little to no use by adult char. Though not captured ninespine stickleback may also use this creek as both a feeding and refuge area.

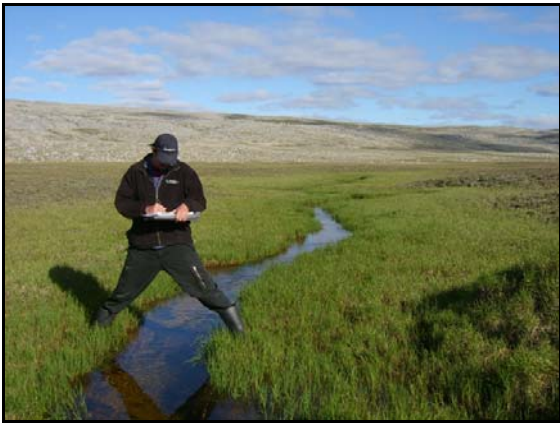
Figure 2: Upstream view from proposed crossing showing more pool habitat.

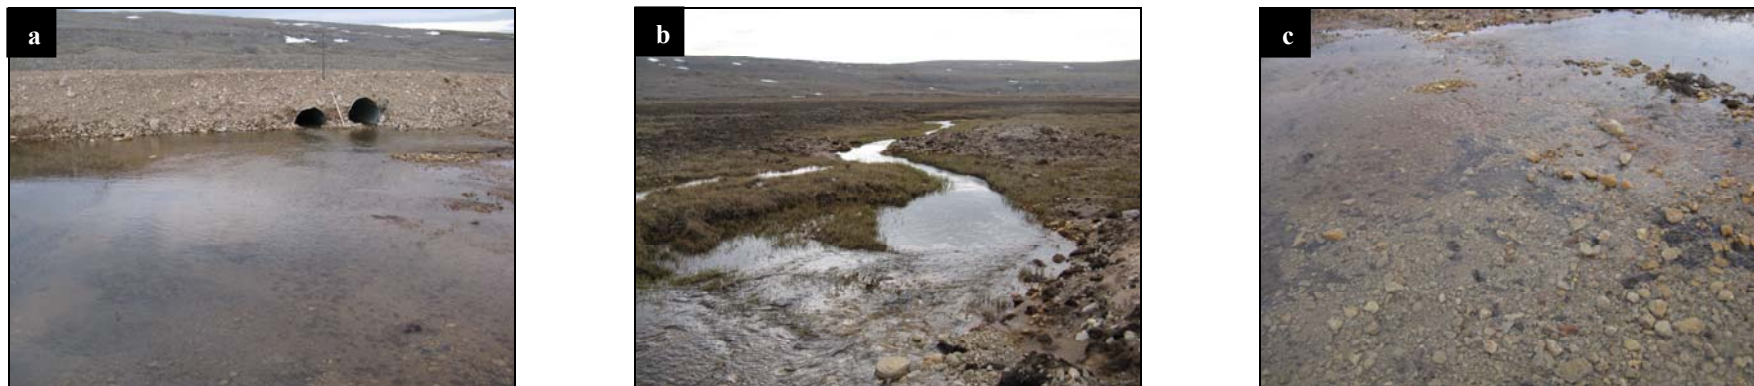
Figure 1. View upstream (a), downstream (b), and across (c) at the habitat assessment site downstream of the crossing at CV-060 during early July, 2009.

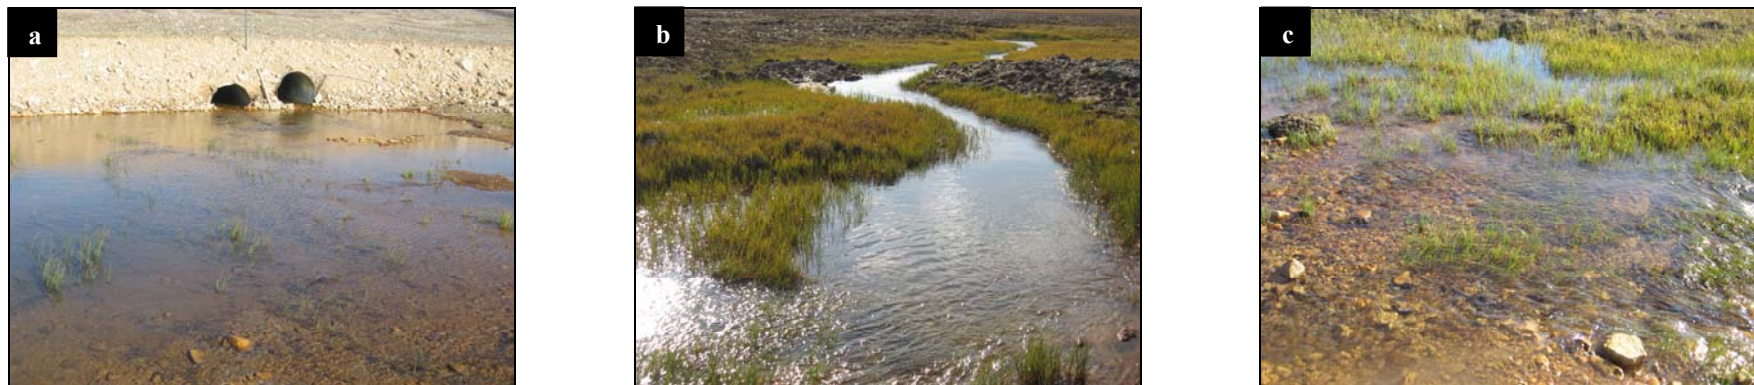
Figure 2. View upstream (a), downstream (b), and across (b) at the habitat assessment site downstream of the crossing at CV-060 during late August, 2009.

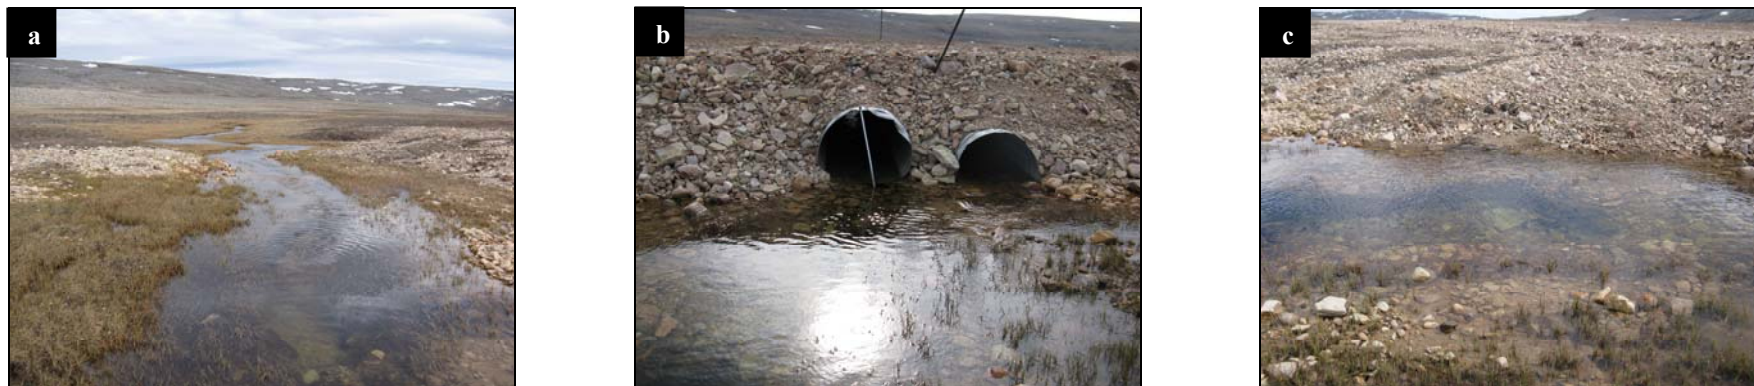
Figure 1. View upstream (a), downstream (b), and across (c) at the habitat assessment site upstream of the crossing at CV-060 during early July, 2009.

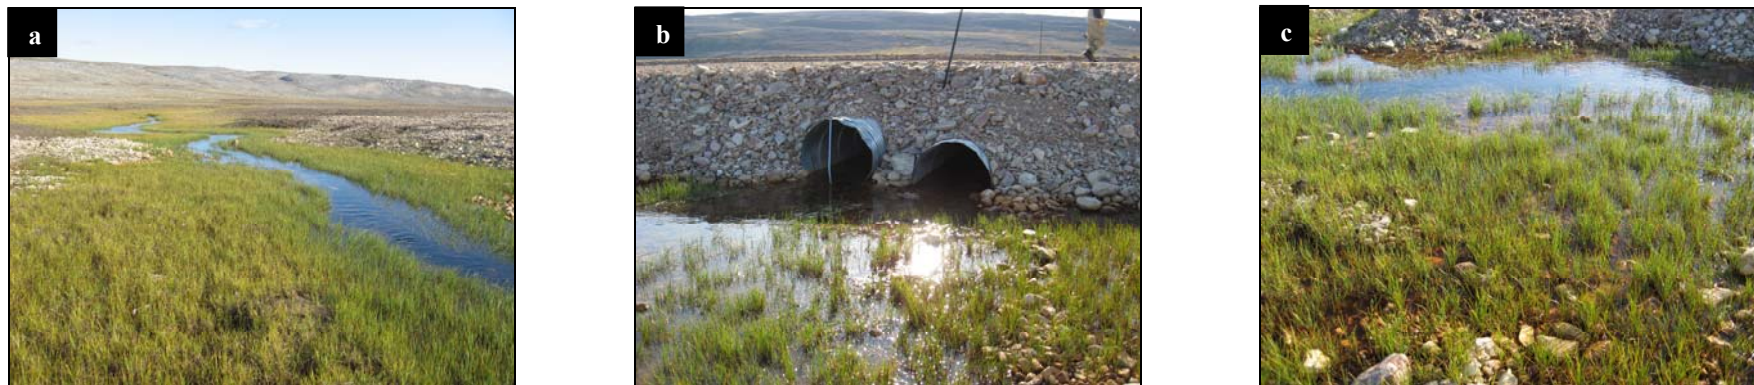
Figure 2. View upstream (a), downstream (b), and across (c) at the habitat assessment site upstream of the crossing at CV-060 during late August, 2009.

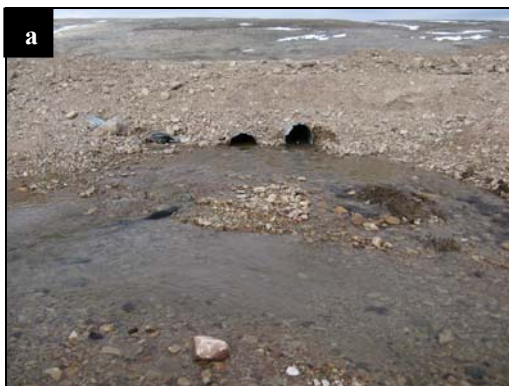
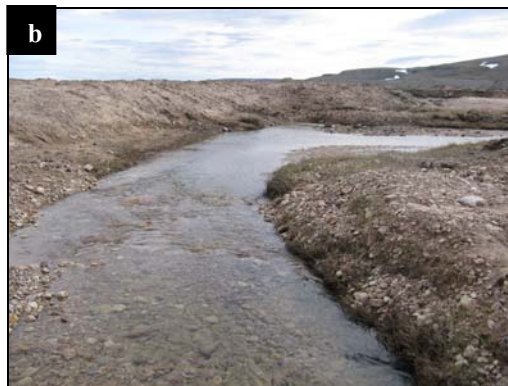
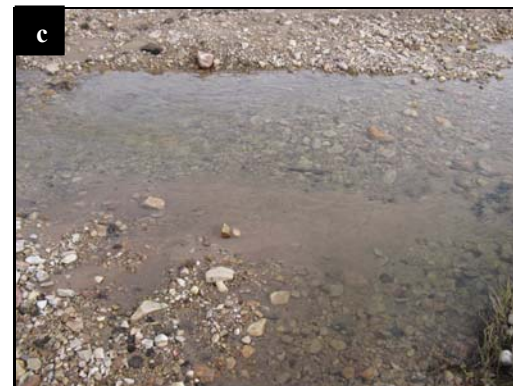
Figure 1. View upstream (a), downstream (b), and across (c) at the habitat assessment site downstream of the crossing at CV-059 during spring, 2009.

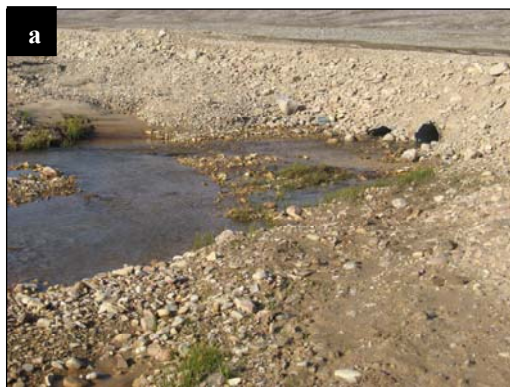
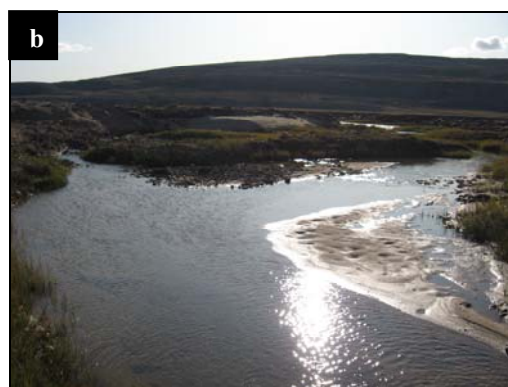
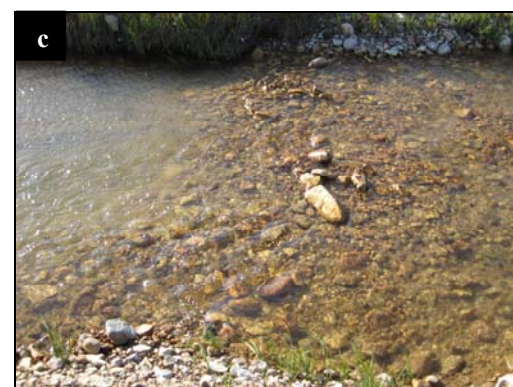
Figure 2. View upstream (a), downstream (b), and across (c) at the habitat assessment site upstream of the crossing at CV-059 during fall, 2009.

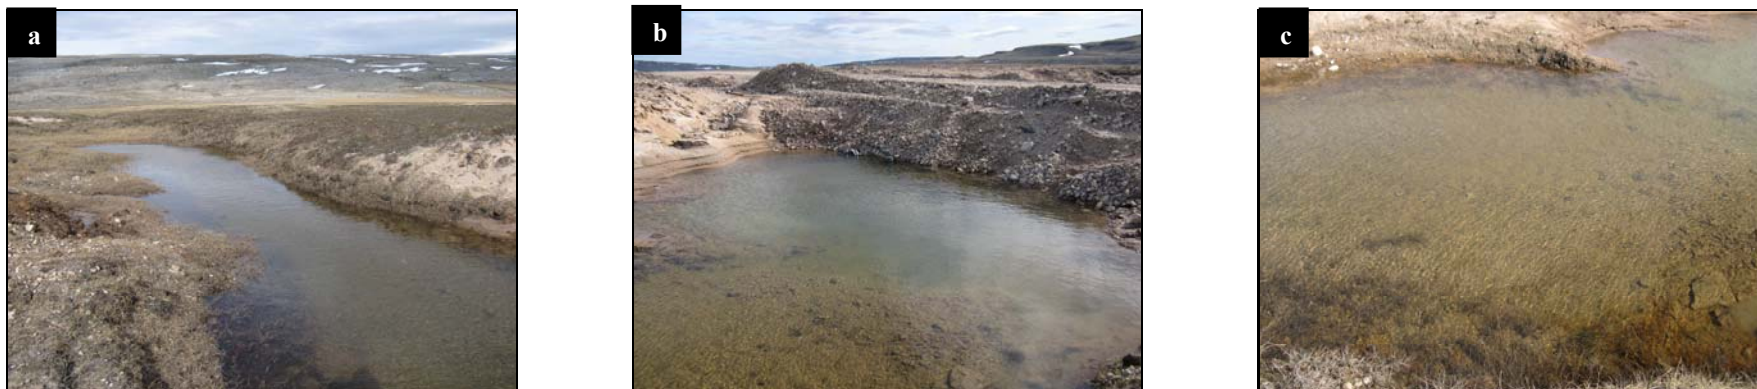
Figure 1. View upstream (a), downstream (b), and across (c) at the habitat assessment site upstream of the crossing at CV-059 during spring, 2009.

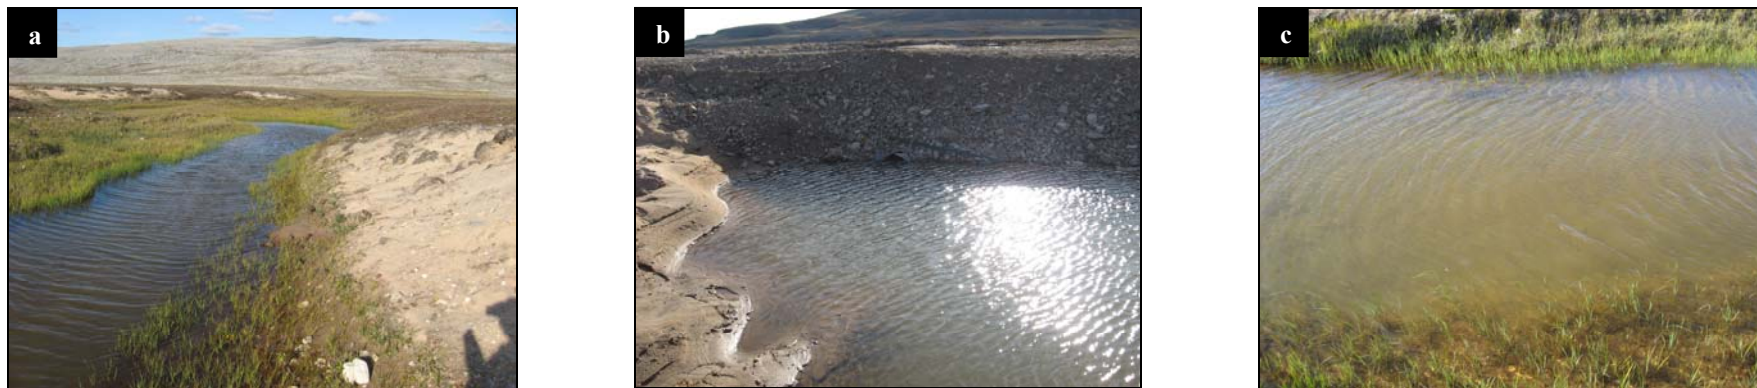
Figure 2. View upstream (a), downstream (b), and across (c) at the habitat assessment site upstream of the crossing at CV-059 during fall, 2009.

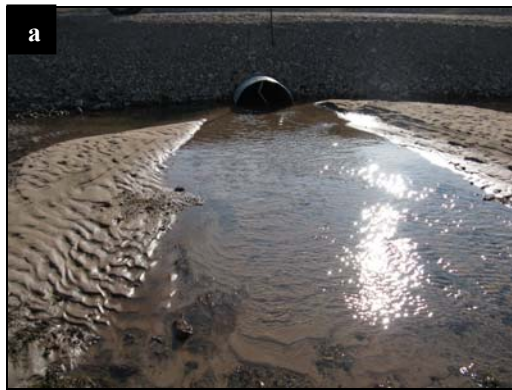
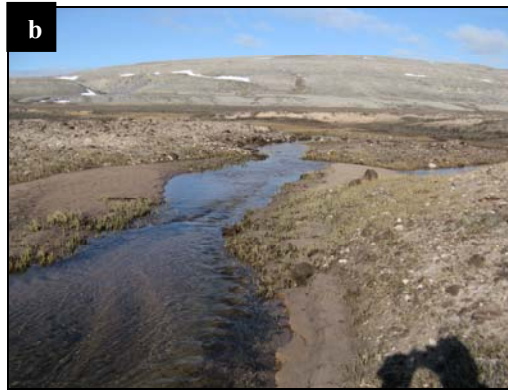
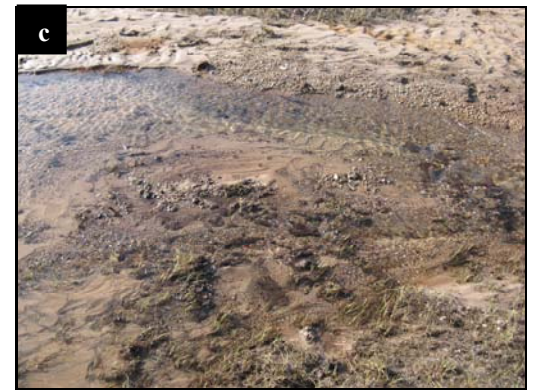
Figure 1. View upstream (a), downstream (b), and across (c) at the habitat assessment site downstream of the crossing at CV-058 during spring, 2009.

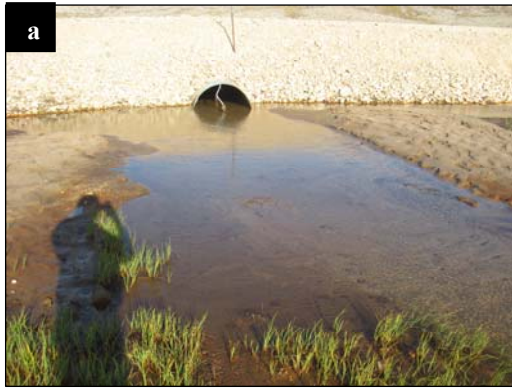
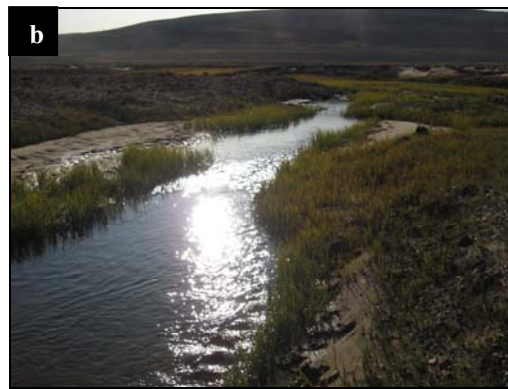
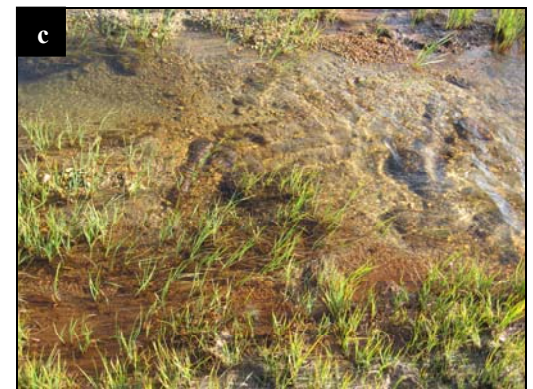
Figure 2. View upstream (a), downstream (b), and across (c) at the habitat assessment site upstream of the crossing at CV-058 during spring, 2009.

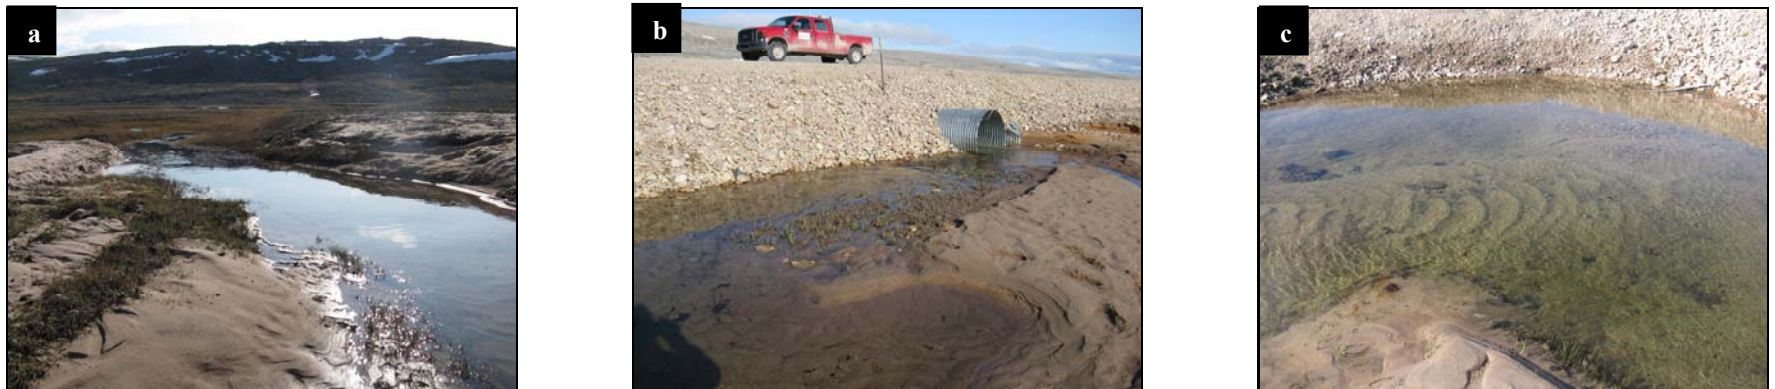
Figure 1. View upstream (a), downstream (b), and across (c) at the habitat assessment site upstream of the crossing at CV-058 during spring, 2009.

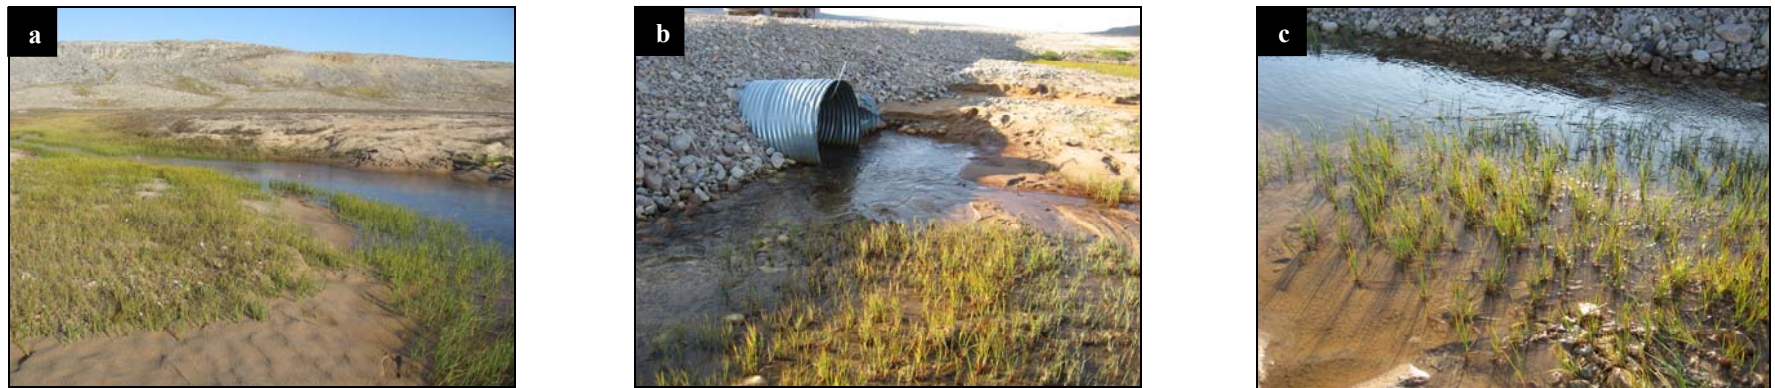
Figure 2. View upstream (a), downstream (b), and across (c) at the habitat assessment site upstream of the crossing at CV-058 during fall, 2009.

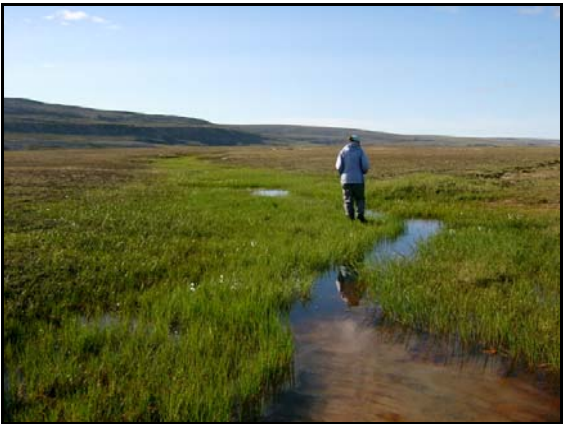
Figure 1: Downstream view from proposed crossing showing pool habitat with vegetation.

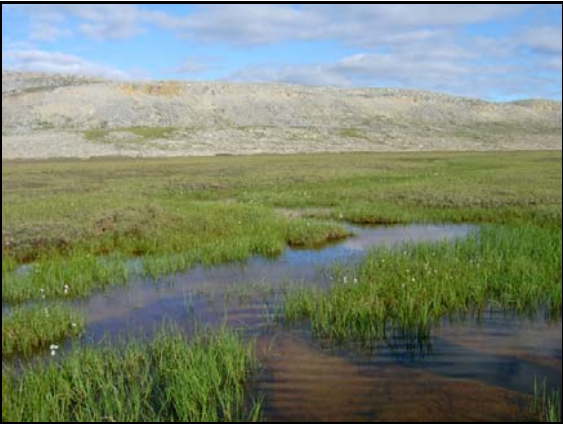
Figure 2: Upstream view from proposed crossing showing more pool habitat.

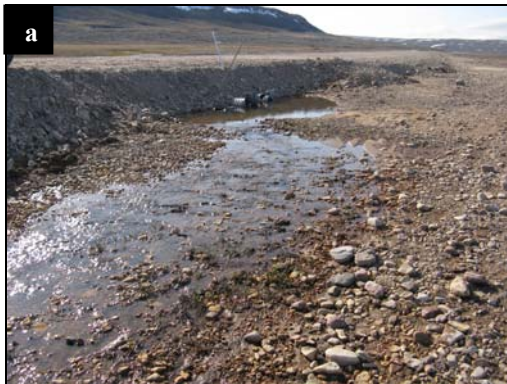
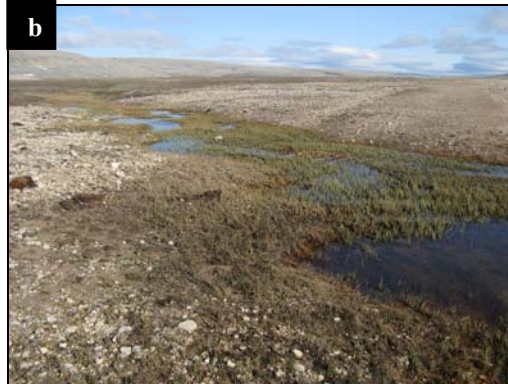
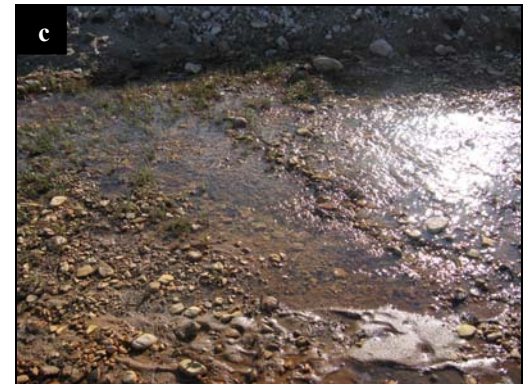
Figure 1. View upstream (a), downstream (b), and across (c) at the habitat assessment site downstream of the crossing at CV-057 during spring, 2009.

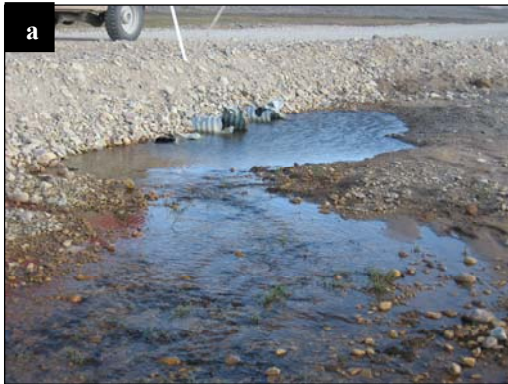
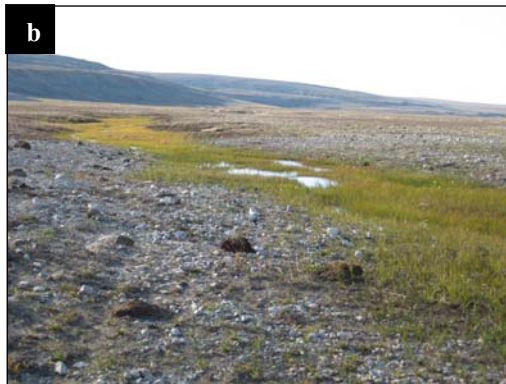
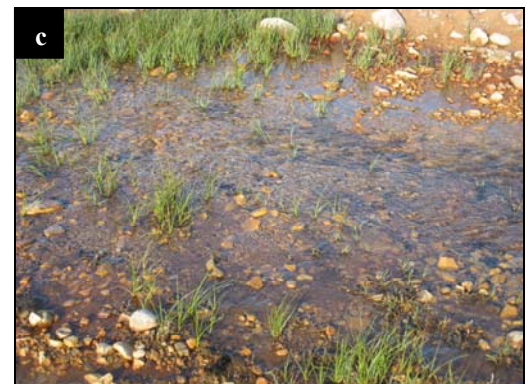
Figure 2. View upstream (a), downstream (b), and across (c) at the habitat assessment site upstream of the crossing at CV-057 during fall, 2009.

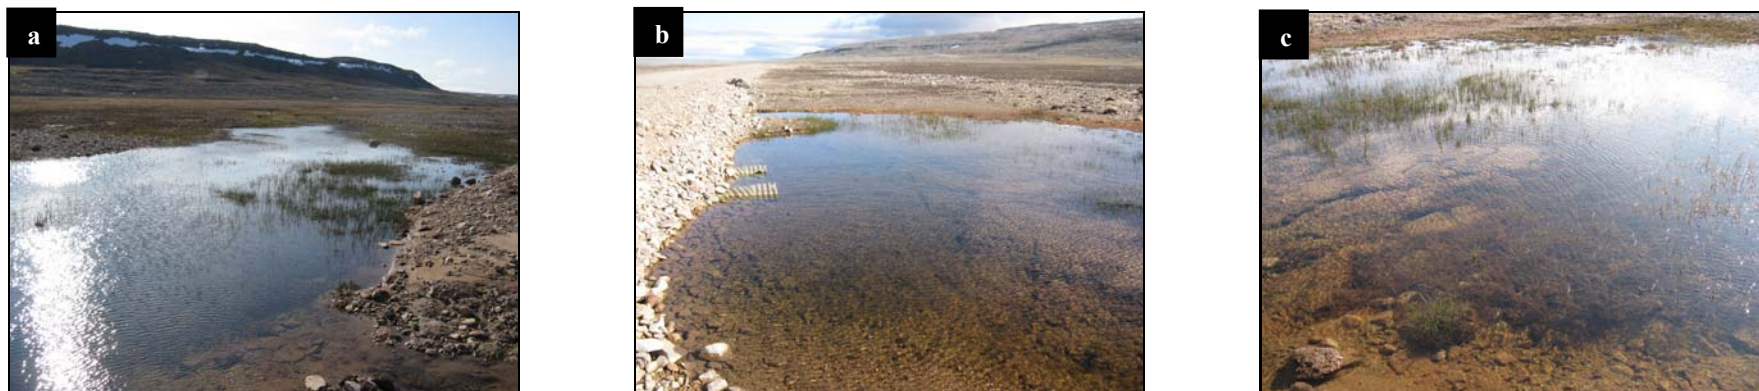
Figure 1. View upstream (a), downstream (b), and across (c) at the habitat assessment site upstream of the crossing at CV-057 during spring, 2009.

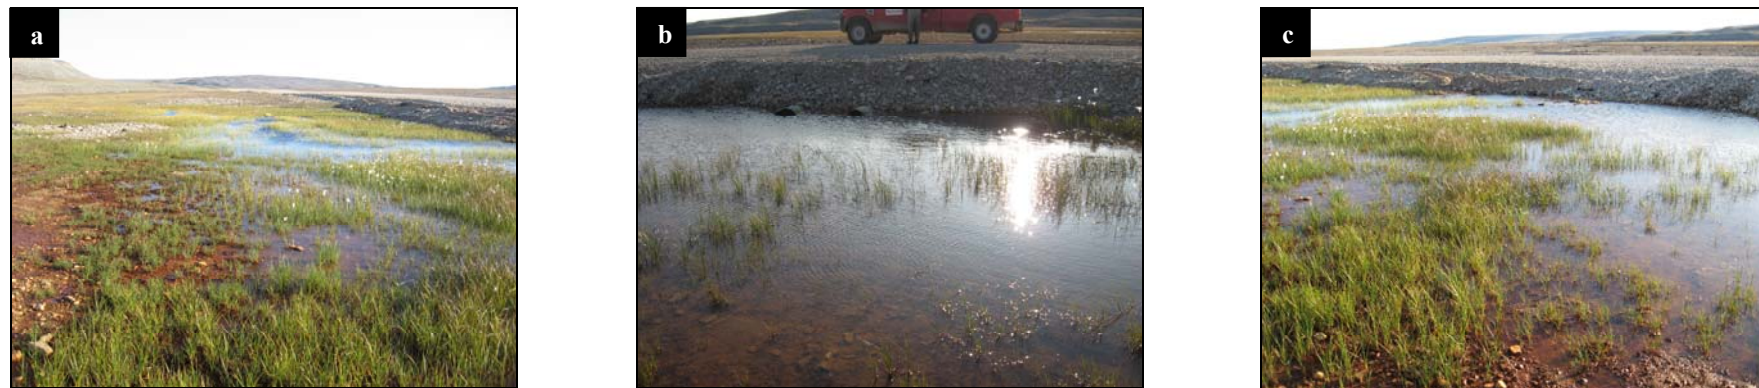
Figure 2. View upstream (a), downstream (b), and across (c) at the habitat assessment site upstream of the crossing at CV-057 during fall, 2009.

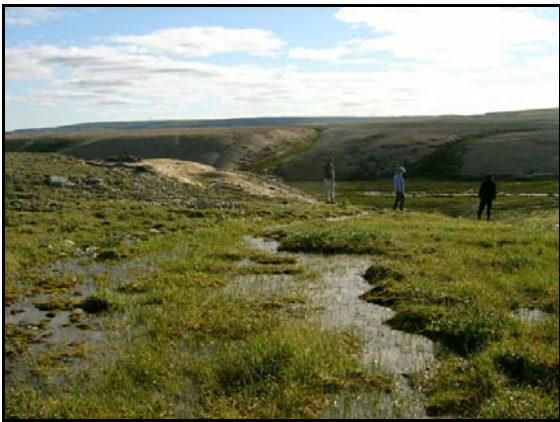
Figure 1: Downstream view from proposed crossing showing riffle habitat with steep drop where the field crew is standing.

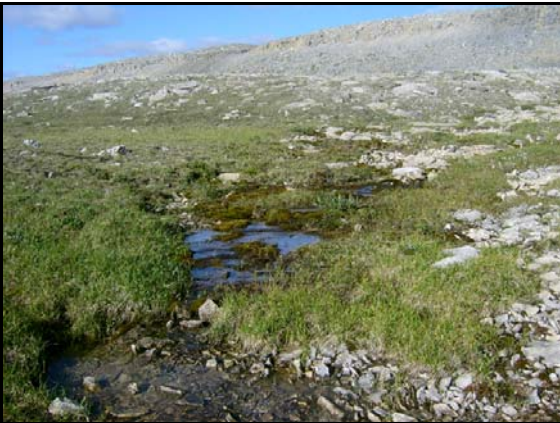
Figure 2: Upstream view from proposed crossing showing more cascade-riffle habitat.

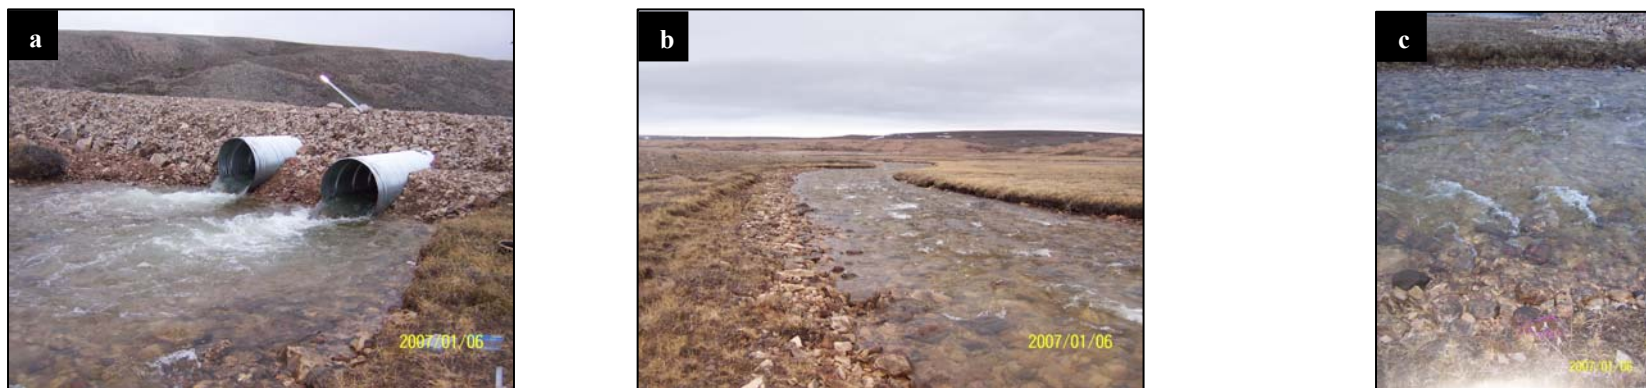
Figure 1. View upstream (a), downstream (b), and across (c) from the habitat assessment downstream of BG-50 during spring 2008.

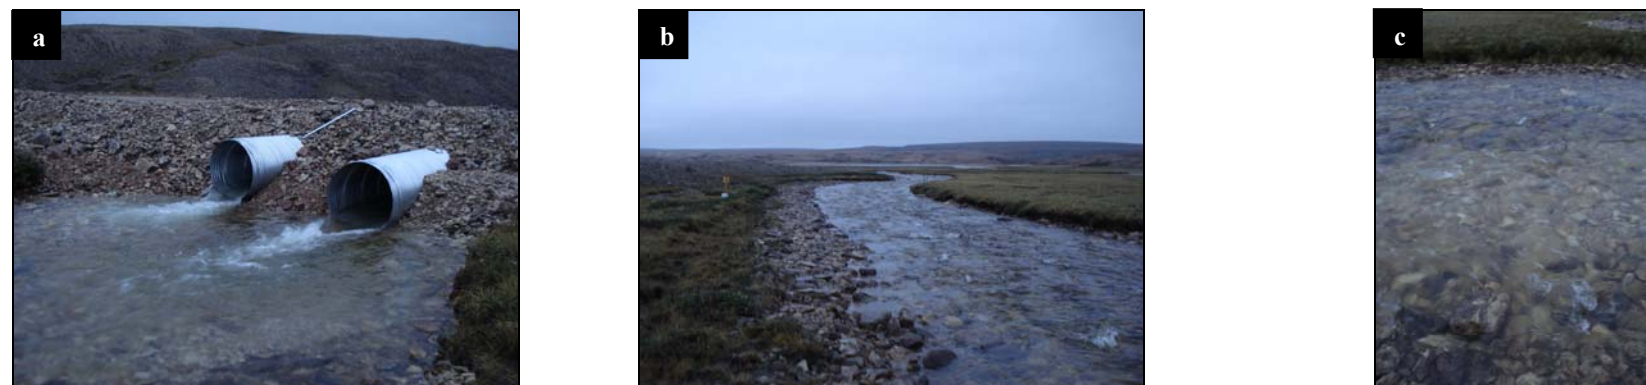
Figure 2. View upstream (a), downstream (b), and across (c) from the habitat assessment downstream of BG-50 during summer 2008.

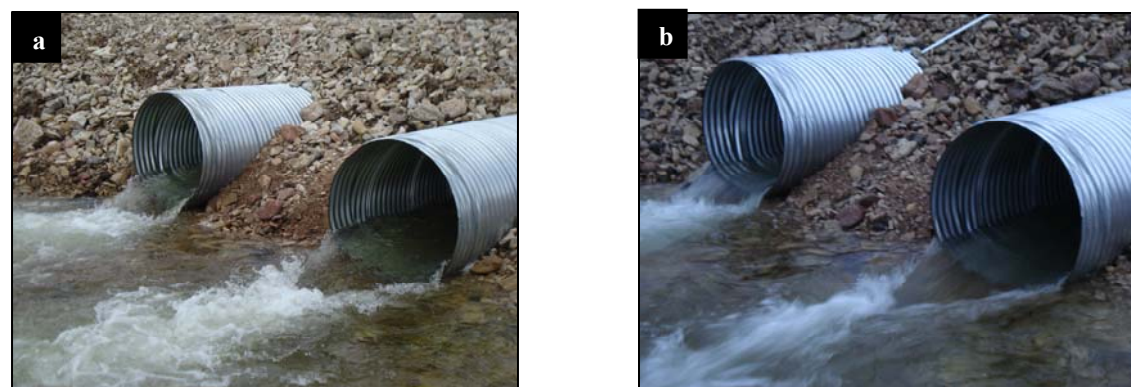
Figure 3. View from the downstream end of the culvert at crossing BG-50 during spring (a) and summer (b) 2008.

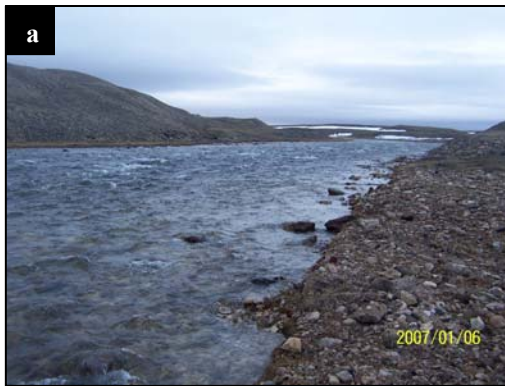
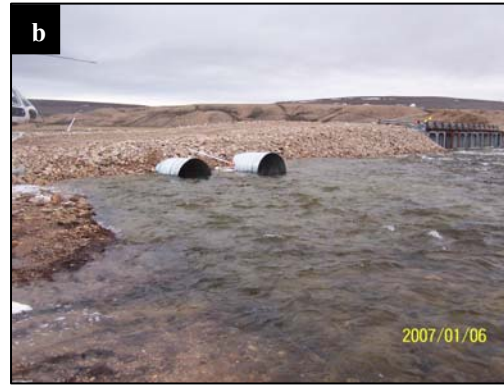
Figure 1. View upstream (a) and downstream (b) from the habitat assessment upstream of BG-50 during spring 2008.

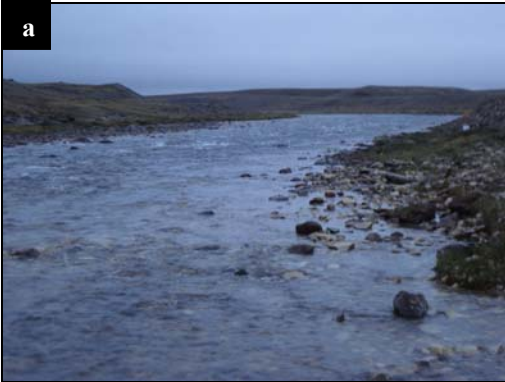
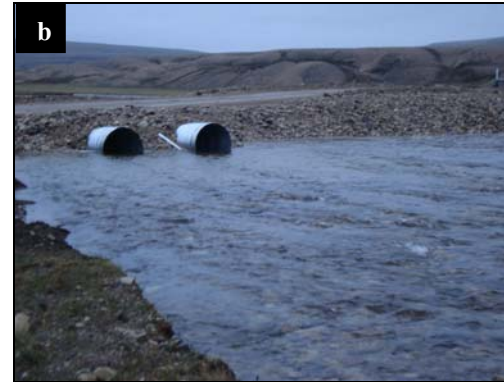
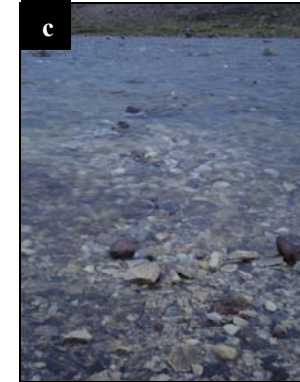
Figure 2. View upstream (a), downstream (b), and across (c) from the habitat assessment upstream of BG-50 during summer 2008.

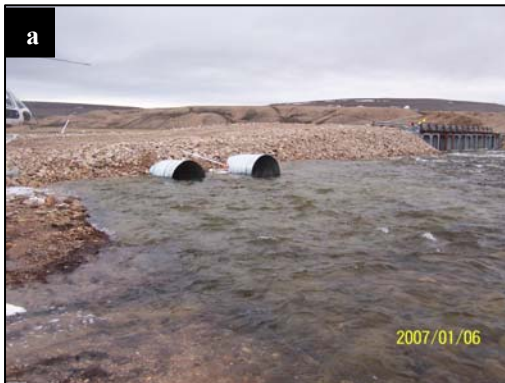
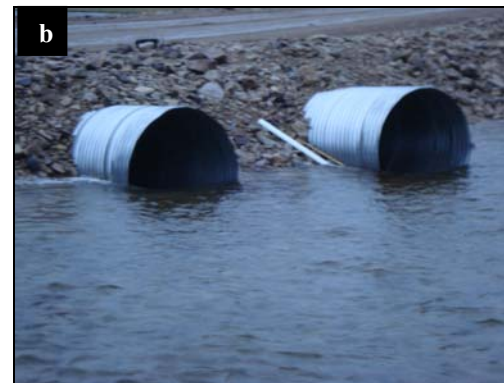
Figure 3. View from the upstream end of the culverts at crossing BG-50 during spring (a) and summer (b) 2008.

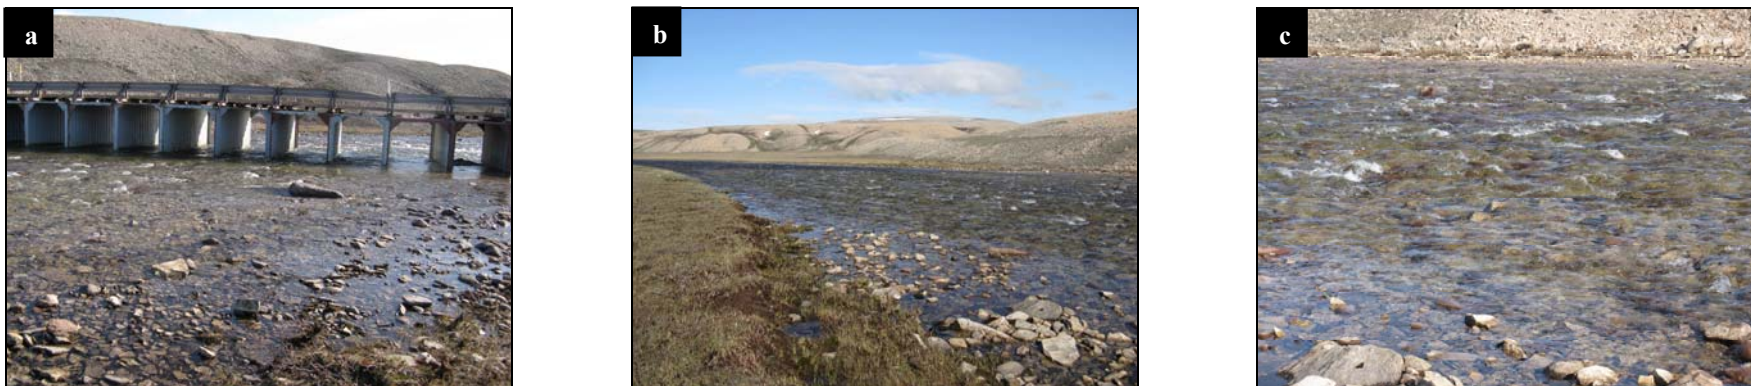
Figure 1. View upstream (a), downstream (b), and across (c) at the habitat assessment site downstream of the sea can crossing at BG-50 during early July, 2009.

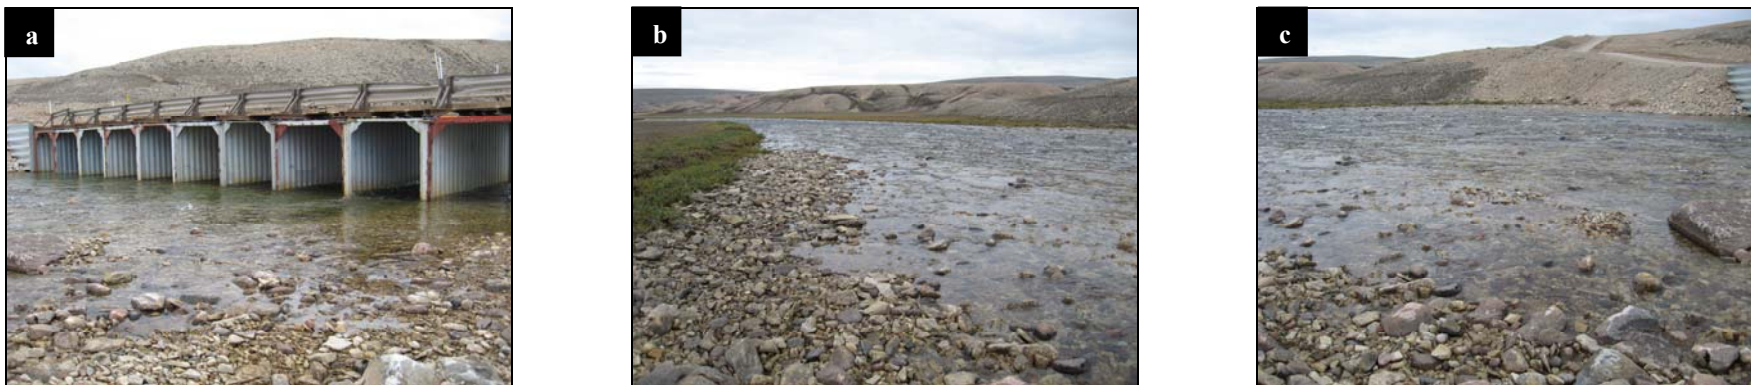
Figure 2. View upstream (a), downstream (b), and across (b) at the habitat assessment site downstream of the sea can crossing at BG-50 during late August, 2009.

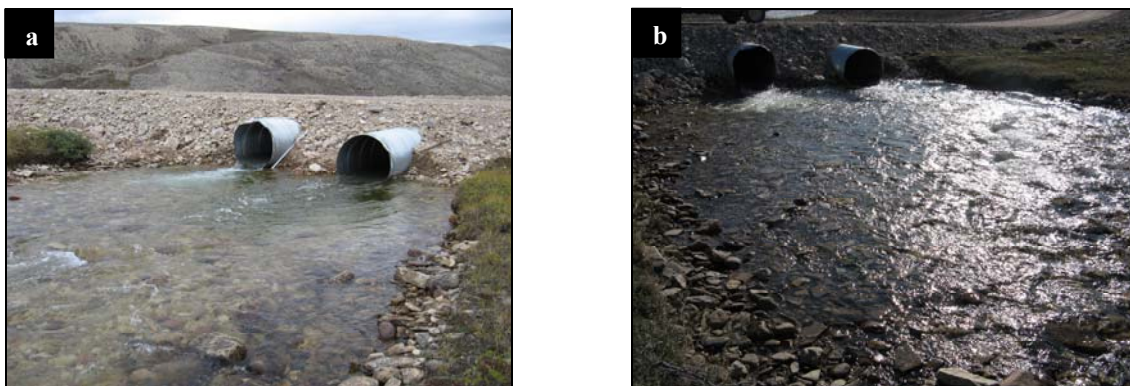
Figure 3. View upstream in early July (a) and late August (b) at the habitat assessment site downstream of the culvert crossing at BG-50.

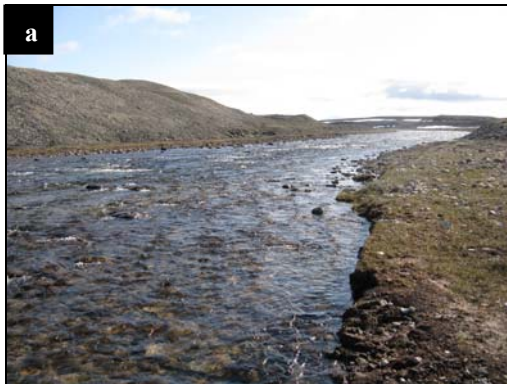
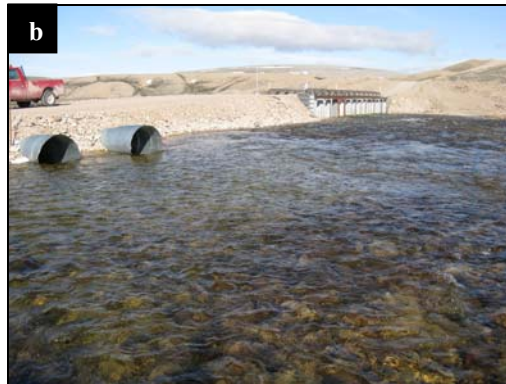
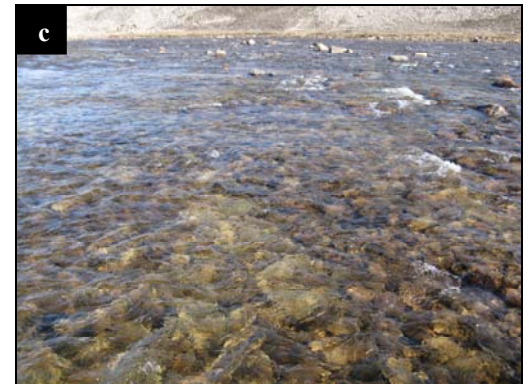
Figure 1. View upstream (a), downstream (b), and across (c) at the habitat assessment site upstream of the crossing at BG-50 during early July, 2009.

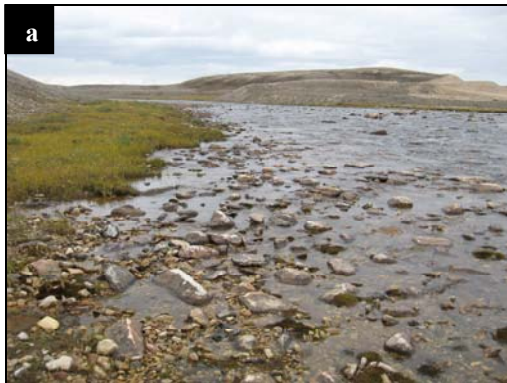
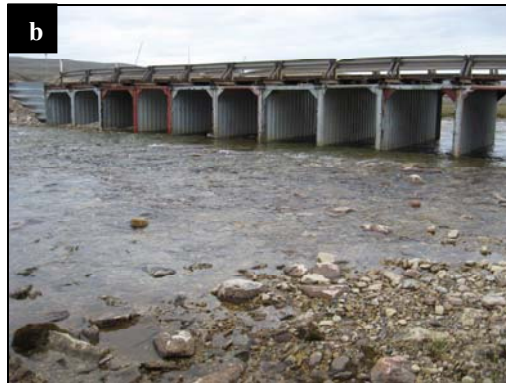
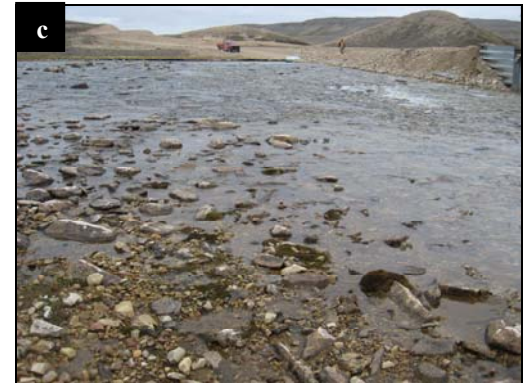
Figure 2. View upstream (a), downstream (b), and across (c) at the habitat assessment site upstream of the crossing at BG-50 during late August, 2009.

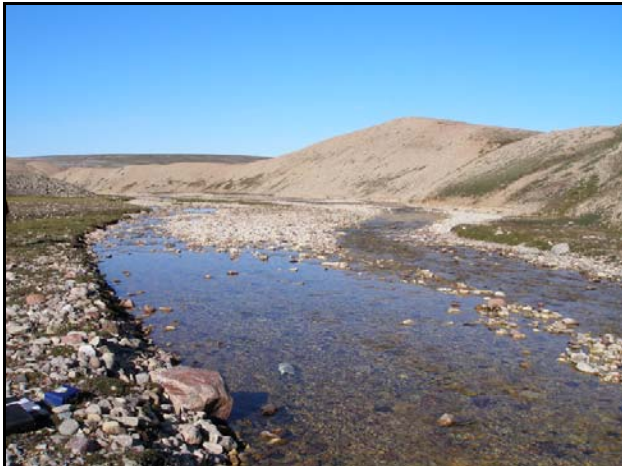
Figure 1: Downstream view from proposed crossing showing riffle habitat with cobble substrate.	Location					
	Site: CV-49		Watercourse Name: Unknown River			
	UTM: 17W 0529676 / 7926541					
	Site Description			Potential Fish Utilization		
				Arctic Char		
	Watershed Size: 11.984 km ²			Spawning: Unlikely		
	Regulated: No			Migration: Possible		
	Channelized: No			Rearing: Possible		
	Bankfull Width: 14.0 m			Overwintering: None		
	Wetted Width: 12.0 m
