APPENDIX 5.3-1.

DETAILED HABITAT ASSESSMENTS AND SUMMARY OF RESULTS FOR WATERBODIES IN QUARRY SITES.

Table A5.3-1.1. Summary of results from surveys and assessments that fall within Quarry boundaries.

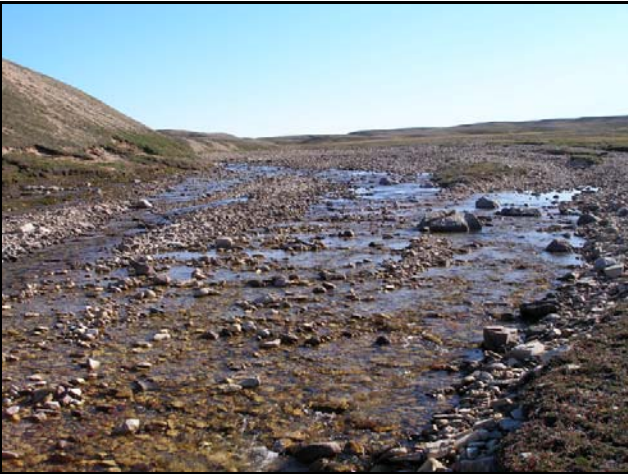
Figure 2: Upstream view from proposed crossing showing more riffle habitat.	Riffle-Crest Depth: 0.10 m			Ninespine Stickleback		
	Pool Depth: N/A			Spawning: Unlikely		
	Residual Pool Depth: N/A			Migration: Unlikely		
	Bankfull Depth: 0.70 m			Rearing: Unlikely		
	Bank Height: 0.60 m			Overwintering: None		
	D ₉₅ : 1.24 m					
	D: 0.004 m					
	Confinement: Partially Confined					
	Channel Morphology: Riffle

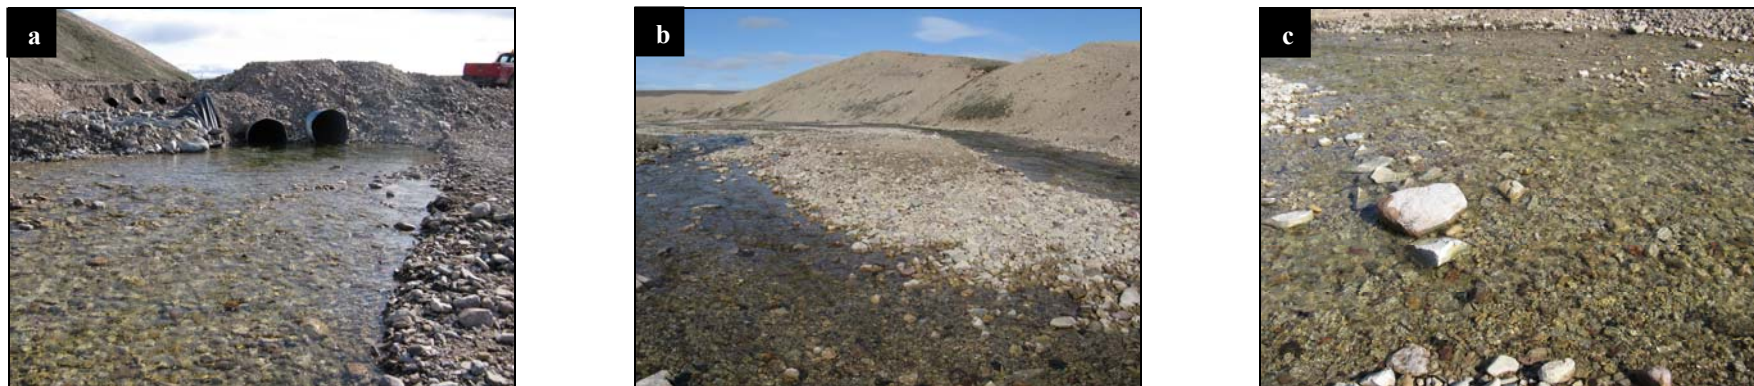
Figure 1. View upstream (a), downstream (b), and across (c) at the habitat assessment site downstream of the crossing at CV-049 during early July, 2009.

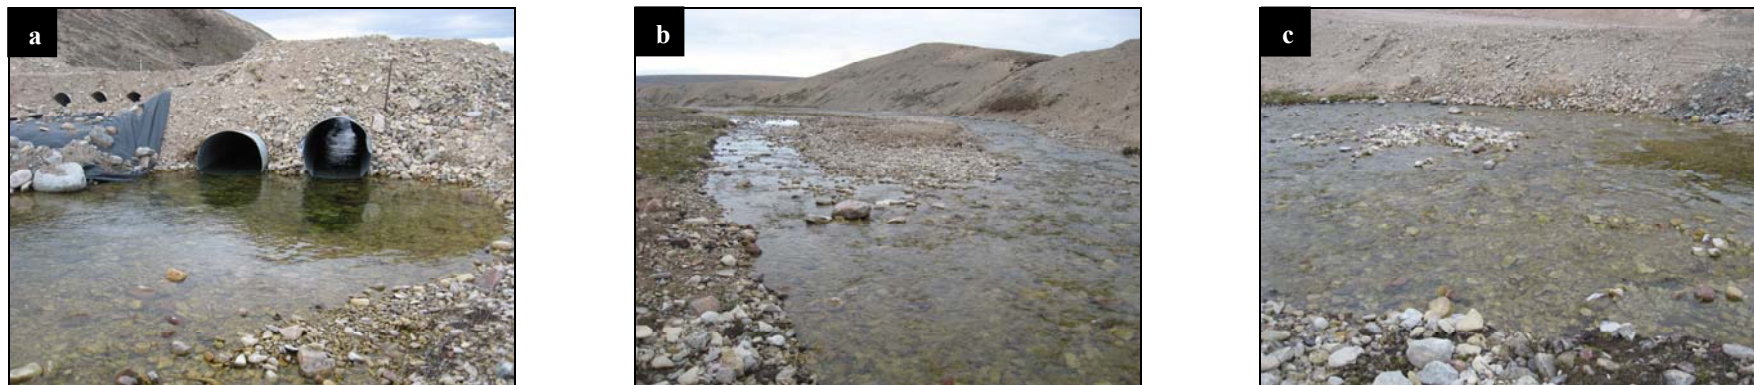
Figure 2. View upstream (a), downstream (b), and across (b) at the habitat assessment site downstream of the crossing at CV-049 during late August, 2009.

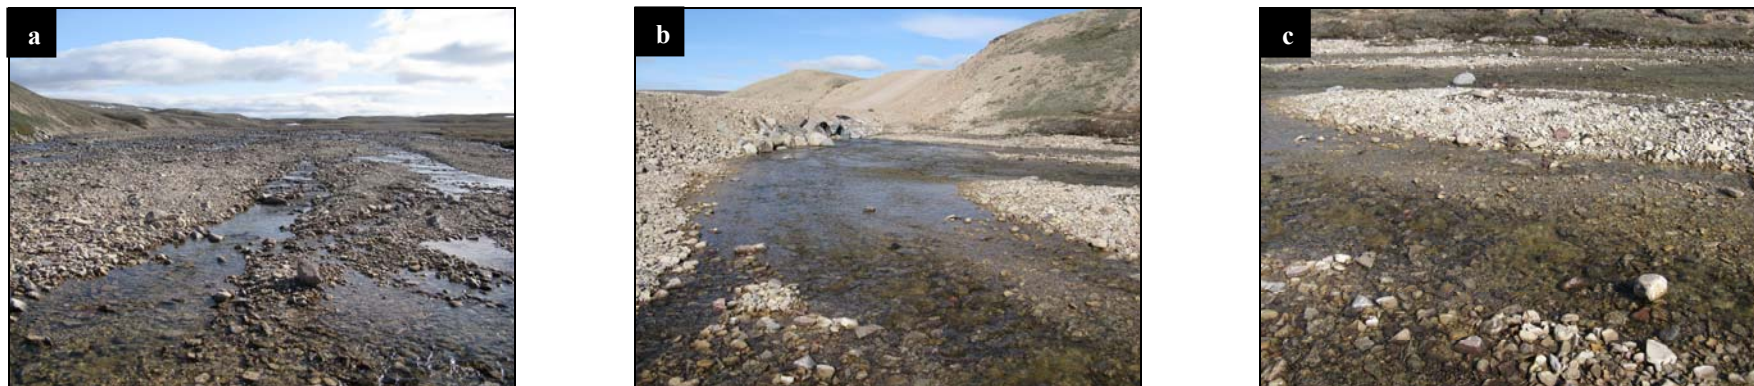
Figure 1. View upstream (a), downstream (b), and across (c) at the habitat assessment site upstream of the crossing at CV-049 during early July, 2009.

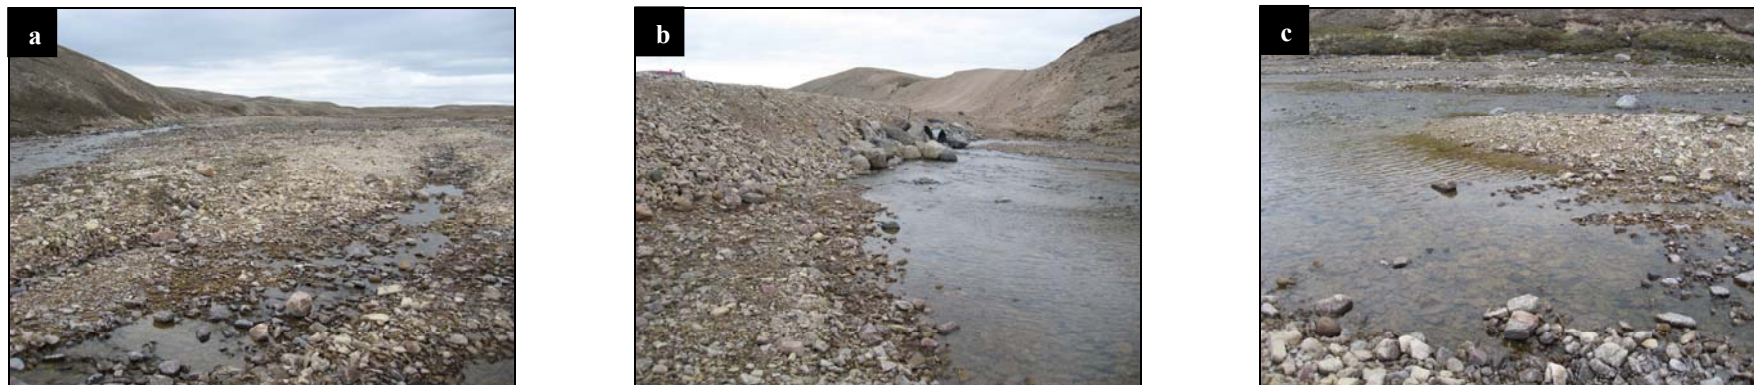
Figure 2. View upstream (a), downstream (b), and across (c) at the habitat assessment site upstream of the crossing at CV-049 during late August, 2009.

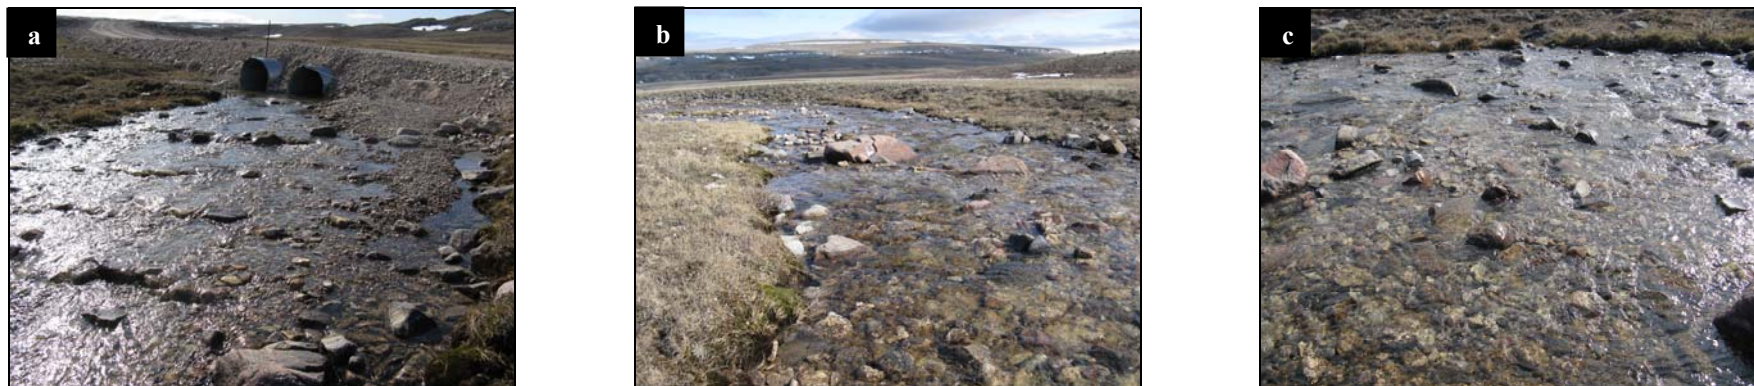
Figure 1. View upstream (a), downstream (b), and across (c) at the habitat assessment site downstream of the crossing at CV-048 during early July, 2009.

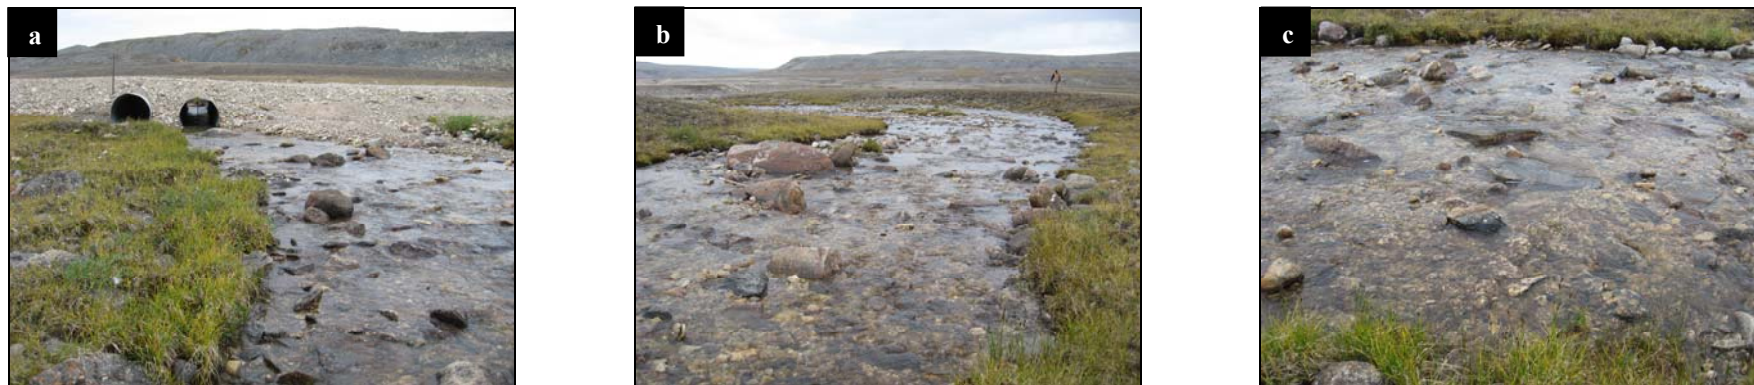
Figure 2. View upstream (a), downstream (b), and across (b) at the habitat assessment site downstream of the crossing at CV-048 during late August, 2009.

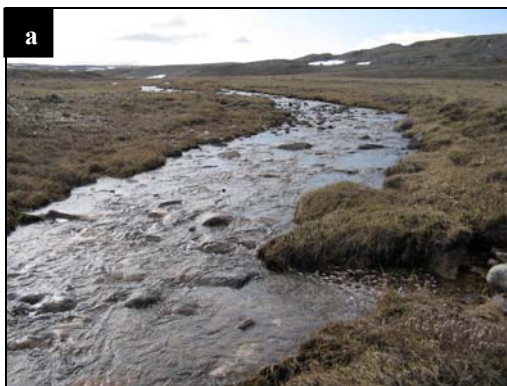
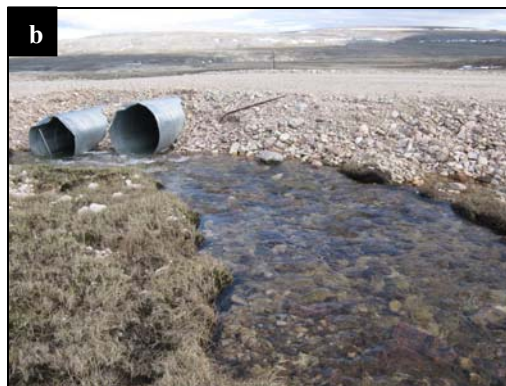
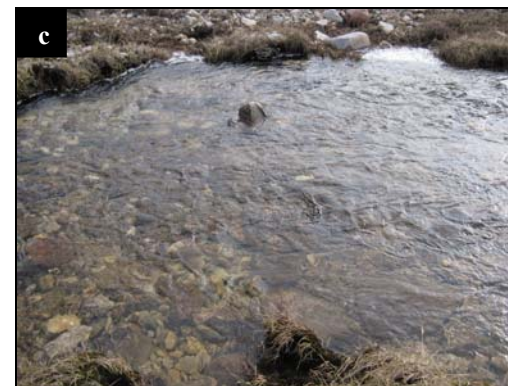
Figure 1. View upstream (a), downstream (b), and across (c) at the habitat assessment site upstream of the crossing at CV-048 during early July, 2009.

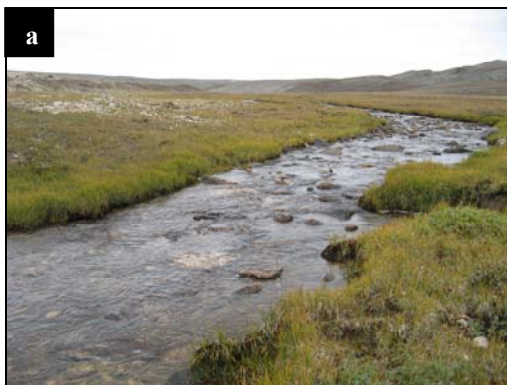
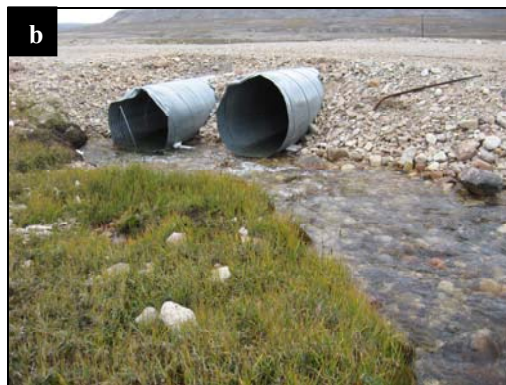
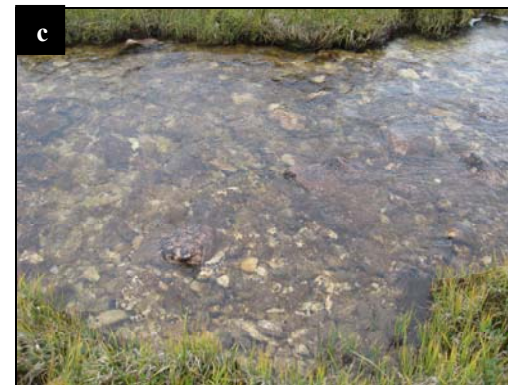
Figure 2. View upstream (a), downstream (b), and across (c) at the habitat assessment site upstream of the crossing at CV-048 during late August, 2009.

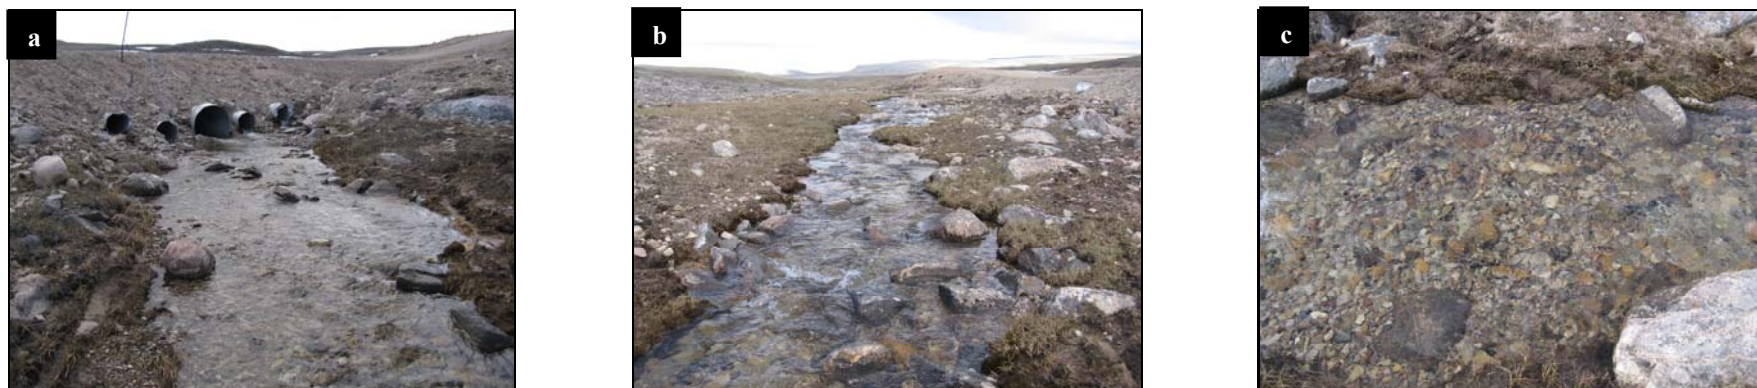
Figure 1. View upstream (a), downstream (b), and across (c) at the habitat assessment site downstream of the crossing at CV-046 during spring, 2009.

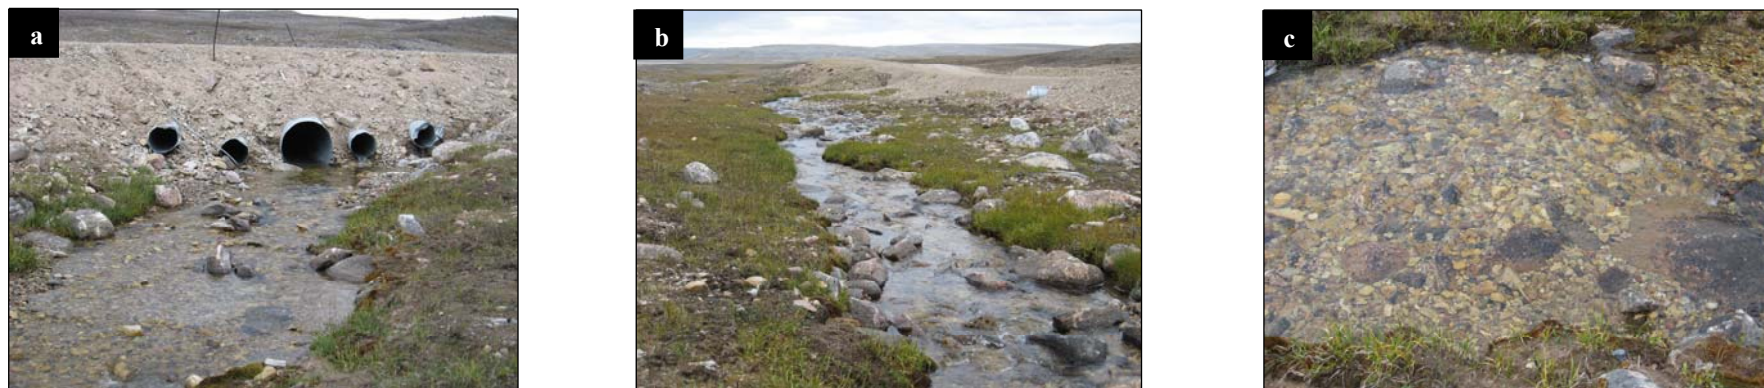
Figure 2. View upstream (a), downstream (b), and across (c) at the habitat assessment site upstream of the crossing at CV-046 during fall, 2009.

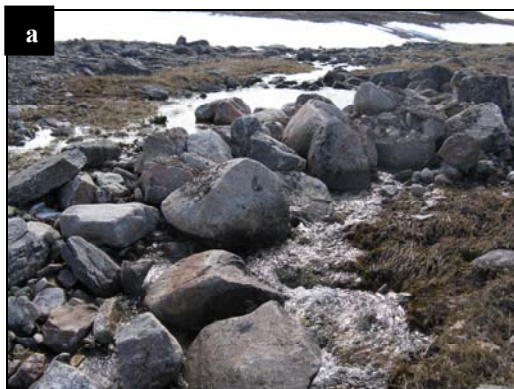
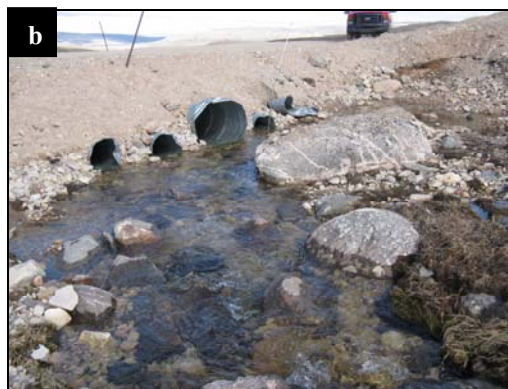
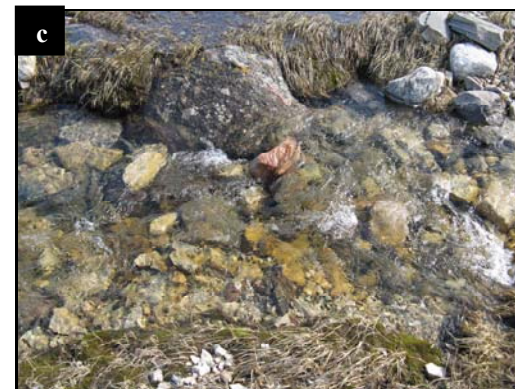
Figure 1. View upstream (a), downstream (b), and across (c) at the habitat assessment site upstream of the crossing at CV-046 during spring, 2009.

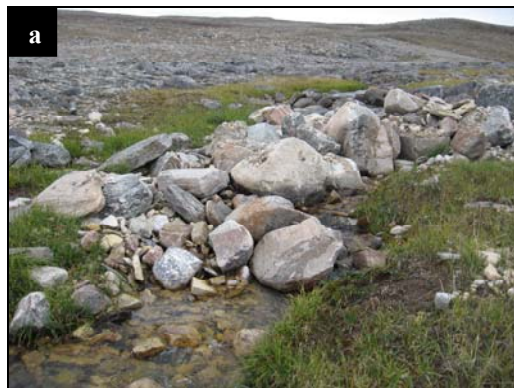
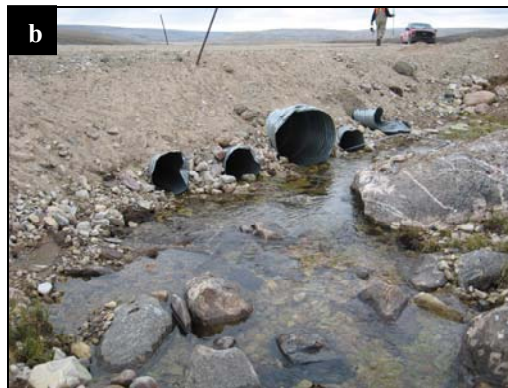
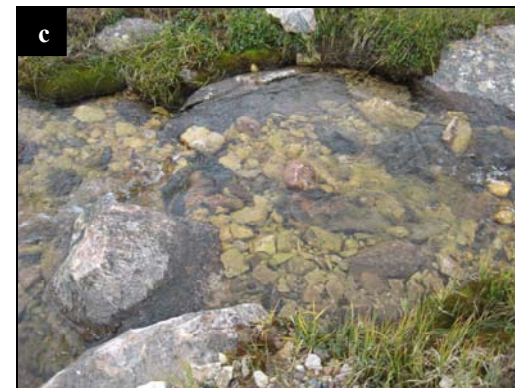
Figure 2. View upstream (a), downstream (b), and across (c) at the habitat assessment site upstream of the crossing at CV-046 during fall, 2009.

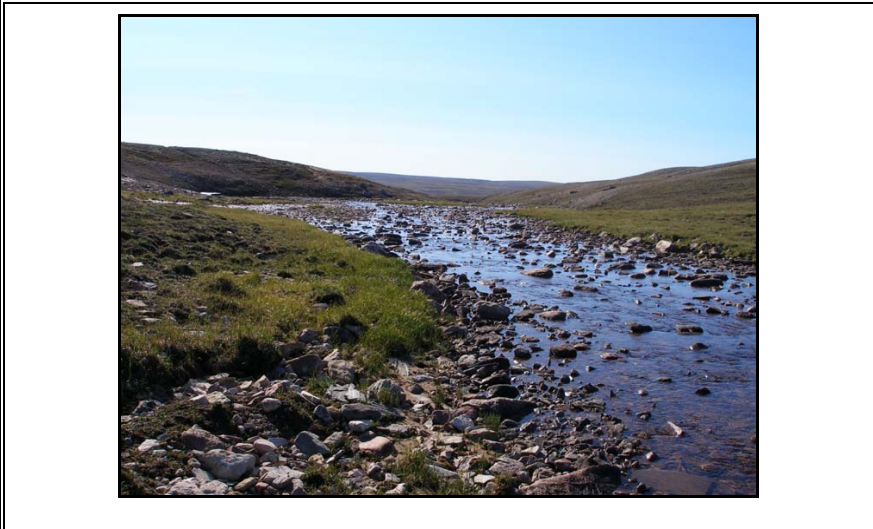
Figure 1: Downstream view from proposed crossing showing riffle habitat with cobble substrate.

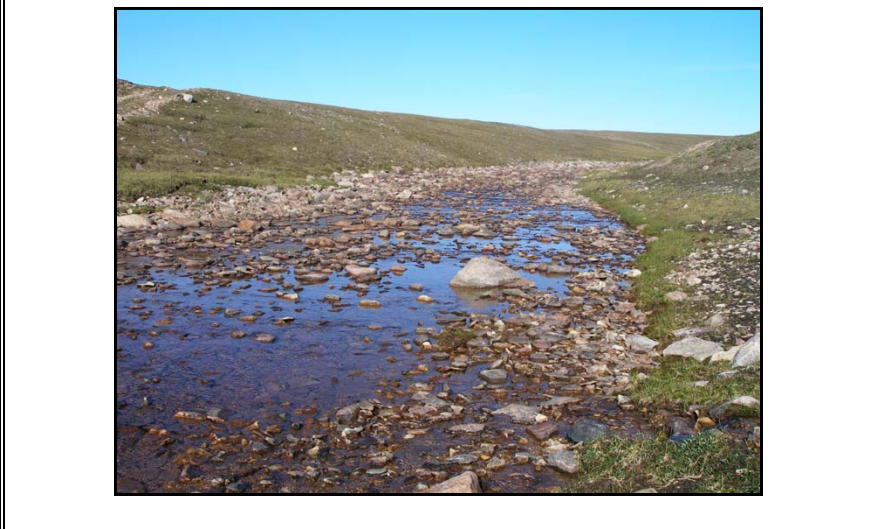
Figure 2: Upstream view from proposed crossing showing more riffle habitat.

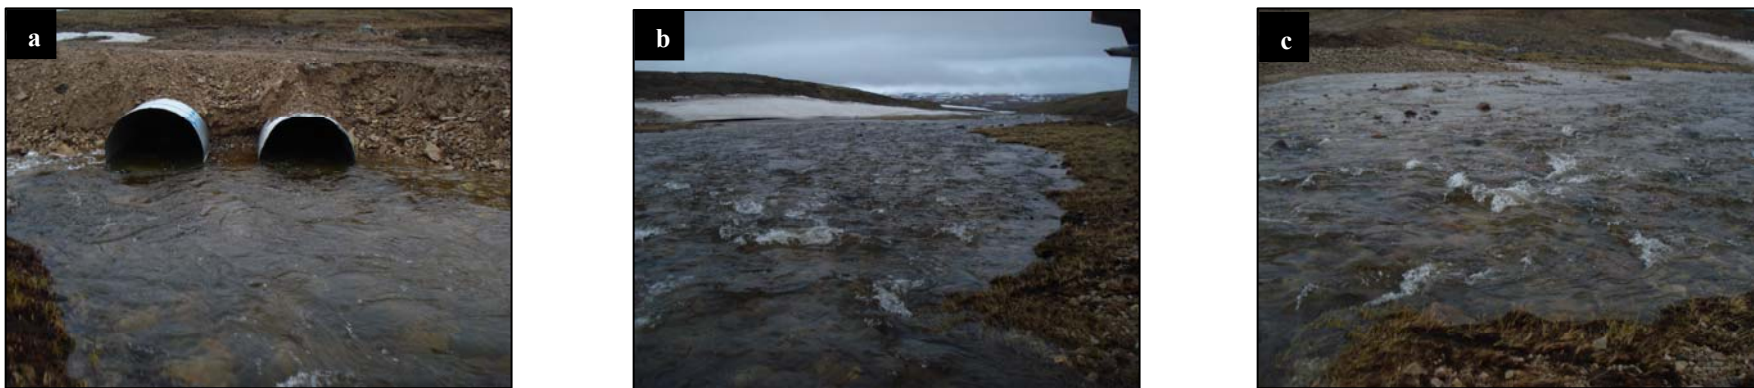
Figure 1. View upstream (a), downstream (b), and across (c) from the habitat assessment downstream of CV-040 during spring 2008.

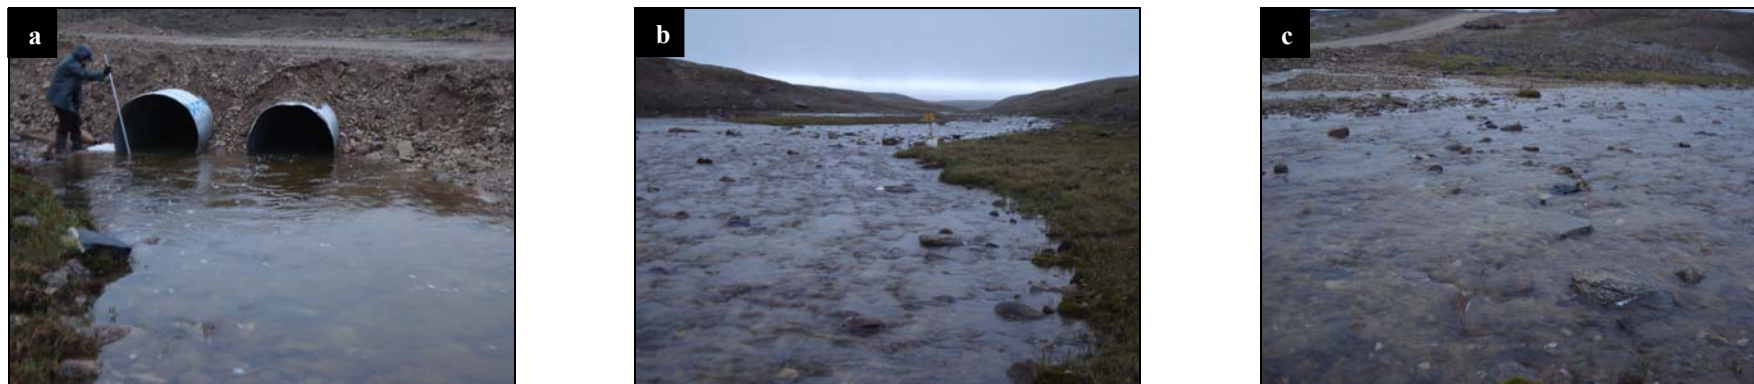
Figure 2. View upstream (a), downstream (b), and across (c) from the habitat assessment downstream of CV-040 during summer 2008.

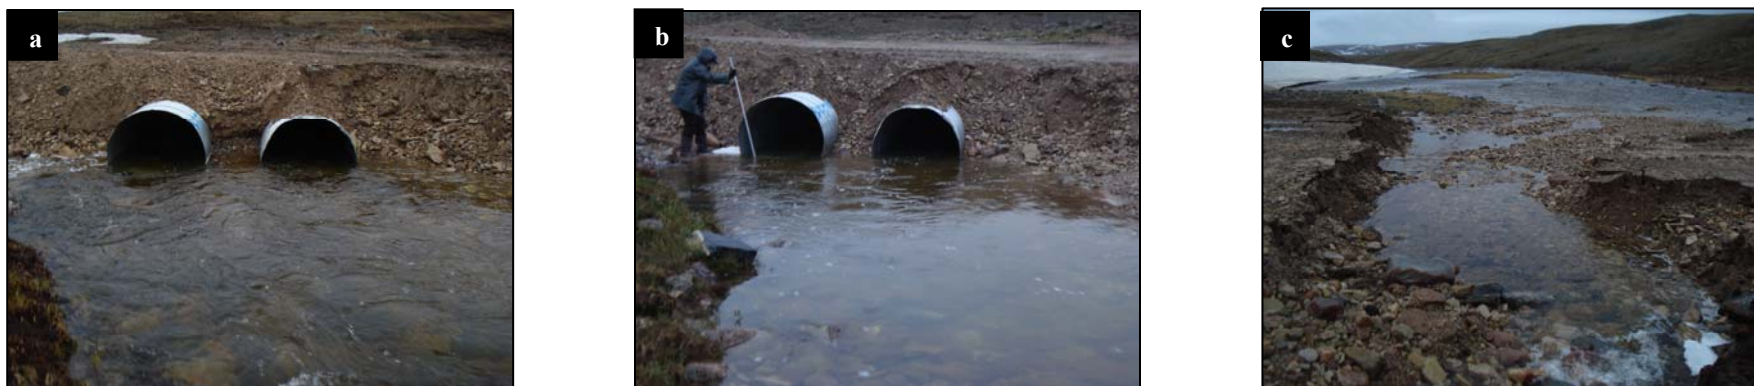
Figure 3. View from the downstream end of the culvert at crossing CV-040 during spring (a) and summer (b) 2008. View of the road washout that occurred at crossing CV-040 during spring 2008 (c).

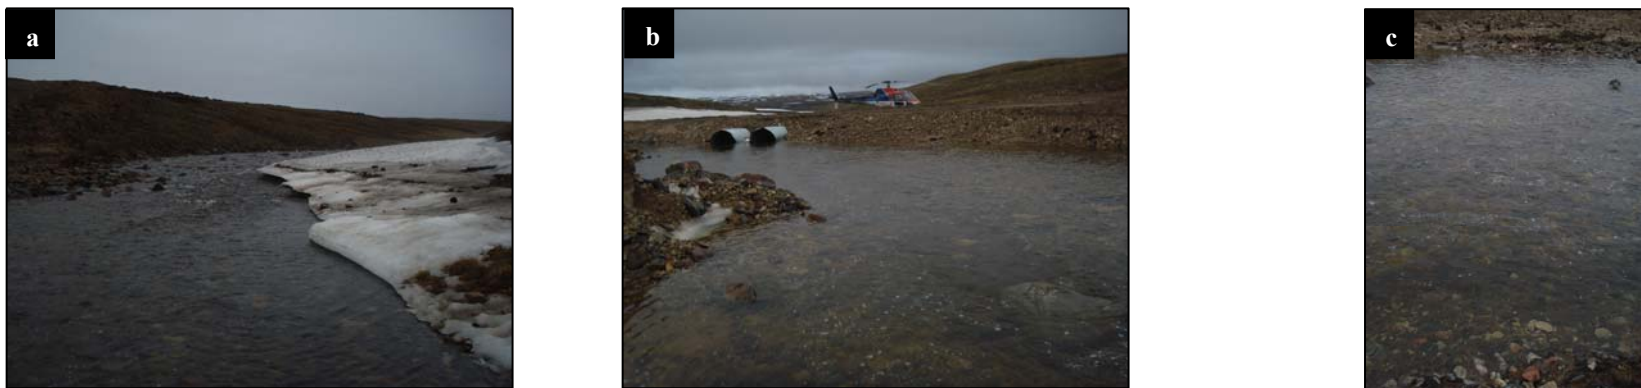
Figure 1. View upstream (a), downstream (b), and across (c) from the habitat assessment upstream of CV-040 during spring 2008.

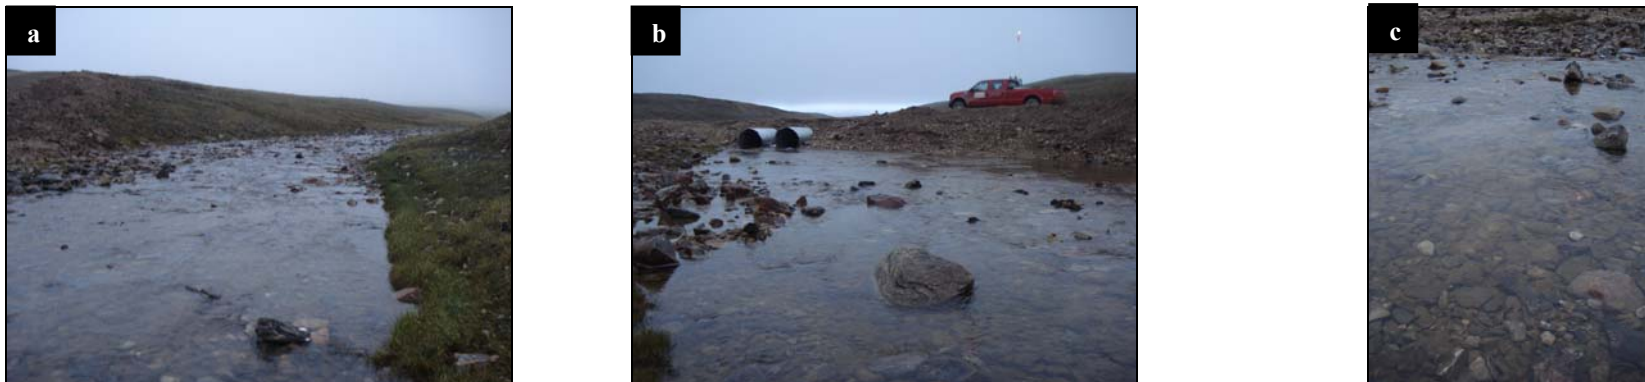
Figure 2. View upstream (a), downstream (b), and across (c) from the habitat assessment upstream of CV-040 during summer 2008.

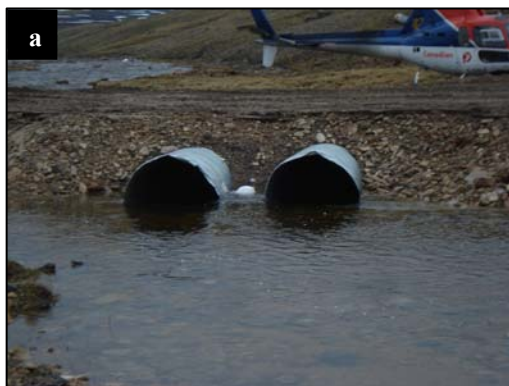
Figure 3. View from the upstream end of the culverts at crossing CV-040 during spring (a) 2008.

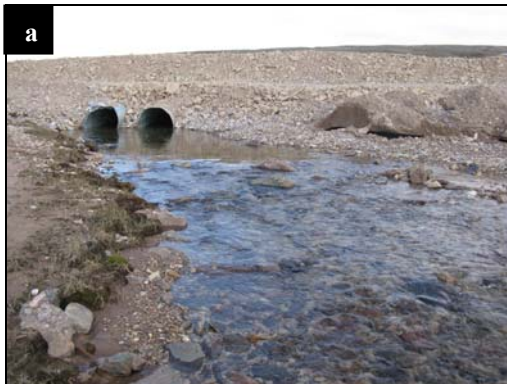
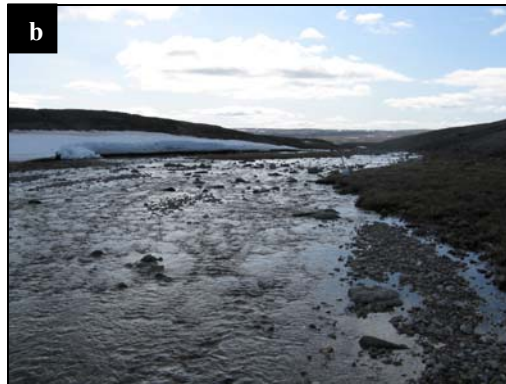
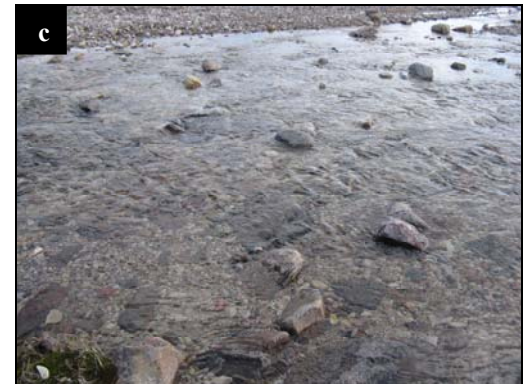
Figure 1. View upstream (a), downstream (b), and across (c) at the habitat assessment site downstream of the crossing at CV-040 during early July, 2009.

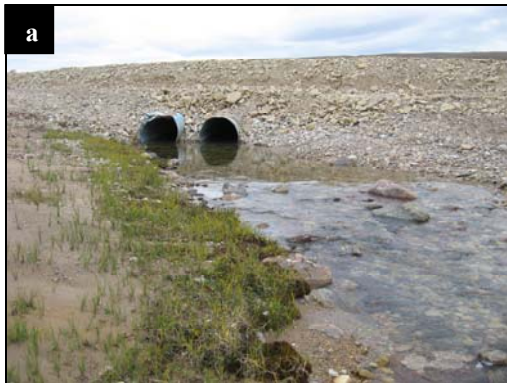
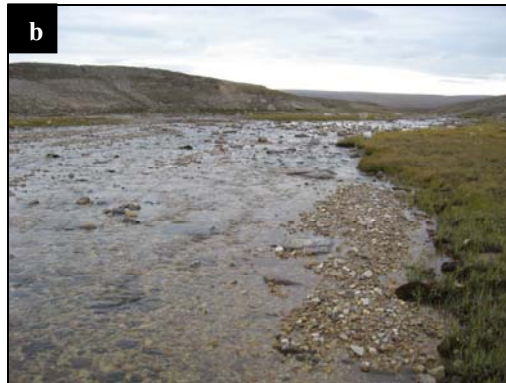
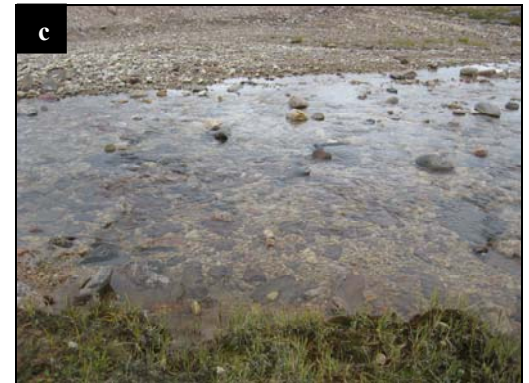
Figure 2. View upstream (a), downstream (b), and across (b) at the habitat assessment site downstream of the crossing at CV-040 during late August, 2009.

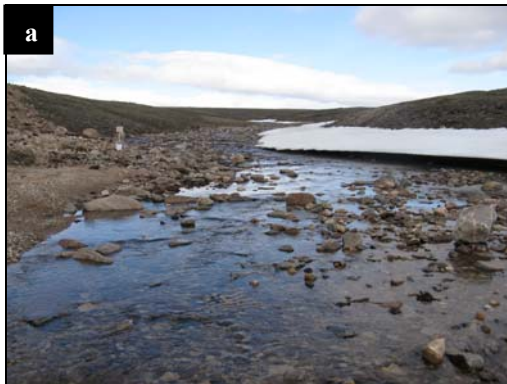
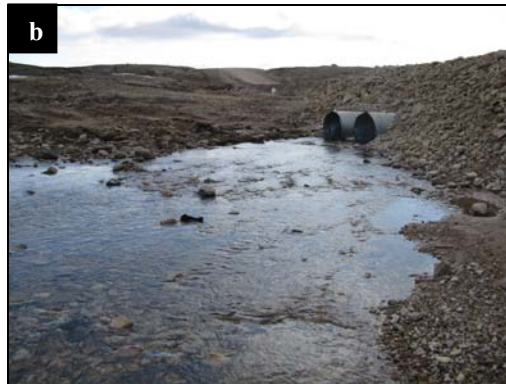
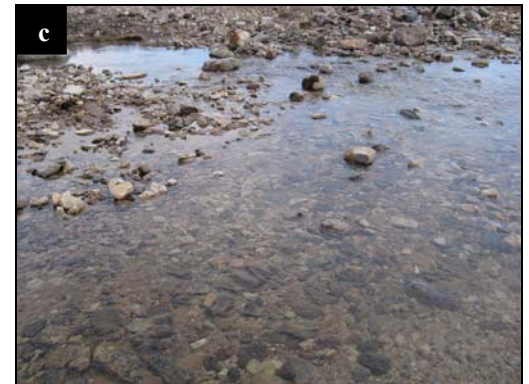
Figure 1. View upstream (a), downstream (b), and across (c) at the habitat assessment site upstream of the crossing at CV-040 during early July, 2009.

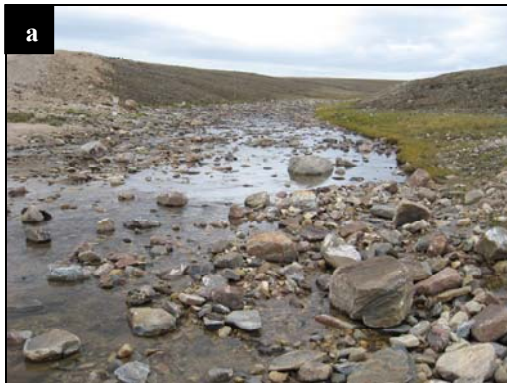
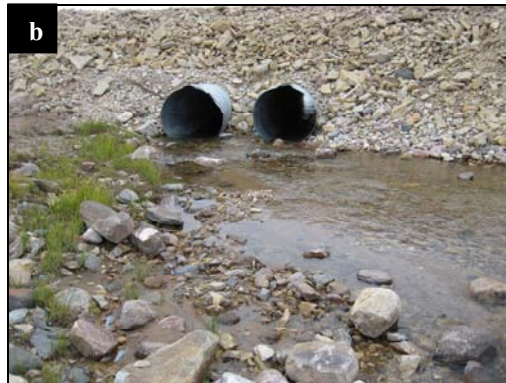
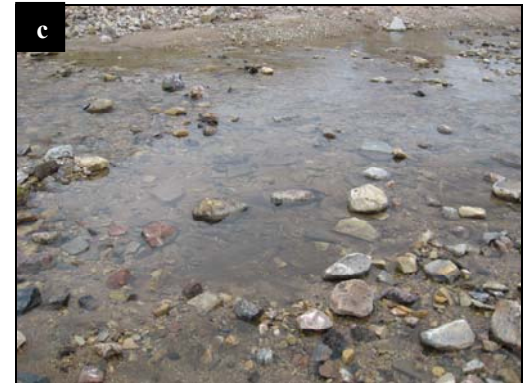
Figure 2. View upstream (a), downstream (b), and across (c) at the habitat assessment site upstream of the crossing at CV-040 during late August, 2009.

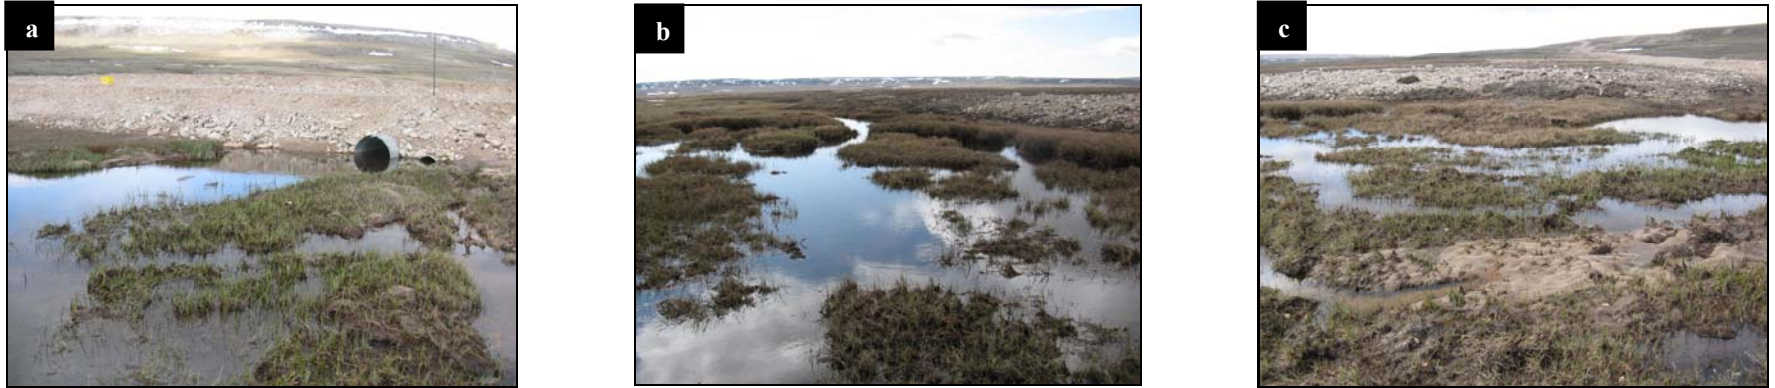
Figure 1. View upstream (a), downstream (b), and across (c) at the habitat assessment site downstream of the crossing at CV-030 during spring, 2009.

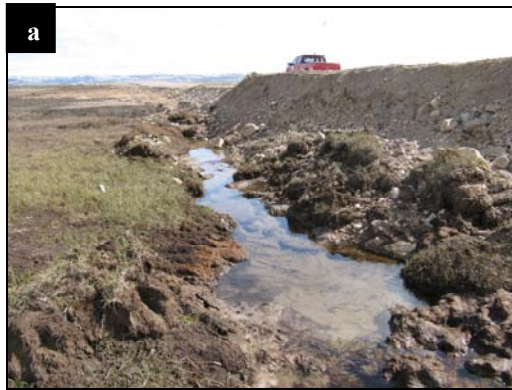
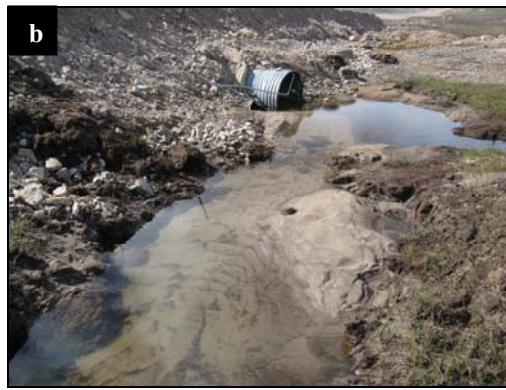
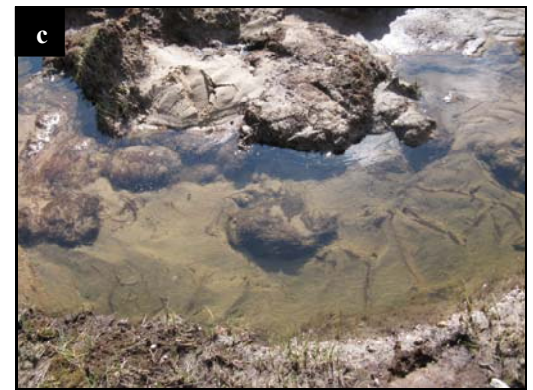
Figure 1. View upstream (a), downstream (b), and across (c) at the habitat assessment site upstream of the crossing at CV-030 during early July, 2009.

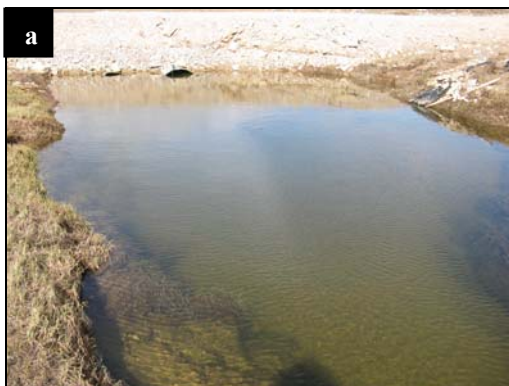
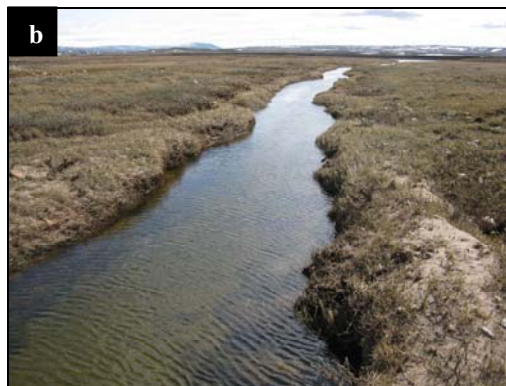
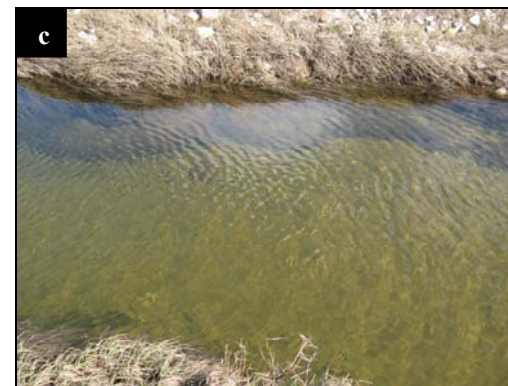
Figure 1. View upstream (a), downstream (b), and across (c) at the habitat assessment site downstream of the crossing at BG-32 during early July, 2009.

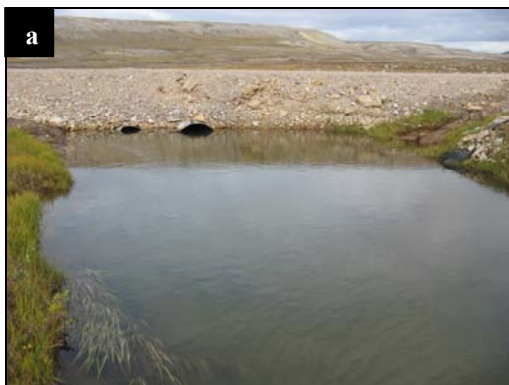
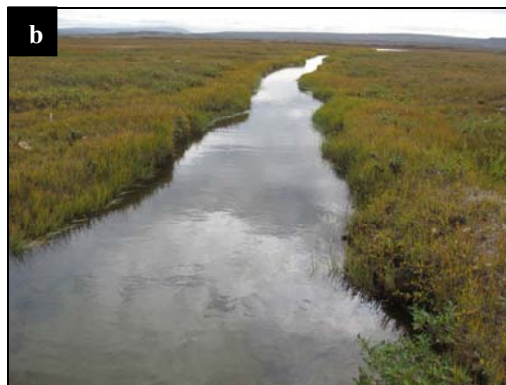
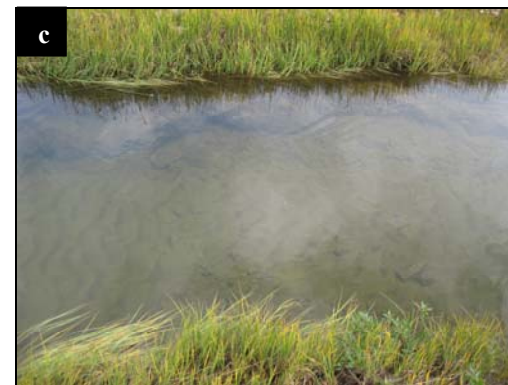
Figure 2. View upstream (a), downstream (b), and across (b) at the habitat assessment site downstream of the crossing at BG-32 during late August, 2009.

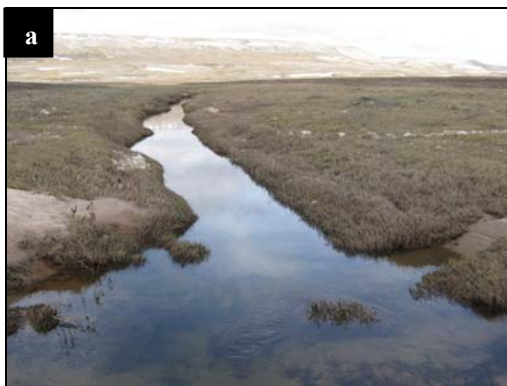
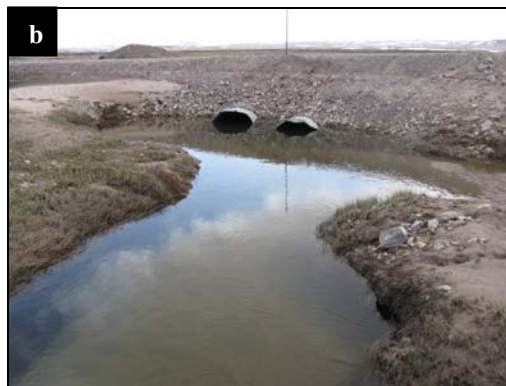
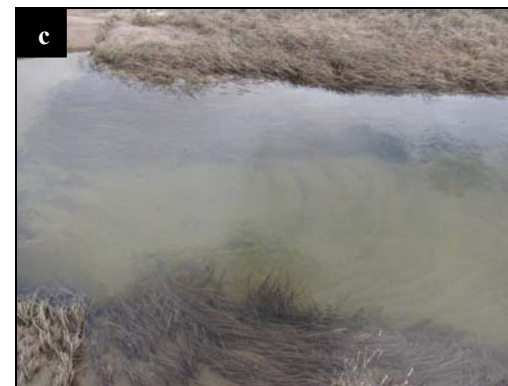
Figure 1. View upstream (a), downstream (b), and across (c) at the habitat assessment site upstream of the crossing at BG-32 during early July, 2009.

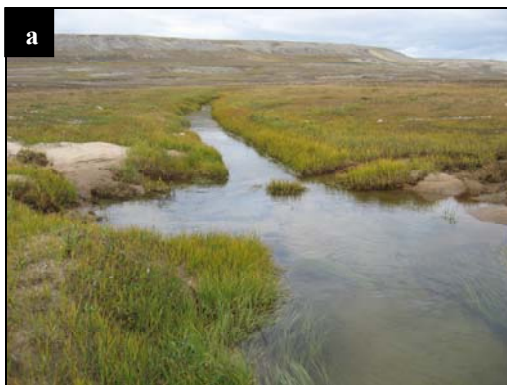
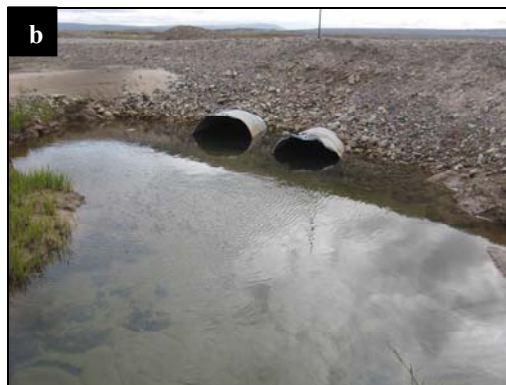
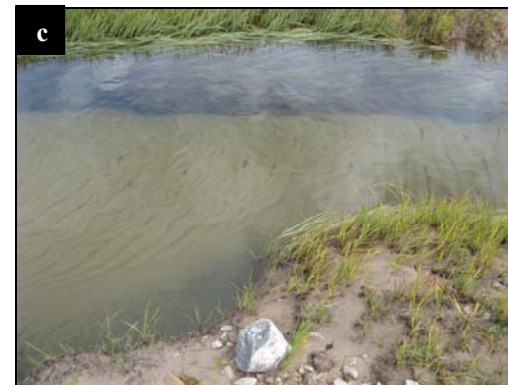
Figure 2. View upstream (a), downstream (b), and across (c) at the habitat assessment site upstream of the crossing at BG-32 during late August, 2009.

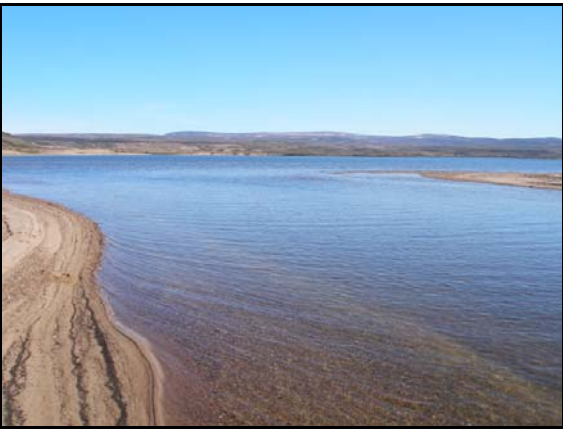
</div> <p>Figure 1: Downstream view from proposed crossing showing flat, sandy habitat with large, unnamed lake visible.</p> <div>

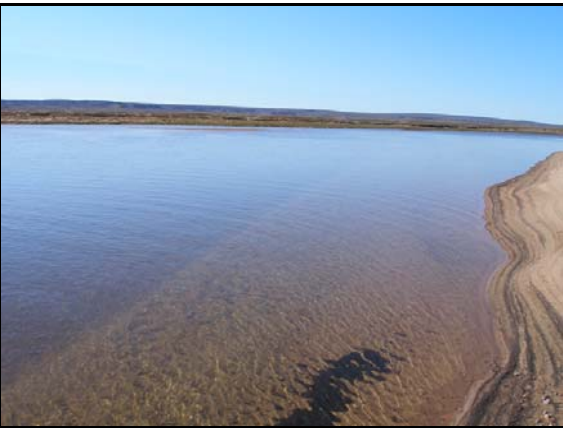
</div> <p>Figure 2: Upstream view from proposed crossing showing flat, sandy habitat.</p> <div>

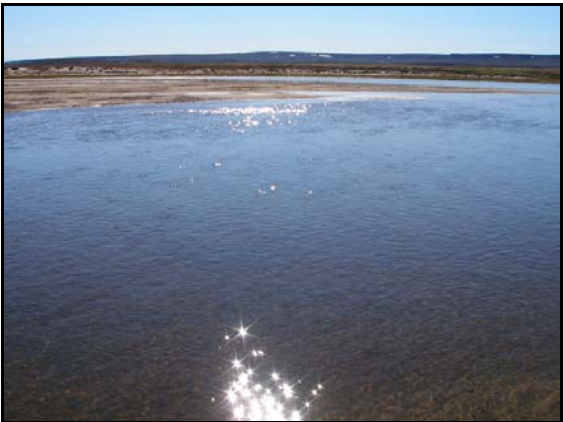
</div> <p>Figure 3: View across CV-217.</p>	Location					
	Site: CV-217		Watercourse Name: Unknown River			
	UTM: 17W 0542218 / 7922157					
	Site Description				Potential Fish Utilization	
	Watershed Size: 153.045 km ²		Mesohabitat Composition: Flat – 100%		Arctic Char	
	Regulated: No		Substrate Composition: Sand – 60%; Gravel – 40%		Spawning: Unlikely	
	Channelized: No		Stream Cover: None		Migration: Yes	
	Bankfull Width: 162.0 m		Riparian Vegetation: Small intermittent patches of small plants, willows and grasses		Rearing: Possible	
	Wetted Width: 124.0 m		Aquatic Vegetation: None		Overwintering: Possible

Flat Depth: 0.42 m		Unique Features: None			
Pool Depth: N/A		Summary: This is an extra large-sized waterbody consisting almost exclusively of flat habitat with fine substrates. The banks have high erosion potential and there is no significant cover.		Ninespine Stickleback		
Residual Pool Depth: N/A				Spawning: Possible		
Bankfull Depth: 7.37 m				Migration: Possible		
Bank Height: 6.95 m				Rearing: Yes		
D ₉₅ : 0.05 m				Overwintering: Possible		
D: <0.001 m						
Confinement: Partially Confined						
Channel Morphology: Flat						
Channel Gradient: 0 ⁰						
Turbidity: 0.00 FTU						
Side Slope R – 15%; L – 15%						
Approach: R – 85%; L – 85%						
Bank Stability: Low						
Erosion Potential: High						
Undercut Banks: None						
		Fish Habitat Quality		Comments		
		Important		This waterbody, which is the major outlet of a large lake, is unlike most crossings along the bulk transport road. It is deep and relatively slow-moving and may not freeze entirely during winter, thus allowing for potential overwintering. However, a lack of cover and fine substrates are not ideal conditions for juveniles in a river that is accessible to adult char. Therefore juvenile use is likely limited and possibly migratory only. Spawning may occur near the crossing or further upstream so this area could be important during fall. In addition, this habitat is more suitable for stickleback use and one was captured during fisheries investigations.

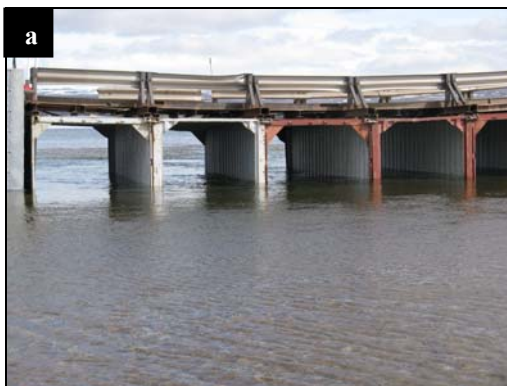
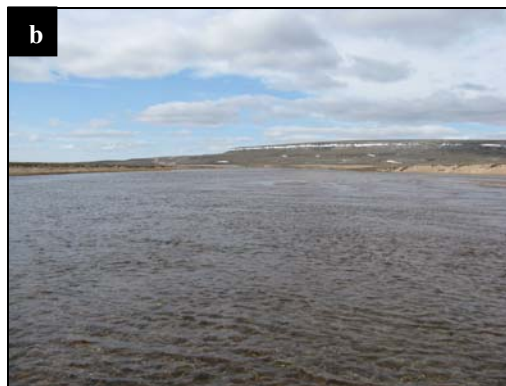
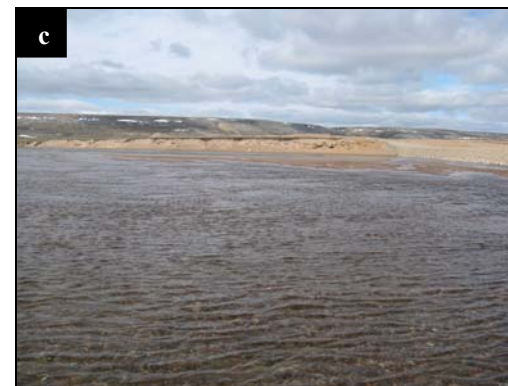
Figure 1. View upstream (a), downstream (b), and across (c) at the habitat assessment site downstream of the sea can crossing at CV-217 during early July, 2009.

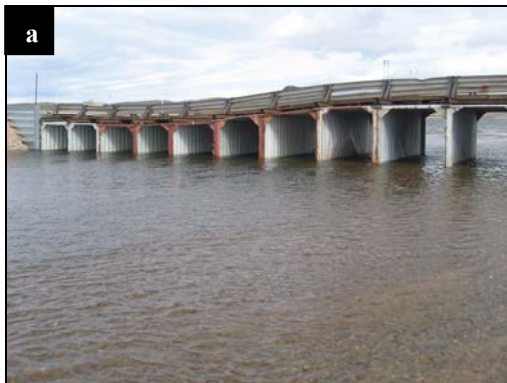
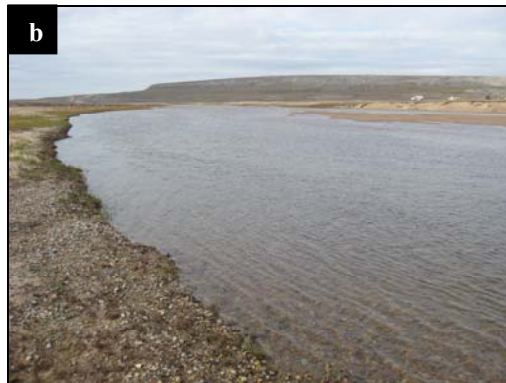
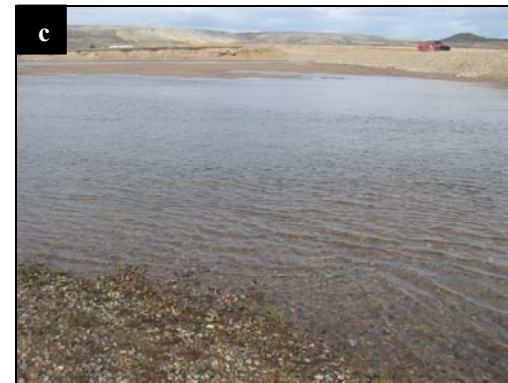
Figure 2. View upstream (a), downstream (b), and across (b) at the habitat assessment site downstream of the sea can crossing at CV-217 during late August, 2009.

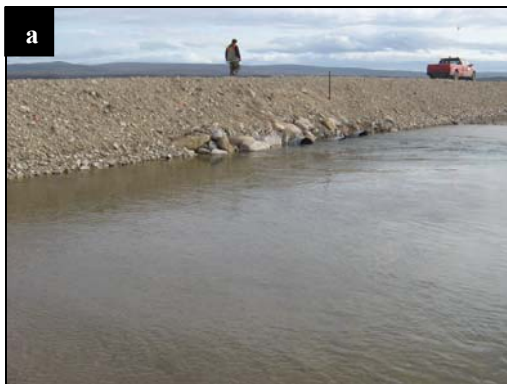
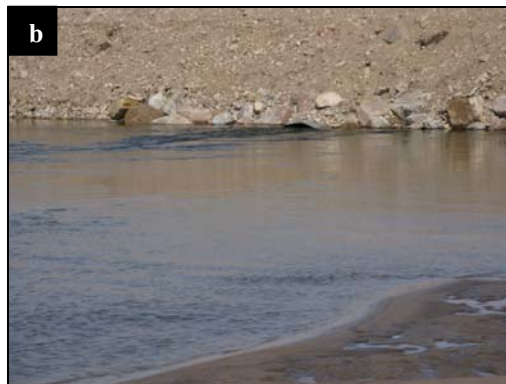
Figure 3. View during early July (a) and late August (b) at the habitat assessment site downstream of the culvert crossing at CV-217.
