APPENDIX 5.3-1.

DETAILED HABITAT ASSESSMENTS AND SUMMARY OF RESULTS FOR WATERBODIES IN QUARRY SITES.

Table A5.3-1.1. Summary of results from surveys and assessments that fall within Quarry boundaries.

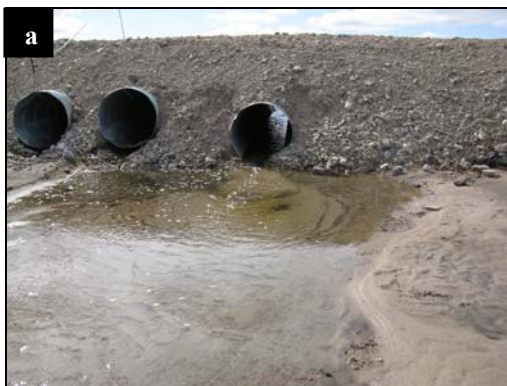
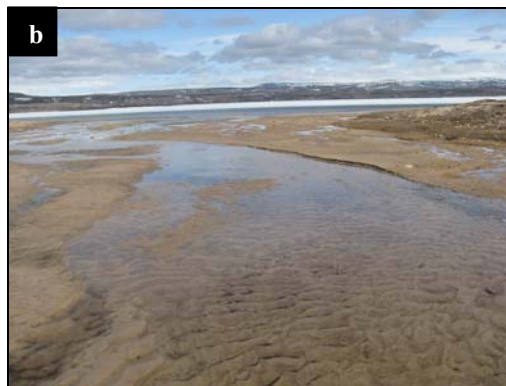
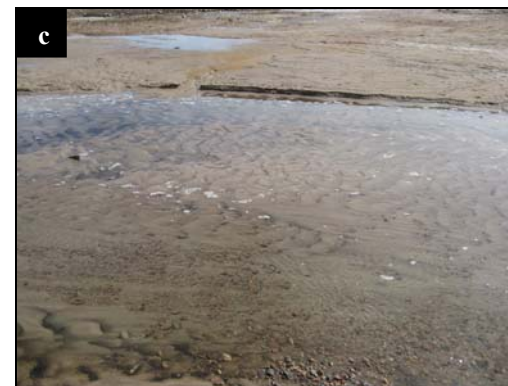
Figure 1. View upstream (a), downstream (b), and across (c) at the habitat assessment site downstream of the crossing at CV-216 during early July, 2009.

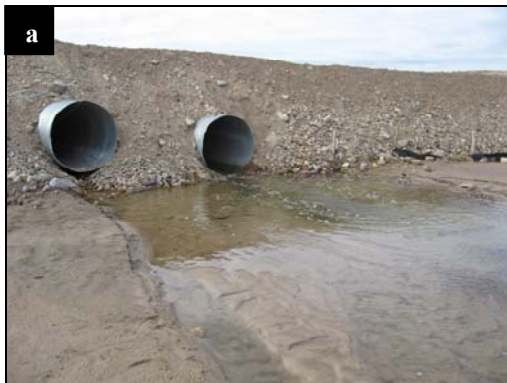
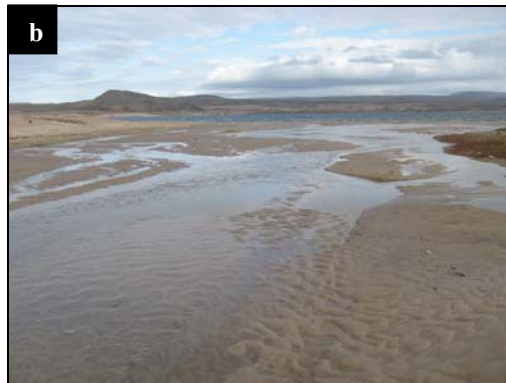
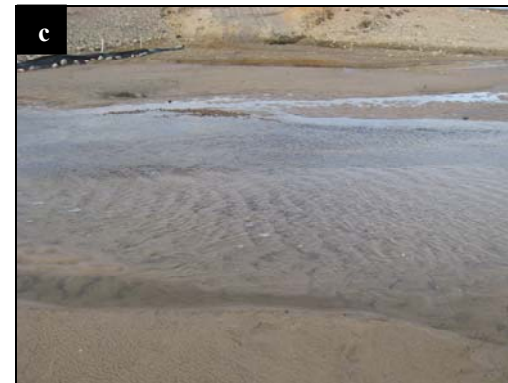
Figure 2. View upstream (a), downstream (b), and across (b) at the habitat assessment site downstream of the crossing at CV-216 during late August, 2009.

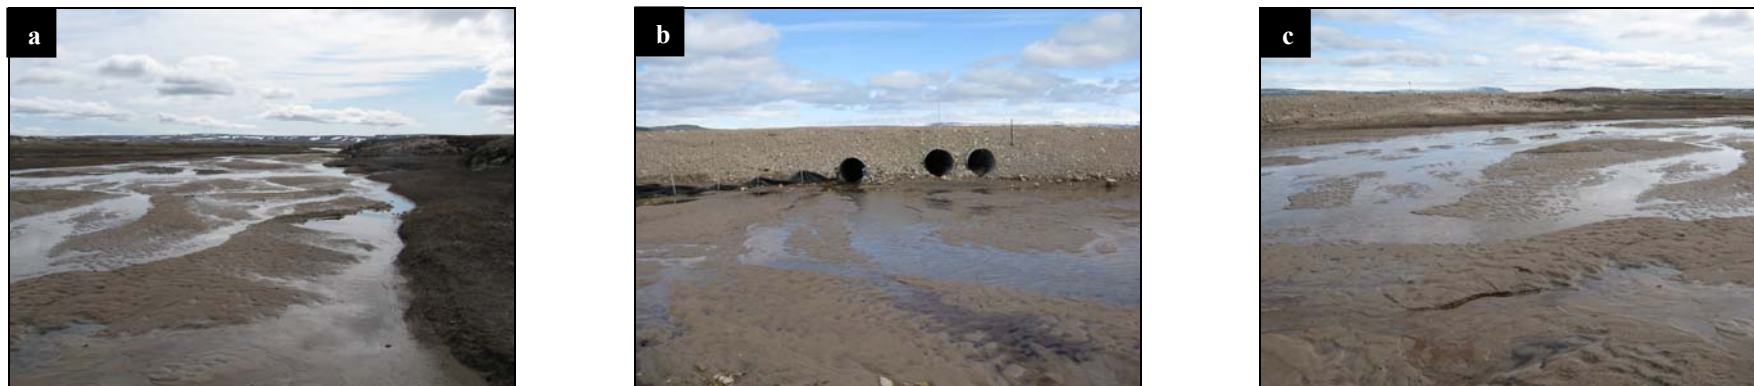
Figure 1. View upstream (a), downstream (b), and across (c) at the habitat assessment site upstream of the crossing at CV-216 during early July, 2009.

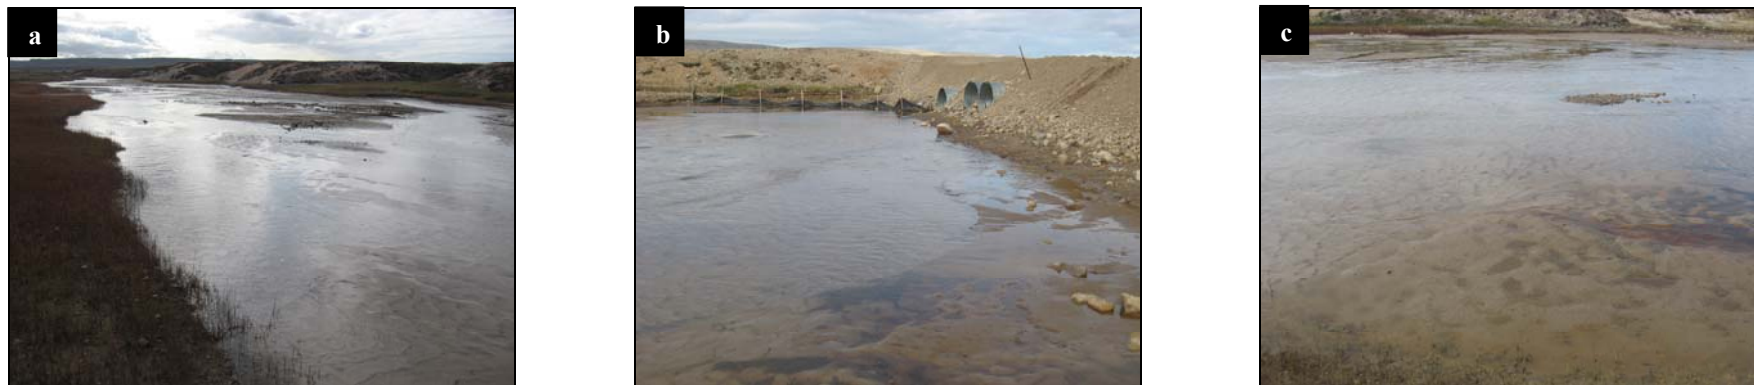
Figure 2. View upstream (a), downstream (b), and across (c) at the habitat assessment site upstream of the crossing at CV-216 during late August, 2009.

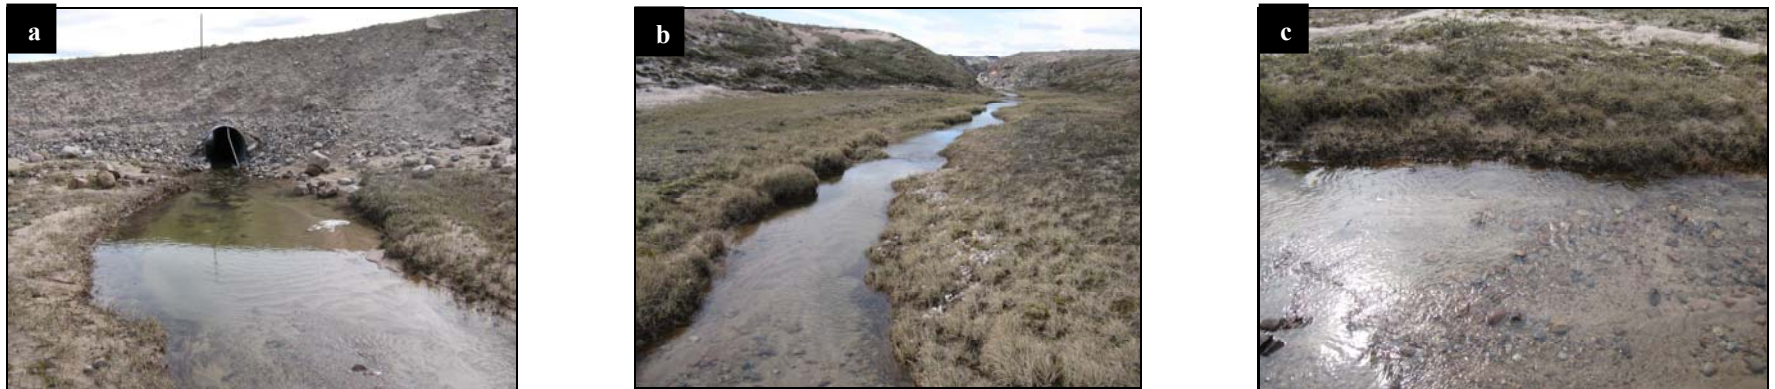
Figure 1. View upstream (a), downstream (b), and across (c) at the habitat assessment site downstream of the crossing at BG-29 during spring, 2009.

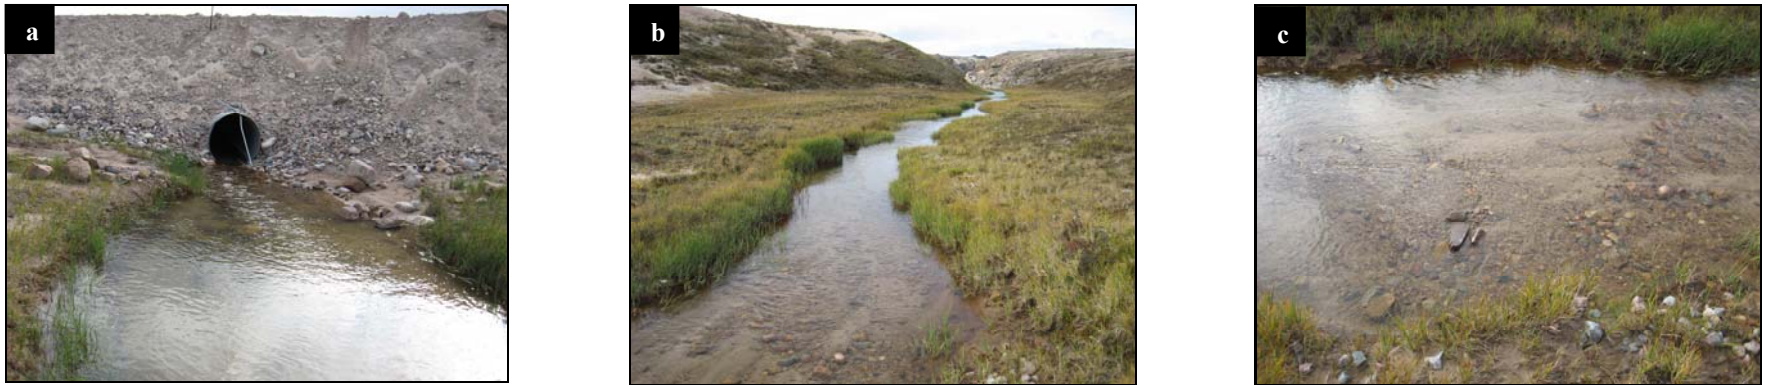
Figure 2. View upstream (a), downstream (b), and across (c) at the habitat assessment site downstream of the crossing at BG-29 during fall, 2009.

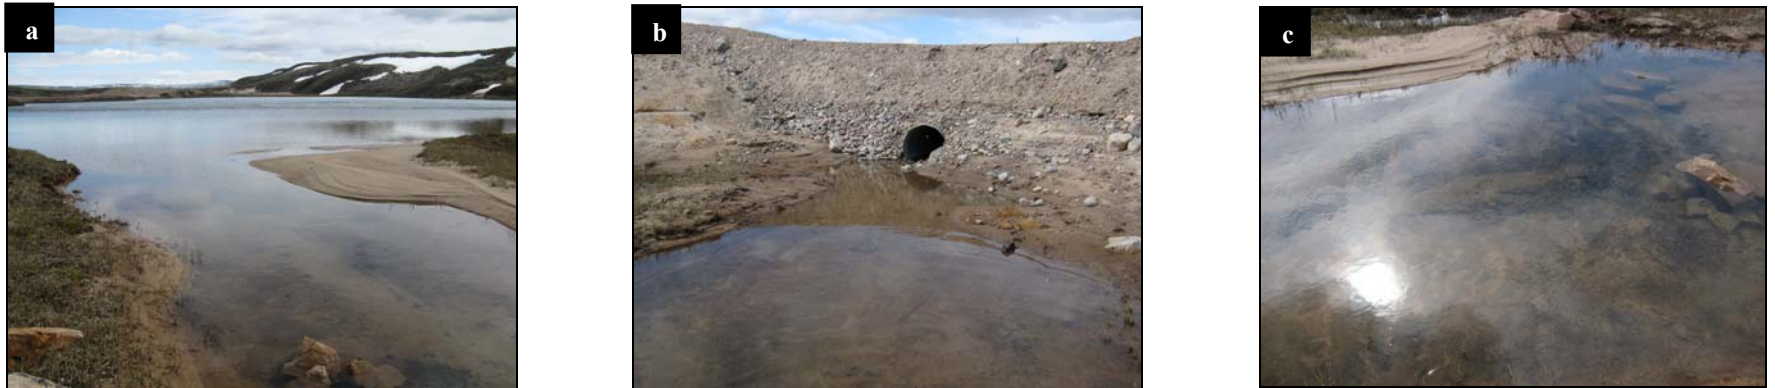
Figure 1. View upstream (a), downstream (b), and across (c) at the habitat assessment site upstream of the crossing at BG-29 during spring, 2009.

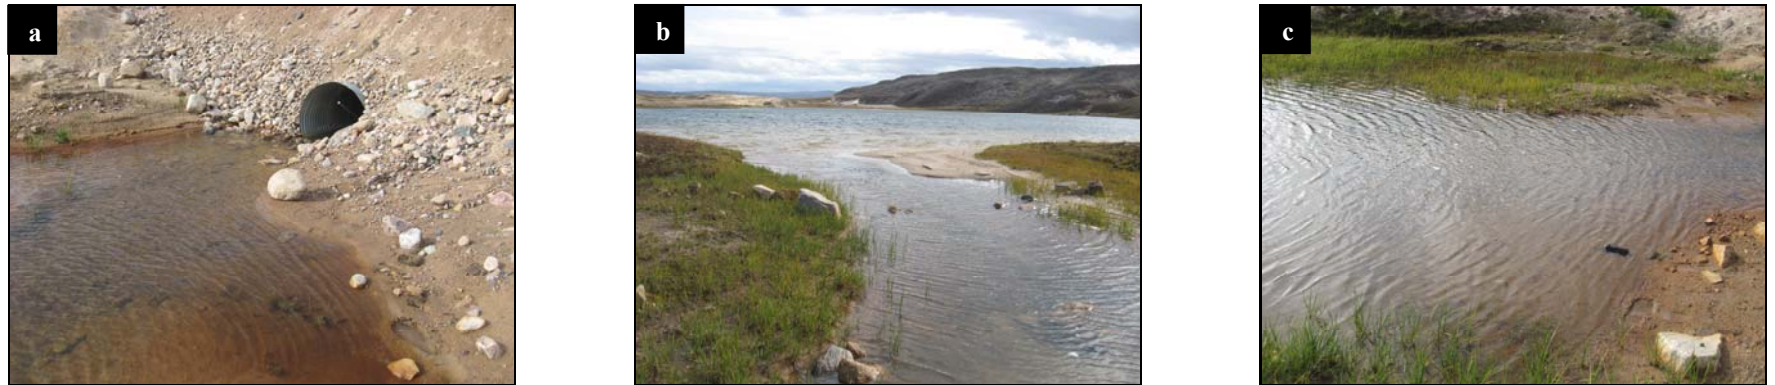
Figure 2. View upstream (a), downstream (b), and across (c) at the habitat assessment site upstream of the crossing at BG-29 during fall, 2009.

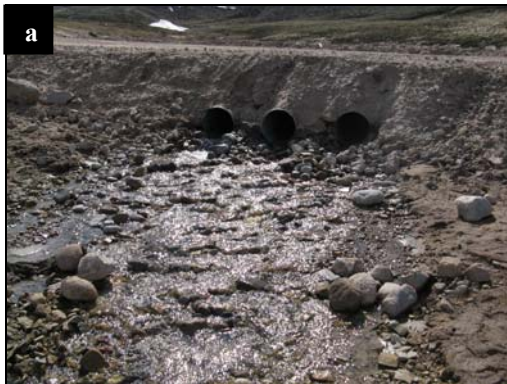
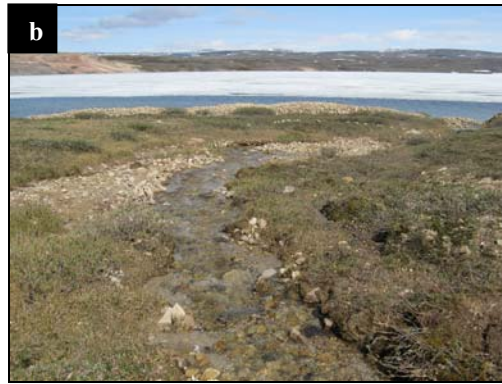
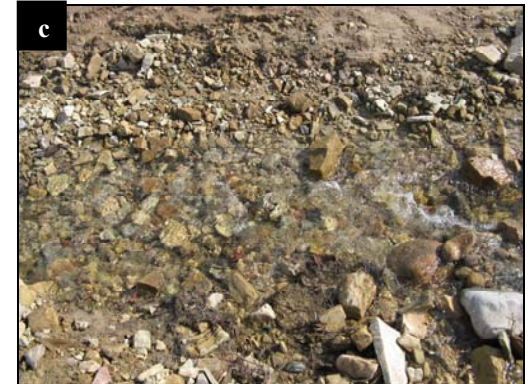
Figure 1. View upstream (a), downstream (b), and across (c) at the habitat assessment site downstream of the crossing at BG-27 during spring, 2009.

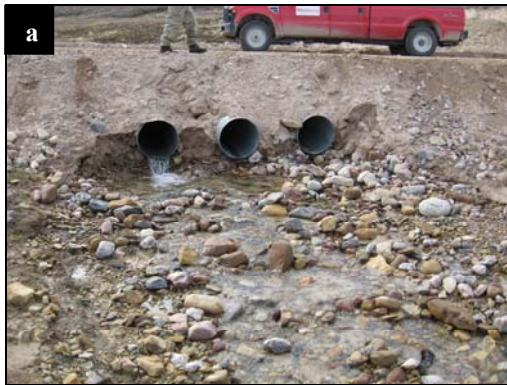
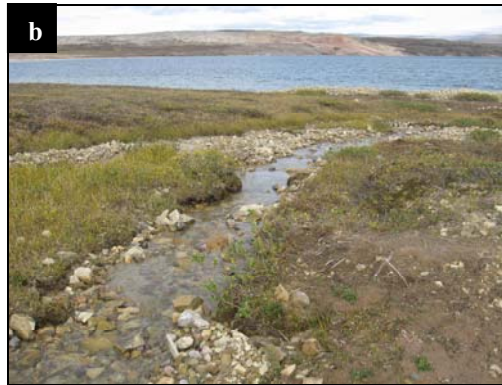
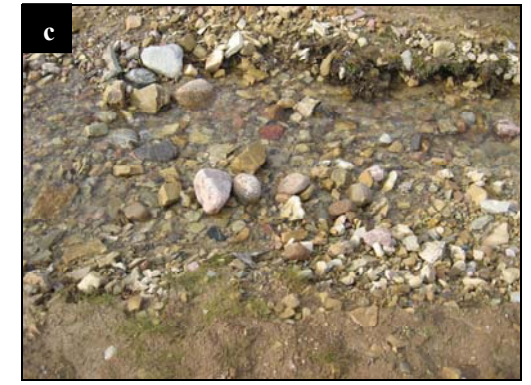
Figure 2. View upstream (a), downstream (b), and across (c) at the habitat assessment site downstream of the crossing at BG-27 during fall, 2009.

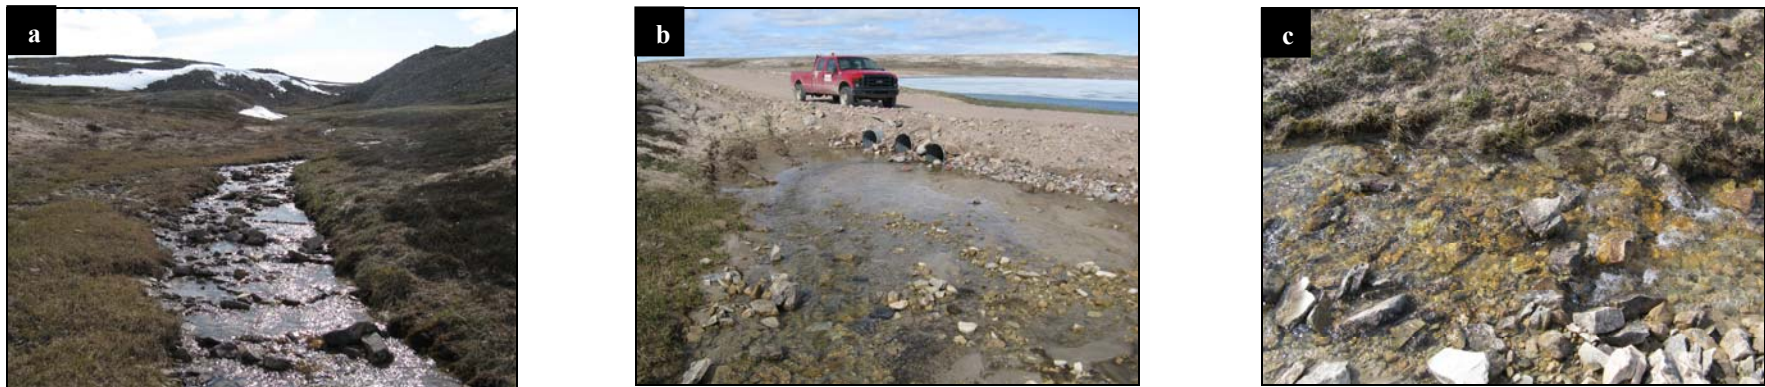
Figure 1. View upstream (a), downstream (b), and across (c) at the habitat assessment site upstream of the crossing at BG-27 during spring, 2009.

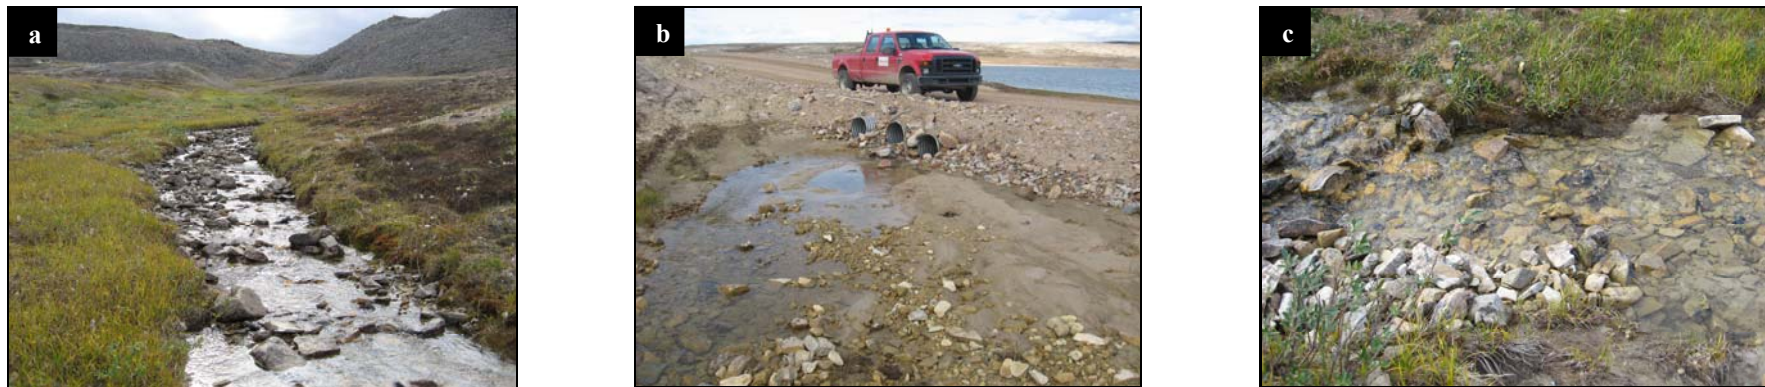
Figure 2. View upstream (a), downstream (b), and across (c) at the habitat assessment site upstream of the crossing at BG-27 during fall, 2009.

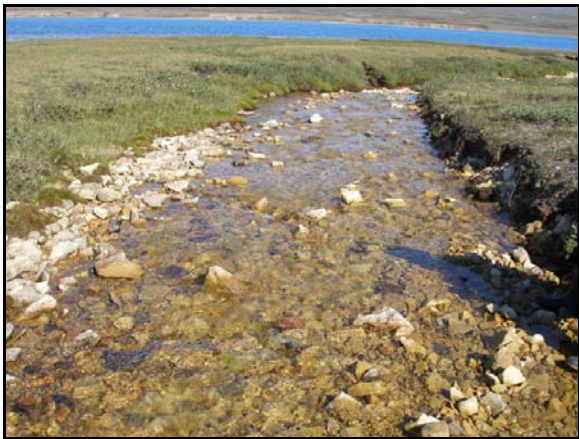
Figure 1: Downstream view from proposed crossing showing riffle and cobble habitat and downstream lake.

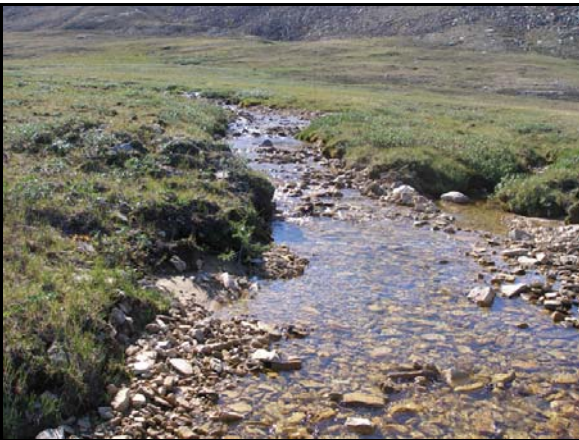
Figure 2: Upstream view from proposed crossing showing riffle-pool habitat.

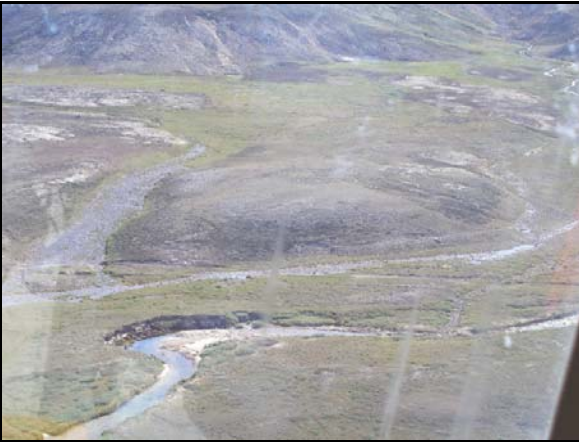
Figure 3: Aerial view of BG-24 showing braided channel.

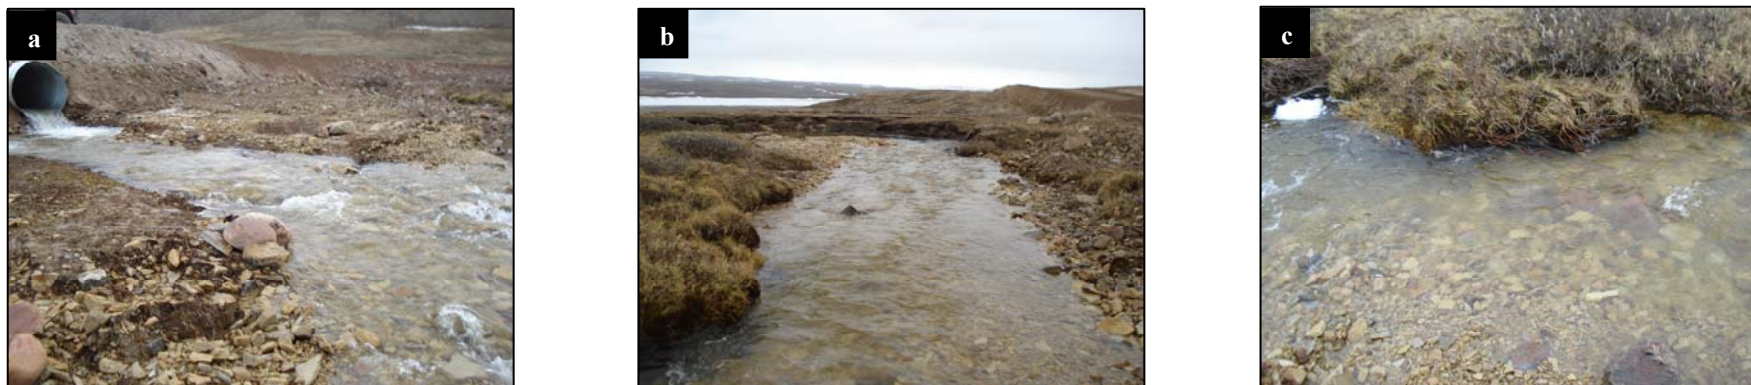
Figure 1. View upstream (a), downstream (b), and across (c) from the habitat assessment downstream of BG-24 during spring 2008.

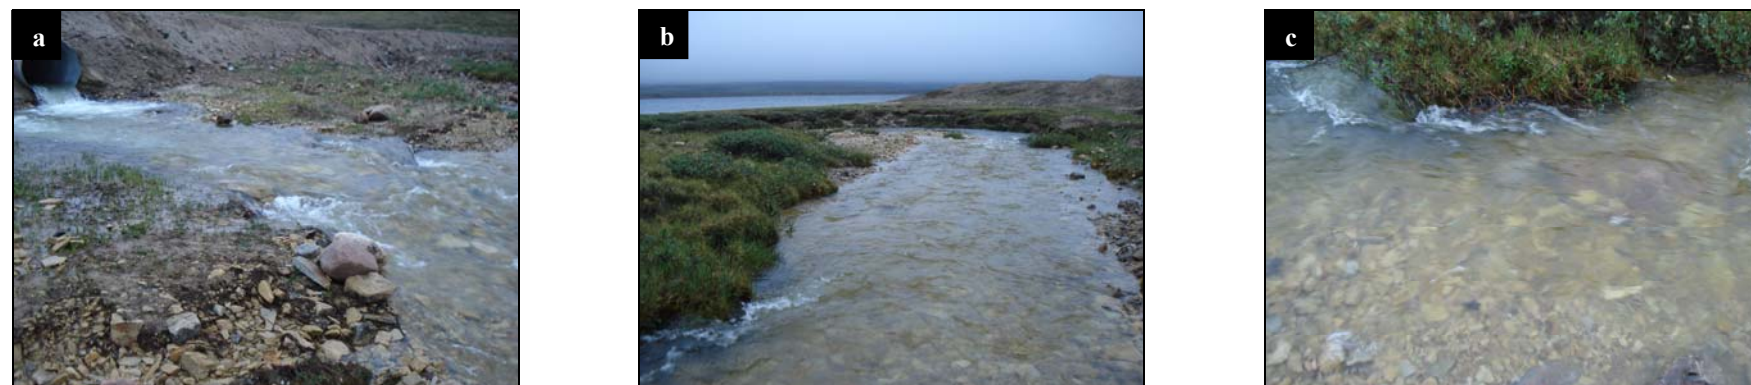
Figure 2. View upstream (a), downstream (b), and across (c) from the habitat assessment downstream of BG-24 during summer 2008.

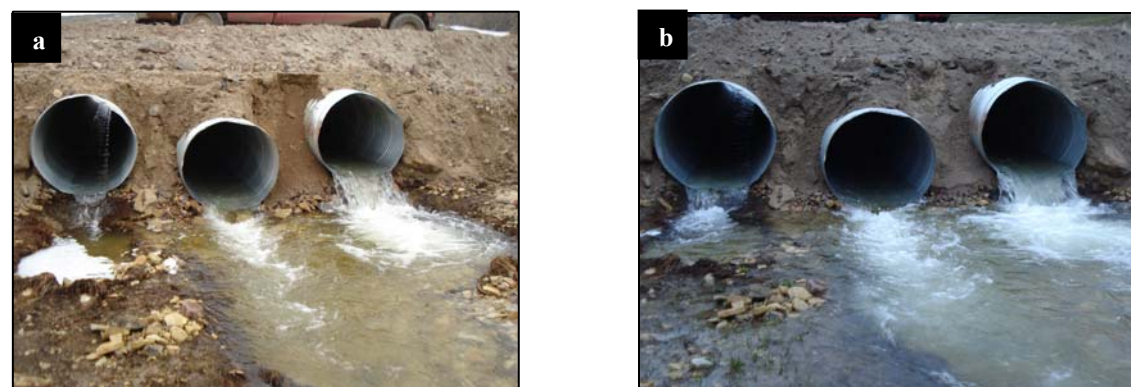
Figure 3. View from the downstream end of the culverts at crossing BG-24 during spring (a) and summer (b) 2008.

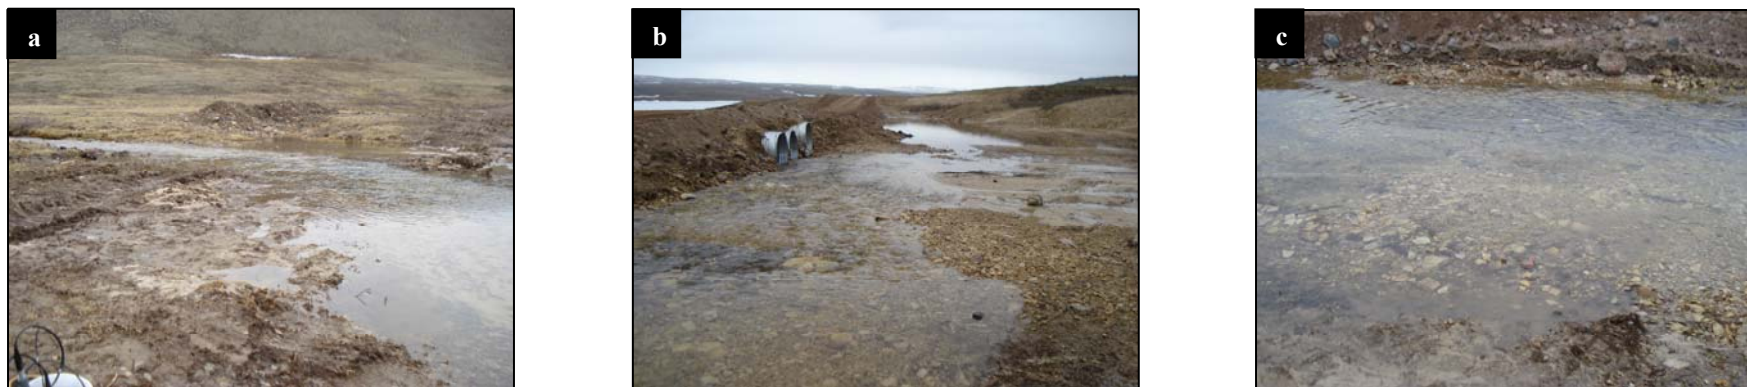
Figure 1. View upstream (a), downstream (b), and across (c) from the habitat assessment upstream of BG-24 during spring 2008.

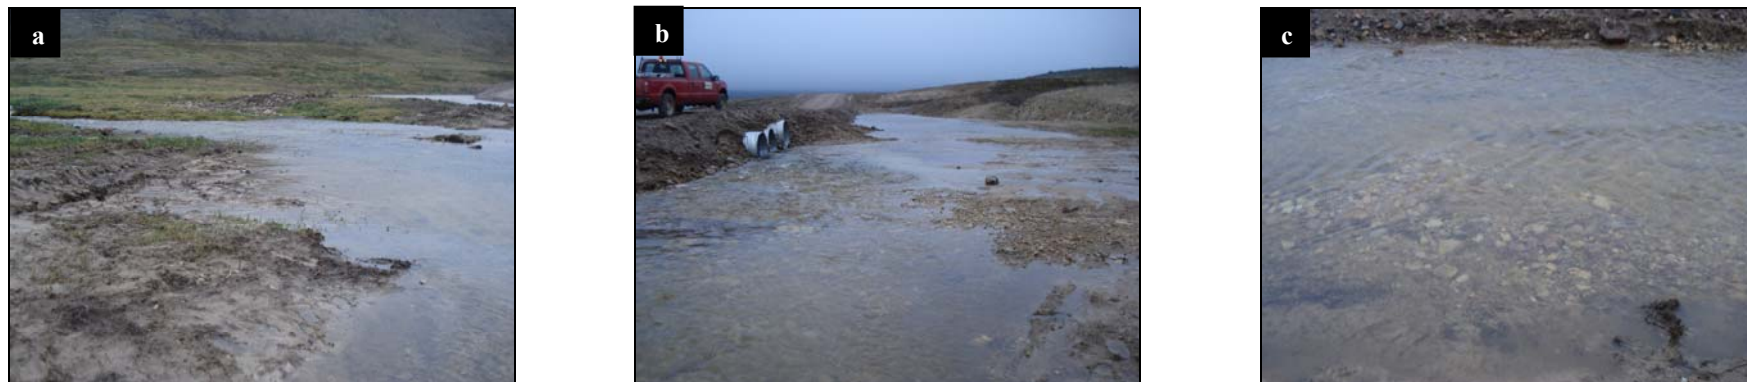
Figure 2. View upstream (a), downstream (b), and across (c) from the habitat assessment upstream of BG-24 during summer 2008.

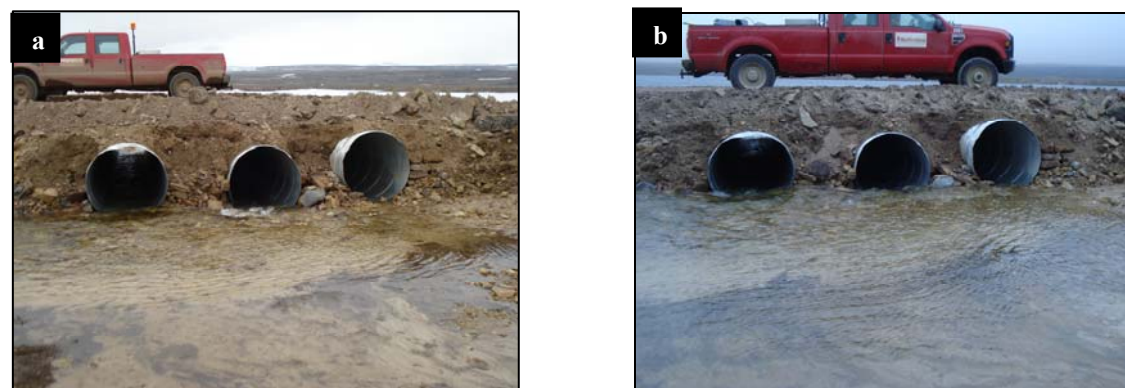
Figure 3. View from the upstream end of the culverts at crossing BG-24 during spring (a) and summer (b) 2008.

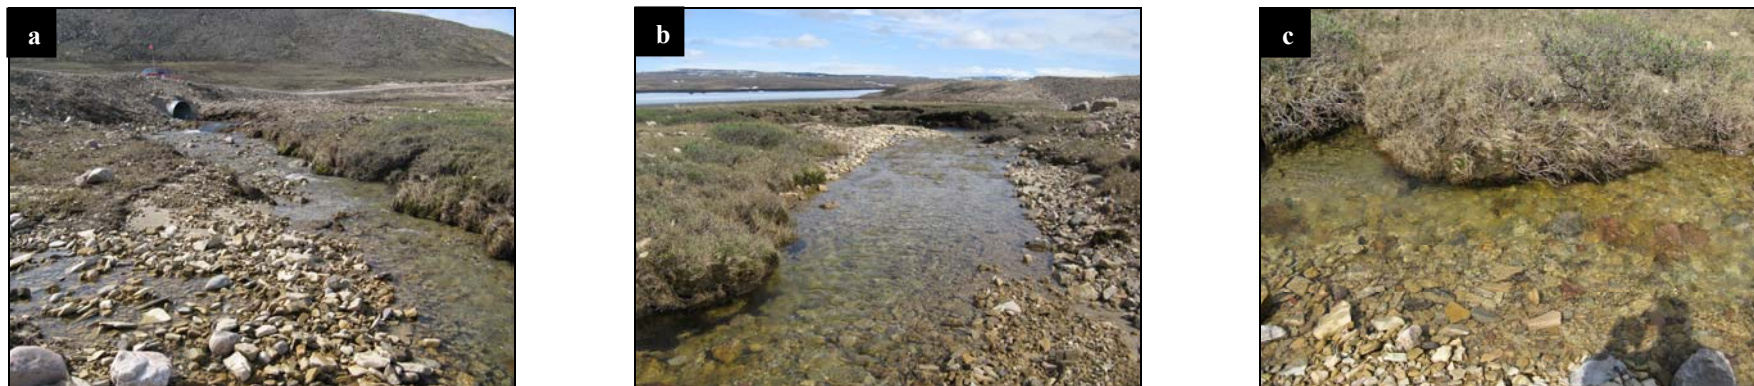
Figure 1. View upstream (a), downstream (b), and across (c) at the habitat assessment site downstream of the crossing at BG-24 during early July, 2009.

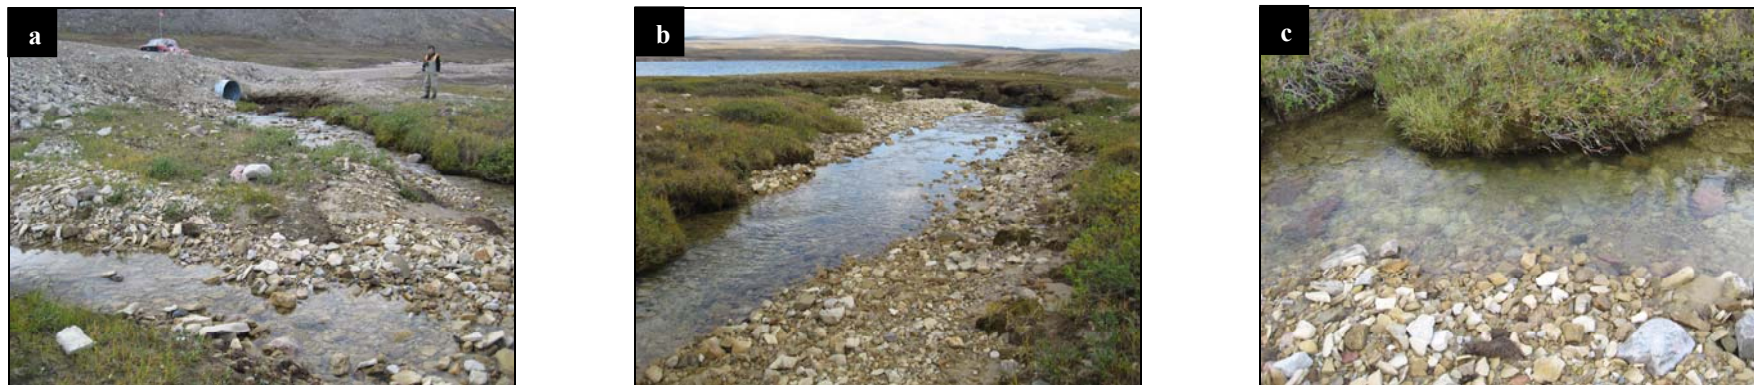
Figure 2. View upstream (a), downstream (b), and across (c) at the habitat assessment site downstream of the crossing at BG-24 during late August, 2009.

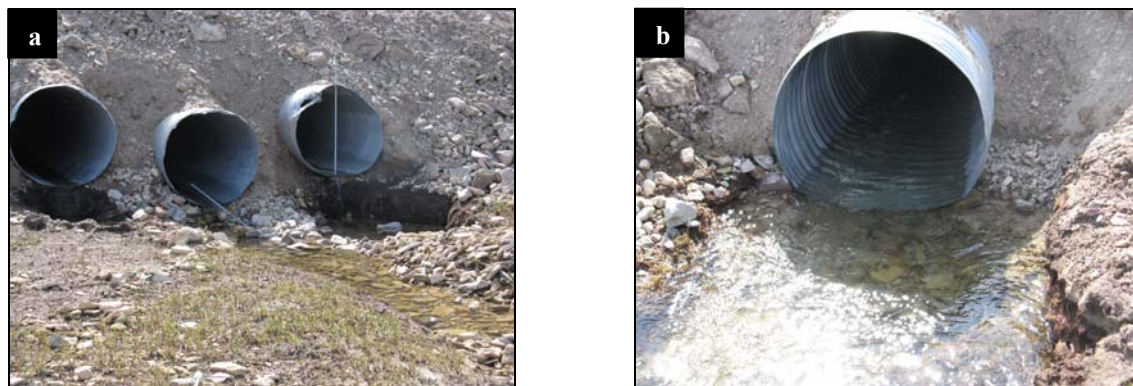
Figure 3. View of old (a) and new culvert(s) (b) installed at crossing at BG-24.

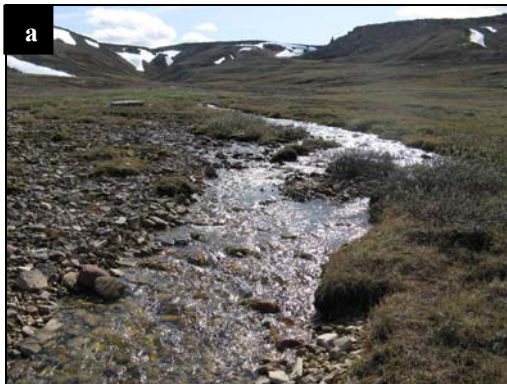
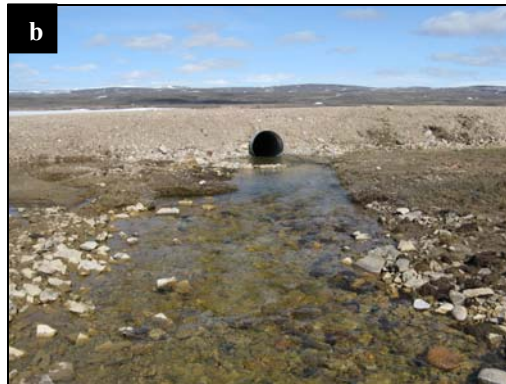
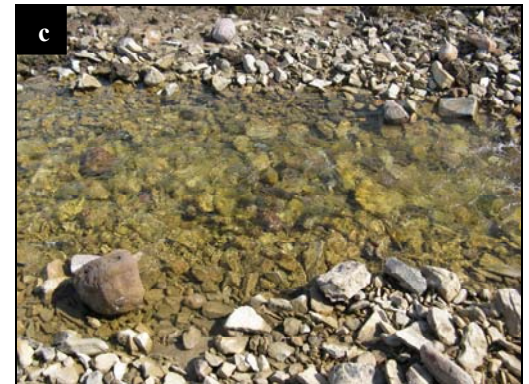
Figure 1. View upstream (a), downstream (b), and across (c) at the habitat assessment site upstream of the crossing at BG-24 during early July, 2009.

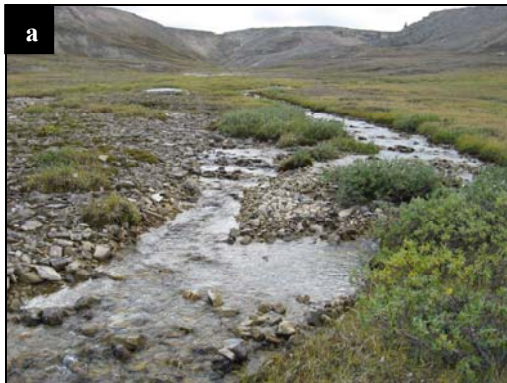
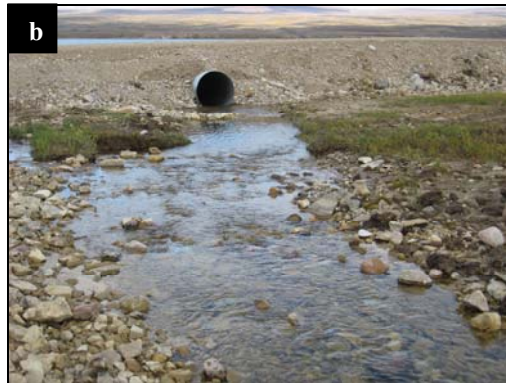
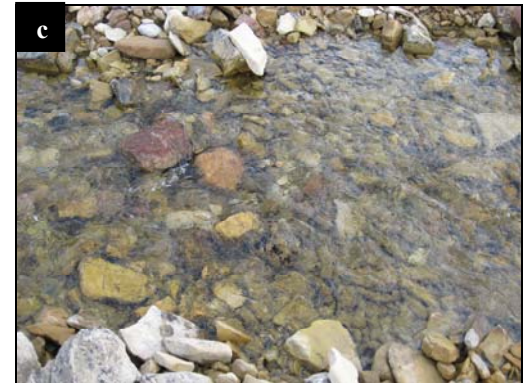
Figure 2. View upstream (a), downstream (b), and across (c) at the habitat assessment site upstream of the crossing at BG-24 during late August, 2009.

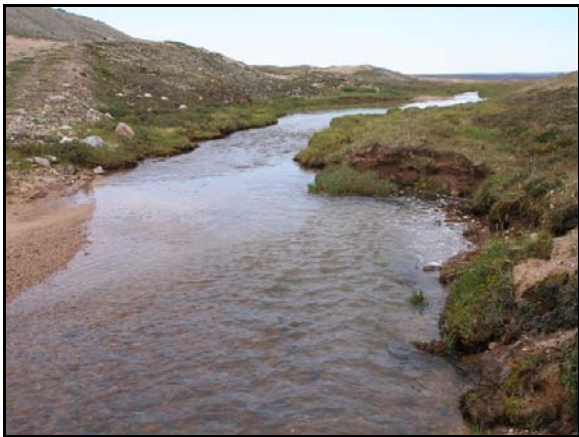
Figure 1: Downstream view from proposed crossing showing riffle-pool habitat, cobble/gravel/sand substrate.

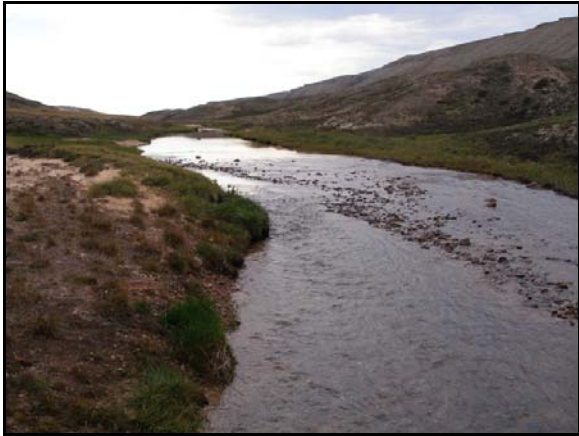
Figure 2: Upstream view from proposed crossing showing more riffle-pool habitat.

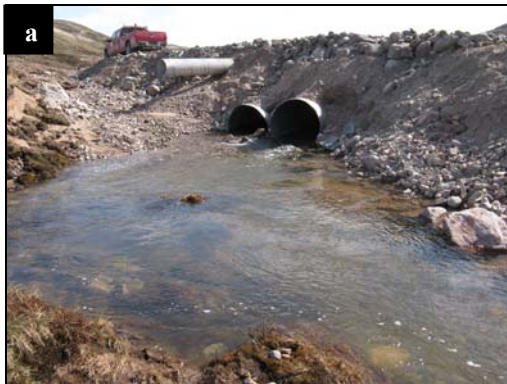
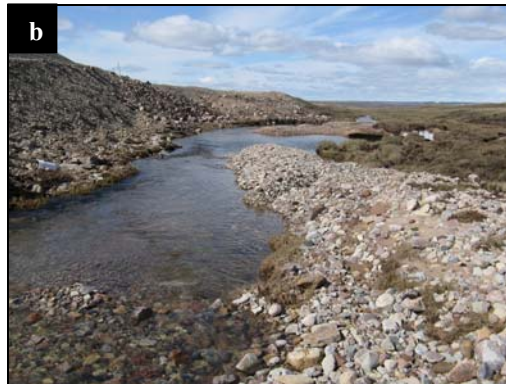
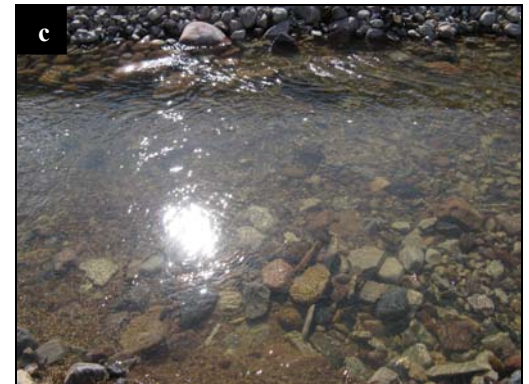
Figure 1. View upstream (a), downstream (b), and across (c) at the habitat assessment site downstream of the crossing at BG-17 during early July, 2009.

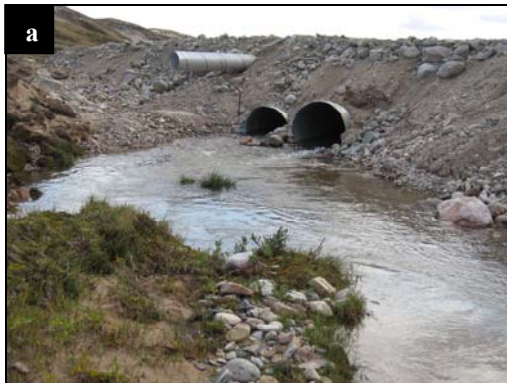
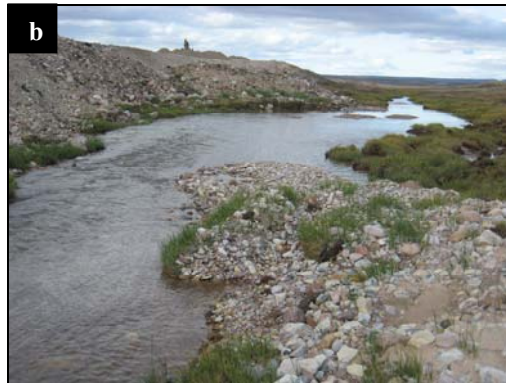
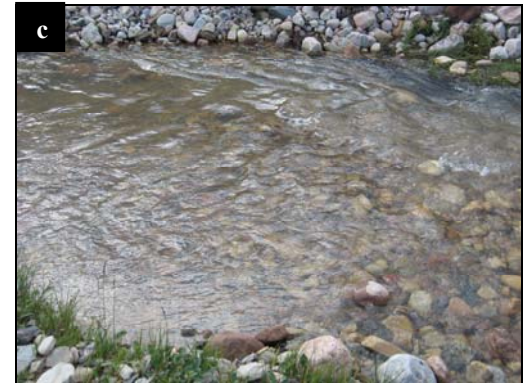
Figure 2. View upstream (a), downstream (b), and across (c) at the habitat assessment site downstream of the crossing at BG-17 during late August, 2009.

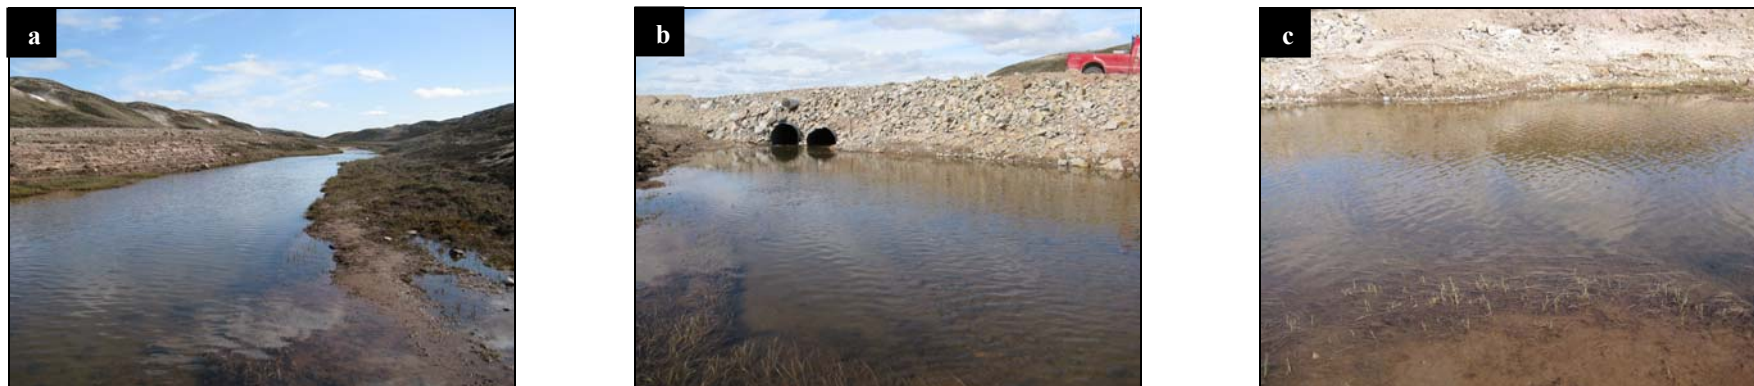
Figure 1. View upstream (a), downstream (b), and across (c) at the habitat assessment site upstream of the crossing at BG-17 during early July, 2009.

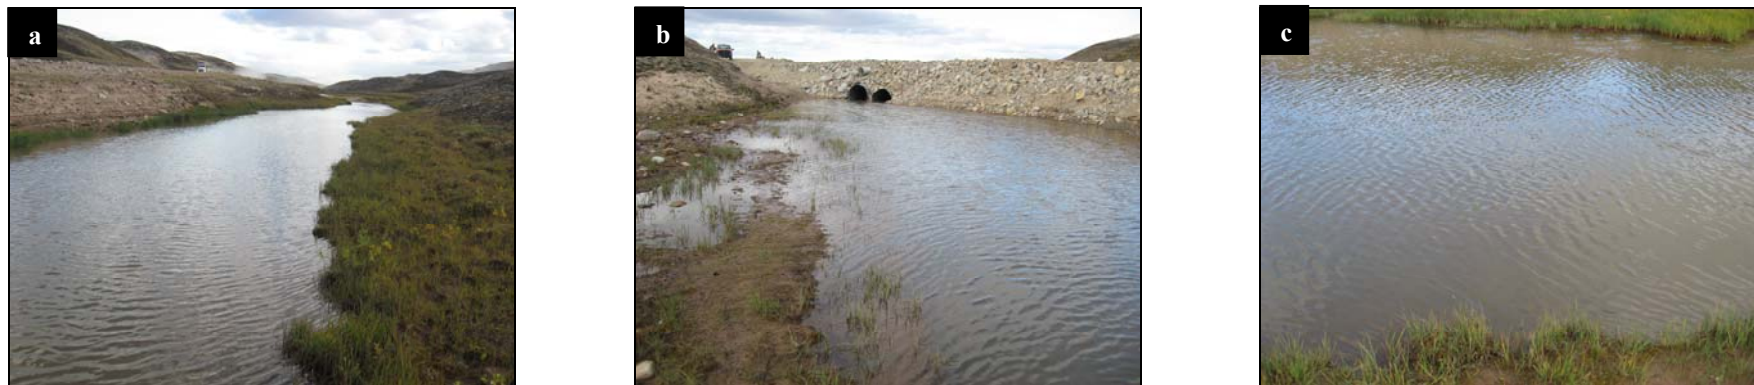
Figure 2. View upstream (a), downstream (b), and across (c) at the habitat assessment site upstream of the crossing at BG-17 during late August, 2009.

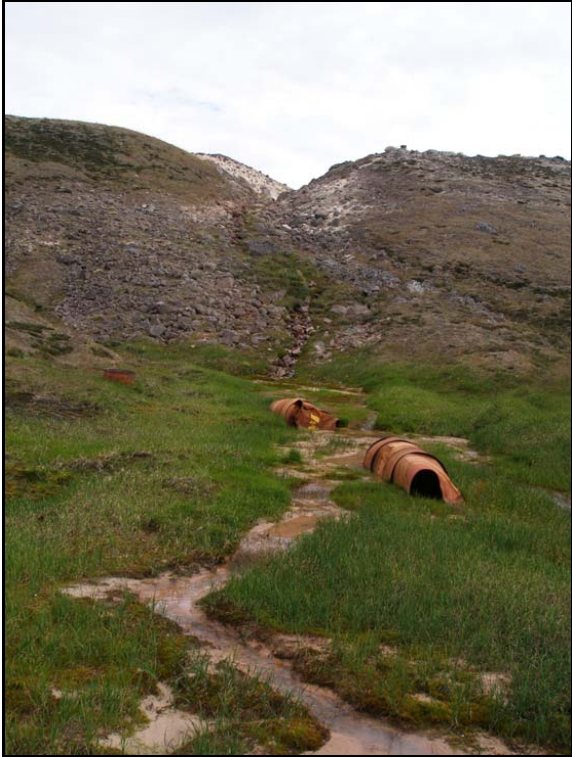
Location			
	Site:	BG-16	Watercourse Name:	Unknown River
	UTM:	17W 0550742 / 7917611		
	Site Description			Potential Fish Utilization
	Watershed Size:	0.064 km ²	Mesohabitat Composition:	N/A
	Regulated:	No	Substrate Composition:	N/A
	Channelized:	No	Stream Cover:	N/A
	Bankfull Width:	N/A	Riparian Vegetation:	N/A
	Wetted Width:	N/A	Aquatic Vegetation:	N/A
	Riffle-Crest Depth:	N/A	Unique Features:	N/A
Baffinland Iron Mines Mary River Project Watercourse Crossing Assessment	Pool Depth:	N/A	Summary:	This is an extra small-sized waterbody that is steep and nearly dry at the time of sampling It is likely only a spring run-off stream
	Residual Pool Depth:	N/A		
	Bankfull Depth:	N/A		
	Bank Height:	N/A		
	D ₉₅ :	N/A		
	D:	N/A		
	Confinement:	N/A		
	Channel Morphology:	N/A		
	Channel Gradient:	N/A		
	Turbidity:	N/A		
	Side Slope	N/A		
	Approach:	N/A		
	Bank Stability:	N/A		
	Erosion Potential:	N/A		
	Undercut Banks:	N/A

Fish Habitat Quality	
			None	
			Comments	
			This site is a tributary of BG-17 and likely only contributes runoff to the much larger BG-17. There appears to be little available fish habitat and, therefore little to no importance for fish populations. There are also empty fuel drums rusting in the stream.

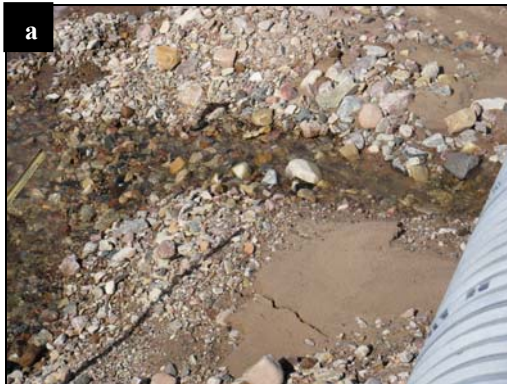
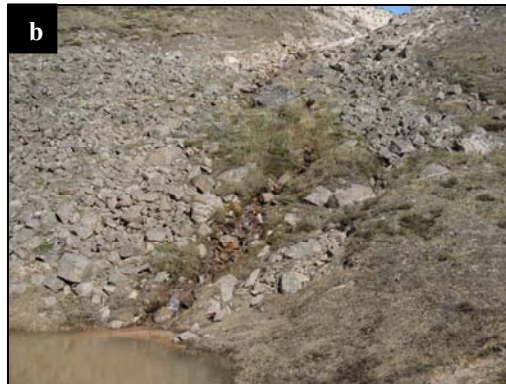
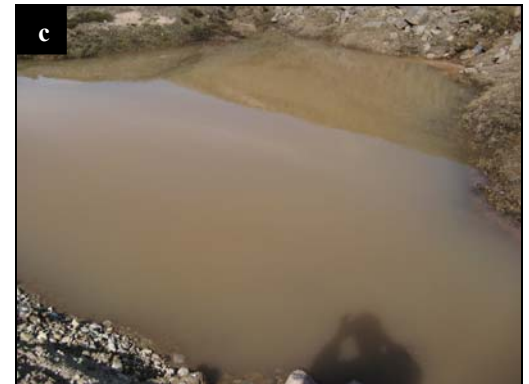
Figure 1. View of downstream (a) and upstream (b) steep gradient barriers and turbid pond below the upstream barrier (c) at BG-16 during early July, 2009.

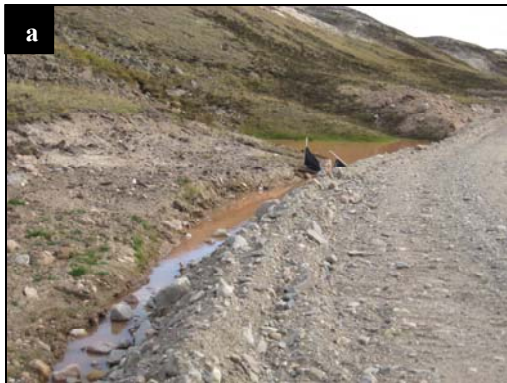
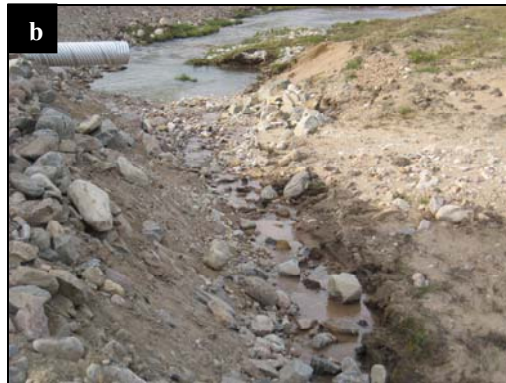
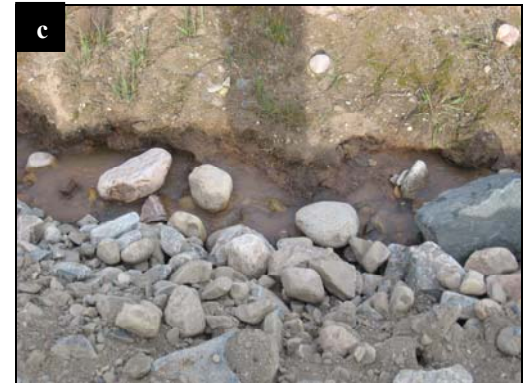
Figure 2. View upstream (a), downstream (b), and across (c) at the habitat assessment site for crossing BG-16 during late August, 2009.

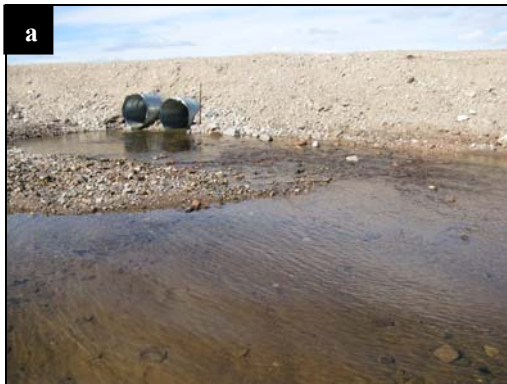
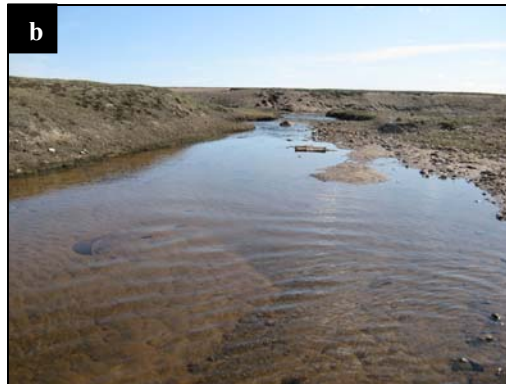
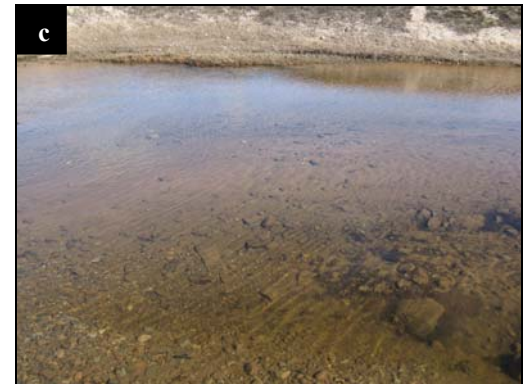
Figure 1. View upstream (a), downstream (b), and across (c) at the habitat assessment site downstream of the crossing at BG-04 during early July, 2009.

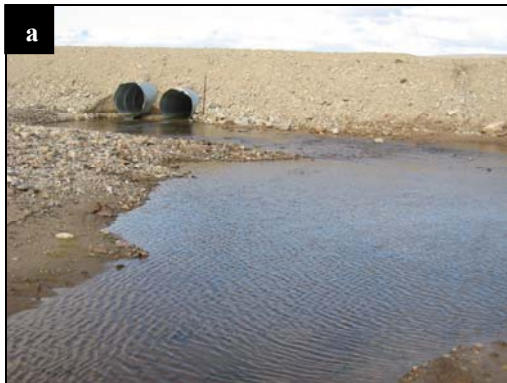
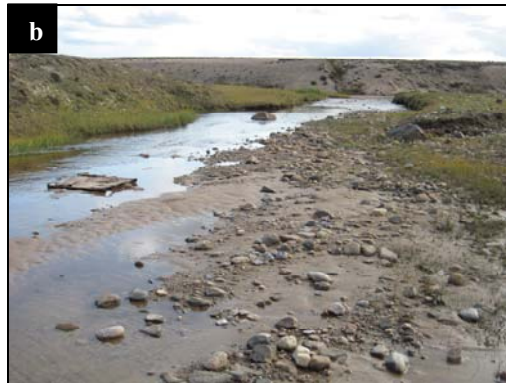
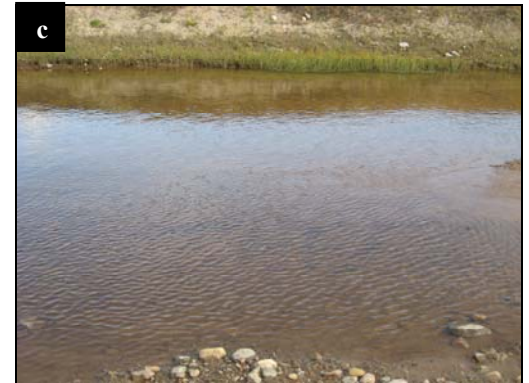
Figure 2. View upstream (a), downstream (b), and across (c) at the habitat assessment site downstream of the crossing at BG-04 during late August, 2009.
