APPENDIX 5.3-1.

DETAILED HABITAT ASSESSMENTS AND SUMMARY OF RESULTS FOR WATERBODIES IN QUARRY SITES.

Table A5.3-1.1. Summary of results from surveys and assessments that fall within Quarry boundaries.

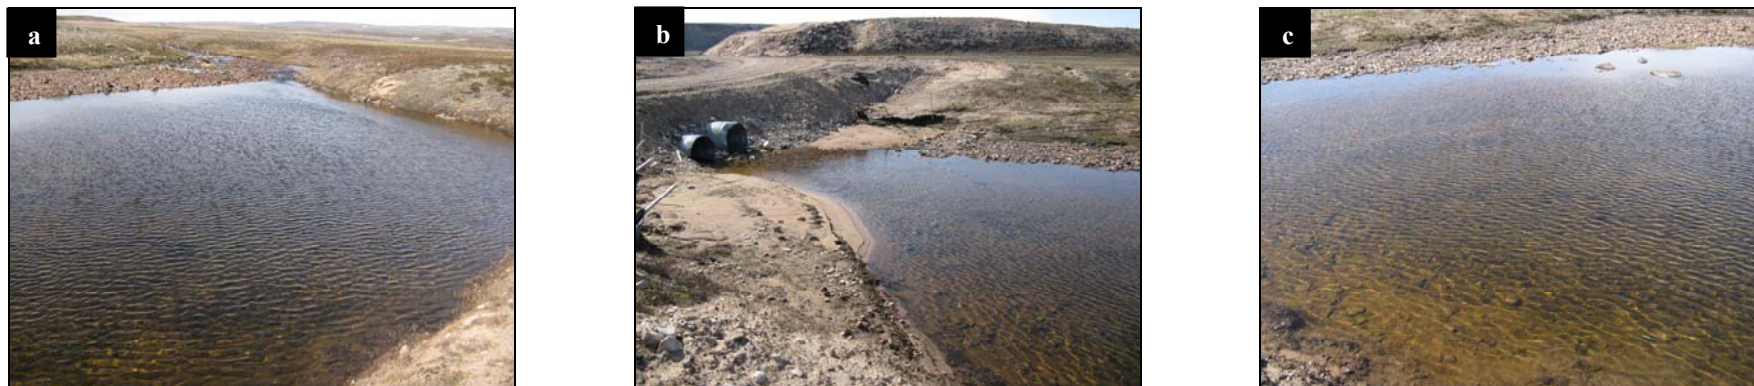
Figure 1. View upstream (a), downstream (b), and across (c) at the habitat assessment site upstream of the crossing at BG-04 during early July, 2009.

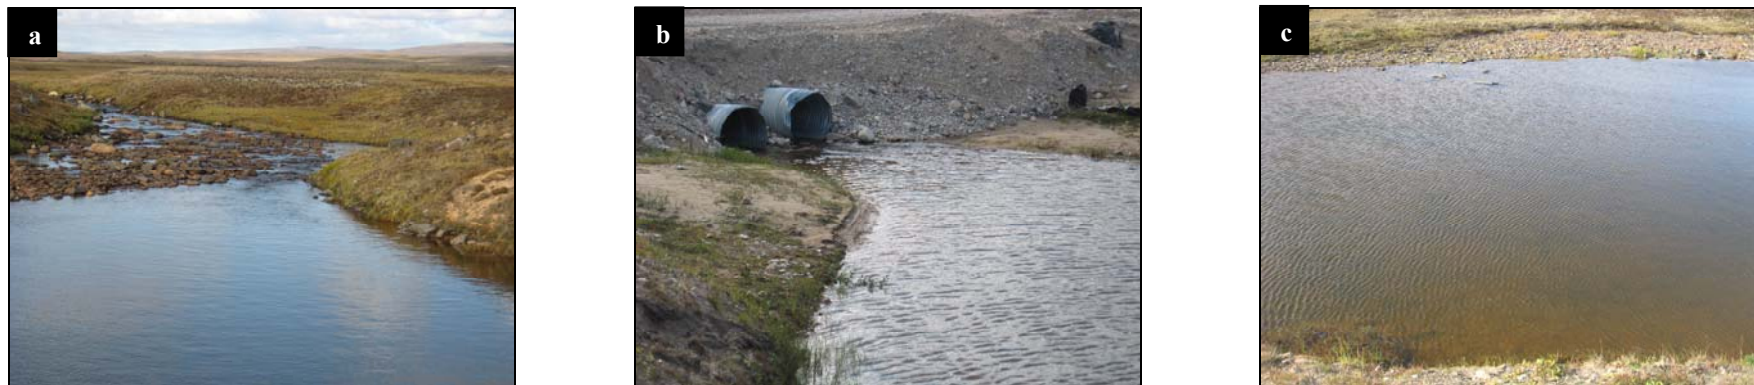
Figure 2. View upstream (a), downstream (b), and across (c) at the habitat assessment site upstream of the crossing at BG-04 during late August, 2009.

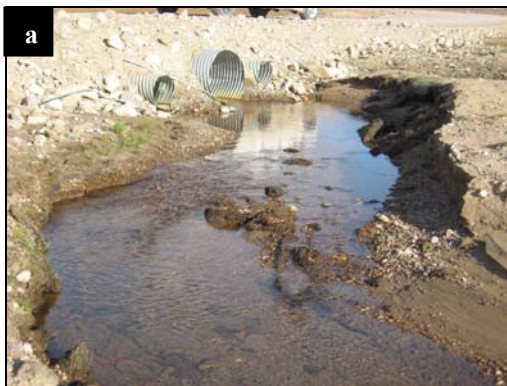
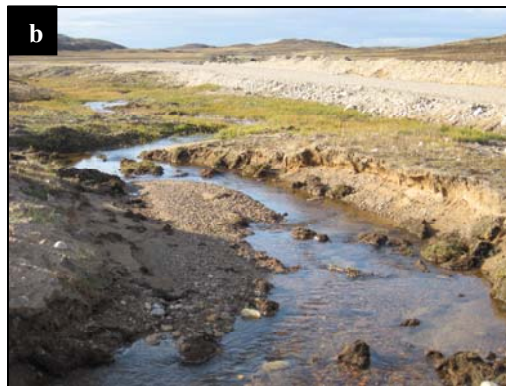
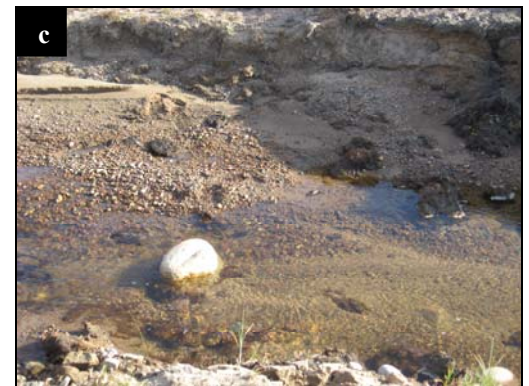
Figure 1. View upstream (a), downstream (b), and across (c) at the habitat assessment site downstream of the crossing at CV-001 during late August, 2009.

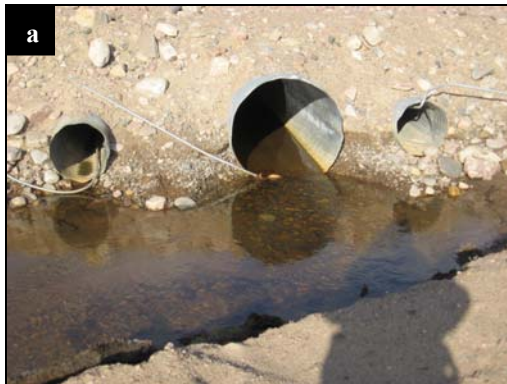
Figure 2. View from the downstream end of the culverts at crossing CV-001 during late August (a), 2009.

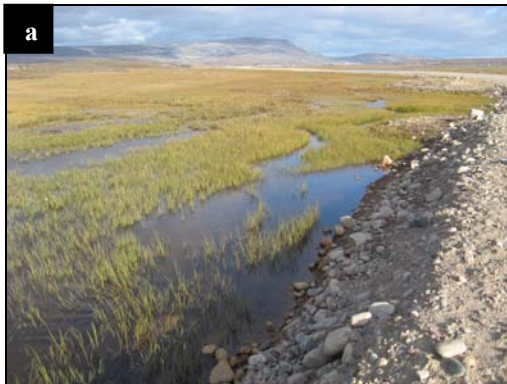
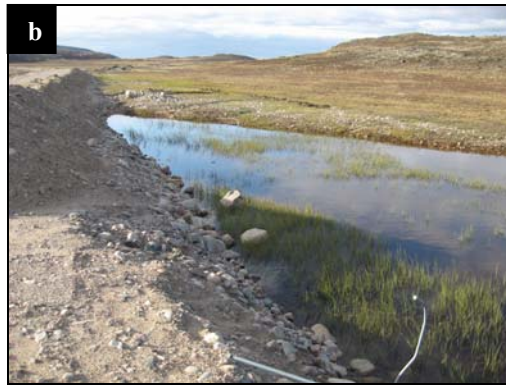
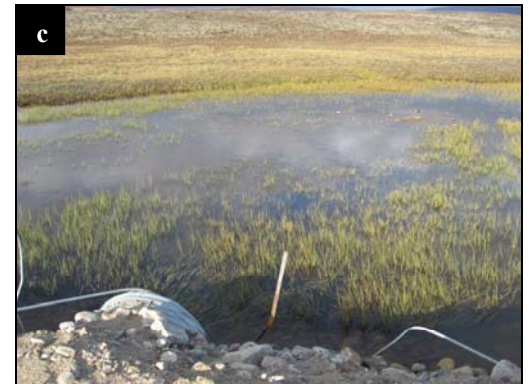
Figure 1. View upstream (a), downstream (b), and across (c) at the habitat assessment site upstream of the crossing at CV-001 during late August, 2009.

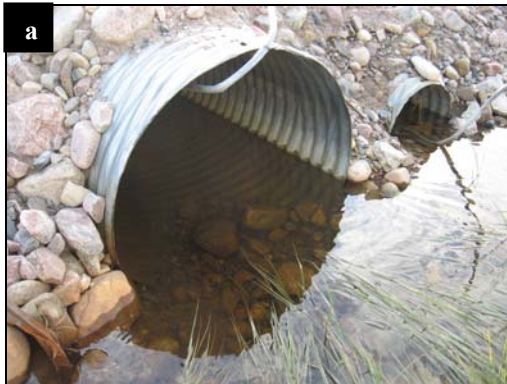
Figure 2. View from the upstream end of the culverts at crossing CV-001 during late August, 2009.

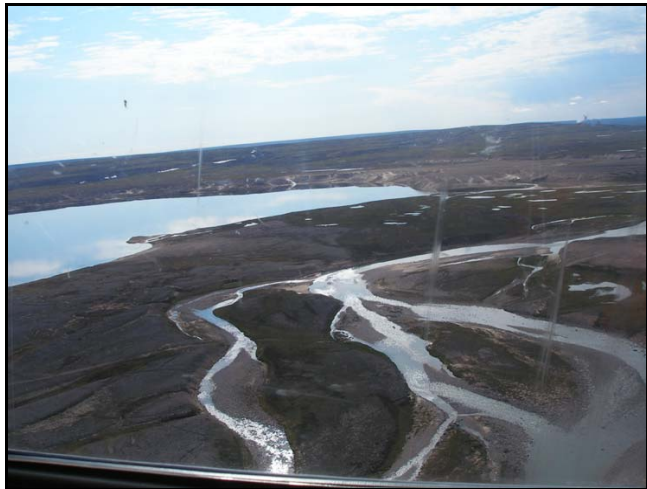
Figure 1: Downstream aerial view from proposed crossing showing riffle-pool habitat and multiple wetted channels.

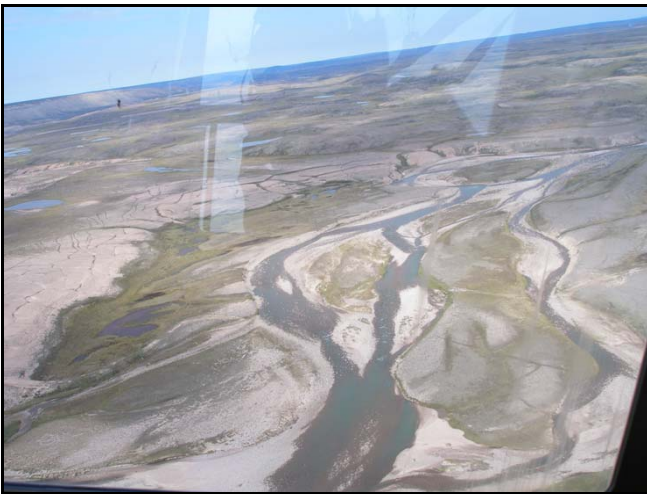
Figure 2: Upstream aerial view from proposed crossing showing the braided channel.

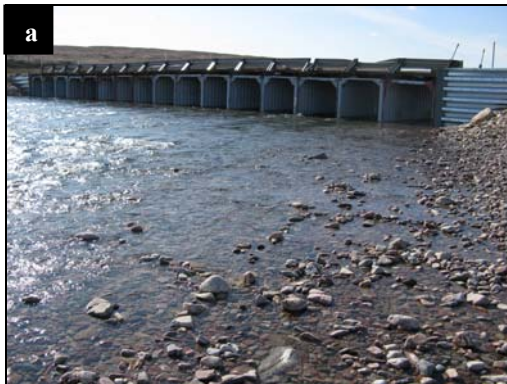
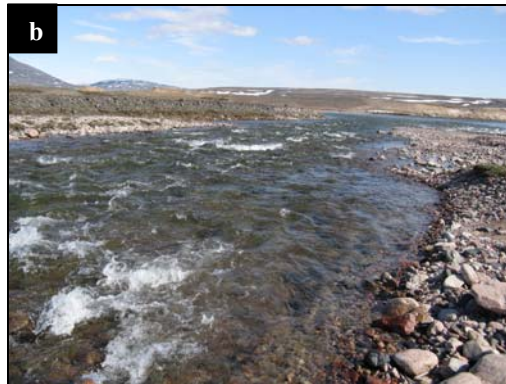
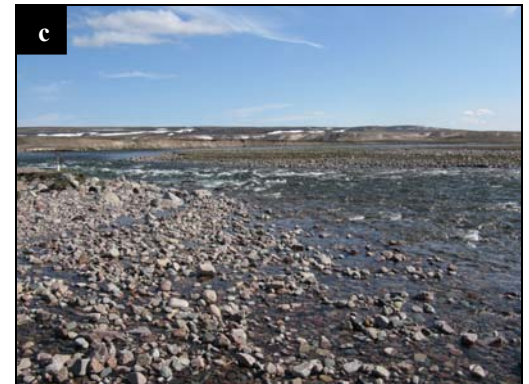
Figure 1. View upstream (a), downstream (b), and across (c) at the habitat assessment site downstream of the crossing at CV-223 during early July, 2009.

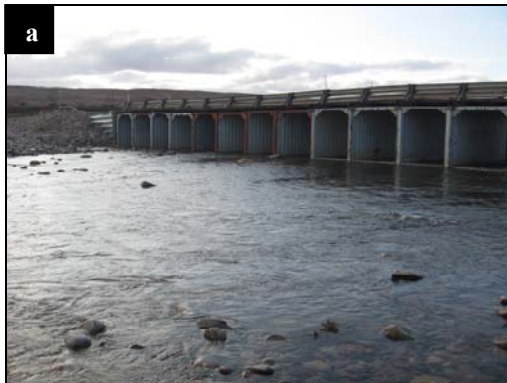
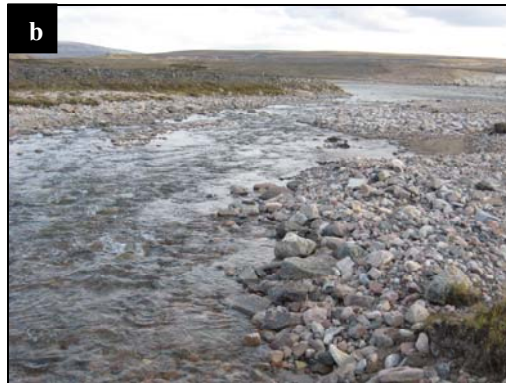
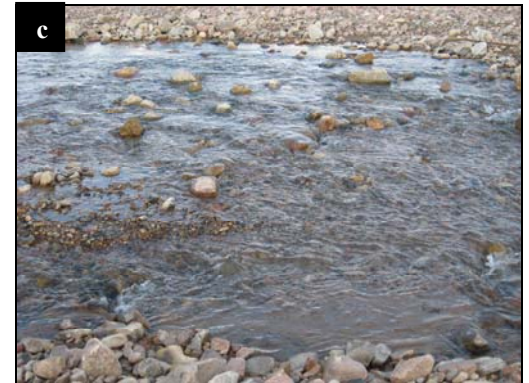
Figure 2. View upstream (a), downstream (b), and across (c) at the habitat assessment site downstream of the crossing at CV-223 during late August, 2009.

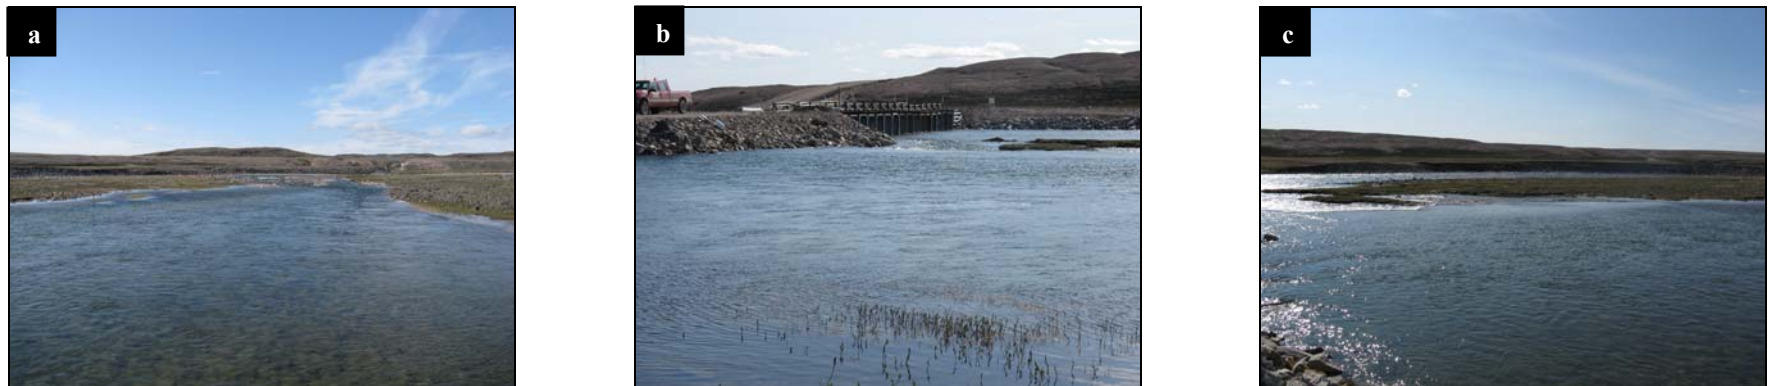
Figure 1. View upstream (a), downstream (b), and across (c) at the habitat assessment site upstream of the crossing at CV-223 during early July, 2009.

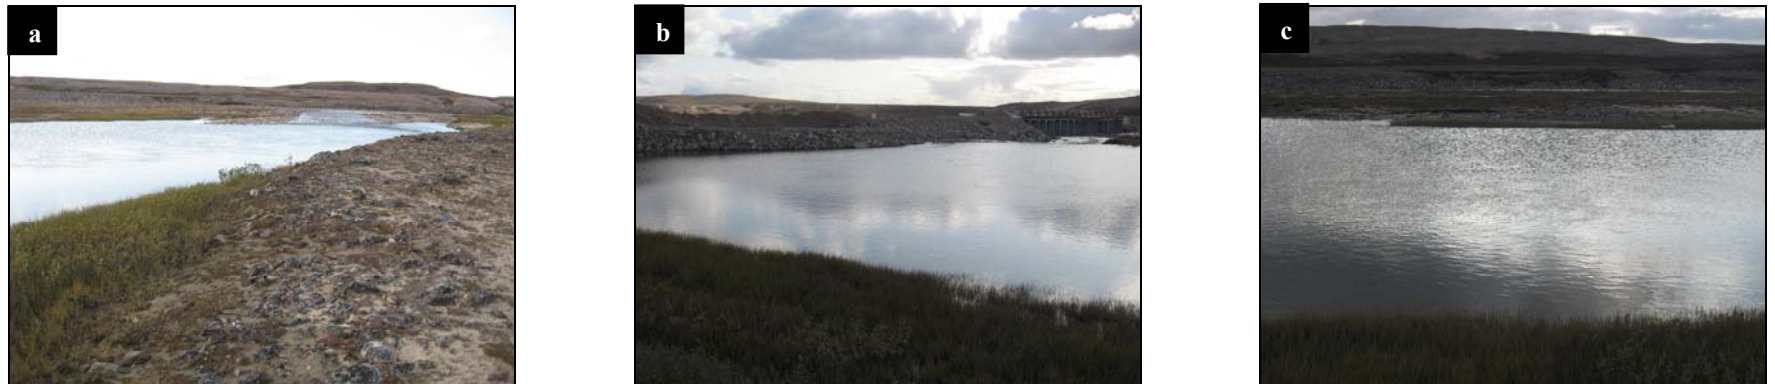
Figure 2. View upstream (a), downstream (b), and across (c) at the habitat assessment site upstream of the crossing at CV-223 during late August, 2009.

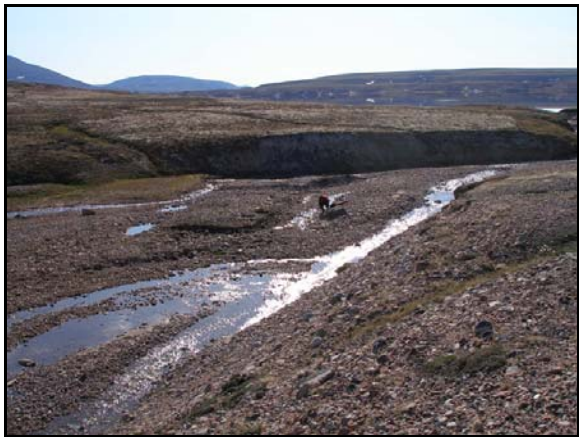
Figure 1: Downstream view from proposed crossing showing riffle-pool habitat and cobble substrate.

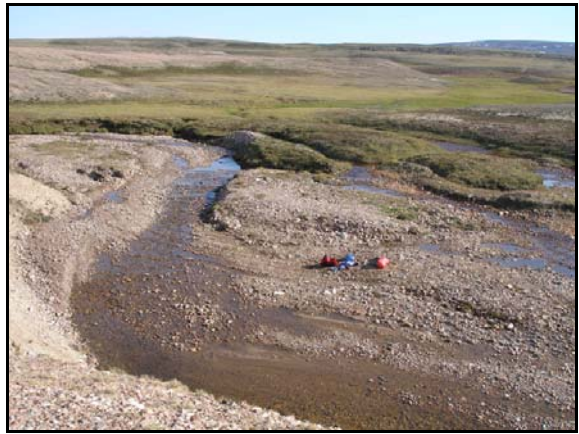
Figure 2: Upstream view from proposed crossing showing more riffle habitat.

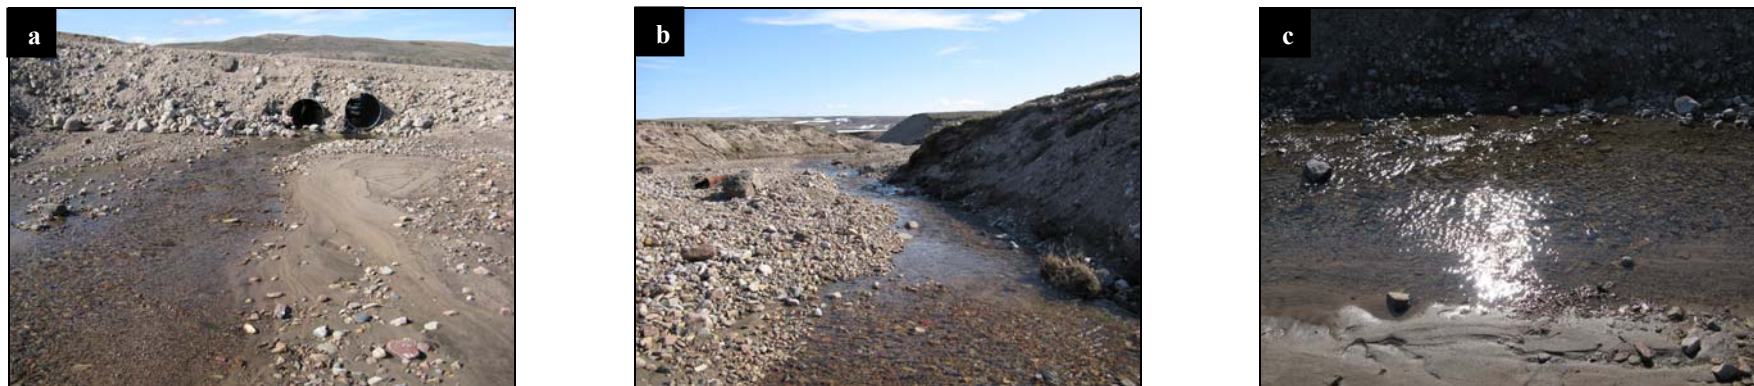
Figure 1. View upstream (a), downstream (b), and across (c) at the habitat assessment site downstream of the crossing at CV-224 during early July, 2009.

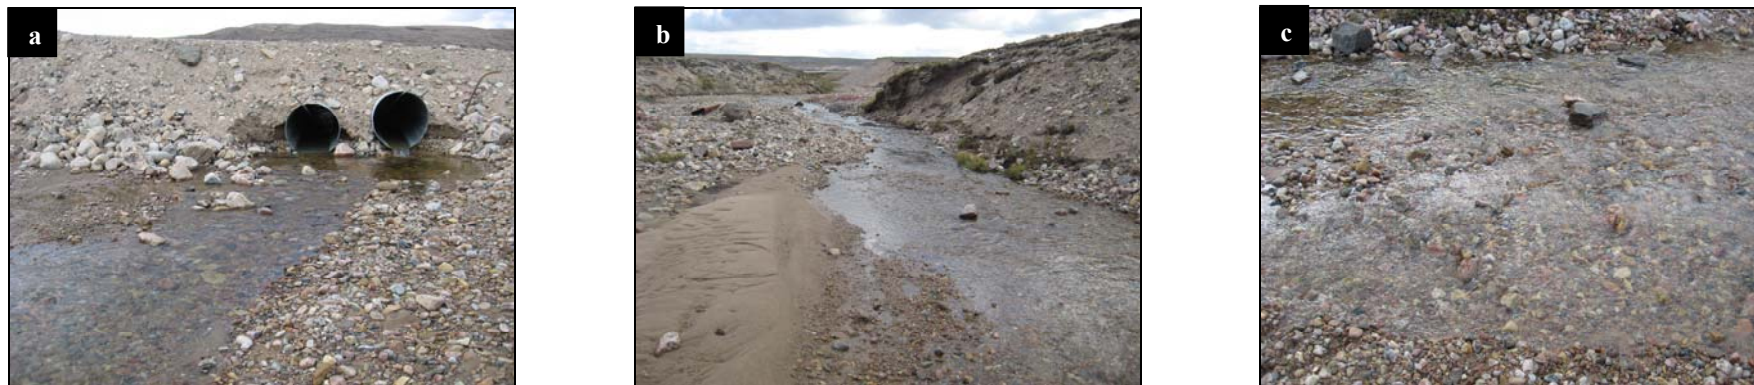
Figure 2. View upstream (a), downstream (b), and across (c) at the habitat assessment site downstream of the crossing at CV-224 during late August, 2009.

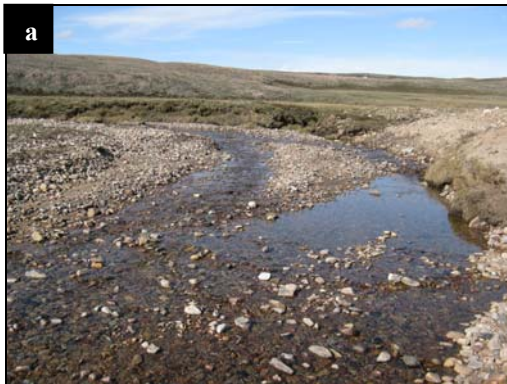
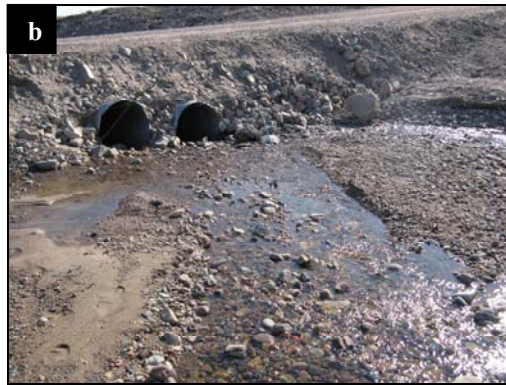
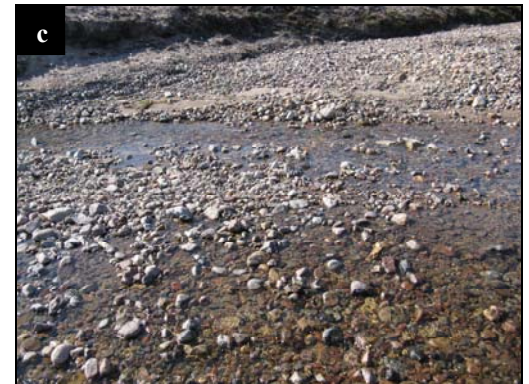
Figure 1. View upstream (a), downstream (b), and across (c) at the habitat assessment site upstream of the crossing at CV-224 during early July, 2009.

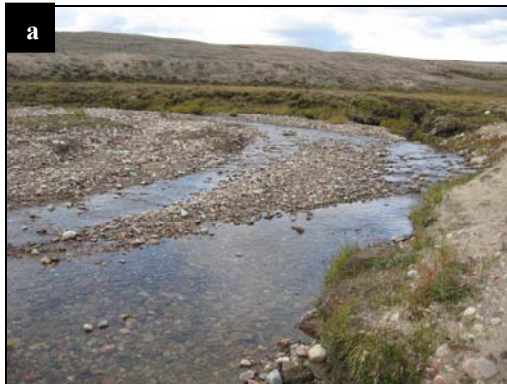
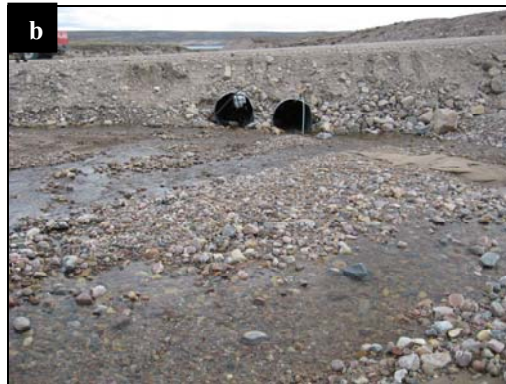
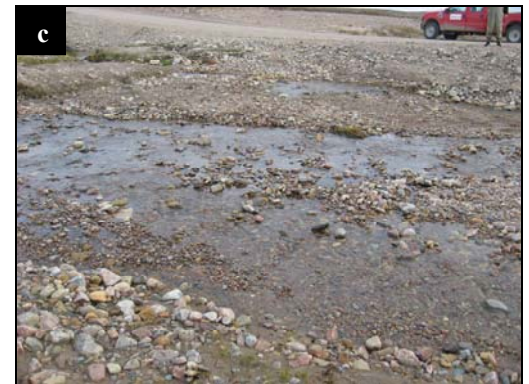
Figure 2. View upstream (a), downstream (b), and across (c) at the habitat assessment site upstream of the crossing at CV-224 during late August, 2009.

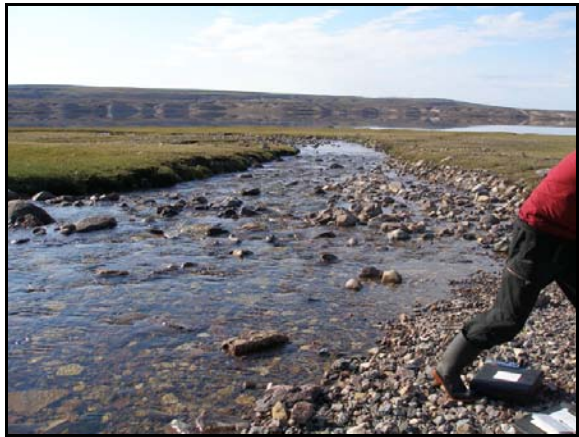
Figure 1: Downstream view from proposed crossing showing riffle-pool habitat, cobble substrate, and Camp Lake.

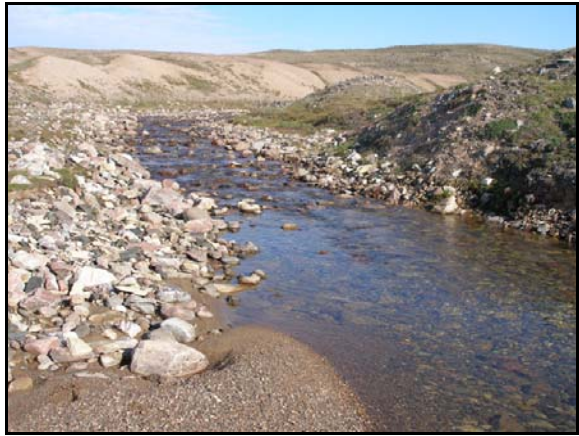
Figure 2: Upstream view from proposed crossing showing more riffle-pool habitat.

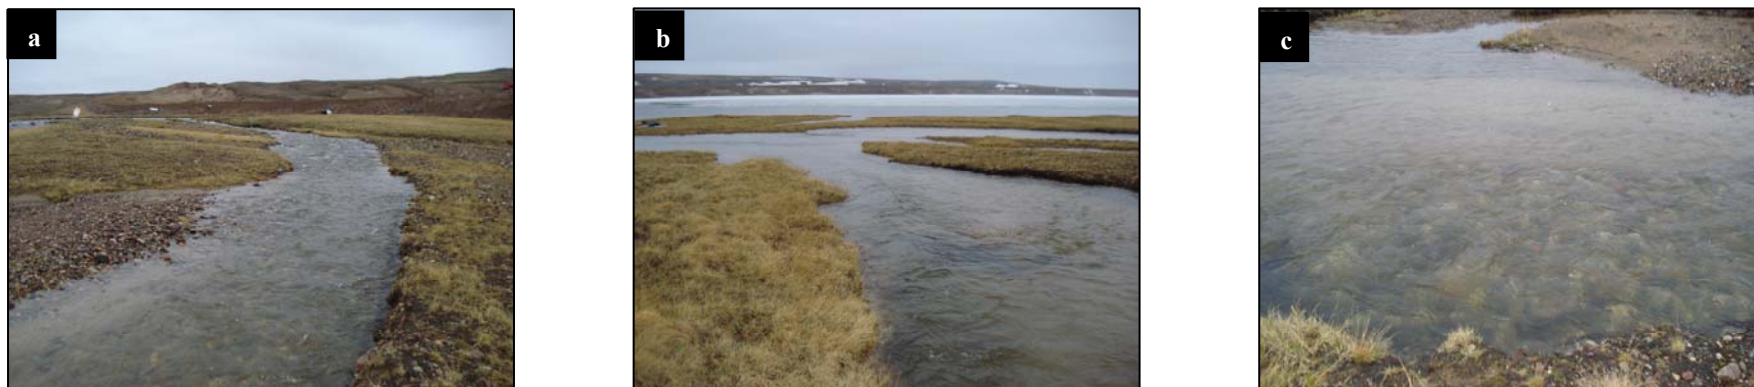
Figure 1. View upstream (a), downstream (b), and across (c) from the habitat assessment downstream of CV-225 during spring 2008.

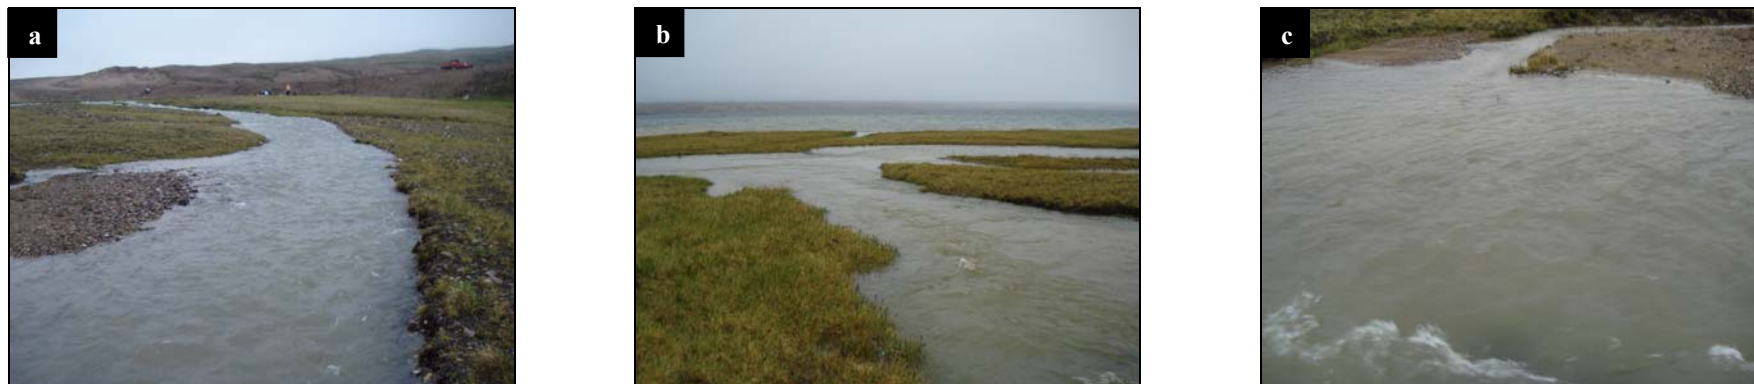
Figure 2. View upstream (a), downstream (b), and across (c) from the habitat assessment downstream of CV-225 during summer 2008.

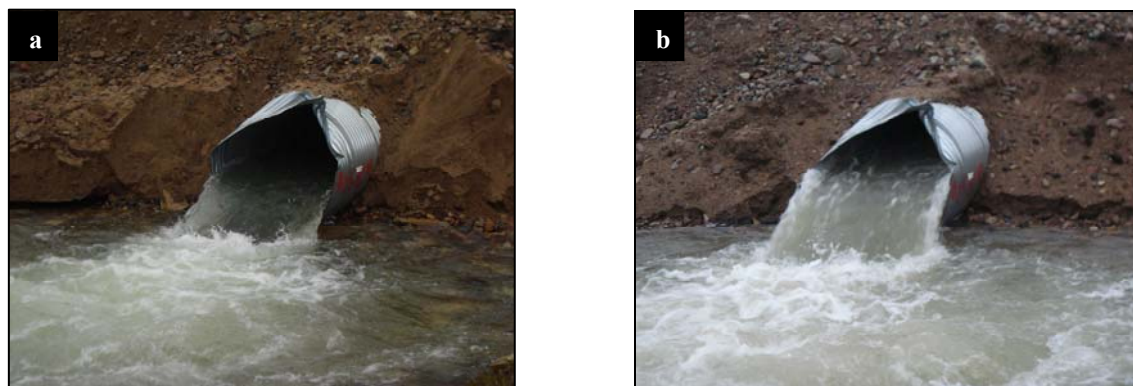
Figure 3. View from the downstream end of the culvert at crossing CV-225 during spring (a) and summer (b) 2008.

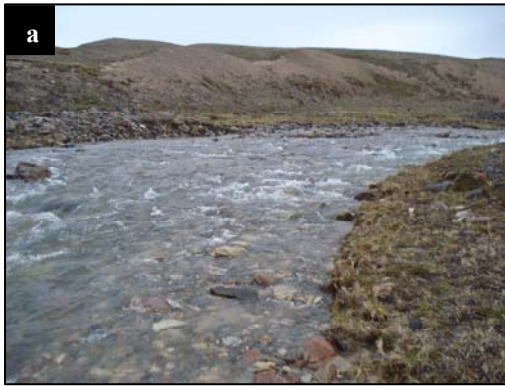
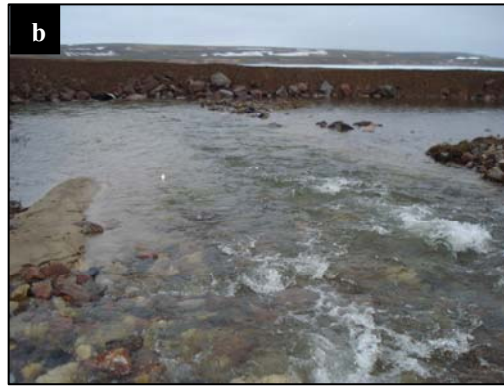
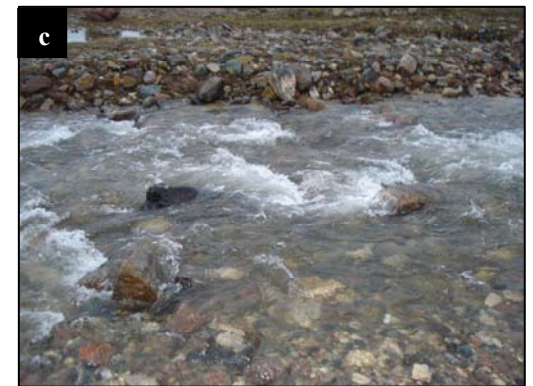
Figure 1. View upstream (a), downstream (b), and across (c) from the habitat assessment upstream of CV-225 during spring 2008.

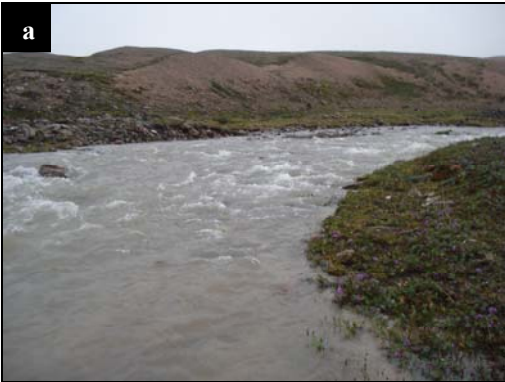
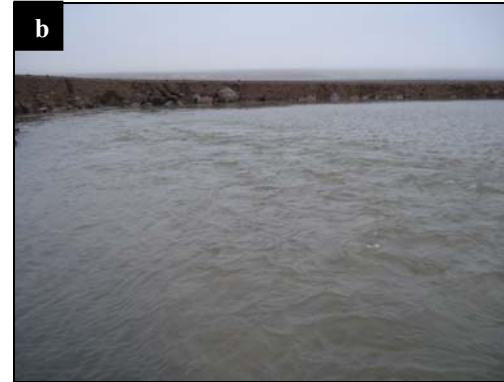
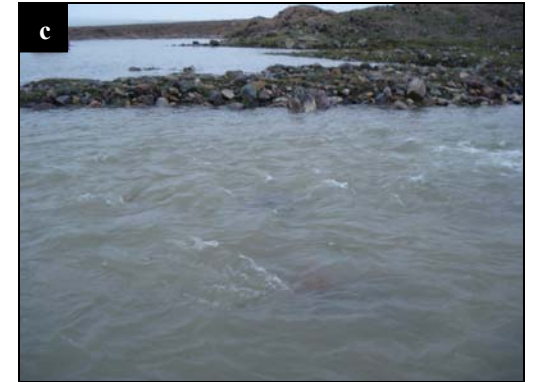
Figure 2. View upstream (a), downstream (b), and across (c) from the habitat assessment upstream of CV-225 during summer 2008.

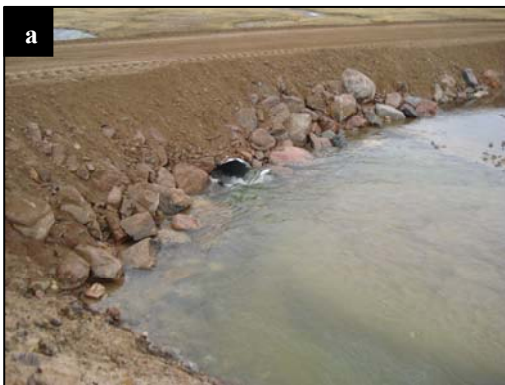
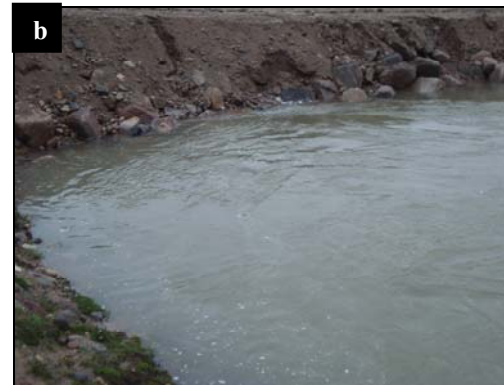
Figure 3. View from the upstream end of the culverts at crossing CV-225 during spring (a) and summer (b) 2008.

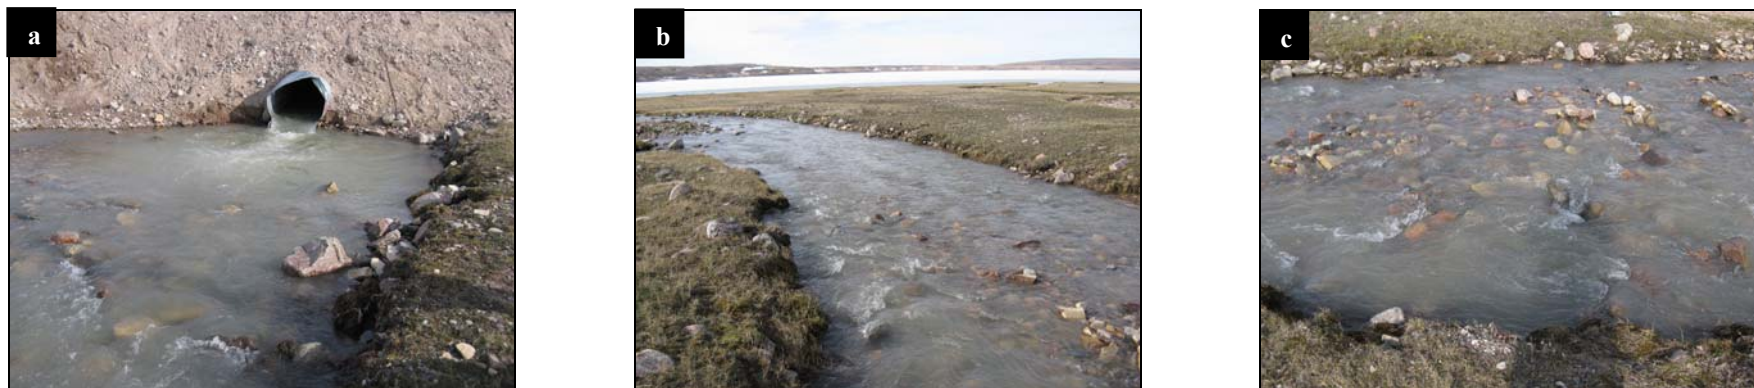
Figure 1. View upstream (a), downstream (b), and across (c) at habitat assessment site downstream of crossing at CV-225 during early July, 2009.

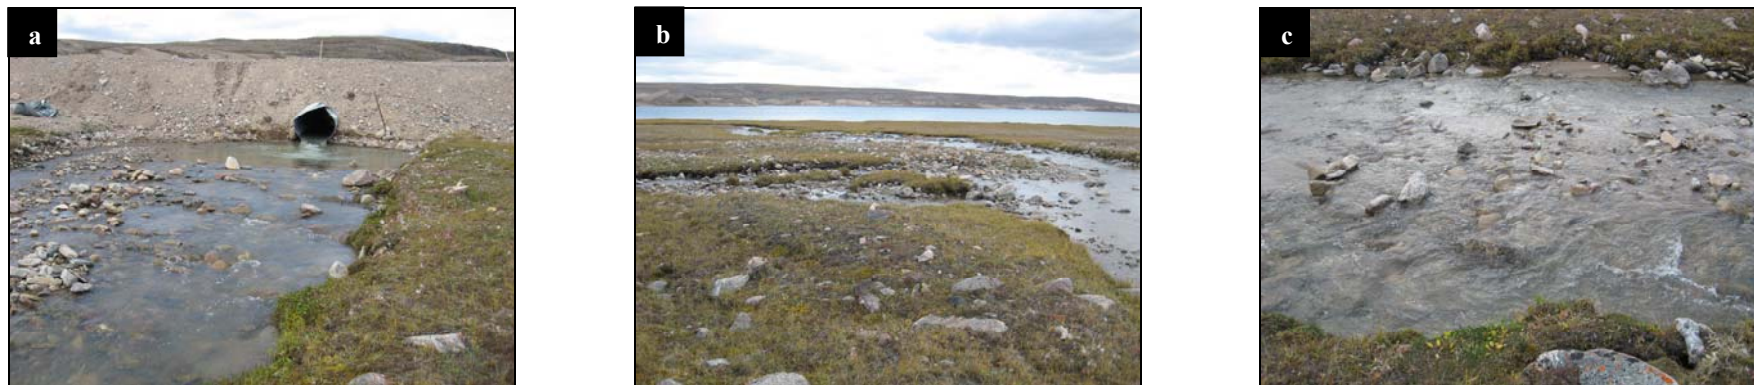
Figure 2. View upstream (a), downstream (b), and across (c) at habitat assessment site downstream of crossing at CV-225 during late August, 2009.

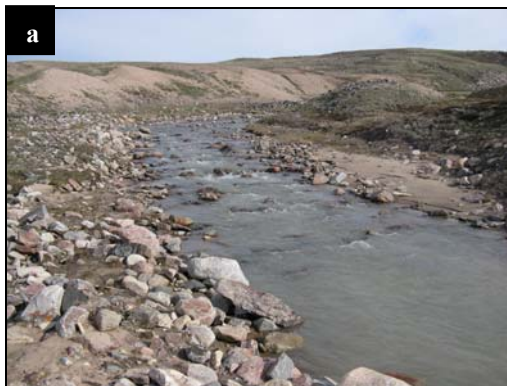
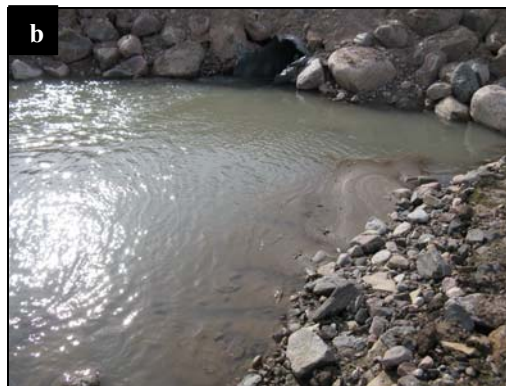
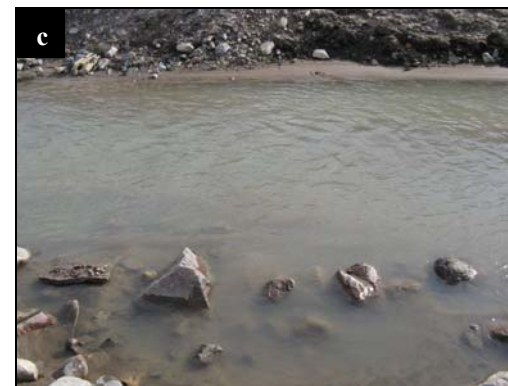
Figure 1. View upstream (a), downstream (b), and across (c) at habitat assessment site upstream of crossing at CV-225 during early July, 2009.

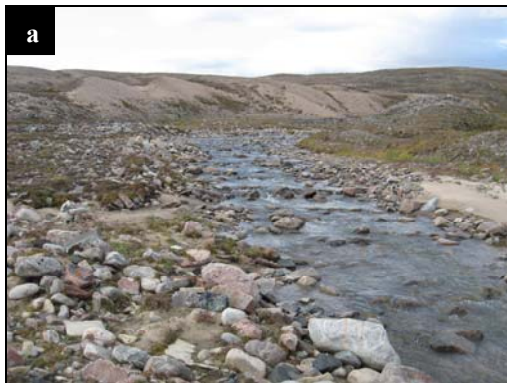
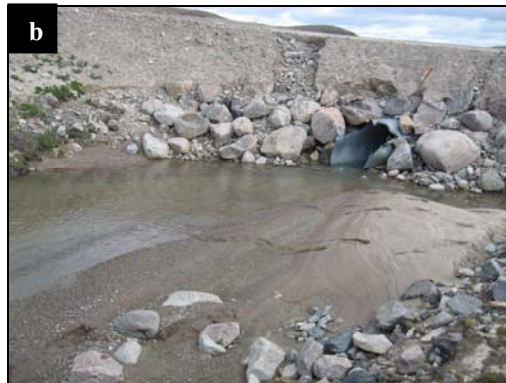
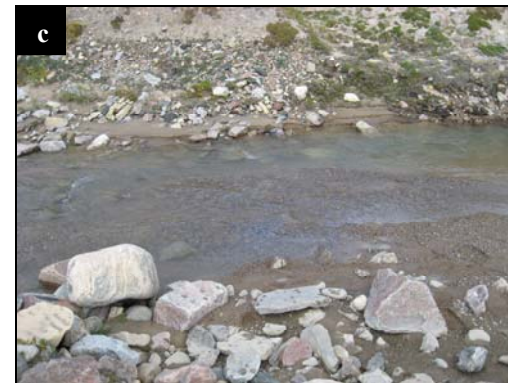
Figure 2. View upstream (a), downstream (b), and across (c) at habitat assessment site upstream of crossing at CV-225 during late August, 2009.

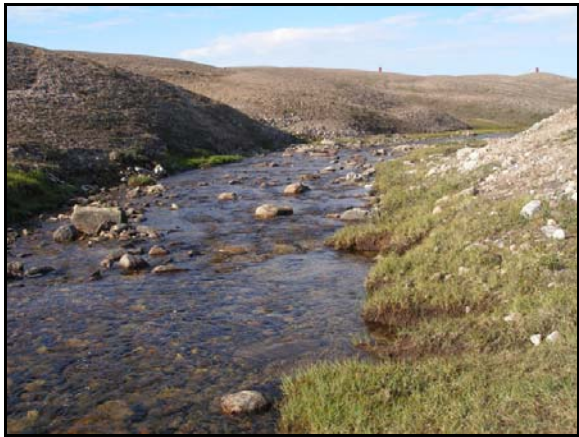
Figure 1: Downstream view from proposed crossing showing riffle-pool habitat and cobble substrate.

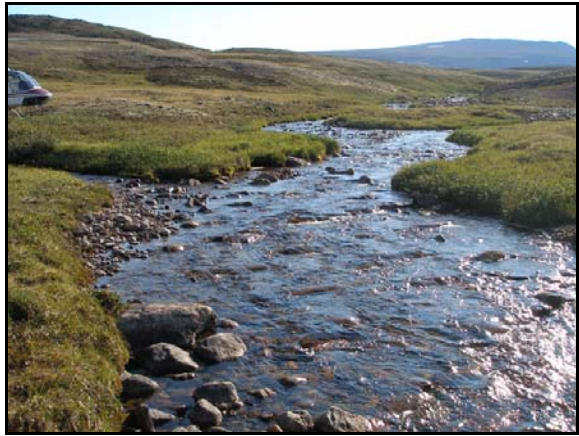
Figure 2: Upstream view from proposed crossing showing more riffle-pool habitat.

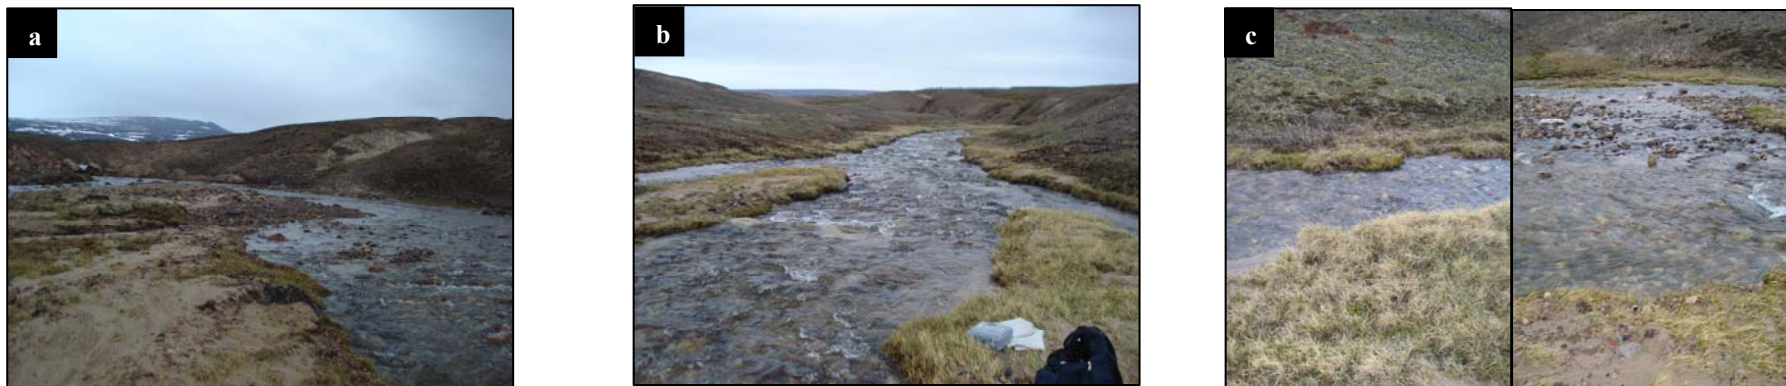
Figure 1. View upstream (a), downstream (b), and across the left and right channels (c) from the habitat assessment downstream of BG-01 during spring 2008.

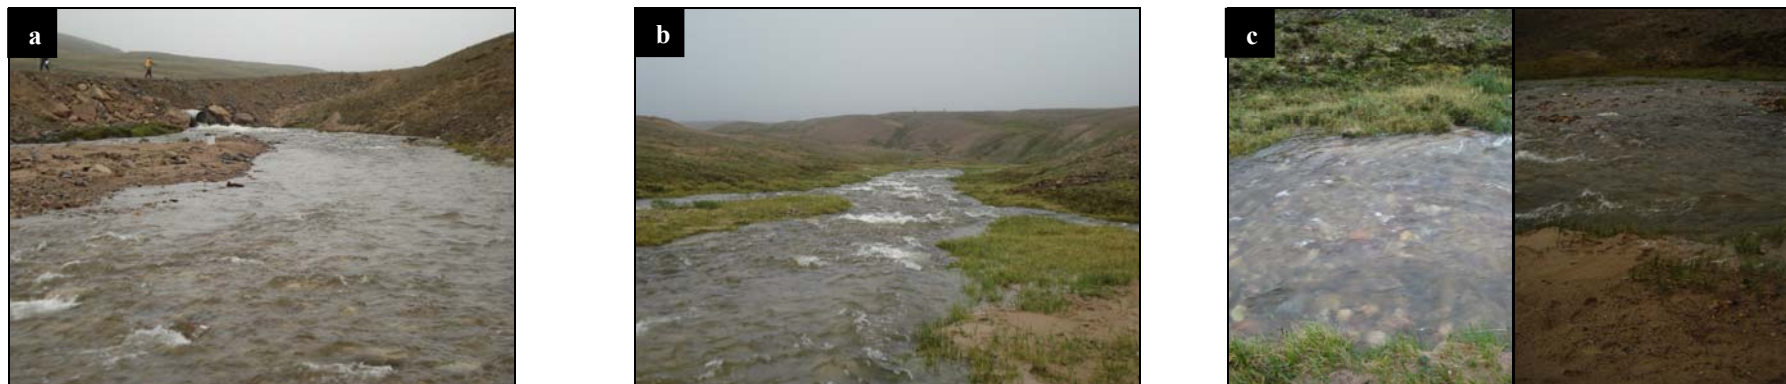
Figure 2. View upstream (a), downstream (b), and across the left and right channels (c) from the habitat assessment downstream of BG-01 during summer 2008.

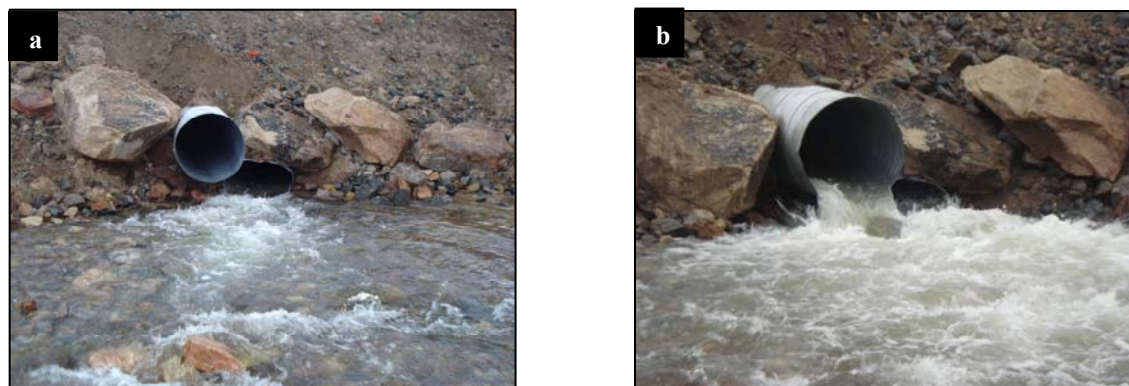
Figure 3. View from the downstream end of the culverts at crossing BG-01 during spring (a) and summer (b) 2008.

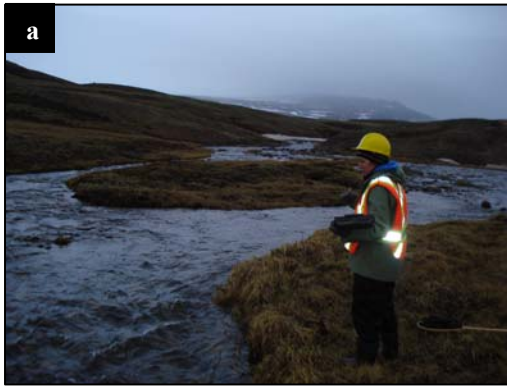
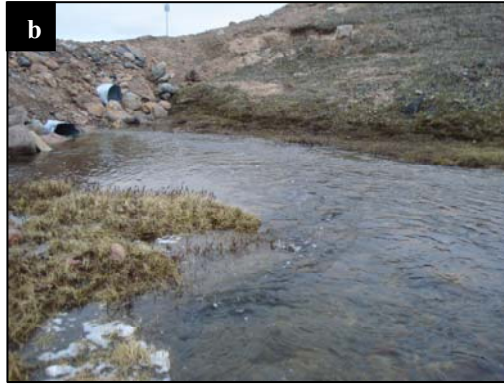
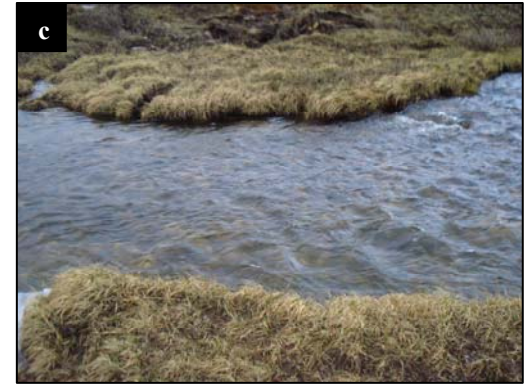
Figure 1. View upstream (a), downstream (b), and across (c) from the habitat assessment upstream of BG-01 during spring 2008.

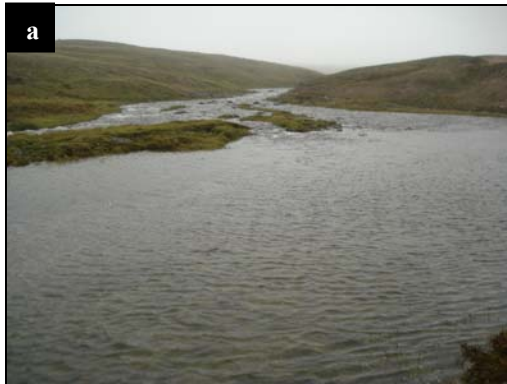
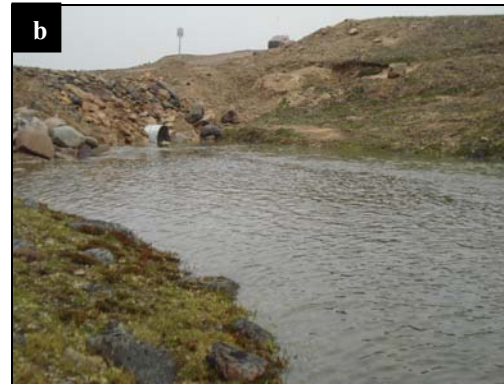
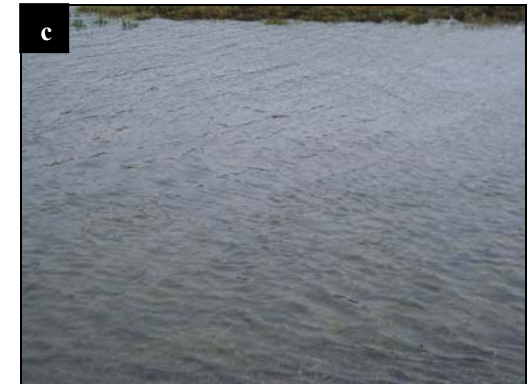
Figure 2. View upstream (a), downstream (b), and across (c) from the habitat assessment upstream of BG-01 during summer 2008.

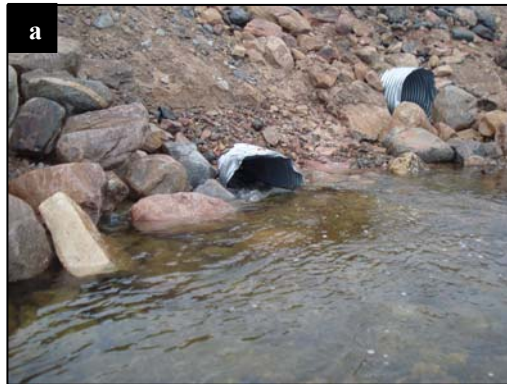
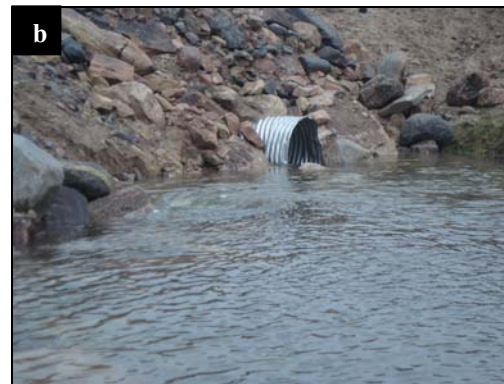
Figure 3. View from the upstream end of the culverts at crossing BG-01 during spring (a) and summer (b) 2008.

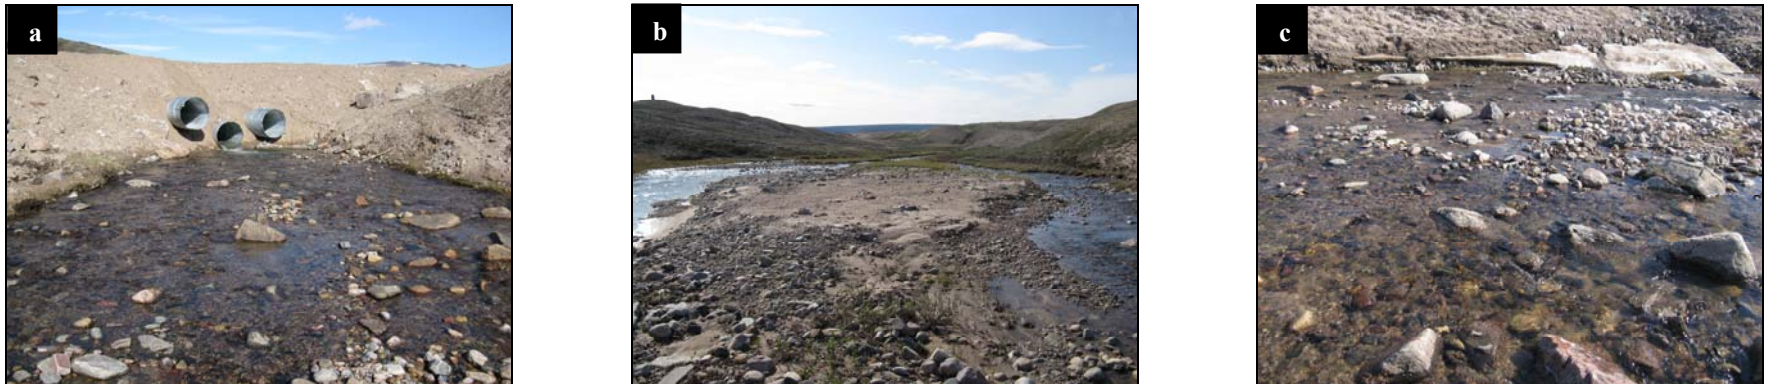
Figure 1. View upstream (a), downstream (b), and across (c) at the habitat assessment site downstream of the crossing at BG-01 during early July, 2009.

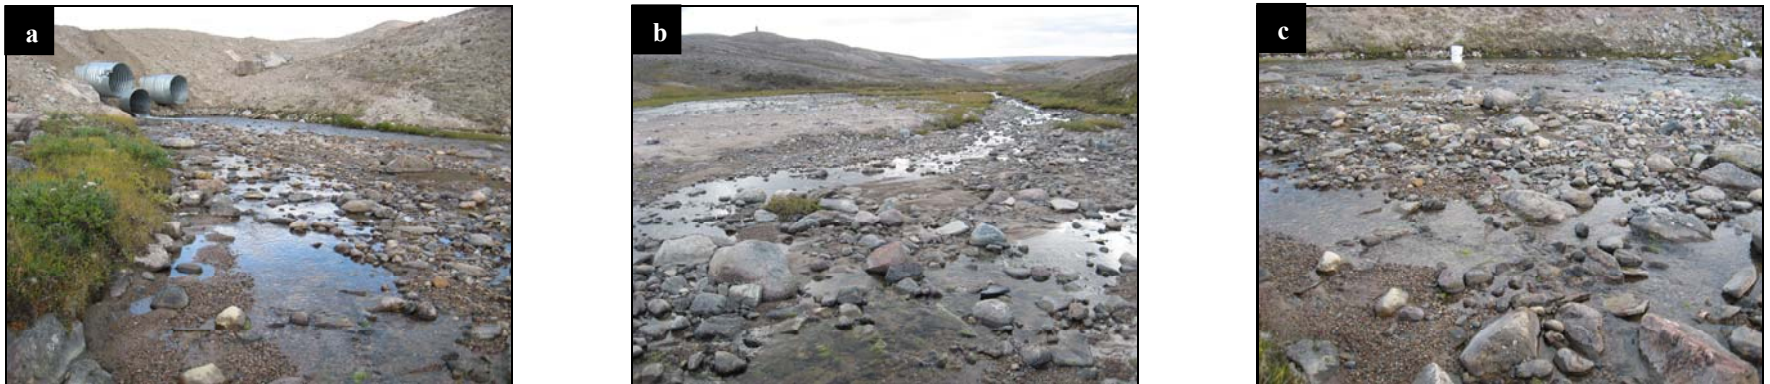
Figure 2. View upstream (a), downstream (b), and across (c) at the habitat assessment site downstream of the crossing at BG-01 during late August, 2009.

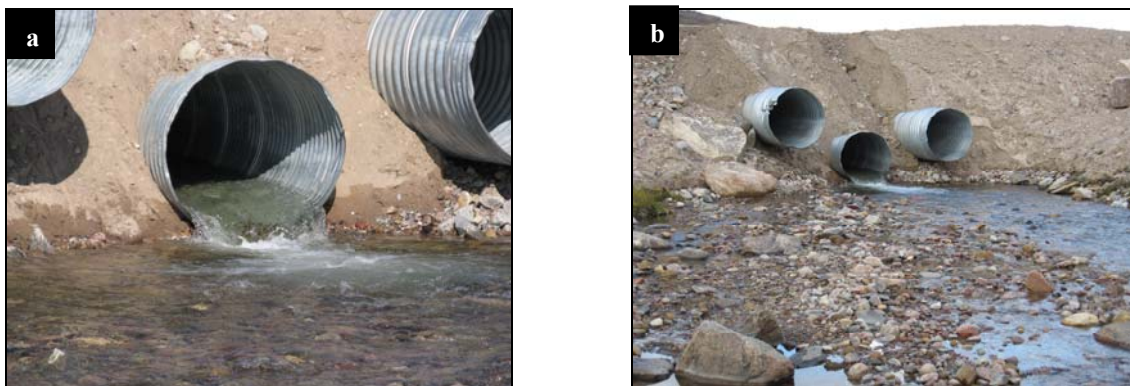
Figure 3. View from the downstream end of the culverts at crossing BG-01 during early July (a) and late August (b), 2009.

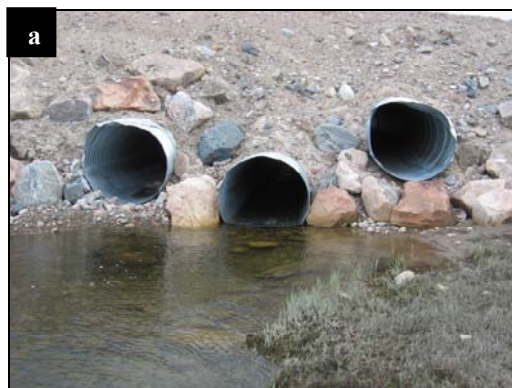
Figure 3. View from the upstream end of the culverts at crossing BG-01 during late August, 2009.

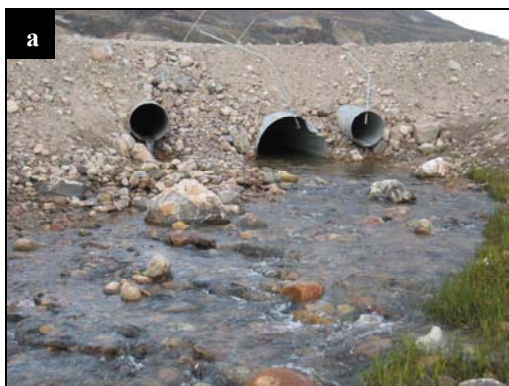
Figure 3. View from the downstream end of the culverts at crossing CV-186 during late August, 2009.
