APPENDIX 5.3-1.

DETAILED HABITAT ASSESSMENTS AND SUMMARY OF RESULTS FOR WATERBODIES IN QUARRY SITES.

Table A5.3-1.1. Summary of results from surveys and assessments that fall within Quarry boundaries.

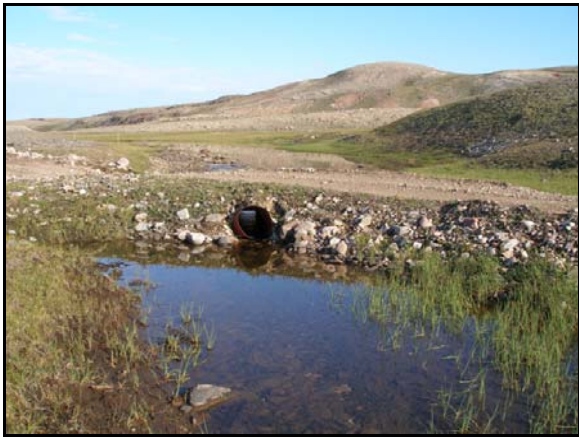
Figure 1: Downstream view from proposed crossing showing pool habitat and existing culvert.

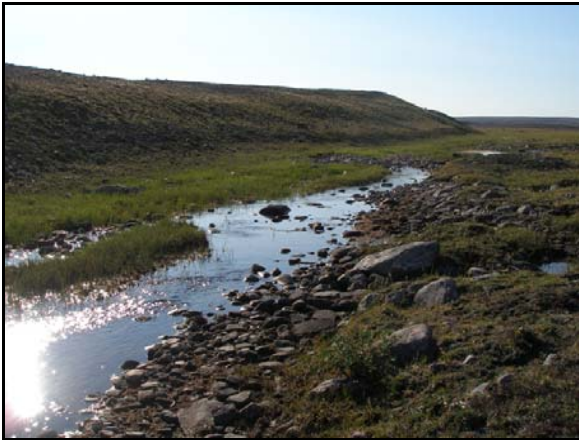
Figure 2: Upstream view from proposed crossing showing riffle-pool habitat.

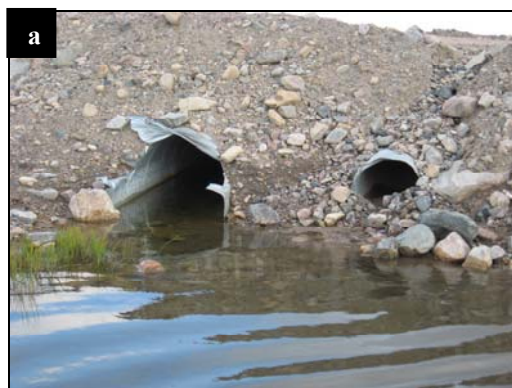
Figure 3. View from the downstream end of the culverts at crossing CV-187 during late August, 2009.
