## AR-CV-144-1

### Description of Crossing Structure

The representative access road culvert, AR-CV-144-1 is located in a section of road that crosses a well-defined valley corridor approximately 90m upstream of proposed rail crossing location CV-144-1, and consists of three 3000mm diameter culverts. The barrels are set in a staggered configuration to ensure that during low-flow conditions there is concentration of flow in the central barrel in order minimize wetted width and maximize flow depth. The secondary culverts are required to convey large design storm events and act as relief culverts if the main barrel becomes blocked by ice and snow during spring freshet. The road embankment slopes will be 1:5:1 with 8.1 m of fill over the culvert invert. The projected 25 year settlement is less than 0.2 m.

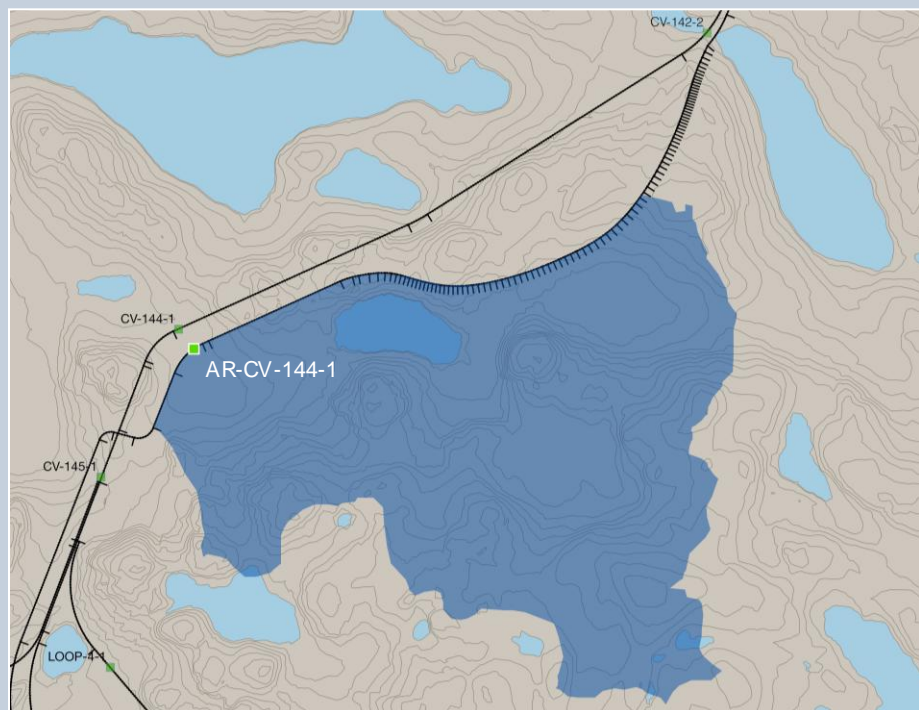
**E337697-2000-07-124-0002**

- Representative Culvert
- ◆ Representative Bridge
- Culvert Locations
- ◆ Bridge Locations
- Drainage Area
- Rail Alignment
- Watercourses
- Lakes

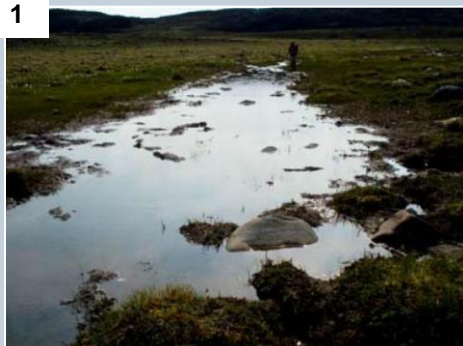
Photo 1 is looking upstream of the crossing. Photo 2 is looking looking downstream and photo 2 is looking across the stream.
