Mary River Iron Mine Nunavut Water Board Water License Application Section 9 Representative Crossing Summary Sheet

CV-52-2

Description of Crossing Structure

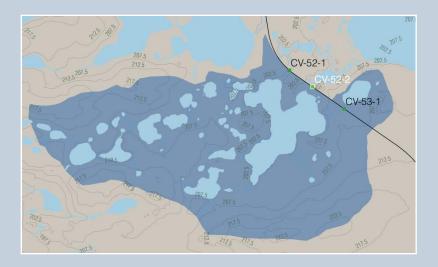
Fish Habitat	Important fish habitat	68 00 100 100
Structure Design	No. Barrels: 4 Diameter: 3m Length: 40m Slope: 0%	CV-52-2
Drainage Area	7.3 km ²	
Design Flow	10 yr 3 day delay = 1.82 m ³ /s 200-yr = 19.8 m ³ /s	
Velocity per Barrel	10 yr 3 day delay = 0.61 m/s 200 yr = 1.01 m/s

The representative culvert CV-52-2 is located approximately 2.5 km northeast of the proposed Mid Rail camp location. CV-52-2 will use four 3 m diameter culverts and the total crossing length is approximately 40 m. The rail culvert crossing will be completely isolated from the access road culvert. The embankment slopes will be 1:2 with 4.9 m of fill over the culvert invert and projected settlement of 25 years is 0.1 m. The culvert gradient will match the channel gradient of 0%
