CV-8-2

E337697-2000-07-124-0008

Description of Crossing Structure

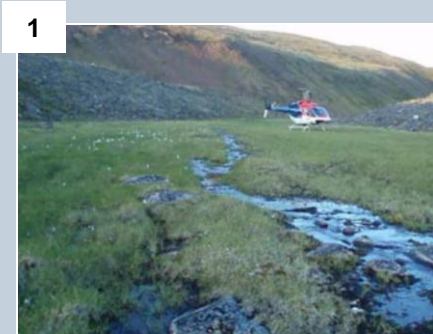
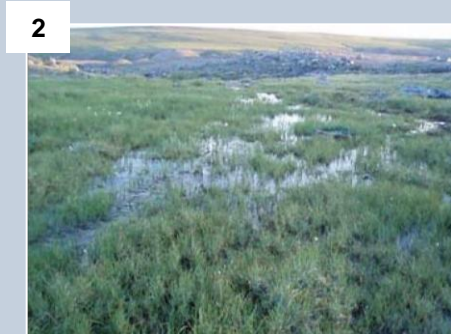
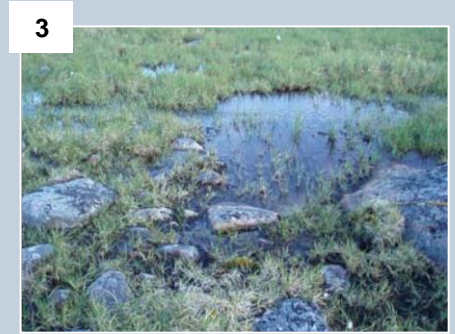
Site Photos

Photo 1 is looking upstream of CV-8-2; both Photo 2 and Photo 3 look downstream.

CV-8-2 is an area of flooded land with a shallow, slightly meandering channel flowing through it. The streambed consists primarily of outwash deposits of sand and gravel intermixed with cobbles and boulders. The channel is a tributary from a pond approximately 500 m upstream of the crossing location. The channel intersects with a larger watercourse (crossed by BR-8-2) that eventually empties into Angajurjualuk Lake. The watercourse at CV-8-2 is not considered fish habitat based on the presence of a very steep cascade downstream of the crossing which fish could not traverse even in high water levels.
