APPENDIX 4.1-1.

DETAILED AQUATIC HABITAT ASSESSMENTS FOR WATERBODIES IN THE MINE AREA BY STREAM AND REACH.

BAFFINLAND IRON MINES CORPORATION		
MARY RIVER PROJECT		
PRESENCE AND ABSENCE OF ARCTIC CHAR IN CAMP LAKE TRIBUTARIES		
  North/South Consultants Inc. Aquatic Environment Specialists	PIANO. -	REF NO. -
	DATE: 01/09/2010	REV -

Mine Site Aquatic Habitat Assessment

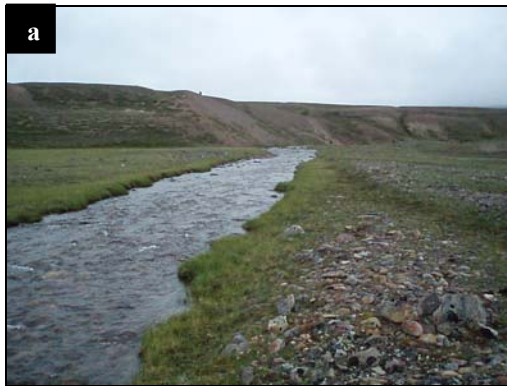
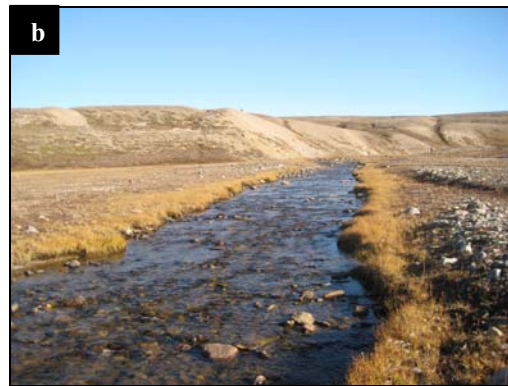
Figure 1. View upstream from habitat assessment in reach 1 of Camp Lake Tributary 1 during summer (a) and fall (b).

Watercourse Name: Camp Lake Tributary #1
Site: Reach 1

Channel Morphology: 90% riffle,
10% pool

Substrate Composition: 90% cobble,
5% sand,
5% boulder

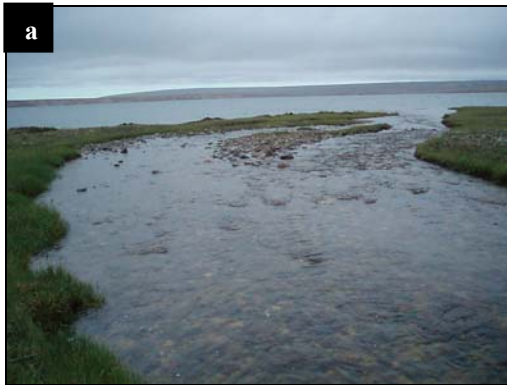
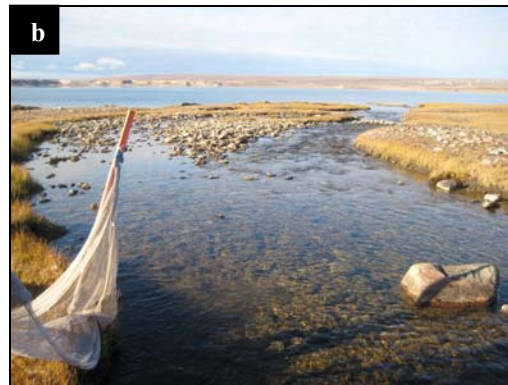
Figure 2. View downstream from habitat assessment in reach 1 of Camp Lake Tributary 1 during summer (a) and fall (b).

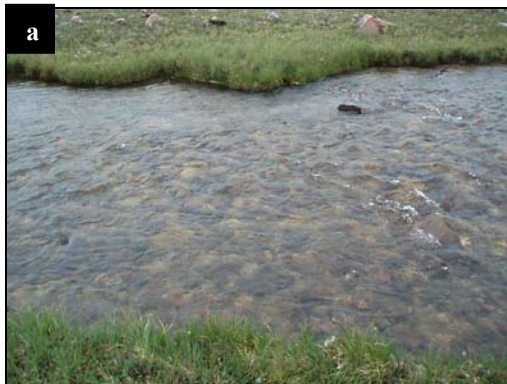
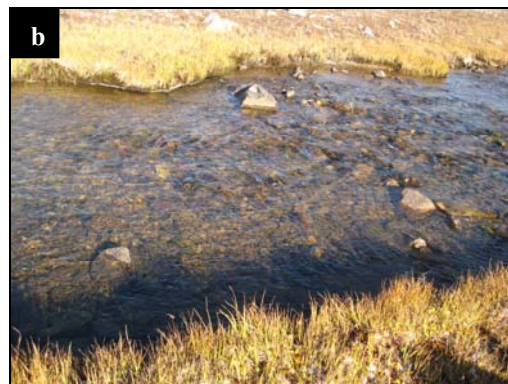
Figure 3. View across the habitat assessment site in reach 1 of Camp Lake Tributary 1 during summer (a) and fall (b).

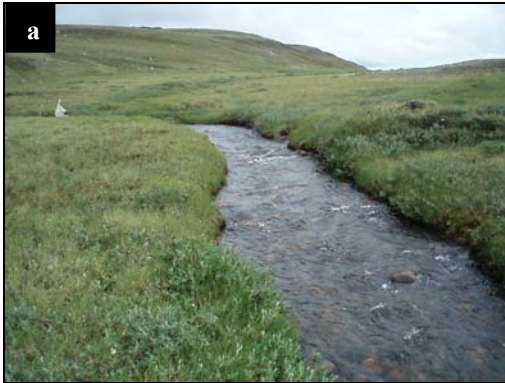
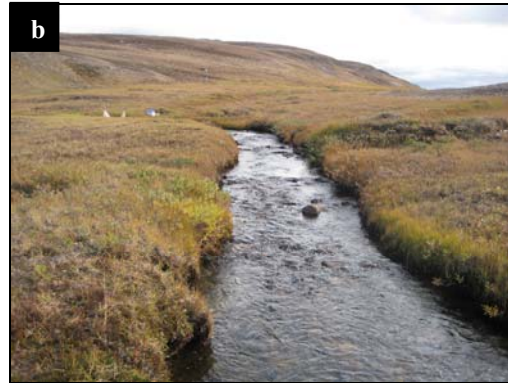
Figure 1. View upstream from habitat assessment in reach 2 of Camp Lake Tributary 1 during summer (a) and fall (b).

Watercourse Name: Camp Lake Tributary #1
Site: Reach 2

Channel Morphology: 85% riffle,
15% pool

Substrate Composition: 90% cobble,
10% boulder

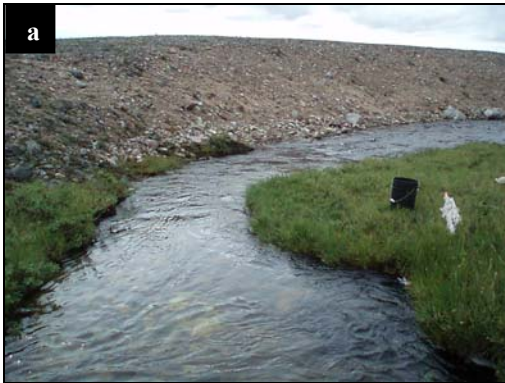
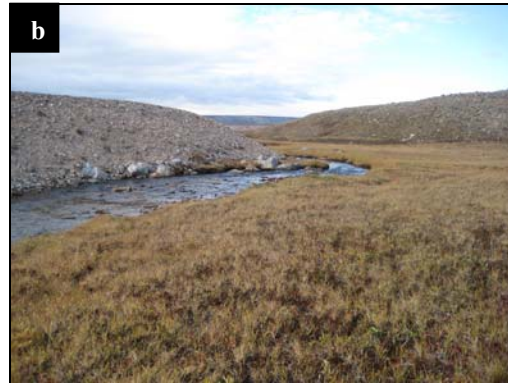
Figure 2. View downstream from habitat assessment in reach 2 of Camp Lake Tributary 1 during summer (a) and fall (b).

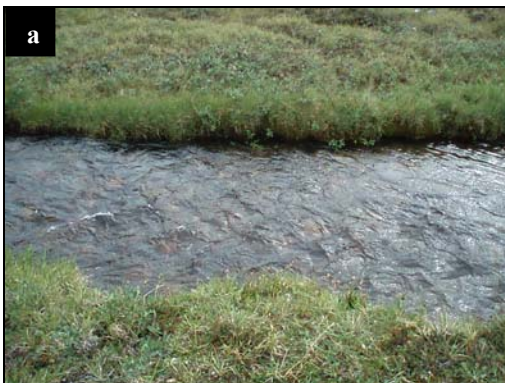
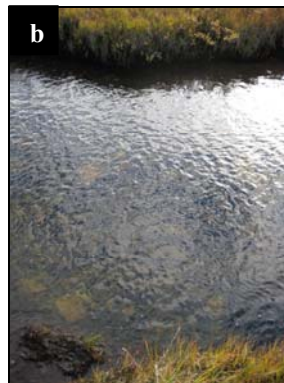
Figure 3. View across the habitat assessment site in reach 2 of Camp Lake Tributary 1 during summer (a) and fall (b).

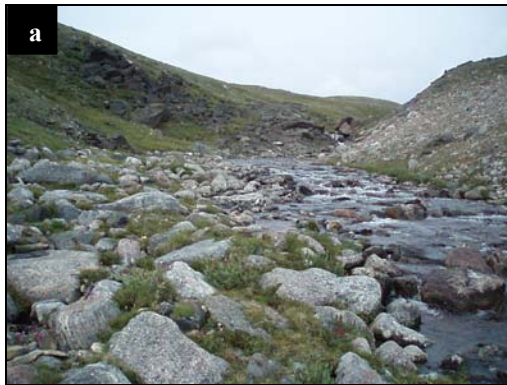
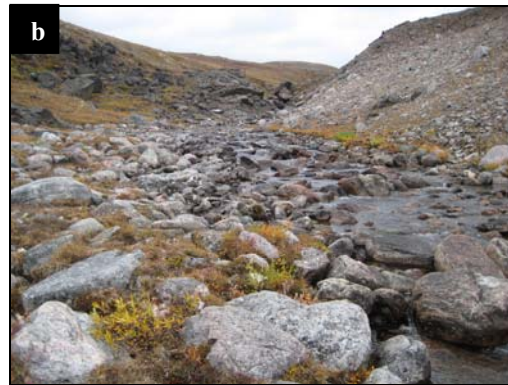
Figure 1. View upstream from habitat assessment in reach 3 of Camp Lake Tributary 1 during summer (a) and fall (b).

Watercourse Name: Camp Lake Tributary #1
Site: Reach 3

Confinement:	Confined		
Channel Gradient:	2.5°		
Hydrology			
	Spr	Sum	Fall
Bankfull Width (m):	NA	18.83	18.83
Wetted Width (m):	NA	9.13	7.40
Cascade-Crest Depth (m):	NA	0.21	0.18
Pool Depth (m):	NA	0.33	0.16
D (m):	NA	0.06	0.03
D₉₅ (m):	NA	0.74	0.74
Point Velocities (m/s)			
Cascade:	NA	1.02	1.26
Pool:	NA	0.02	0.05
Behind a rock:	NA	0.01	NM

Stream/Riparian Habitat			
Channel Morphology:	60% cascade, 40% pool		
Substrate Composition:	60% cobble, 35% boulder, 5% sand		
Stream Cover:	35% boulder, 5% deep pool		
Aquatic Vegetation:	Periphyton		
Riparian Vegetation:	Grasses, moss, willow, wildflowers		
Barriers Present (Y/N):	Y		
Location:	US ~ 50m		
Lakes Present (Y/N):	Y		
Location:	DS – Camp L.		
L/R Bank Characteristics			
	Spr	Sum	Fall
Bank Height (L/R; m):	NA	UD	UD
Bank Stability:	NA	NM	NM
Erosion Potential:	NA	NM	NM

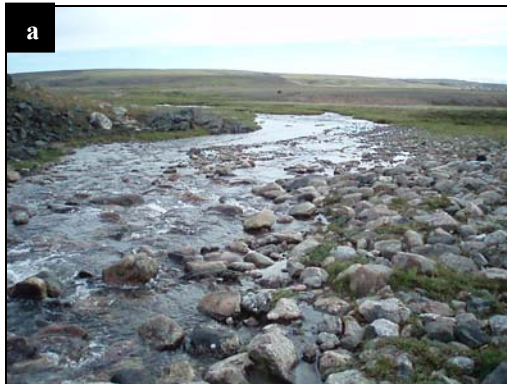
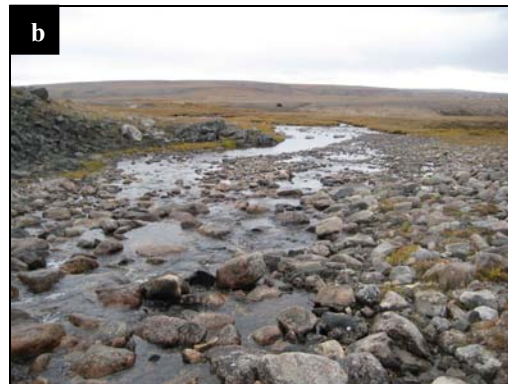
Figure 2. View downstream from habitat assessment in reach 3 of Camp Lake Tributary 1 during summer (a) and fall (b).

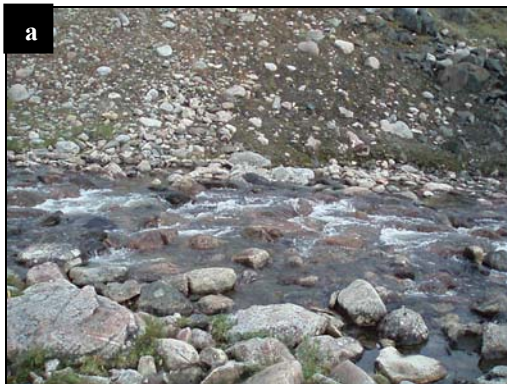
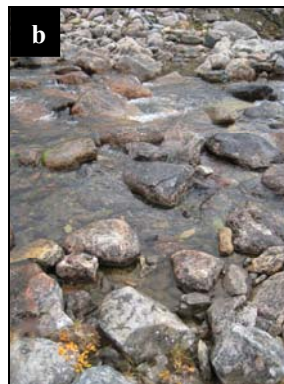
Figure 3. View across the habitat assessment site in reach 3 of Camp Lake Tributary 1 during summer (a) and fall (b).

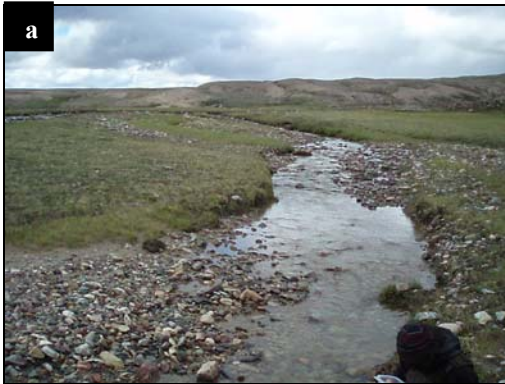
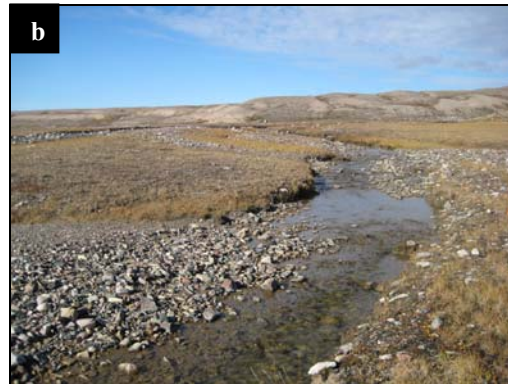
Figure 1. View upstream from habitat assessment in reach 1 (right channel) of Camp Lake Tributary 2 during summer (a) and fall (b).

Watercourse Name: Camp Lake Tributary #2
Site: Reach 1

Channel Morphology: 50% riffle, 50% pool

Substrate Composition: 35% cobble, 35% gravel, 30% sand

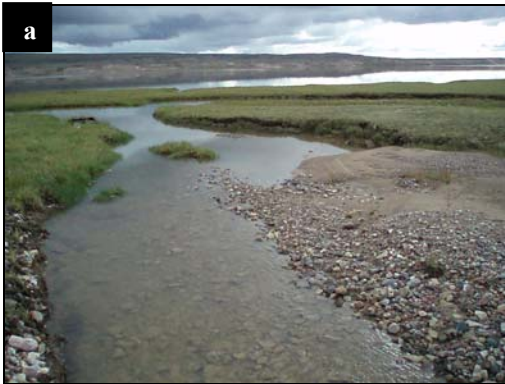
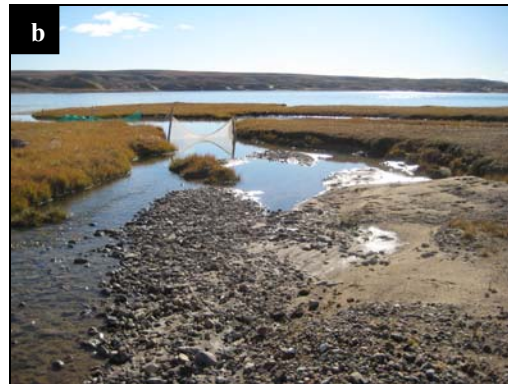
Figure 2. View downstream from habitat assessment in reach 1 (right channel) of Camp Lake Tributary 2 during summer (a) and fall (b).

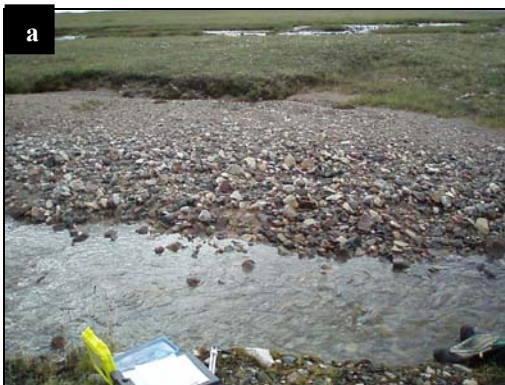
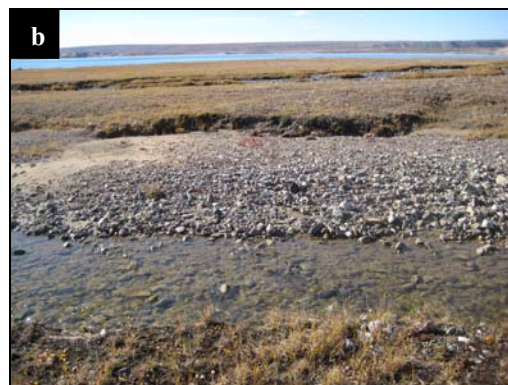
Figure 3. View across the habitat assessment site in reach 1 (right channel) of Camp Lake Tributary 2 during summer (a) and fall (b).

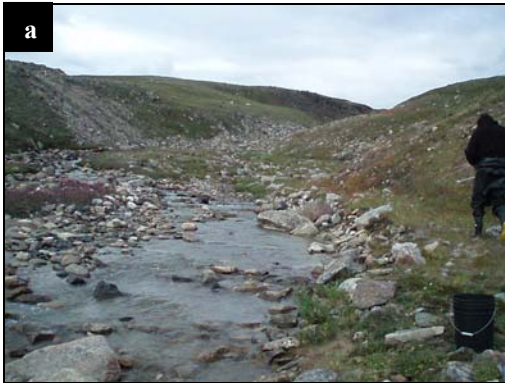
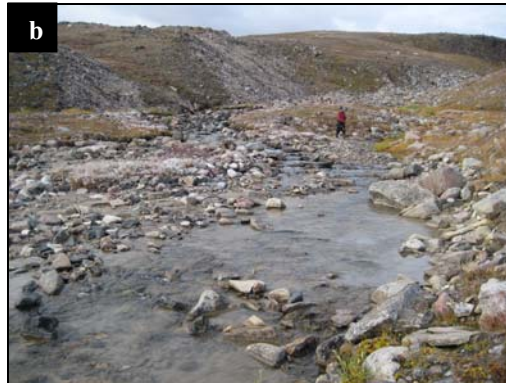
Figure 1. View upstream from habitat assessment in reach 2 of Camp Lake Tributary 2 during summer (a) and fall (b).

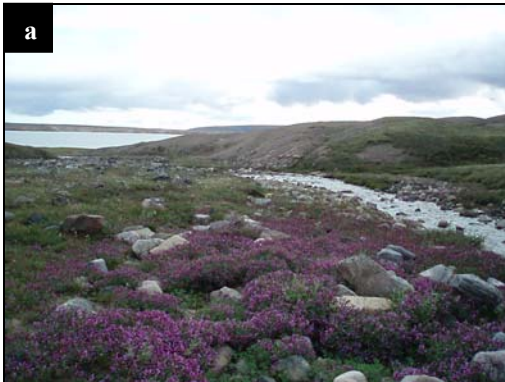
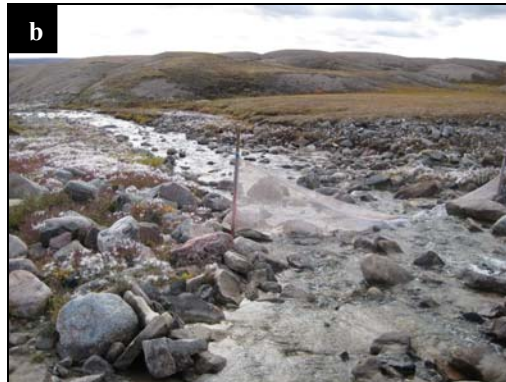
Figure 2. View downstream from habitat assessment in reach 2 of Camp Lake Tributary 2 during summer (a) and fall (b).

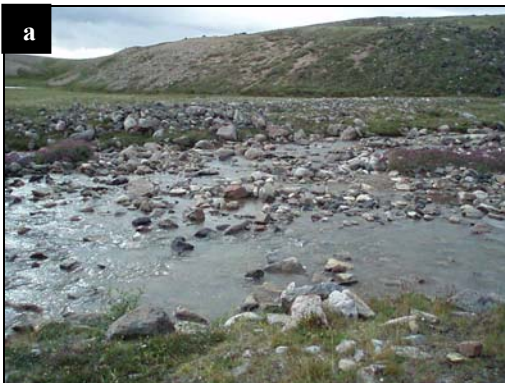
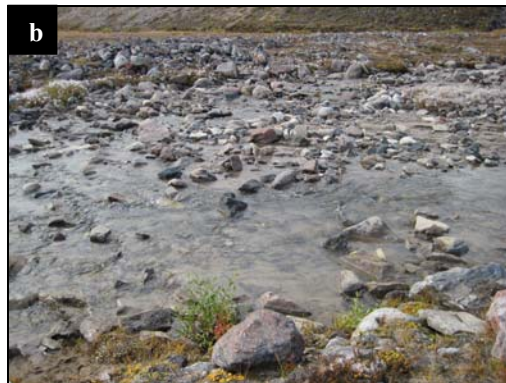
Figure 3. View across the habitat assessment site in reach 2 of Camp Lake Tributary 2 during summer (a) and fall (b).

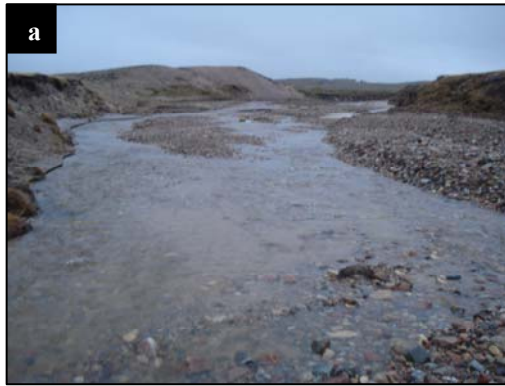
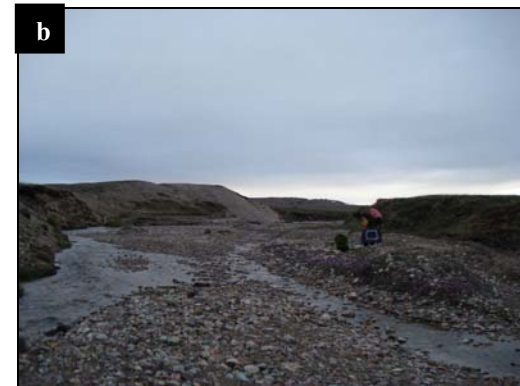
Figure 1. View upstream from habitat assessment in reach 1 of Camp Lake Tributary 3 during spring (a) and summer (b) 2008.

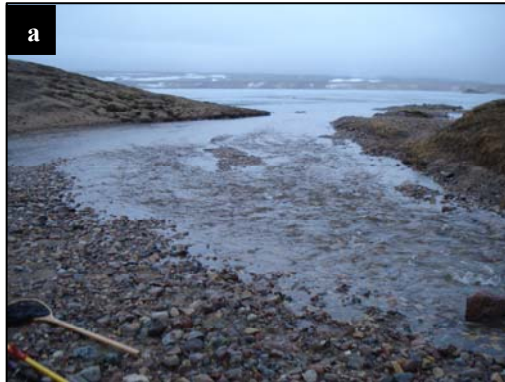
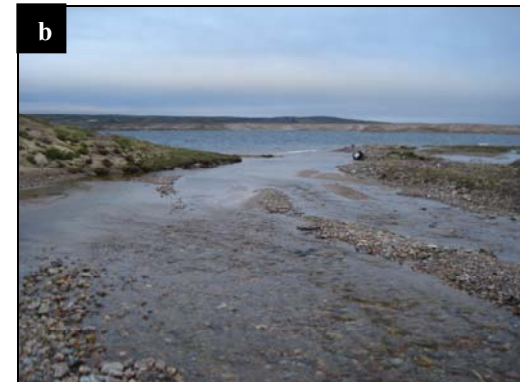
Figure 2. View downstream from habitat assessment in reach 1 of Camp Lake Tributary 3 during spring (a) and summer (b) 2008.

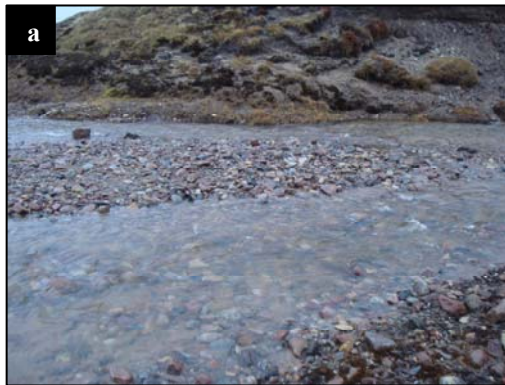
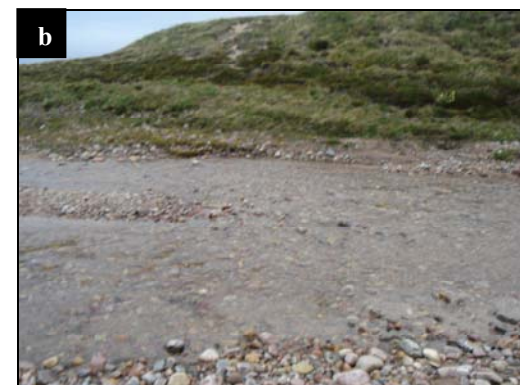
Figure 3. View across the habitat assessment site in reach 1 of Camp Lake Tributary 3 during spring (a) and summer (b) 2008.

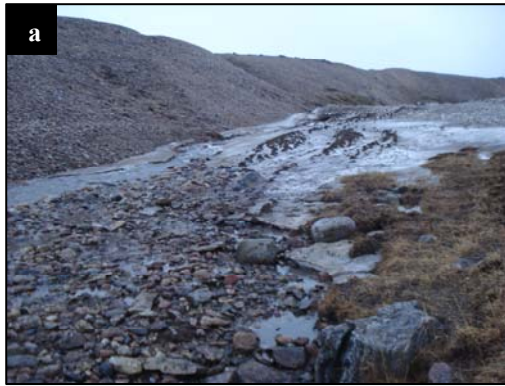
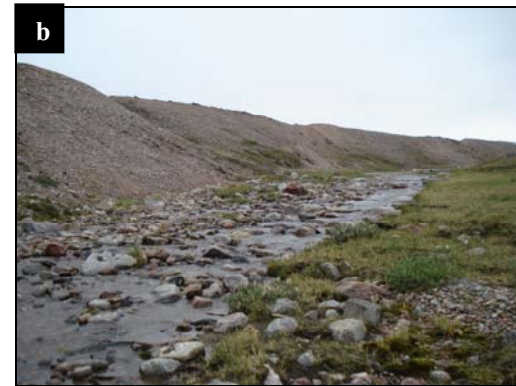
Figure 1. View upstream from habitat assessment in reach 2 of Camp Lake Tributary 3 during spring (a) and summer (b) 2008.

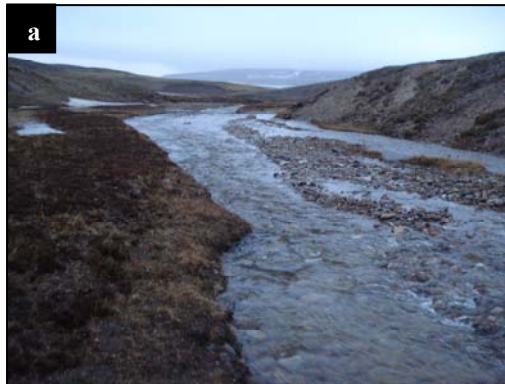
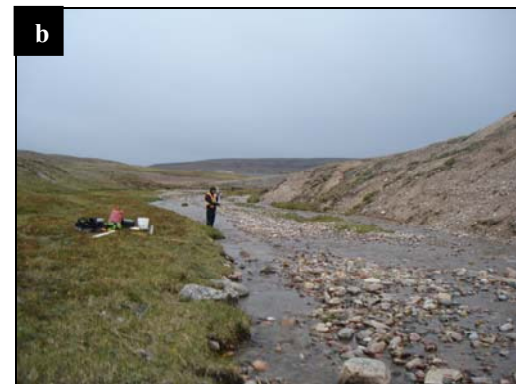
Figure 2. View downstream from habitat assessment in reach 2 of Camp Lake Tributary 3 during spring (a) and summer (b) 2008.

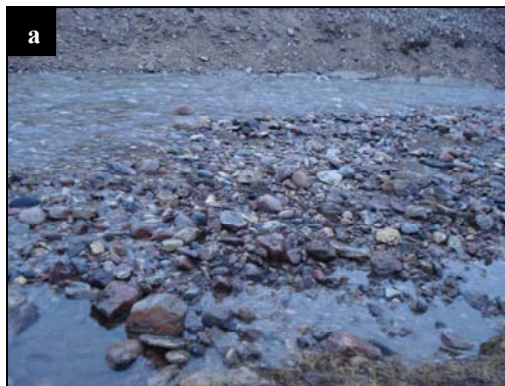
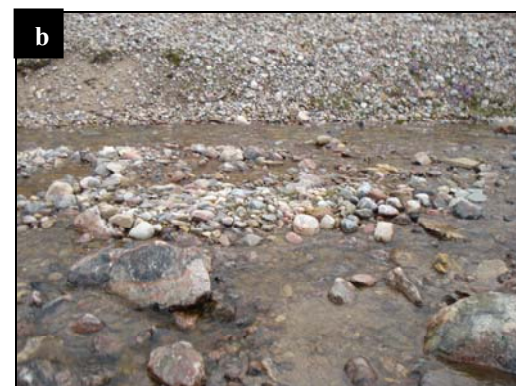
Figure 3. View across from habitat assessment in reach 2 of Camp Lake Tributary 3 during spring (a) and summer (b) 2008.

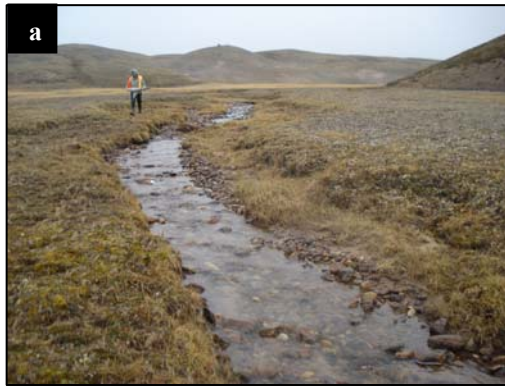
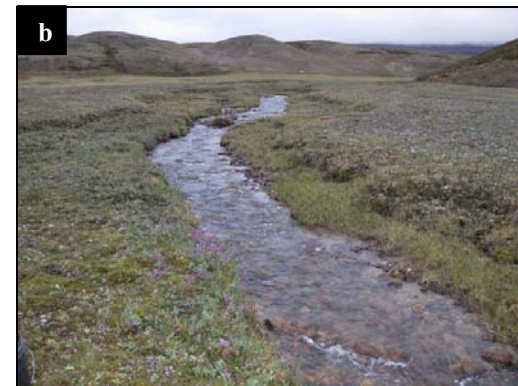
Figure 1. View upstream from habitat assessment in Reach 1 of Camp Lake Tributary 4 during spring (a) and summer (b) 2008.

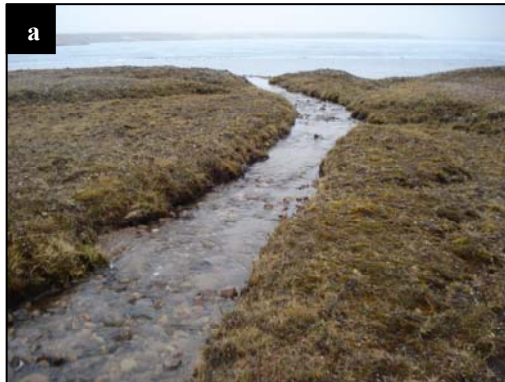
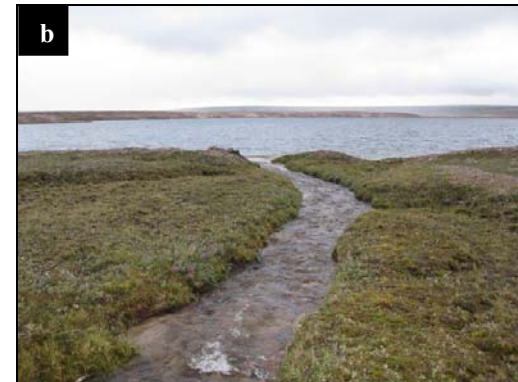
Figure 2. View downstream from habitat assessment in Reach 1 of Camp Lake Tributary 4 during spring (a) and summer (b) 2008.

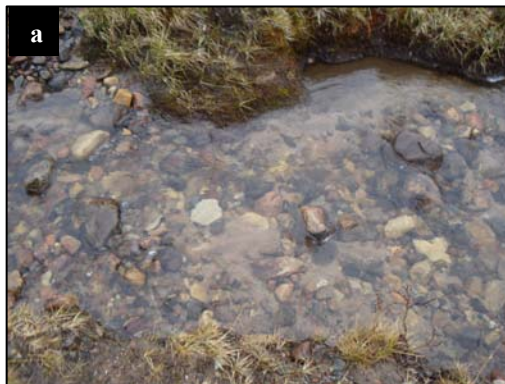
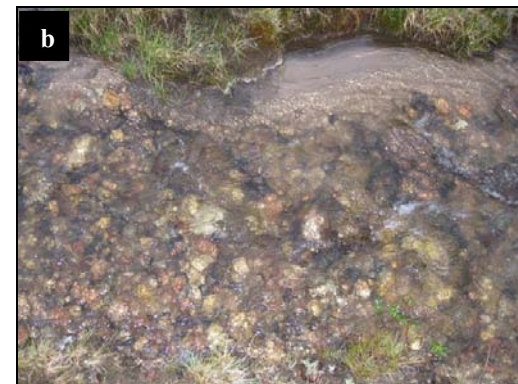
Figure 3. View across the habitat assessment site in Reach 1 of Camp Lake Tributary 4 during spring (a) and summer (b) 2008.

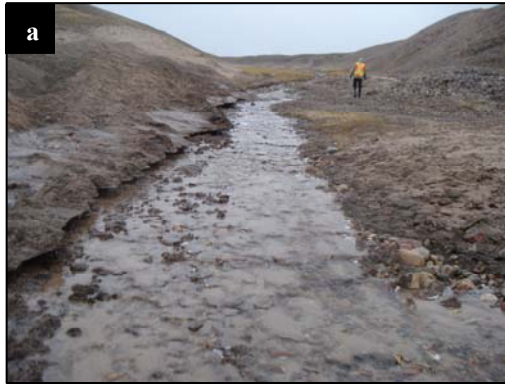
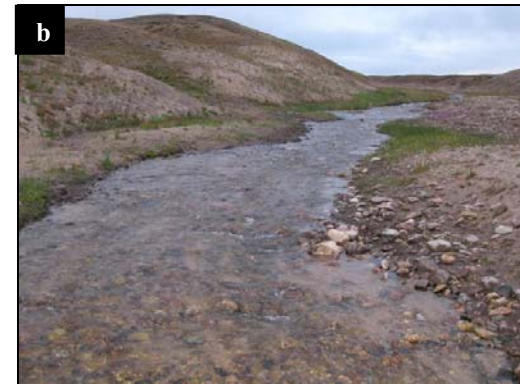
Figure 1. View upstream from habitat assessment in Reach 2 of Camp Lake Tributary 4 during spring (a) and summer (b) 2008.

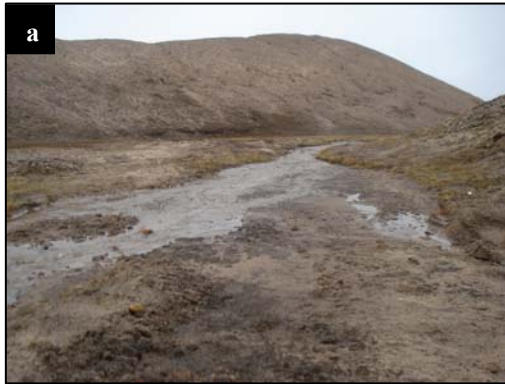
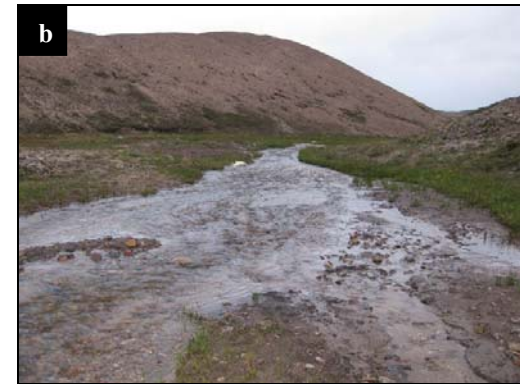
Figure 2. View downstream from habitat assessment in Reach 2 of Camp Lake Tributary 4 during spring (a) and summer (b) 2008.

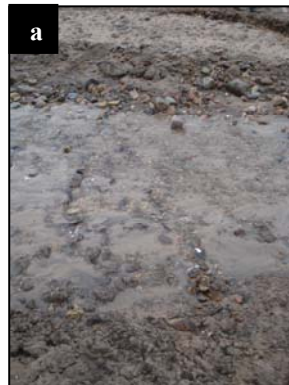
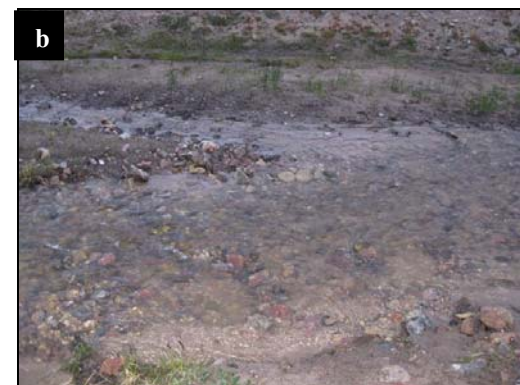
Figure 3. View across from habitat assessment in Reach 2 of Camp Lake Tributary 4 during spring (a) and summer (b) 2008.

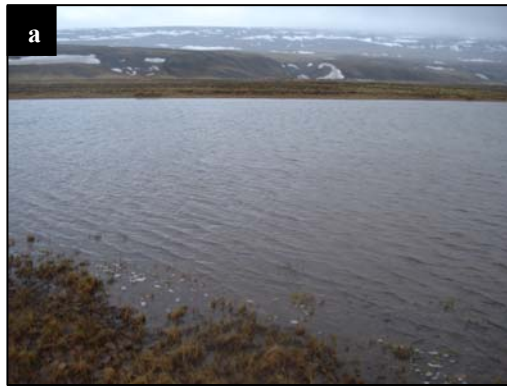
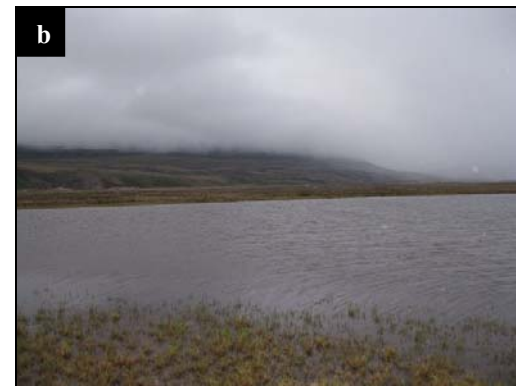
Figure 1. View northeast from habitat assessment in upstream pond of Camp Lake Tributary 4 during spring (a) and summer (b) 2008.

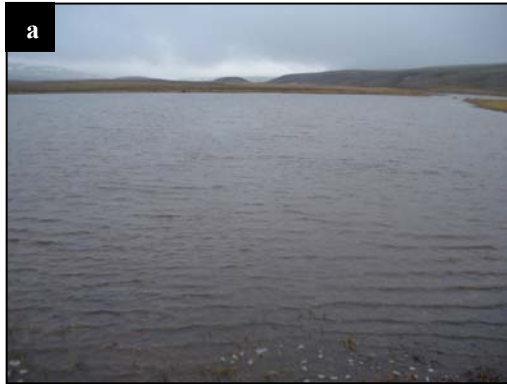
Figure 2. View ESE from habitat assessment in upstream pond of Camp Lake Tributary 4 during spring (a) and summer (b) 2008.

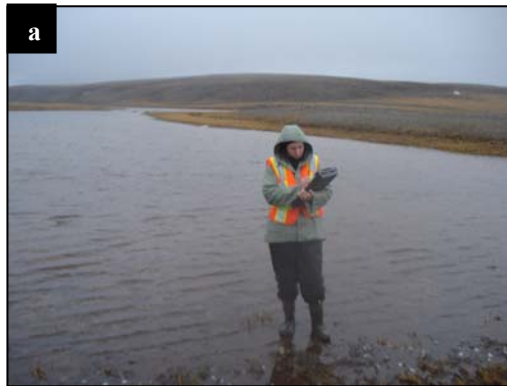
Figure 3. View SE from habitat assessment in upstream pond of Camp Lake Tributary 4 during spring (a) and summer (b) 2008.

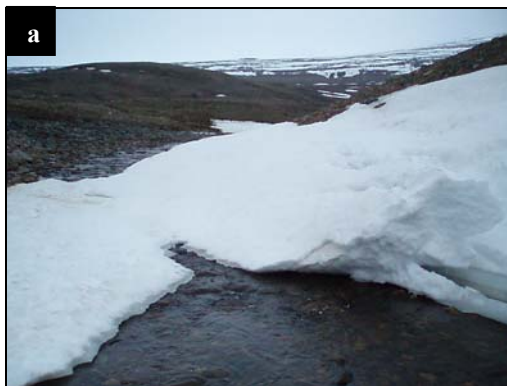
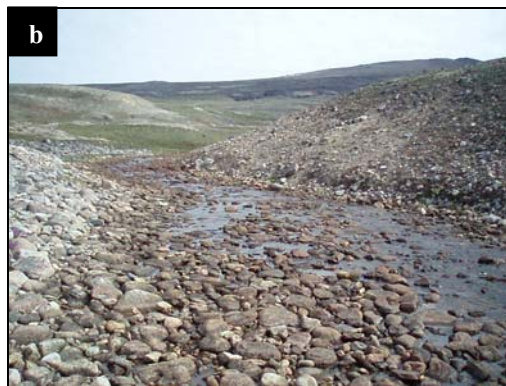
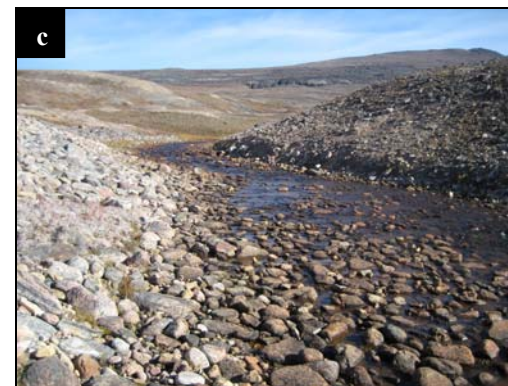
Figure 1. View upstream from habitat assessment in reach 1 of Sheardown Lake Tributary 1 during spring (a), summer (b), and fall (c).

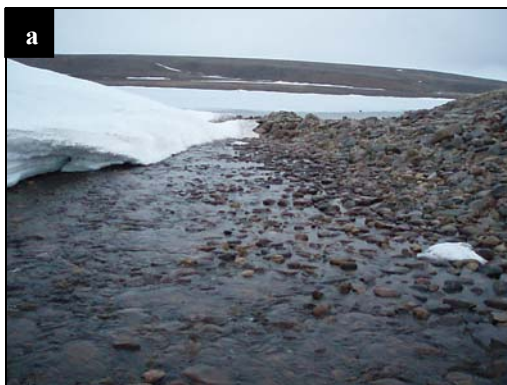
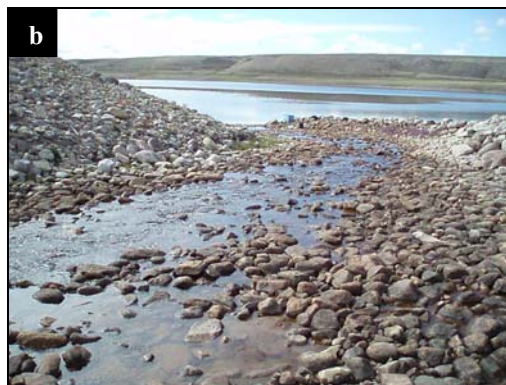
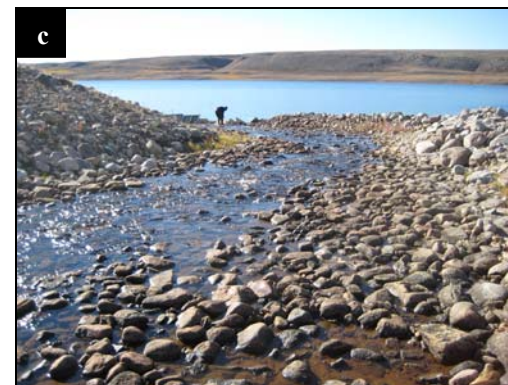
Figure 2. View downstream from habitat assessment in reach 1 of Sheardown Lake Tributary 1 during spring (a), summer (b), and fall (c).

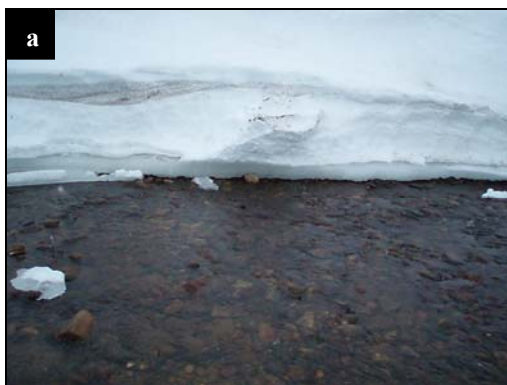
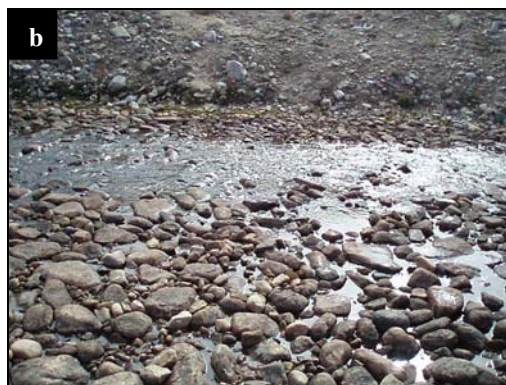
Figure 3. View across the habitat assessment site in reach 1 of Sheardown Lake Tributary 1 during spring (a), summer (b), and fall (c).

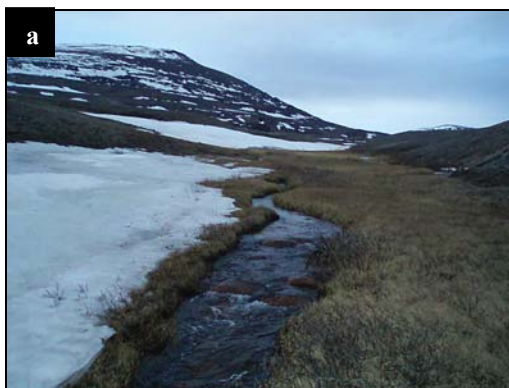
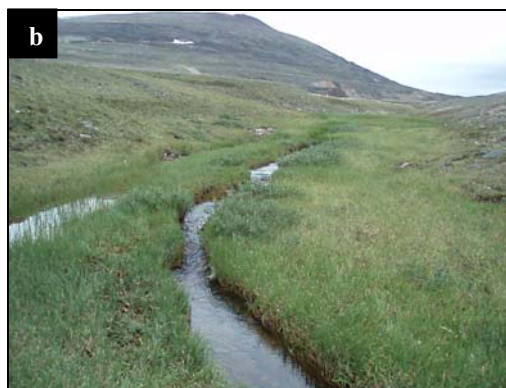
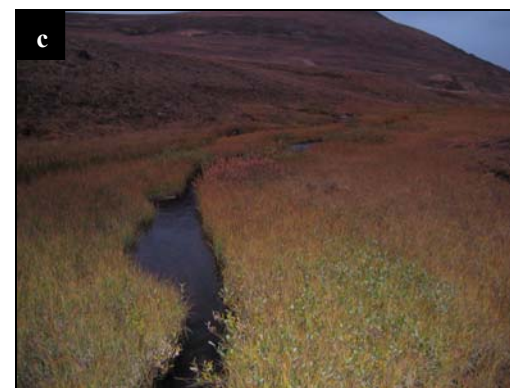
Figure 1. View upstream from habitat assessment in reach 2 of Sheardown Lake Tributary 1 during spring (a), summer (b), and fall (c).

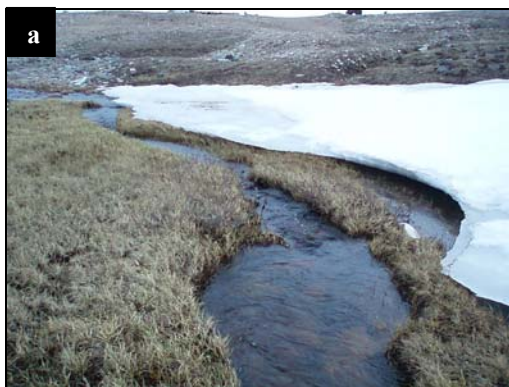
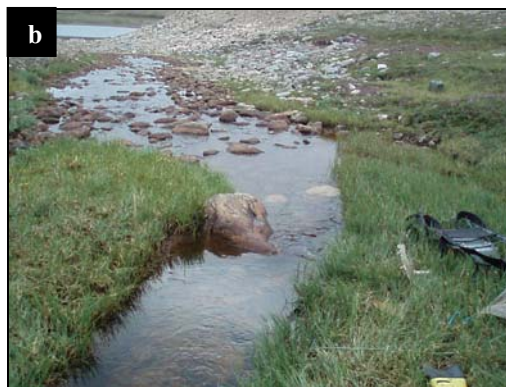
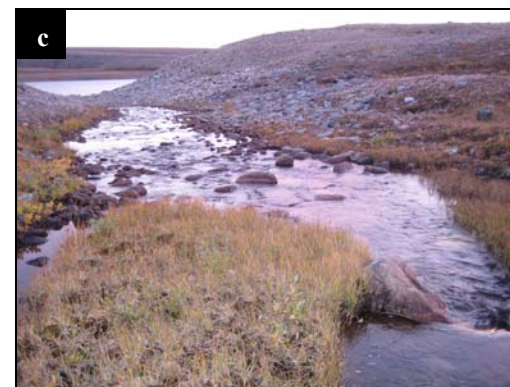
Figure 2. View downstream from habitat assessment in reach 2 of Sheardown Lake Tributary 1 during spring (a), summer (b), and fall (c).

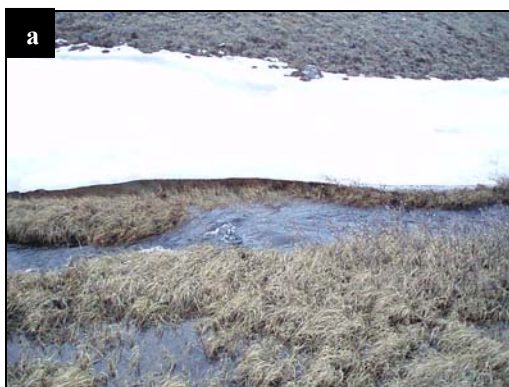
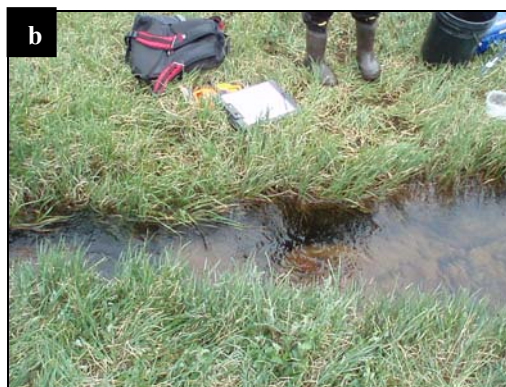
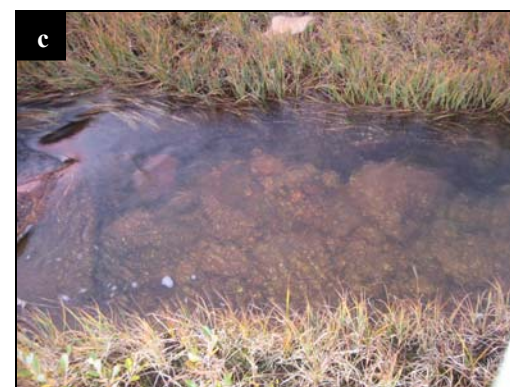
Figure 3. View across the habitat assessment site in reach 2 of Sheardown Lake Tributary 1 during spring (a), summer (b), and fall (c).

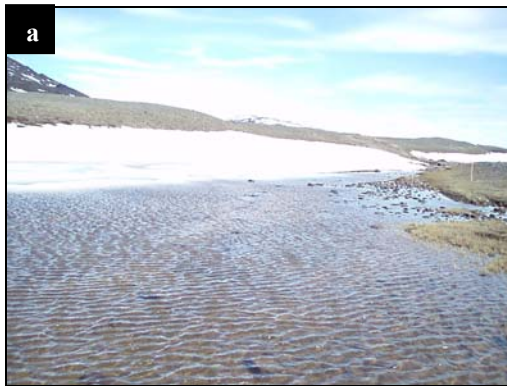
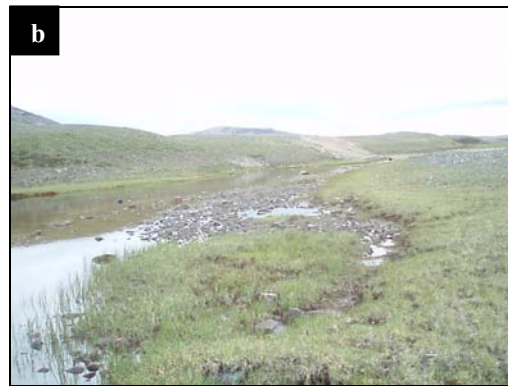
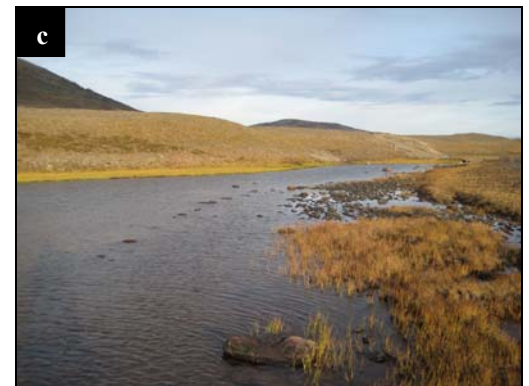
Figure 1. View upstream from habitat assessment in reach 3 of Sheardown Lake Tributary 1 during spring (a), summer (b), and fall (c).

Watercourse Name: Sheardown Lake Tributary #1
Site: Reach 3

Channel Morphology: 100% pool
Substrate Composition: 90% silt,
5% sand,
5% boulder
Stream Cover: 5% boulder
Aquatic Vegetation: Periphyton,
submerged RV
Riparian Vegetation: Grasses and moss
Barriers Present (Y/N): N
Location: NA
Lakes Present (Y/N): Y
Location: DS – Sheardown L.

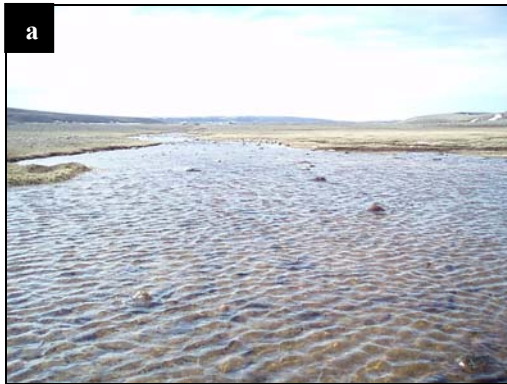
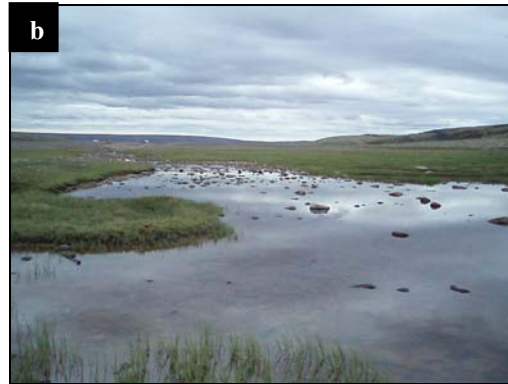
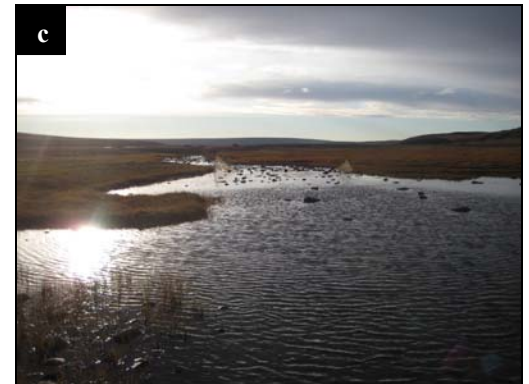
Figure 2. View downstream from habitat assessment in reach 3 of Sheardown Lake Tributary 1 during spring (a), summer (b), and fall (c).

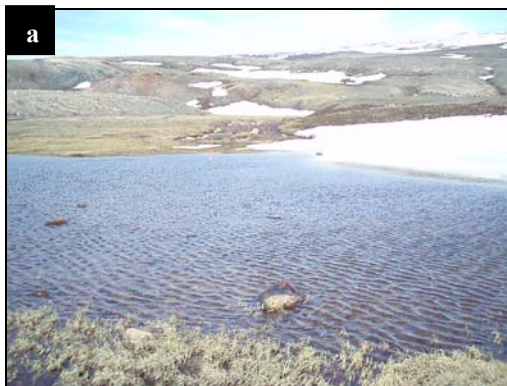
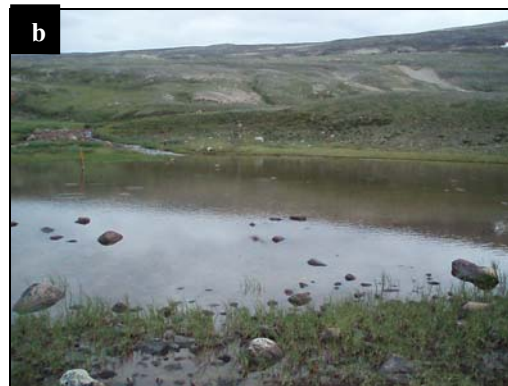
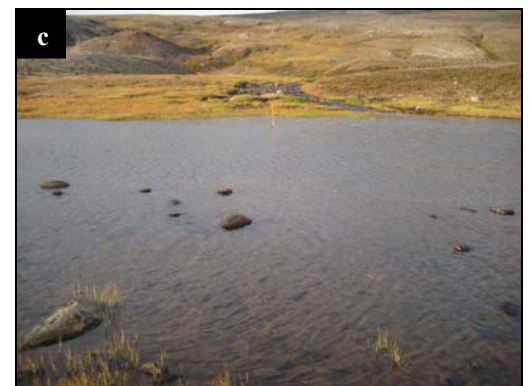
Figure 3. View across the habitat assessment site in reach 3 of Sheardown Lake Tributary 1 during spring (a), summer (b), and fall (c).

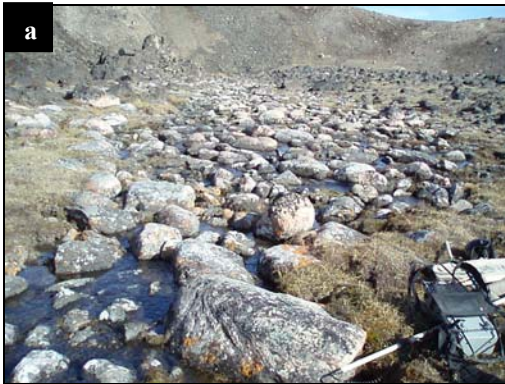
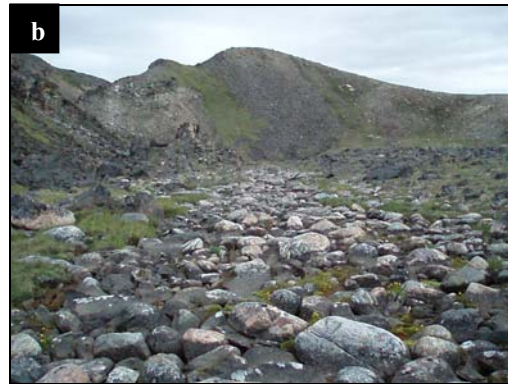
Figure 1. View upstream from habitat assessment in reach 4 of Sheardown Lake Tributary 1 during spring (a) and summer (b).

Watercourse Name: Sheardown Lake Tributary #1
Site: Reach 4

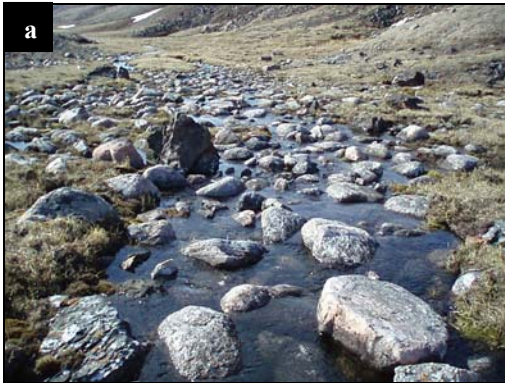
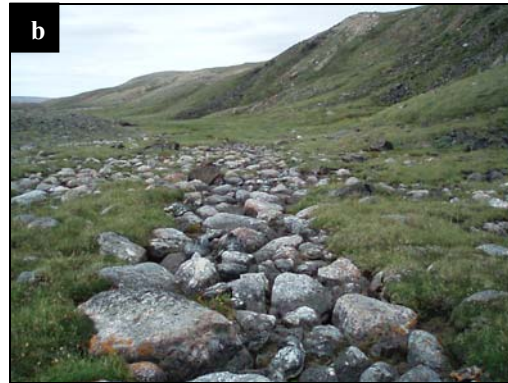
Figure 2. View downstream from habitat assessment in reach 4 of Sheardown Lake Tributary 1 during spring (a) and summer (b).

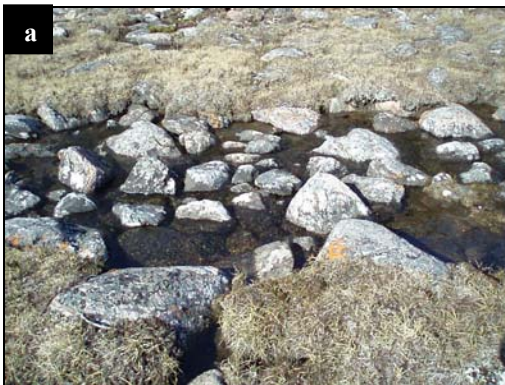
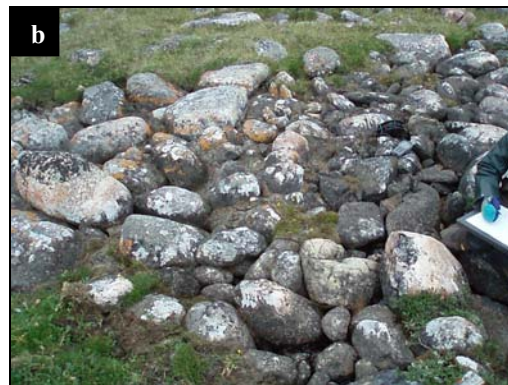
Figure 3. View across the habitat assessment site in reach 4 of Sheardown Lake Tributary 1 during spring (a) and summer (b).

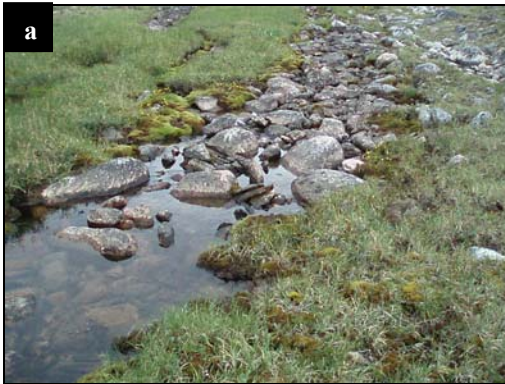
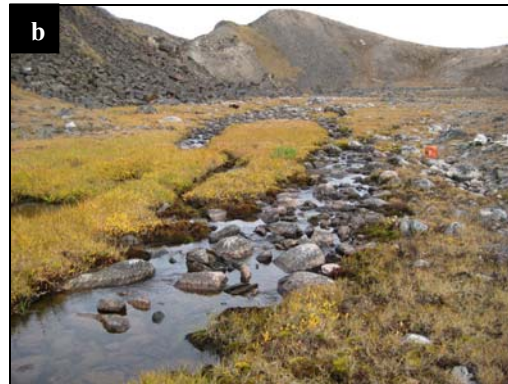
Figure 1. View upstream from habitat assessment in reach 4b of Sheardown Lake Tributary 1 during summer (a) and fall (b).

Watercourse Name: Sheardown Lake Tributary #1
Site: Reach 4b

Channel Morphology: 60% riffle, 40% pool

Substrate Composition: 70% cobble, 20% boulder, 10% gravel

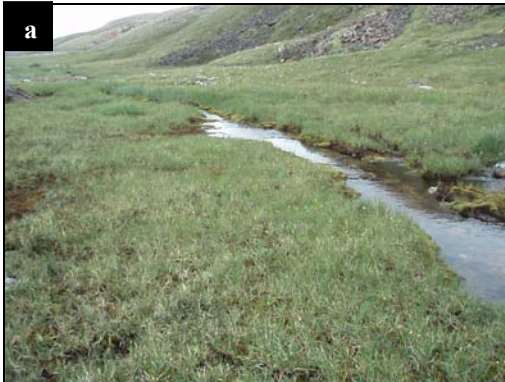
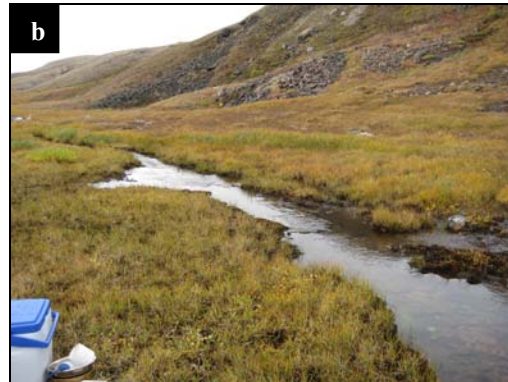
Figure 2. View downstream from habitat assessment in reach 4b of Sheardown Lake Tributary 1 during summer (a) and fall (b).

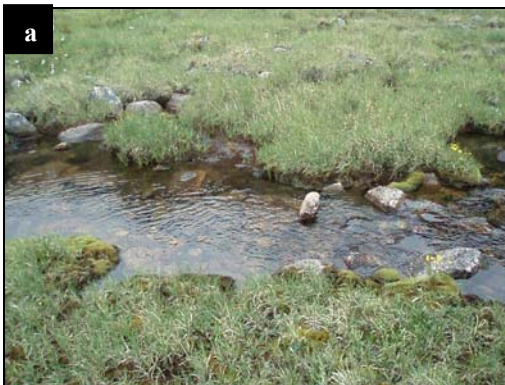
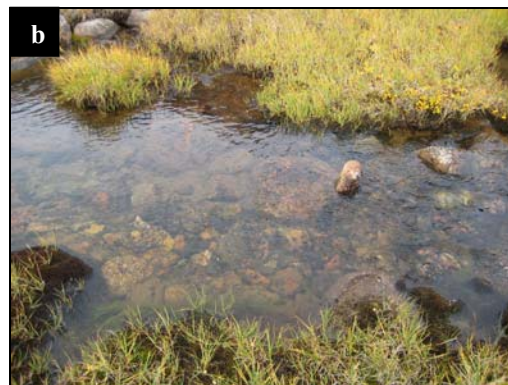
Figure 3. View across the habitat assessment site in reach 4b of Sheardown Lake Tributary 1 during summer (a) and fall (b).

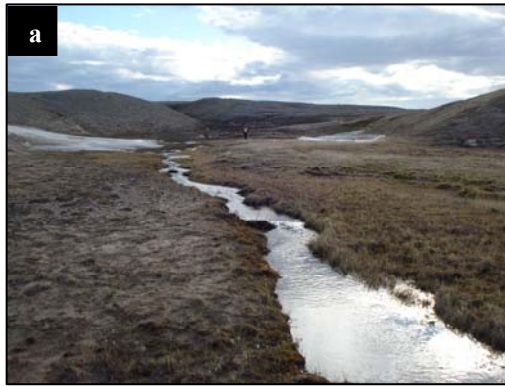
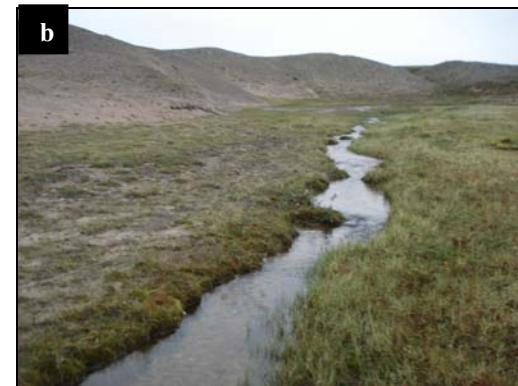
Figure 1. View upstream from habitat assessment in reach 1 of Sheardown Lake Tributary #7 during spring (a) and summer (b) 2008.

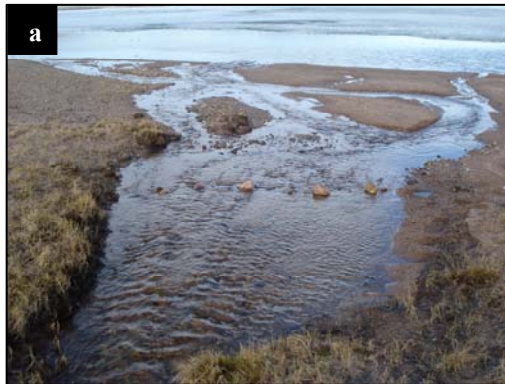
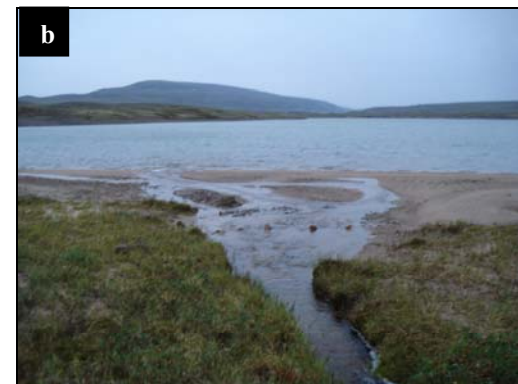
Figure 2. View downstream from habitat assessment in reach 1 of Sheardown Lake Tributary #7 during spring (a) and summer (b) 2008.

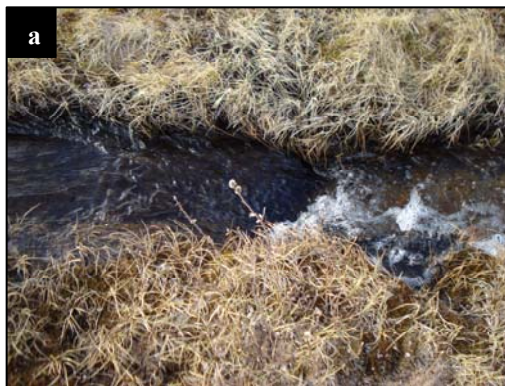
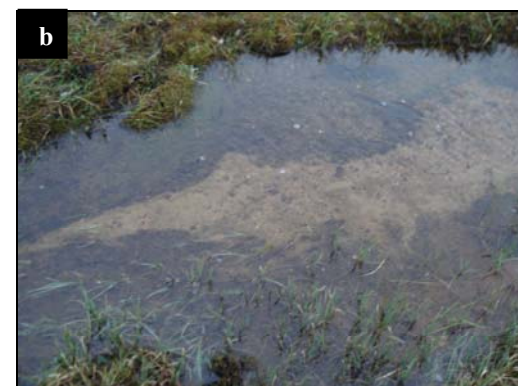
Figure 3. View across the habitat assessment site in reach 1 of Sheardown Lake Tributary #7 during spring (a) and summer (b) 2008.

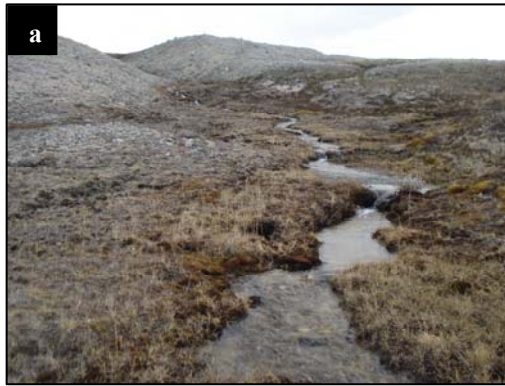
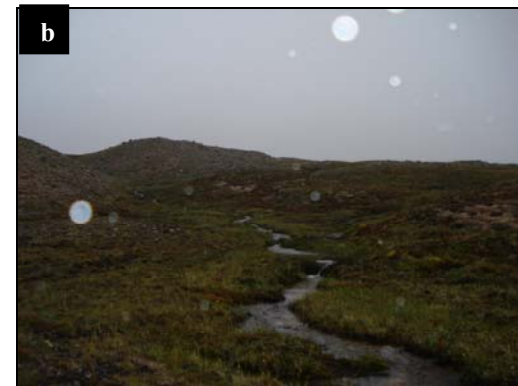
Figure 1. View upstream from habitat assessment in reach 2 of Sheardown Lake Tributary #7 during spring (a) and summer (b) 2008.

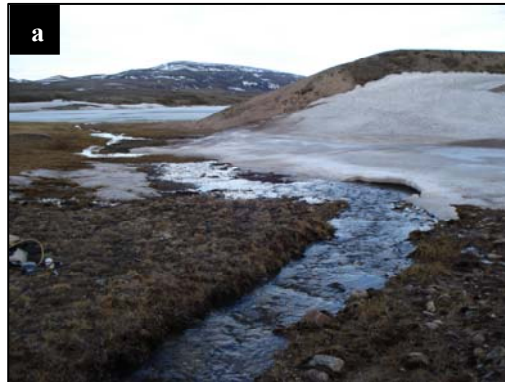
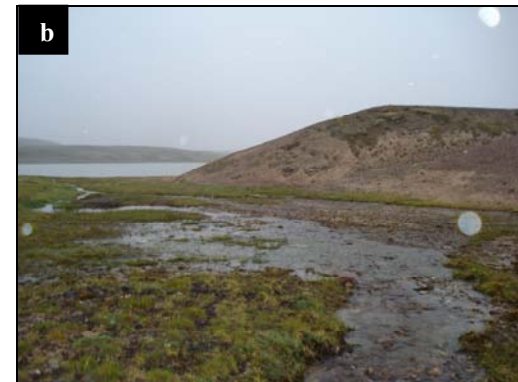
Figure 2. View downstream from habitat assessment in reach 2 of Sheardown Lake Tributary #7 during spring (a) and summer (b) 2008.
