APPENDIX 4.1-1.

DETAILED AQUATIC HABITAT ASSESSMENTS FOR WATERBODIES IN THE MINE AREA BY STREAM AND REACH.

BAFFINLAND IRON MINES CORPORATION		
MARY RIVER PROJECT		
PRESENCE AND ABSENCE OF ARCTIC CHAR IN CAMP LAKE TRIBUTARIES		
  North/South Consultants Inc. Aquatic Environment Specialists	PIANO. -	REF NO. -
	DATE: 01/09/2010	REV -

Mine Site Aquatic Habitat Assessment

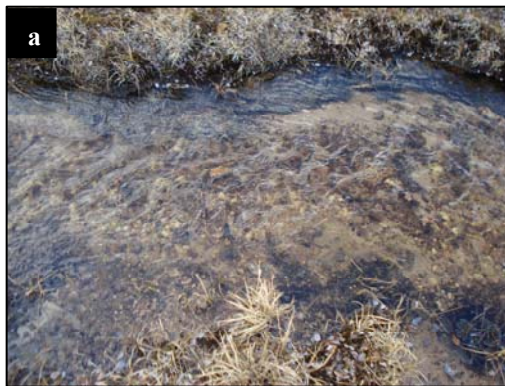
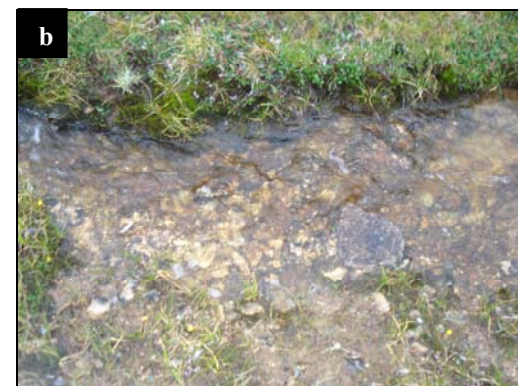
Figure 3. View across the habitat assessment site in reach 2 of Sheardown Lake Tributary #7 during spring (a) and summer (b) 2008.

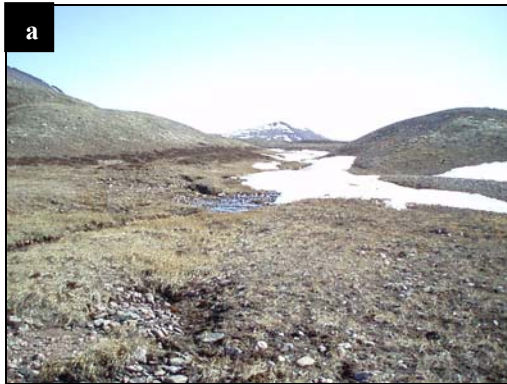
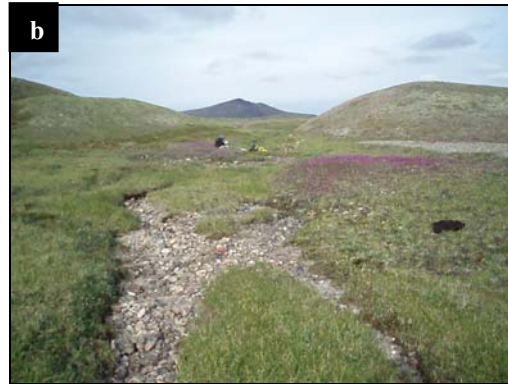
Figure 1. View upstream from habitat assessment in reach 1 of Sheardown Lake Tributary 9 during spring (a) and summer (b).

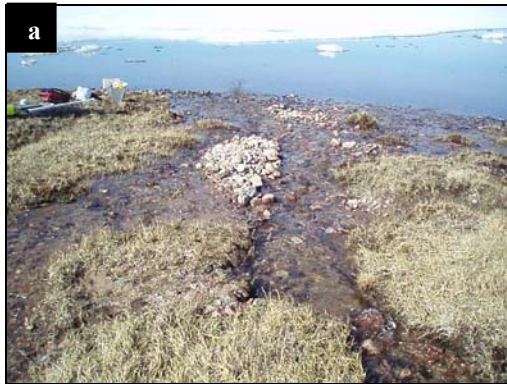
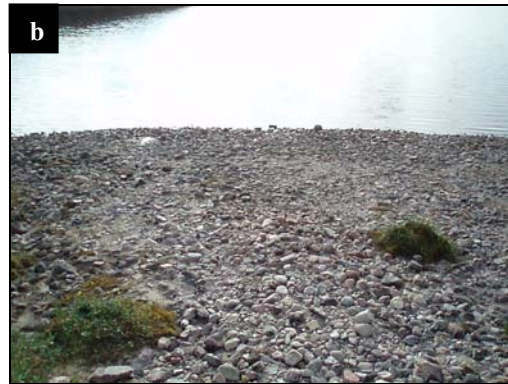
Figure 2. View downstream from habitat assessment in reach 1 of Sheardown Lake Tributary 9 during spring (a) and summer (b).

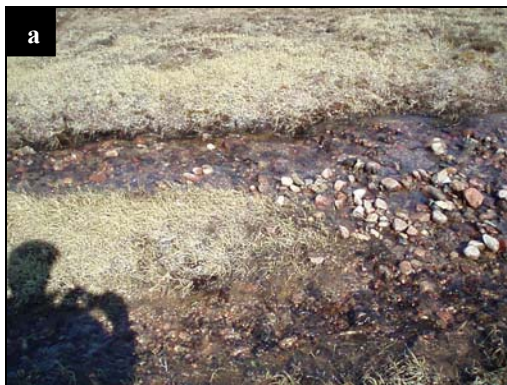
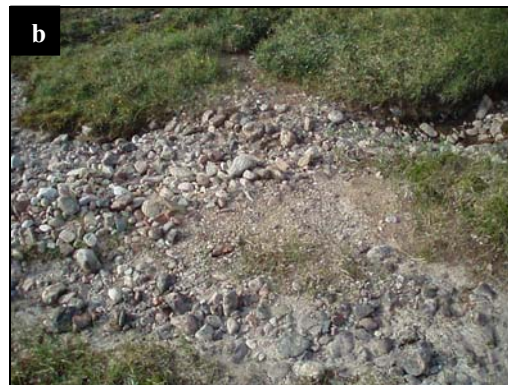
Figure 3. View across the habitat assessment site in reach 1 of Sheardown Lake Tributary 9 during spring (a) and summer (b).

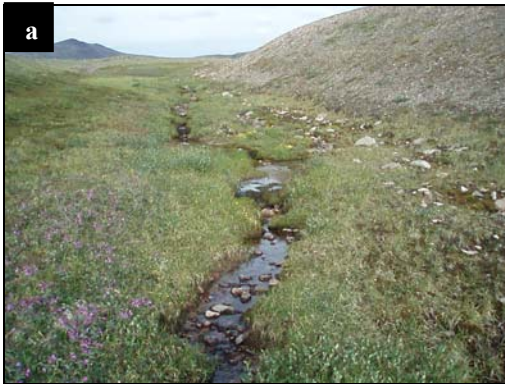
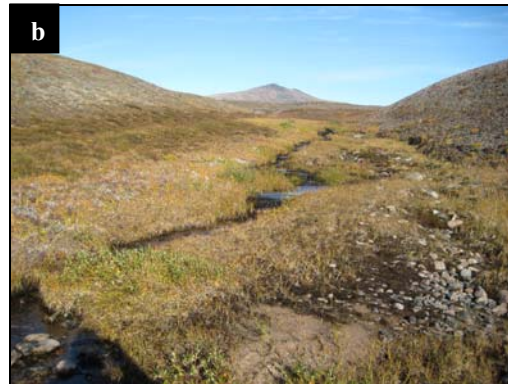
Figure 1. View upstream from habitat assessment in reach 1b of Sheardown Lake Tributary 9 during summer (a) and fall (c).

Watercourse Name: Sheardown Lake Tributary #9
Site: Reach 1b

Channel Morphology: 75% pool, 20% riffle, 5% cascade

Substrate Composition: 60% cobble, 20% gravel, 20% sand

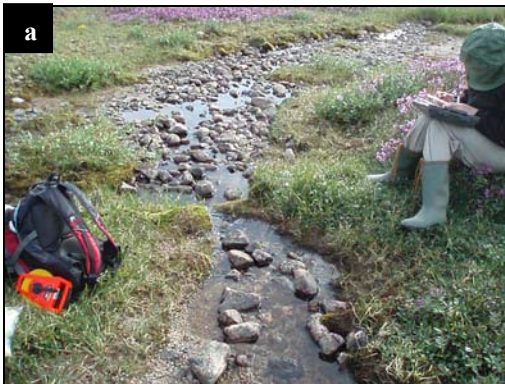
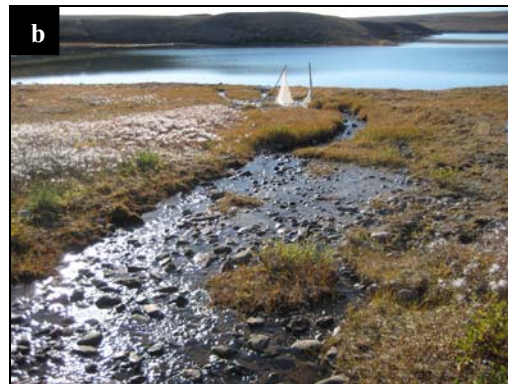
Figure 2. View downstream from habitat assessment in reach 1b of Sheardown Lake Tributary 9 during summer (a) and fall (c).

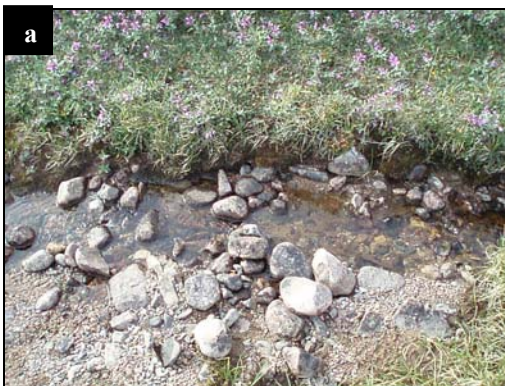
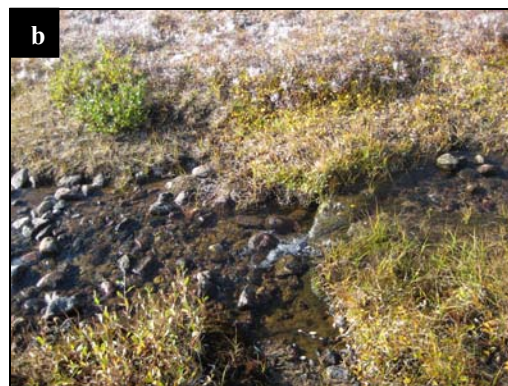
Figure 3. View across the habitat assessment site in reach 1b of Sheardown Lake Tributary 9 during summer (a) and fall (c).

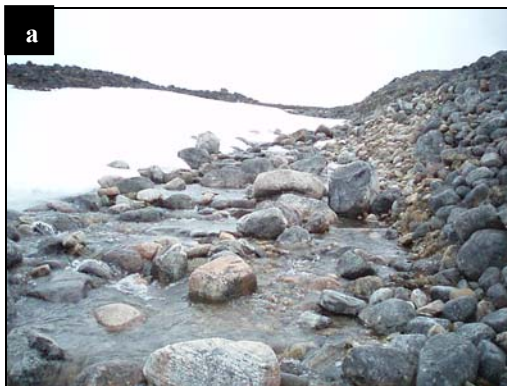
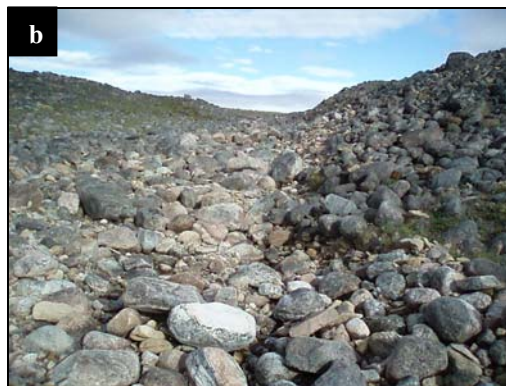
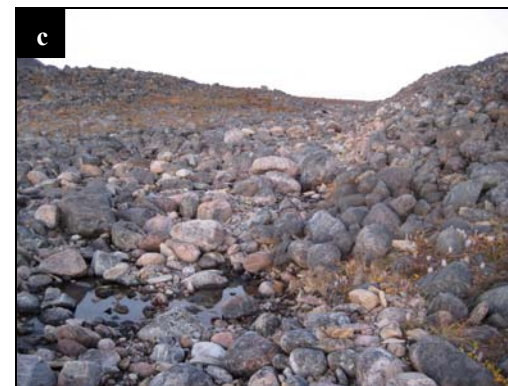
Figure 1. View upstream from habitat assessment in reach 1 of Sheardown Lake Tributary 12 during spring (a), summer (b), and fall (c).

Watercourse Name: Sheardown Lake Tributary #12
Site: Reach 1

Channel Morphology: 60% cascade (spr),
40% pool (spr)
95% pool (sum, fall),
5% riffle (sum, fall)

Substrate Composition: 45% cobble,
45% boulder,
10% gravel

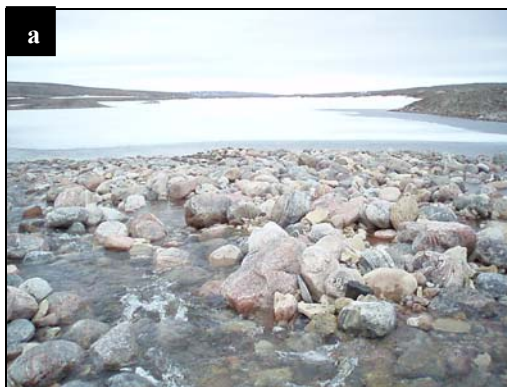
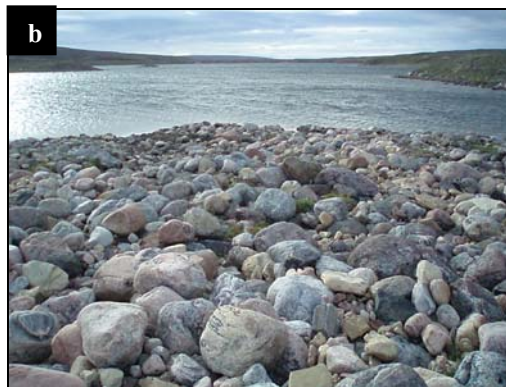
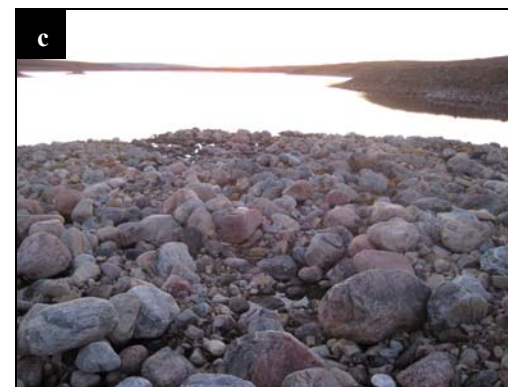
Figure 2. View downstream from habitat assessment in reach 1 of Sheardown Lake Tributary 12 during spring (a), summer (b), and fall (c).

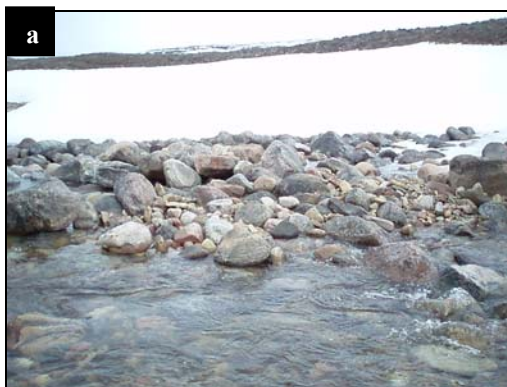
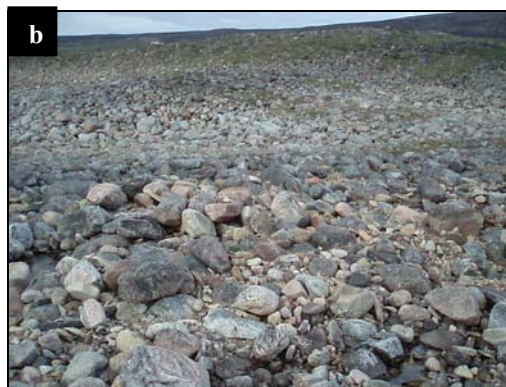
Figure 3. View across the habitat assessment site in reach 1 of Sheardown Lake Tributary 12 during spring (a), summer (b), and fall (c).

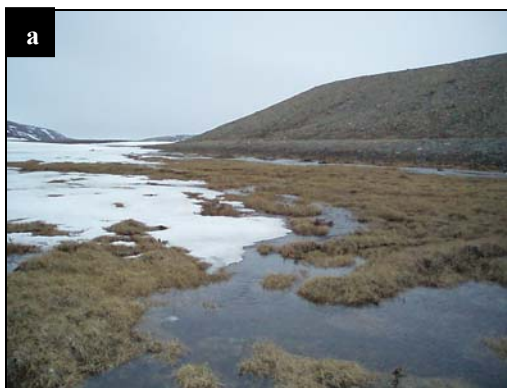
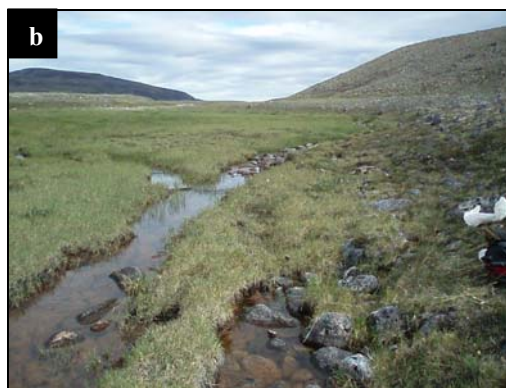
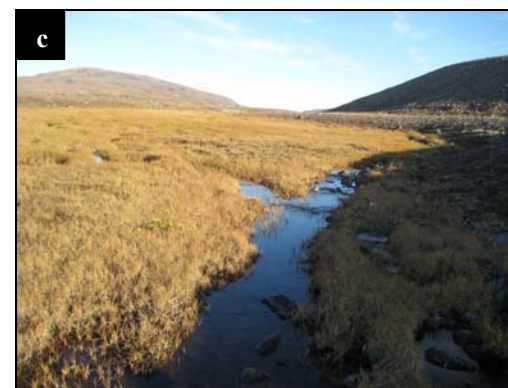
Figure 1. View upstream from habitat assessment in reach 2 of Sheardown Lake Tributary 12 during spring (a), summer (b), and fall (c).

Watercourse Name: Sheardown Lake Tributary #12
Site: Reach 2

Stream/Riparian Habitat	
Channel Morphology:	70% pool (spr), 30% riffle (spr) 95% pool (sum, fall), 5% riffle (sum, fall)
Substrate Composition:	90% silt, 5% cobble, 5% boulder
Stream Cover:	15% deep pool, 10% undercut banks, 5% boulder
Aquatic Vegetation:	Periphyton, submerged RV
Riparian Vegetation:	Grasses and willow
Barriers Present (Y/N):	Y
Location:	DS ~ 50m
Lakes Present (Y/N):	Y
Location:	DS – Sheardown L.

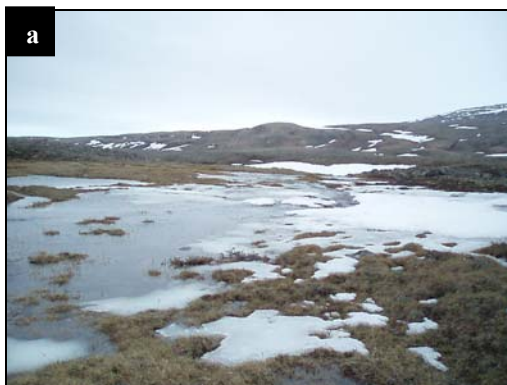
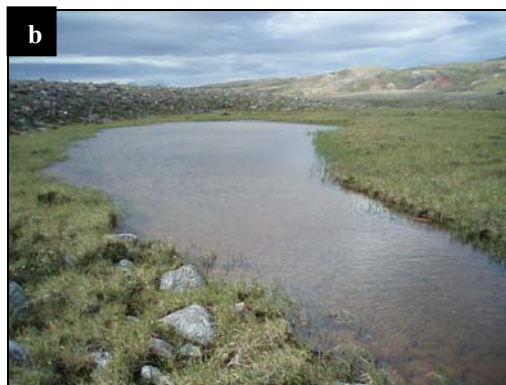
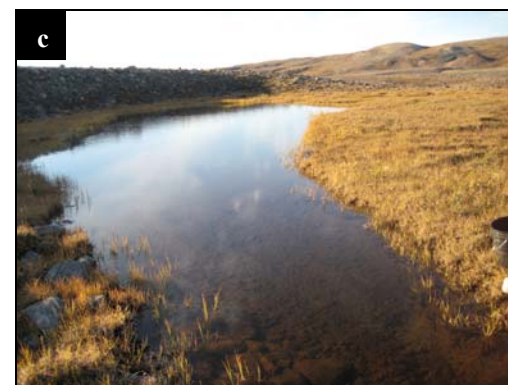
Figure 2. View downstream from habitat assessment in reach 2 of Sheardown Lake Tributary 12 during spring (a), summer (b), and fall (c).

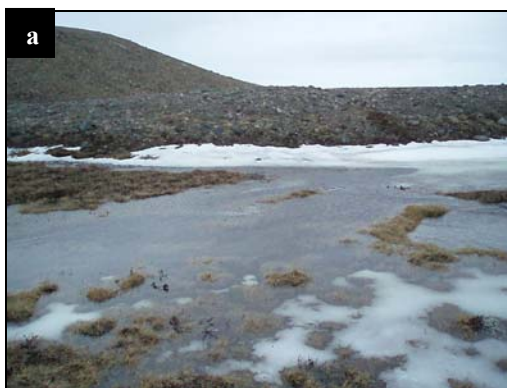
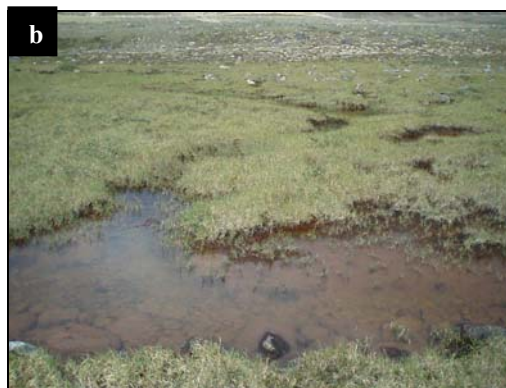
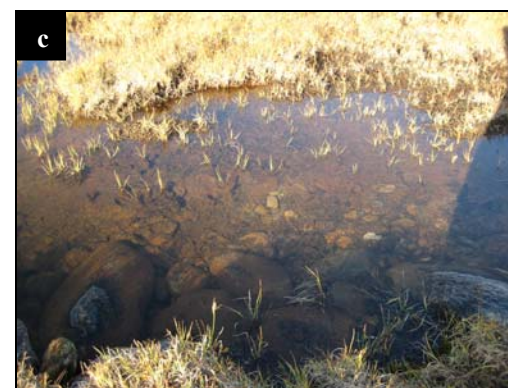
Figure 3. View across the habitat assessment site in reach 2 of Sheardown Lake Tributary 12 during spring (a), summer (b), and fall (c).

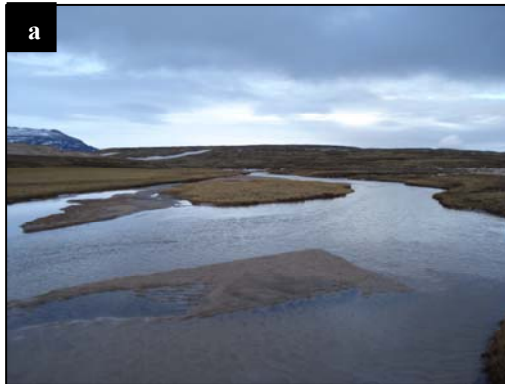
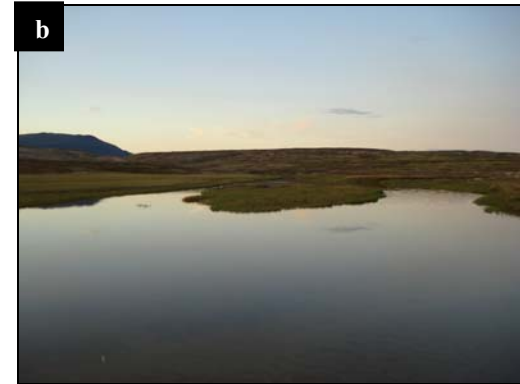
Figure 1. View upstream from habitat assessment in reach 1 of Mary Lake – North Tributary #1 during spring (a) and summer (b) 2008.

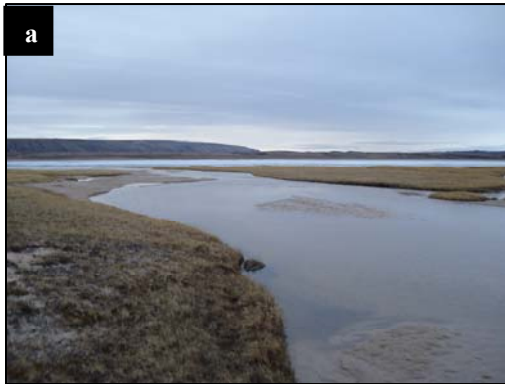
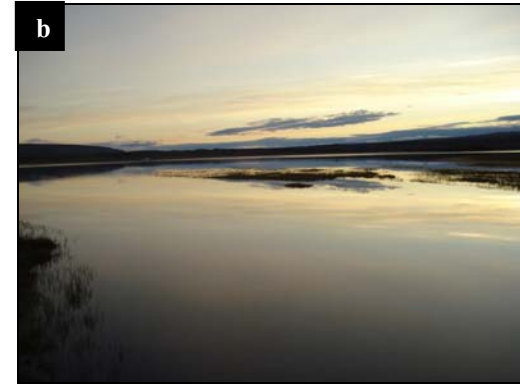
Figure 2. View downstream from habitat assessment in reach 1 of Mary Lake – North Tributary #1 during spring (a) and summer (b) 2008.

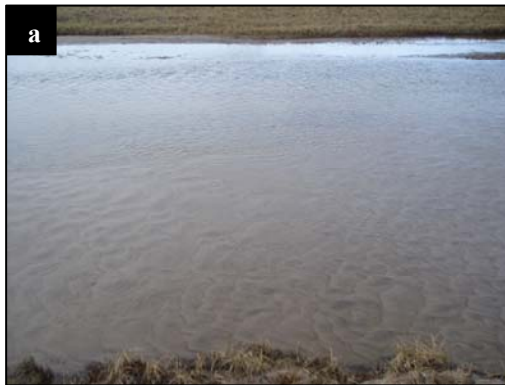
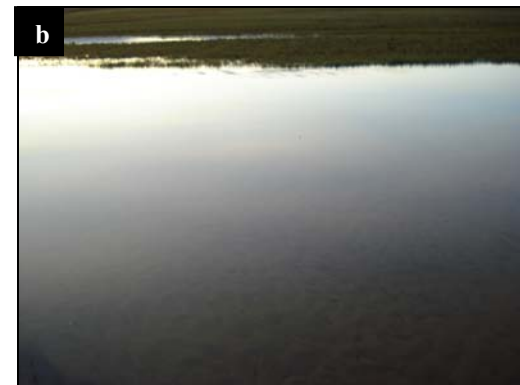
Figure 3. View across the habitat assessment site in reach 1 of Mary Lake – North Tributary #1 during spring (a) and summer (b) 2008.

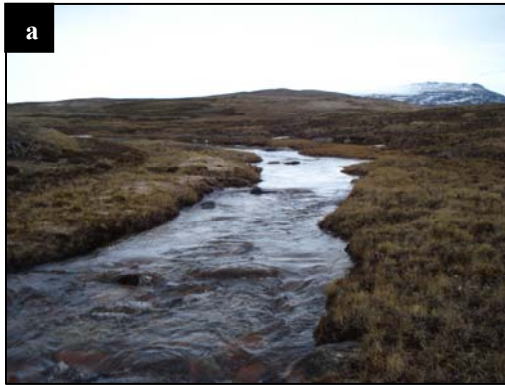
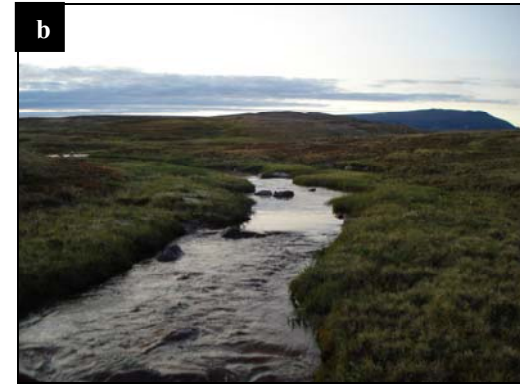
Figure 1. View upstream from habitat assessment in reach 2 of Mary Lake – North Tributary #1 during spring (a) and summer (b) 2008.

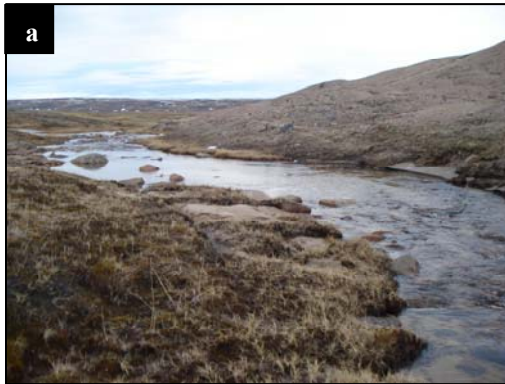
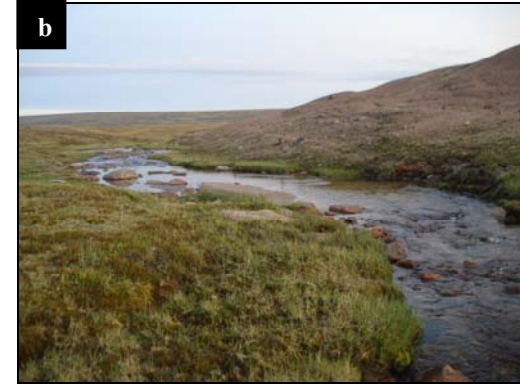
Figure 2. View downstream from habitat assessment in reach 2 of Mary Lake – North Tributary #1 during spring (a) and summer (b) 2008.

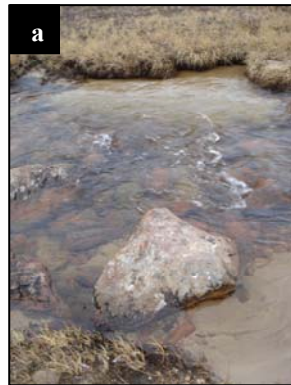
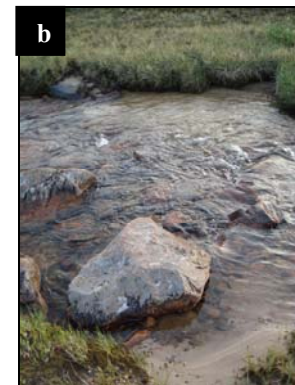
Figure 3. View across the habitat assessment site in reach 2 of Mary Lake – North Tributary #1 during spring (a) and summer (b) 2008.

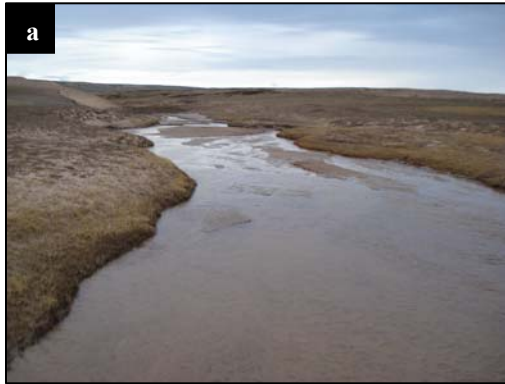
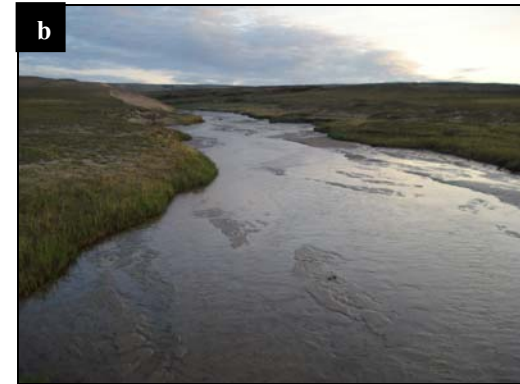
Figure 1. View upstream from habitat assessment in reach 1 of Mary Lake – North Tributary #2 during spring (a) and summer (b) 2008.

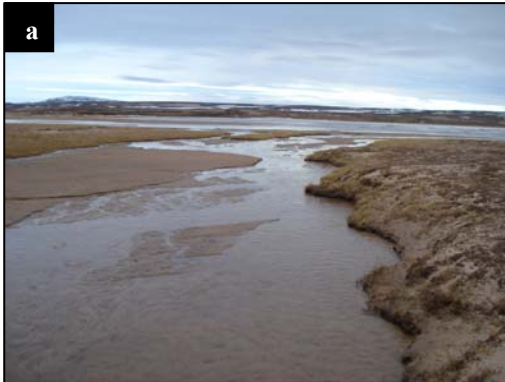
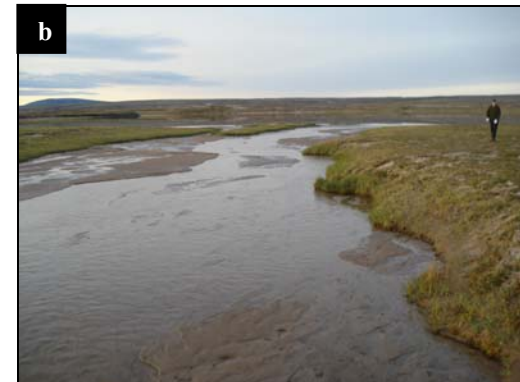
Figure 2. View downstream from habitat assessment in reach 1 of Mary Lake – North Tributary #2 during spring (a) and summer (b) 2008.

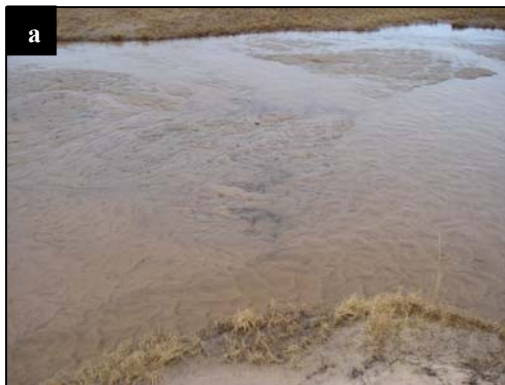
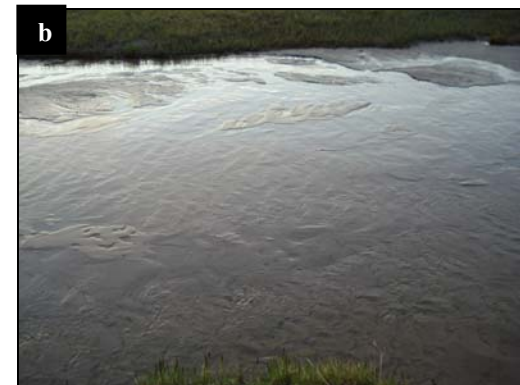
Figure 3. View across the habitat assessment site in reach 1 of Mary Lake – North Tributary #2 during spring (a) and summer (b) 2008.

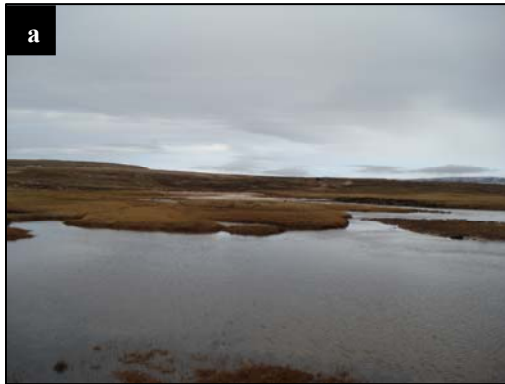
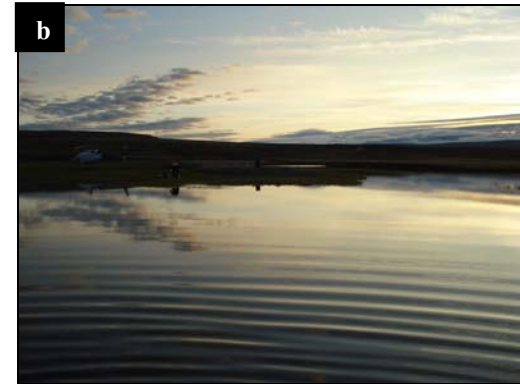
Figure 1. View upstream from habitat assessment in reach 1 of Mary Lake – North Tributary #3 during spring (a) and summer (b) 2008.

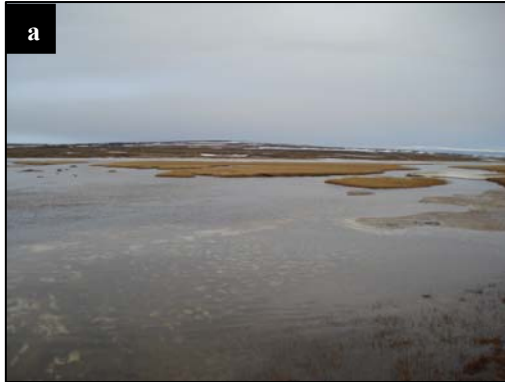
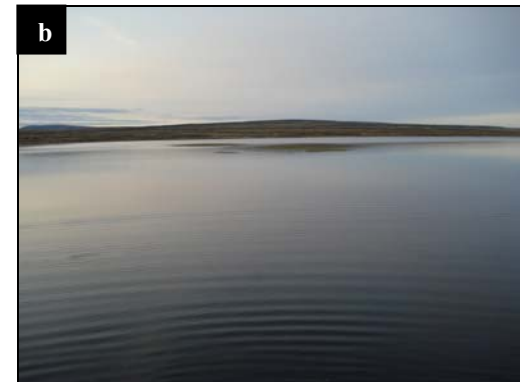
Figure 2. View downstream from habitat assessment in reach 1 of Mary Lake – North Tributary #3 during spring (a) and summer (b) 2008.

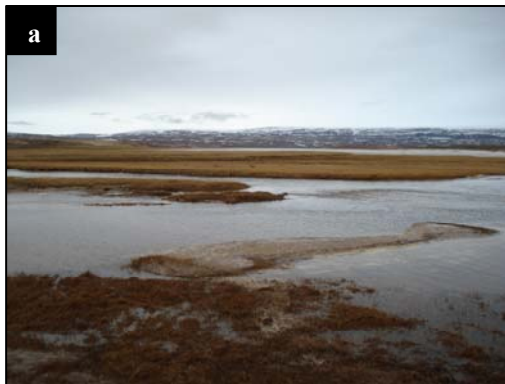
Figure 3. View across the habitat assessment site in reach 1 of Mary Lake – North Tributary #3 during spring (a) and summer (b) 2008.

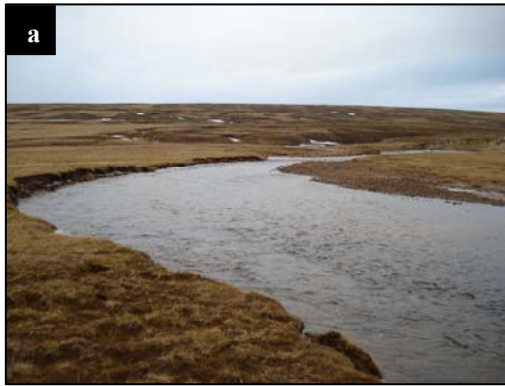
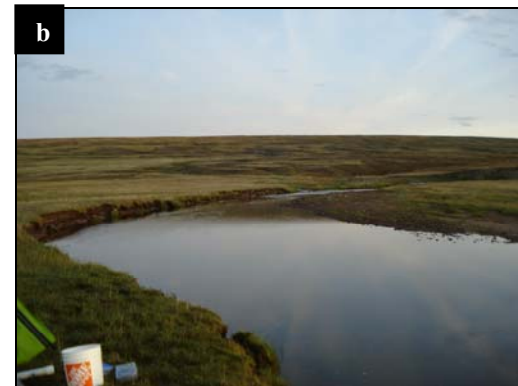
Figure 1. View upstream from habitat assessment in reach 2 of Mary Lake – North Tributary #3 during spring (a) and summer (b) 2008.

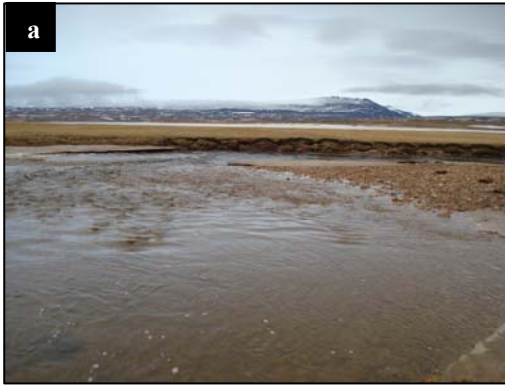
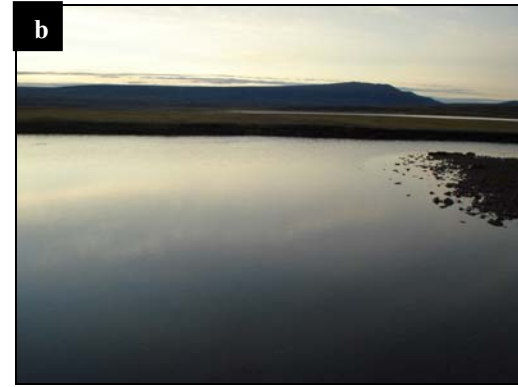
Figure 2. View downstream from habitat assessment in reach 2 of Mary Lake – North Tributary #3 during spring (a) and summer (b) 2008.

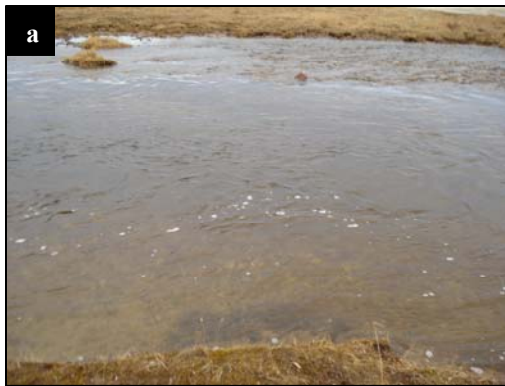
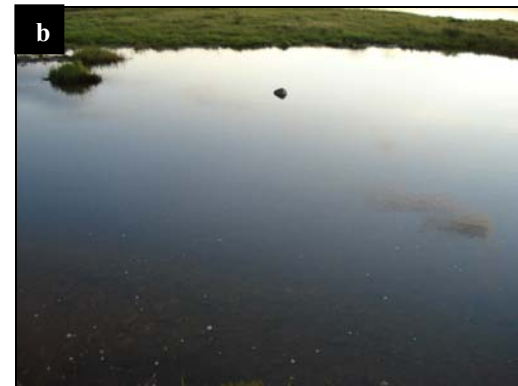
Figure 3. View across the habitat assessment site in reach 2 of Mary Lake – North Tributary #3 during spring (a) and summer (b) 2008.

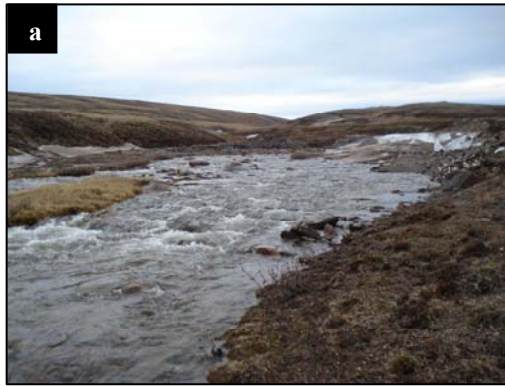
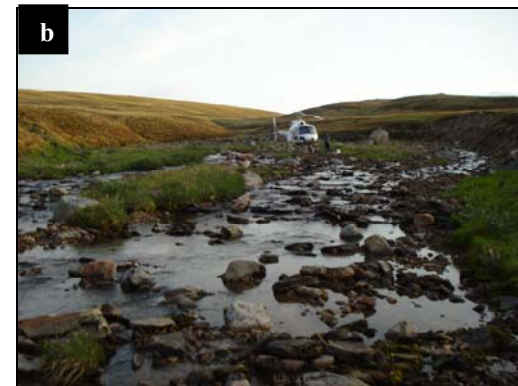
Figure 1. View upstream from habitat assessment in reach 3 of Mary Lake – North Tributary #3 during spring (a) and summer (b) 2008.

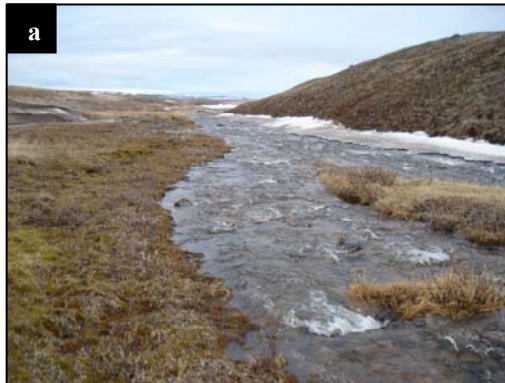
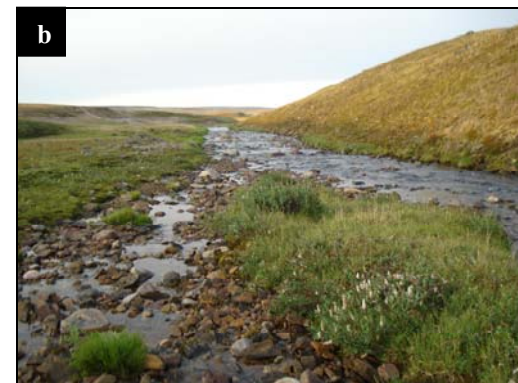
Figure 2. View downstream from habitat assessment in reach 3 of Mary Lake – North Tributary #3 during spring (a) and summer (b) 2008.

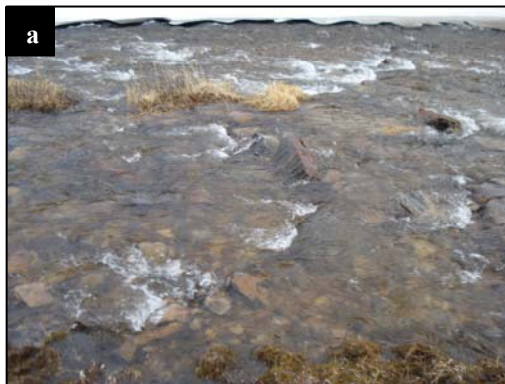
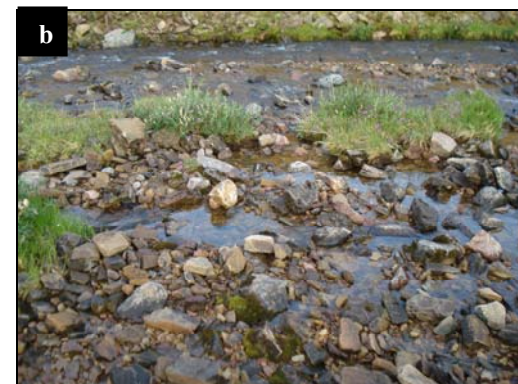
Figure 3. View across the habitat assessment site in reach 3 of Mary Lake – North Tributary #3 during spring (a) and summer (b) 2008.

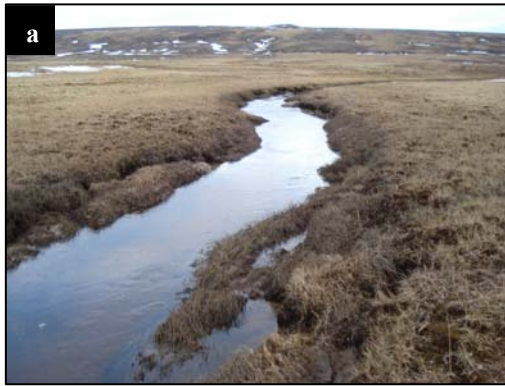
Figure 1. View upstream from habitat assessment in reach 1 of Mary Lake – North Tributary #4 during spring (a) and summer (b) 2008.

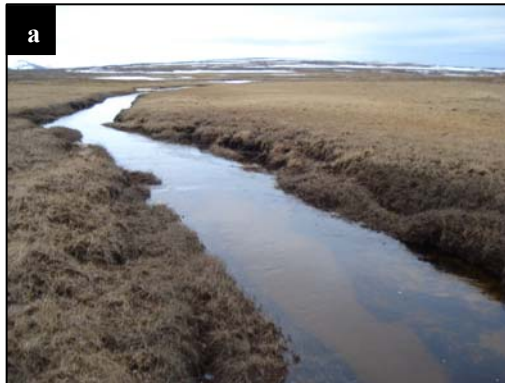
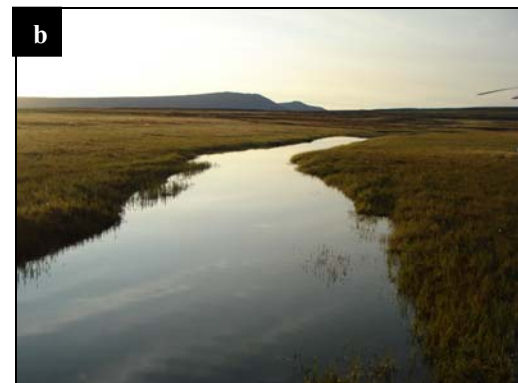
Figure 2. View downstream from habitat assessment in reach 1 of Mary Lake – North Tributary #4 during spring (a) and summer (b) 2008.

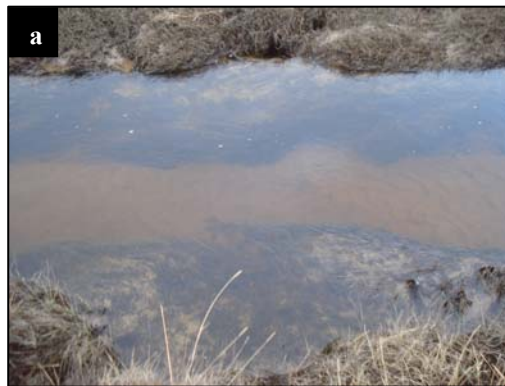
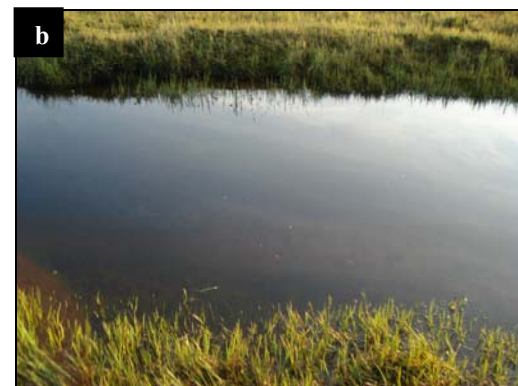
Figure 3. View across the habitat assessment site in reach 1 of Mary Lake – North Tributary #4 during spring (a) and summer (b) 2008.

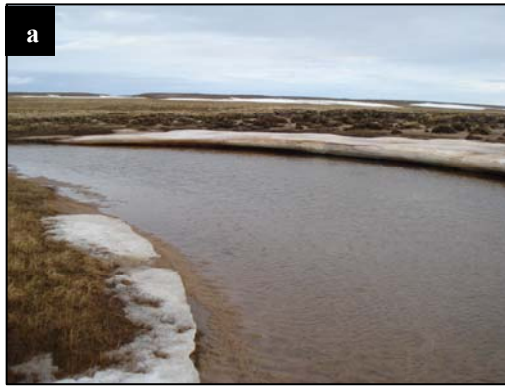
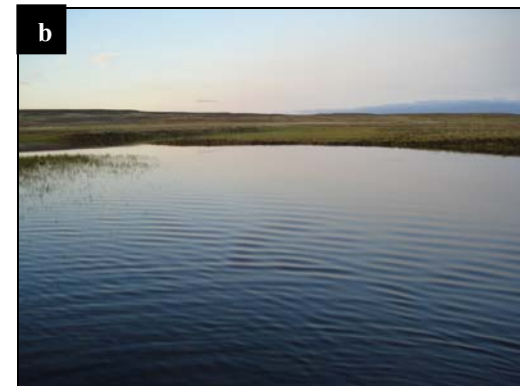
Figure 1. View upstream from habitat assessment in reach 1 of Mary Lake – South Tributary #1 during spring (a) and summer (b) 2008.

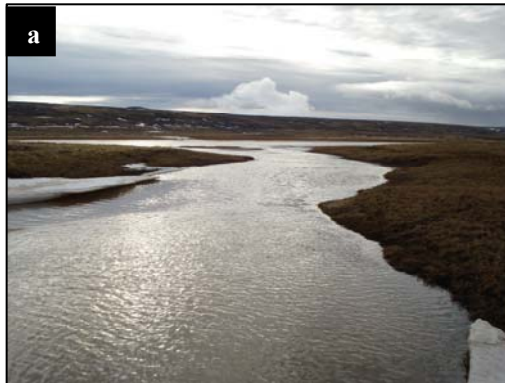
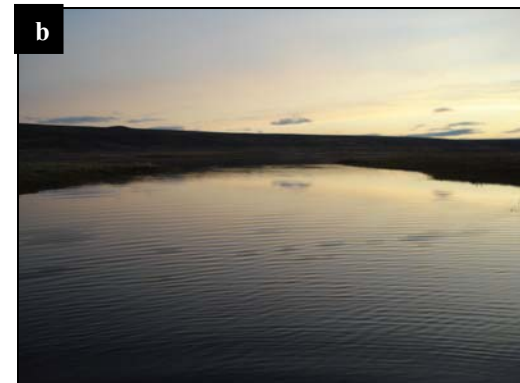
Figure 2. View downstream from habitat assessment in reach 1 of Mary Lake – South Tributary #1 during spring (a) and summer (b) 2008.

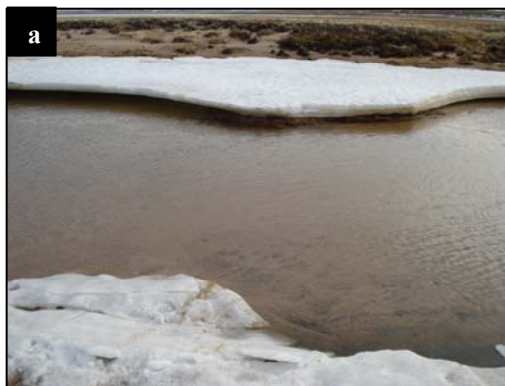
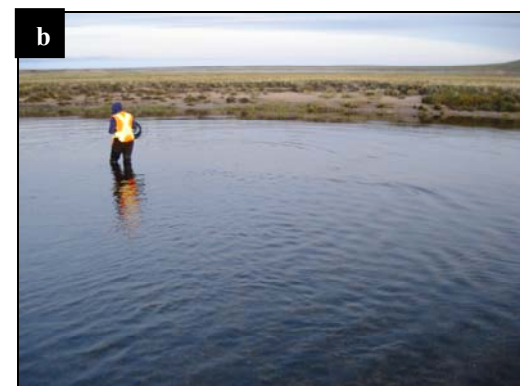
Figure 3. View across the habitat assessment site in reach 1 of Mary Lake – South Tributary #1 during spring (a) and summer (b) 2008.

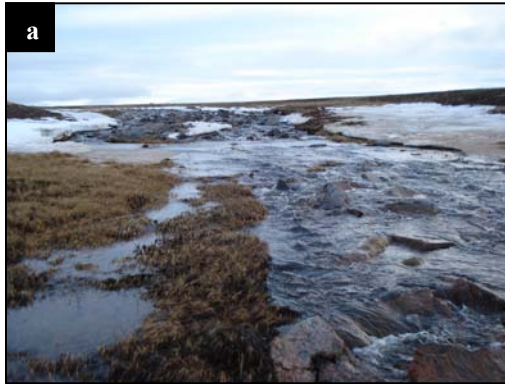
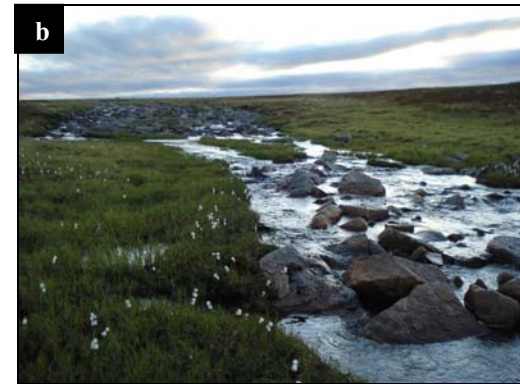
Figure 1. View upstream from habitat assessment in reach 1 of Mary Lake – South Tributary #2 during spring (a) and summer (b) 2008.

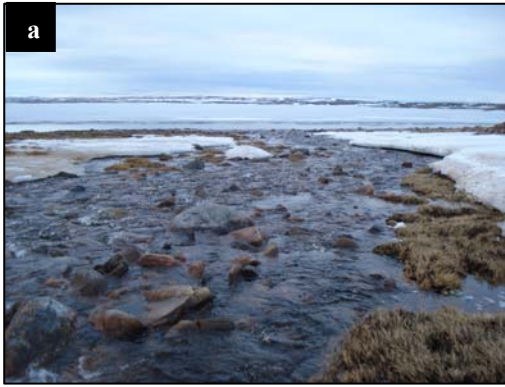
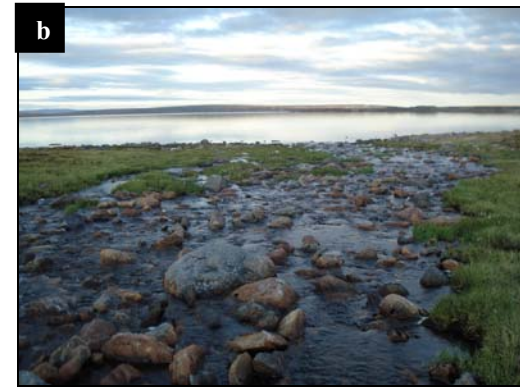
Figure 2. View downstream from habitat assessment in reach 1 of Mary Lake – South Tributary #2 during spring (a) and summer (b) 2008.

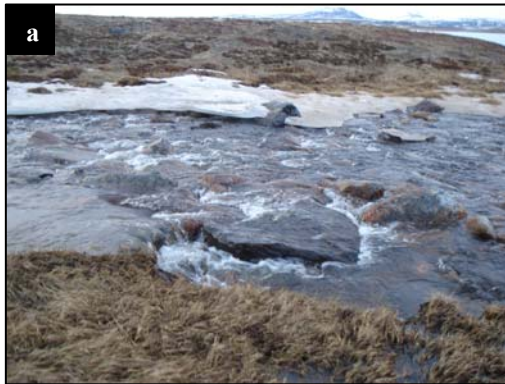
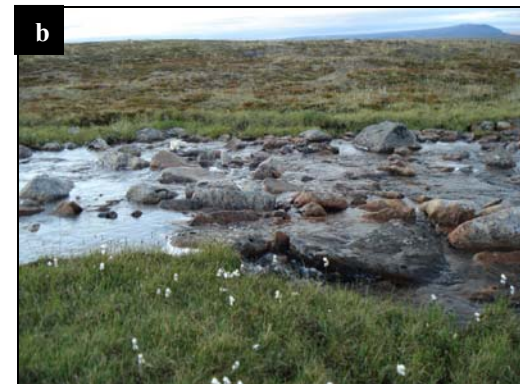
Figure 3. View across the habitat assessment site in reach 1 of Mary Lake – South Tributary #2 during spring (a) and summer (b) 2008.

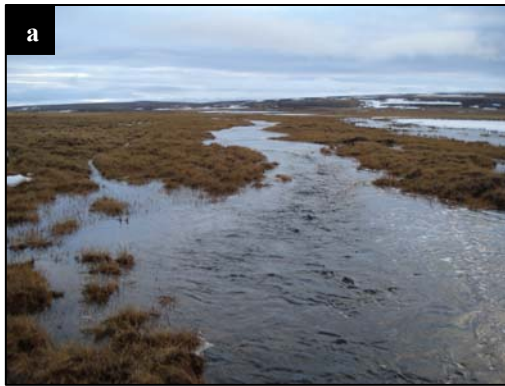
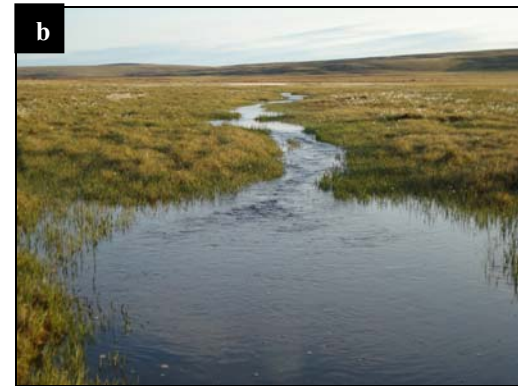
Figure 1. View upstream from habitat assessment in reach 2 of Mary Lake – South Tributary #2 during spring (a) and summer (b) 2008.

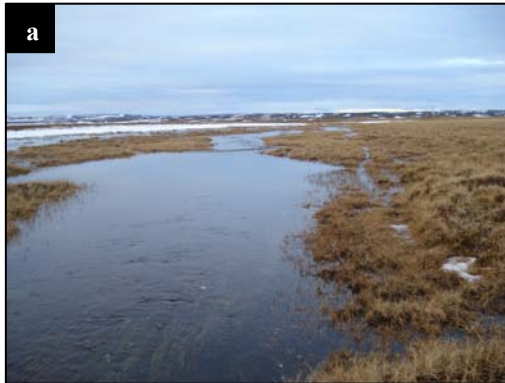
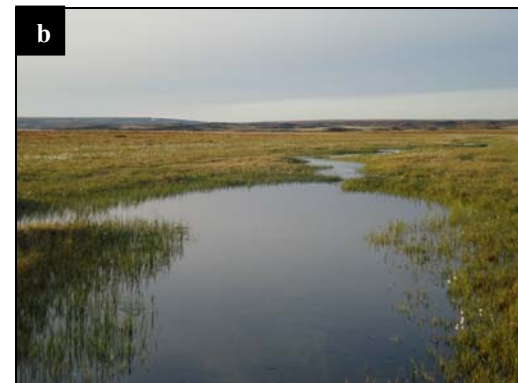
Figure 2. View downstream from habitat assessment in reach 2 of Mary Lake – South Tributary #2 during spring (a) and summer (b) 2008.

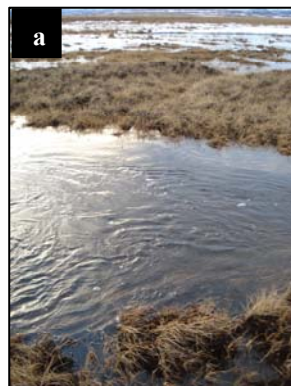
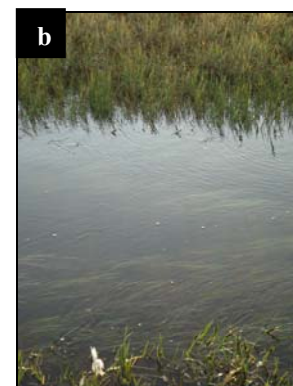
Figure 3. View across the habitat assessment site in reach 2 of Mary Lake – South Tributary #2 during spring (a) and summer (b) 2008.

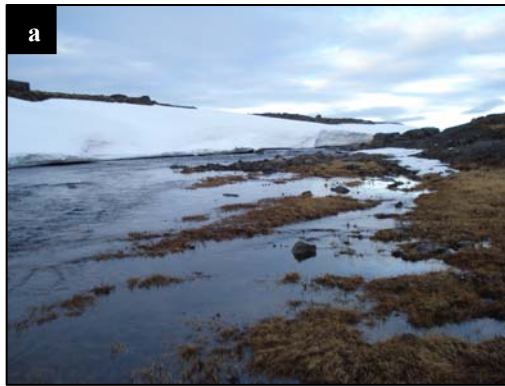
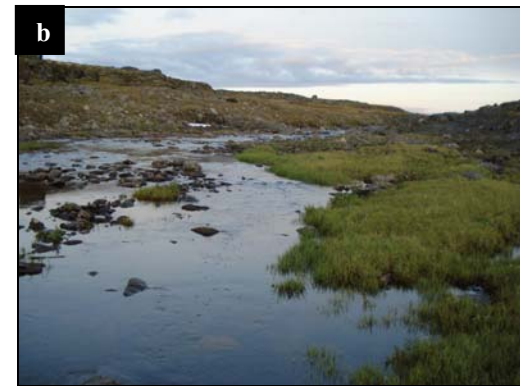
Figure 1. View upstream from habitat assessment in reach 1 of Mary Lake – South Tributary #3 during spring (a) and summer (b) 2008.

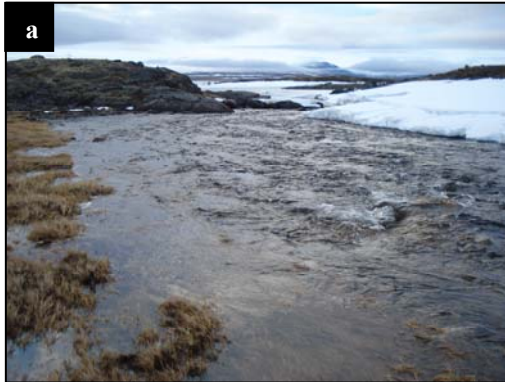
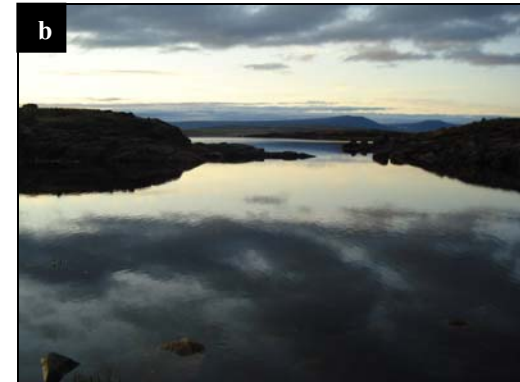
Figure 2. View downstream from habitat assessment in reach 1 of Mary Lake – South Tributary #3 during spring (a) and summer (b) 2008.

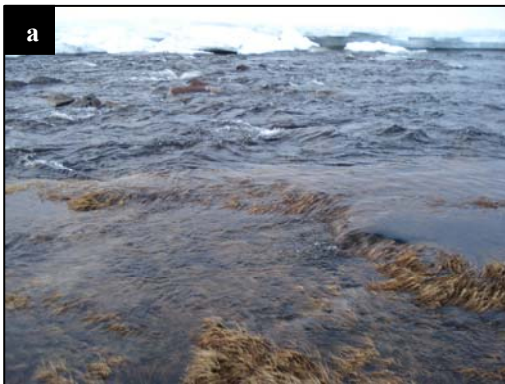
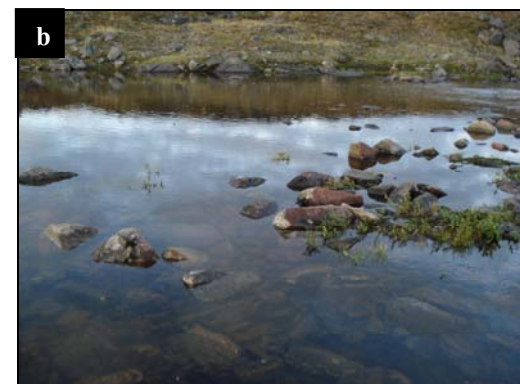
Figure 3. View across the habitat assessment site in reach 1 of Mary Lake – South Tributary #3 during spring (a) and summer (b) 2008.

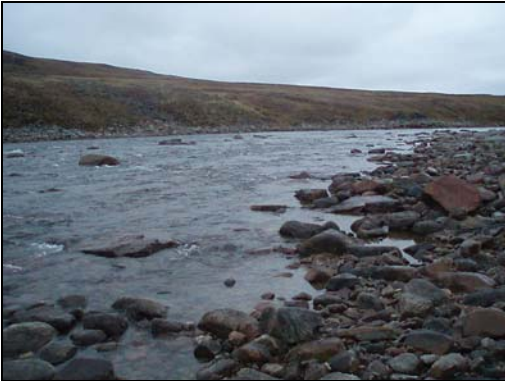
Figure 1. View upstream from habitat assessment at Site A0-01 in Mary River during fall.

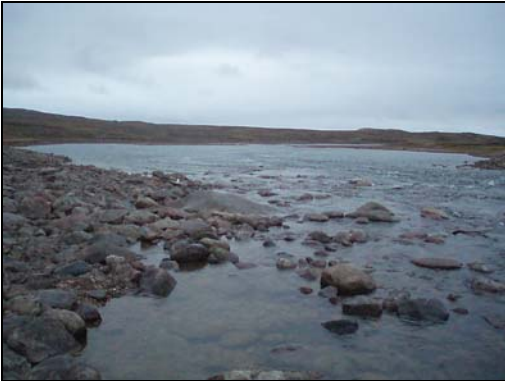
Figure 2. View downstream from habitat assessment at Site A0-01 in Mary River during fall.

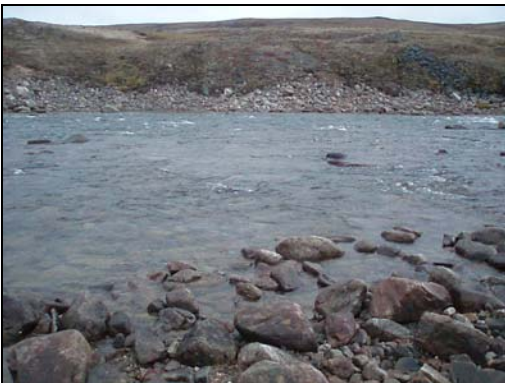
Figure 3. View across the habitat assessment site at Site A0-01 in Mary River during fall.

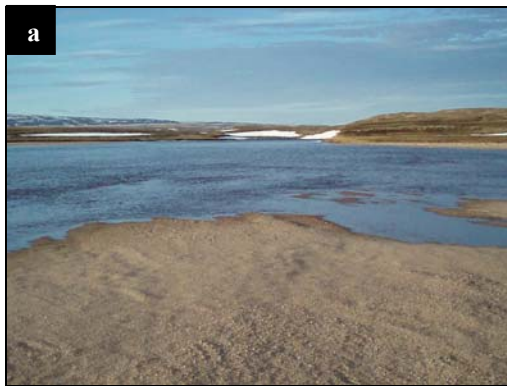
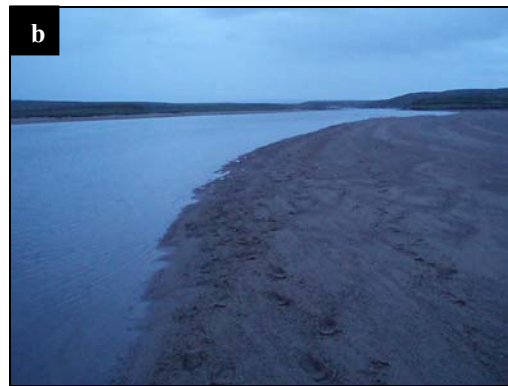
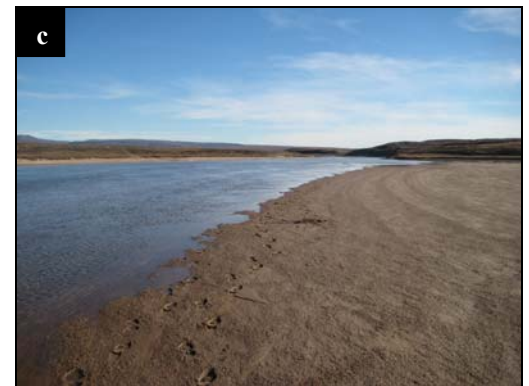
Figure 1. View upstream from habitat assessment at Reach 1 in Mary River during spring (a), summer (b), and fall (c).

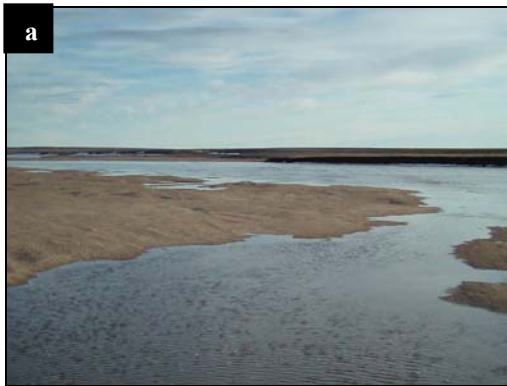
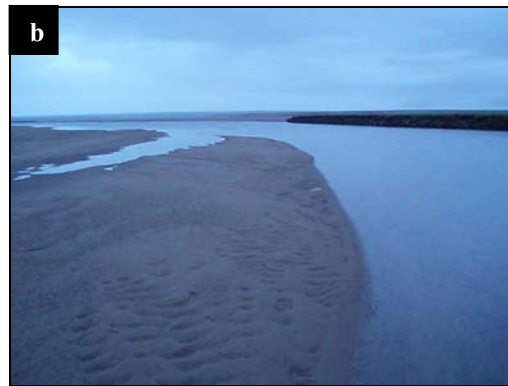
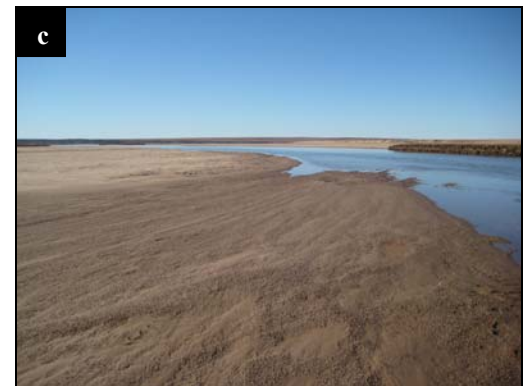
Figure 2. View downstream from habitat assessment at Reach 1 in Mary River during spring (a), summer (b), and fall (c).

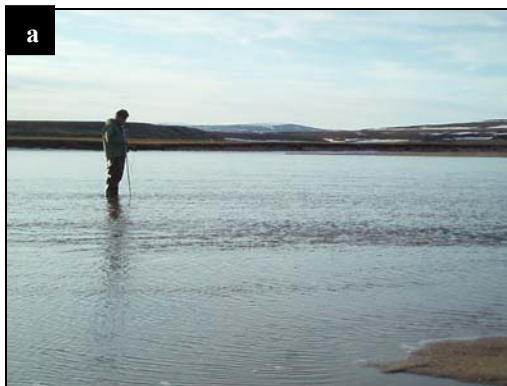
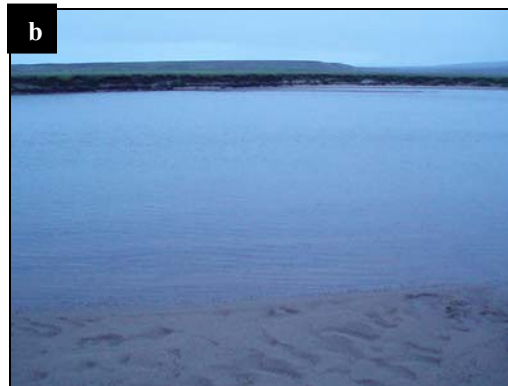
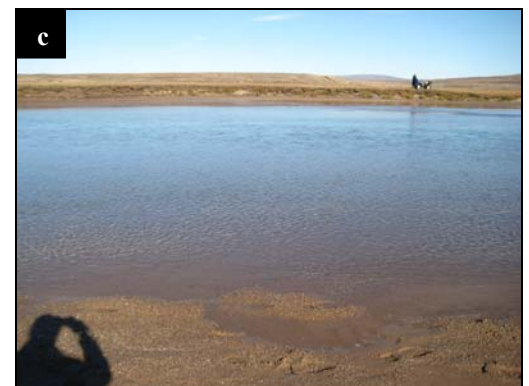
Figure 3. View across the habitat assessment site at Reach 1 in Mary River during spring (a), summer (b), and fall (c).
