APPENDIX 4.1-1.

DETAILED AQUATIC HABITAT ASSESSMENTS FOR WATERBODIES IN THE MINE AREA BY STREAM AND REACH.

BAFFINLAND IRON MINES CORPORATION		
MARY RIVER PROJECT		
PRESENCE AND ABSENCE OF ARCTIC CHAR IN CAMP LAKE TRIBUTARIES		
  North/South Consultants Inc. Aquatic Environment Specialists	PIANO. -	REF NO. -
	DATE: 01/09/2010	REV -

Mine Site Aquatic Habitat Assessment

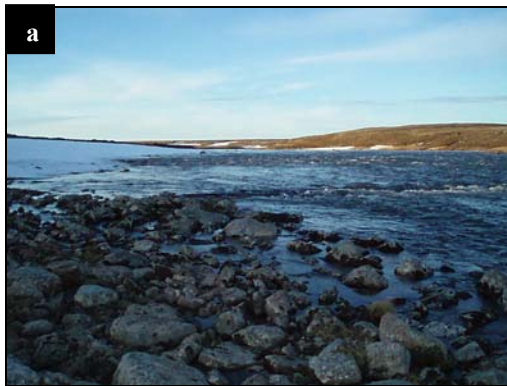
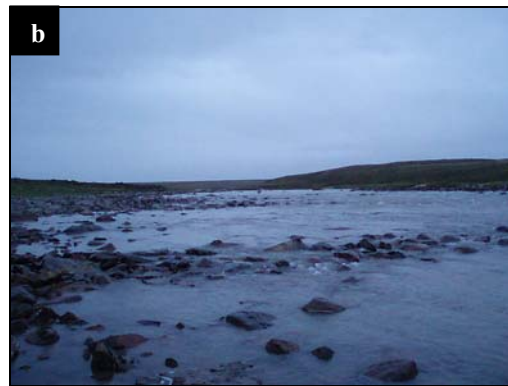
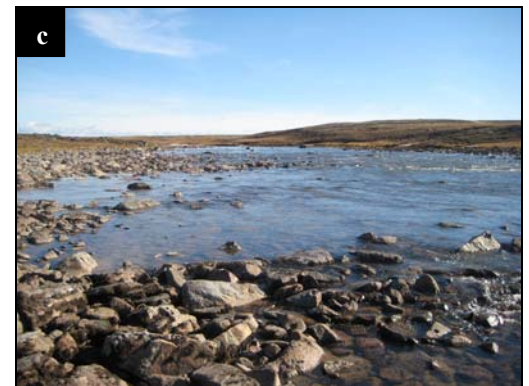
Figure 1. View upstream from habitat assessment at Site C0-01 in Mary River during spring (a), summer (b), and fall (c).

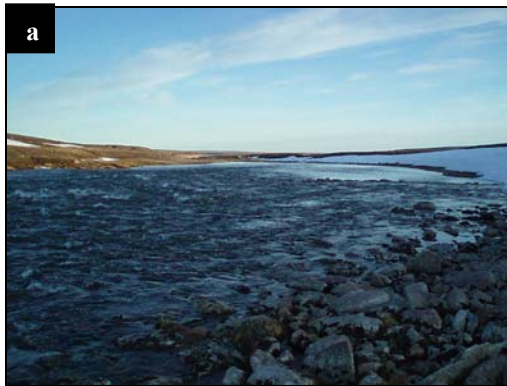
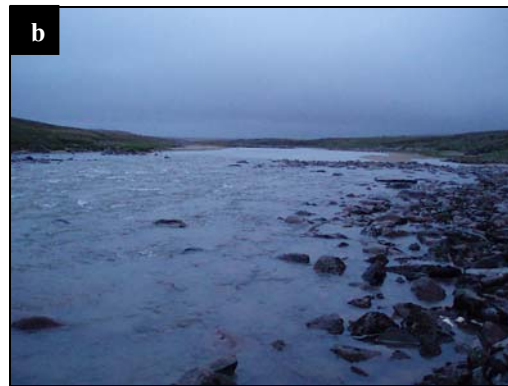
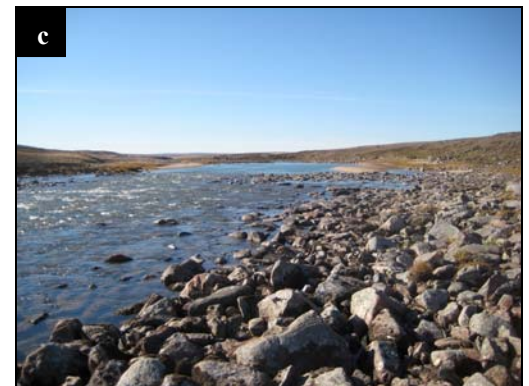
Figure 2. View downstream from habitat assessment at Site C0-01 in Mary River during spring (a), summer (b), and fall (c).

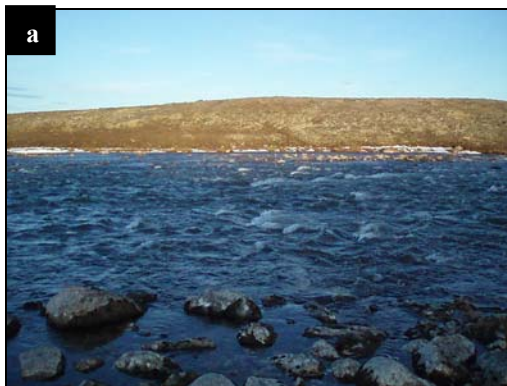
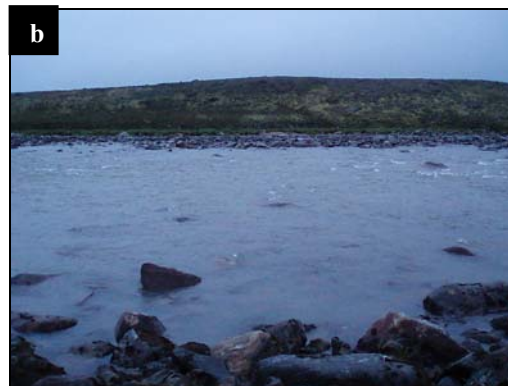
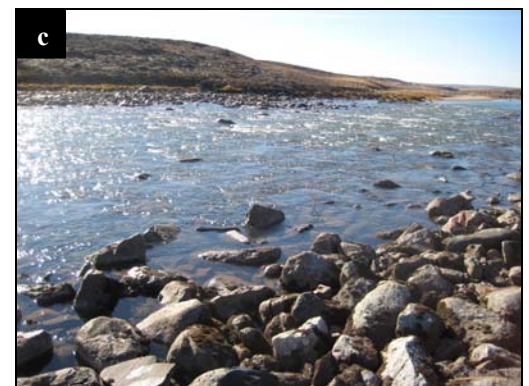
Figure 3. View across the habitat assessment site at Site C0-01 in Mary River during spring (a), summer (b), and fall (c).

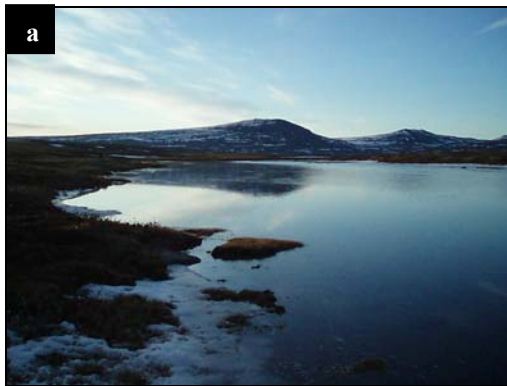
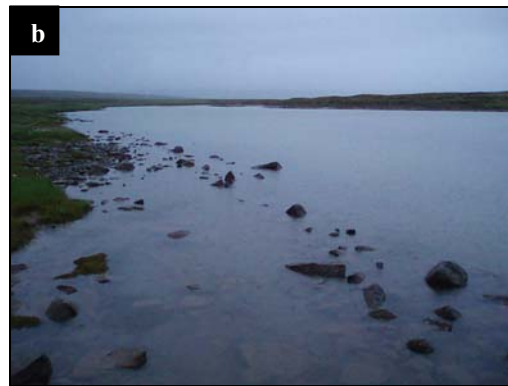
Figure 1. View upstream from habitat assessment at Site C0-05 in Mary River during spring (a), summer (b), and fall (c).

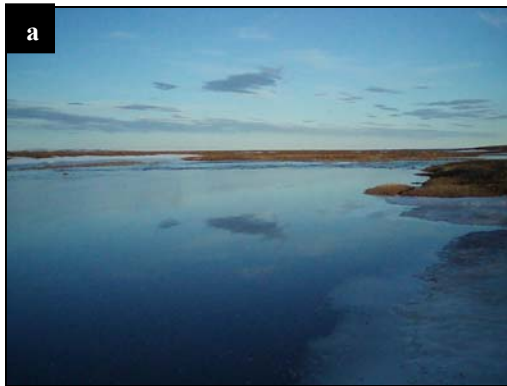
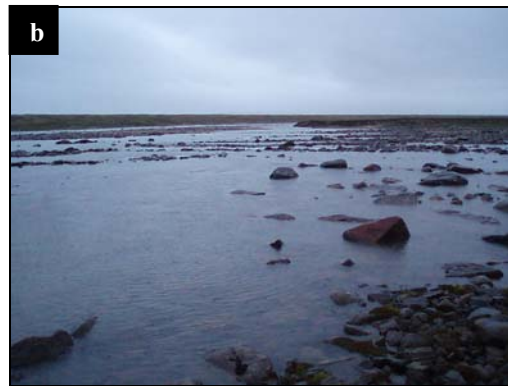
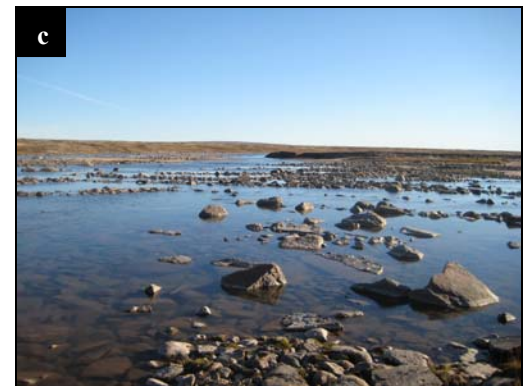
Figure 2. View downstream from habitat assessment at Site C0-05 in Mary River during spring (a), summer (b), and fall (c).

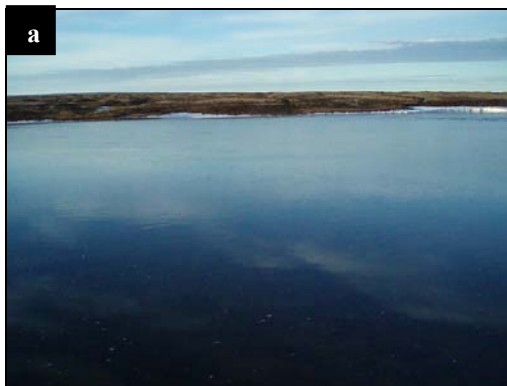
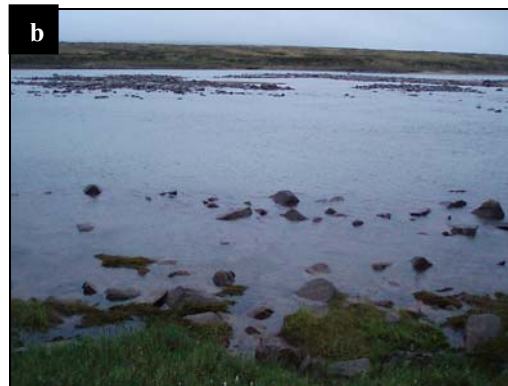
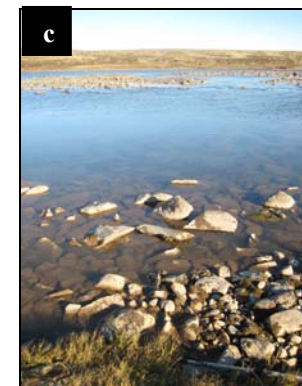
Figure 3. View across the habitat assessment site at Site C0-05 in Mary River during spring (a), summer (b), and fall (c).

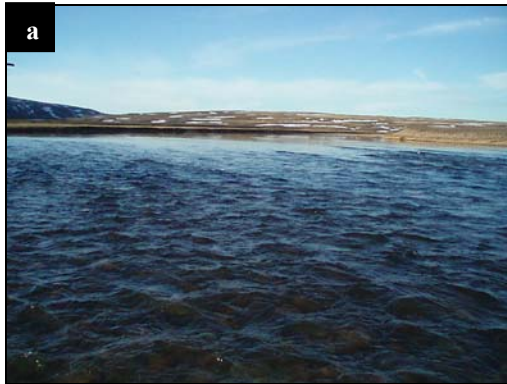
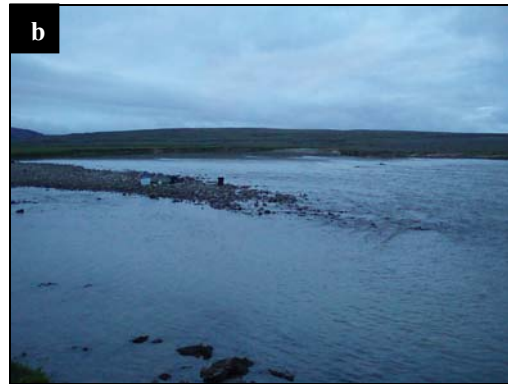
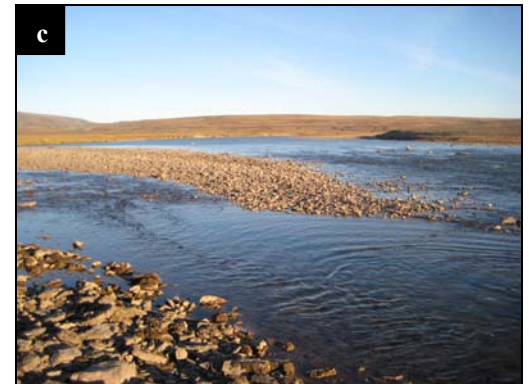
Figure 1. View upstream from habitat assessment at Site C0-10 in Mary River during spring (a), summer (b), and fall (c).

Confinement: Partial

Channel Morphology: 100% riffle (spr)
90% riffle (sum, fall),
10% pool (sum, fall)

Substrate Composition: 80% cobble,
10% boulder,
5% gravel,
5% sand

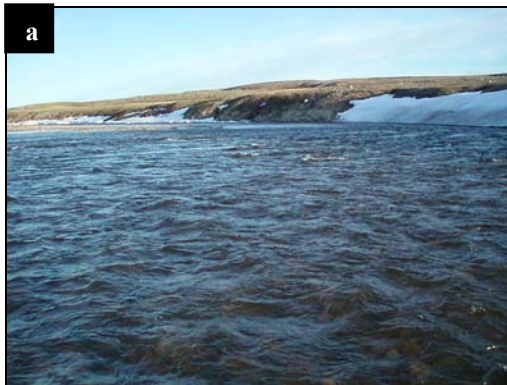
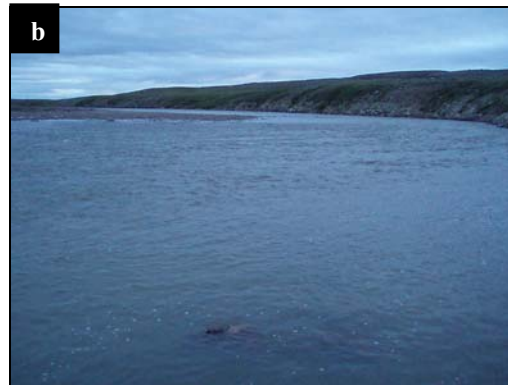
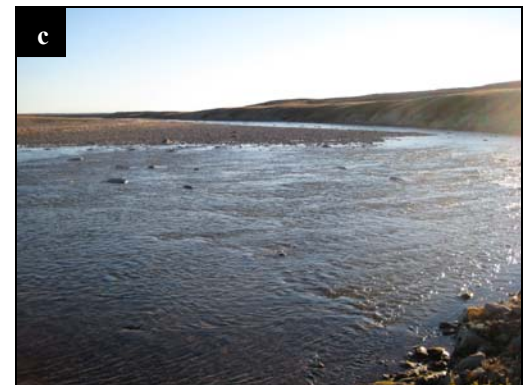
Figure 2. View downstream from habitat assessment at Site C0-10 in Mary River during spring (a), summer (b), and fall (c).

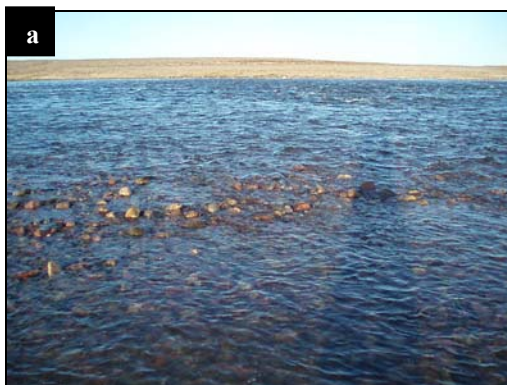
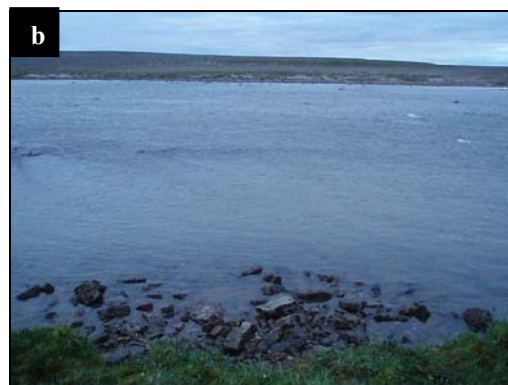
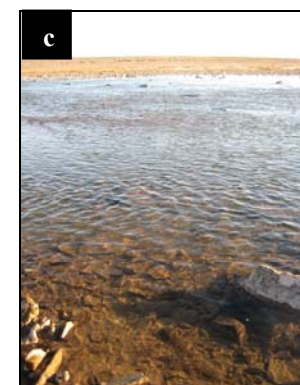
Figure 3. View across the habitat assessment site at Site C0-10 in Mary River during spring (a), summer (b), and fall (c).

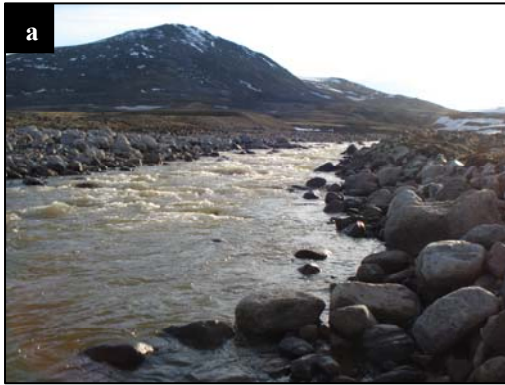
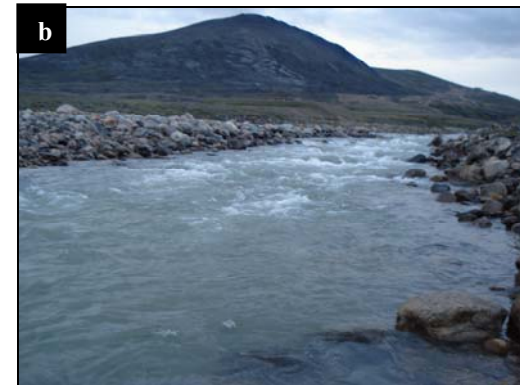
Figure 1. View upstream from habitat assessment in reach E0-01 of Mary River during spring (a) and summer (b) 2008.

Channel Morphology: 50% rapid, 50% run

Substrate Composition: 65% cobble, 20% boulder, 10% gravel, 5% sand

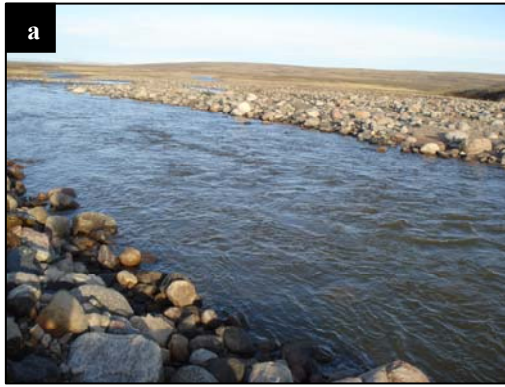
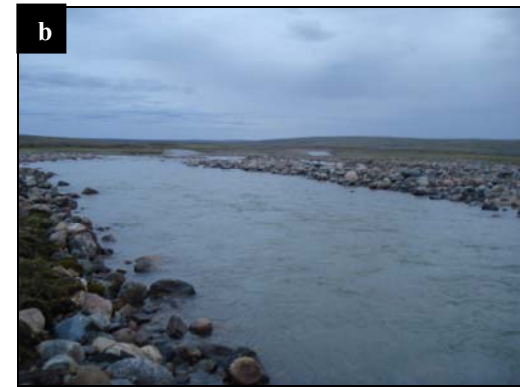
Figure 2. View downstream from habitat assessment in reach E0-01 of Mary River during spring (a) and summer (b) 2008.

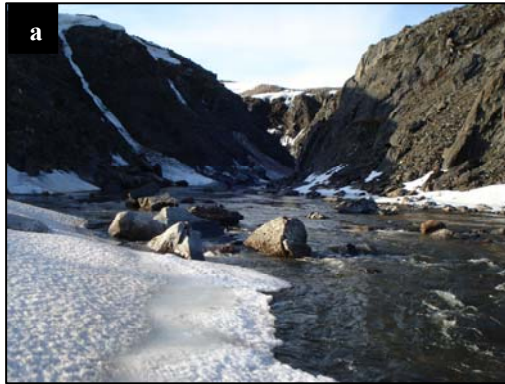
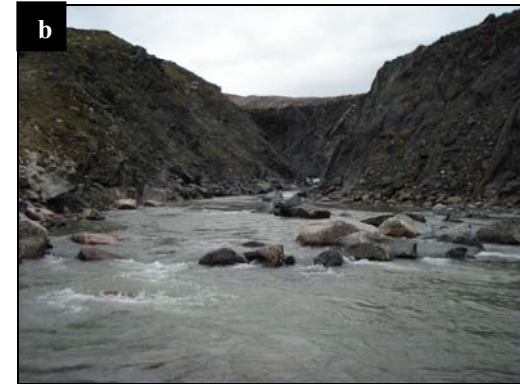
Figure 1. View upstream from habitat assessment in reach E0-01a of Mary River during spring (a) and summer (b) 2008.

Stream/Riparian Habitat		
Channel Morphology:	50% pool, 40% cascade/rapid, 10% run	
Substrate Composition:	60% cobble, 40% boulder,	
Stream Cover:	50% lg cobble 40% boulder	
Aquatic Vegetation:	Periphyton	
Riparian Vegetation:	Grasses and moss	
Barriers Present (Y/N):	Y	
Location:	Falls US	
Lakes Present (Y/N):	Y	
Location:	DS – Mary & Sheardown Lakes	
L/R Bank Characteristics		
	Spr	Sum
Bank Height (L/R; m):	Undef	Undef
Bank Stability:	NA	NA
Erosion Potential:	NA	NA

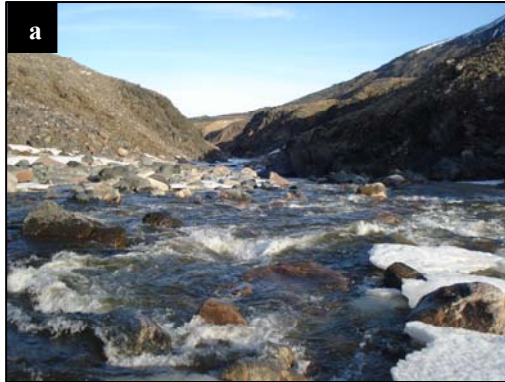
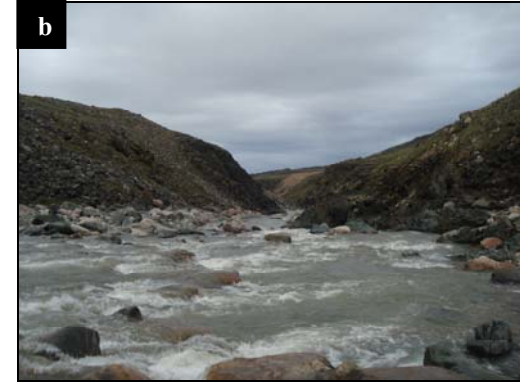
Figure 2. View downstream from habitat assessment in reach E0-01a of Mary River during spring (a) and summer (b) 2008.

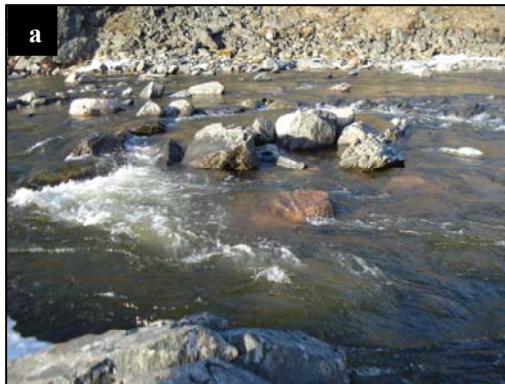
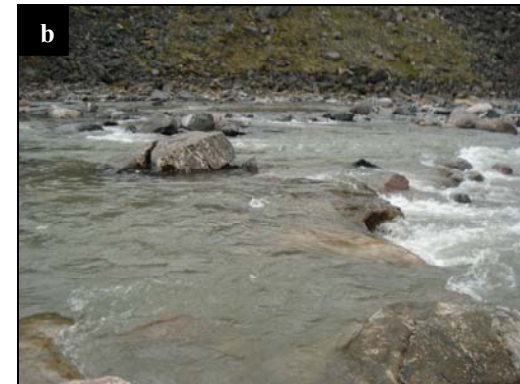
Figure 3. View across the habitat assessment site in reach E0-01a of Mary River during spring (a) and summer (b) 2008.

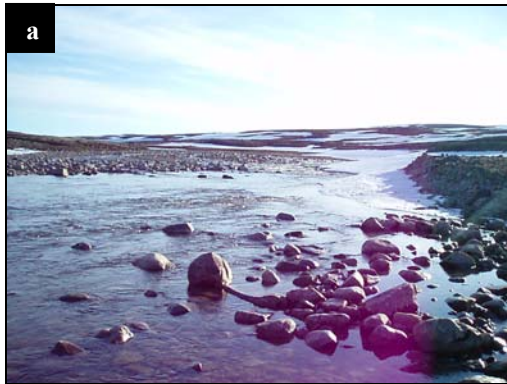
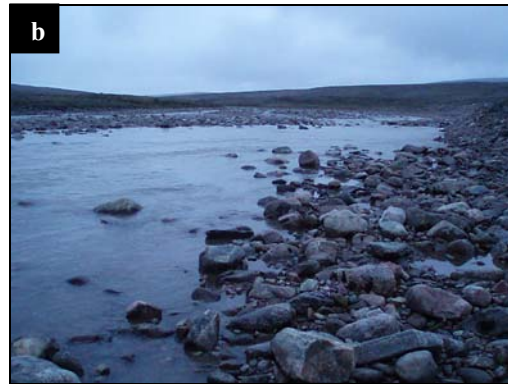
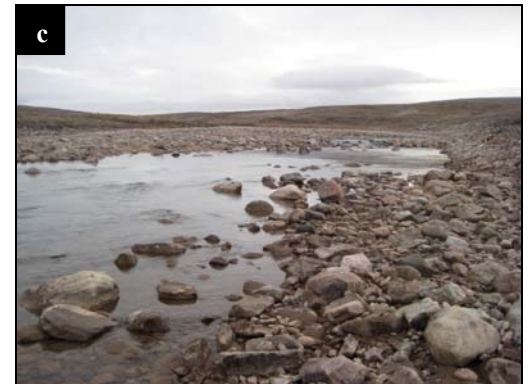
Figure 1. View upstream from habitat assessment at Site G0-09 in Mary River during spring (a), summer (b), and fall (c).

Channel Morphology: 95% riffle (spr),
5% run (spr)
50% riffle (sum, fall),
45% run (sum, fall),
5% pool (sum, fall)

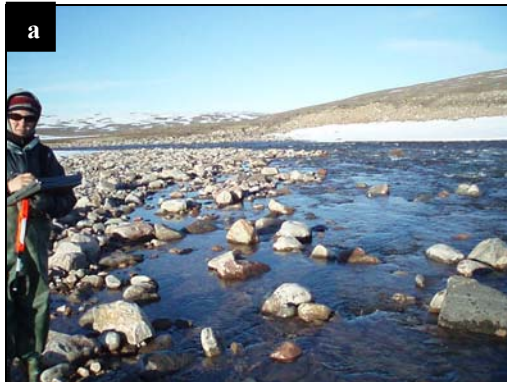
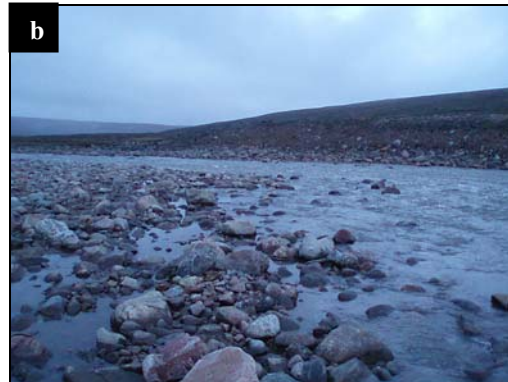
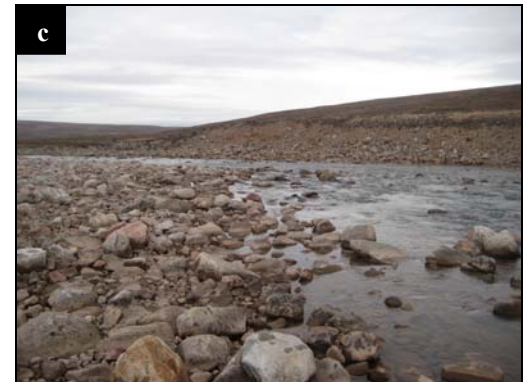
Figure 2. View downstream from habitat assessment at Site G0-09 in Mary River during spring (a), summer (b), and fall (c).

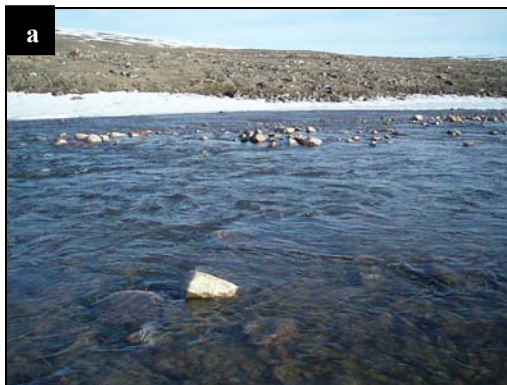
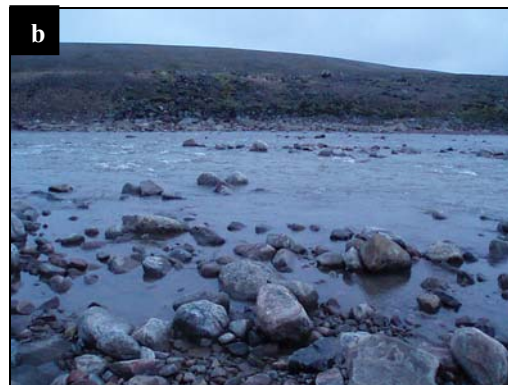
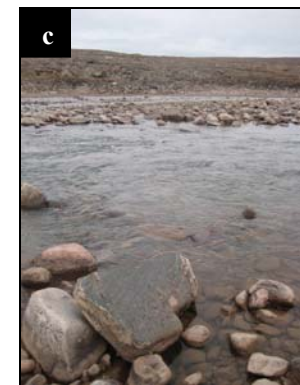
Figure 3. View across the habitat assessment site at Site G0-09 in Mary River during spring (a), summer (b), and fall (c).

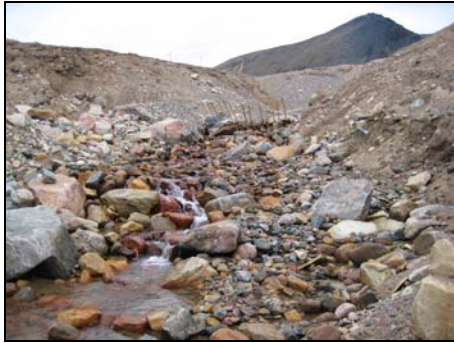
Figure 1: View upstream of E3-01.

Location	
Crossing ID: E3-01 UTM: 17W 563829 / 7913062	Date/Time Surveyed: 24-Aug-07 / 11:50
Site Description/Physical Characteristics	Biotic Characteristics
Floodplain Width (m): 6.40 Channel Pattern: sinuous Channel Confinement: C Channel Gradient: 7°	Fisheries Electrofishing Conducted (Y/N): Y Effort: 600s Settings: 200V 30Hz Fish Observed (Y/N): N Species/Totals: N/A Length Range: N/A
Hydrology	Potential Fish Utilization
Bankfull Width (m): 6.40 Wetted Width (m): 4.57 Depth Profile (25%, 50%, 75%; m): N/M Max Depth (m): 0.30 Flow Regime: per	Arctic char (ARCH) Spawning: N Rearing: N Overwintering: N Migration: N Ninespine stickleback (NNST) Spawning: N Rearing: N Overwintering: N Migration: N
Bank Characteristics	Habitat Assessment Summary & Potential Habitat Compensation Notes
Bank Height (L/R; m): UD / UD Bank Shape (L/R): S / S Bank Stability: low	<p>Two sets of cascades near the confluence of E0-03 with the Mary River prevent fish from accessing this site.</p> <p>The conductivity in E3-01 was very high. Electrofishing at the confluence revealed that fish were not present in the Mary River within at least 20 m downstream of the outflow from E3-01.</p> <p>E3-01 is not fish habitat. However, impacts to E3-01 affect important fish habitat in the Mary River downstream of the confluence and requires further study and possible compensation.</p>

Stream/Riparian Habitat	Fish Habitat Quality
Channel Morphology: 50% Ca, 50% Po Substrate Composition: 30% Sa, 10% Gr, 58% Co, 2% Bo Stream Cover: 2% Bo Barriers Present (Y/N): Y Description/Location: cascades ~ 50m DS Lakes Present (Y/N): Y Description/Location: several km DS (Mary L.)	No Fish Habitat

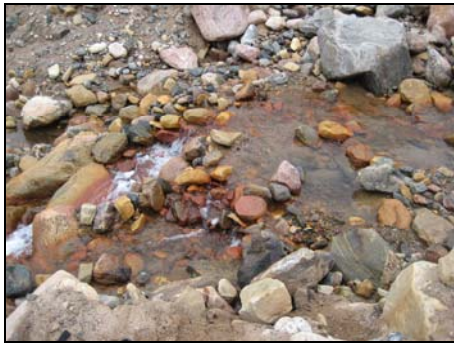
Figure 2: View across E3-01 from right bank.

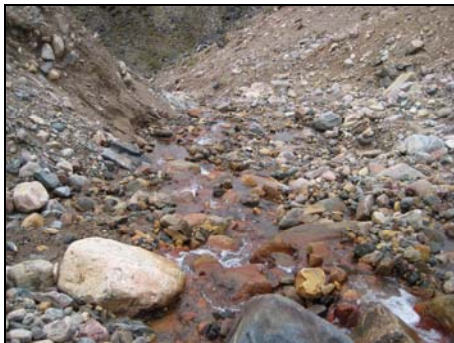
Figure 3: View downstream of E3-01.

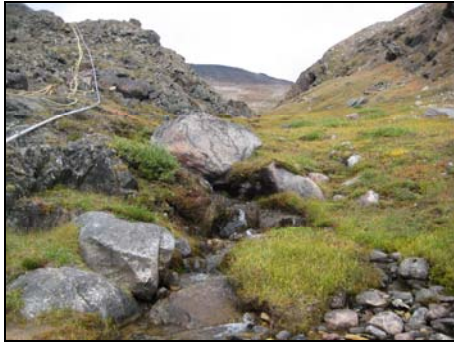
Figure 1: View upstream of E4-01.

Location	
Crossing ID: E4-01 UTM: 17W 563927 / 7913090	Date/Time Surveyed: 26-Aug-07 / 10:47
Site Description/Physical Characteristics	Biotic Characteristics
Floodplain Width (m): N/M Channel Pattern: sinuous Channel Confinement: PC Channel Gradient: 10°	Fisheries Electrofishing Conducted (Y/N): Y Effort: 300s Settings: 400V 30Hz Fish Observed (Y/N): N Species/Totals: N/A Length Range: N/A
Hydrology	Potential Fish Utilization
Bankfull Width (m): 1.00 Wetted Width (m): 0.80 Depth Profile (25%, 50%, 75%; m): N/M Max Depth (m): 0.20 Flow Regime: int - per	Arctic char (ARCH) Spawning: N Rearing: N Overwintering: N Migration: N Ninespine stickleback (NNST) Spawning: N Rearing: N Overwintering: N Migration: N
Bank Characteristics	Habitat Assessment Summary & Potential Habitat Compensation Notes
Bank Height (L/R; m): 0.15 / 0.15 Bank Shape (L/R): UC / UC Bank Stability: moderate	<p>Cascades near E4-01's confluence with the Mary River prevent fish from accessing the stream.</p> <p>Electrofishing was conducted in the Mary River near the confluence with E4-01, and 5-10 large, juvenile ARCH were captured.</p> <p>Conductivity in E4-01 is marginally higher than other streams on the exploration property, and could provide moderate fish habitat if it were accessible. The reach of the Mary River that directly receives water from E4-01 is excellent fish habitat.</p>

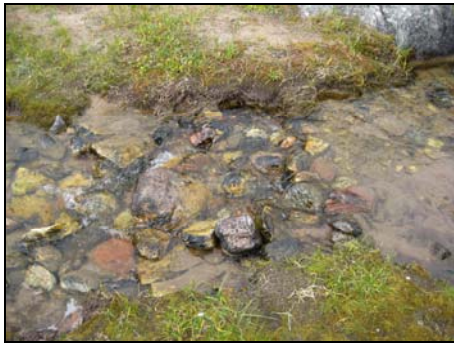
Figure 2: View across E4-01 from right bank.

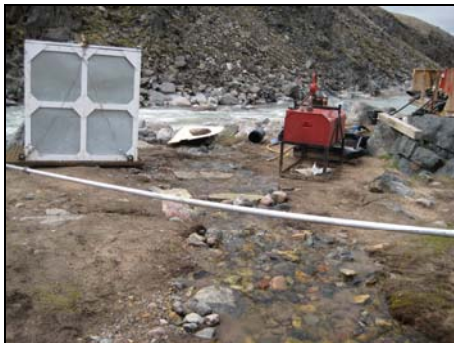
Figure 3: View downstream of E4-01.

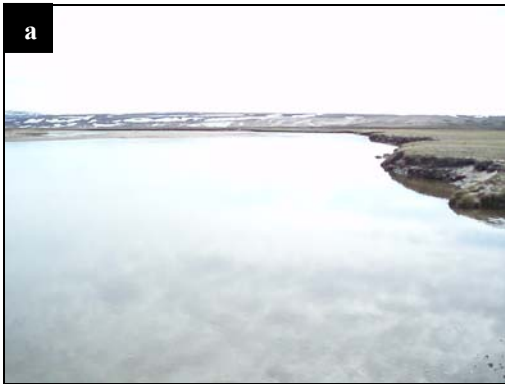
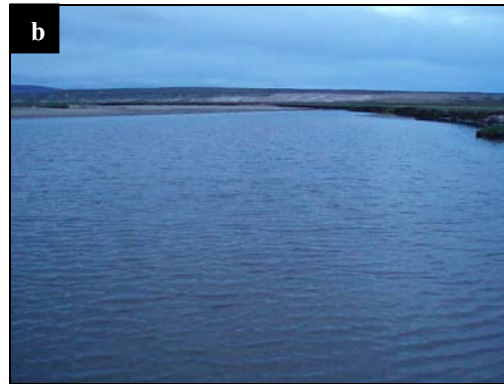
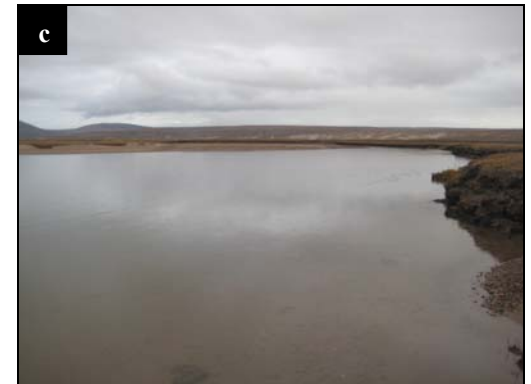
Figure 1. View upstream from the habitat assessment site in Reach I0-01 in Tom River during spring (a), summer (b), and fall (c).

Channel Morphology: 90% run (spr),
10% riffle (spr)
85% riffle (sum, fall),
15% run (sum, fall)

Substrate Composition: 80% sand,
15% gravel,
5% cobble

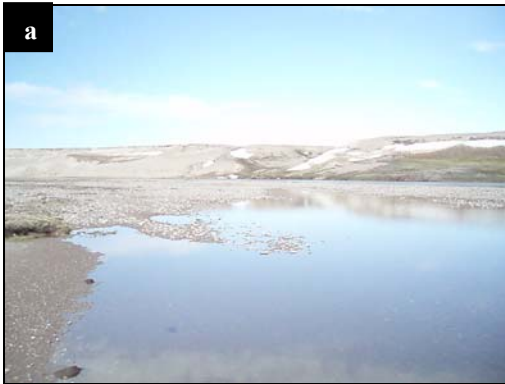
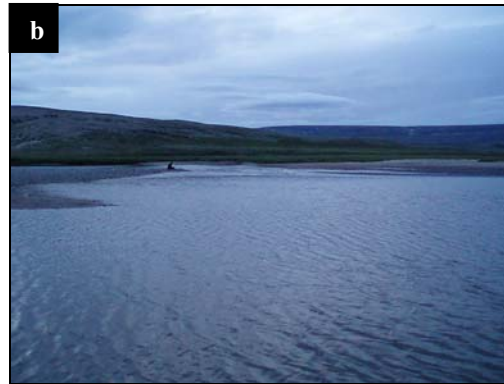
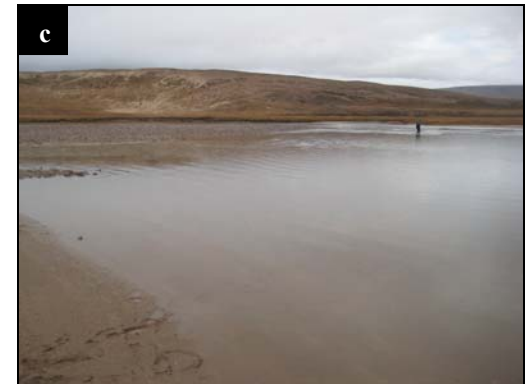
Figure 2. View downstream from the habitat assessment site in Reach I0-01 in Tom River during spring (a), summer (b), and fall (c).

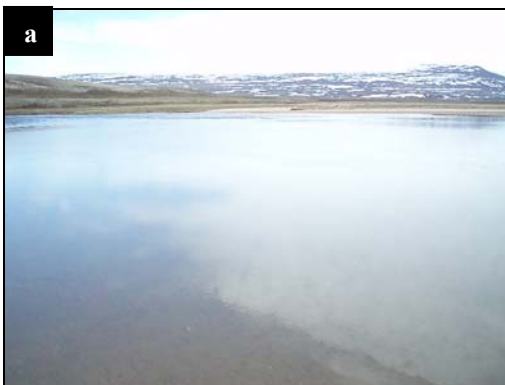
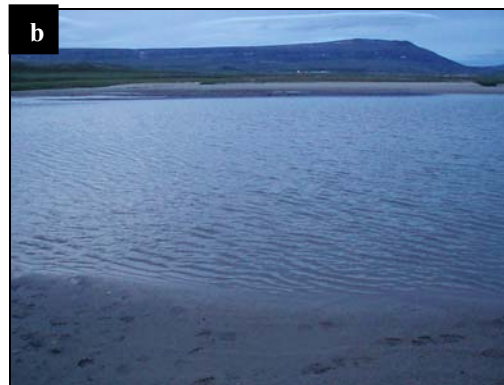
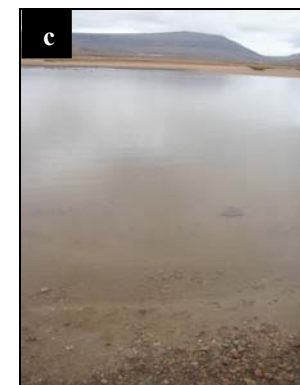
Figure 3. View across the habitat assessment site in Reach I0-01 in Tom River during spring (a), summer (b), and fall (c).

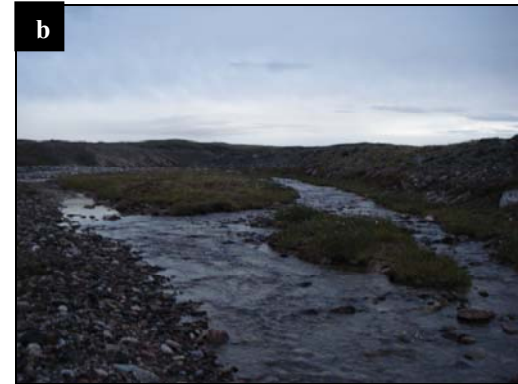
Figure 1. View upstream from the habitat assessment in Reach I0-01a in Tom River during spring (a) and summer (b) 2008.

Channel Morphology: 80% riffle, 20% pool

Substrate Composition: 70% cobble, 15% gravel, 14% sand, 1% boulder

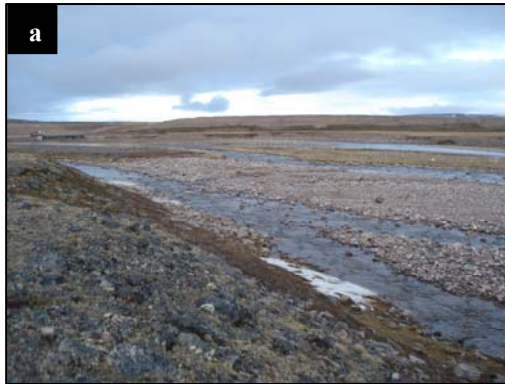
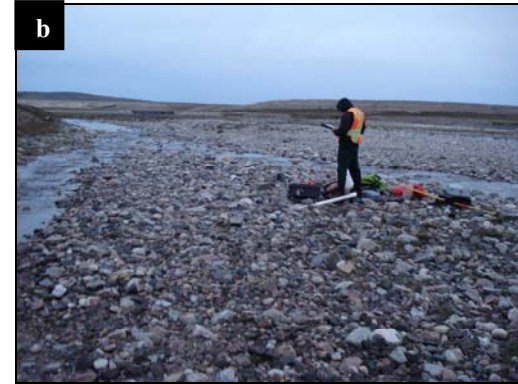
Figure 2. View downstream from the habitat assessment in Reach I0-01a in Tom River during spring (a) and summer (b) 2008.

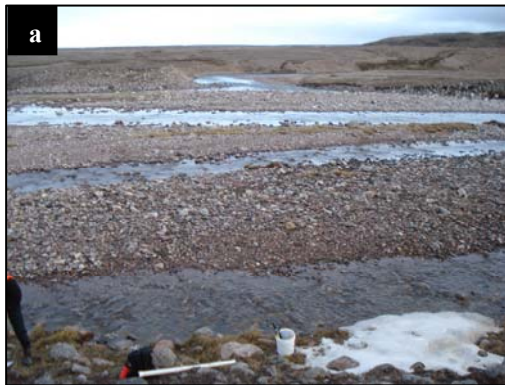
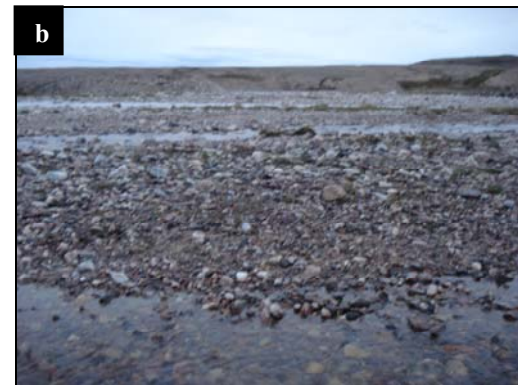
Figure 3. View across the habitat assessment in Reach I0-01a in Tom River during spring (a) and summer (b) 2008.

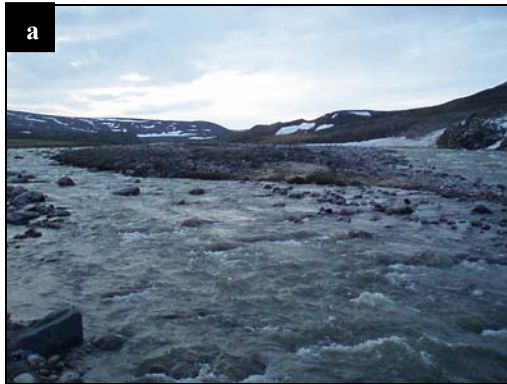
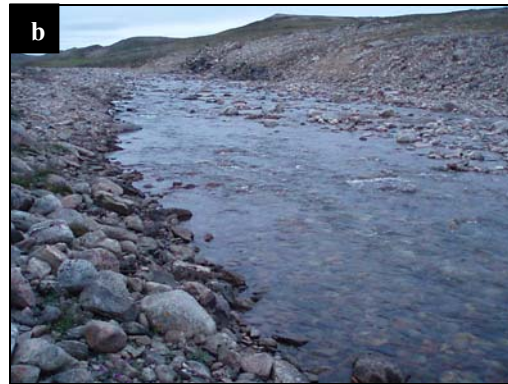
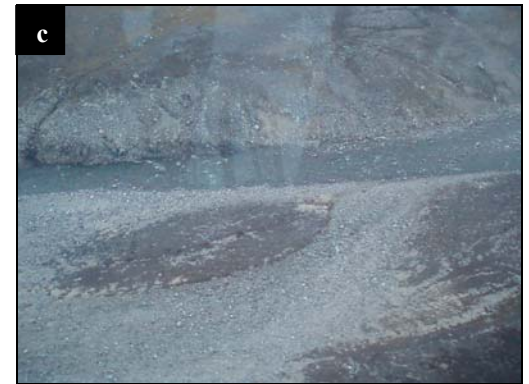
Figure 1. View upstream from the habitat assessment in Reach I0-04 in Tom River during spring (a) and summer (b) and aerial view during fall (c).

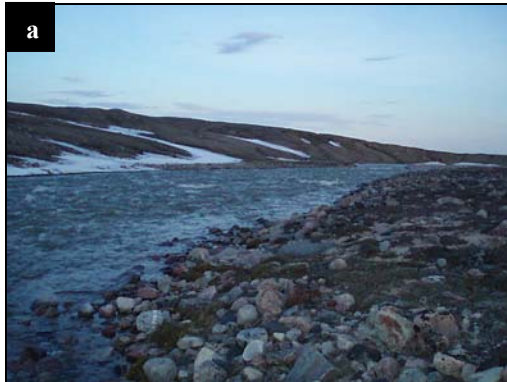
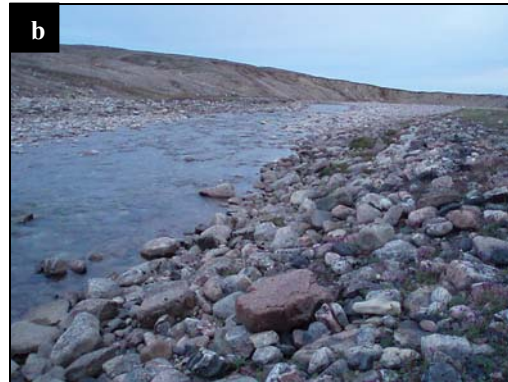
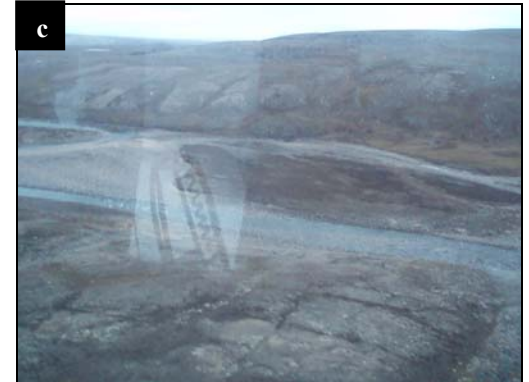
Figure 2. View upstream from the habitat assessment in Reach I0-04 in Tom River during spring (a) and summer (b) and aerial view during fall (c).

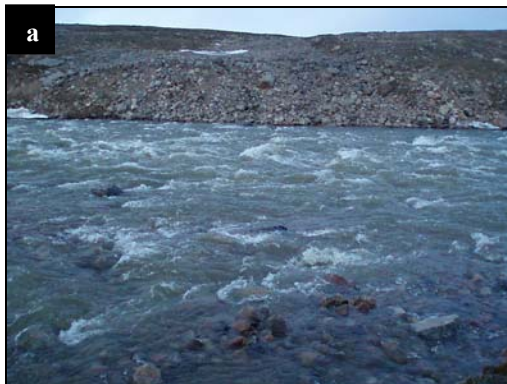
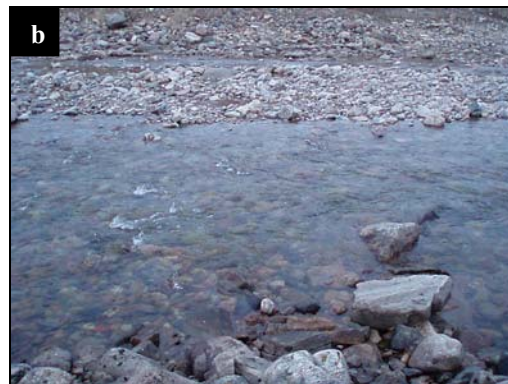
Figure 3. View across the habitat assessment in Reach I0-04 in Tom River during spring (a) and summer (b).

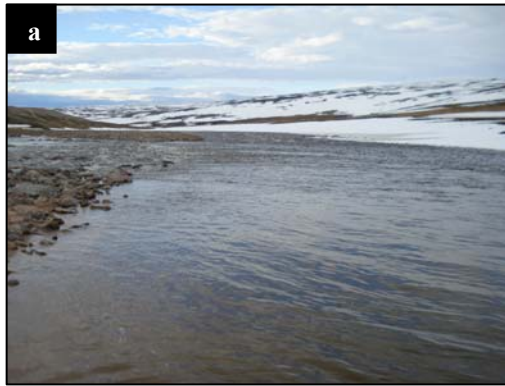
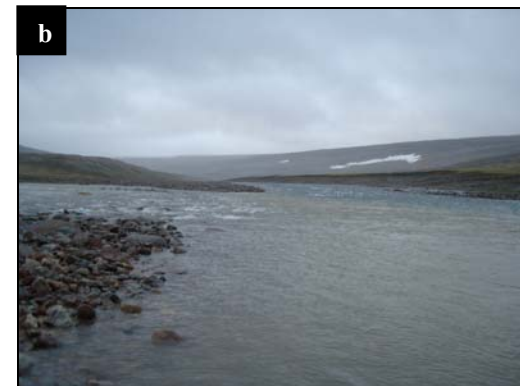
Figure 1. View upstream from habitat assessment in reach 1 of Candidate Reference Stream #2 during spring (a) and summer (b) 2008.

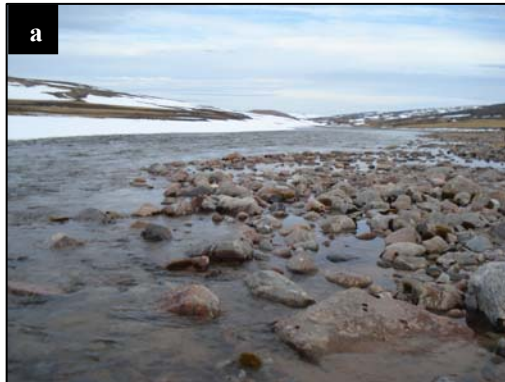
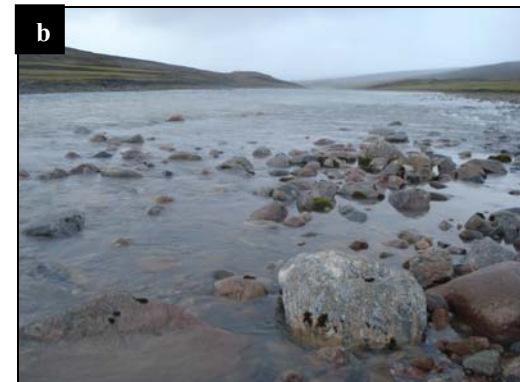
Figure 2. View downstream from habitat assessment in reach 1 of Candidate Reference Stream #2 during spring (a) and summer (b) 2008.

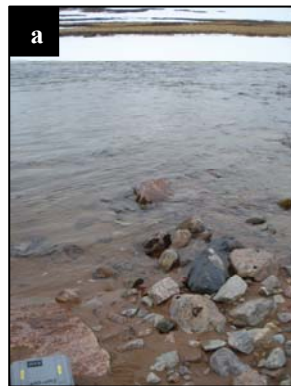
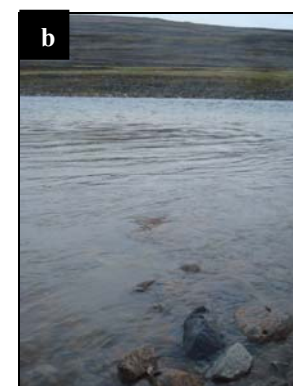
Figure 3. View across the habitat assessment site in reach 1 of Candidate Reference Stream #2 during spring (a) and summer (b) 2008.

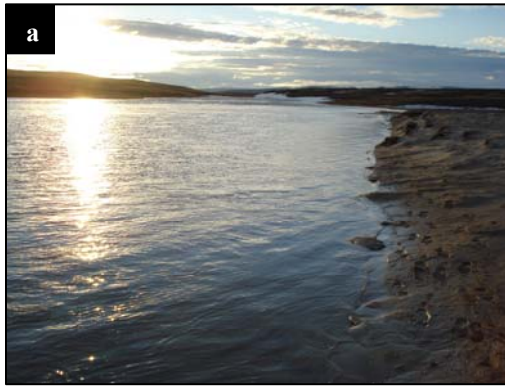
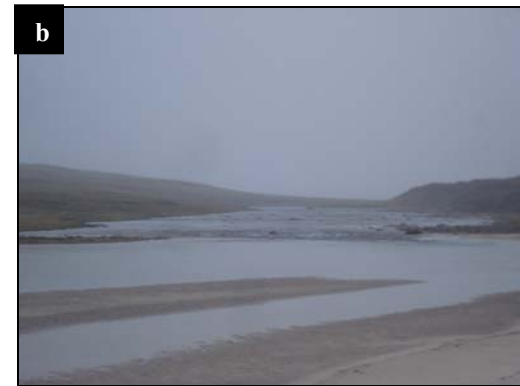
Figure 1. View upstream from habitat assessment in reach 1 of Candidate Reference Stream #3 during spring (a) and summer (b) 2008.

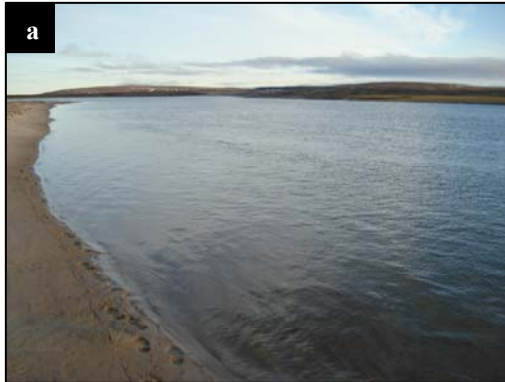
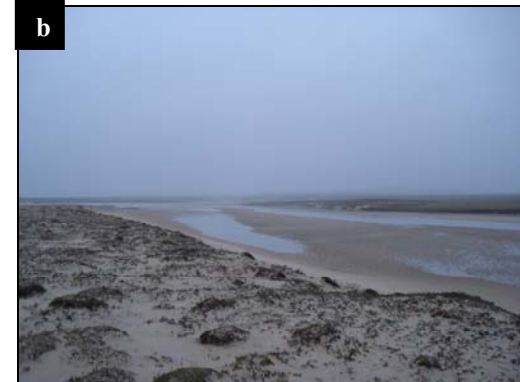
Figure 2. View downstream from habitat assessment in reach 1 of Candidate Reference Stream #3 during spring (a) and summer (b) 2008.

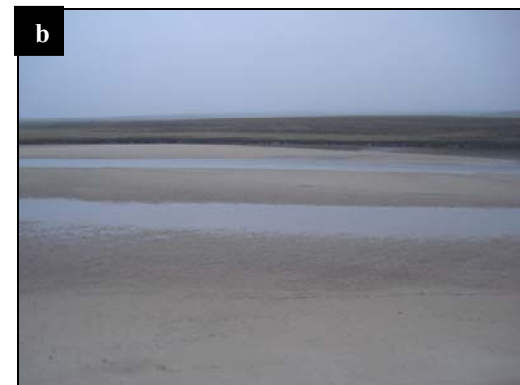
Figure 3. View across the habitat assessment site in reach 1 of Candidate Reference Stream #3 during spring (a) and summer (b) 2008.
