RAIL CV-104-2

LOCATION AND CROSSING DESCRIPTION

**BAFFINLAND IRON MINES
MARY RIVER PROJECT**

North/South Consultants Inc.
Aquatic Environment Specialists

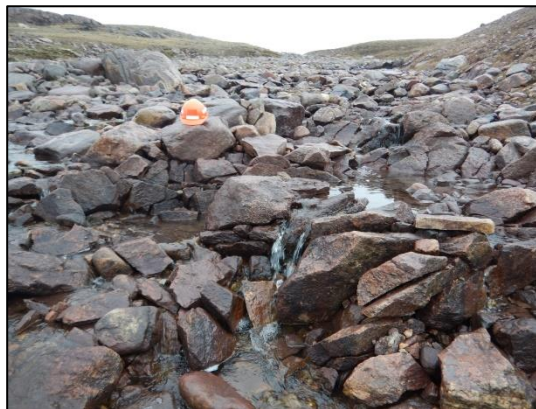
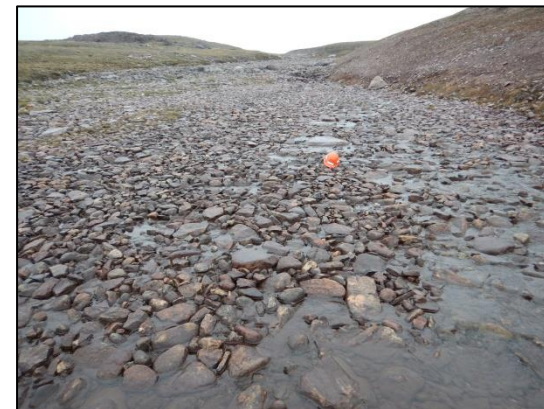
Upstream/ Downstream	UTM		Barrier Type			Height (m)	Gradient (°)	Description	Site Label
	Easting	Northing	1	2	3				
Downstream	NO BARRIERS								
Upstream	557926	7915221	VD	SHALL		0.3		Intermittent Barrier: When combined with low water, vertical drops may become barrier	A
Upstream	560456	7916125	VD			0.6		Permanent Barrier: >3.5 km upstream of crossing	B

A steeper 50-m long reach with small vertical drops starting at 130 m upstream from the centreline may act as a barrier under low water levels, but fish were found upstream of this feature in spring and summer/fall 2019. There is a permanent barrier (an impassable vertical drop) approximately 3.5 km upstream from the rail centreline. There are no natural downstream barriers to fish movement, though high velocities have been observed at the outflow from the Tote Road culvert during periods of high water.

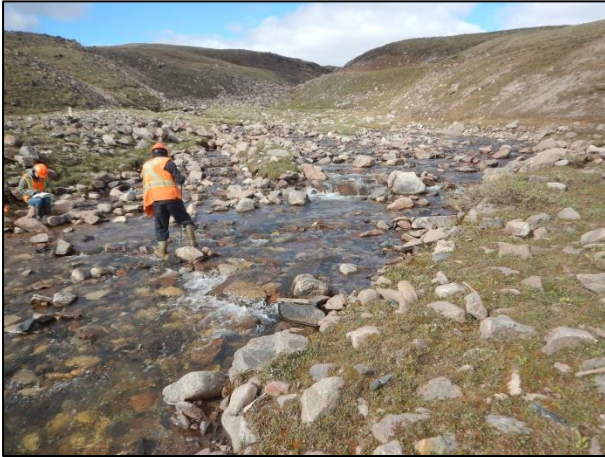
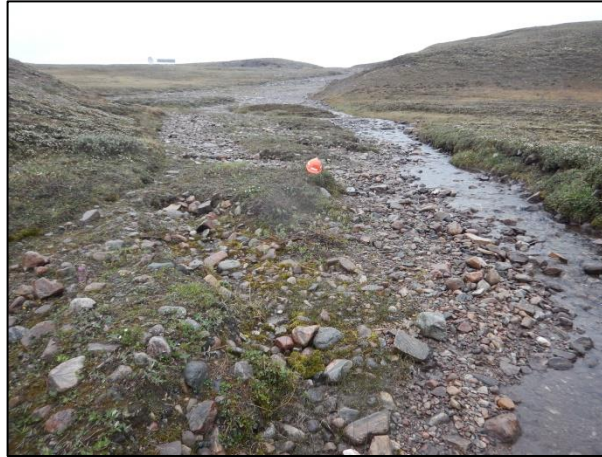
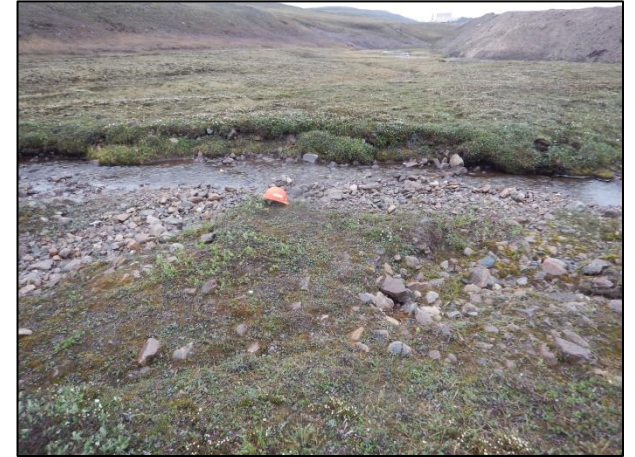
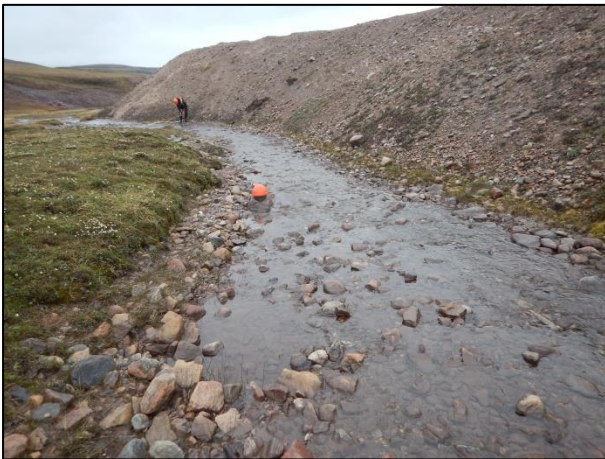
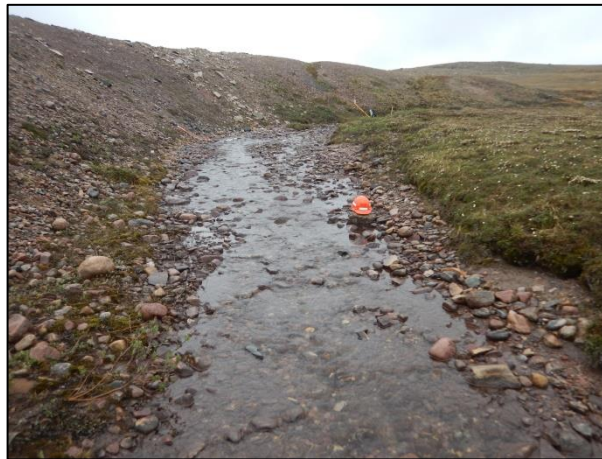
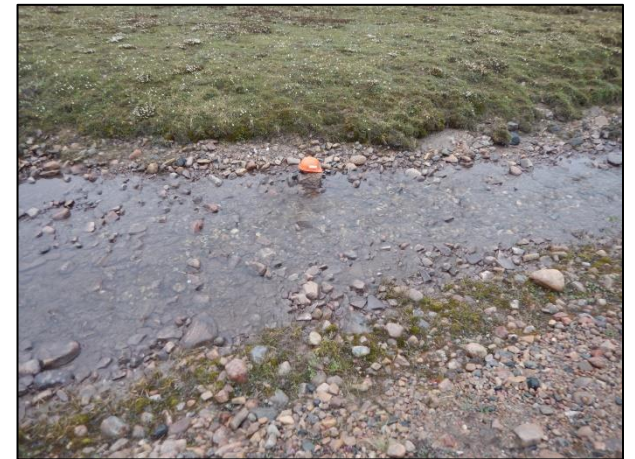
Photos 1. Photos taken at the crossing centreline (top) and 20 m downstream (bottom) in spring: (A,D) facing upstream; (B,E) facing downstream; and (C,F) across (right bank looking at left bank).

Habitat in the stream is shallow riffle/cascade/pool with moderate velocities over mainly cobble/gravel substrate.

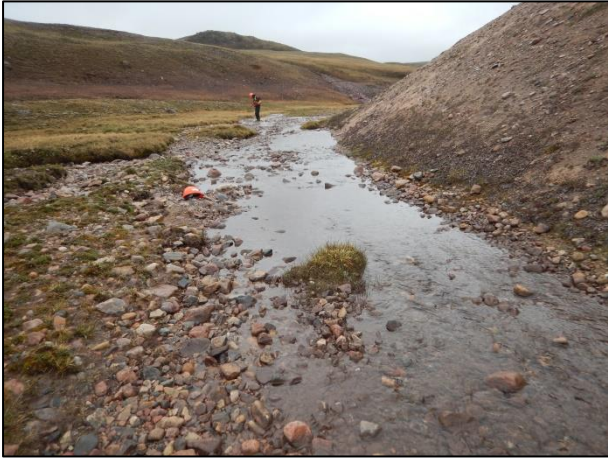
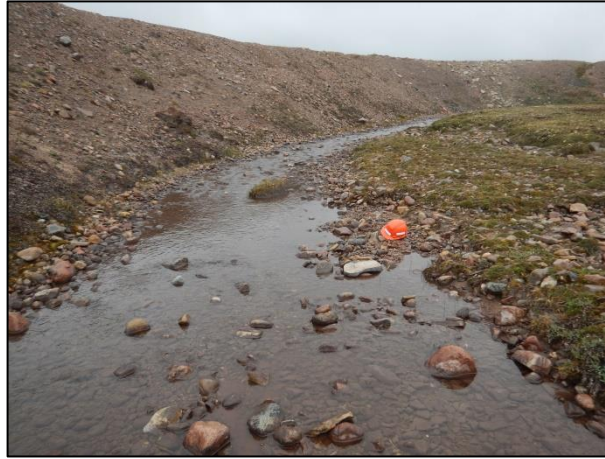
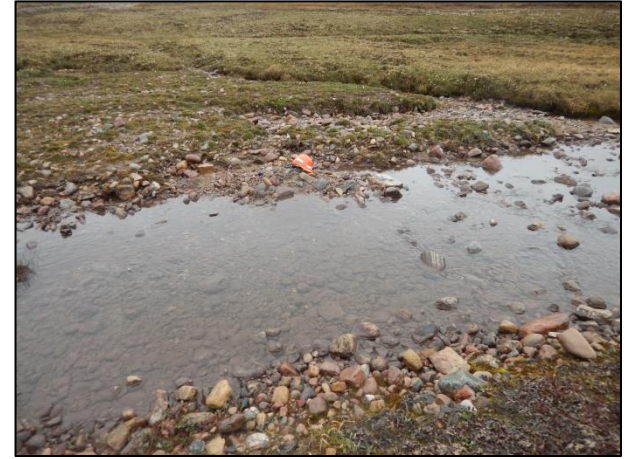
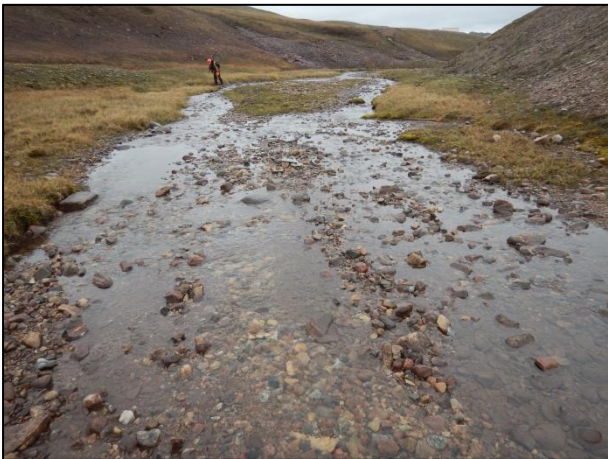
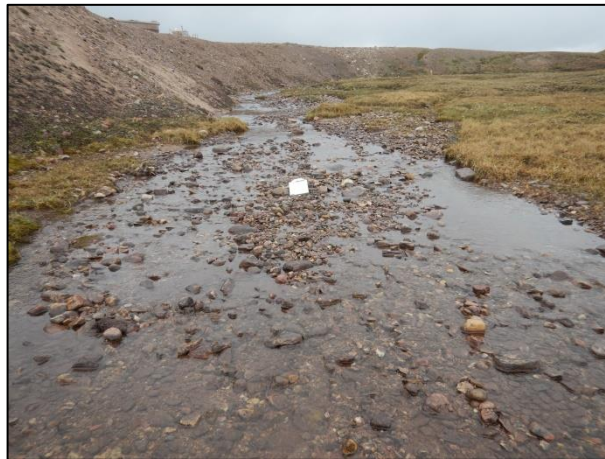
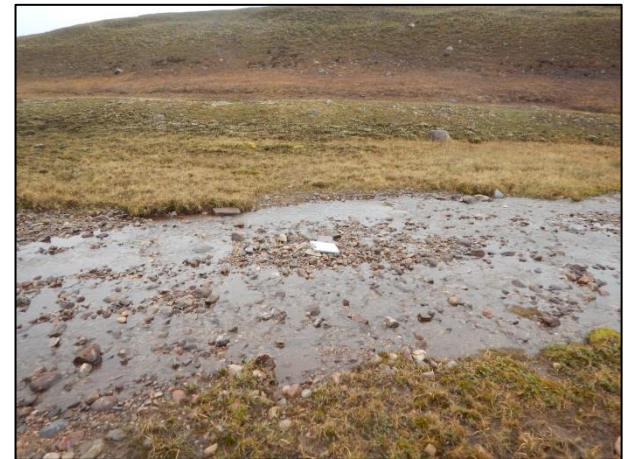
Photos 2. Photos taken 40 m downstream (top) and 60 m downstream (bottom) in spring: (A,D) facing upstream; (B,E) facing downstream; and (C,F) across (right bank looking at left bank).

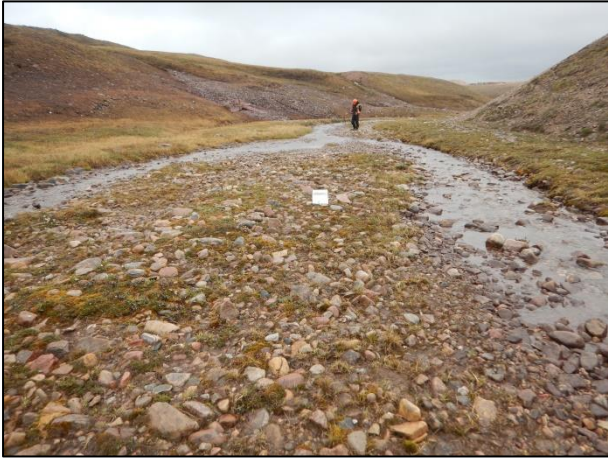
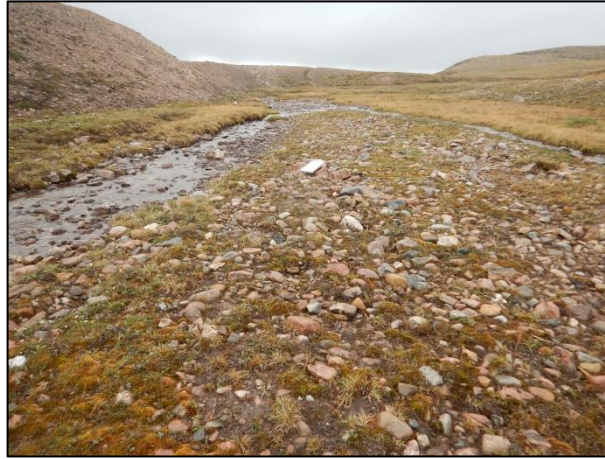
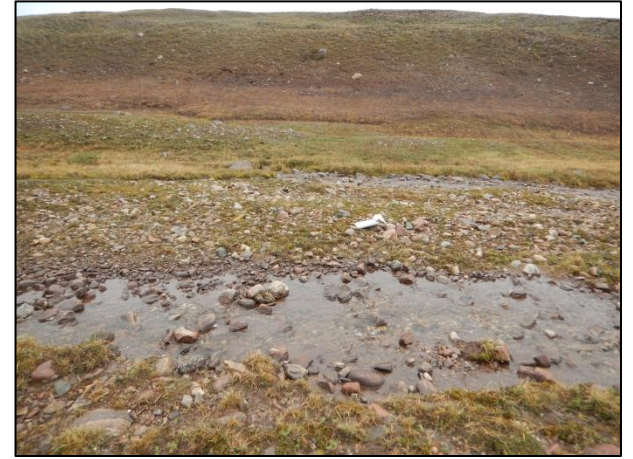
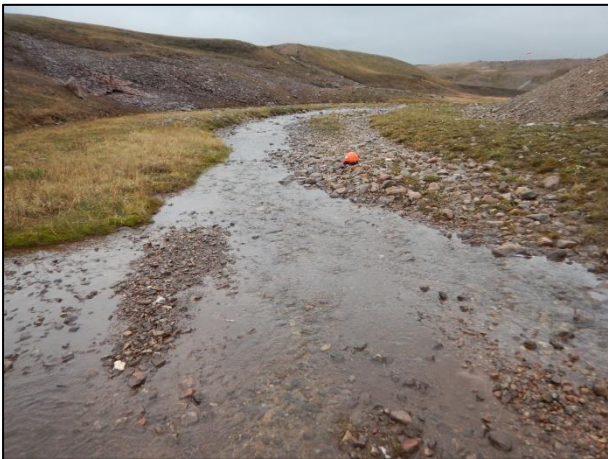
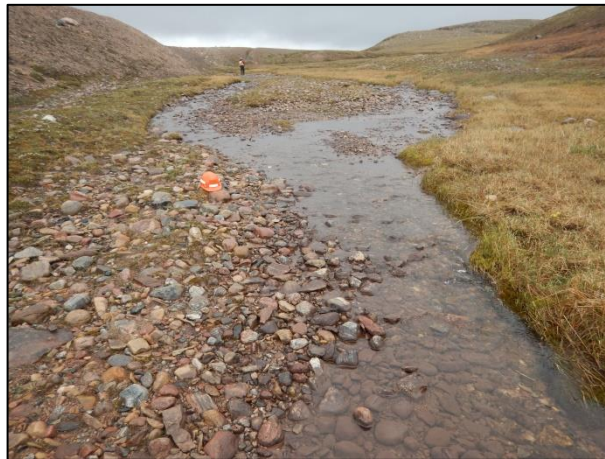
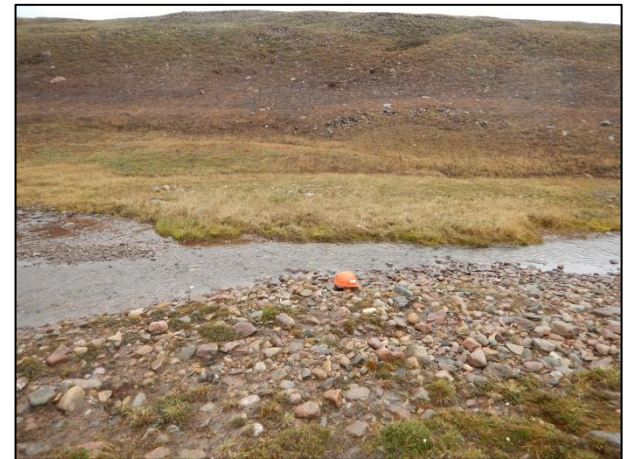
Photos 3. Photos taken 80 m downstream (top) and 100 m downstream (bottom) in spring: (A,D) facing upstream; (B,E) facing downstream; and (C,F) across (right bank looking at left bank).

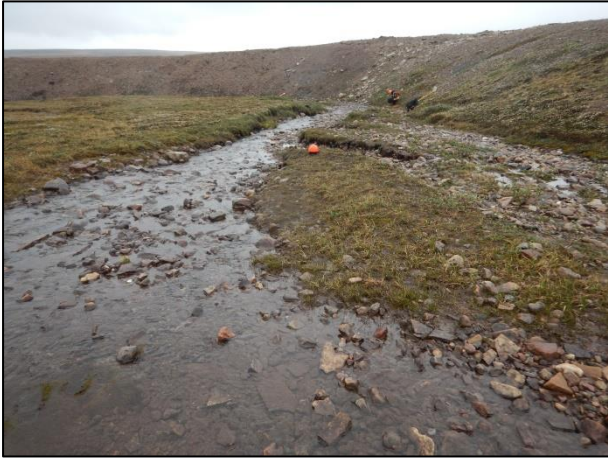
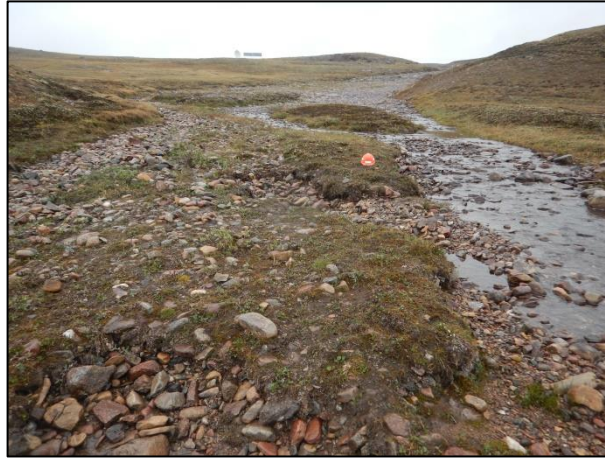
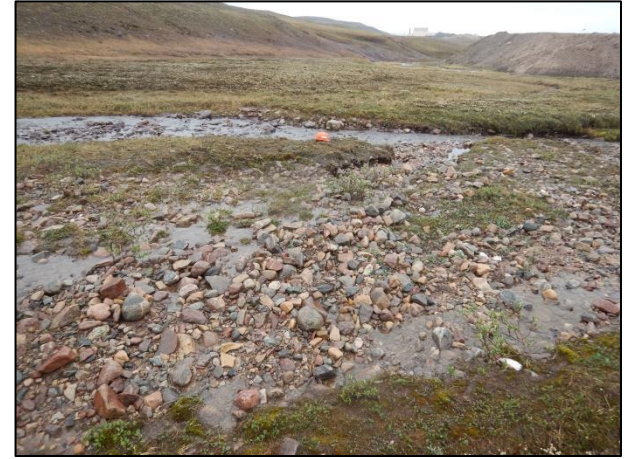
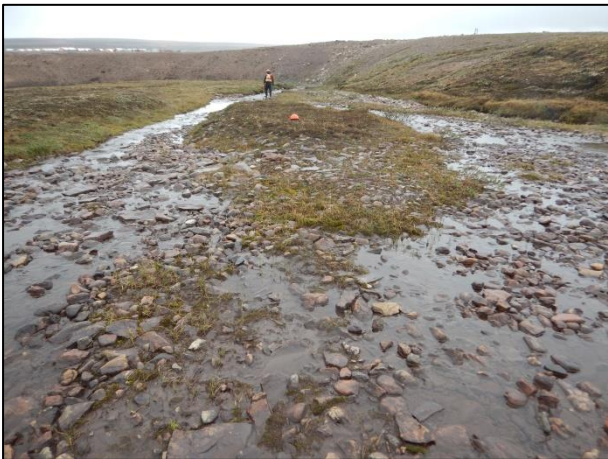
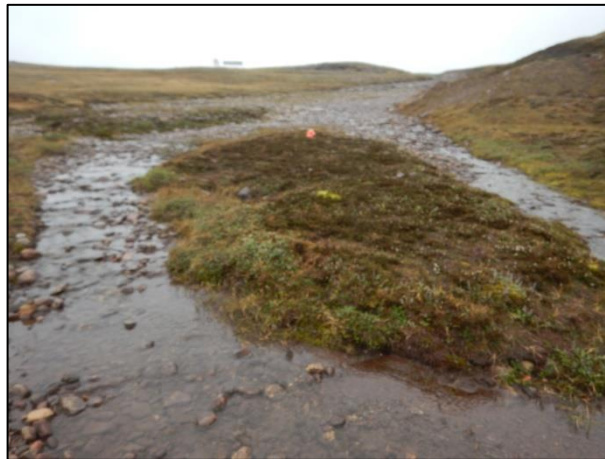
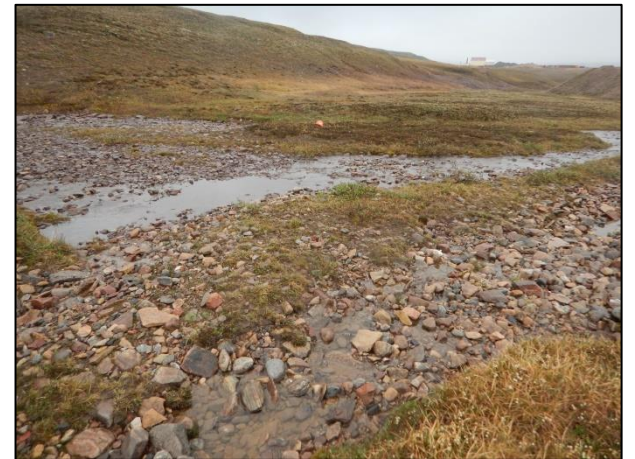
Photos 4. Photos taken 20 m upstream (top) and 40 m upstream (bottom) in spring: (A,D) facing upstream; (B,E) facing downstream; and (C,F) across (right bank looking at left bank).

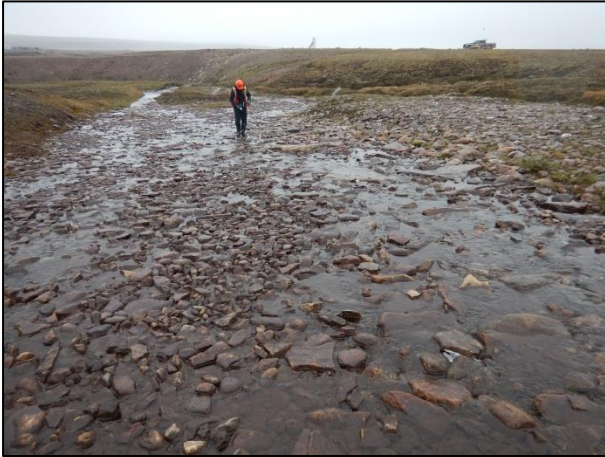
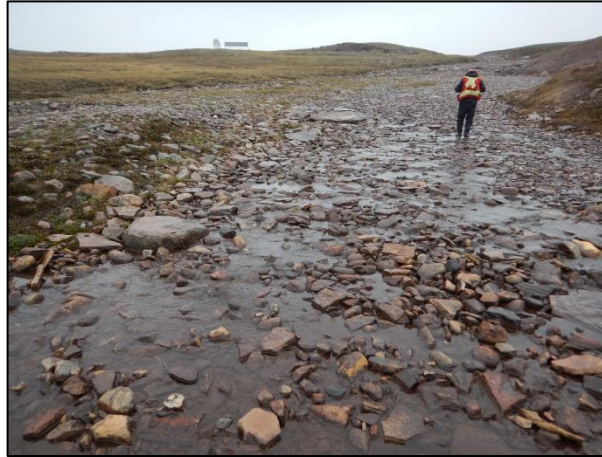
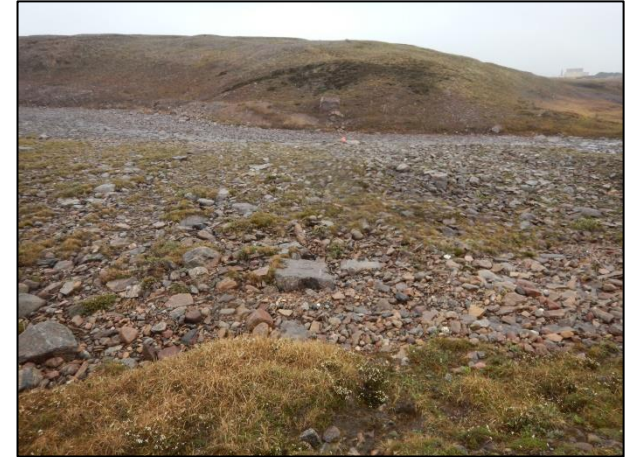
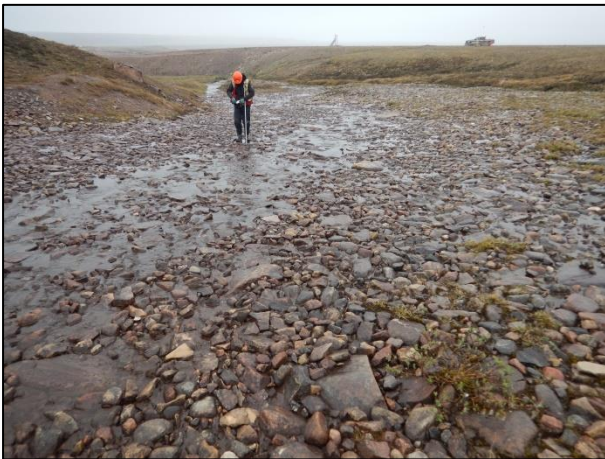
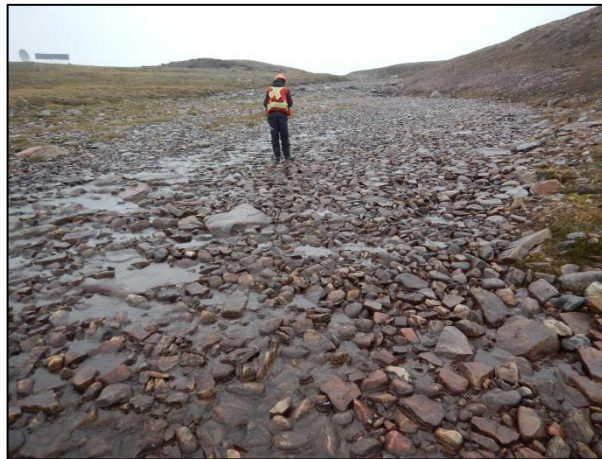
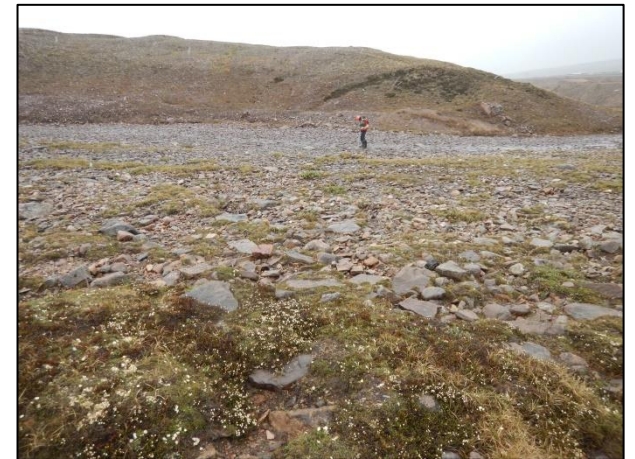
Photos 5. Photos taken 60 m upstream (top) and 80 m upstream (bottom) in spring: (A) facing upstream; (B) facing downstream; and (C) across (right bank looking at left bank).

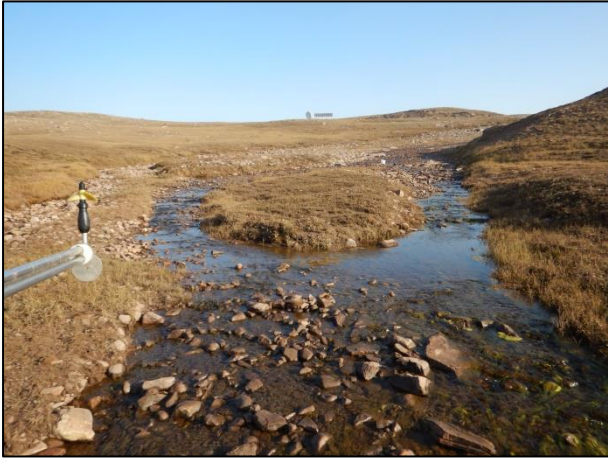
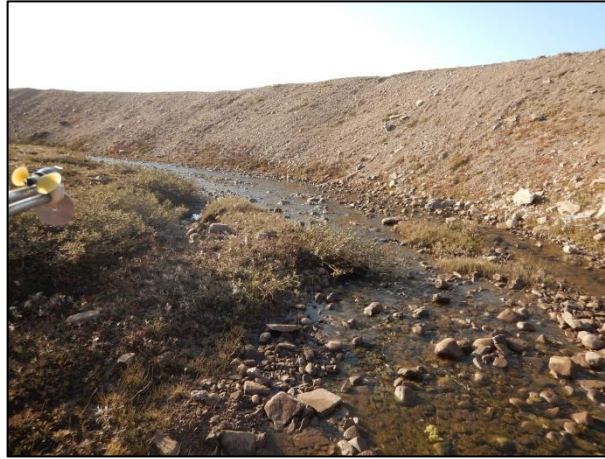
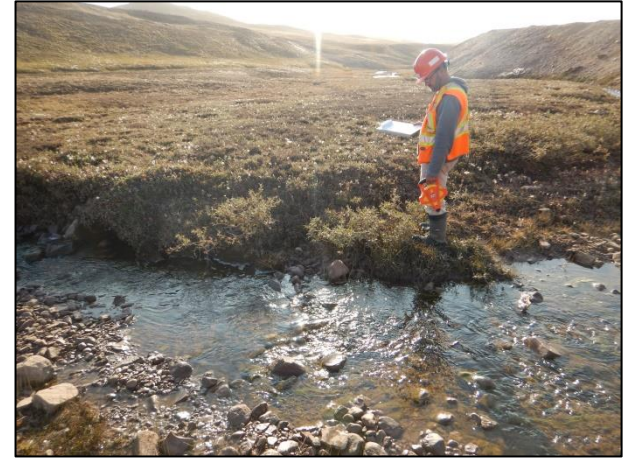
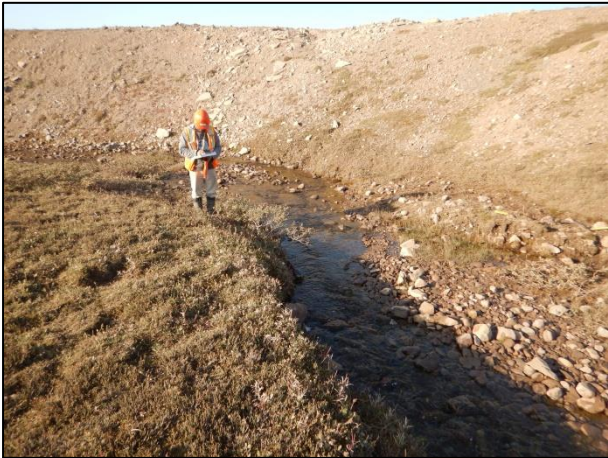
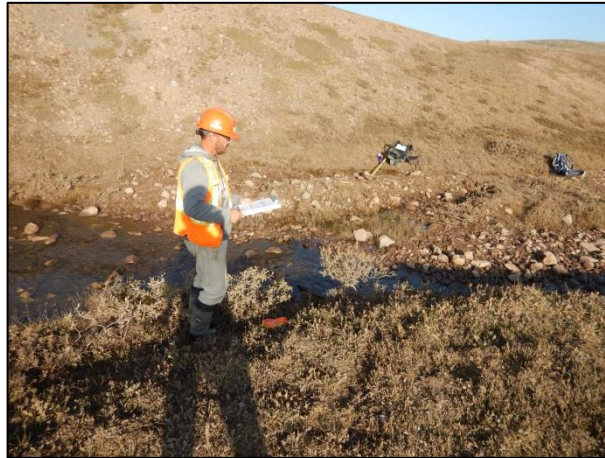
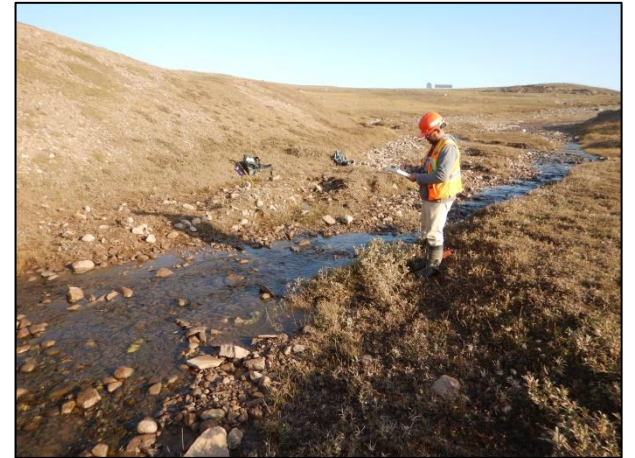
Photos 7. Photos taken at the crossing centerline in summer/fall: (A) facing upstream; (B) facing downstream; (C) across (left bank looking at right bank); (D) diagonal from right bank above the centreline looking downstream; (E) across (right bank looking at left bank); and (F) diagonal from right bank below the centreline looking upstream.

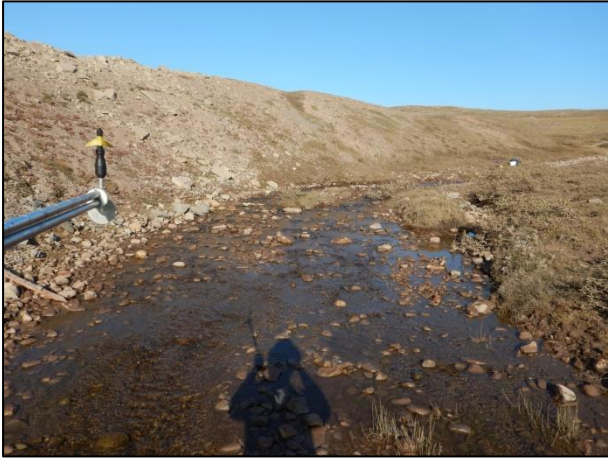
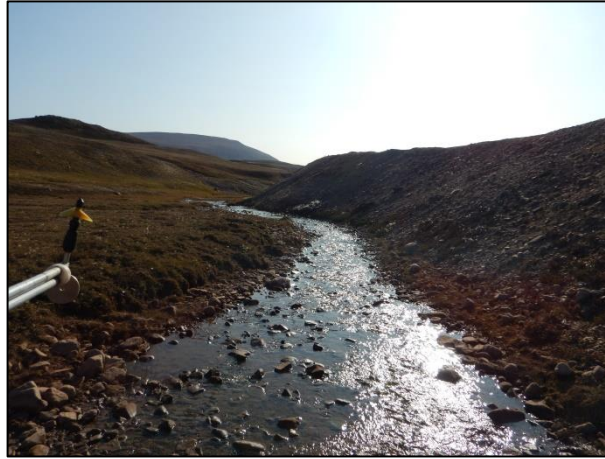
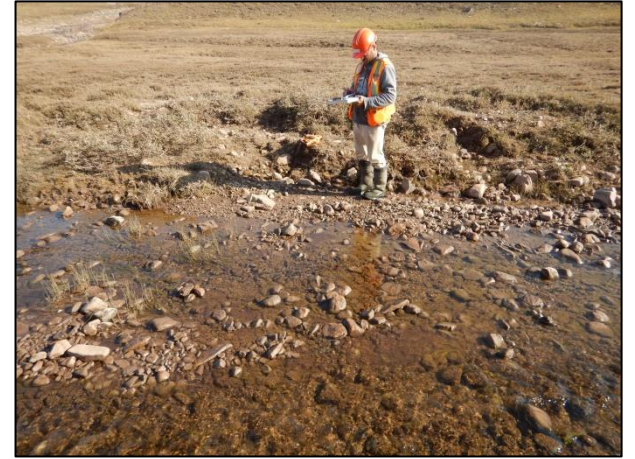
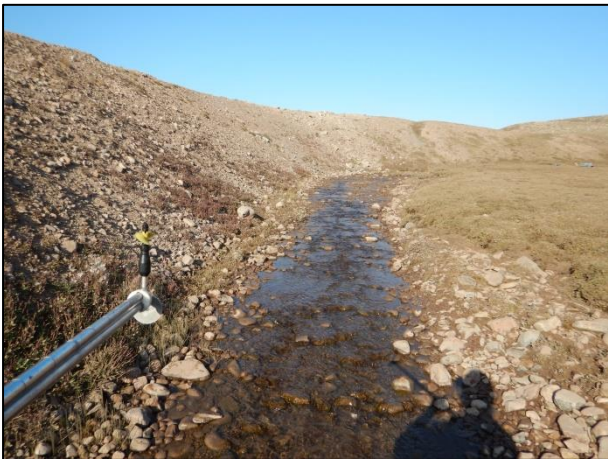
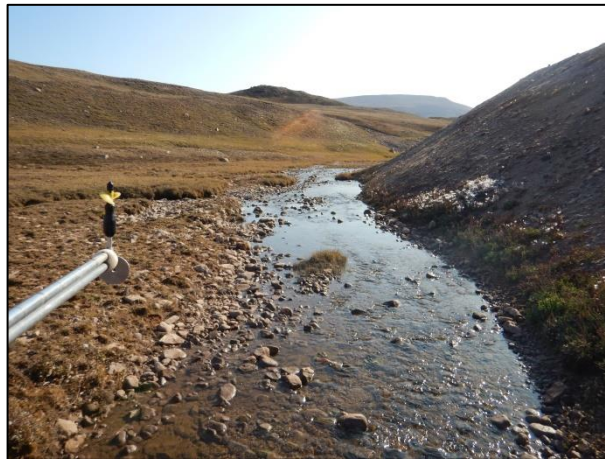
Photos 8. Photos taken 20 m downstream (top) and 40 downstream (bottom) in summer/fall: (A,D) facing upstream; (B,E) facing downstream; and (C,F) across (left bank looking at right bank).

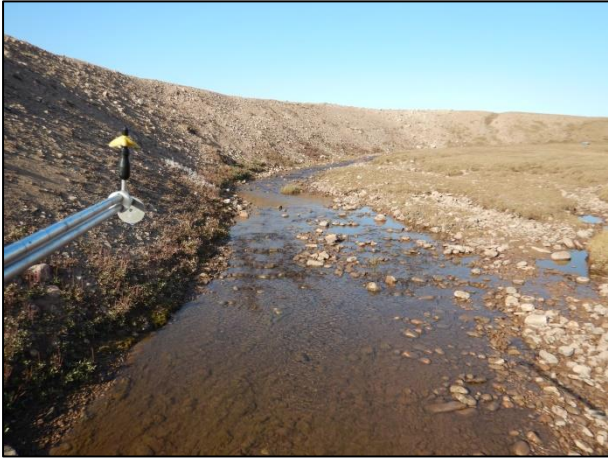
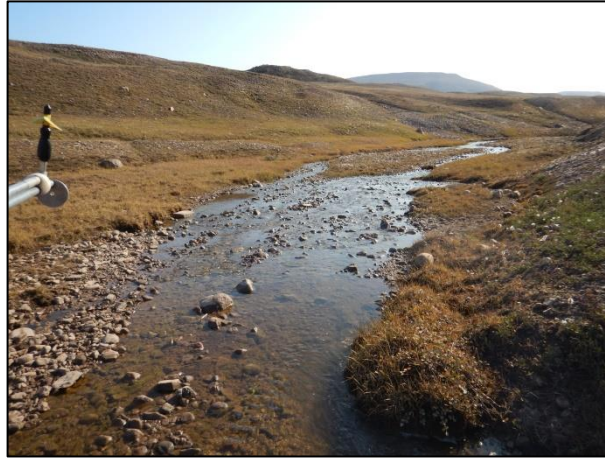
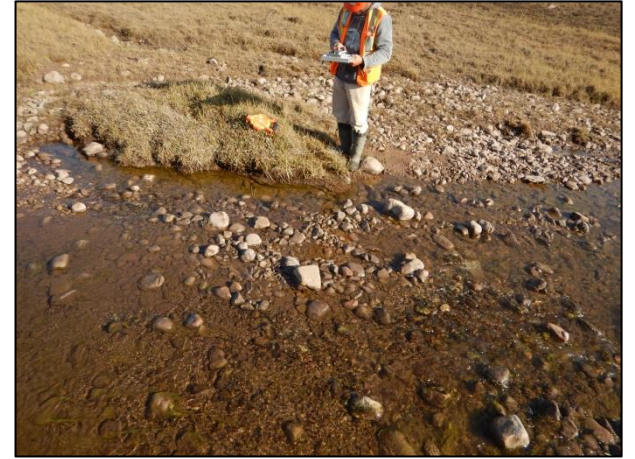
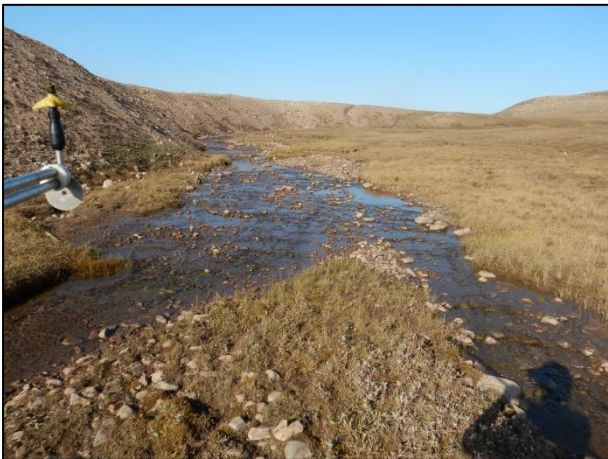
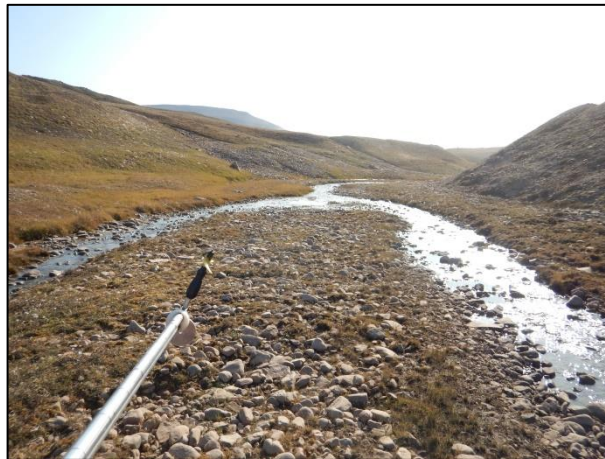
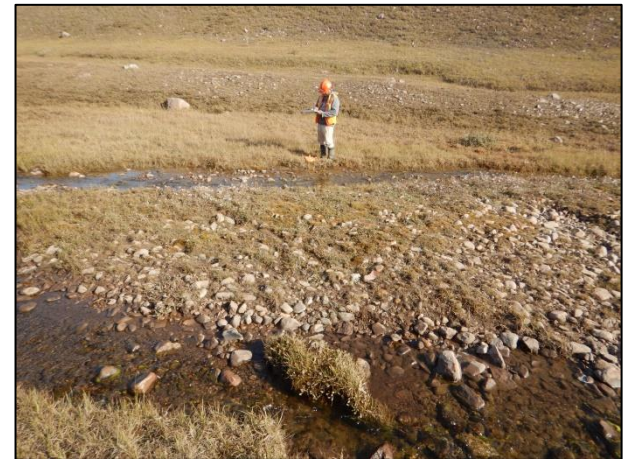
Photos 9. Photos taken 60 m downstream (top) and 80 downstream (bottom) in summer/fall: (A,D) facing upstream; (B,E) facing downstream; and (C,F) across (left bank looking at right bank).

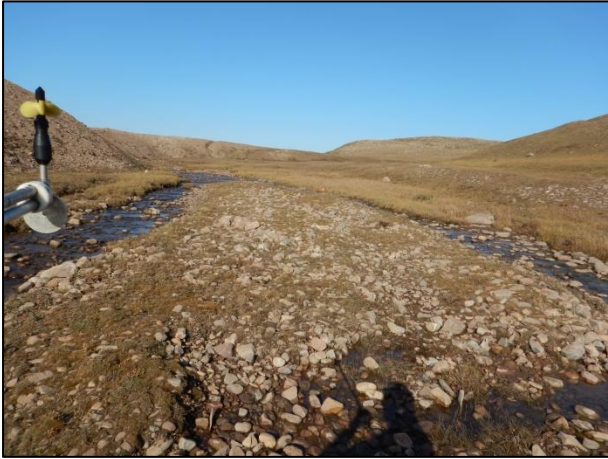
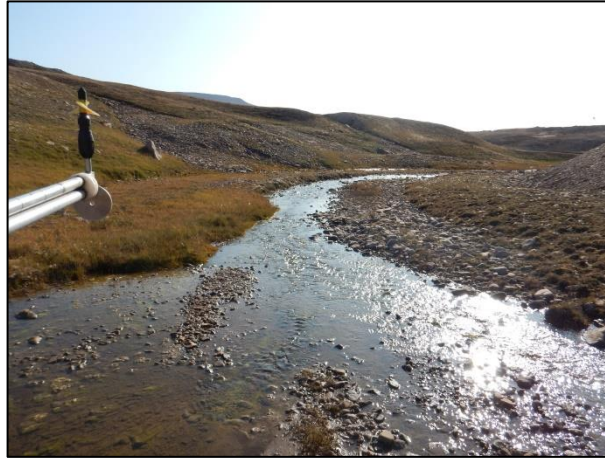
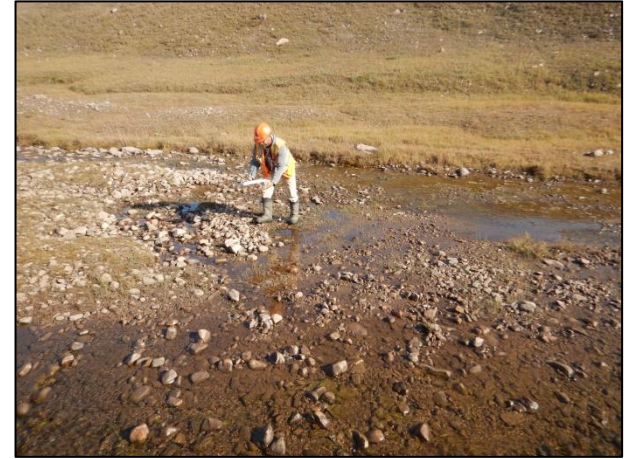
Photos 10. Photos taken 100 m downstream in summer/fall: (A) facing upstream; (B) facing downstream; and (C) across (left bank looking at right bank).

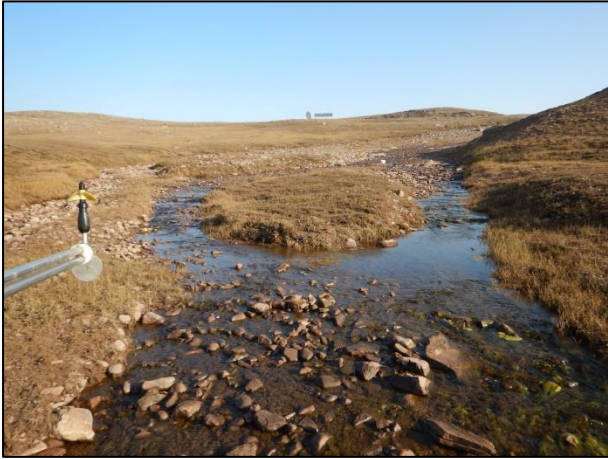
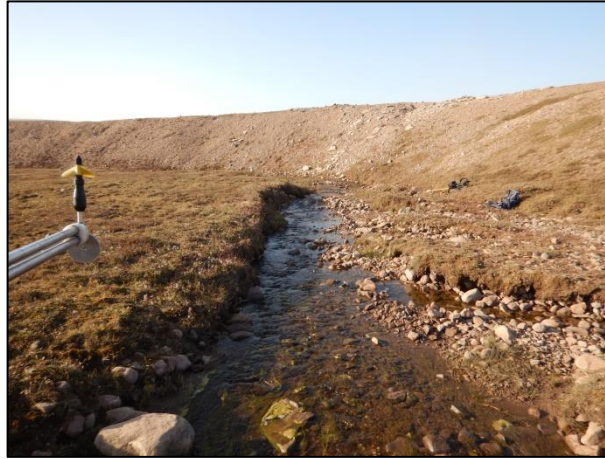
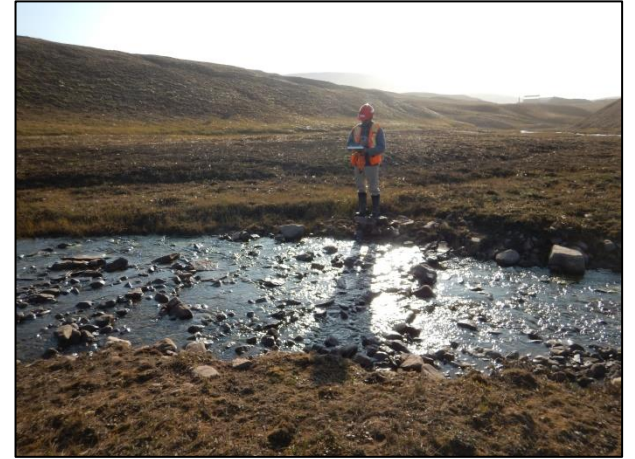
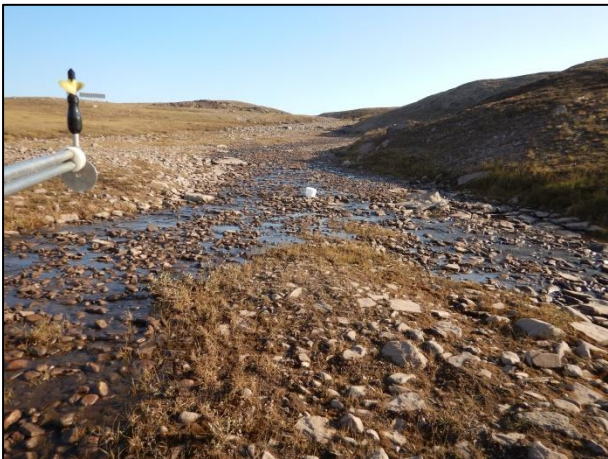
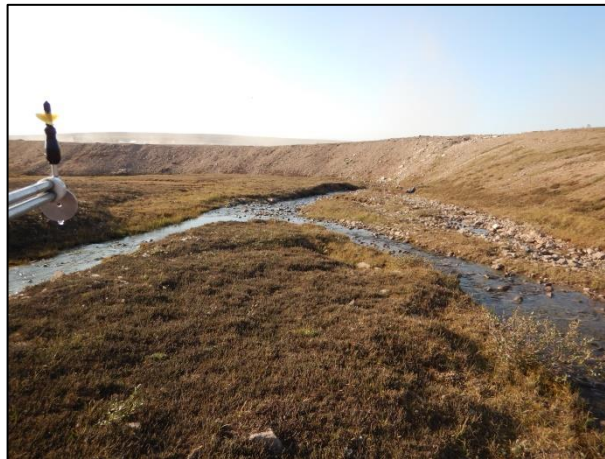
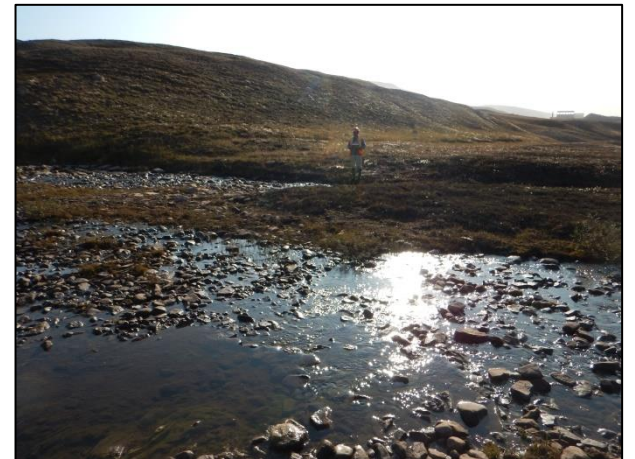
Photos 11. Photos taken 20 m upstream (top) and 40 m upstream (bottom) in summer/fall: (A,D) facing upstream; (B,E) facing downstream; and (C,F) across (left bank looking at right bank).

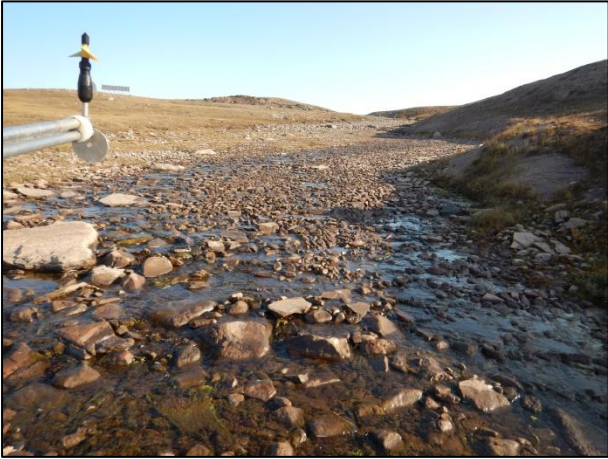
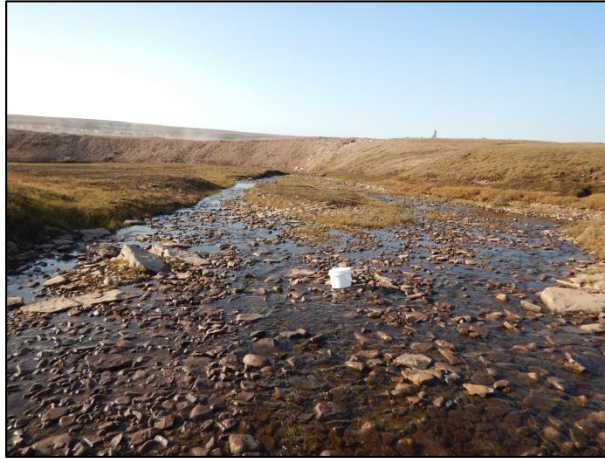
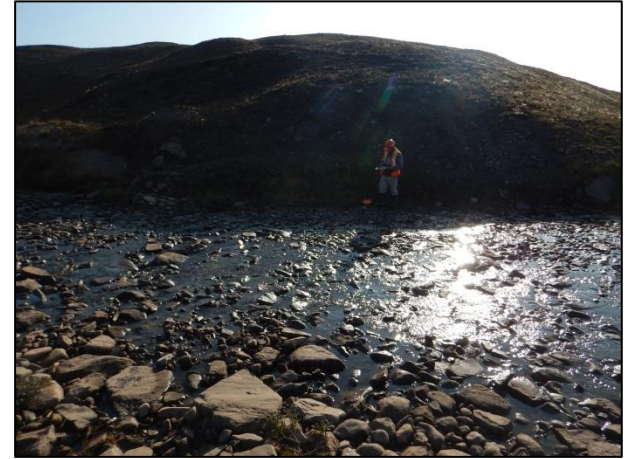
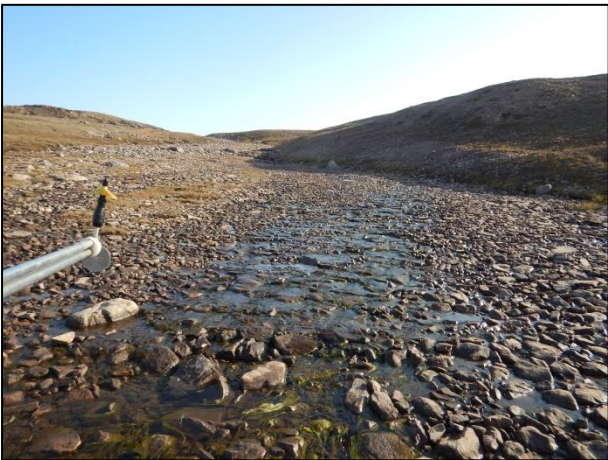
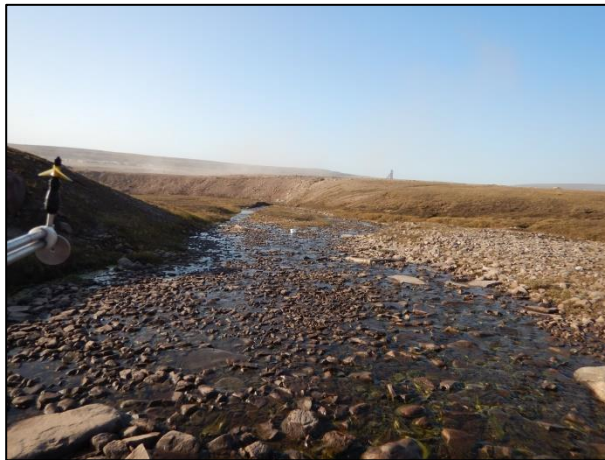
Photos 12. Photos taken 60 m upstream (top) and 80 m upstream (bottom) in summer/fall: (A,D) facing upstream; (B,E) facing downstream; and (C,F) across (left bank looking at right bank).

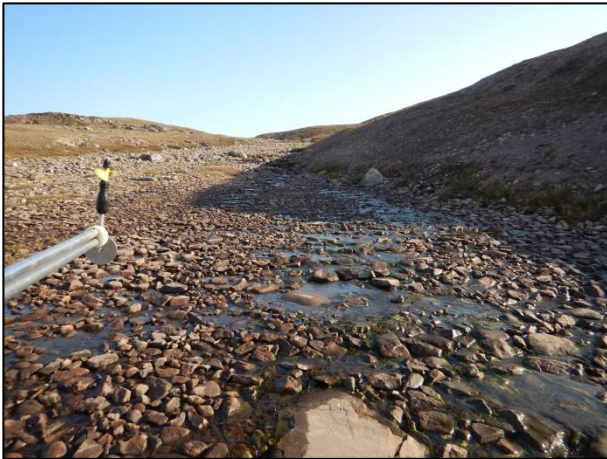
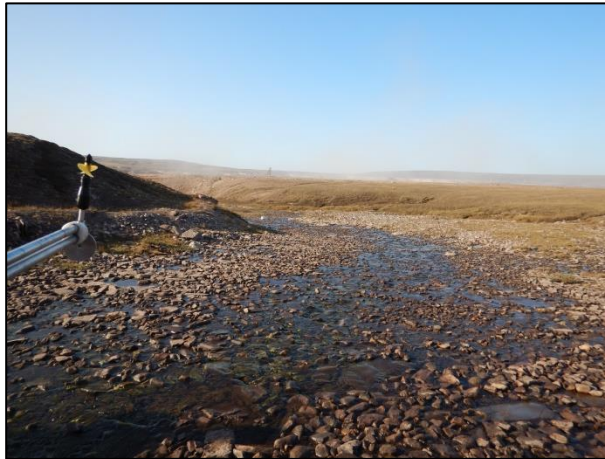
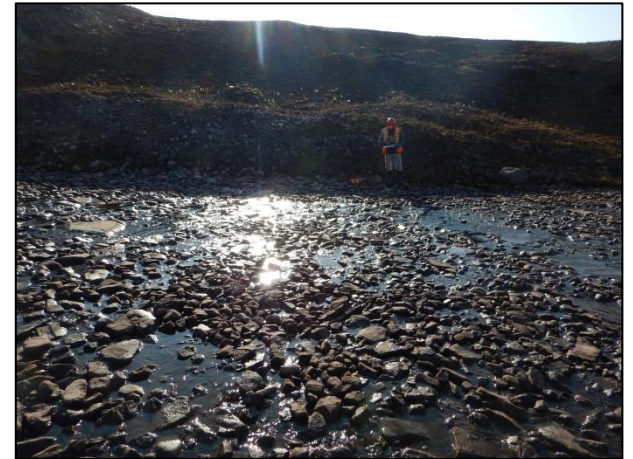
Photos 13. Photos taken 100 m upstream in summer/fall: (A) facing upstream; (B) facing downstream; and (C) across (left bank looking at right bank).

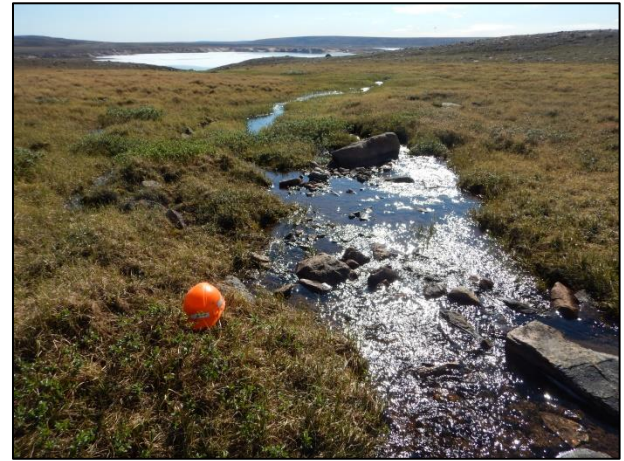
D

Photos 14. Photos taken 340 m upstream (top) and 400 m upstream (bottom) in summer/fall: (A,C) facing upstream; and (B,D) facing downstream.

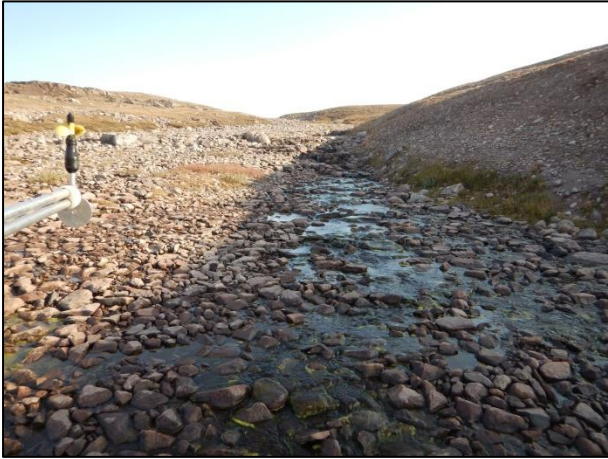
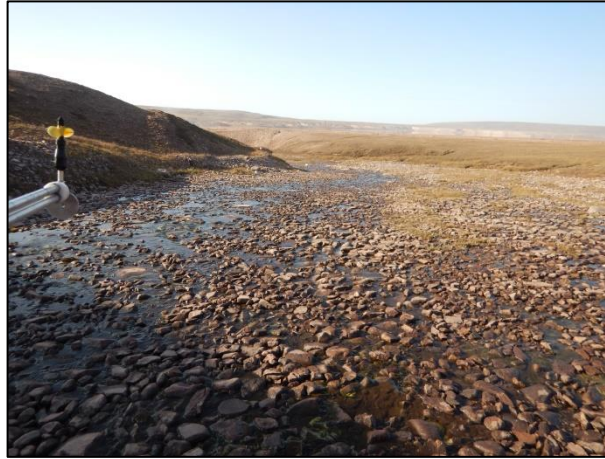
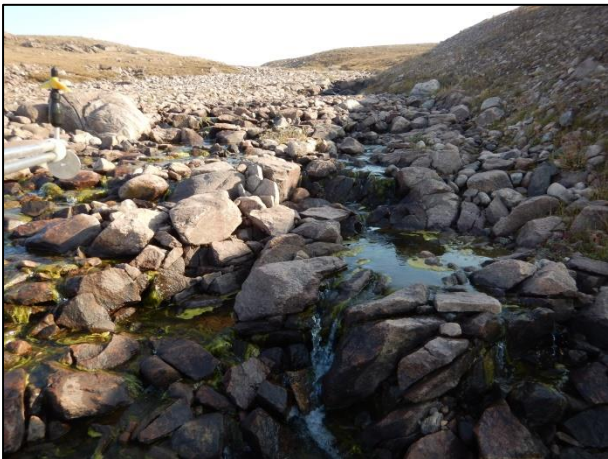
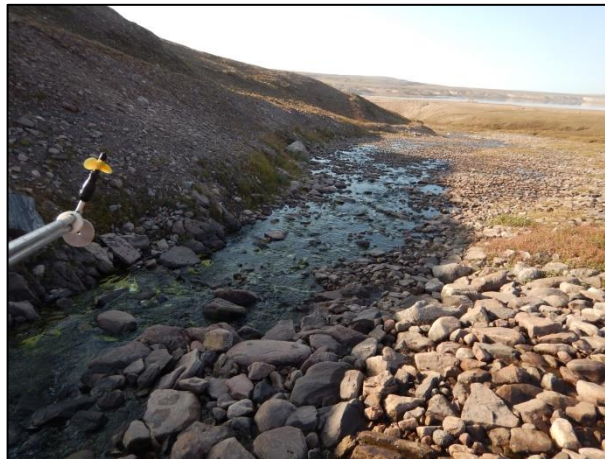
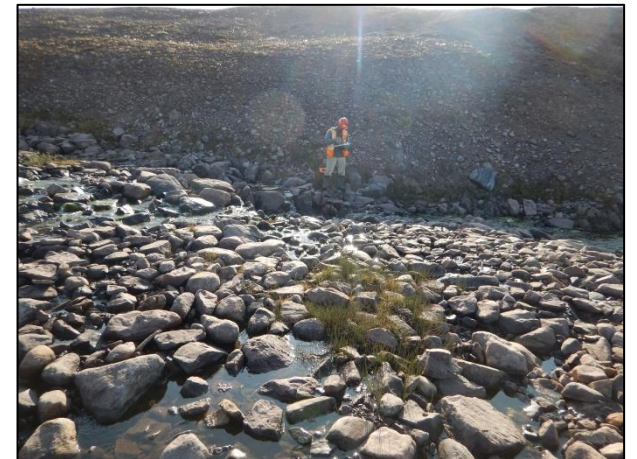
Photos 15. Photos taken 120 m upstream (top) and 140 m upstream (bottom) in summer/fall: (A,D) facing upstream; (B,E) facing downstream; and (C,F) across (left bank looking at right bank). Note: all photos taken while standing at the transect centreline.

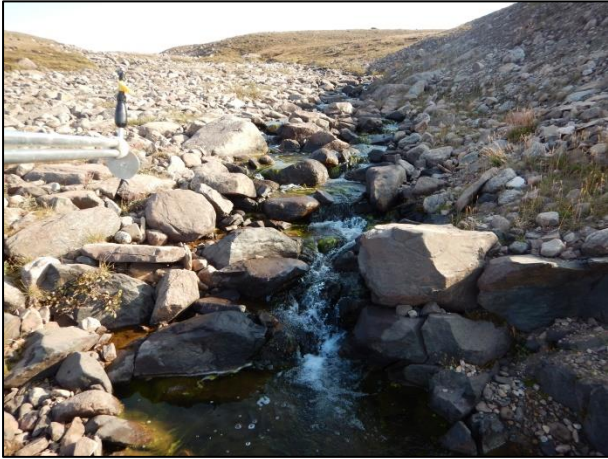
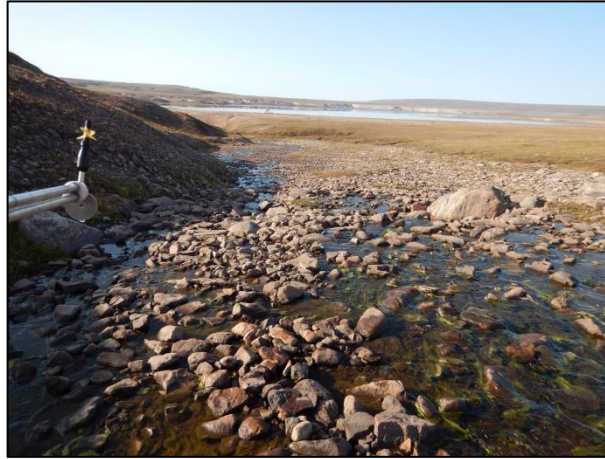
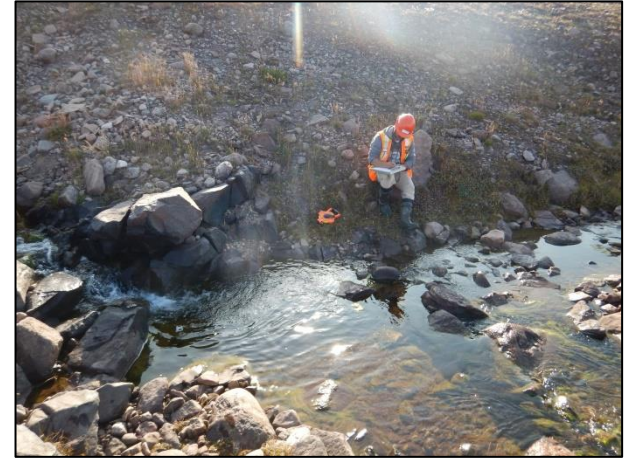
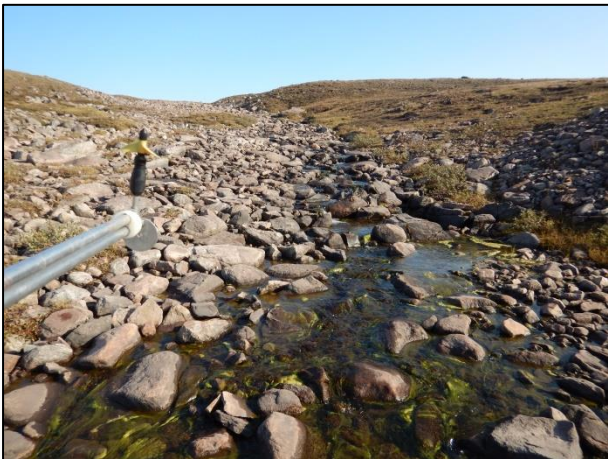
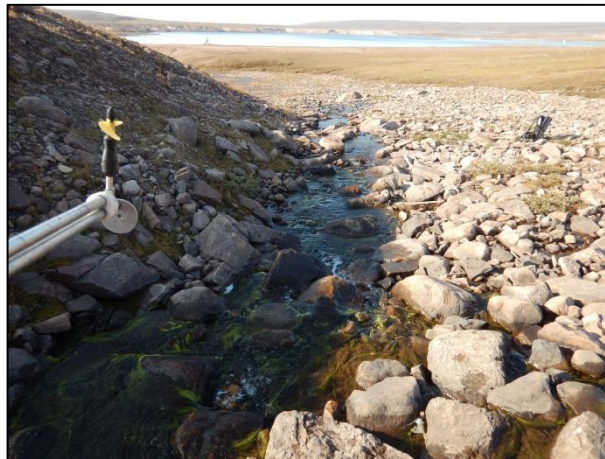
Photos 16. Photos taken 160 m upstream (top) and 180 m upstream (bottom) in summer/fall: (A,D) facing upstream; (B,E) facing downstream; and (C,F) across (left bank looking at right bank). Note: all photos taken while standing at the transect centreline.

During spring, all fish were captured at or upstream from the rail centreline. During summer/fall, two fish were captured downstream and three upstream from the crossing centreline; four additional char were observed from 140 to 185 m upstream. Stickleback were not observed or captured in this stream in 2018 or 2019 and have not been captured in the stream crossed at CV-104-5 upstream of the Tote Road since monitoring began in 2006.
