RAIL CV-104-2

LOCATION AND CROSSING DESCRIPTION

**BAFFINLAND IRON MINES
MARY RIVER PROJECT**

North/South Consultants Inc.
Aquatic Environment Specialists

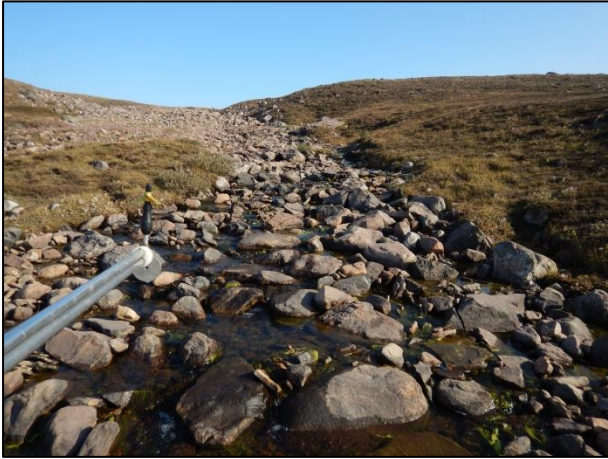
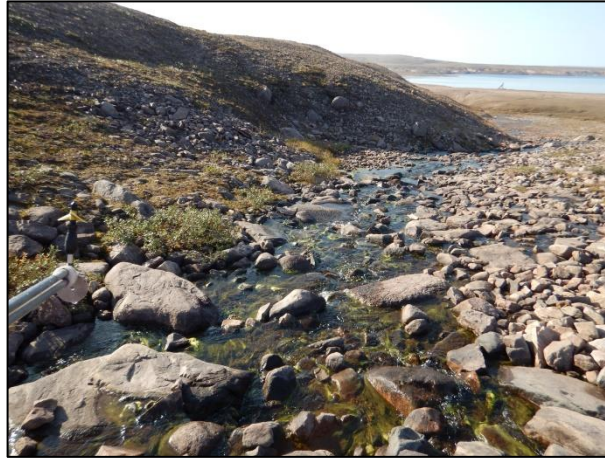
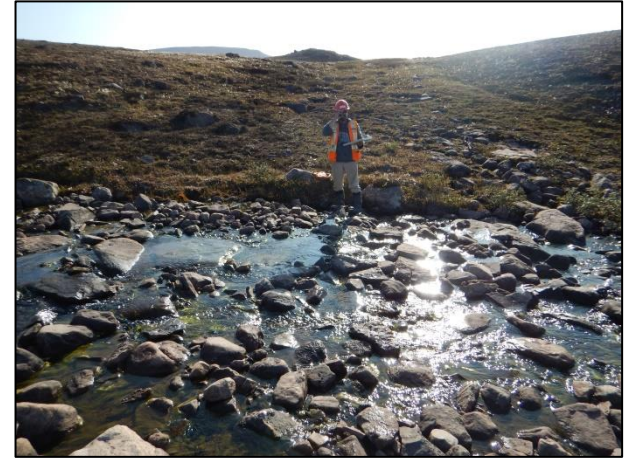
Photos 17. Photos taken 200 m upstream in summer/fall: (A) facing upstream; (B) facing downstream; and (C) across (right bank looking at left bank). Note: all photos taken while standing at the transect centreline.

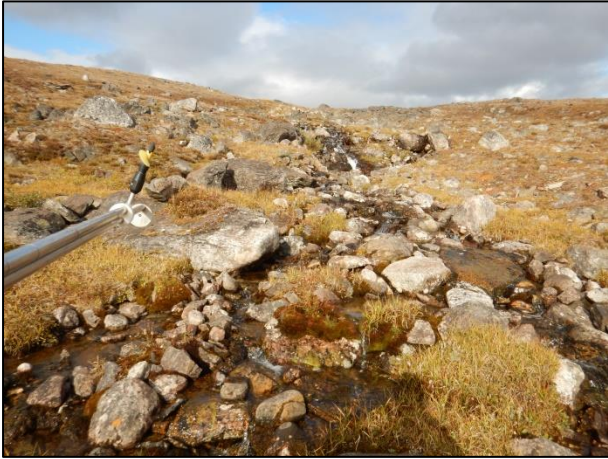
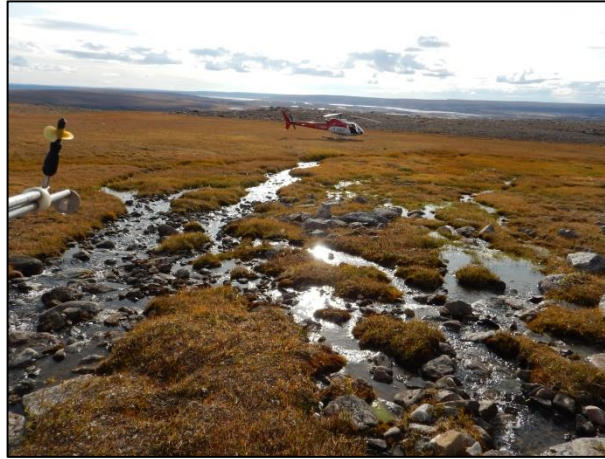
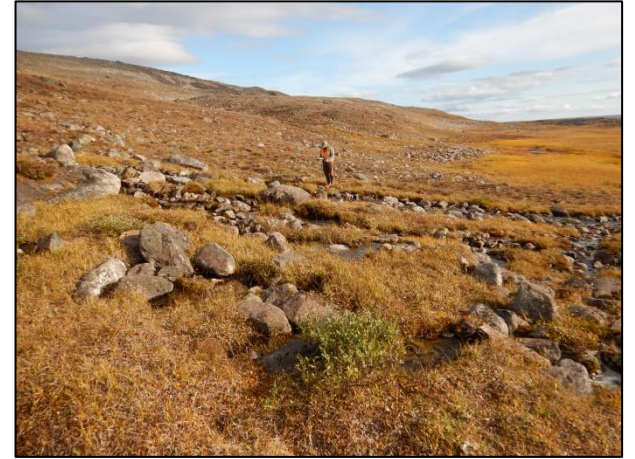
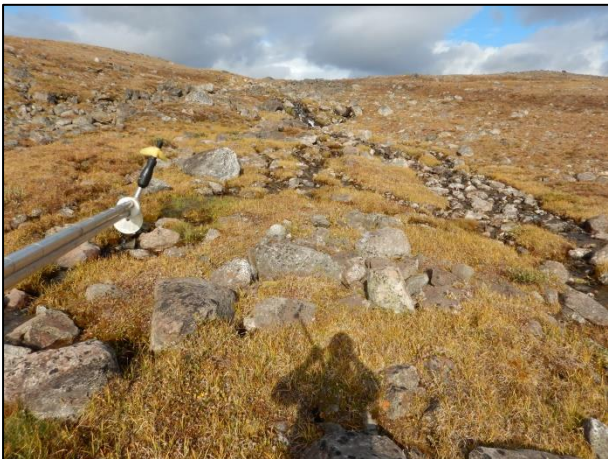
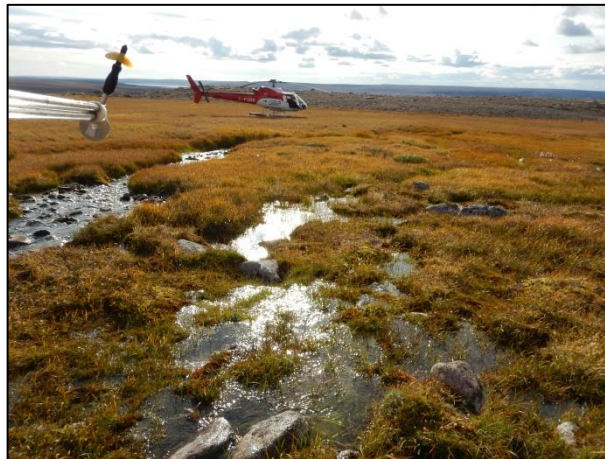
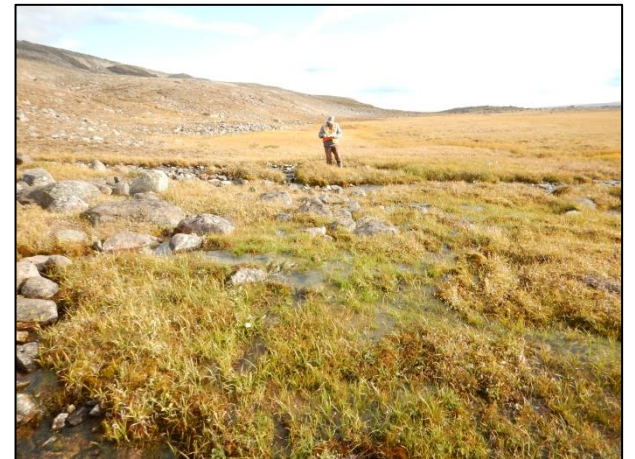
Photos 18. Photos taken 20 m downstream (top) and 40 m downstream (bottom) from the barrier in summer/fall: (A,D) facing upstream; (B,E) facing downstream; and (C,F) across (right bank looking at left bank). Note: all photos taken while standing at the transect centreline.

A steeper 50-m long reach with small vertical drops starting at 130 m upstream from the centreline may act as a barrier under low water levels, but fish were found upstream of this feature in spring and summer/fall 2019. There is a permanent barrier (an impassable vertical drop) approximately 3.5 km upstream from the rail centreline. There are no natural downstream barriers to fish movement, though high velocities have been observed at the outflow from the Tote Road culvert during periods of high water.

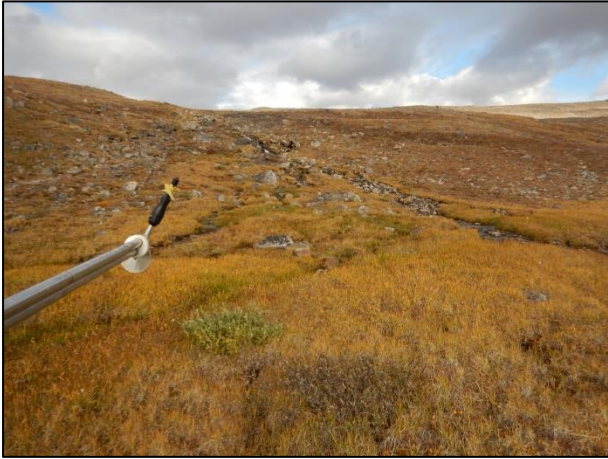
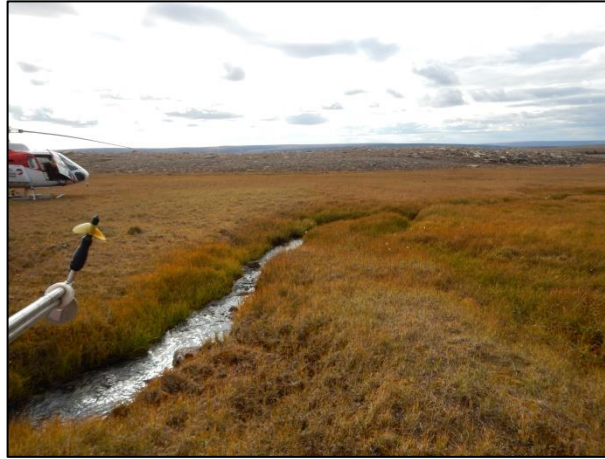
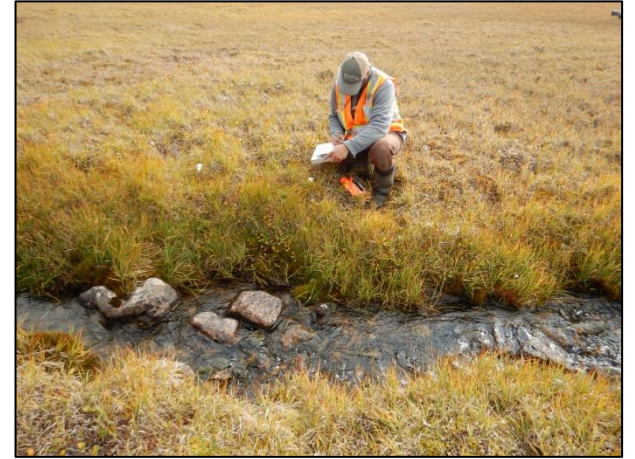
Photos 19. Photos taken 60 m downstream from the barrier in summer/fall: (A) facing upstream; (B) facing downstream; and (C) across (right bank looking at left bank). Note: all photos taken while standing at the transect centreline.
