RAIL CV-104-3

LOCATION AND CROSSING DESCRIPTION

**BAFFINLAND IRON MINES
MARY RIVER PROJECT**

North/South Consultants Inc.
Aquatic Environment Specialists

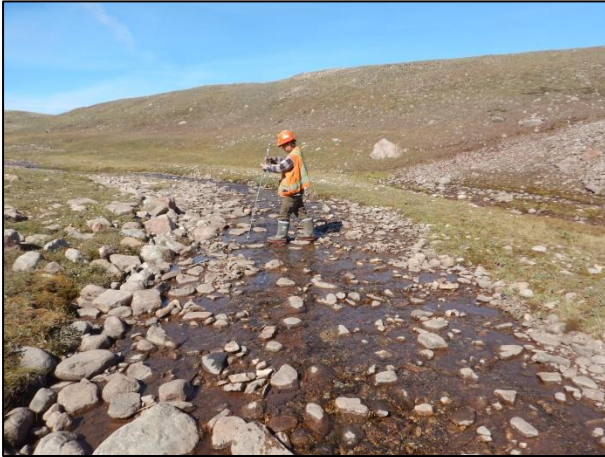
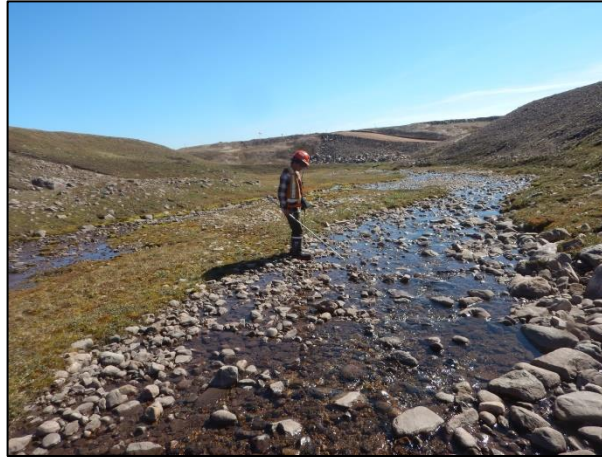
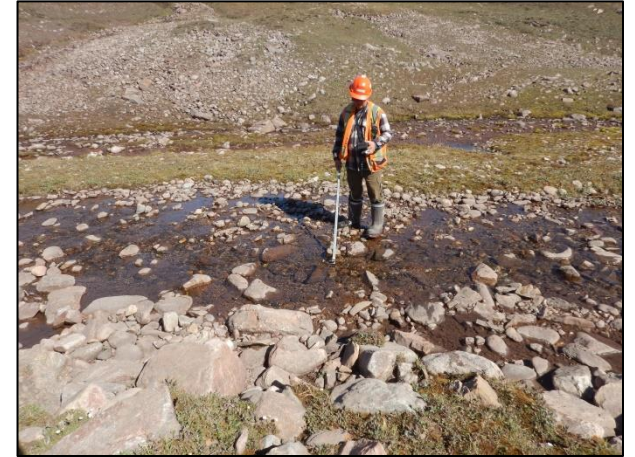
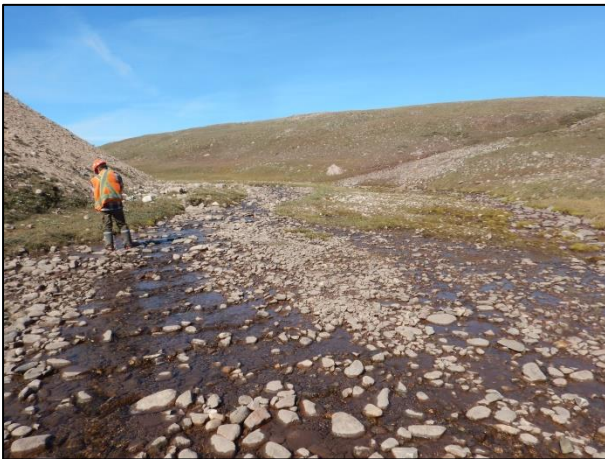
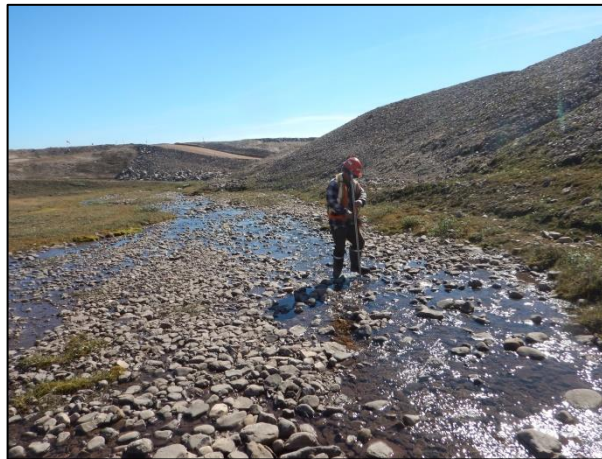
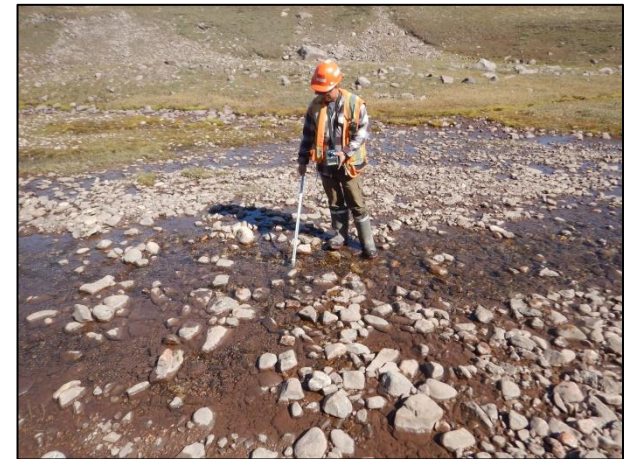
Photos 1. Photos taken at the crossing centreline (top) and 20 m downstream (bottom) in spring: (A,D) facing upstream; (B,E) facing downstream; and (C,F) across (left bank looking at right bank).

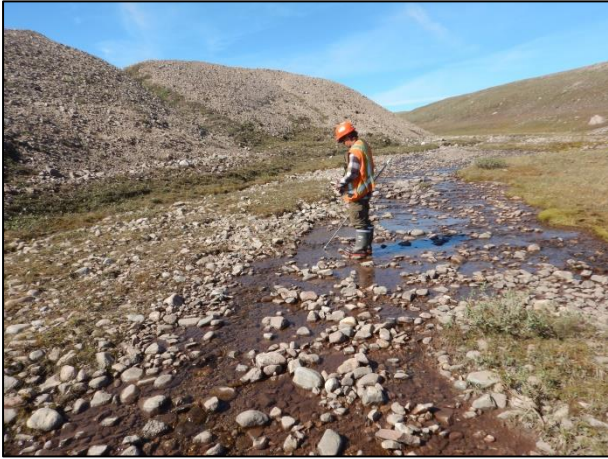
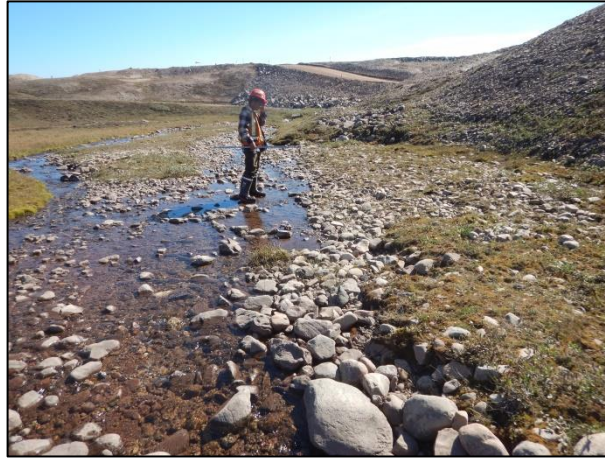
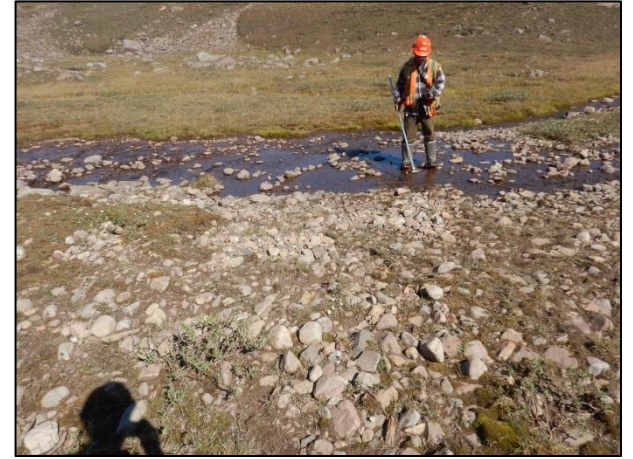
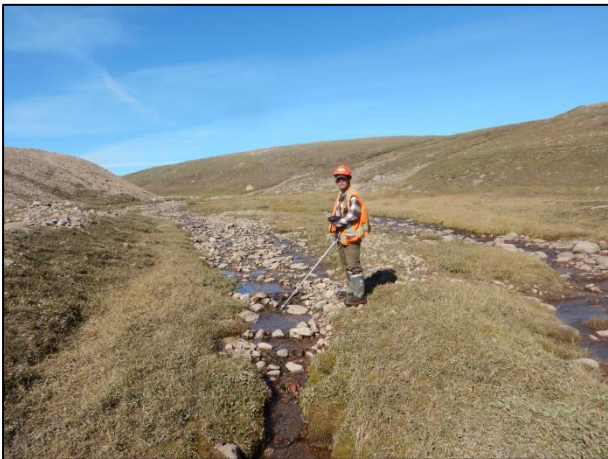
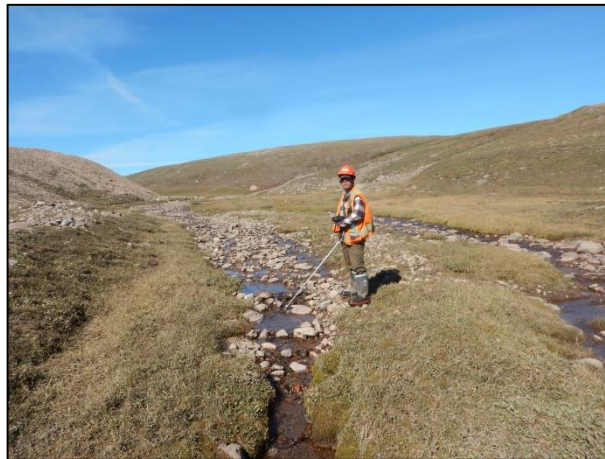
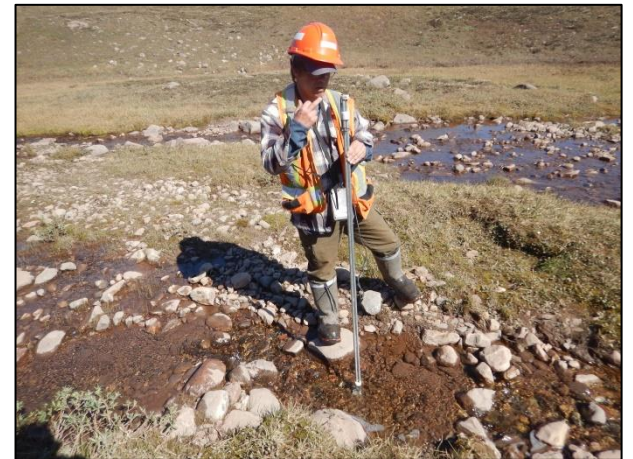
Photos 2. Photos taken 40 m downstream (top) and 60 m downstream (bottom) in spring: (A,D) facing upstream; (B,E) facing downstream; and (C,F) across (left bank looking at right bank).

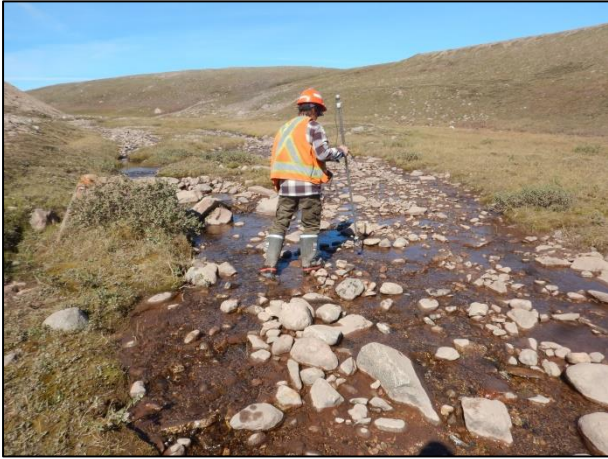
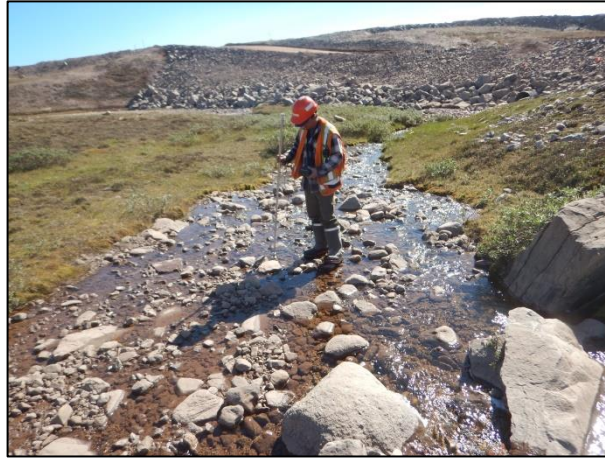
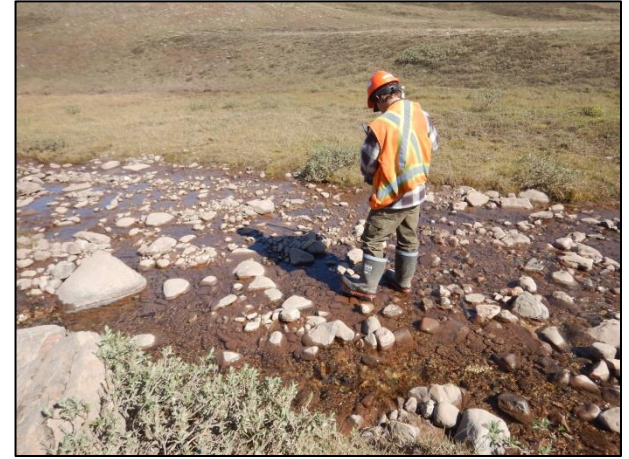
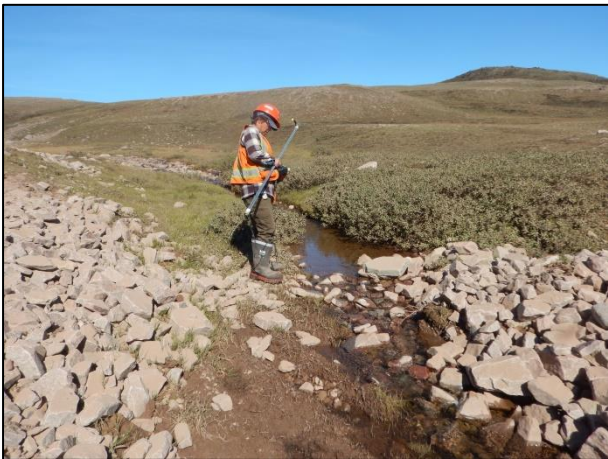
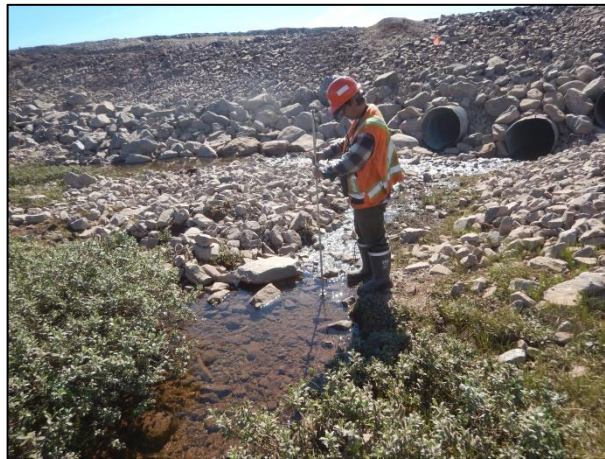
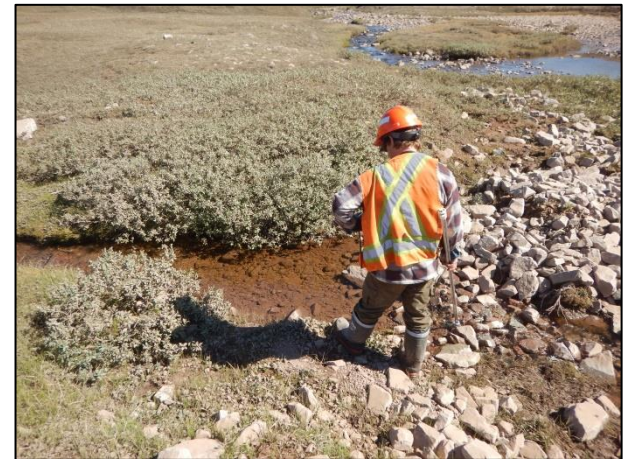
Photos 3. Photos taken 80 m downstream (top) and 100 m downstream (bottom) in spring: (A,D) facing upstream; (B,E) facing downstream; and (C,F) across (left bank looking at right bank).

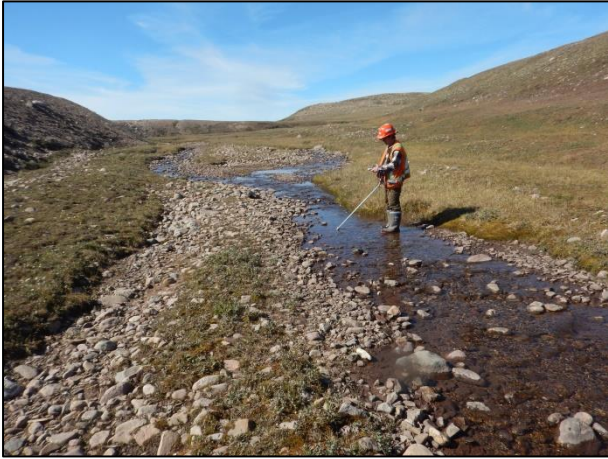
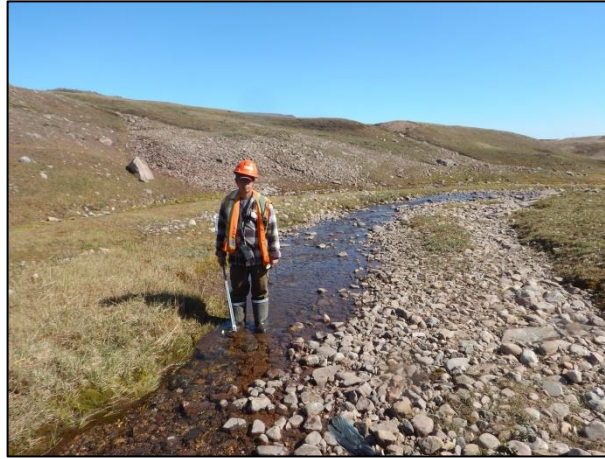
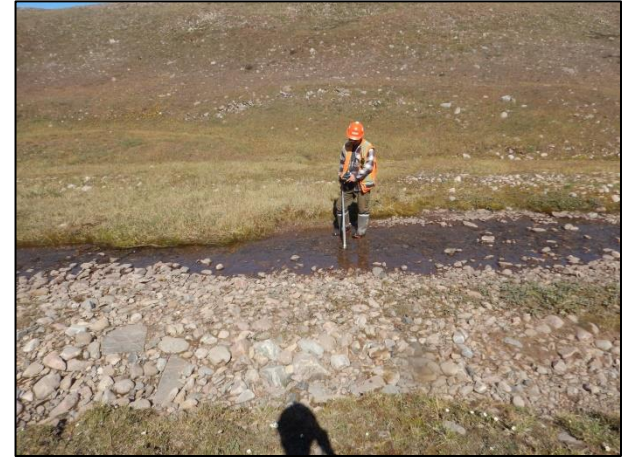
Photos 4. Photos taken 20 m upstream in spring: (A) facing upstream; (B) facing downstream; (C) across (left bank looking at right bank).

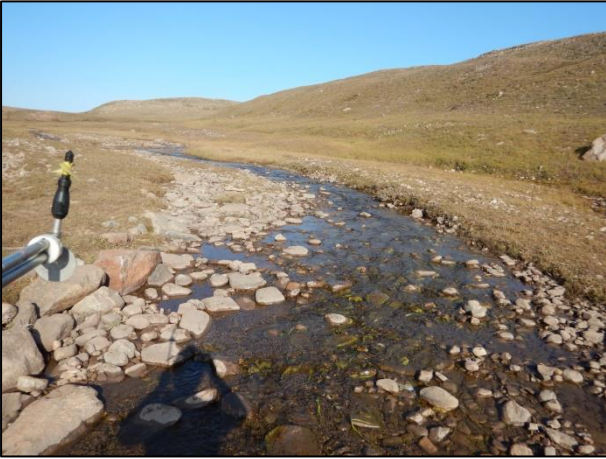
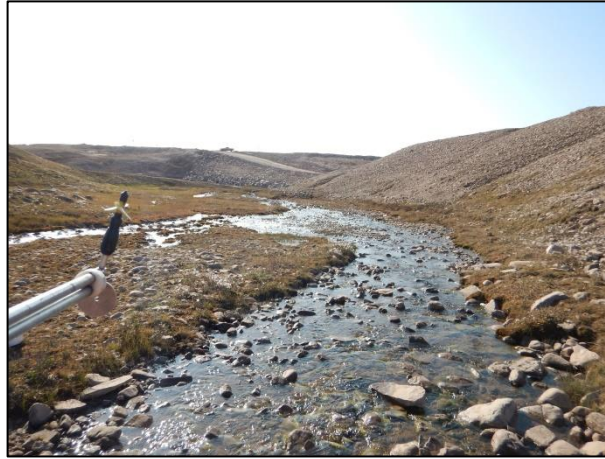
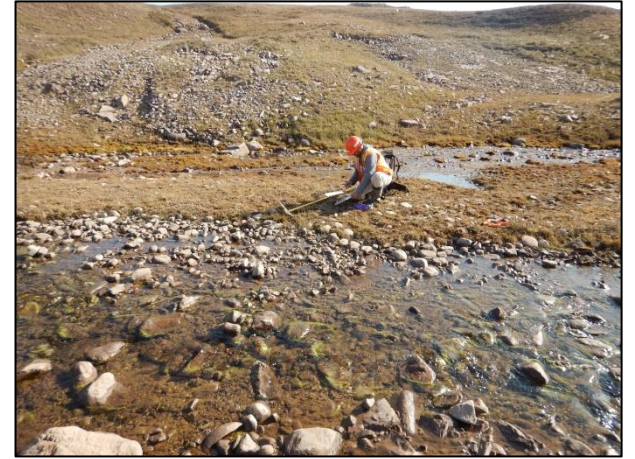
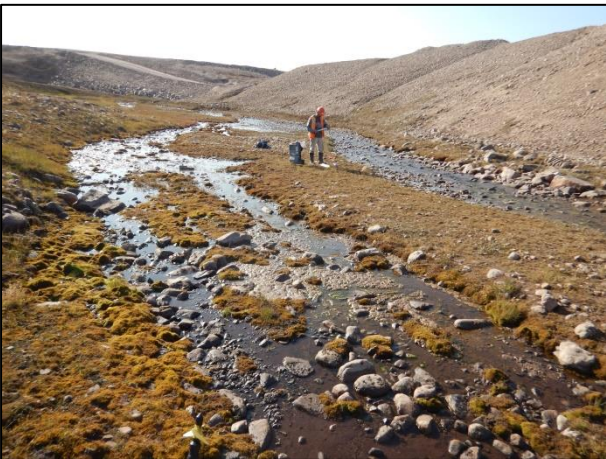
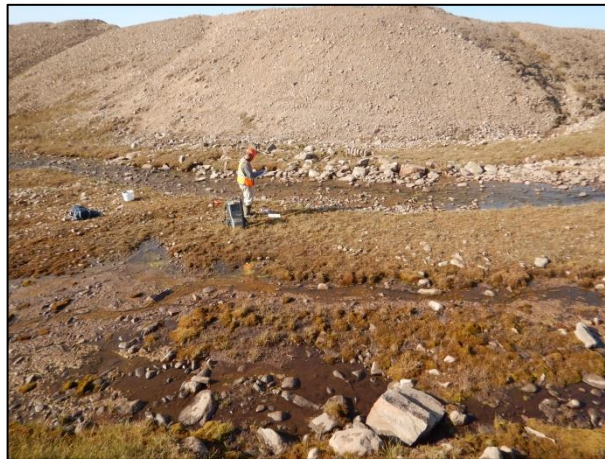
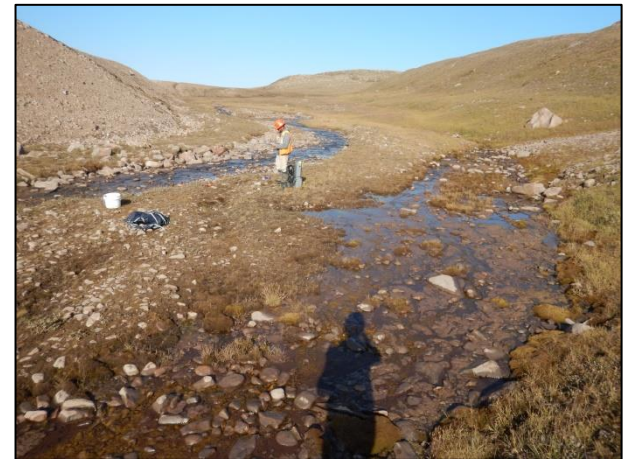
Photos 5. Photos taken at the crossing centerline in summer/fall: (A) facing upstream; (B) facing downstream; (C) across (left bank looking at right bank); (D) diagonal from right bank above the centreline looking downstream; (E) across (right bank looking at right bank); and (F) diagonal from right bank below the centreline looking upstream.

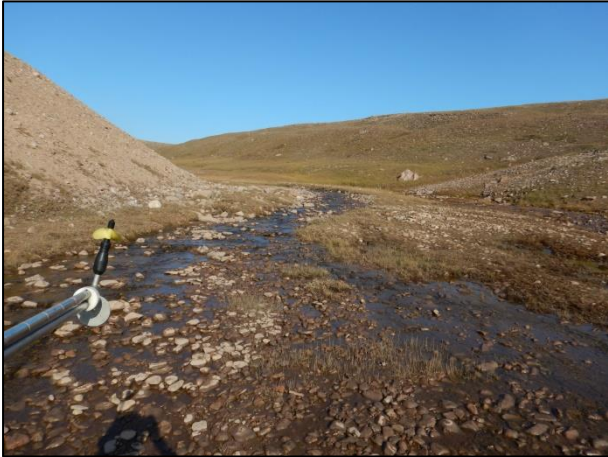
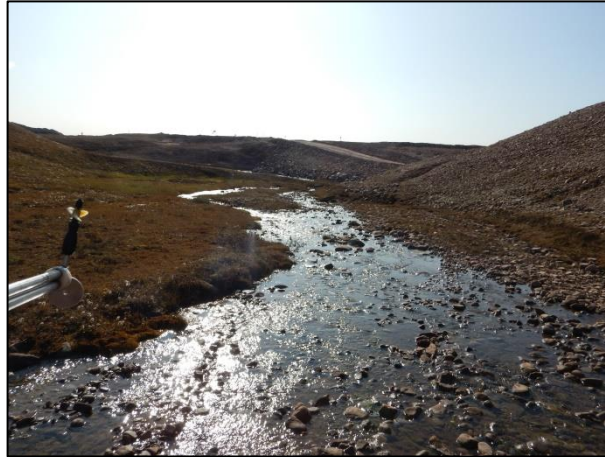
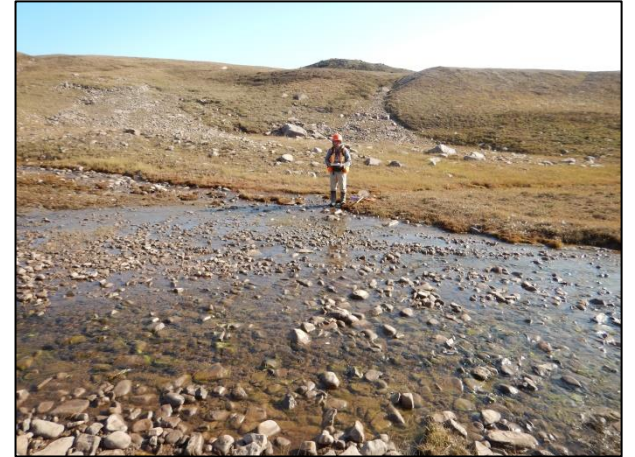
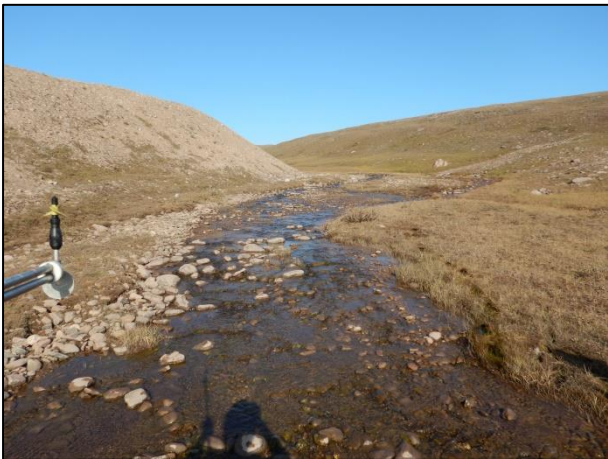
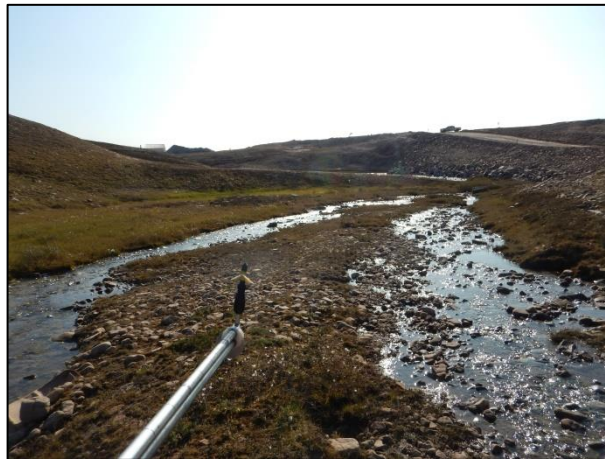
Photos 6. Photos taken 20 m downstream (top) and 40 downstream (bottom) in summer/fall: (A,D) facing upstream; (B,E) facing downstream; and (C,F) across (left bank looking at right bank).

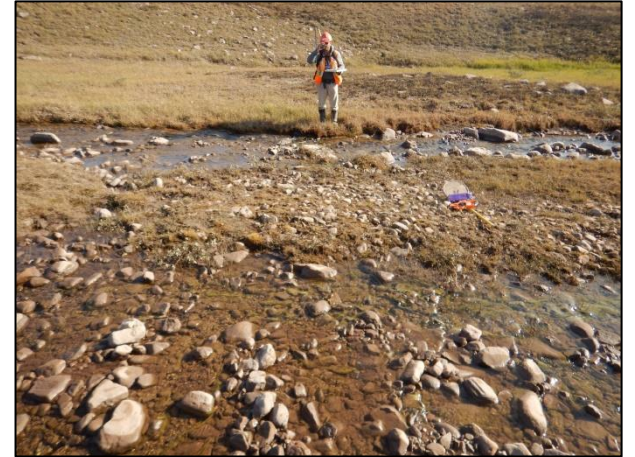
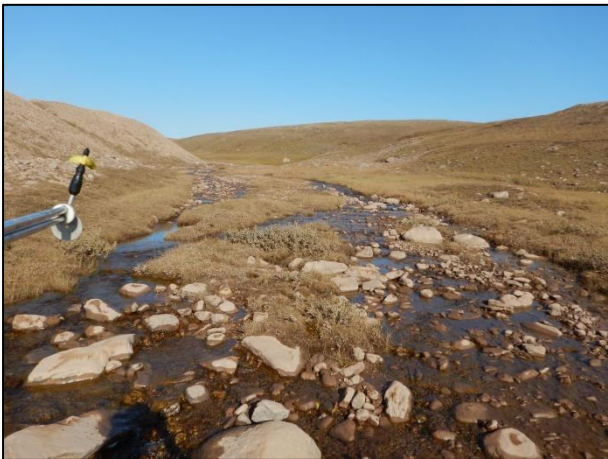
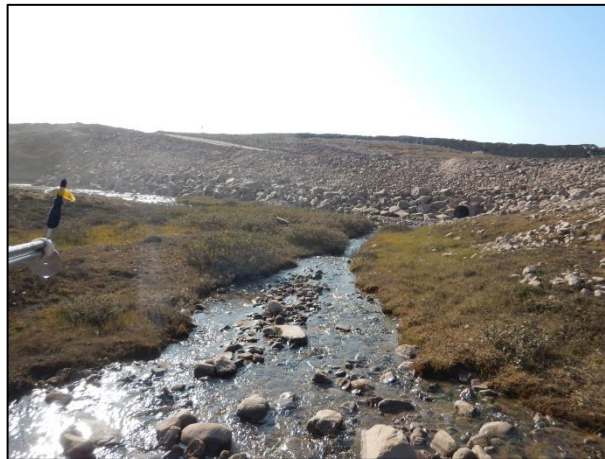
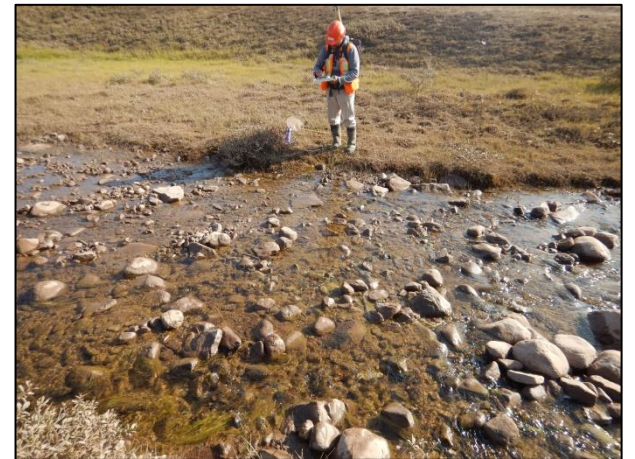
Photos 7. Photos taken 60 m downstream (top) and 80 downstream (bottom) in summer/fall: (A,D) facing upstream; (B,E) facing downstream; and (C,F) across (left bank looking at right bank).

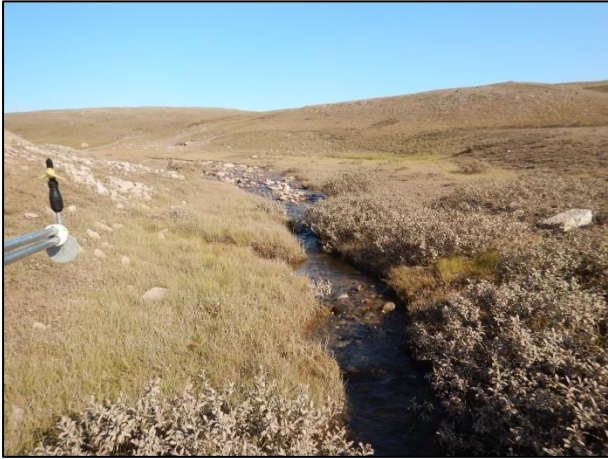
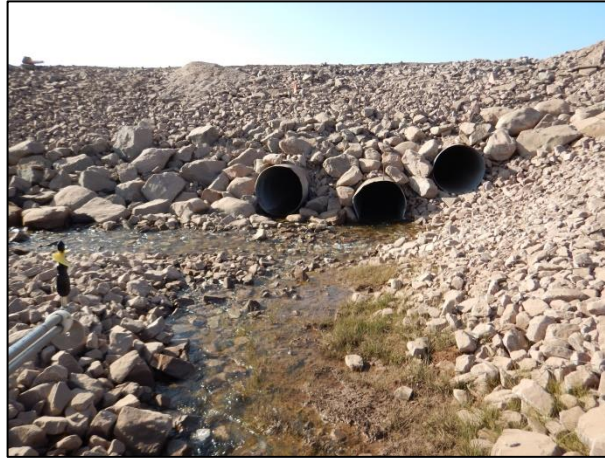
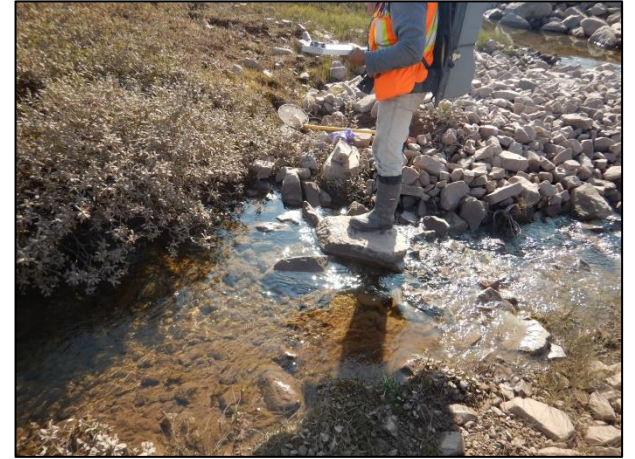
Photos 8. Photos taken 100 m downstream in summer/fall: (A) facing upstream; (B) facing downstream; (C) across (left bank looking at right bank).

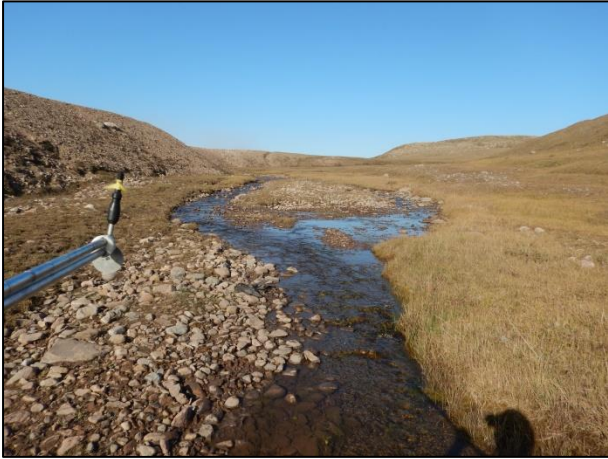
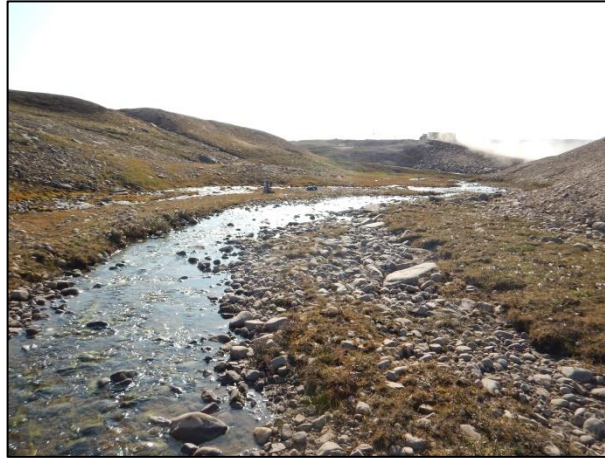
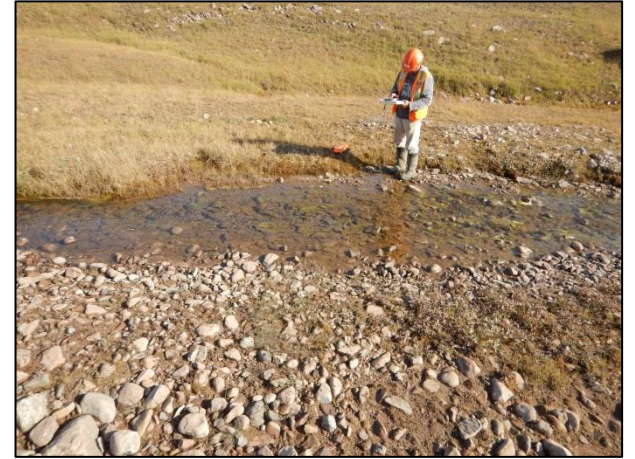
Photos 9. Photos taken 20 m upstream in summer/fall: (A) facing upstream; (B) facing downstream; and (C) across (left bank looking at right bank).
