LOCATION AND CROSSING DESCRIPTION

Site ID:	CV-104-5	Dates Surveyed:	22-Jun-19; 19-Aug-19	Waterbody Type:	Stream
Project Interaction:	Rail Plate Arch Culvert	Centreline UTM Coordinates:	17W 558340 E 7914885 N	Culvert Length (m):	64
Number of Barrels:	1	Culvert Diameter/Span (mm):	6,990	Slope (%):	5

BAFFINLAND IRON MINES MARY RIVER PROJECT

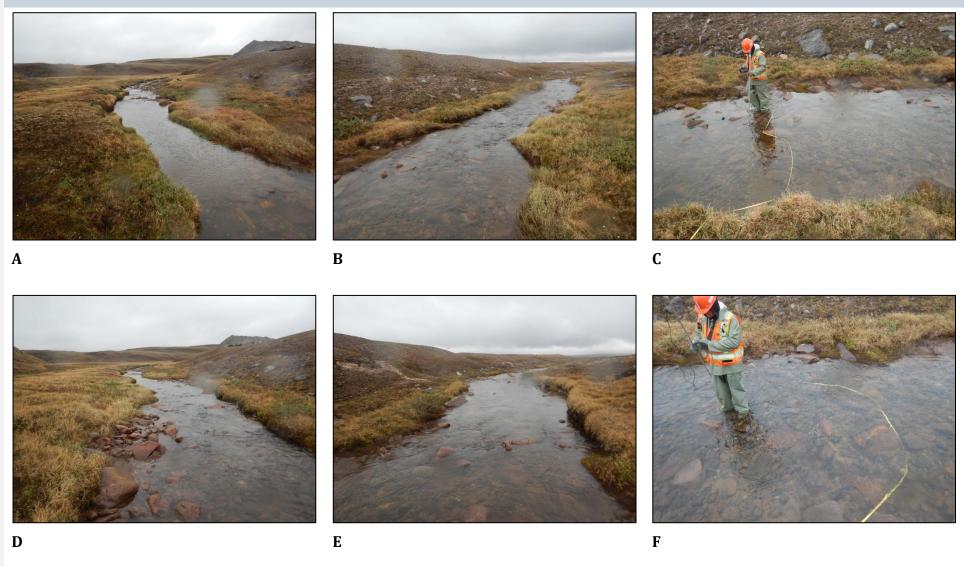
Photos 1. Photos taken at the crossing centreline (top) and 20 m downstream (bottom) in spring: (A,D) facing upstream; (B,E) facing downstream; and (C,F) across (left bank looking at right bank).

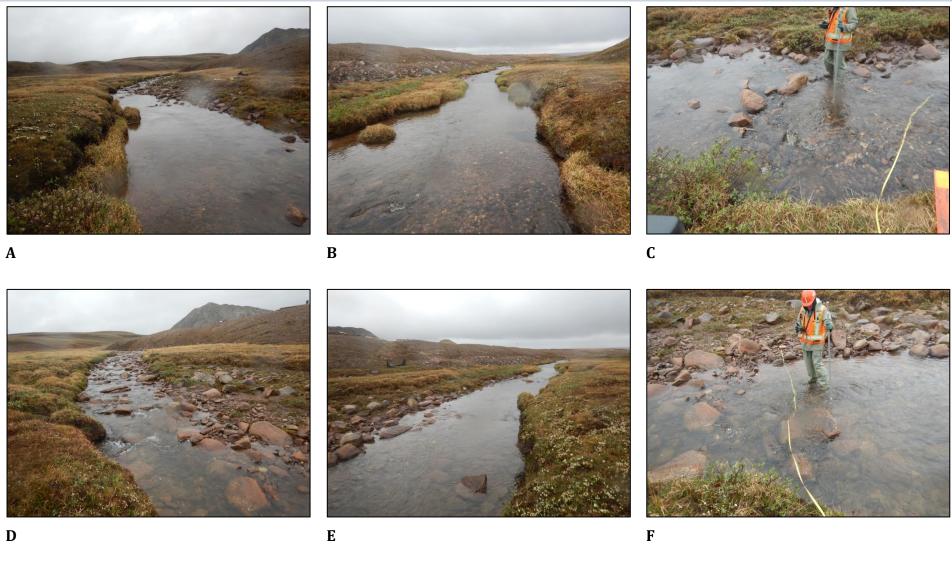
Photos 4. Photos taken 20 m upstream (top) and 40 m upstream (bottom) in spring: (A,D) facing upstream; (B,E) facing downstream; and (C,F) across (left bank looking at right bank).

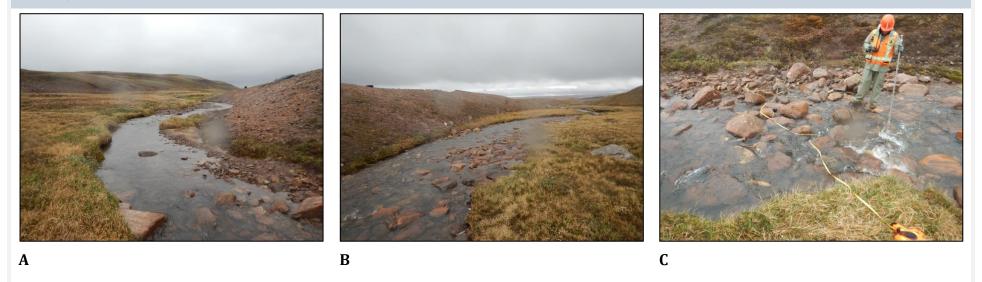
Photos 6. Photos taken 100 m upstream (top) in spring: (A) facing upstream; (B) facing downstream; and (C) across (left bank looking at right bank).

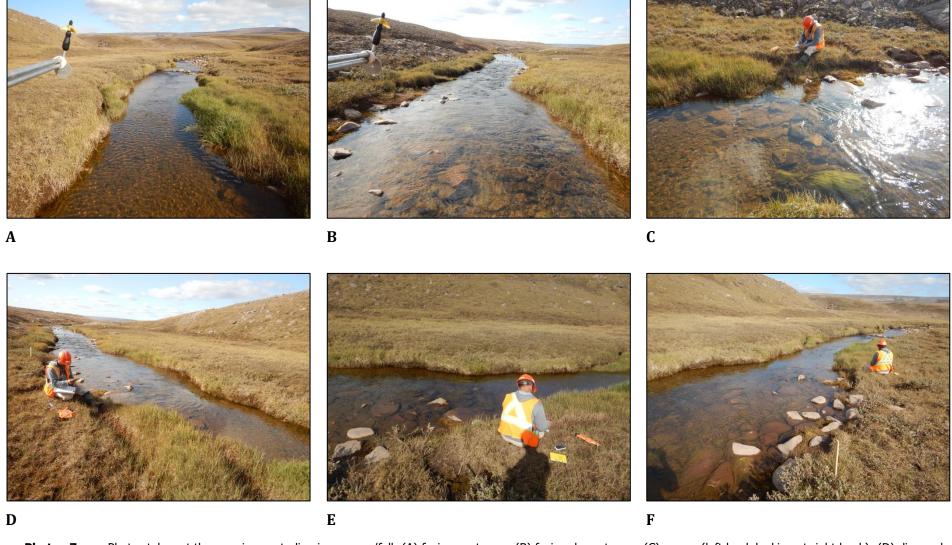
Photos 7. Photos taken at the crossing centerline in summer/fall: (A) facing upstream; (B) facing downstream; (C) across (left bank looking at right bank); (D) diagonal from right bank above the centreline looking downstream; (E) across (right bank looking at left bank); and (F) diagonal from right bank below the centreline looking upstream.

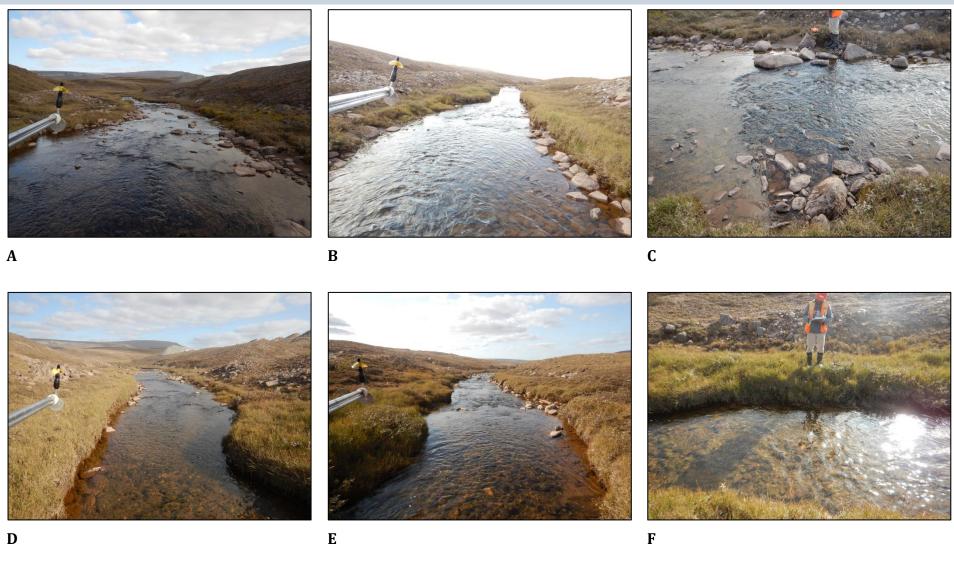
Photos 9. Photos taken 60 m downstream (top) and 80 downstream (bottom) in summer/fall: (A,D) facing upstream; (B,E) facing downstream; and (C,F) across (left bank looking at right bank).

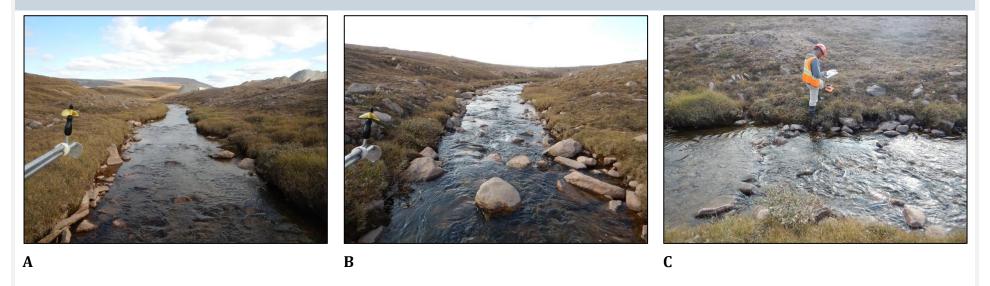
Photos 10. Photos taken 100 m downstream in summer/fall: (A) facing upstream; (B) facing downstream; and (C) across (left bank looking at right bank).

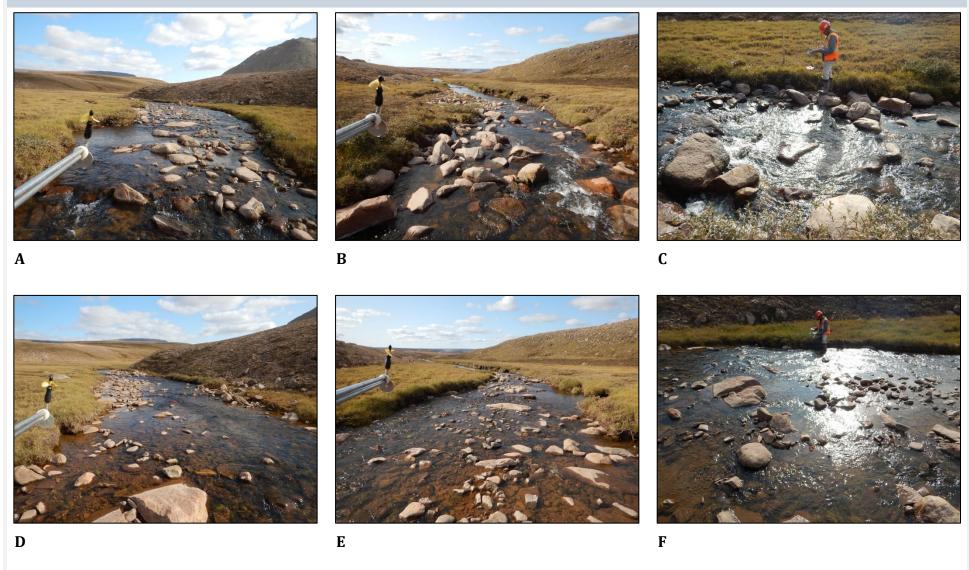
Photos 12. Photos taken 60 m upstream (top) and 80 m upstream (bottom) in summer/fall: (A,D) facing upstream; (B,E) facing downstream; and (C,F) across (left bank looking at right bank).

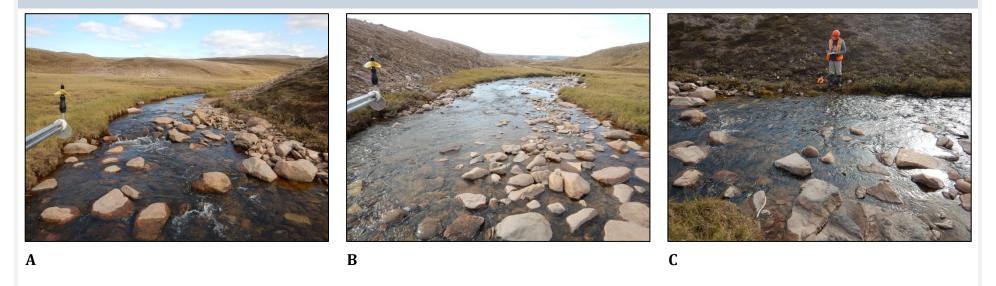
Photos 13. Photos taken 100 m upstream in summer/fall: (A) facing upstream; (B) facing downstream; and (C) across (left bank looking at right bank).

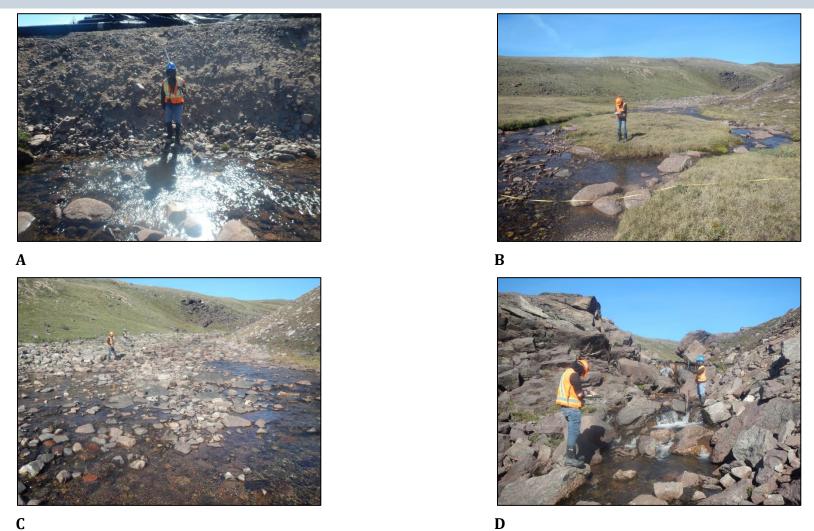
22-JUN-19: UPSTREAM SURVEY

Photos 14. Photos of habitat taken during spring: (A) at 140 m upstream; (B) 220 m upstream; (C) 280 m upstream; and (D) 360 m upstream.

The stream splits into two channels over a distance of approximately 20 m, 200 m upstream from the rail centreline. At 280 m upstream, the habitat transitions to steeper cascades and ultimately vertical drops at approximately 360 m upstream. Habitat at the permanent barrier is primarily cascade/pool over cobble/boulder.

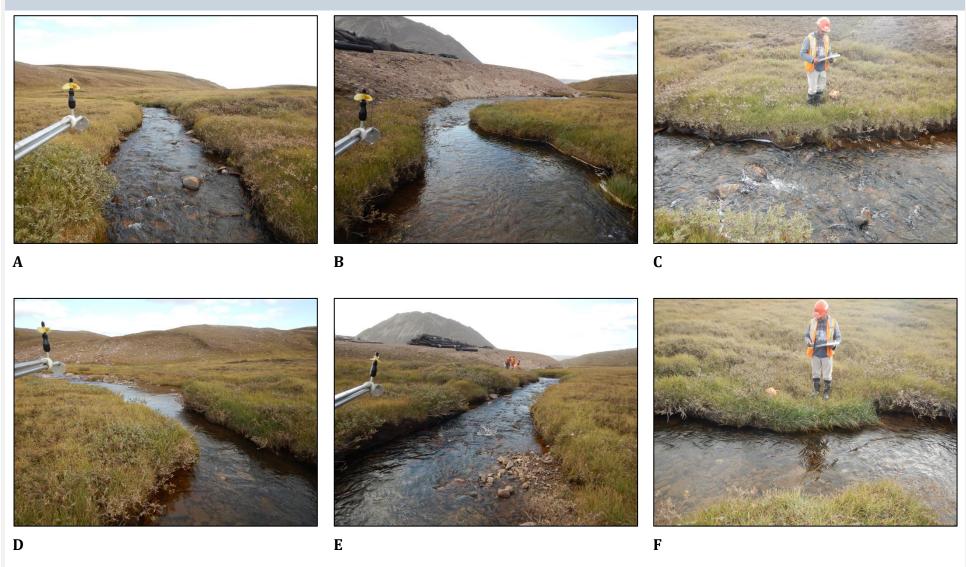
19-AUG-19: UPSTREAM SURVEY

Photos 16. Photos taken 160 m upstream (top) and 180 m upstream (bottom) in summer/fall: (A,D) facing upstream; (B,E) facing downstream; and (C,F) across (left bank looking at right bank). Note: all photos taken while standing at the transect centreline.
