RAIL CV-105-2

LOCATION AND CROSSING DESCRIPTION

**BAFFINLAND IRON MINES
MARY RIVER PROJECT**

North/South Consultants Inc.
Aquatic Environment Specialists

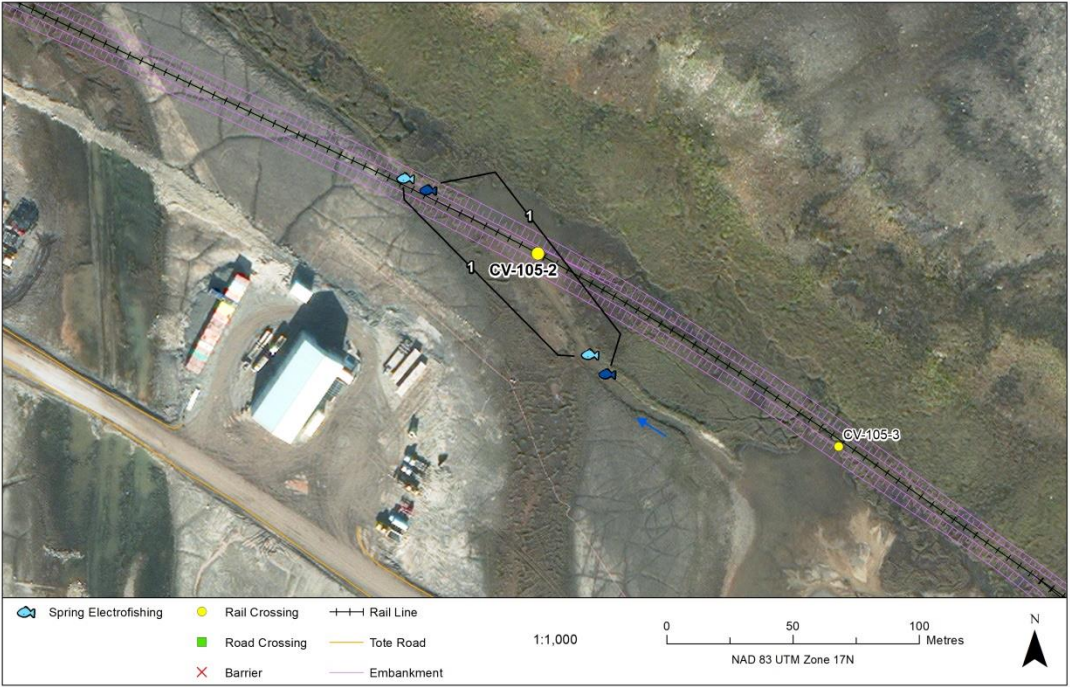
FISHING SITES

Species	Season	Pass	Effort (Seconds)	Fish Captured	Fish Observed	CPUE (No. Fish/60 Seconds)	Length Range (mm)
ARCH	Spring	1	329	15	1	2.74	89 – 95 (measured)
NNST	Spring	1	329	3	0	0.55	53 – 75 (measured)

Species	Season	Pass	Effort (Seconds)	Fish Captured	Fish Observed	CPUE (No. Fish/60 Seconds)	Length Range (mm)
ARCH	Summer/Fall	1	460	2	0	0.26	84 – 94 (measured)
NNST	Summer/Fall	1	460	2	0	0.13	59 (measured)

Char and stickleback were found throughout the survey reaches in both seasons from 100 m downstream to as far upstream as the confluence with the pond encroached by the rail at site CV-105-3 (approximately 100 m upstream). Both species were also captured in this reach in spring and summer/fall 2018. The char were most abundant in the deeper runs while stickleback were found in all habitat types within the CV-105-2 survey area.

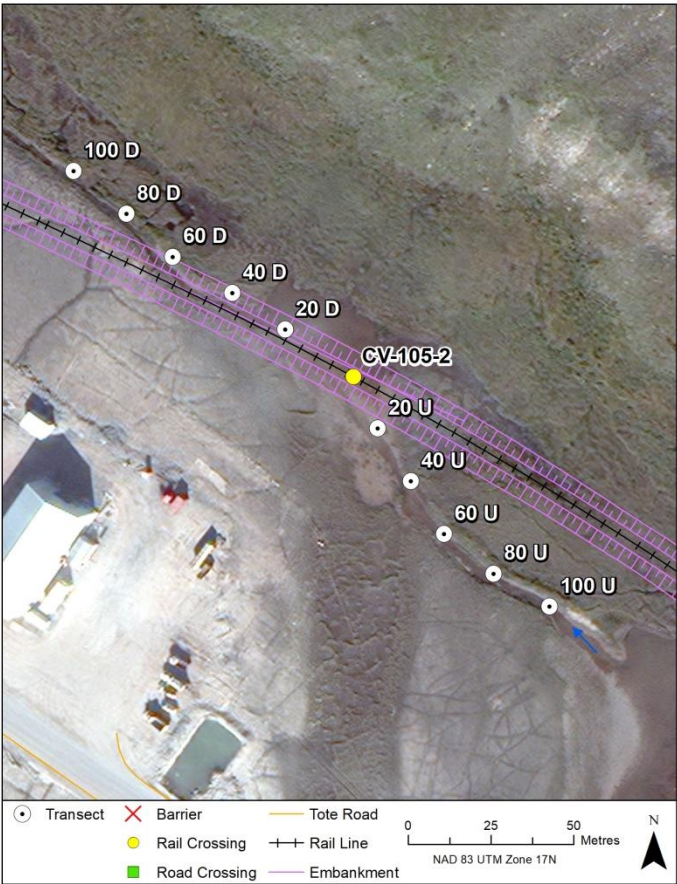
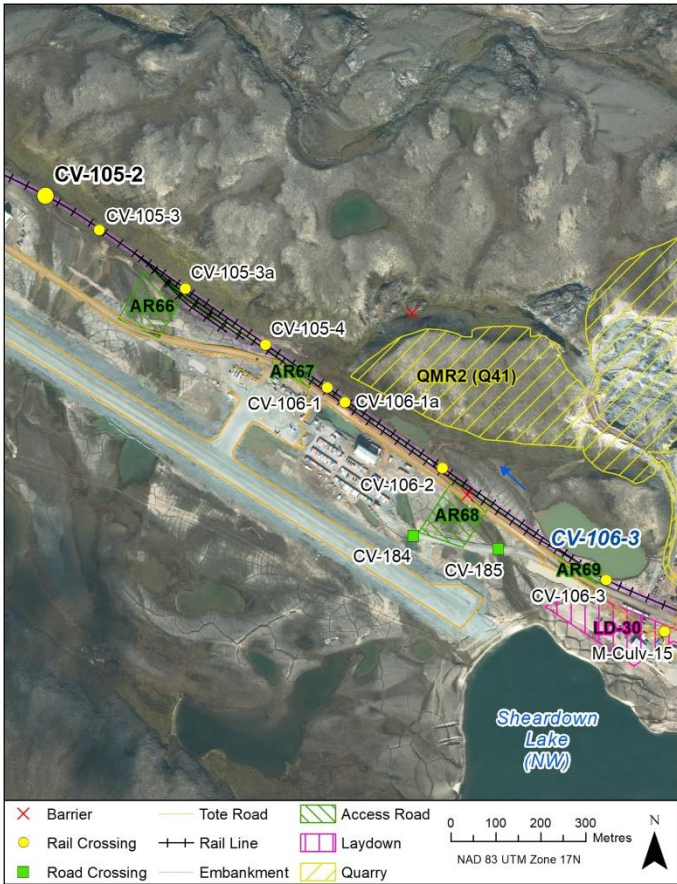
HABITAT SURVEY SITES

Site	Channel Width (m)		Water Depth (m)				Water Velocity (m/s)			
	Bankfull	Wetted	25%	50%	75%	Max	25%	50%	75%	Max
100D	2.8	1.7	0.06	0.06	0.09	0.20	0.09	0.10	0.16	0.16
80D	3.1	1.7	0.06	0.03	0.02	0.11	0.16	0.21	0.00	0.25
60D	3.1	2.1	0.03	0.03	0.02	0.25	0.16	0.21	0.00	0.28
40D	6.0	2.6	0.06	0.03	0.02	0.30	0.20	0.18	0.00	0.20
20D	22.9	21.0	0.02	0.02	0.02	0.60	0.09	0.00	0.00	0.02
0 (Centreline)	37.5	27.4	0.07	0.03	0.03	0.60	0.26	0.00	0.00	0.26
20U	15.8	3.6	0.07	0.03	0.03	0.30	0.00	0.00	0.00	0.00
40U	9.0	6.5	0.07	0.05	0.04	0.10	0.00	0.00	0.18	0.18
60U	5.0	2.3	0.02	0.03	0.04	0.10	0.00	0.05	0.10	0.14
80U	3.2	2.1	0.06	0.11	0.09	0.20	0.00	0.02	0.02	0.19
100U	5.7	3.6	0.06	0.08	NR	0.10	0.00	0.03	0.04	0.12

Site	Stream Morphology Composition (%)							Substrate Composition (%)				
	Riffle	Pool (<0.2 m)	Pool (>0.2 m)	Run	Cascade	Flat	Rapids	Fines	Gravel	Small Cobble	Large Cobble	Boulders
100D	50	-	-	50	-	-	-	20	40	40	-	-
80D	50	-	-	50	-	-	-	-	50	50	-	-
60D	25	-	-	75	-	-	-	-	60	40	-	-
40D	25	-	-	75	-	-	-	20	50	30	-	-
20D	-	100	-	-	-	-	-	90	-	10	-	-
0 (Centreline)	-	100	-	-	-	-	-	95	-	5	-	-
20U	-	-	-	100	-	-	-	95	-	5	-	-
40U	-	50	-	50	-	-	-	75	20	5	-	-
60U	-	-	-	100	-	-	-	15	70	15	-	-
80U	-	50	-	50	-	-	-	30	10	40	20	-
100U	-	75	-	25	-	-	-	90	8	2	-	-

Generally shallow, slow-moving stream with a small pond from 20 m downstream to a few metres upstream of the crossing centreline and a much larger pond ~ 120 m upstream. Riverine sections are mainly riffle/run. Substrate is cobble/gravel downstream transitioning to gravel/fines upstream. Nearest potential overwintering lakes are either Camp Lake downstream or the small, unnamed upstream lake at CV-106-3. The latter likely only provides overwintering for stickleback and juvenile char. There are no adult char in this stream.

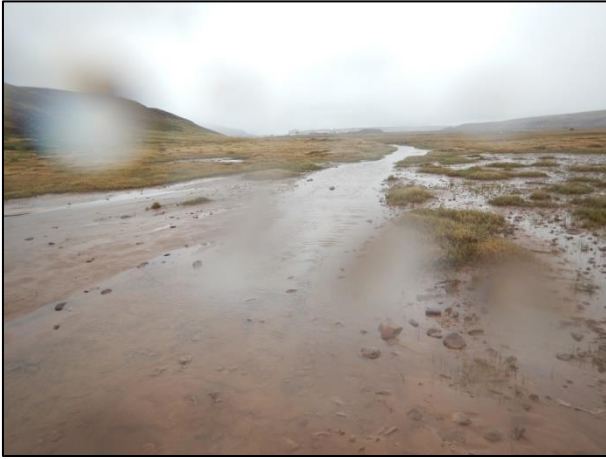
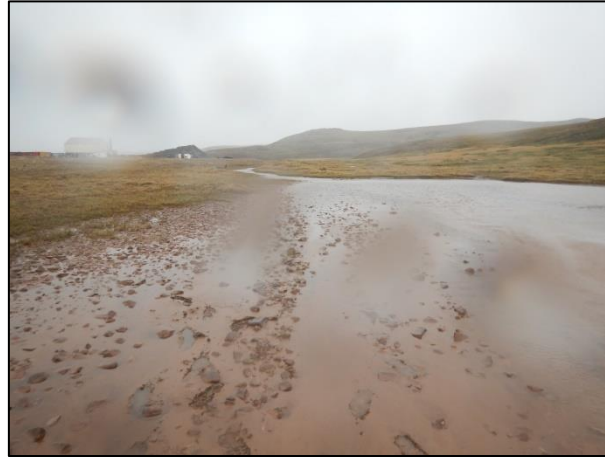
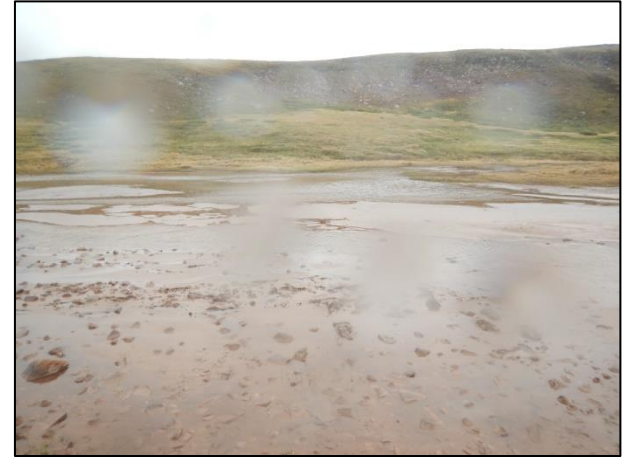
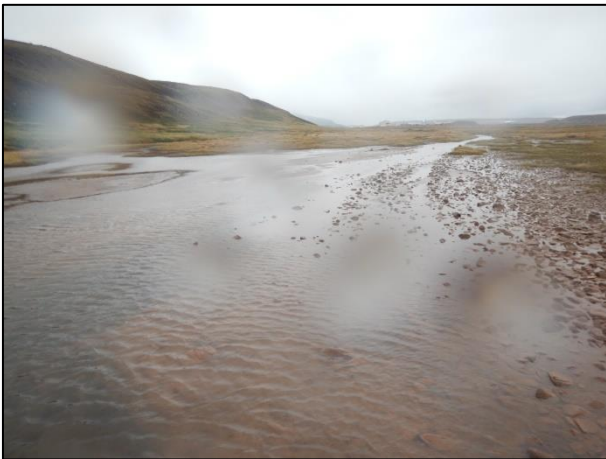
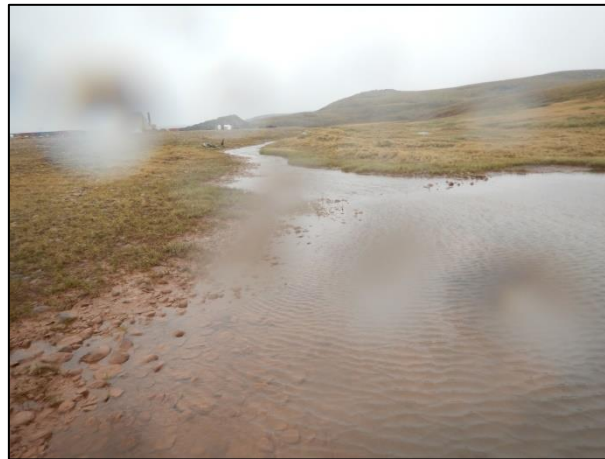
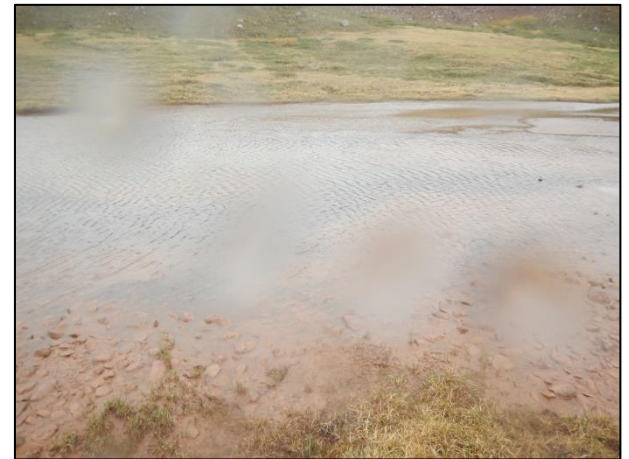
Photos 1. Photos taken at the crossing centreline (top) and 20 m downstream (bottom) in spring: (A,D) facing upstream; (B,E) facing downstream; and (C,F) across (left bank looking at right bank)

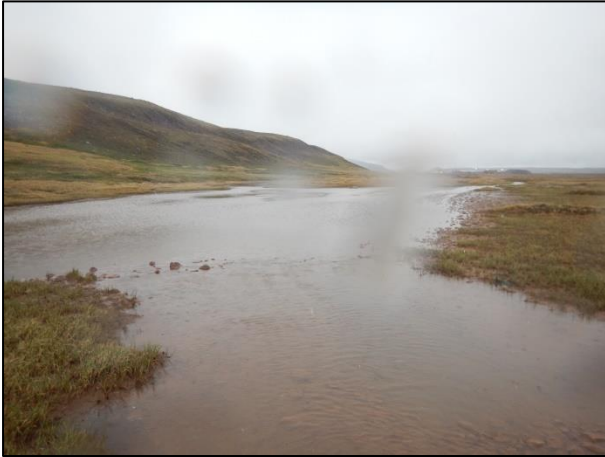
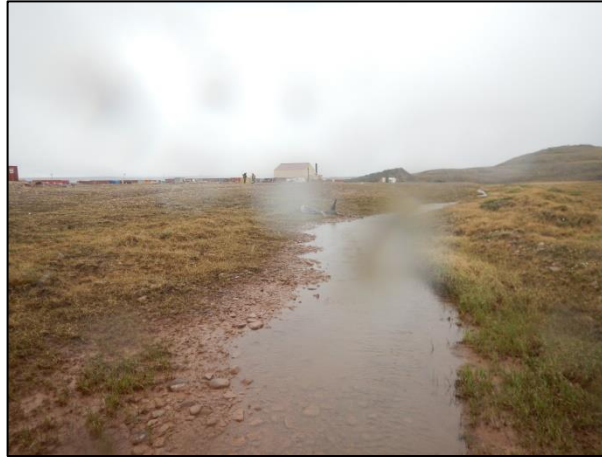
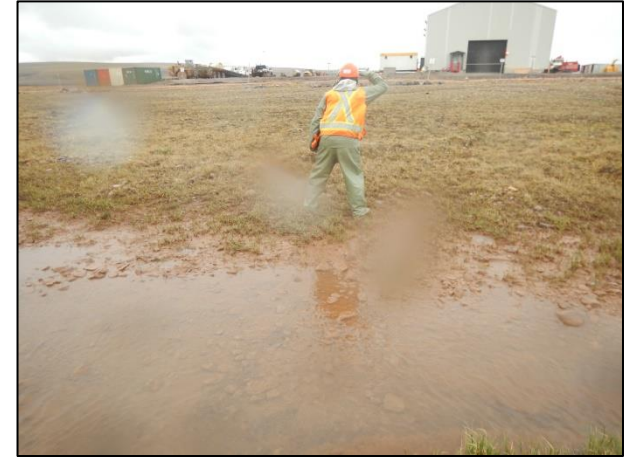
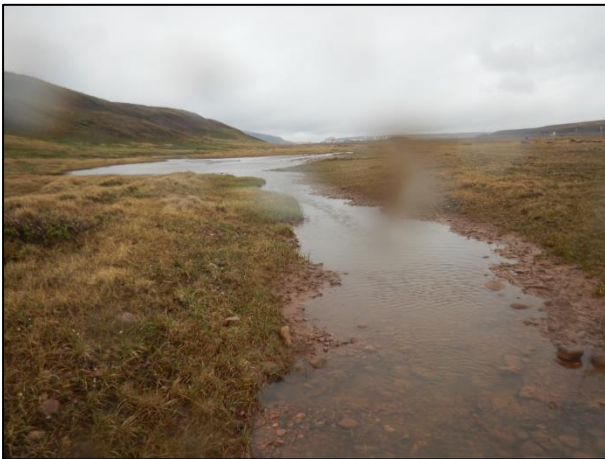
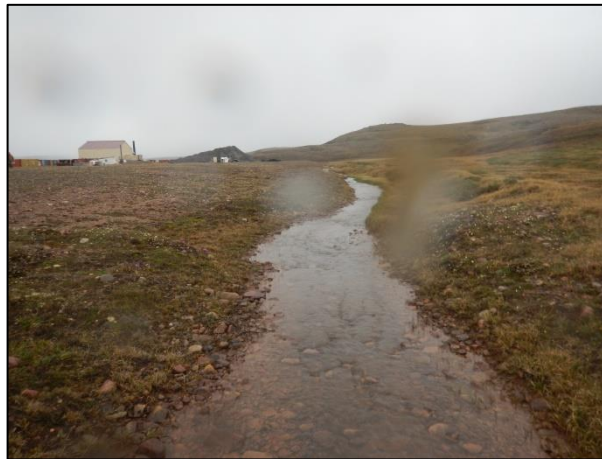
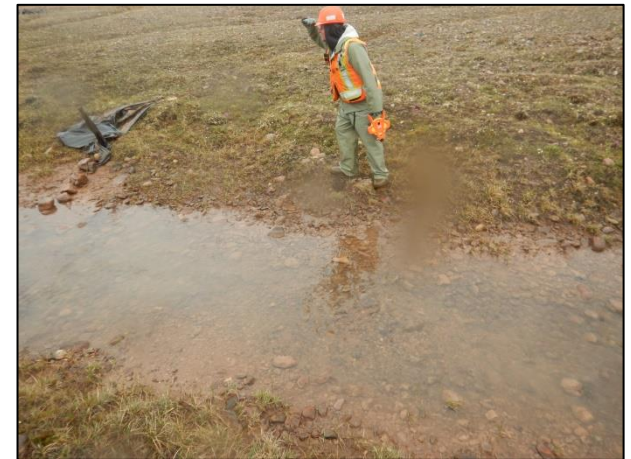
Photos 2. Photos taken 40 m downstream (top) and 60 m downstream (bottom) in spring: (A,D) facing upstream; (B,E) facing downstream; and (C,F) across (left bank looking at right bank)

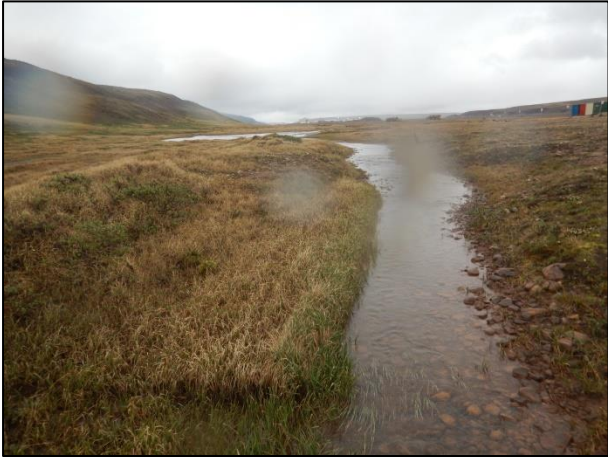
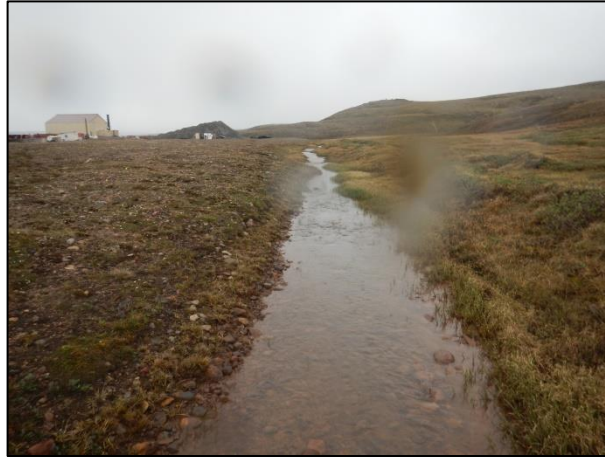
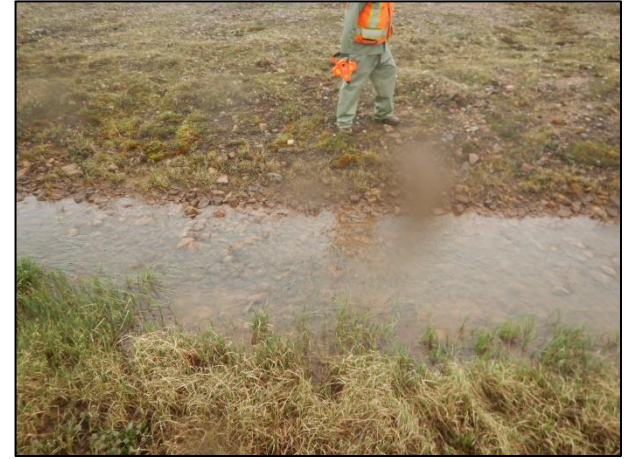
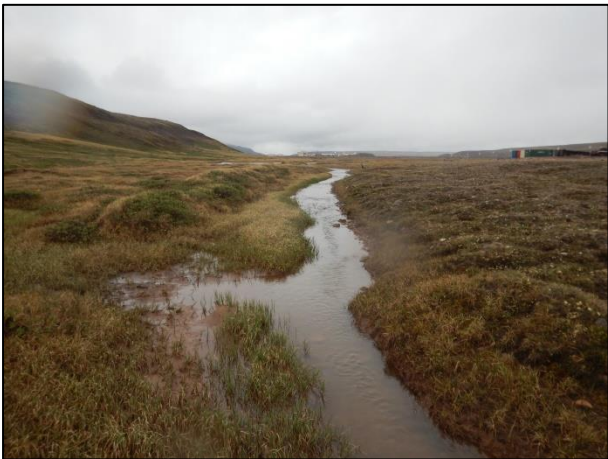
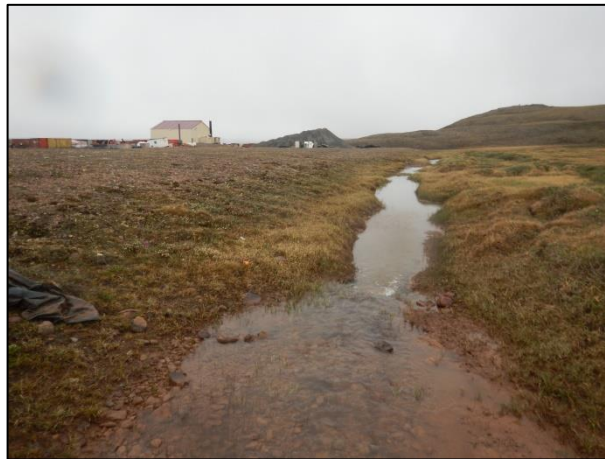
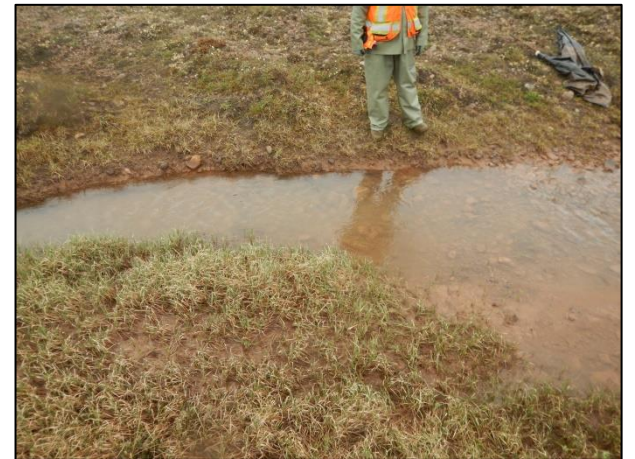
Photos 3. Photos taken 80 m downstream (top) and 100 m downstream (bottom) in spring: (A,D) facing upstream; (B,E) facing downstream; and (C,F) across (left bank looking at right bank).

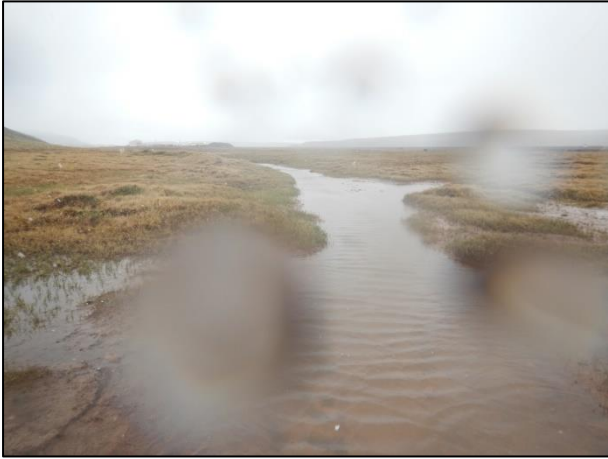
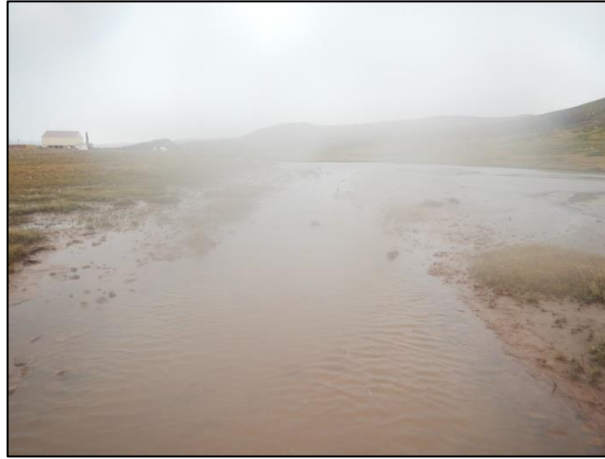
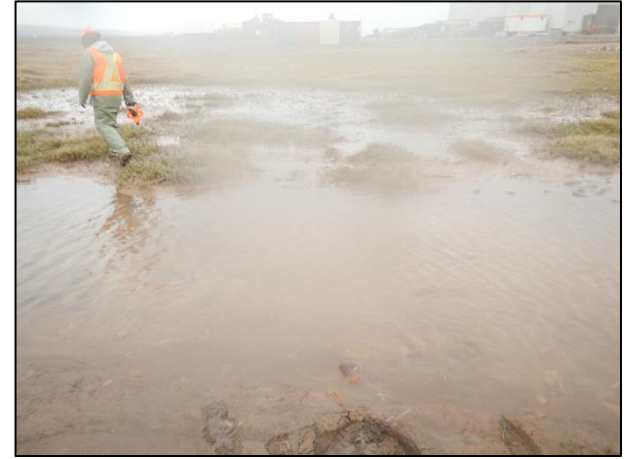
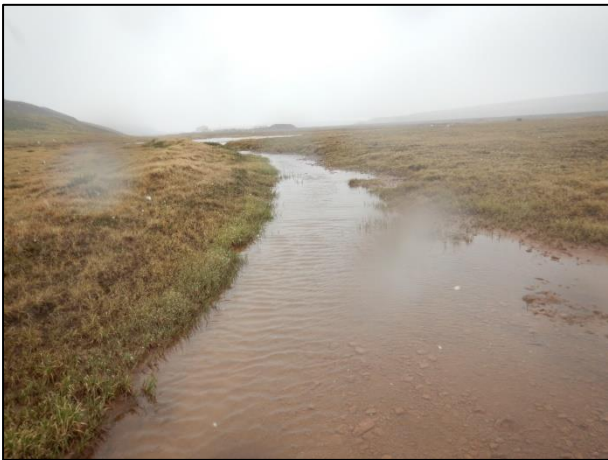
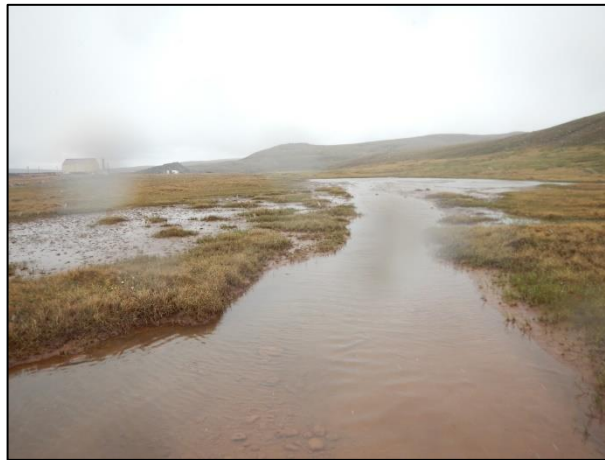
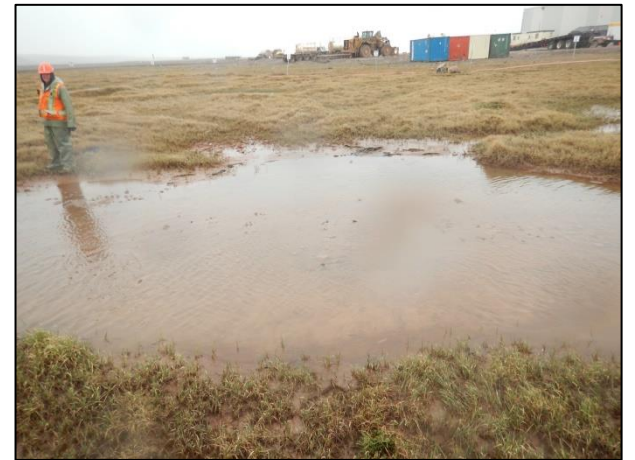
Photos 4. Photos taken 20 m upstream (top) and 40 m upstream (bottom) in spring: (A,D) facing upstream; (B,E) facing downstream; and (C,F) across (left bank looking at right bank).

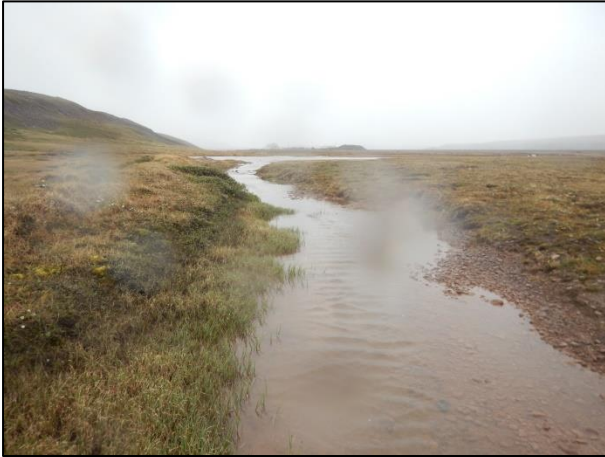
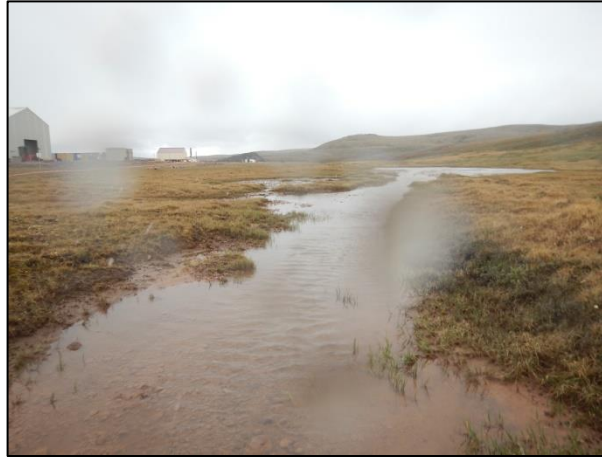
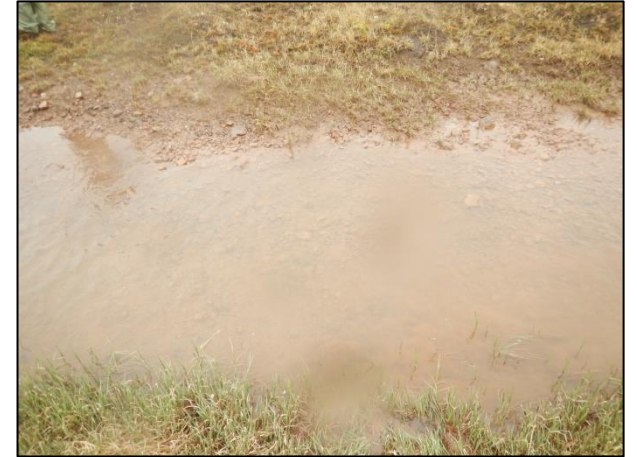
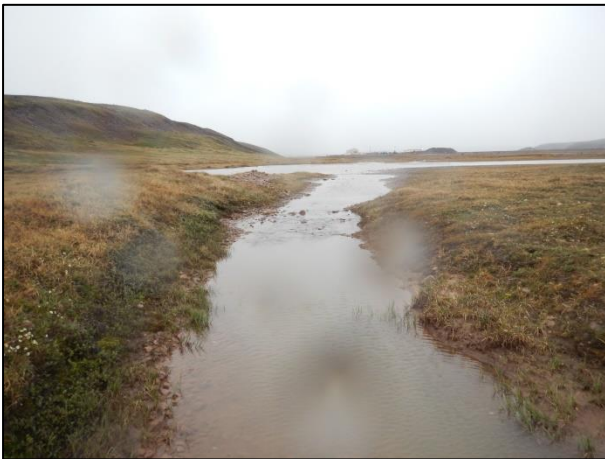
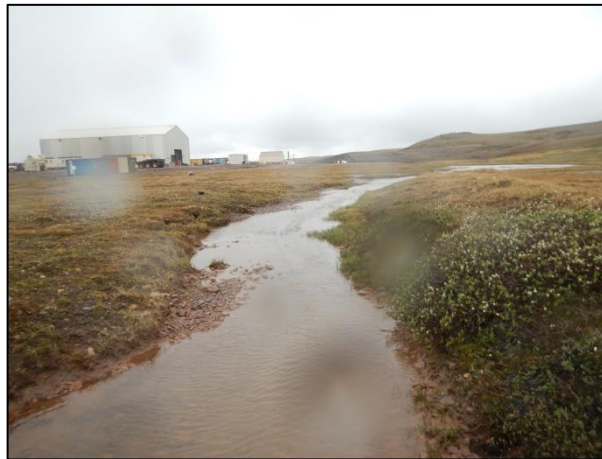
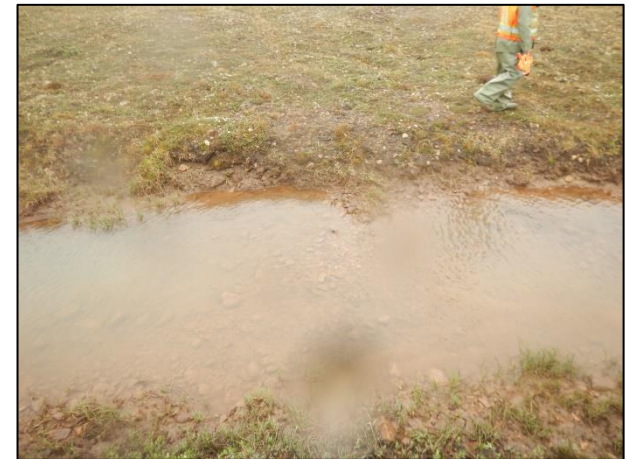
Photos 5. Photos taken 60 m upstream (top) and 80 m upstream (bottom) in spring: (A,D) facing upstream; (B,E) facing downstream; and (C,F) across (left bank looking at right bank).

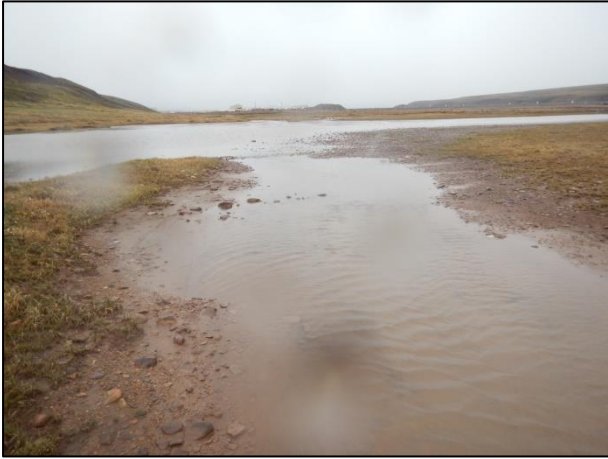
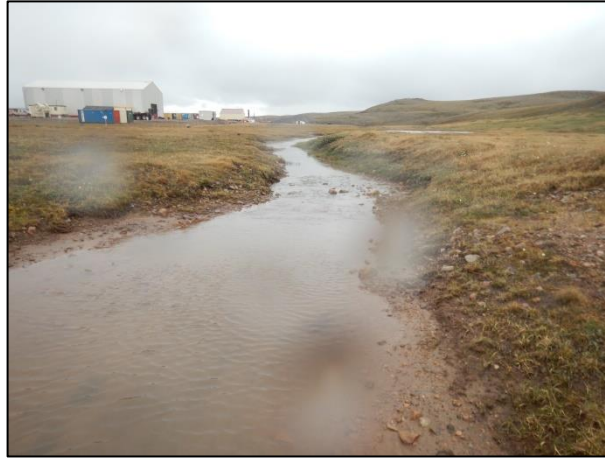
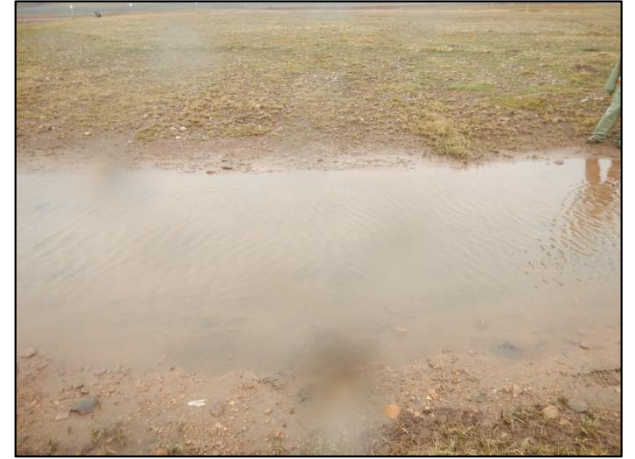
Photos 6. Photos taken 100 m upstream (top) in spring: (A) facing upstream; (B) facing downstream; and (C) across (left bank looking at right bank).
