RAIL CV-106-1A

LOCATION AND CROSSING DESCRIPTION

**BAFFINLAND IRON MINES
MARY RIVER PROJECT**

North/South Consultants Inc.
Aquatic Environment Specialists

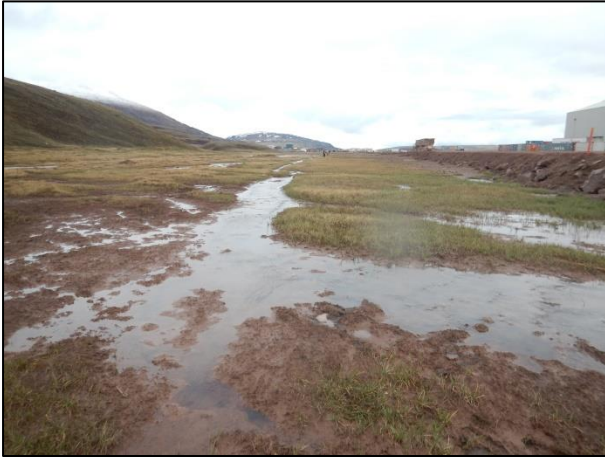
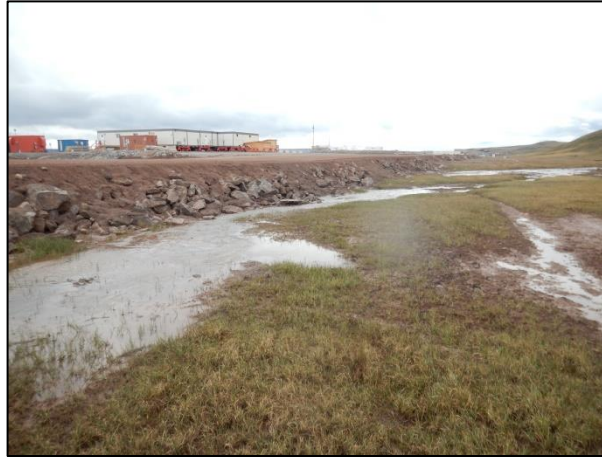
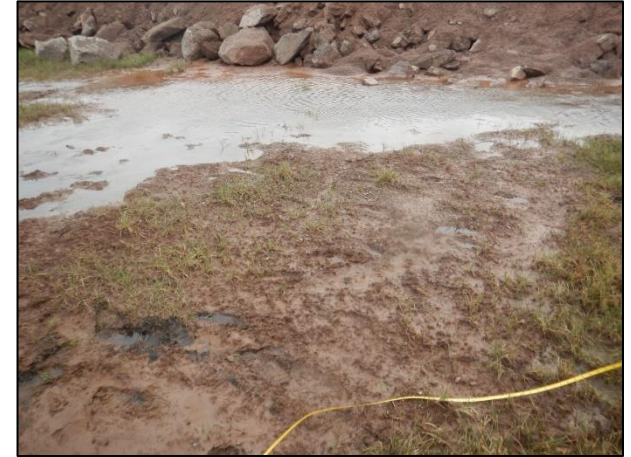
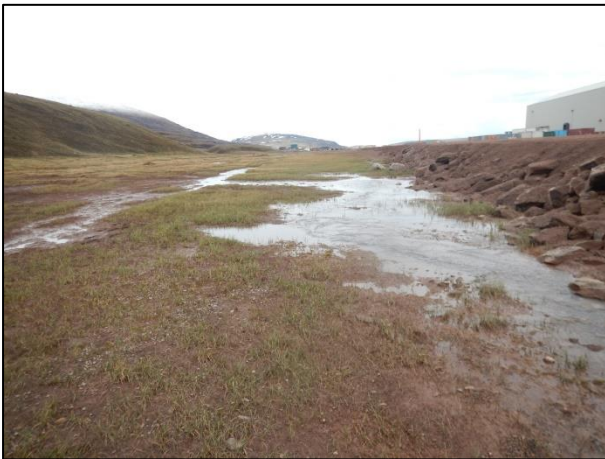
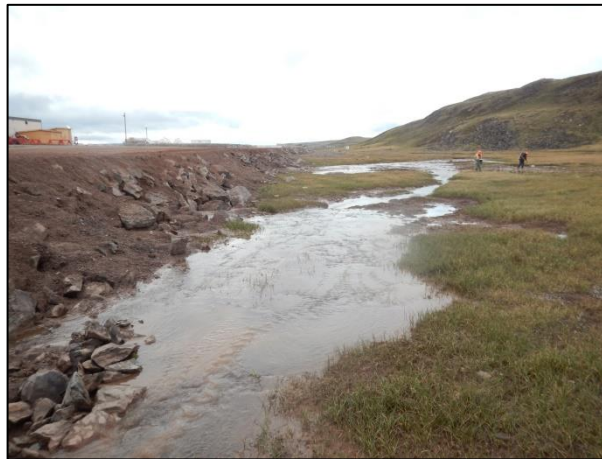
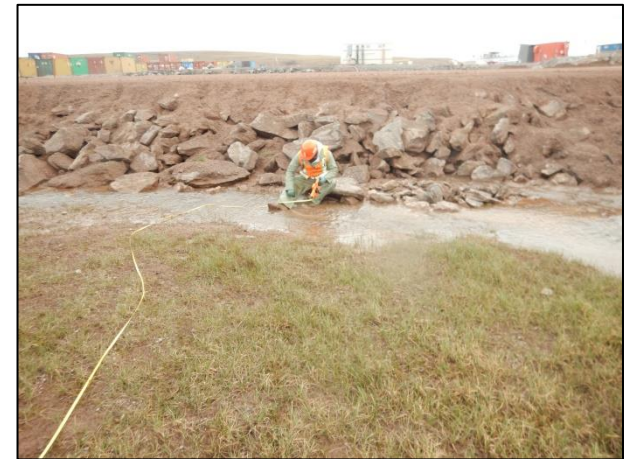
Photos 1. Photos taken at the crossing centreline (top) and 20 m downstream (bottom) in spring: (A,D) facing upstream; (B,E) facing downstream; and (C,F) across (left bank looking at right bank).

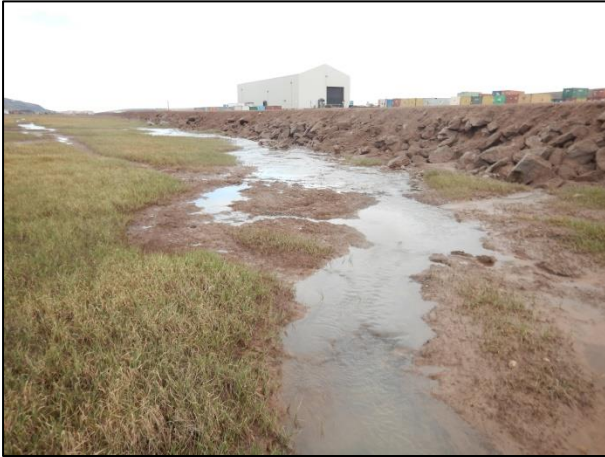
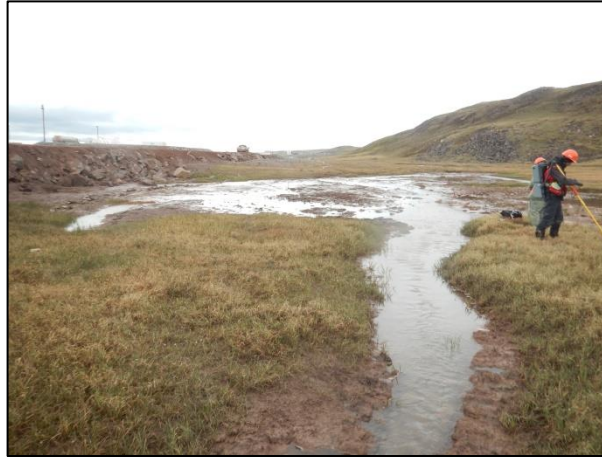
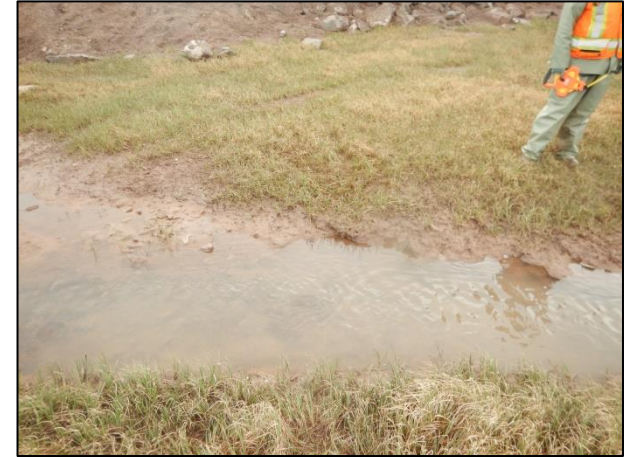
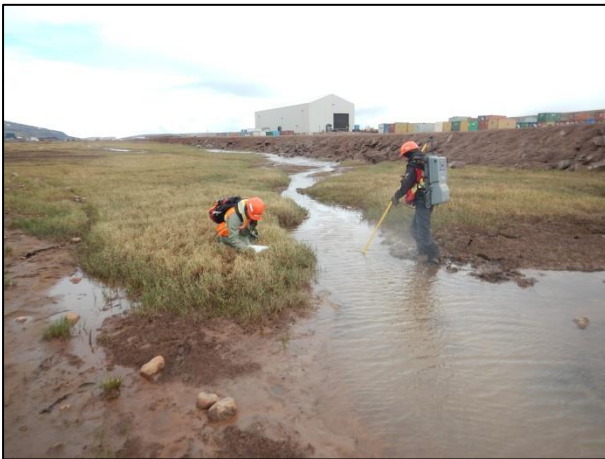
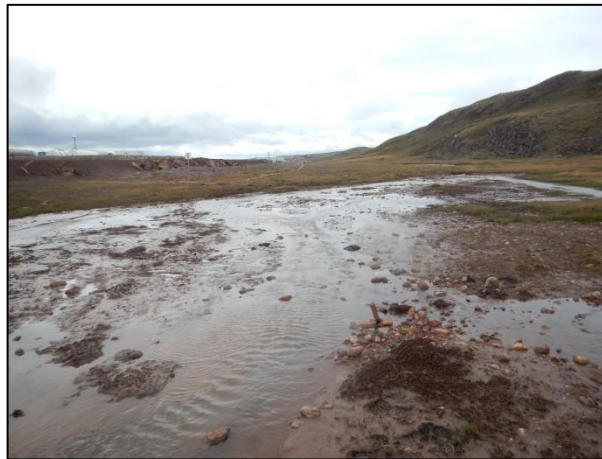
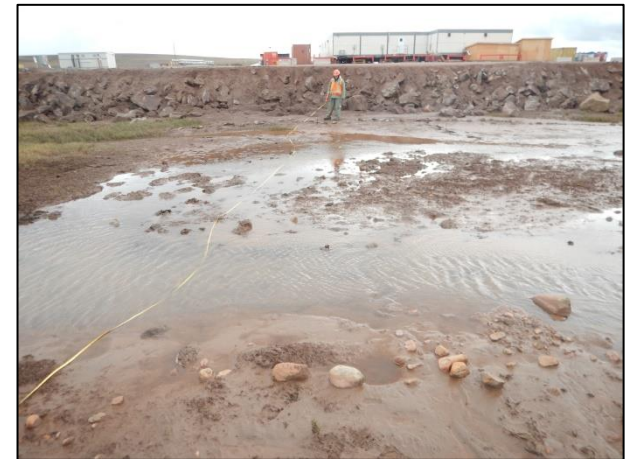
Photos 2. Photos taken 40 m downstream (top) and 60 m downstream (bottom) in spring: (A,D) facing upstream; (B,E) facing downstream; and (C,F) across (left bank looking at right bank).

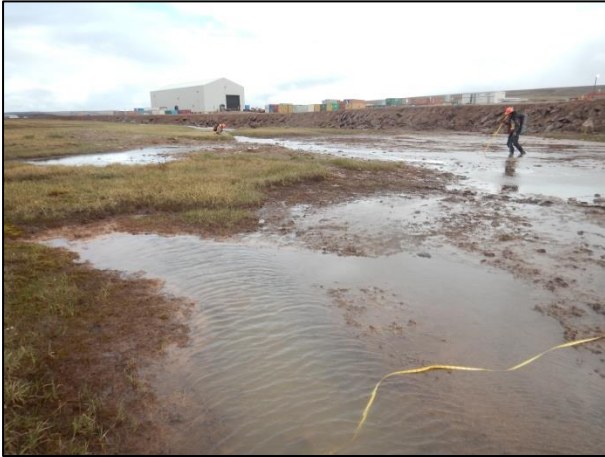
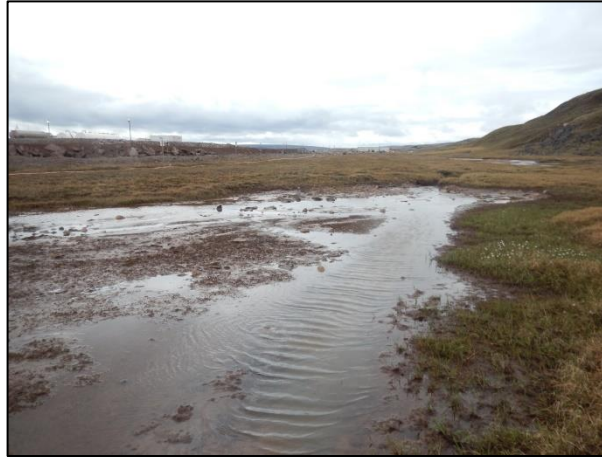
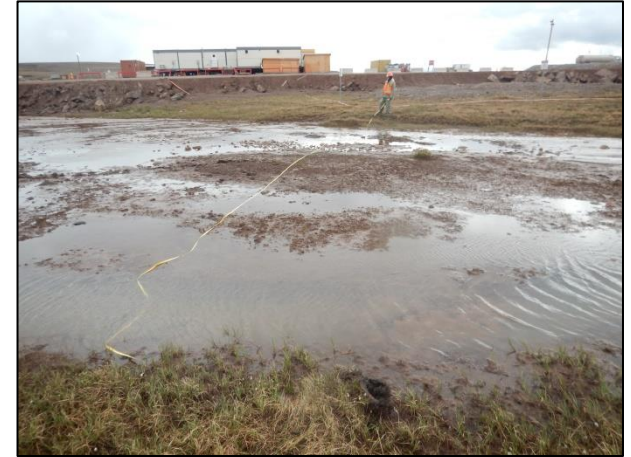
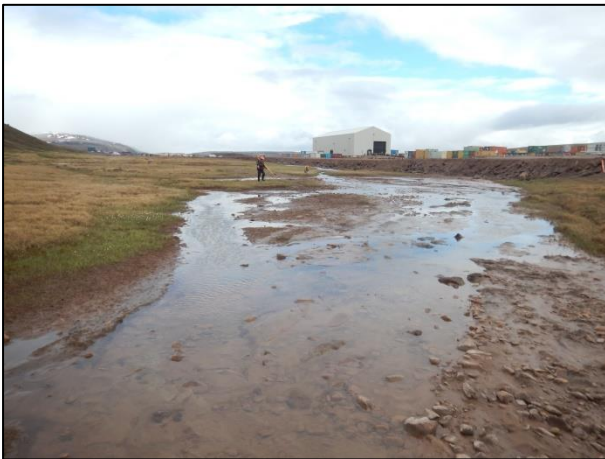
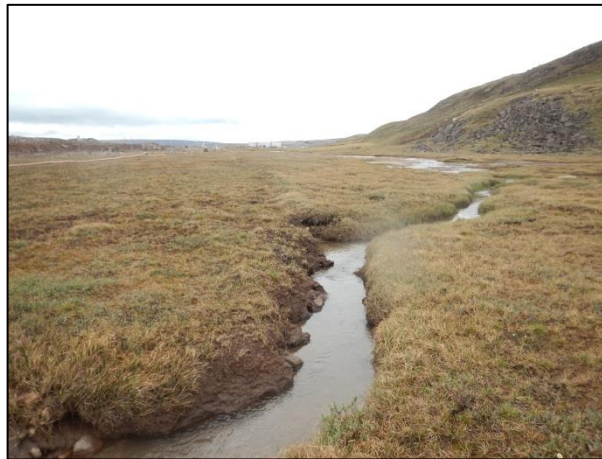
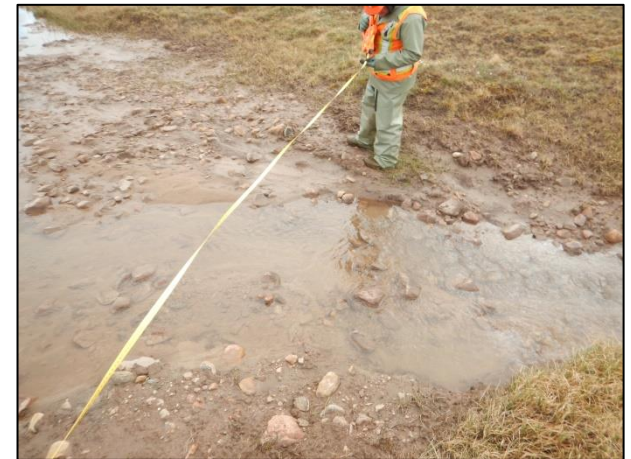
Photos 3. Photos taken 80 m downstream (top) and 100 m downstream (bottom) in spring: (A,D) facing upstream; (B,E) facing downstream; and (C,F) across (left bank looking at right bank).

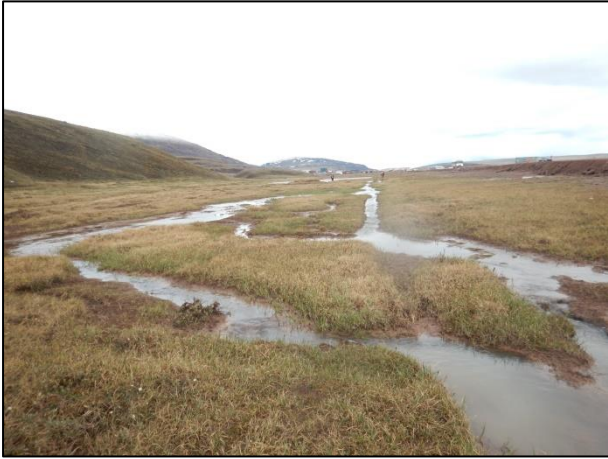
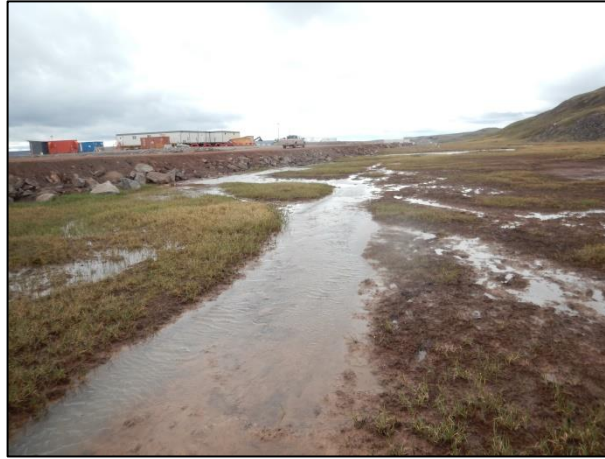
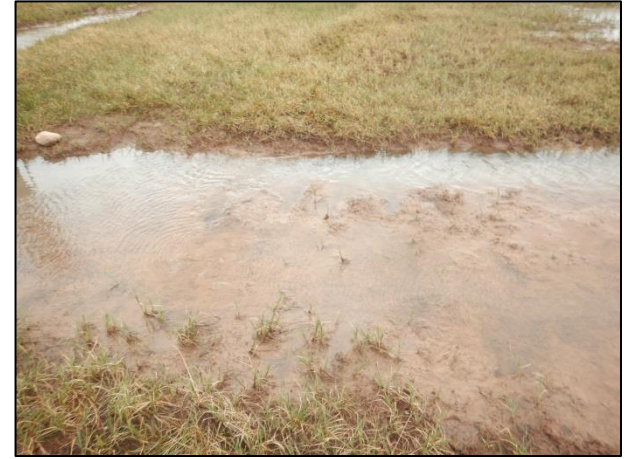
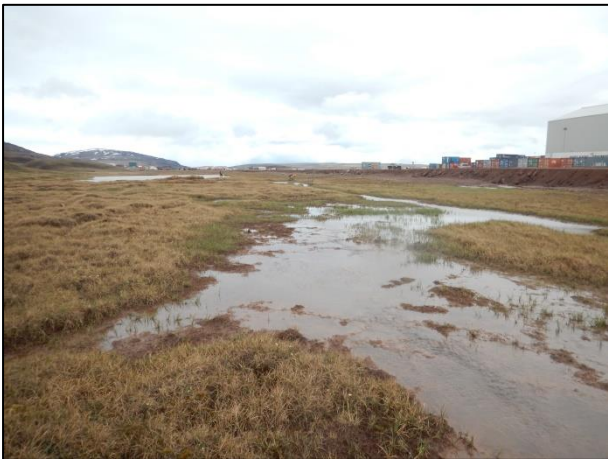
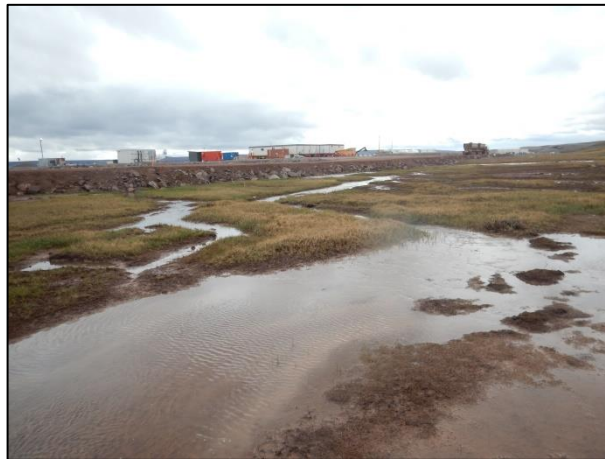
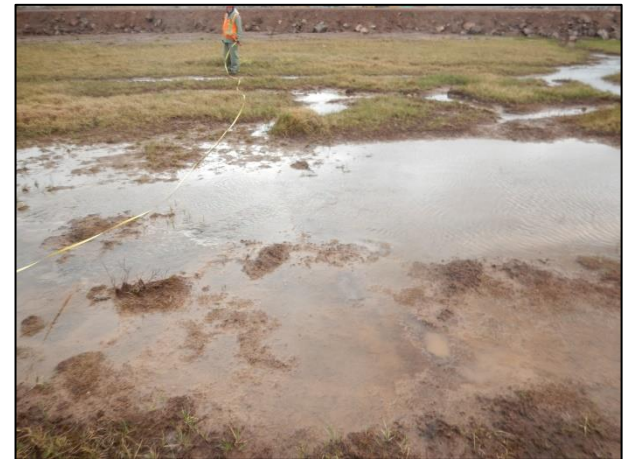
Photos 4. Photos taken 20 m upstream (top) and 40 m upstream (bottom) in spring: (A,D) facing upstream; (B,E) facing downstream; and (C,F) across (left bank looking at right bank).

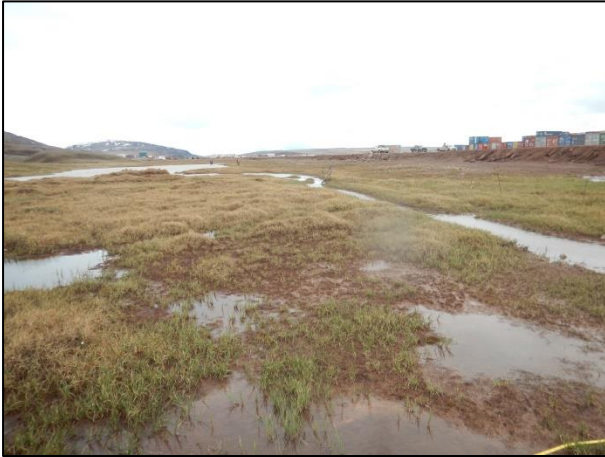
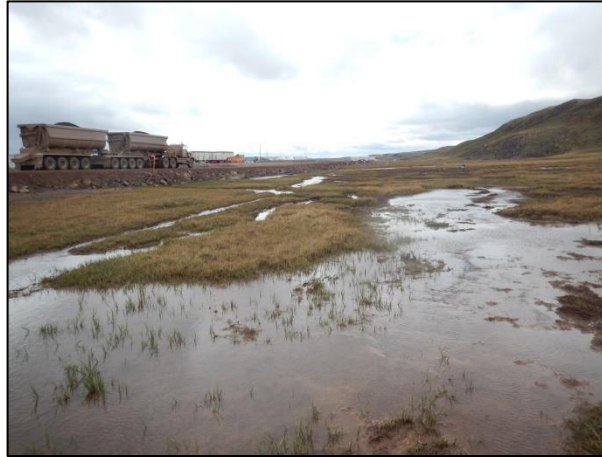
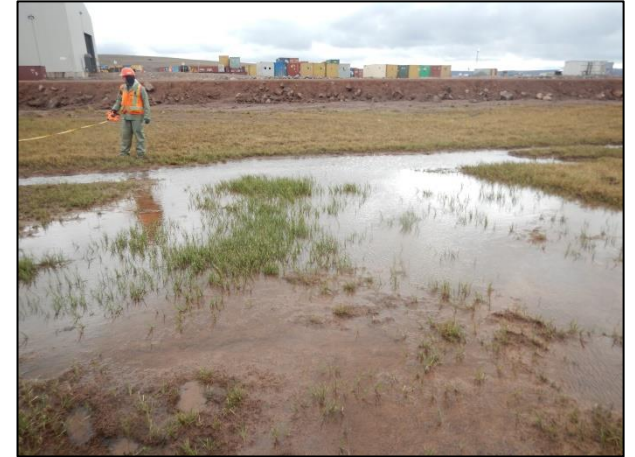
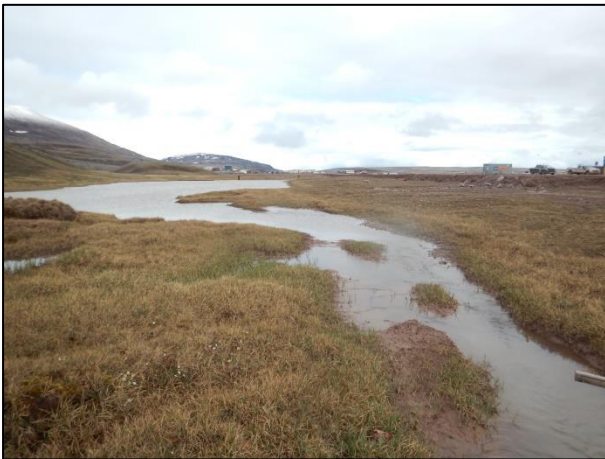
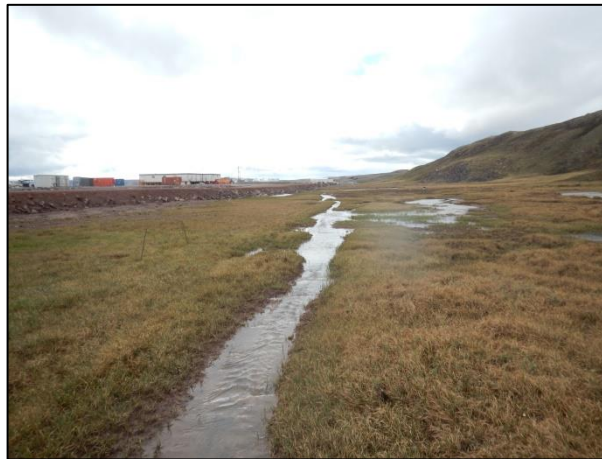
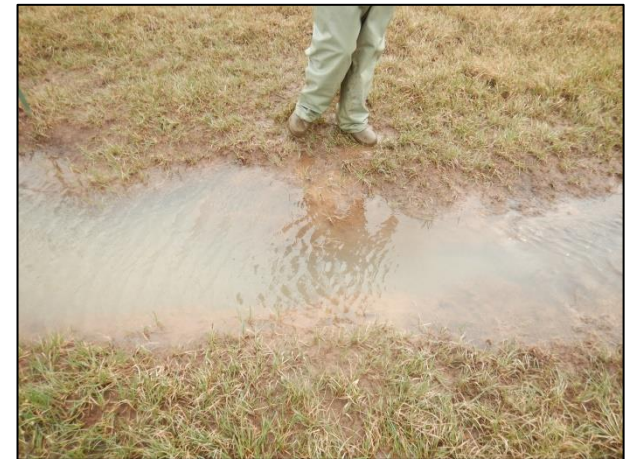
Photos 5. Photos taken 60 m upstream (top) and 80 m upstream (bottom) in spring: (A,D) facing upstream; (B,E) facing downstream; and (C,F) across (left bank looking at right bank).

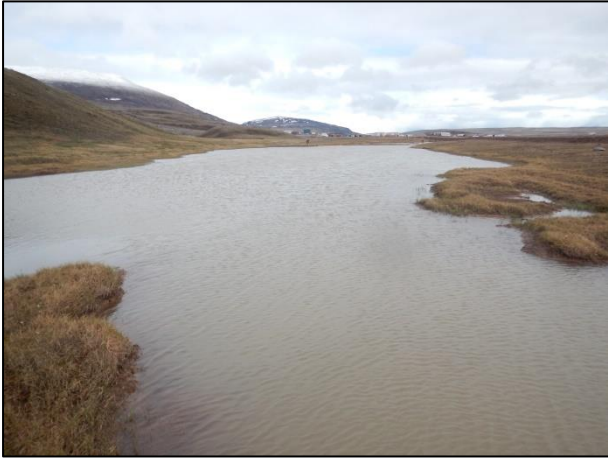
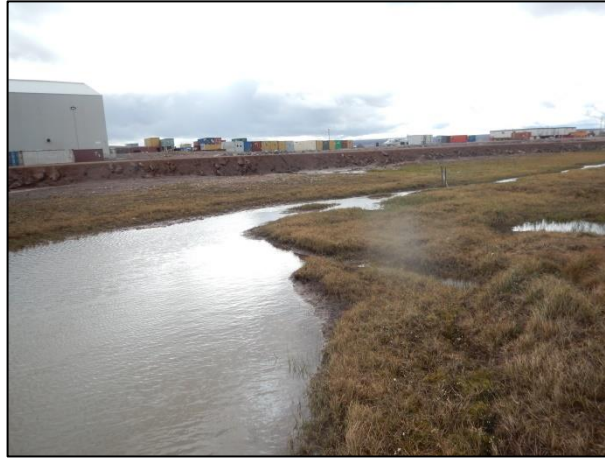
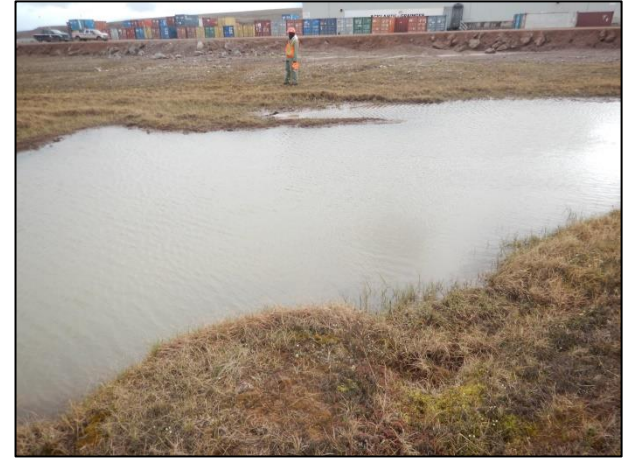
Photos 6. Photos taken 100 m upstream (top) in spring: (A) facing upstream; (B) facing downstream; and (C) across (left bank looking at right bank).

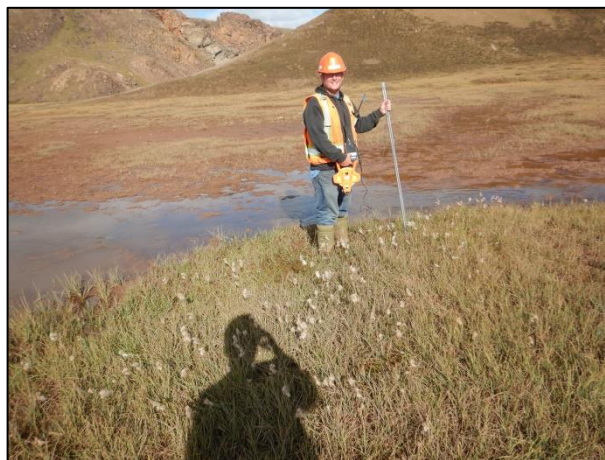
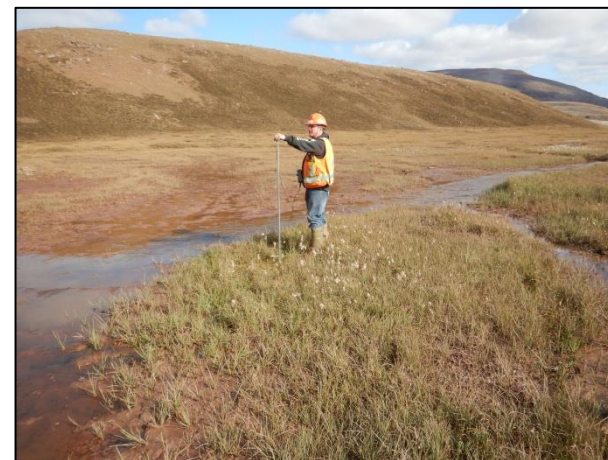
Photos 7. Photos taken at the crossing centerline in summer/fall: (A) facing upstream; (B) facing downstream; (C) across (left bank looking at right bank); (D) diagonal from right bank above the centreline looking downstream; (E) across (right bank looking at left bank); and (F) diagonal from right bank below the centreline looking upstream.
